BILL OF SALE AND PURCHASE AGREEMENT FOR MOTOR
VEHICLES

IDENTIFIED DEFECTS/ REPAIRS IN INSPECTION REPORT

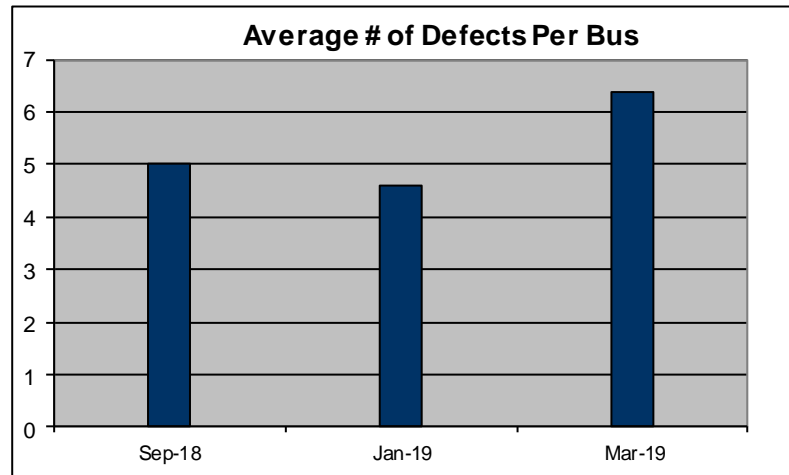
The total number of defects found during this audit was 102, or an average of 6.38 defects per bus. As can be seen in the chart which follows, this inspection showed an increase in the average number of defects per bus when compared to the initial audit conducted in September 2018 and the January 2019 audit.

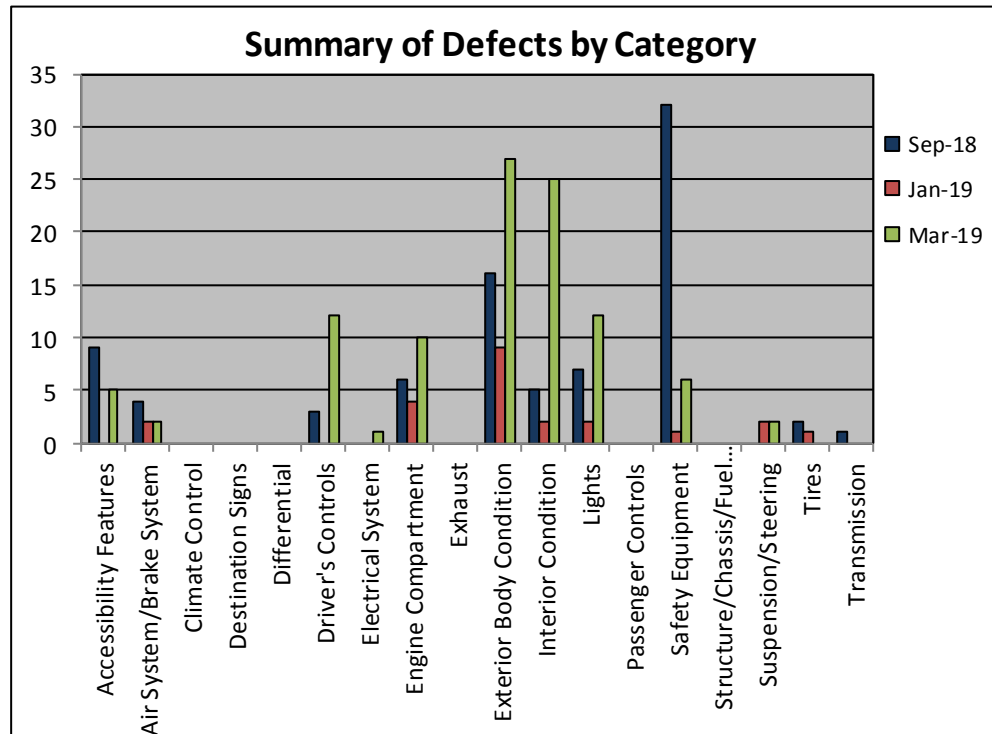
Defects were found in the Accessibility Features, Air System/Brake System, Driver's Controls, Electrical Systems, Engine Compartment, Exterior Body Condition, Interior Condition, Lights, Safety Equipment, and Suspension/Steering categories. The Exterior Body Condition category showed the most defects during this current audit with a total of twenty-seven (27) defects, followed by the Interior Condition category with a total of twenty-five (25) defects. A breakdown of defects by category can be found in Table 2 and the chart below.

Table 2			
Summary of Defects By Category	9/15/18	1/20/19	3/23/19
Accessibility Features	9	0	5
Air System/Brake System	4	2	3
Climate Control	0	0	0
Destination Signs	0	0	0
Differential	0	0	0
Driver's Controls	3	0	12
Electrical System	0	0	1
Engine Compartment	6	4	10
Exhaust	0	0	0
Exterior Body Condition	16	9	27
Interior Condition	5	2	25
Lights	7	2	12
Passenger Controls	0	0	0
Safety Equipment	32	1	6
Structure/Chassis/Fuel Tank	0	0	0
Suspension/Steering	0	2	1
Tires	2	1	0
Transmission	1	0	0
Total Defects:	85	23	102
Avg. Defects Per Bus:	5.00	4.60	6.38

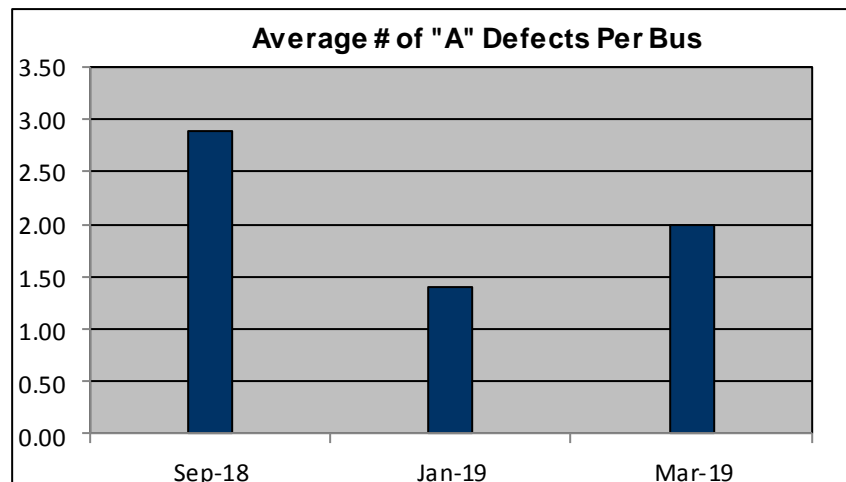
A Class "A" defect is a safety-related defect that requires immediate repair and keeps the bus from returning to revenue service until the defect is corrected. Class "A" defects were found on twelve (12) of the 16 buses inspected. The 32 Class "A" defects had to be repaired before these twelve buses could be allowed to return to revenue service. As can be seen in the chart below, this current inspection showed an increase in the average number of Class "A" defects per bus when compared to the January 2019 audit but showed a decrease when compared to the initial audit conducted in September 2018.
