# BRIDGE INSPECTION REPORT

INSPECTION TYPE: Annual

Milepost 407.48  
 Location Santa Paula Branch Line  
Saticoy, CA  
 Stream X Overpass        Other         
 Train Operating Speed: Freight: 10 mph Passenger: 15 mph

MAINLINE/SUBDIVISION: VCTC

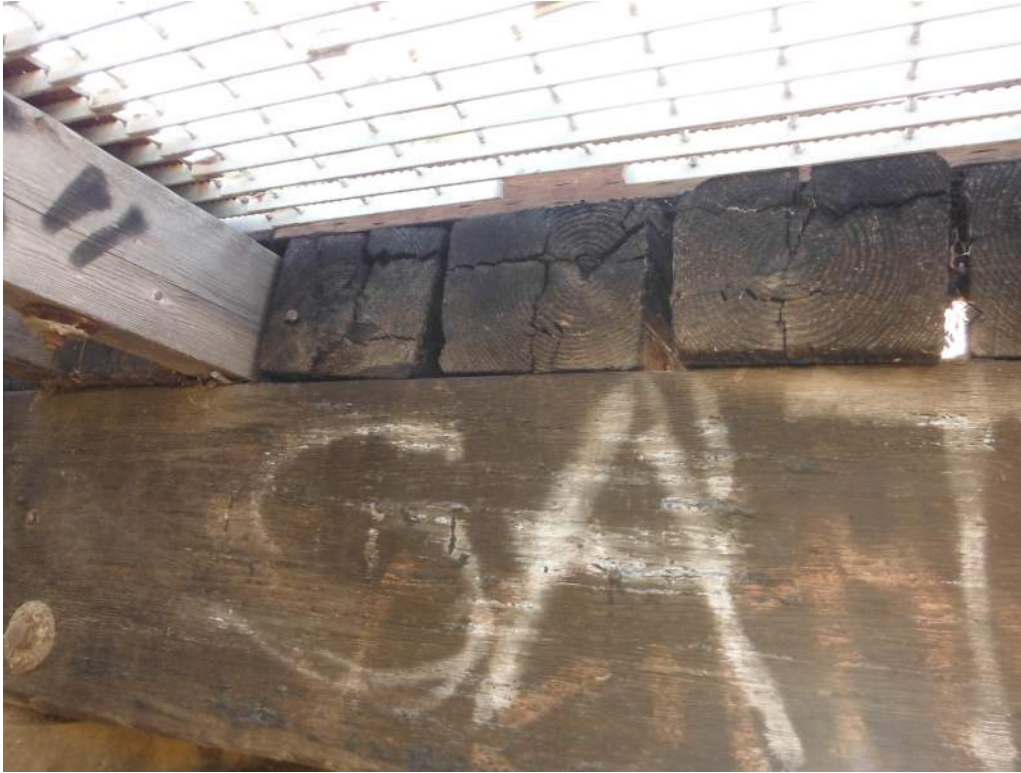
**407.48 Typical Tie Condition - Split**

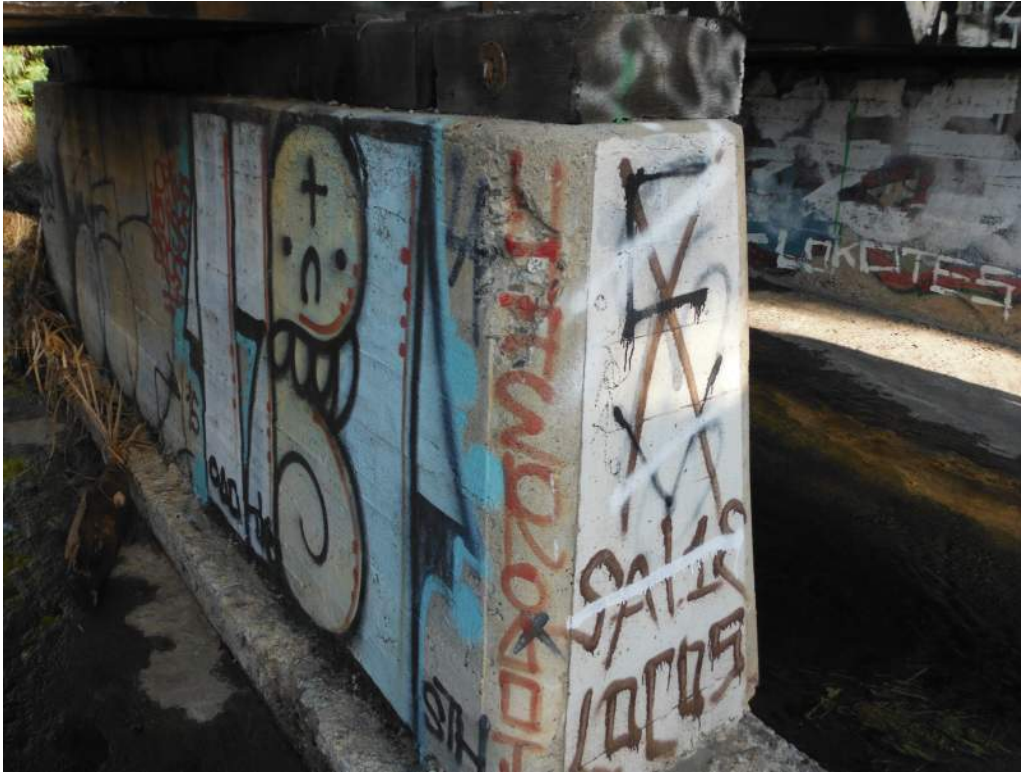
407.48 Spall on south side of Pier 2

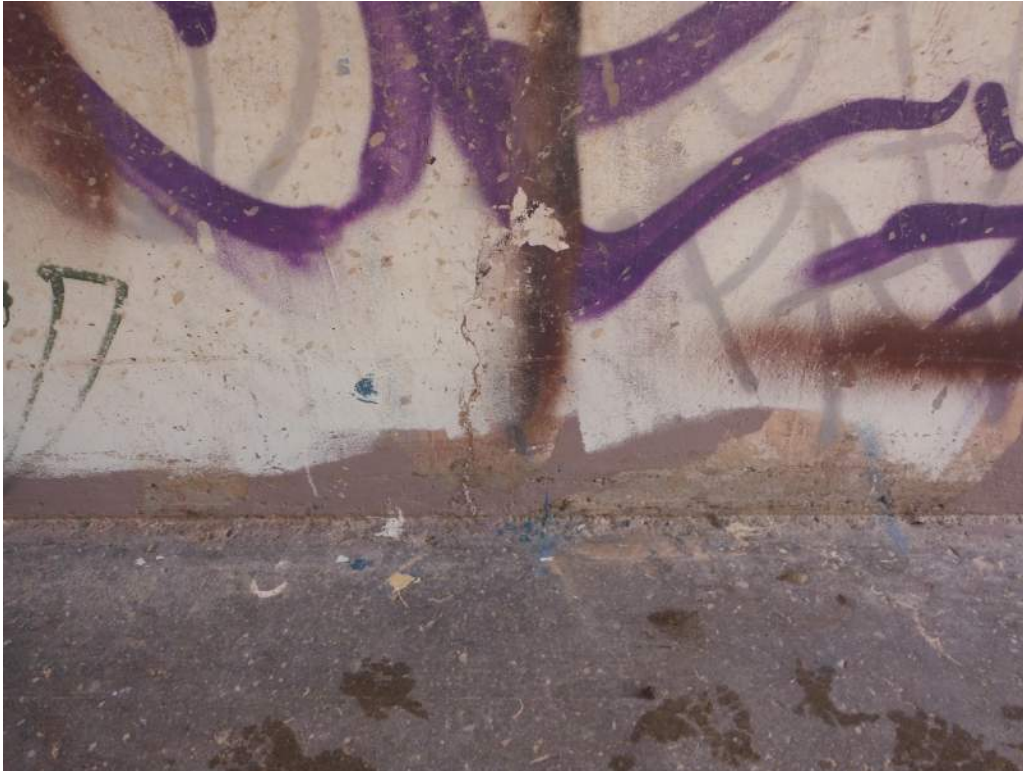
**408.02 Vertical crack center of Abutment (typ.)**

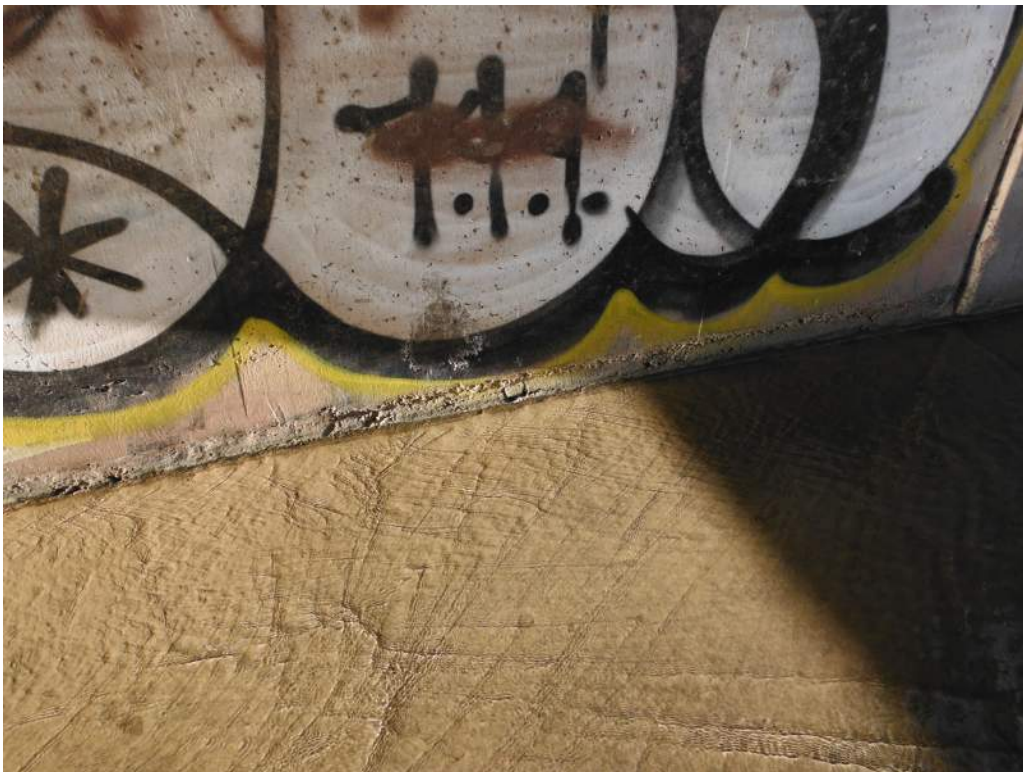
**408.02 Scaling at base of Abutment #1**

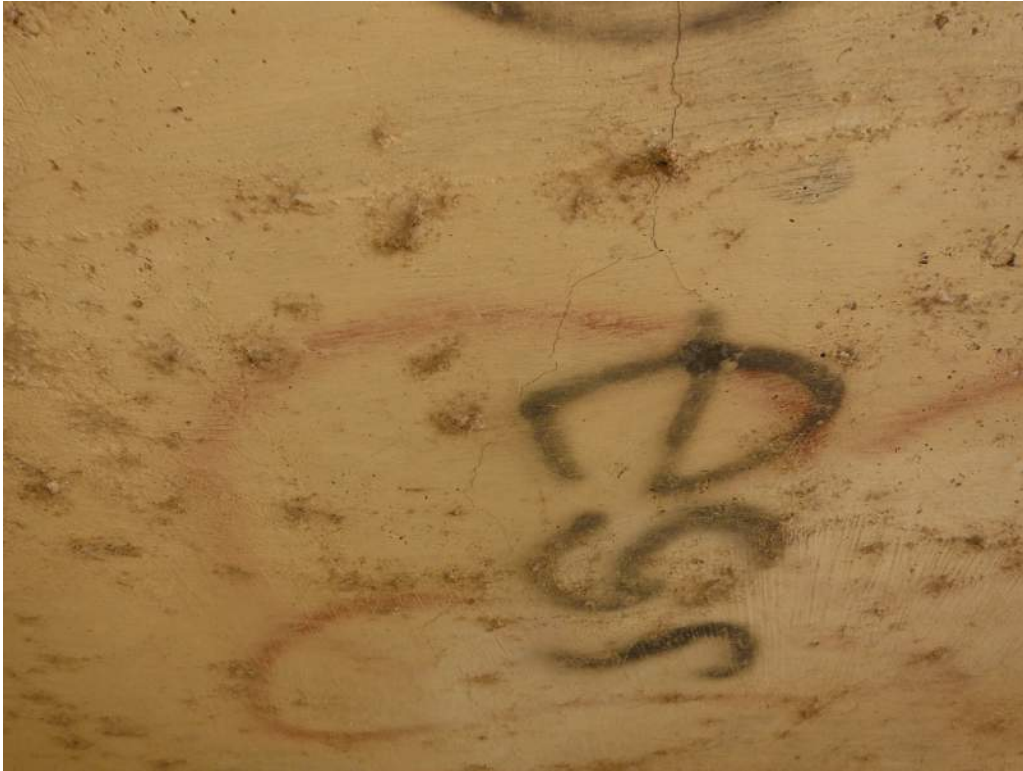
**408.02 Hairline cracking underside of top slab, south side**

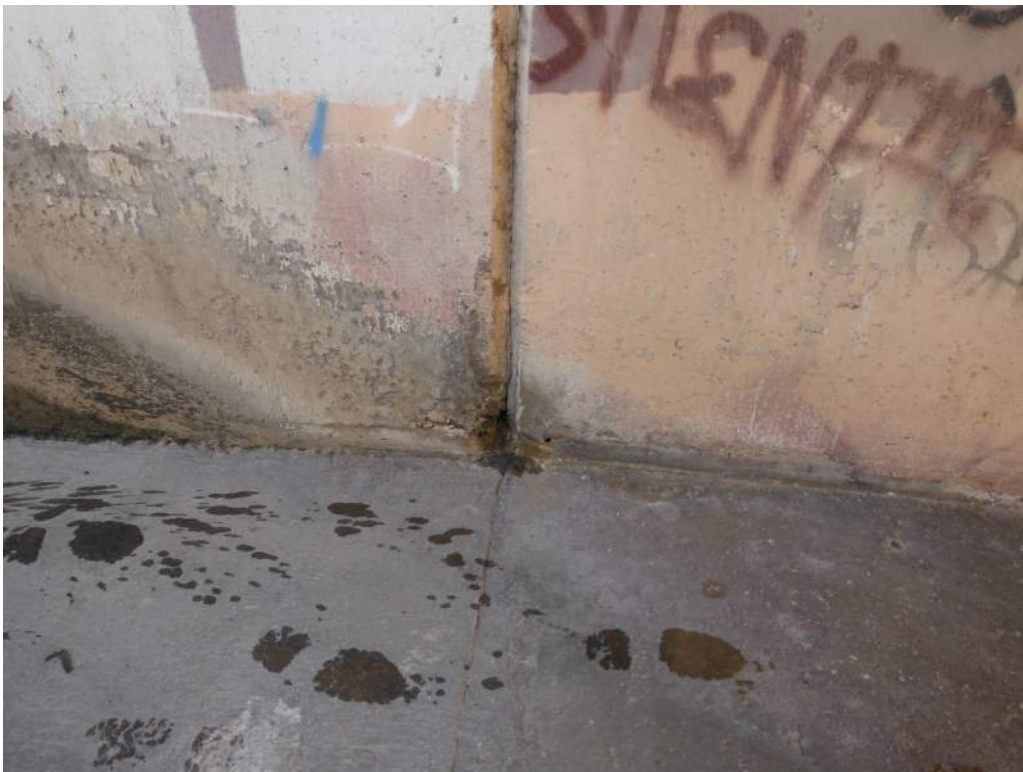
**408.02 Spall at NE wingwall**

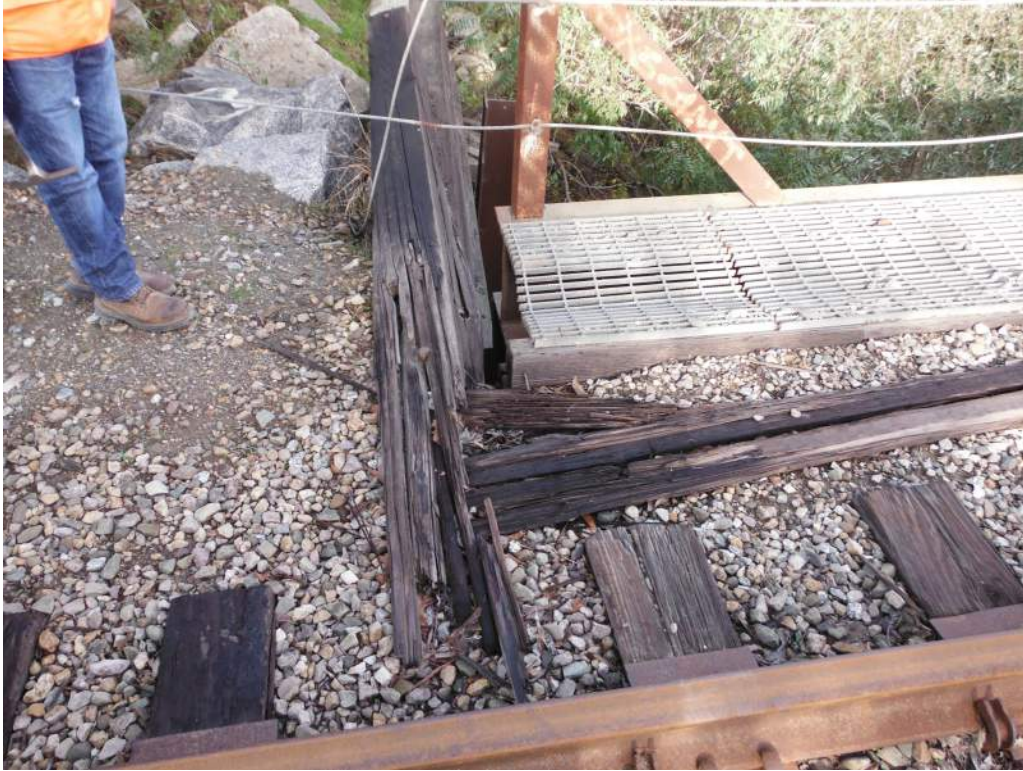
**408.84 Rotten/failing backwall at Abutment 1**

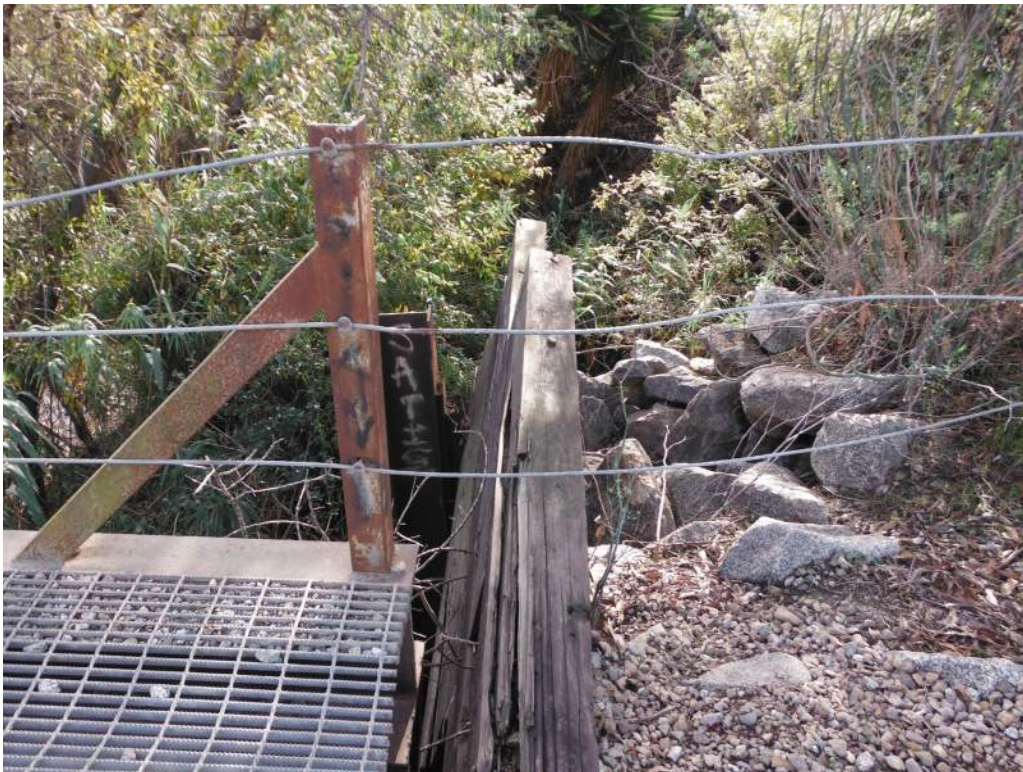
**408.84 Abutment 1 backwall leaning**

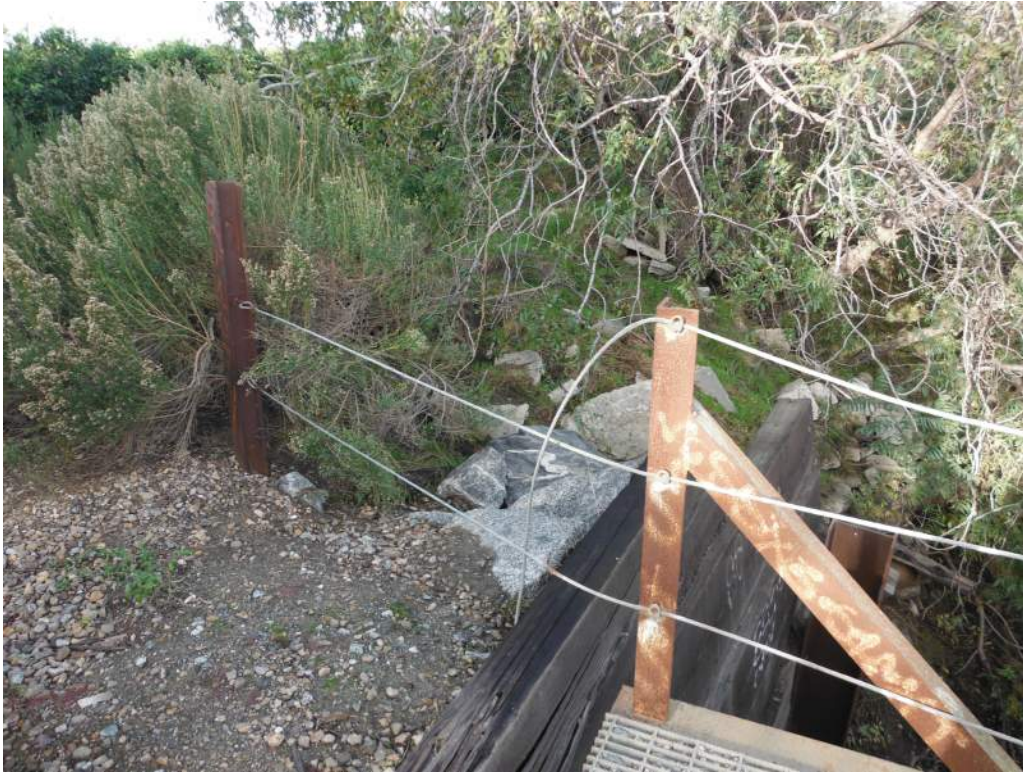
**408.84 Loose/broken handrail cable – Span 1 north side**

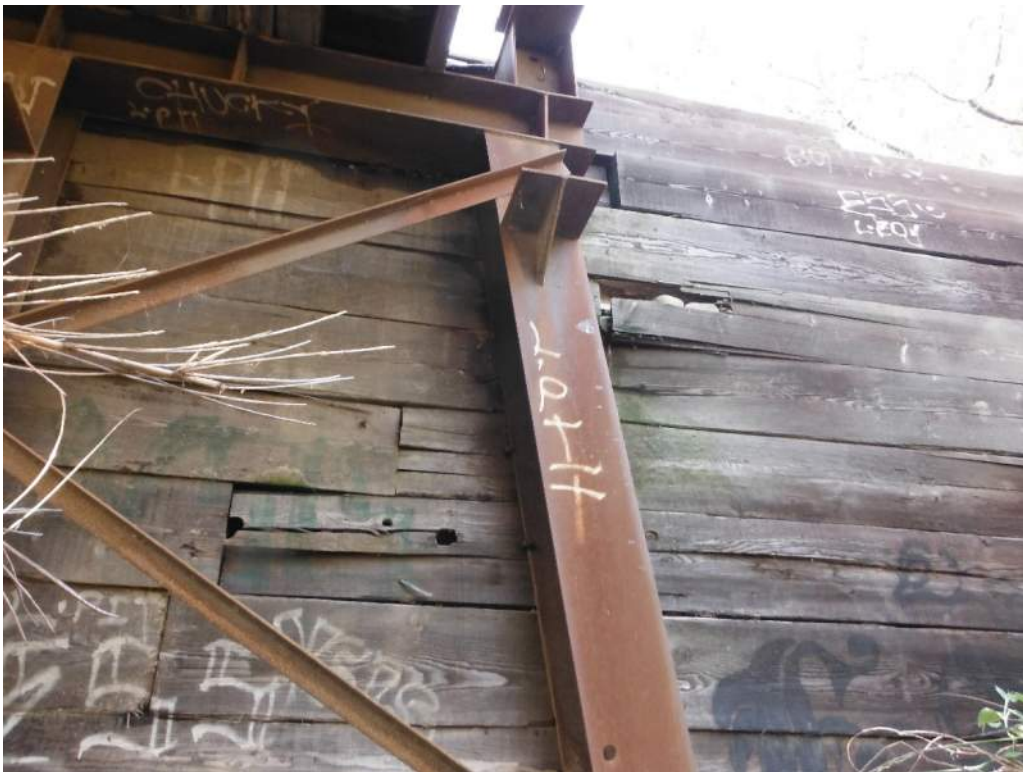
**408.84 Abutment 1 Backwall rotten**

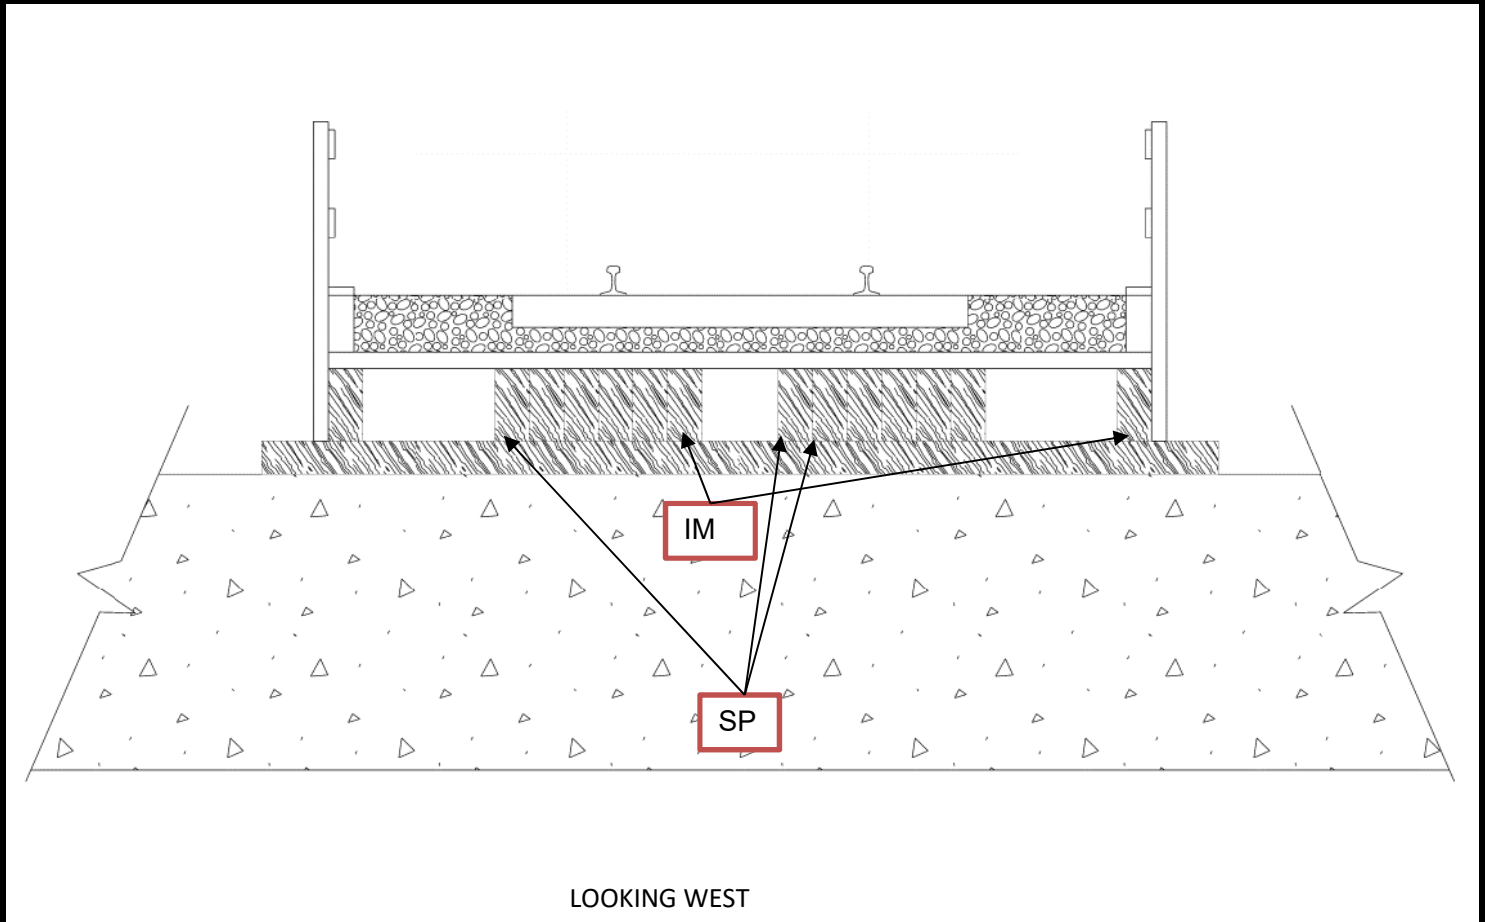
BRIDGE INSPECTION REPORT --- CONCRETE ABUTMENT				
Span: 1	Alignment: Tangent	Vert. Clear: 5'	Bridge No.	409.74
DETAILS - ABUT NUMBER: 1			Span Length:	16'

<b>Description: Looking West - (14) Stringers - 8"x17.5", Concrete Abutment</b>			
Remarks:			
1. SP- Stringers 6 , 7, and 13 split - see photo			
2. IM- Impact damage on stringer 1 and 8 - see photo			
3. Wingwall leaning on south side, erosion behind wingwall - see photo			
Inspected By:	Joseph Holste, PE	Date Inspected:	12/11/2019

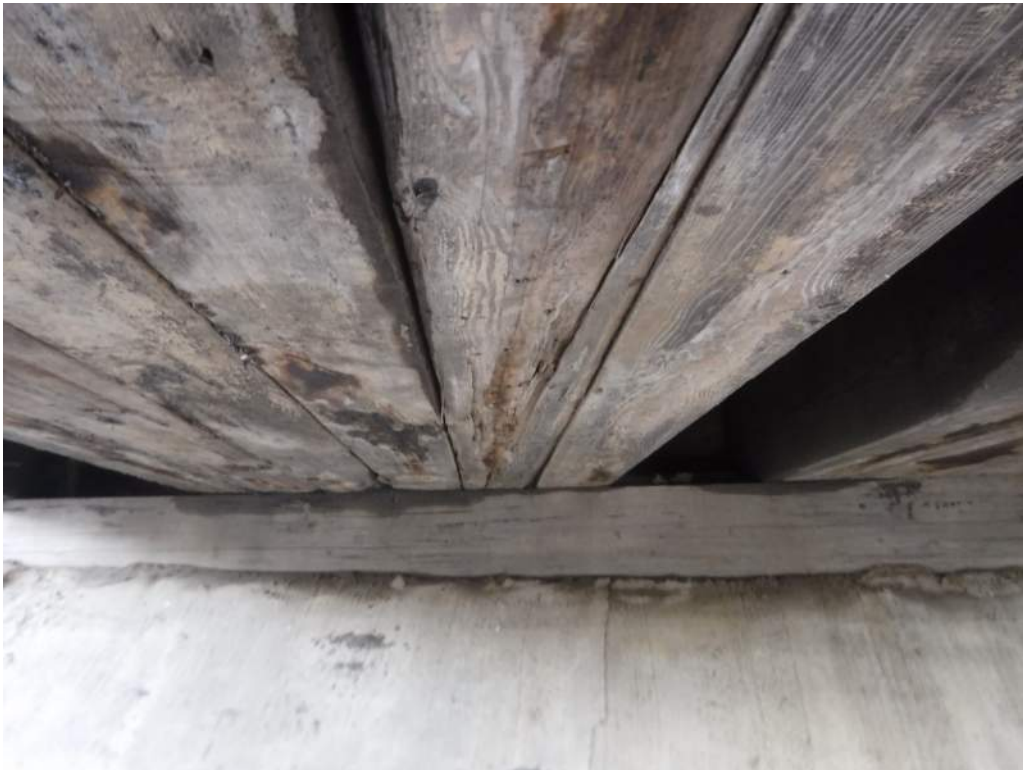
**409.74 Stringer 6 split**

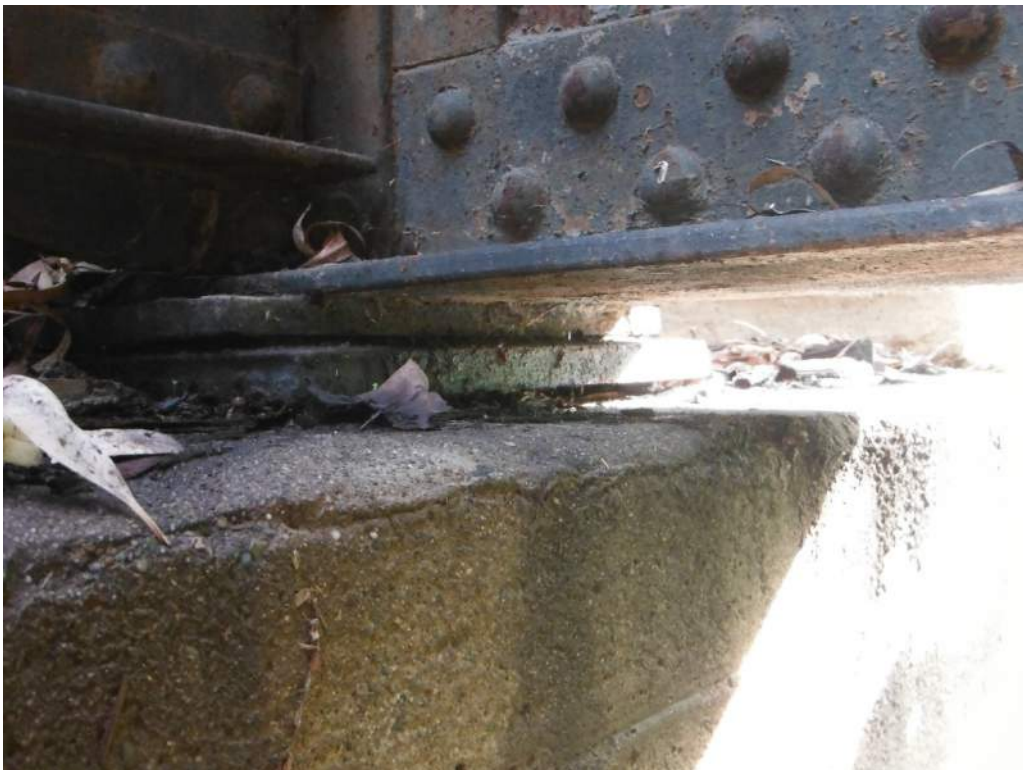
**410.40 Debris around bearings. Abutment 1 & 2**

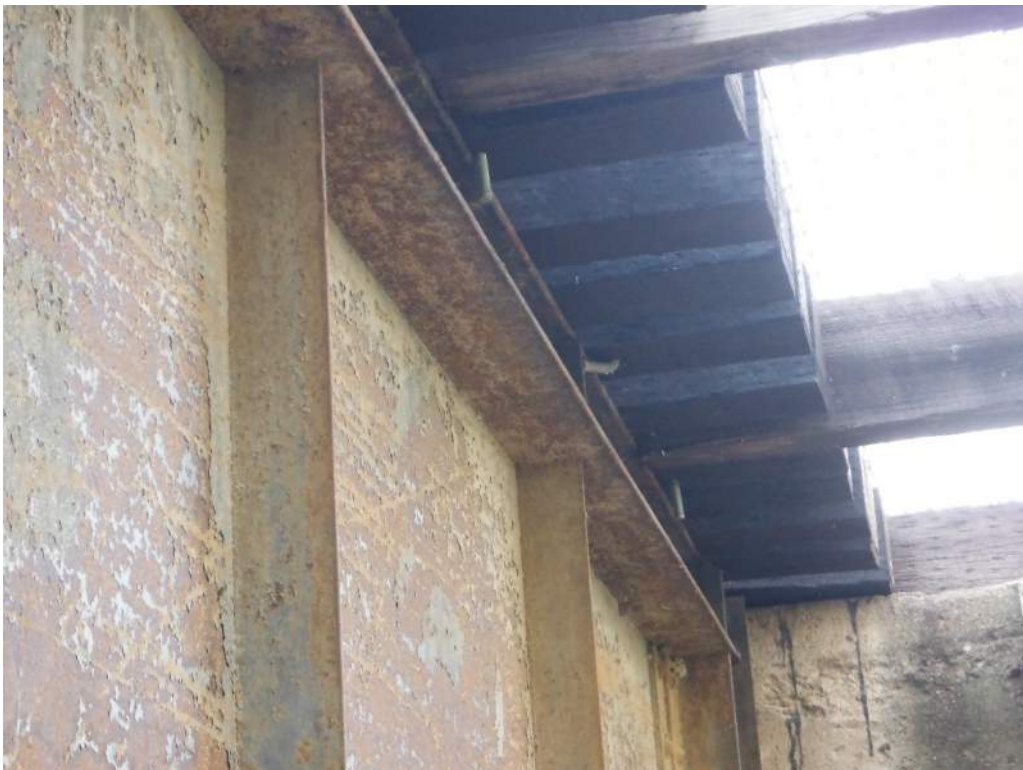
**410.40 J-bolt current conditions**

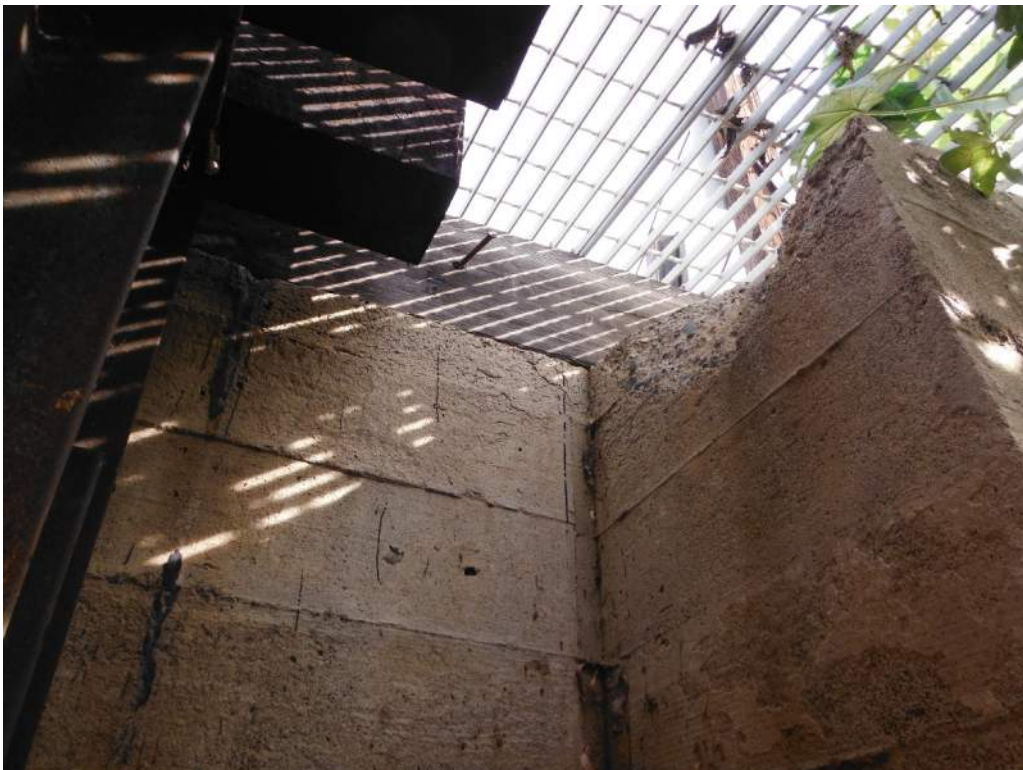
**410.40 SE Wingwall Spall – Abutment 2**

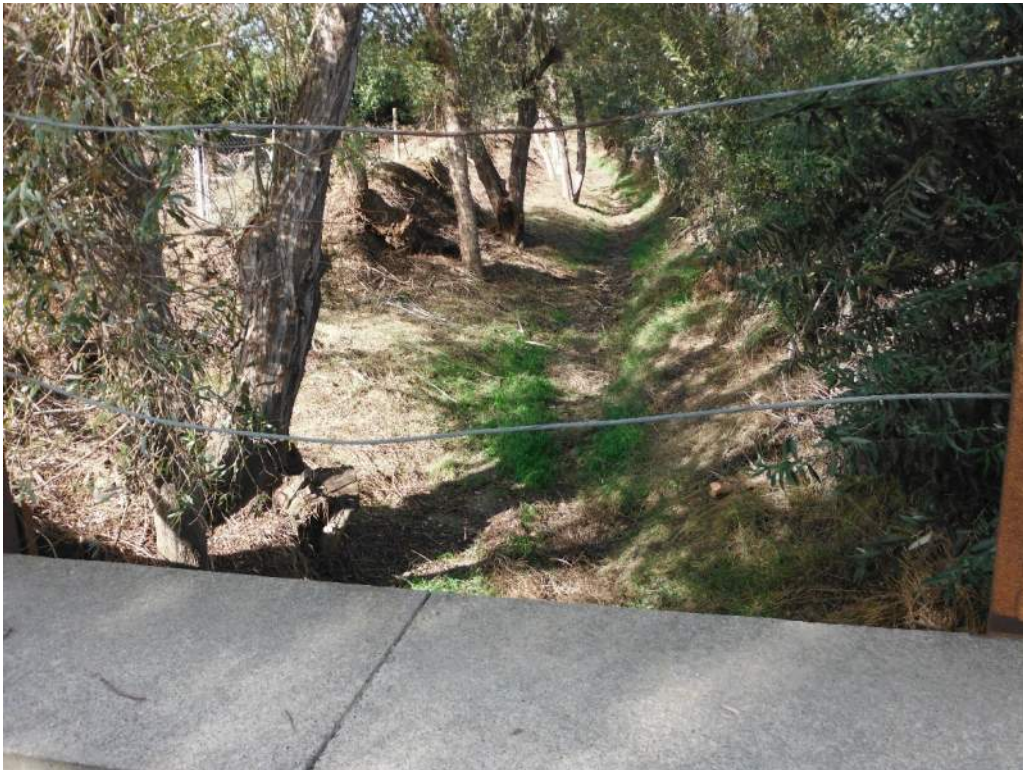
**411.97 Handrail loose (typ.)**

MAINTENANCE RECOMMENDATIONS	
Priority	Description
D01, B	Replace rail to meet tonnage use
D03, A	Repair handrail
E03, B	Raise approaches

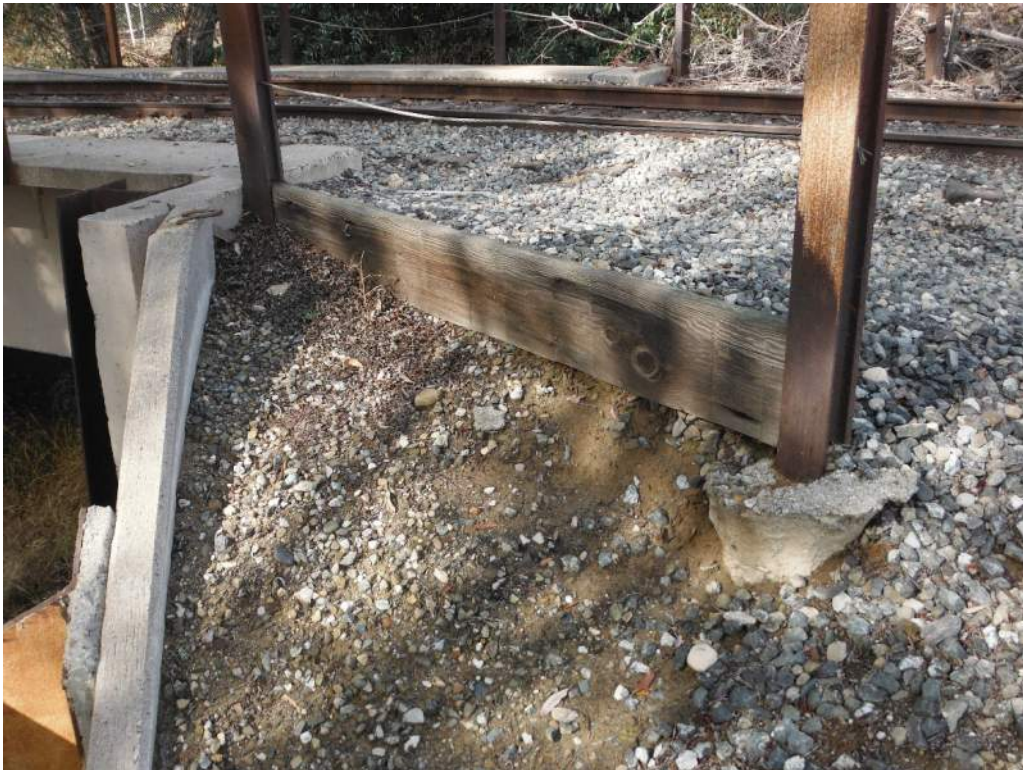
**411.97 Abutment 2 undermining SE Ballast retainer**

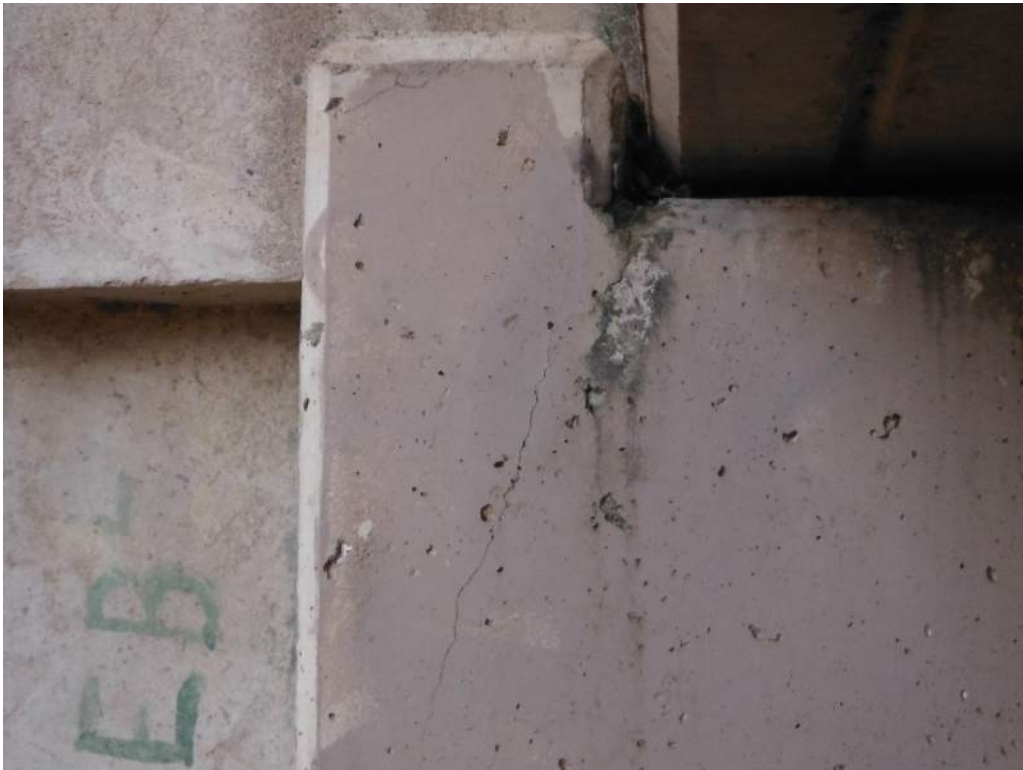
**411.97 Abutment 1 South keeper cracking**

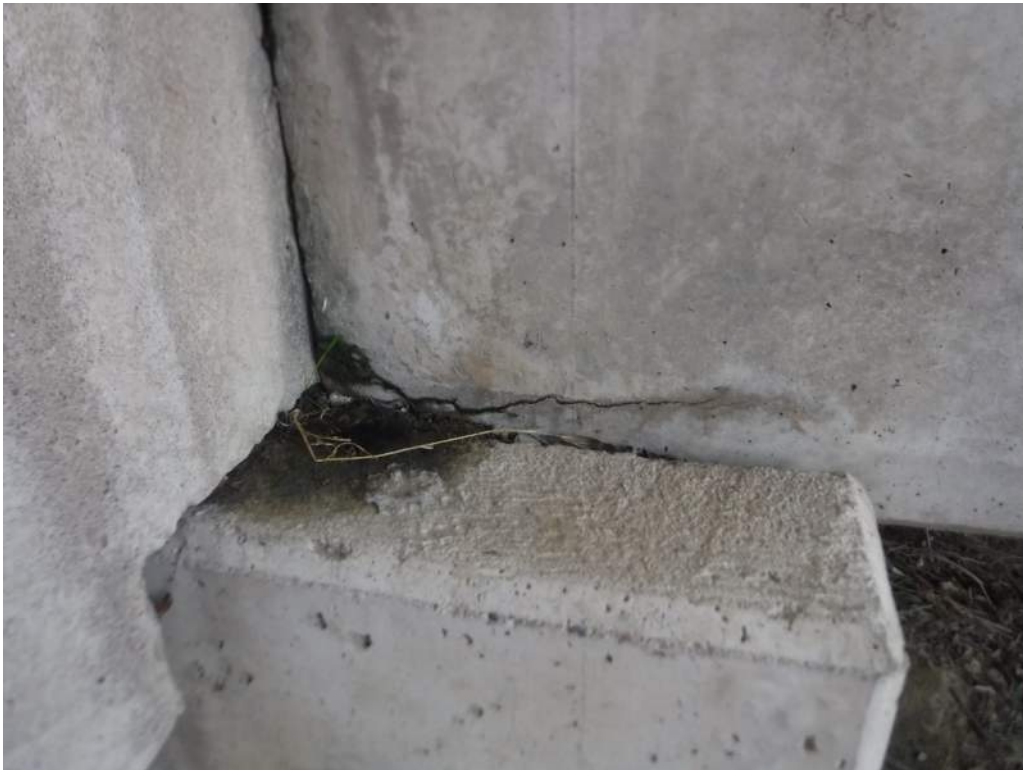
**411.97 Girder 1 cracking at Abutment 1**

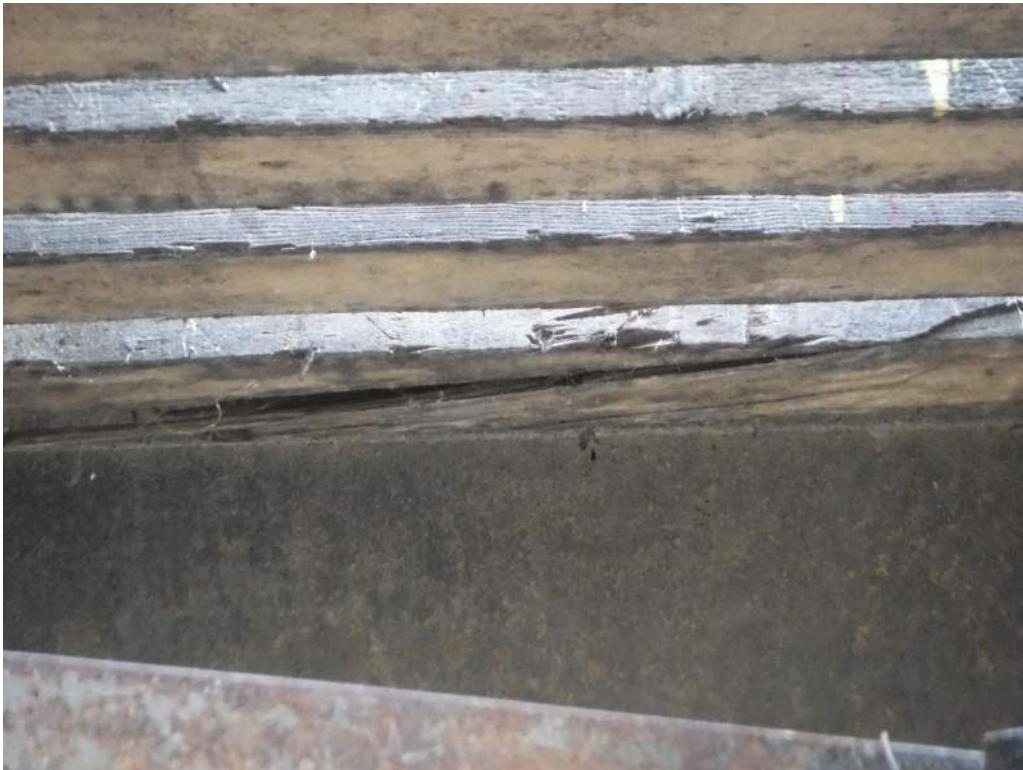
**412.25 Split Tie**

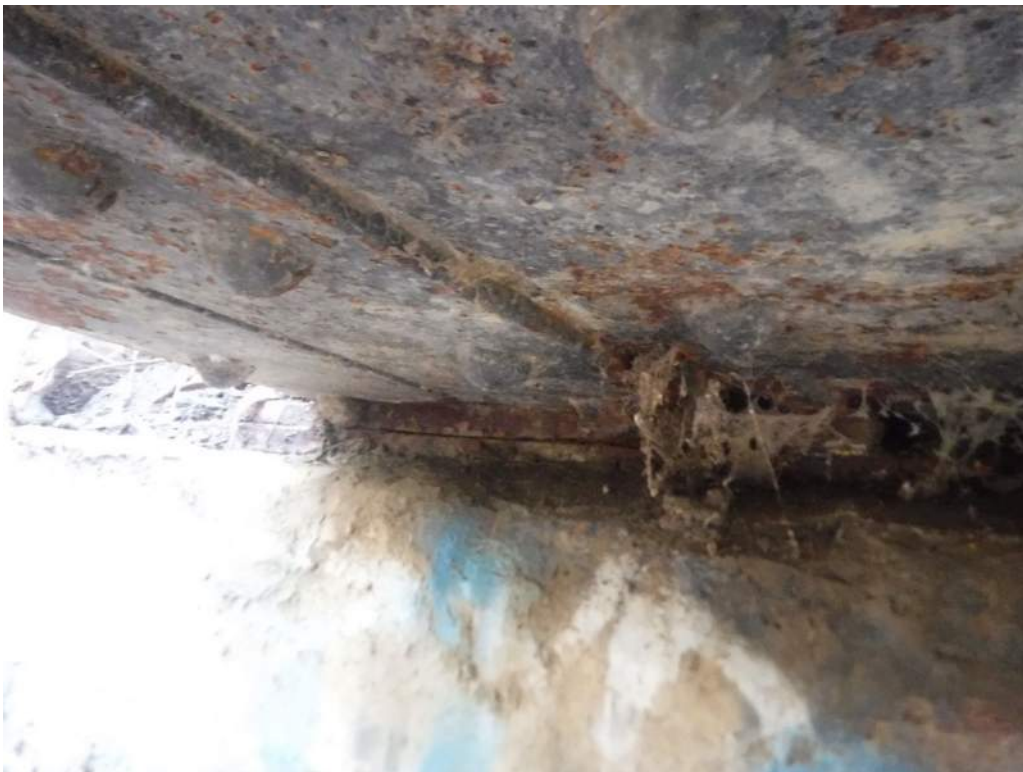
**412.25 Minor section loss/pack rust at bearings (typ.)**

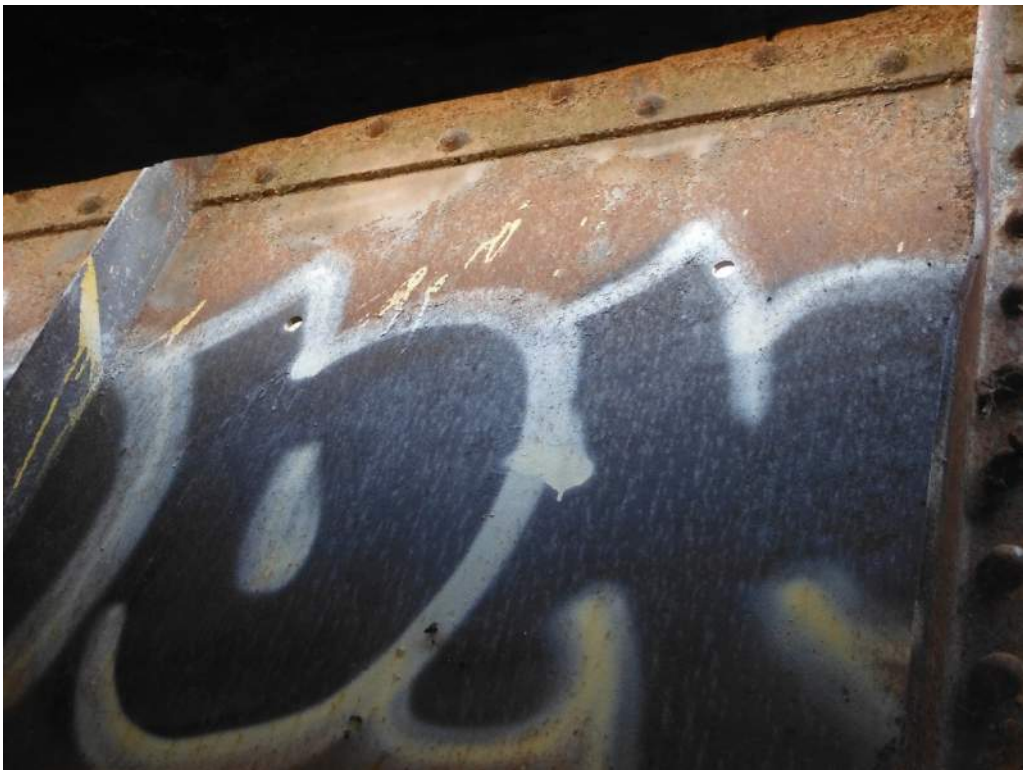
**412.25 Hole in web and stiffener damage at midspan G2**

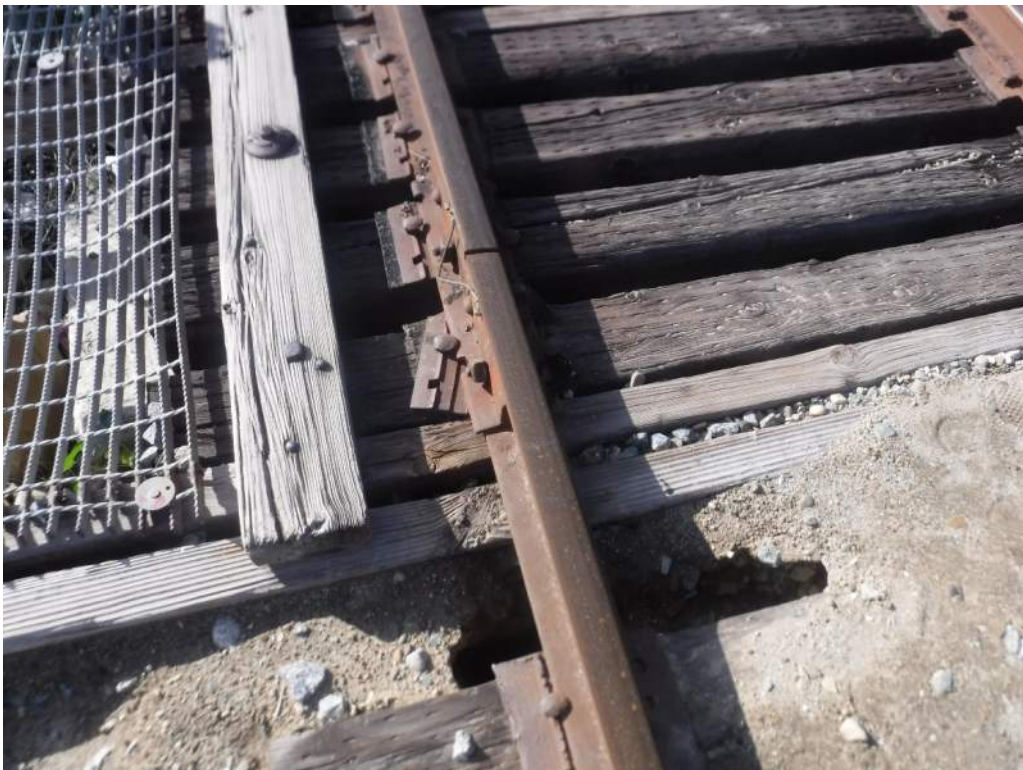
**415.32 Tie Plate Loose**

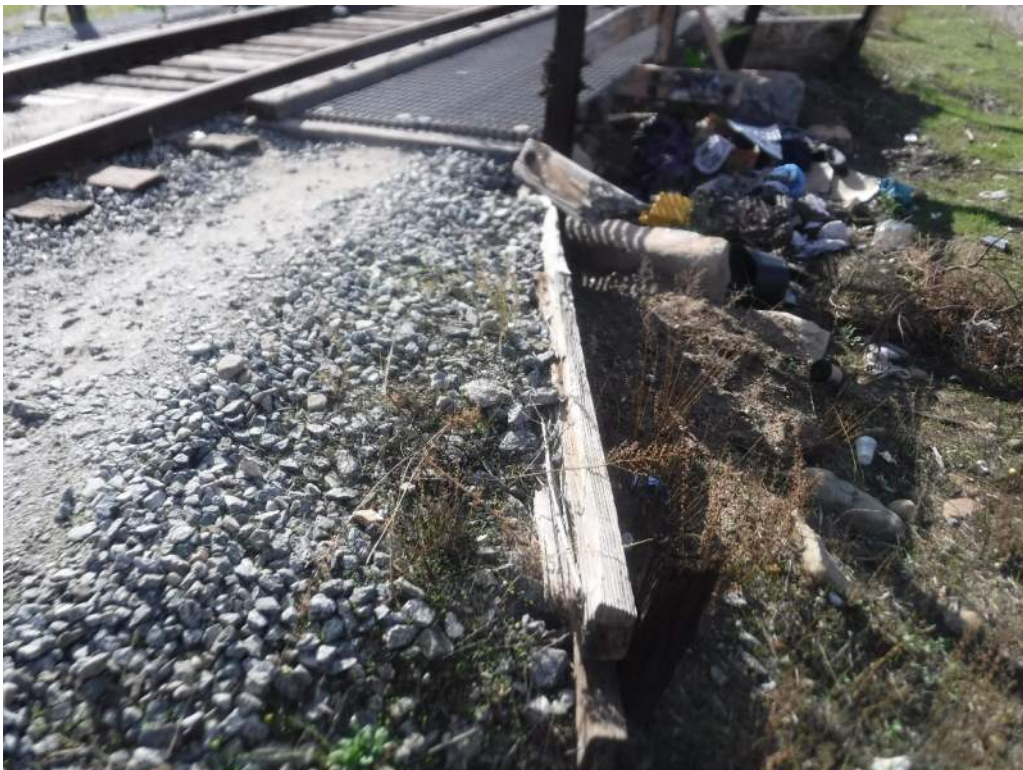
**415.32 Wingwall failing, typ all corners**

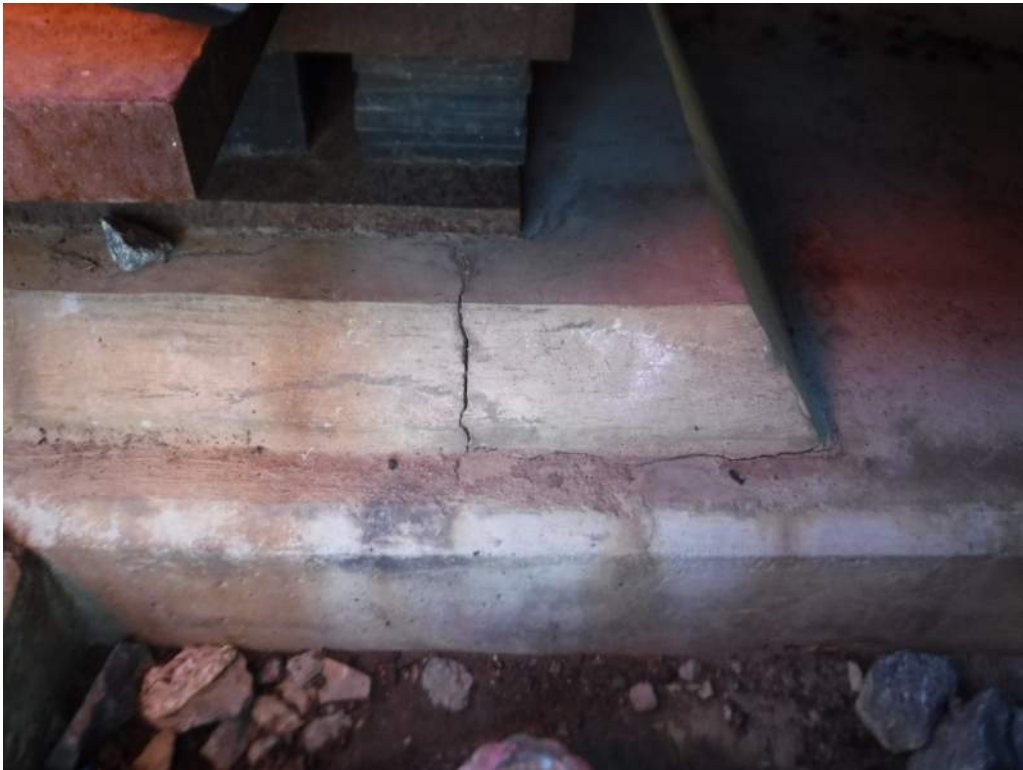
**415.59 Grout pad cracked under bearing, Pier 2**

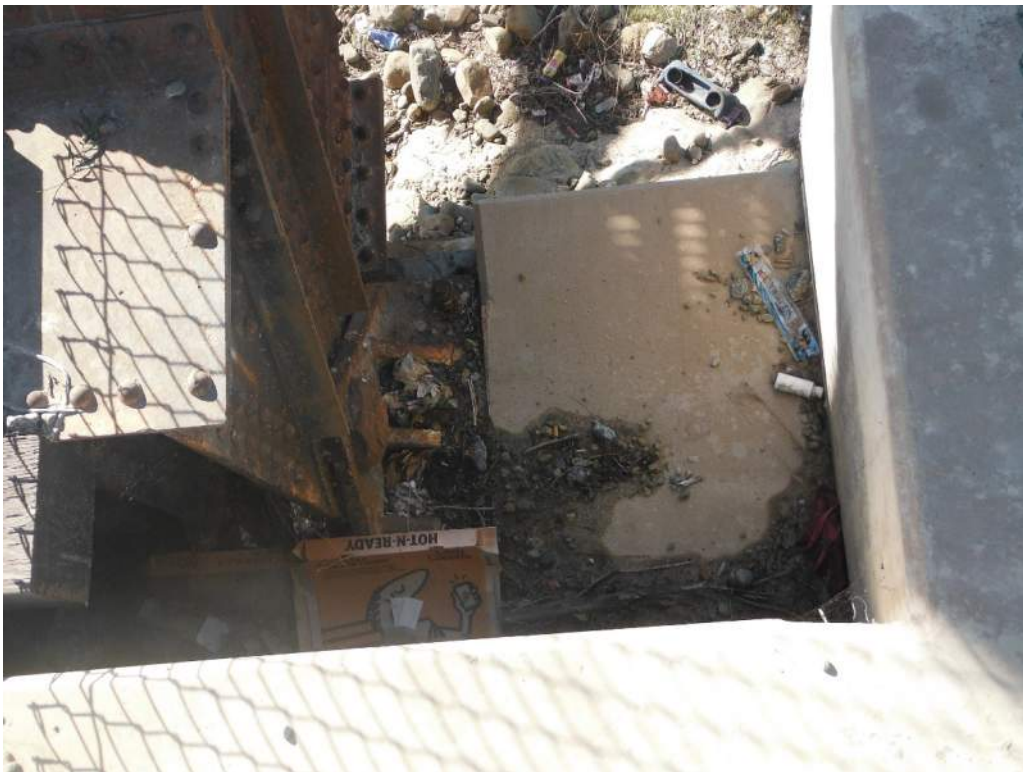
**415.59 Debris at NE Bearing**

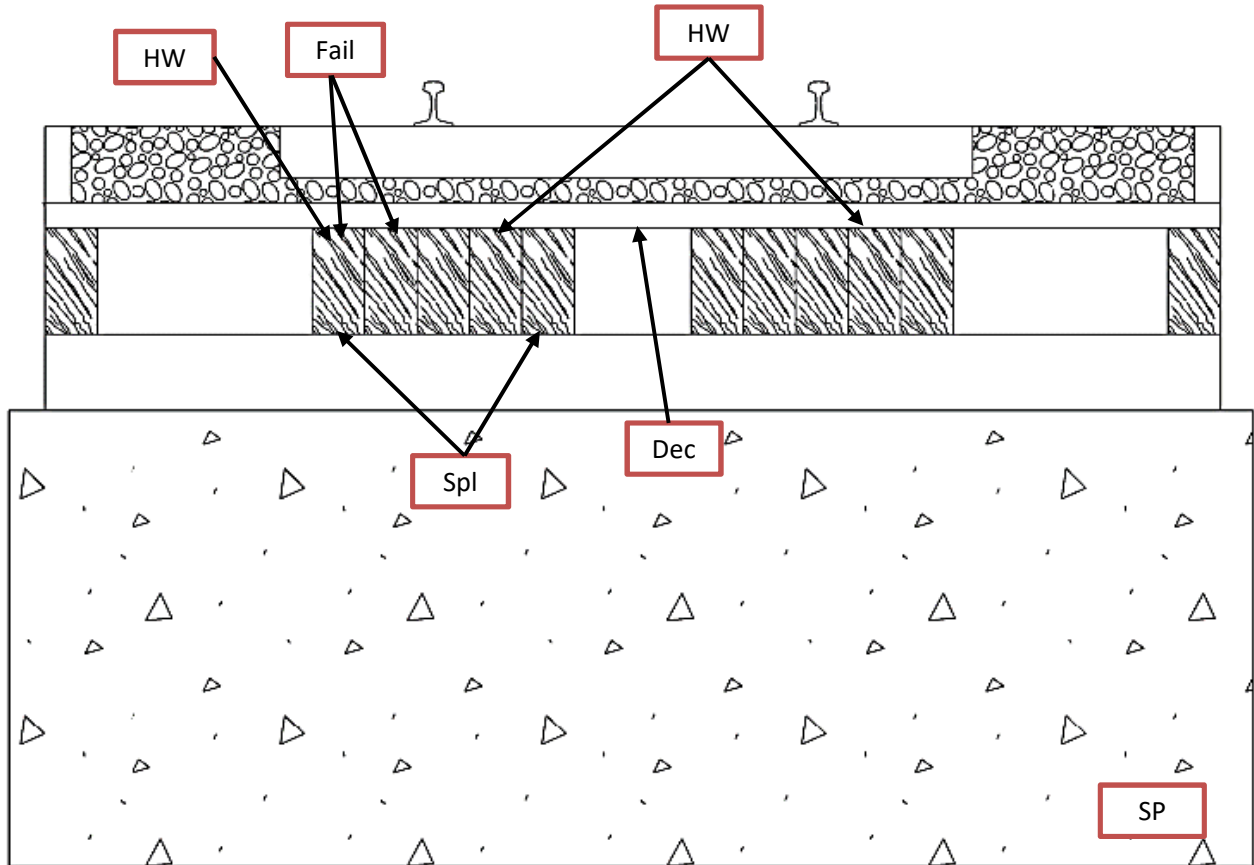
Span: 2	Alignment: TANGENT	Vert. Clear: 6'-7"	Bridge No.	415.69
DETAILS - PIER NUMBER: 2			Span Length:	15'

1. SP - Minor spalls on pier - see photo
2. Signs of minor hits on chord and ballast stringer - see photo
3. Dec - Ballast planks between chord are showing signs of decay
4. HW - Stringers #3 and #8 are hollow
5. Deck plank rotten with hole - see photo
6. Spl - Stringer #7 and #11 longitudinal split and bulging
7. Fail - Stringers #10 and #11 are failed
8. Stringer #10 deflected 1.75" - see photo
