# BRIDGE INSPECTION REPORT

INSPECTION TYPE: Annual

Milepost 407.48  
 Location Santa Paula Branch Line  
Saticoy, CA  
 Stream X Overpass        Other         
 Train Operating Speed: Freight: 10 mph Passenger: 15 mph

MAINLINE/SUBDIVISION: VCTC

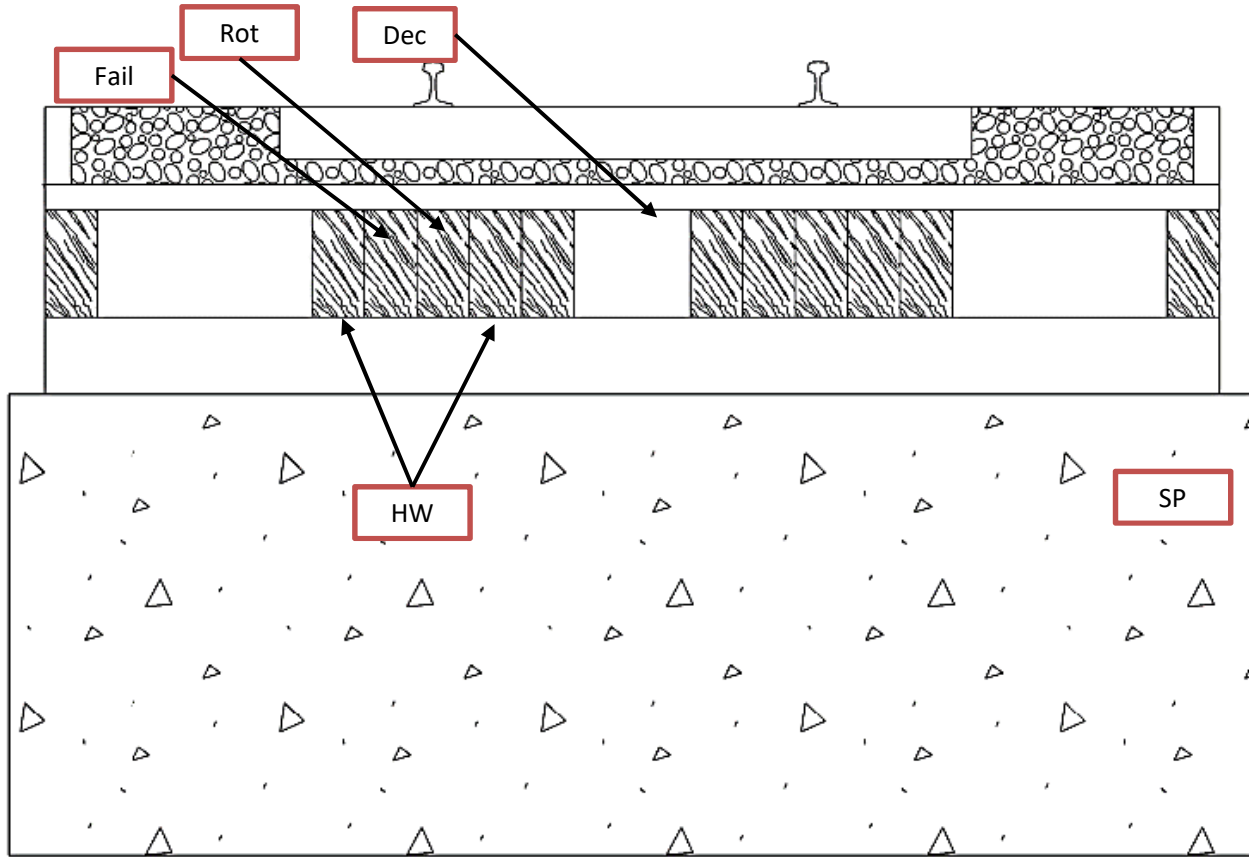
Span: 3	Alignment: TANGENT	Vert. Clear: 6'-10"	Bridge No.	415.69
DETAILS - PIER NUMBER: 3			Span Length:	14'-6"

1. Stringers show signs of impact
2. Dec - Ballast planks show signs of decay with ballast showing in holes - see photo
3. Update clearance signs to 6'-10"
4. Stringers #8 & #11 hollow near pier #3
5. Stringer 6 rotated 1" - see photo
6. Spall North side pier #3
7. Stringer #10 is failed and deflected 0.5"

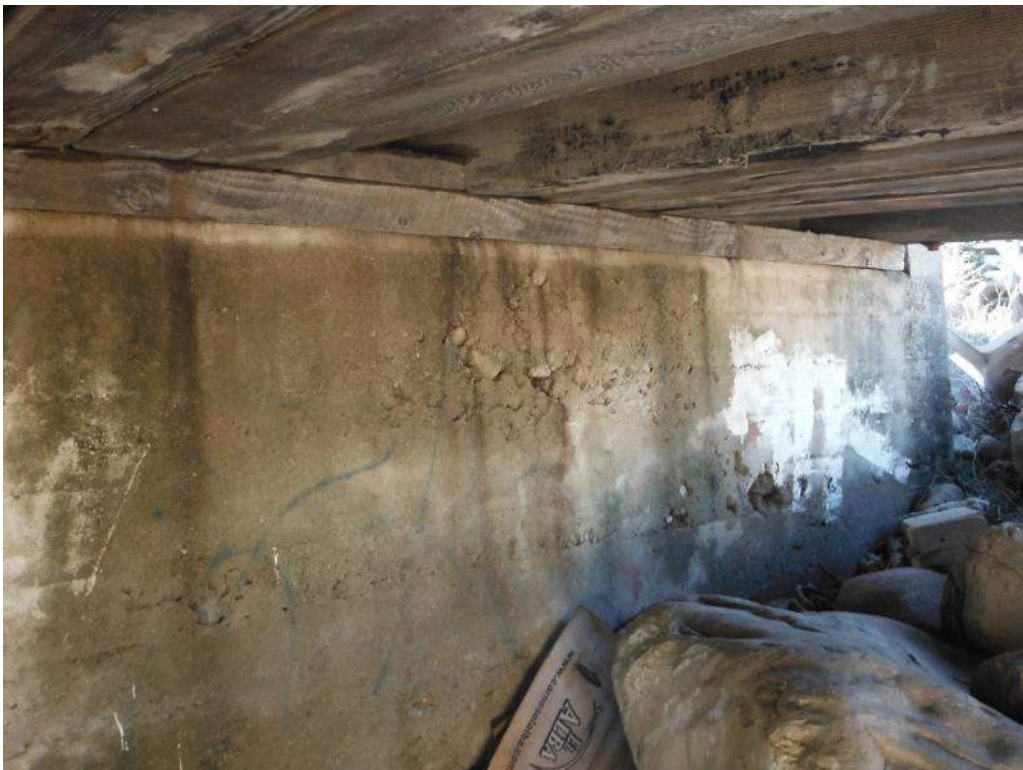
**415.69 Abutment 1 Spall**

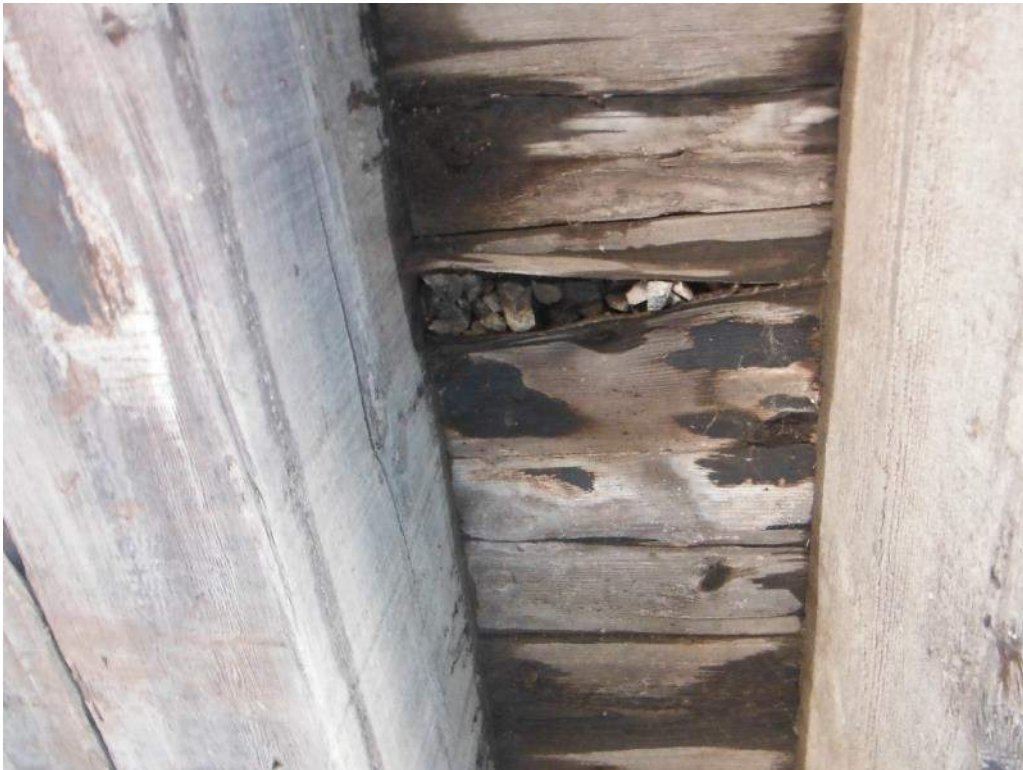
**415.69 Poor ballast planks (typ.)**

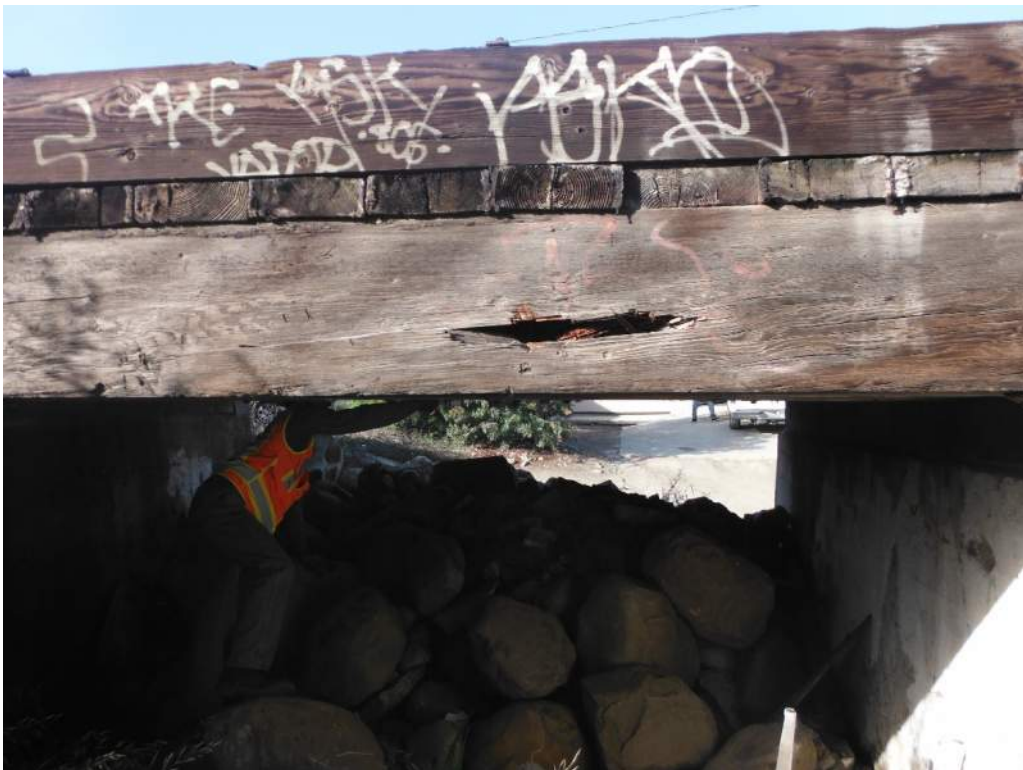
**415.69 Stringer 12 is rotten/failed – Span 1**

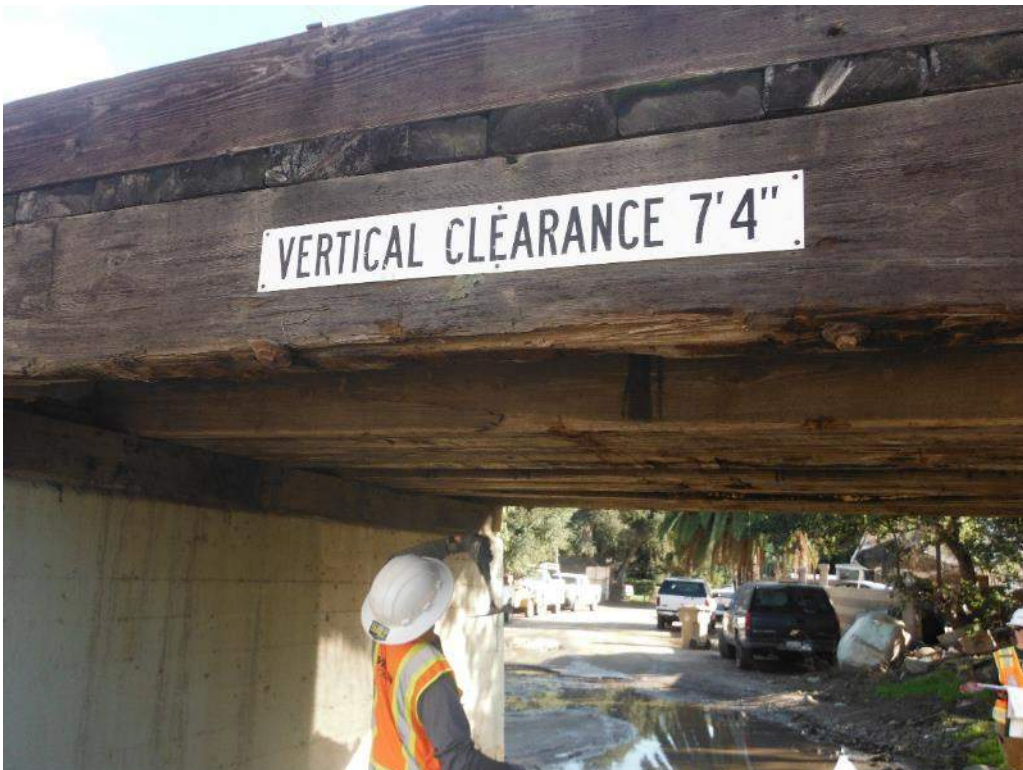
**415.69 Major impact damage to Stringer 1, typ Span 2 and 3**

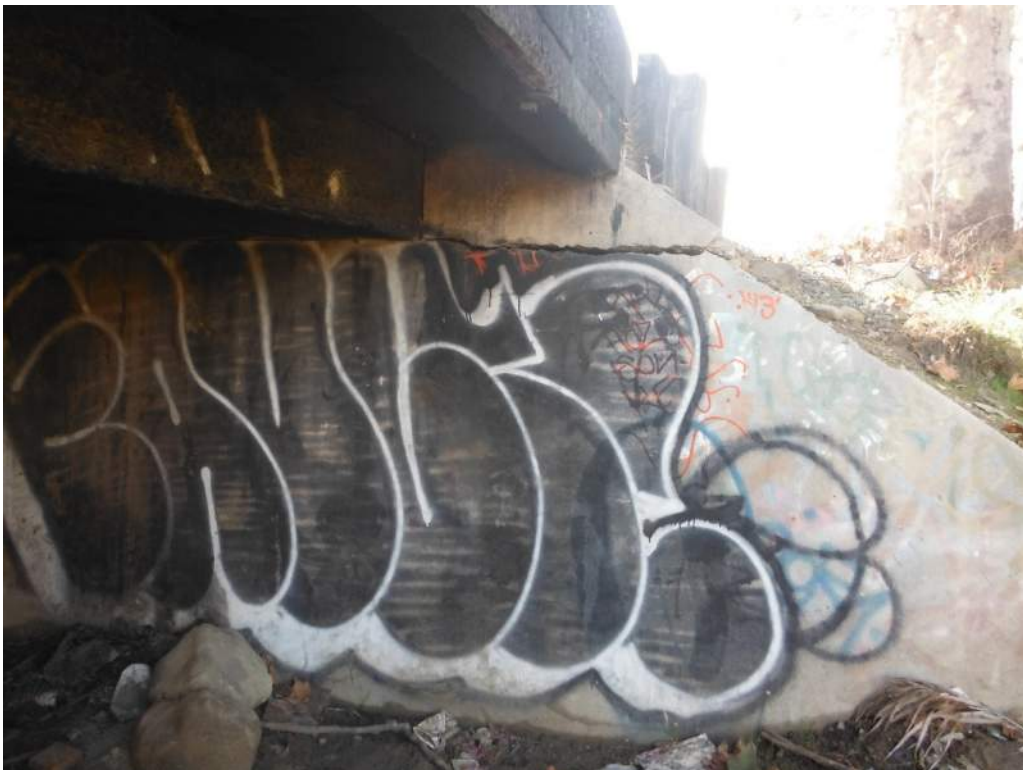
**415.82 Abutment stringer retainers cracked – typical all 4 corners**

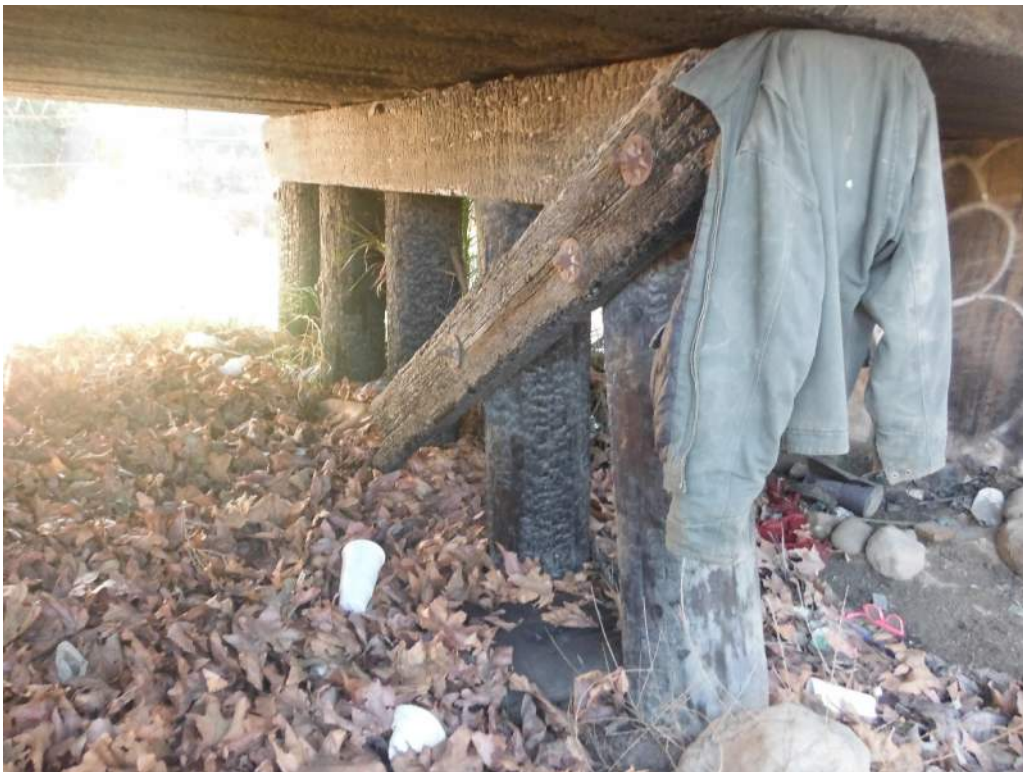
**415.82 Failed sway brace – pier 2**

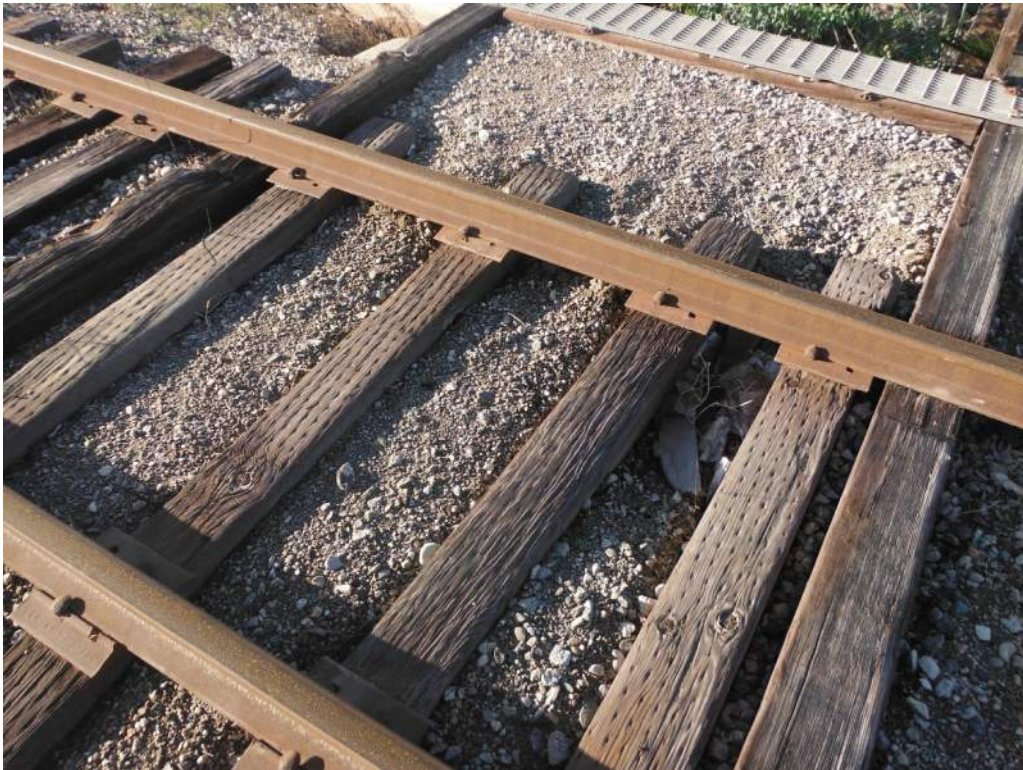
**415.92 Ballast leak – Span 2 north side**

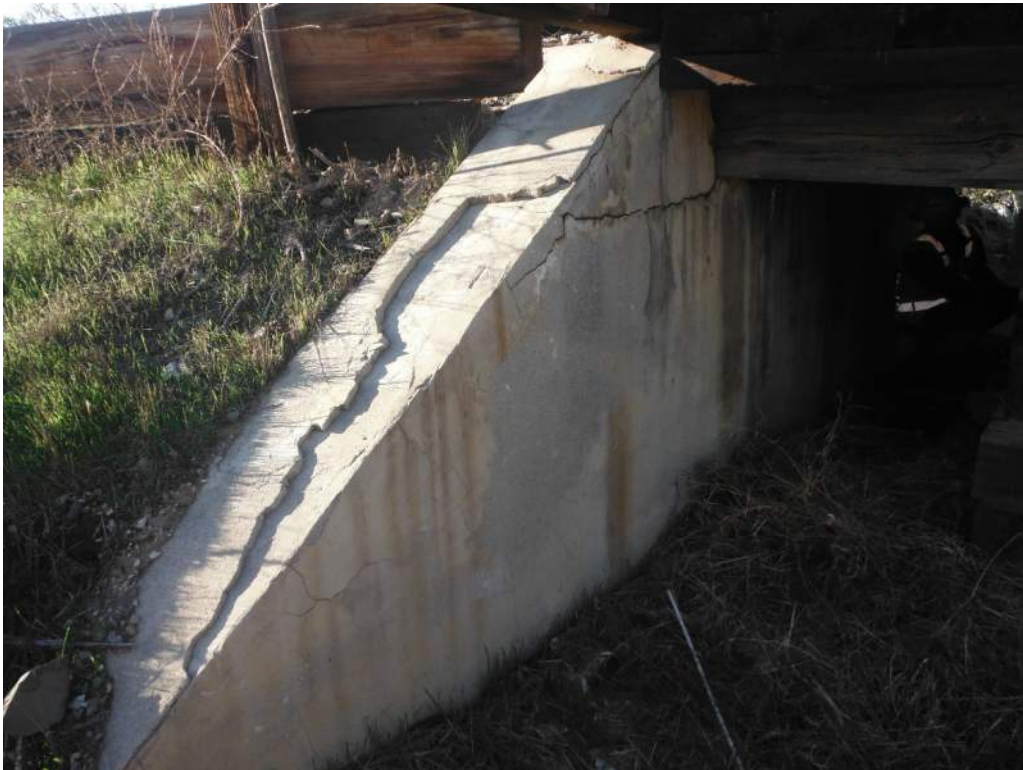
**415.92 Abutment stringer retainer cracked- typical NW, SW, SE**

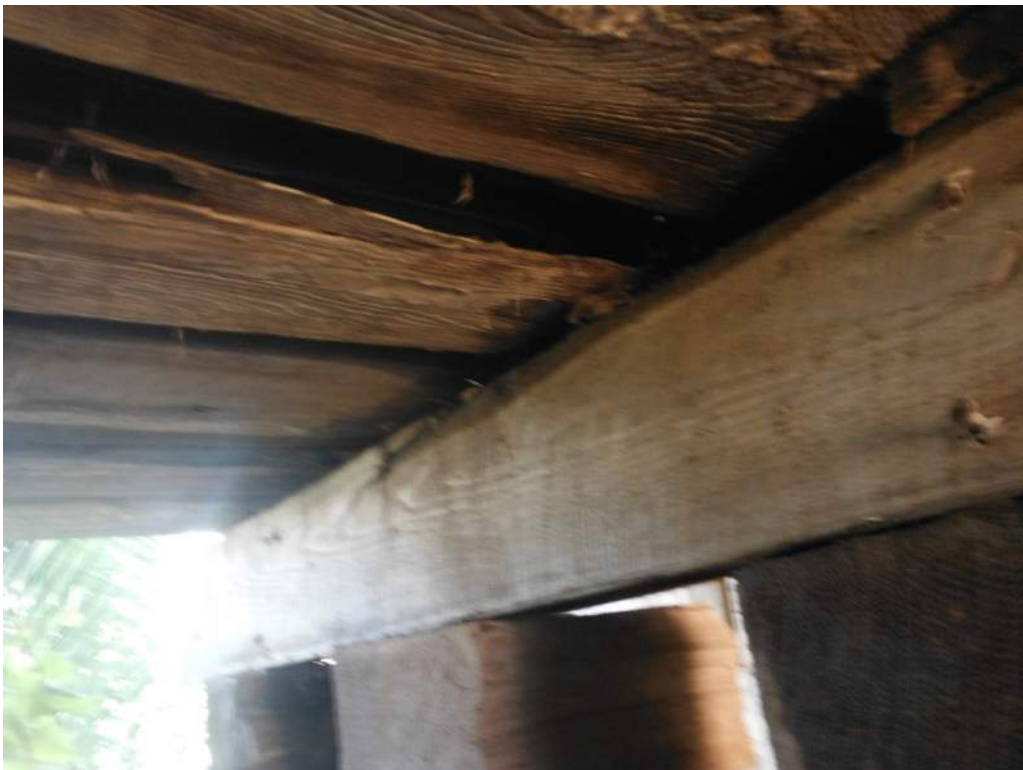
**415.92 Stringer 5 rotten, Stringer 2 & 4 failed, Span 2**

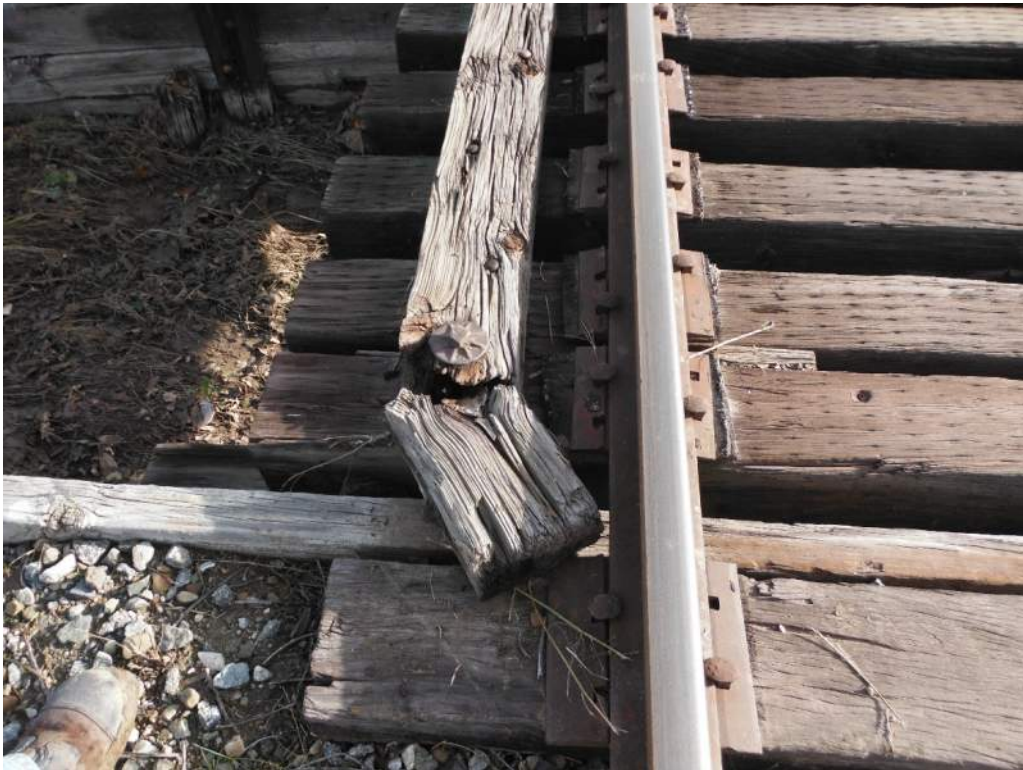
**416.63 Guard ties rotten and broken**

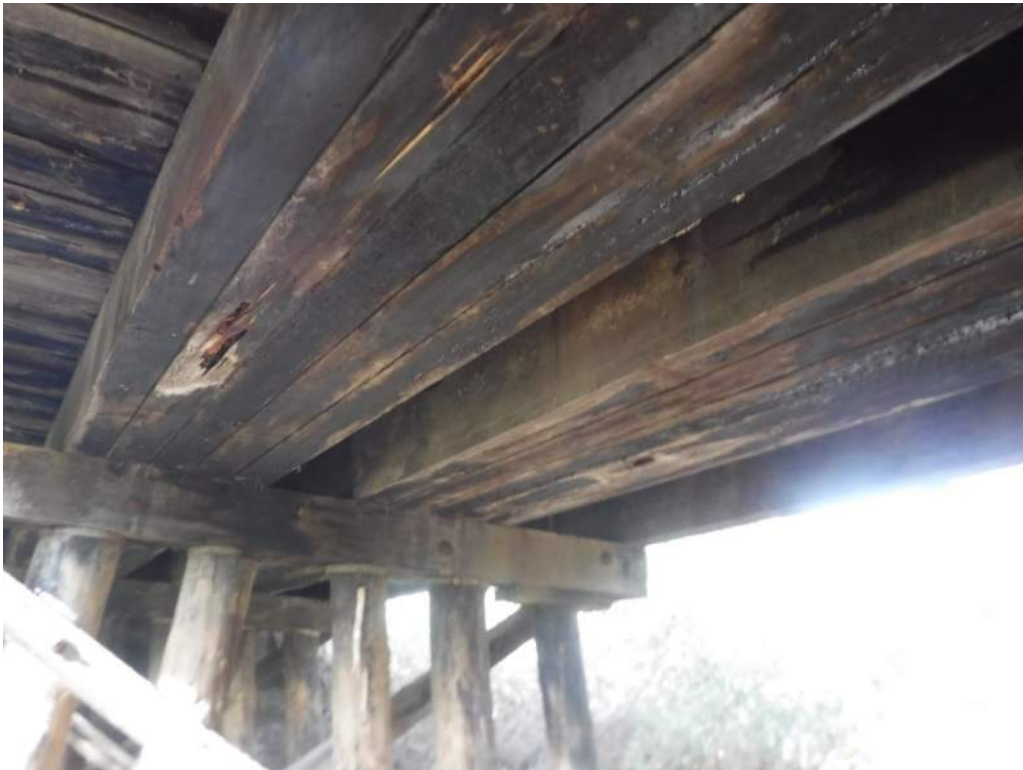
**417.24 Stringer 10 failed, Span 3**

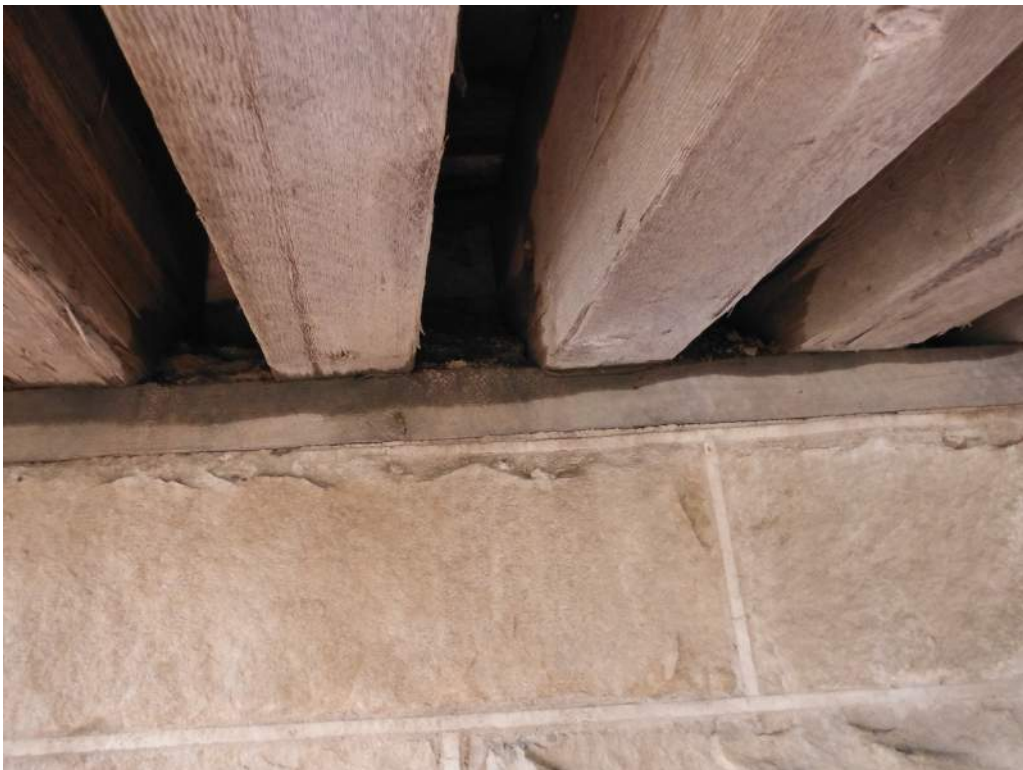
**418.02 Debris and moisture on sill plate**

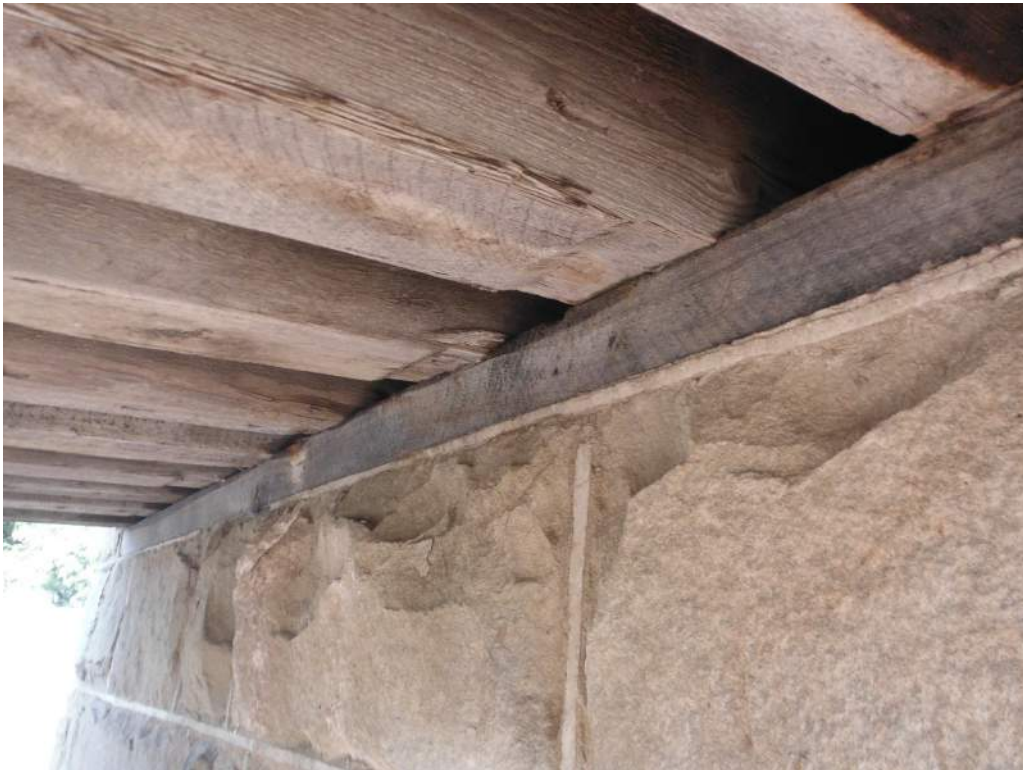
**418.02 Stringers #5, 6, 7 crushing at Abutment 2**

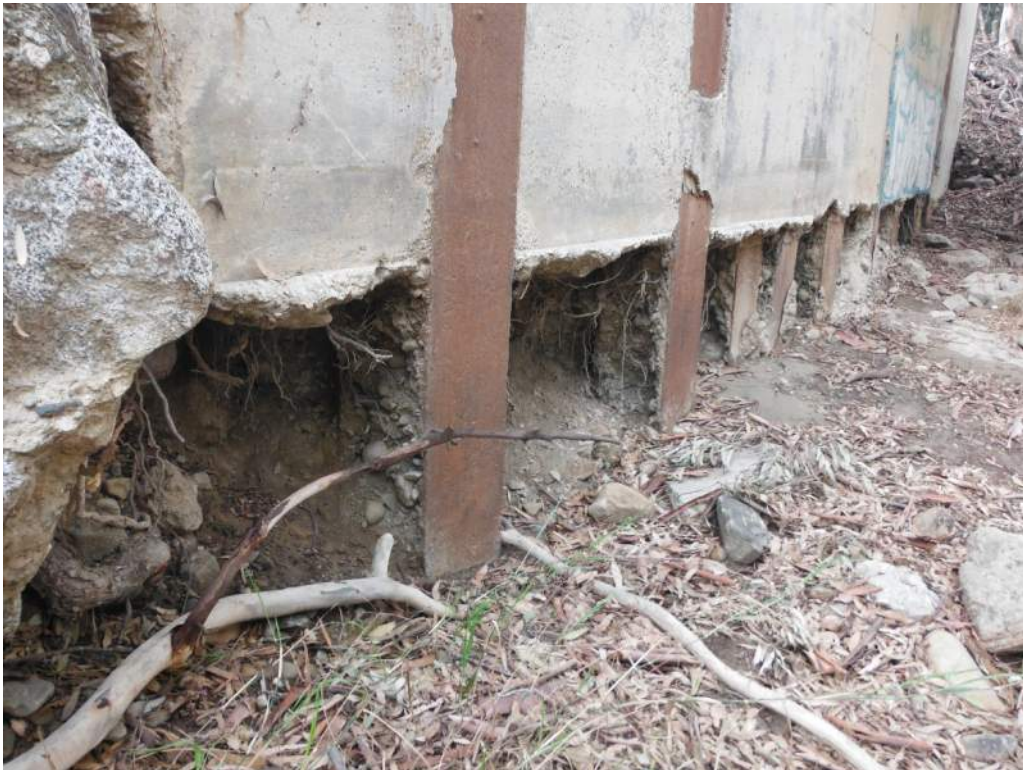
**419.42 Scour - Abutment 1**

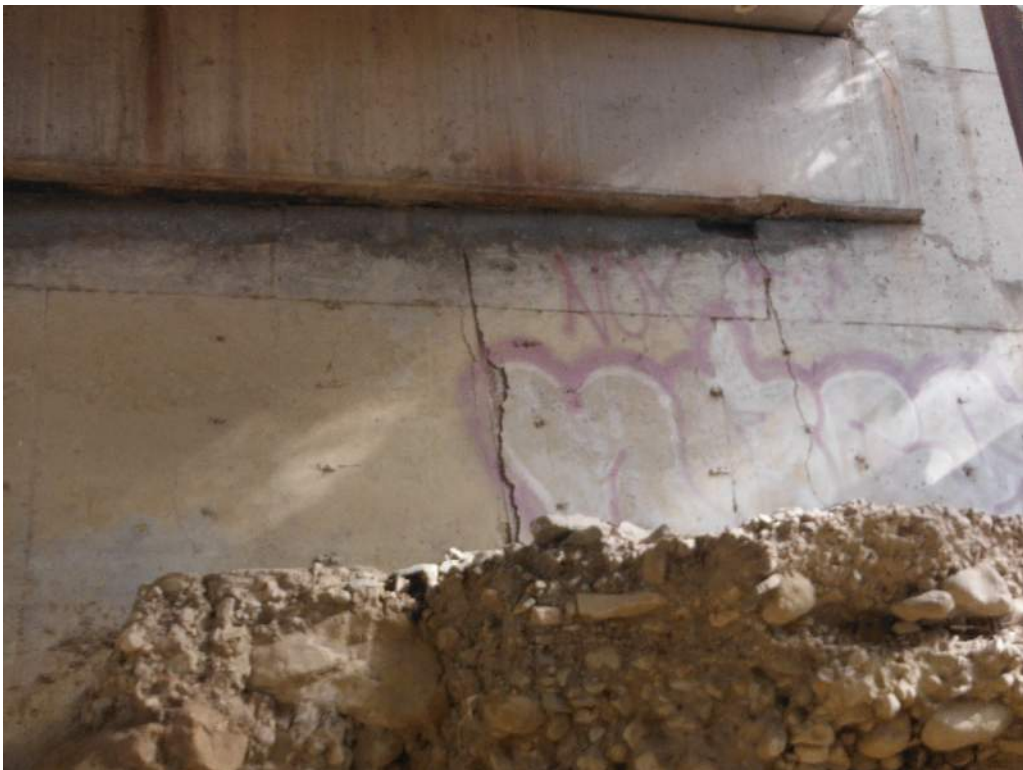
**419.42 Cracking and spall with exposed rebar - Abutment 2**

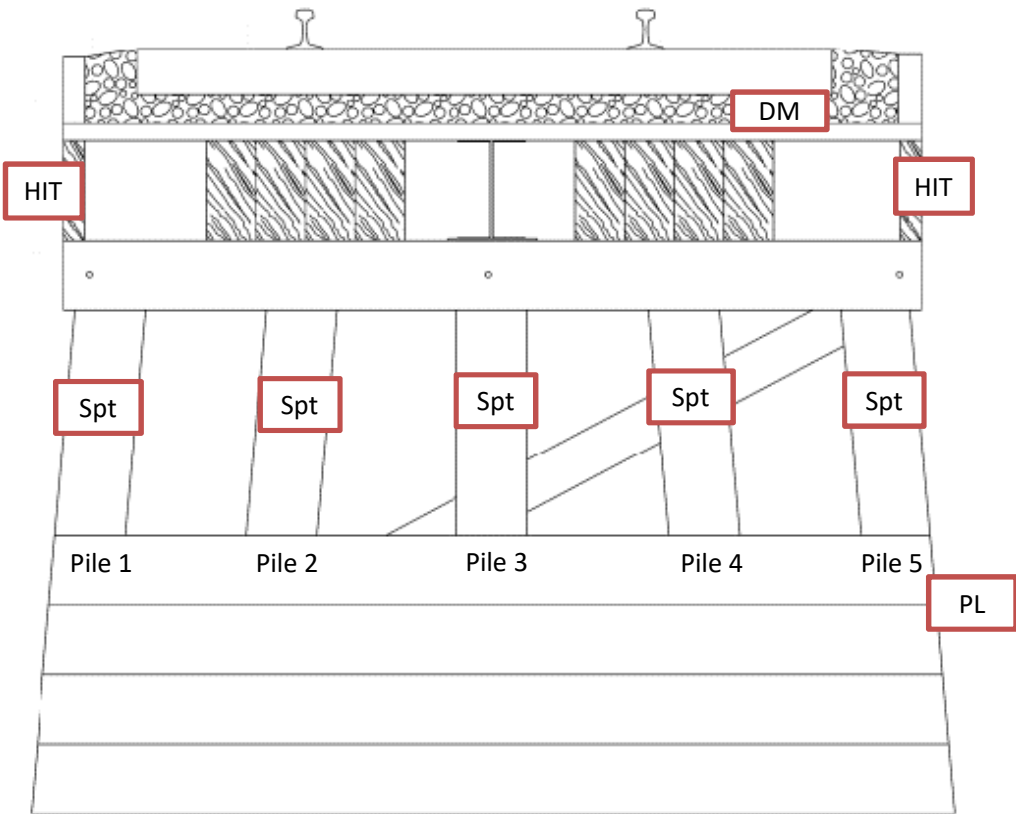
BRIDGE INSPECTION REPORT --- TIMBER BENT				
Span: 3	Alignment: TANGENT	Vert. Clear: 8'-3"	Bridge No.	420.20
DETAILS - BENT NUMBER: 3			Span Length:	15'

1. SPT - Piles #1,#2,#3, #4 and #5 have vertical splits - see photo				
2. DM - Stringer #8 has minor damage from high impact load				
3. PL - Bent has 2"x12" planking to protect pile from vehicles on road

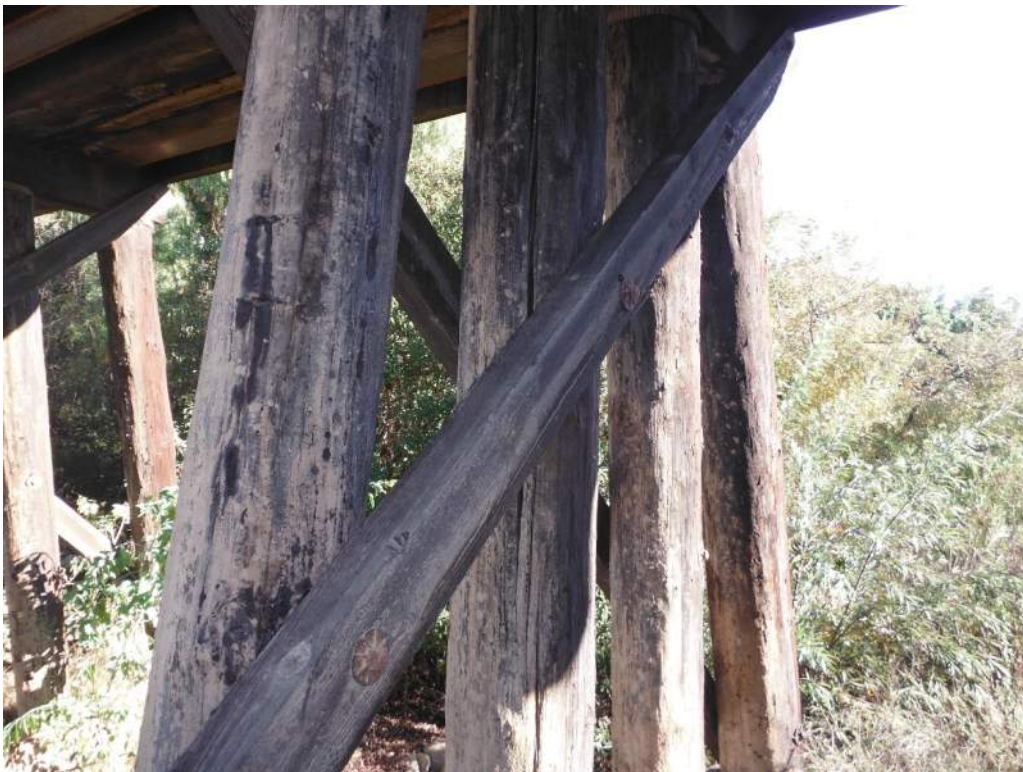
**420.46 Pile 3 vertical split, Bent 3**

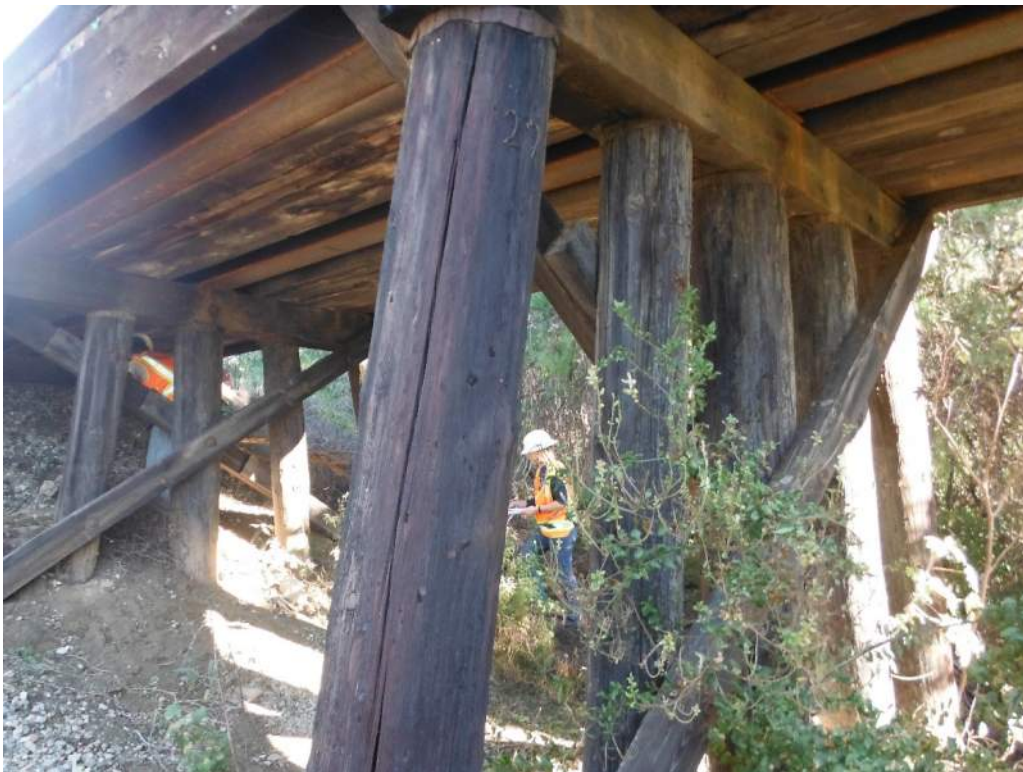
**420.46 Pile 1 vertical split, Bent 5**

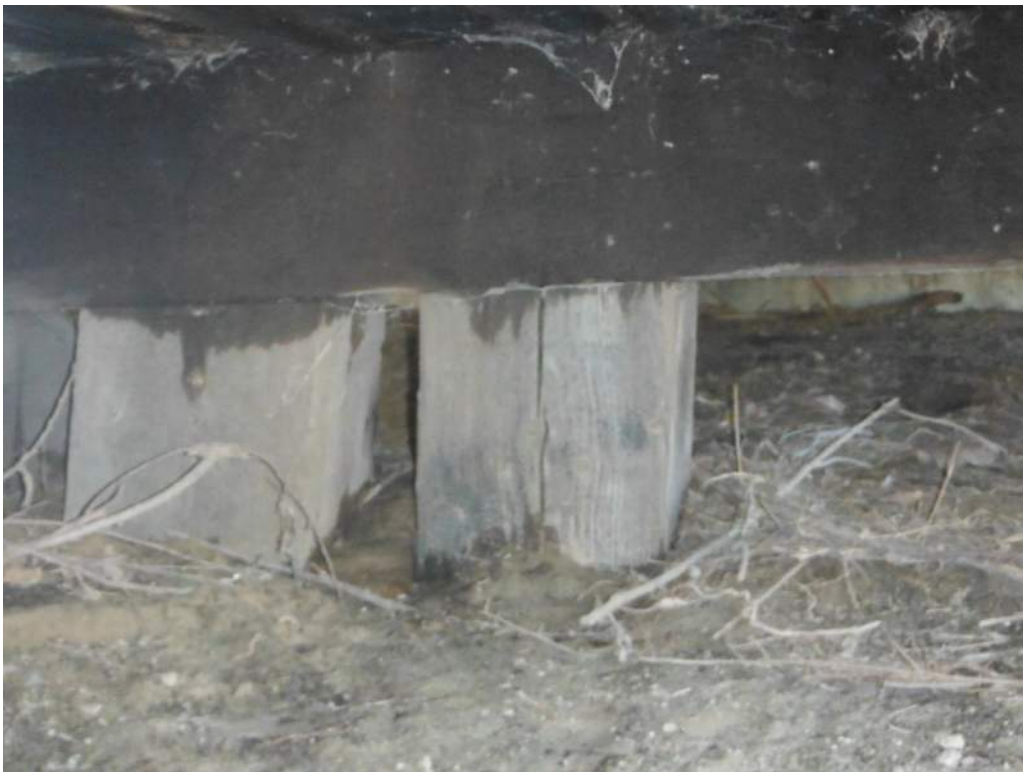
**421.23 Pile #4 Splitting, Bent 2**

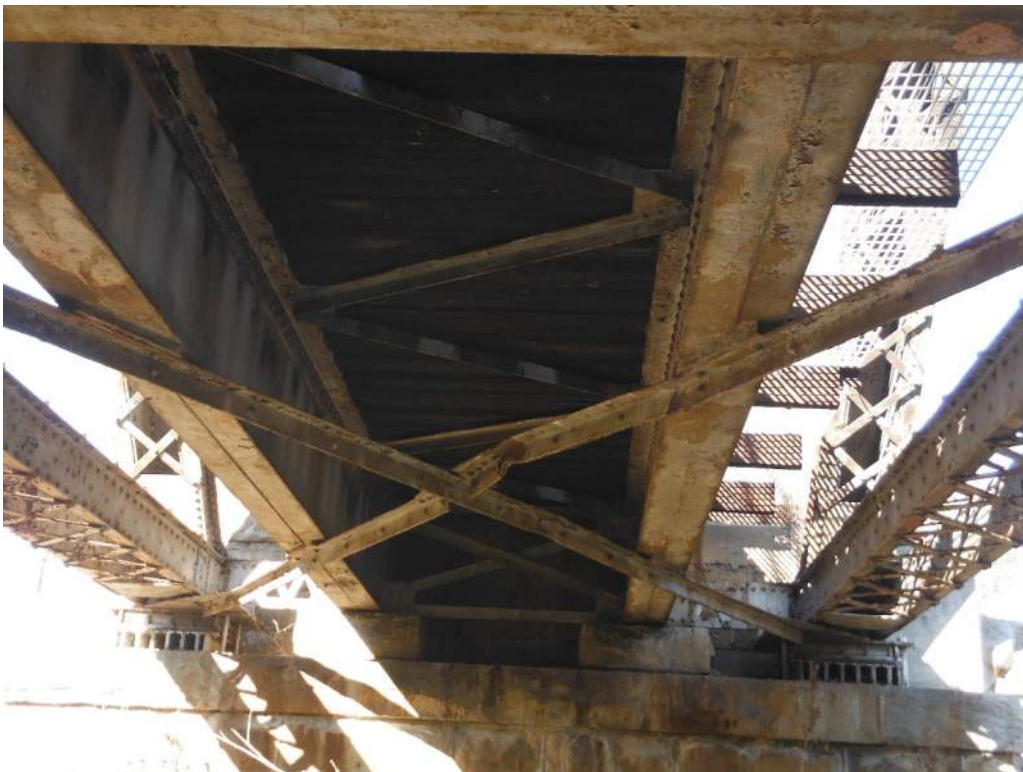
**423.28 Minor impact damage to cross bracing near Abutment 1**

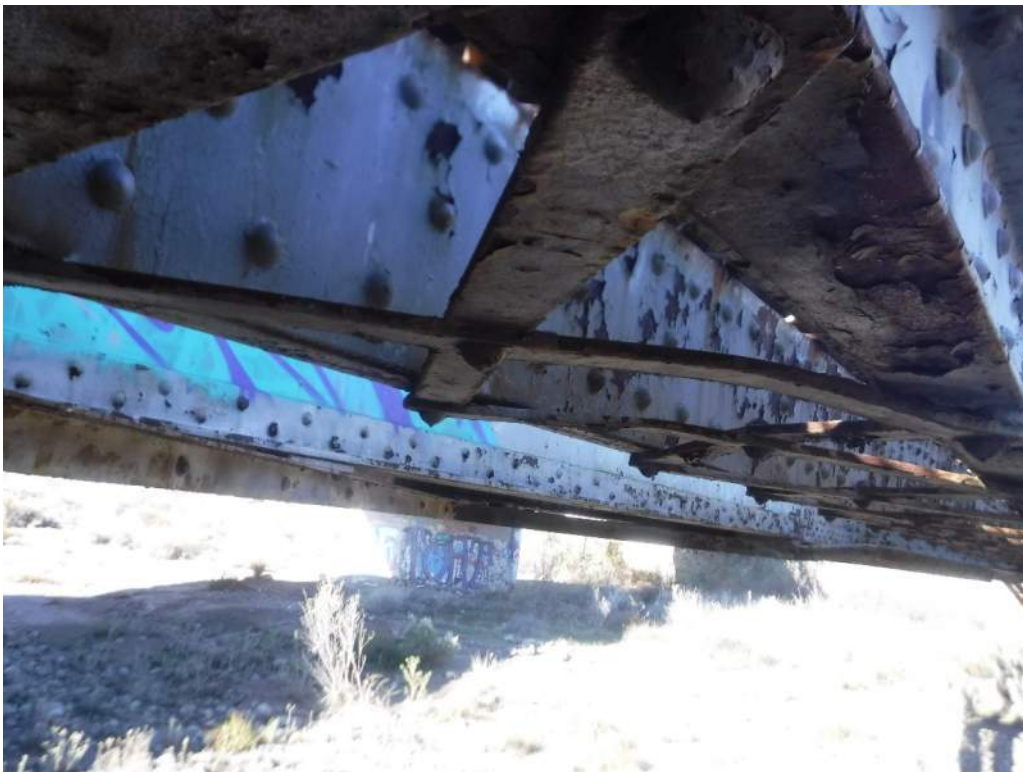
**423.28 Impact damage to bottom chord lattice bracing at bay 7**

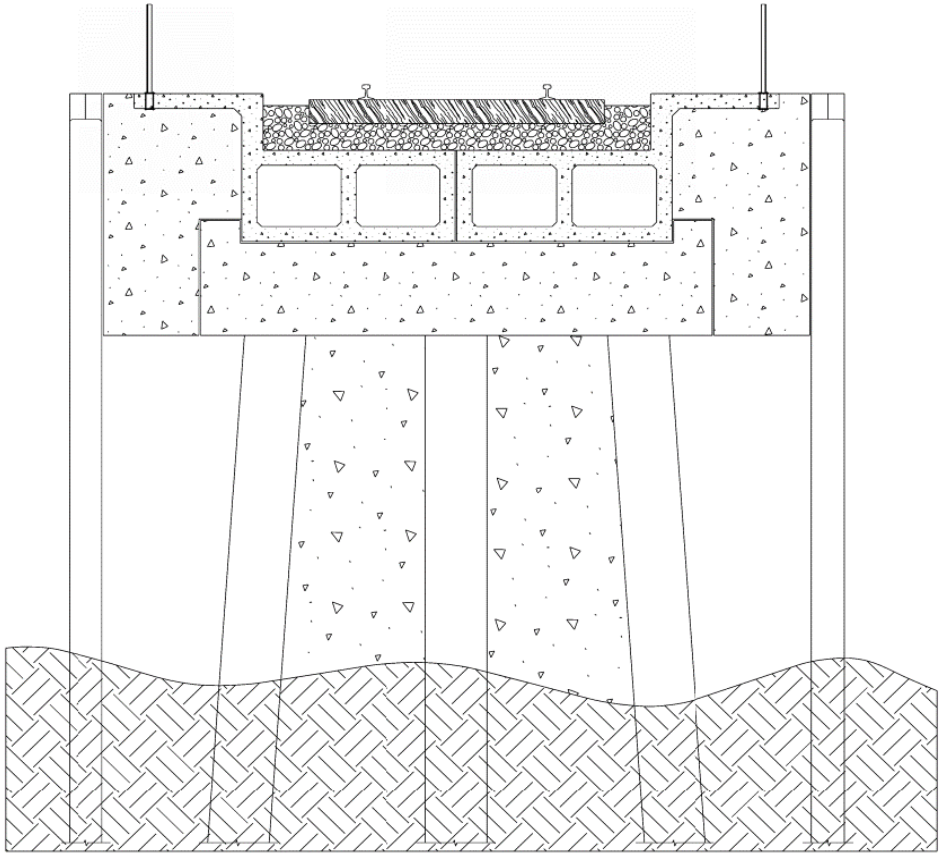
BRIDGE INSPECTION REPORT --- CONCRETE STRUCTURE/CONCRETE ABUTMENT			
Alignment: <b>TANGENT</b>	Vert. Clear: <b>14'</b>	Bridge No.	<b>423.44</b>
DETAILS - ABUT NUMBER: <b>16</b>		Span Length:

Description: Looking East (2) 80"x30" Concrete box, concrete abutment with steel piles			
Remarks:			
1. Ballast leaking on bearing seats - see photo			
Inspected By:	Joseph Holste, PE	Date Inspected:	12/13/2019

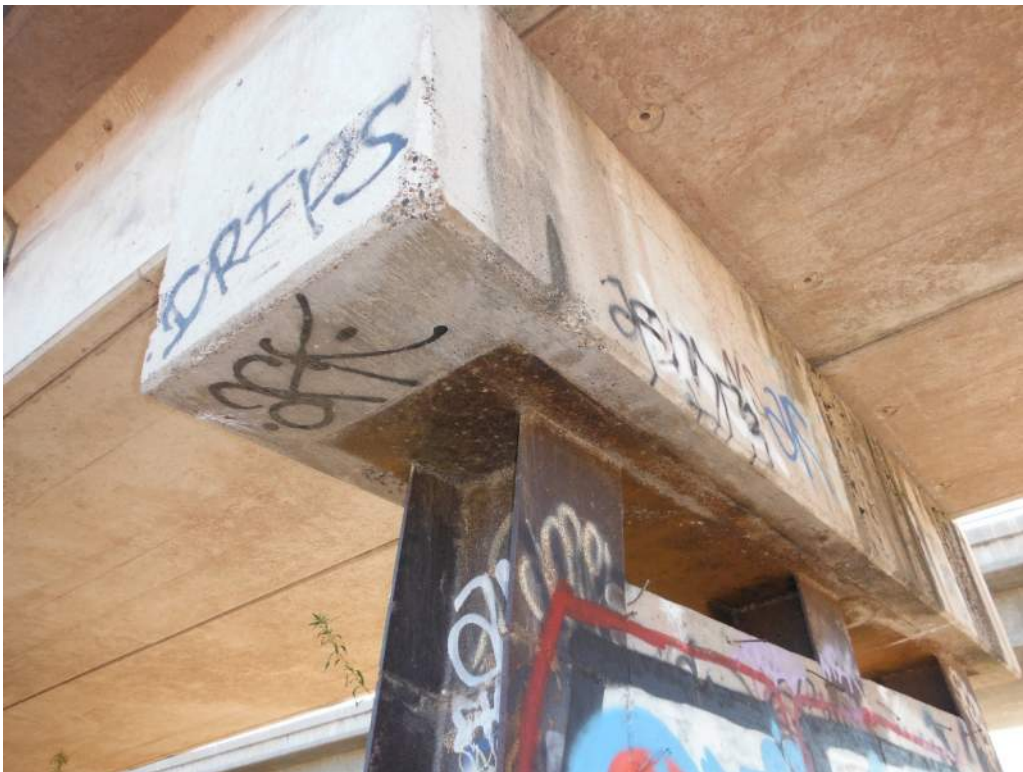
**423.44 Minor spall on bottom corner of pier cap, Pier 5**

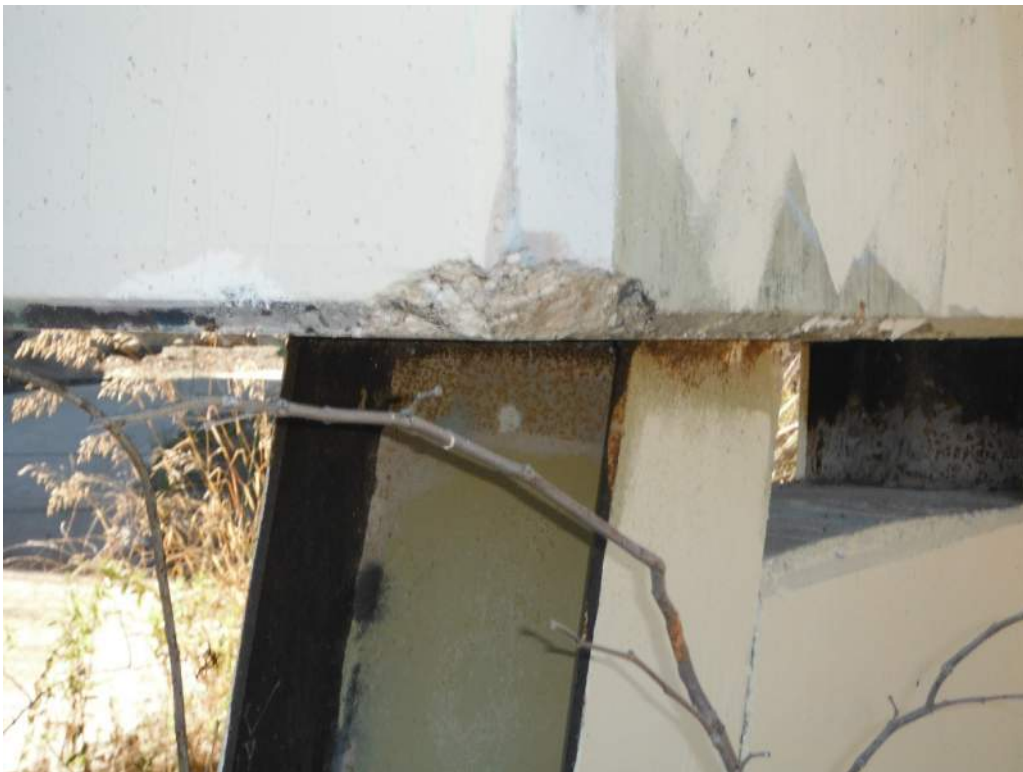
**423.44 Spall NE bottom corner of cap, Pier 14**

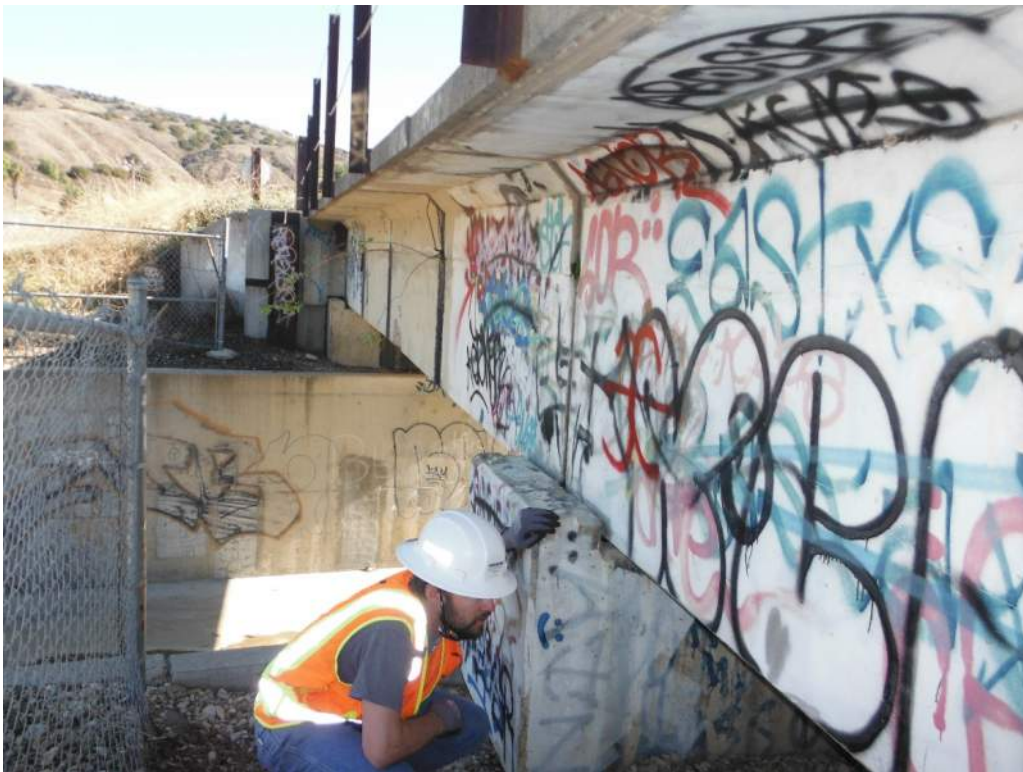
**425.15 Vegetation growing in drain holes**

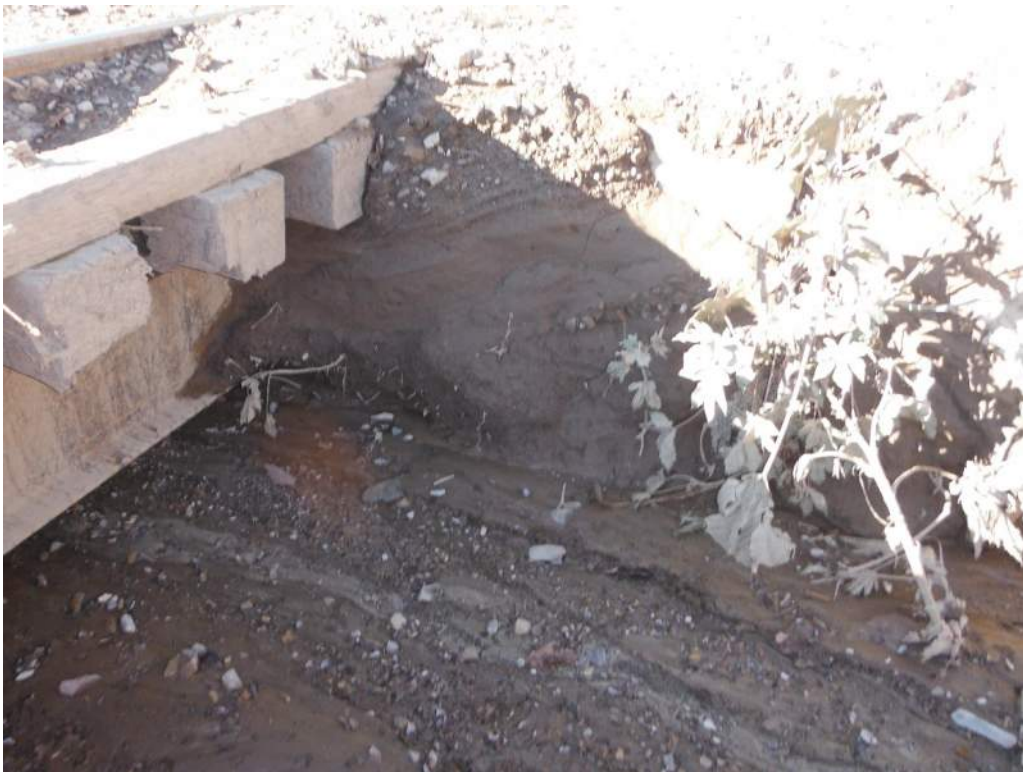
**427.64 Backwall rotting – top timber of backwall failing, Abutment 1**
