# BRIDGE INSPECTION REPORT

INSPECTION TYPE: Annual

Milepost 407.48  
 Location Santa Paula Branch Line  
Saticoy, CA  
 Stream X Overpass        Other         
 Train Operating Speed: Freight: 10 mph Passenger: 15 mph

MAINLINE/SUBDIVISION: VCTC

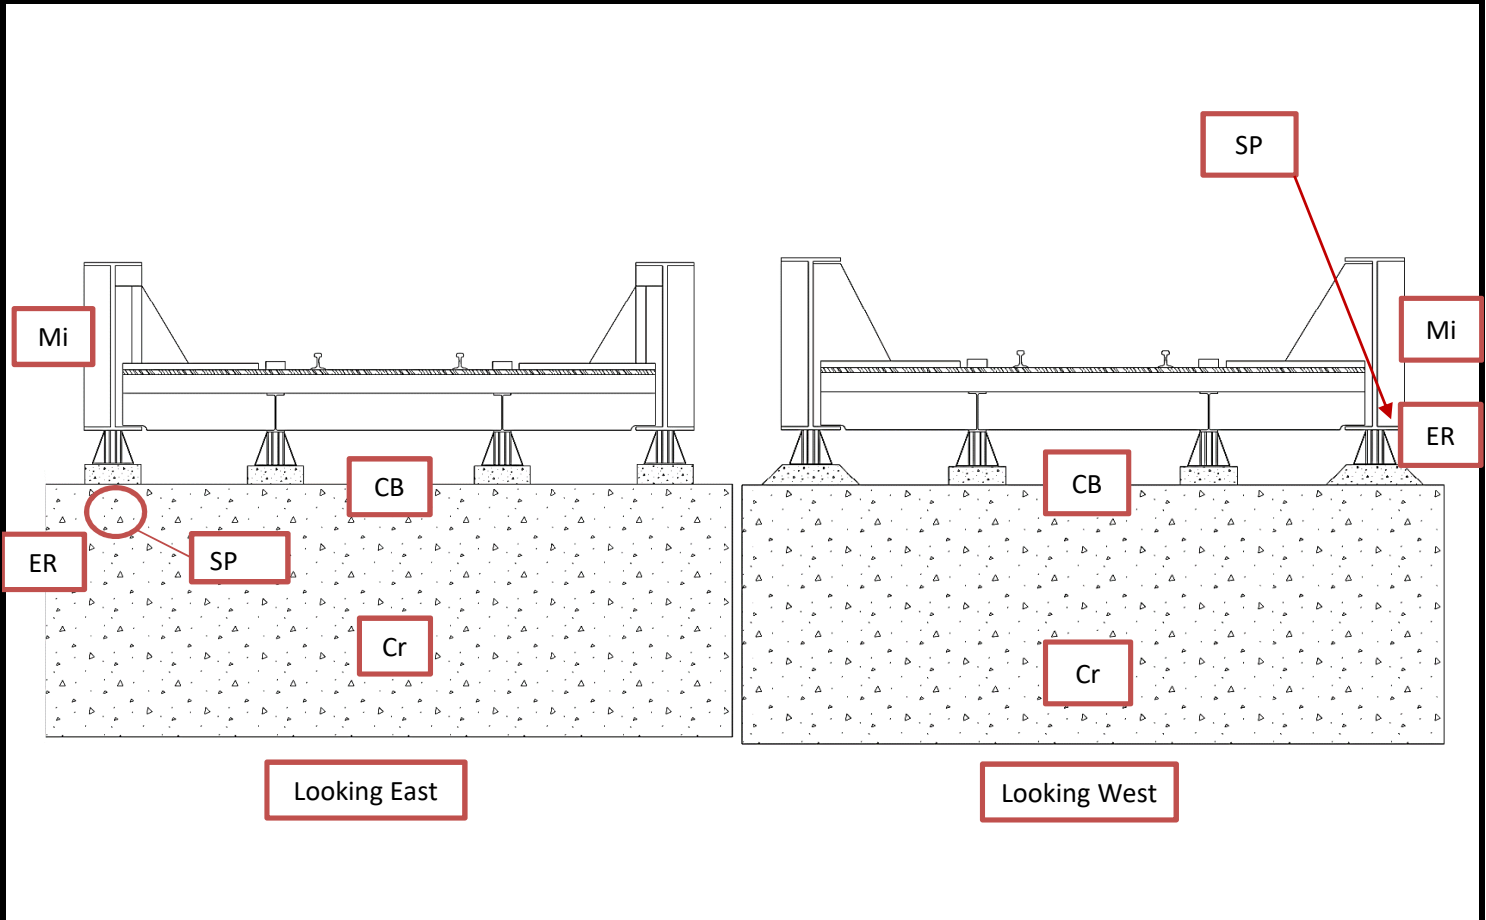
BRIDGE INSPECTION REPORT --- STEEL STRUCTURE/CONCRETE PIER				
Span: 2	Alignment: TANGENT	Vert. Clear: Varies	Bridge No.	429.79b
DETAILS - PIER NUMBER: 2			Span Length:	70', 82'

<b>Remarks:</b>	
1. CB - Between thru plate girder, seats are covered with silt from high water at stringers and floorbeam. Needs cleaning around bearings and seat	
2. CB - Some silting outside seat bearing pad	
3. Mi: Minor impact damage to intermediate stiffeners on north side - see photo	
4. Cr: Pier #2 - many horizontal and vertical cracks upstream side due to impact from rocks in stream (see photo)	
5. ER: Pier has exposed rebar on top north end (see photo)	
6. SP - Span #2 bearing seat spall (see photo)	
7. Span #2 floor beam #4 impact damage top flange	
8. Sheared rivet GI mid span - see photo	
9. Stringers #1 and #2 has south loose anchor bolt. Pedestal is cracked	
10. Multiple members have miss punched holes in flanges. See photo	
Inspected By:	Joseph Holste, PE
Date Inspected:	12/13/2019

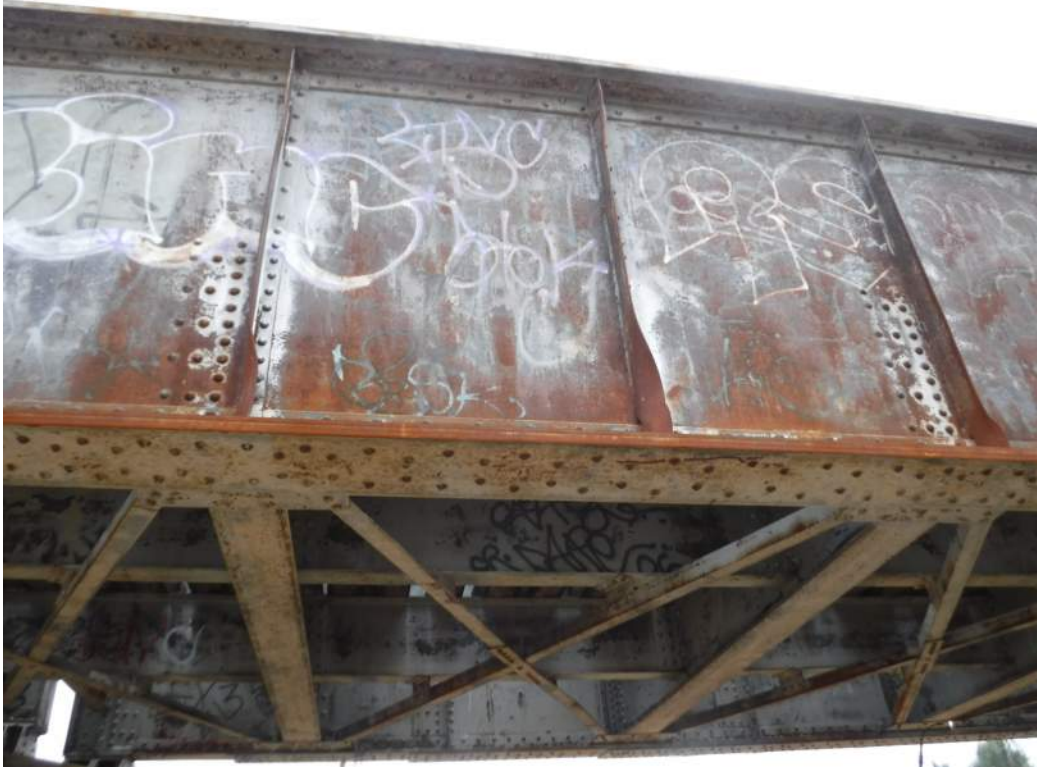
429.79 Multiple stiffeners Impact damage - Span 1 north side
