Ventura County Transportation Commission (VCTC)

Santa Paula Branch Line (SPBL) Track Assessment Report

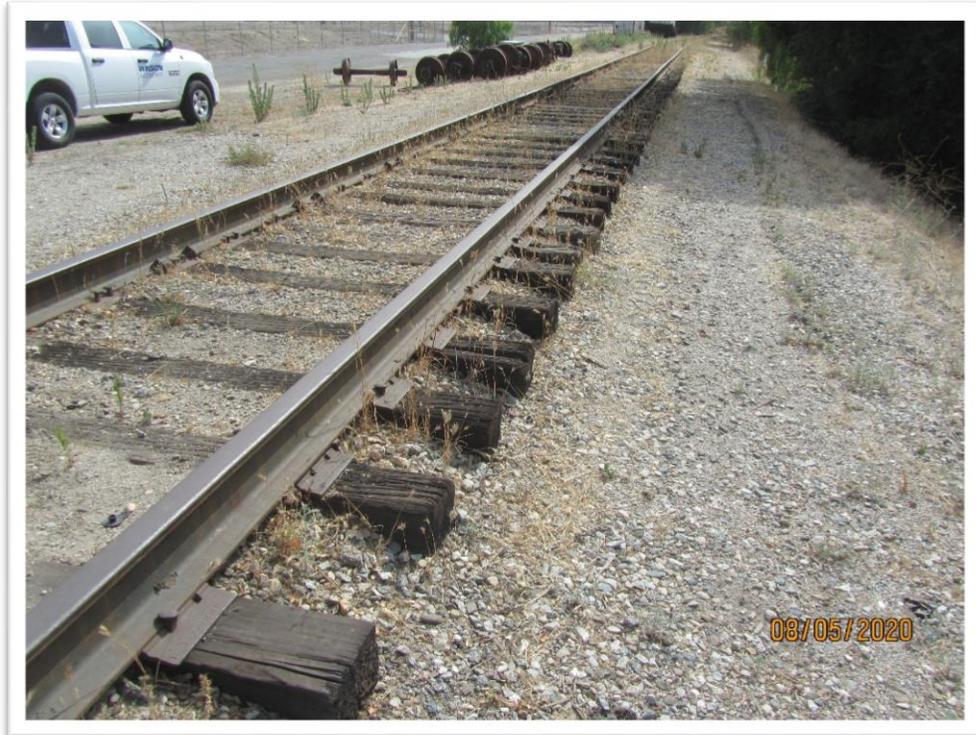
Approximately 50% of the remaining SPBL between MP 407.79 to MP 429.23 consists of alluvial rock rounded in shape, with no angular edges present, poorly graded on top of a weak subgrade as shown in Figure 3. Over most of the site the ballast rock is fouled with dirt and fine soils.

Image 4. MP 425.00 Track Roadbed.

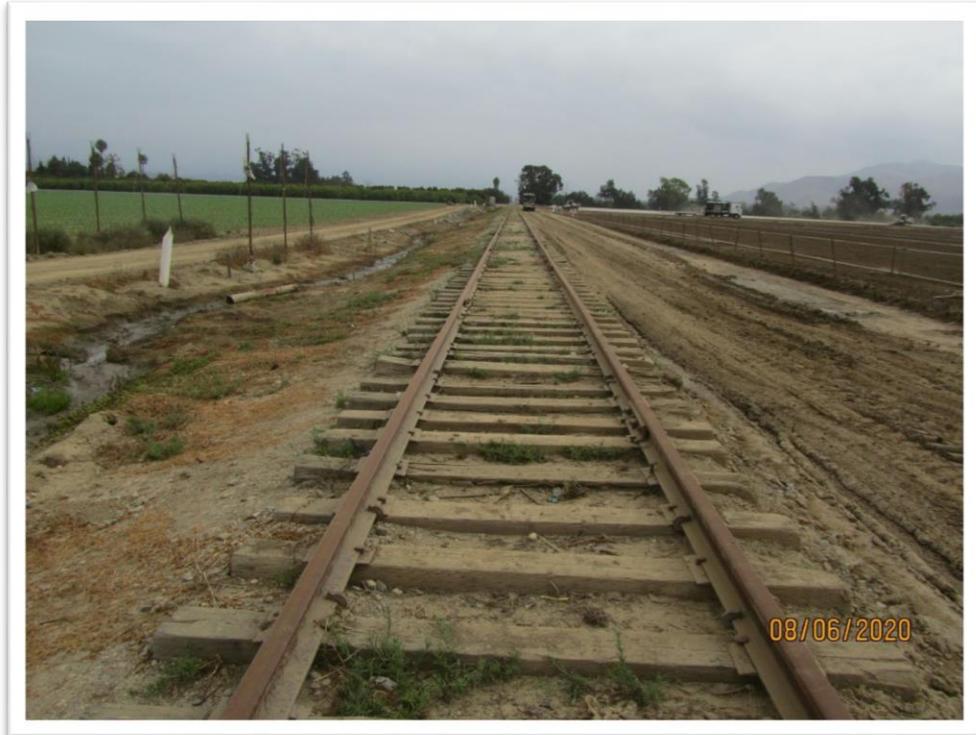
The remaining 50% of the remaining SPBL between MP 407.79 to MP 429.23 showed little or no signs of ballast. Drainage is a key objective in track design and maintenance, inadequate track drainage is one of the major reasons for shortened track component life. The fouled ballast found in the SPBL roadbed is failing to provide drainage for the tracks. The fine soils from the subgrade layer have risen to the surface preventing drainage of the storm water which in turn is causing accelerated decay of cross-ties and inducing alignment and surface deviations along the tracks.

Image 5. MP 408.5 Lack of Ballast.

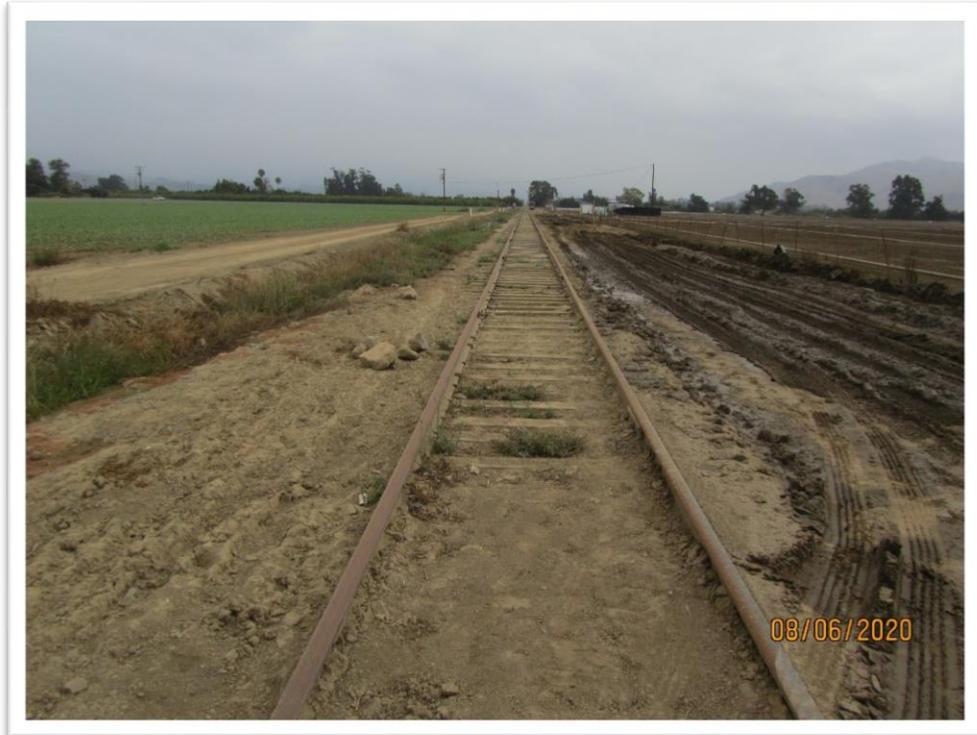
Special attention to the roadbed is needed between Mileposts 408.15 and 412.50. Very poor and/or no ballast was observed which is the main cause of erosion of soil between and around ties. Although no rainfall was detected prior to this assessment, the south side of tracks within this section indicate signs of erosion and standing water (Figure 6). In addition to rainfall, irrigation from numerous farms located on both sides of tracks may be enhancing this issue. Poorly graded ballast rock does not drain adequately creating subgrade saturation. Design of an underdrain system and replacement of the track structure with properly graded ballast rock is recommended to fix this issue.

Image 6. MP 408.3 Erosion / Poor Ballast

- D) Design of an underdrain system (or surface drainage) and replacement of the track structure with properly graded ballast rock is recommended to fix the drainage deficiencies between Mileposts 408.15 and 412.50. Inadequate track drainage is one of the major reasons for shortened track component life.

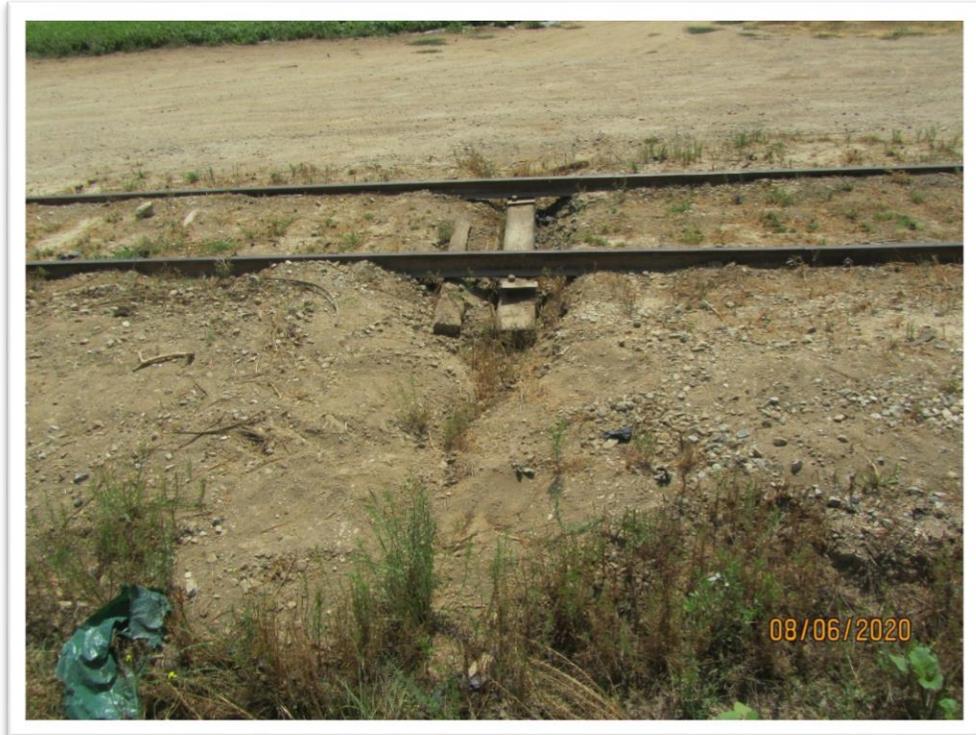
There is a missing/buried 18-inch CMP at MP 412.15. As a result, water is sheet flowing through the ties causing erosion around and under the tie. A similar issue of sheet flow through ties resulting in erosion was noted at MP 412.17. Replacement and/or a properly maintained BMP with adequate ballast is recommended at these locations.

Image 7. MP 412.15 Erosion

- E) There is a missing/buried 18-inch Corrugated Metal Pipe (CMP) at MP 412.15. As a result, water is sheet flowing through the ties causing erosion around and under the tie. A similar issue of sheet flow through ties resulting in erosion was noted at MP 412.17. Replacement and/or a properly maintained Best Management Practice (BMP) with adequate ballast is recommended at these locations.

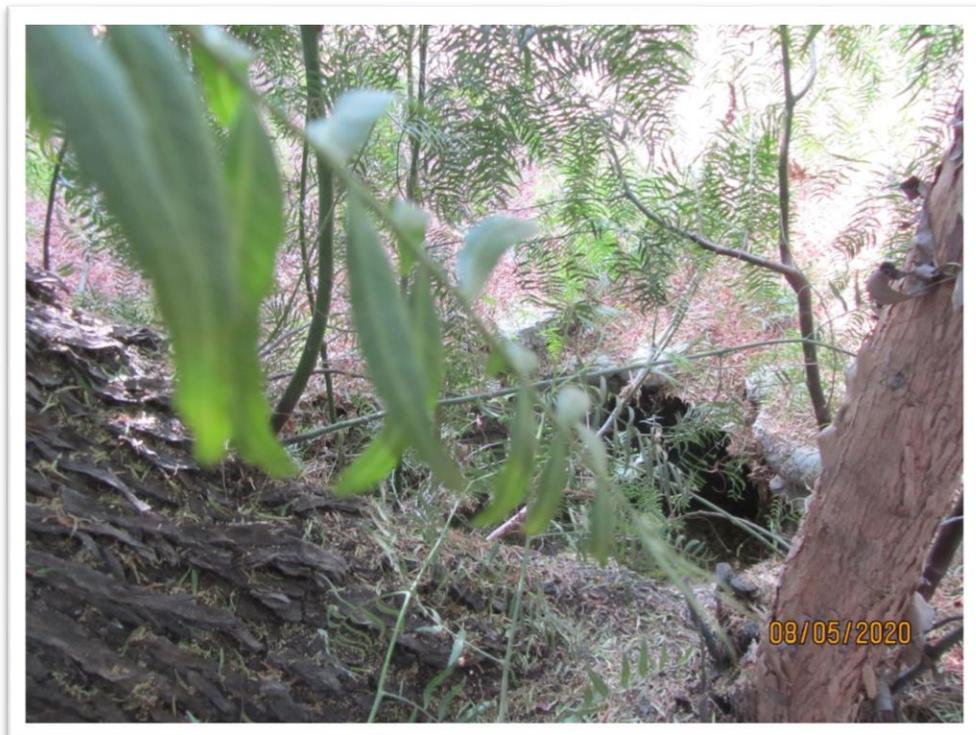
All pipe elements located were structurally sound. The majority present conditions of accumulated sediment and material inside and by the approaches of the pipes which could block the expected flow of water. It is recommended to maintain all BMP's to ensure proper flow of water as originally designed.

Image 8. MP 425.05 Tree Growing at 30" CMP Opening

- F) The majority of culvert elements present conditions of accumulated sediment and material inside and by the approaches of the pipes which could block the expected flow of water. It is recommended to maintain all BMP's to ensure proper flow of water as designed.

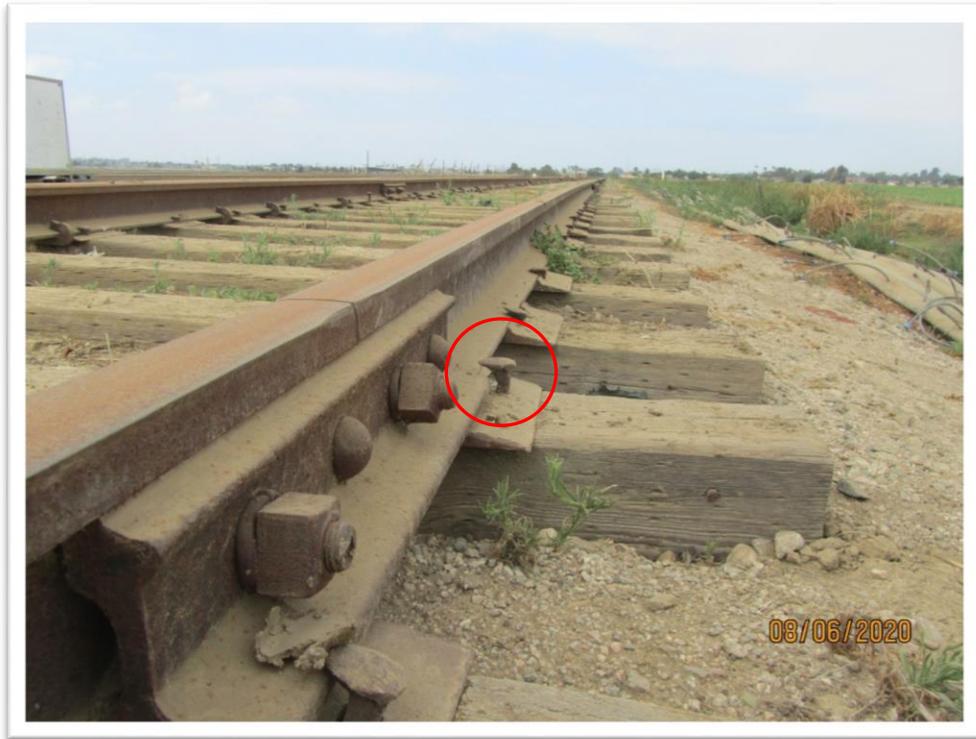
Approximately 15% of the existing ties at the SPBL show deterioration from decay in the spike areas. Most of these ties were observed on the eastern portion of the SPBL. Special attention should be provided around MP 421.5 and MP 428.0. Some ties along the corridor were covered in silt and could not be observed. Rotten spots completely covered by the tie plates are evident by loose spikes and hollow sound when stepping on top of them. The TSS requires sufficient effective ties in a track segment to hold gauge, surface and alignment. Using the TSS minimum crosstie numbers as maintenance standards is inadvisable, safe operations require more than the minimum number of effective crossties. As a point of reference, industrial branch lines should have around of 5 effective tangent crossties and 6 in curve per 39 feet (there are typically 24 crossties in a 39 foot rail).

Image 11. Example of loose spike in tie.

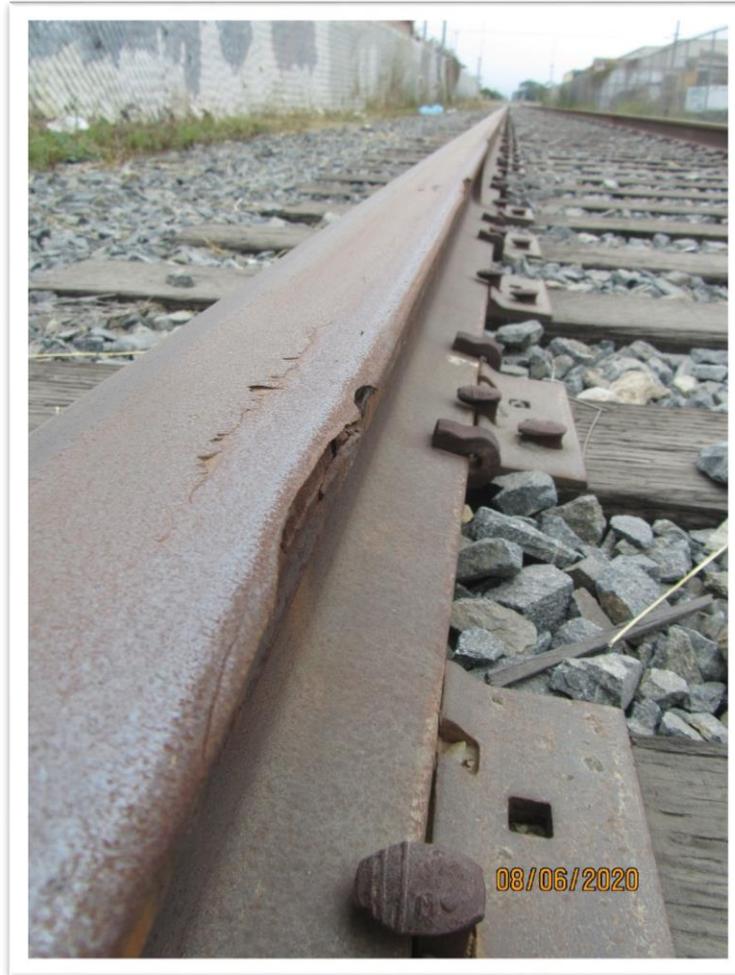
Shells are one type of rolling contact fatigue identified throughout the SPBL. Shells are identified as progressive horizontal separations, generally on the gauge side of the rail head, which may crack out at any level, usually at the upper gauge corner. Shelling may turn down to form a transverse separation and, once detected, is classified as a detail fracture. Uncapped or gutted shells will result in the dislodgement of parent metal from the rail section.

Image 12. 132# Rail Gauge Side Shell Showing Parent Metal Decay, MP 407.55

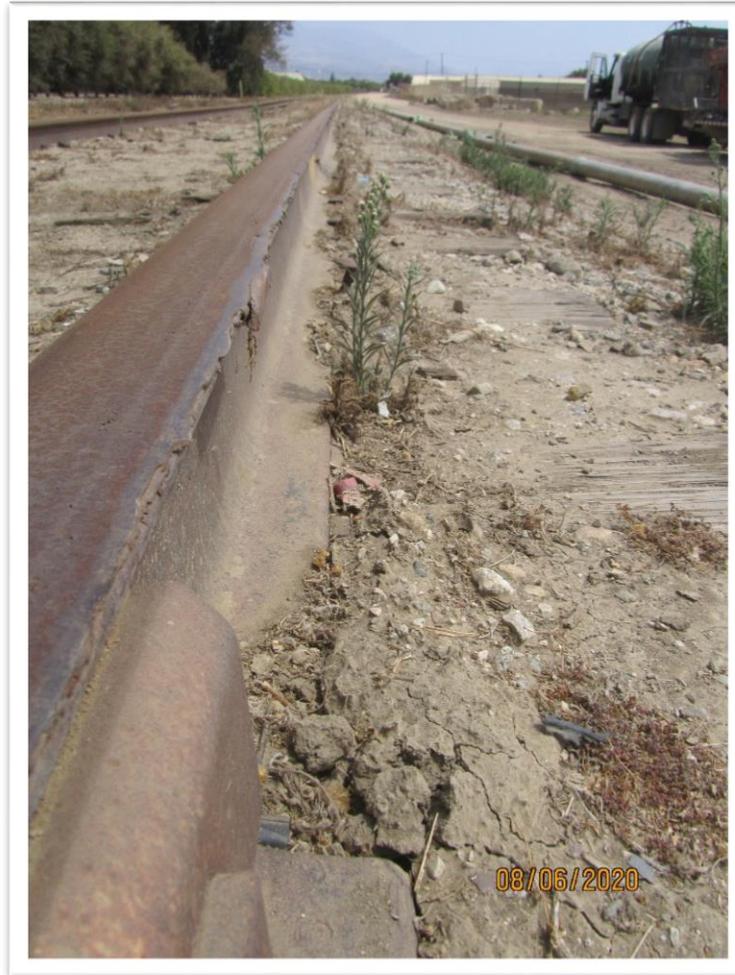
Much of the rail along the SPBL appears to have swapped with opposite (outer) gauge side rail. This is evident from signs of grinding and/or metal decay shown on the opposite rail gauge side as shown in the photo below.

Image 13. Rail Opposite Gauge Side Shell Showing Parent Metal Decay, MP 411.10

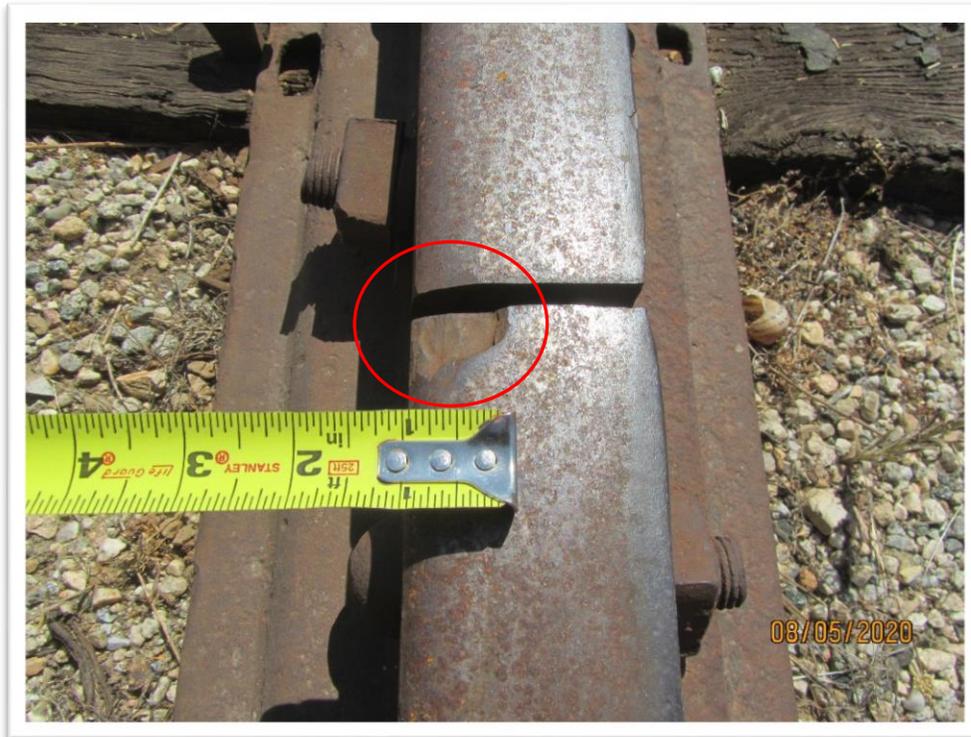
No major rail defects were identified during the SPBL spot-check. Special attention must be given to rail conditions not covered by the TSS, such as chipped rail ends found at numerous joint locations, and several areas presenting rolling contact fatigue (metal flow) along the tracks.

Image 14. Chipped Rail end at MP 422.5

Remedial actions for rail defects should be addressed immediately upon discovery. Generally, rail replacement is the best long-term solution for rail defects, with the remedial actions governing operations before removal of the defective rail. The assigned person (designated by TSS) must visually supervise each operation over the chipped rail ends found at SPBL until rail sections are replaced.

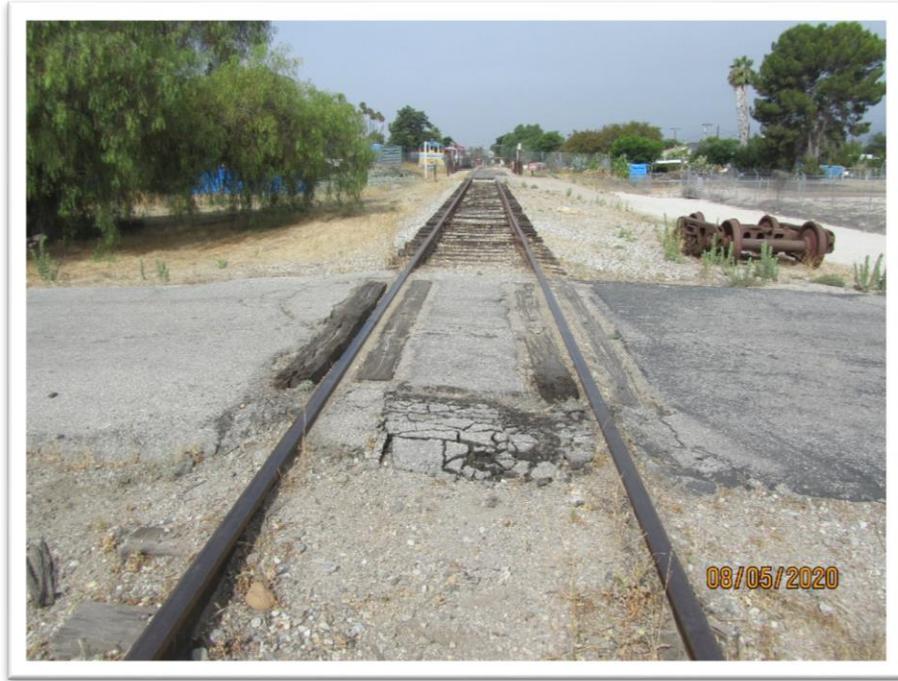
The Texaco Private at-grade crossing located at MP 424.98 is recommended to be upgraded. This crossing consists of deteriorated wood with exposed rebar which could cause damage to vehicular traffic.

Image 84. MP 424.98 Texaco Private At-Grade Crossing.

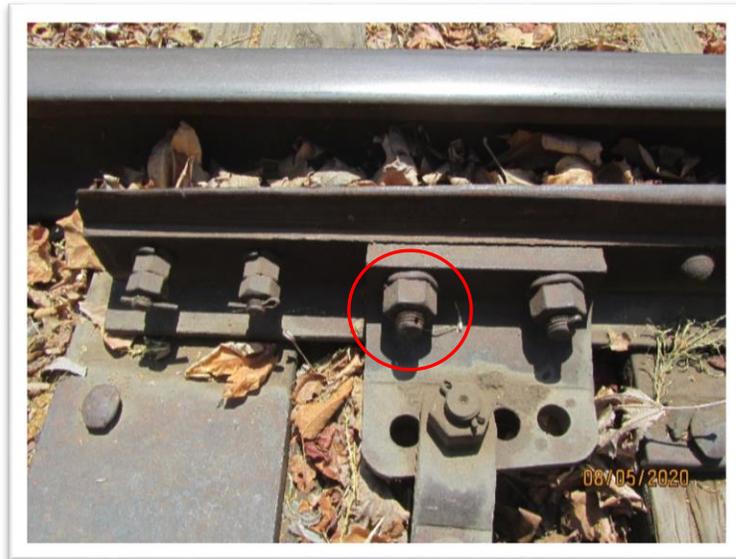
Switch 3860 at MP 424.24 and switch 3864 at MP 424.44 are missing cotter pin. It is recommended all switches shall have functional cotter pins.

Image 99. Switch 3860 Missing Cotter Pin
