# BRIDGE INSPECTION REPORT

INSPECTION TYPE: Annual

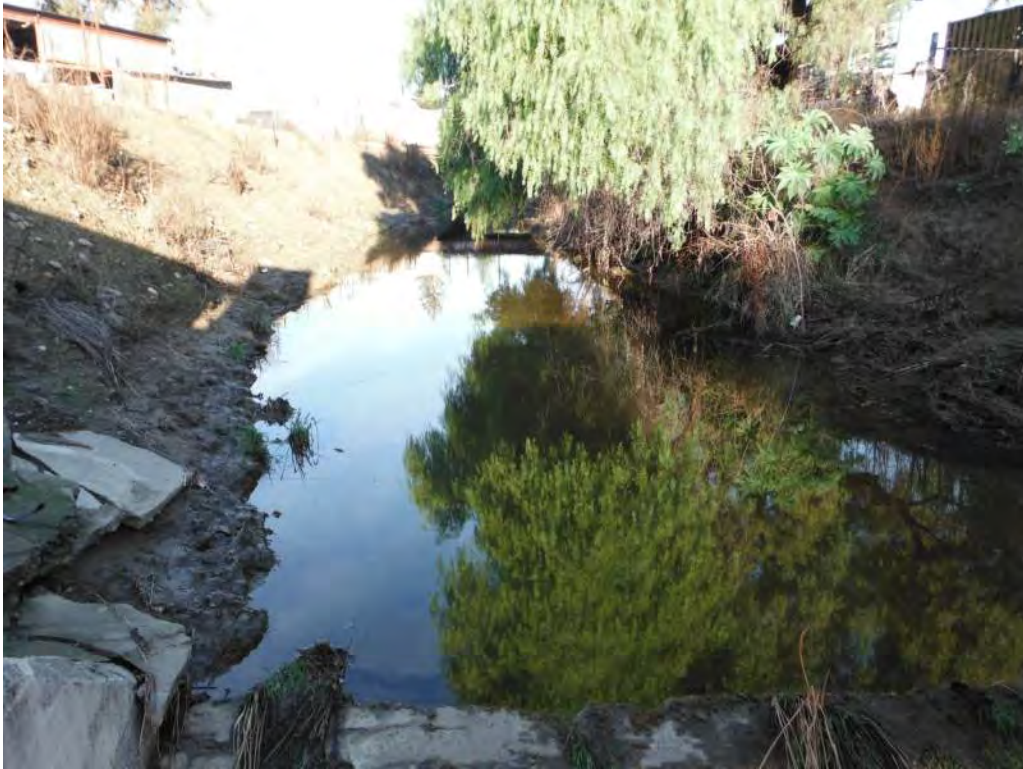
**407.48 Channel Condition – Looking Upstream**

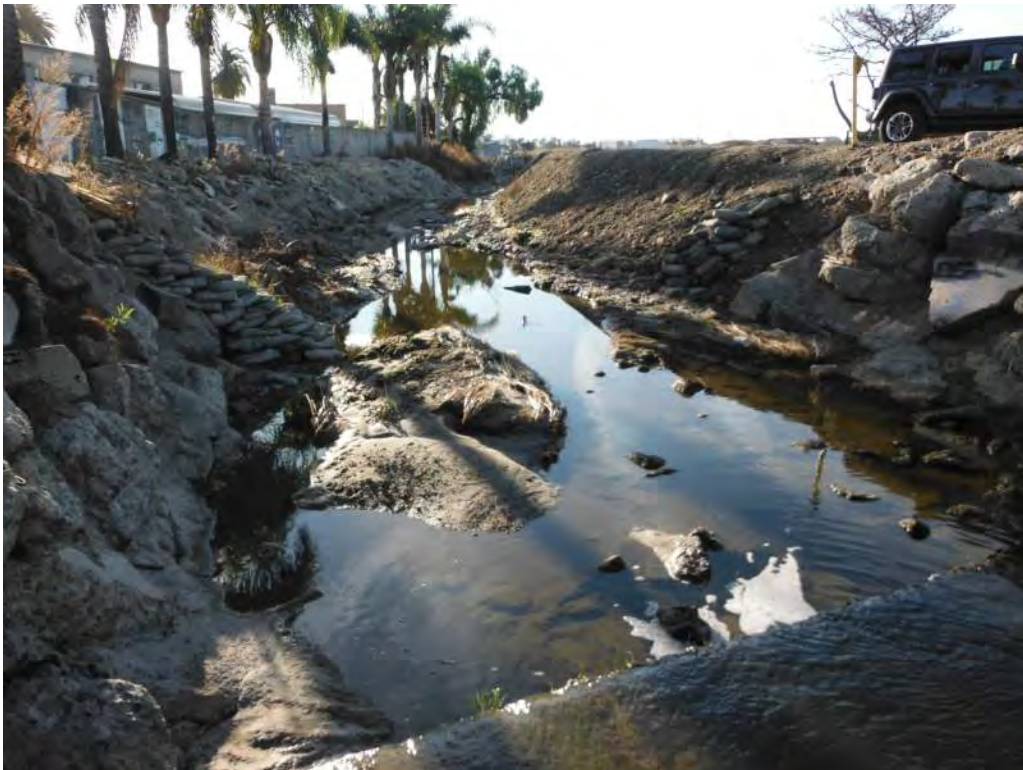
**407.48 Channel Condition – Looking Downstream**

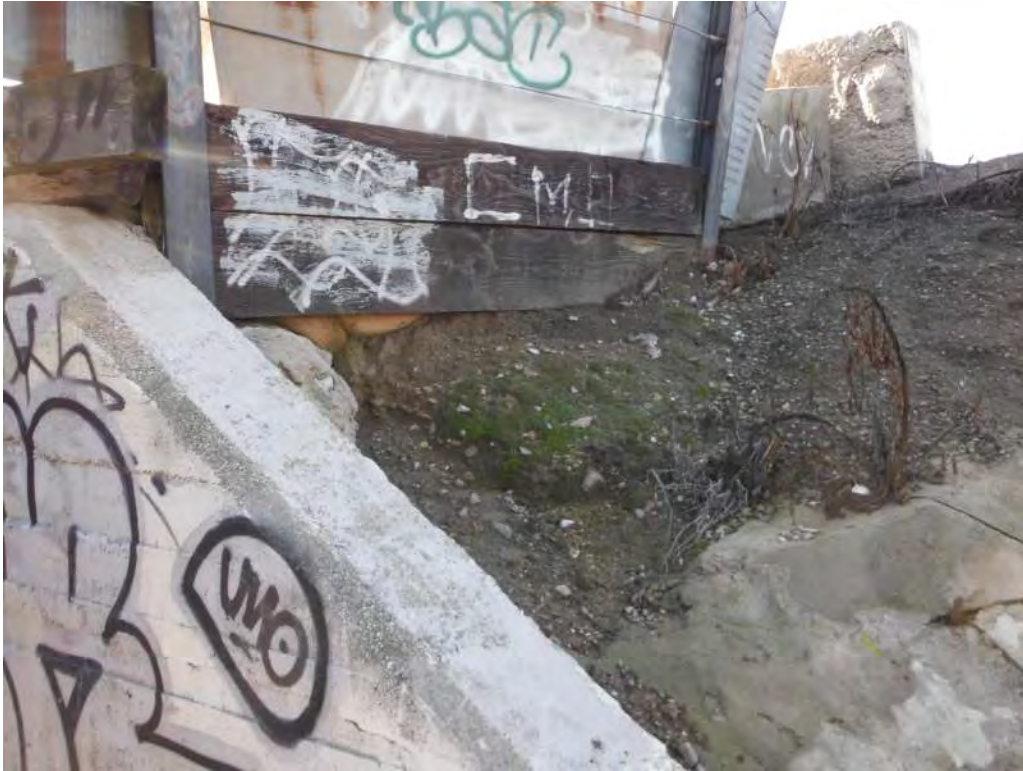
**407.48 Northwest Wingwall Undermining**

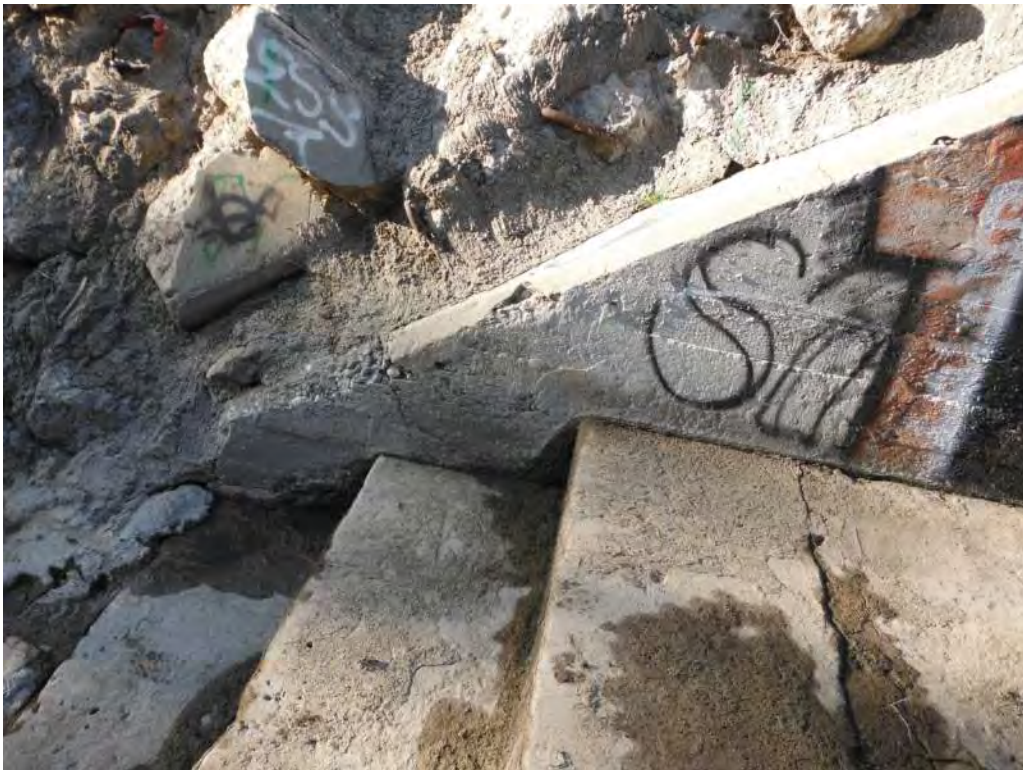
**407.48 Southwest Wingwall Crack**

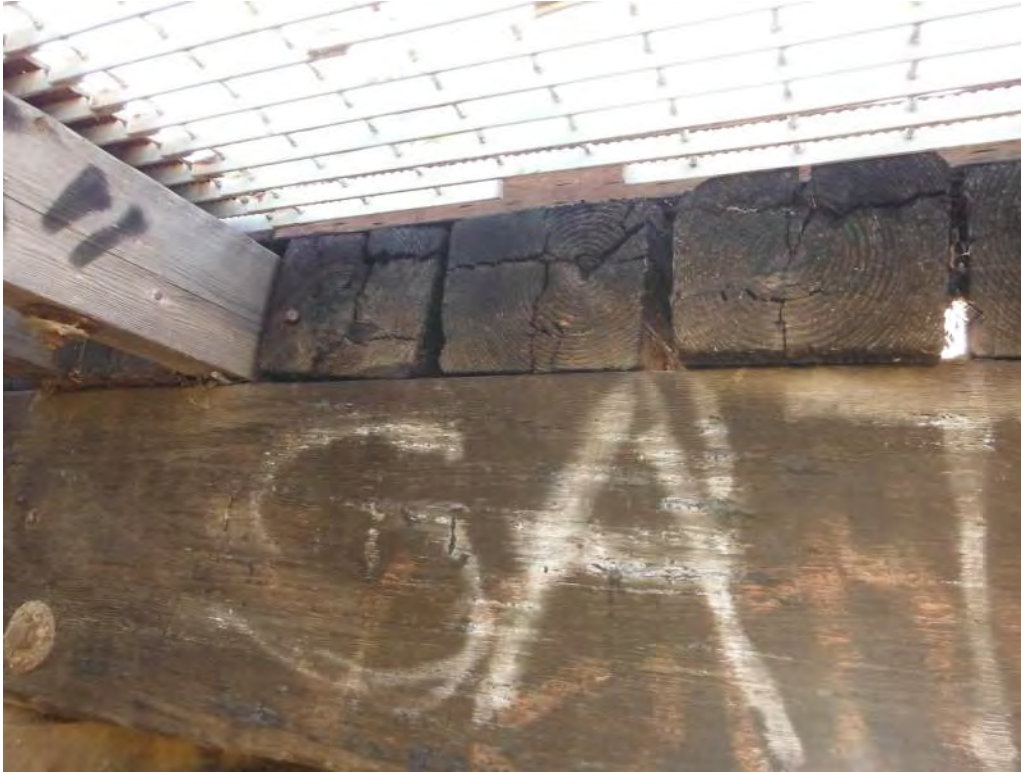
**407.48 Typical Tie Condition - Split**

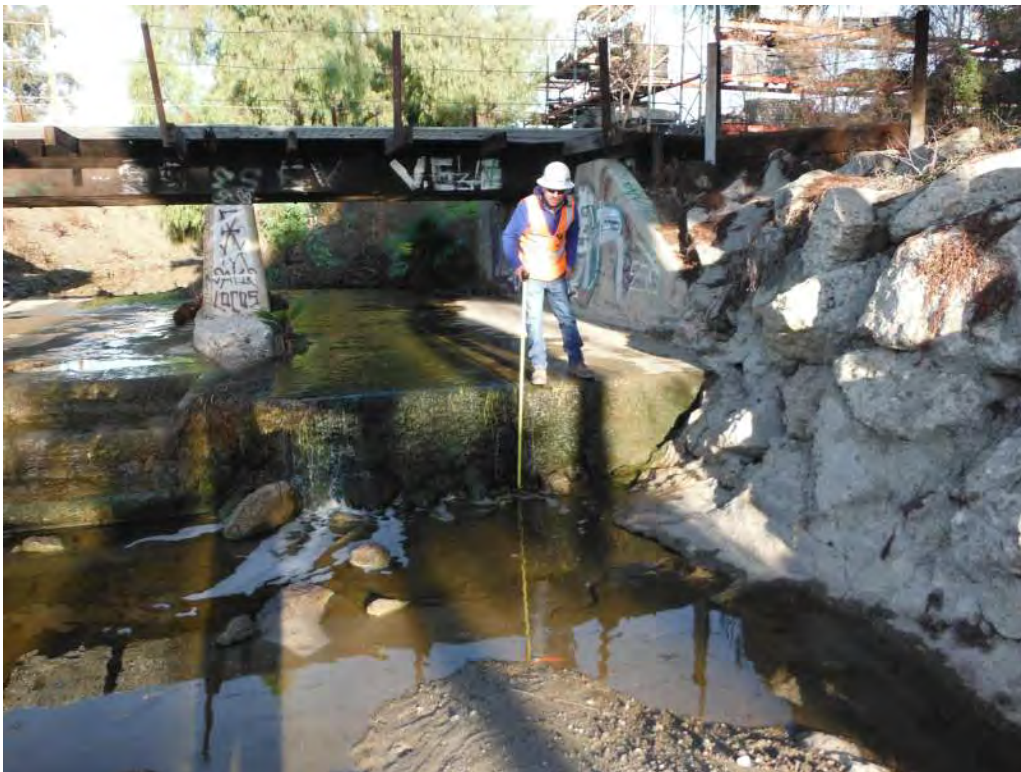
**407.48 Scour at Downstream End of Channel Paving – approximately 3'**

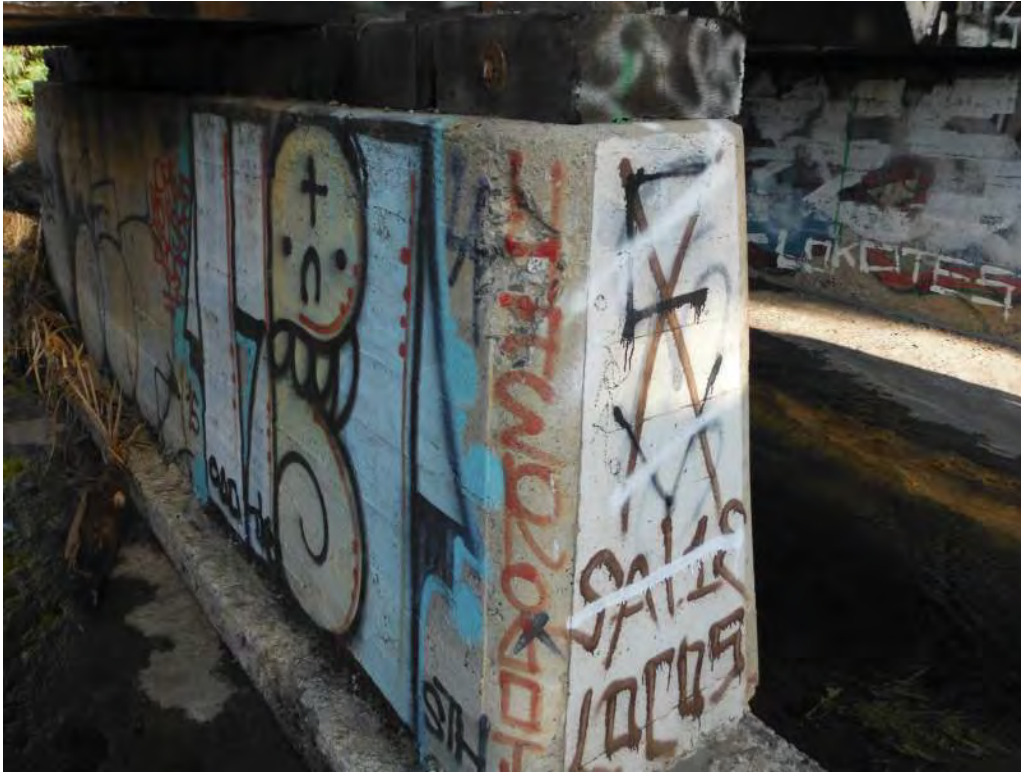
407.48 Spall on south side of Pier 2

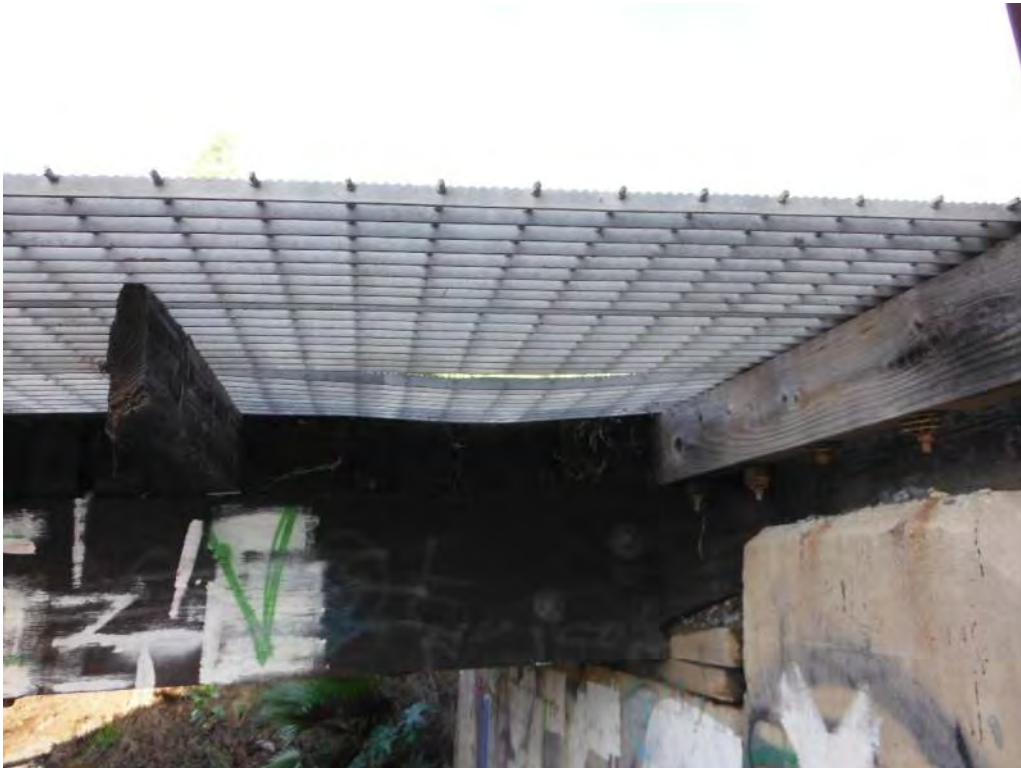
407.48 SE Walkway Panel Deflection Damage

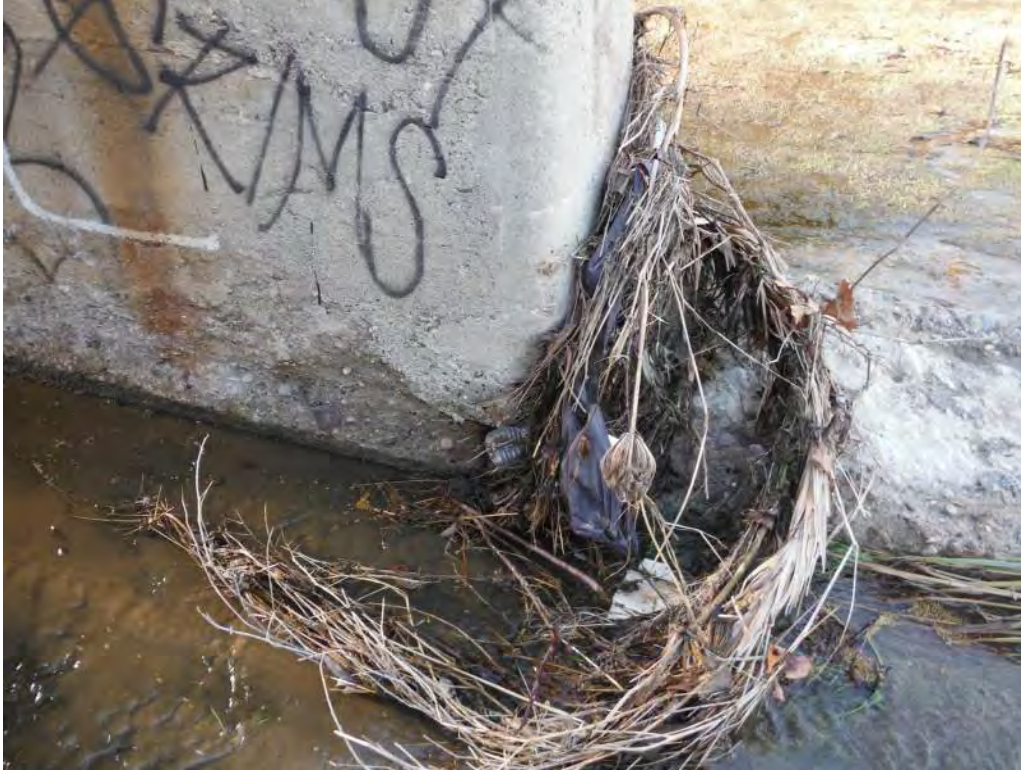
**407.48 Spall and debris on upstream side of Pier**

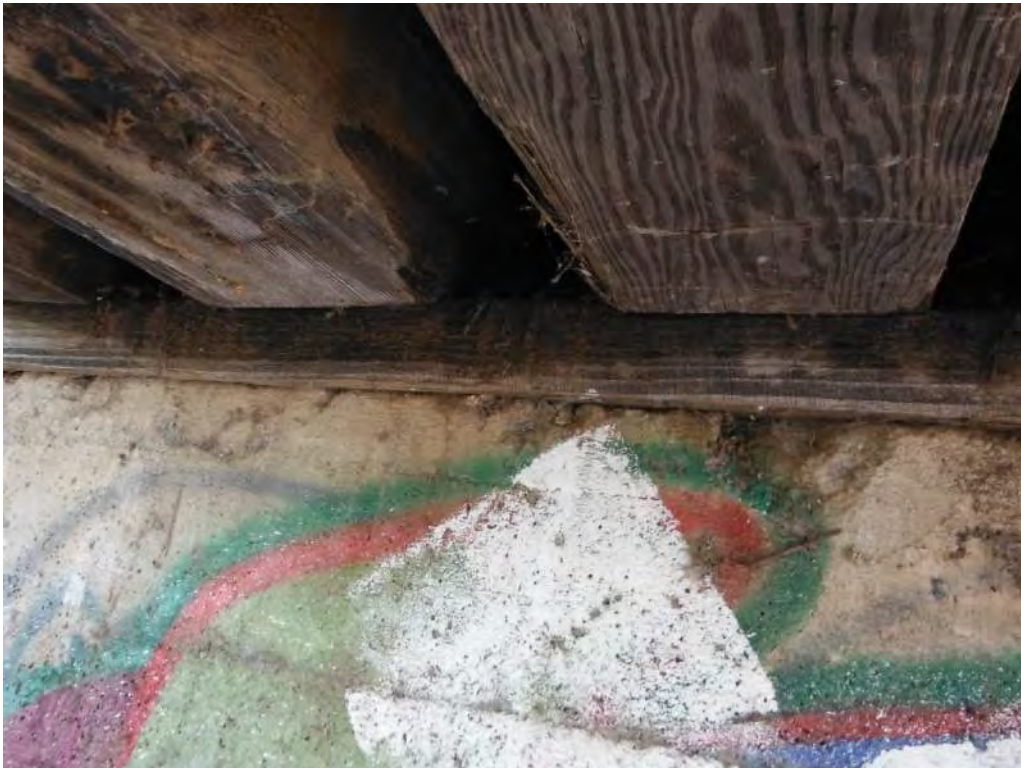
**407.48 Stringers crushing  $\frac{1}{4}$ " at Abutment 3**

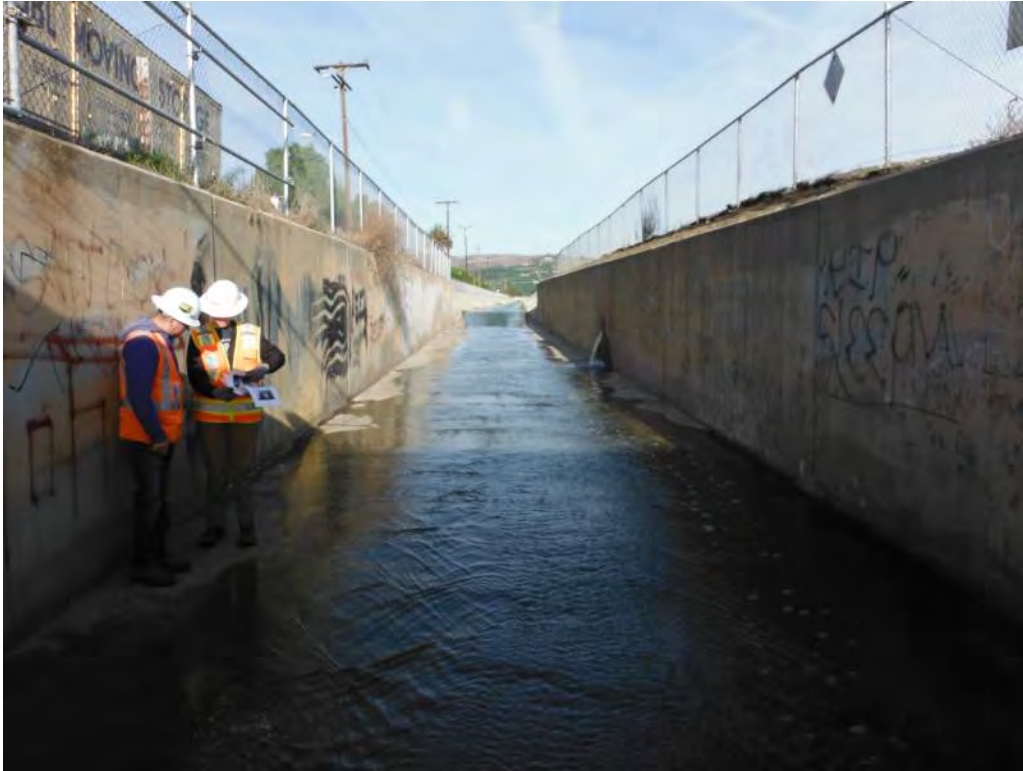
**408.02 Channel Condition - Looking Upstream**

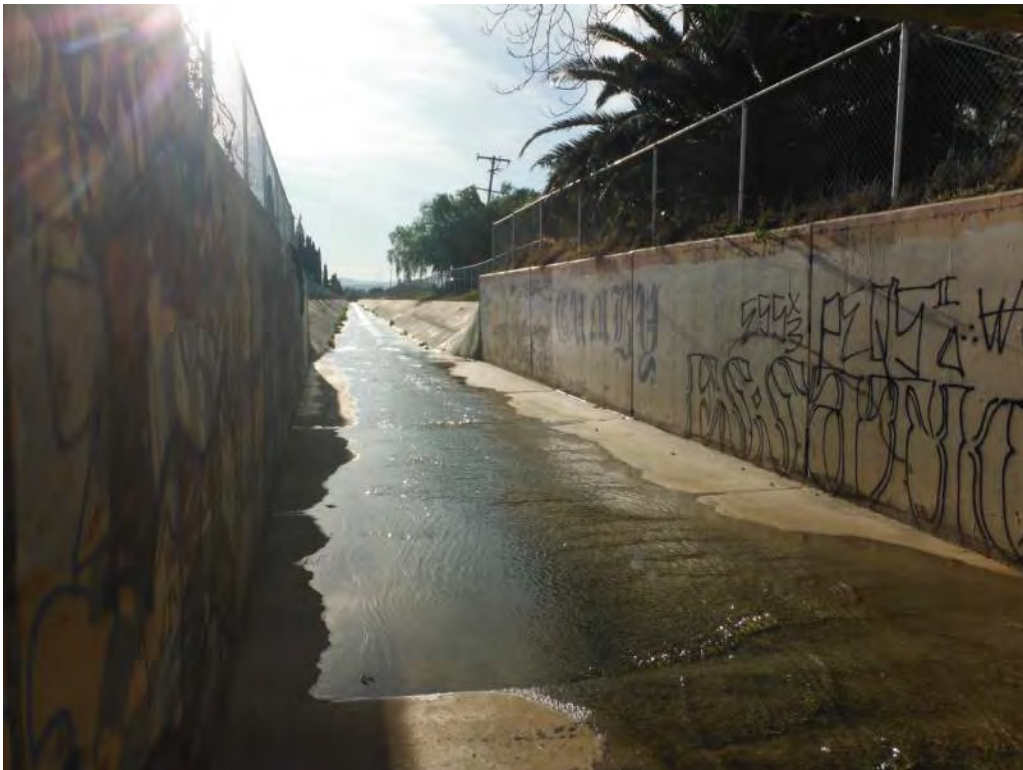
**408.02 Channel Condition - Looking Downstream**

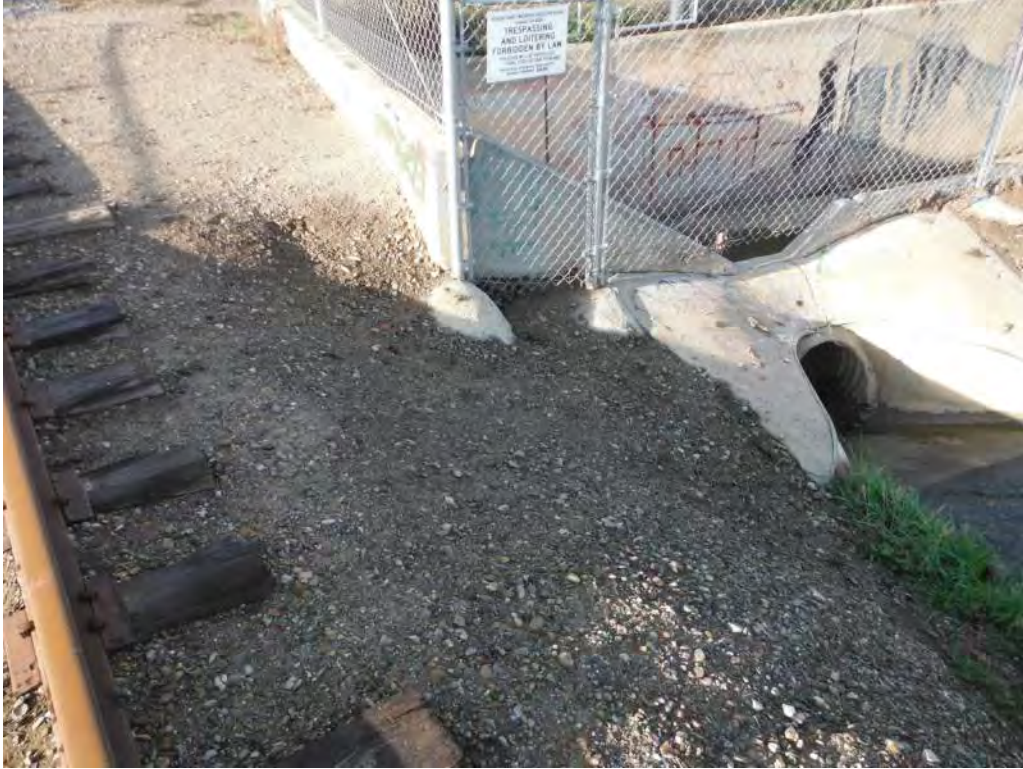
**408.02 Fouled Ballast across Culvert**

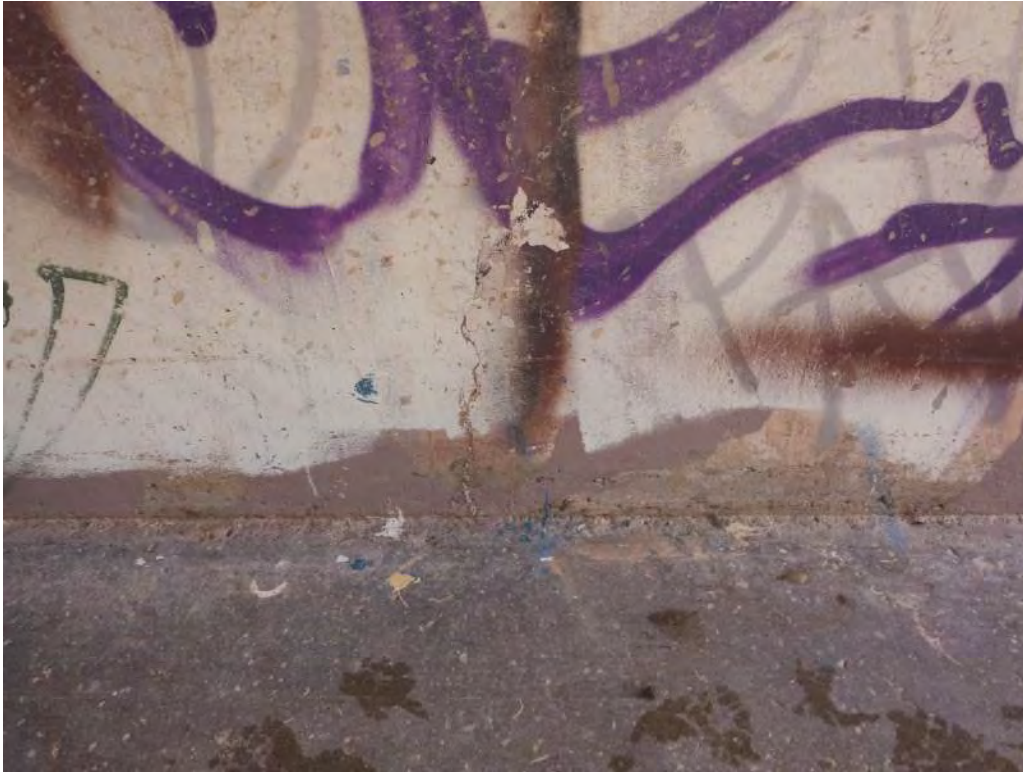
**408.02 Vertical crack center of Abutment (typ.)**

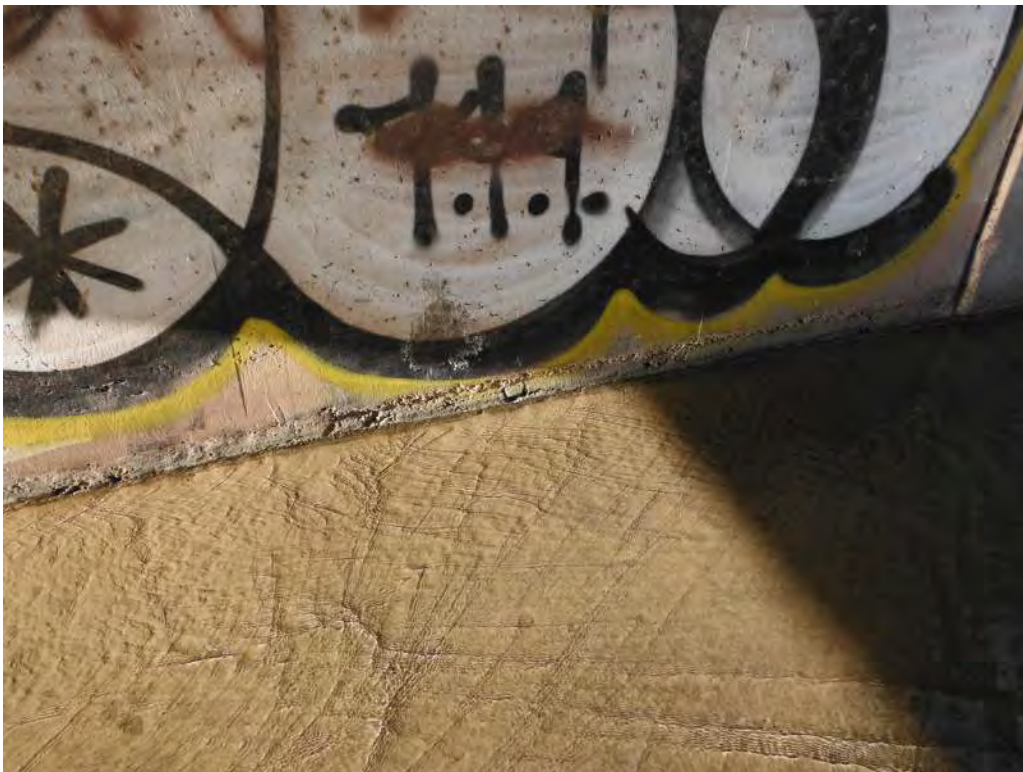
**408.02 Scaling at base of Abutment #1**

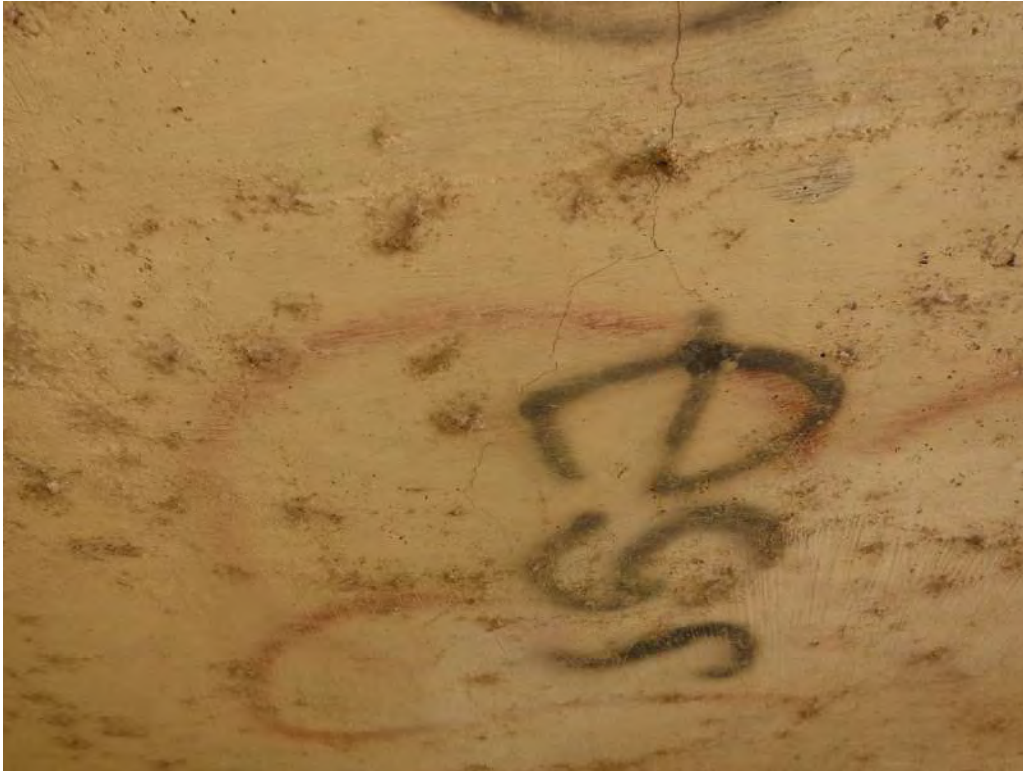
**408.02 Hairline cracking underside of top slab, south side**

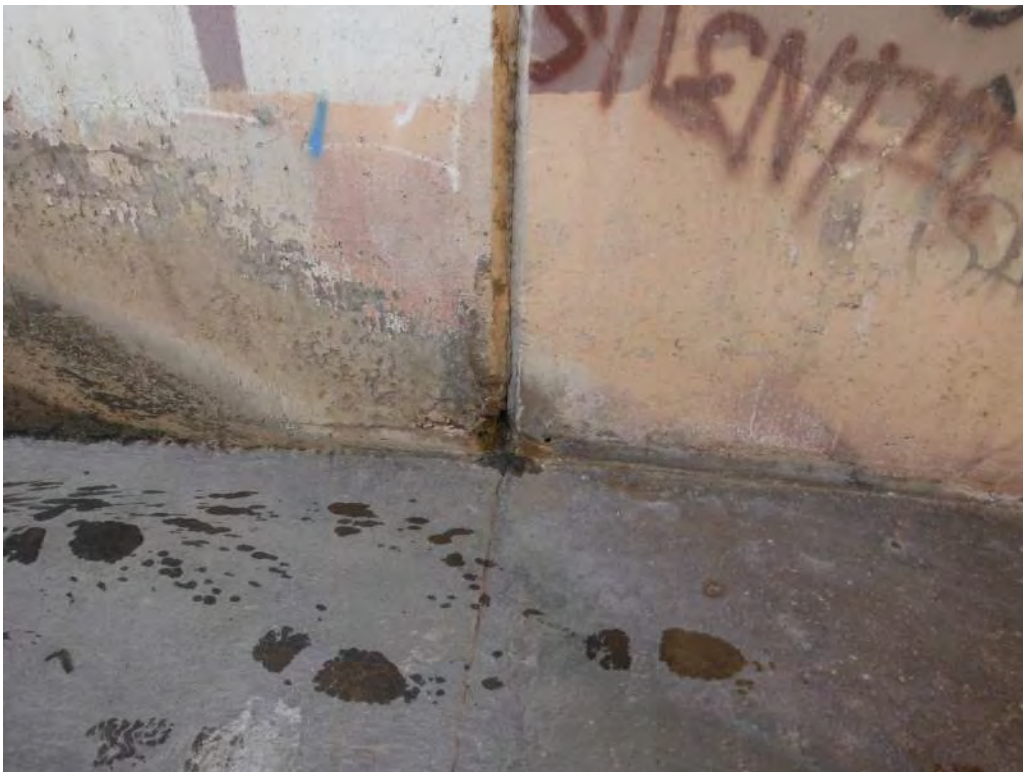
**408.02 Spall at NE wingwall**

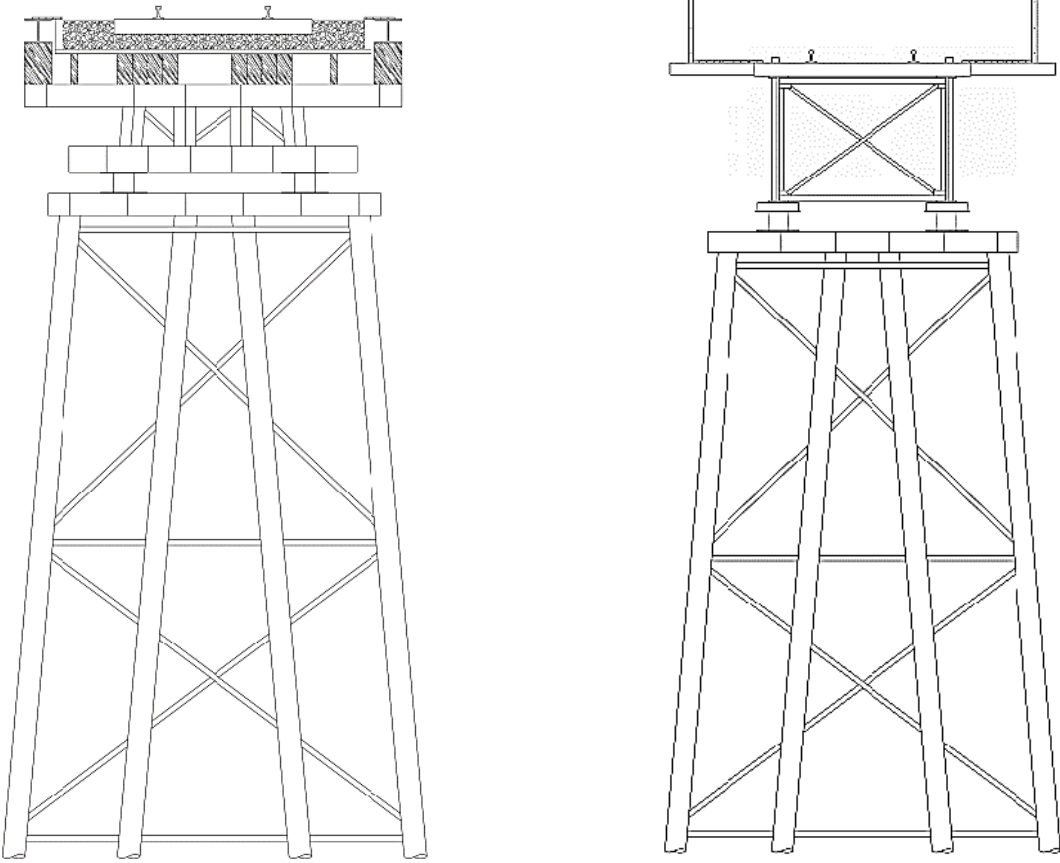
Description: Looking West/East Respectively - Steel Built-up Cap with H14x89 Piles, Plates Welded to Piles at Base				
Remarks:				
1. Top of built-up bent is slightly rotated - see photo				
Inspected By:	Joseph Holste, PE		Date Inspected:	12/11/2019

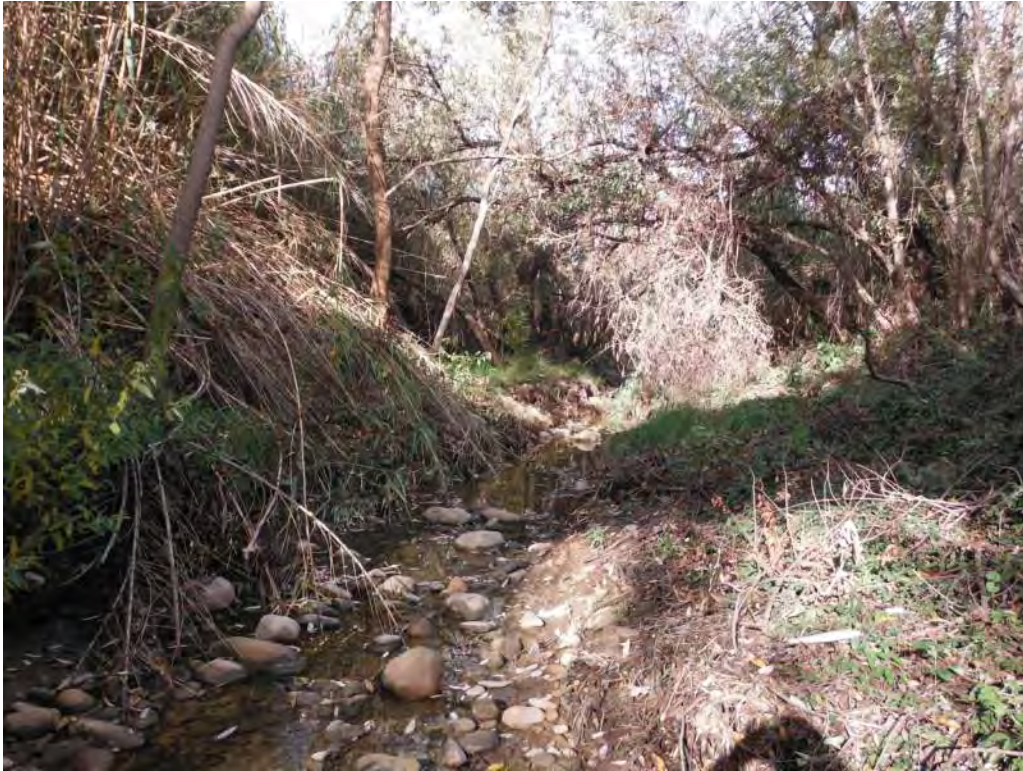
**408.84 Channel Condition - Looking Upstream**

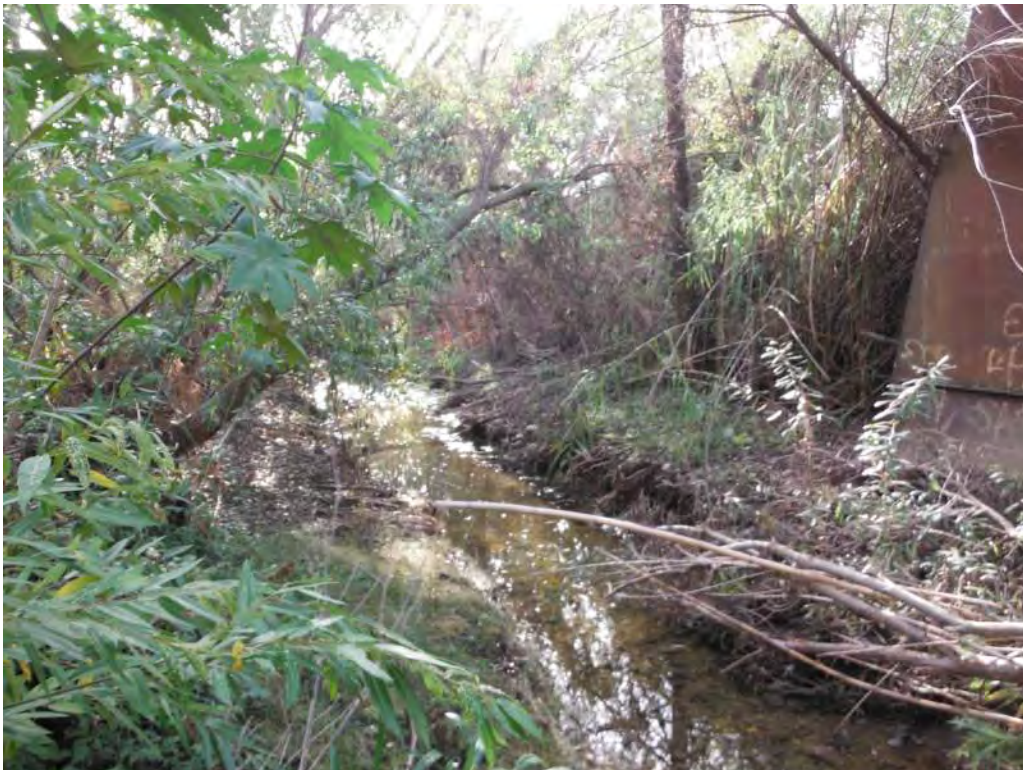
**408.84 Channel Condition - Looking Downstream**

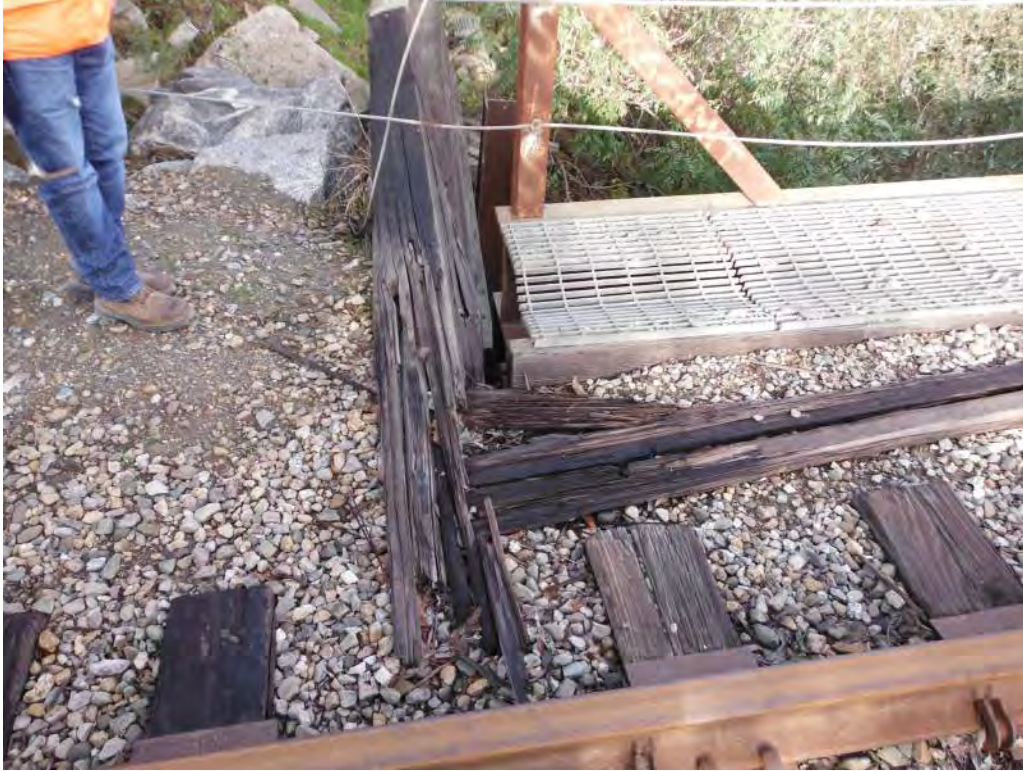
**408.84 Rotten/failing backwall at Abutment 1**

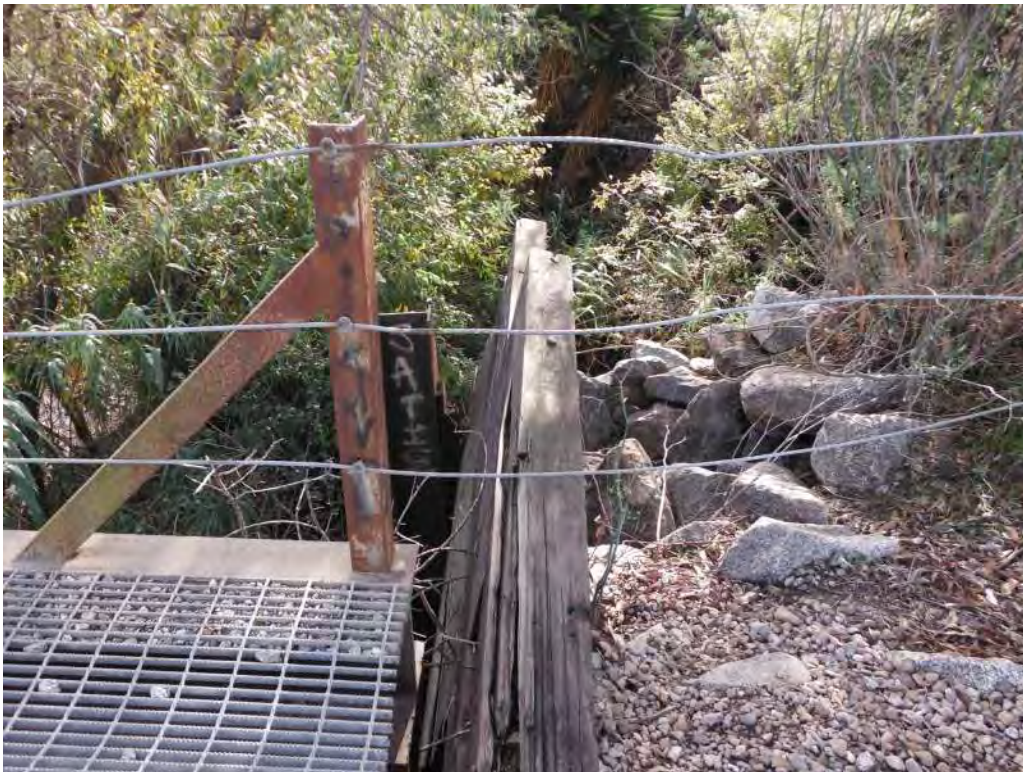
**408.84 Abutment 1 backwall leaning**

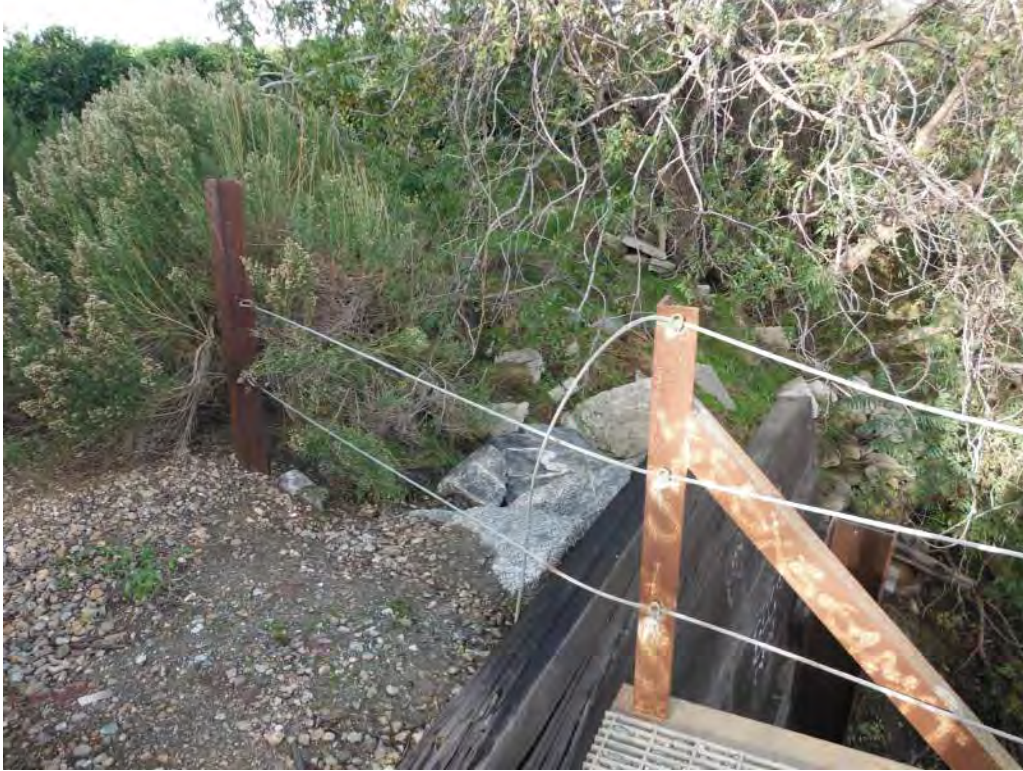
**408.84 Loose/broken handrail cable – Span 1 north side**

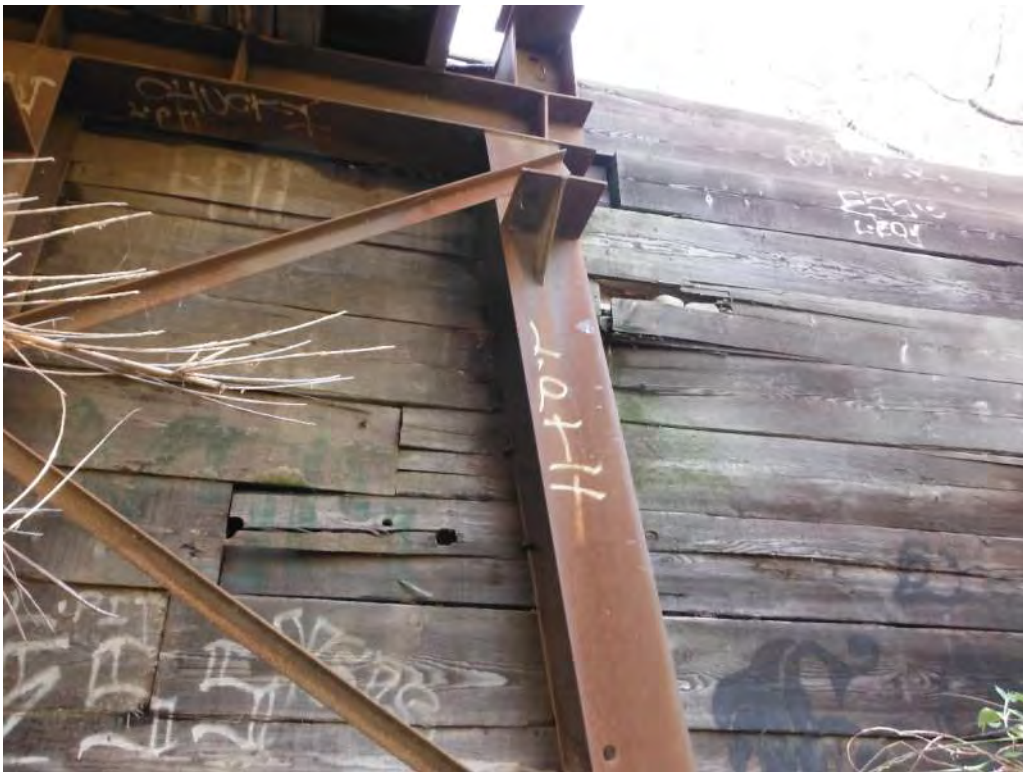
**408.84 Abutment 1 Backwall rotten**

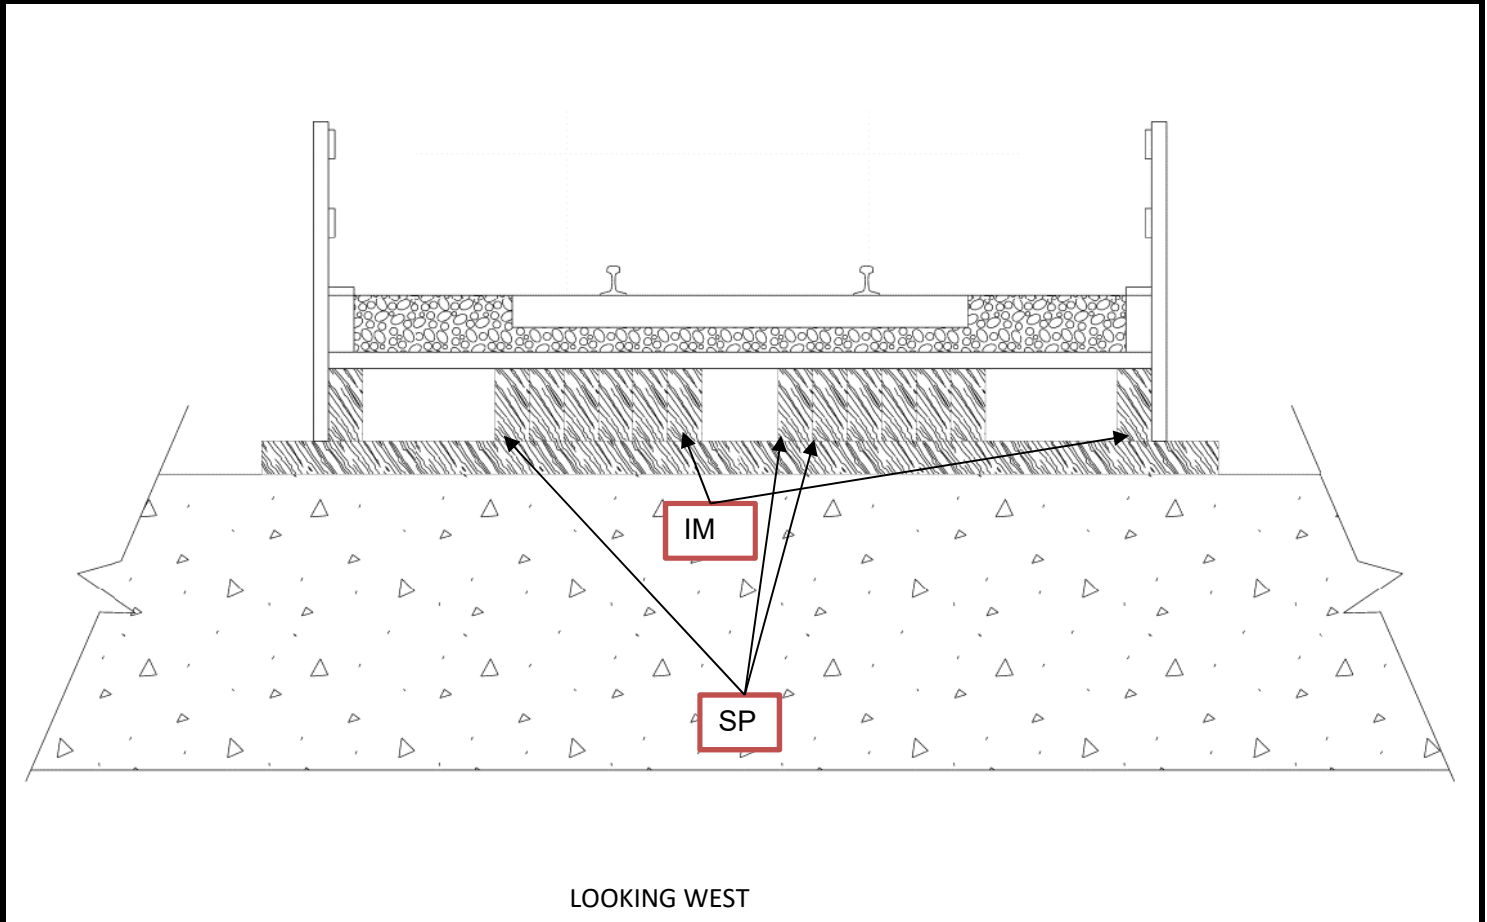
Description: Looking West - (14) Stringers - 8"x17.5", Concrete Abutment			
Remarks:			
1. SP- Stringers 6 , 7, and 13 split - see photo			
2. IM- Impact damage on stringer 1 and 8 - see photo			
3. Wingwall leaning on south side, erosion behind wingwall - see photo			
Inspected By:	Joseph Holste, PE	Date Inspected:	12/11/2019

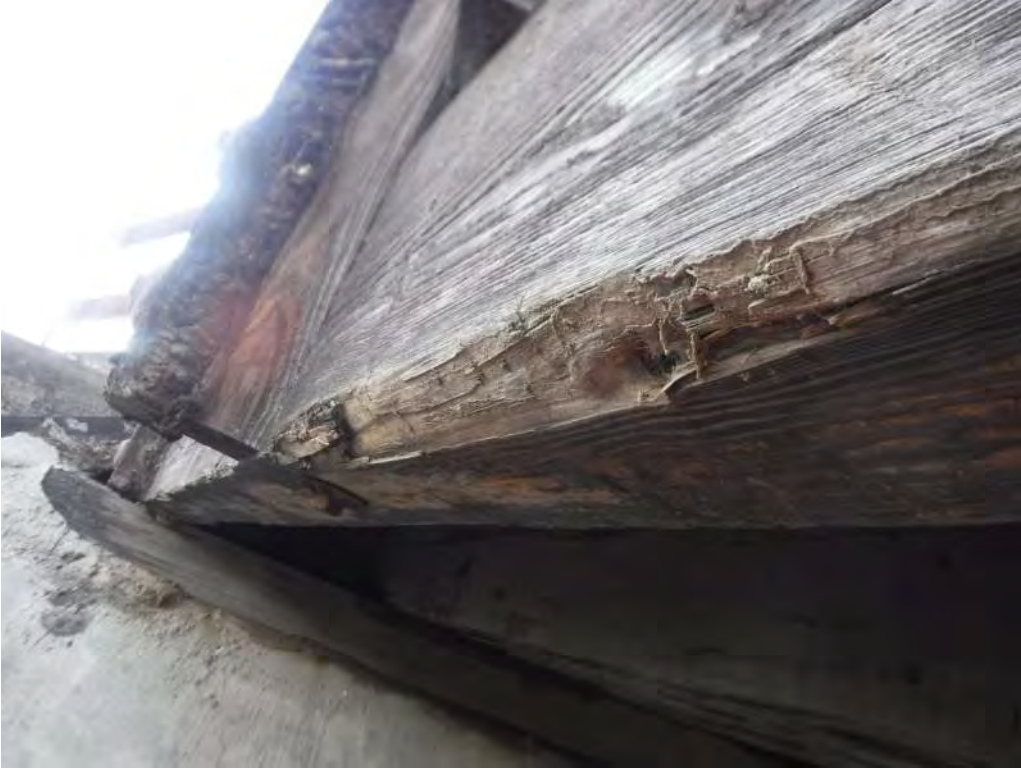
**409.74 Stringer 1 impact damage**

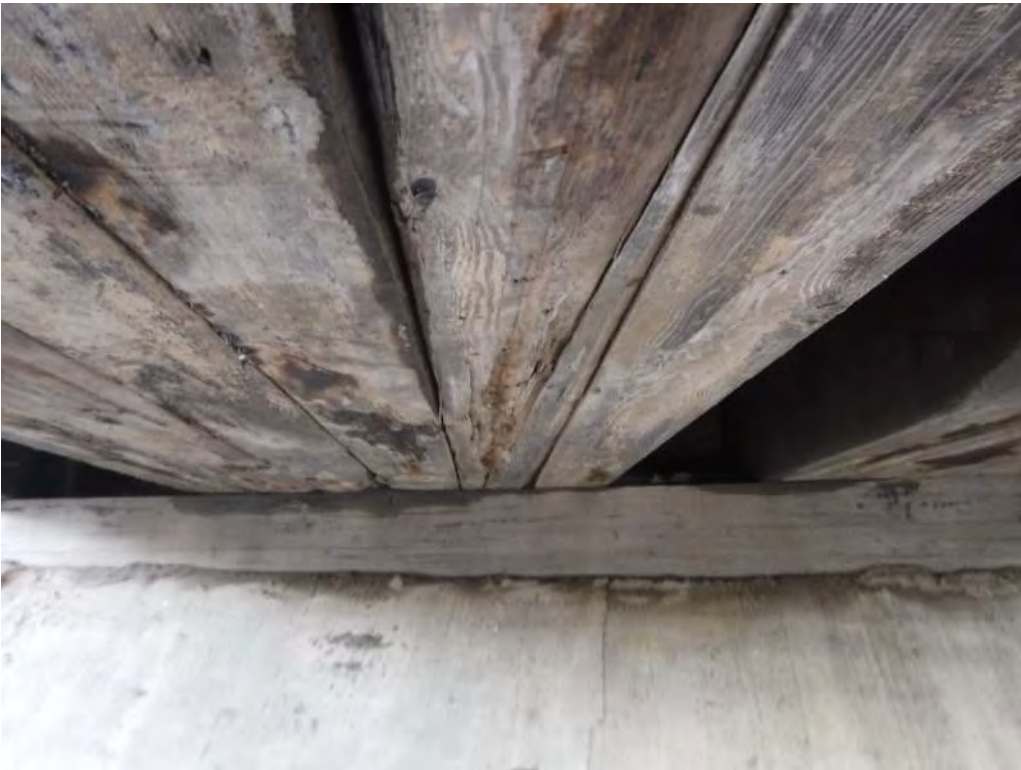
**409.74 Stringer 6 split**

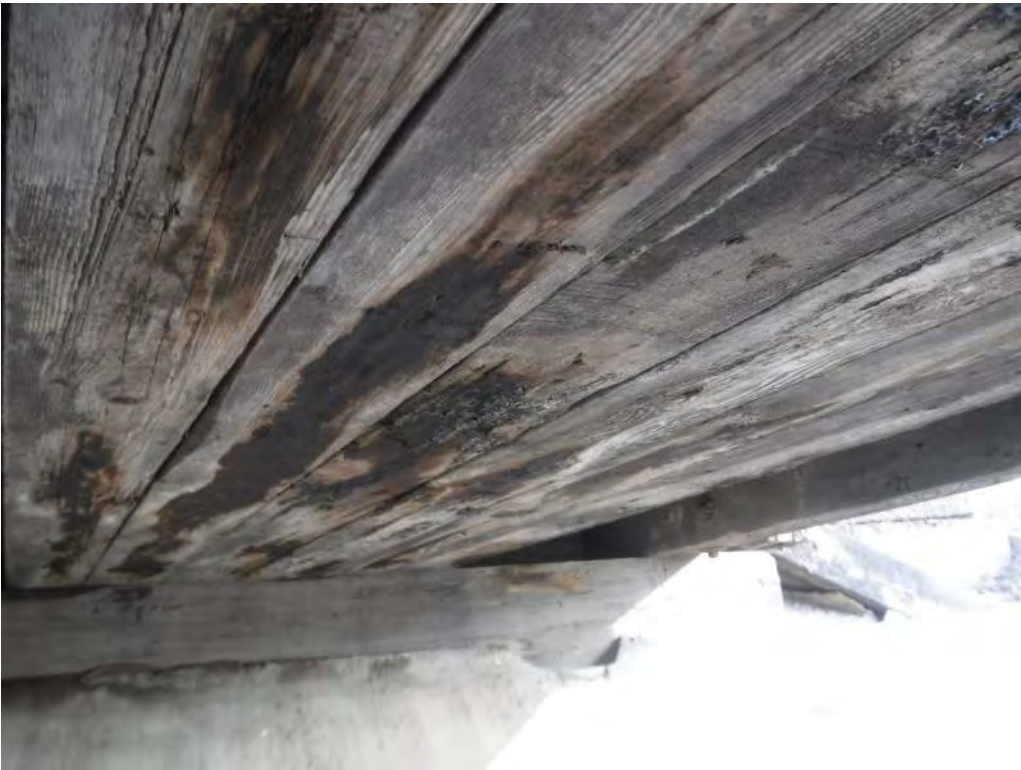
**409.74 Stringer 8 impact damage**
