# BRIDGE INSPECTION REPORT

INSPECTION TYPE: Annual

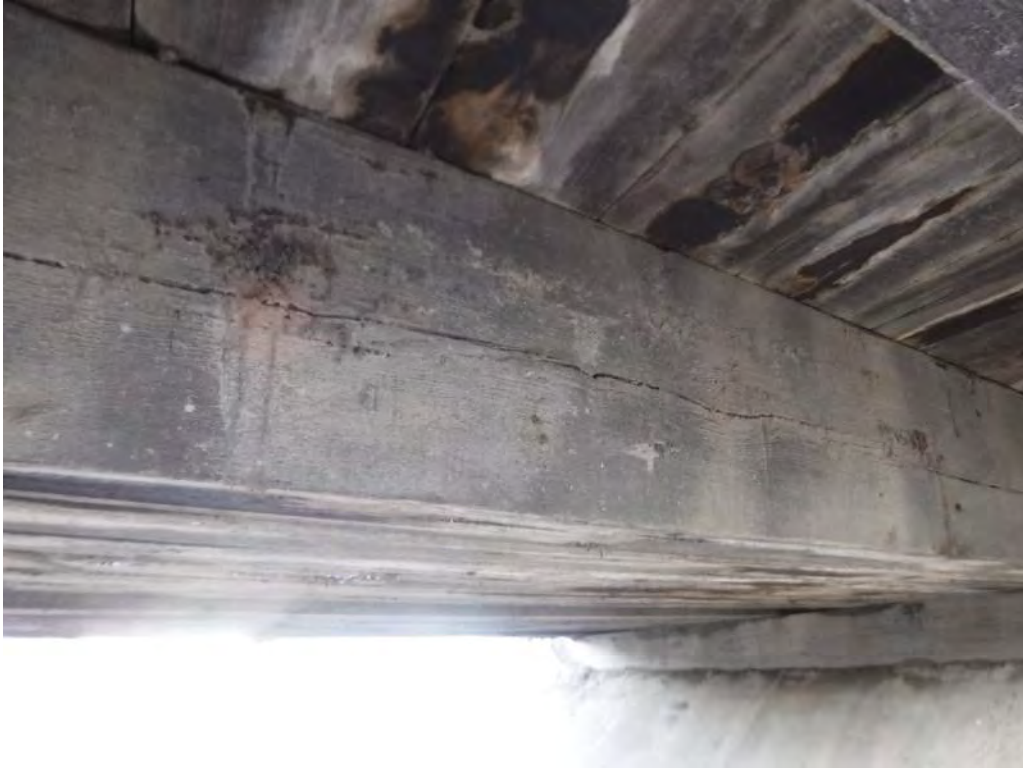
**409.74 Stringer 13 split on vertical face**

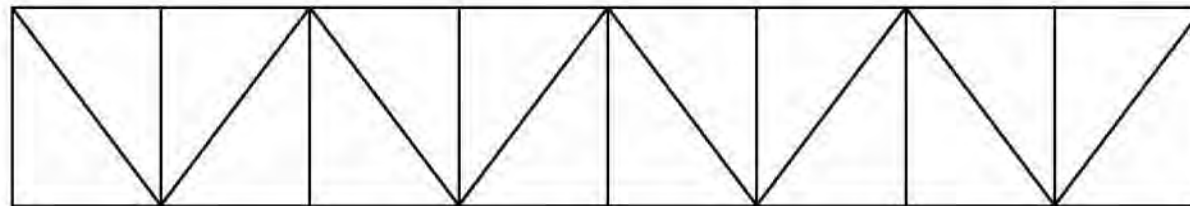
BRIDGE INSPECTION REPORT --- STEEL STRUCTURE/CONCRETE ABUTMENT					
Span:	1	Alignment:	TANGENT	Vert. Clear:	5'-10"
				Bridge No.	410.40
DETAILS - ABUTMENT NUMBER: 1			Span Length:		39'
<b>Description: Looking West - Steel Deck Plate Girders, Concrete Abutment</b>					
<b>Remarks:</b>					
1. SP - Minor spalling on backwall - see photo					
2. UM - Undermining and scour behind NW wingwall upstream - see photo					
3. FL - Open flange holes near bearing - see photo					
4. DEB - Debris around bearings - see photo					
5. Hole in ballast due to undermining of ballast retainer - see photo					
6. Appears to have had equipment run over grating and is causing tripping hazard - see photo					
Inspected By:		Joseph Holste, PE		Date Inspected:	12/11/2019

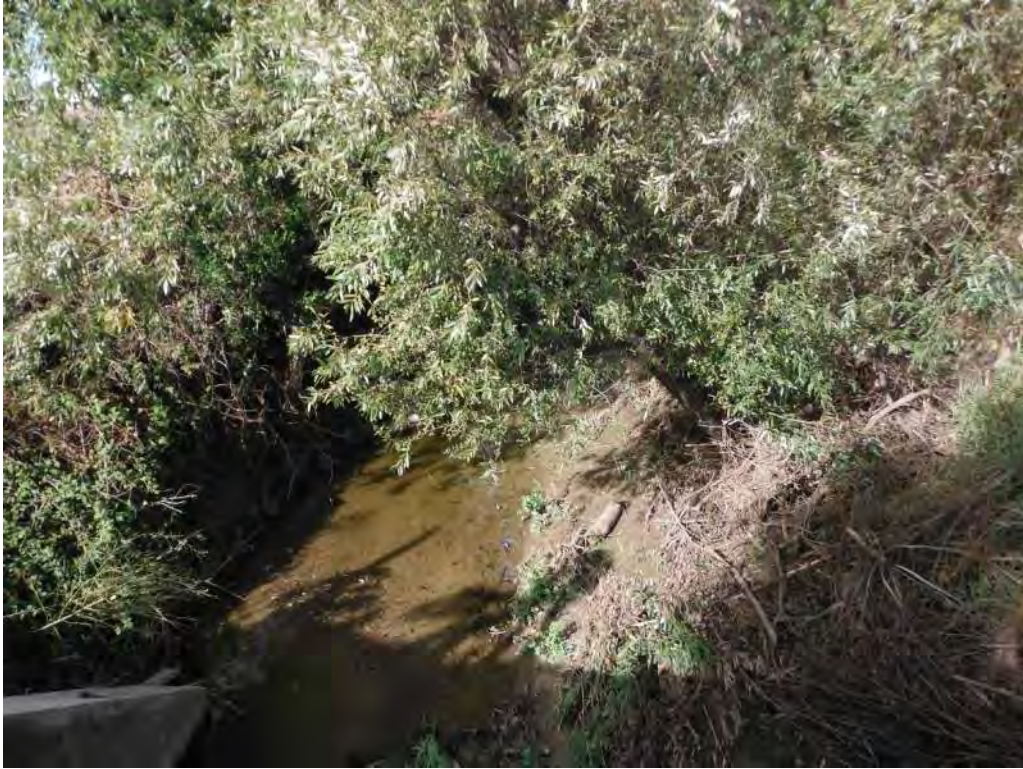
**410.40 Channel Condition - Looking Upstream**

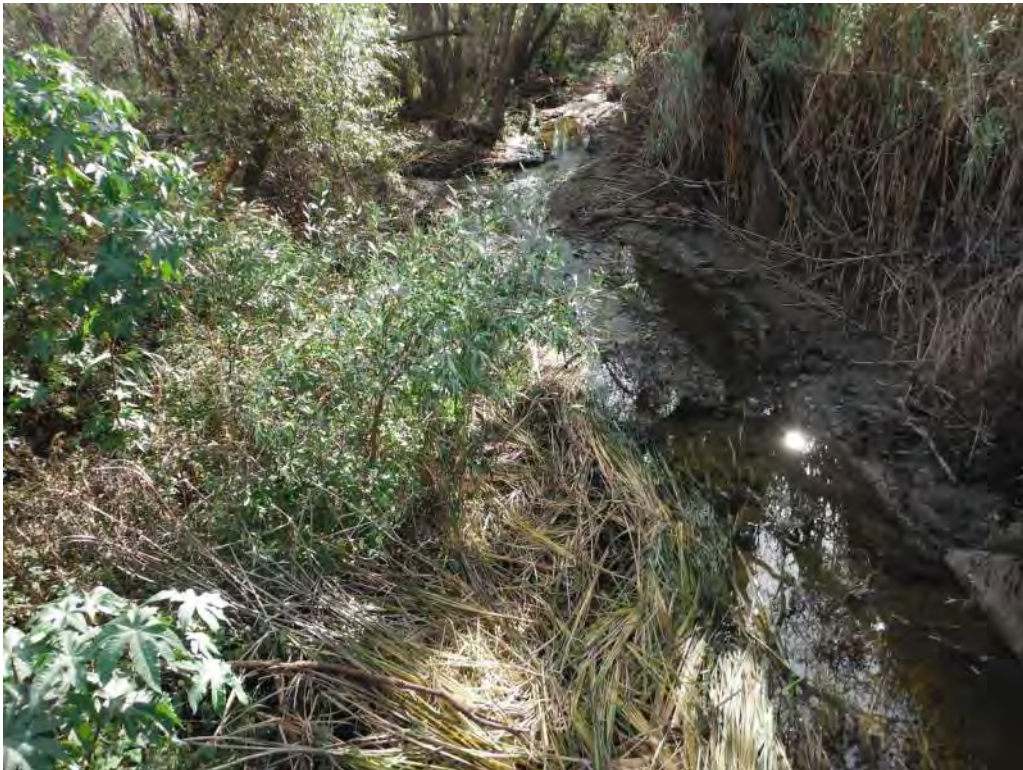
**410.40 Channel Condition - Looking Downstream**

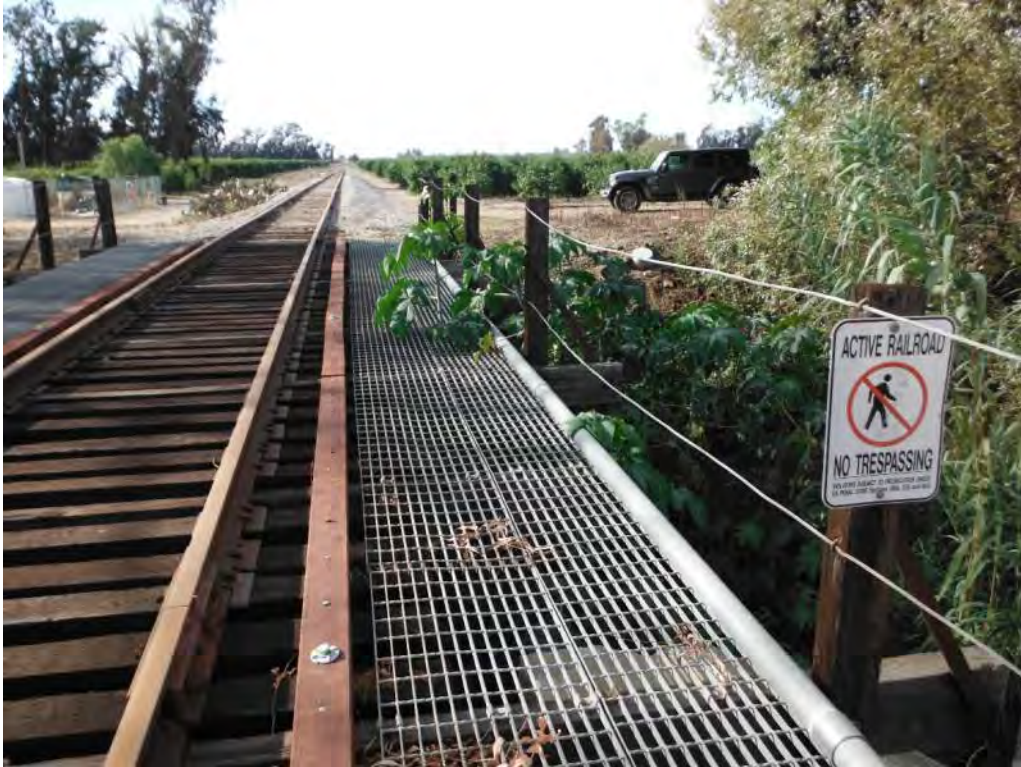
**410.40 Loose handrail cables (Typ.)**

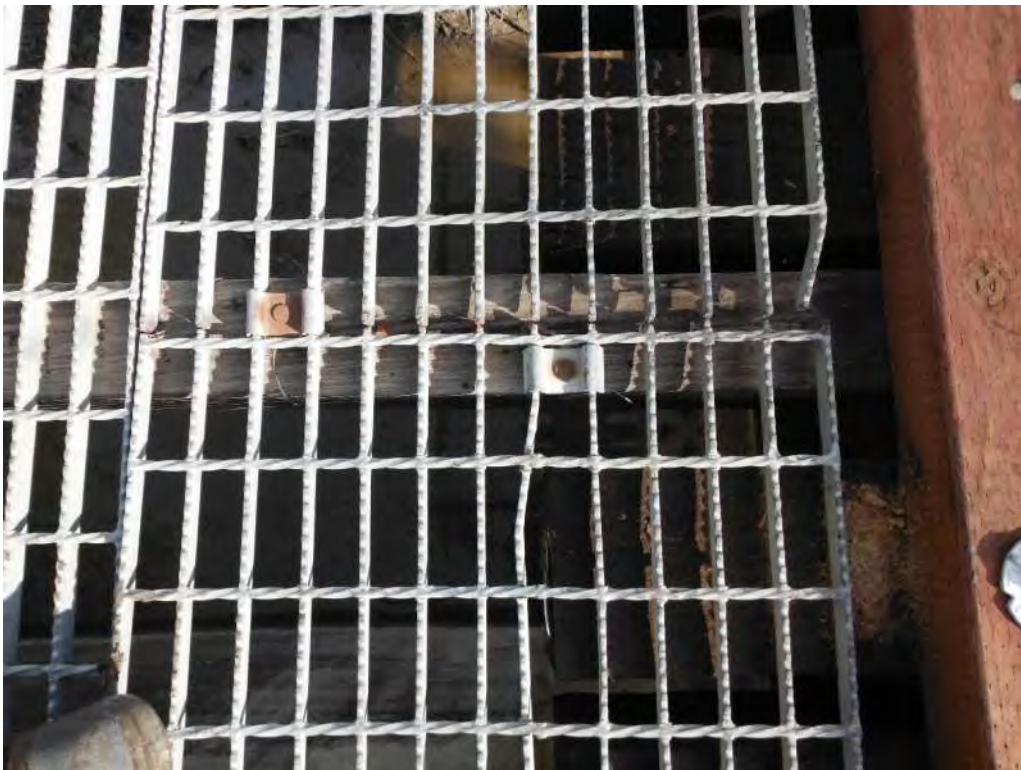
**410.40 Grating causing tripping hazard**

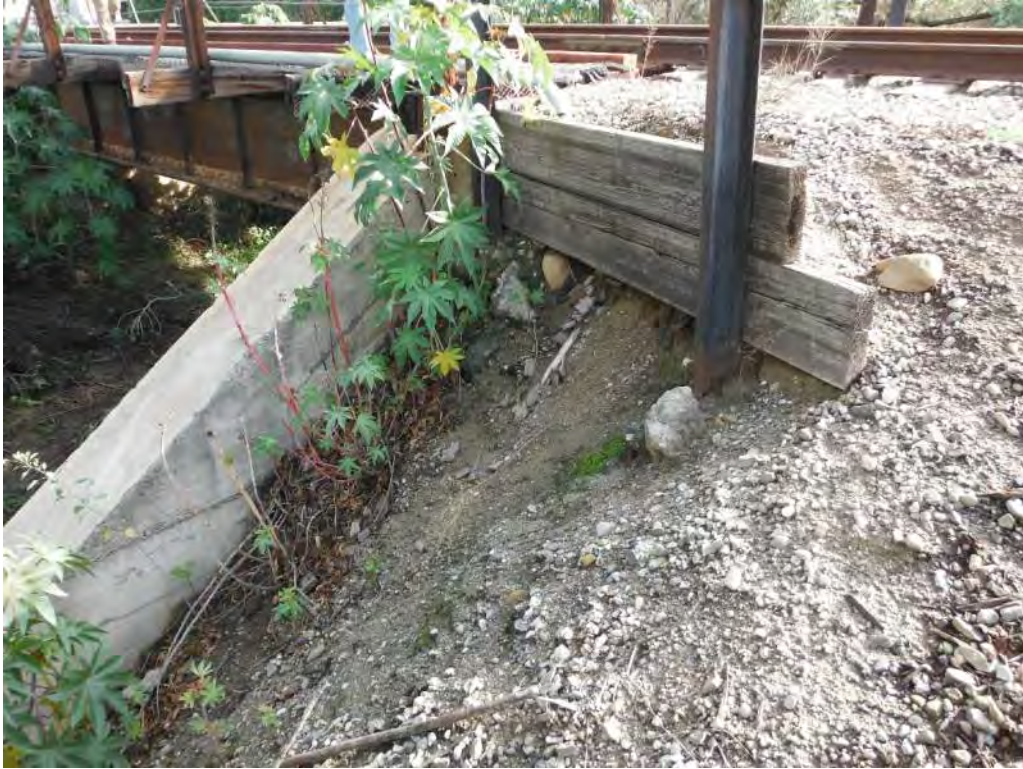
**410.40 NW ballast retainer undermining**

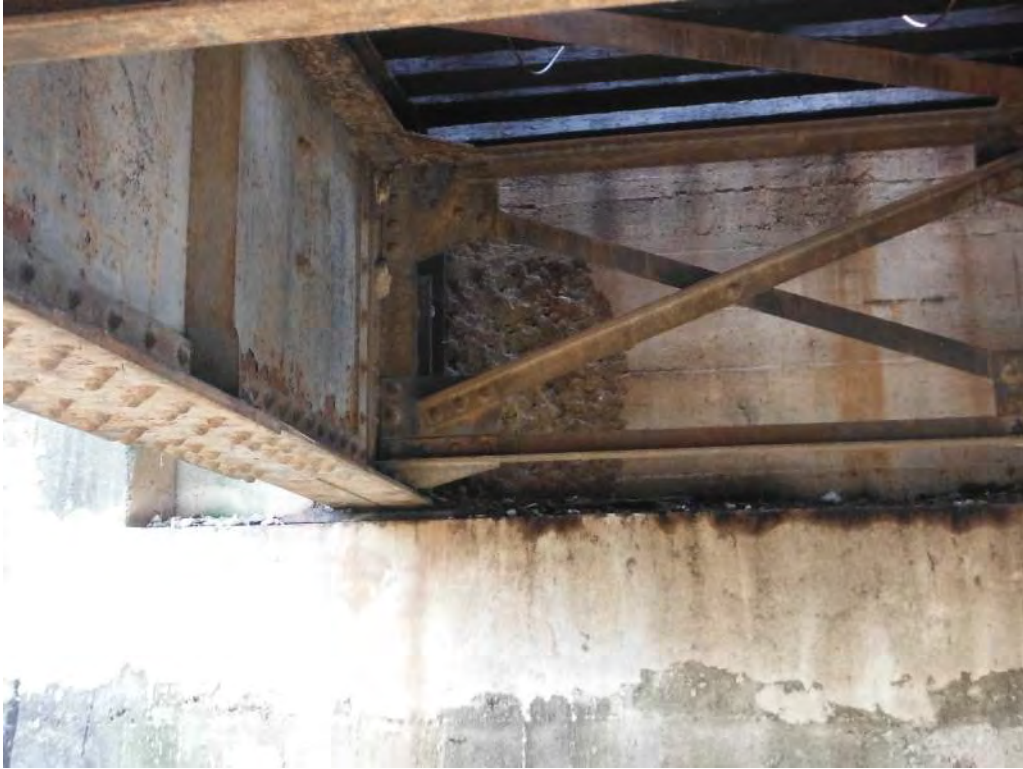
**410.40 Backwall spall – Abutment 1**

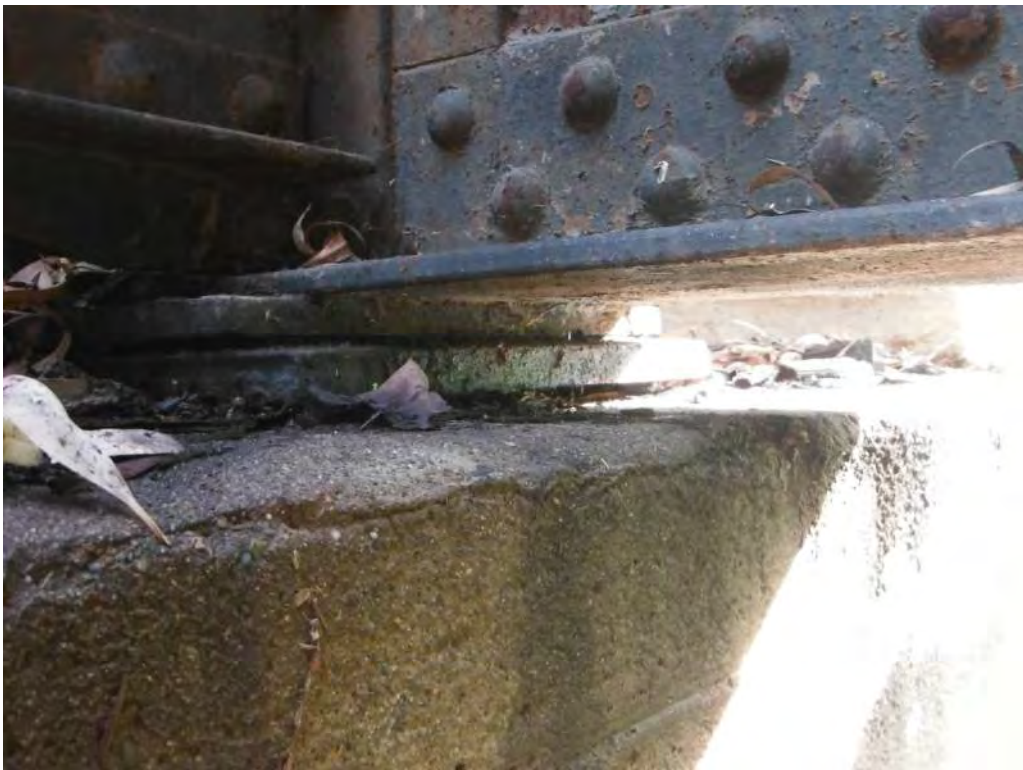
**410.40 Debris around bearings. Abutment 1 & 2**

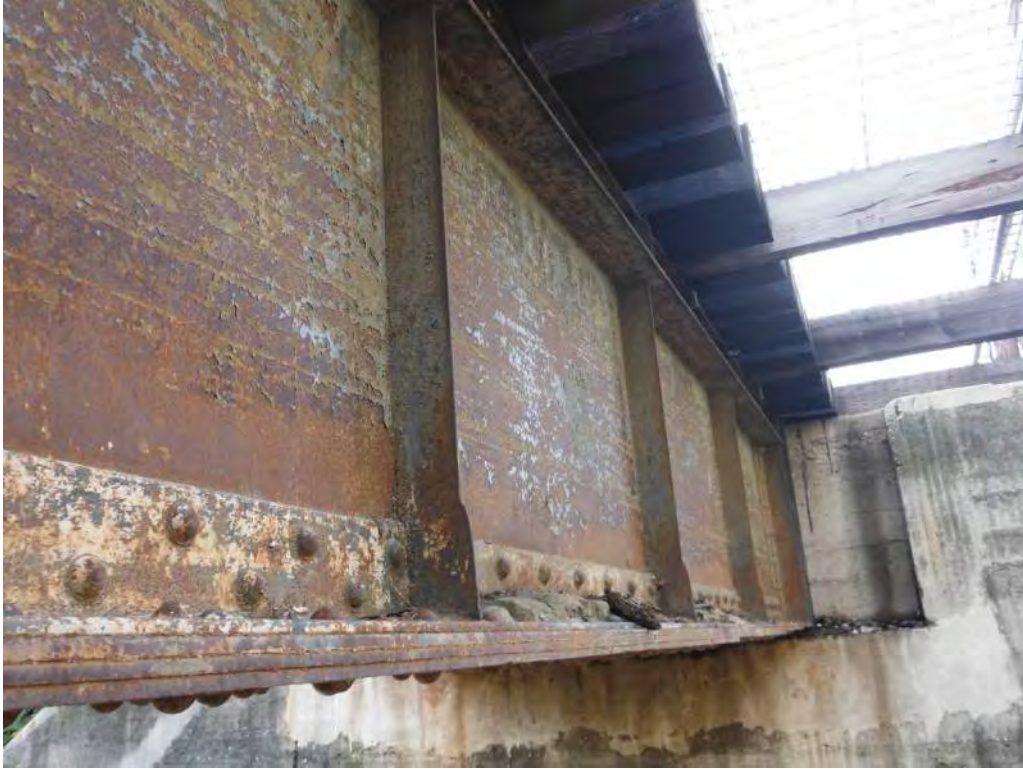
**410.40 Deck girder is in fair condition with paint failure and surface rust**

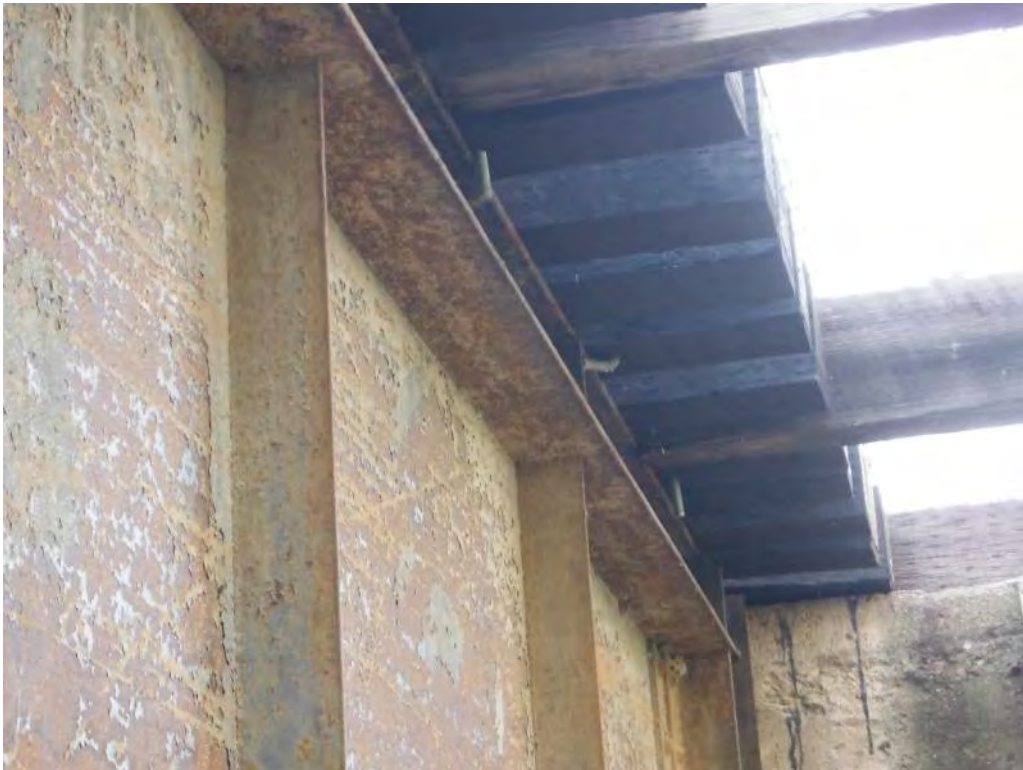
**410.40 J-bolt current conditions**

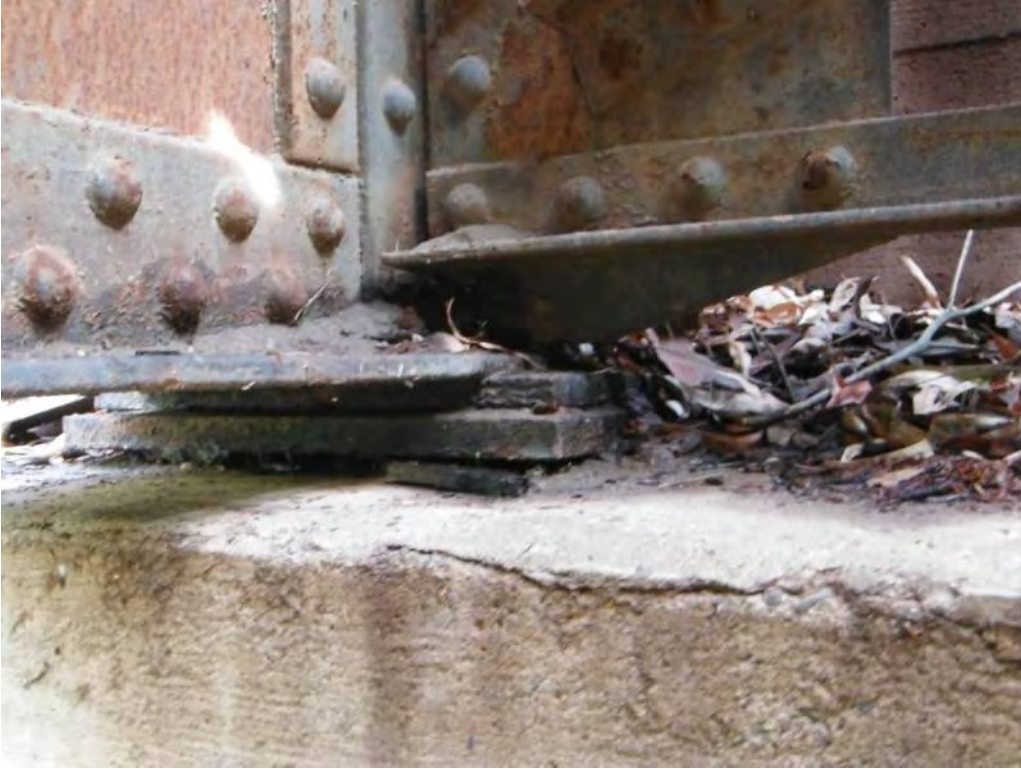
**410.40 Broken grout under bearing plates, Abutment 2**

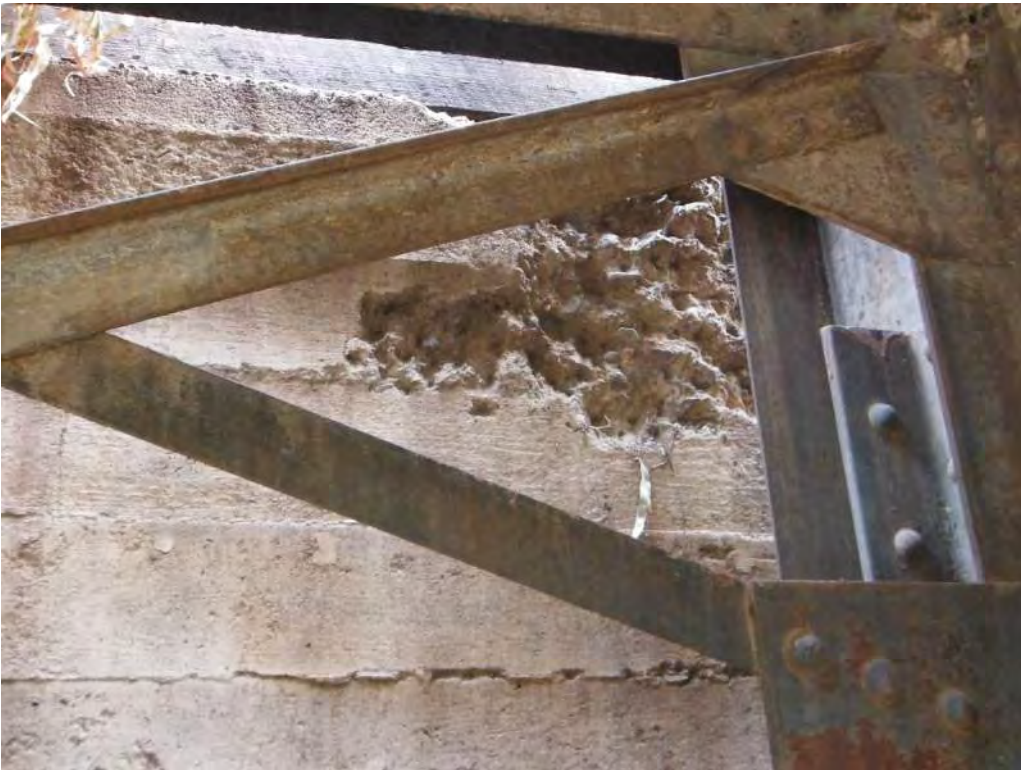
**410.40 Backwall spall – Abutment 2**

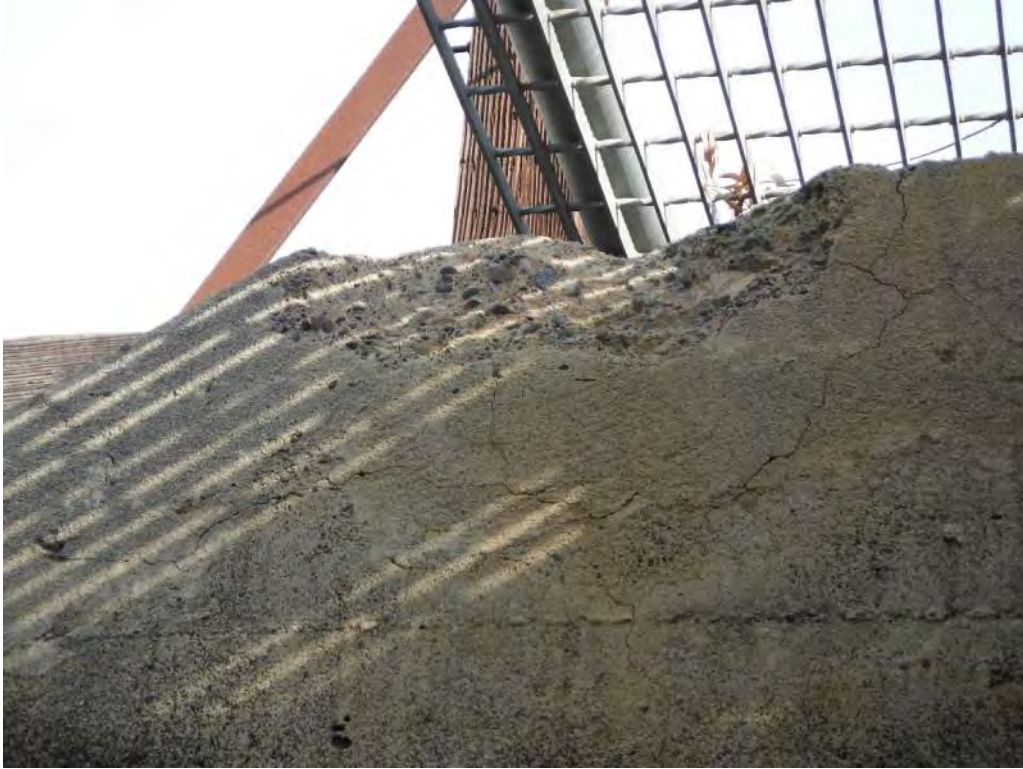
**410.40 NE Wingwall spall – Abutment 2**

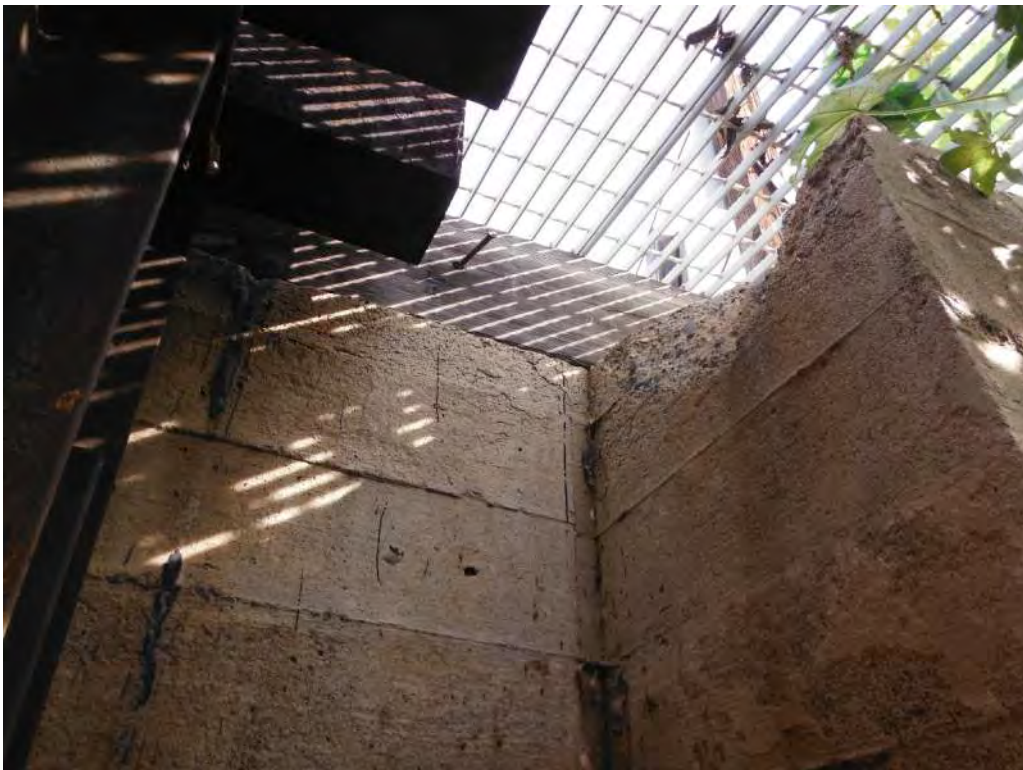
**410.40 SE Wingwall Spall – Abutment 2**

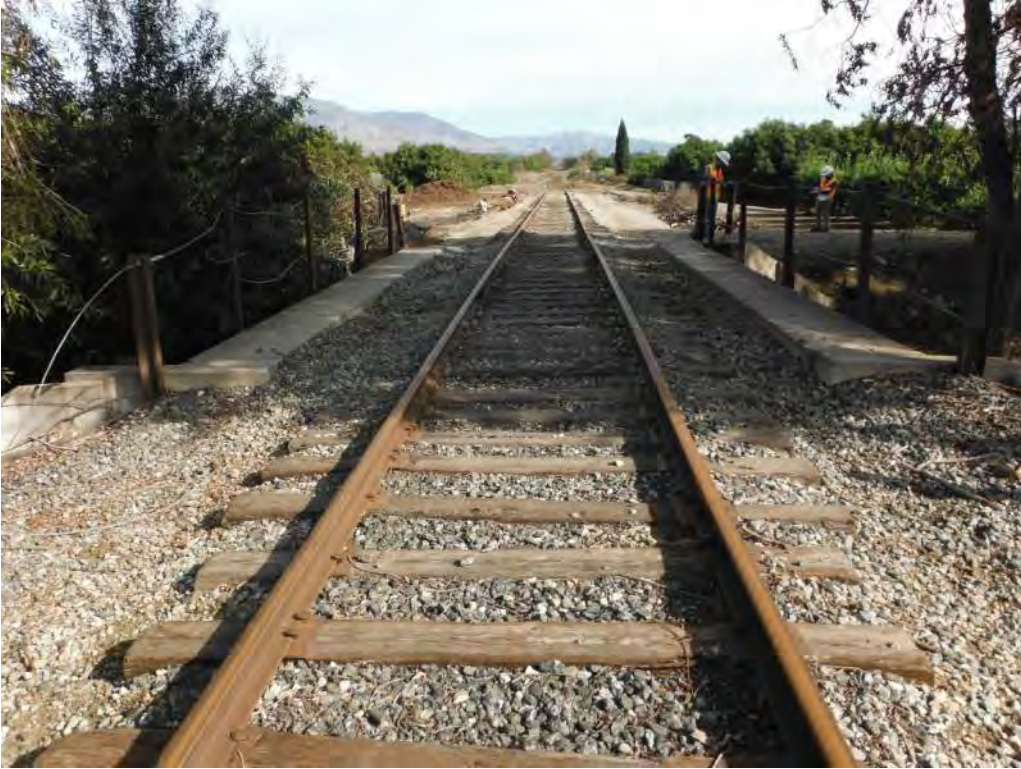
**411.97 Looking East**

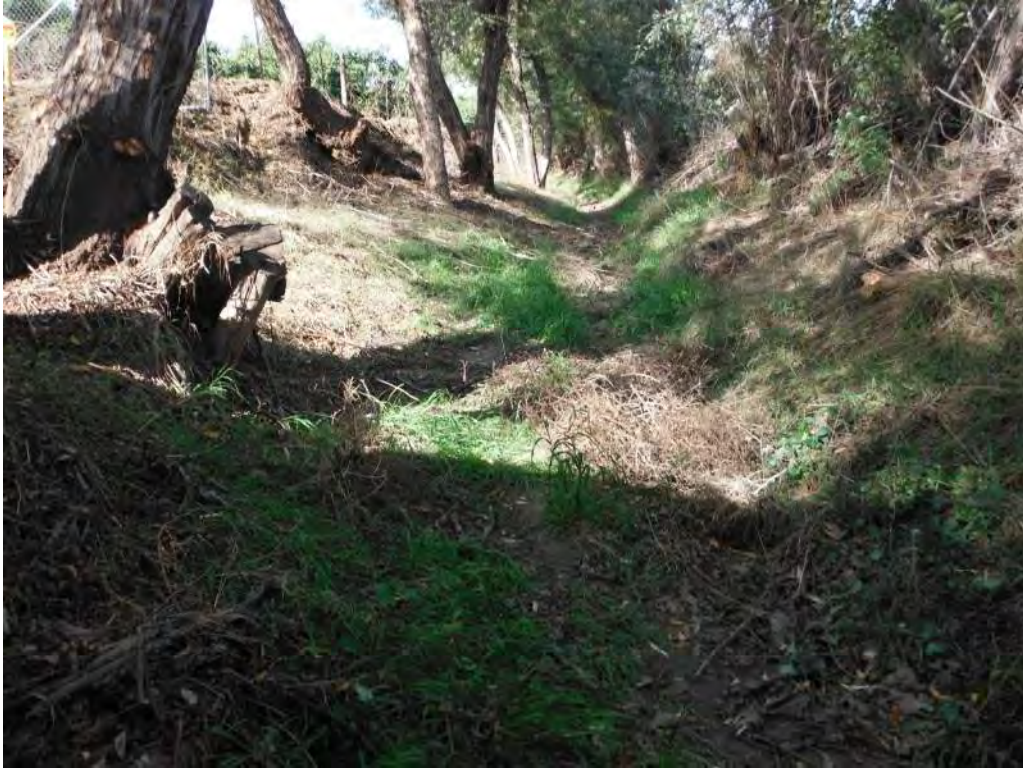
**411.97 Channel Conditions - Looking Upstream**

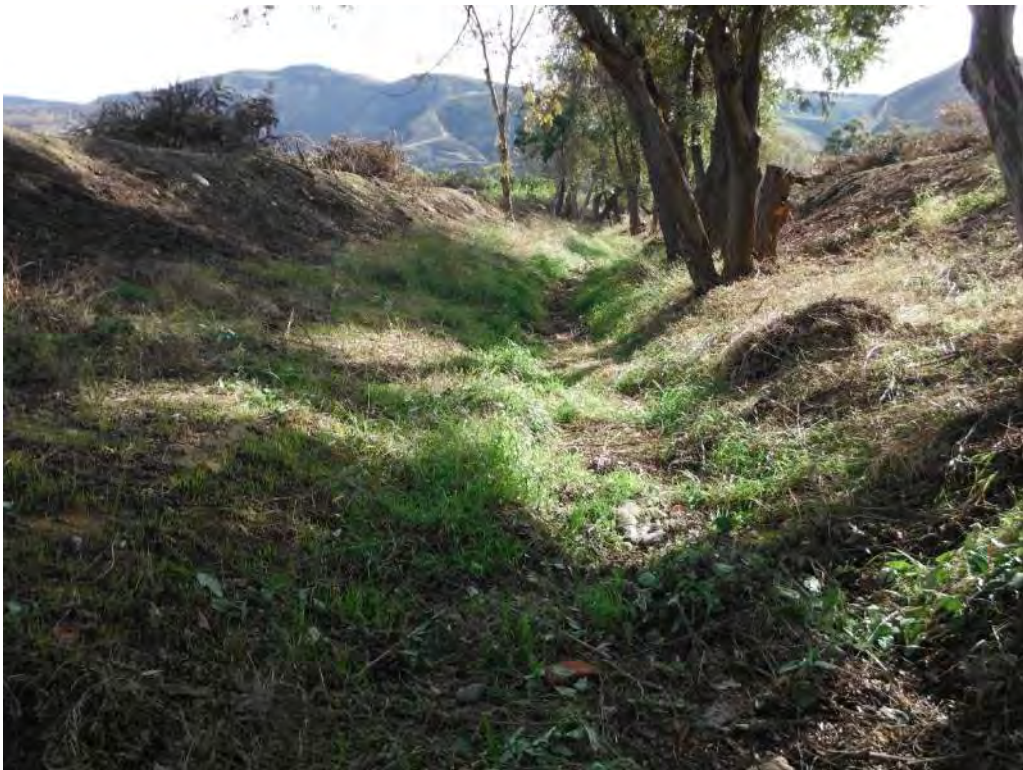
**411.97 Channel Conditions - Looking Downstream**

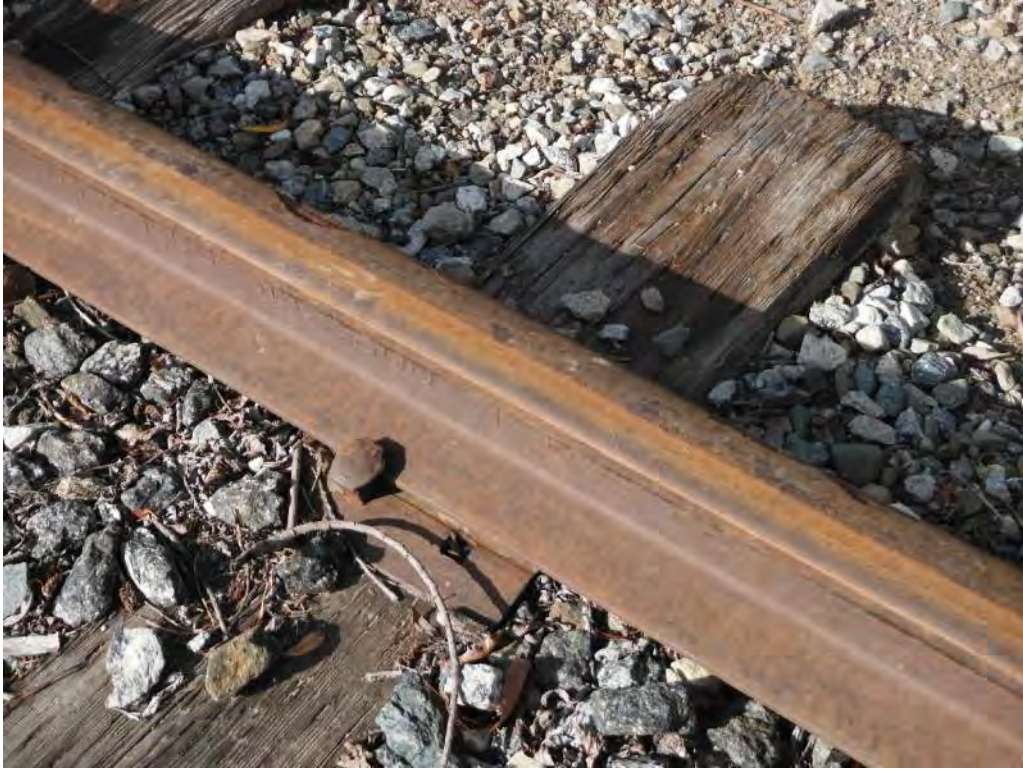
**411.97 NW rail section loss**

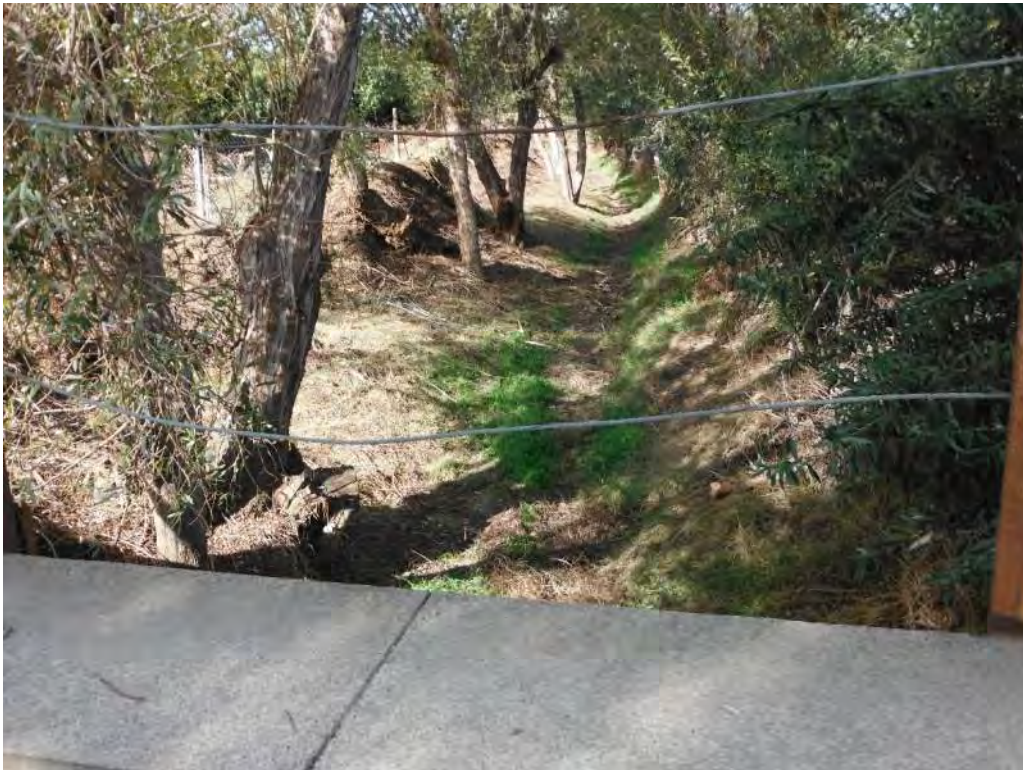
**411.97 Handrail loose (typ.)**

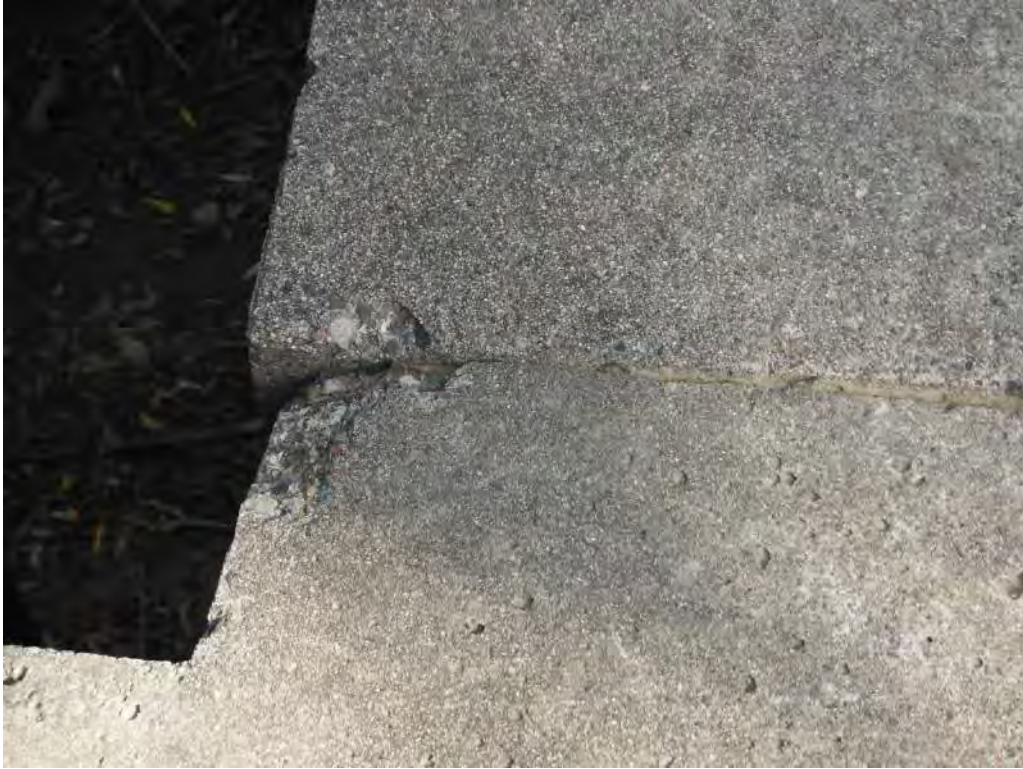
**411.97 Spall on NW Corner of Walkway**

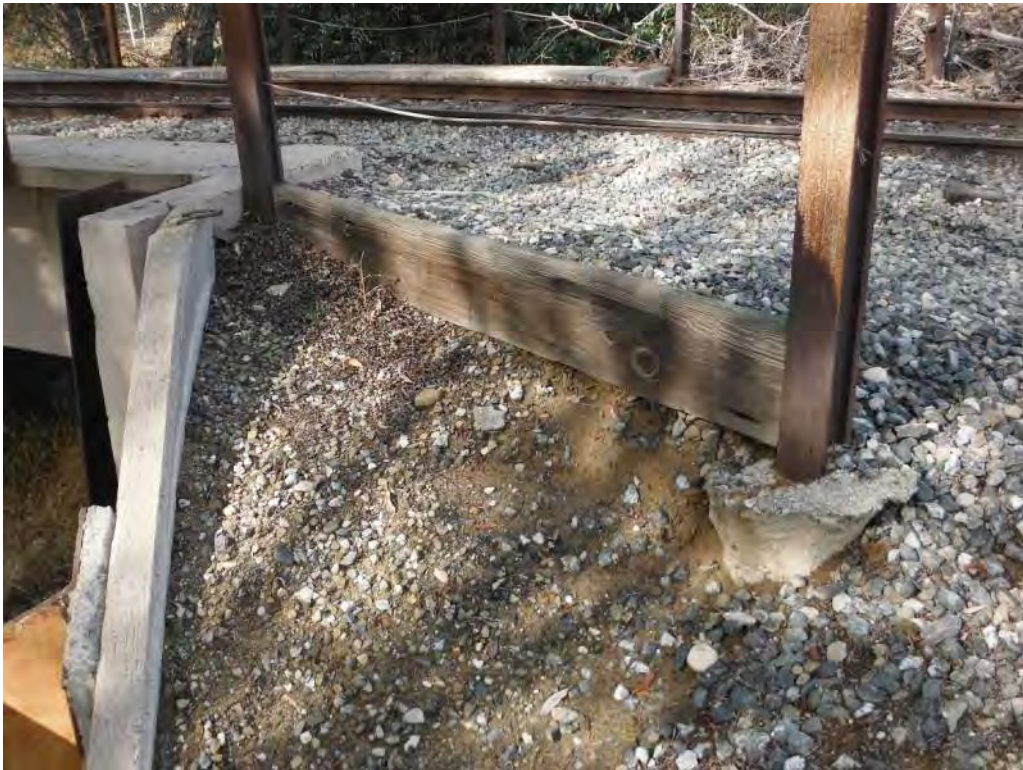
**411.97 Abutment 2 undermining SE Ballast retainer**

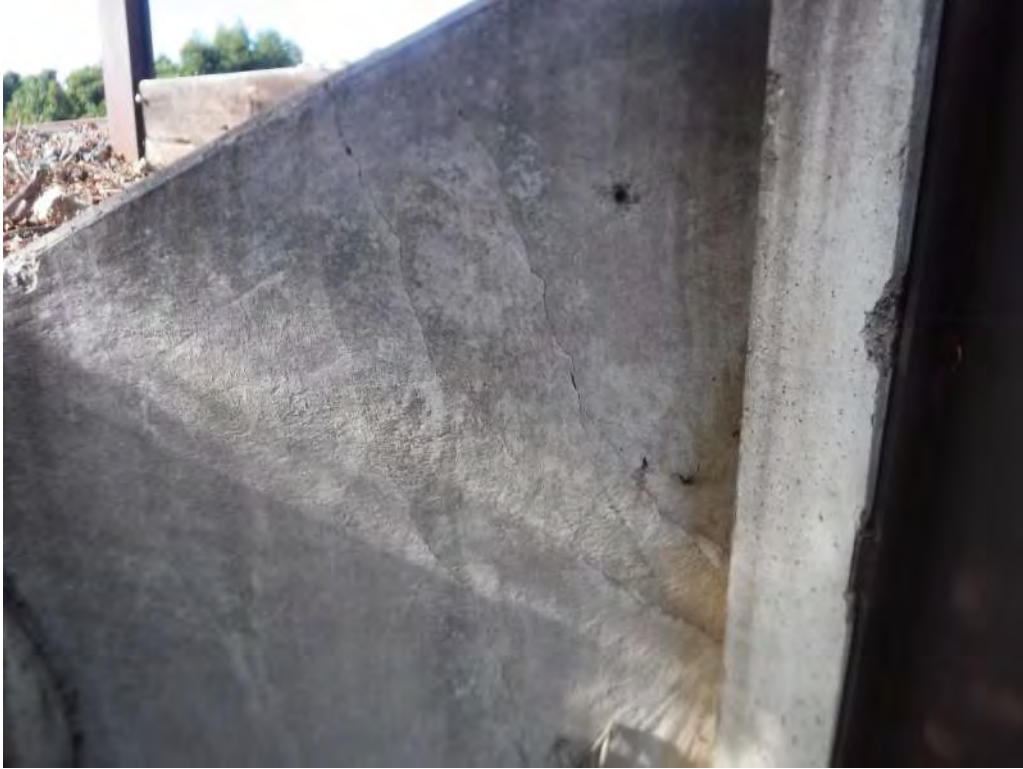
**411.97 Southwest wingwall cracking**

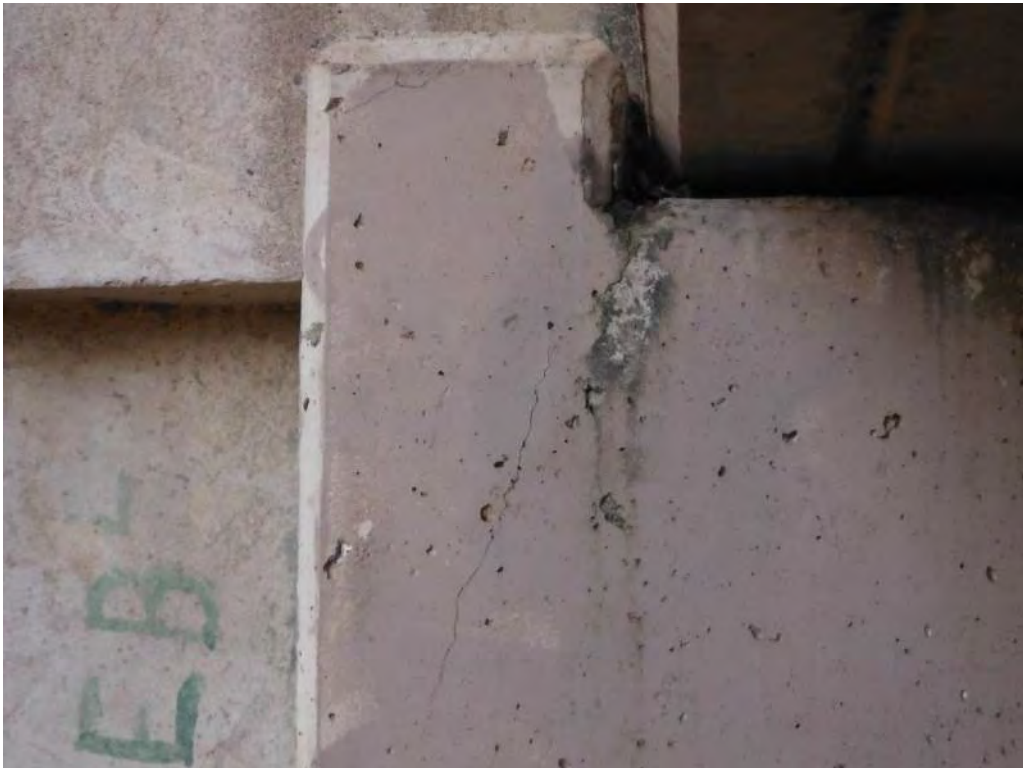
**411.97 Abutment 1 South keeper cracking**

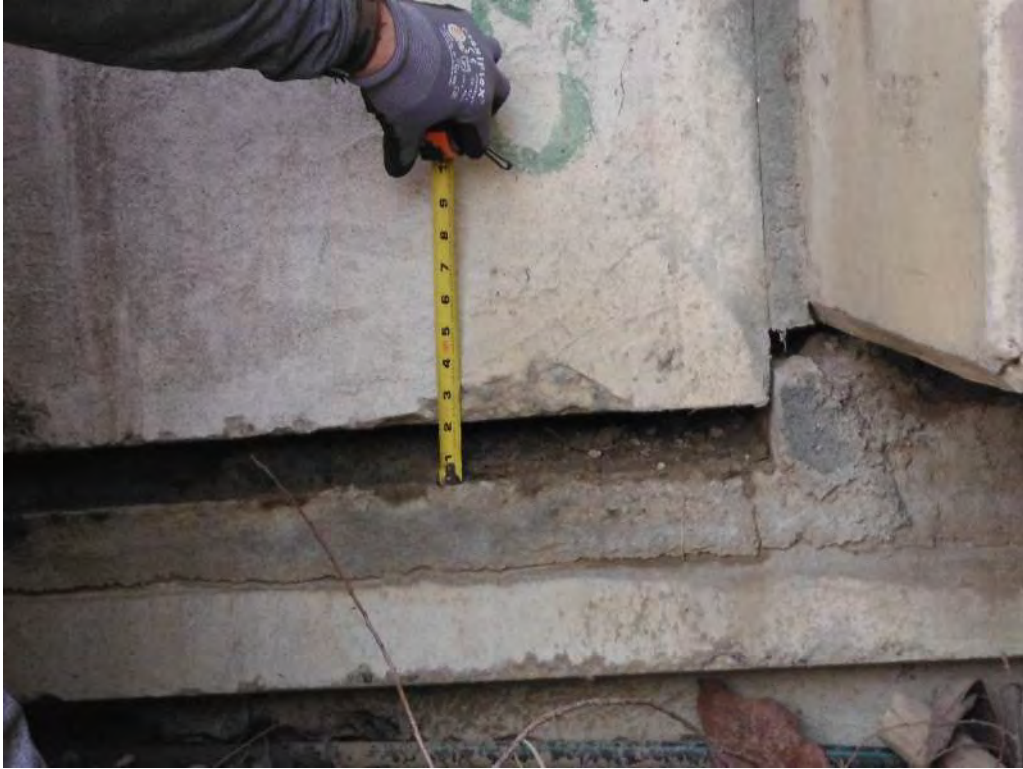
**411.97 2" gap between Abutment 1 and wingwall**

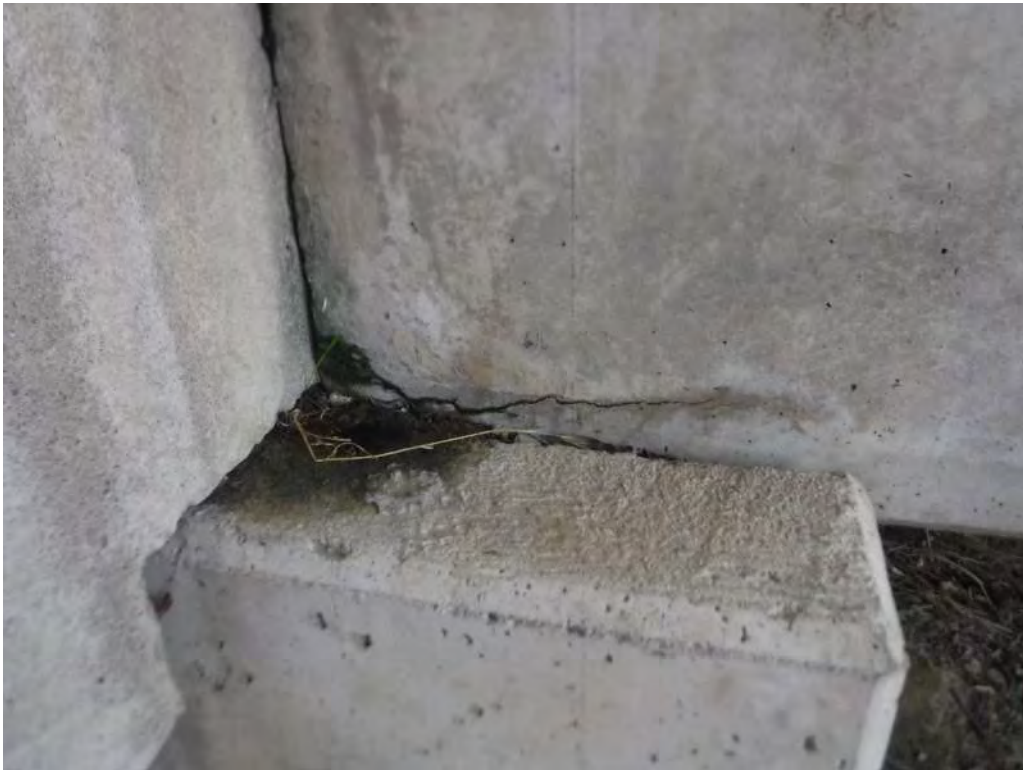
**411.97 Girder 1 cracking at Abutment 1**

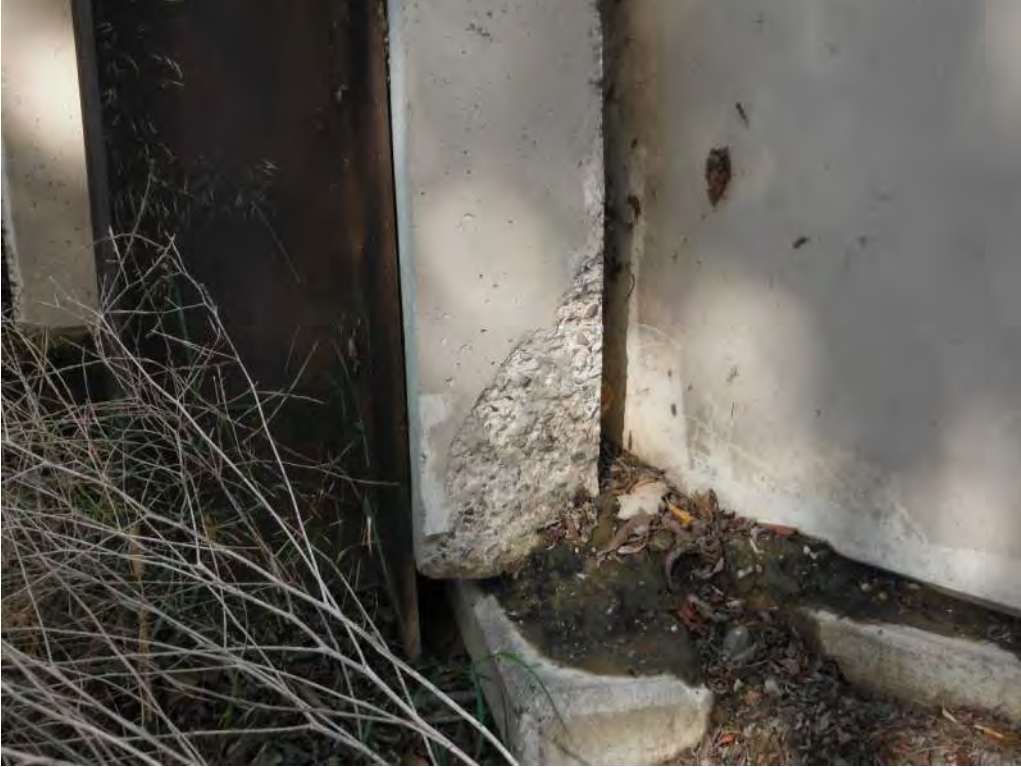
**411.97 Southeast Backwall Spall**

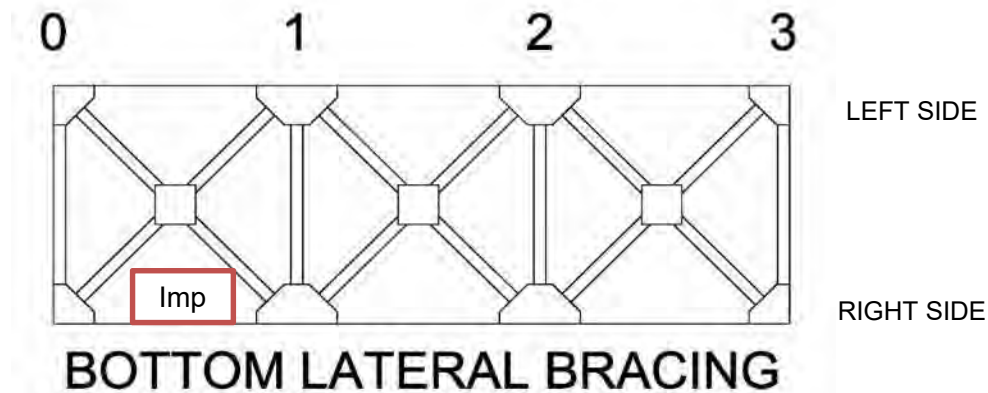
DIVISION	Santa Paula	SPAN LENGTH	29'	NUMBER OF TRACKS	1
CROSSING	Creek	TRACK ALIGNMENT	TANGENT	SPAN No.	1
<b>INSPECTION FINDINGS</b>					
Imp	Bay #1 right side cross bracing show signs of impact and slight deflection - see photo				
	Debris build-up on bottom flange, bearings, and cross bracing

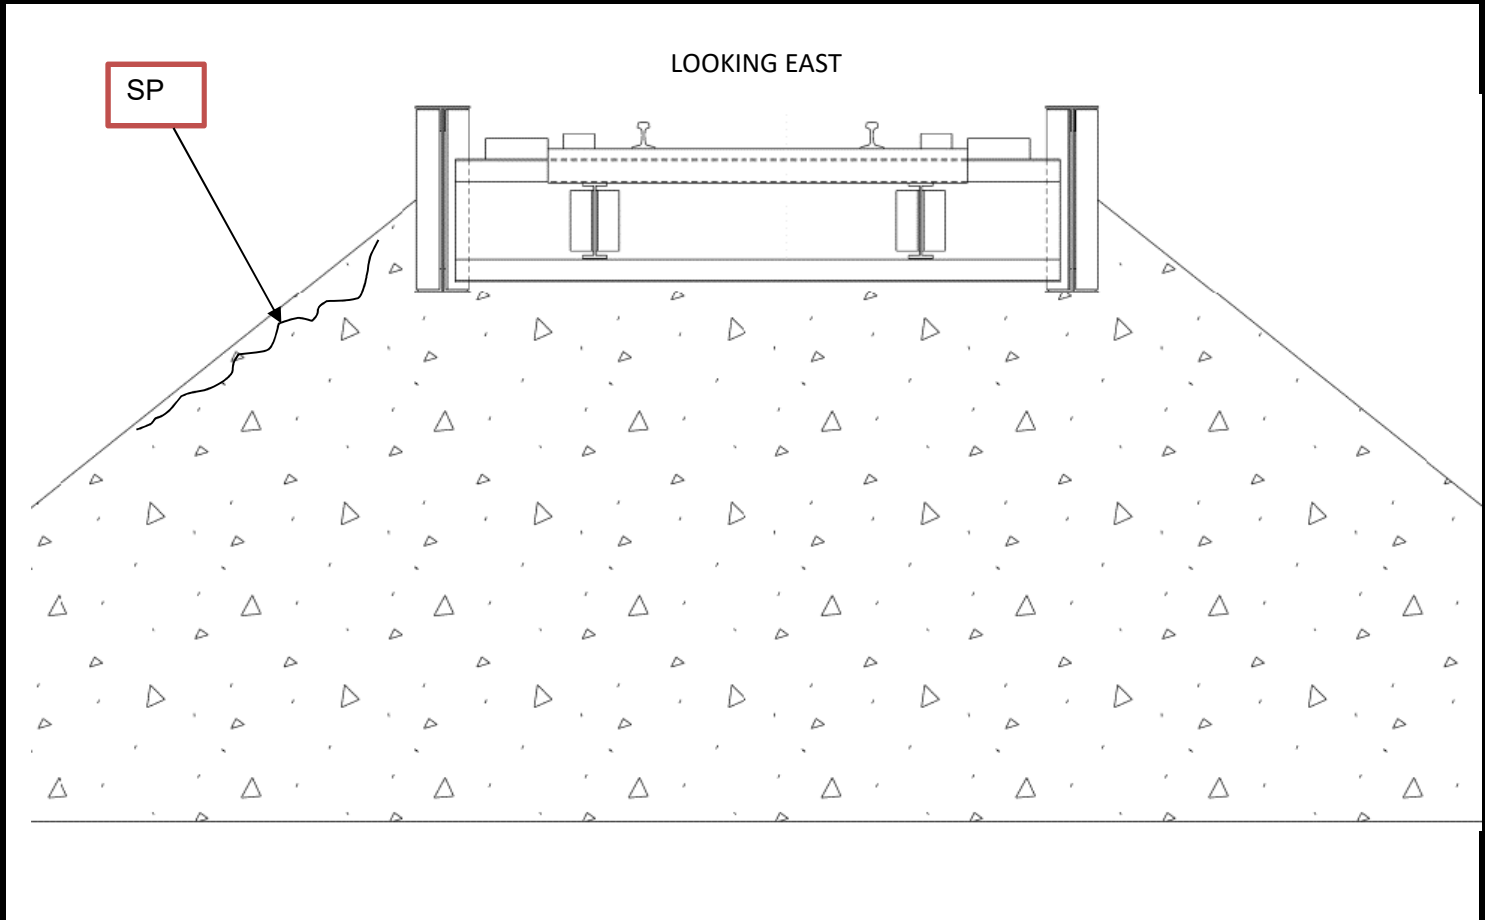
<b>Description: Thru Plate Girders, Concrete Abutment</b>			
<b>Remarks:</b>			
1. Abutment needs to be cleared of debris			
2. End bearing areas show minor section loss due to rust			
3. Pack rust at bearing plates - see photo			
4. SP - Spalling along north wingwall			
Inspected By:	Joseph Holste, PE	Date Inspected:	12/11/2019
