# BRIDGE INSPECTION REPORT

INSPECTION TYPE: Annual

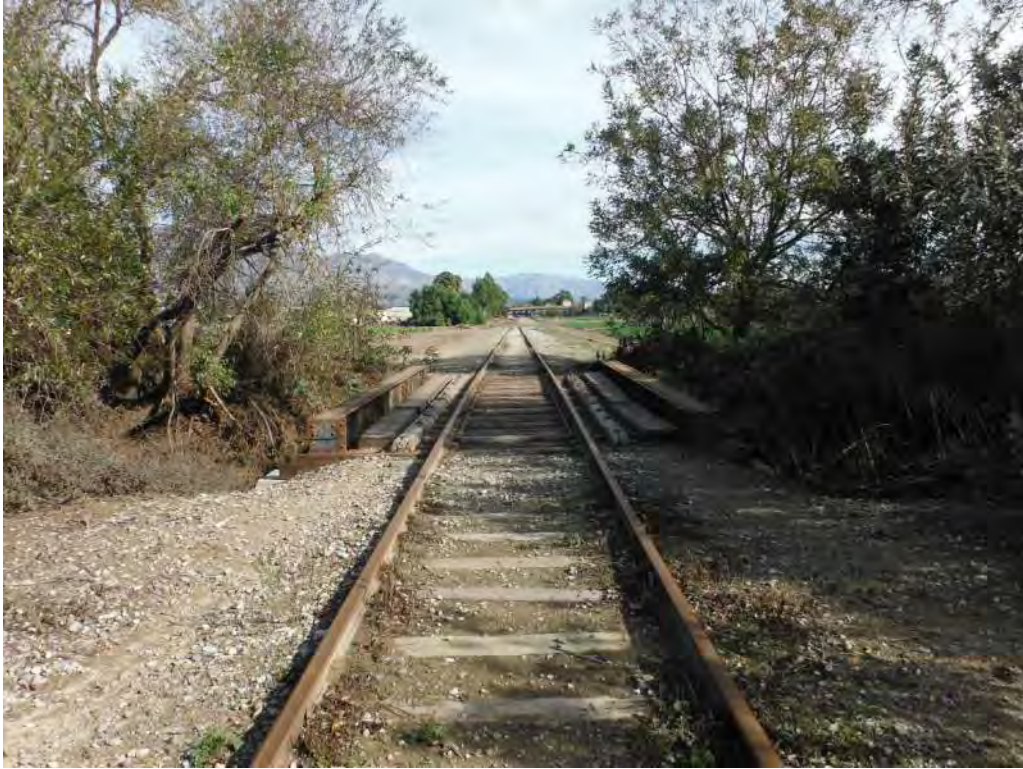
**412.25 Looking East**

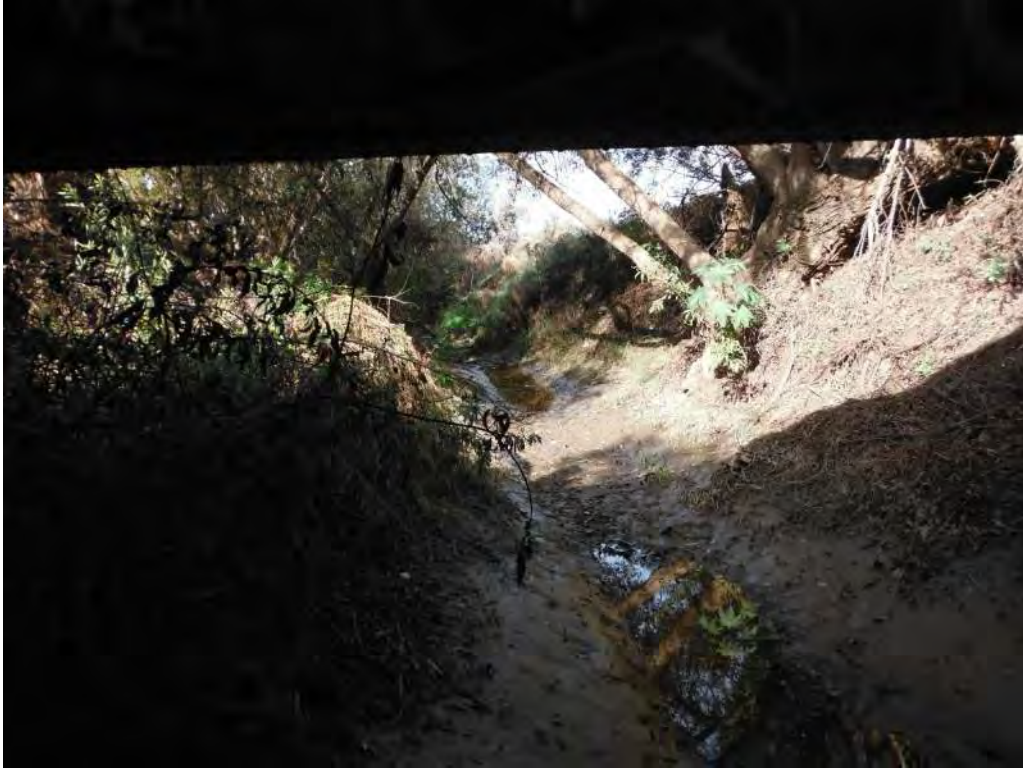
**412.25 Channel Condition - Looking Upstream**

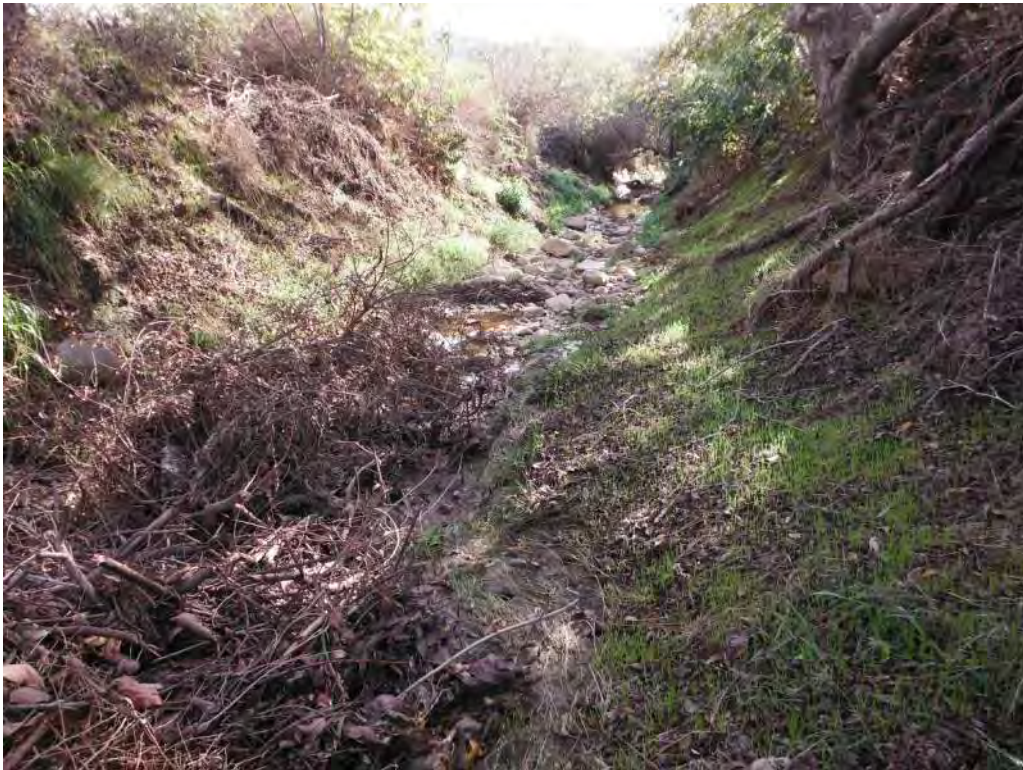
**412.25 Channel Condition - Looking Downstream**

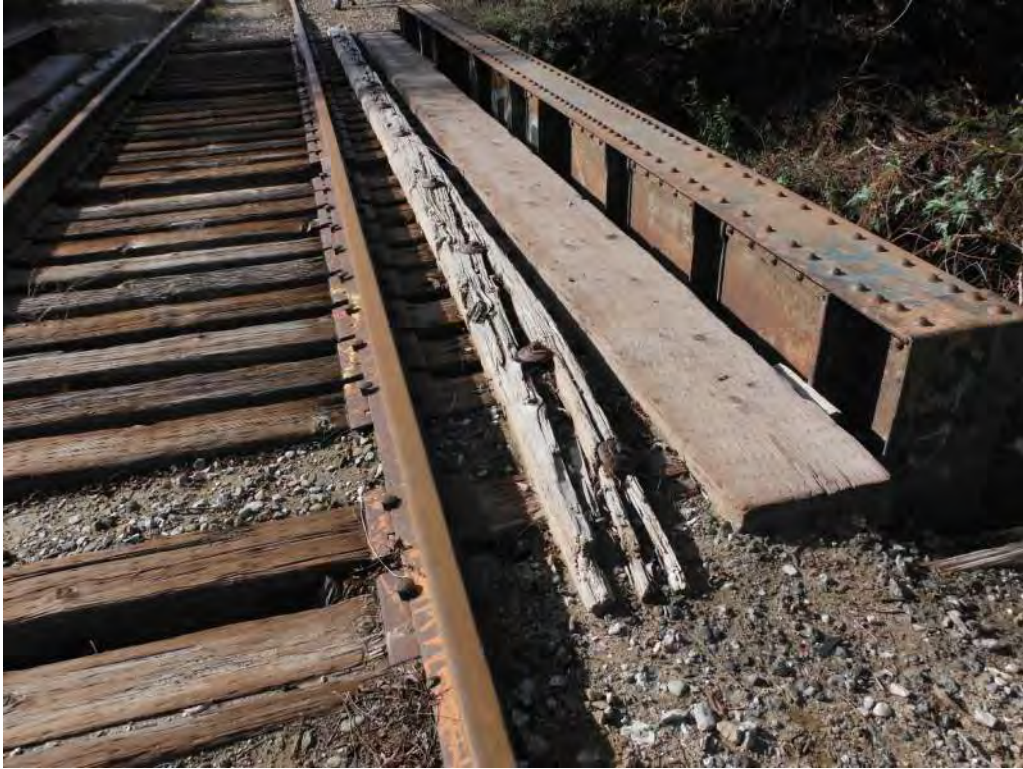
**412.25 Damaged curbs at east end**

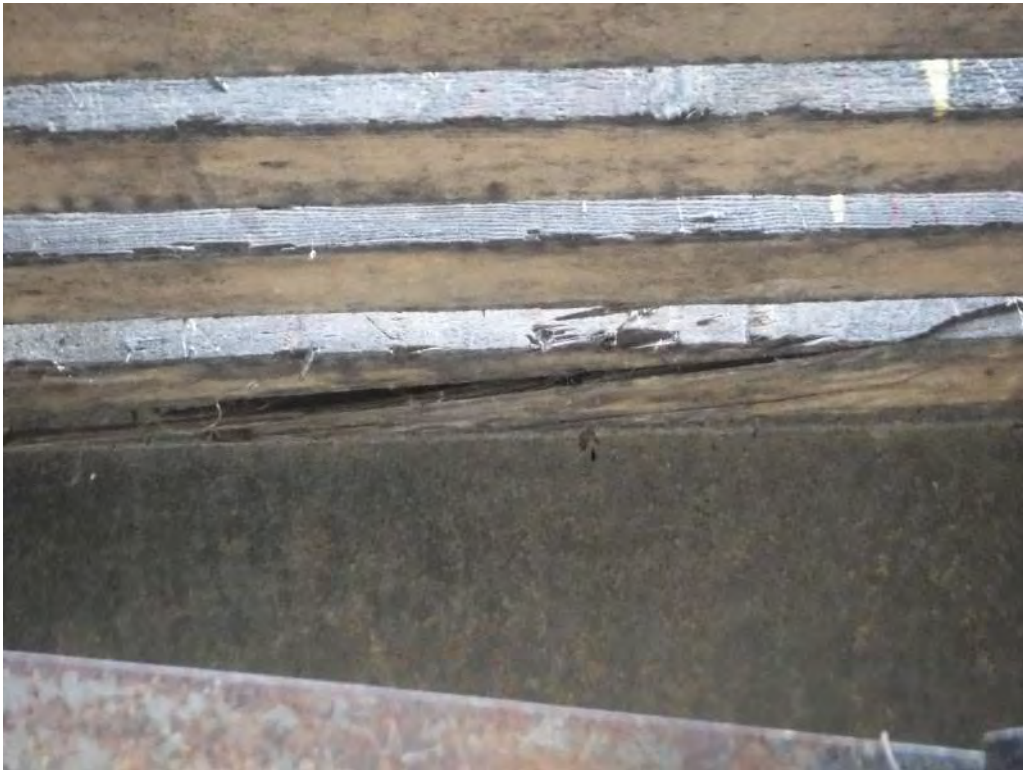
**412.25 Split Tie**

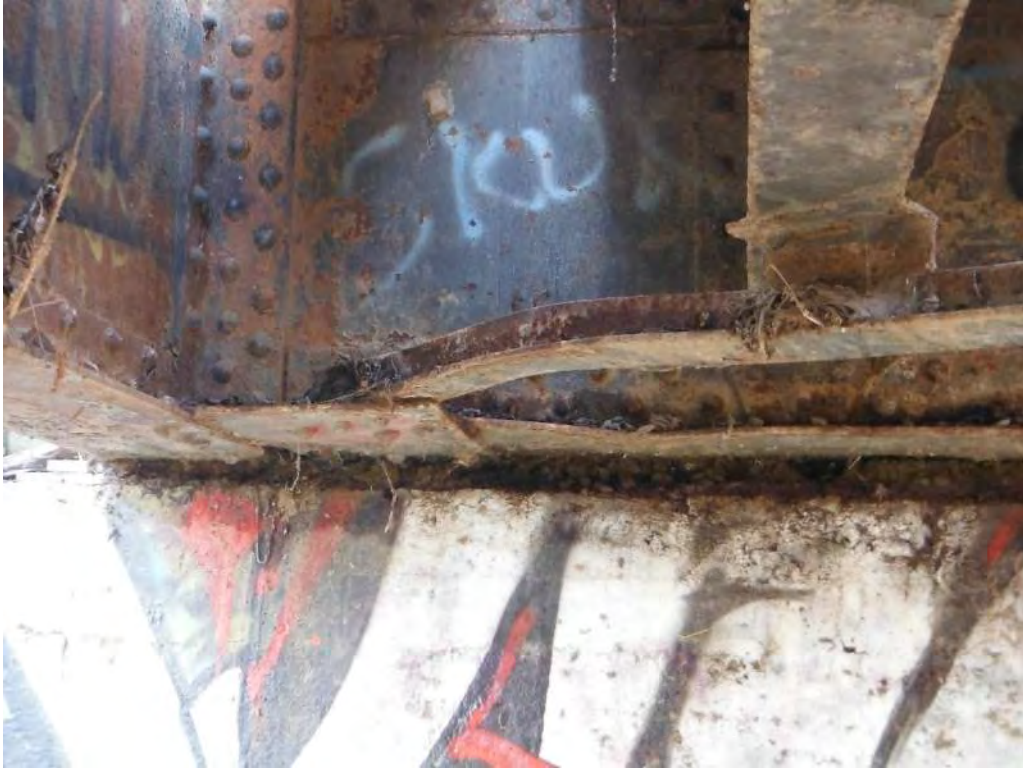
**412.25 Minor impact damage near Abutment 1**

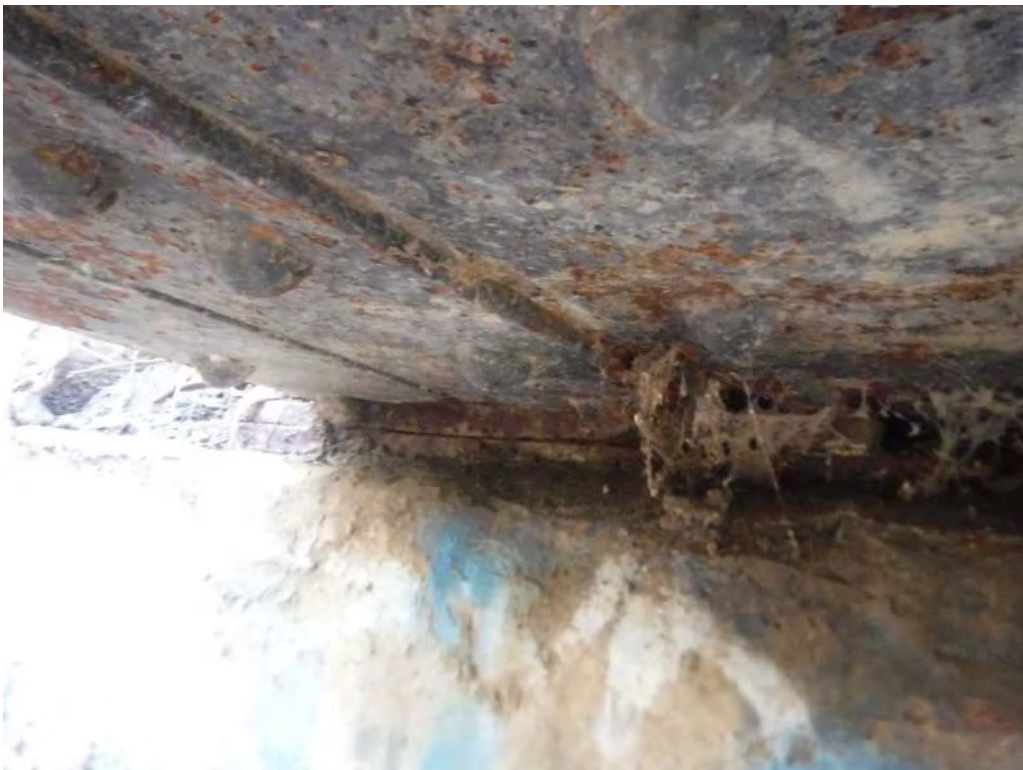
**412.25 Minor section loss/pack rust at bearings (typ.)**

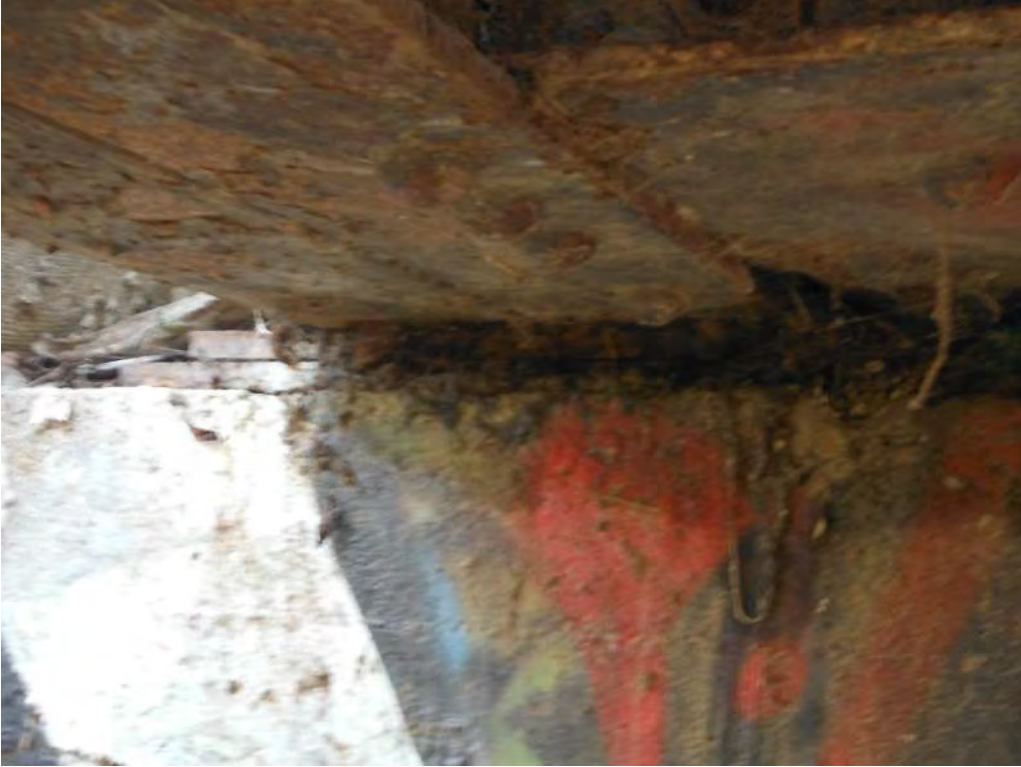
**412.25 Pack rust at bearing plates (typ.)**

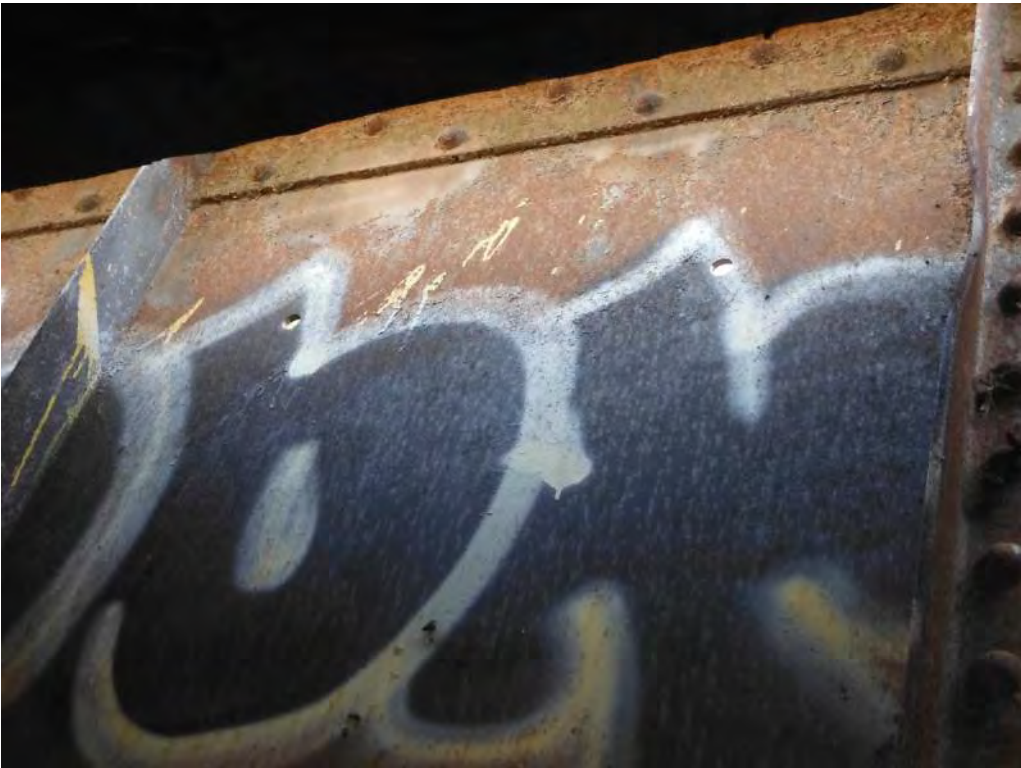
**412.25 Hole in web and stiffener damage at midspan G2**

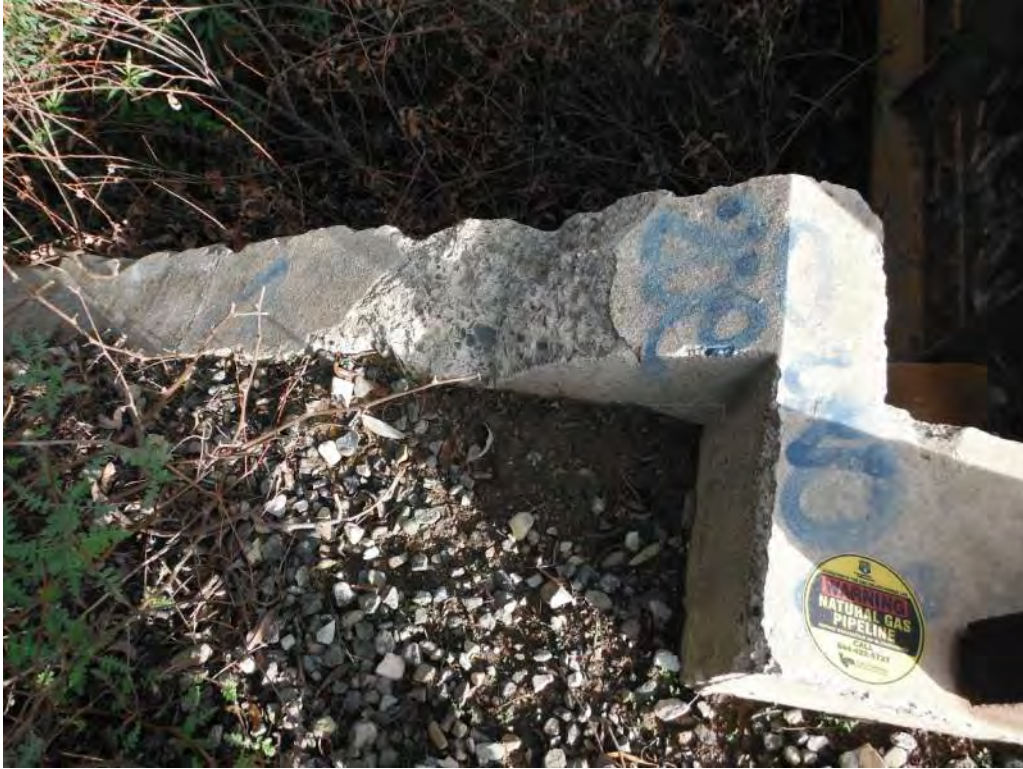
**412.25 Spalling on wingwall – see report for locations**

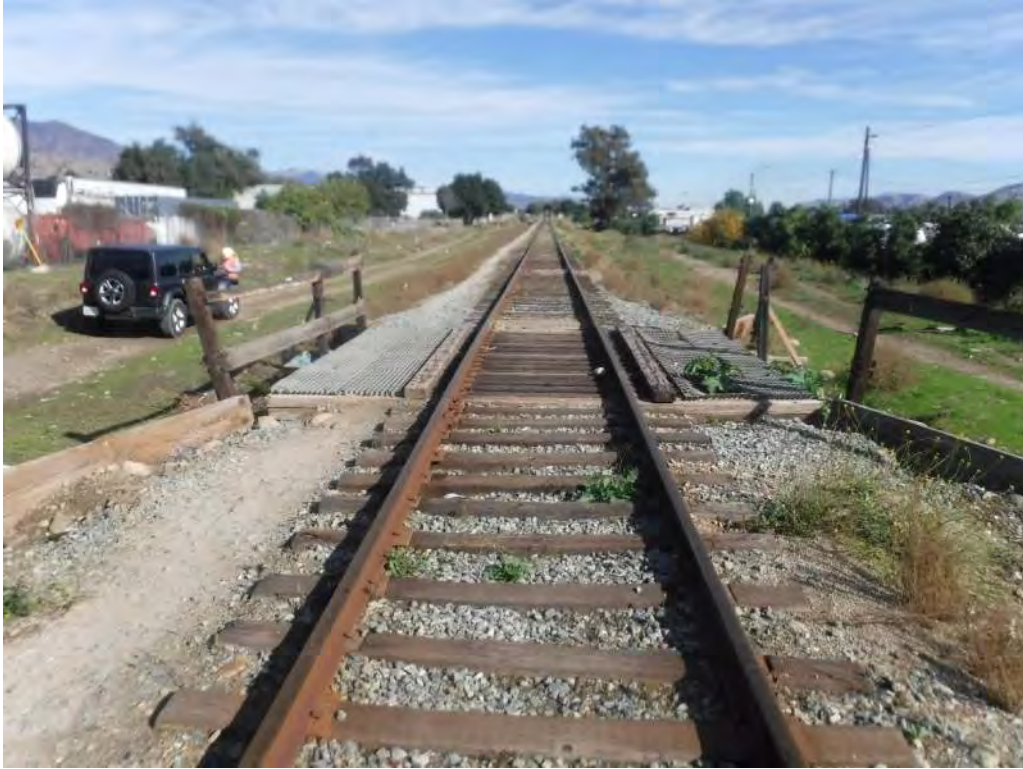
**415.32 Looking East**

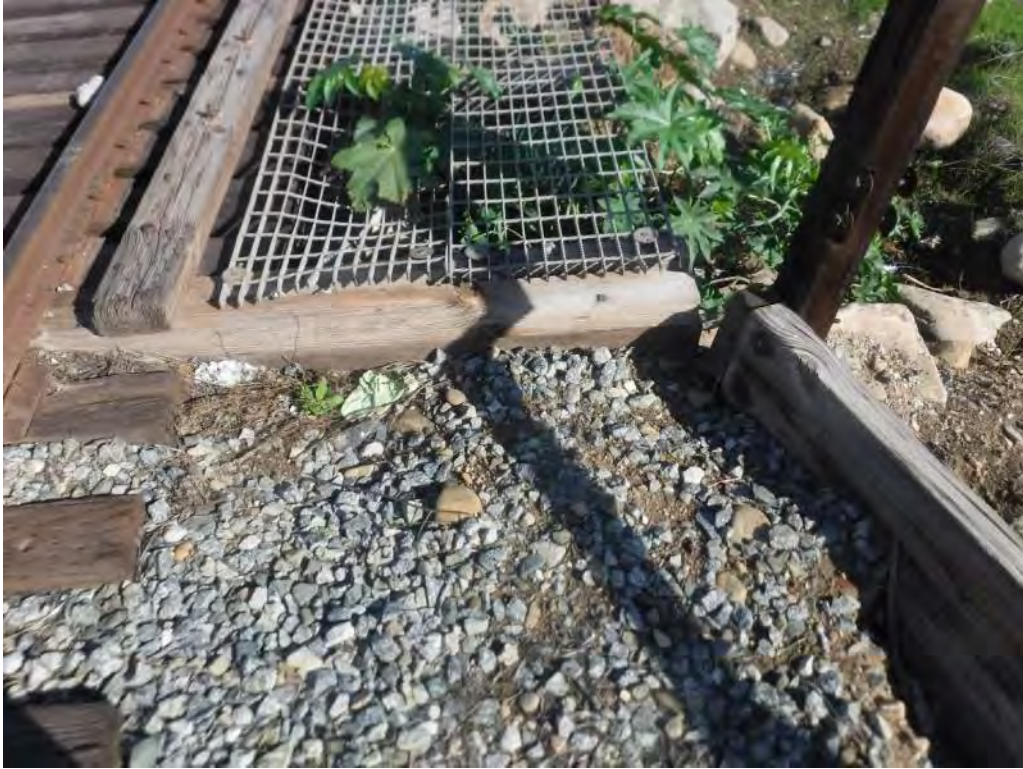
**415.32 Damaged walkway – south side**

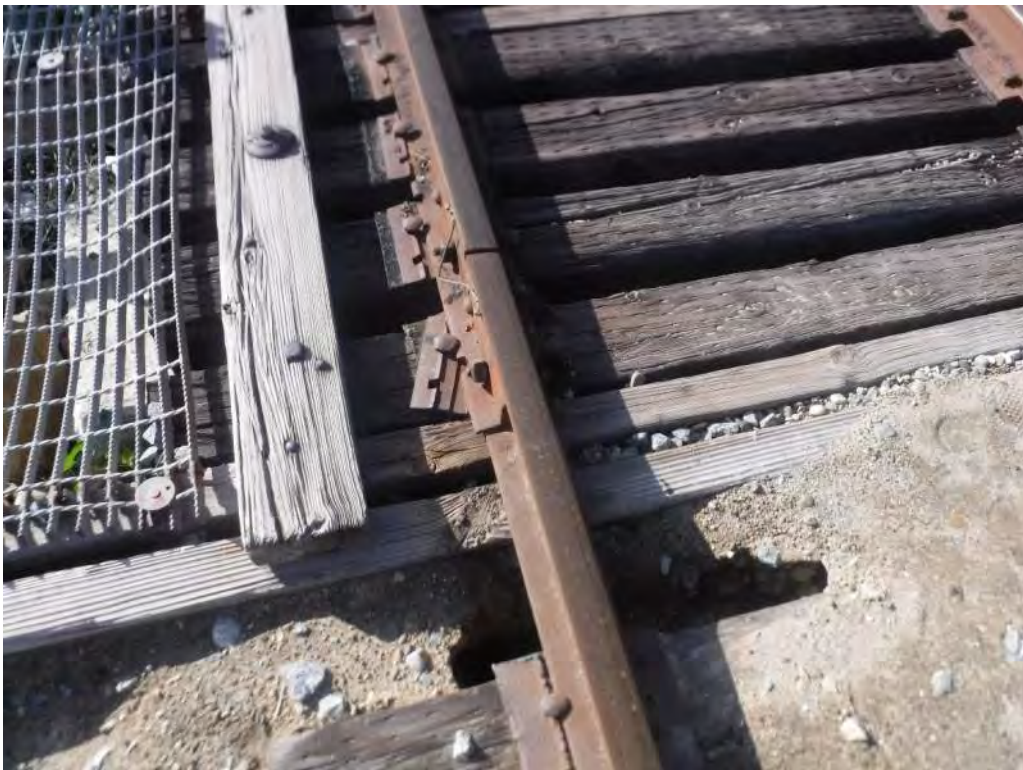
**415.32 Tie Plate Loose**

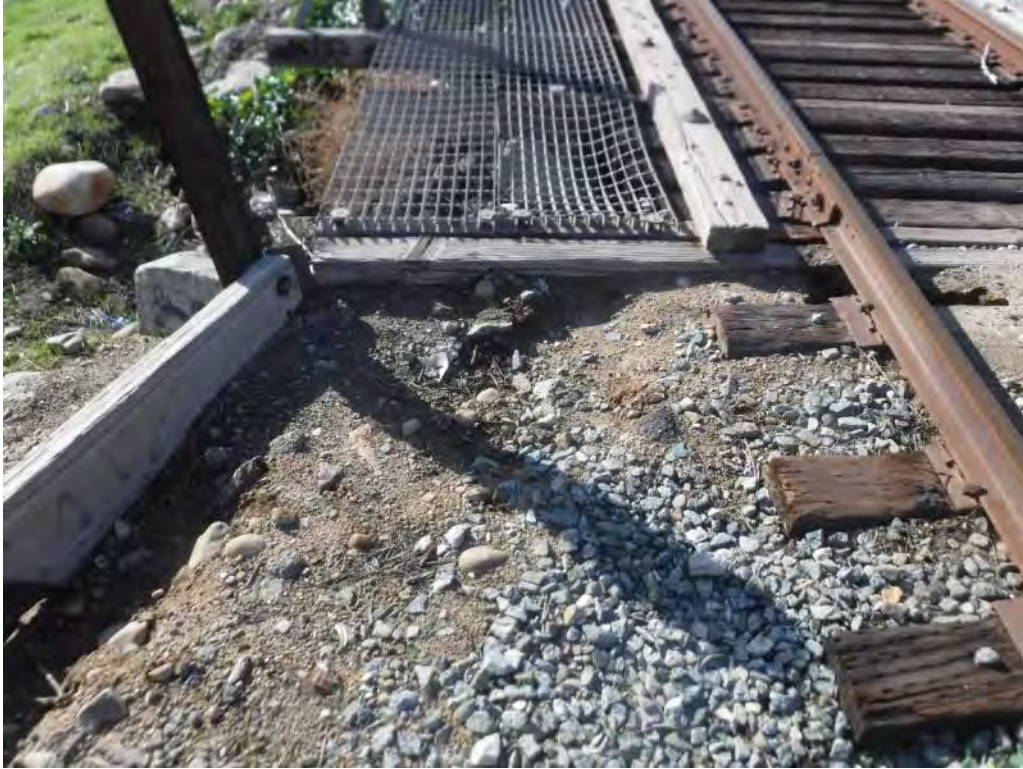
**415.32 Hole in Ballast, SE Corner**

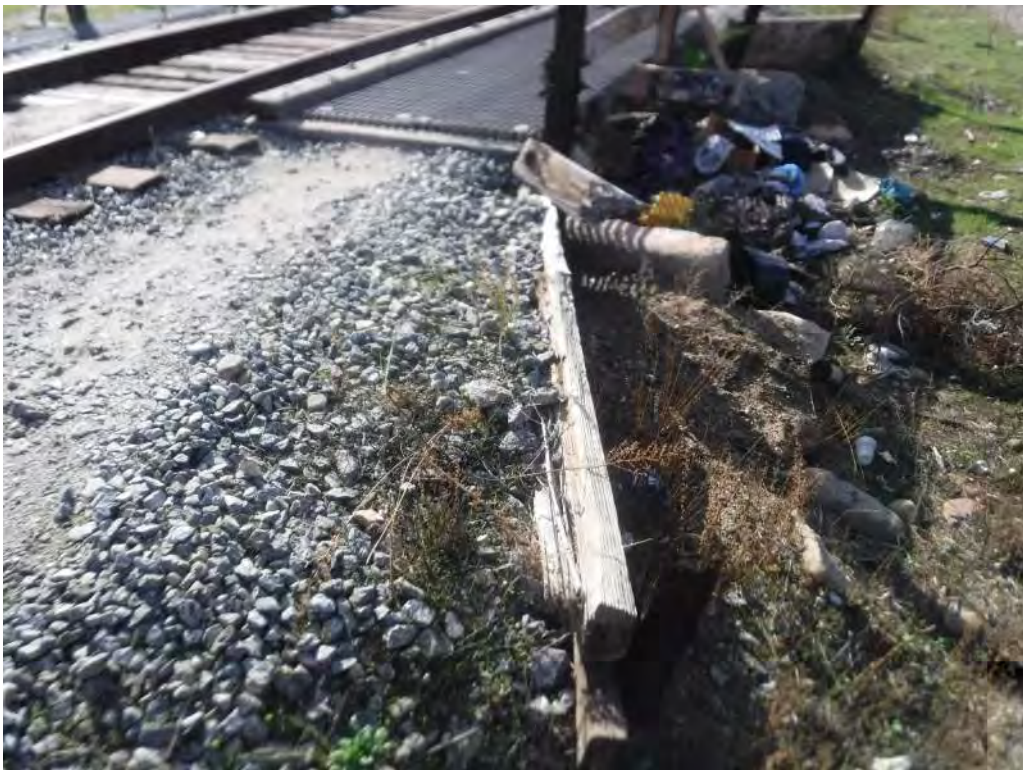
**415.32 Wingwall failing, typ all corners**

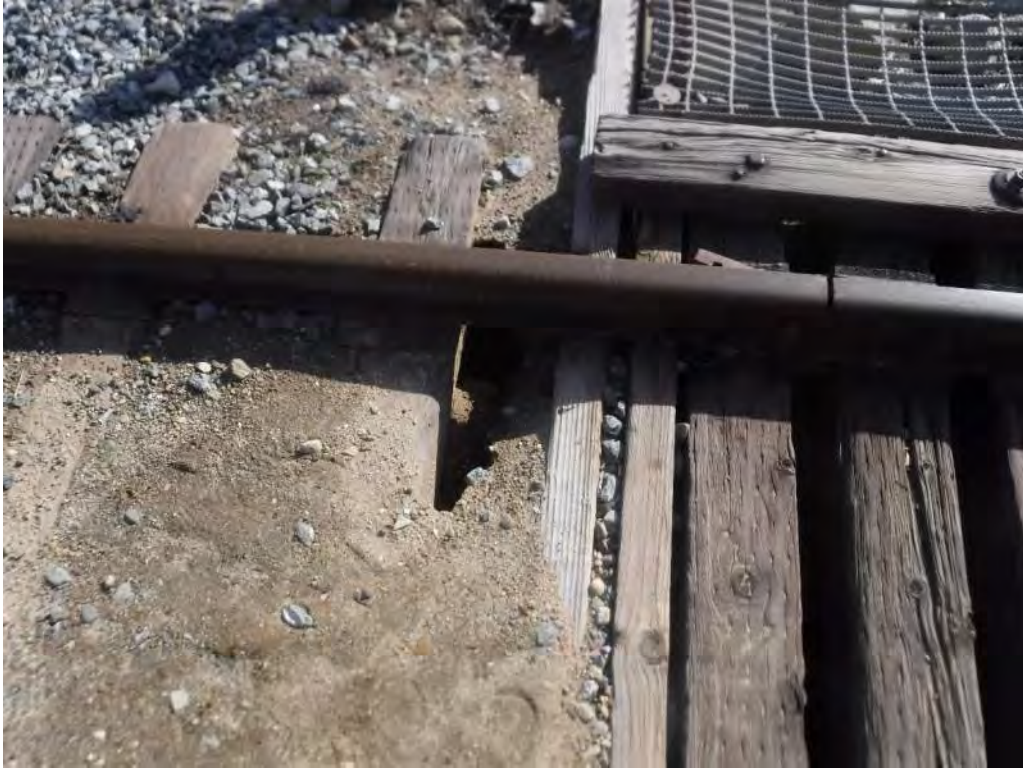
**415.32 Hole in soil behind Abutment 2**

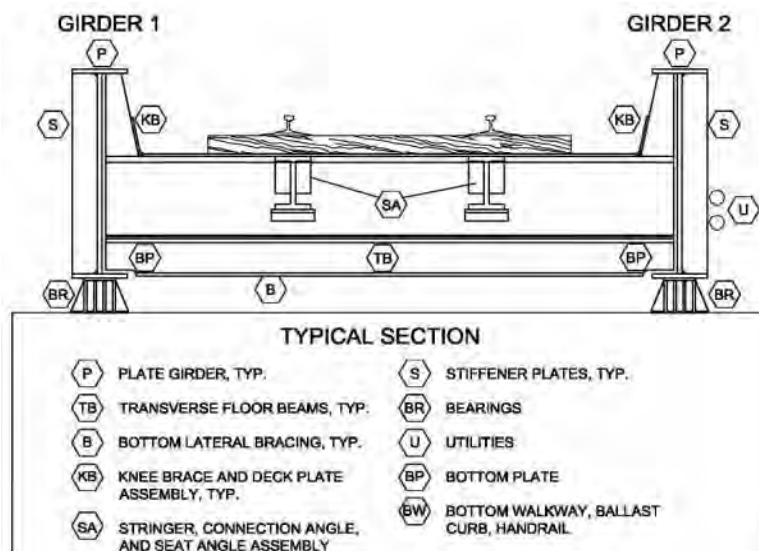
DIVISION	Santa Paula	SPAN LENGTH	66'-8"
NUMBER OF TRACKS	1	CROSSING	Santa Paula Creek
TRACK ALIGNMENT	TANGENT	SPAN No.	1
INSPECTION FINDINGS			
	Grout pad cracked under bearing at pier 2 - see photo

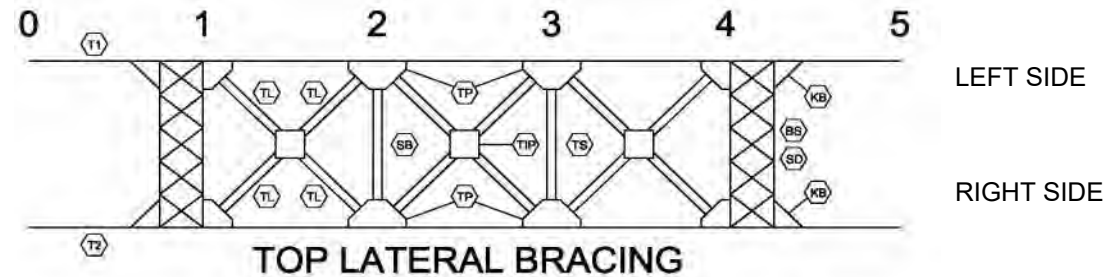
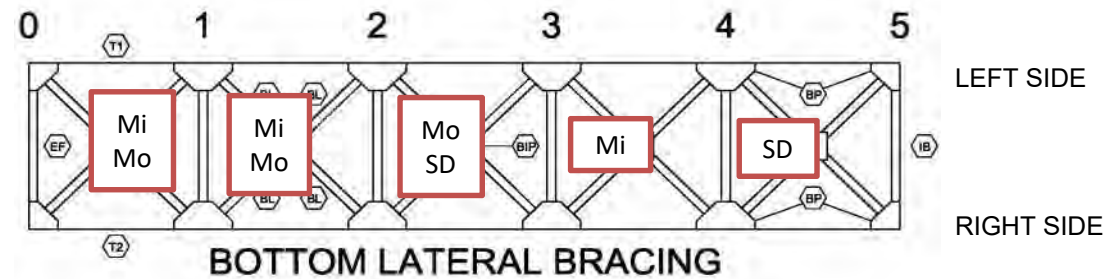
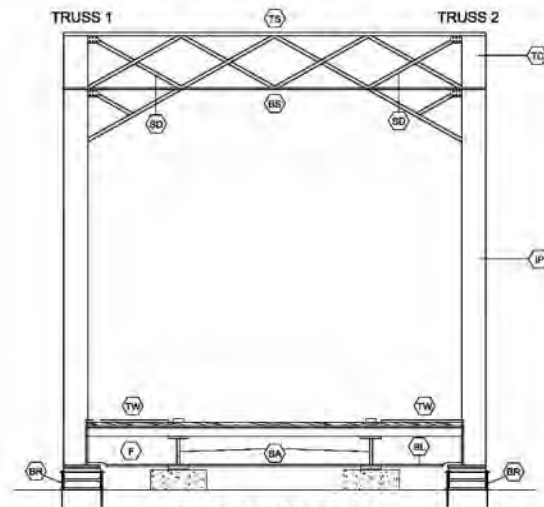
- SC BOTTOM CHORD
- BP BOTTOM LATERAL INTERSECTION PLATE
- BL BOTTOM LATERALS
- IP BOTTOM LATERAL PLATE
- BR BEARINGS
- DS SWAY BRACING - BOTTOM STRUT
- D DIAGONALS
- BA END FLOORBEAM
- EP END POST
- F FLOORBEAM
- FB FLOORBEAM BRACKET AND CONNECTION ANGLE ASSEMBLY
- GP GUSSET PLATE
- H HANGER
- IB INTERMEDIATE FLOORBEAM
- IP INTERMEDIATE POST
- KB KNEE BRACE
- S1 STRINGER 1 - LEFT SIDE
- S2 STRINGER 2 - RIGHT SIDE
- SA STRINGER, CONNECTION ANGLE AND SEAT ANGLE ASSEMBLY
- SB SWAY BRACING
- SD SWAY BRACING - DIAGONALS
- SL STRINGER LATERALS
- SP STRINGER LATERAL PLATE
- SS STRINGER STRUT
- T1 TRUSS 1 - LEFT SIDE
- T2 TRUSS 2 - RIGHT SIDE
- TL TOP CHORD
- TP TOP LATERAL INTERSECTION PLATE
- TS TOP LATERALS
- TP TOP LATERAL PLATE
- TS SWAY BRACING - TOP STRUT
- TW TOP WALKWAY, BALLAST CURB, AND HANDRAIL

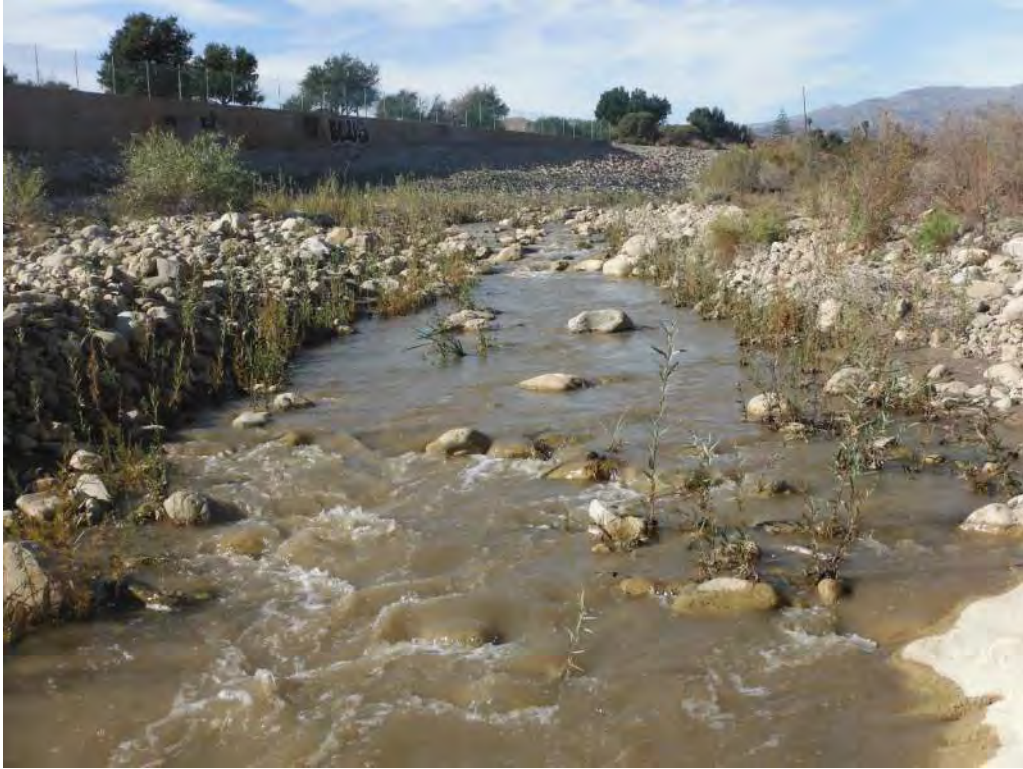
**415.59 Channel Condition. Looking upstream**

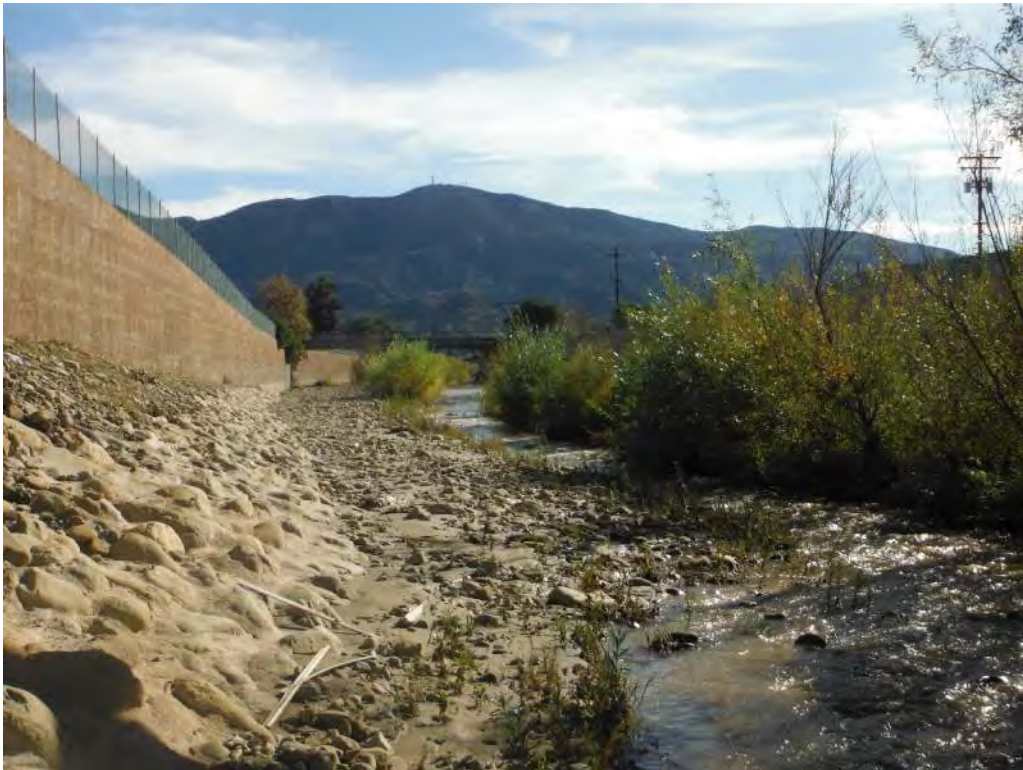
**415.59 Channel Condition. Looking downstream**

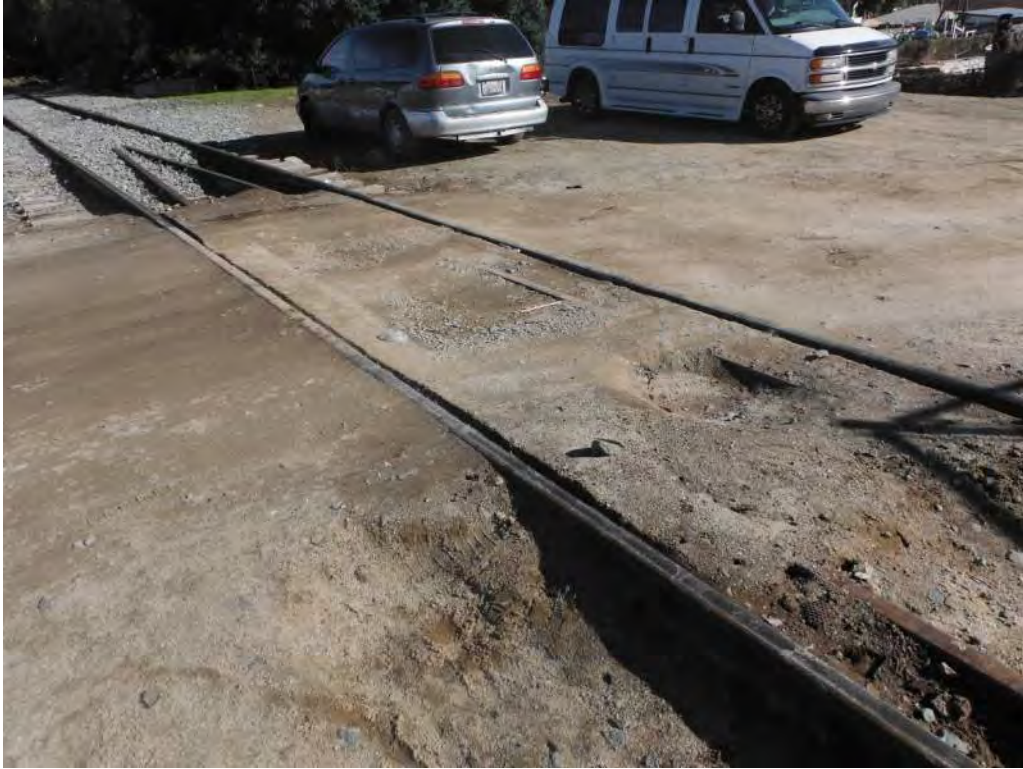
**415.59 Material between inside guardrail and running rail, typ both sides**

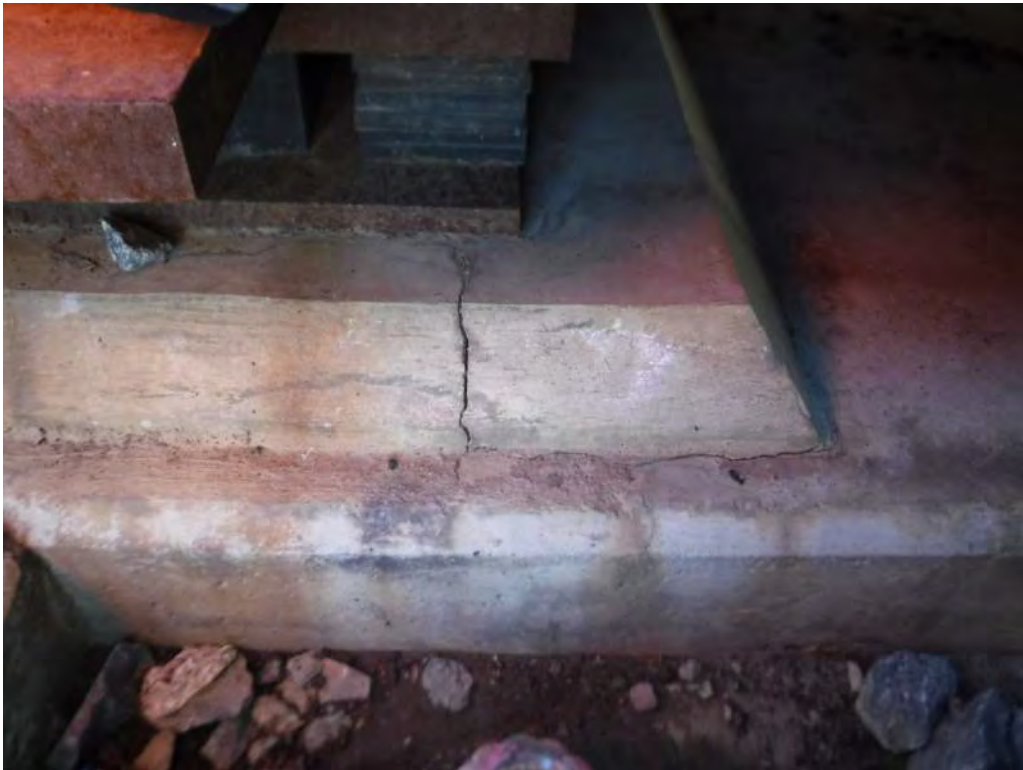
**415.59 Grout pad cracked under bearing, Pier 2**

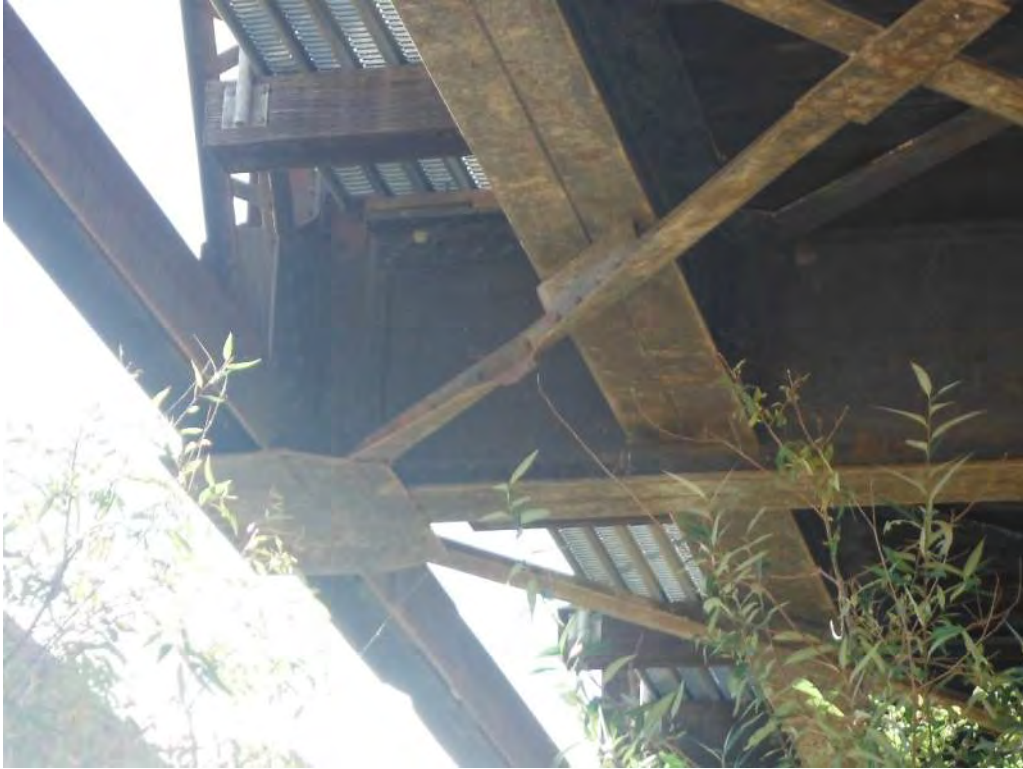
**415.59 Minor impact damage – typical bottom cross bracing**

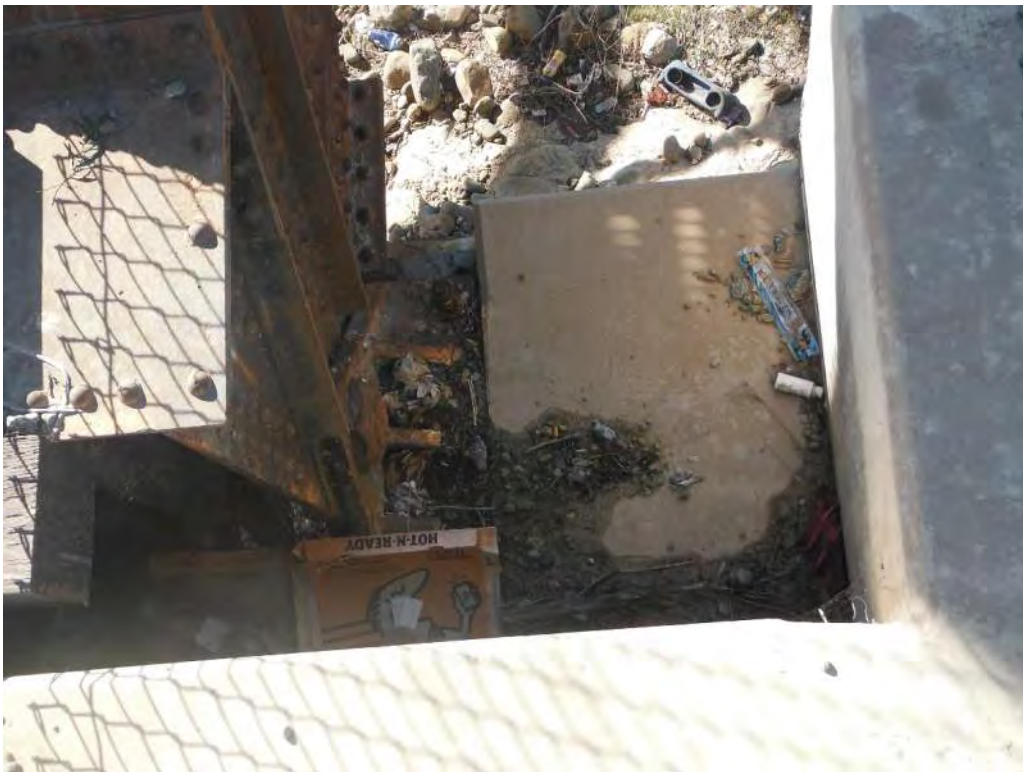
**415.59 Debris at NE Bearing**

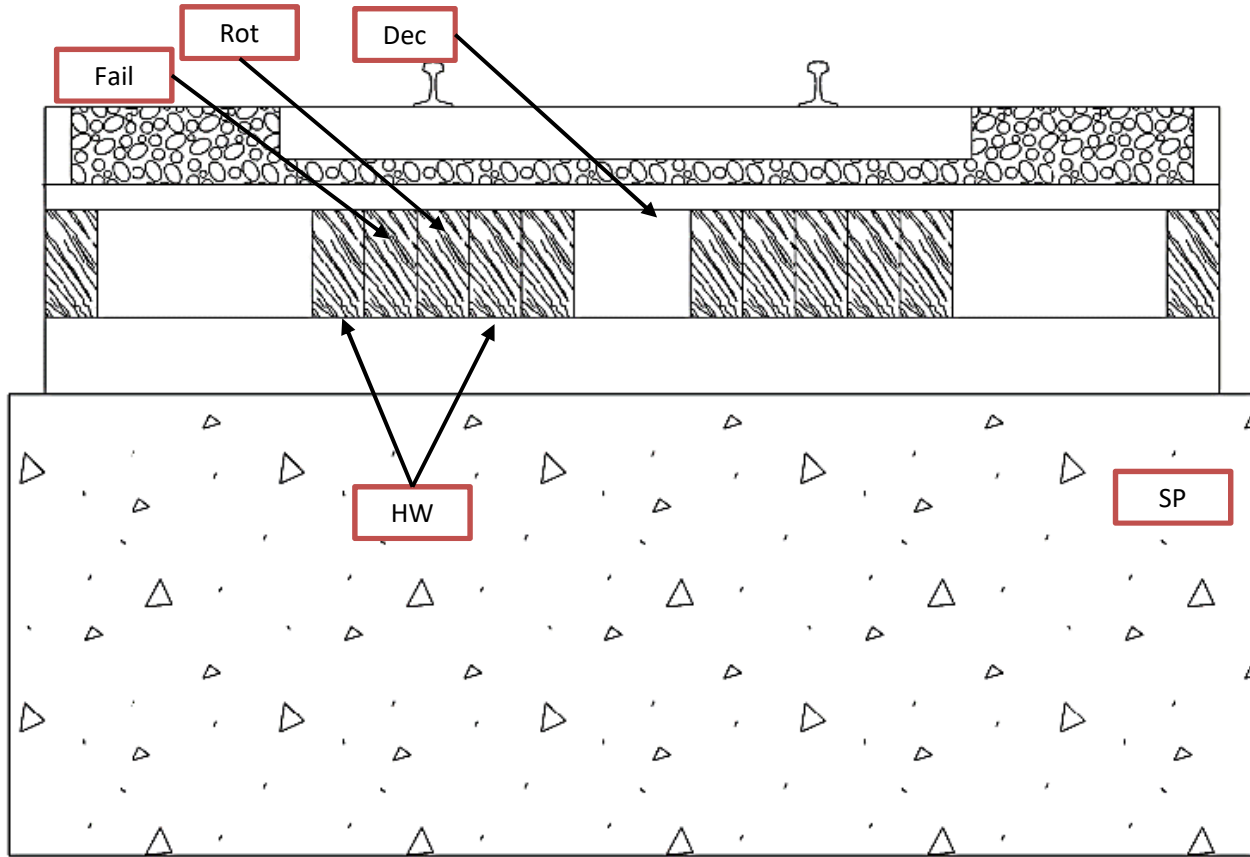
### Description: Looking West - (12) 8"x17" Timber Stringers, Concrete Pier

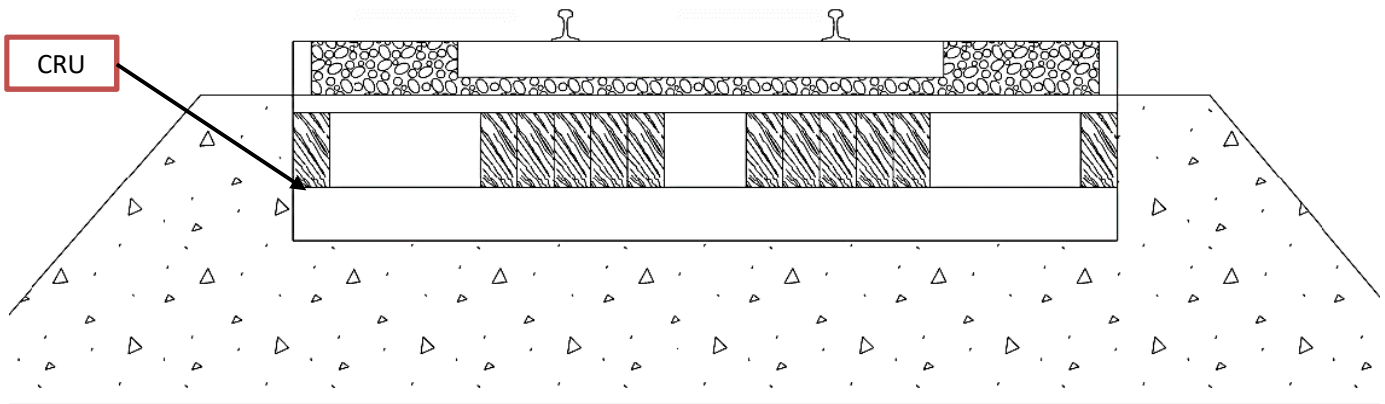
**Description: Looking East - (12) 8"x17" Timber Stringers, Concrete Abutment**

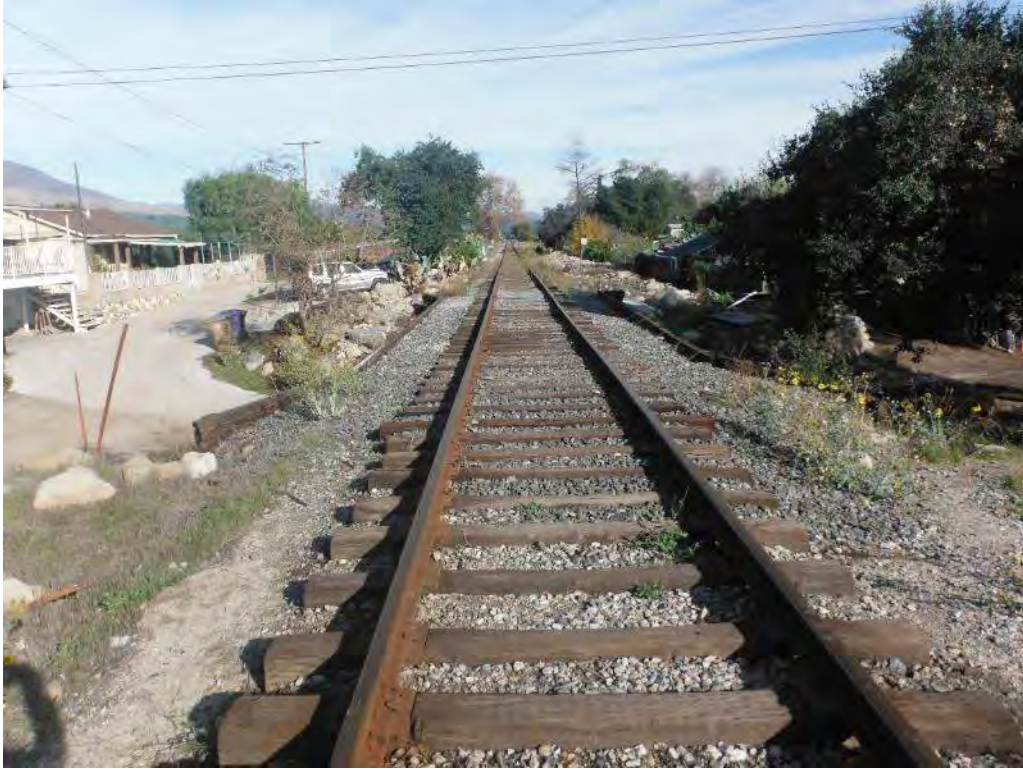
**415.69 Looking East**

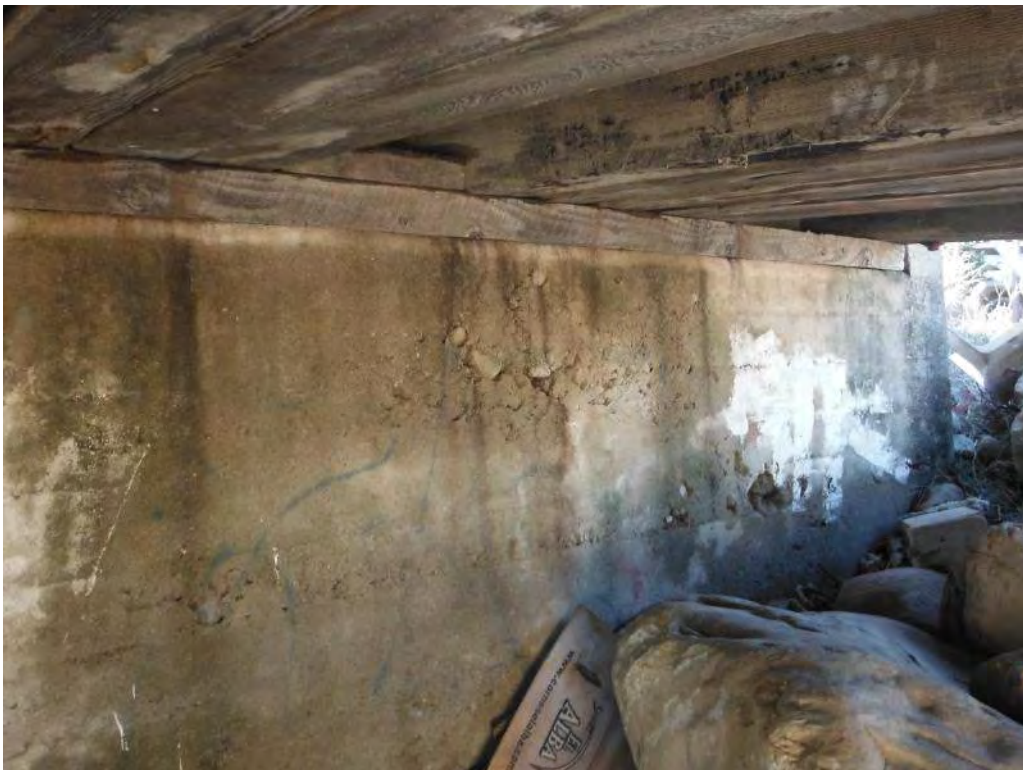
**415.69 Abutment 1 Spall**

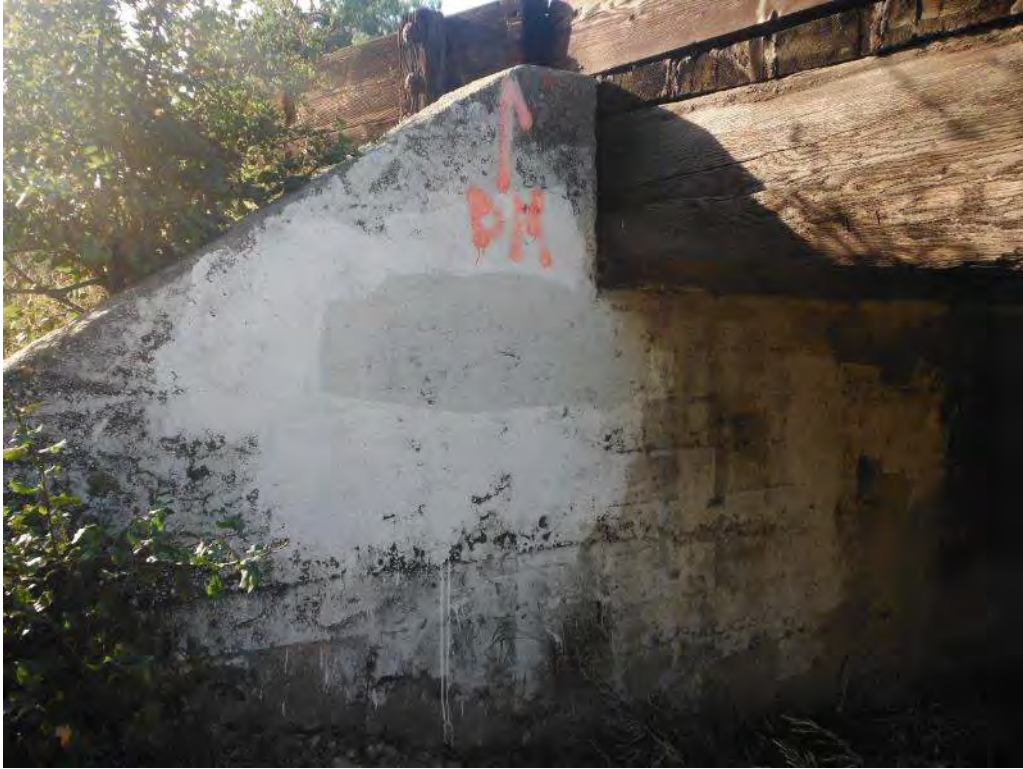
**415.69 Cracks in Southwest Wingwall**
