# BRIDGE INSPECTION REPORT

INSPECTION TYPE: Annual

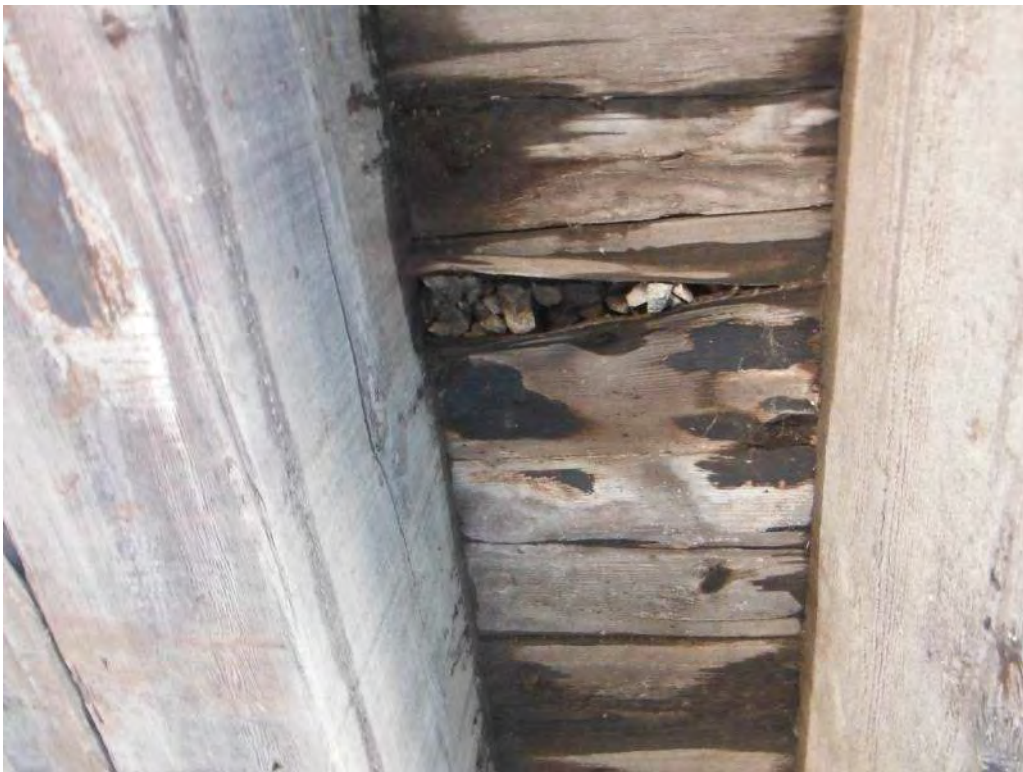
**415.69 Poor ballast planks (typ.)**

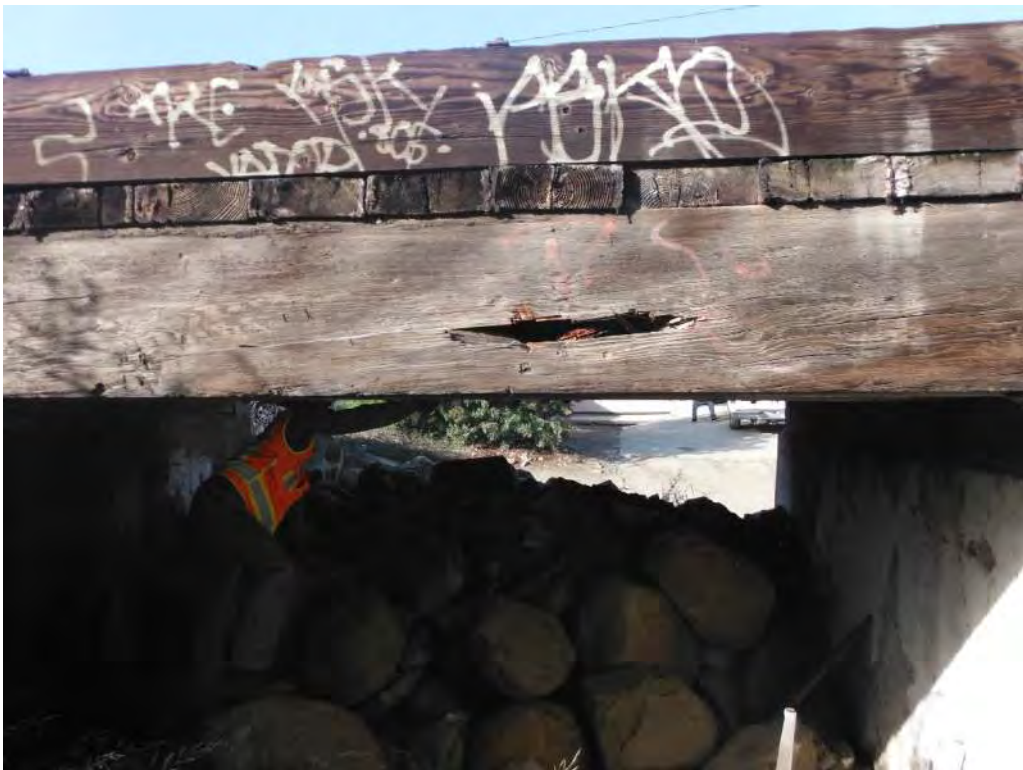
**415.69 Stringer 12 is rotten/failed – Span 1**

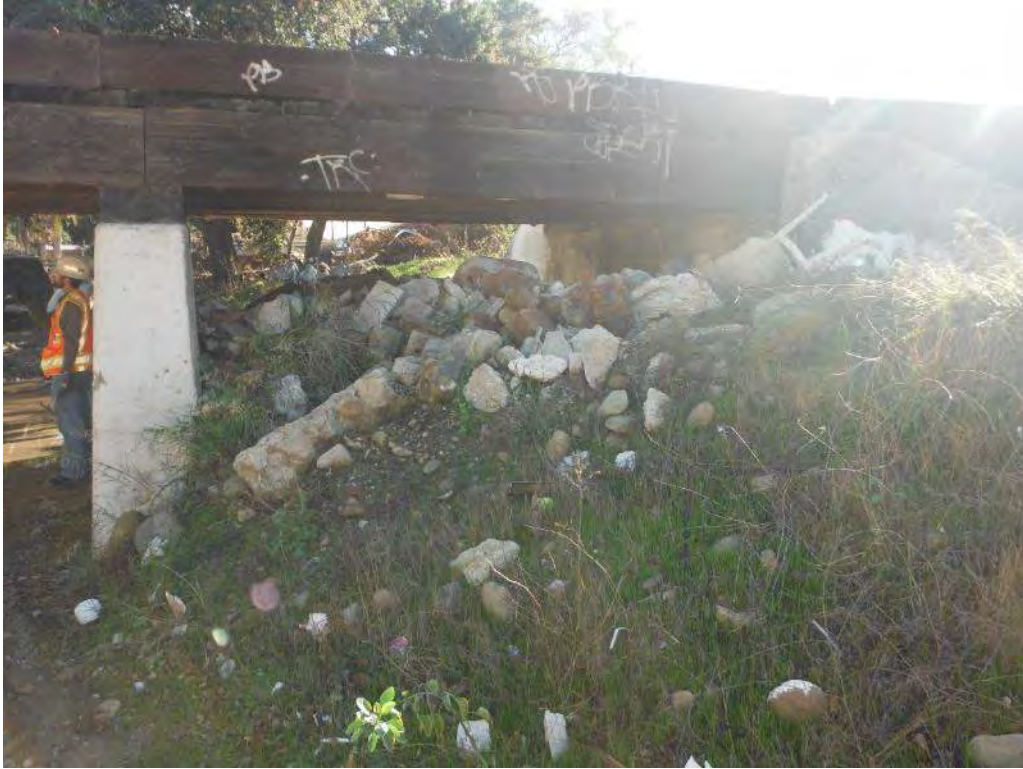
**415.69 Debris under Span 1**

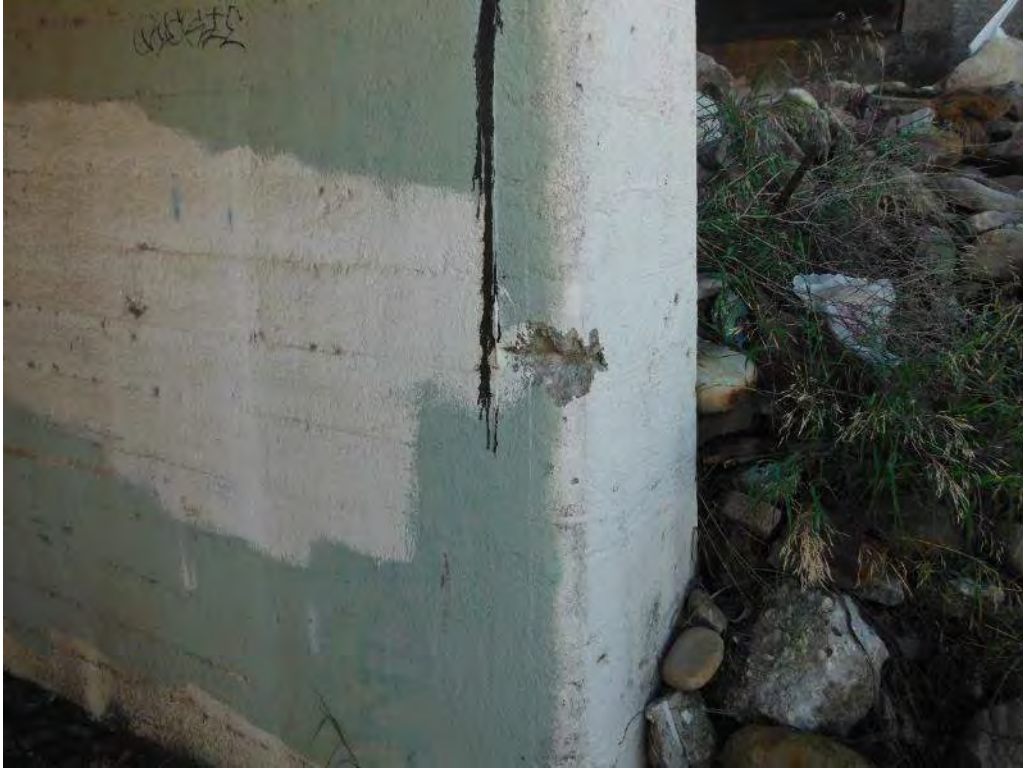
**415.69 Spall North Side of Pier 2**

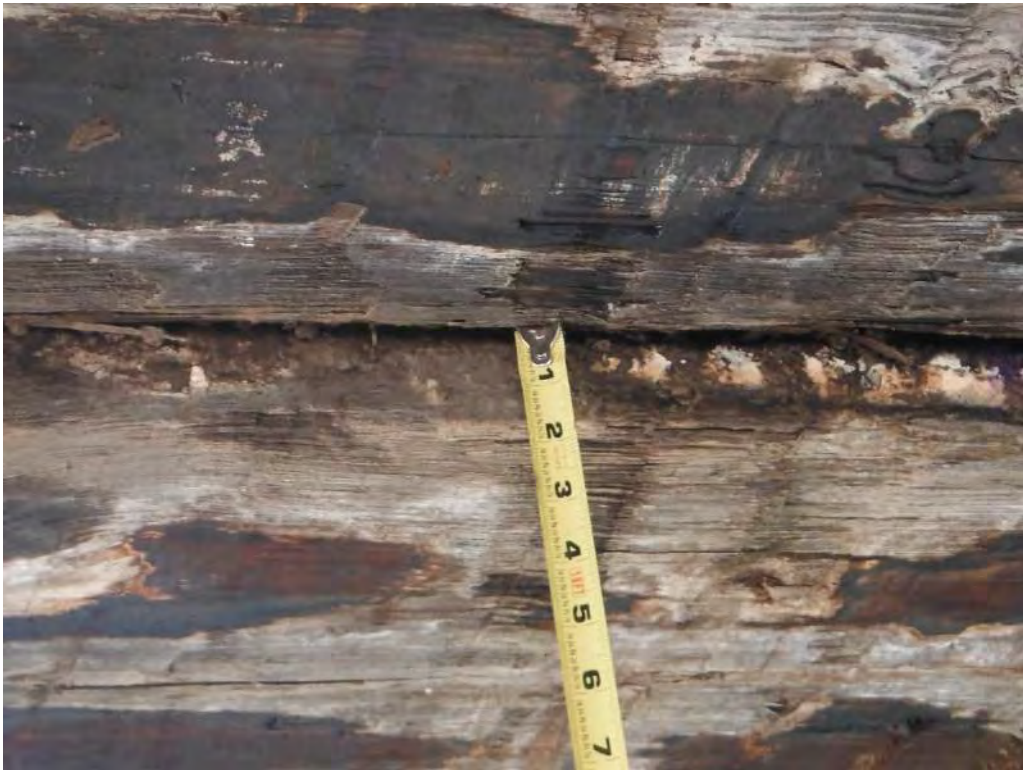
**415.69 Stringer 10 deflected 1.75" – Span 2**

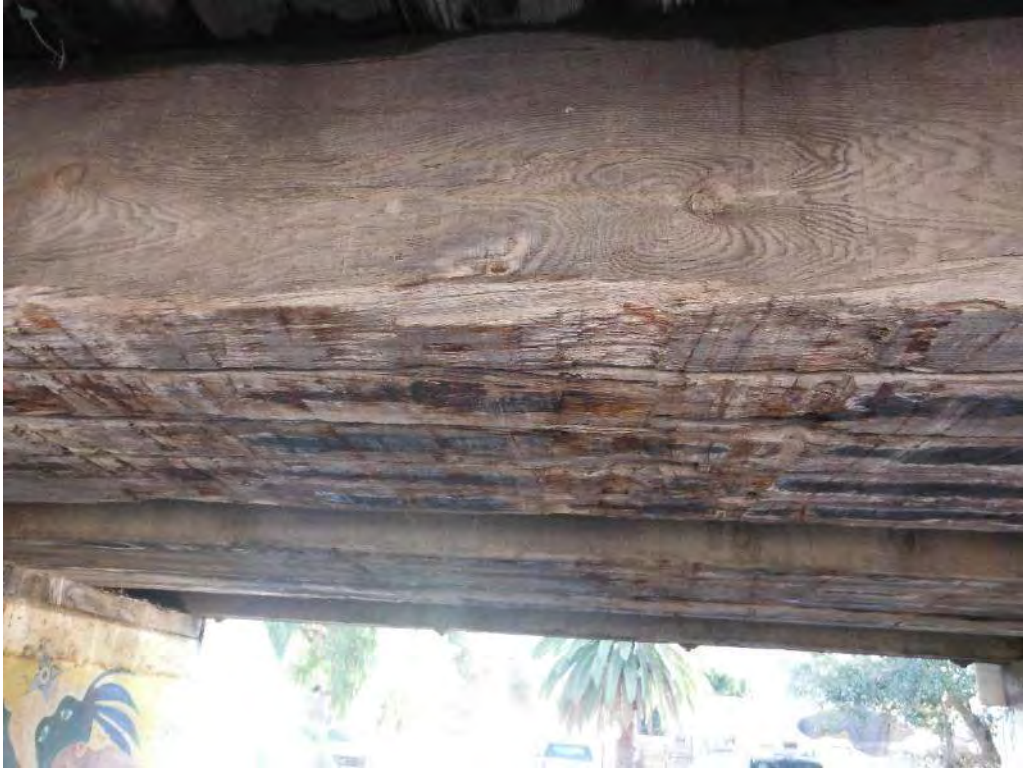
**415.69 Impact damage on stringers (typ.)**

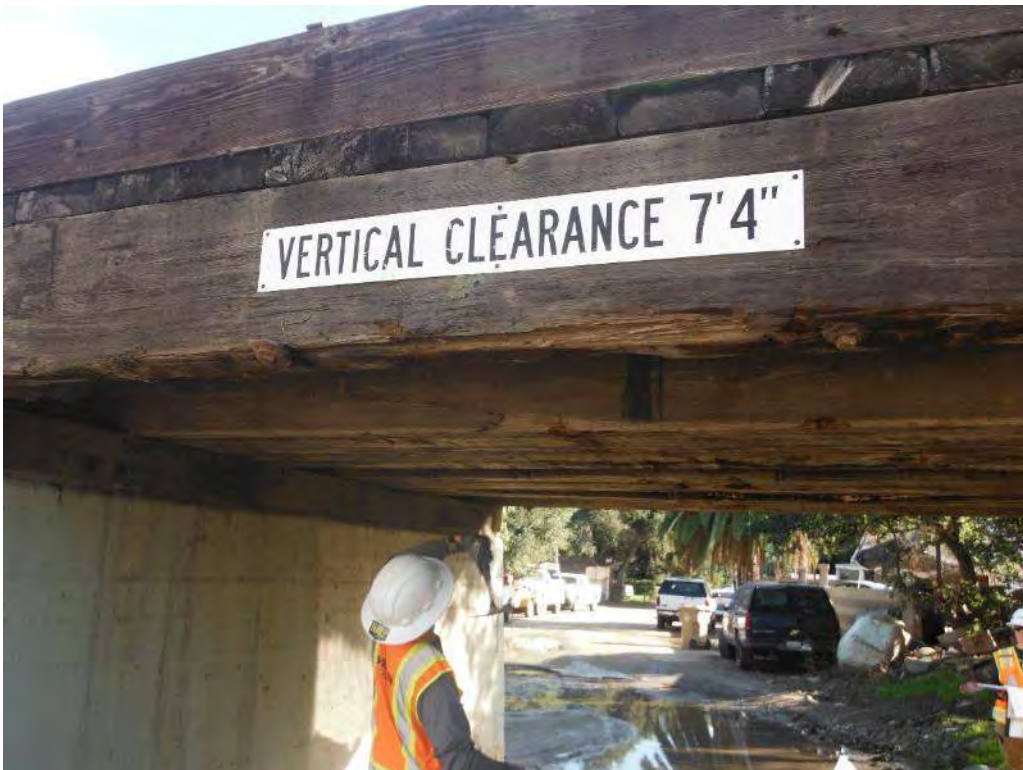
**415.69 Major impact damage to Stringer 1, typ Span 2 and 3**

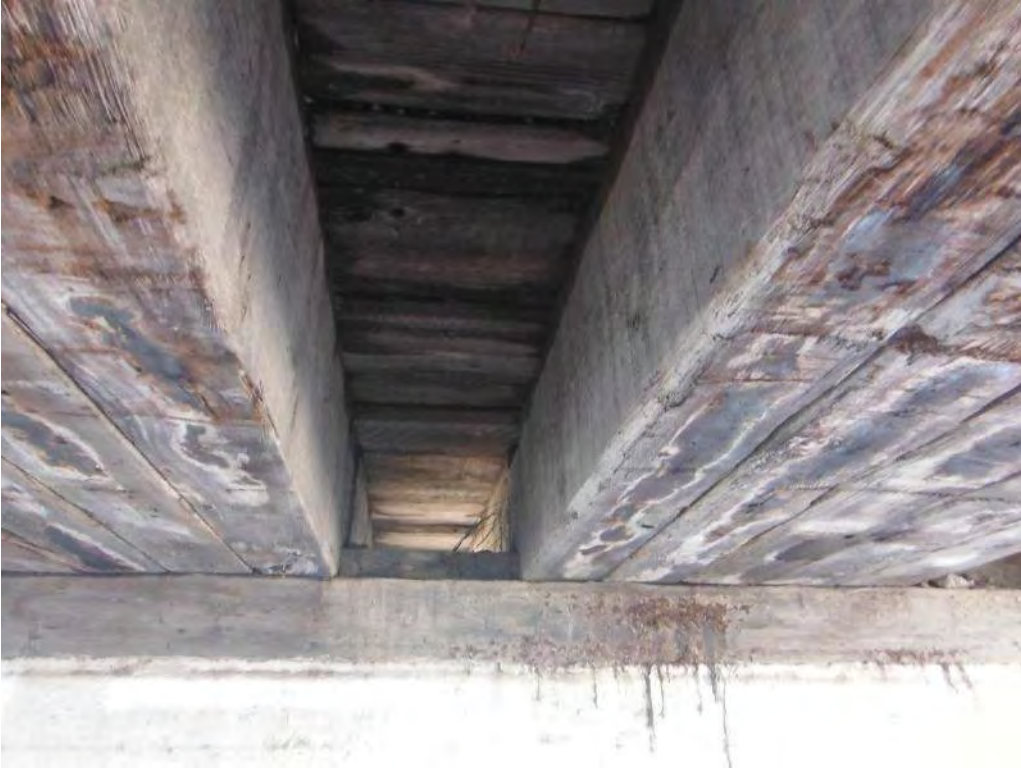
**415.69 Stringer 6 rotated 1" at Pier 3 & Abutment 4**

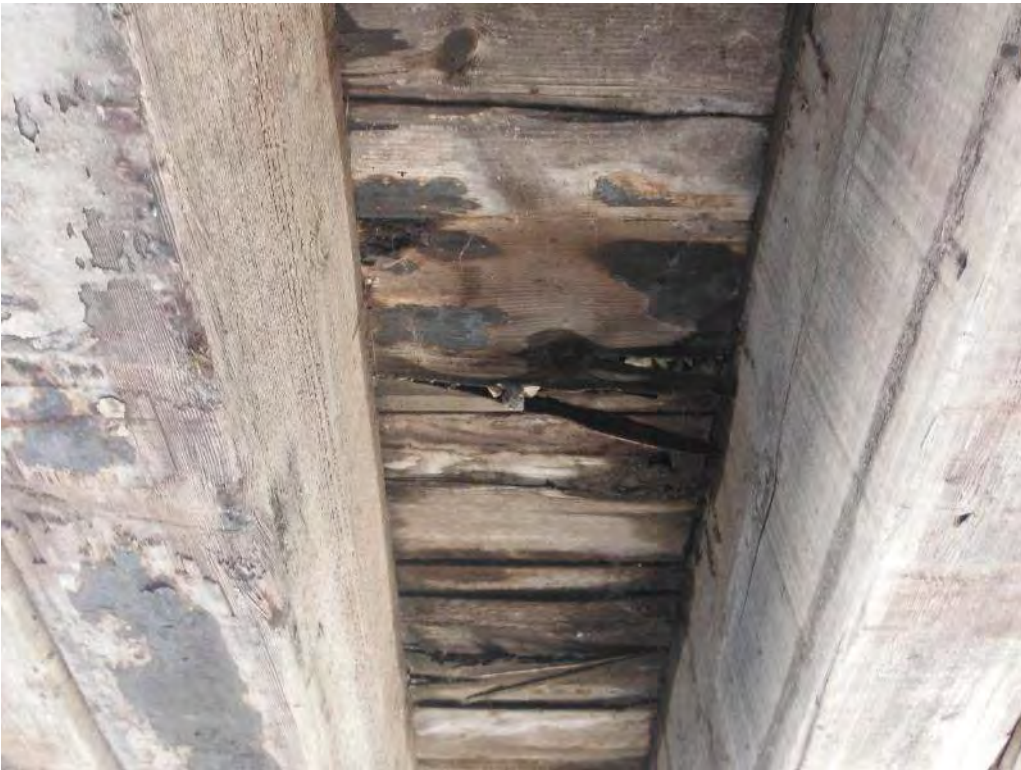
**415.69 Decay of deck ballast plank. Mid-span, Span 3**

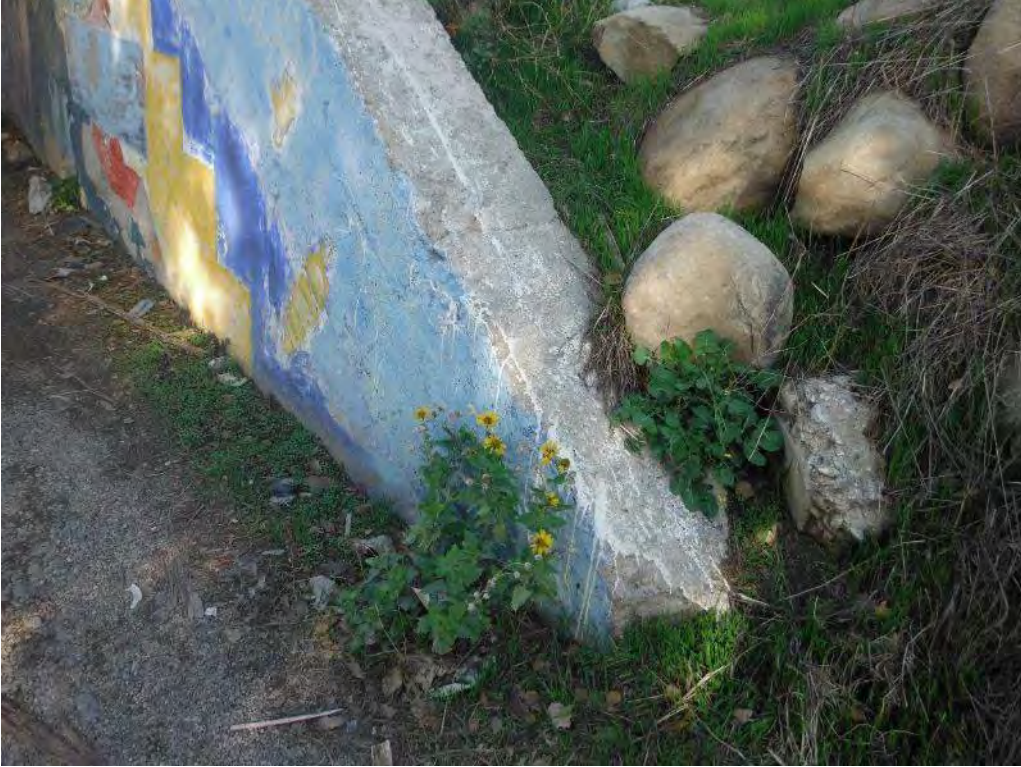
**415.69 Spall on wingwall at abutment 4**

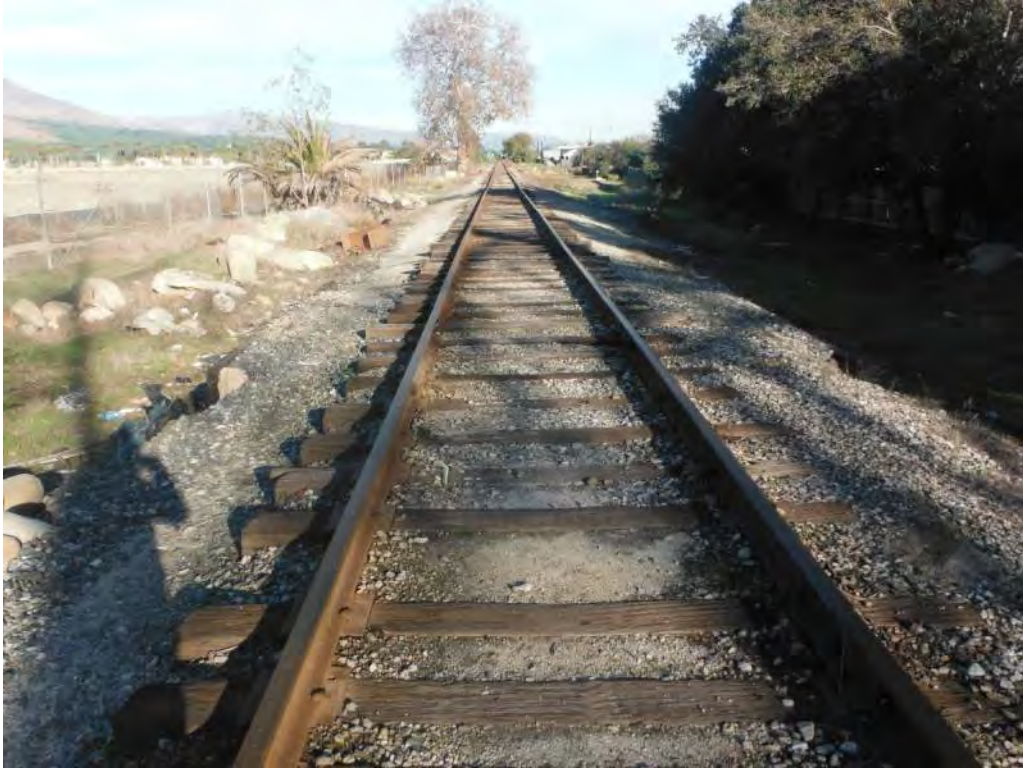
**415.79 Looking East**

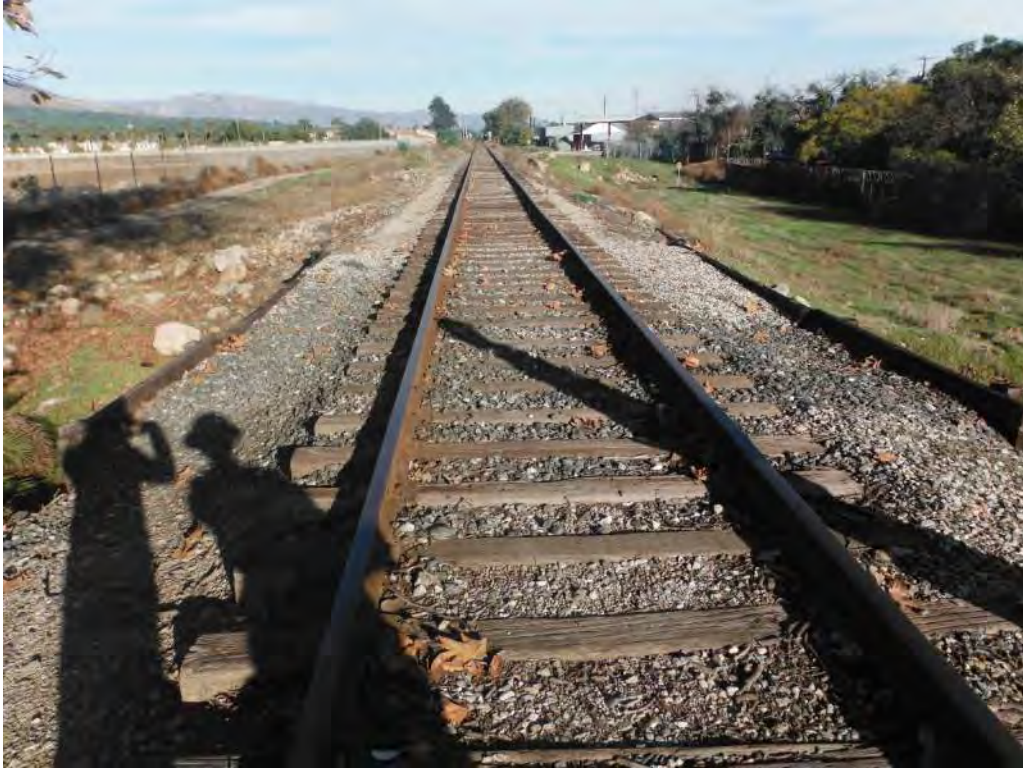
**415.82 Looking East**

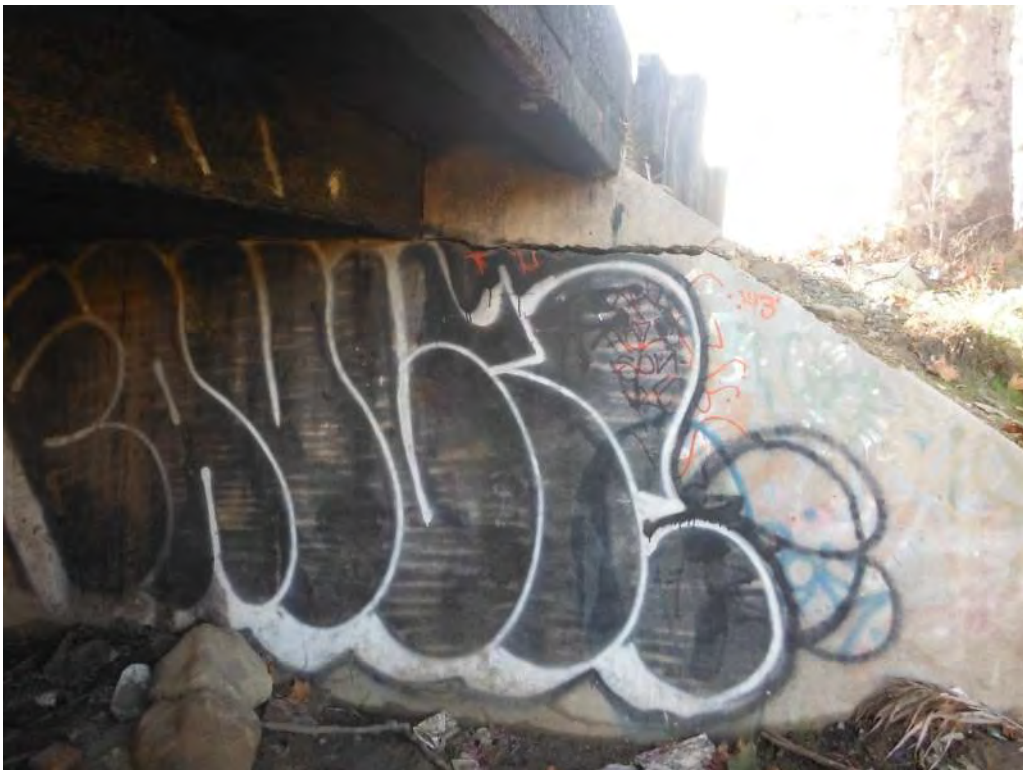
**415.82 Abutment stringer retainers cracked – typical all 4 corners**

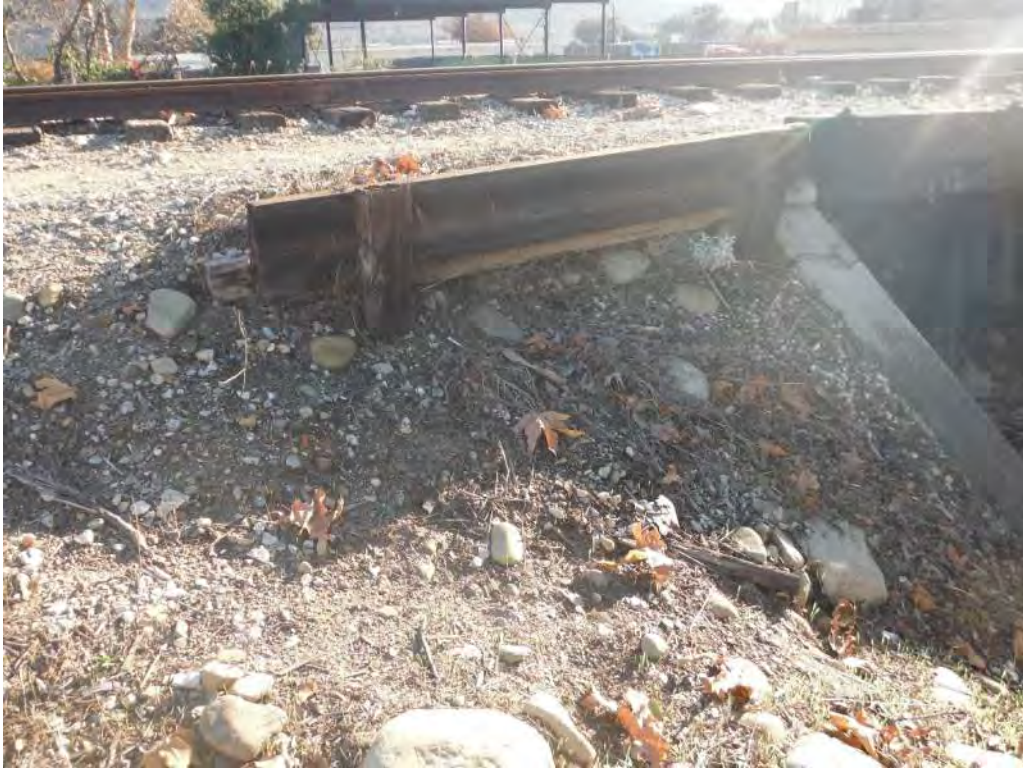
**415.82 Wingwalls undermined – typical all 4 corners**

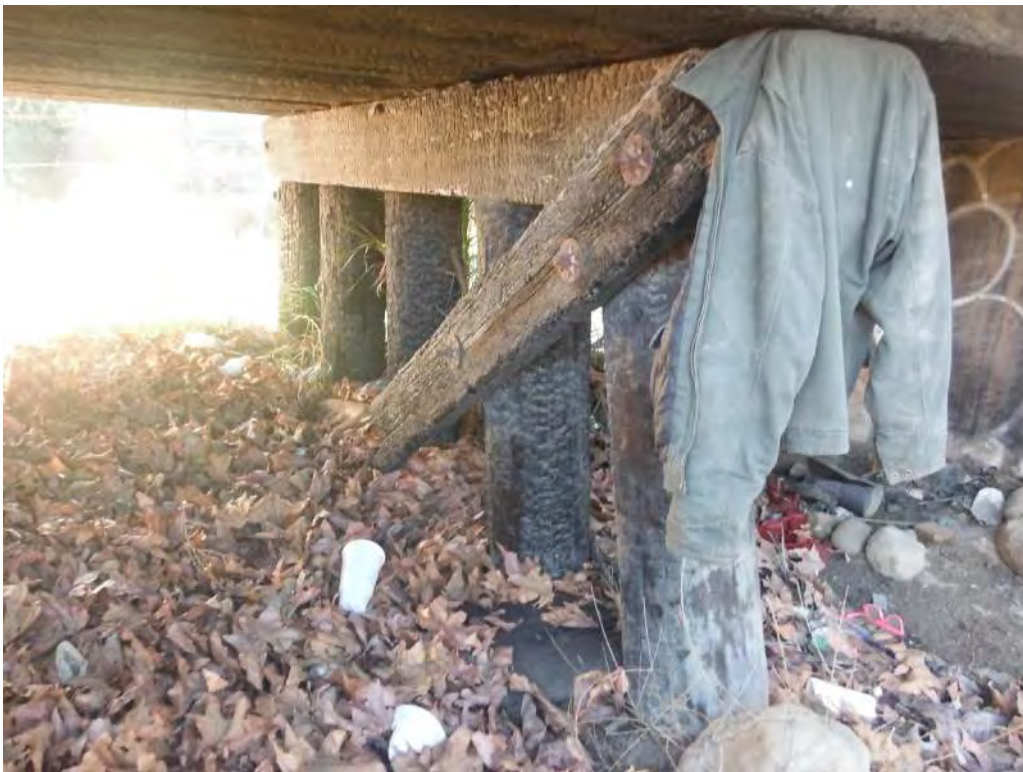
**415.82 Failed sway brace – pier 2**

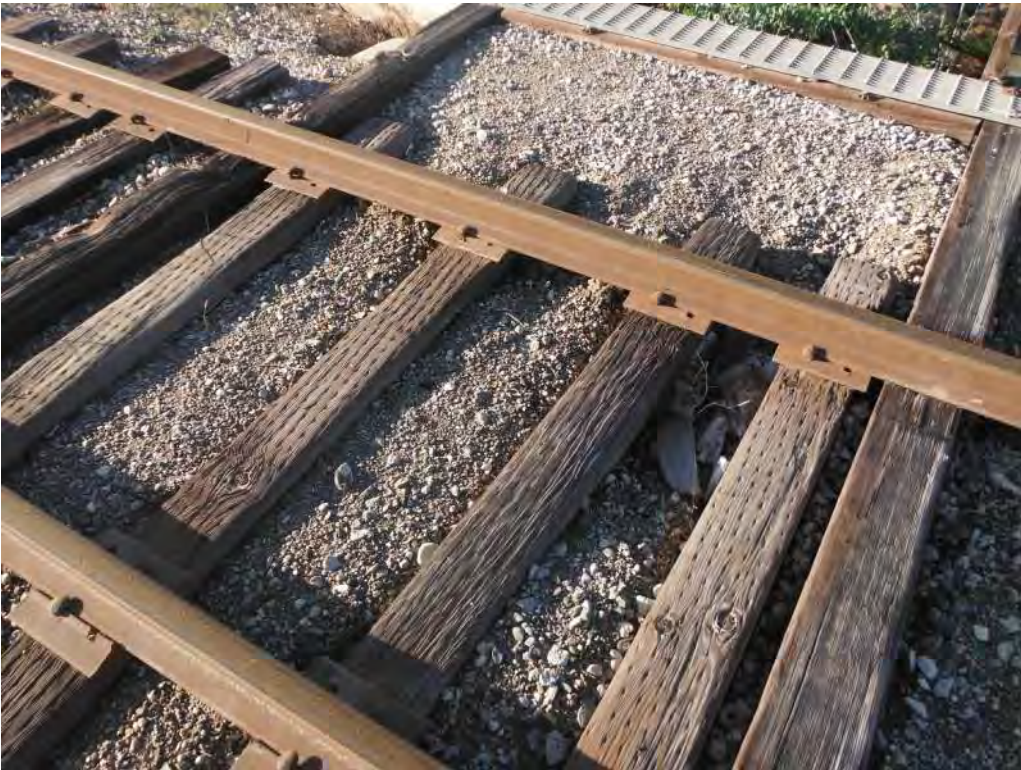
**415.92 Ballast leak – Span 2 north side**

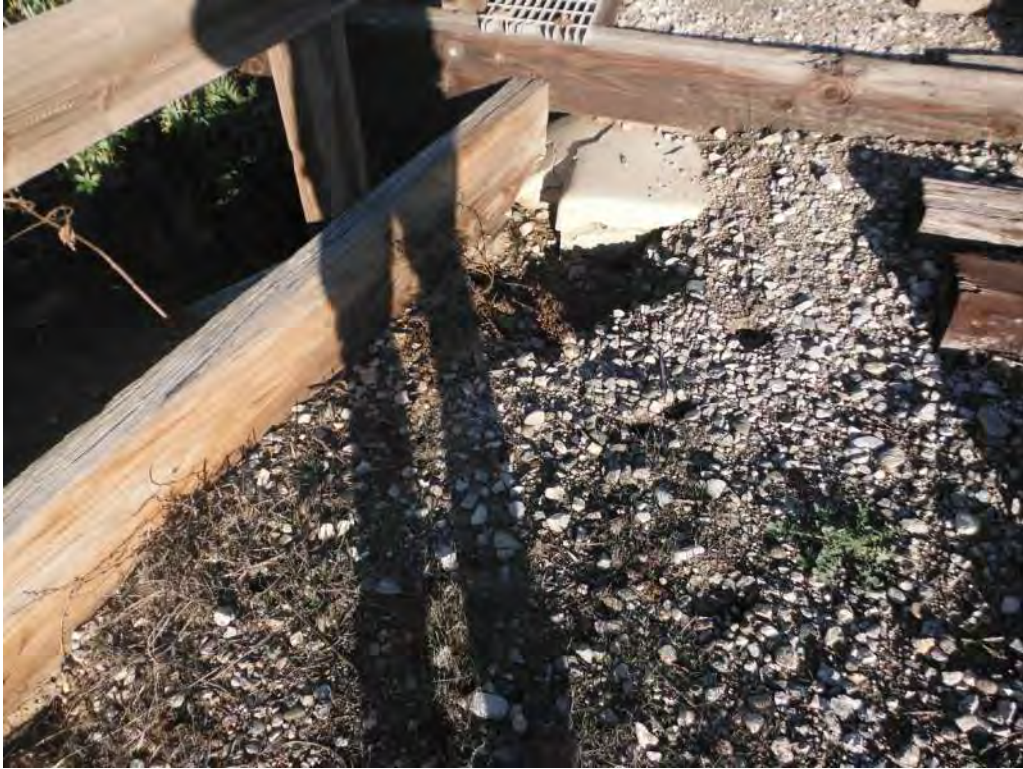
**415.92 NW wingwall leaking**

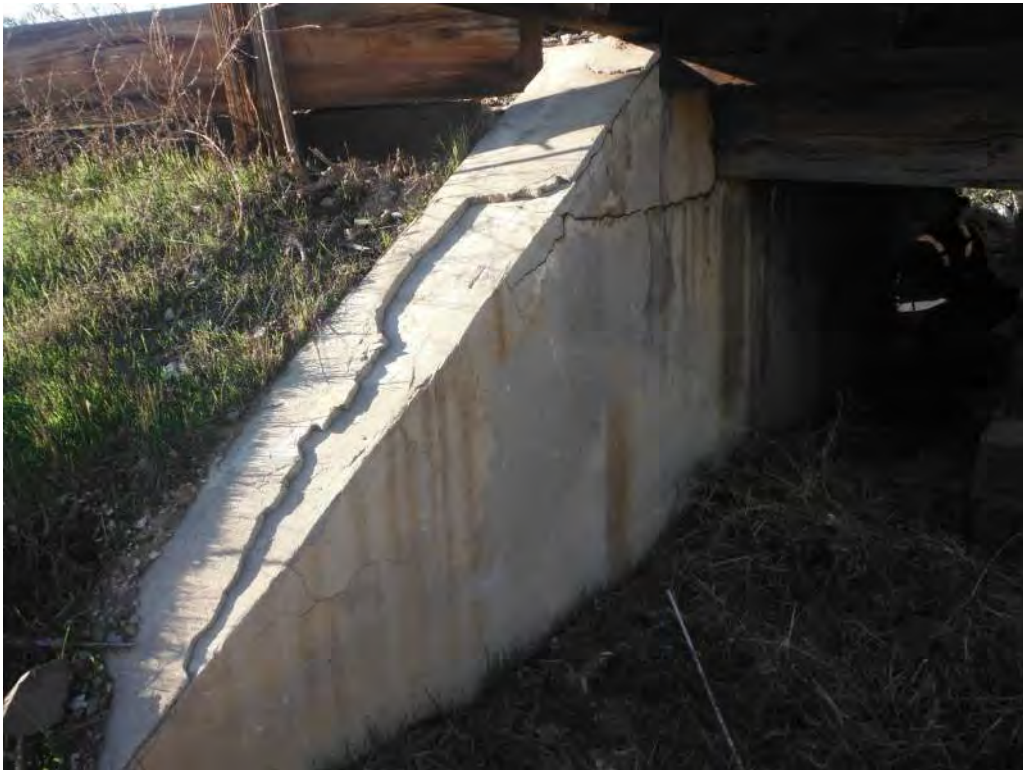
**415.92 Abutment stringer retainer cracked- typical NW, SW, SE**

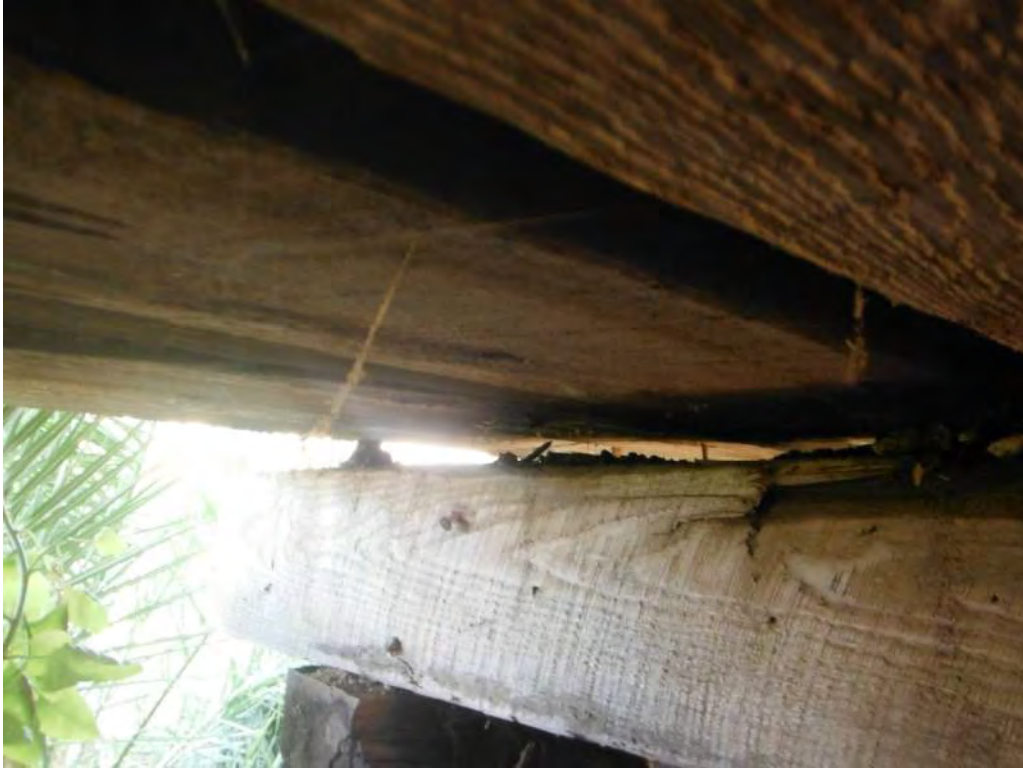
**415.92 Helper bents not shimmed to stringers – both spans**

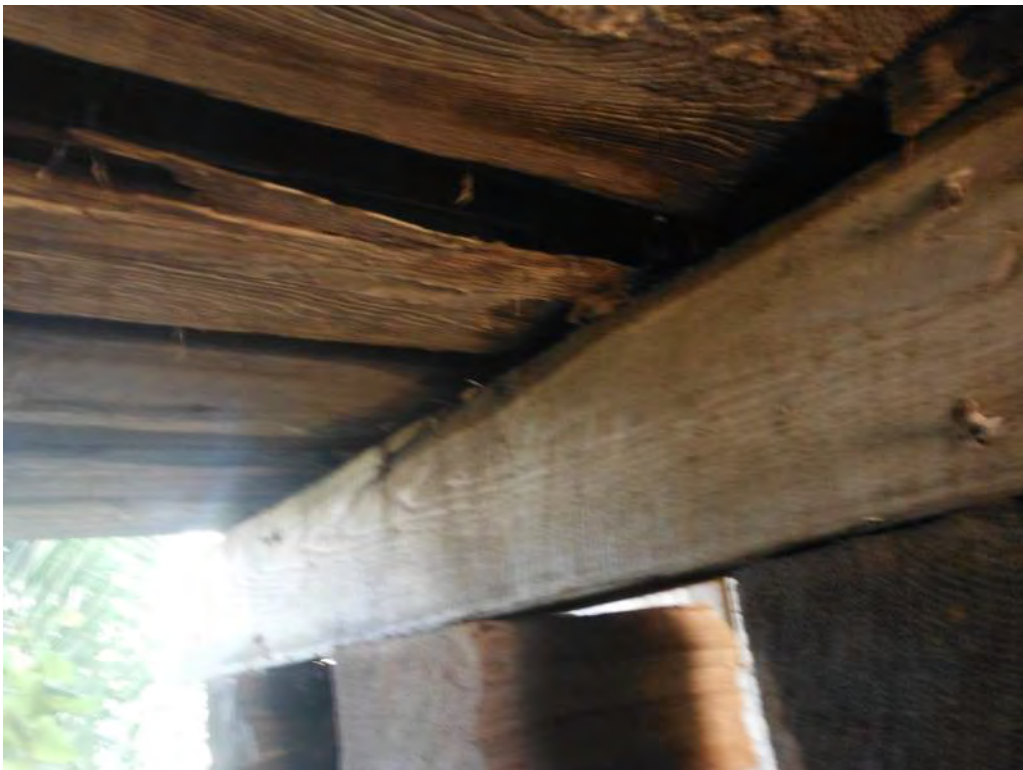
**415.92 Stringer 5 rotten, Stringer 2 & 4 failed, Span 2**

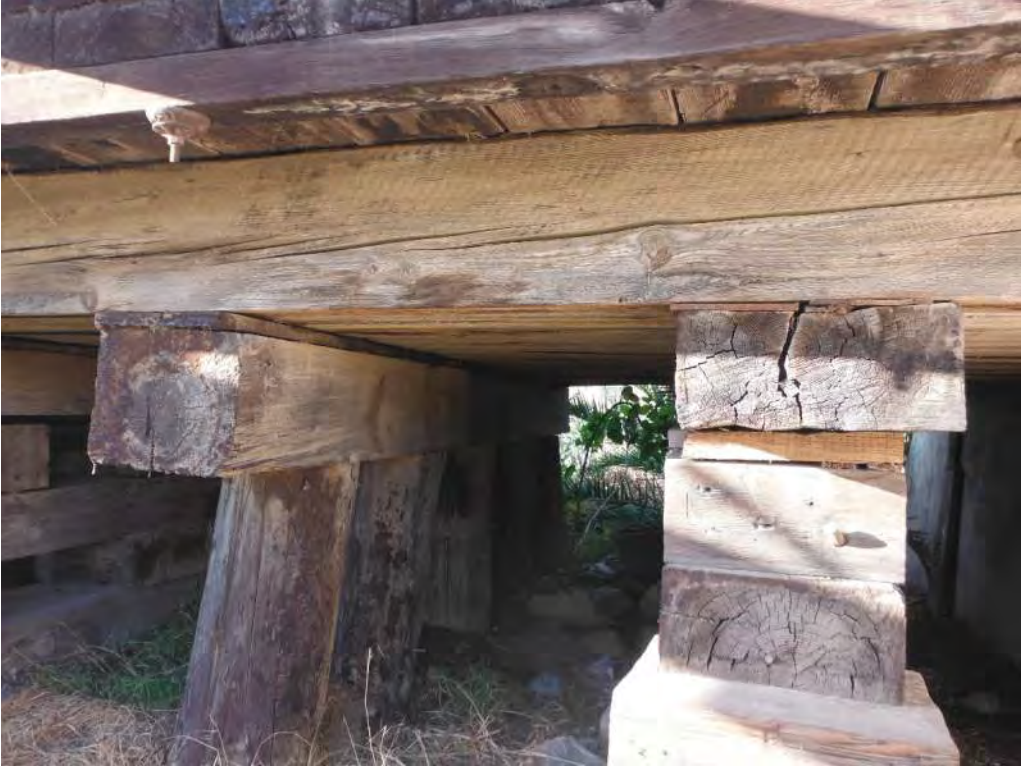
**415.92 Stringer 12 deep checking**

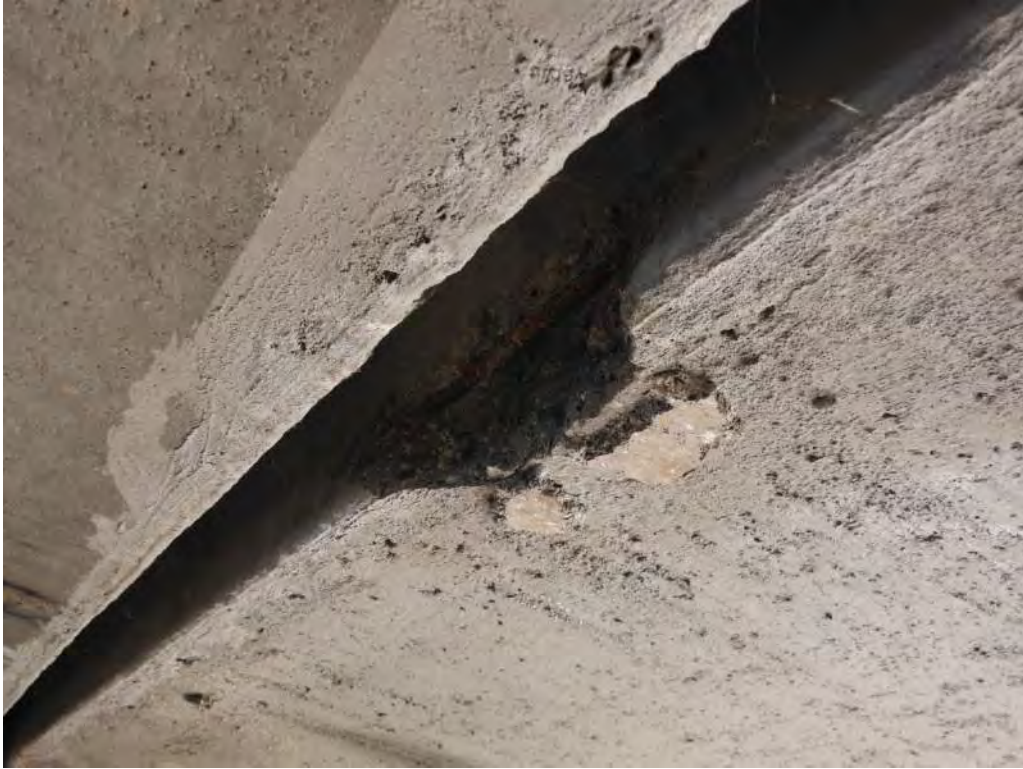
**416.21 Cell 3 concrete spall on underside of top slab. Rebar exposed**

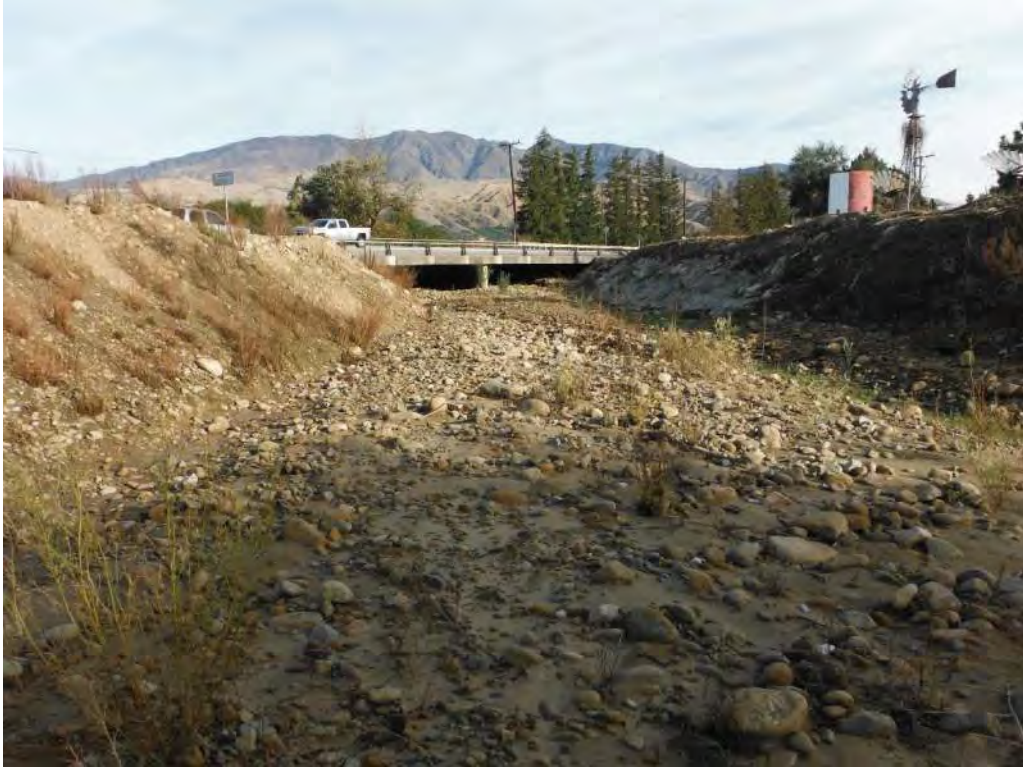
**416.32 Channel condition. Looking Upstream**

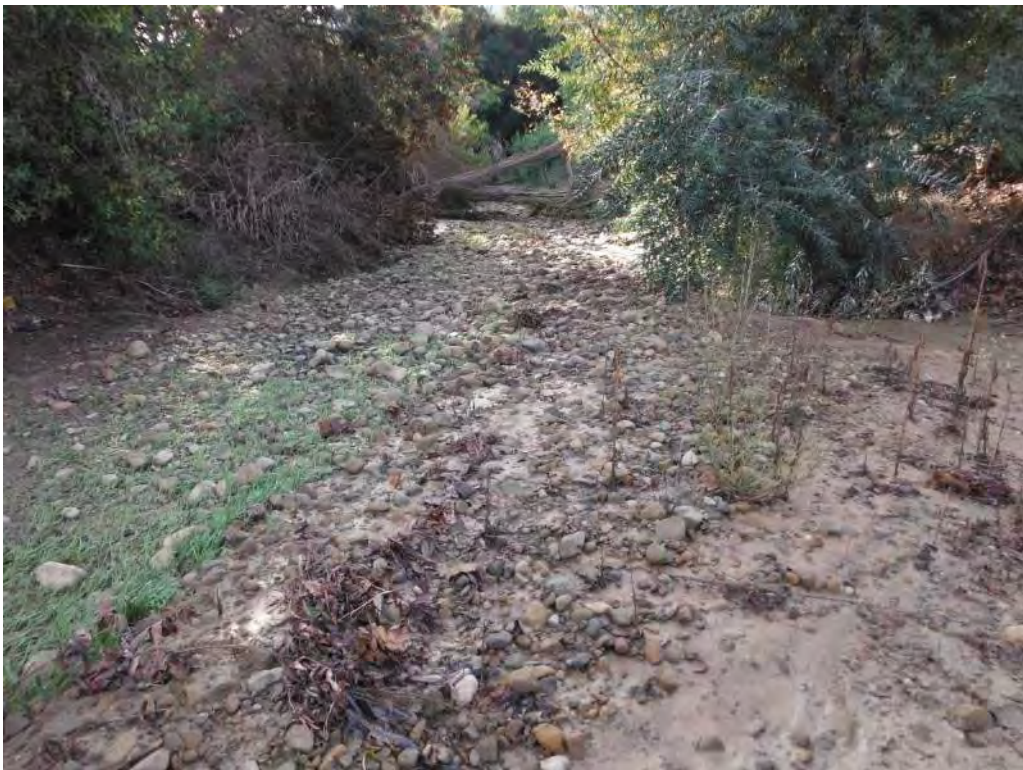
**416.32 Channel condition. Looking Downstream**

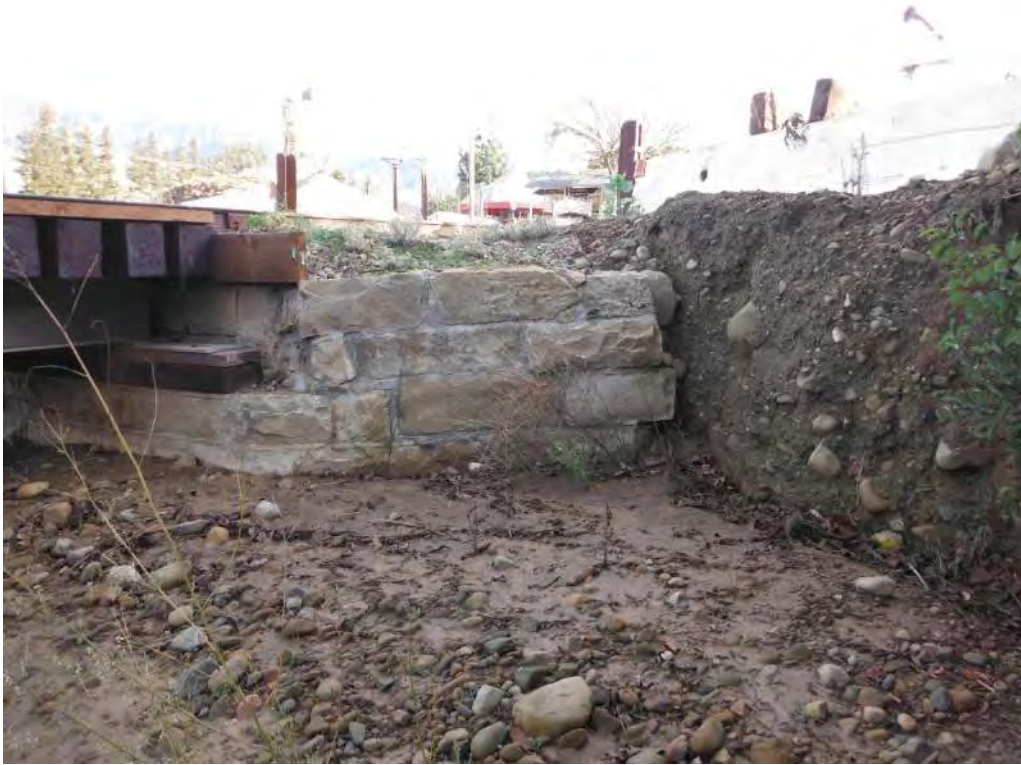
**416.32 Erosion around wingwalls (typ.)**

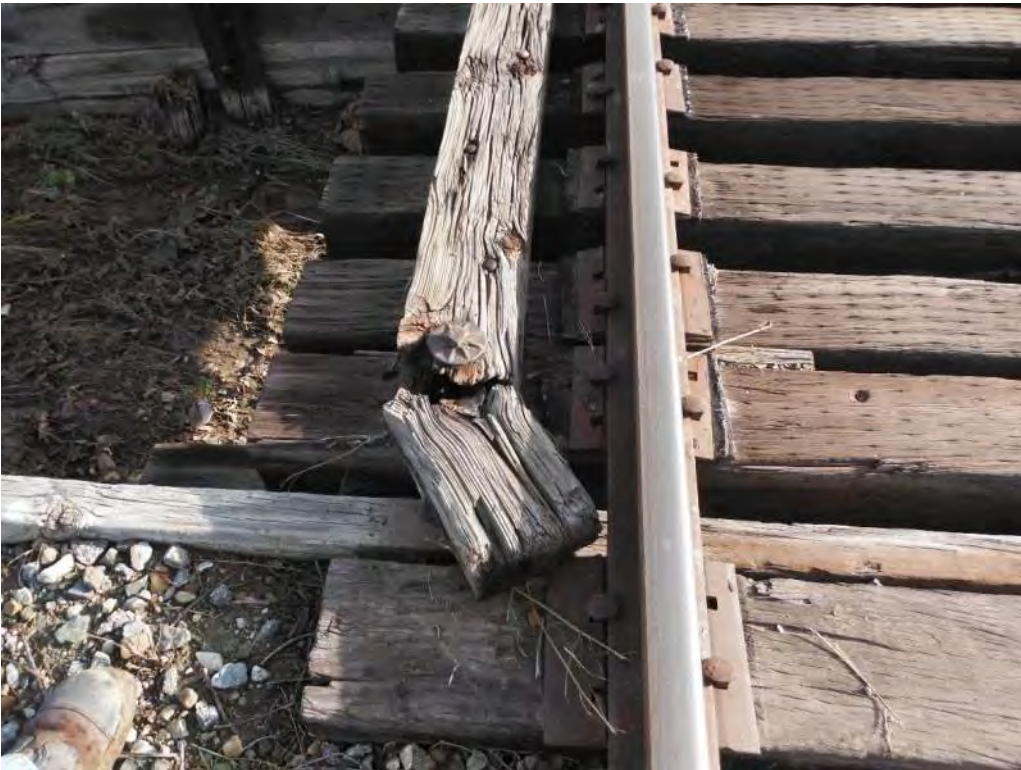
**416.63 Guard ties rotten and broken**

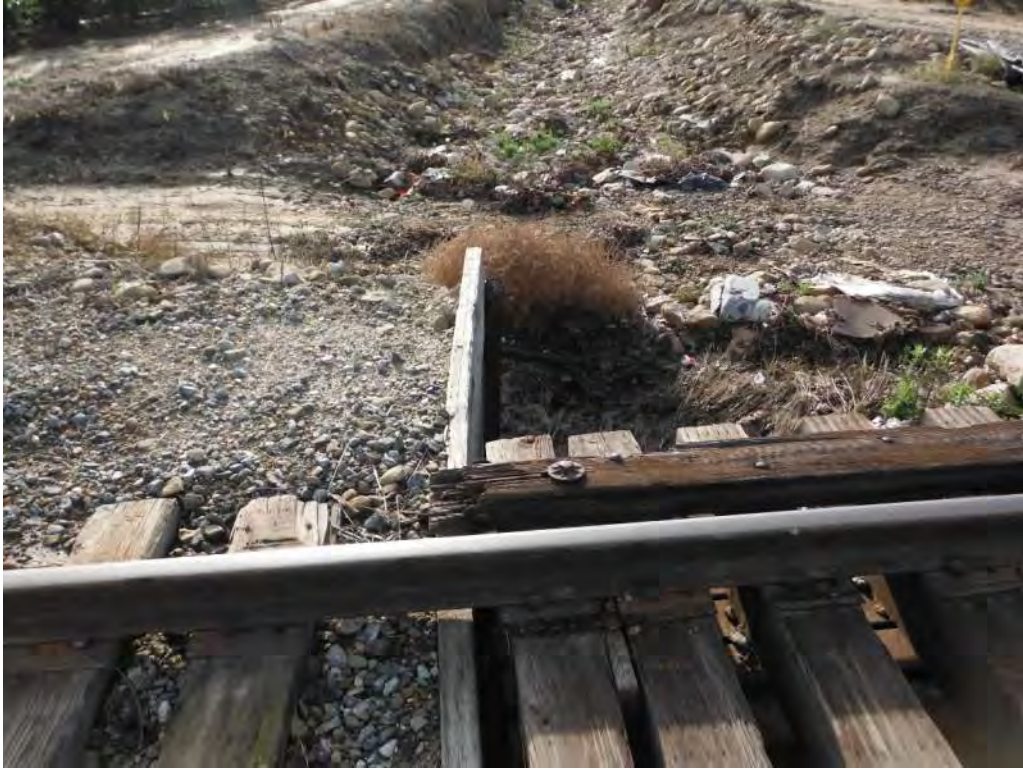
**416.63 Backwall leaning - Abutment 1 & 2**

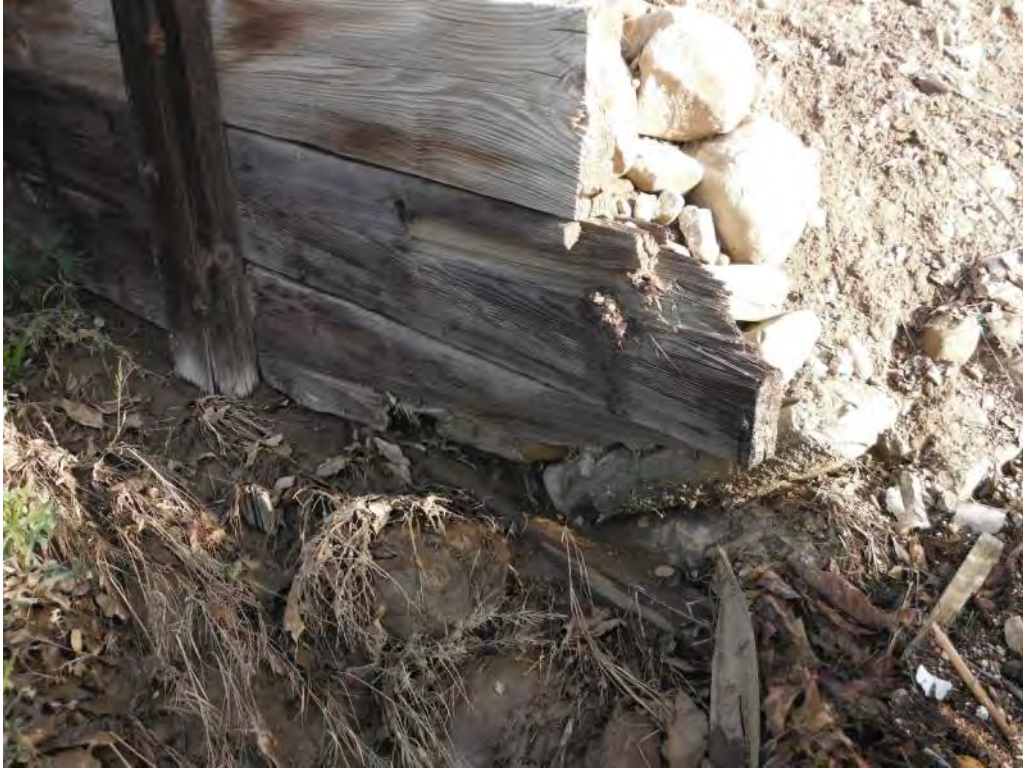
**416.63 Backwall rotting/leaking material at bottom (Typ.)**

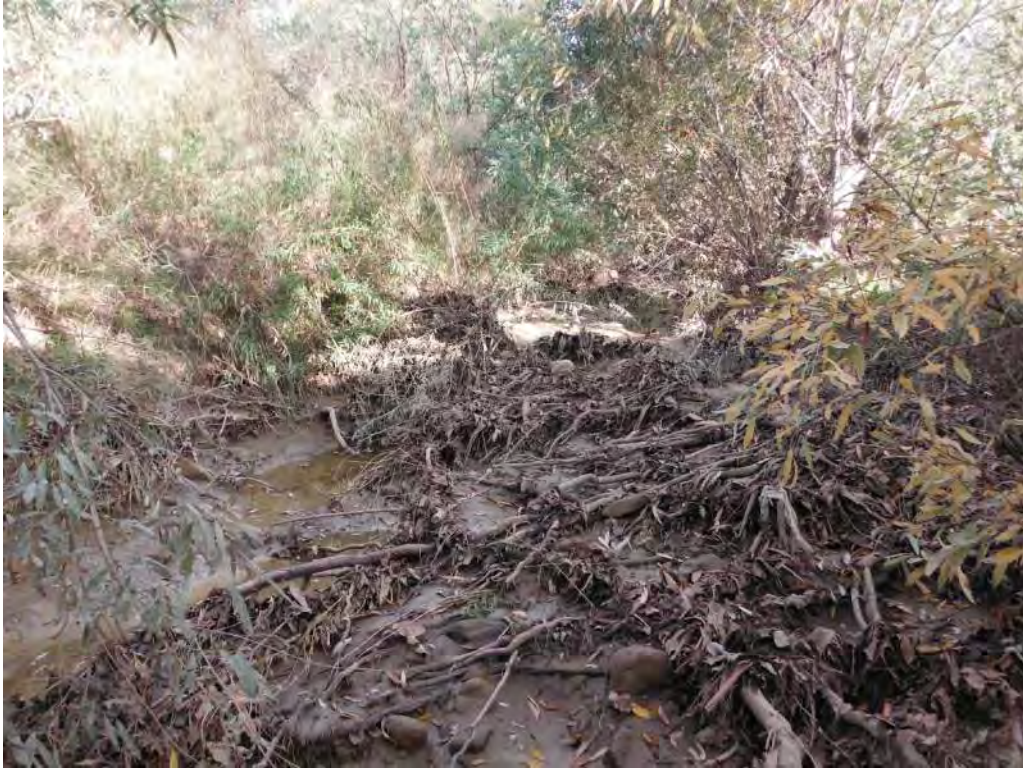
**417.24 Channel Condition – Looking Upstream**
