# BRIDGE INSPECTION REPORT

INSPECTION TYPE: Annual

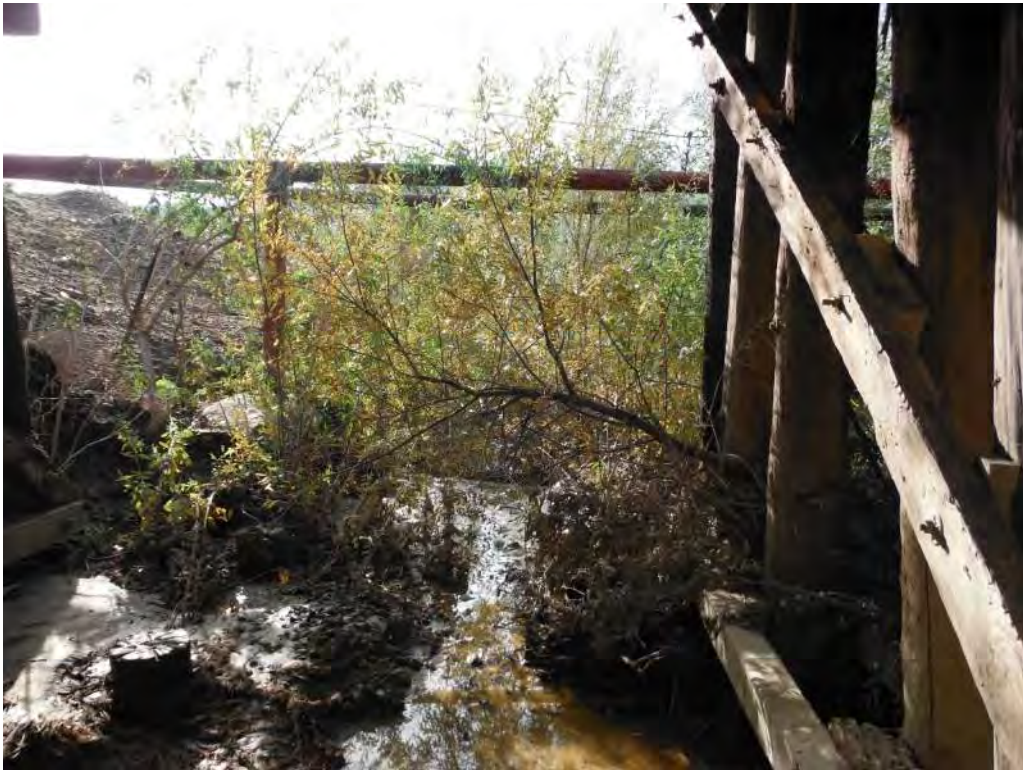
**417.24 Channel Condition – Looking Downstream**

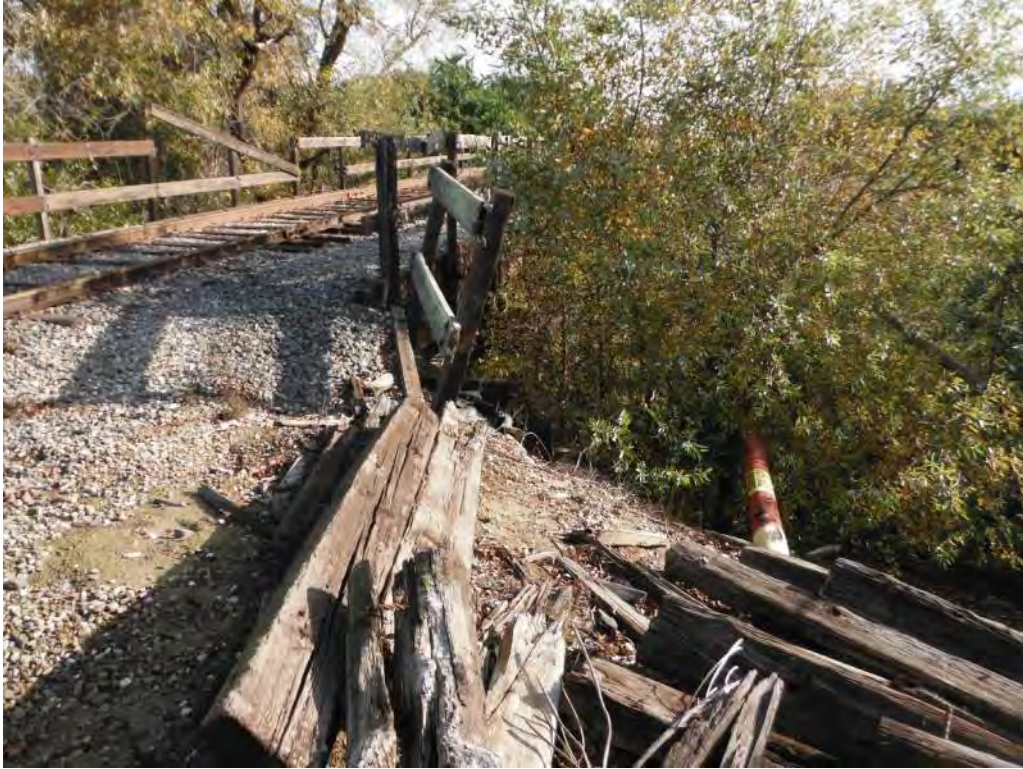
**417.24 Southwest ballast retainer leaning – ballast leaking**

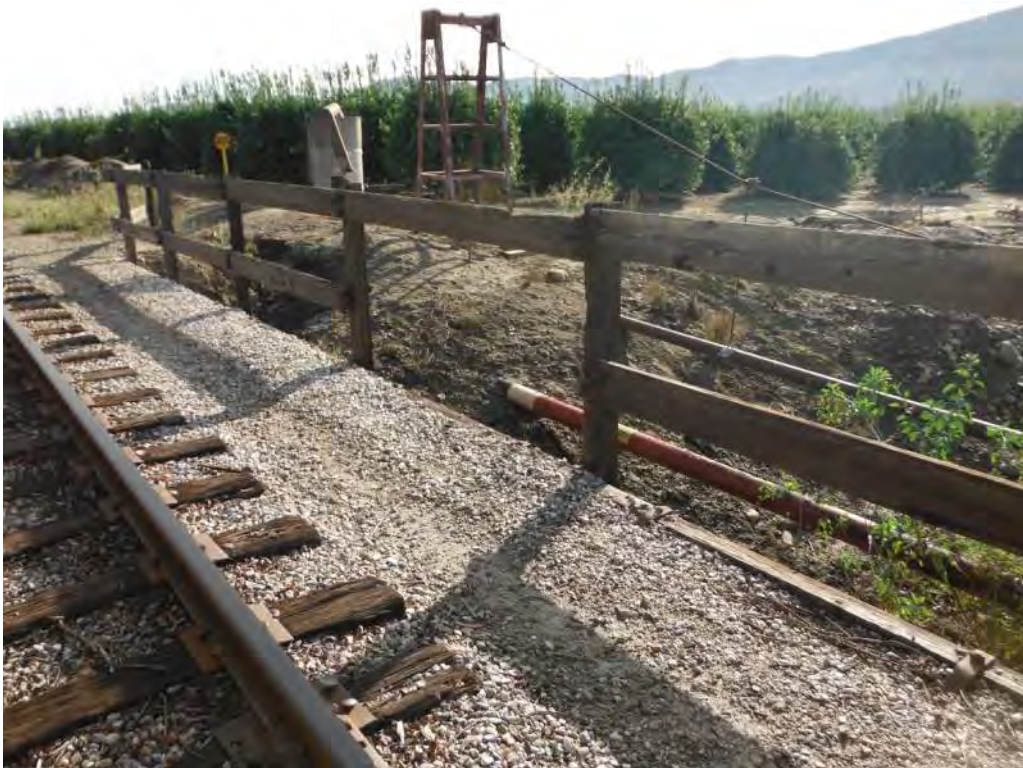
**417.24 Handrail mid-rail failed in two locations**

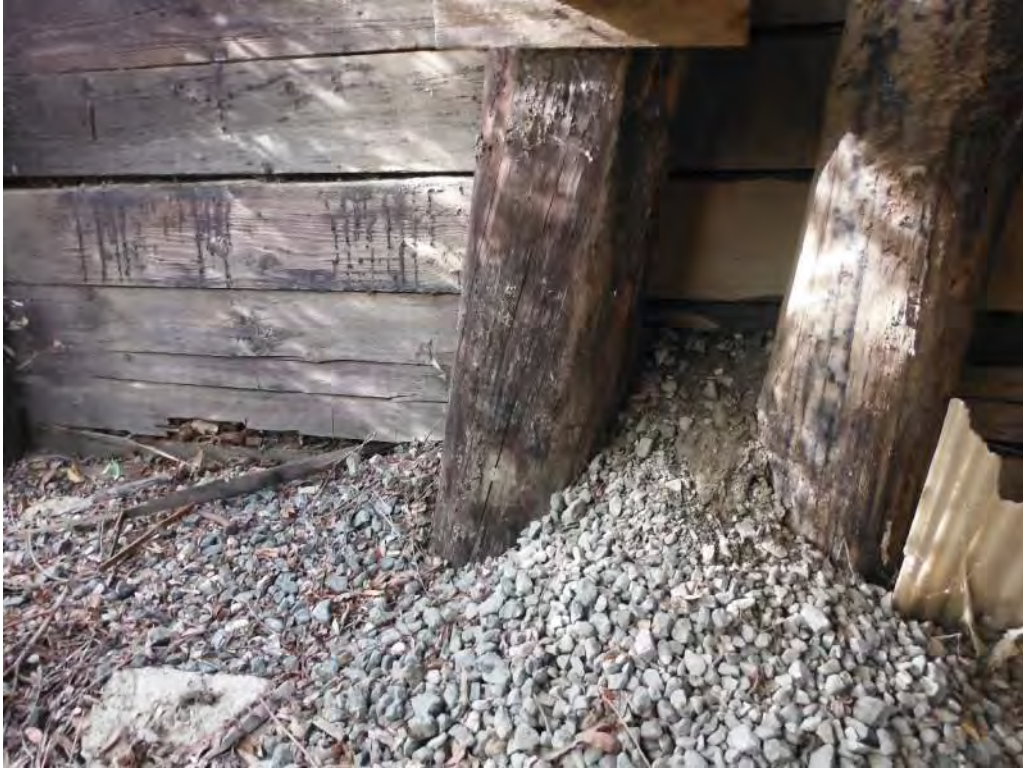
**417.24 Abutment 1 bulging and rotten bottom beam with ballast leaking**

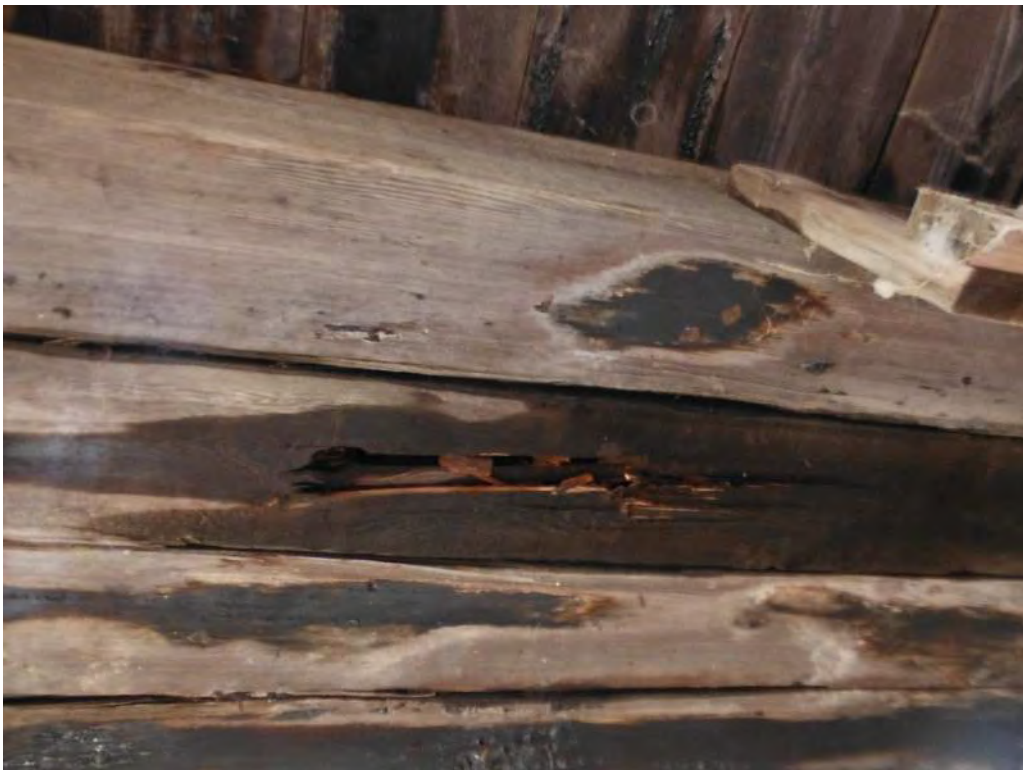
**417.24 Stringer 3 failed, Span 1**

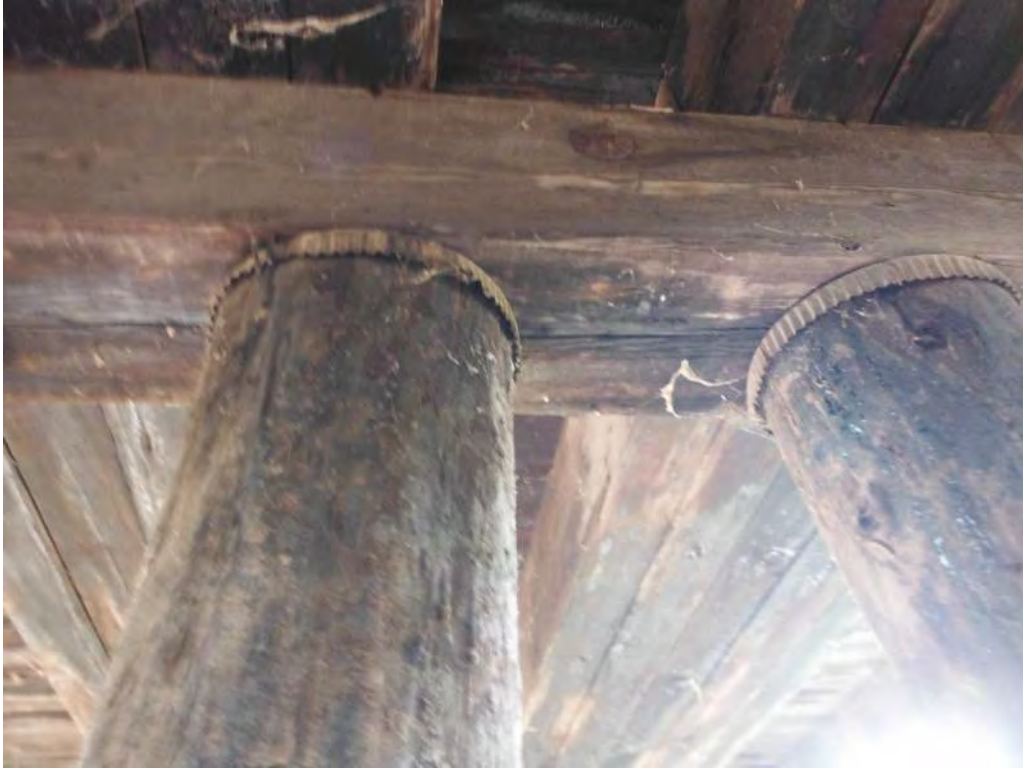
**417.24 Bent 2 cap split**

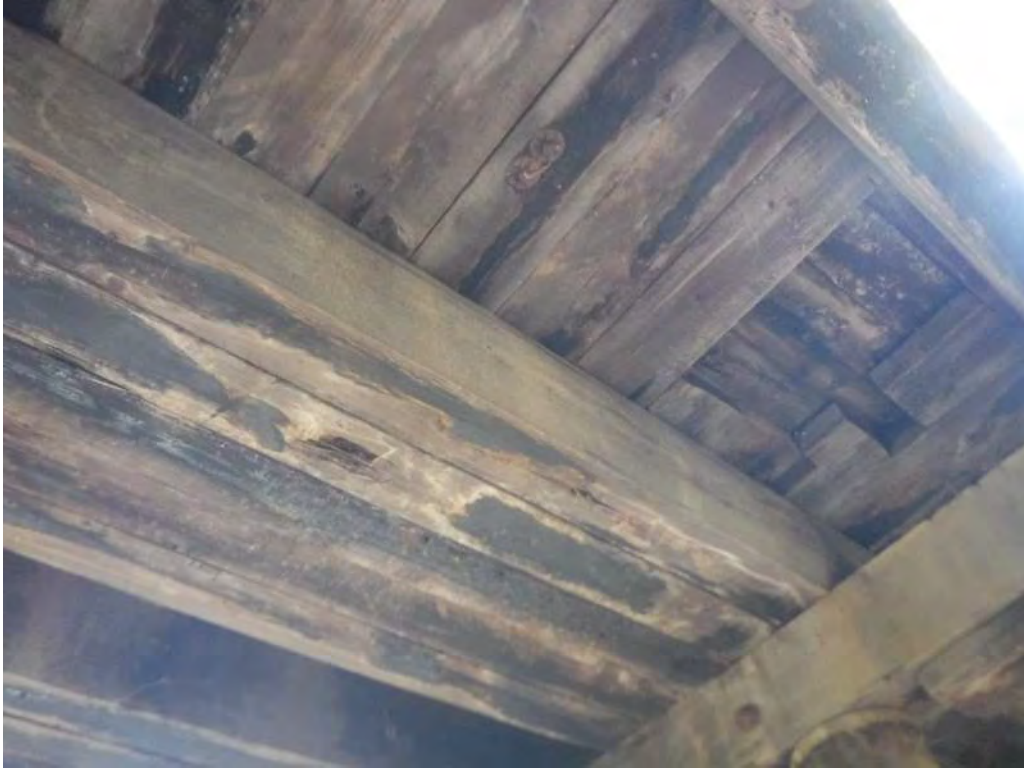
**417.24 Stringer 2 failed, Stringer 3 rotten with 3" hole depth, Span 3**

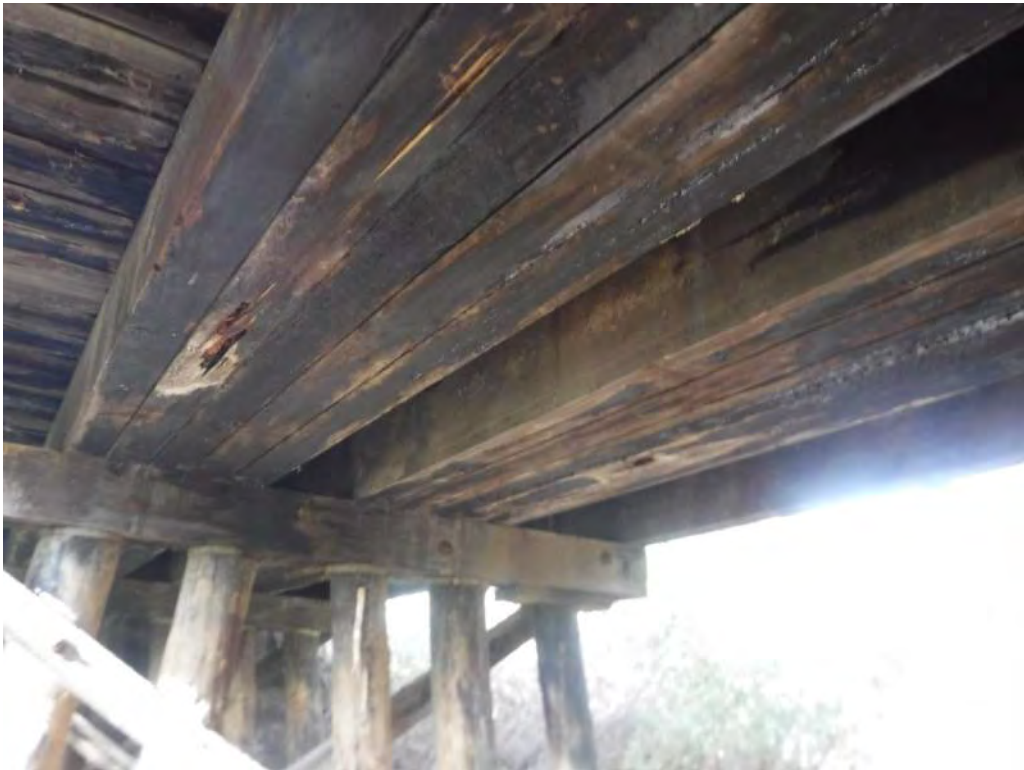
**417.24 Stringer 10 failed, Span 3**

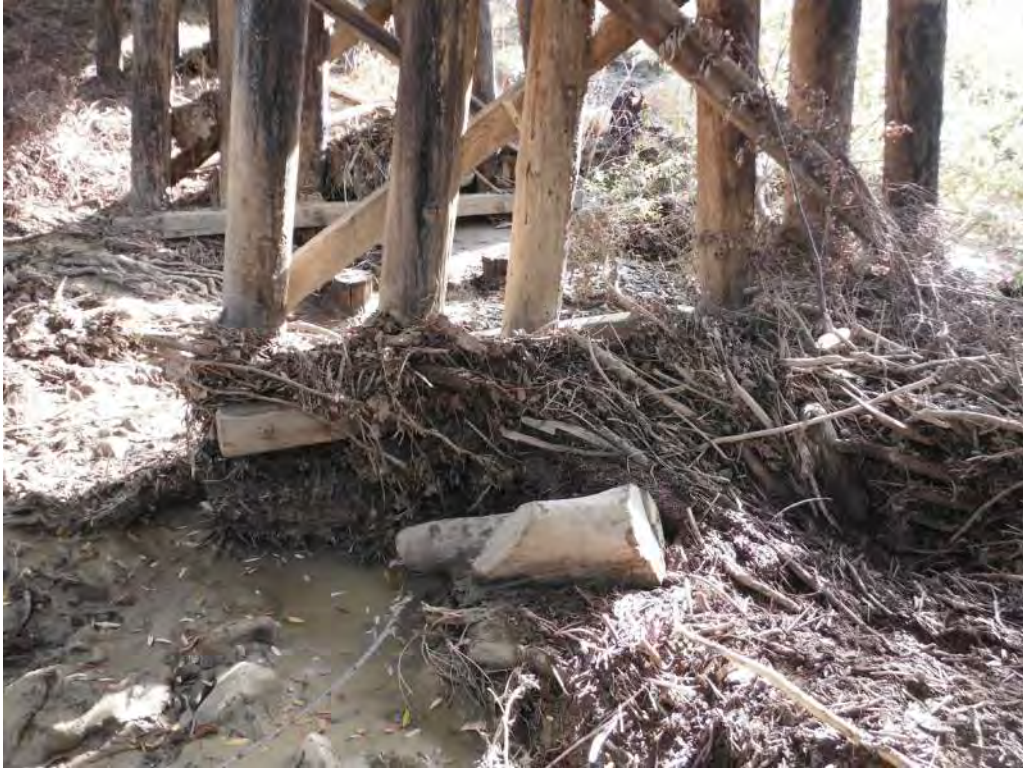
**417.24 Span 3 sash brace covered in dirt and debris at bent 3**

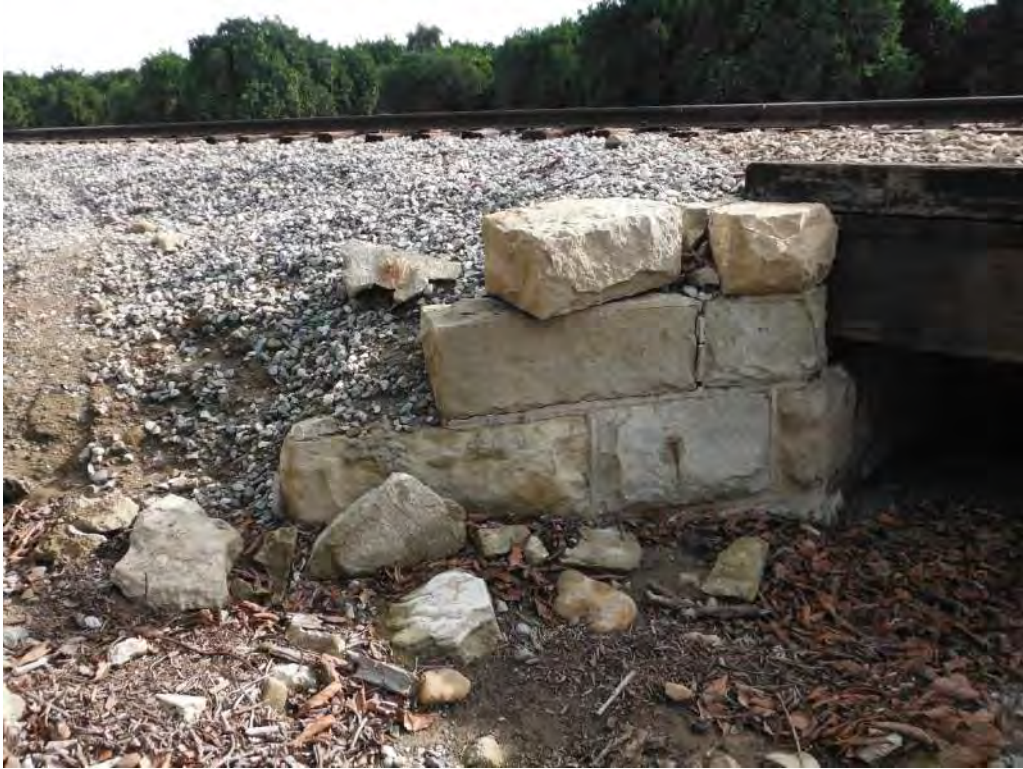
**417.96 Loose block in wingwall – Abutment 2**

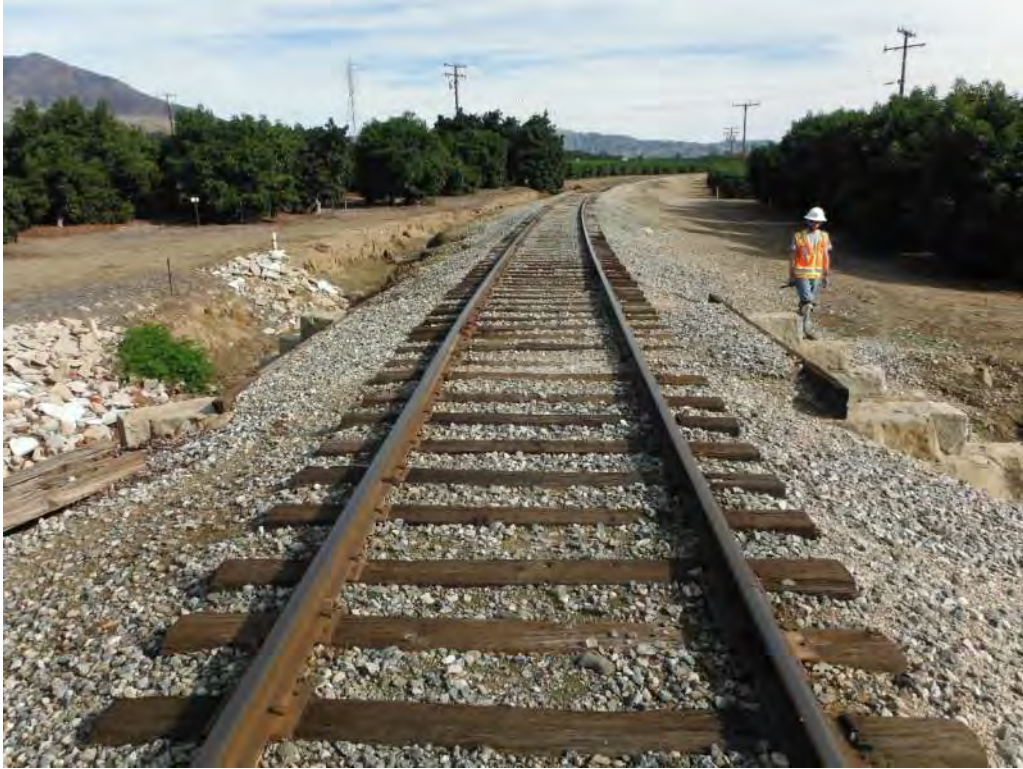
**418.02 Looking East**

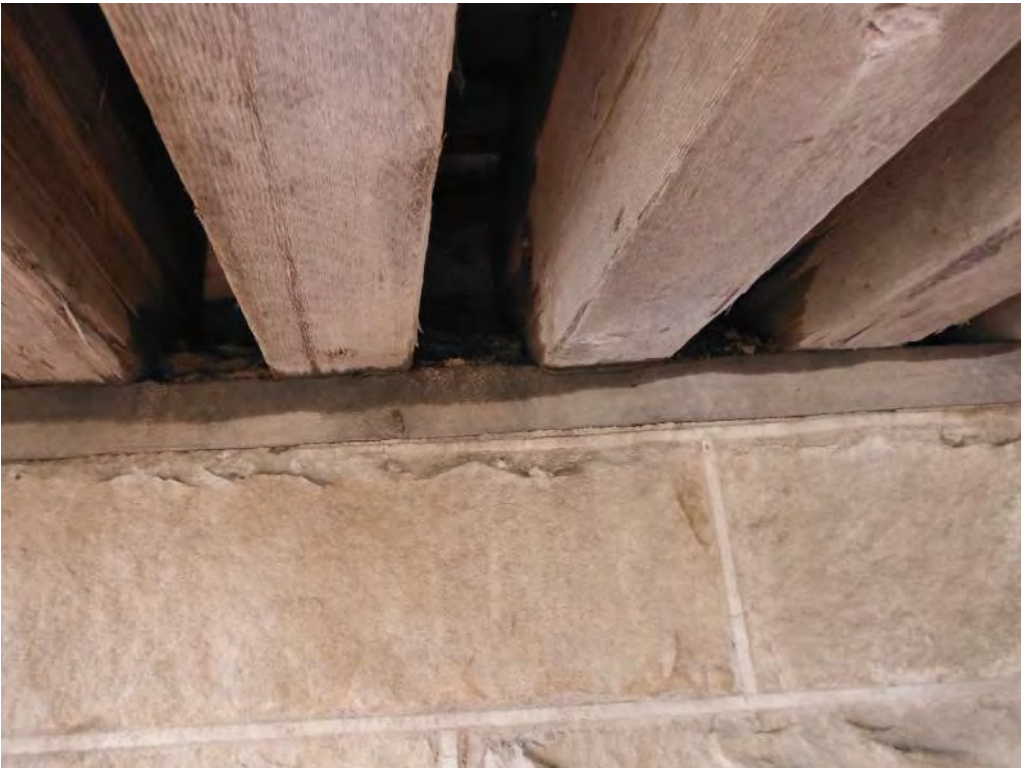
**418.02 Debris and moisture on sill plate**

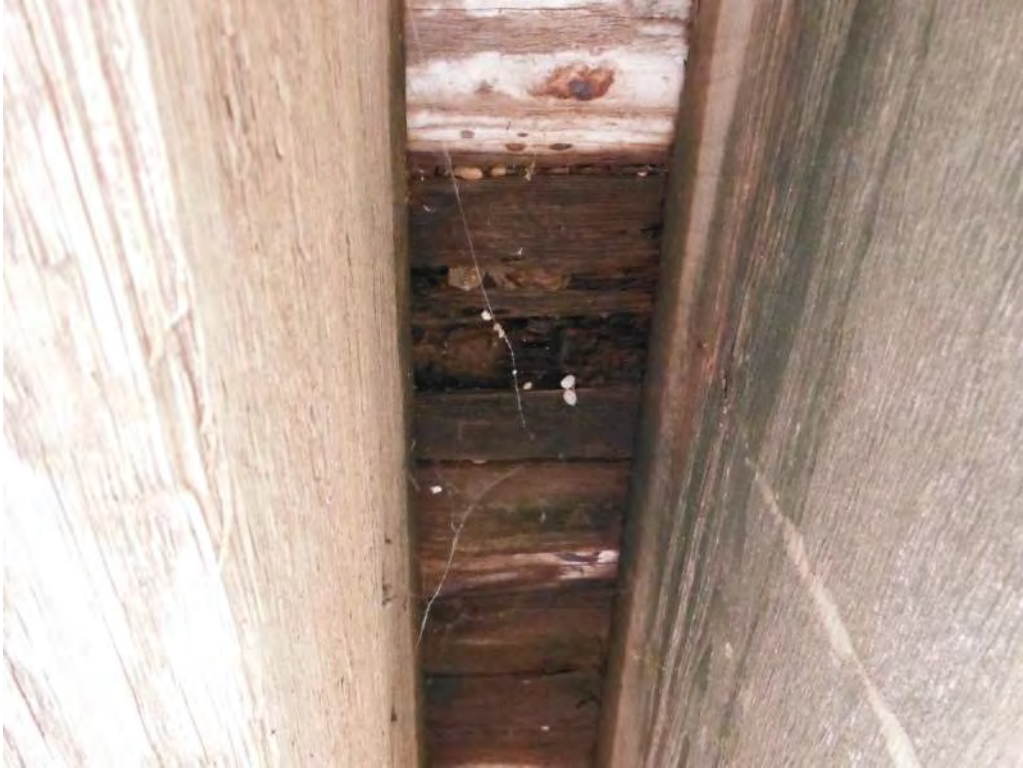
**418.02 Deck planks showing signs of rot and multiple holes**

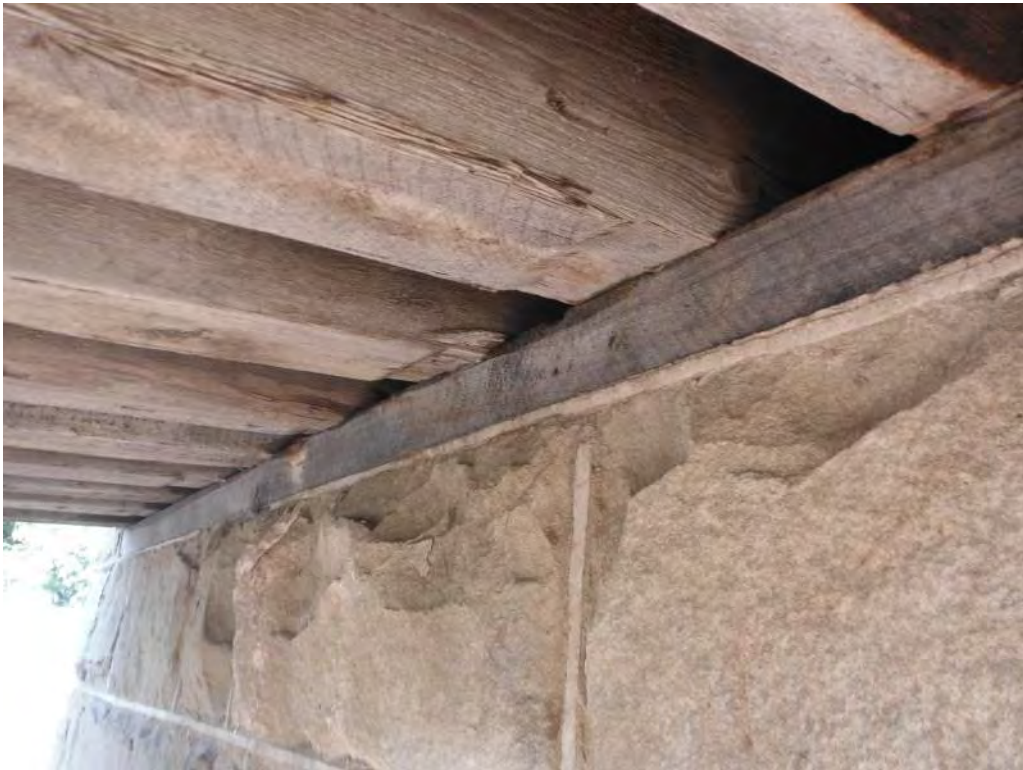
**418.02 Stringers #5, 6, 7 crushing at Abutment 2**

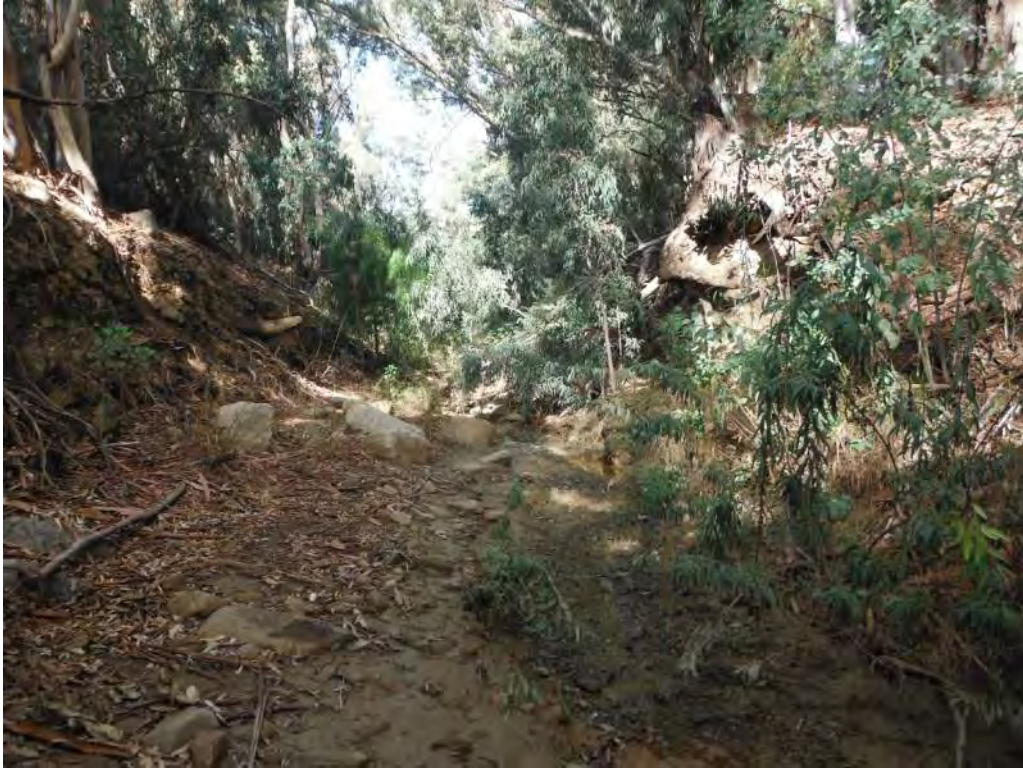
**419.42 Channel Condition - Looking Upstream**

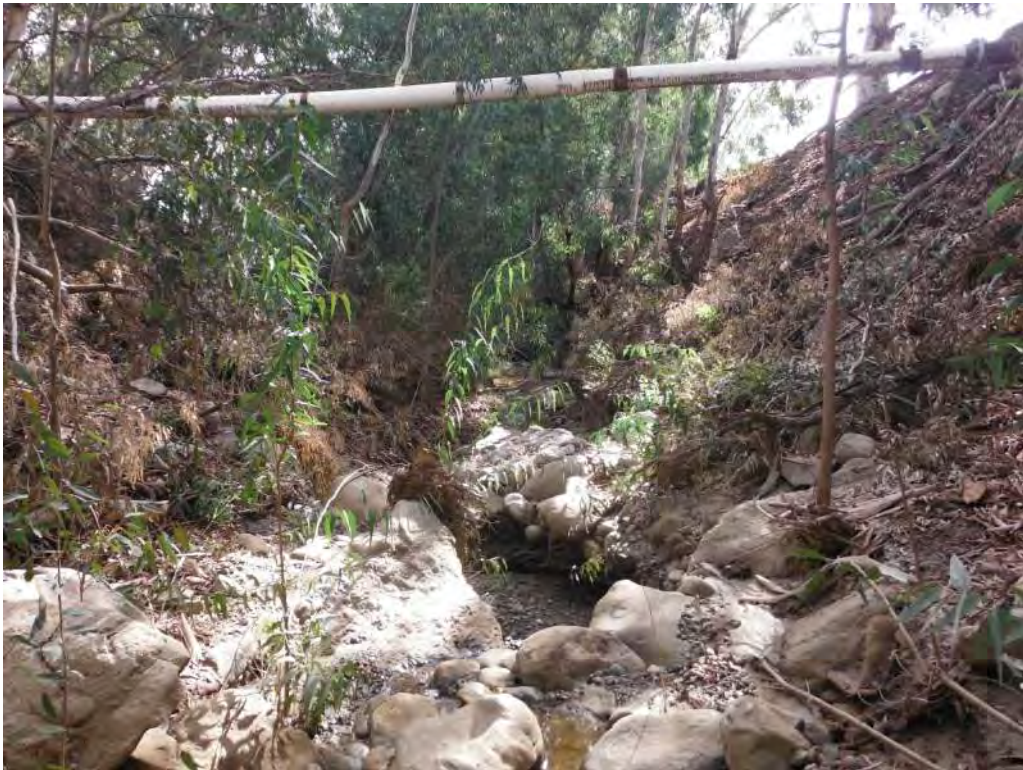
**419.42 Channel Condition – Looking Downstream**

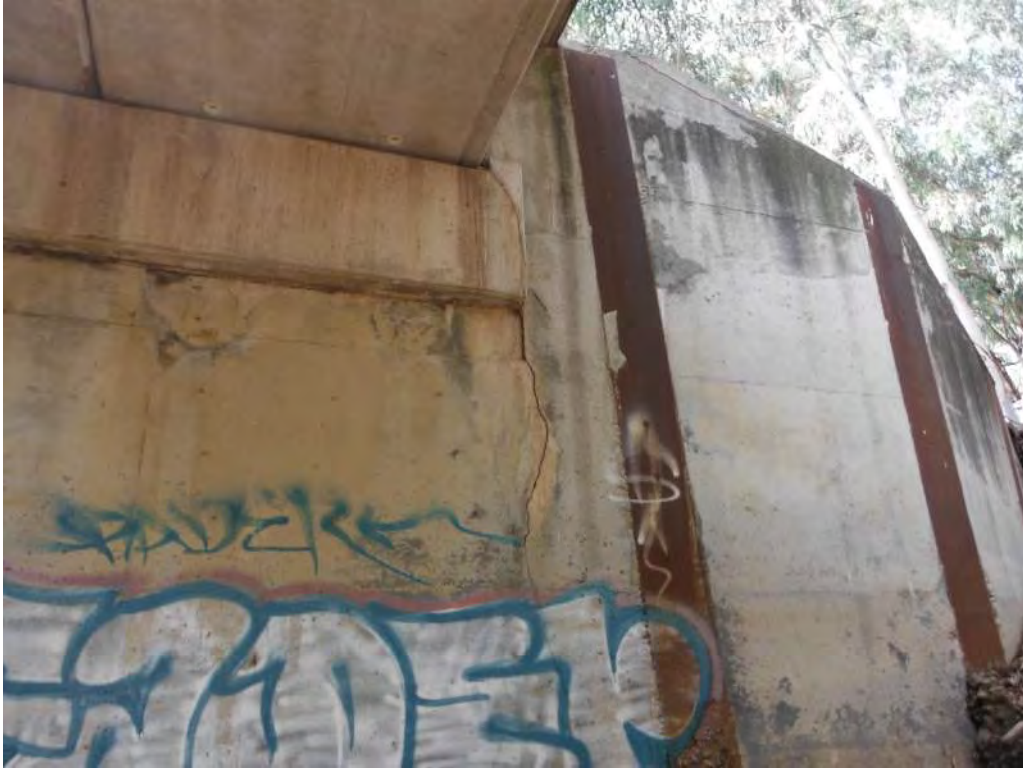
**419.42 Abutment 1 crack and keeper block cracked – North edge of cap**

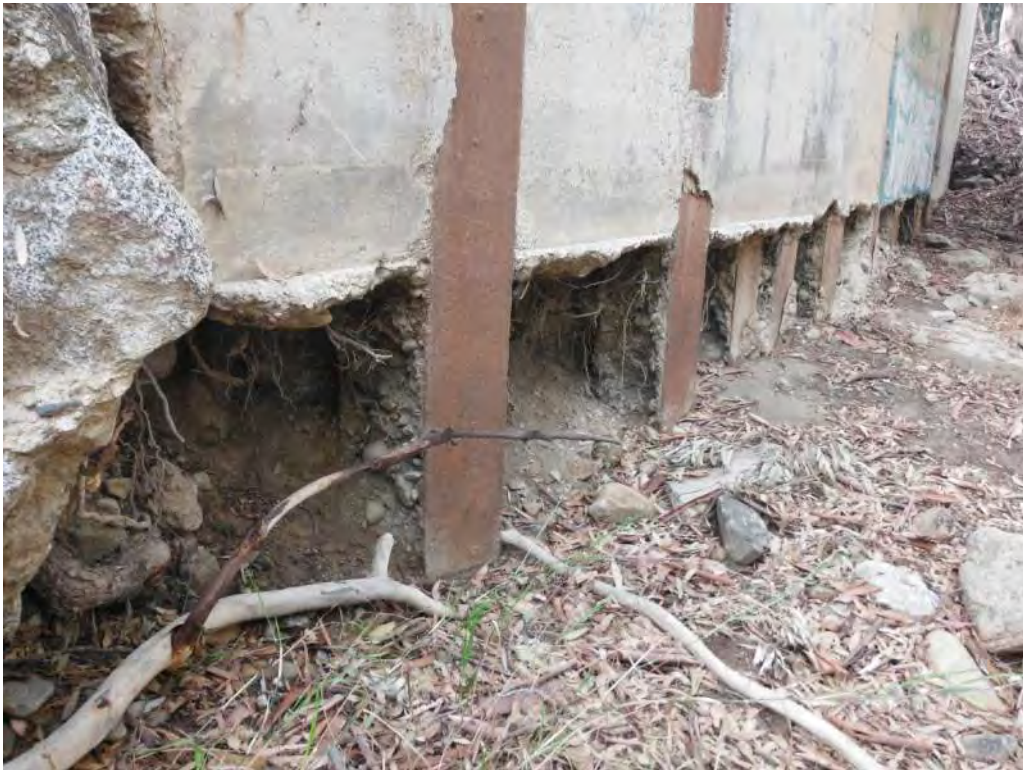
**419.42 Scour - Abutment 1**

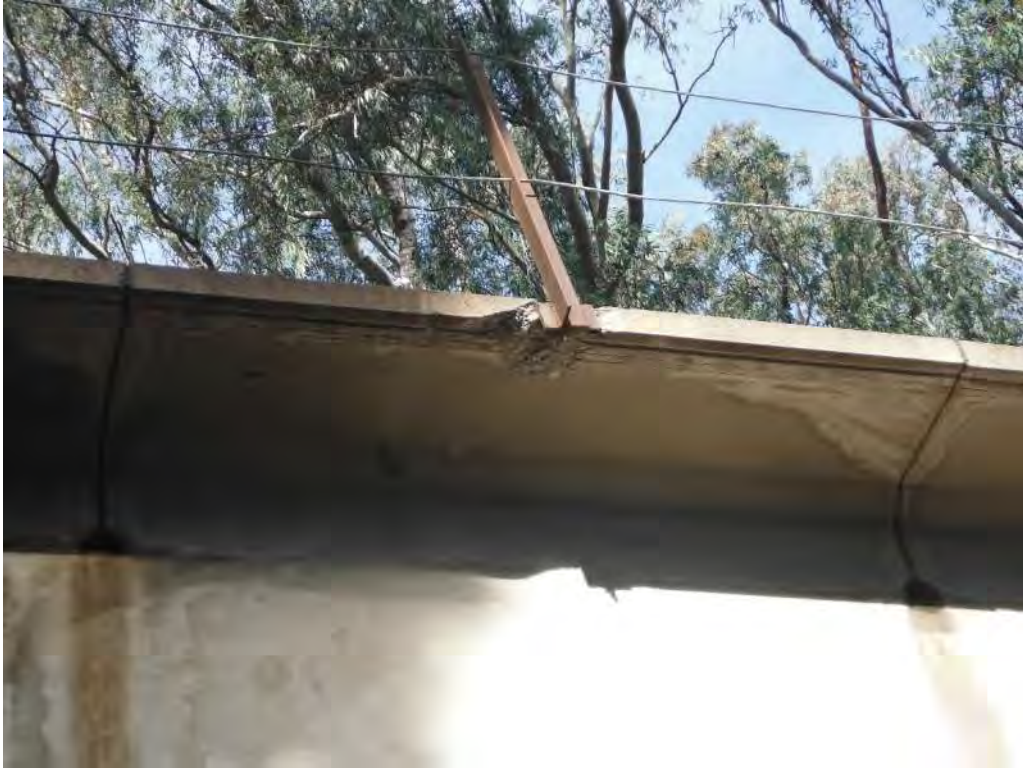
**419.42 Spall on South walkway**

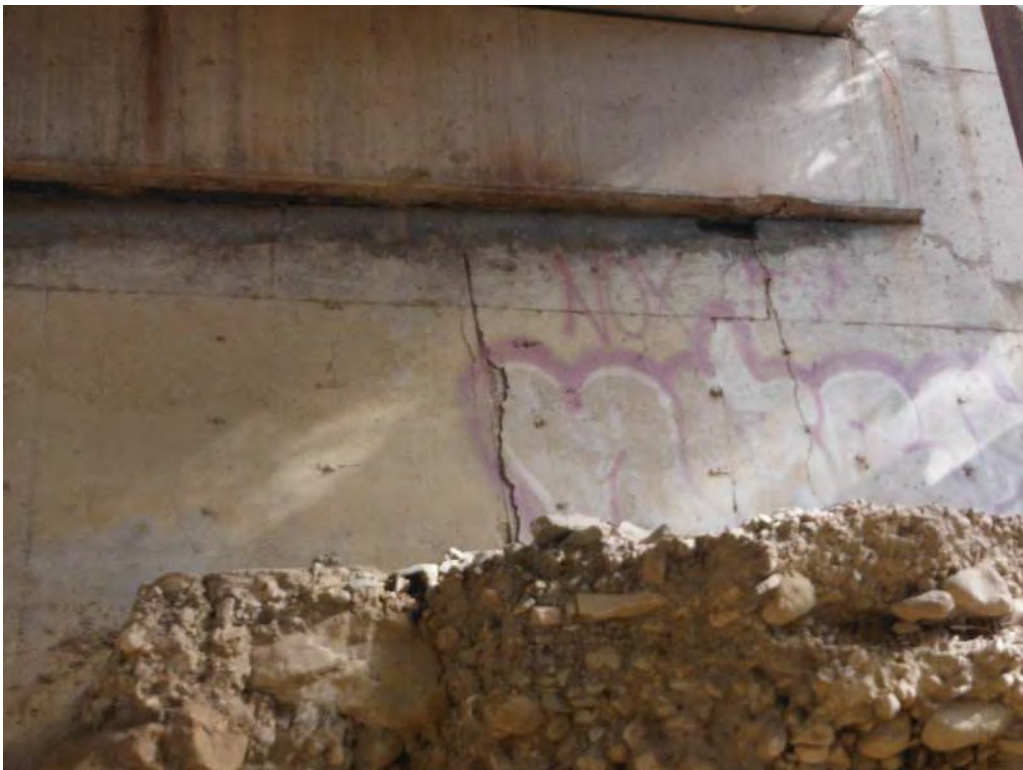
**419.42 Cracking and spall with exposed rebar - Abutment 2**

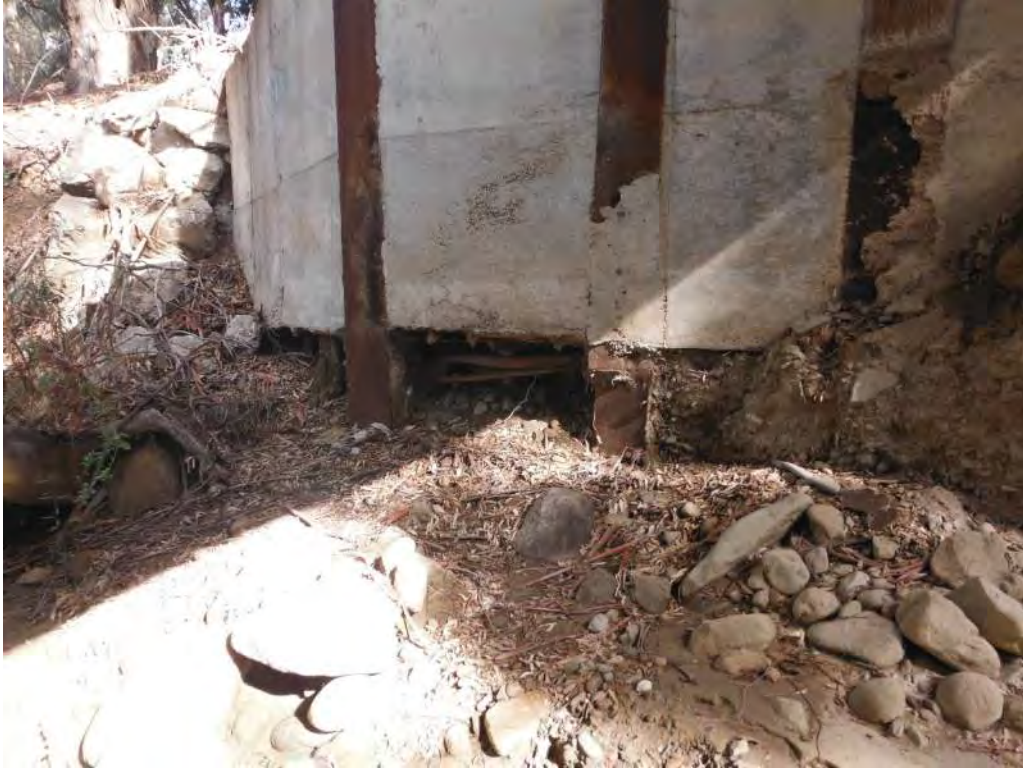
**419.42 Scour - Abutment 2**

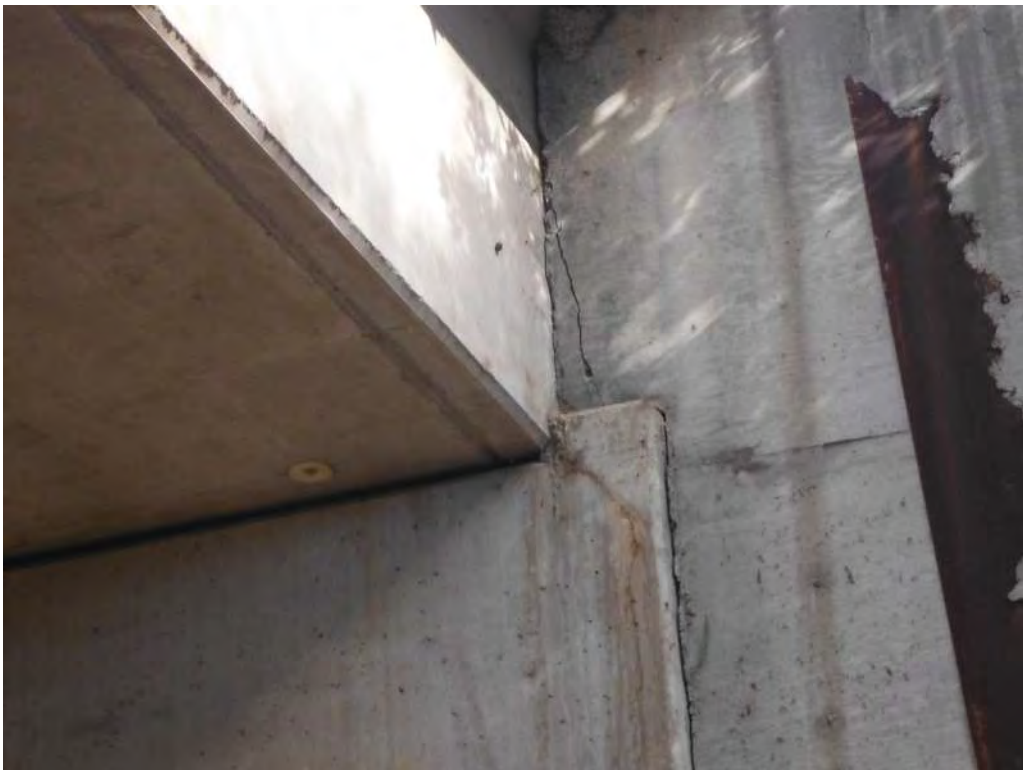
**419.42 Crack in backwall, and crack and spall on south keeper – Abutment 2**

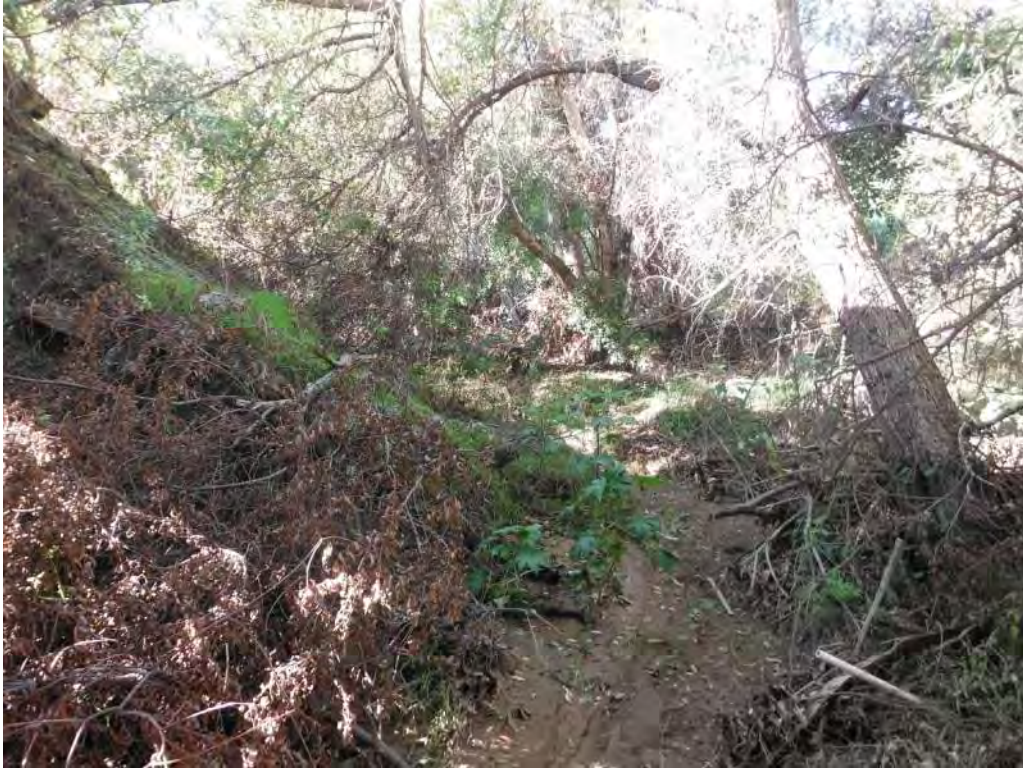
**419.92 Channel Condition – Looking Upstream**

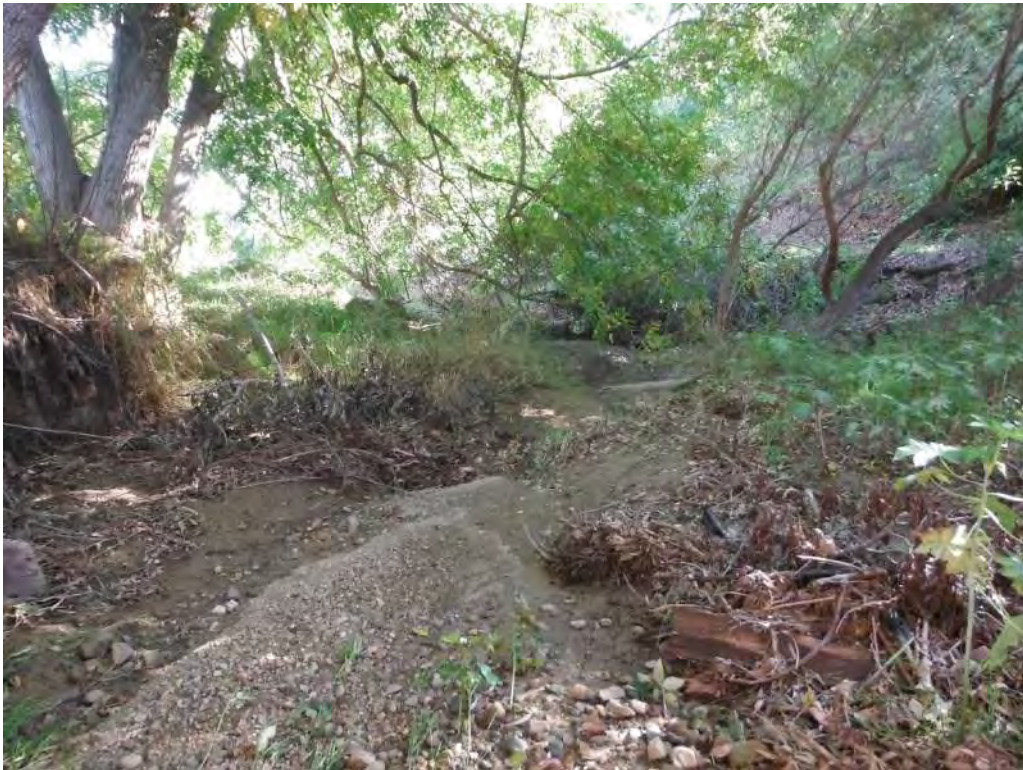
**419.92 Channel Condition - Looking Downstream**

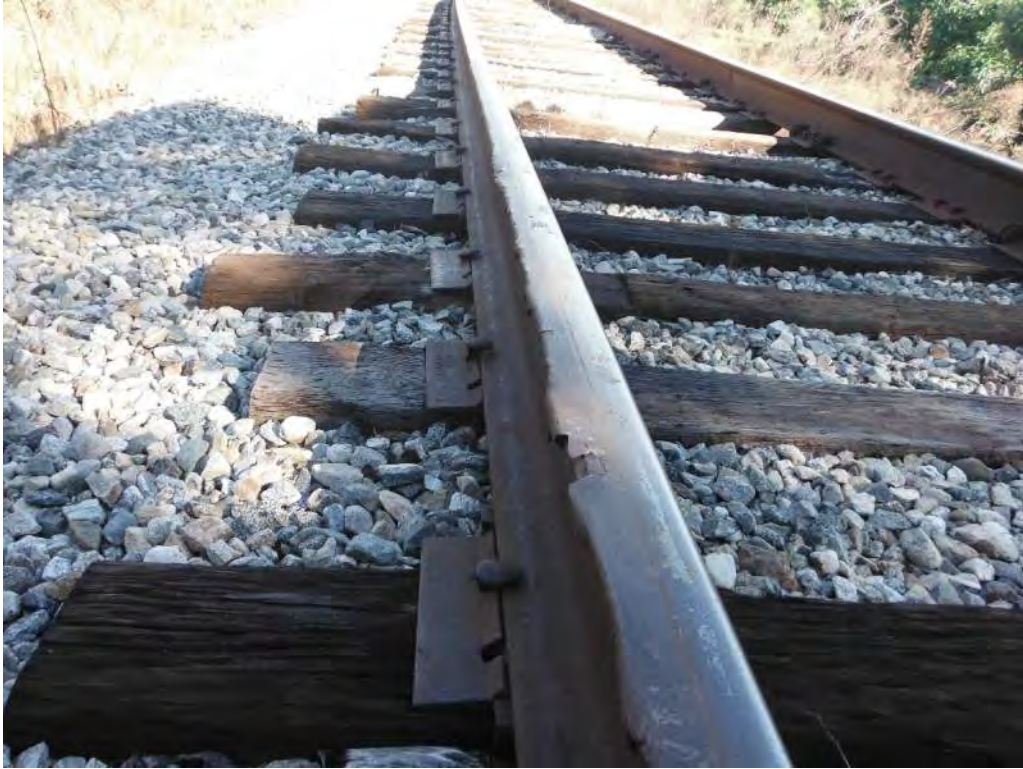
**419.92 Rail section loss – east and west sides and along length of bridge**

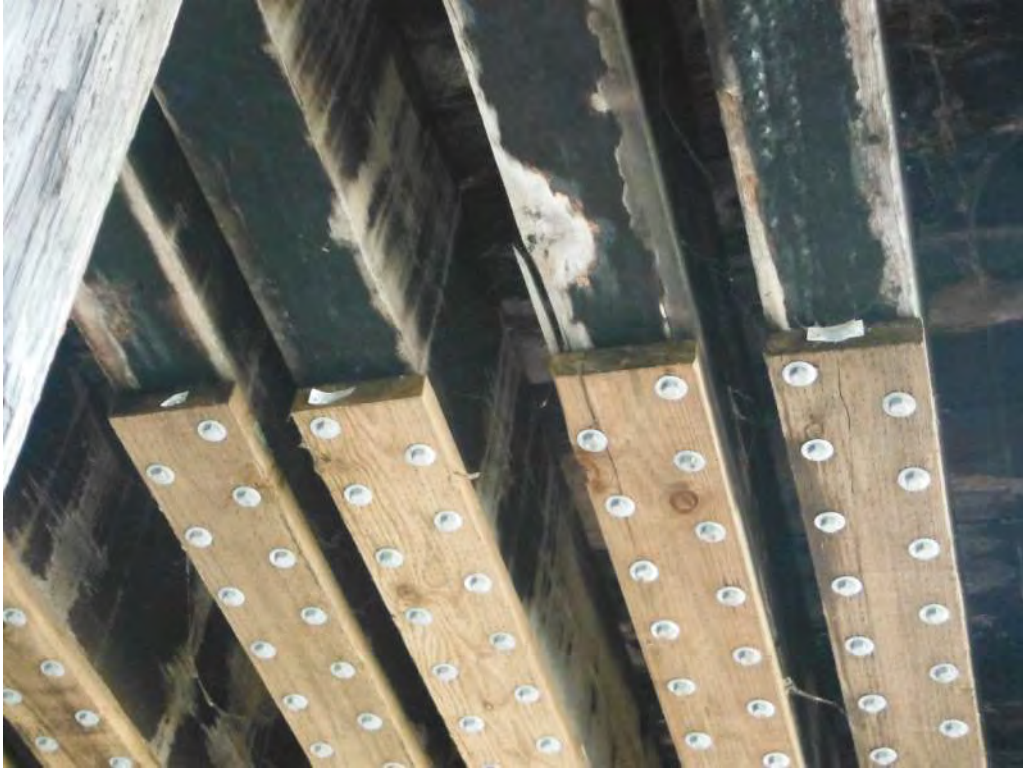
**419.92 Stringer 4 split at ends of repair locations - Bent 4**

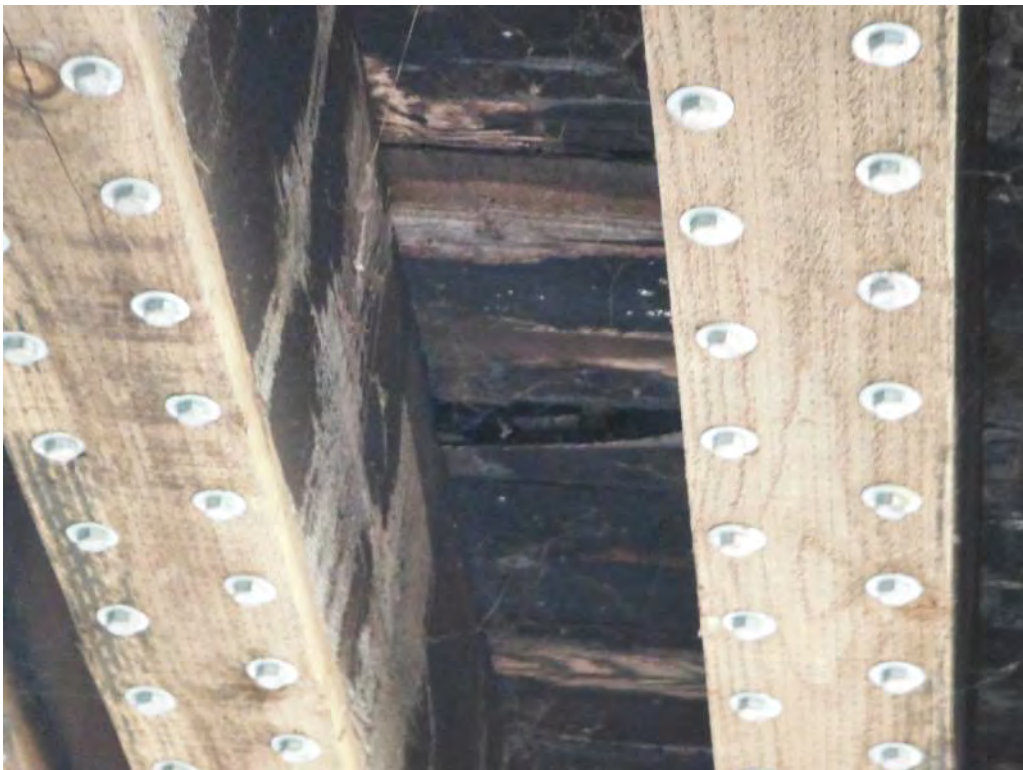
**419.92 Hole beginning in deck between stringer 6 and 7 - Span 4**

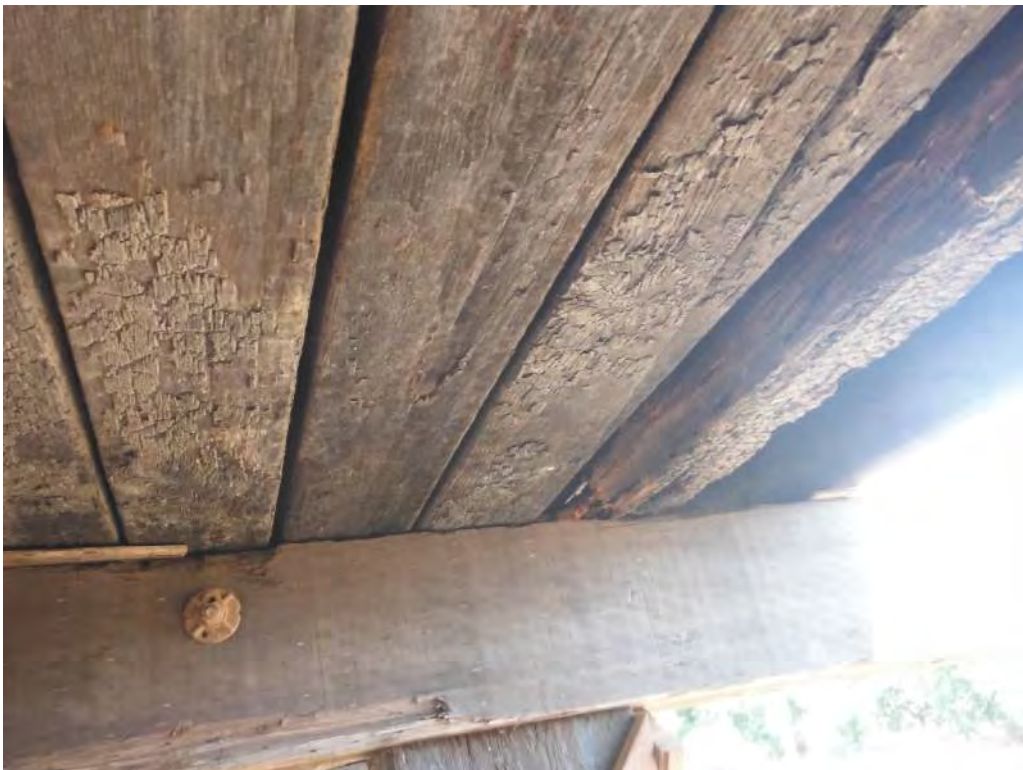
**420.20 Stringer 8 shear split and Stringer 9 failed Span 2**

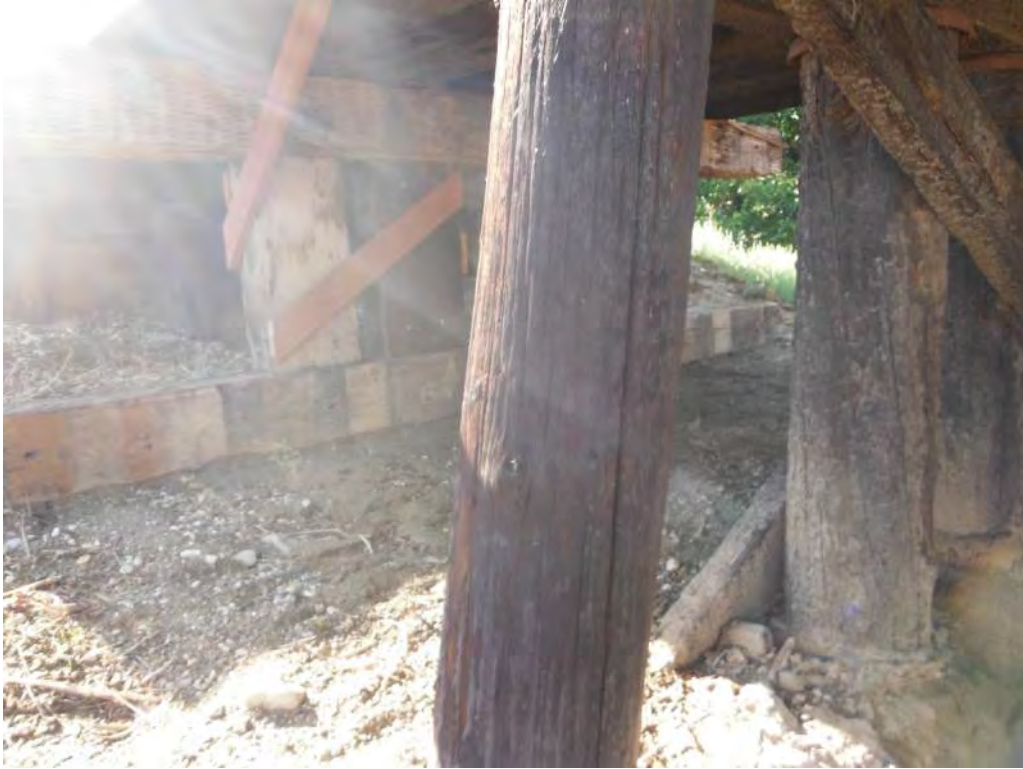
**420.20 Bent 2 Pile 5 Split**
