# BRIDGE INSPECTION REPORT

INSPECTION TYPE: Annual

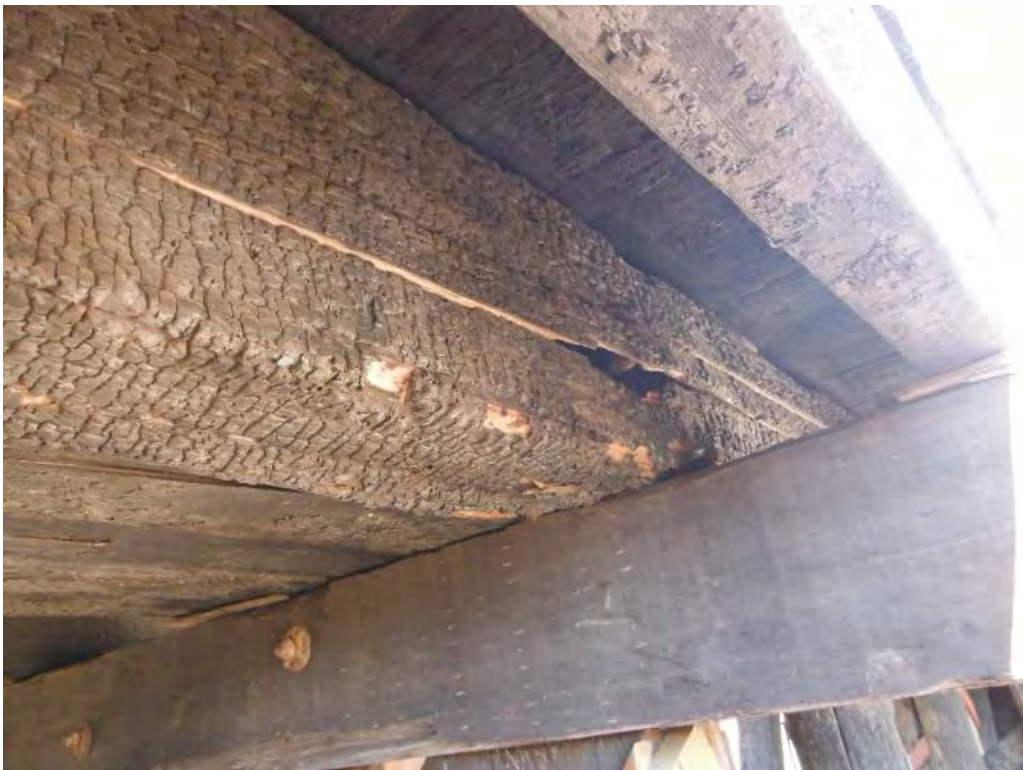
**420.20 Span 2, Stringer 9 failed at helper bent**

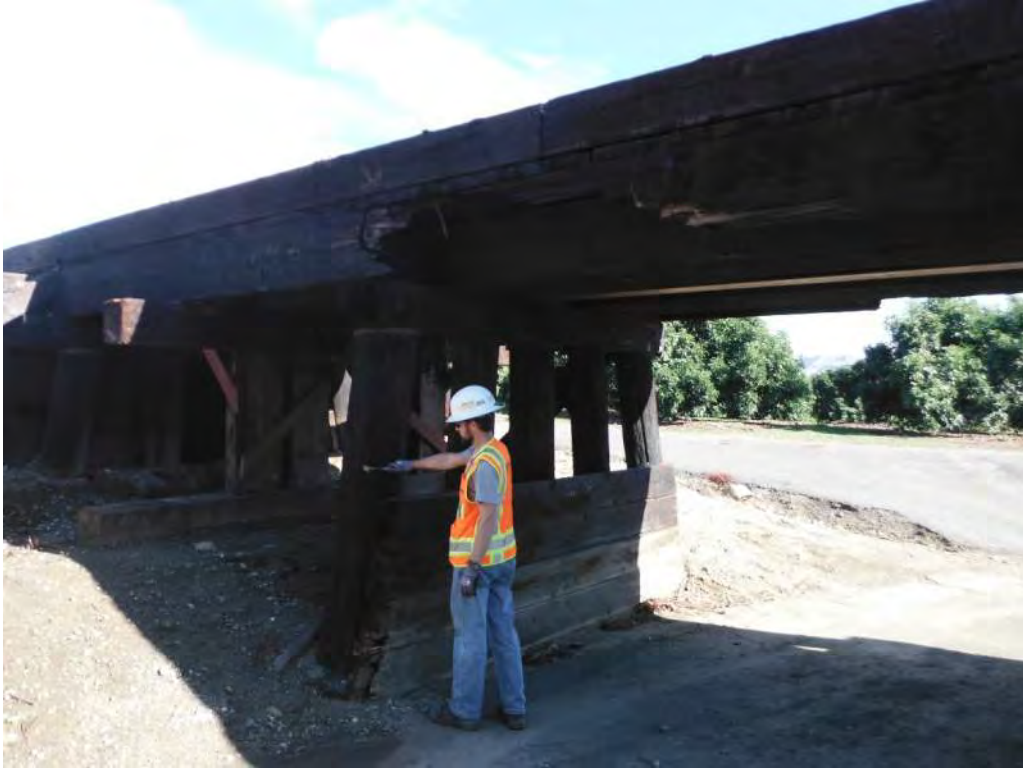
**420.20 Exterior stringer failed due to impact - Span 3 typ**

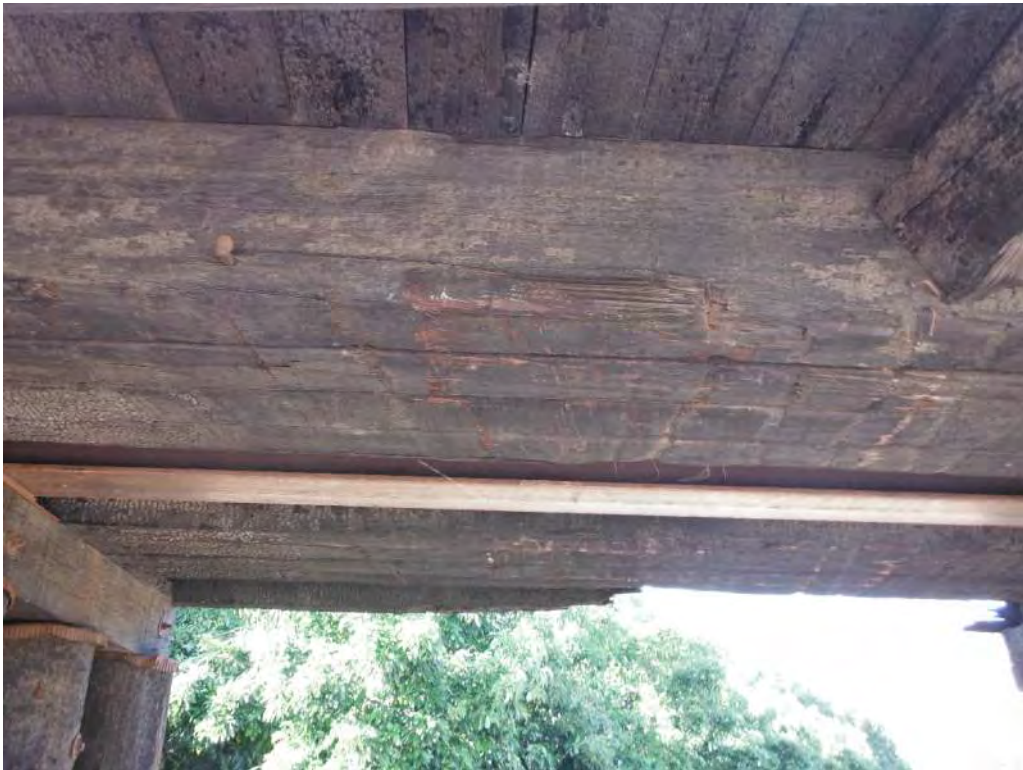
**420.20 Impact Damage – Span 3**

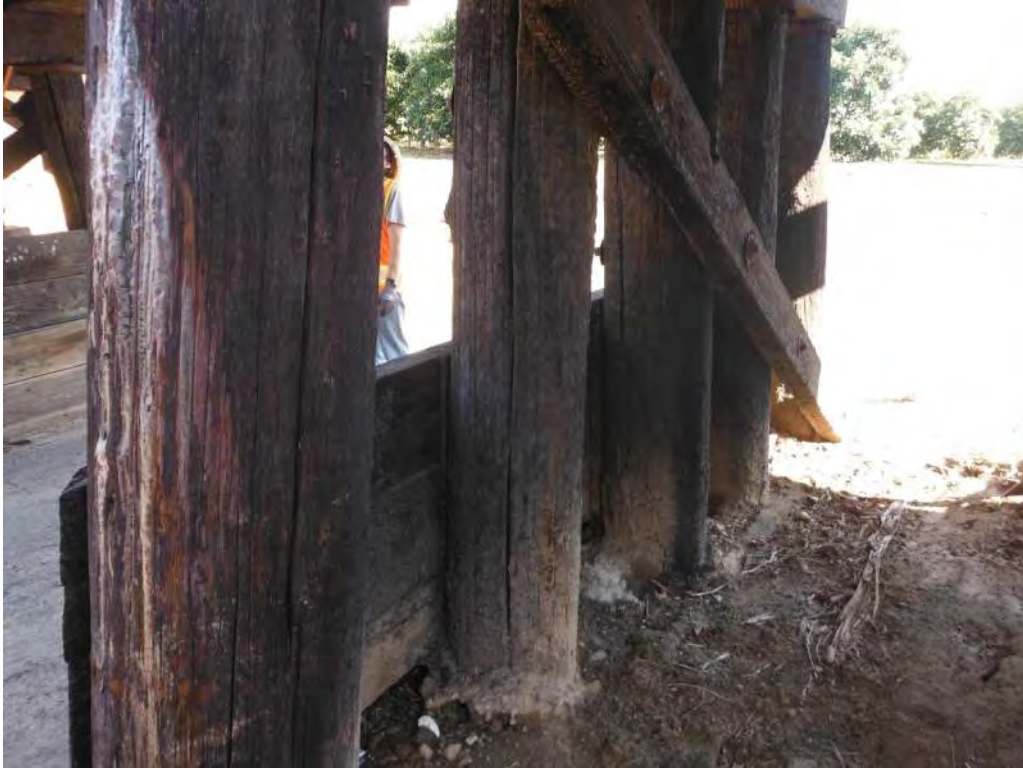
**420.20 Bent 3 piles split**

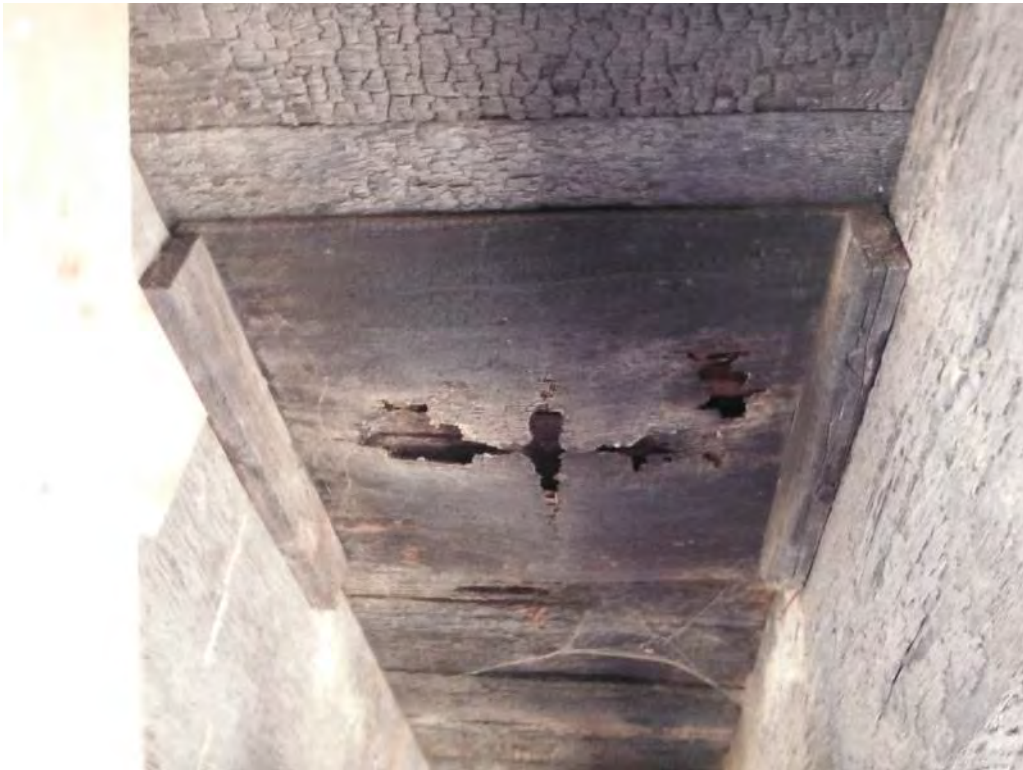
**420.20 Failing Deck Plank – Span 4**

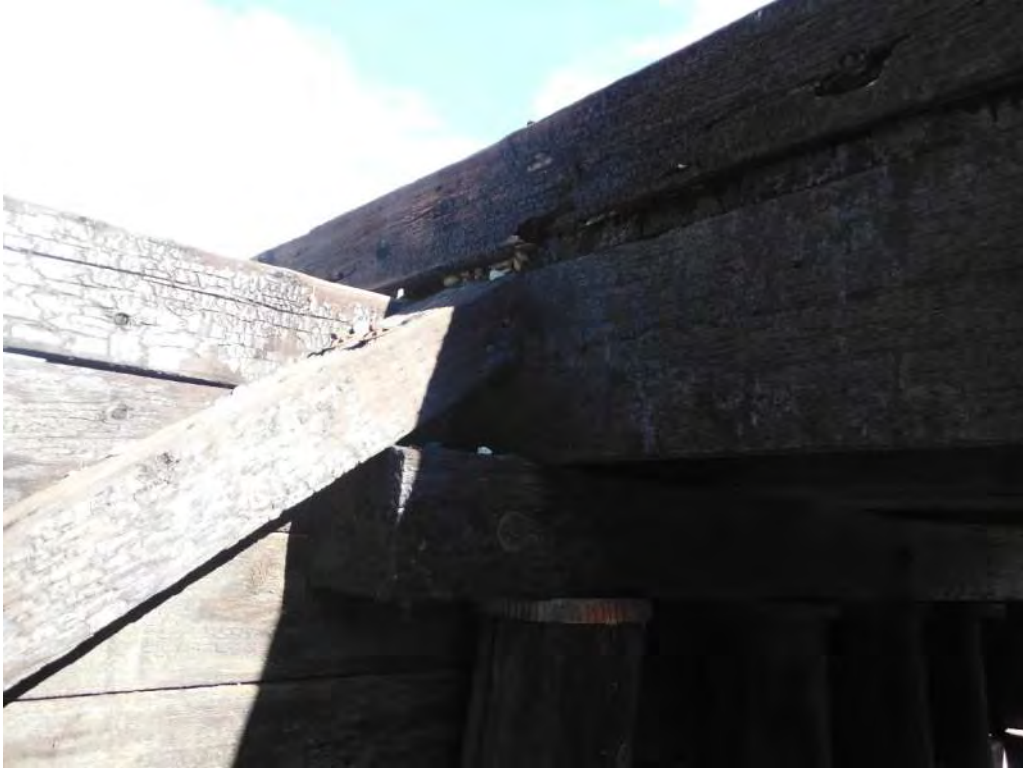
**420.20 Ballast boards failing at Abutment 5**

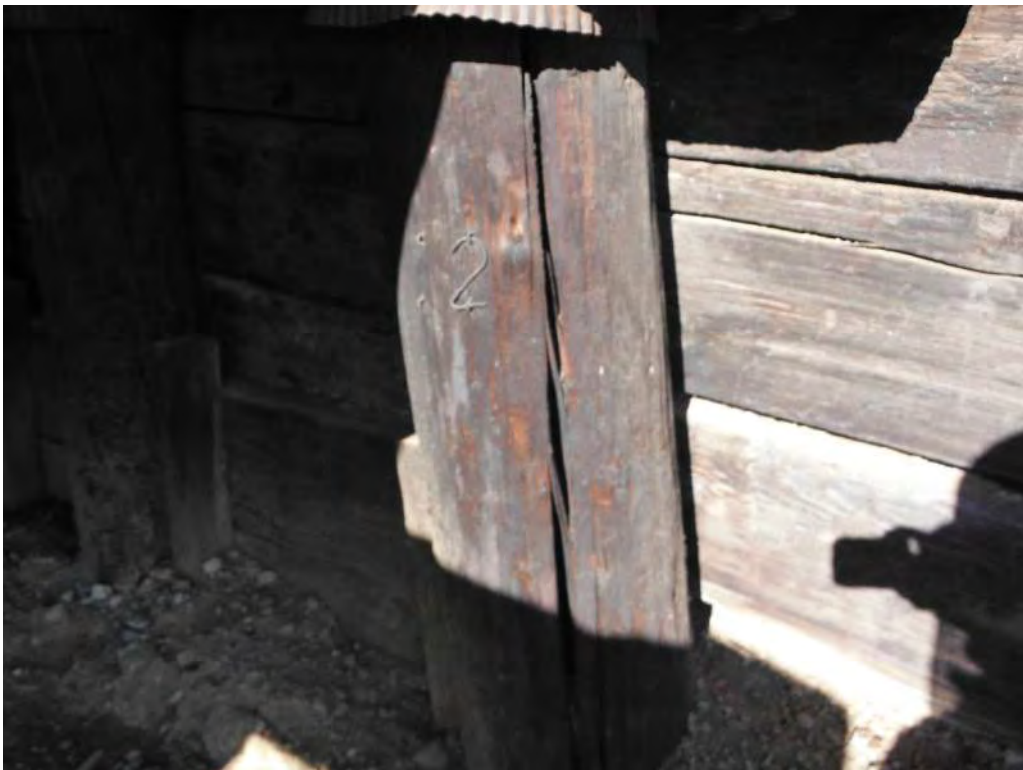
**420.20 Abutment 5 Pile 5 split**

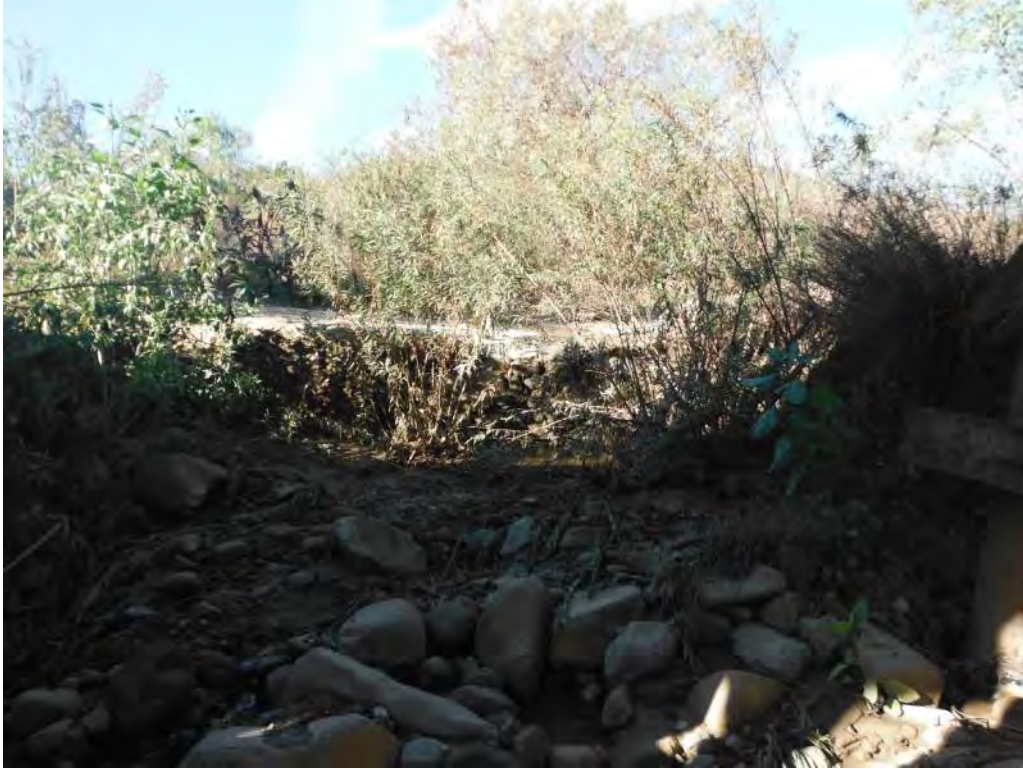
**420.46 Channel Condition – Looking Upstream**

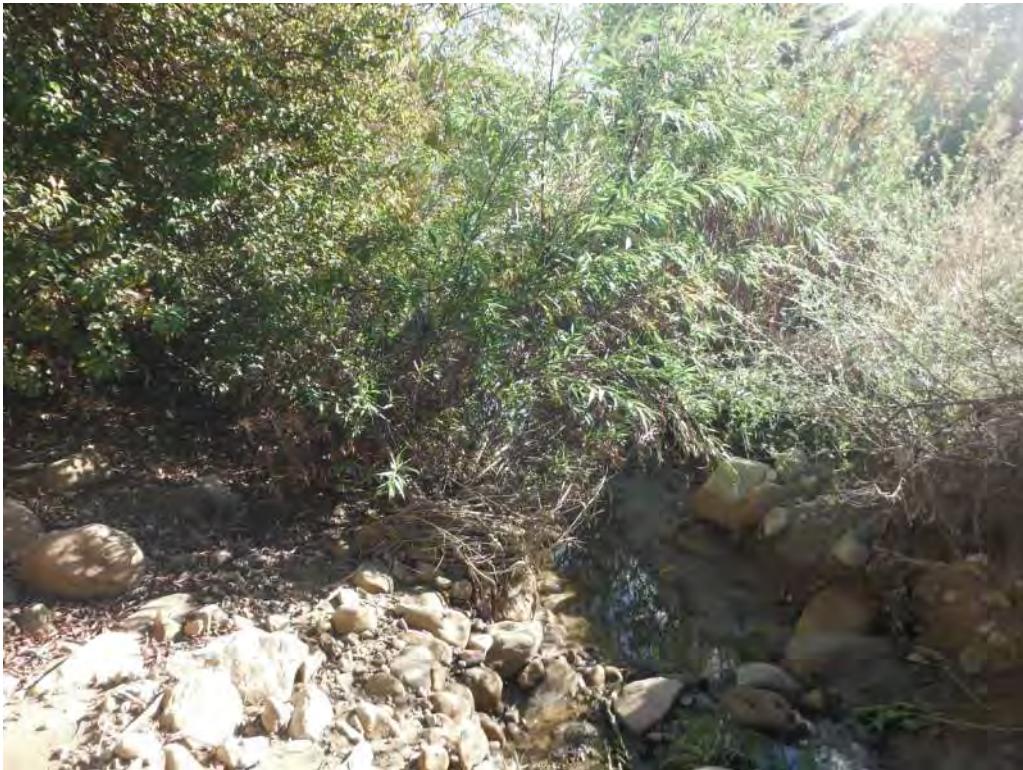
**420.46 Channel Condition - Looking Downstream**

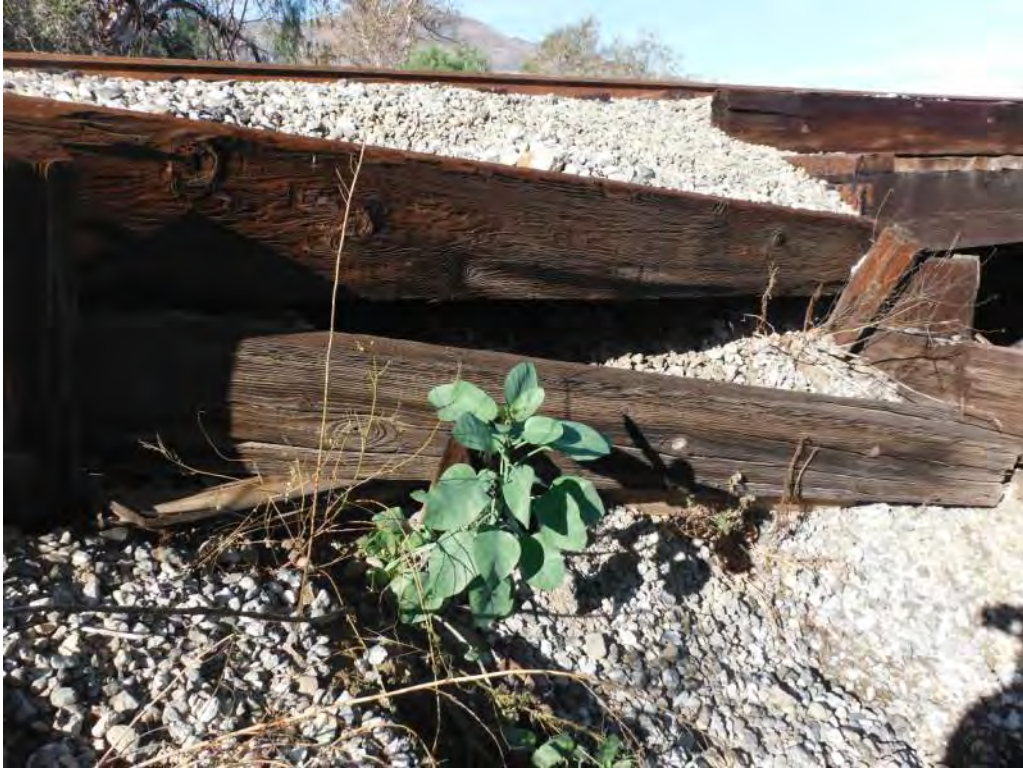
**420.46 Southwest wing failing**

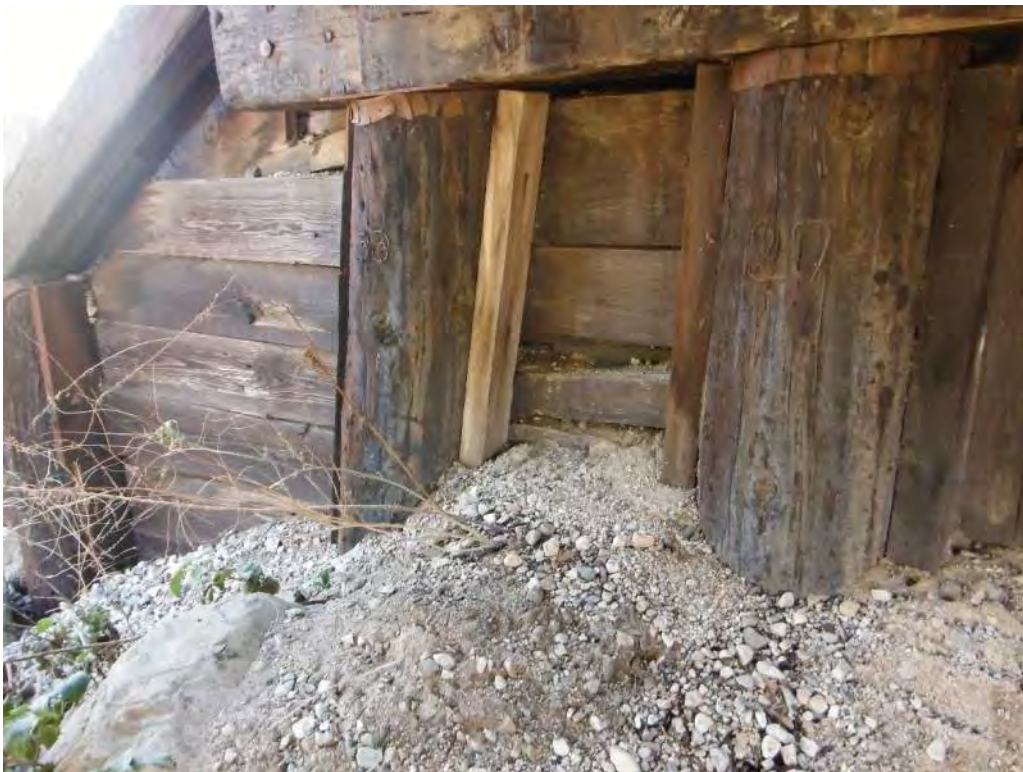
**420.46 Abutment 1 backwall failed plank's supplement failed**

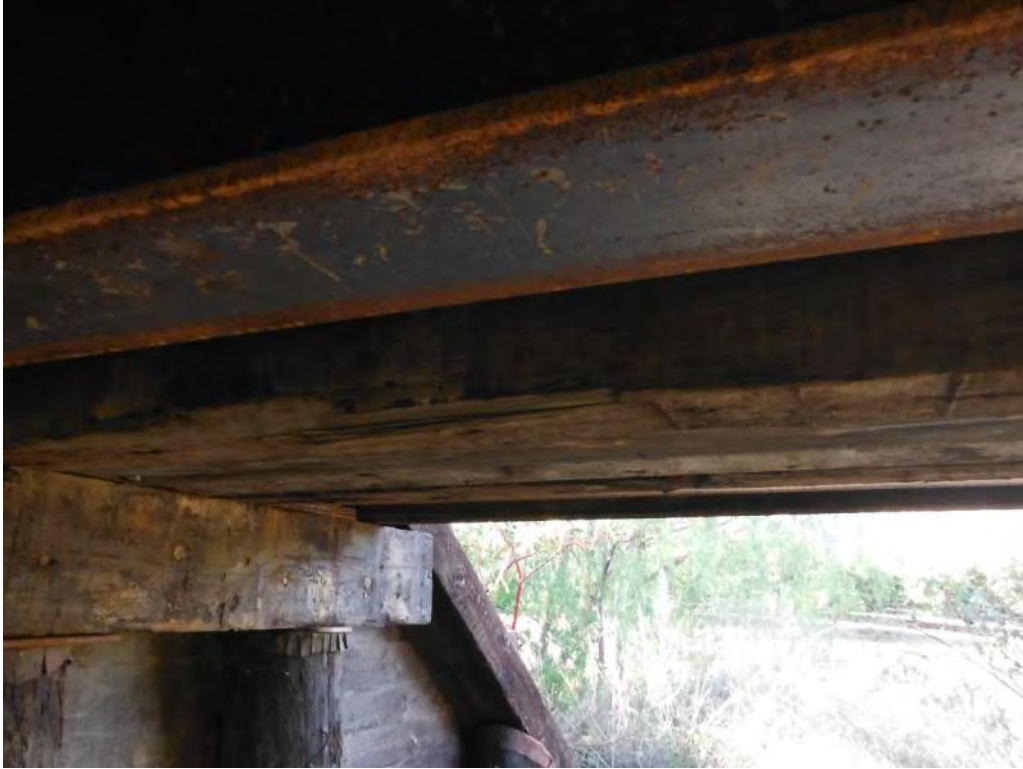
**420.46 Stringer 4 corner split, Abutment 1**

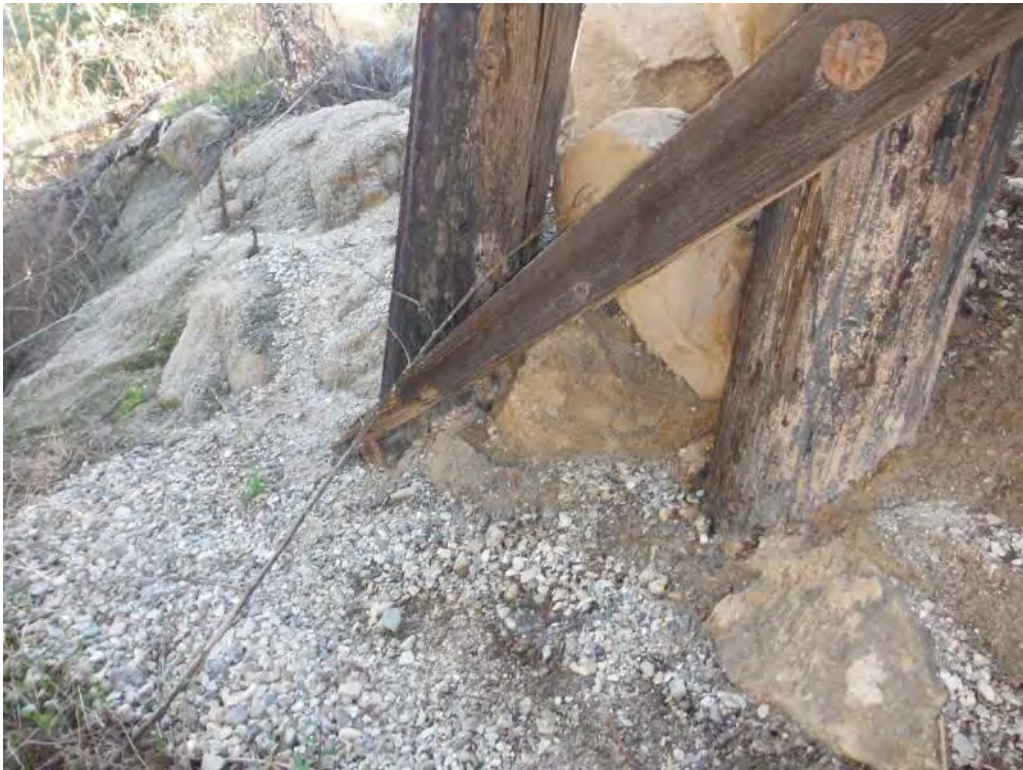
**420.46 Span 2, Bent 2 sway brace is broken on right side at pile 5**

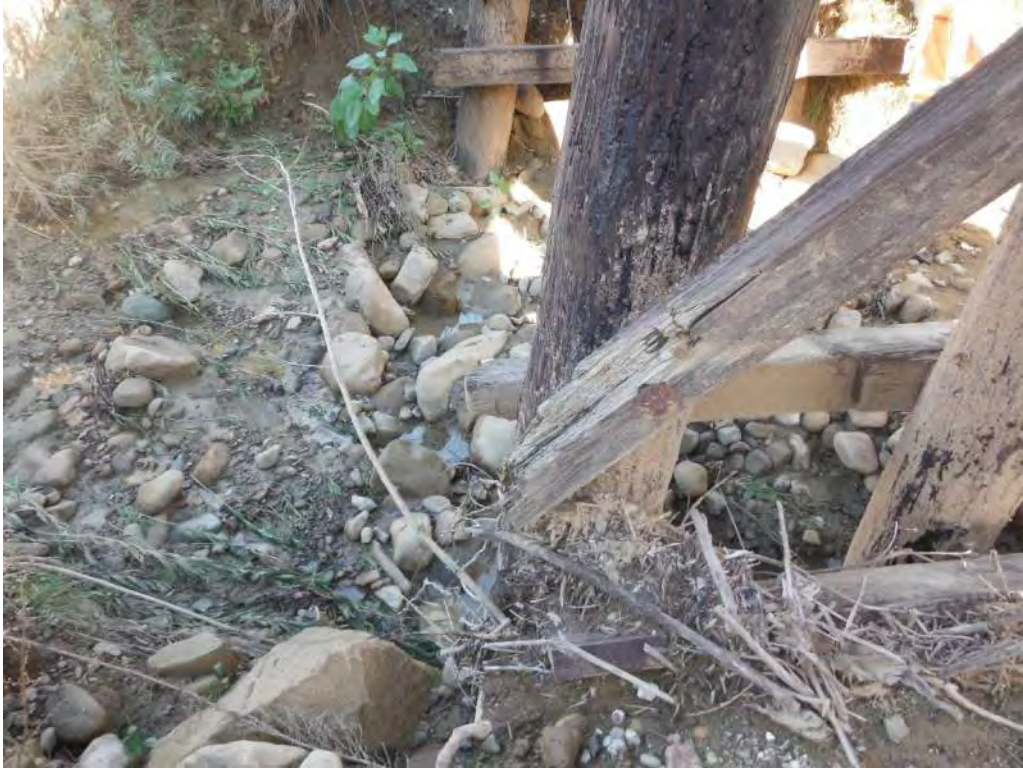
**420.46 Span 2 & Bent 3, tier 1 sash brace is broken on left side**

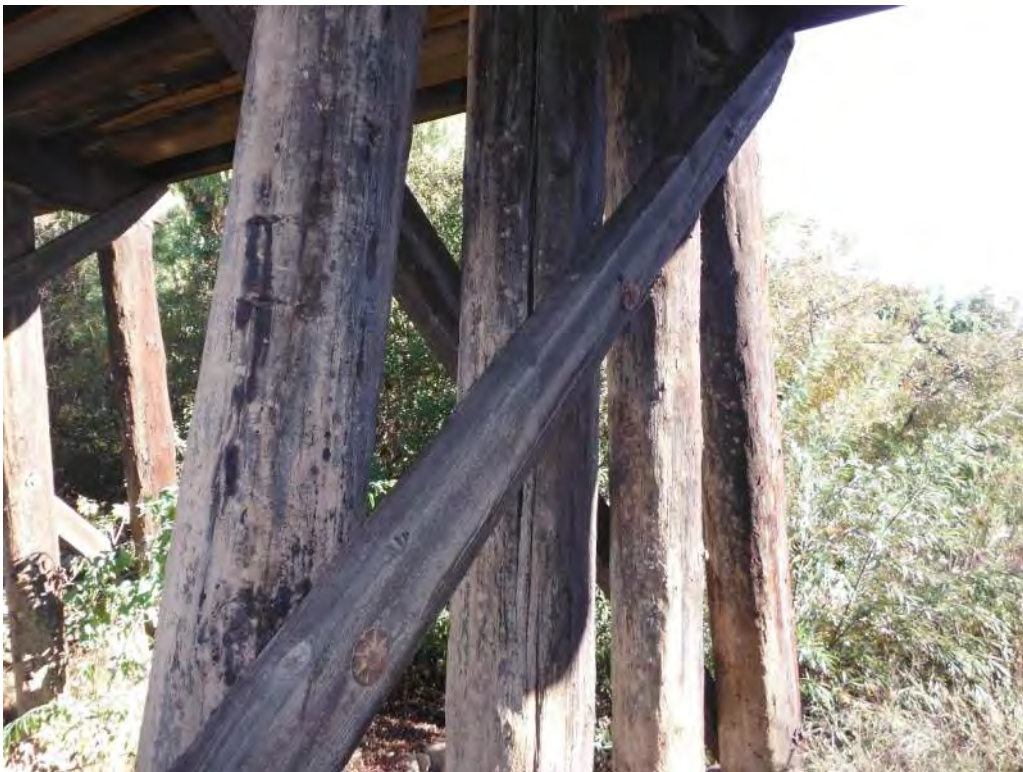
**420.46 Pile 3 vertical split, Bent 3**

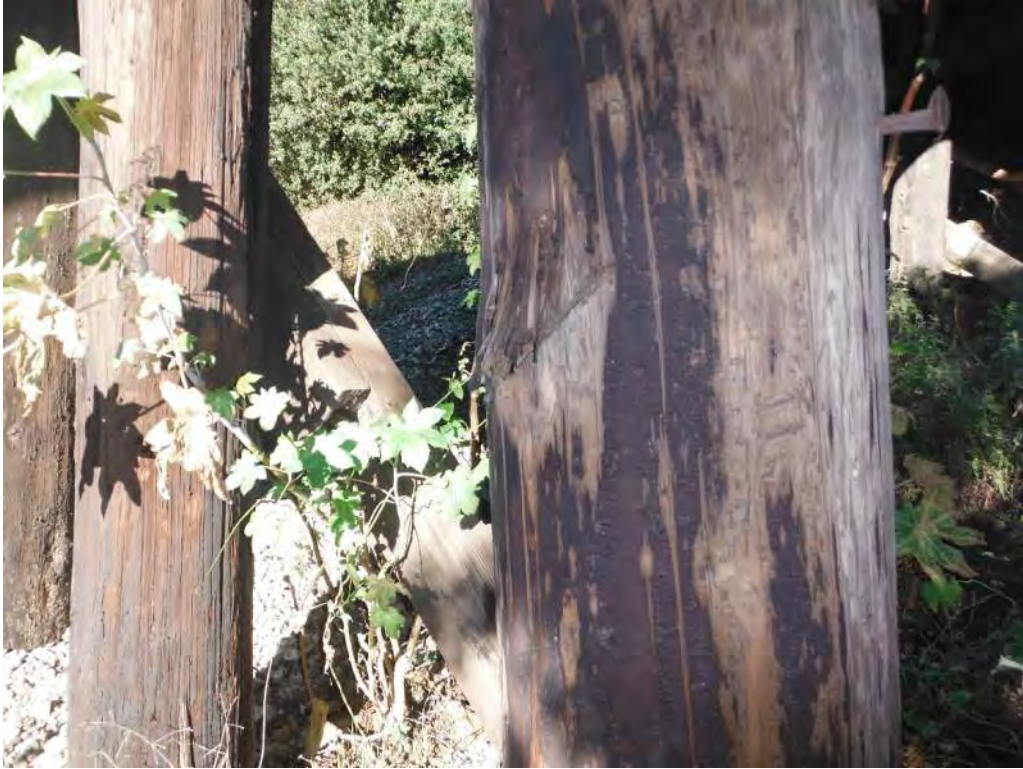
**420.46 Impact damage pile 5, Bent 5**

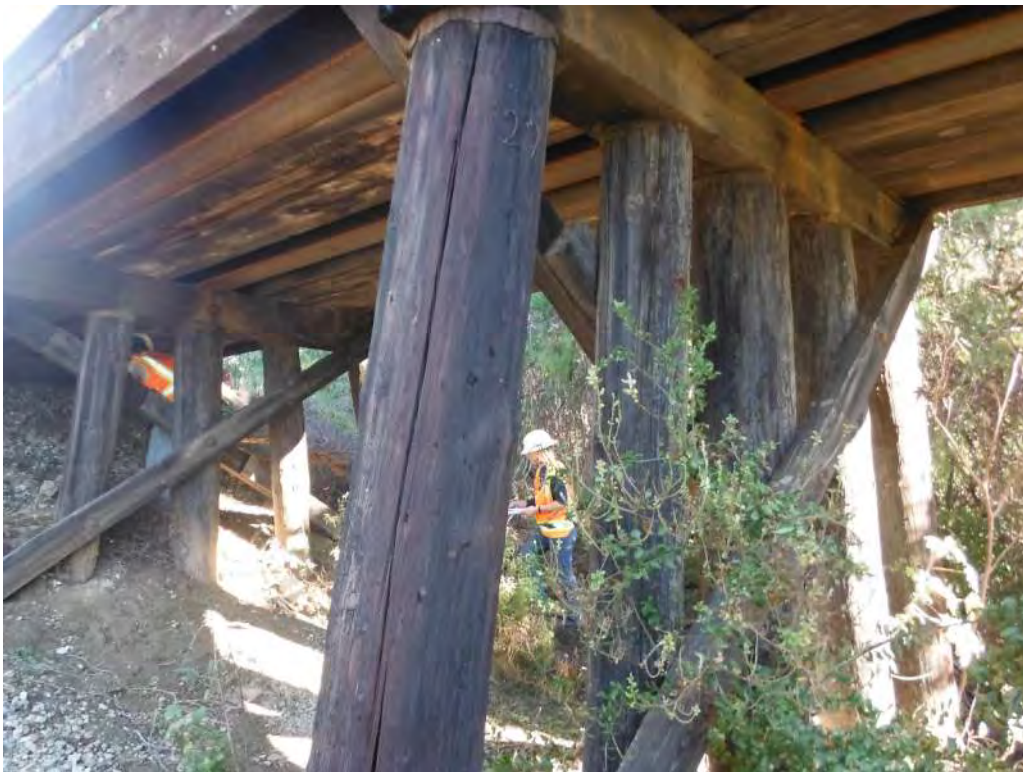
**420.46 Pile 1 vertical split, Bent 5**

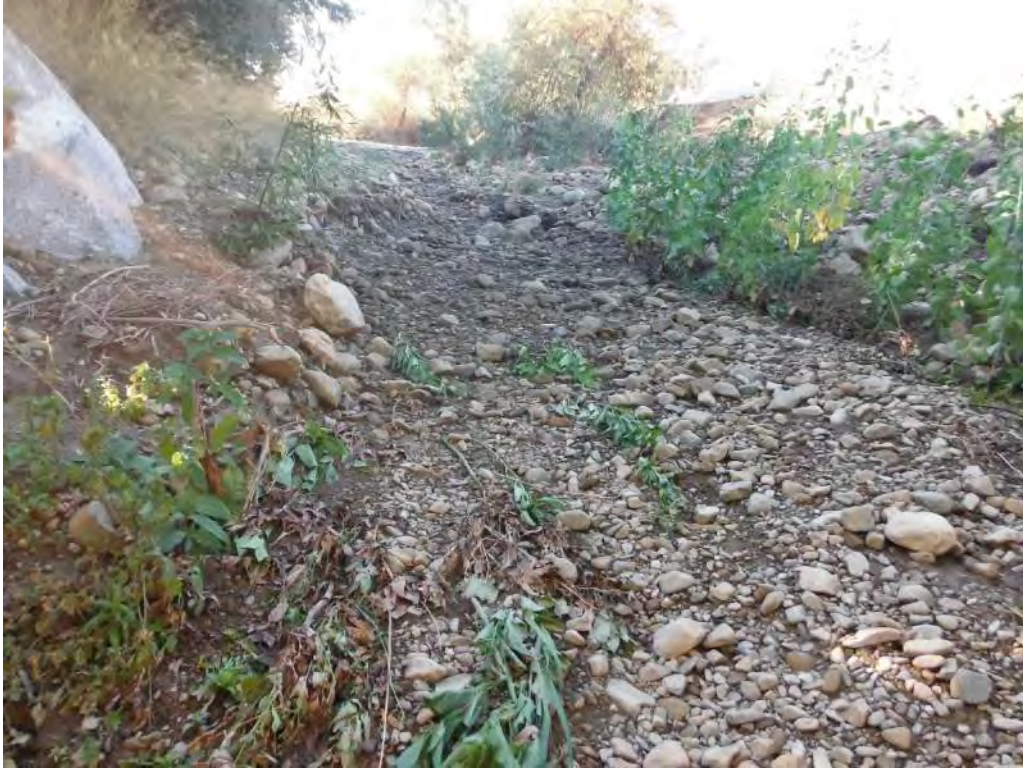
**421.05 Channel Condition – Looking Upstream**

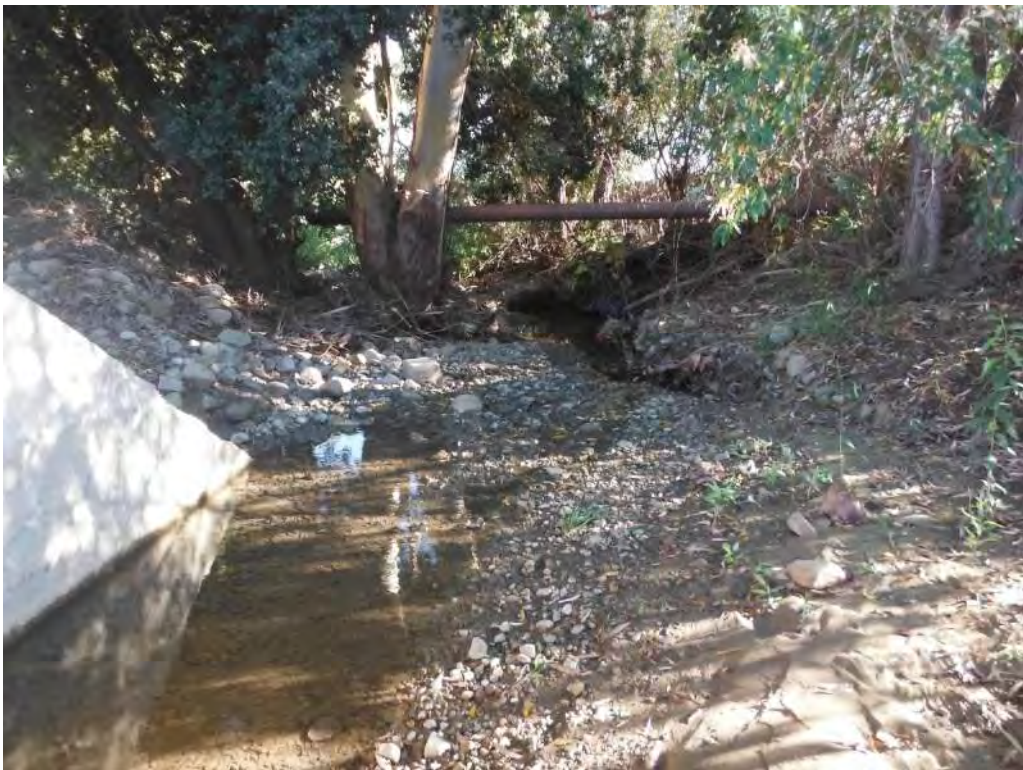
**421.05 Channel Condition - Looking Downstream**

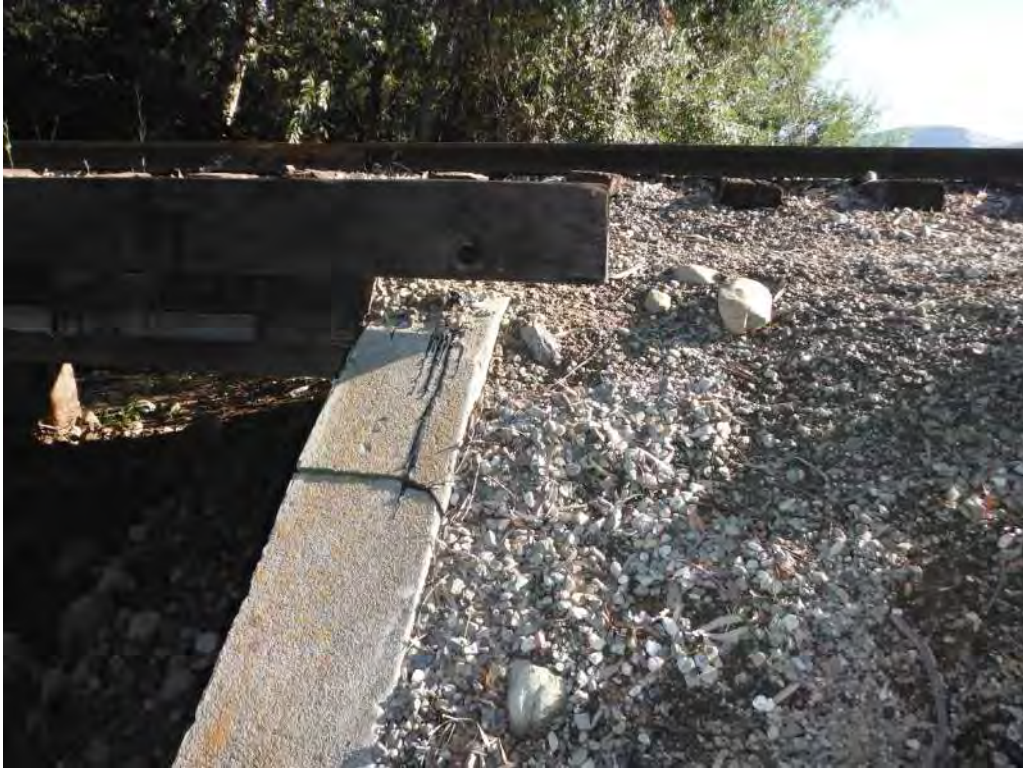
**421.05 Ballast Curb Undermined all 4 Corners**

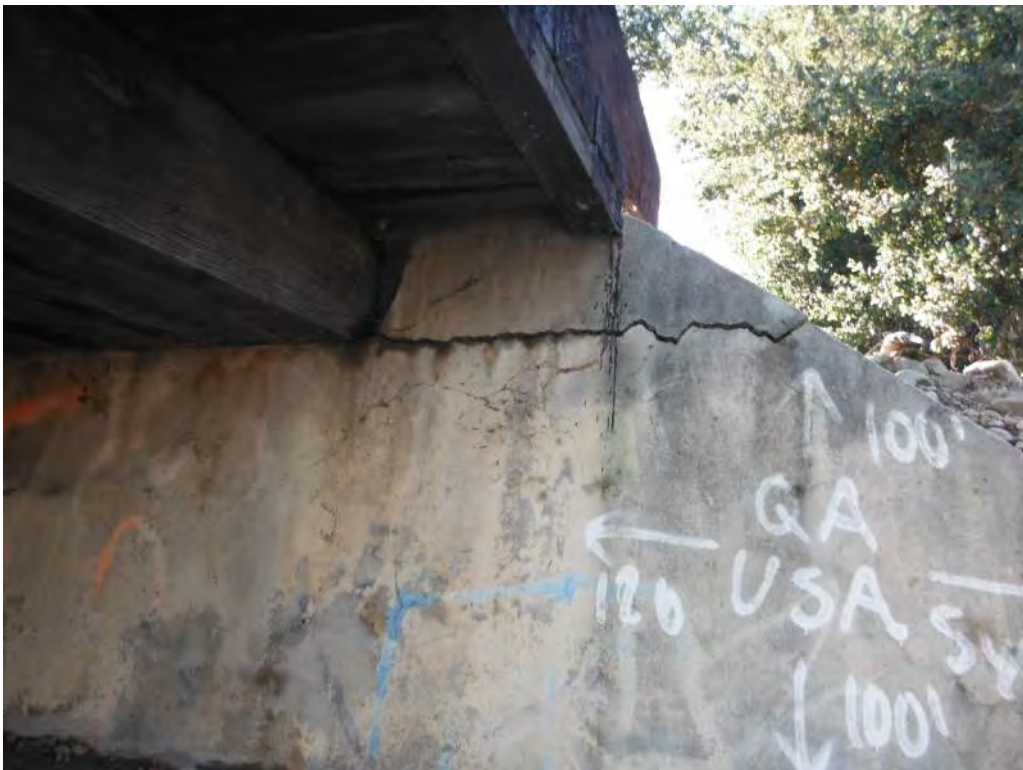
**421.05 Abutment stringer retainer cracked – typical all 4 corners**

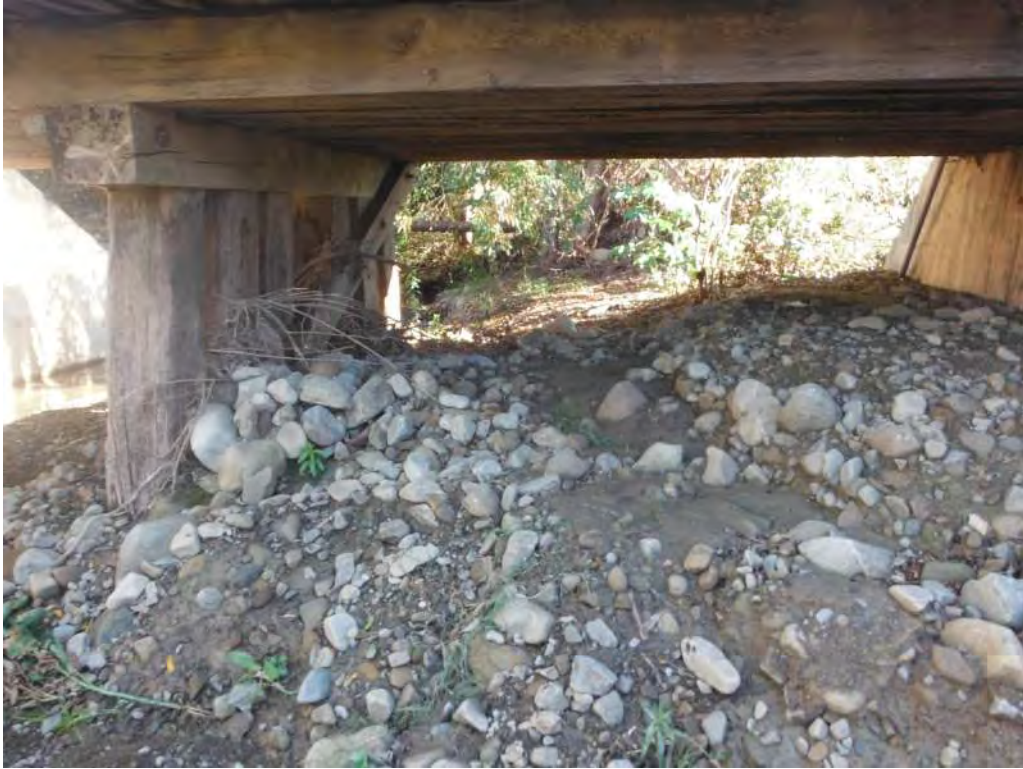
**421.05 Span 1 silting in**

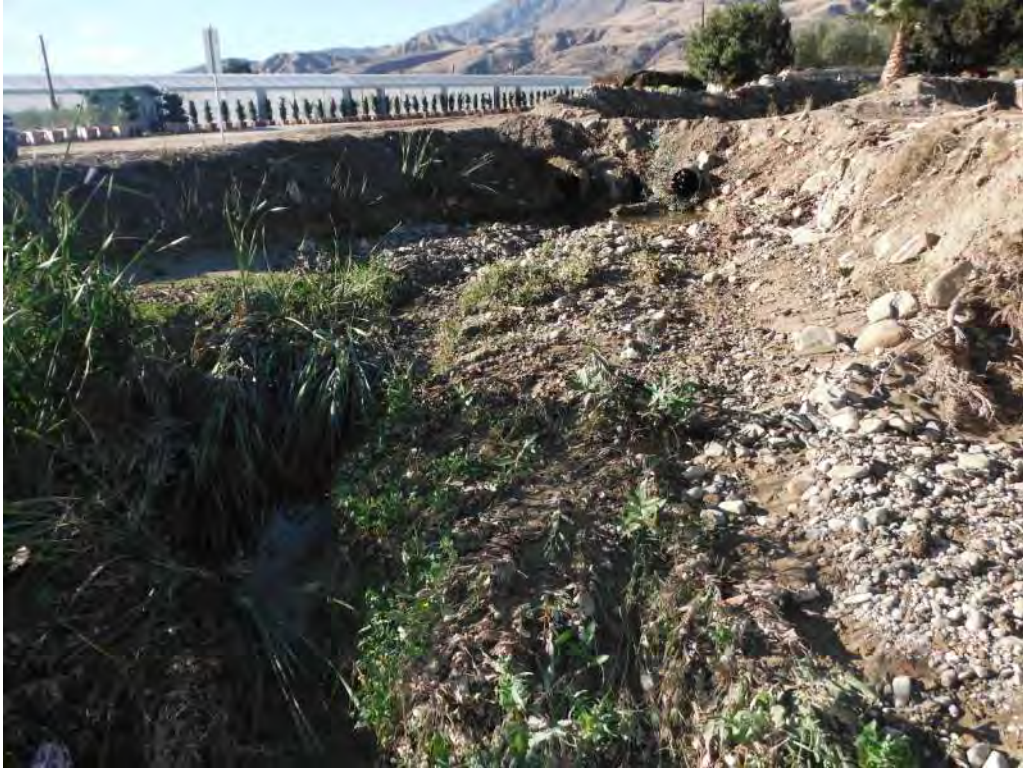
**421.23 Channel Condition – Looking Upstream**

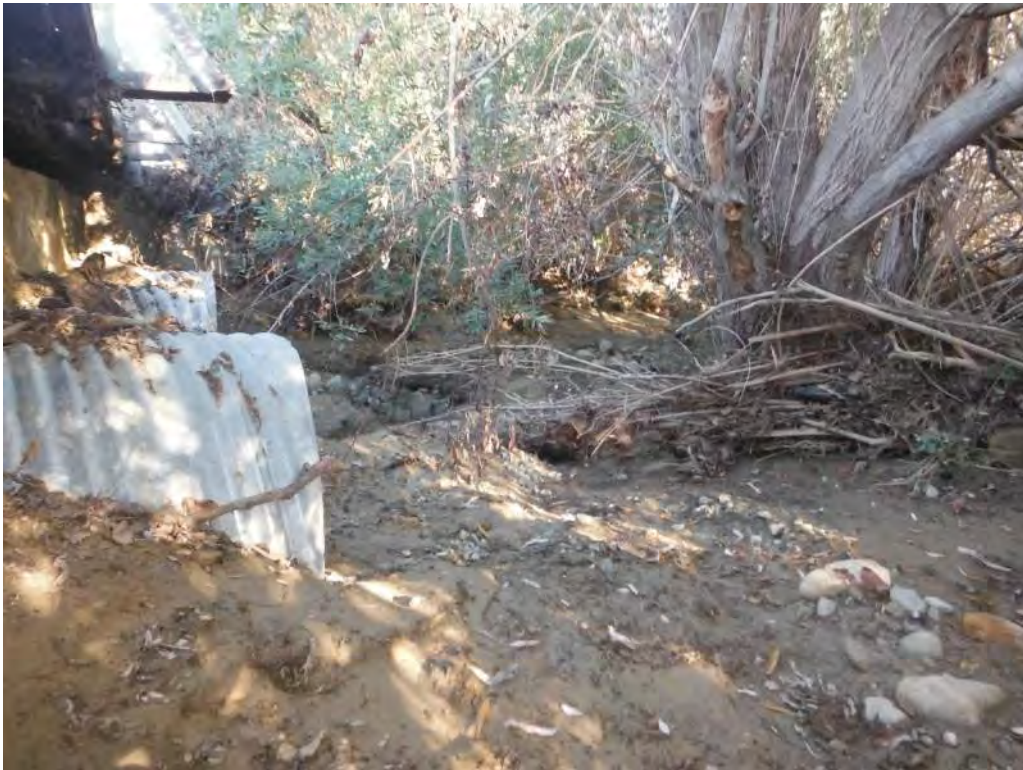
**421.23 Channel Condition – Looking Downstream**

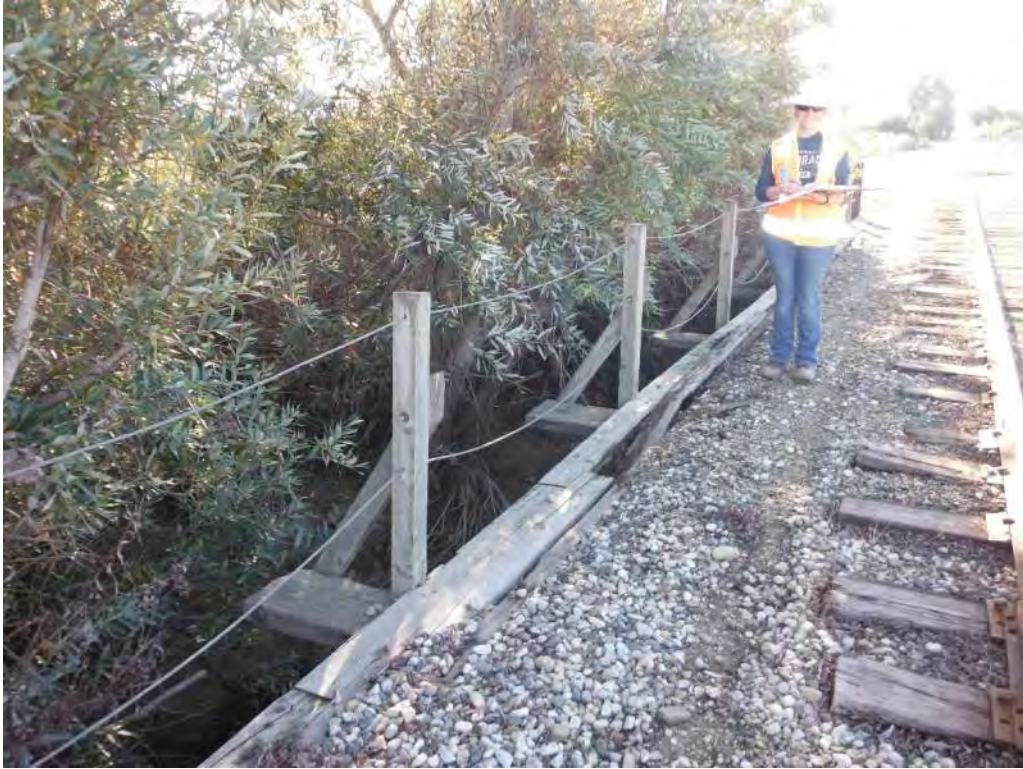
**421.23 Loose Handrail Cable Both Sides**

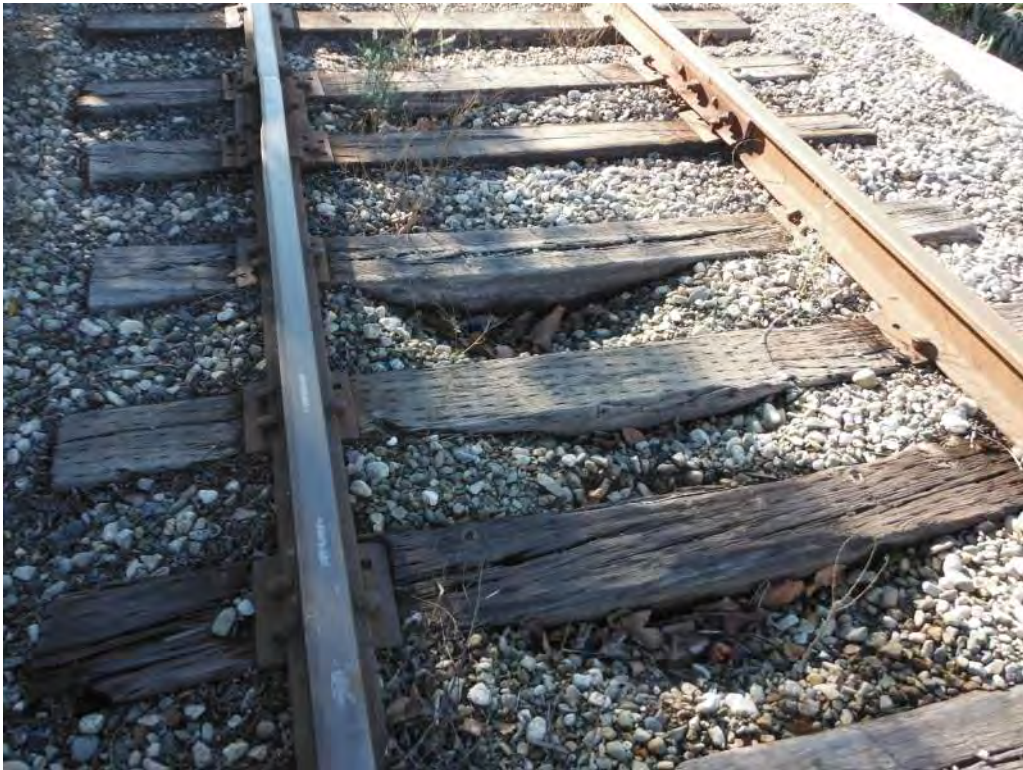
**421.23 Hole in Ballast**

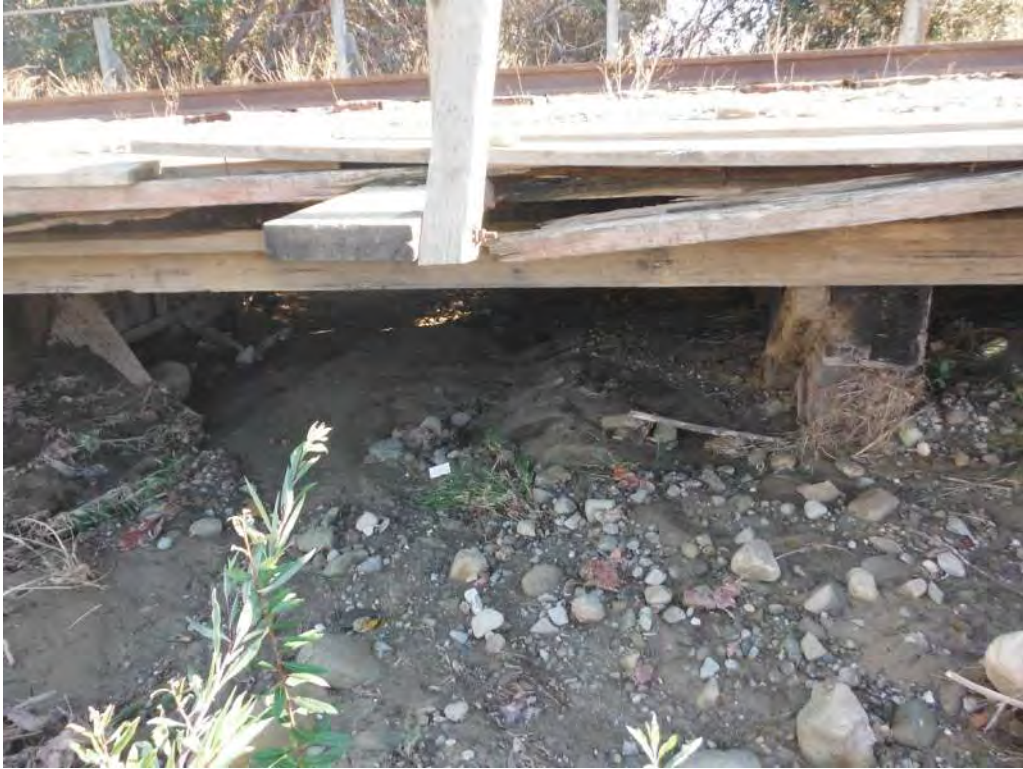
**421.23 Walkway Timbers Broken on North Side Span 2**

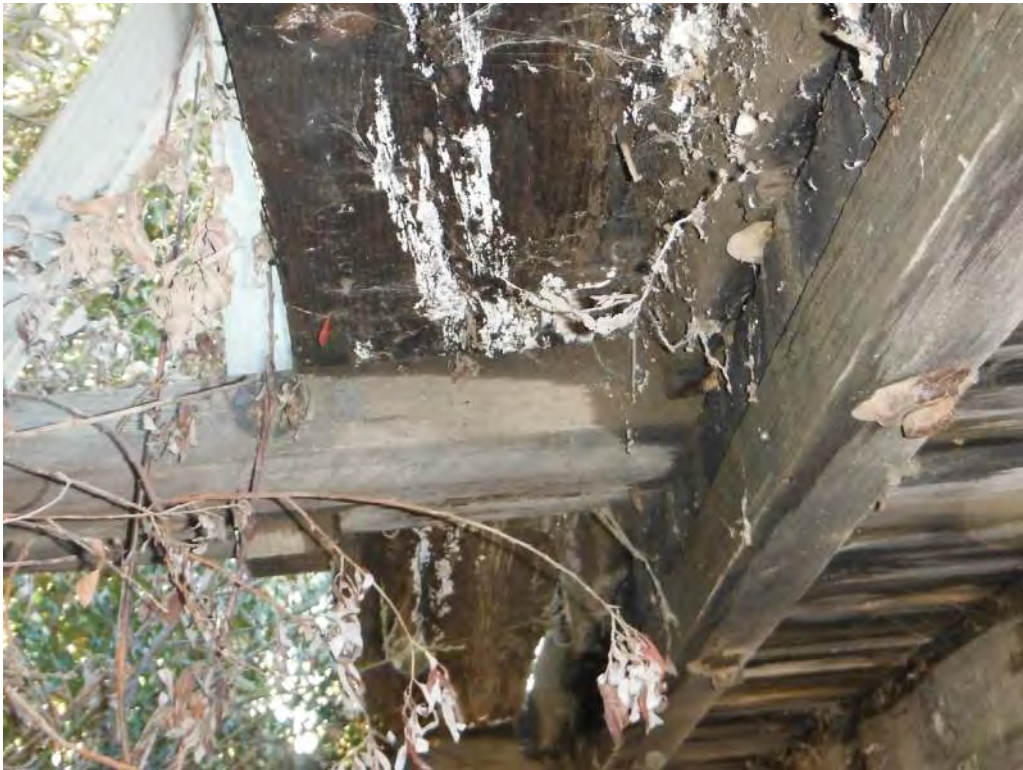
**421.23 South walkway rotten**

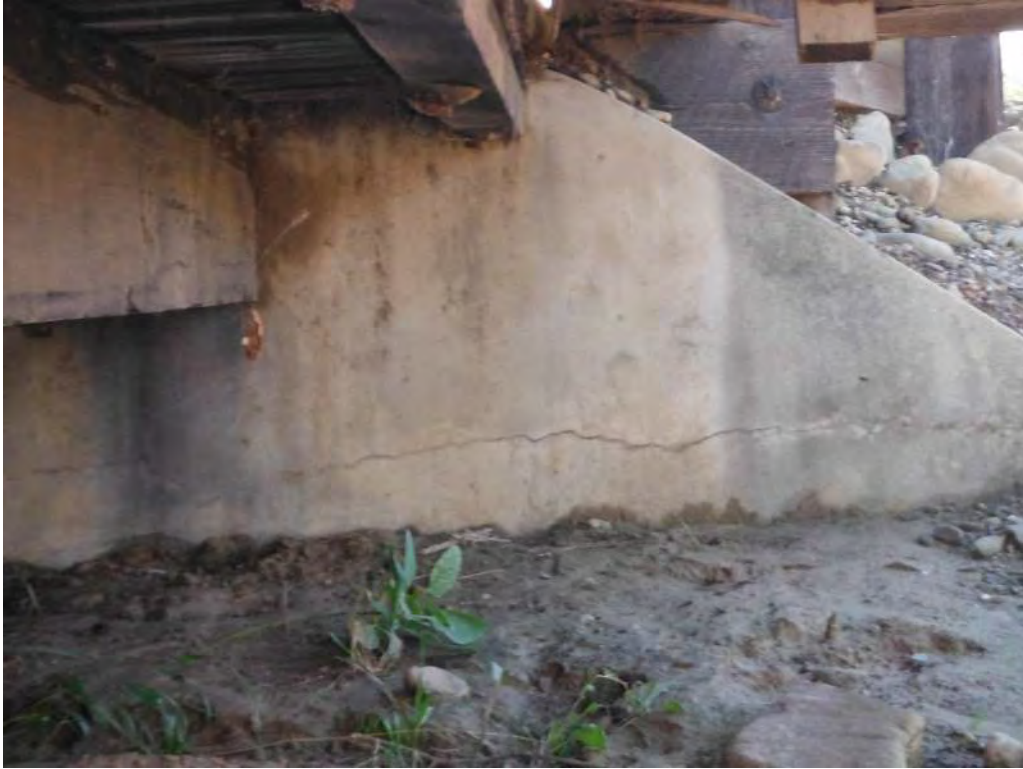
**421.23 Horizontal Crack in North Side Abutment 1**
