# BRIDGE INSPECTION REPORT

INSPECTION TYPE: Annual

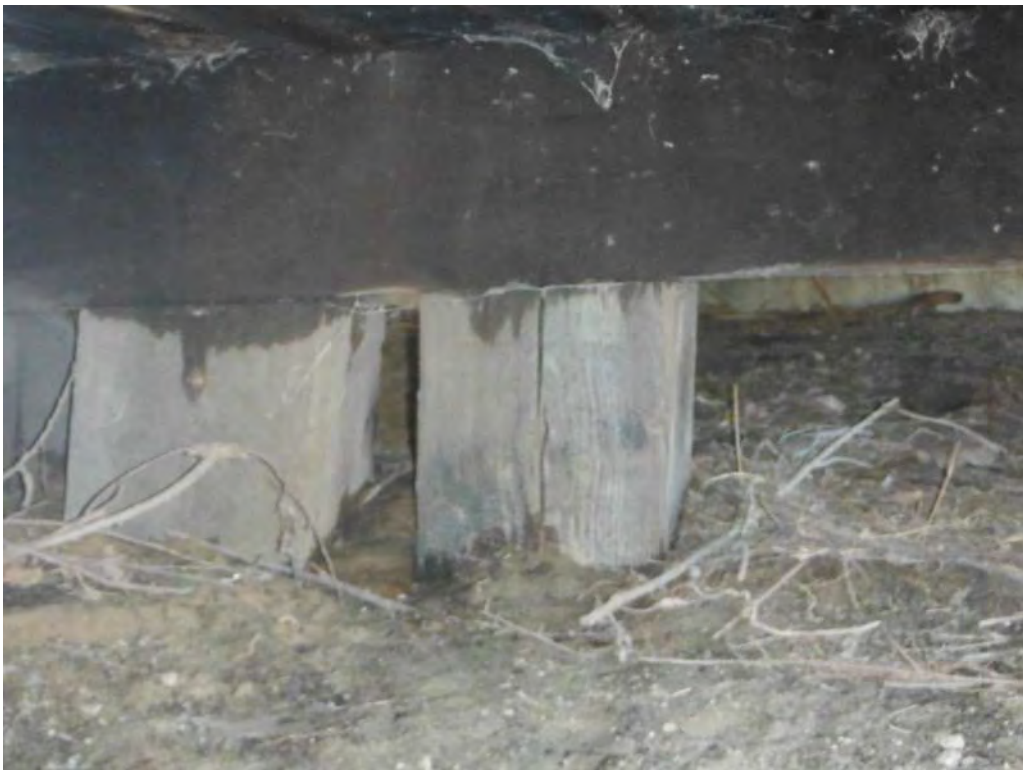
**421.23 Pile #4 Splitting, Bent 2**

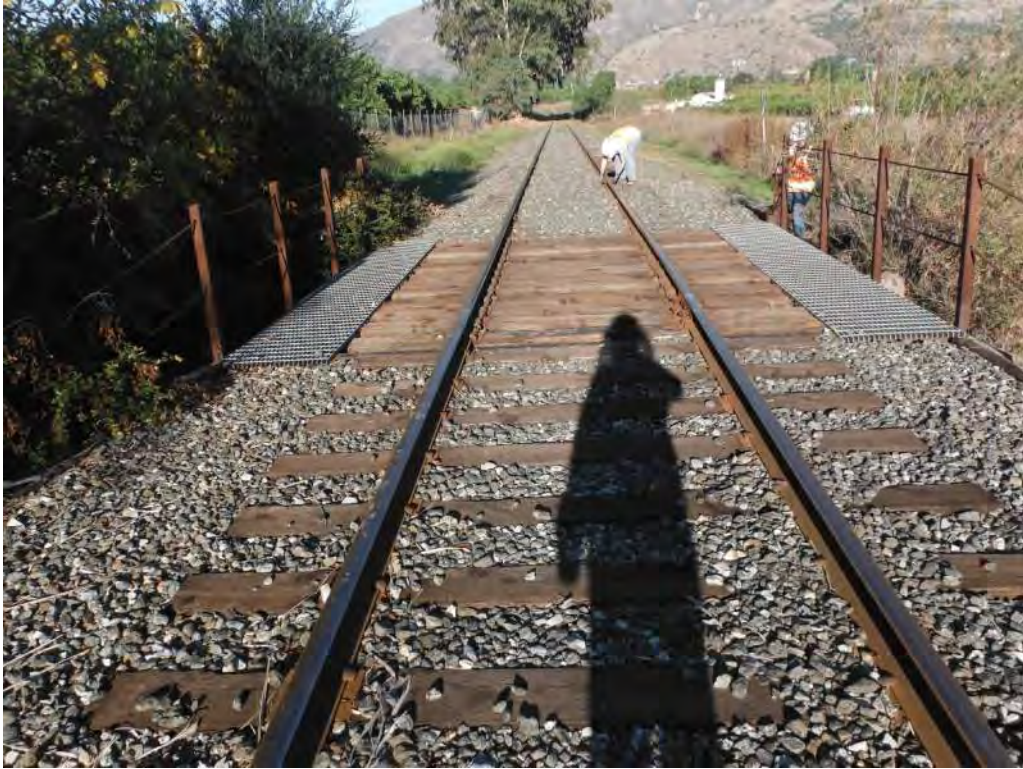
**422.53 Looking East**

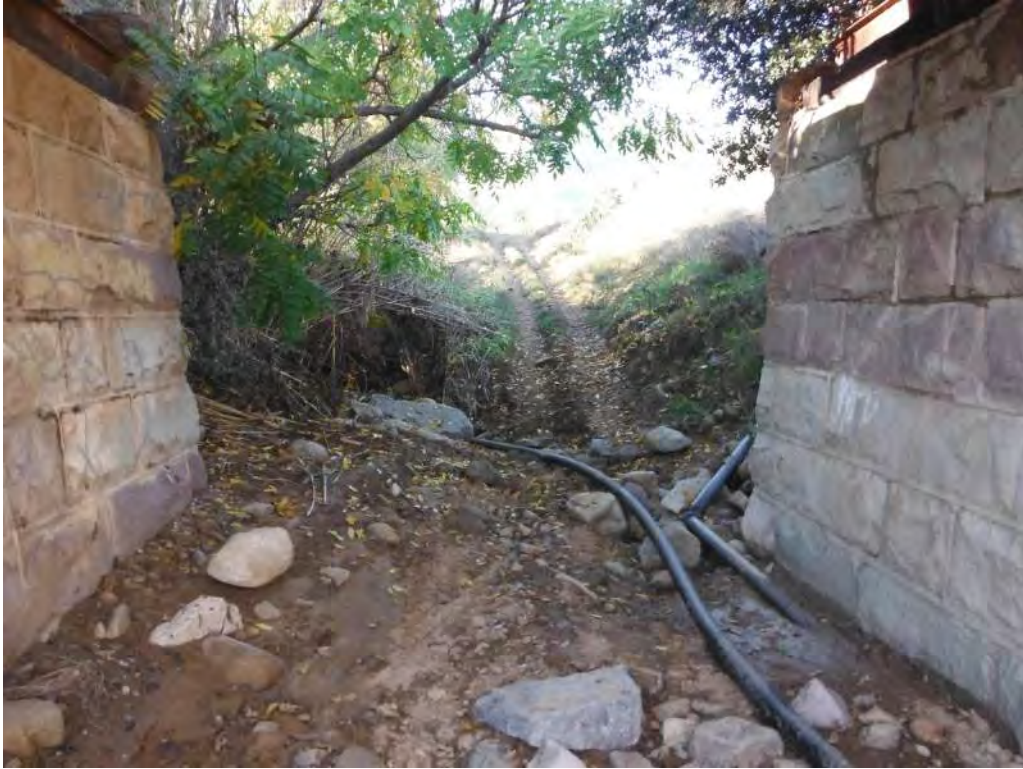
**422.53 Upstream channel condition**

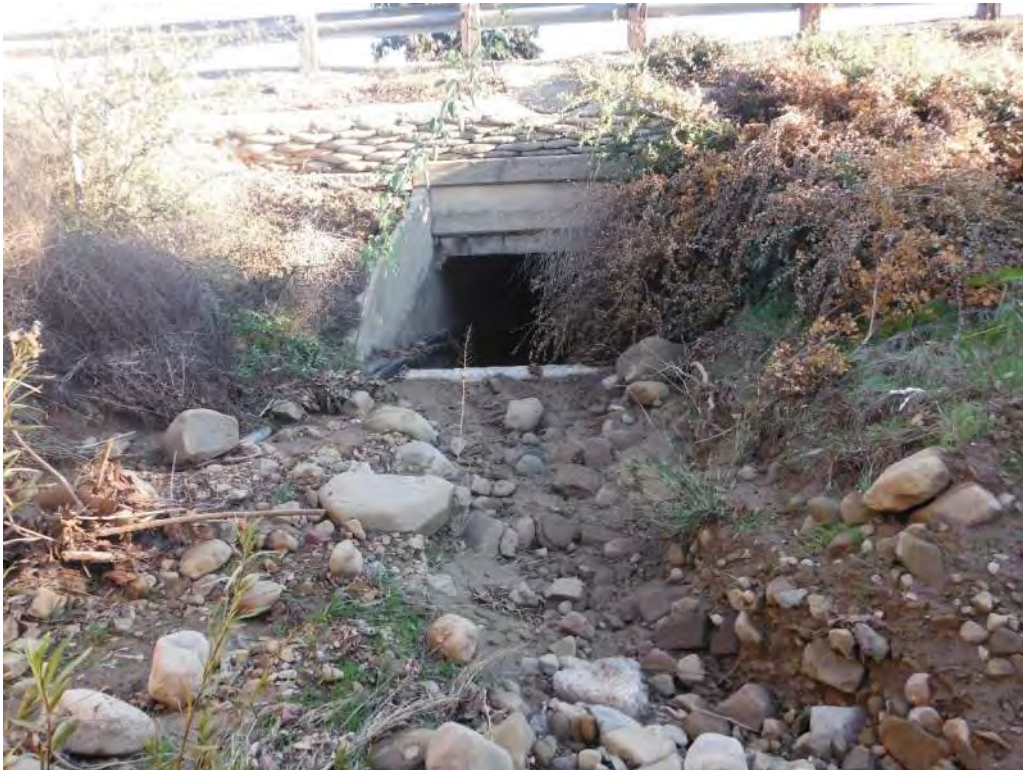
**422.53 Downstream channel condition**

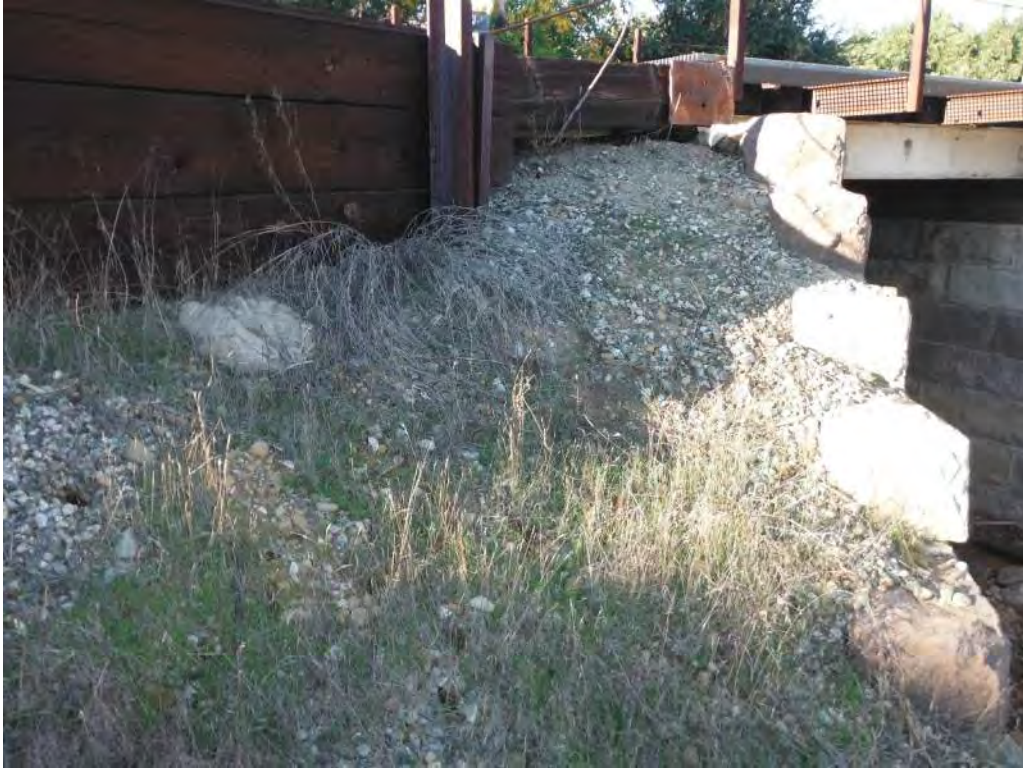
**422.53 Southwest ballast curb undermined**

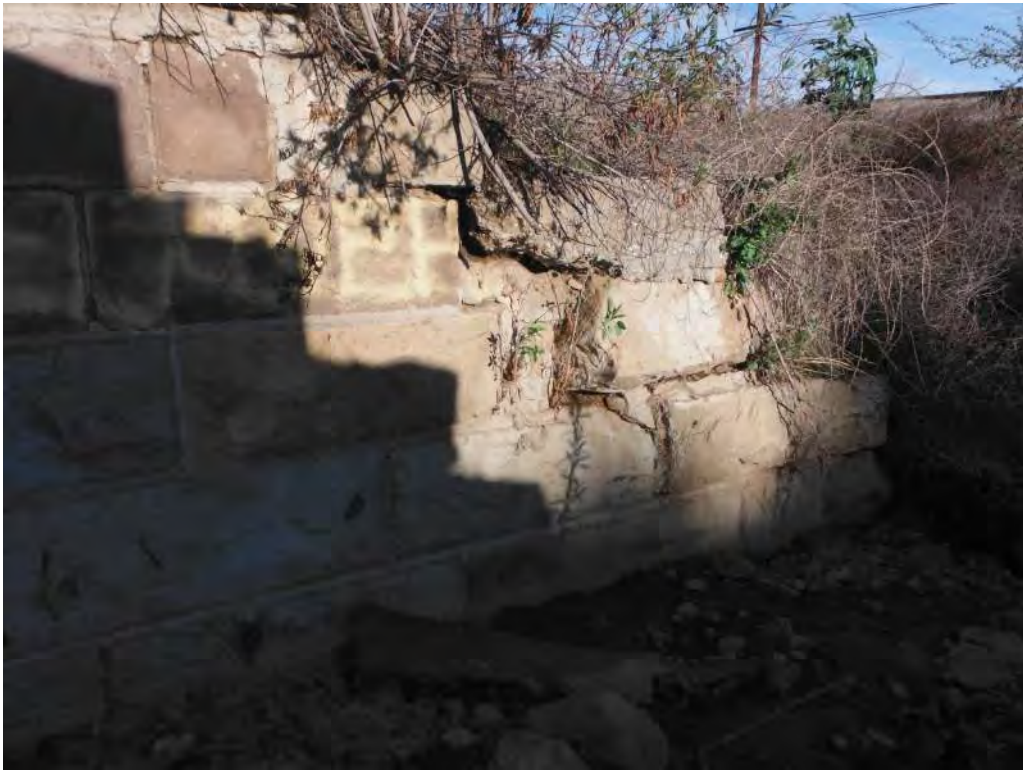
**422.53 Southeast Wingwall Blocks Loose**

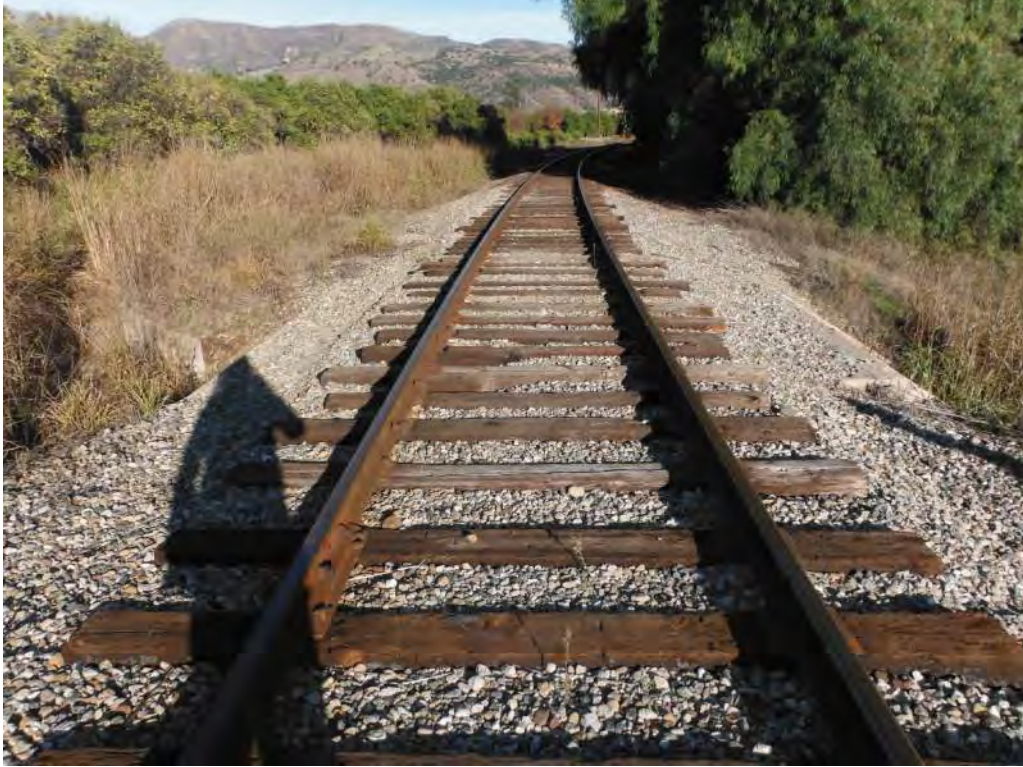
**422.89 Looking East**

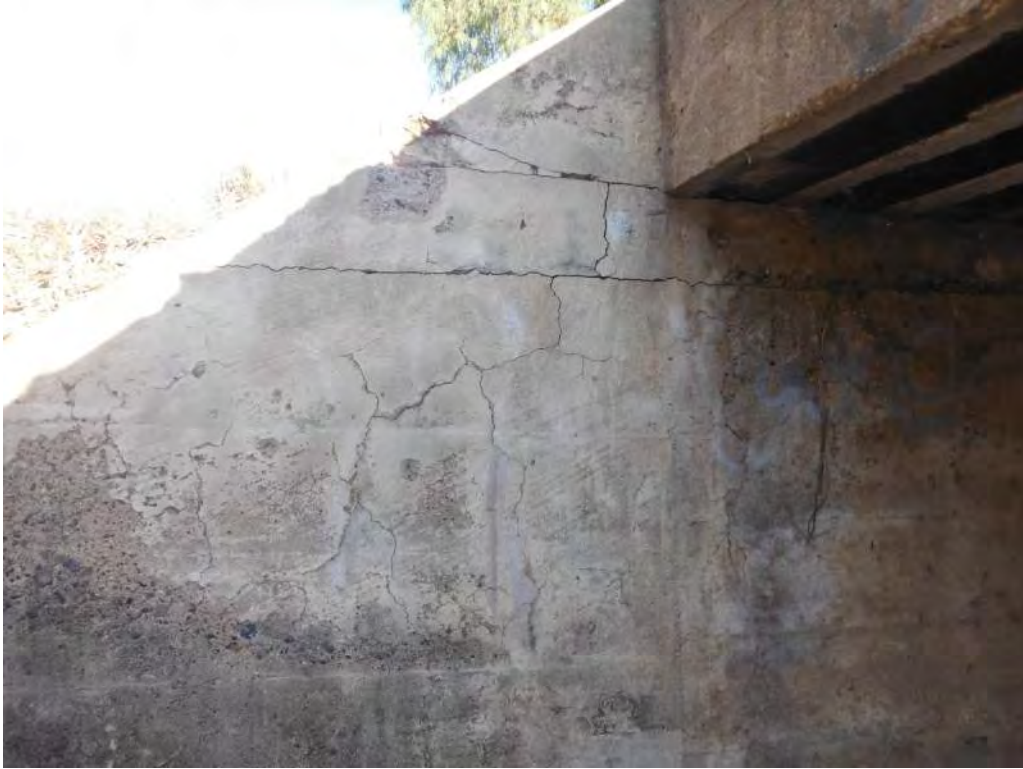
**422.89 Abutment 2 cracking – cracking typical both sides each Abutment**

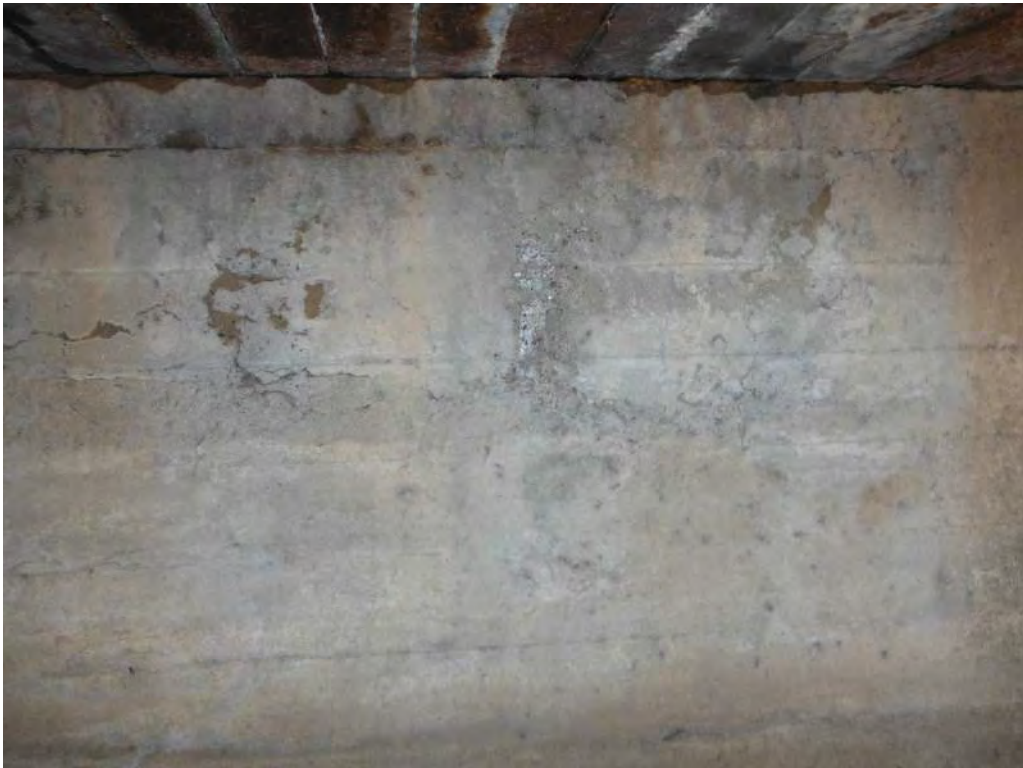
**422.89 Abutment scaling – typical each Abutment**

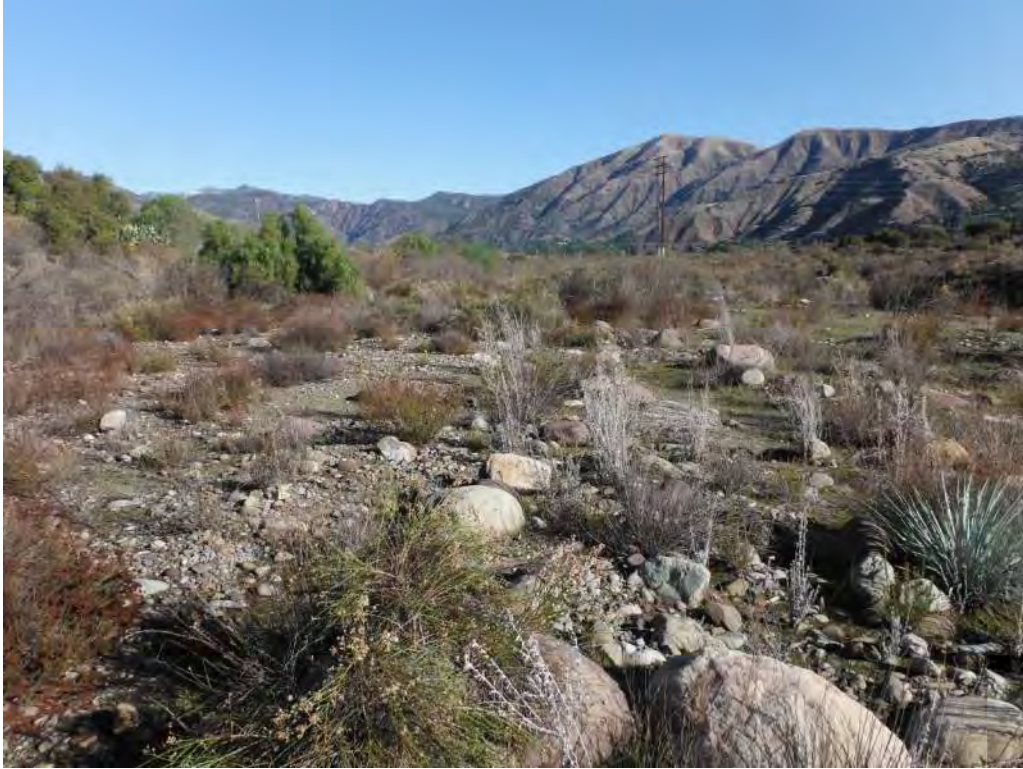
**423.28 Channel Condition – Looking Upstream**

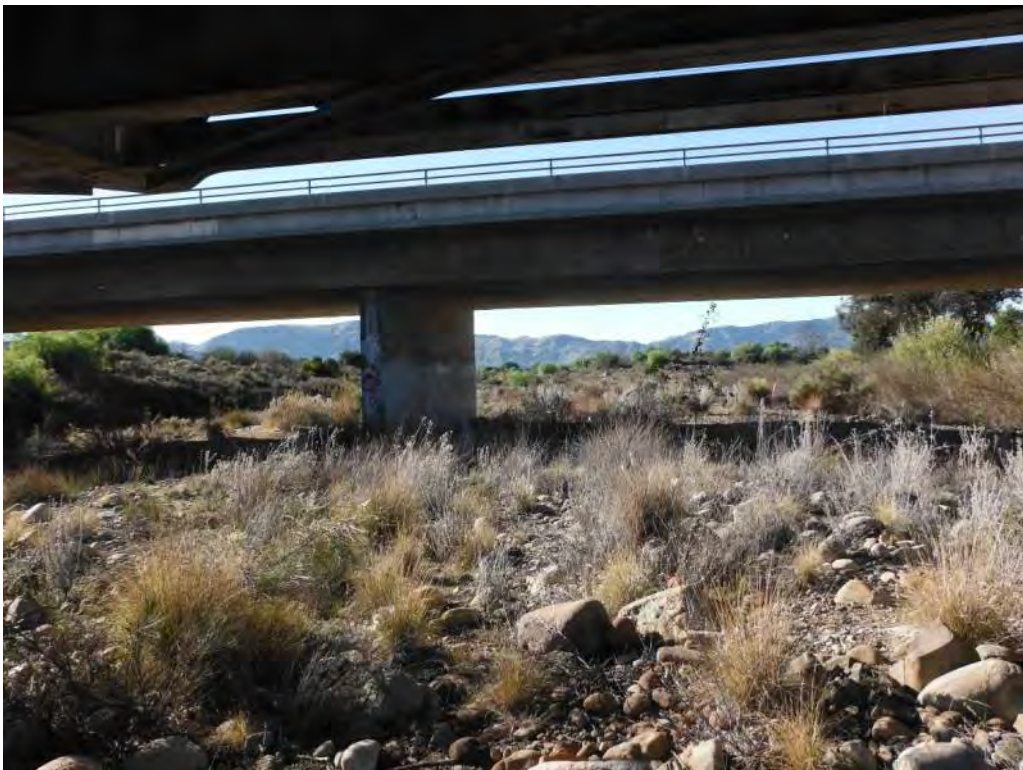
**423.28 Channel Condition – Looking Downstream**

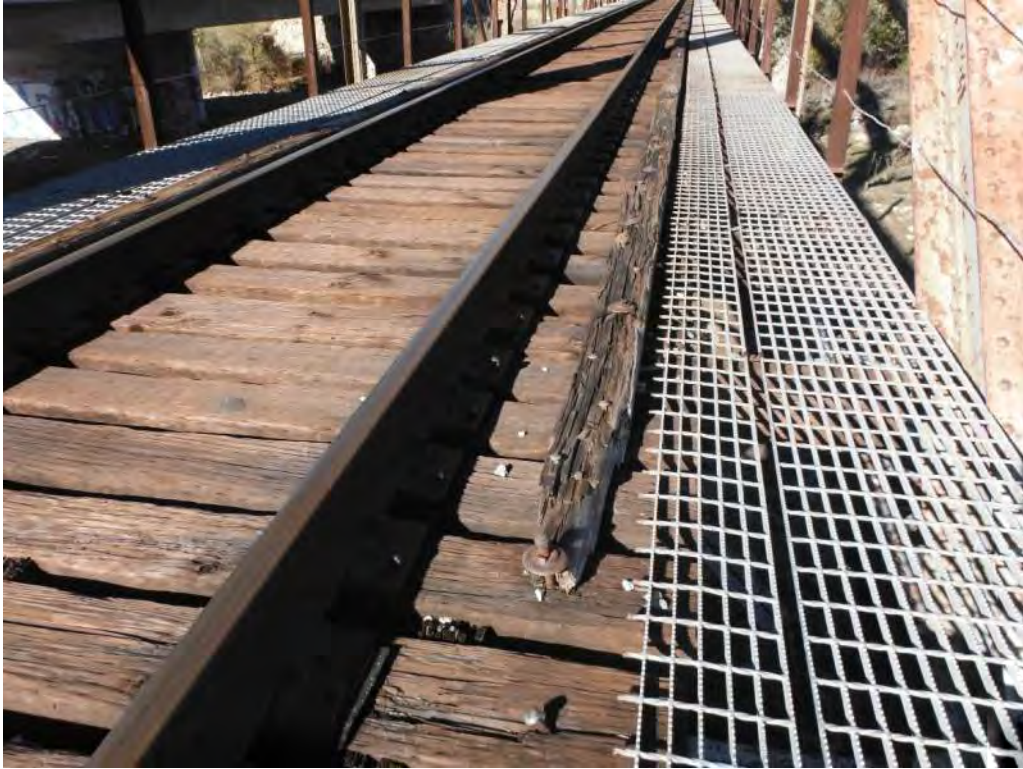
**423.28 Damaged timber curb west and east side, typ**

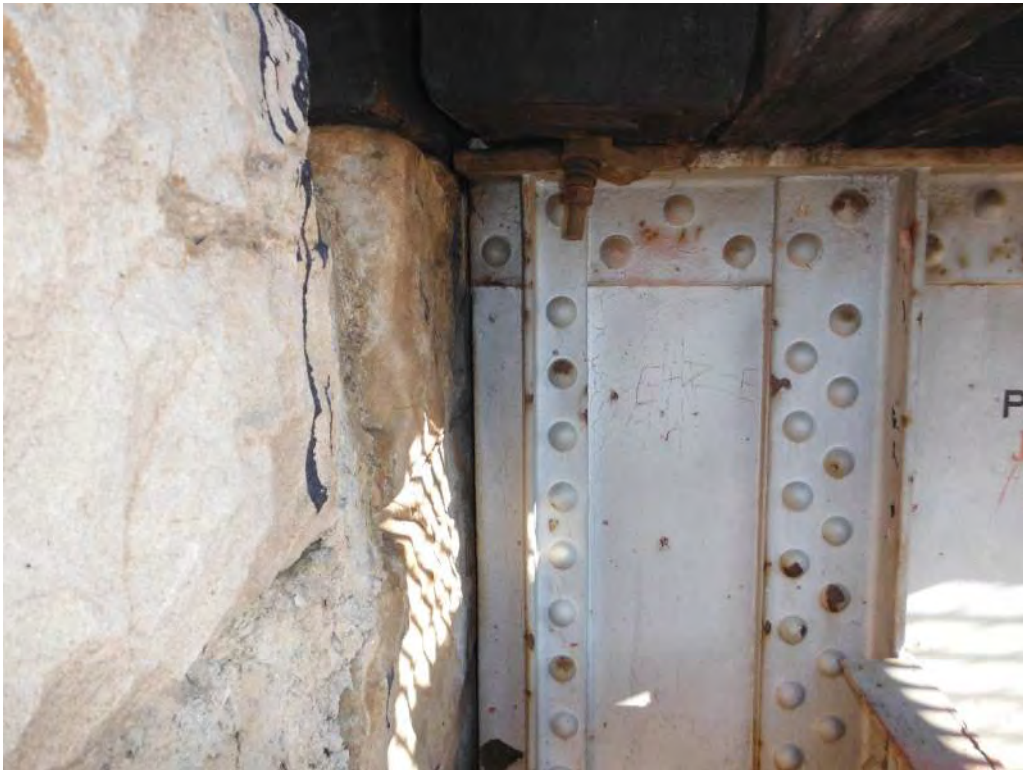
**423.28 No gap between end of stringer and backwall – Abutment 1**

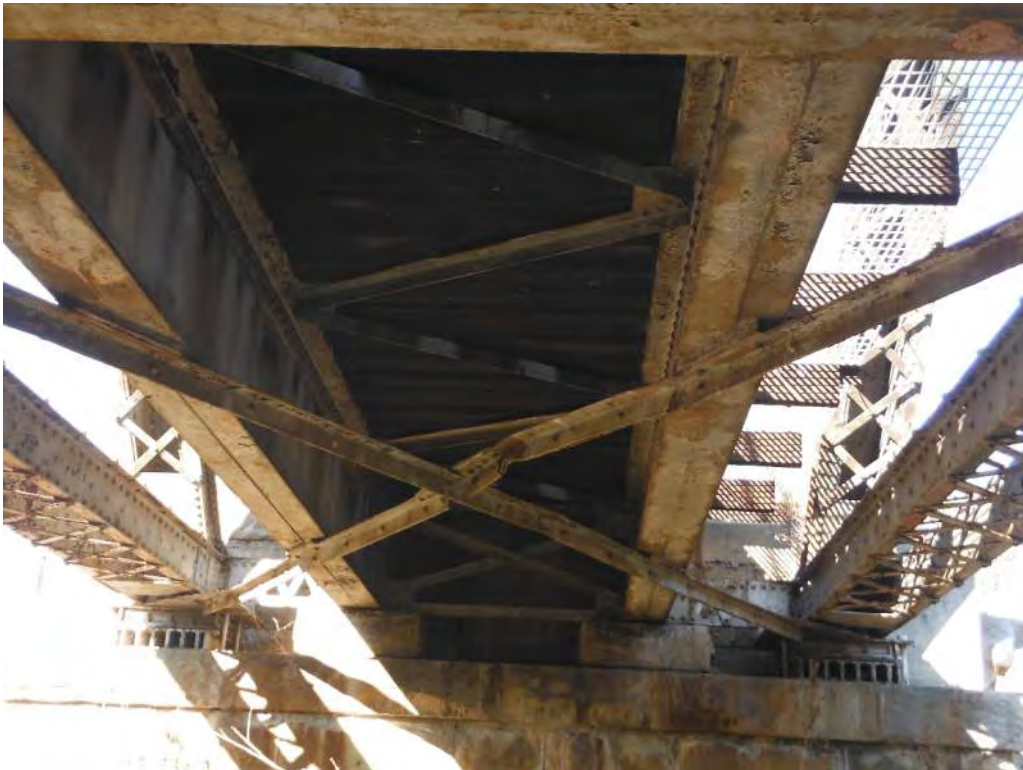
**423.28 Minor impact damage to cross bracing near Abutment 1**

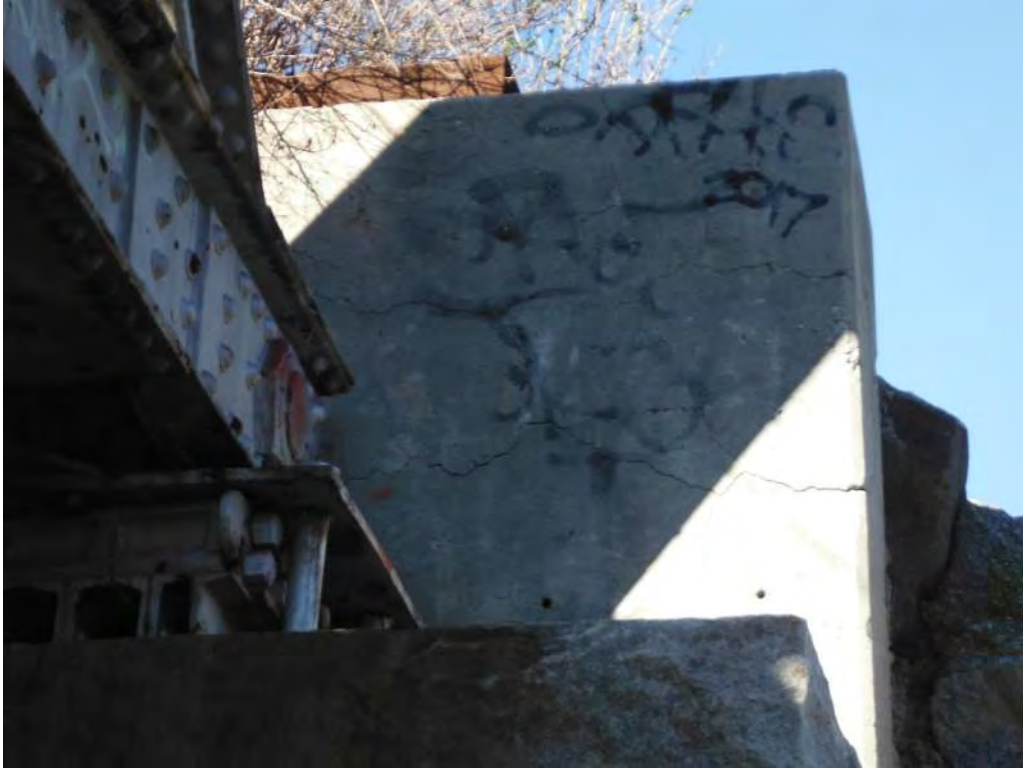
**423.28 Map cracking Northside of backwall - Abutment 1**

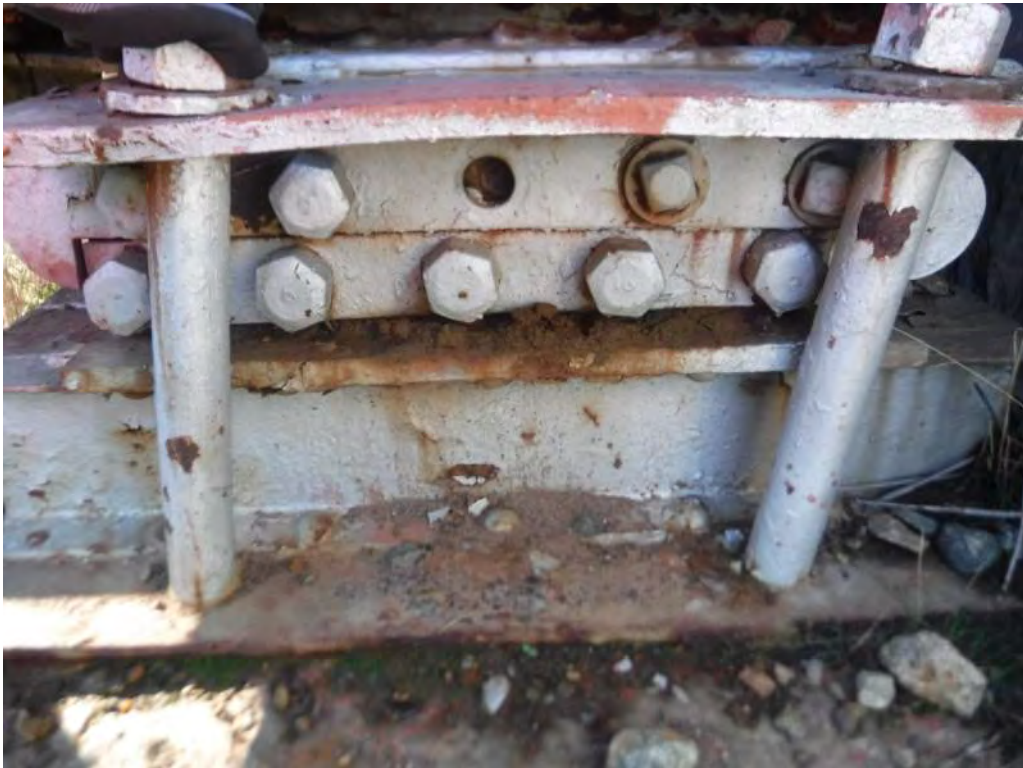
**423.28 Bolt missing at Northwest bearing bridge rollers**

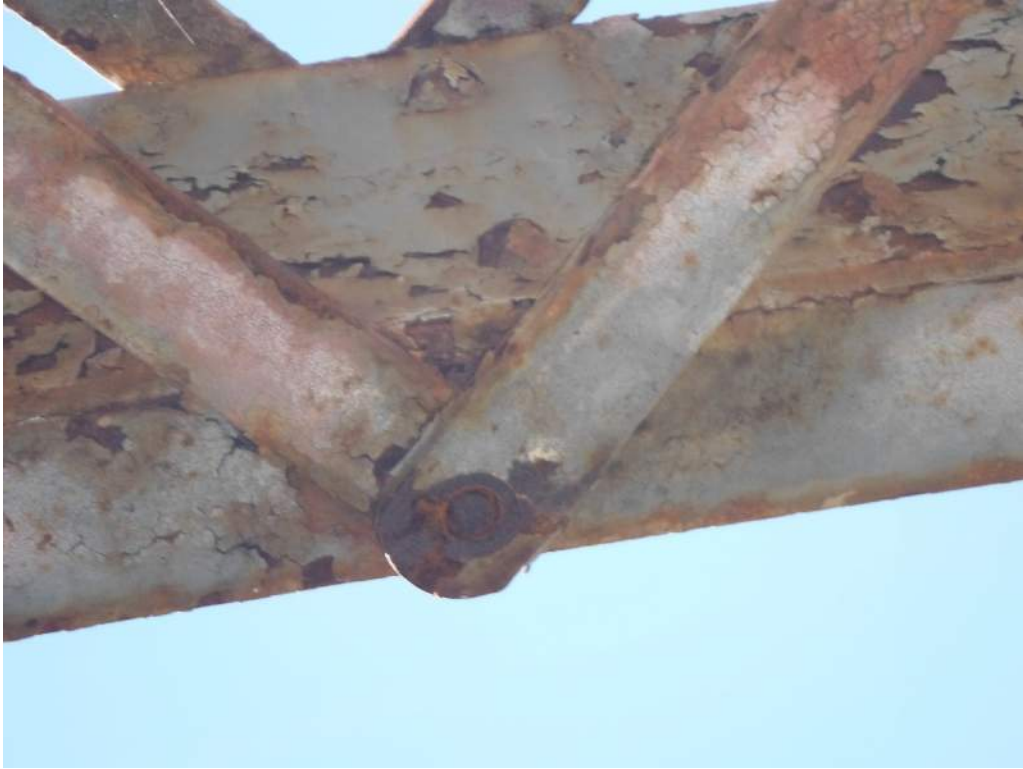
**423.28 Missing rivet near Bay 2 bottom chord**

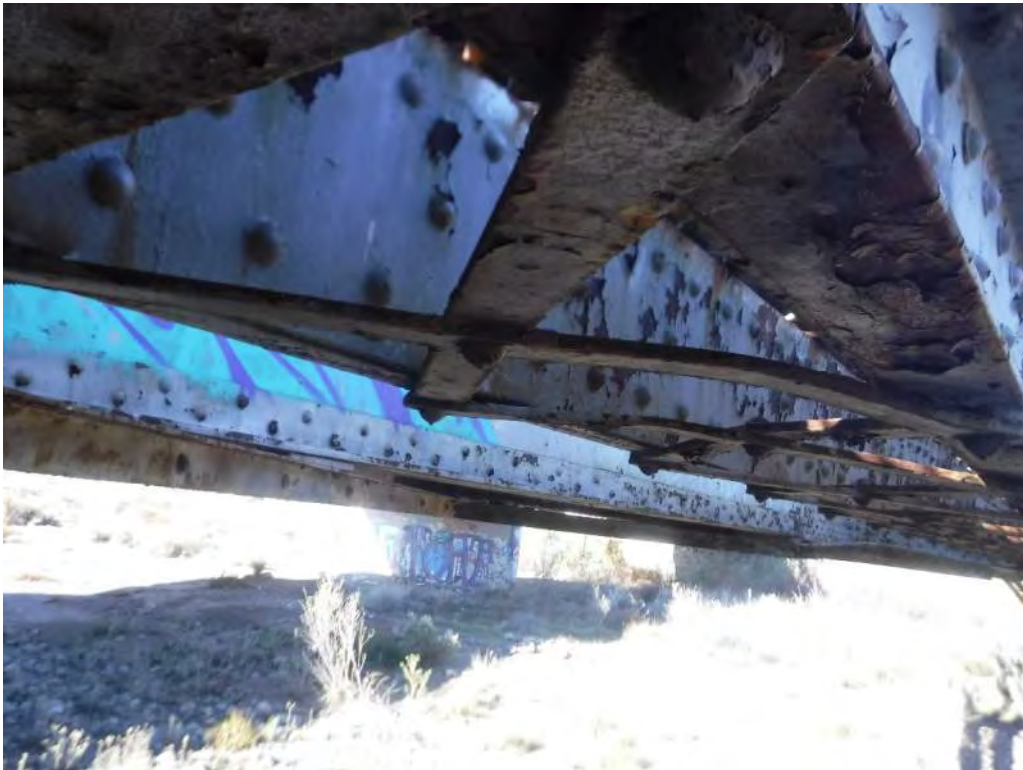
**423.28 Impact damage to bottom chord lattice bracing at bay 7**

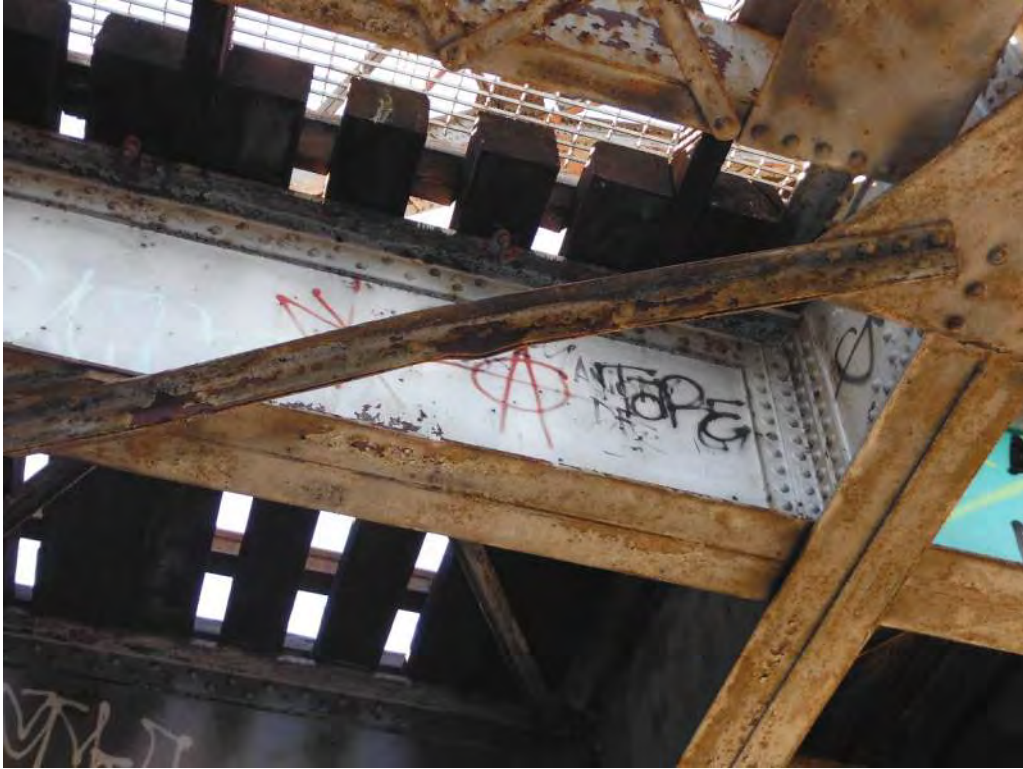
**423.28 Minor impact damage to cross bracing near Abutment 2**

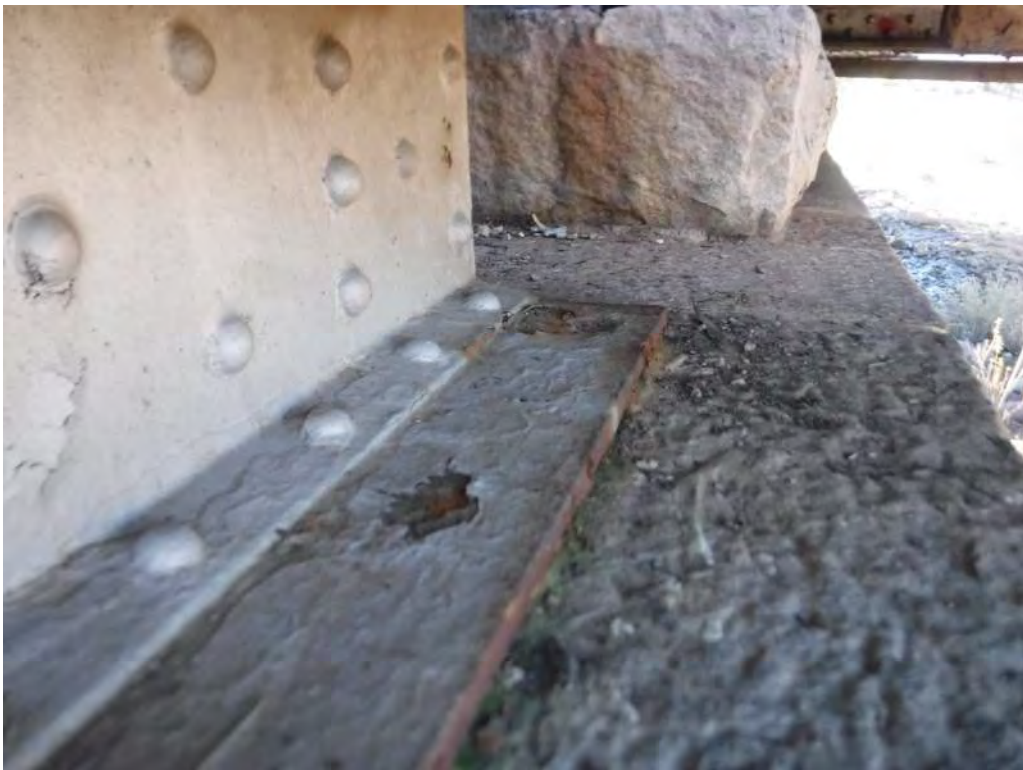
**423.28 North bearing, Abutment 2 – Missing SW anchor**

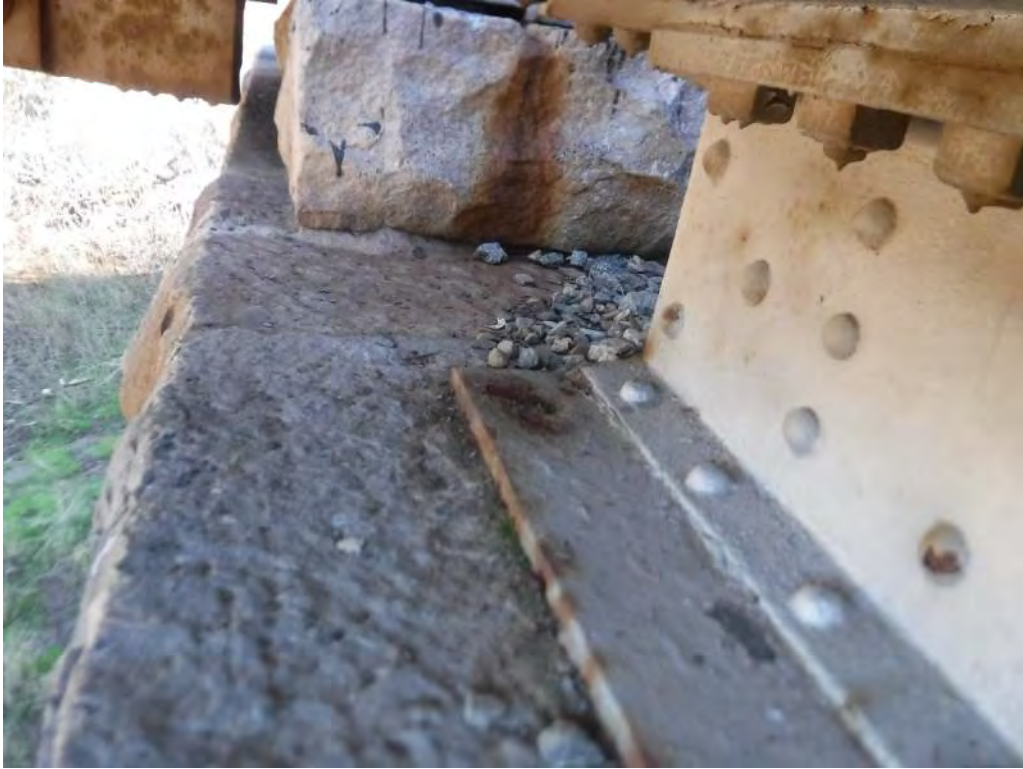
**423.28 South bearing, Abutment 2 – Missing NW anchor**

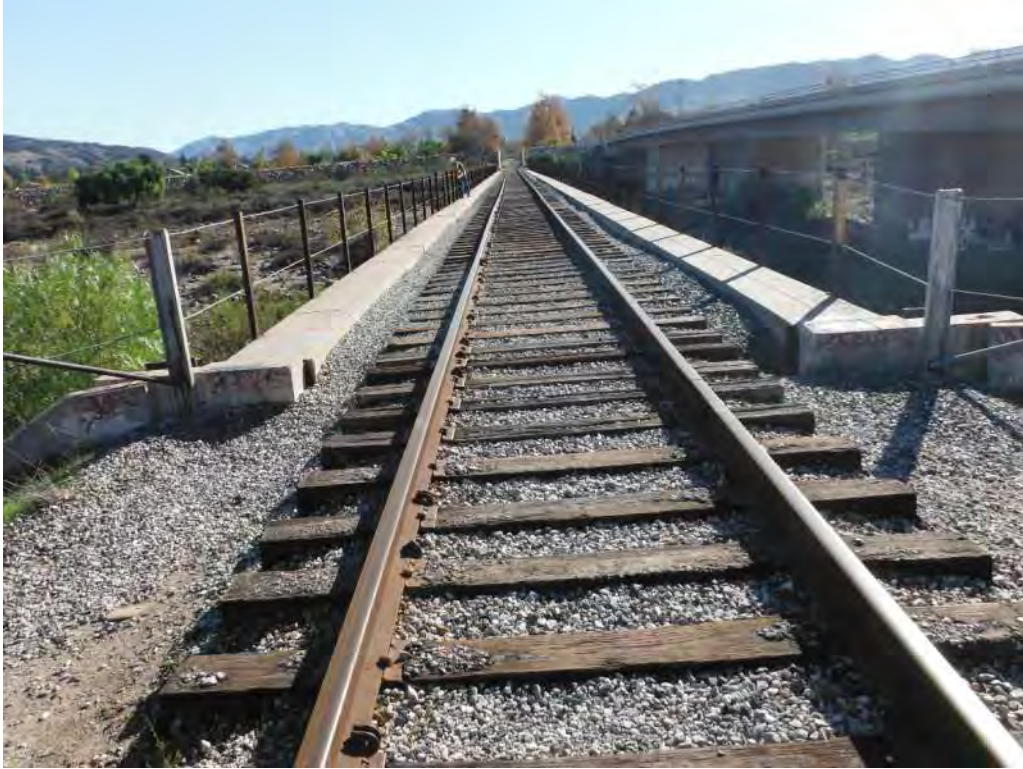
**423.44 Looking East**

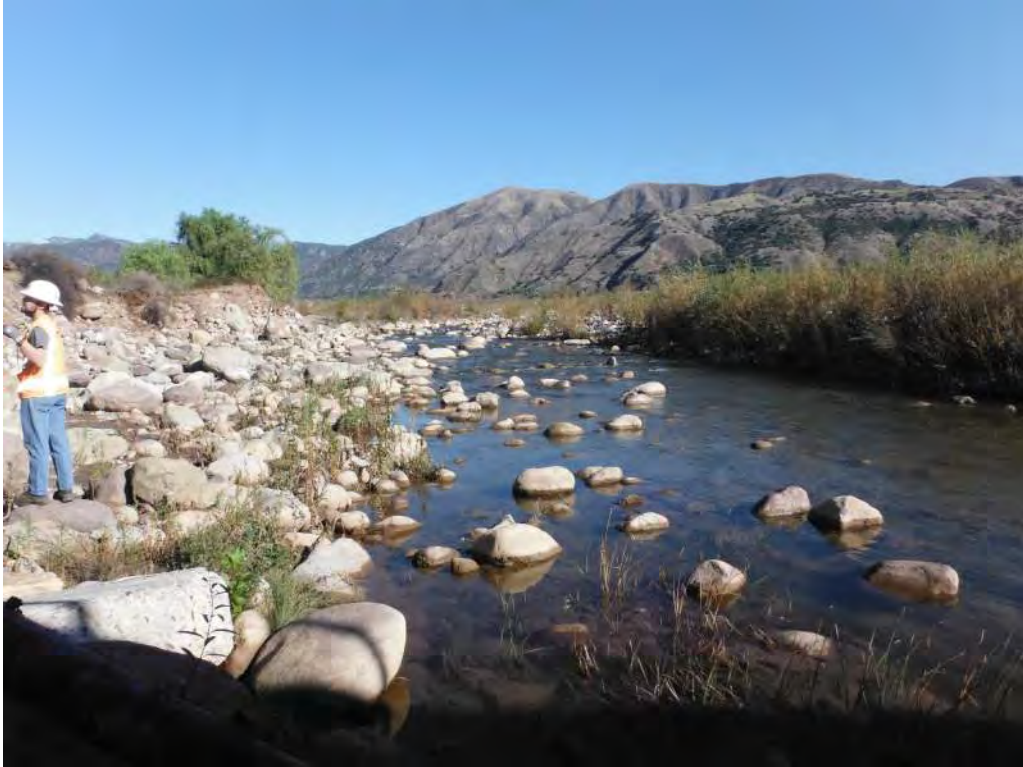
**423.44 Channel condition looking upstream**

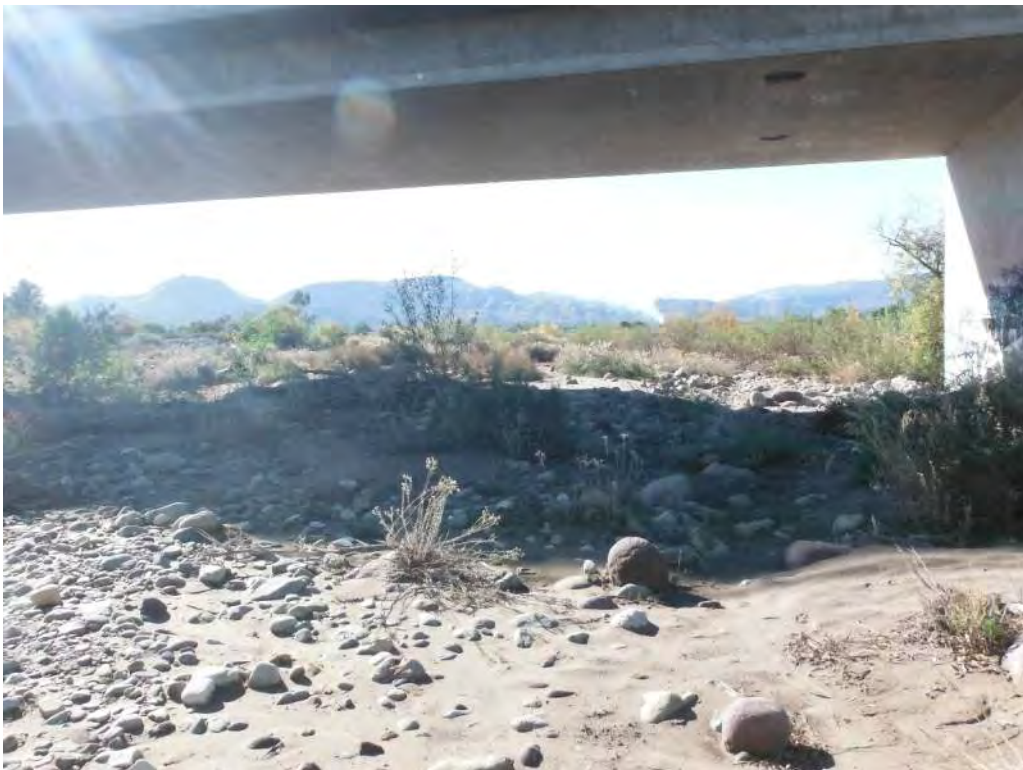
**423.44 Channel condition looking downstream**

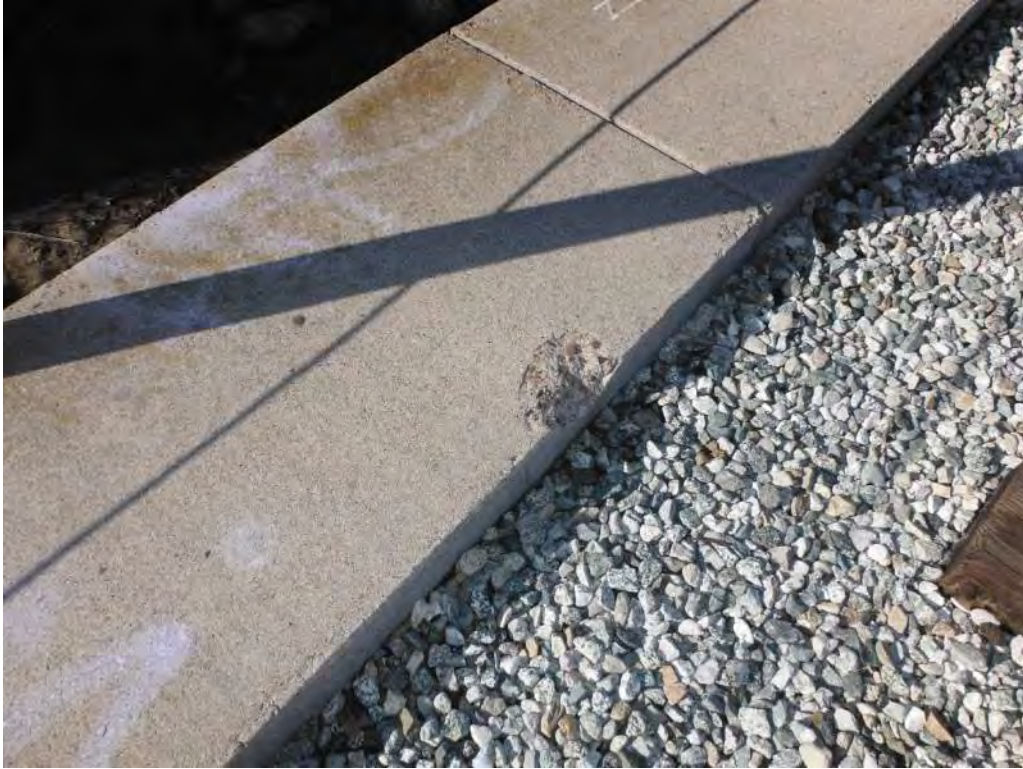
**423.44 Walkway Spall on Span 2 and multiple locations**

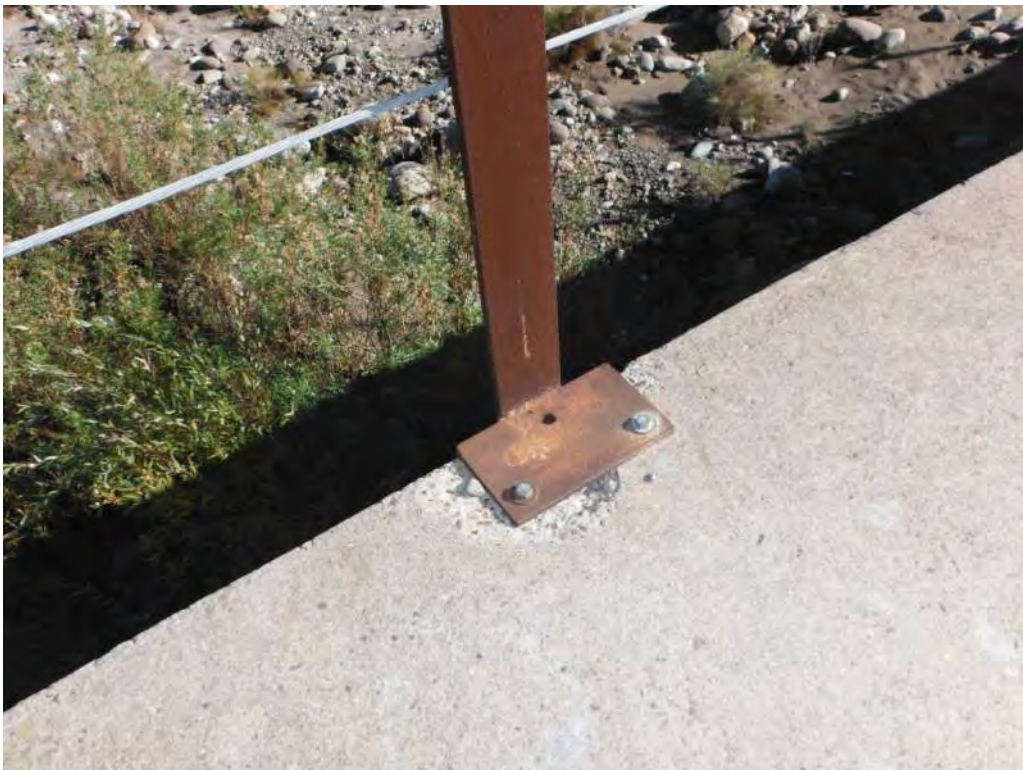
**423.44 Handrail embed failed. Post held with bolts, Span 3 and 4**

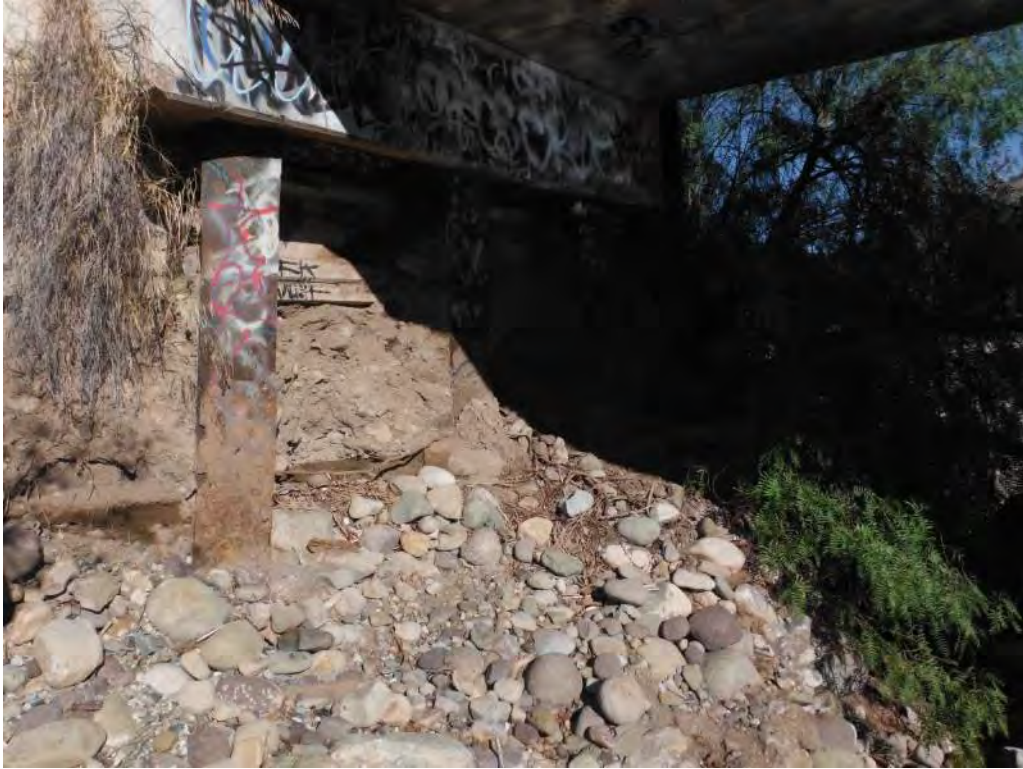
**423.44 Scour - Abutment 1**

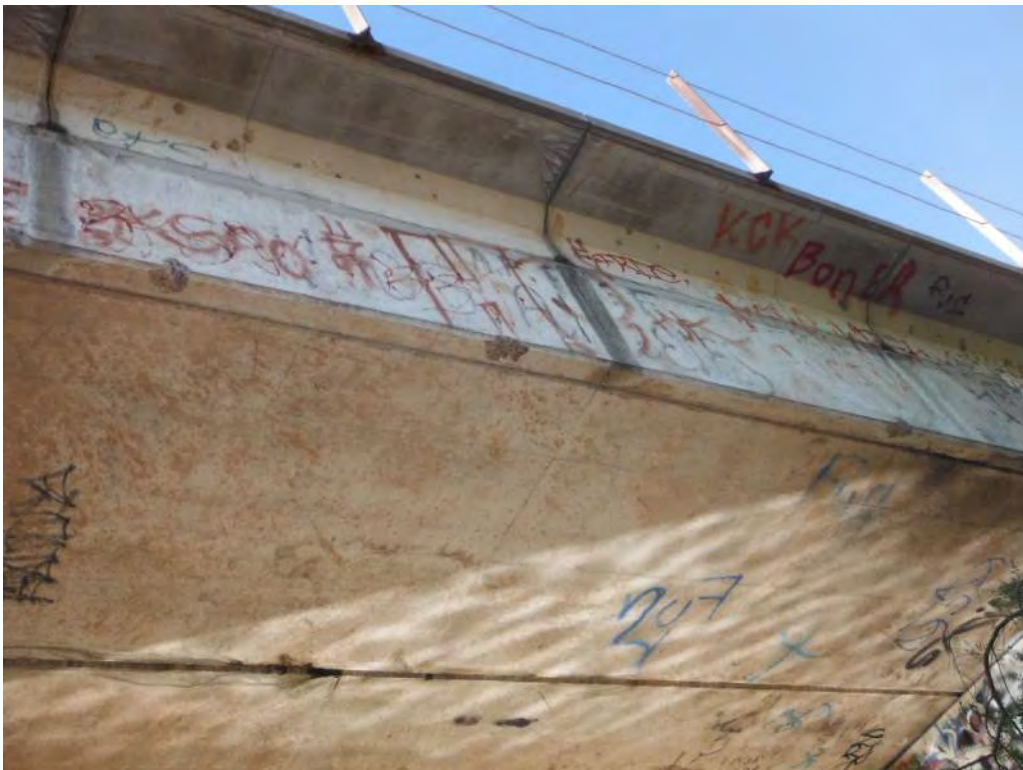
**423.44 Span 1 Impact Damage**

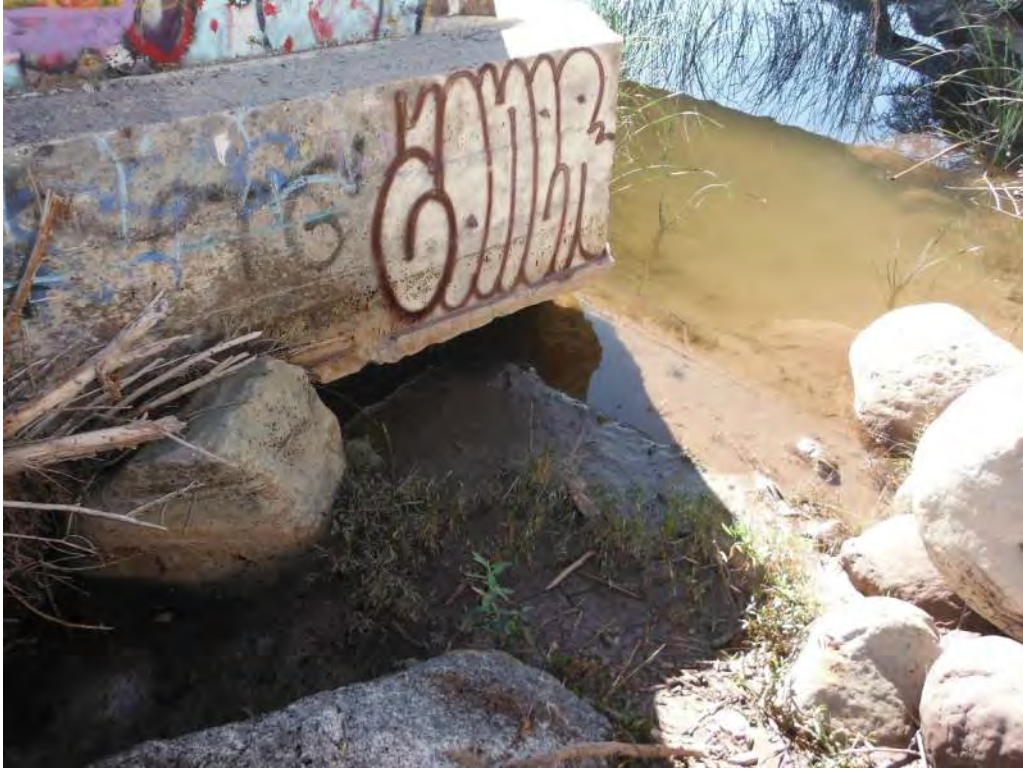
**423.44 2' Scour under cap 2**
