# BRIDGE INSPECTION REPORT

INSPECTION TYPE: Annual

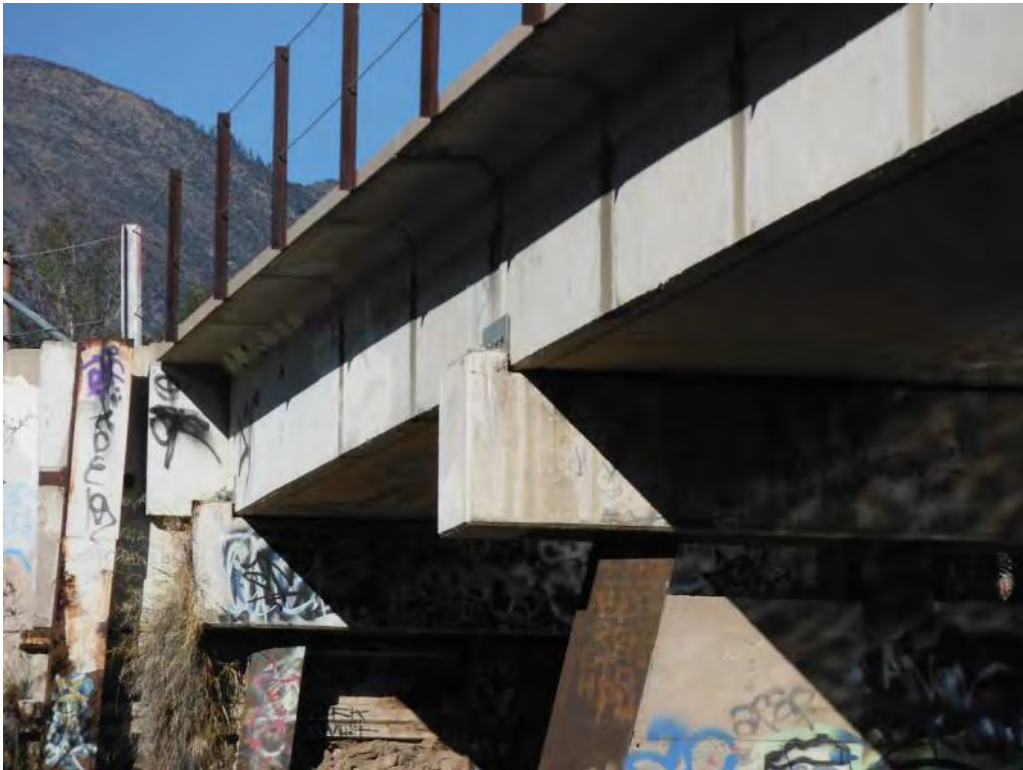
**423.44 Keeper spall on Pier 2**

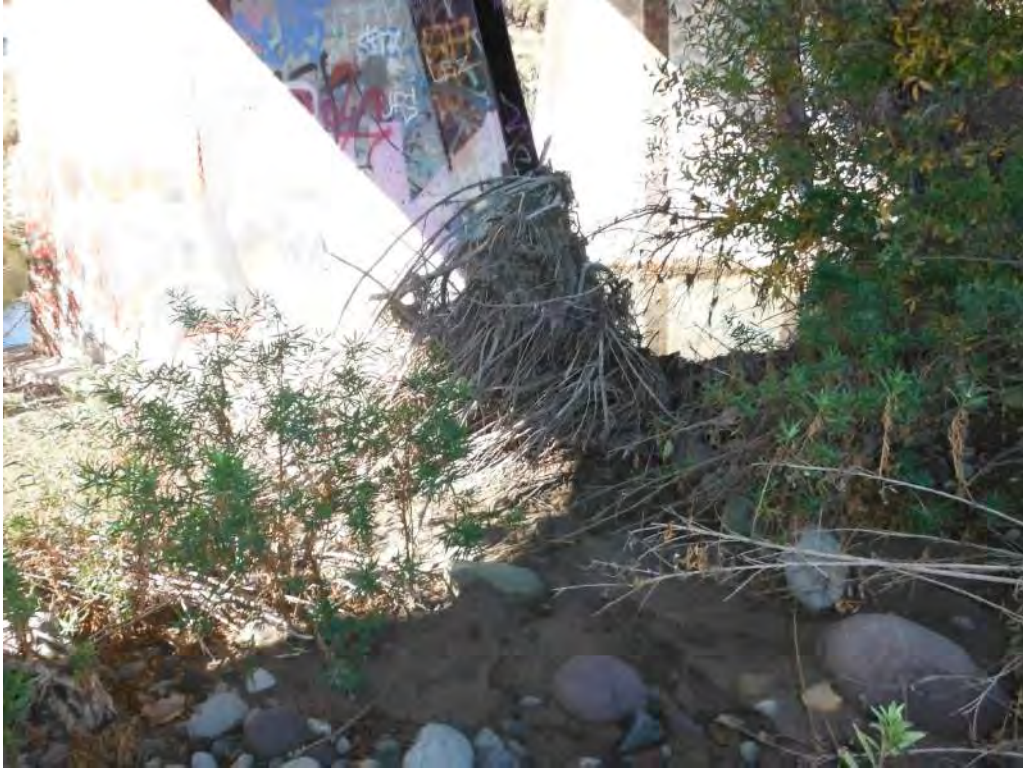
**423.44 Debris Upstream on Pier 4**

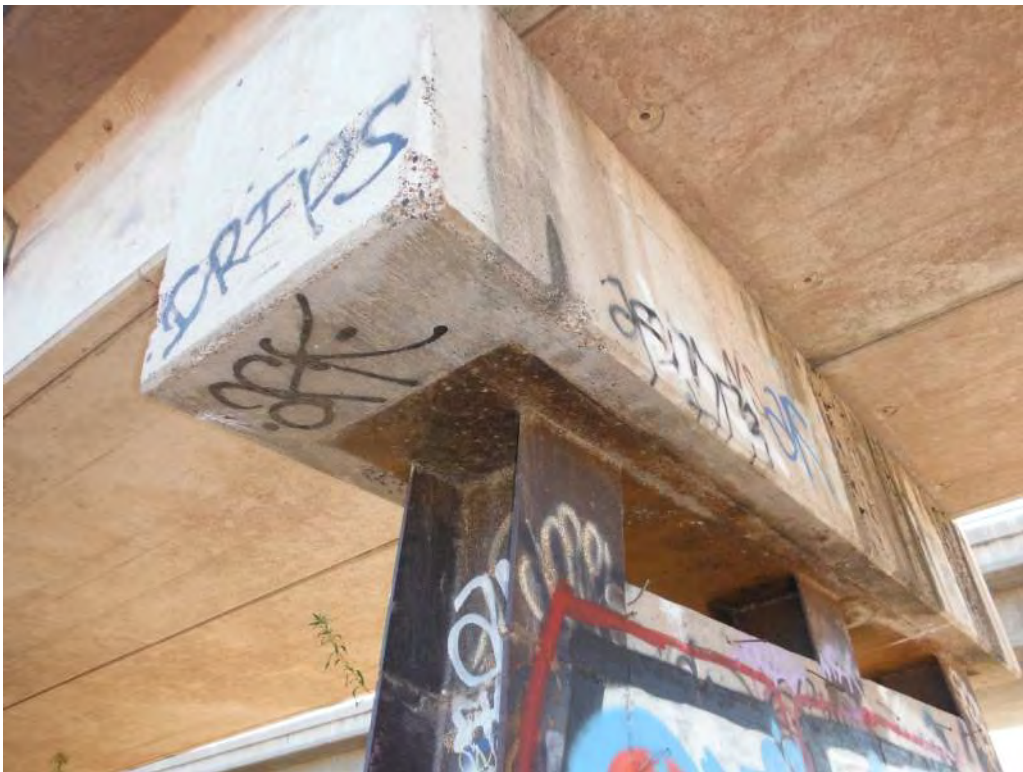
**423.44 Minor spall on bottom corner of pier cap, Pier 5**

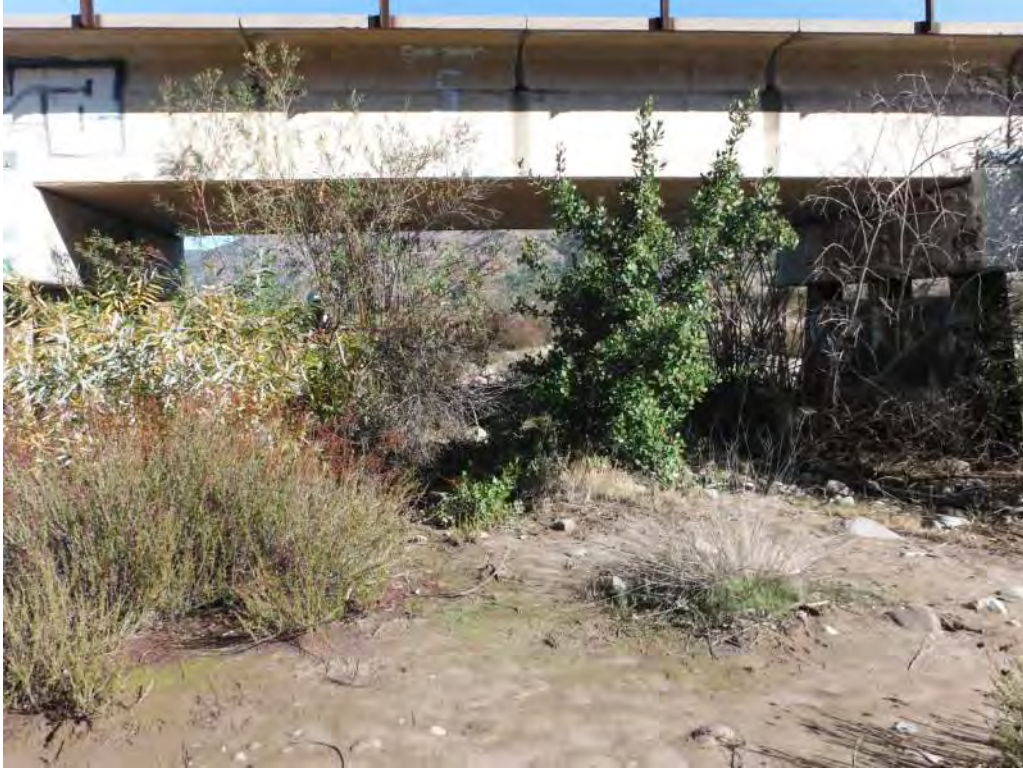
**423.44 Trees under Span 7 and 8 on south side**

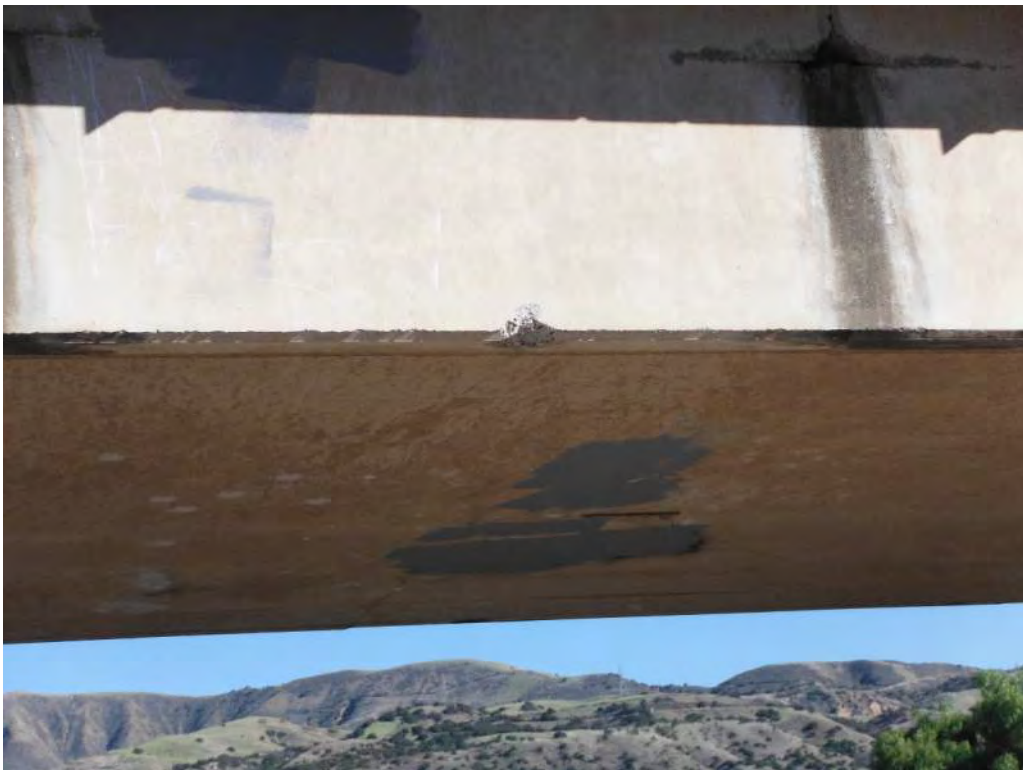
**423.44 Minor spall midspan, Span 11**

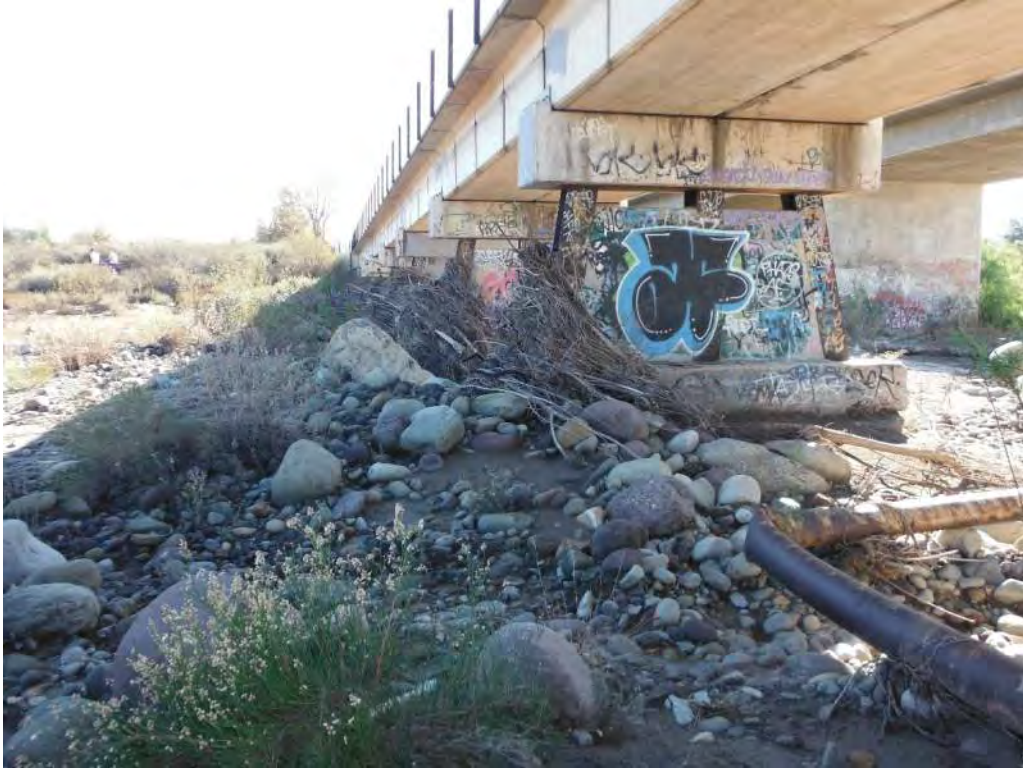
**423.44 Debris – Multiple locations**

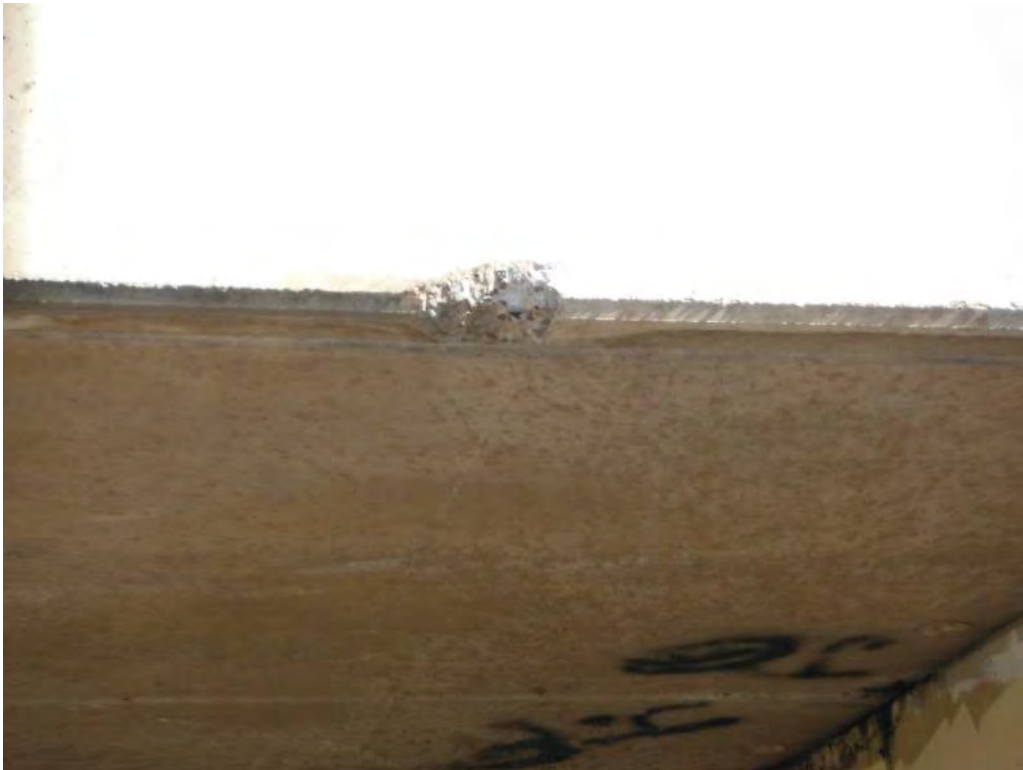
**423.44 Minor spall - south side Span 13**

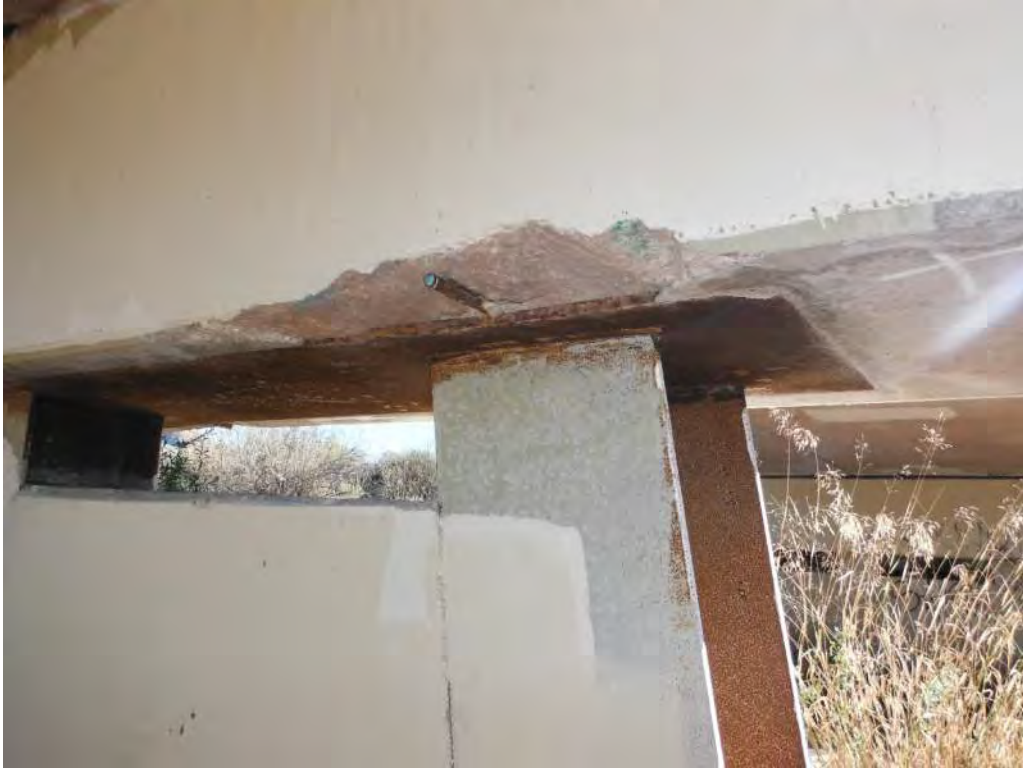
**423.44 Spall along underside of cap with exposed rebar – west side Pier 14**

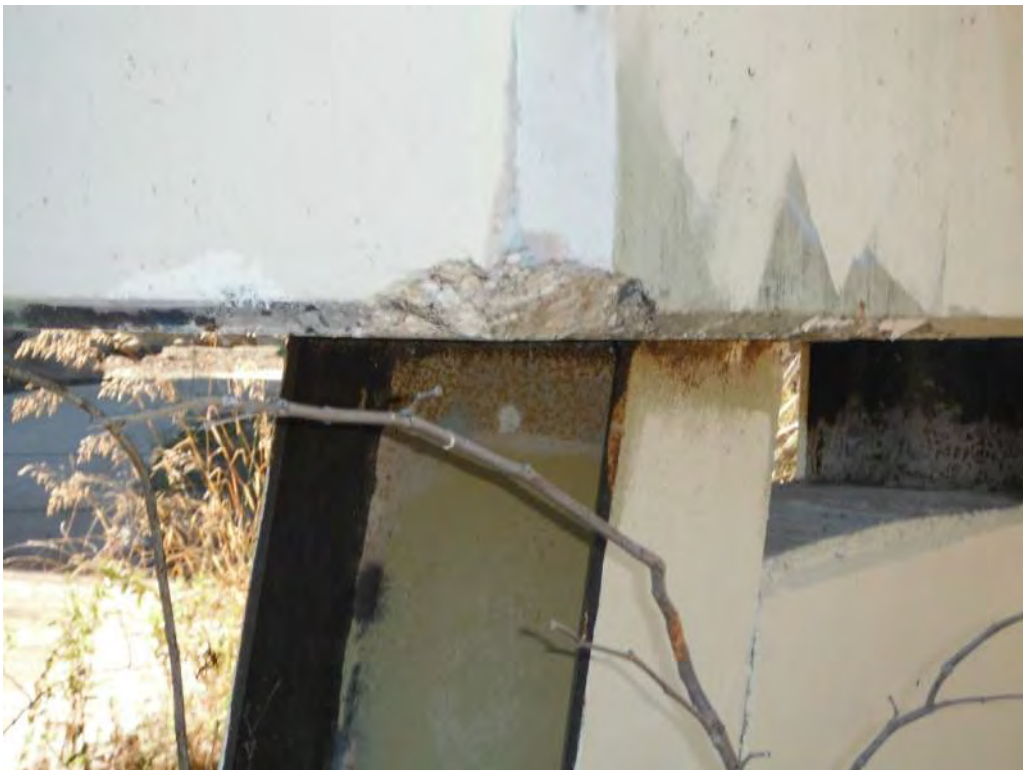
**423.44 Spall NE bottom corner of cap, Pier 14**

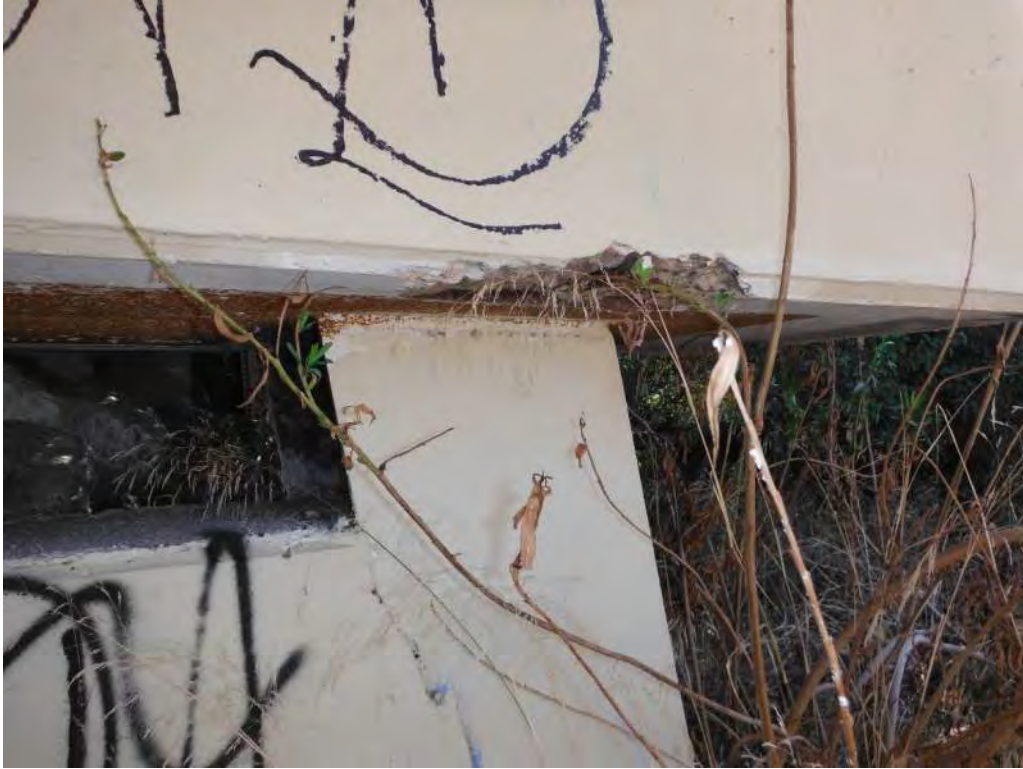
**423.44 Spall with Exposed Rebar – Pier 15 west side**

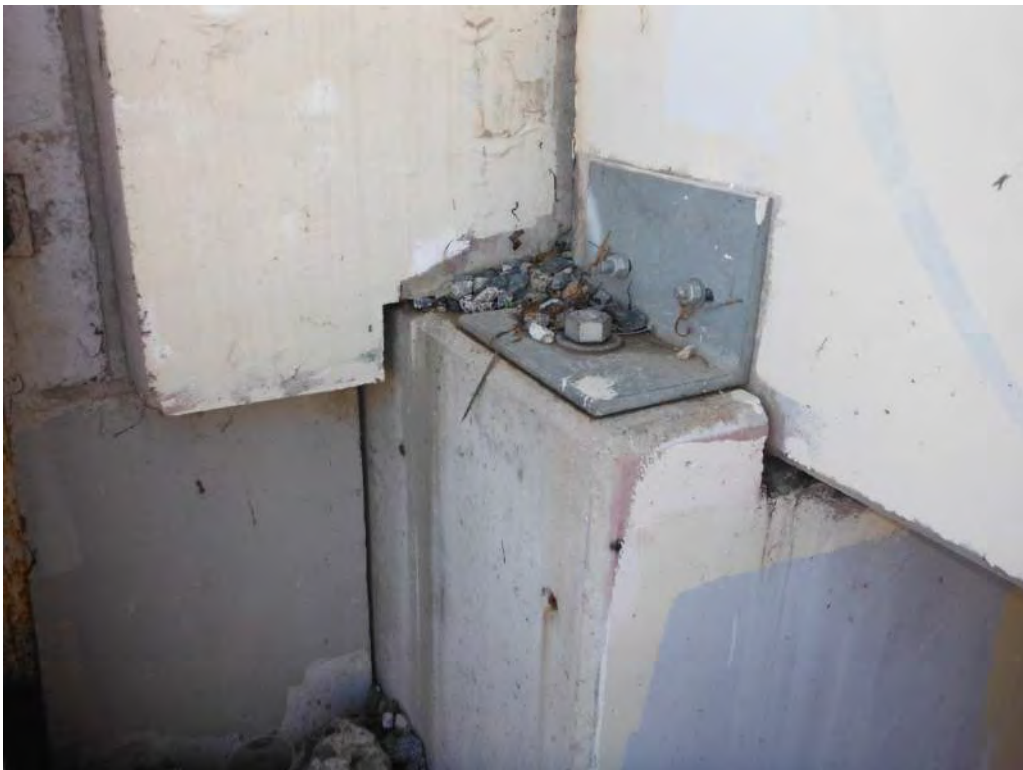
**423.44 Ballast leaking on bearing seats, near Abutment 16**

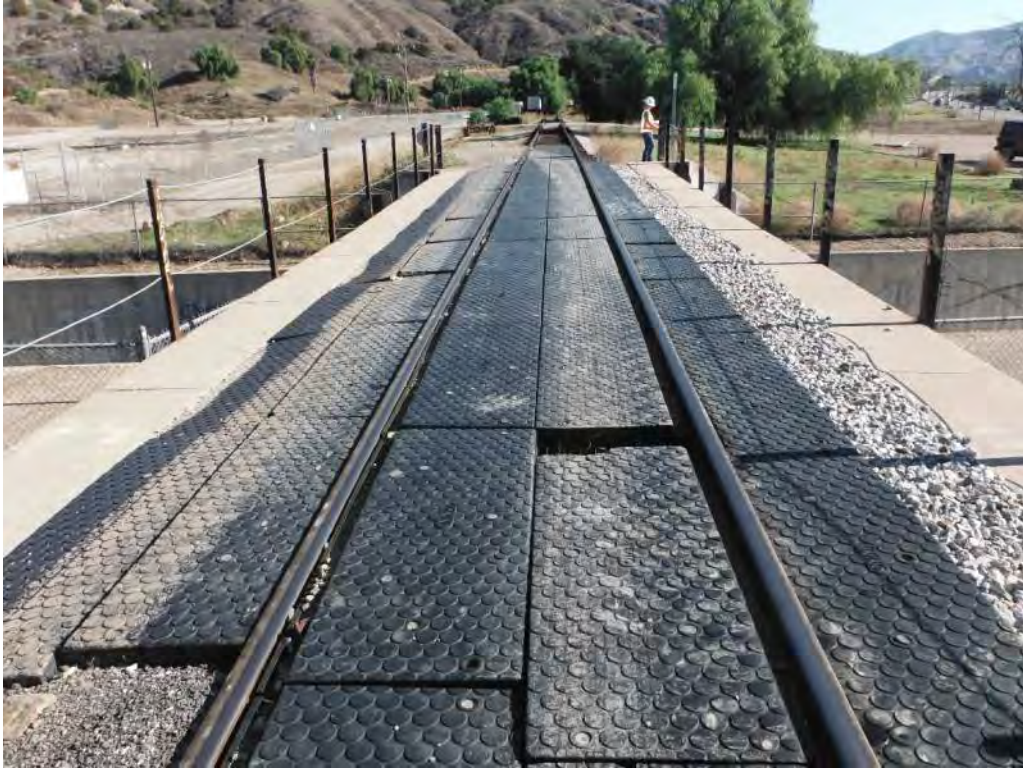
**425.15 Looking East**

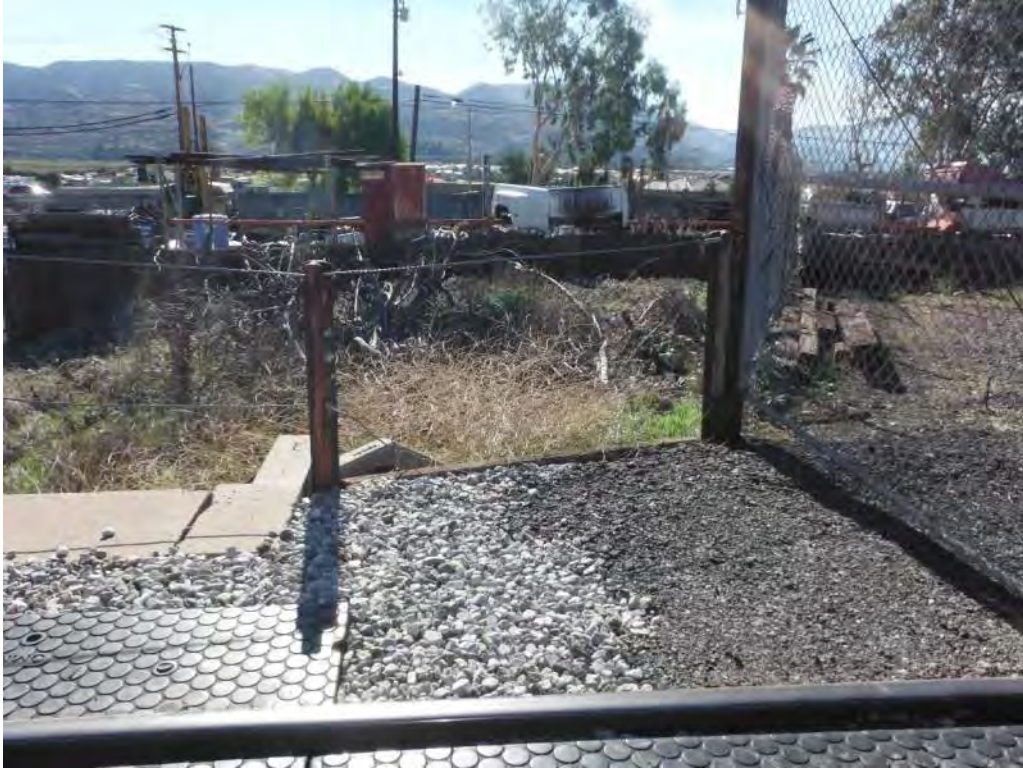
**425.15 Cable broken at southwest corner**

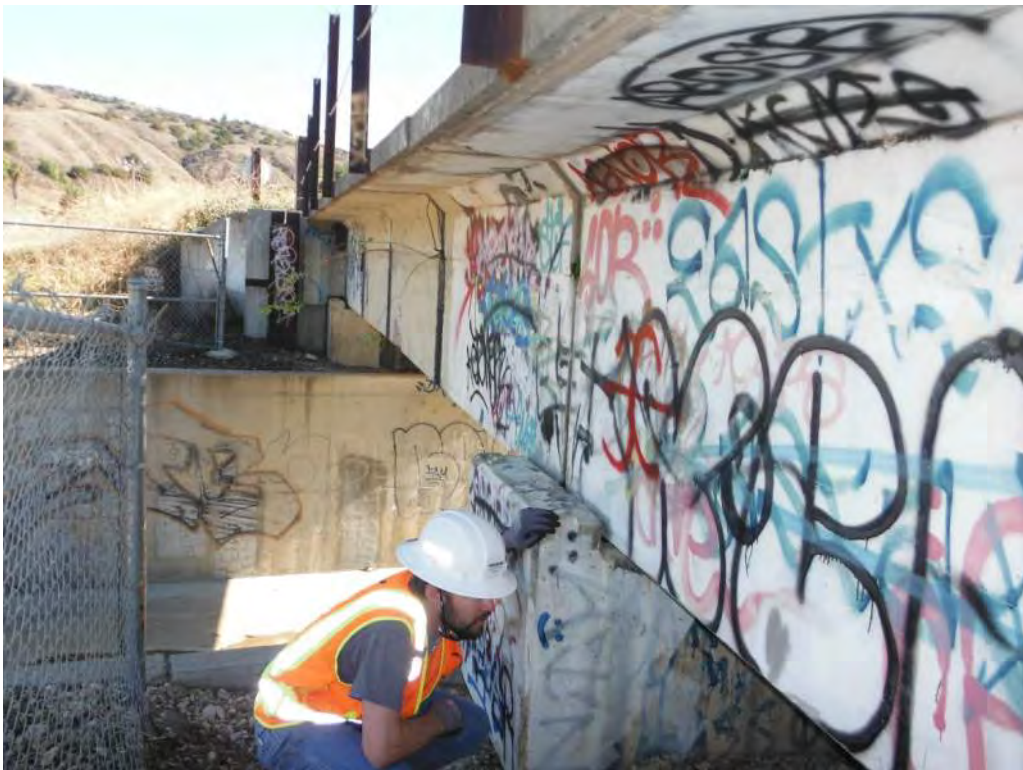
**425.15 Vegetation growing in drain holes**

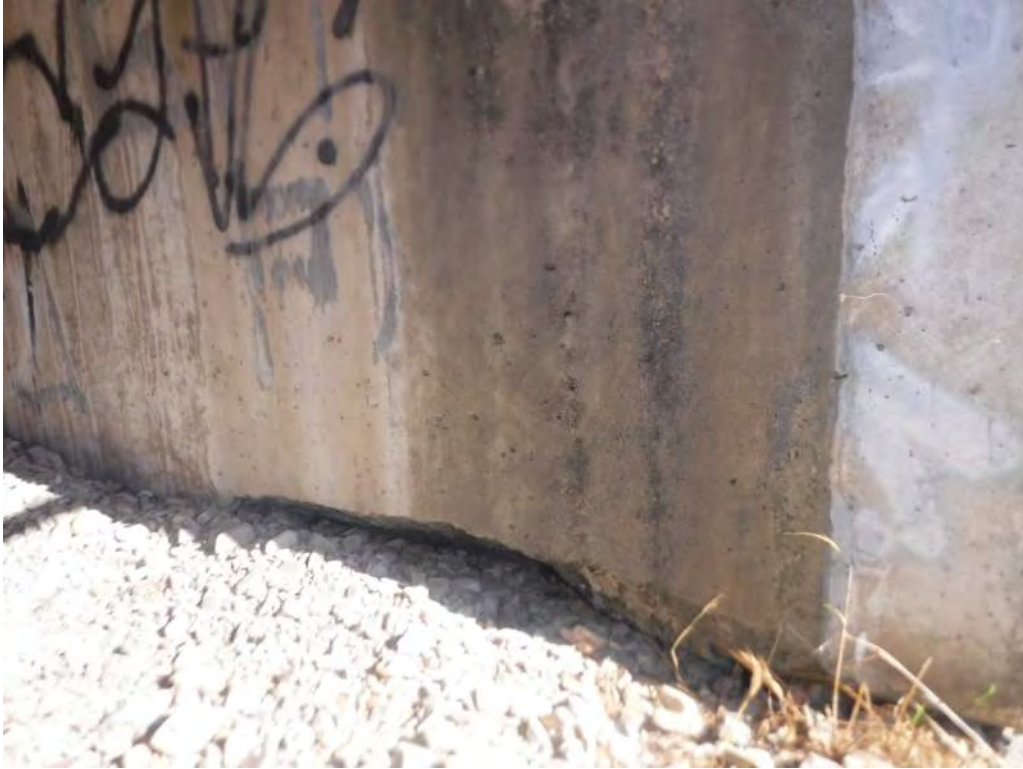
**425.15 Spall - Southwest pier 2**

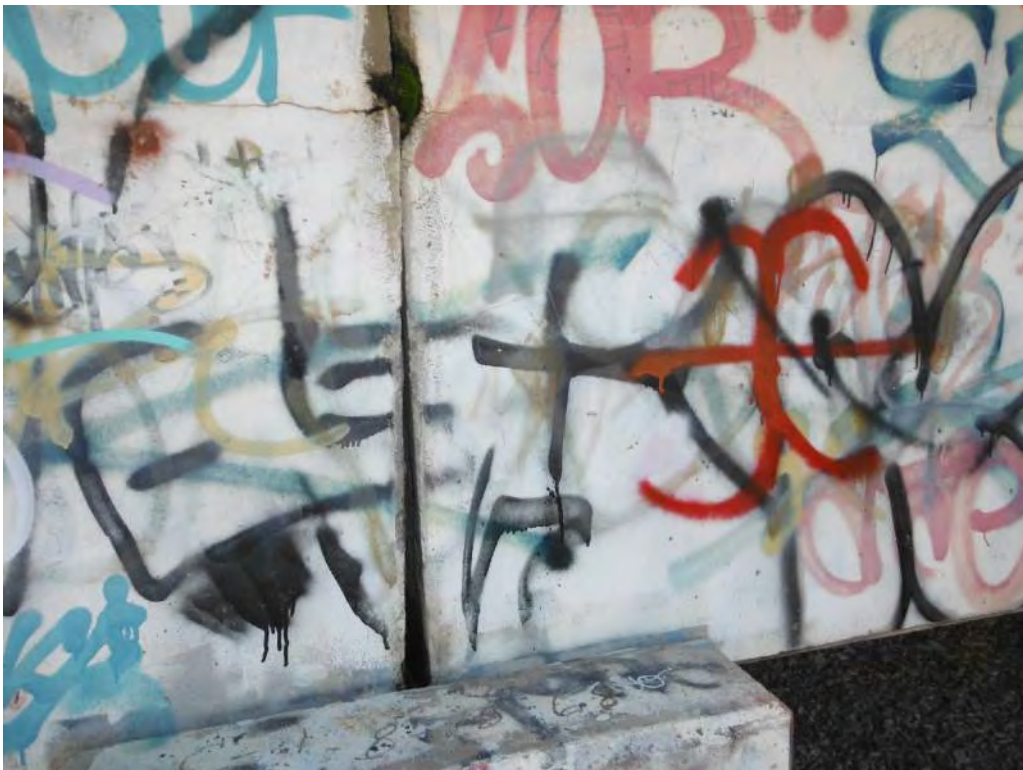
**425.15 No gap between girders - Pier 2**

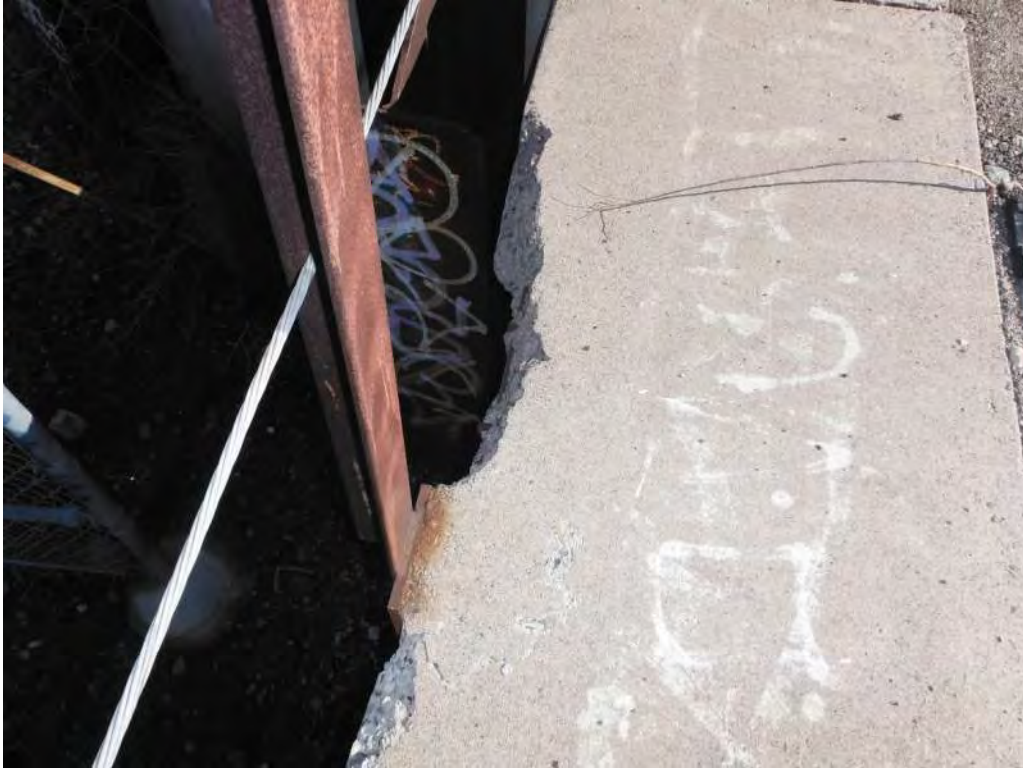
**425.15 Spall with exposed rebar - Span 2 north side**

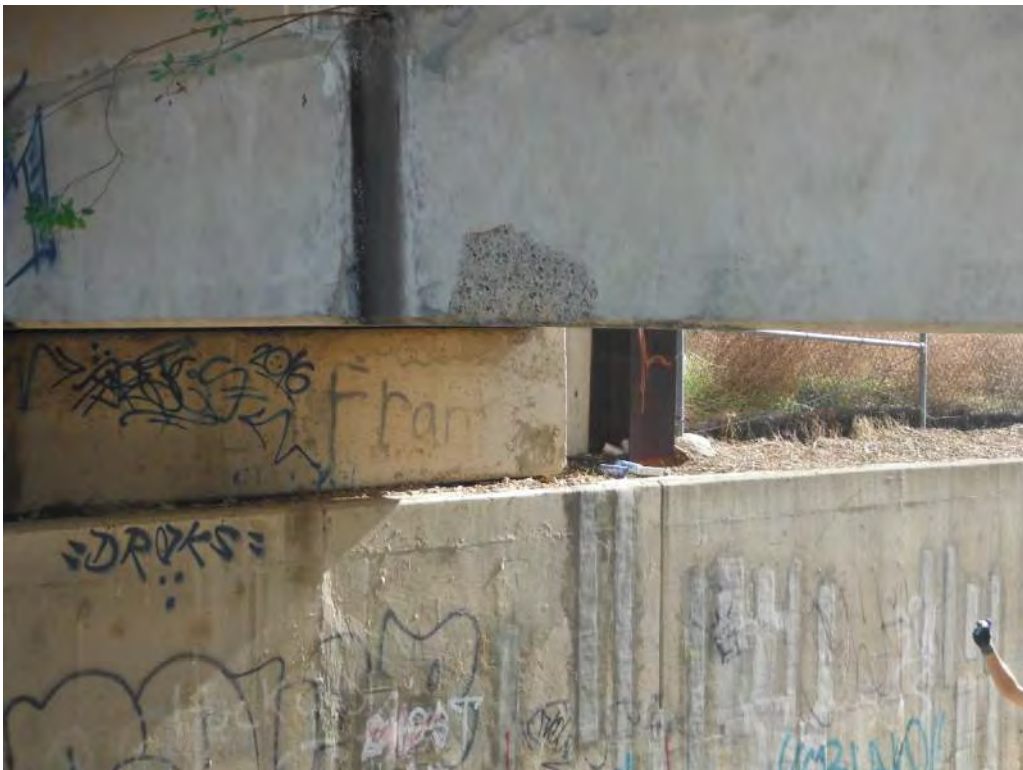
**425.15 Spall at midspan - Span 2 north side**

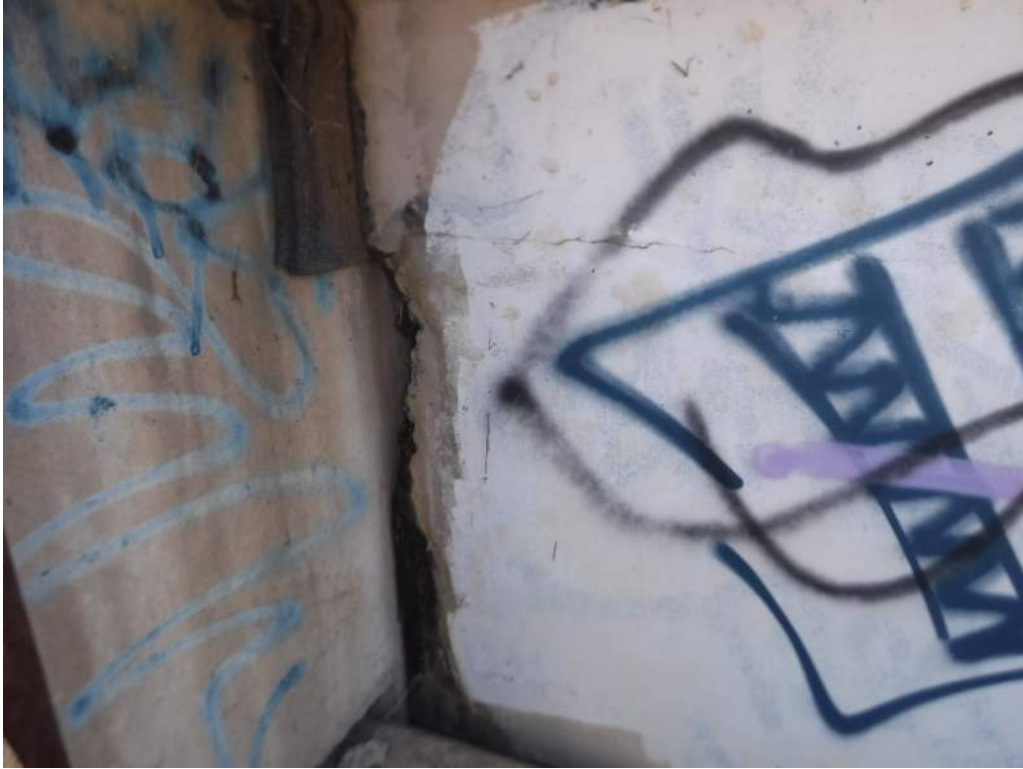
**425.15 Crack and spall in girder near Abutment 3 north side**

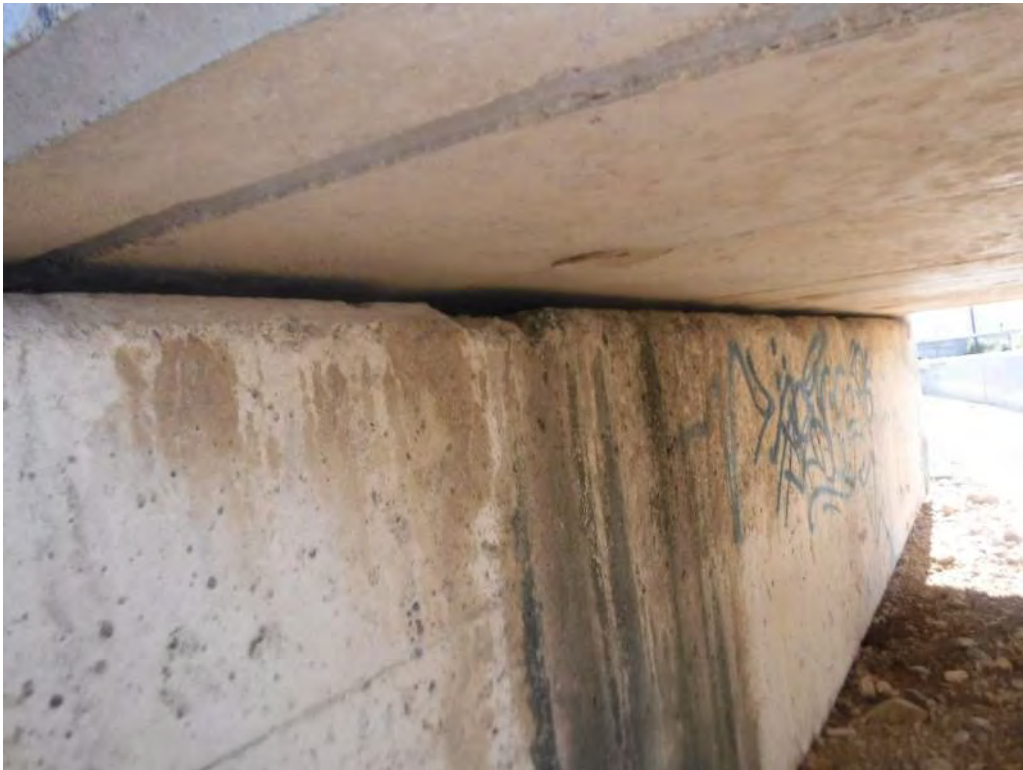
**425.15 Abutment 3 Cap Spall**

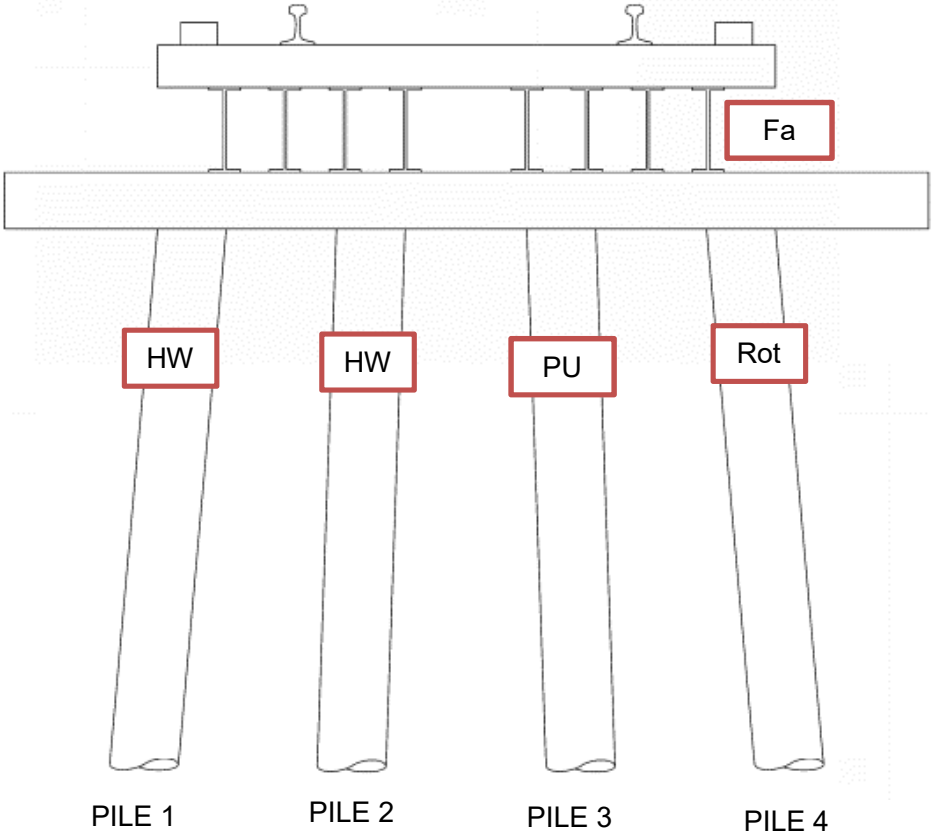
<div style="display: flex; justify-content: space-around; margin-top: 10px;"> <span>PILE 1</span> <span>PILE 2</span> <span>PILE 3</span> <span>PILE 4</span> </div>			
<b>Description: Looking East - (8) Steel Stringers, Abutment #2 is timber</b>			
<b>Remarks:</b>

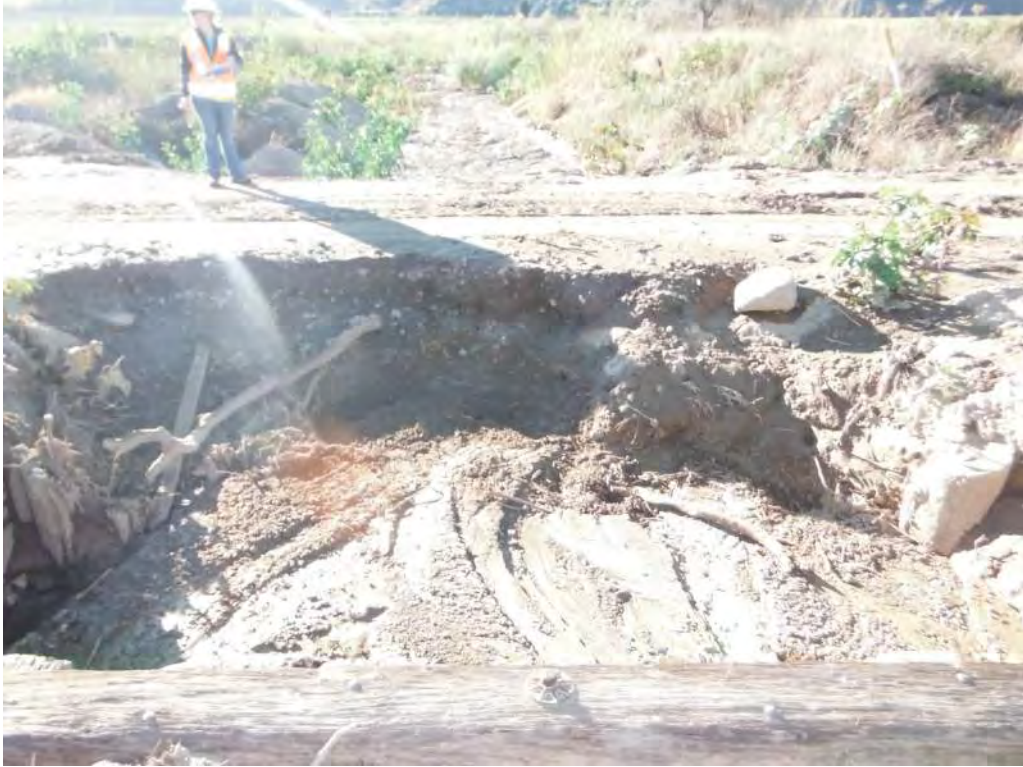
**427.64 Downstream channel condition**

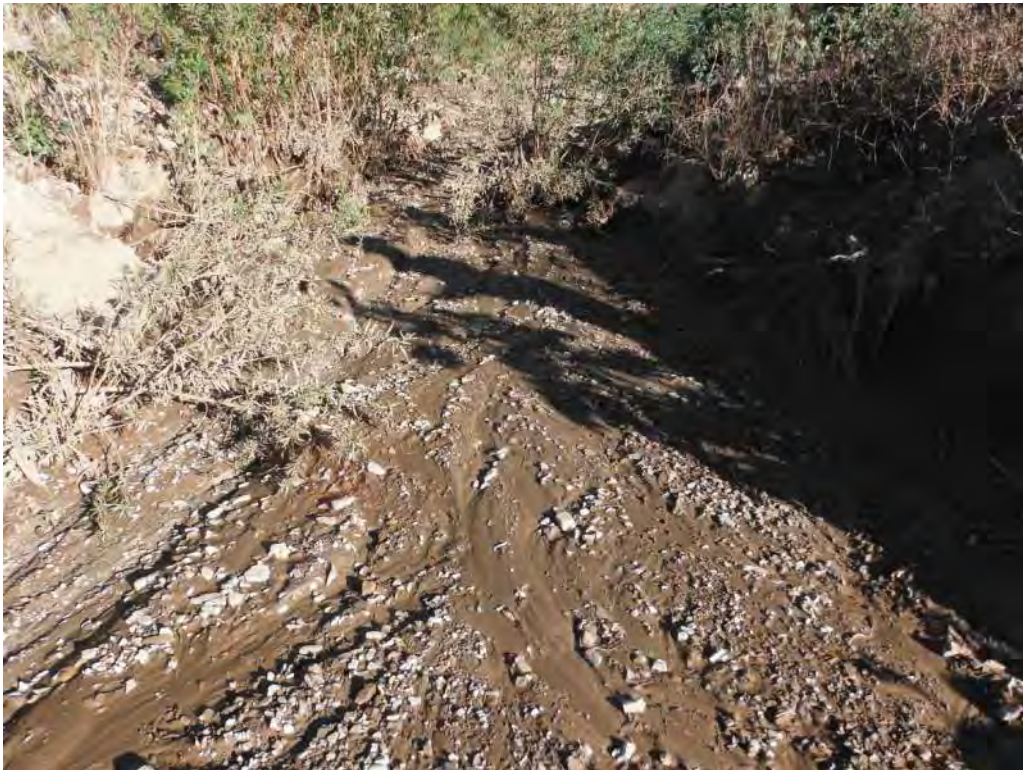
**427.64 Upstream channel condition**

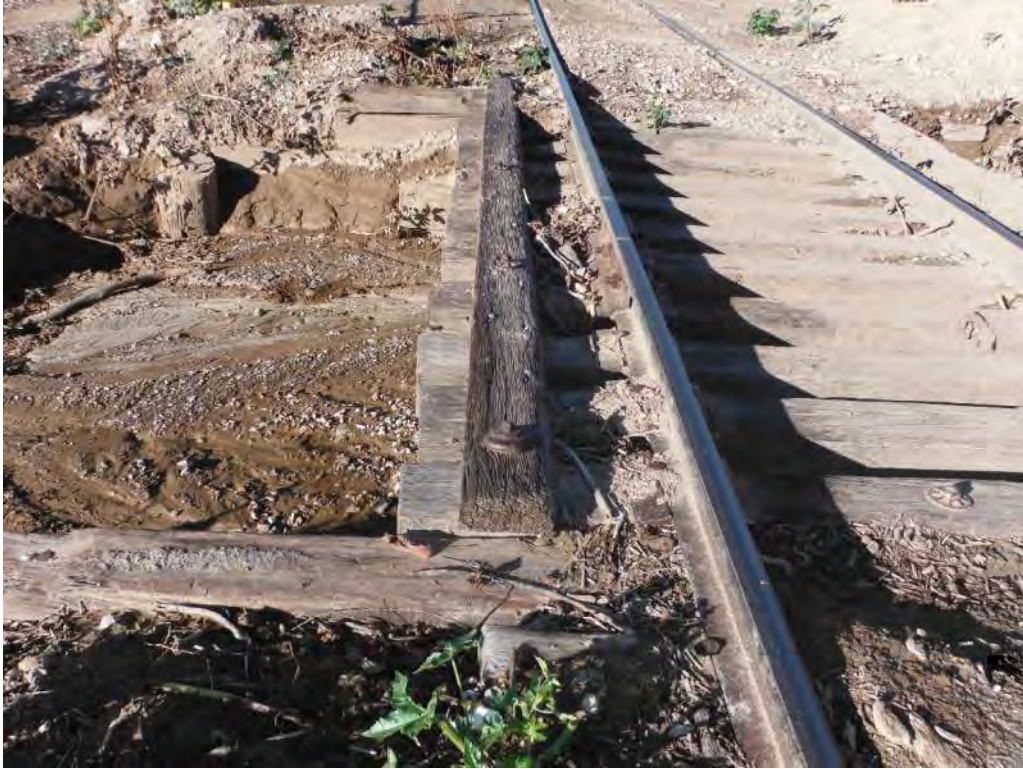
**427.64 Hole in ballast behind Abutment 2**

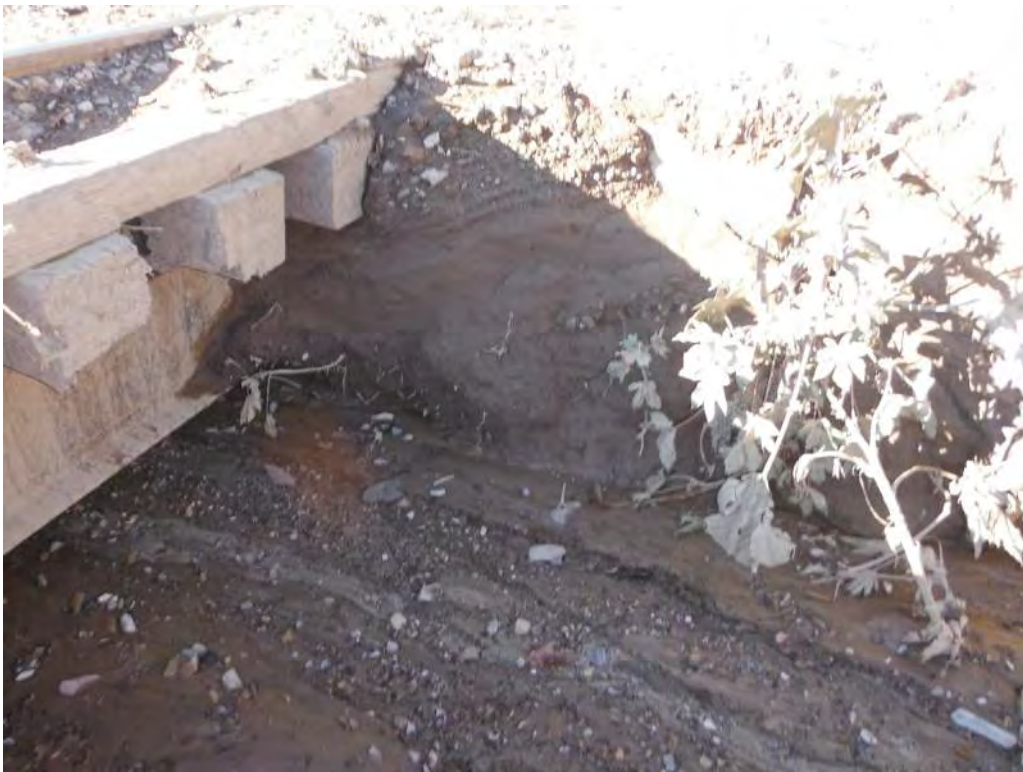
**427.64 Backwall rotting – top timber of backwall failing, Abutment 1**

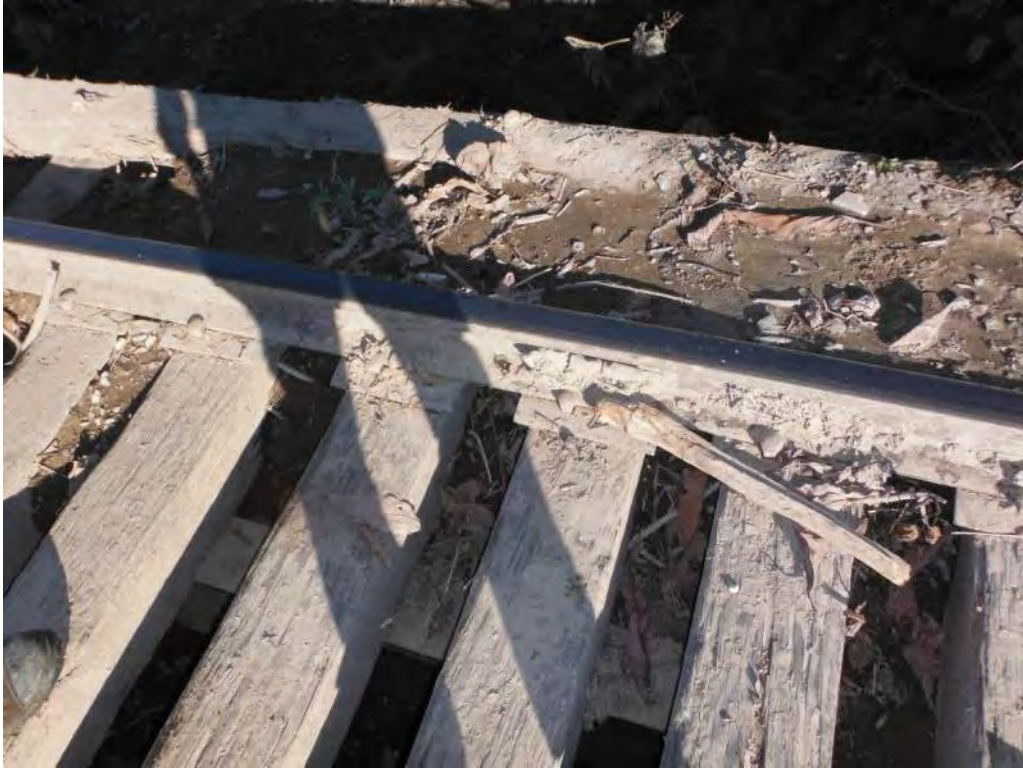
**427.64 Debris covering stringers**

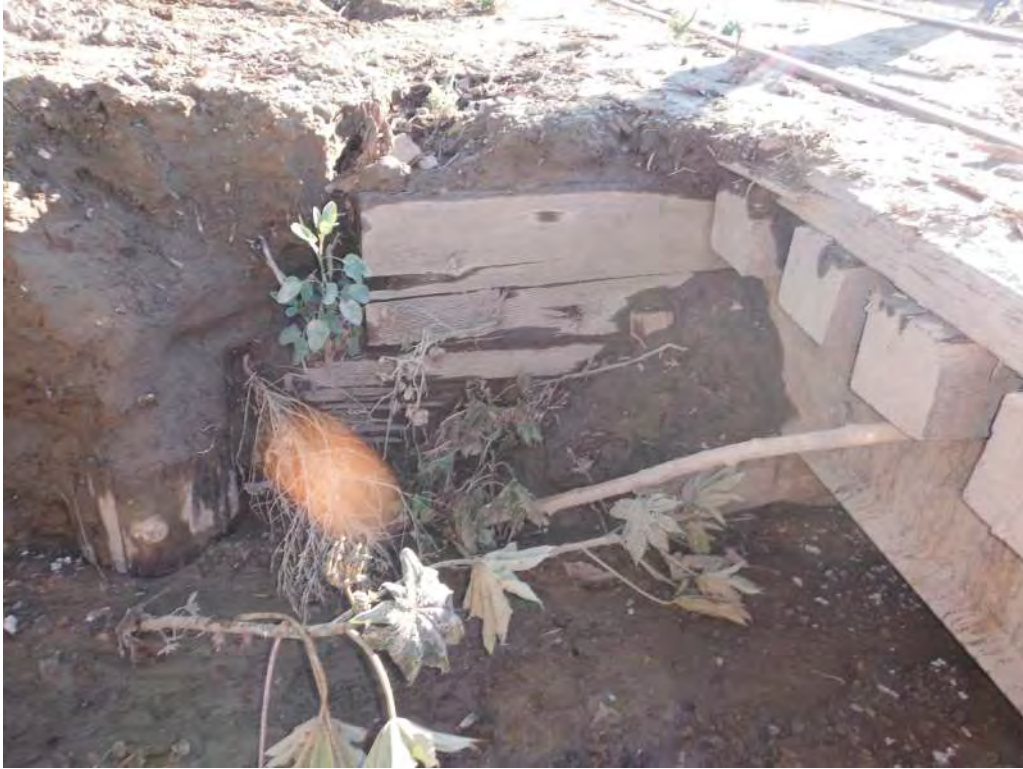
**427.64 Backwall failing – Abutment 2**

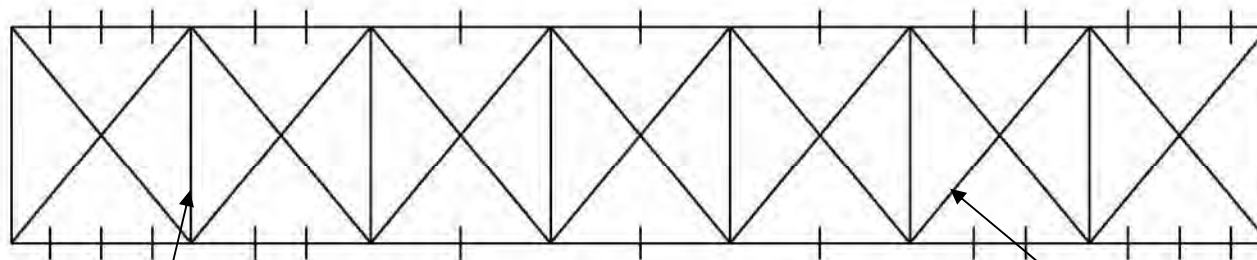
1. Cr - Abutment has minor cracking
2. SP - Spall on abutment - see photo
3. Deb - Damage due to high water debris - see photo
4. AB - Loose anchor bolt, stringer 1 and 2 - see photo
5. Sandy silt buildup on bottom flanges of floor beams

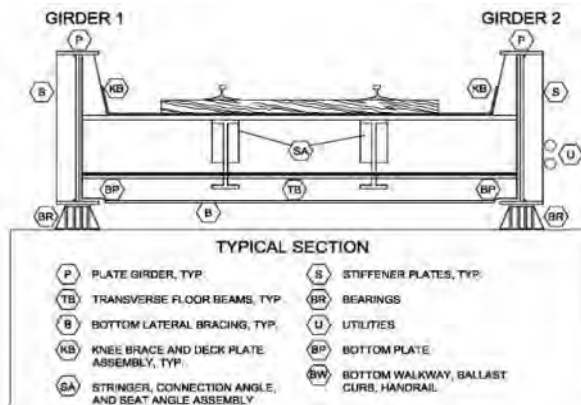
DIVISION	Santa Paula	SPAN LENGTH	70'-0"	NUMBER OF TRACKS	1
CROSSING	Hopper Creek	TRACK ALIGNMENT	Tangent	SPAN No.	1
INSPECTION FINDINGS					
	ALL BEARING AREAS REQUIRE CLEANNING				
	North G1 stiffeners have minor impact				
	Impact damage to bottom flange floor beam 1 - see photo				
	Impact damage to bay 5 cross bracing

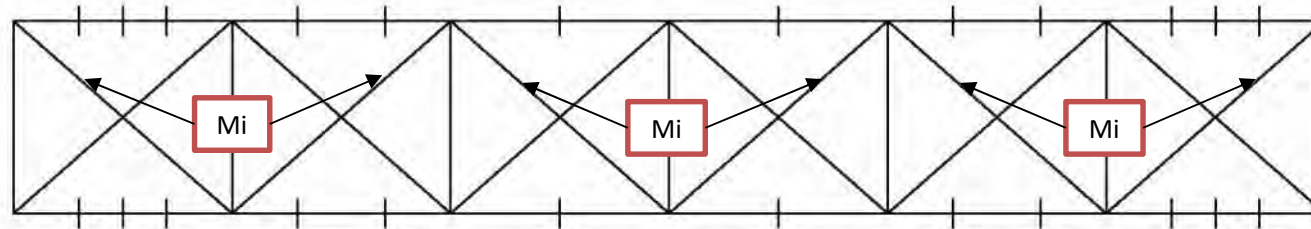
Inspected By:	Joseph Holste, PE	Date Inspected:	12/13/2019
---------------	-------------------	-----------------	------------

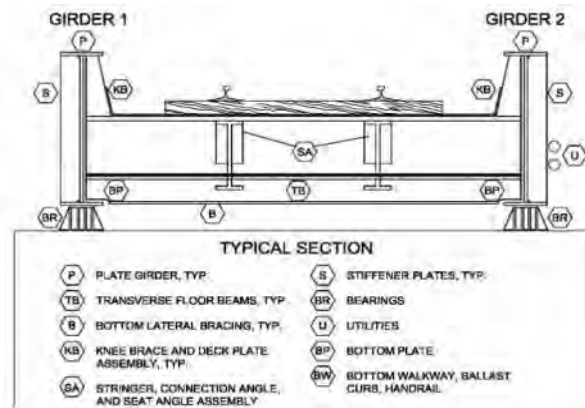
DIVISION	Santa Paula	SPAN LENGTH	82'-0"	NUMBER OF TRACKS	1
CROSSING	Hopper Creek	TRACK ALIGNMENT	Tangent	SPAN No.	2
INSPECTION FINDINGS					
Mi	Lower cross bracing has minor impact throughout - see photo				
	Impact damage to bay 1 crossbracing
