# BRIDGE INSPECTION REPORT

INSPECTION TYPE: Annual

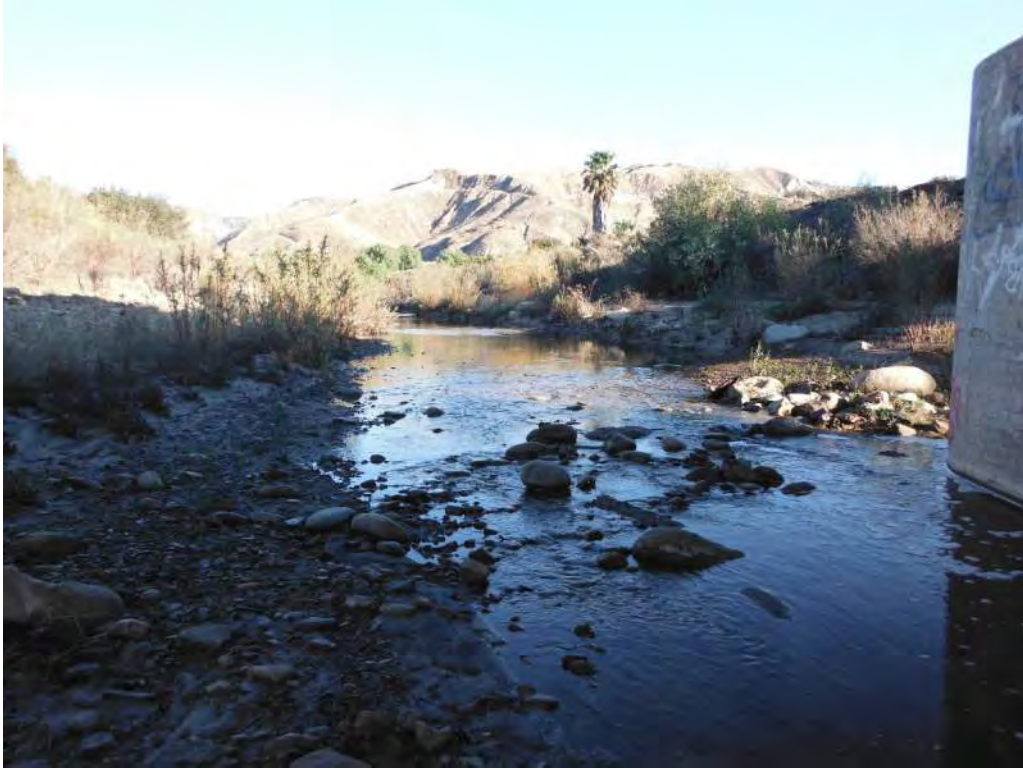
**429.79 Channel Condition – Looking Upstream**

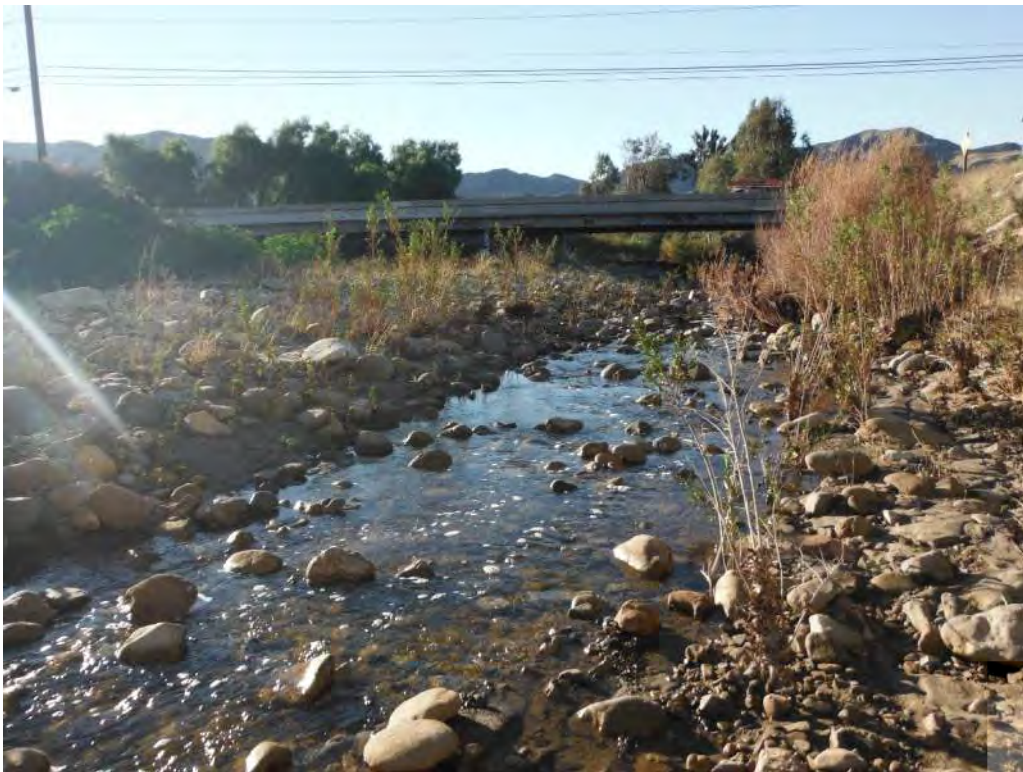
**429.79 Channel Condition – Looking Downstream**

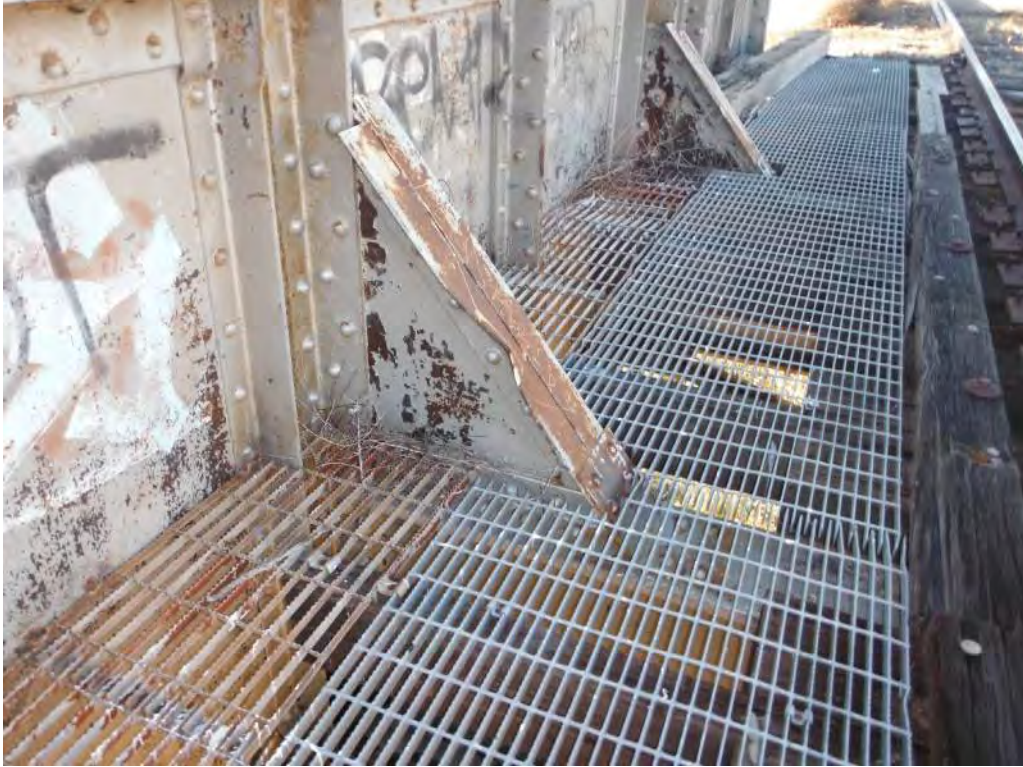
**429.79 Minor impact damage on knee braces**

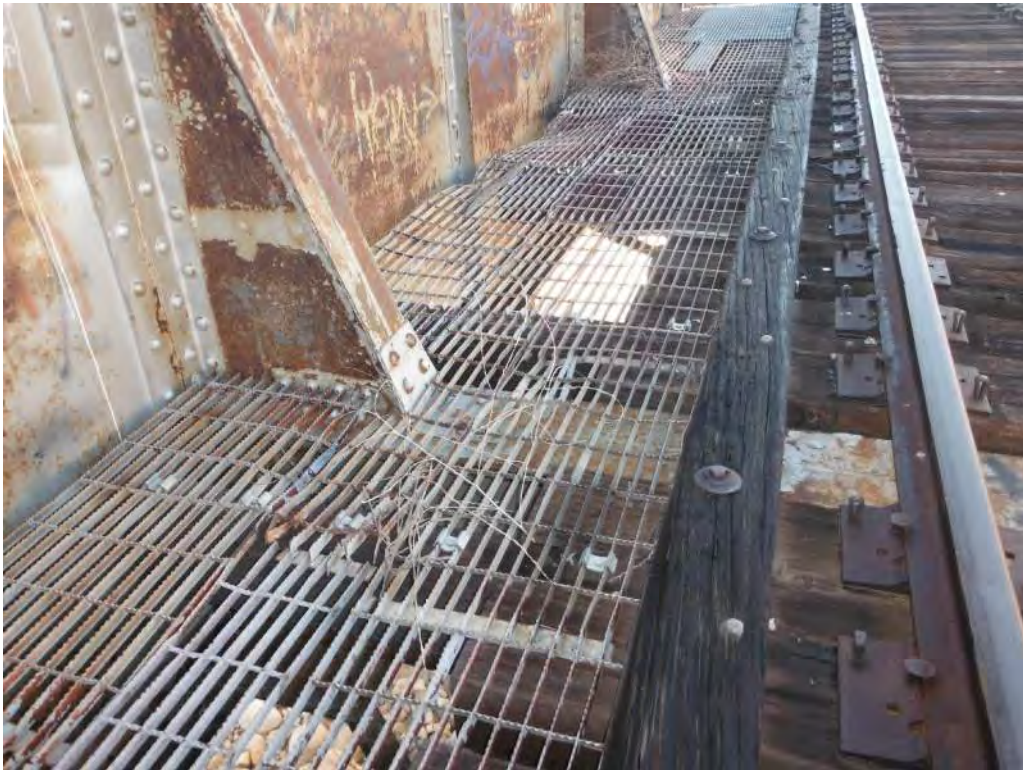
**429.79 South walkway damaged near Pier 2**

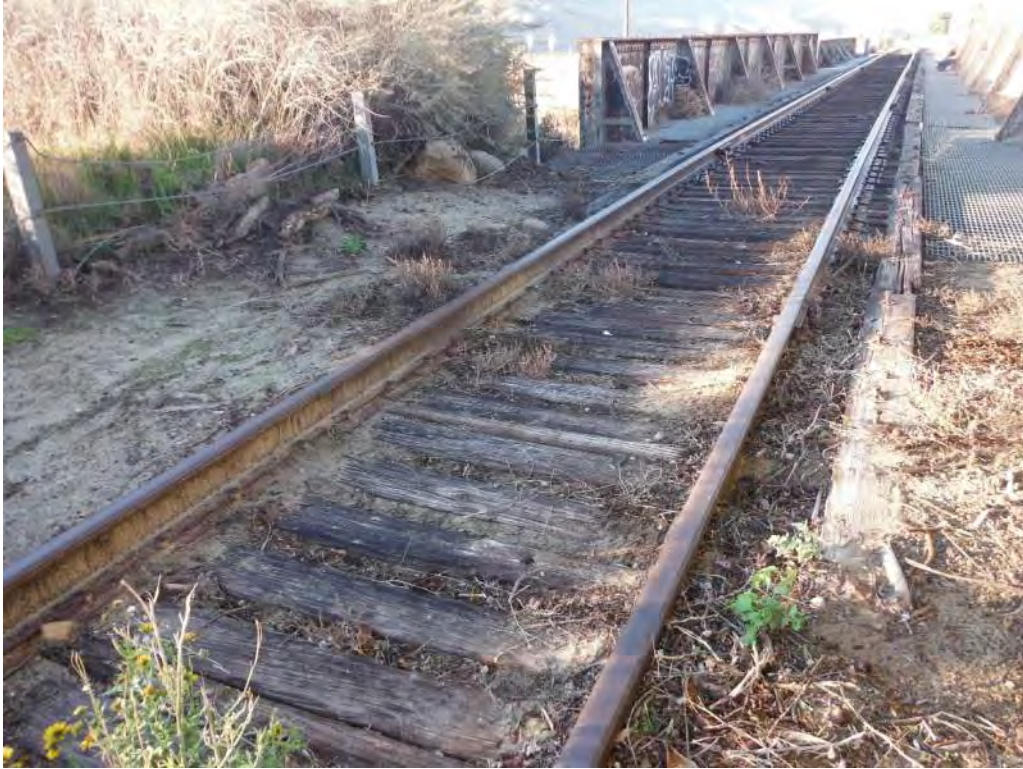
**429.79 Timber approach spans fully silted in**

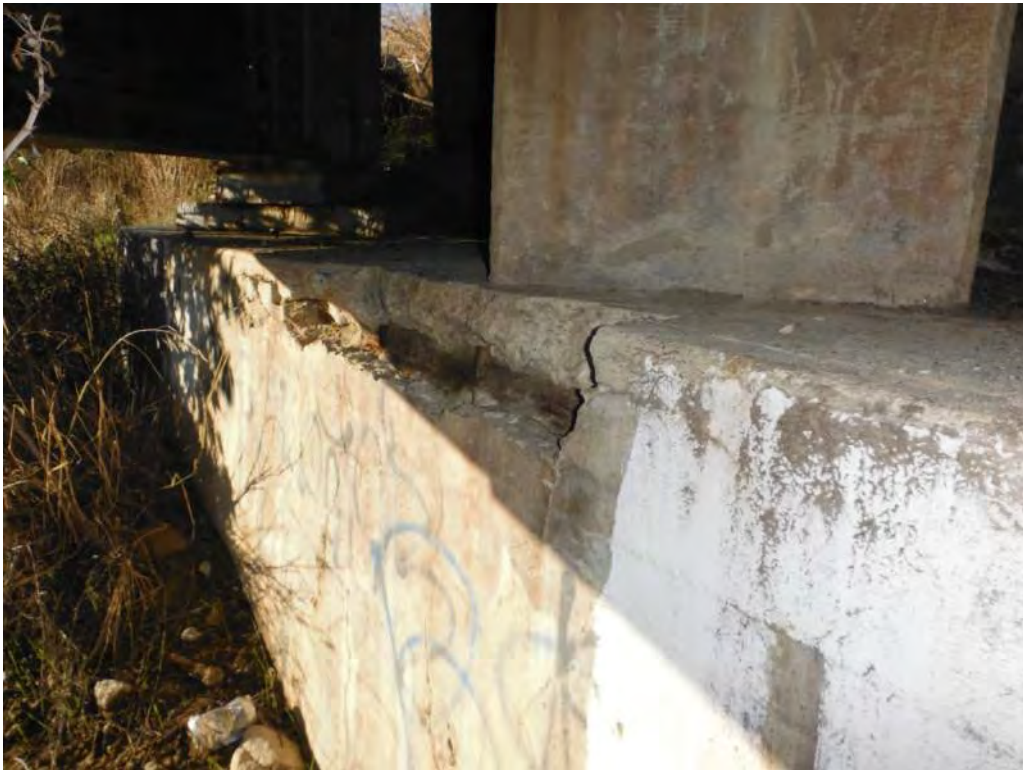
**429.79 Spall - Abutment 1**

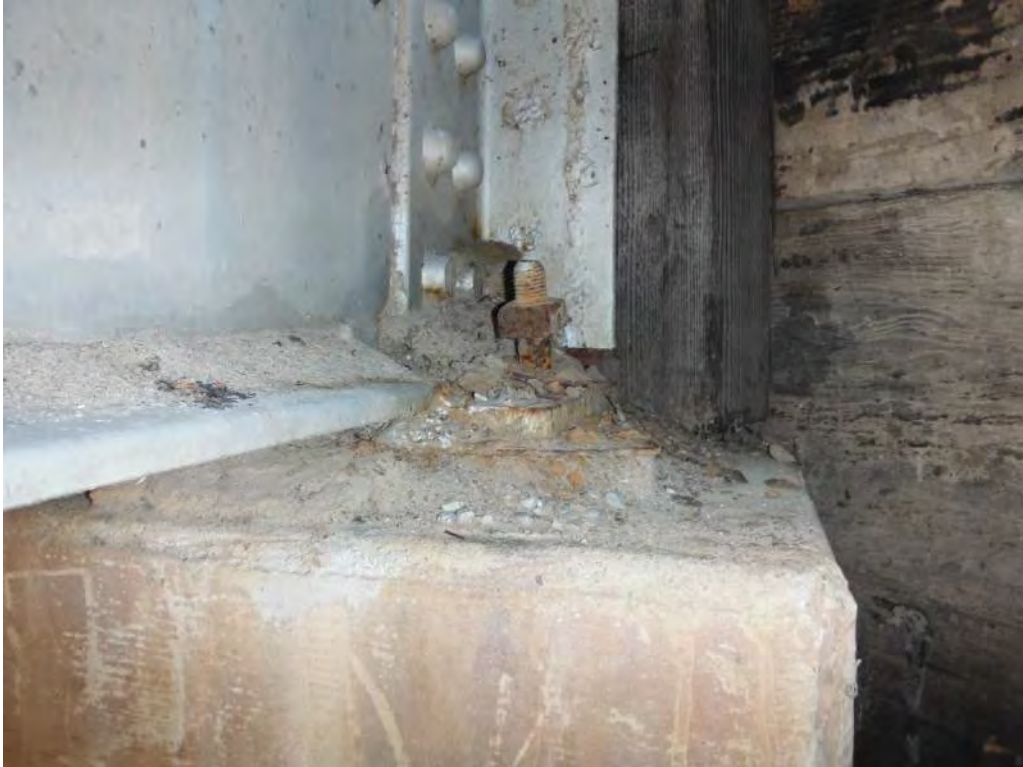
**429.79 Loose anchor bolt – Stringer 1 & 2, Abutment 1**

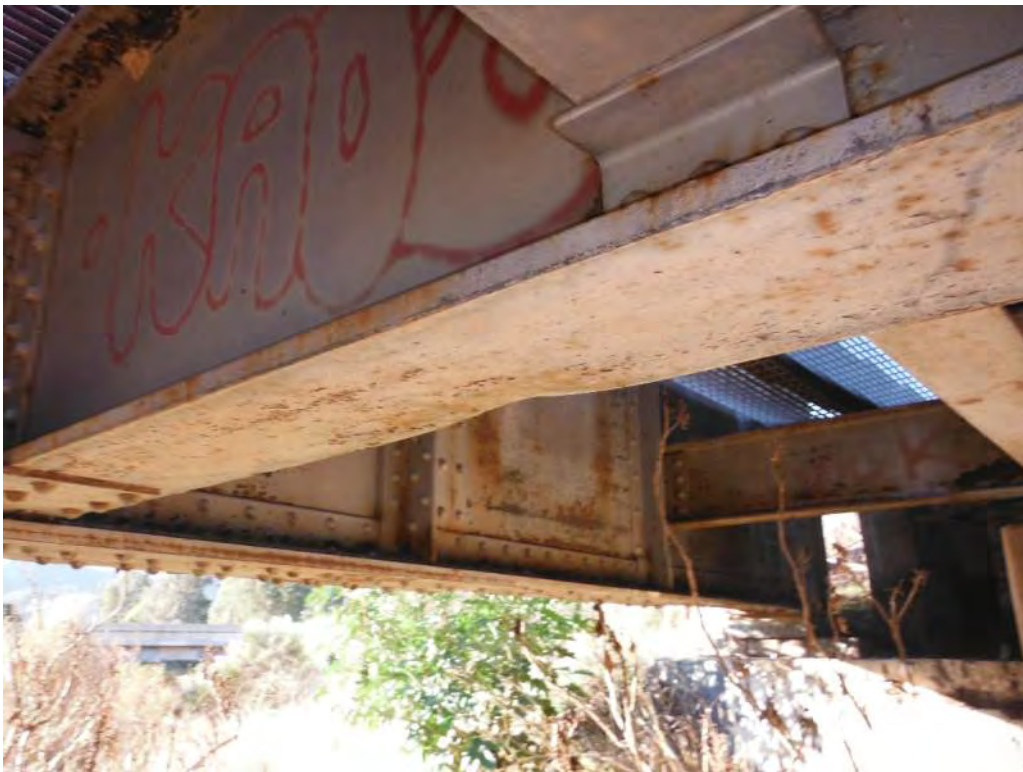
**429.79 Impact damage to bottom flange floor beam 1 – Span 1**

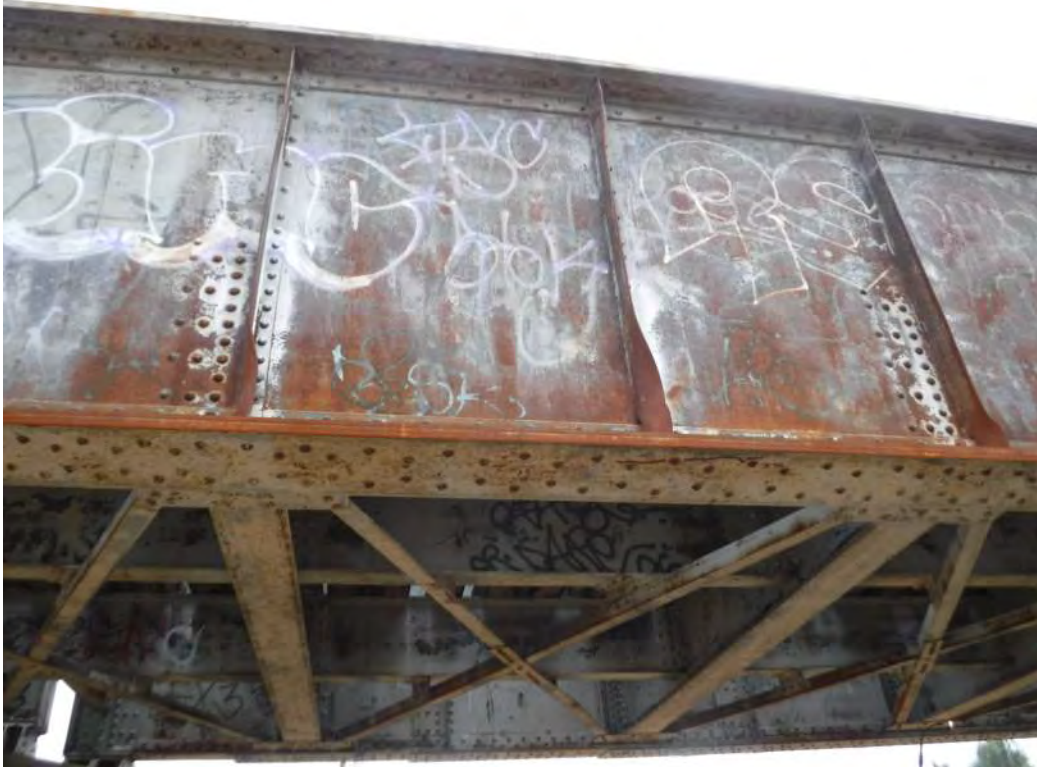
429.79 Multiple stiffeners Impact damage - Span 1 north side

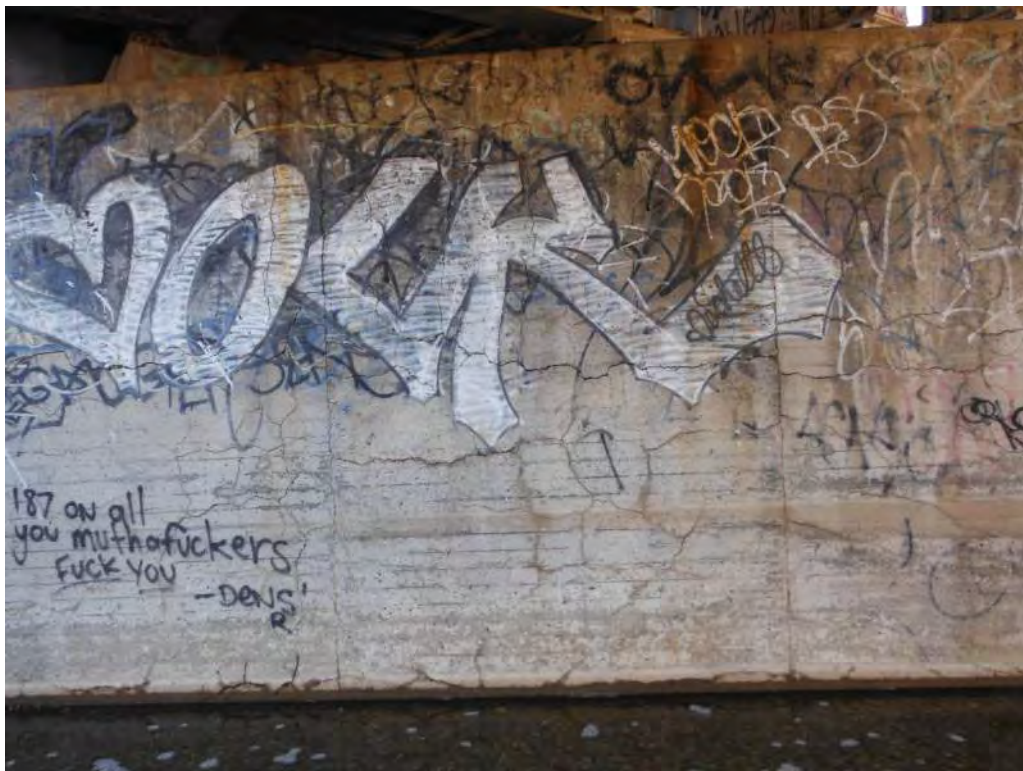
429.79 Typical cracking - Pier 2

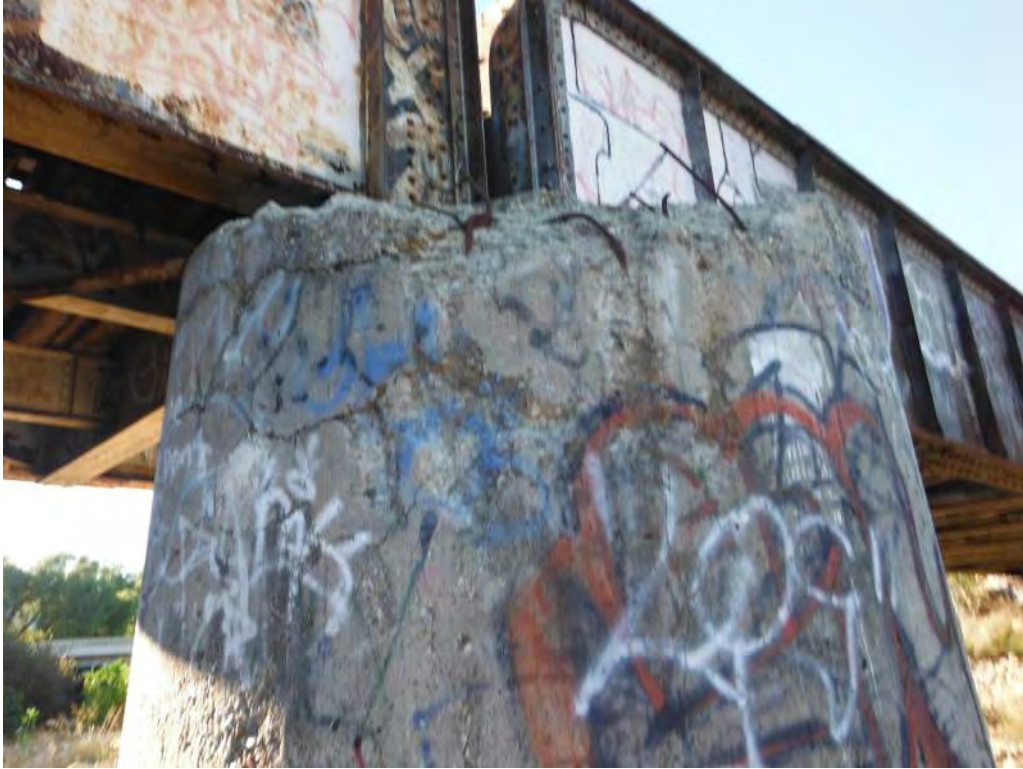
**429.79 Exposed rebar - Pier 2 north side**

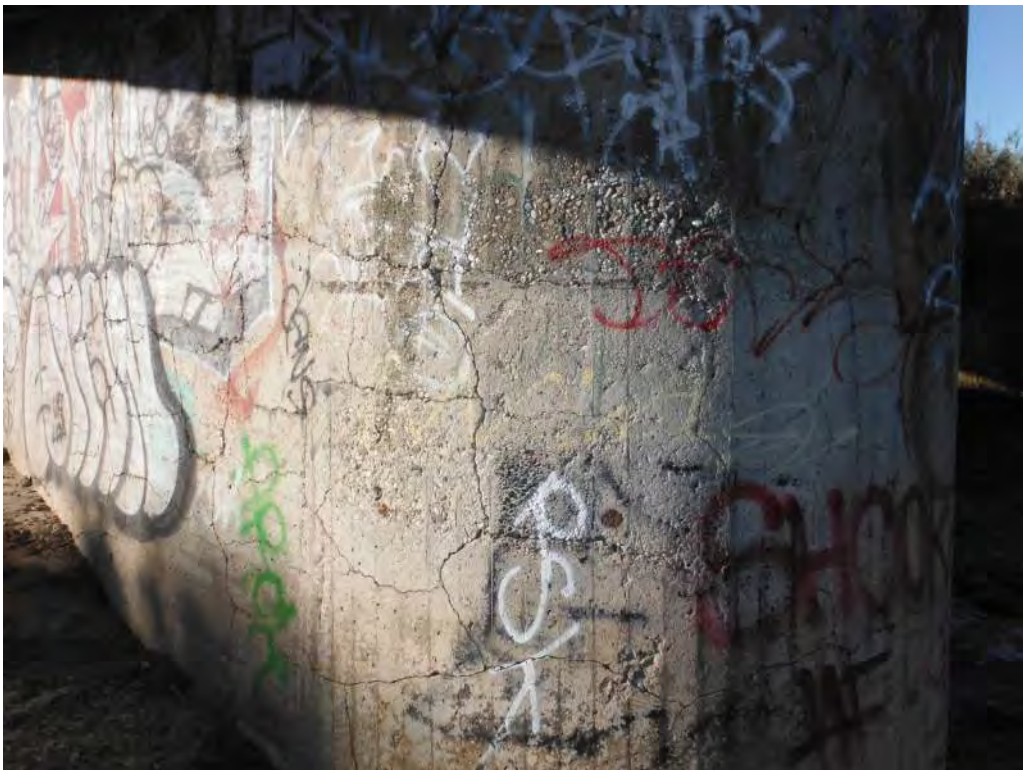
**429.79 Minor impact damage - Pier 2**

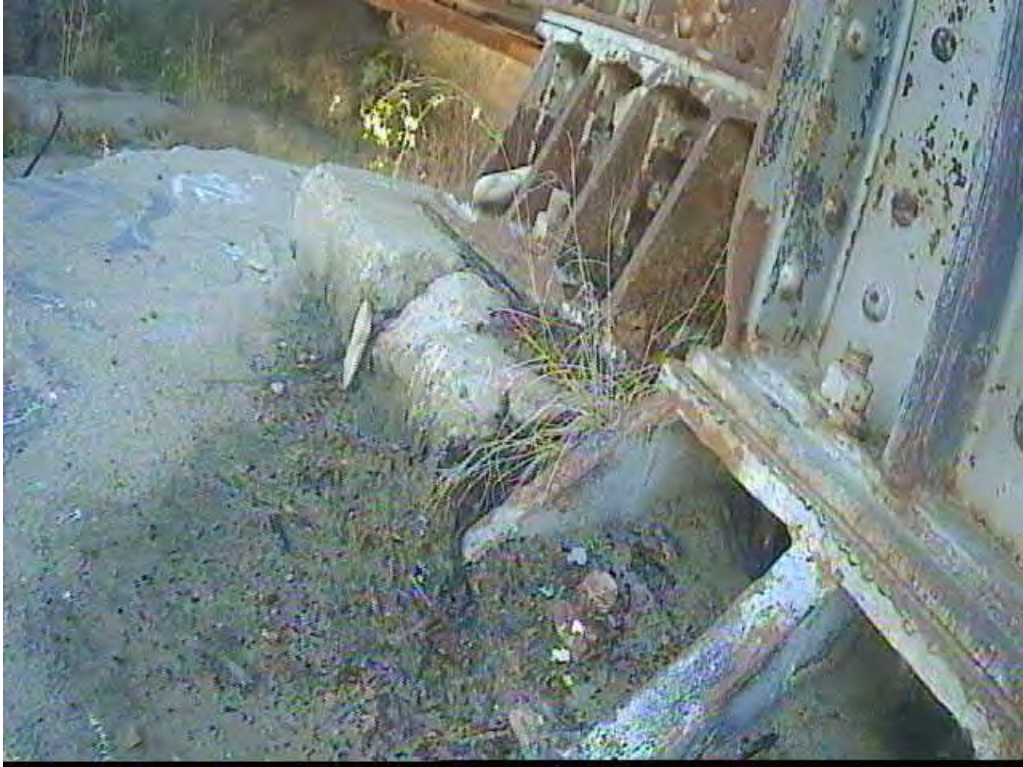
**429.79 Spalling under bearing - Pier 2**

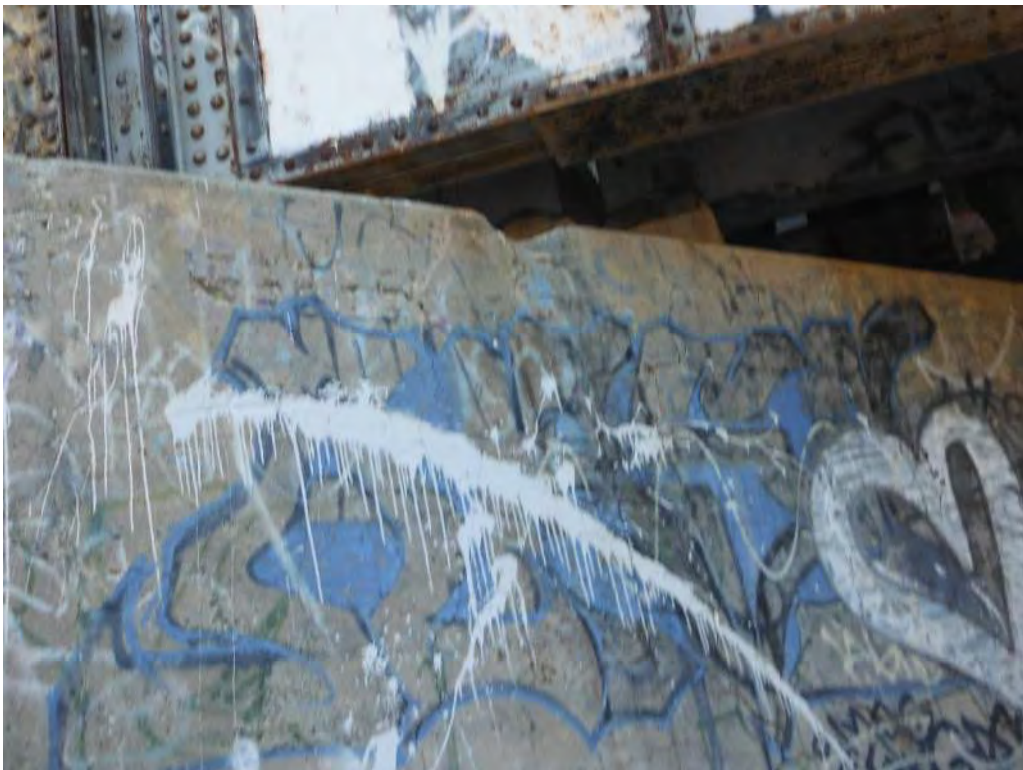
**429.79 Spall under bearing – Pier 2**

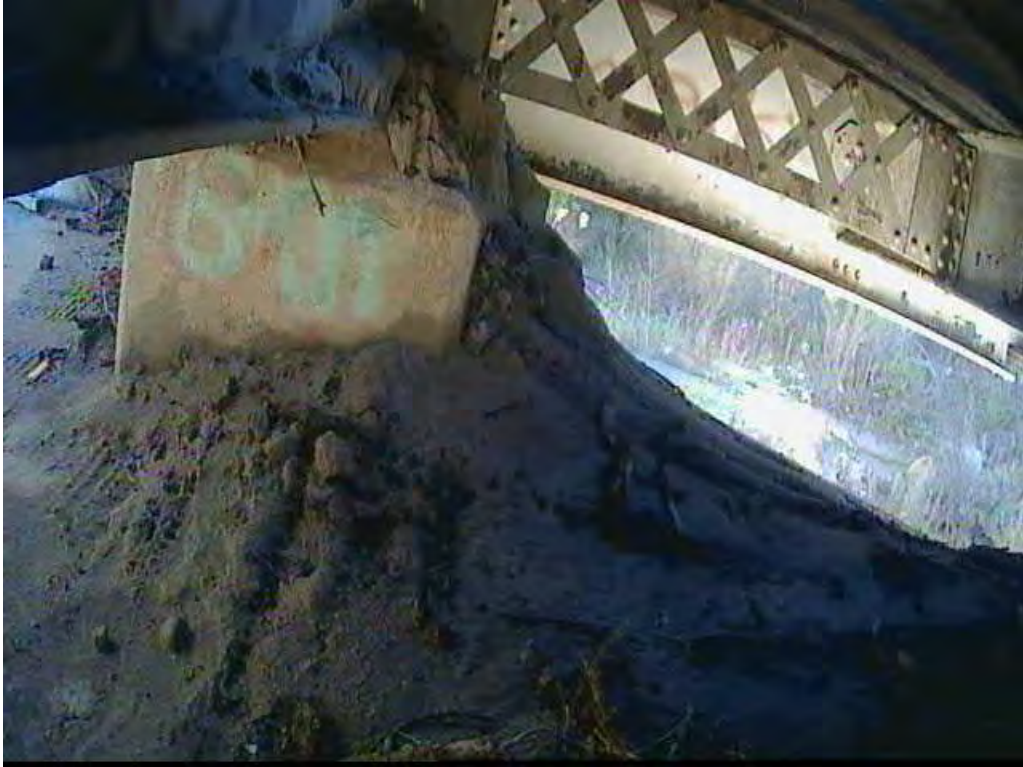
**429.79 Seats are covered with silt, Pier 2 Bearing**
