# BRIDGE INSPECTION REPORT

INSPECTION TYPE: Annual

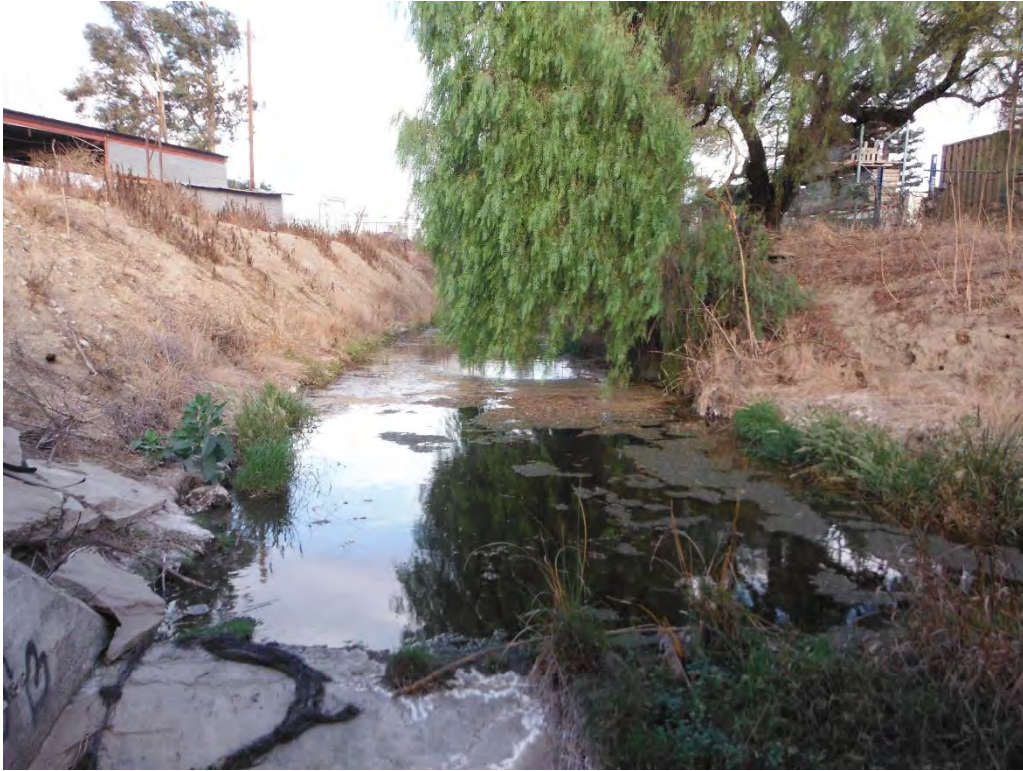
**407.48 Channel Condition – Looking Upstream**

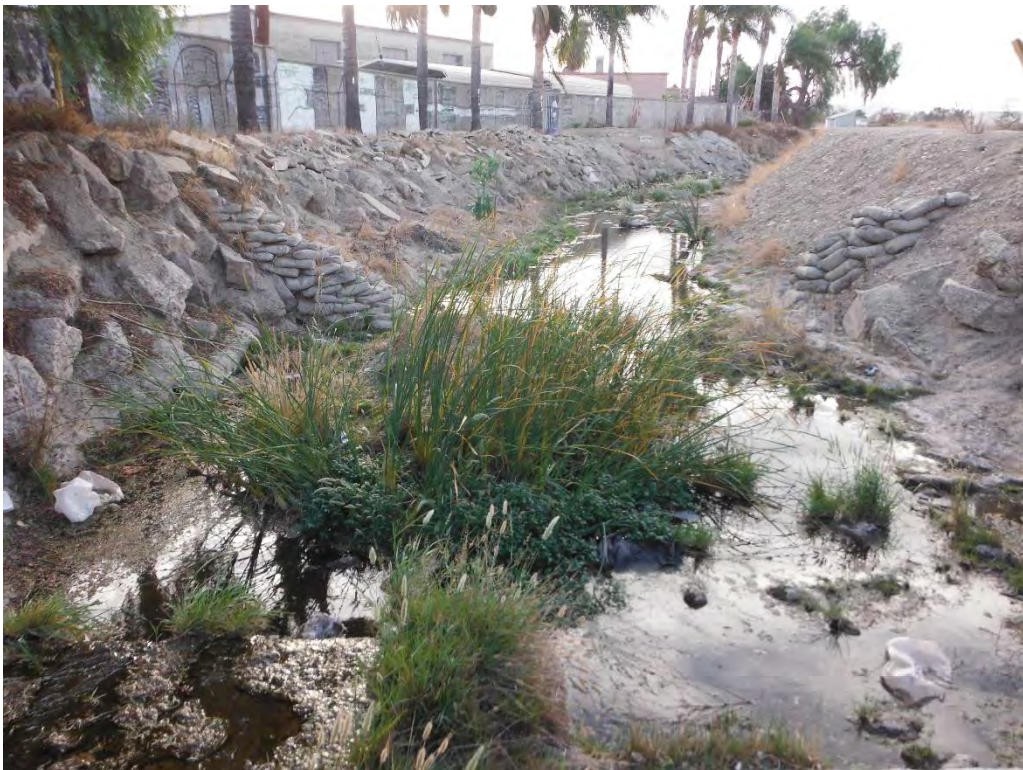
**407.48 Channel Condition – Looking Downstream**

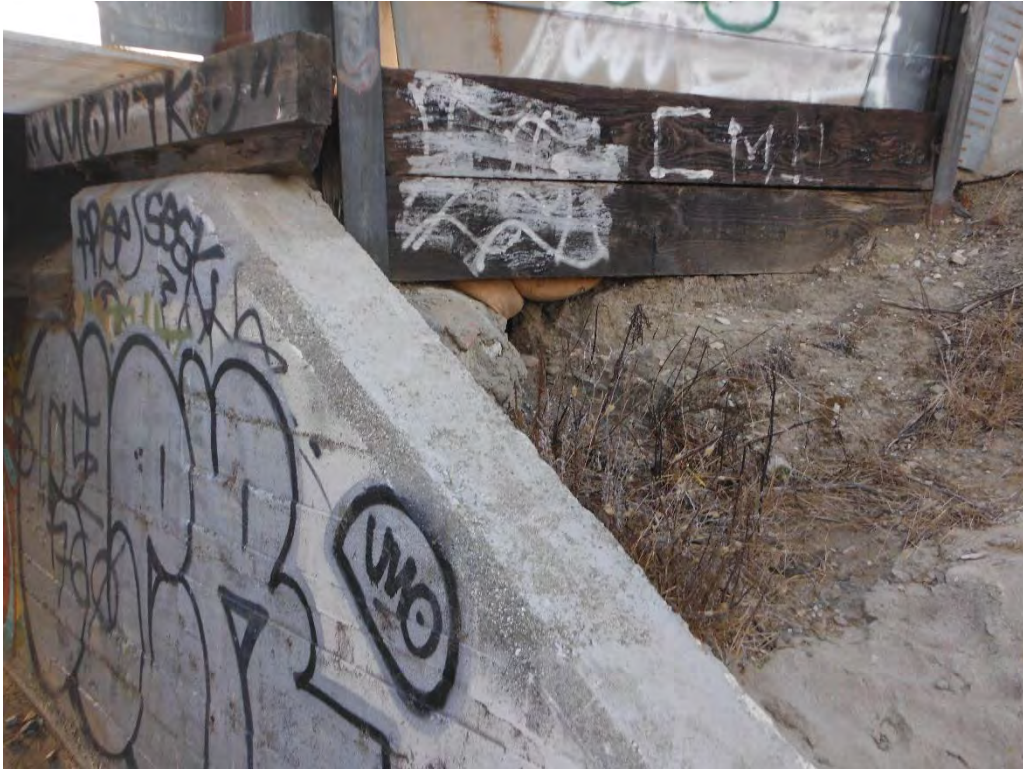
**407.48 Northwest Wingwall Undermining**

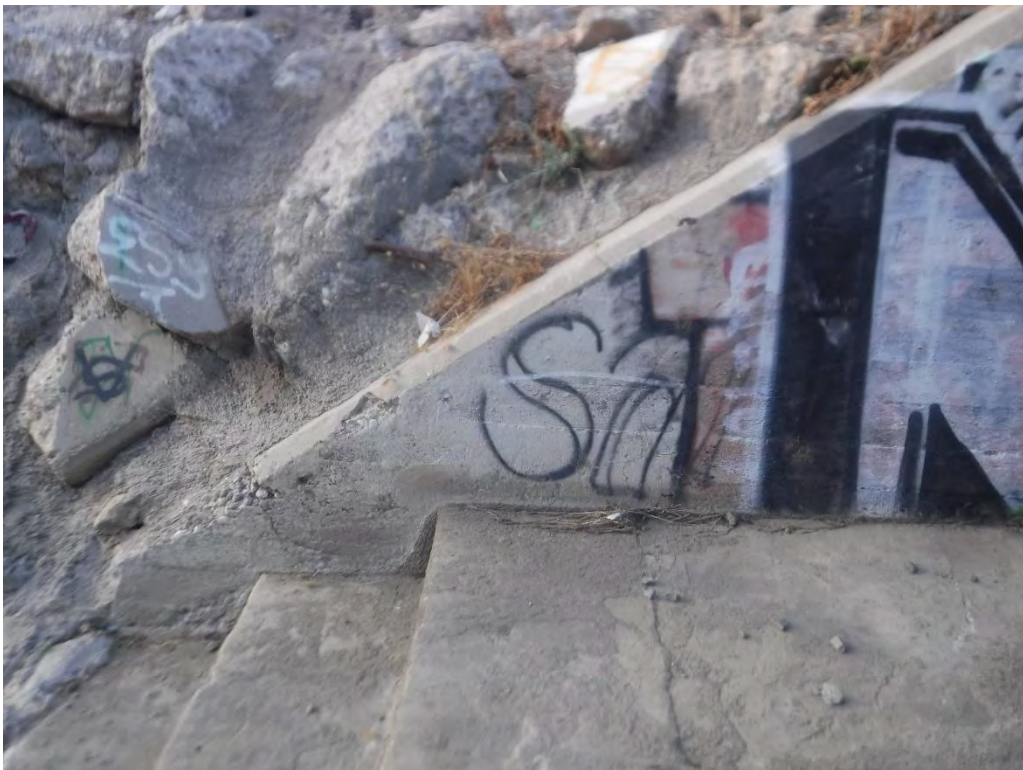
**407.48 Southwest Wingwall Crack**

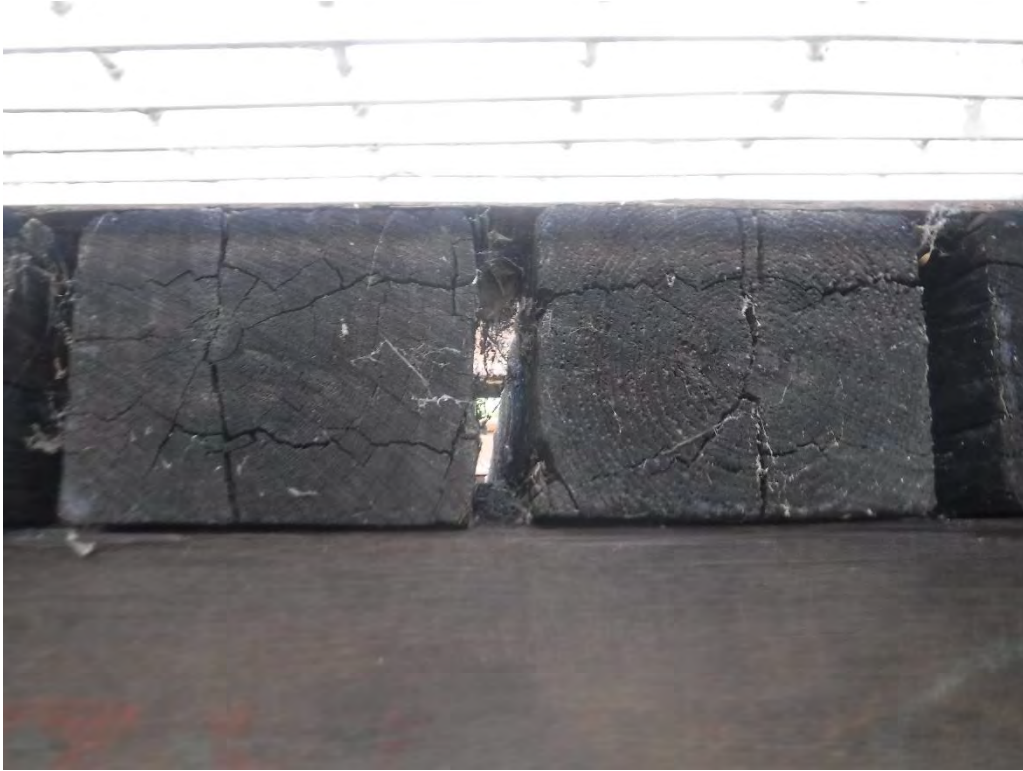
**407.48 Typical Tie Condition - Split**

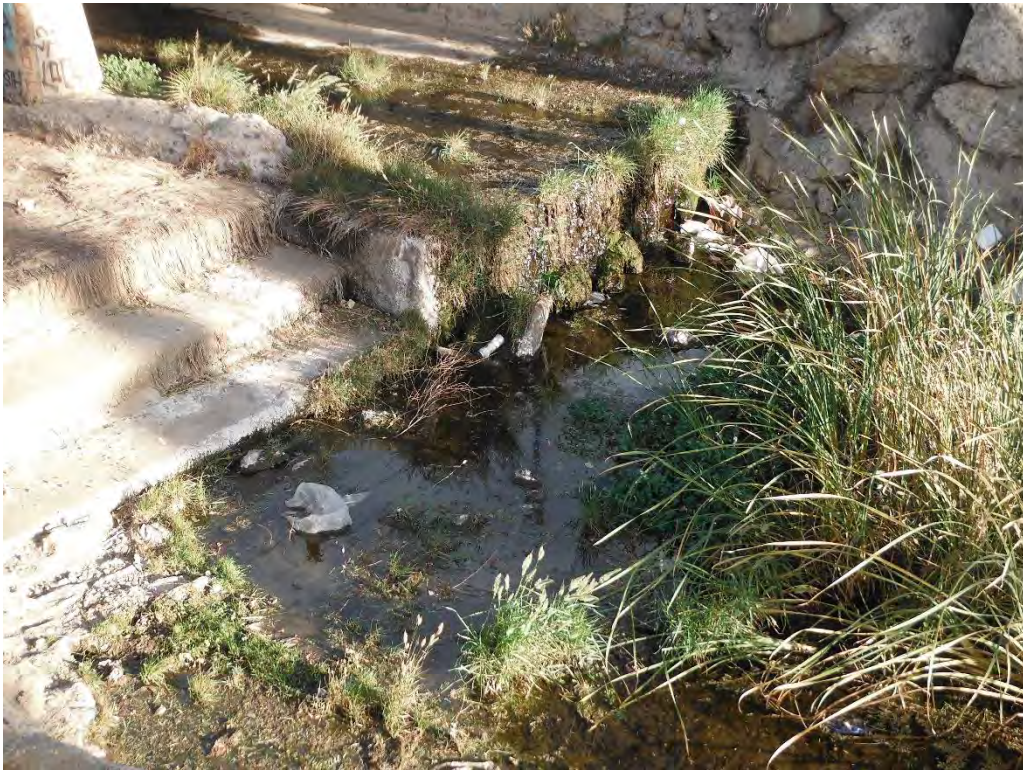
**407.48 Scour at Downstream End of Channel Paving – approximately 3'**

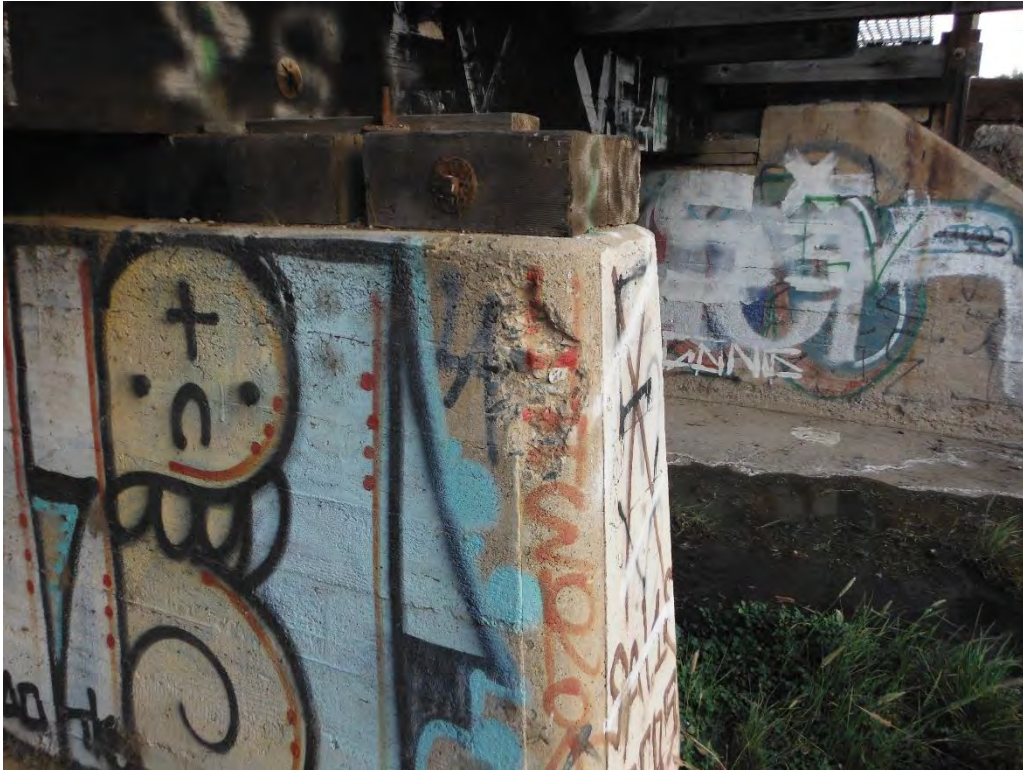
**407.48 Spall on south side of Pier 2**

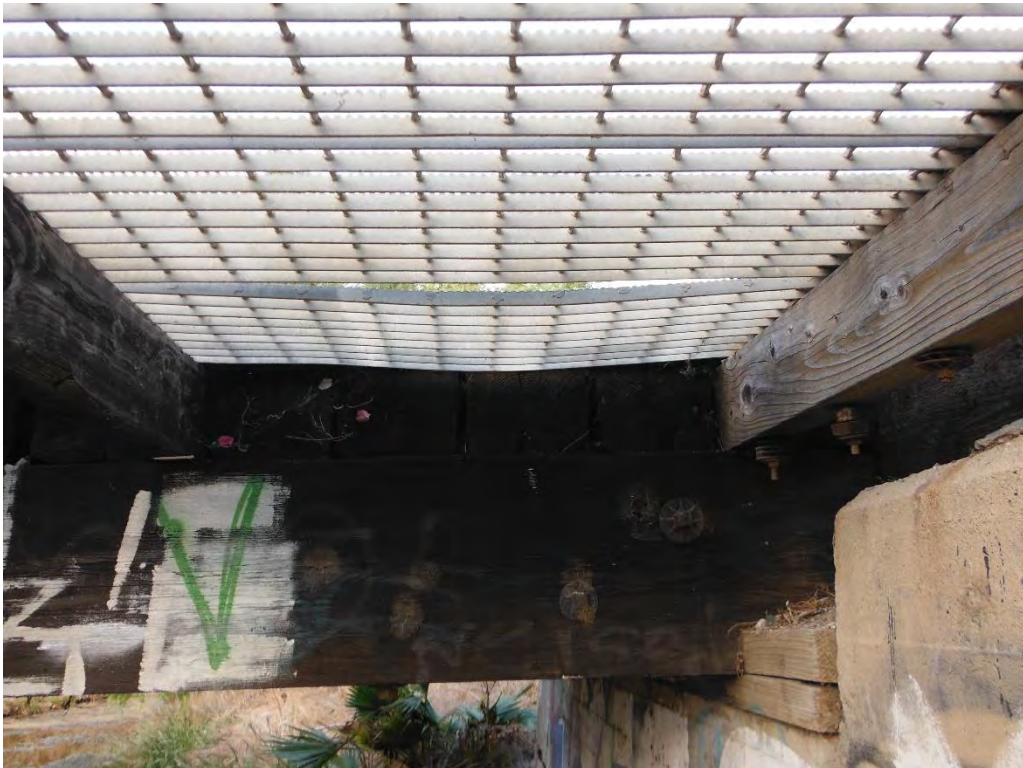
**407.48 SE Walkway Panel Deflection Damage**

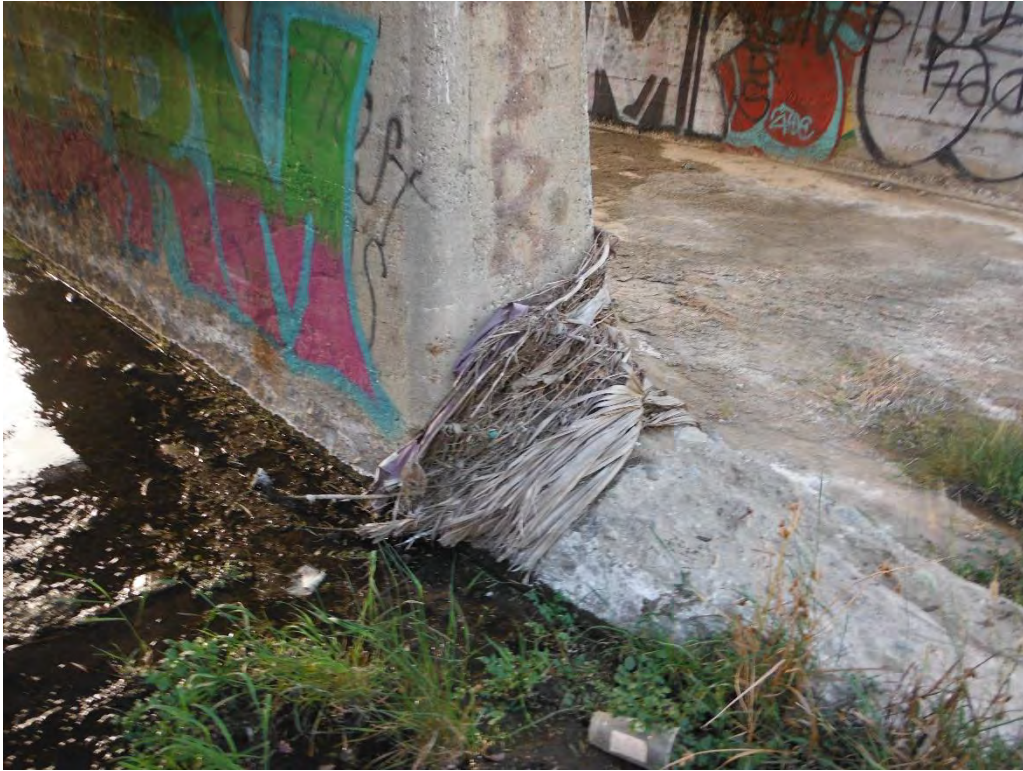
**407.48 Spall and debris on upstream side of Pier**

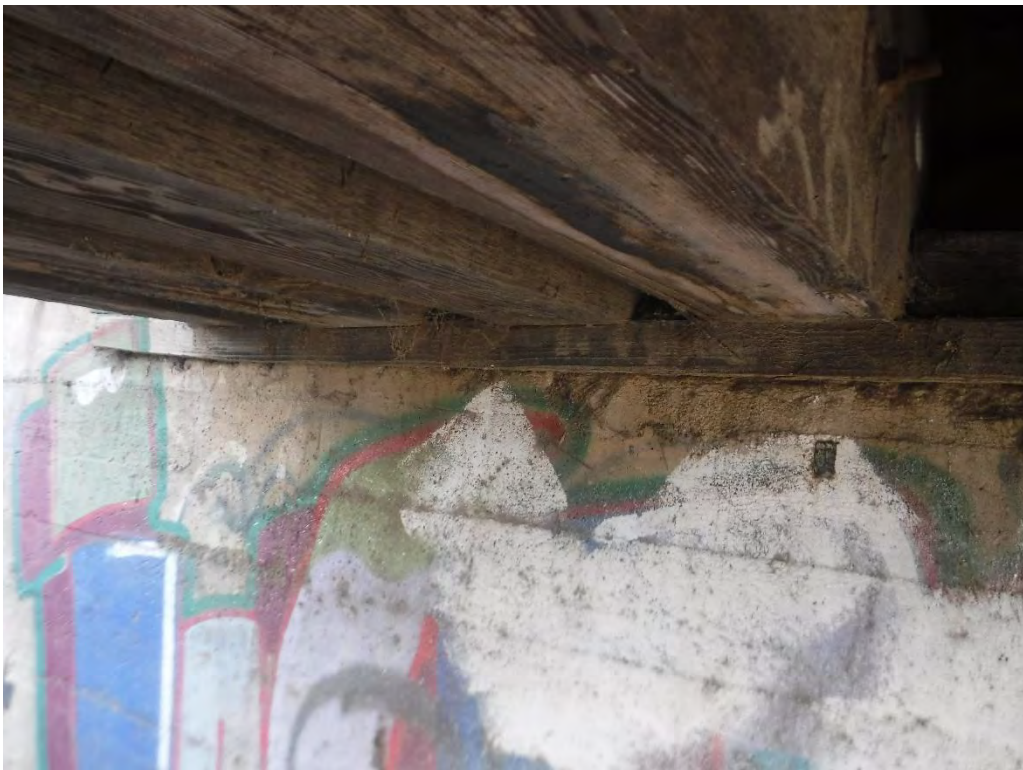
**407.48 Stringers crushing  $\frac{1}{4}$ " at Abutment 3**

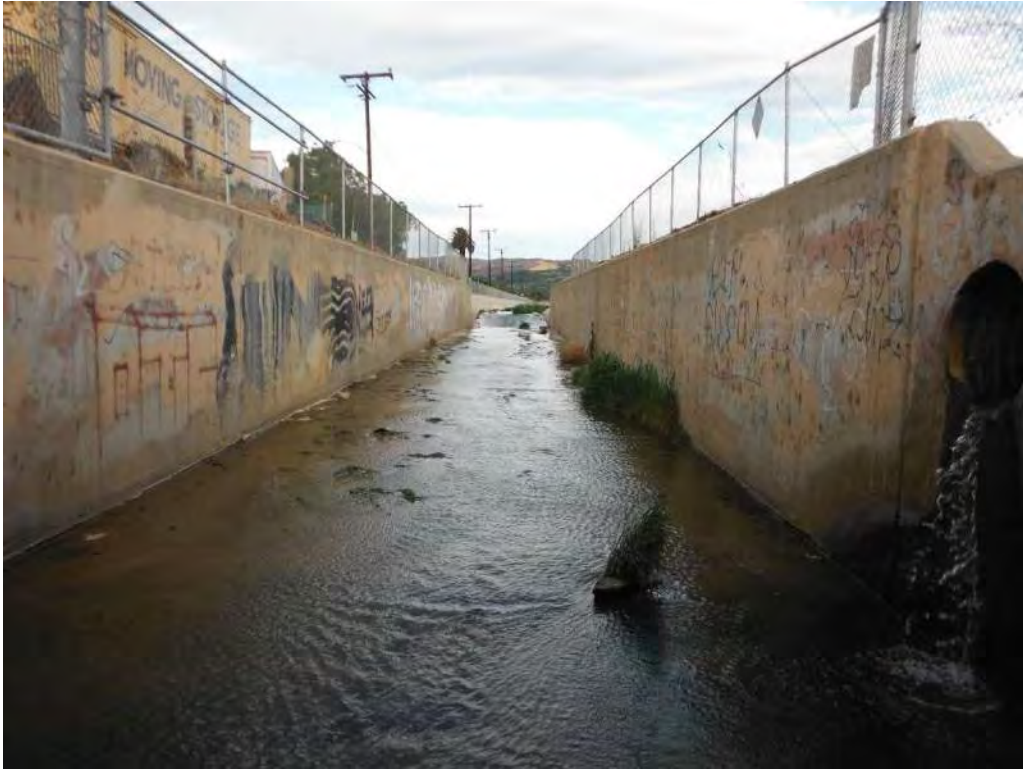
**408.02 Channel Condition - Looking Upstream**

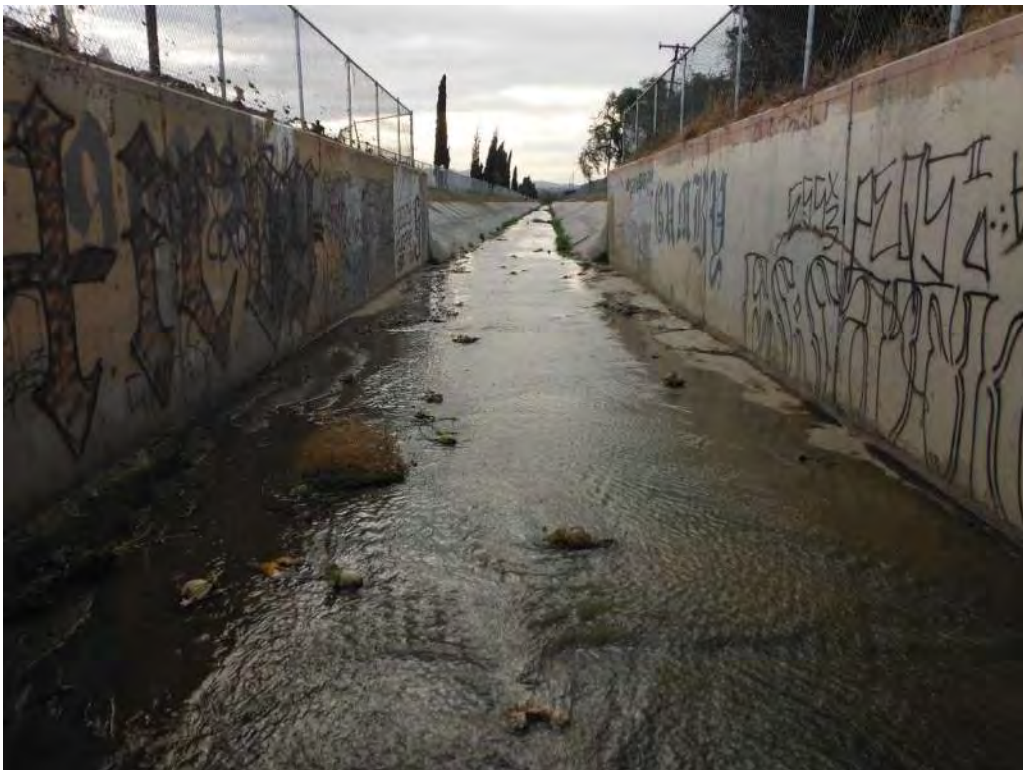
**408.02 Channel Condition - Looking Downstream**

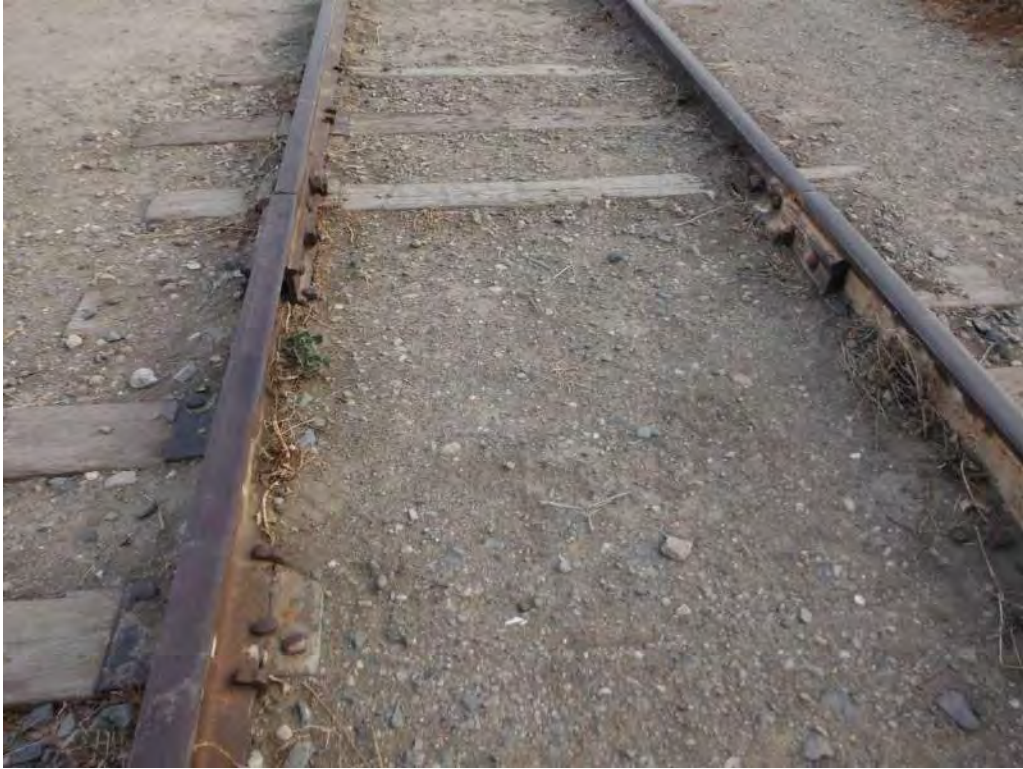
**408.02 Fouled Ballast across Culvert**

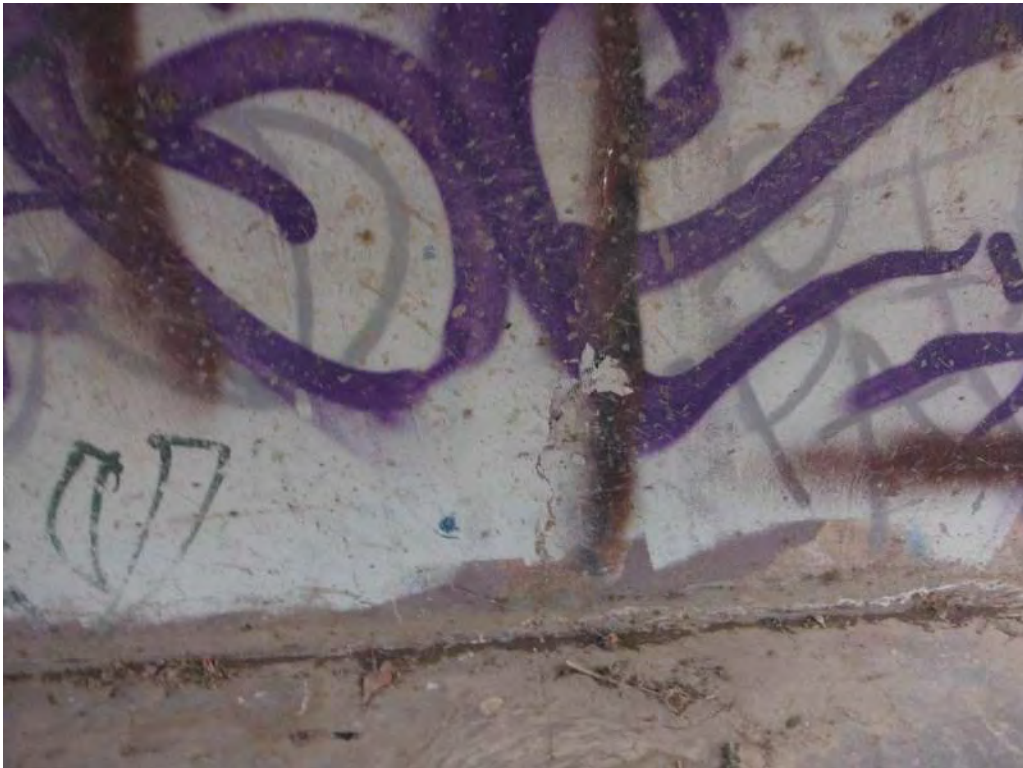
**408.02 Vertical crack center of Abutment (typ.)**

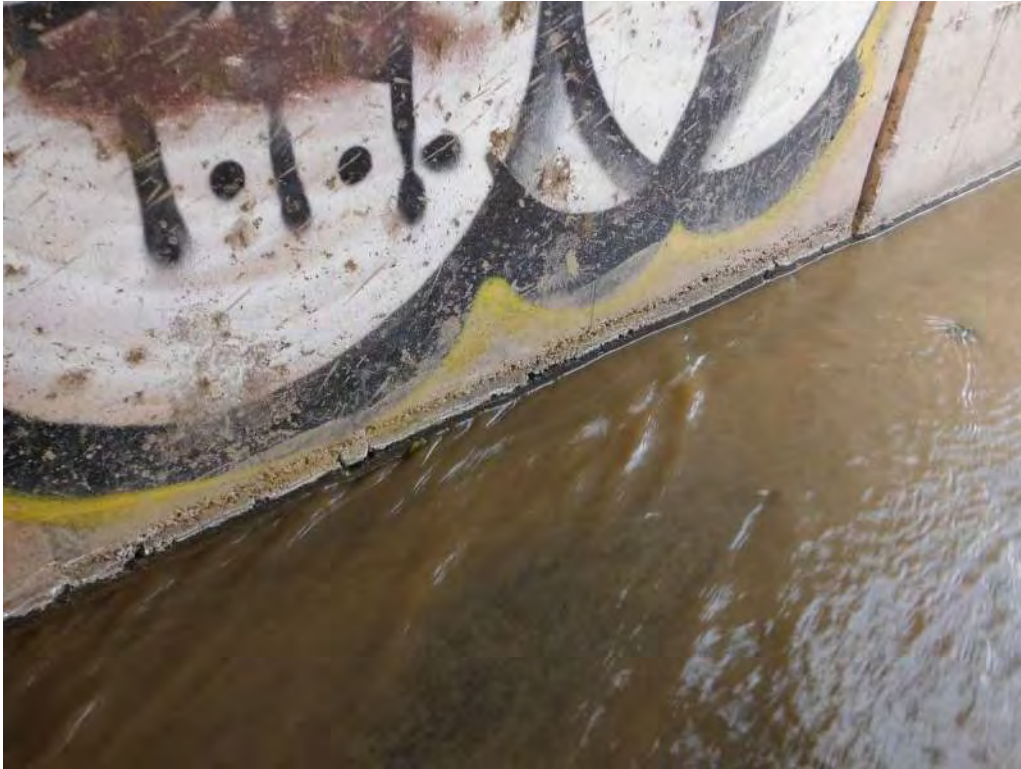
**408.02 Scaling at base of Abutment #1**

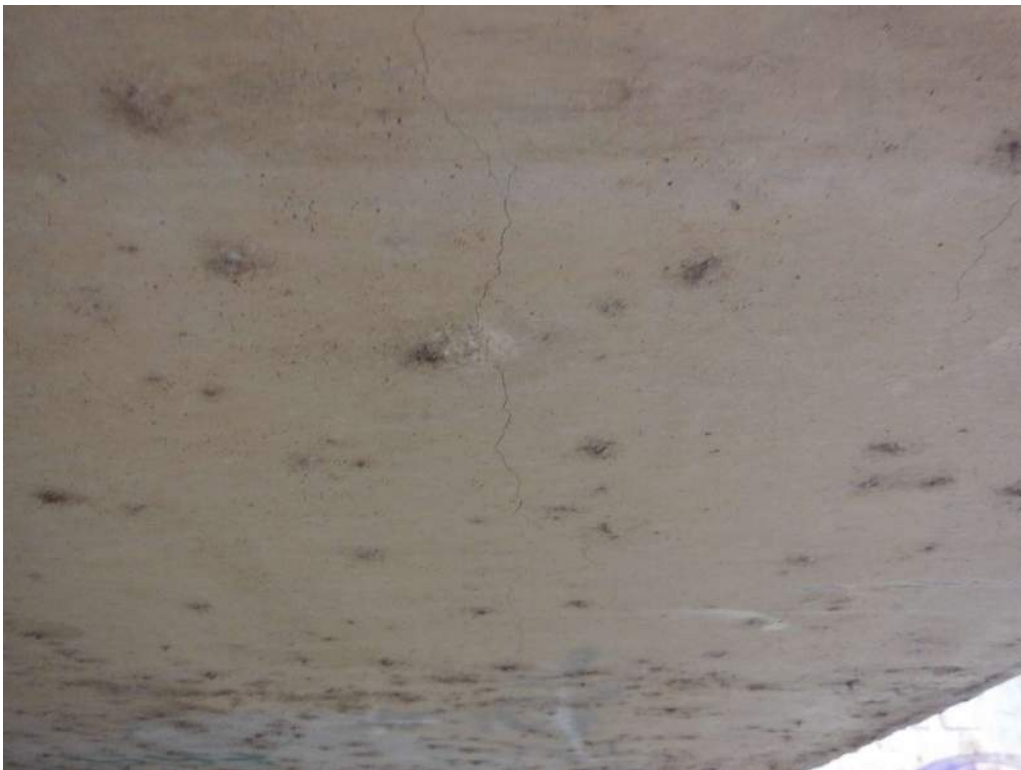
**408.02 Hairline cracking underside of top slab, south side**

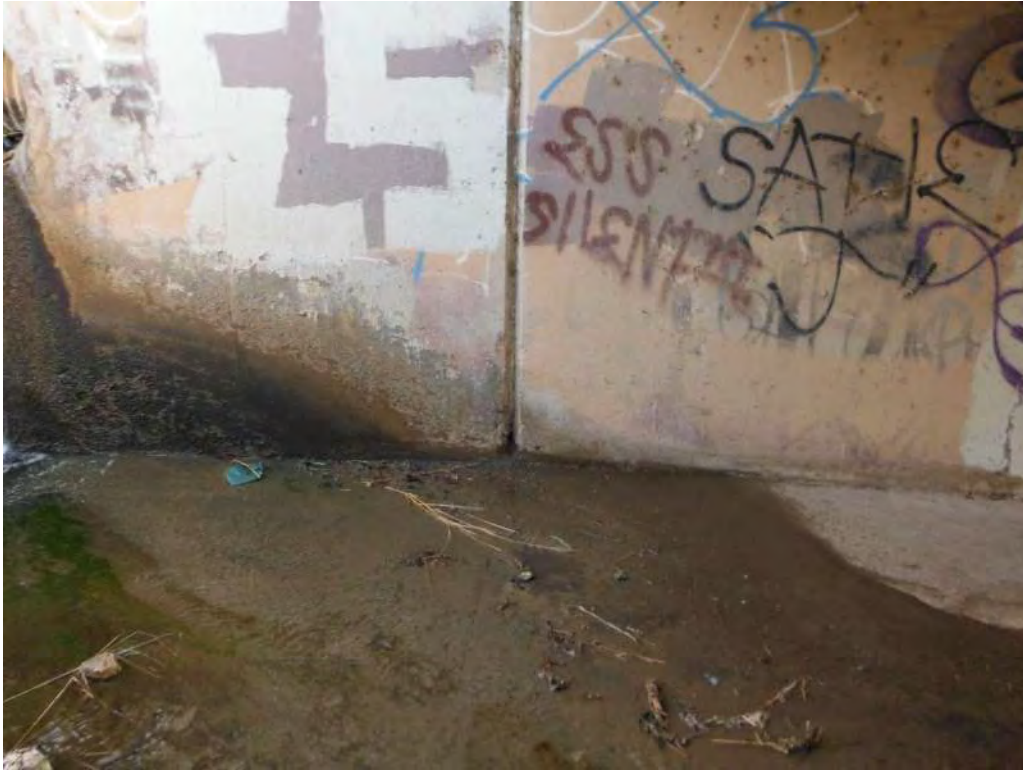
408.02 Spall at NE wingwall

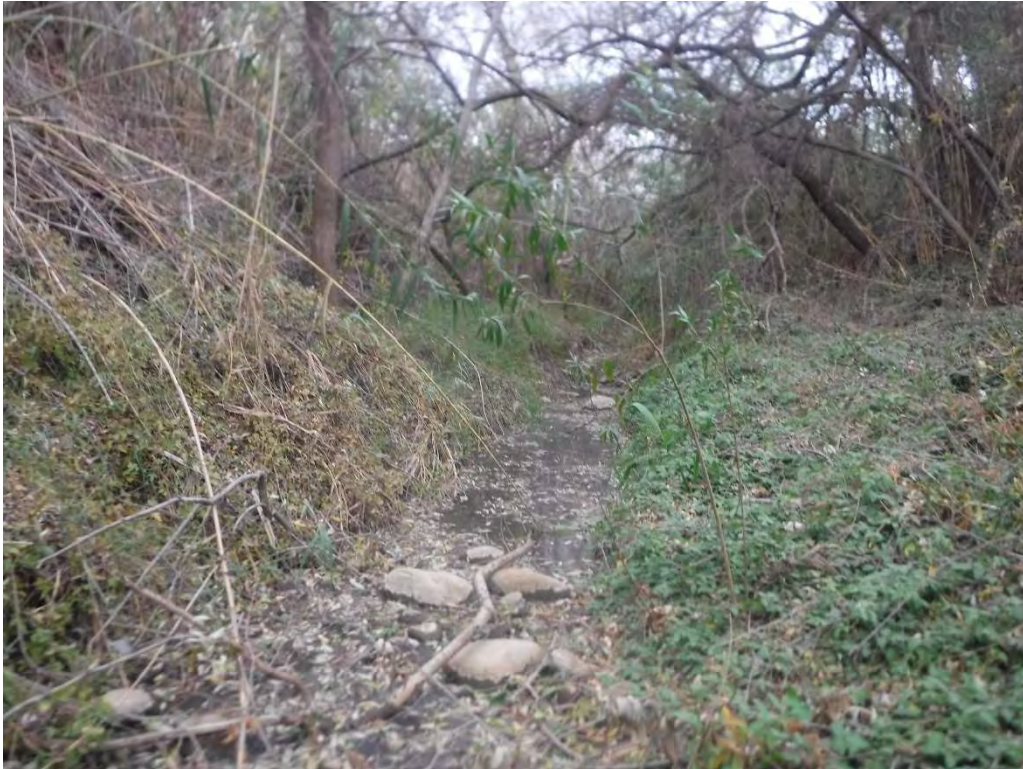
**408.84 Channel Condition - Looking Upstream**

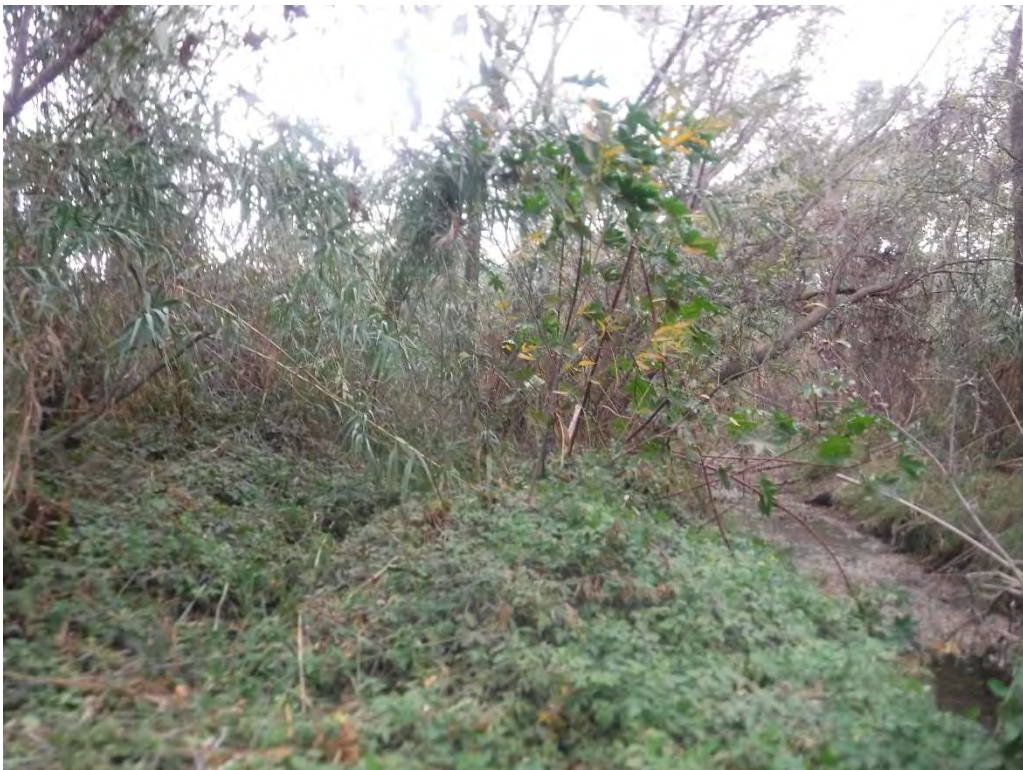
**408.84 Channel Condition - Looking Downstream**

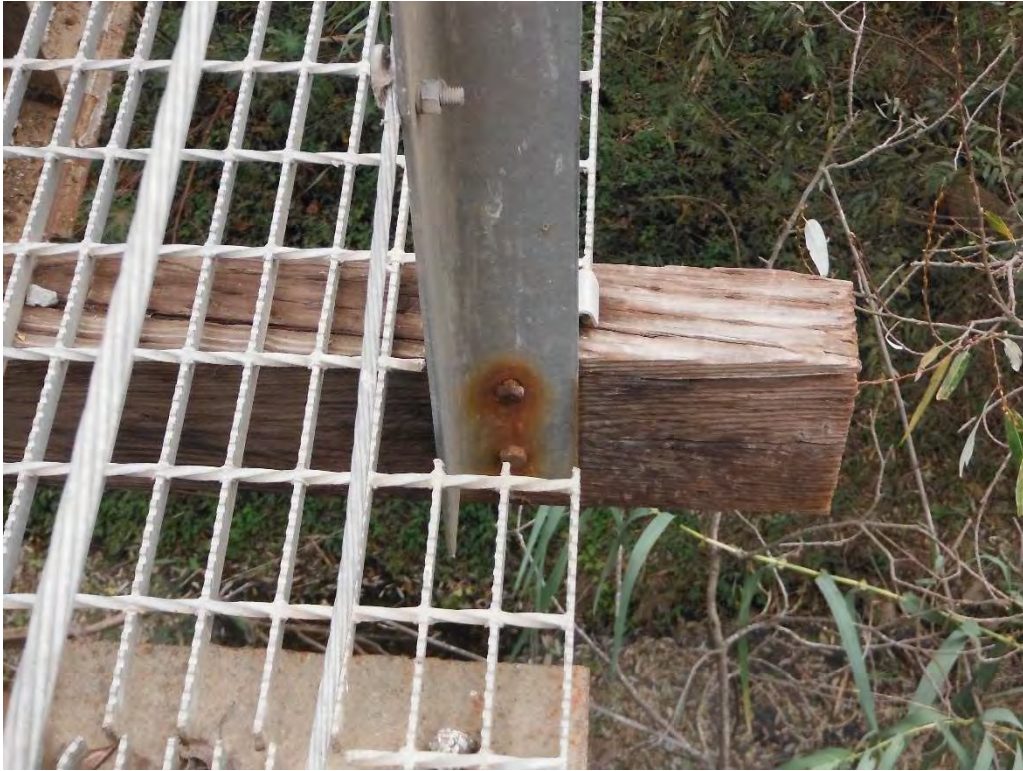
**408.84 Broken handrail post bolt on SW of Span 3**

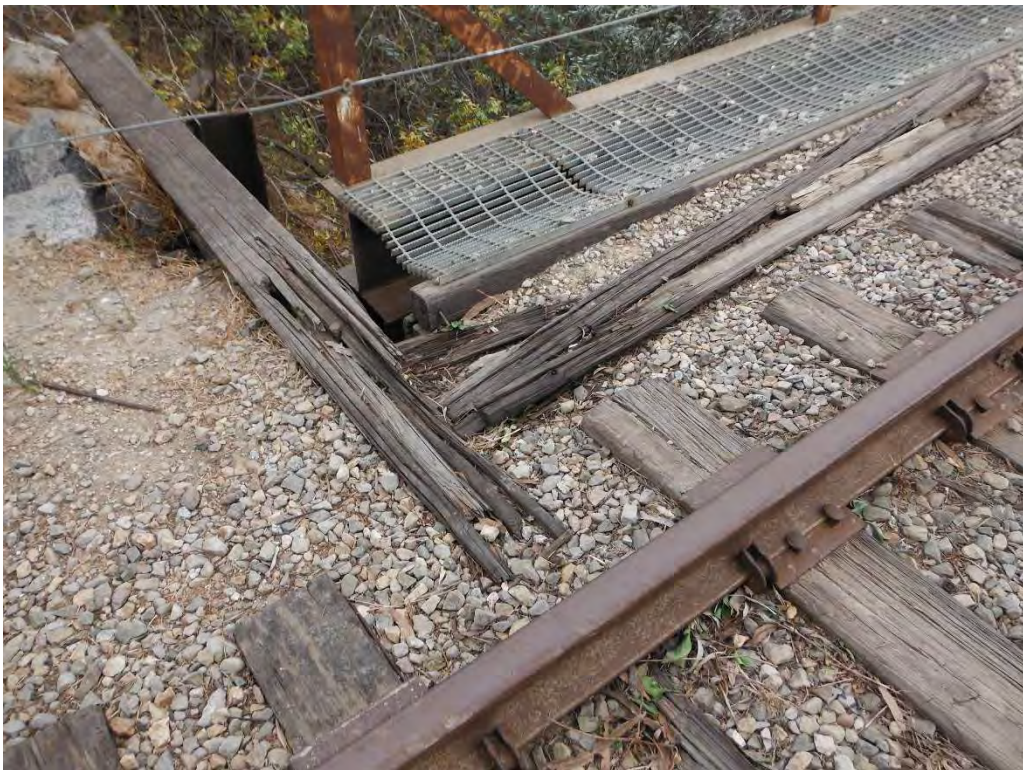
**408.84 Rotten/failing backwall at Abutment 1**

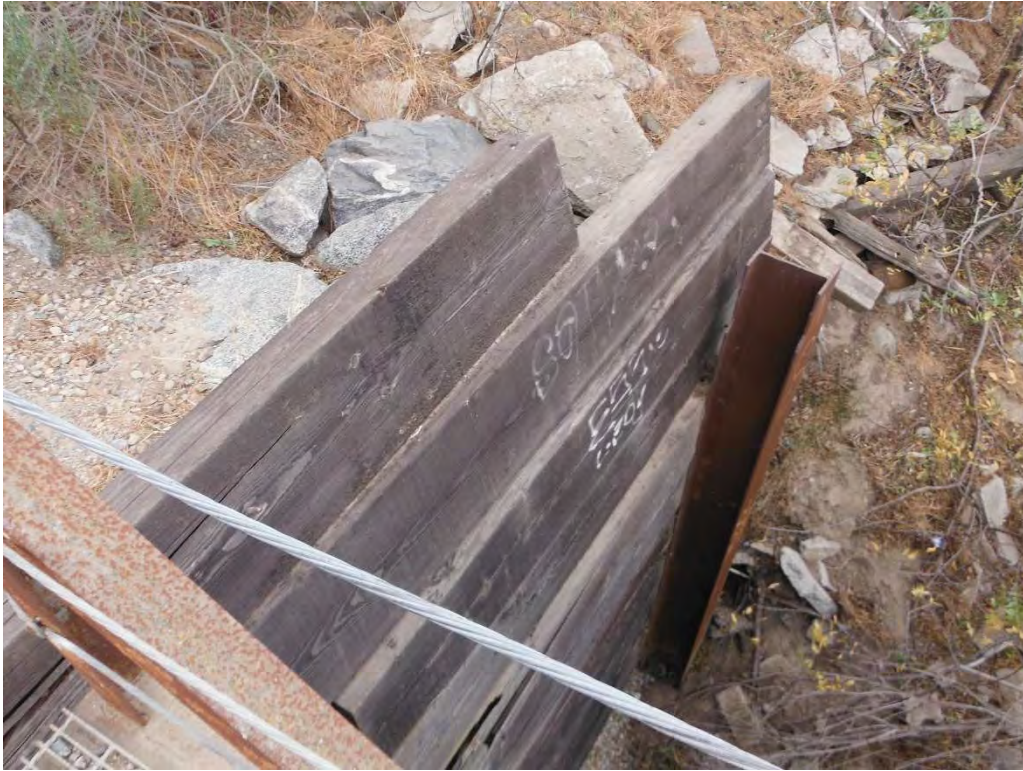
**408.84 Abutment 1 backwall leaning**

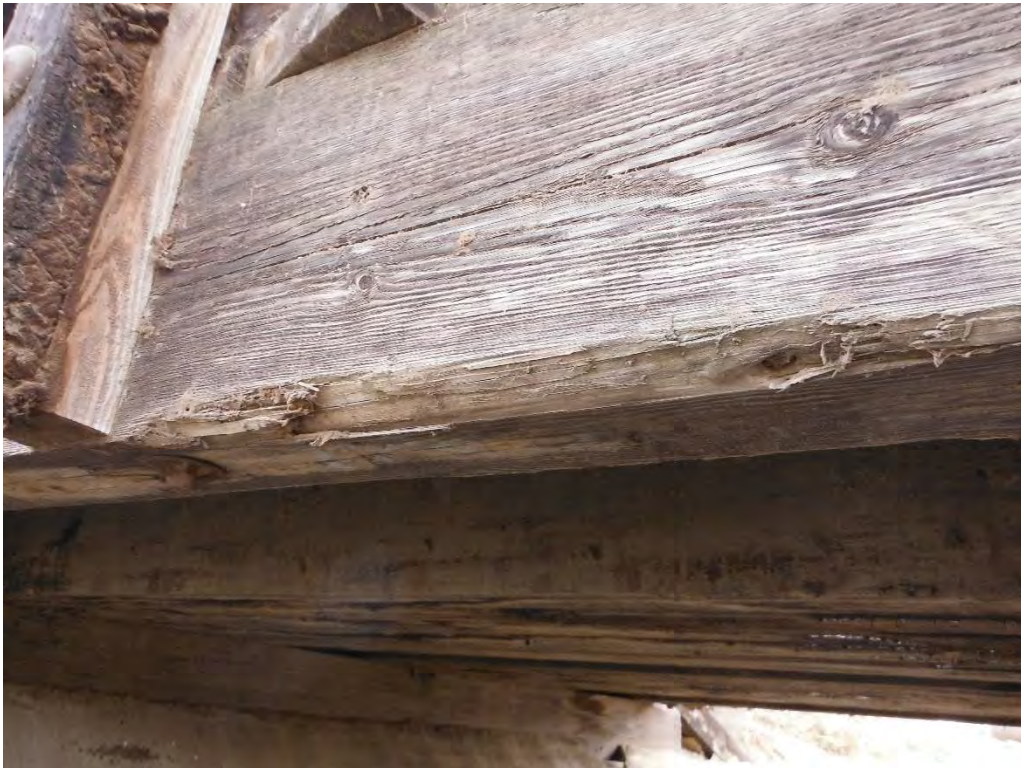
**409.74 Stringer 1 impact damage**

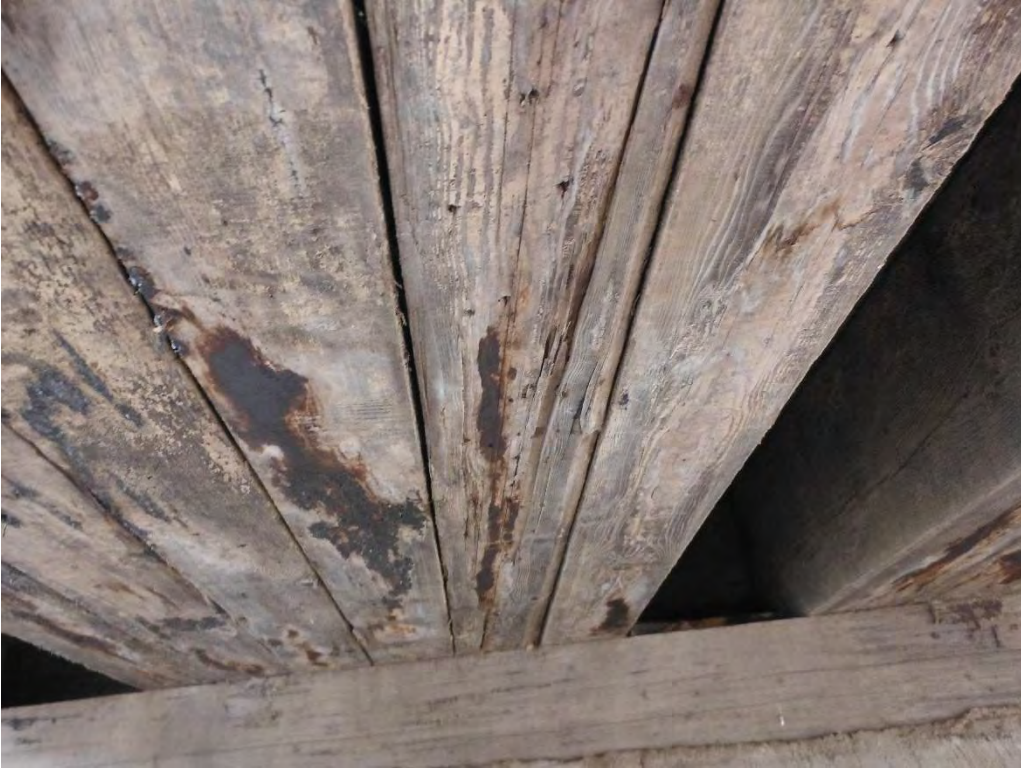
**409.74 Stringer 6 split**

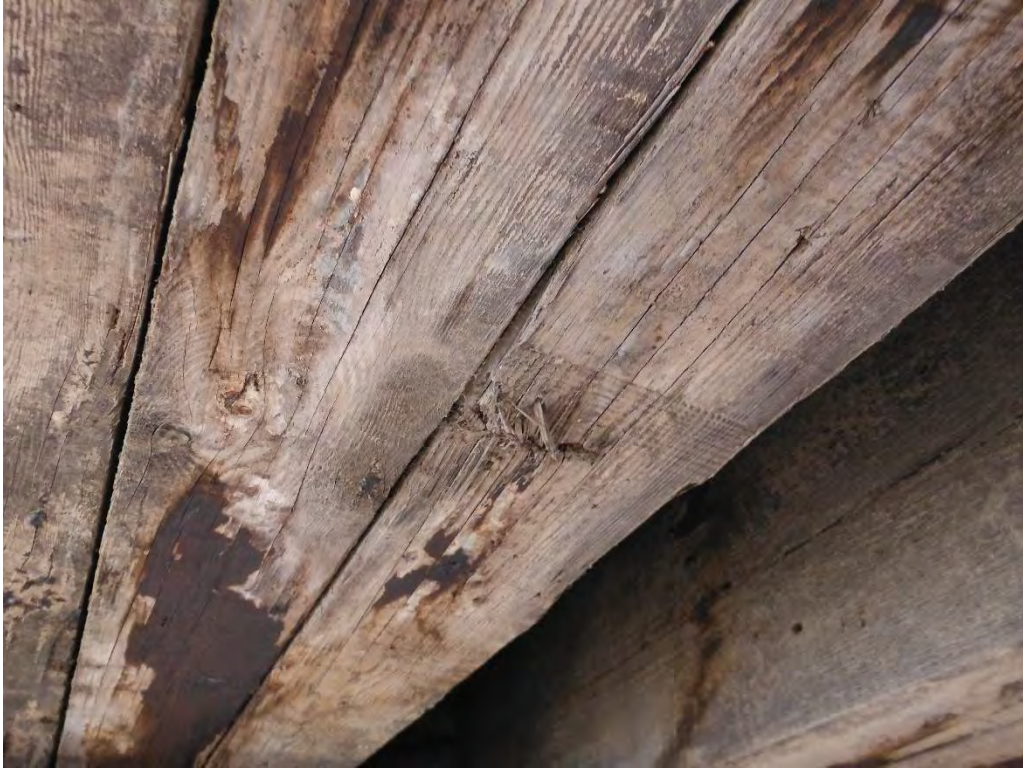
**409.74 Stringer 8 impact damage**

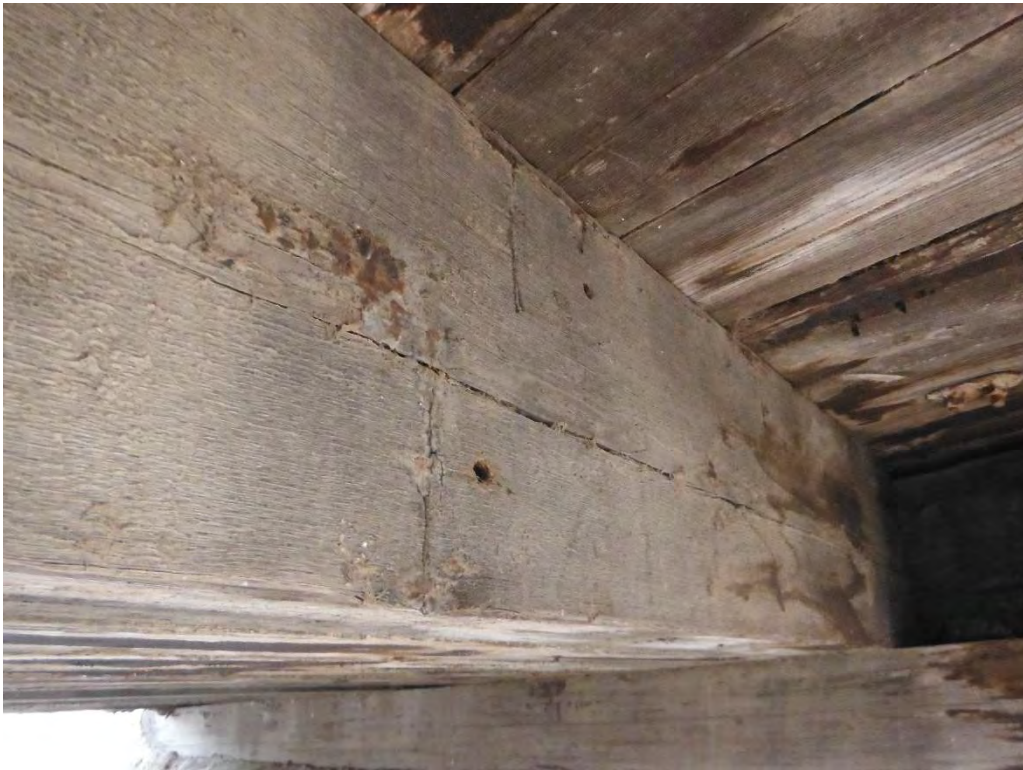
**409.74 Stringer 13 split on vertical face**

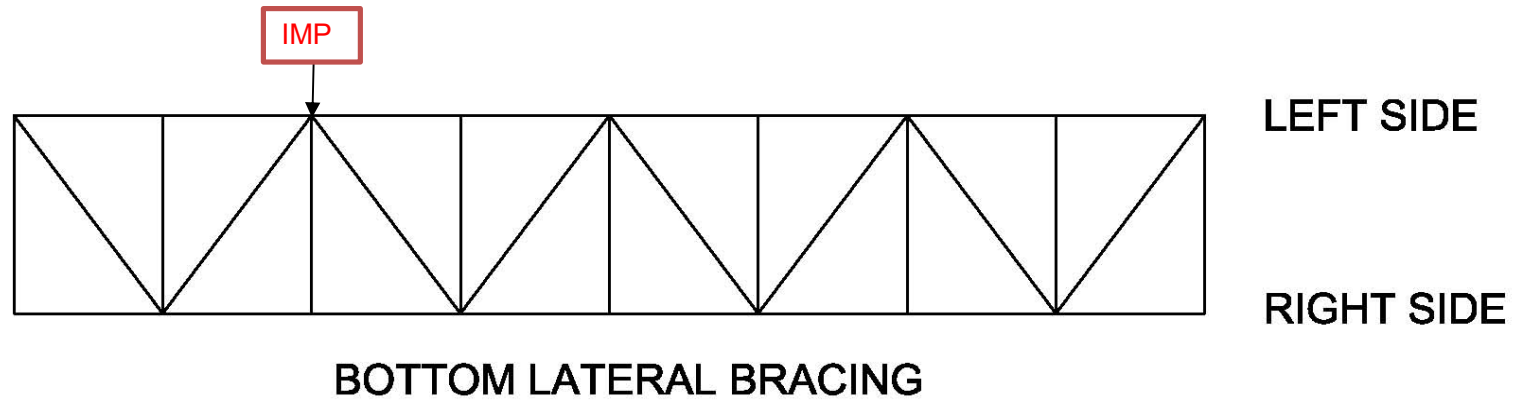
DIVISION	Santa Paula	SPAN LENGTH	39'	NUMBER OF TRACKS	1
CROSSING		TRACK ALIGNMENT	TANGENT	SPAN No.	1
INSPECTION FINDINGS					
	Deck girder is in fair condition with paint failure and surface rust - see photo				
IMP	Bent stiffener on north side near Abutment 2 - See photo.

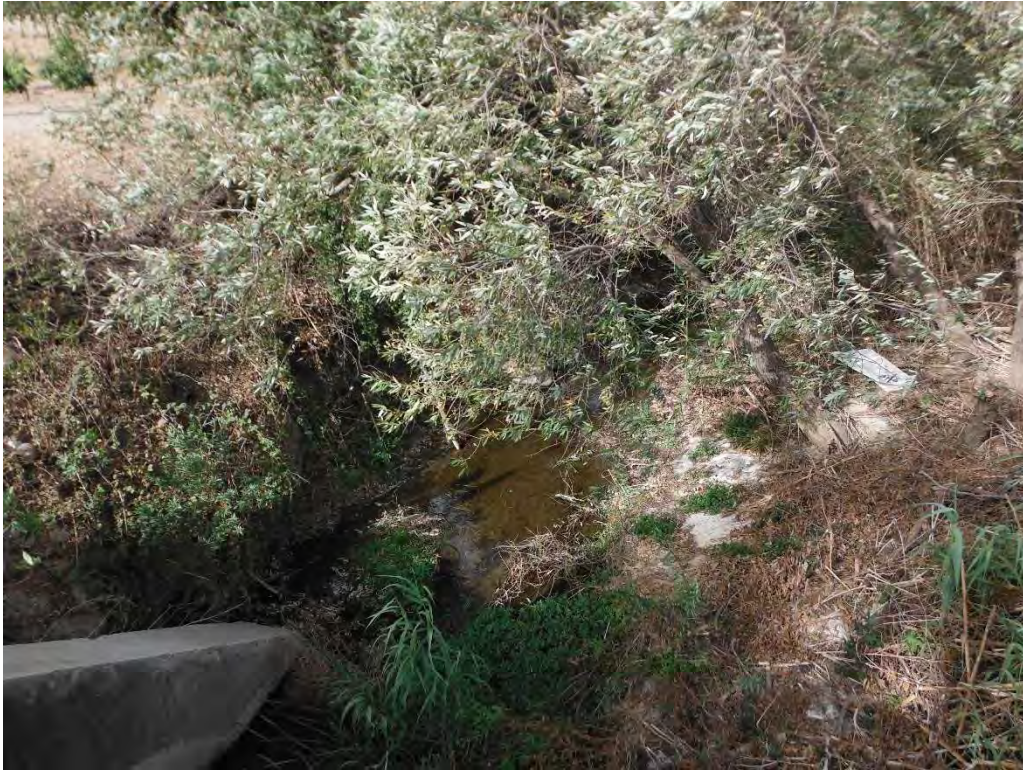
**410.40 Channel Condition - Looking Upstream**

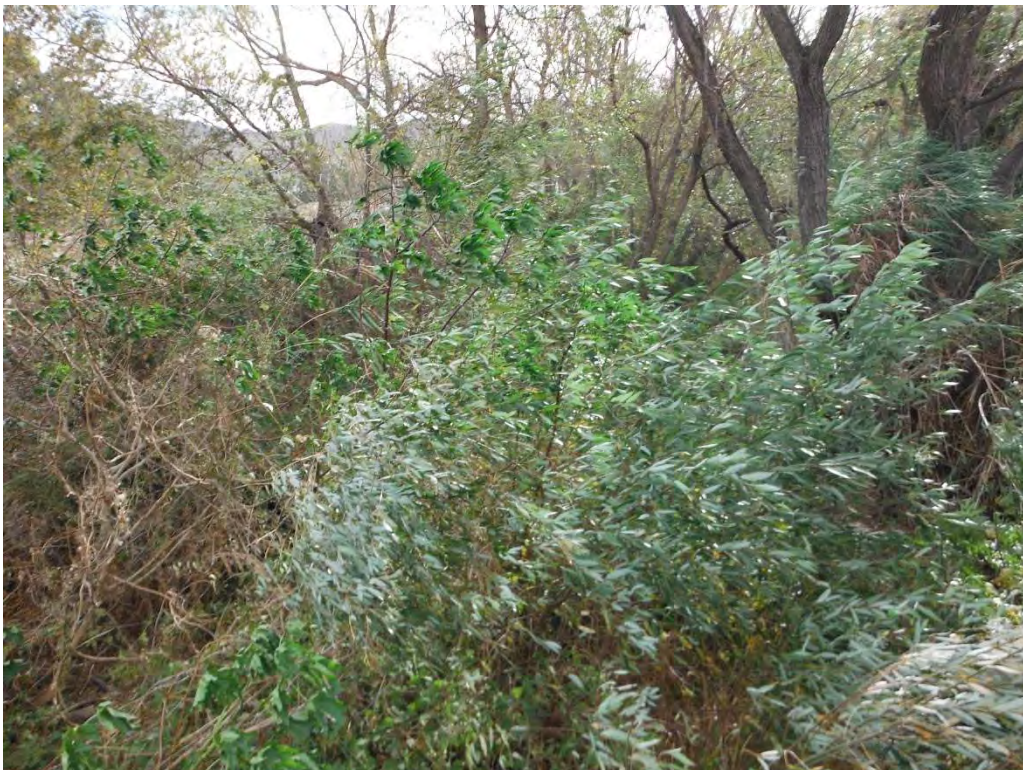
**410.40 Channel Condition - Looking Downstream**
