# BRIDGE INSPECTION REPORT

INSPECTION TYPE: Annual

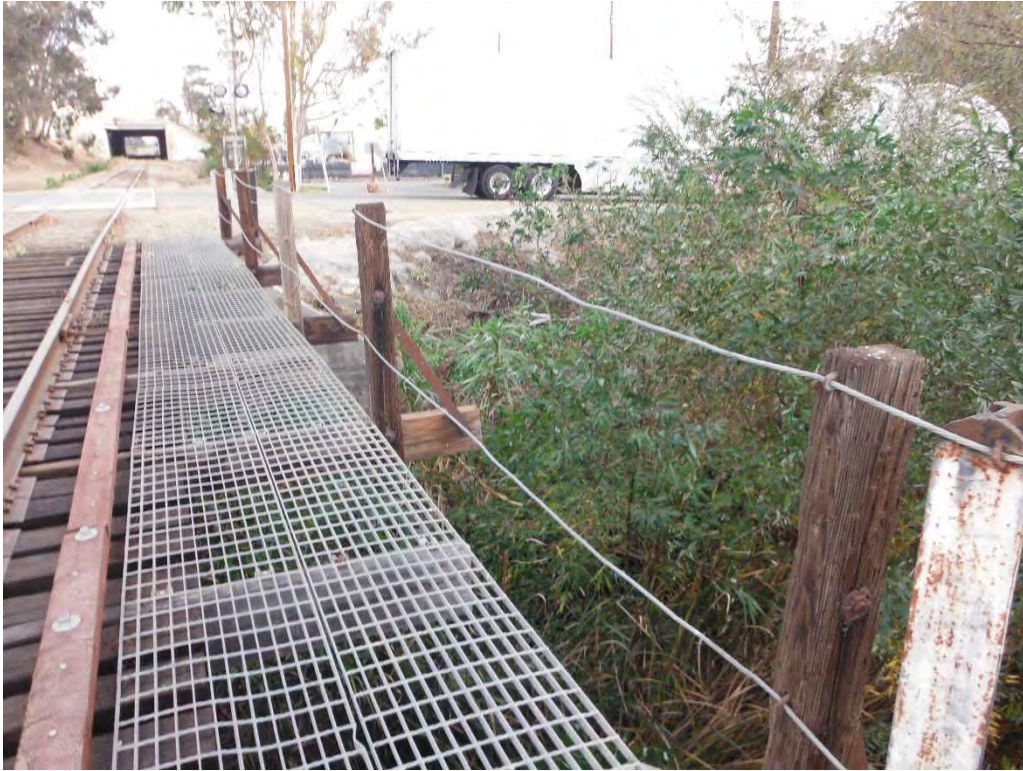
**410.40 Loose handrail cables (Typ.)**

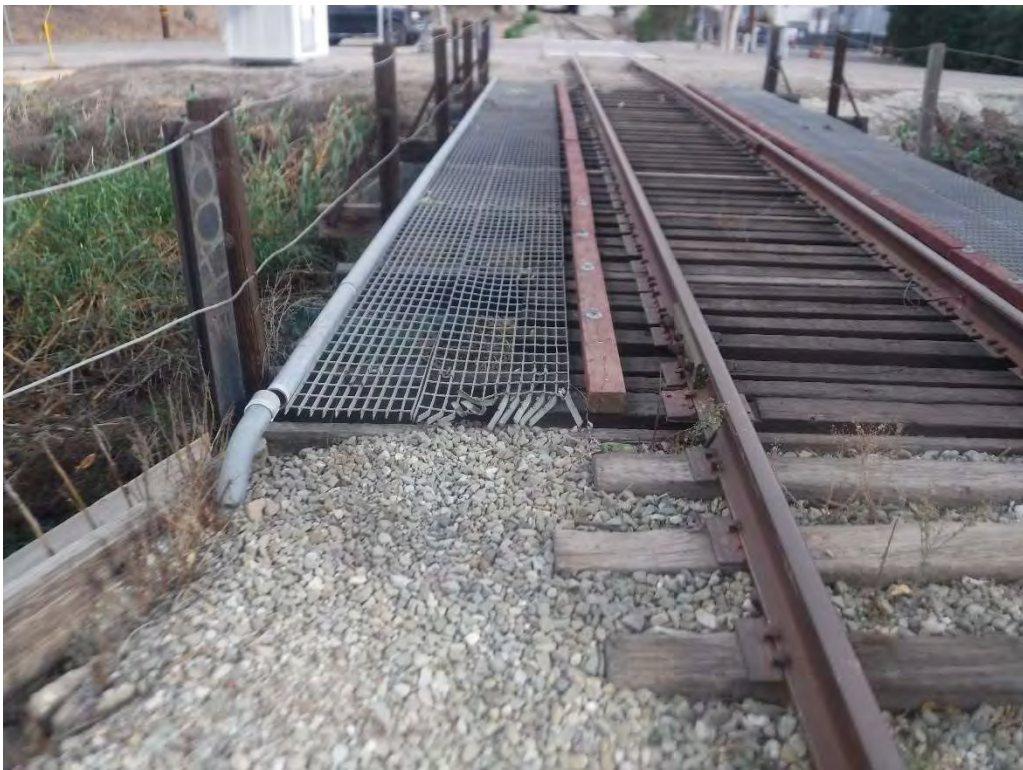
**410.40 Grating causing tripping hazard**

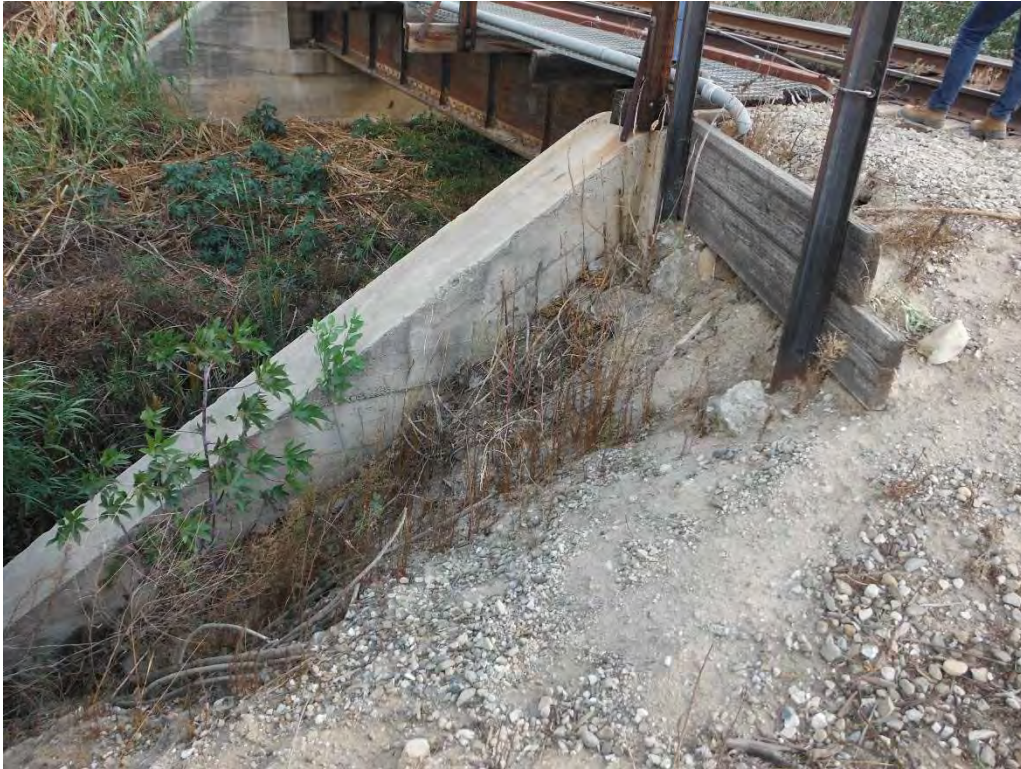
**410.40 NW ballast retainer undermining**

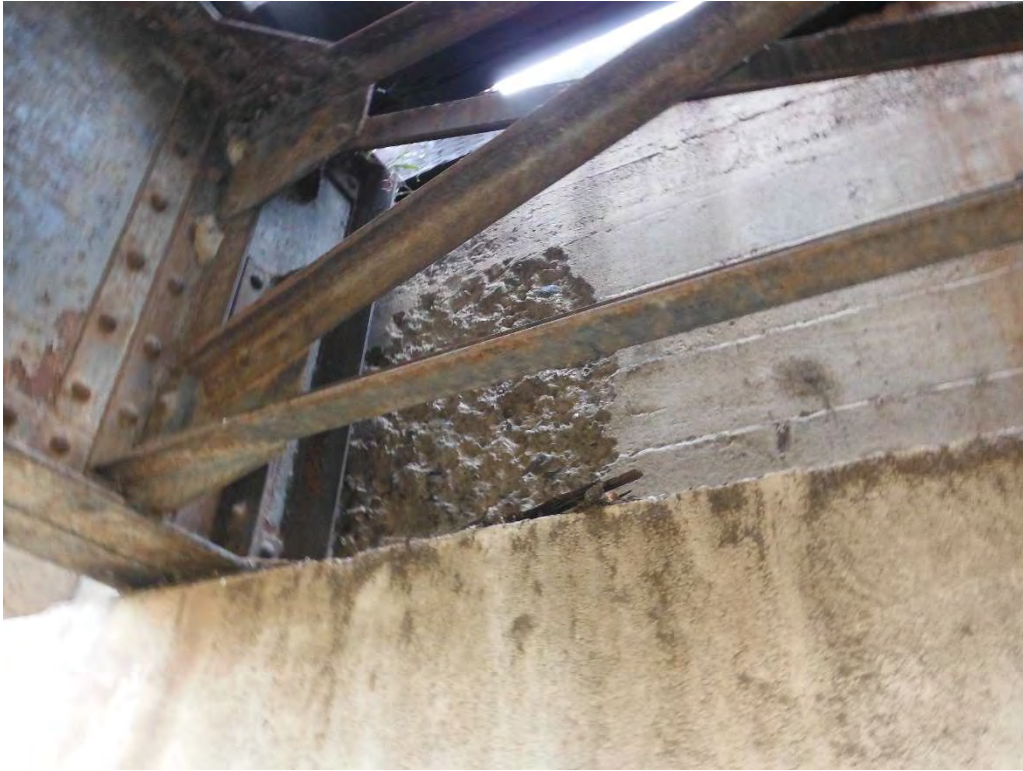
**410.40 Backwall spall – Abutment 1**

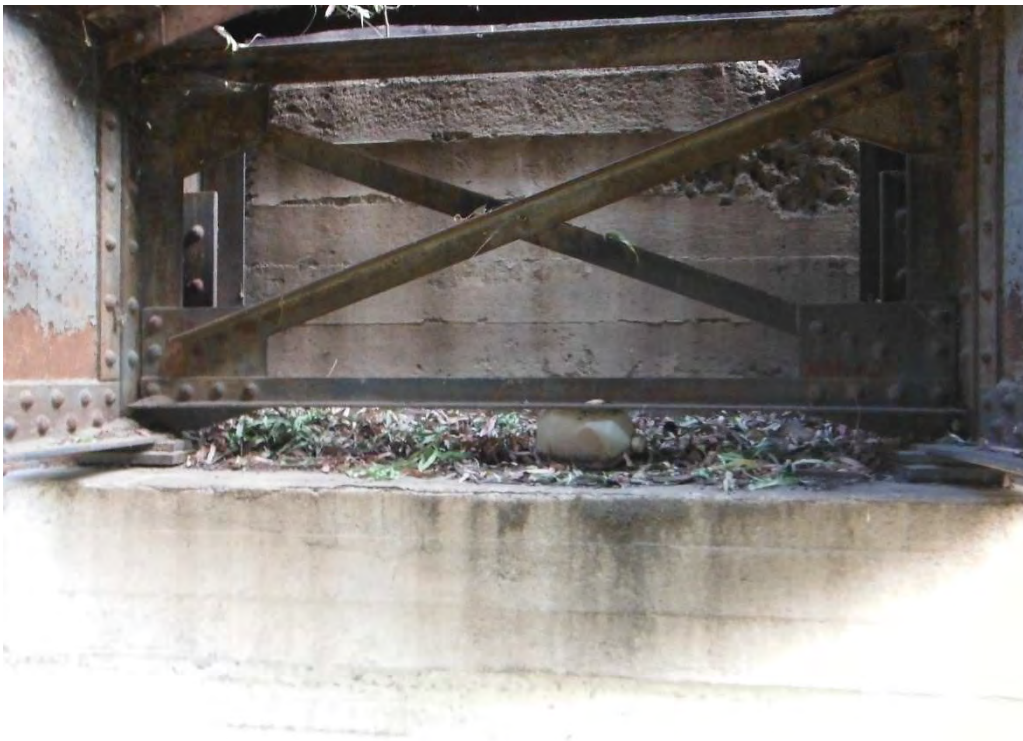
**410.40 Debris around bearings. Abutment 1 & 2**

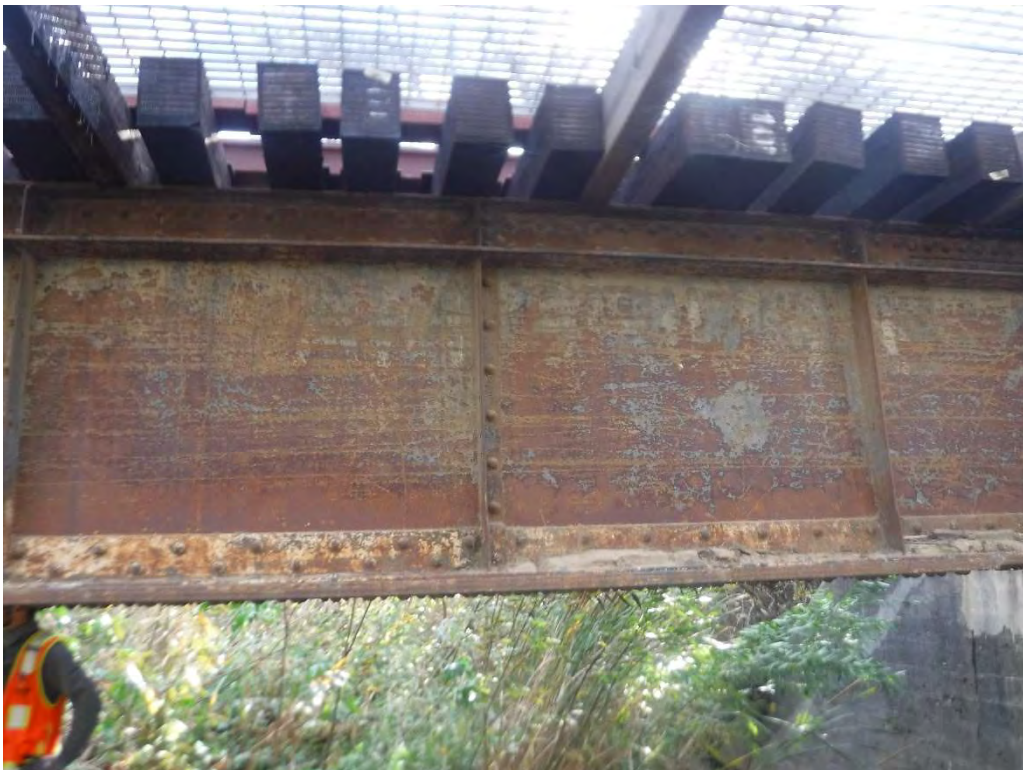
**410.40 Deck girder is in fair condition with paint failure and surface rust**

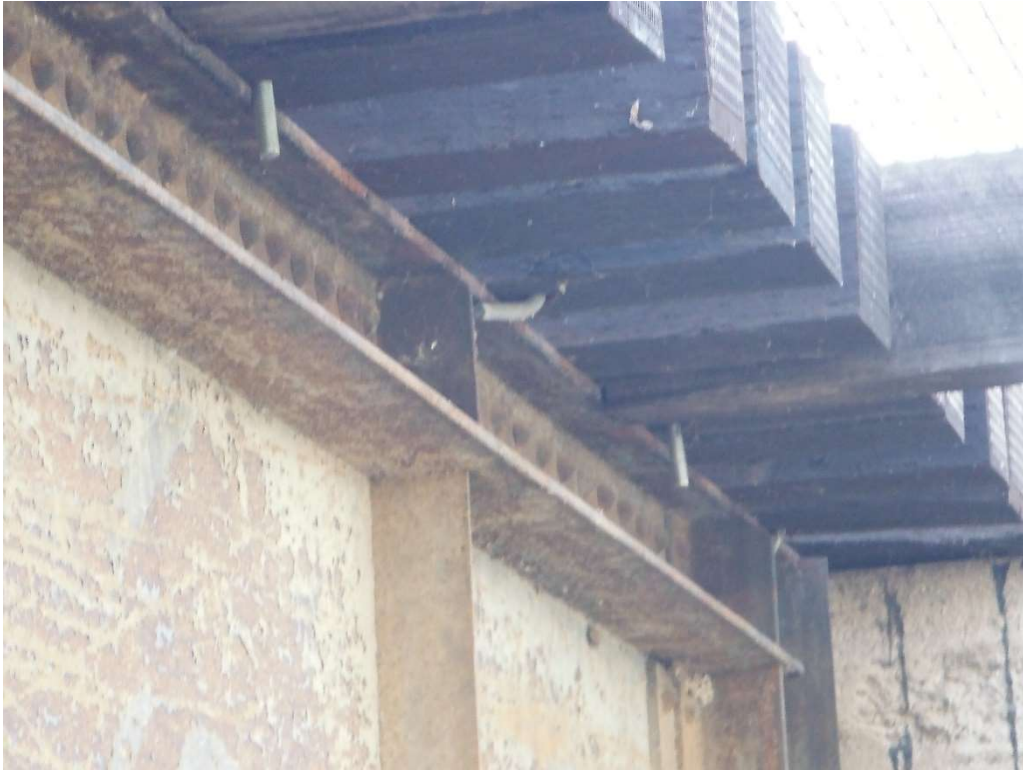
**410.40 J-bolt current conditions**

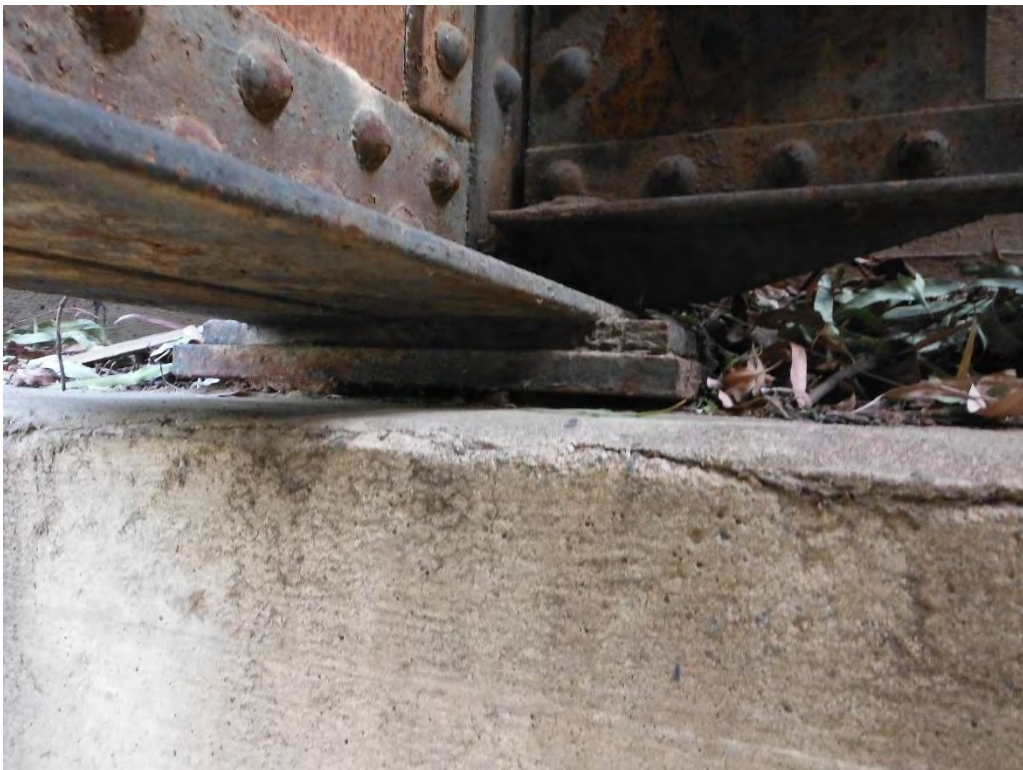
**410.40 Broken grout under bearing plates, Abutment 2**

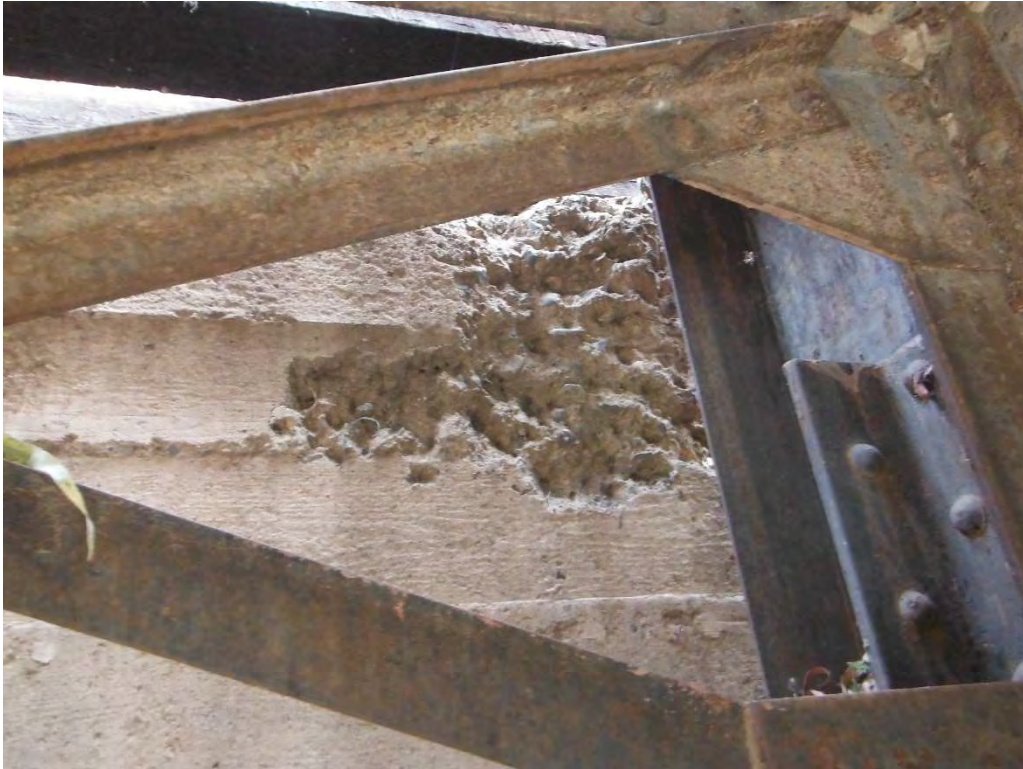
**410.40 Backwall spall – Abutment 2**

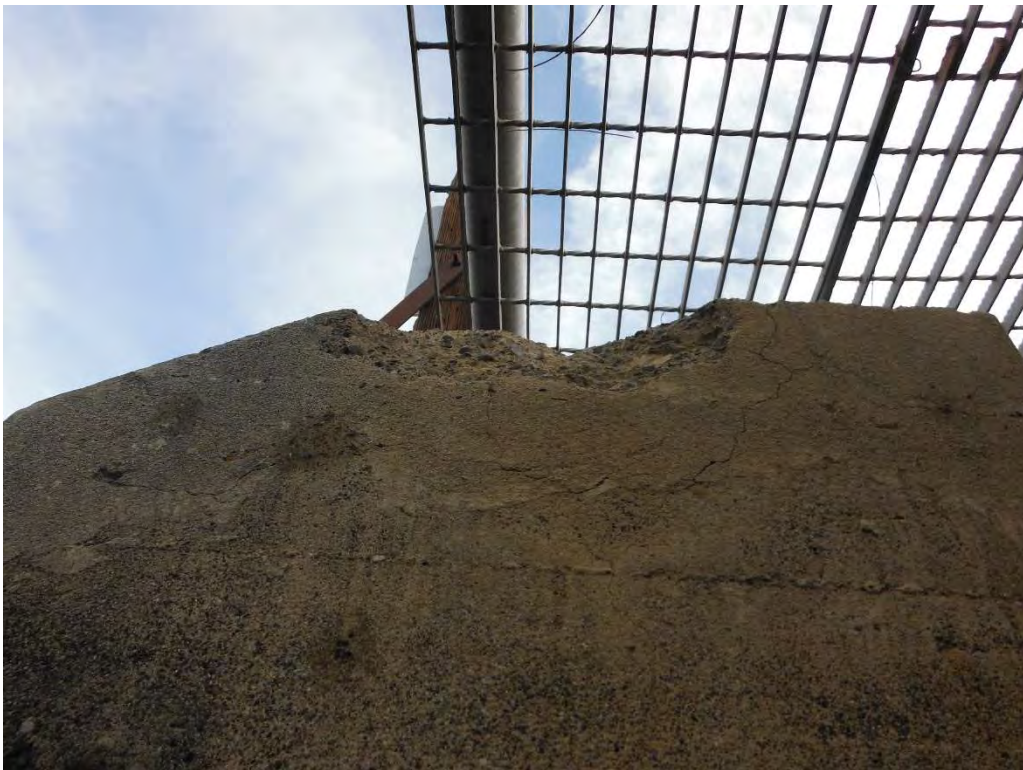
**410.40 NE Wingwall spall – Abutment 2**

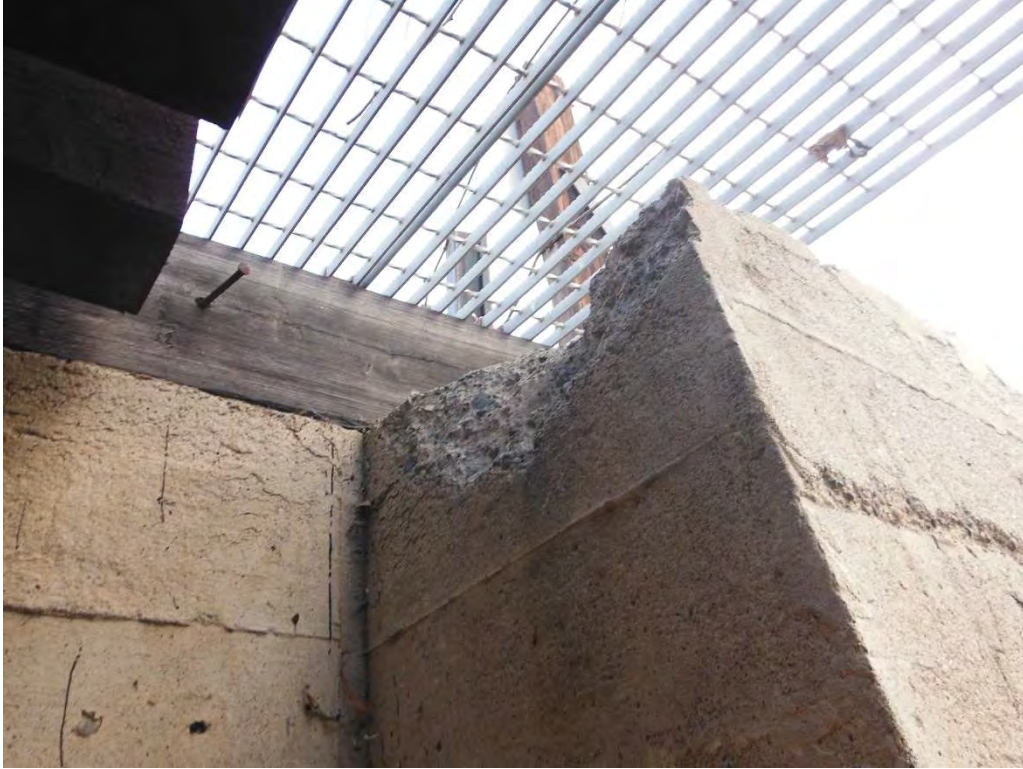
**410.40 SE Wingwall Spall – Abutment 2**

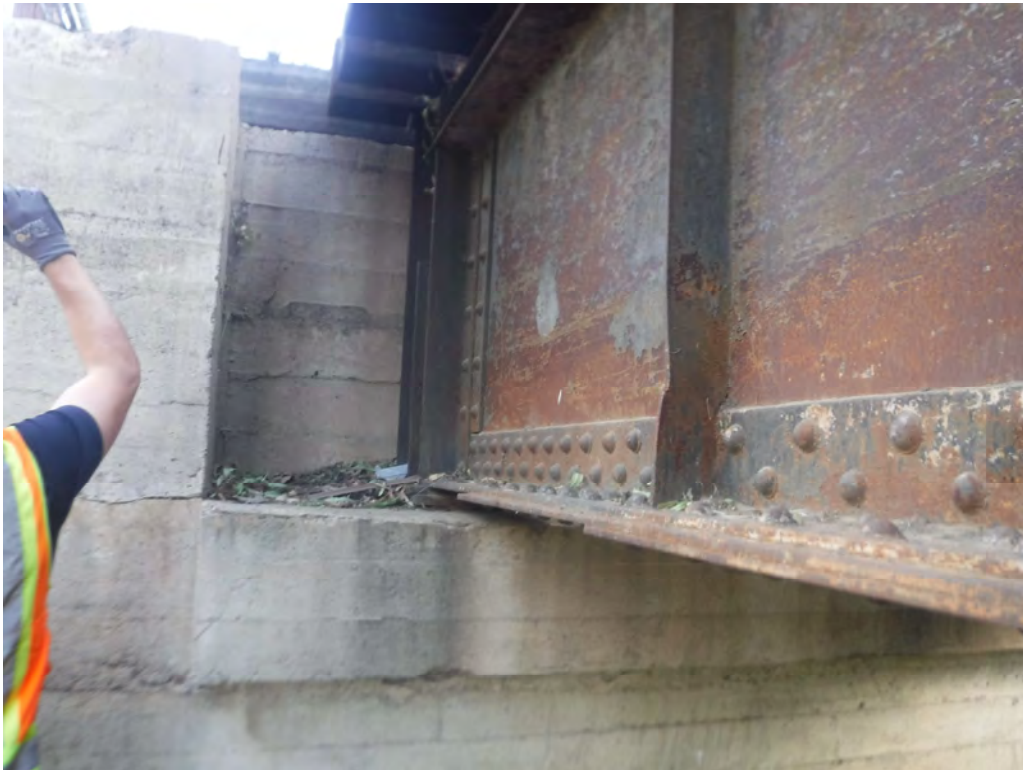
**410.40 Bent stiffener on north side near Abutment 2**

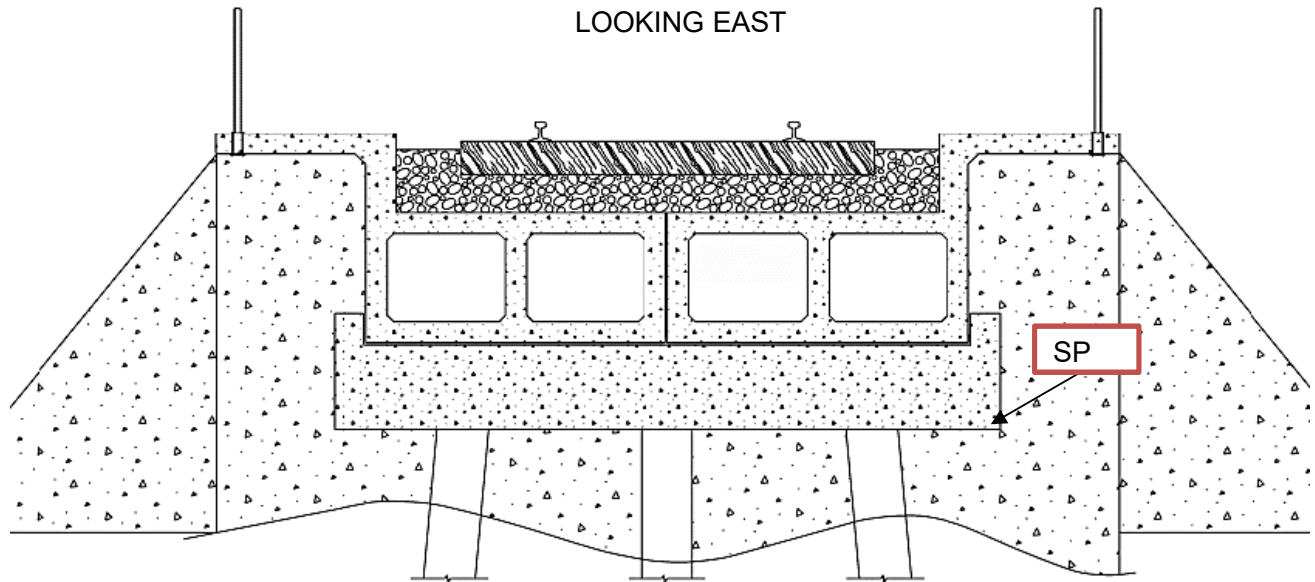
**Description: 80" x 30" Box Girders, Concrete Caps, H14x89 piles**

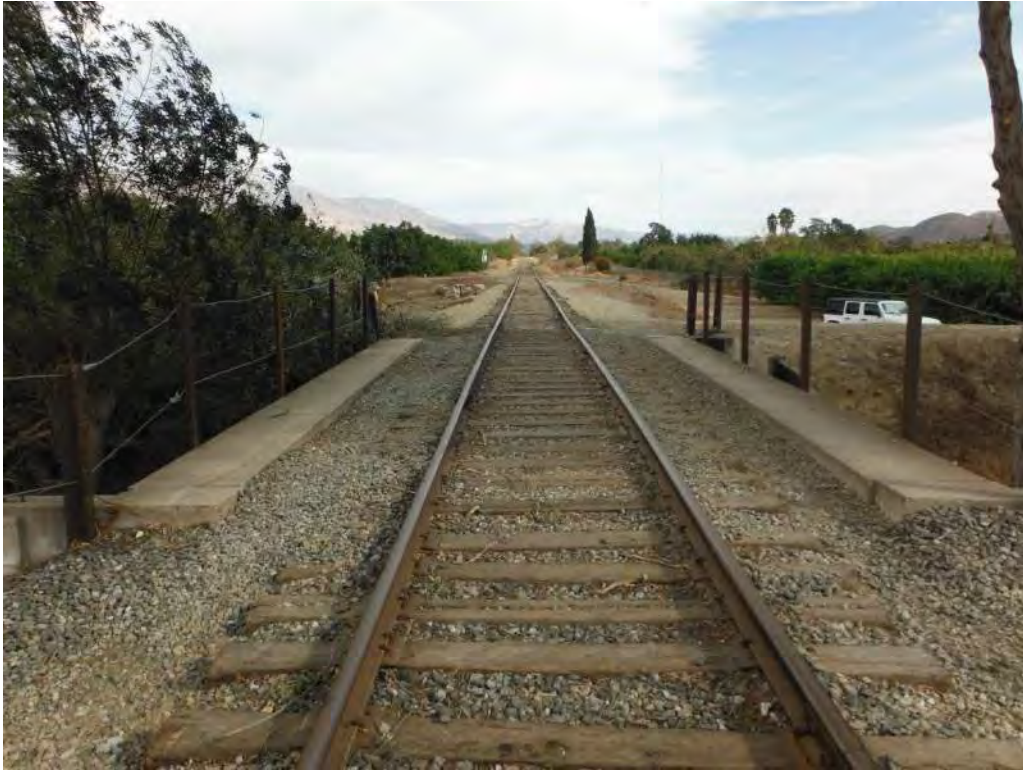
**411.97 Looking East**

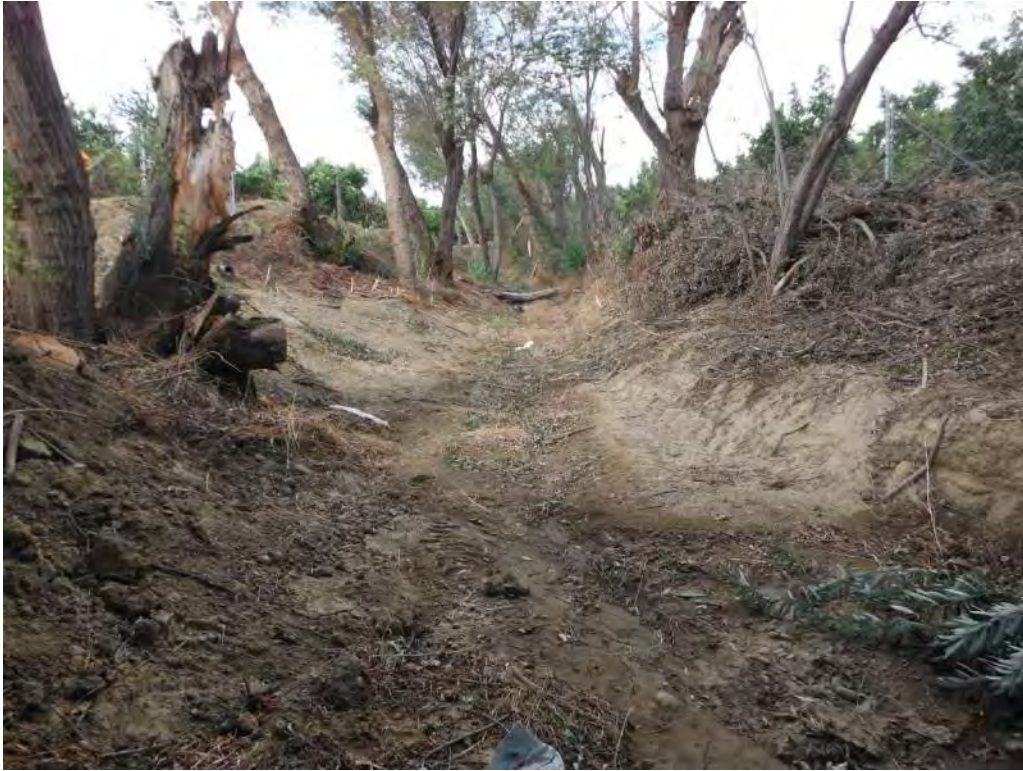
**411.97 Channel Conditions - Looking Upstream**

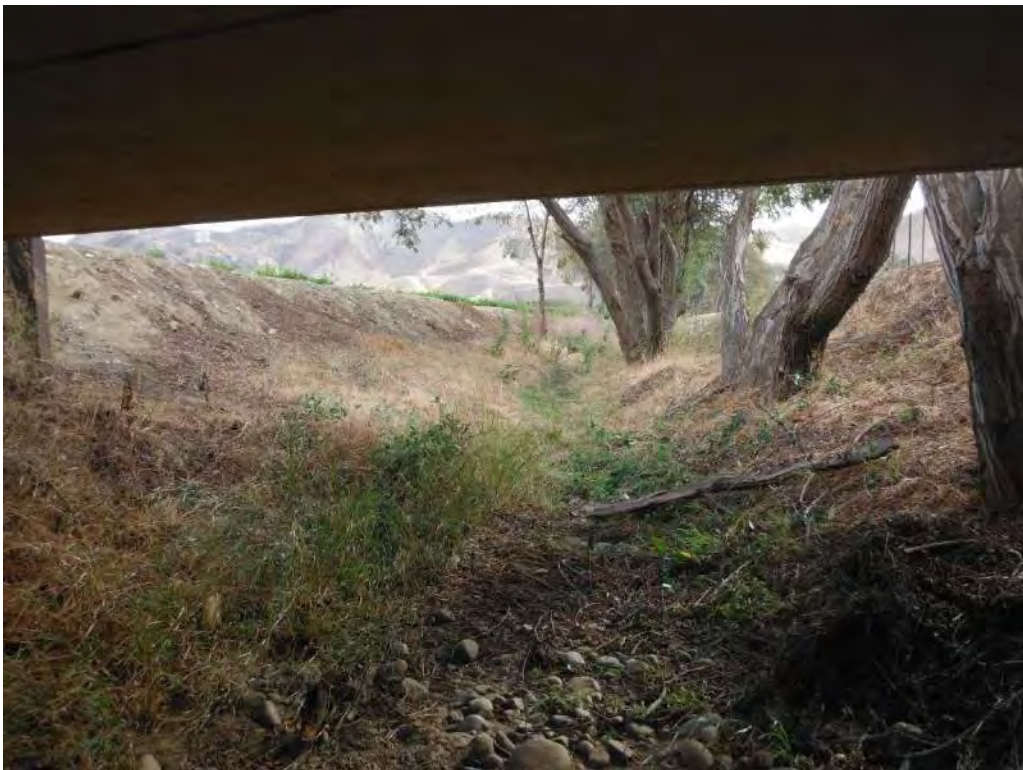
**411.97 Channel Conditions - Looking Downstream**

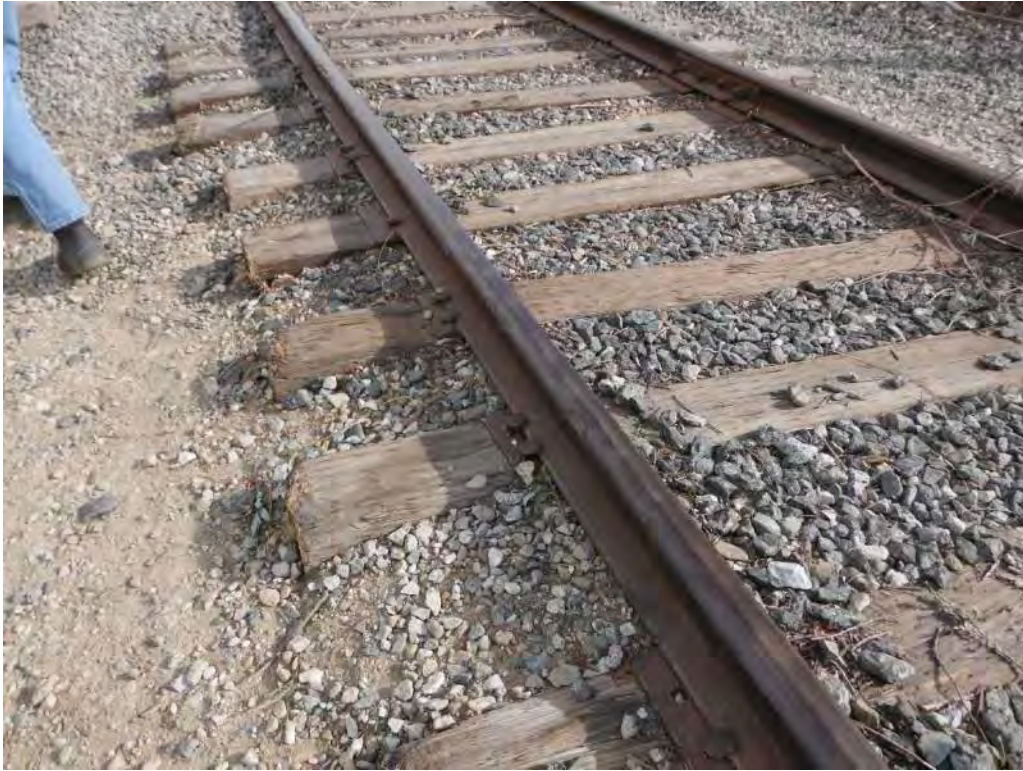
**411.97 NW rail section loss**

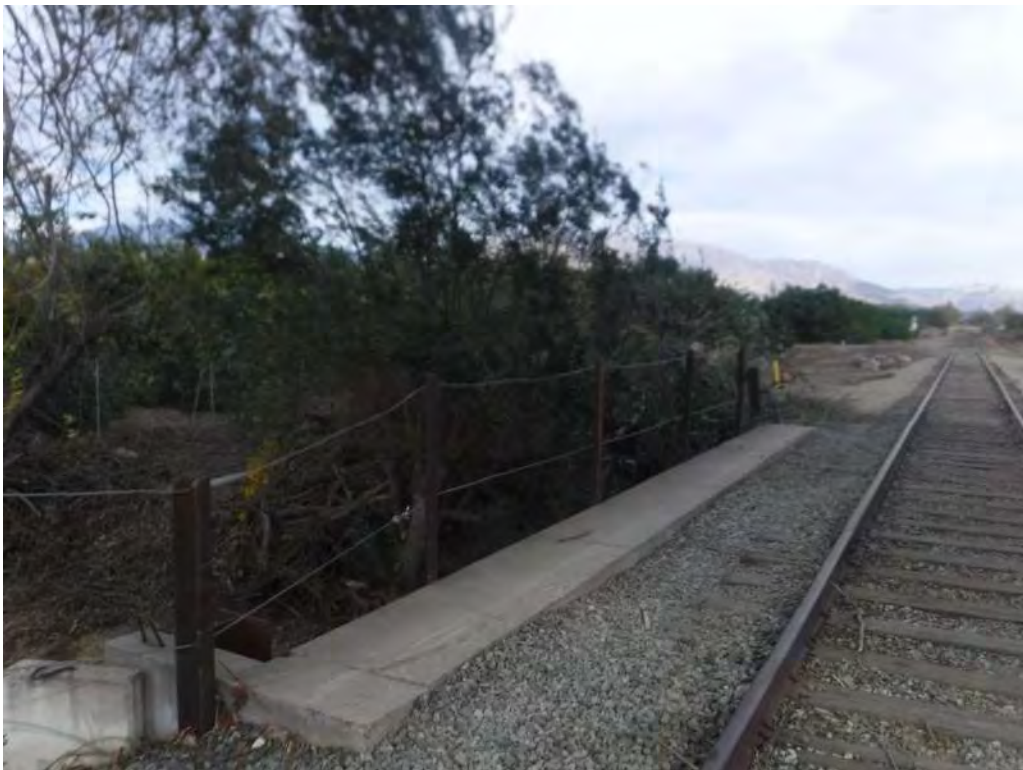
**411.97 Handrail loose (typ.)**

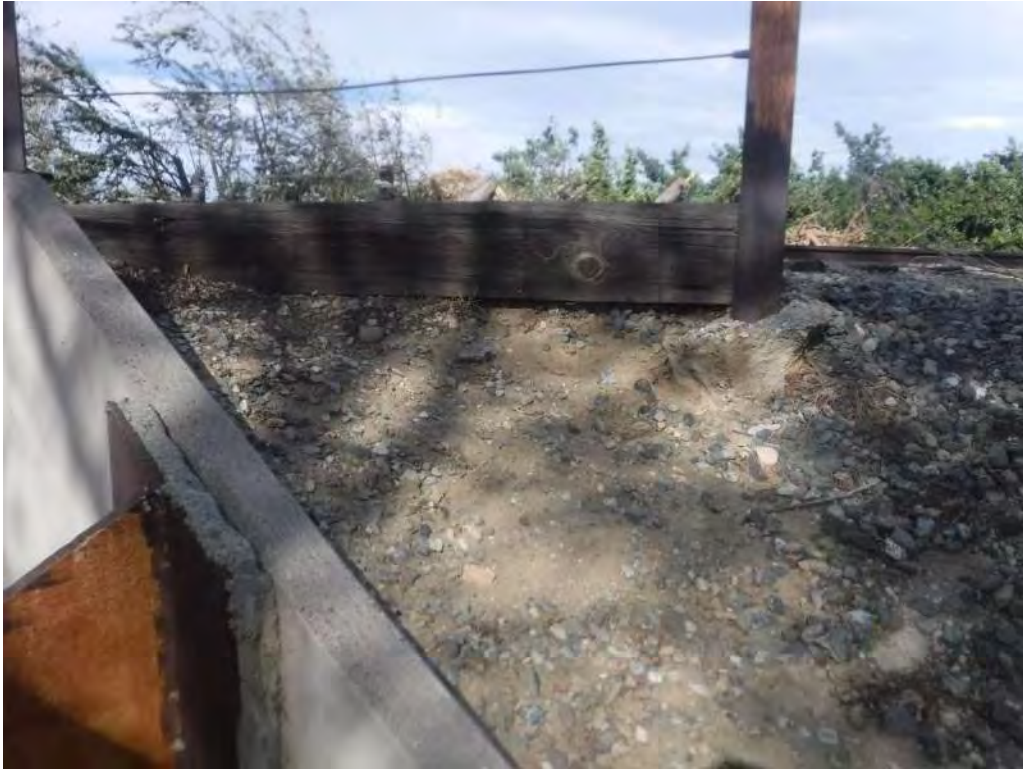
**411.97 Abutment 2 undermining SE Ballast retainer**

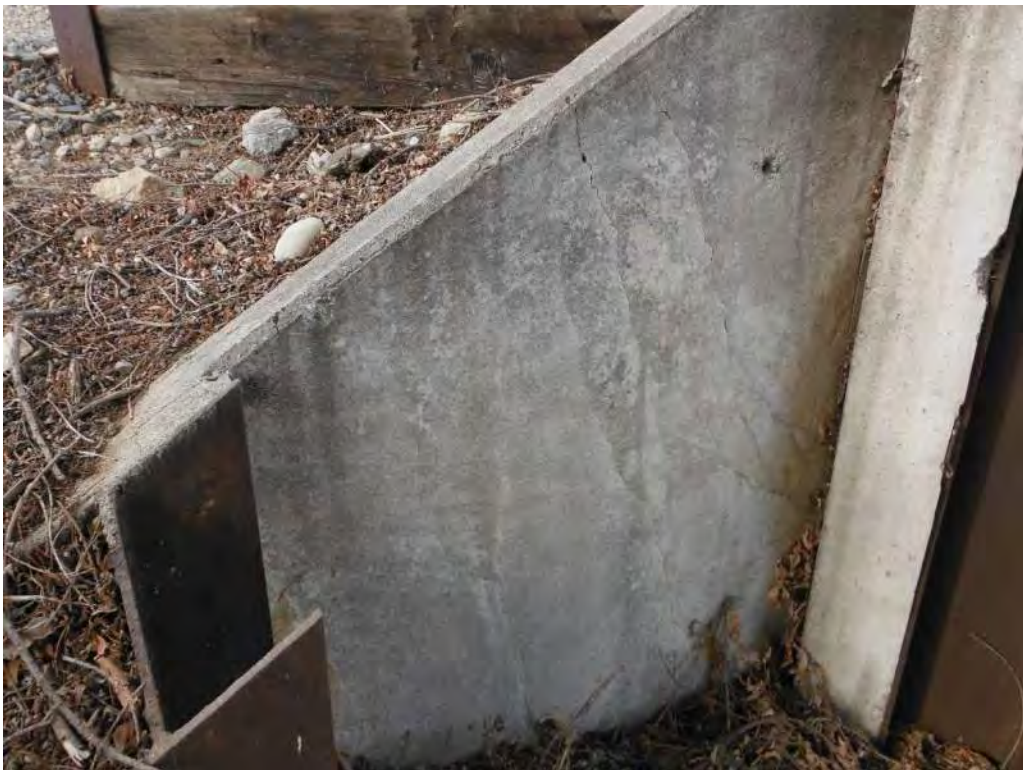
**411.97 Southwest wingwall cracking**

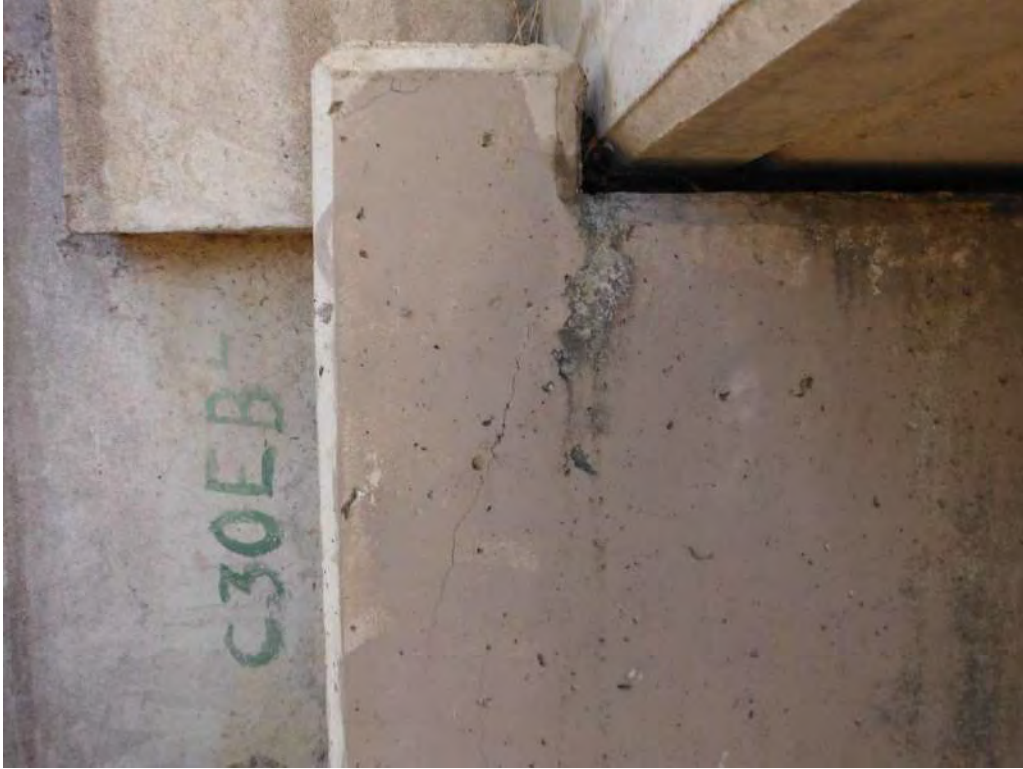
**411.97 Abutment 1 South keeper cracking**

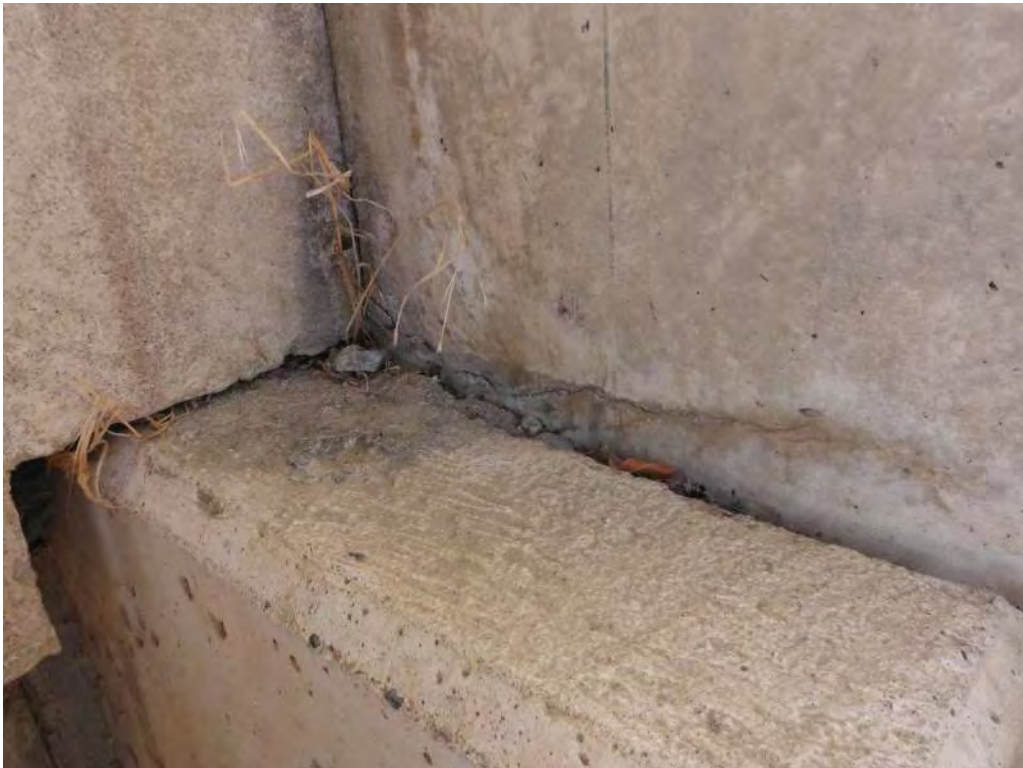
**411.97 Girder 1 cracking at Abutment 1**

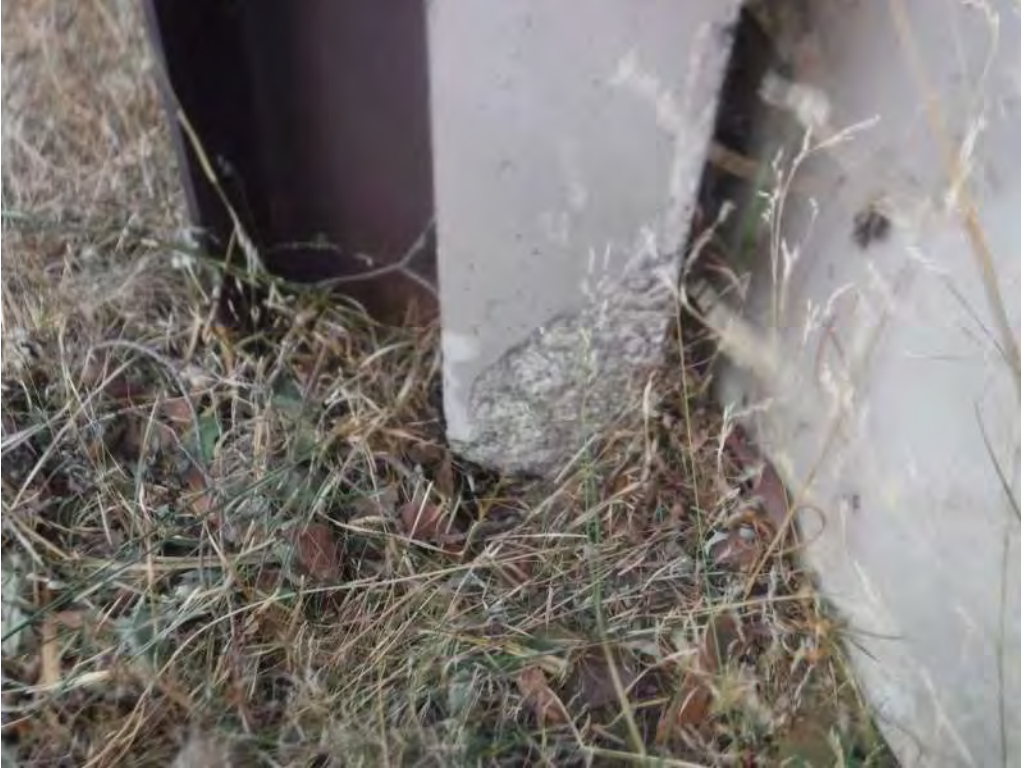
**411.97 Southeast Backwall Spall**

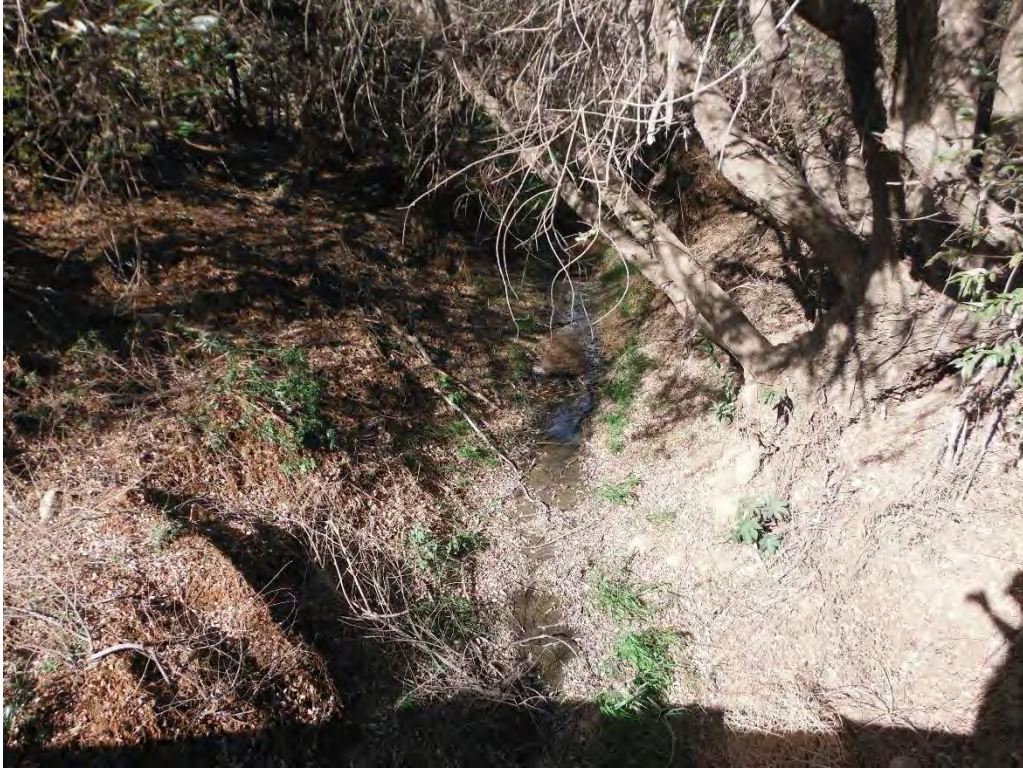
**412.25 Channel Condition - Looking Upstream**

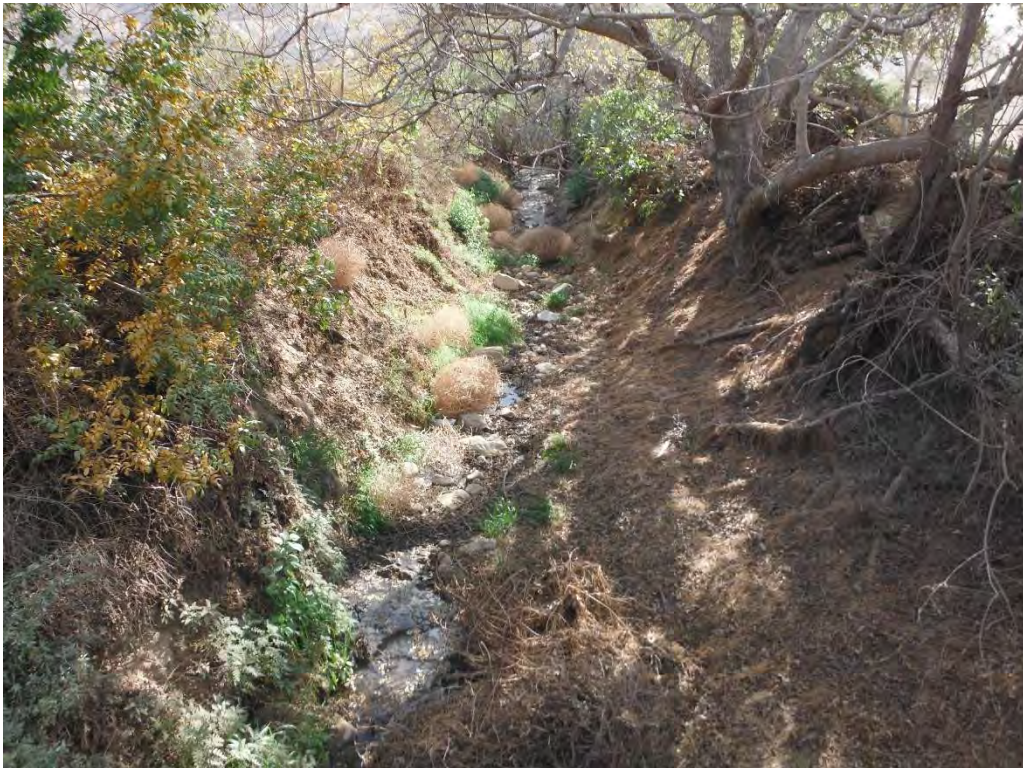
**412.25 Channel Condition - Looking Downstream**

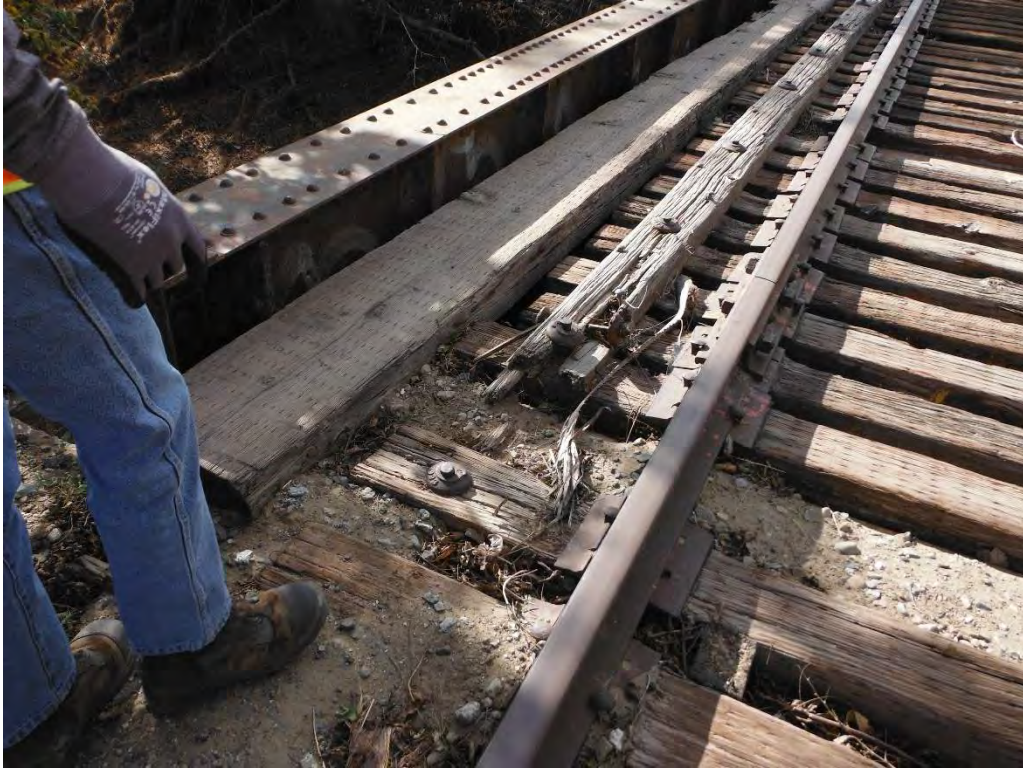
**412.25 Damaged curbs at east end**

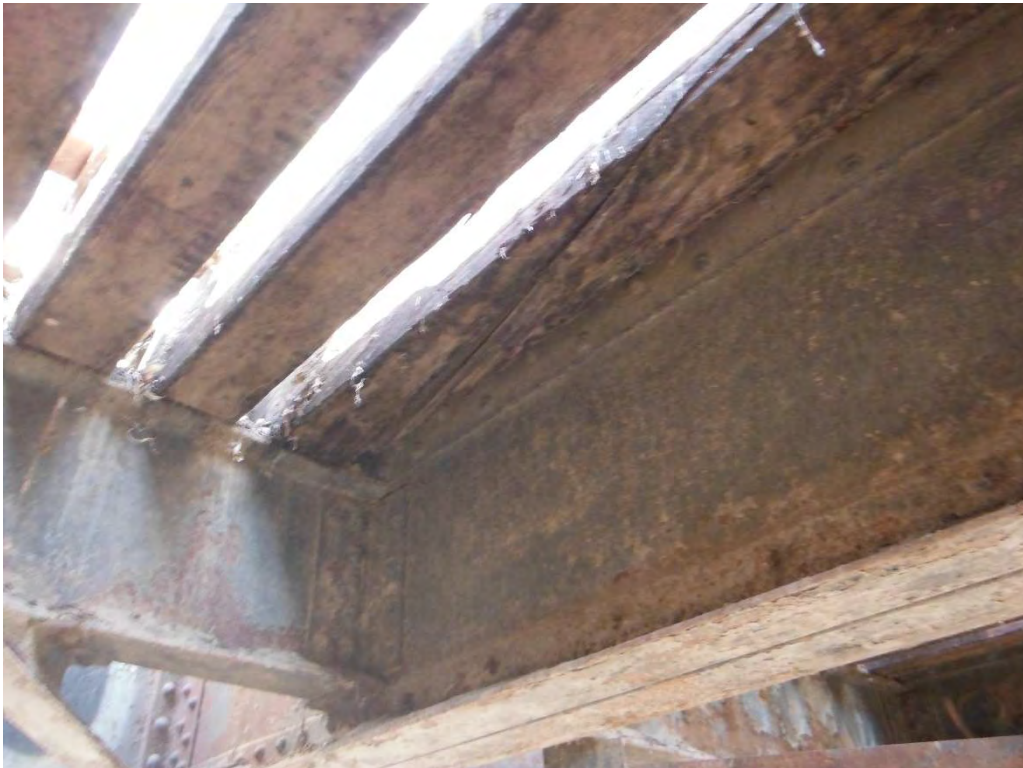
**412.25 Split Tie**

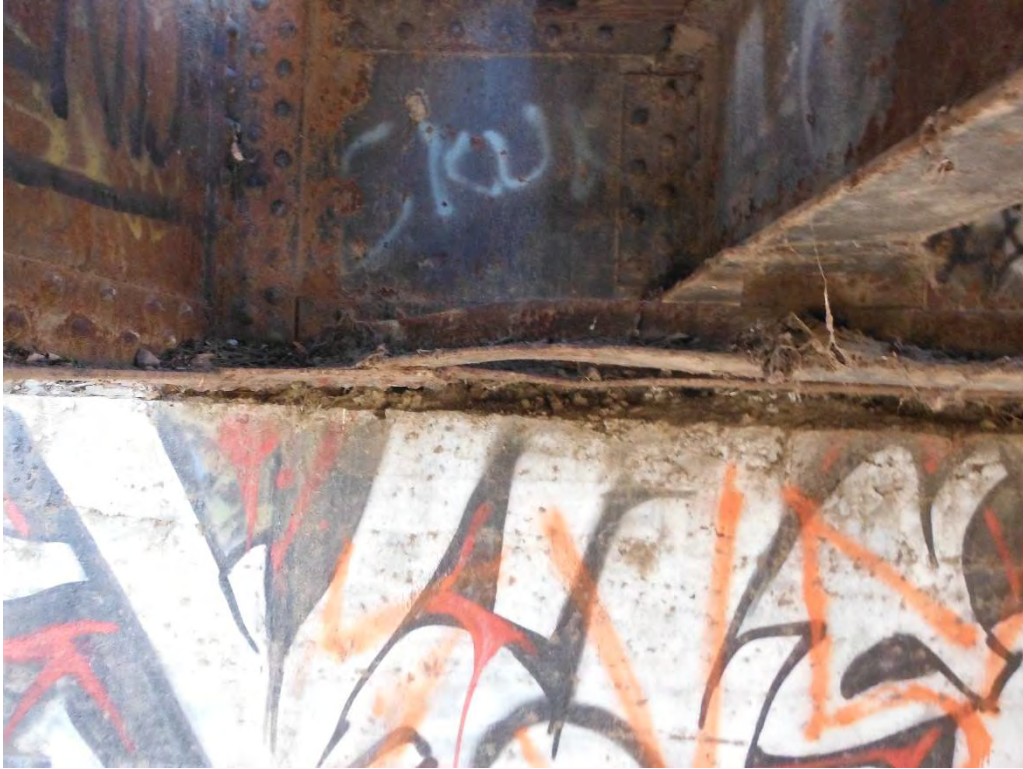
**412.25 Minor impact damage near Abutment 1**

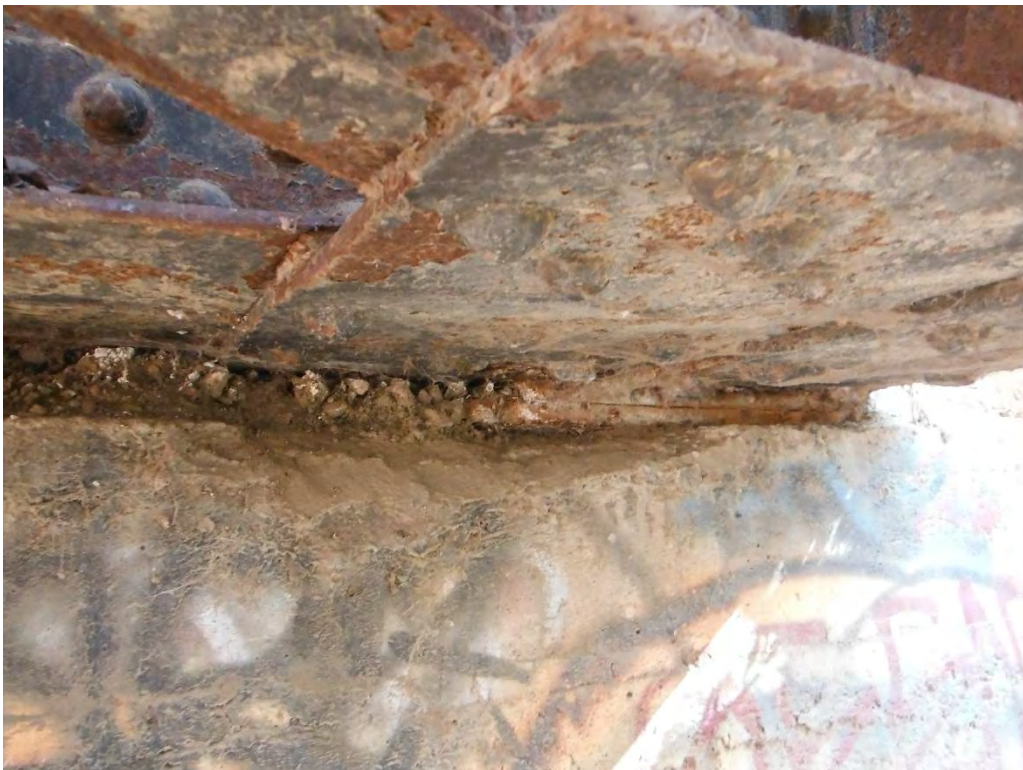
**412.25 Minor section loss/pack rust at bearings (typ.)**
