# BRIDGE INSPECTION REPORT

INSPECTION TYPE: Annual

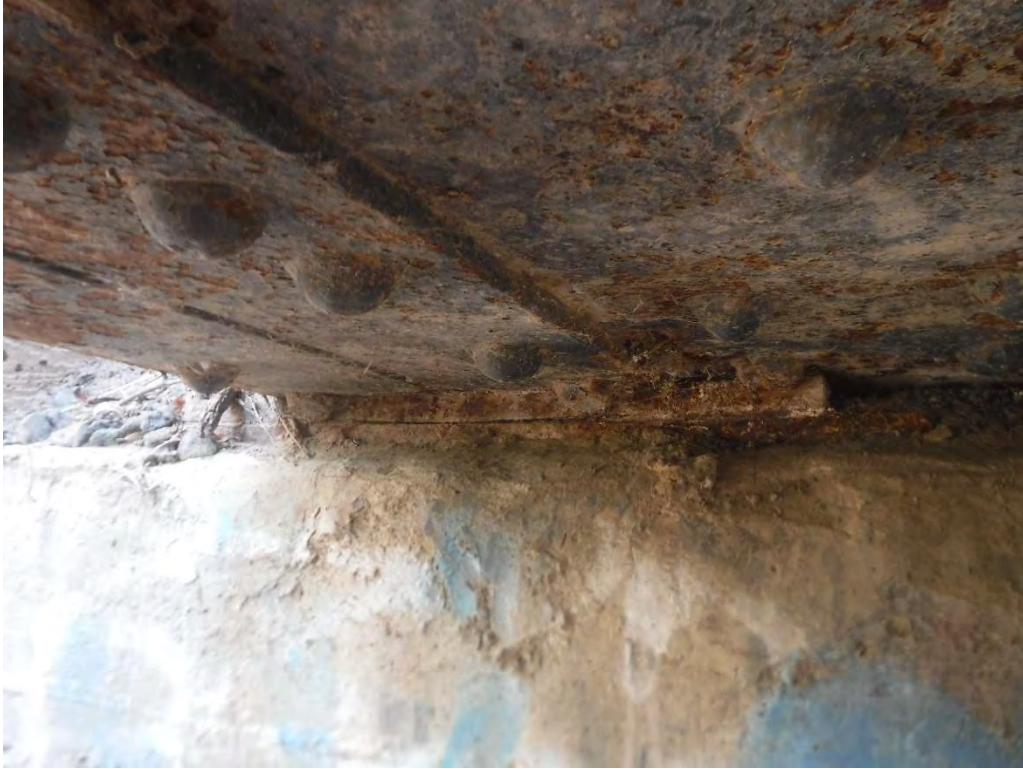
**412.25 Pack rust at bearing plates (typ.)**

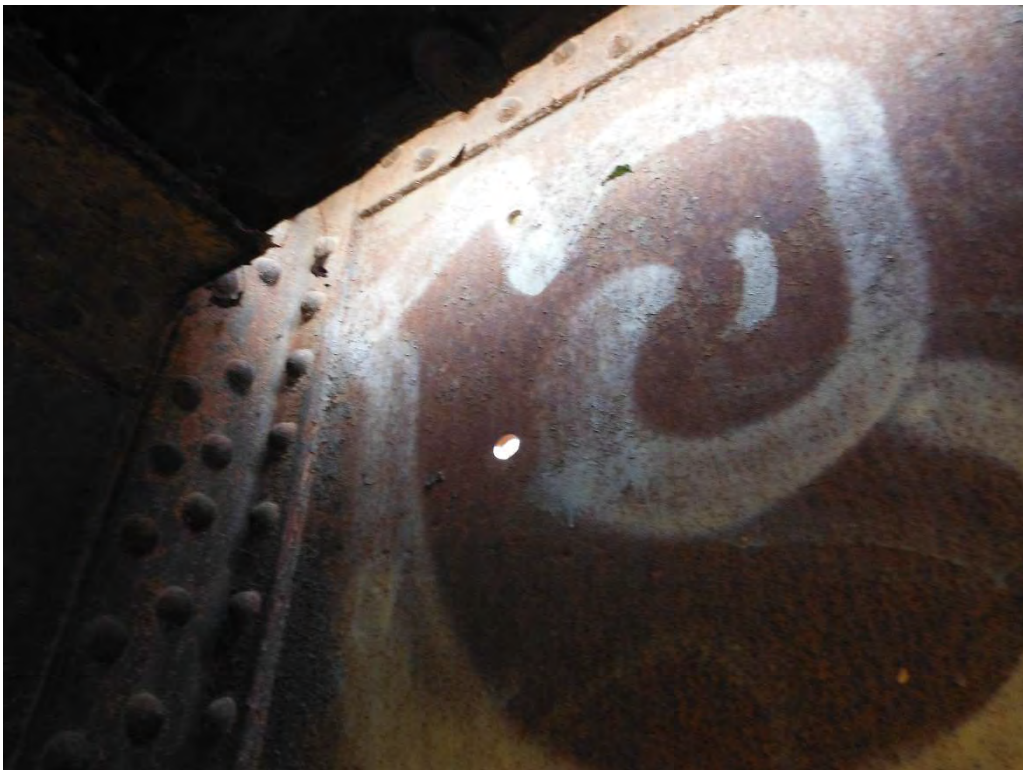
**412.25 Hole in web and stiffener damage at midspan G2**

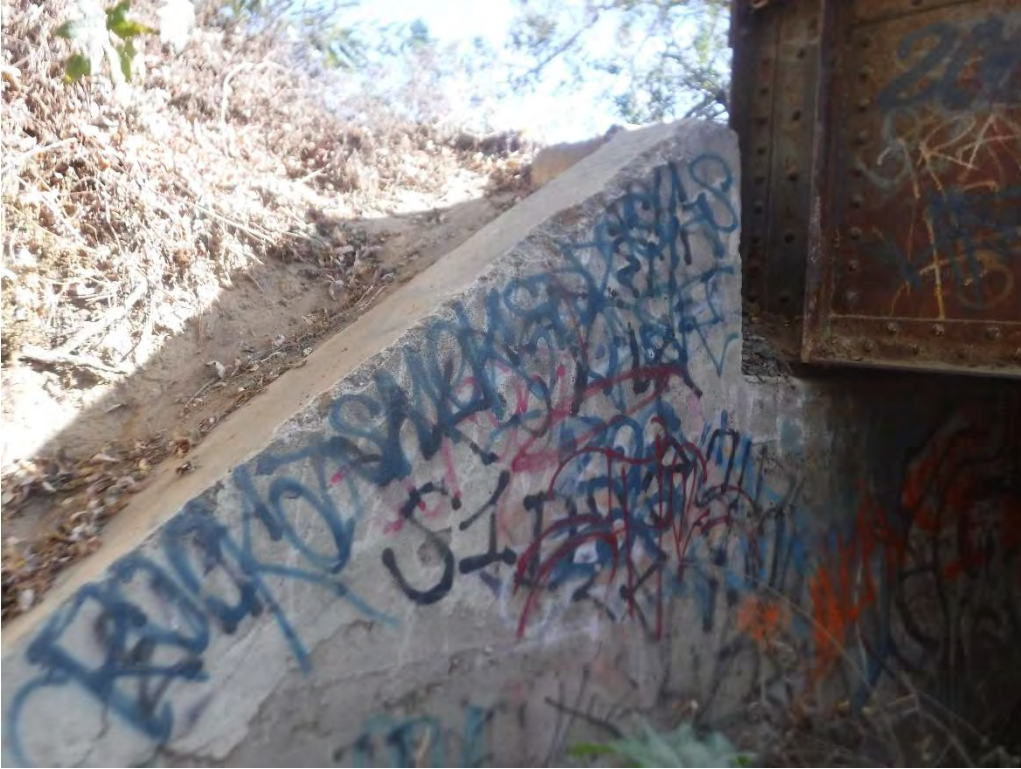
**412.25 Spalling on wingwall – see report for locations**

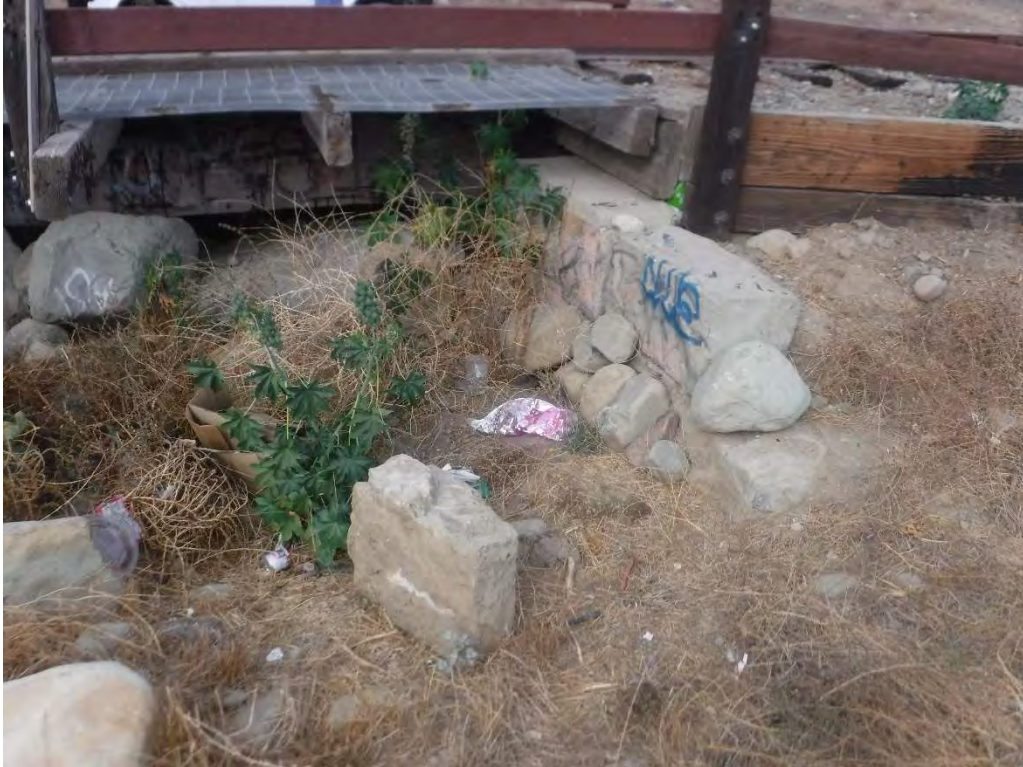
**415.32 Damaged walkway – south side**

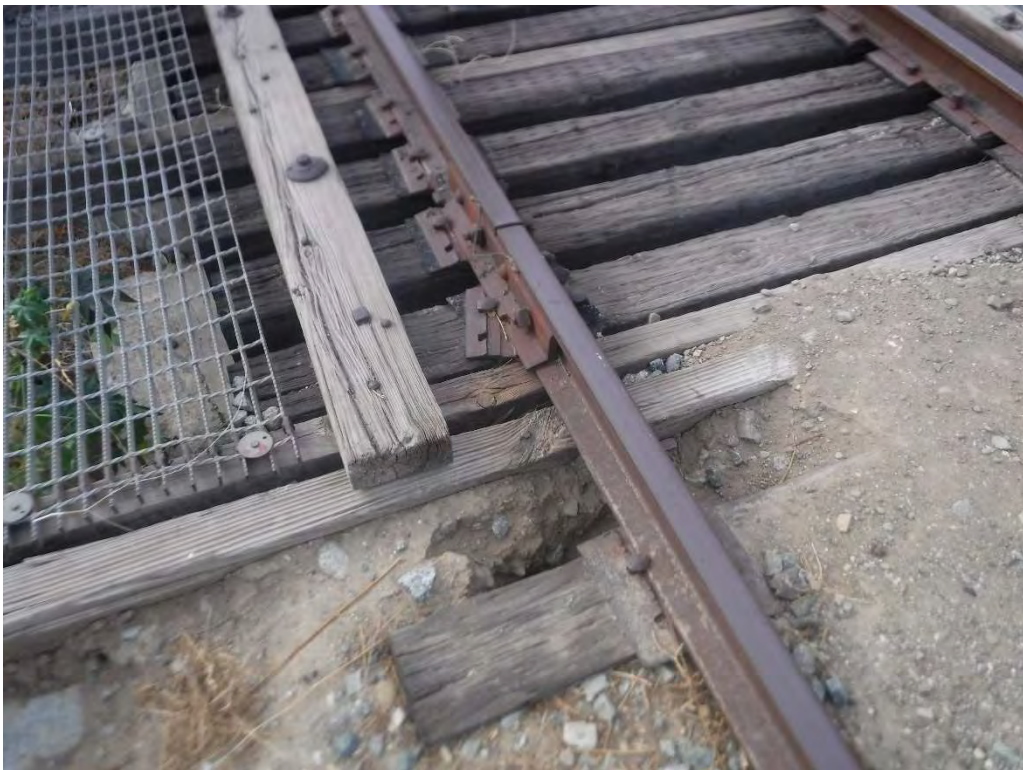
**415.32 Tie Plate Loose**

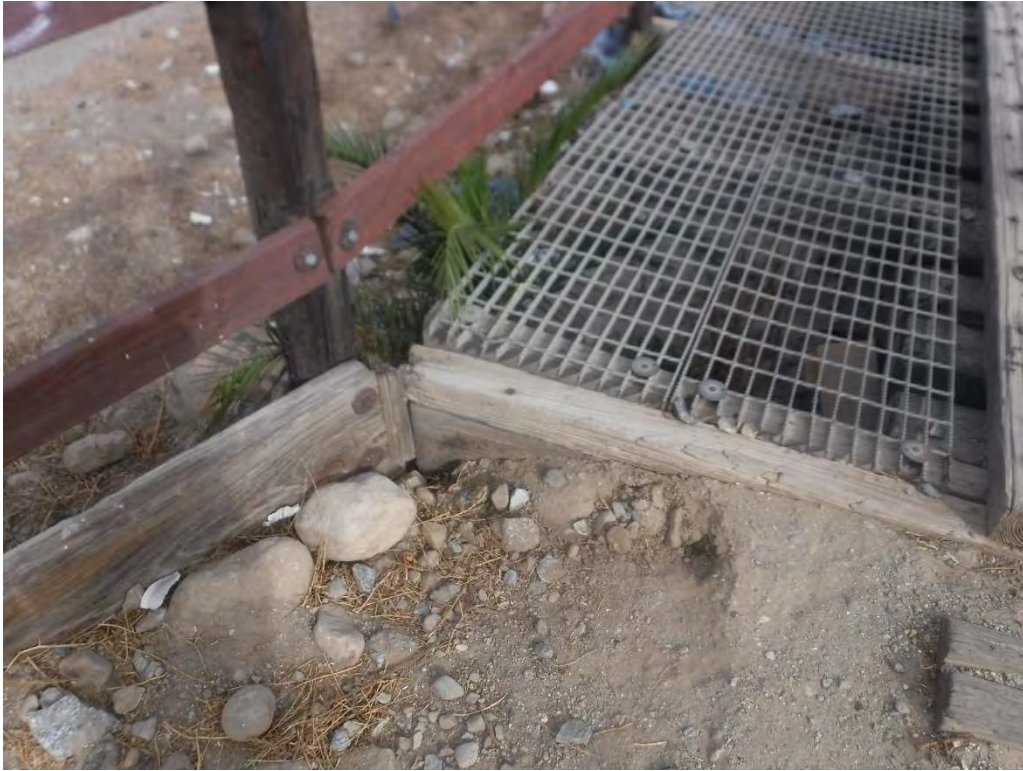
**415.32 Hole in Ballast, SE Corner**

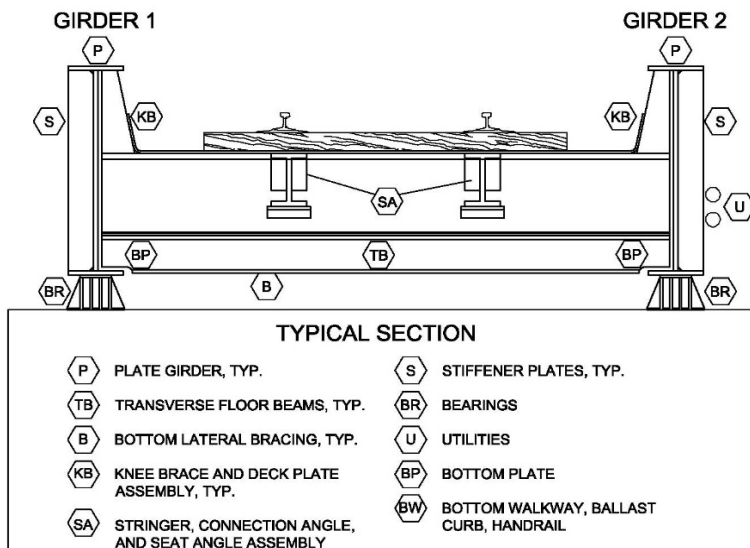
DIVISION	Santa Paula	SPAN LENGTH	66'-8"
NUMBER OF TRACKS	1	CROSSING	Santa Paula Creek
TRACK ALIGNMENT	TANGENT	SPAN No.	1
INSPECTION FINDINGS			
	Grout pad cracked under bearing at pier 2 - see photo

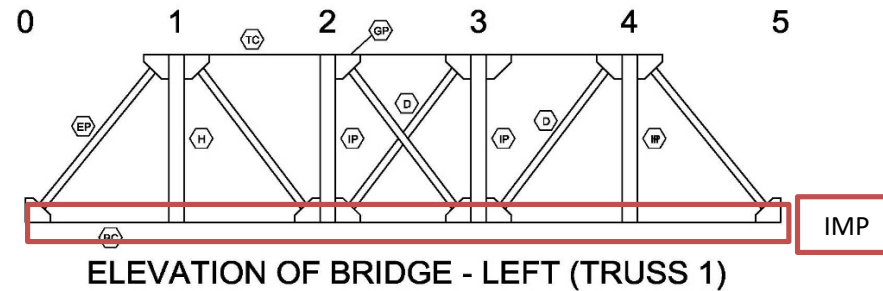
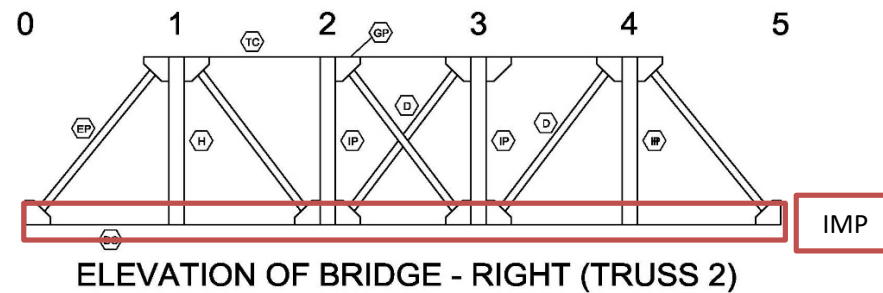
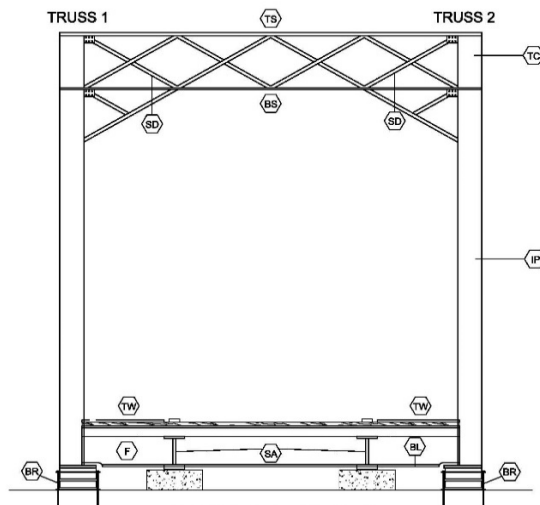
BC	BOTTOM CHORD	GP	GUSSET PLATE	SL	STRINGER LATERALS
BL	BOTTOM LATERAL INTERSECTION PLATE	H	HANGER	SS	STRINGER STRUT
BL	BOTTOM LATERALS	IB	INTERMEDIATE FLOORBEAM	T1	TRUSS 1 - LEFT SIDE
BP	BOTTOM LATERAL PLATE	IP	INTERMEDIATE POST	T2	TRUSS 2 - RIGHT SIDE
BR	BEARINGS	KB	KNEE BRACE	TC	TOP CHORD
BS	SWAY BRACING - BOTTOM STRUT	S1	STRINGER 1 - LEFT SIDE	TIP	TOP LATERAL INTERSECTION PLATE
D	DIAGONALS	S2	STRINGER 2 - RIGHT SIDE	TL	TOP LATERALS
EP	END FLOORBEAM	SA	STRINGER, CONNECTION ANGLE, AND SEAT ANGLE ASSEMBLY	TP	TOP LATERAL PLATE
EP	END POST	SB	SWAY BRACING	TS	SWAY BRACING - TOP STRUT
F	FLOORBEAM	SD	SWAY BRACING - DIAGONALS	TW	TOP WALKWAY, BALLAST CURB, AND HANDRAIL
FB	FLOORBEAM BRACKET AND CONNECTION ANGLE ASSEMBLY	SL	STRINGER LATERALS

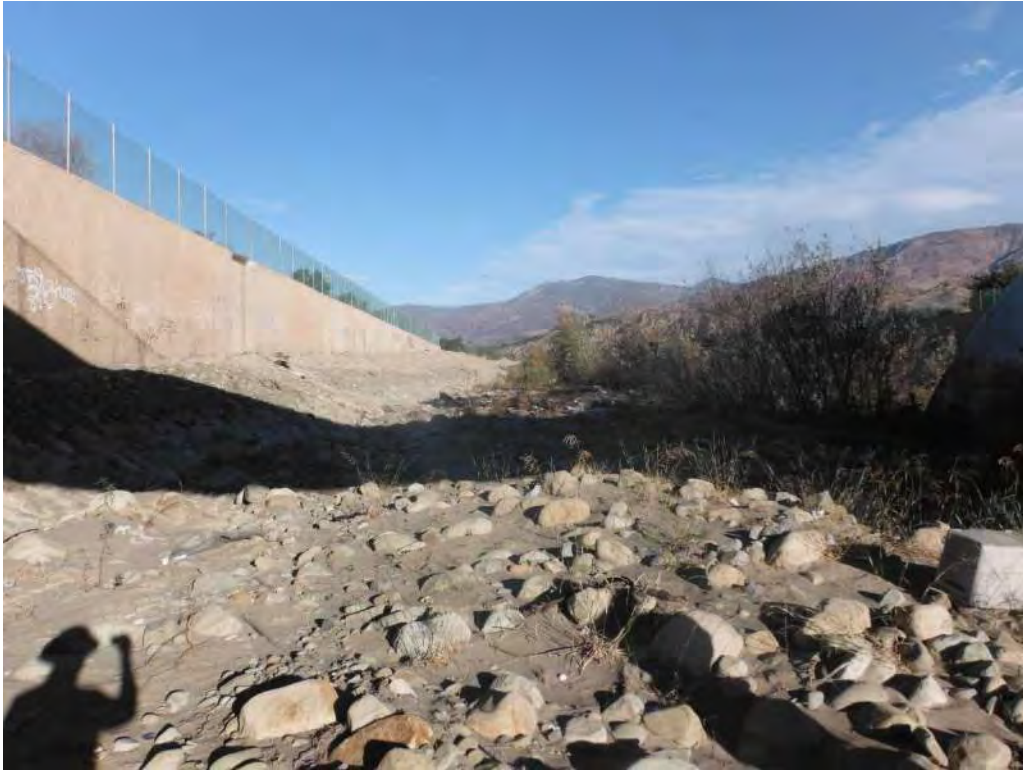
**415.59 Channel Condition. Looking upstream**

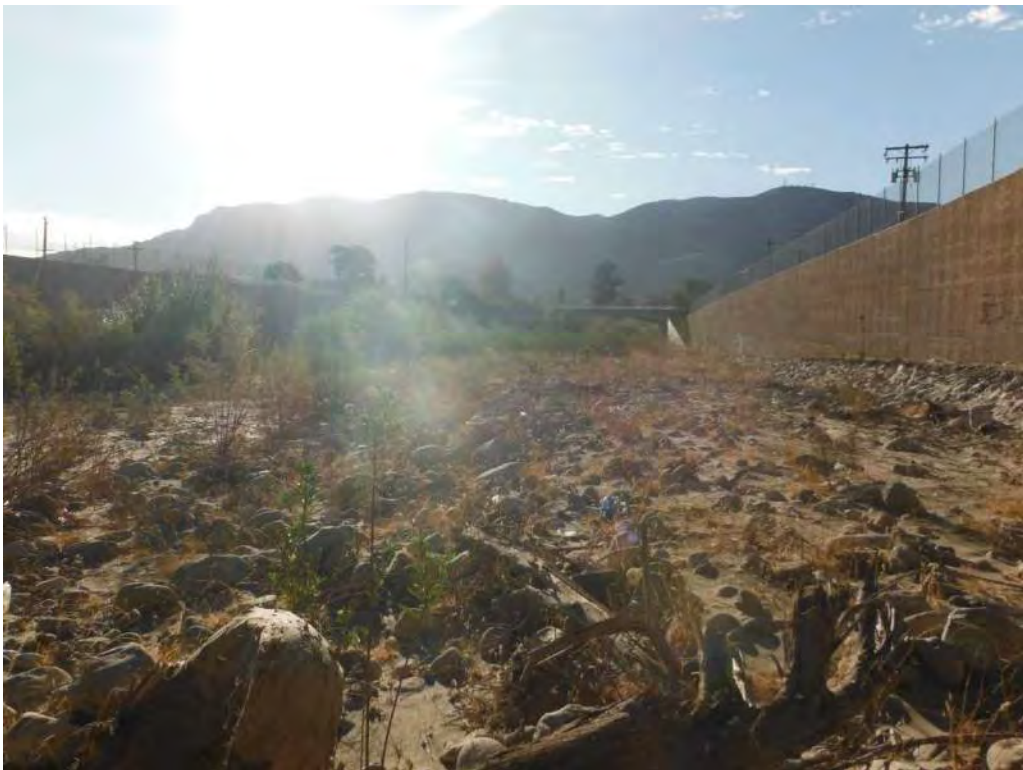
**415.59 Channel Condition. Looking downstream**

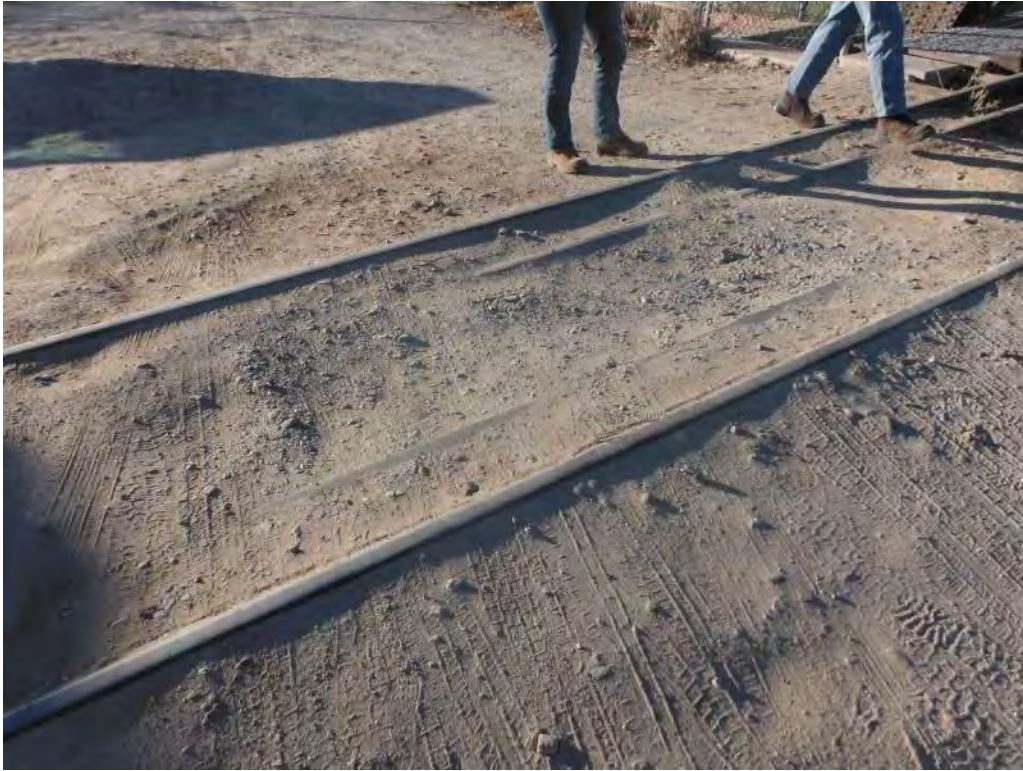
**415.59 Material between inside guardrail and running rail, typ both sides**

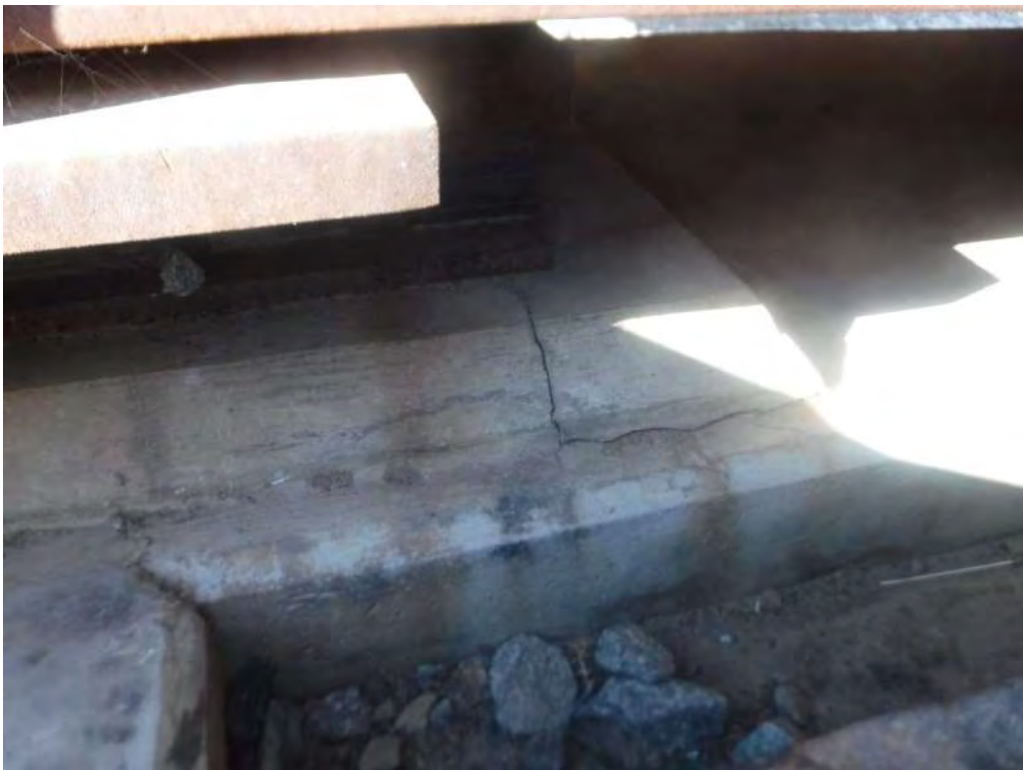
**415.59 Grout pad cracked under bearing, Pier 2**

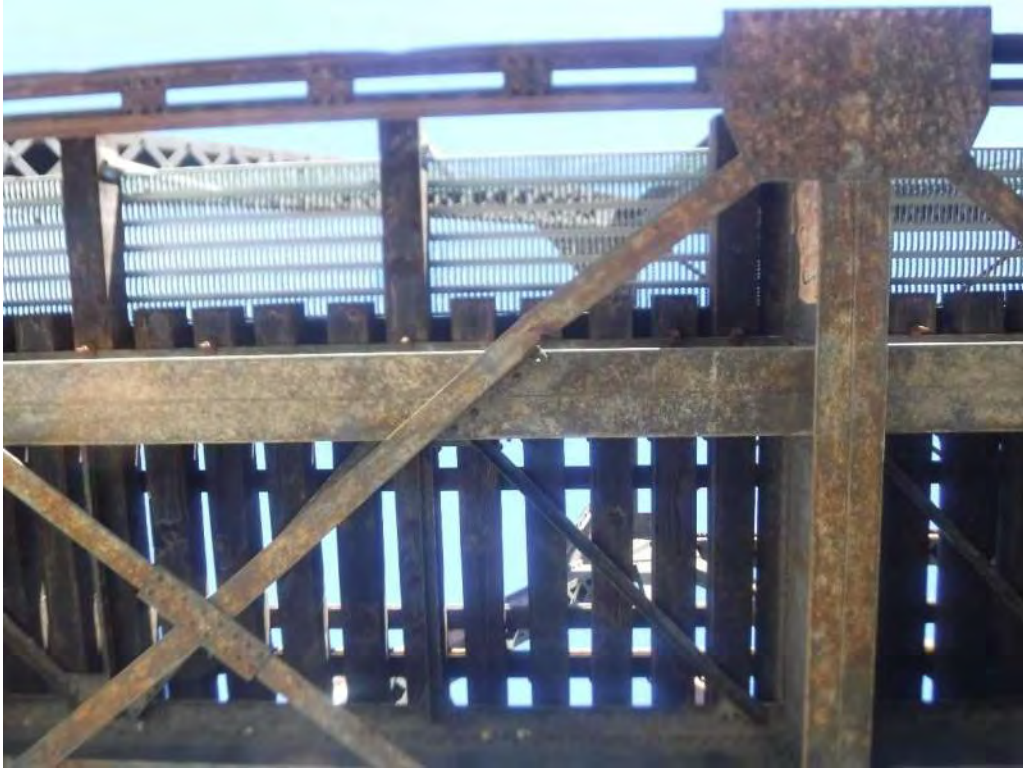
**415.59 Minor impact damage – typical bottom cross bracing**

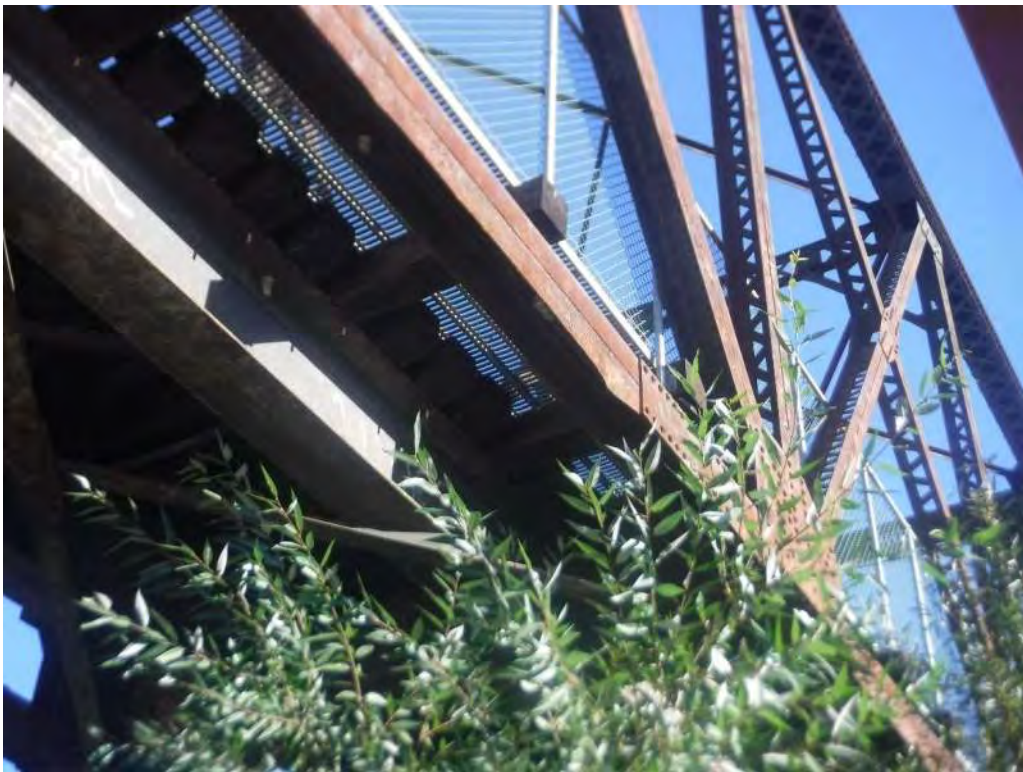
**415.59 Gash in right bottom chord, Bay 3.**

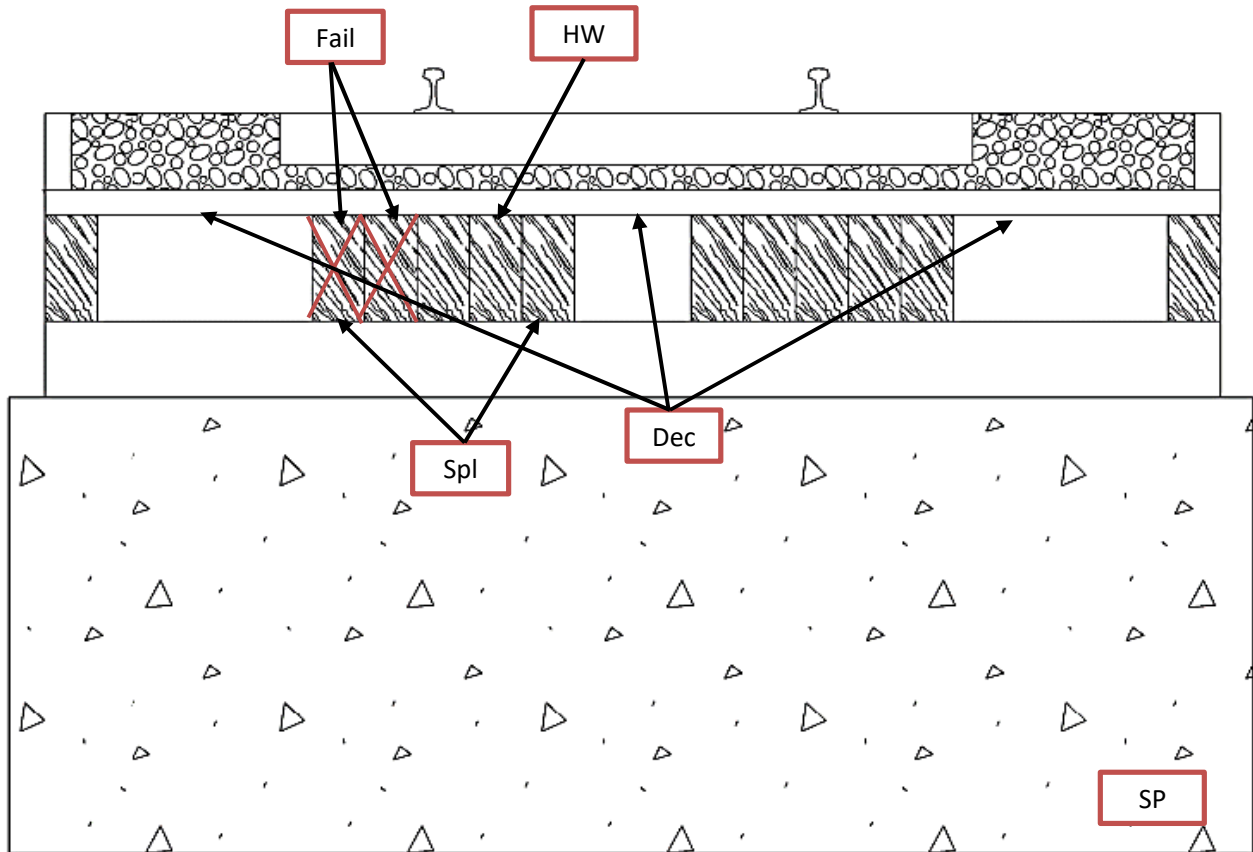
### Description: Looking West - (12) 8"x17" Timber Stringers, Concrete Pier

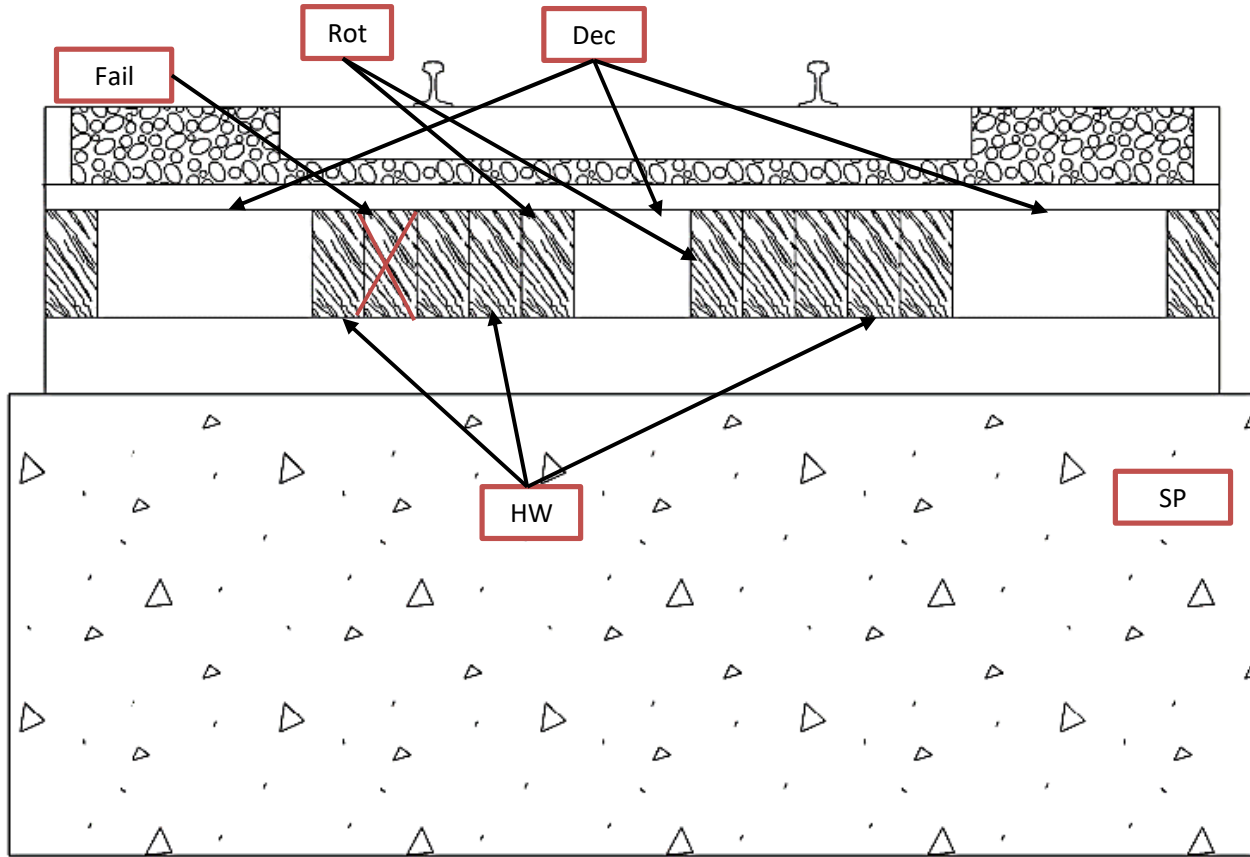
### Description: Looking West - (12) 8"x17" Timber Stringers, Concrete Pier

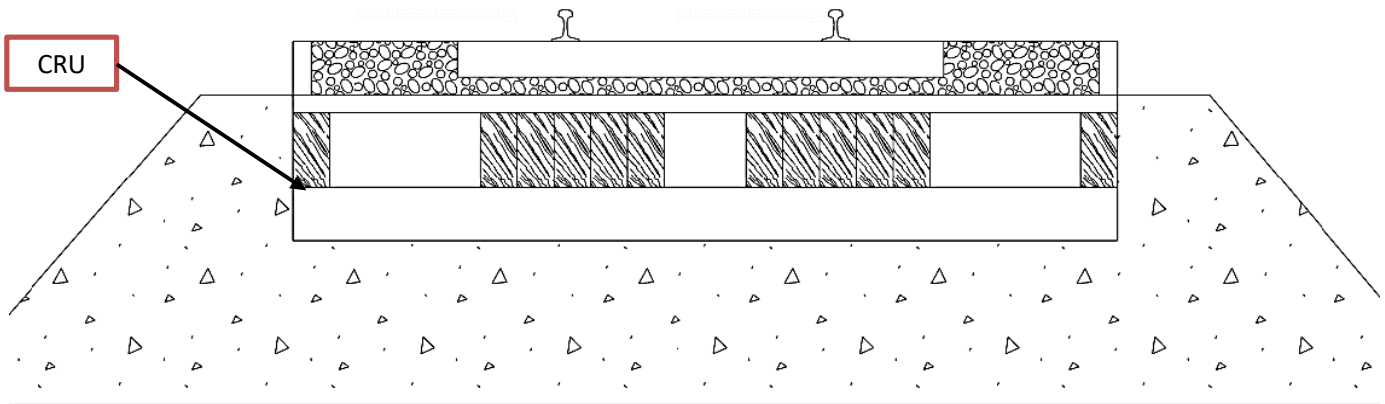
**Description: Looking East - (12) 8"x17" Timber Stringers, Concrete Abutment**

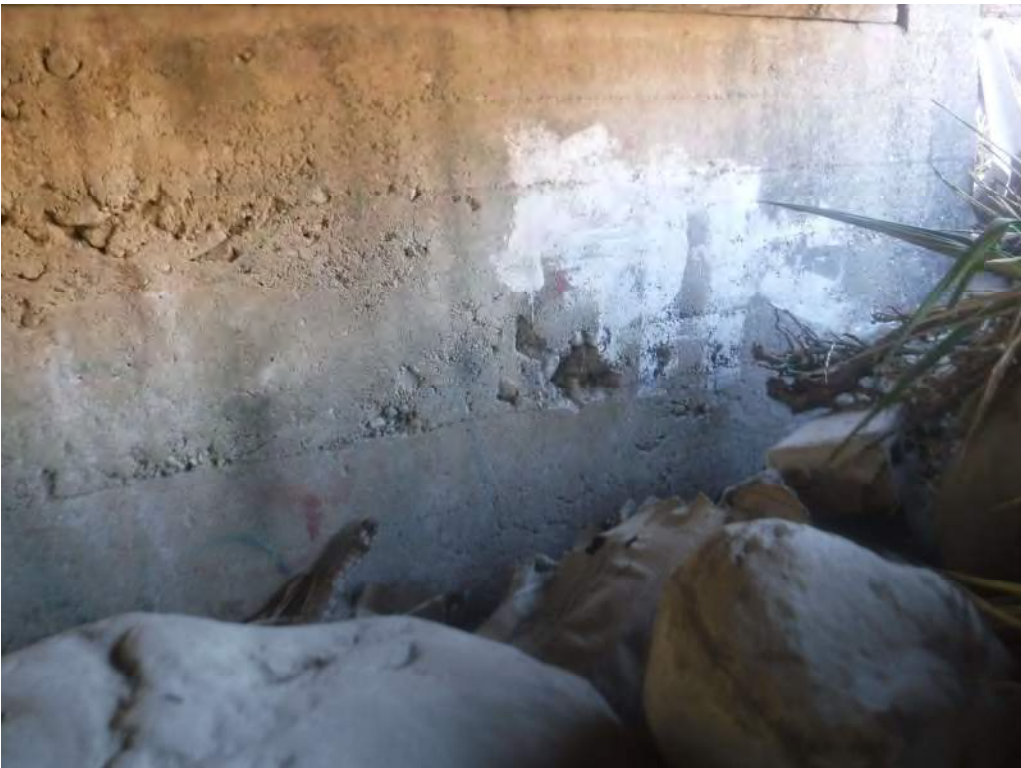
**415.69 Abutment 1 Spall**

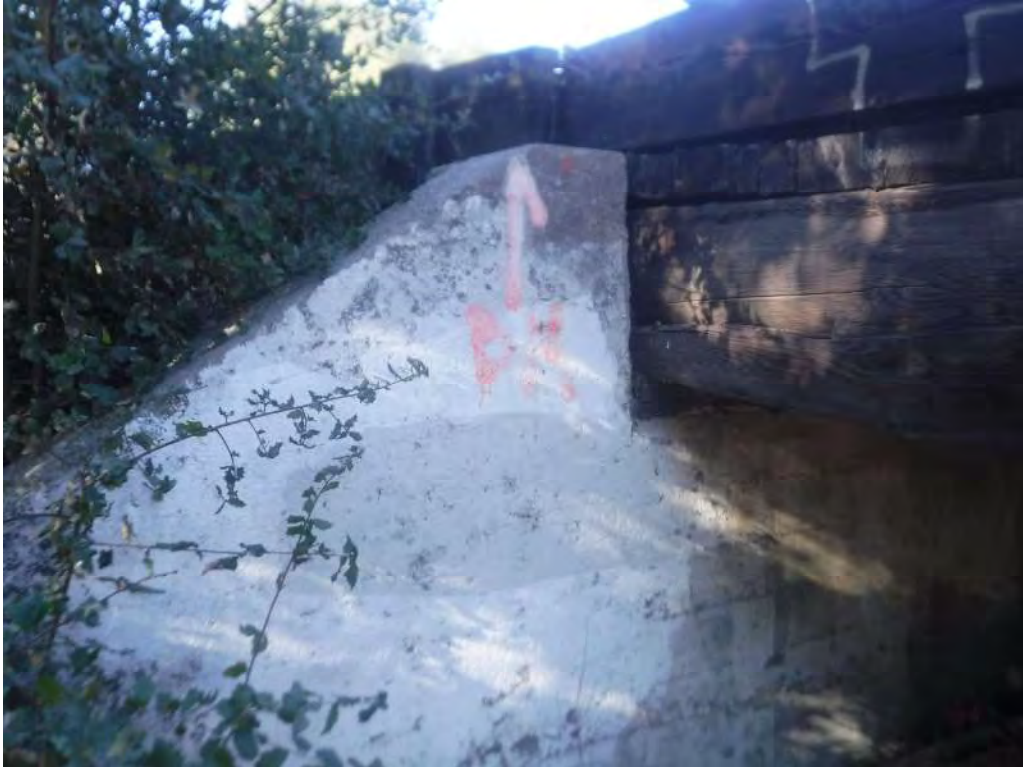
**415.69 Cracks in Southwest Wingwall**

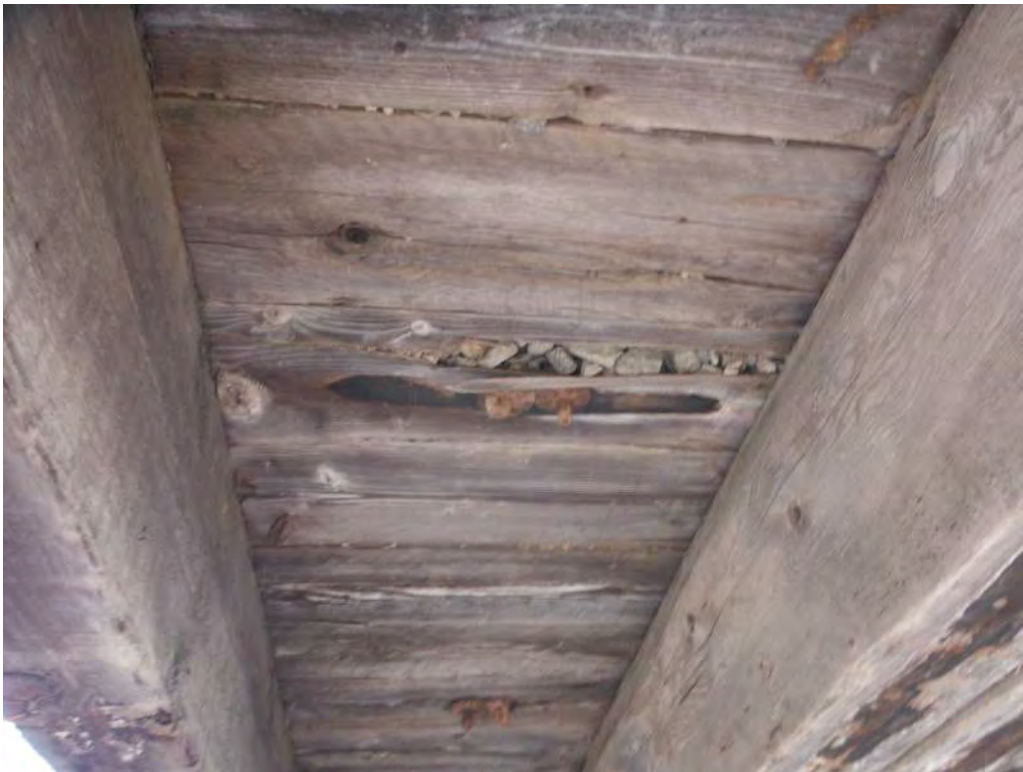
**415.69 Poor ballast planks (typ.)**

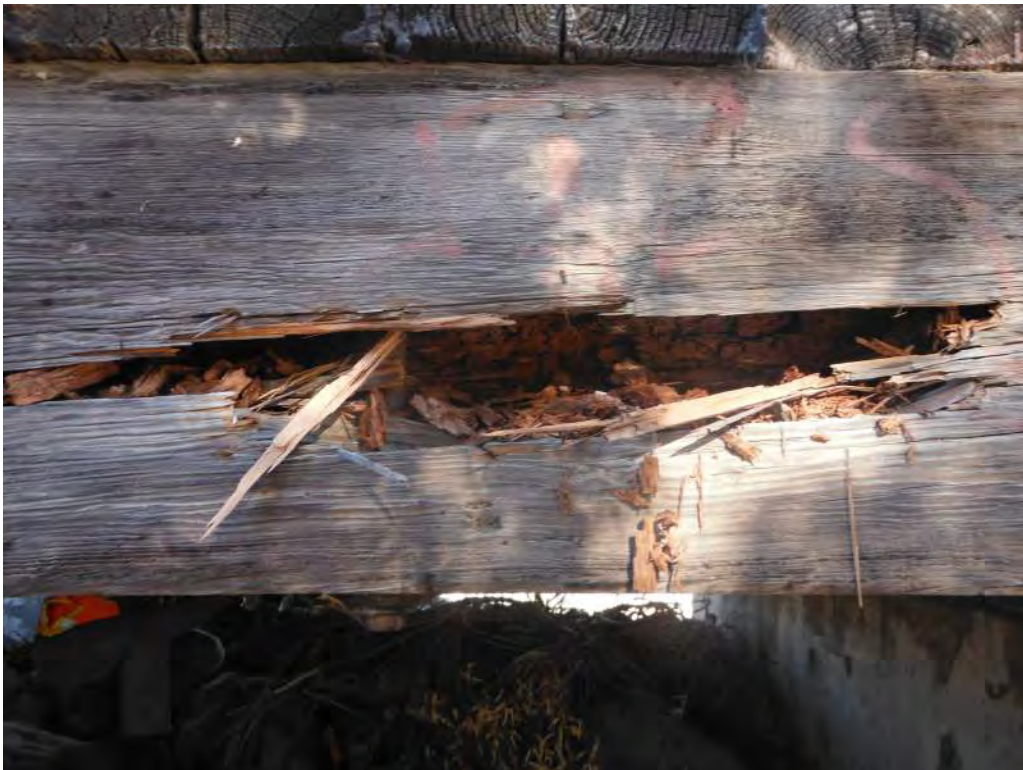
**415.69 Stringer 12 is rotten/failed – Span 1**

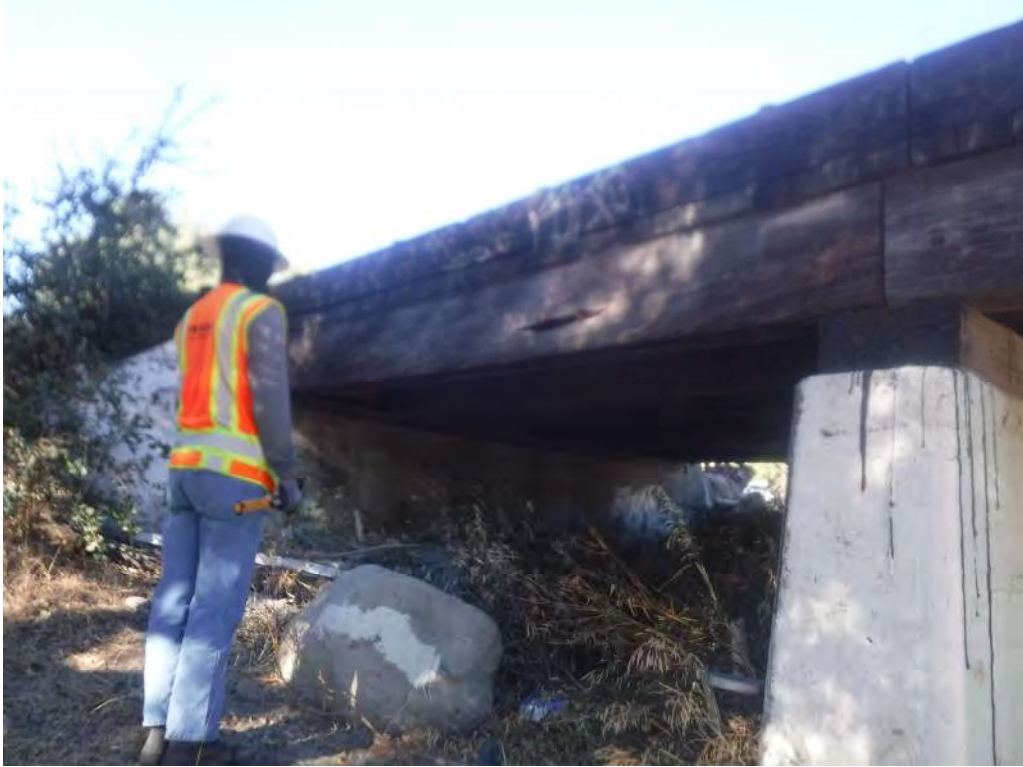
**415.69 Debris under Span 1**

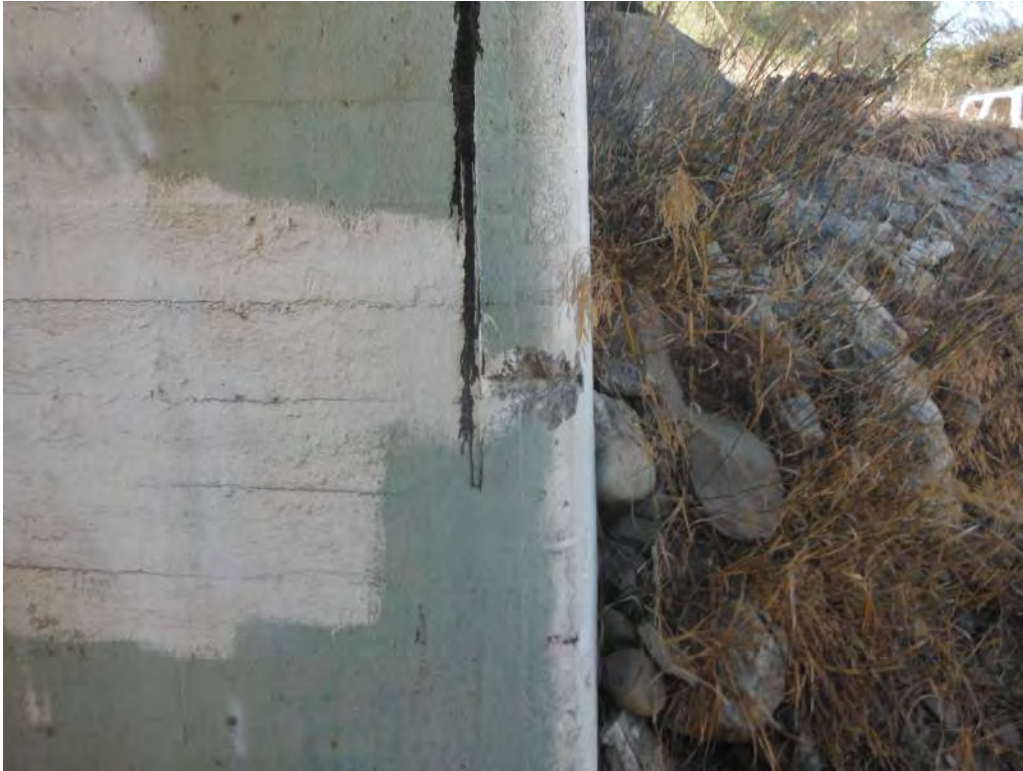
**415.69 Spall North Side of Pier 2**

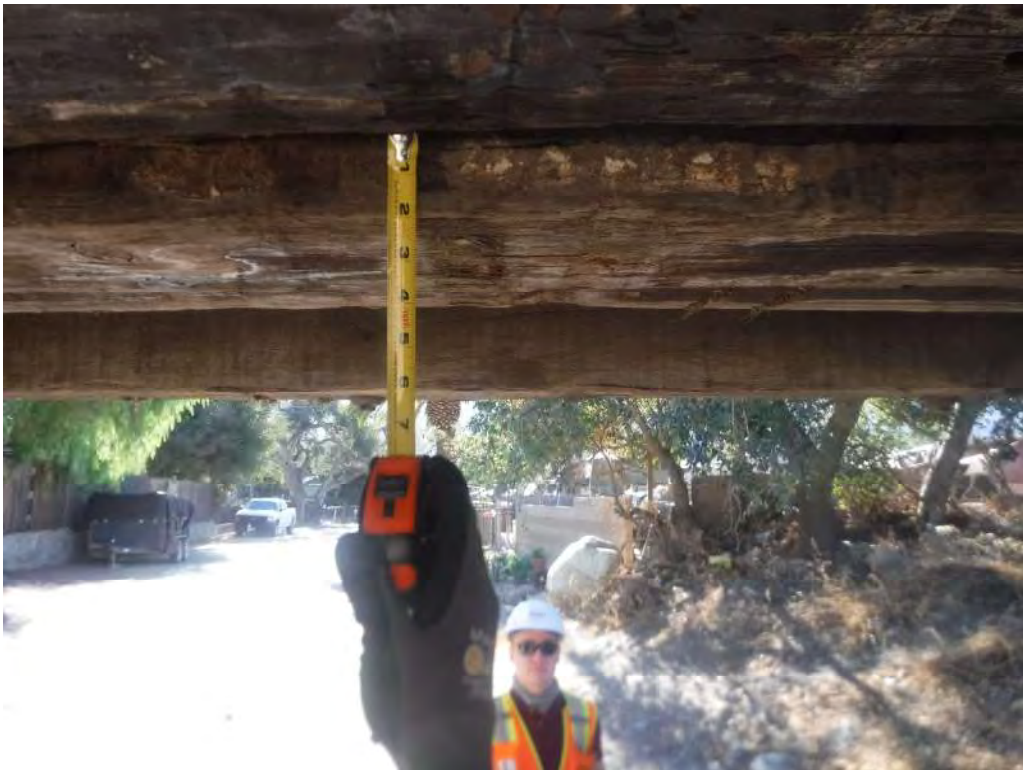
**415.69 Stringer 10 deflected 3" – Span 2**

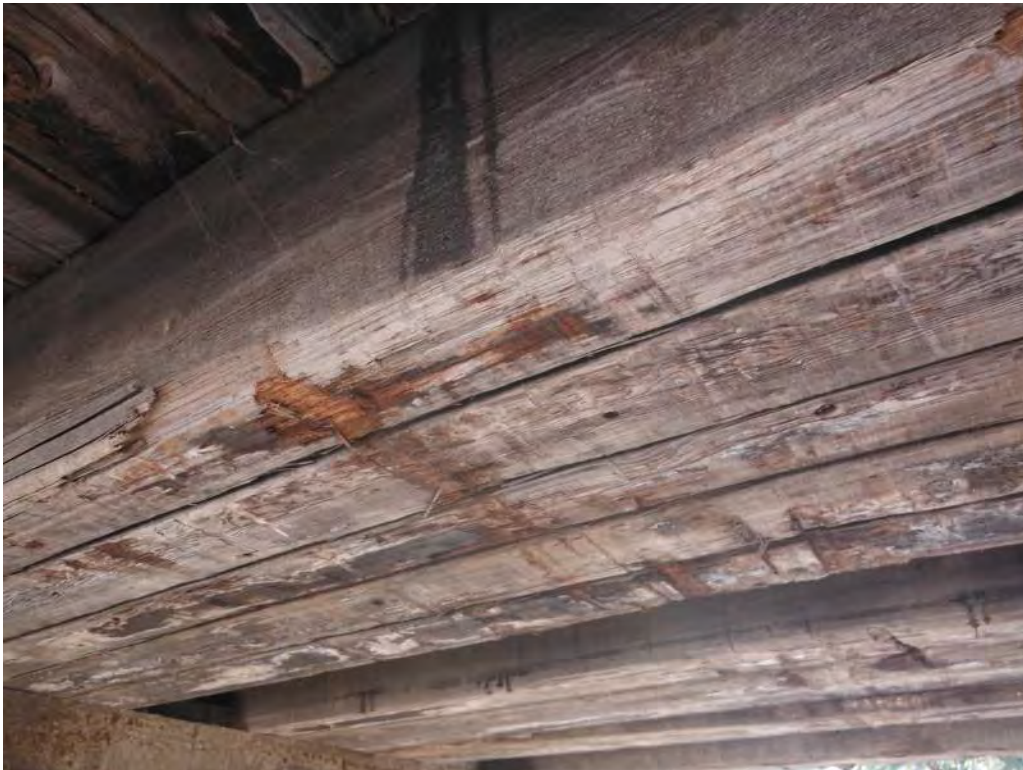
**415.69 Impact damage on stringers (typ.)**

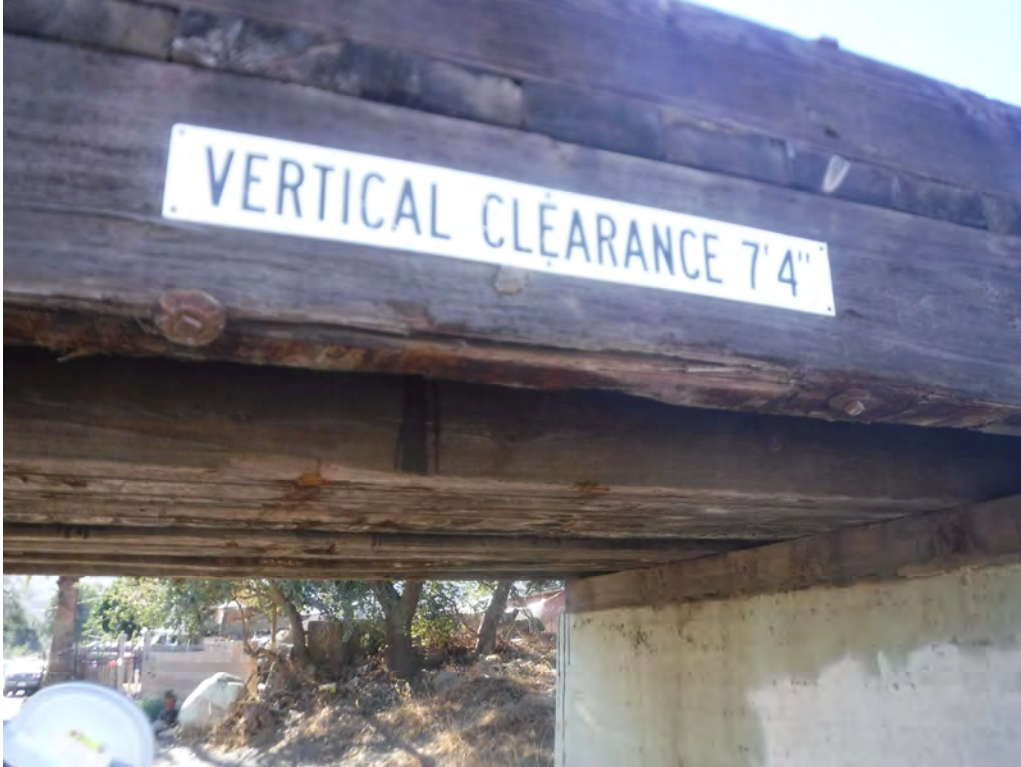
**415.69 Major impact damage to Stringer 1, typ Span 2 and 3**

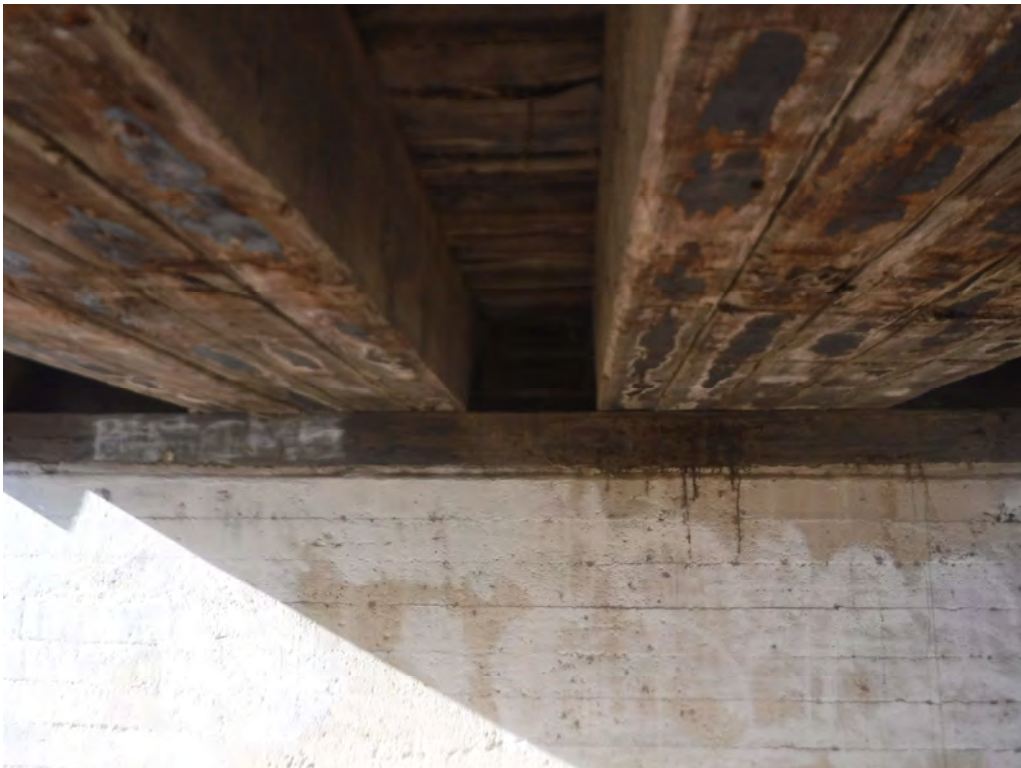
**415.69 Stringer 6 rotated 1" at Pier 3 & Abutment 4**

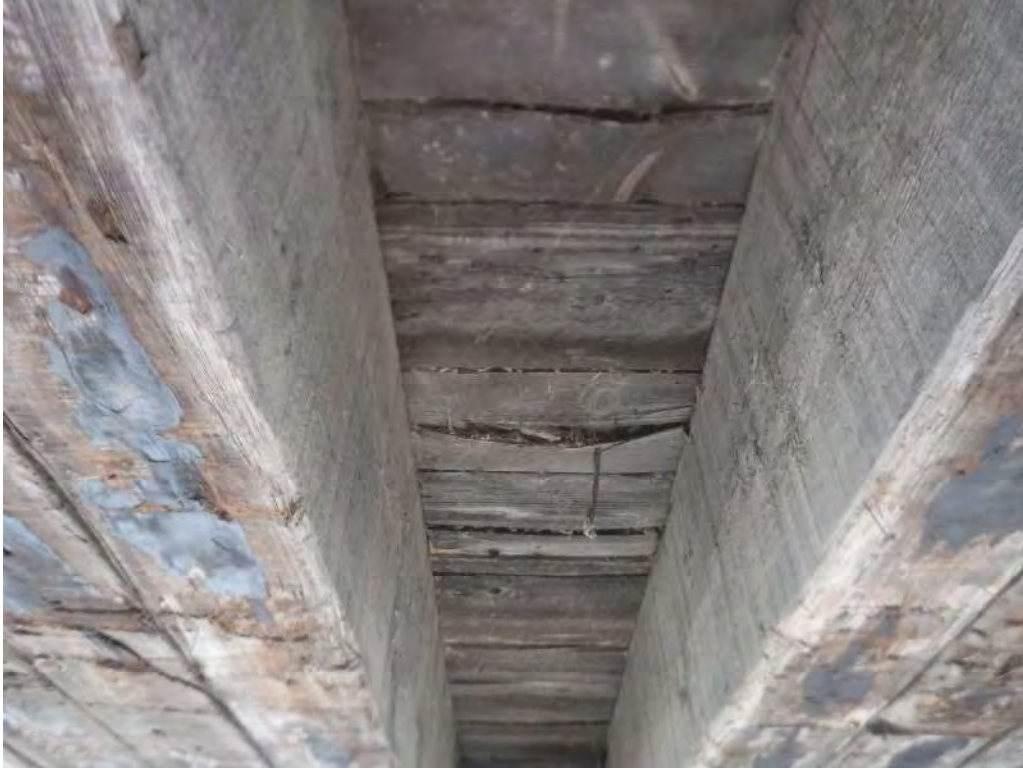
**415.69 Decay of deck ballast plank. Mid-span, Span 3**
