# BRIDGE INSPECTION REPORT

INSPECTION TYPE: Annual

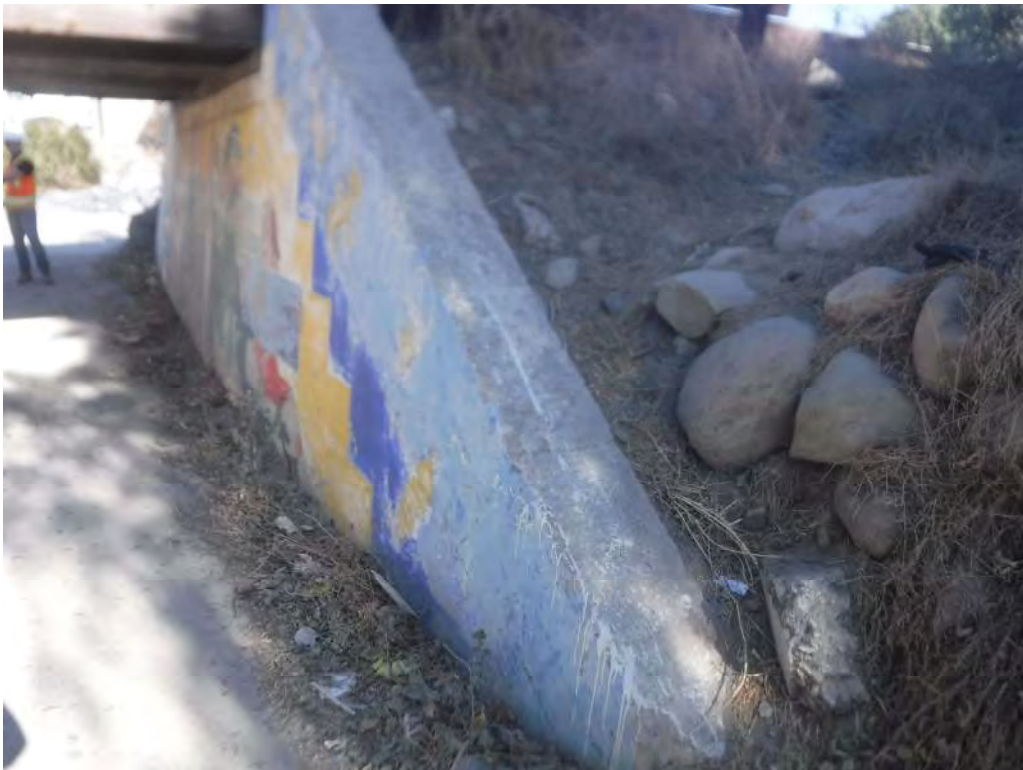
**415.69 Spall on wingwall at abutment 4**

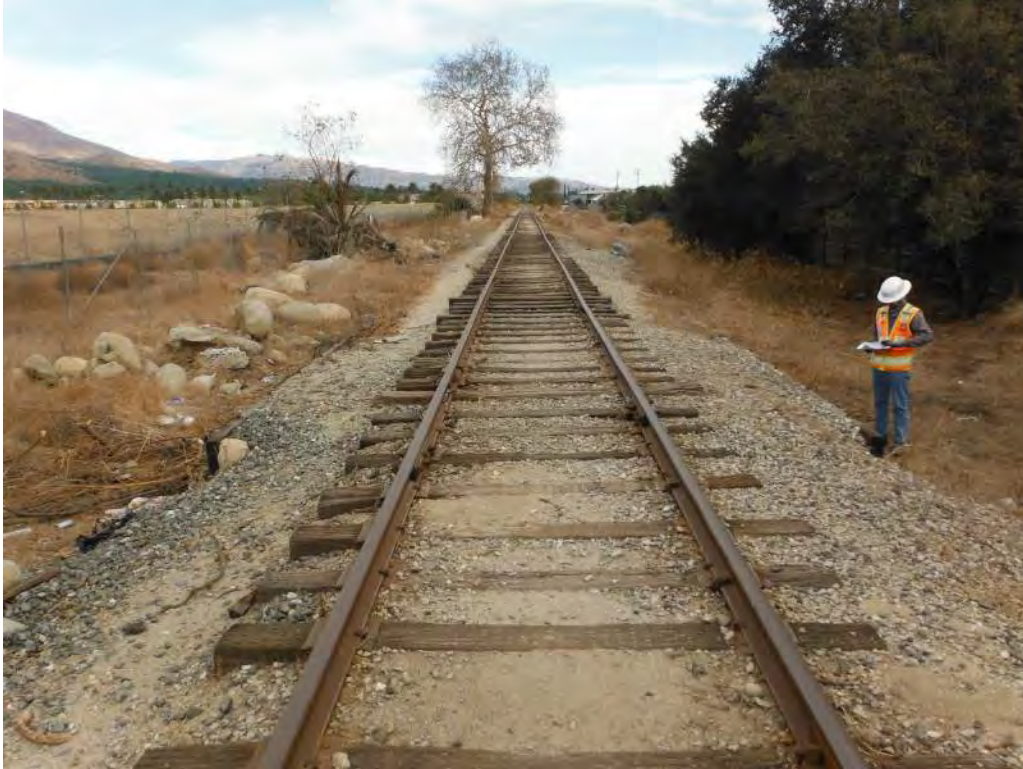
**415.79 Looking East**

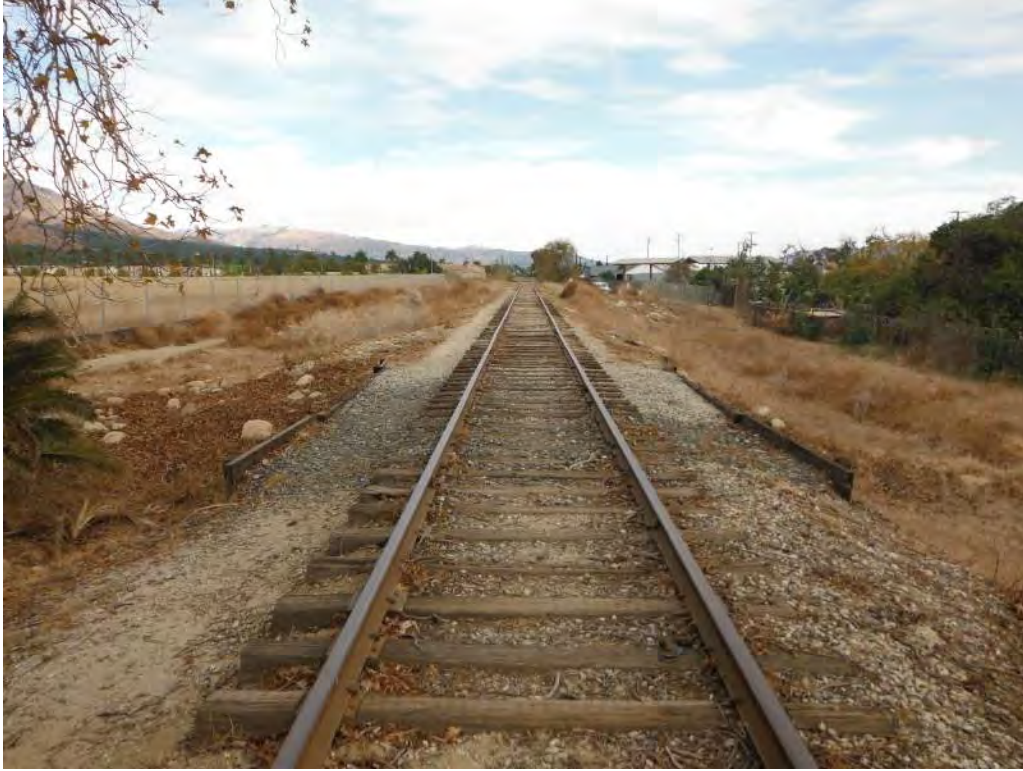
**415.82 Looking East**

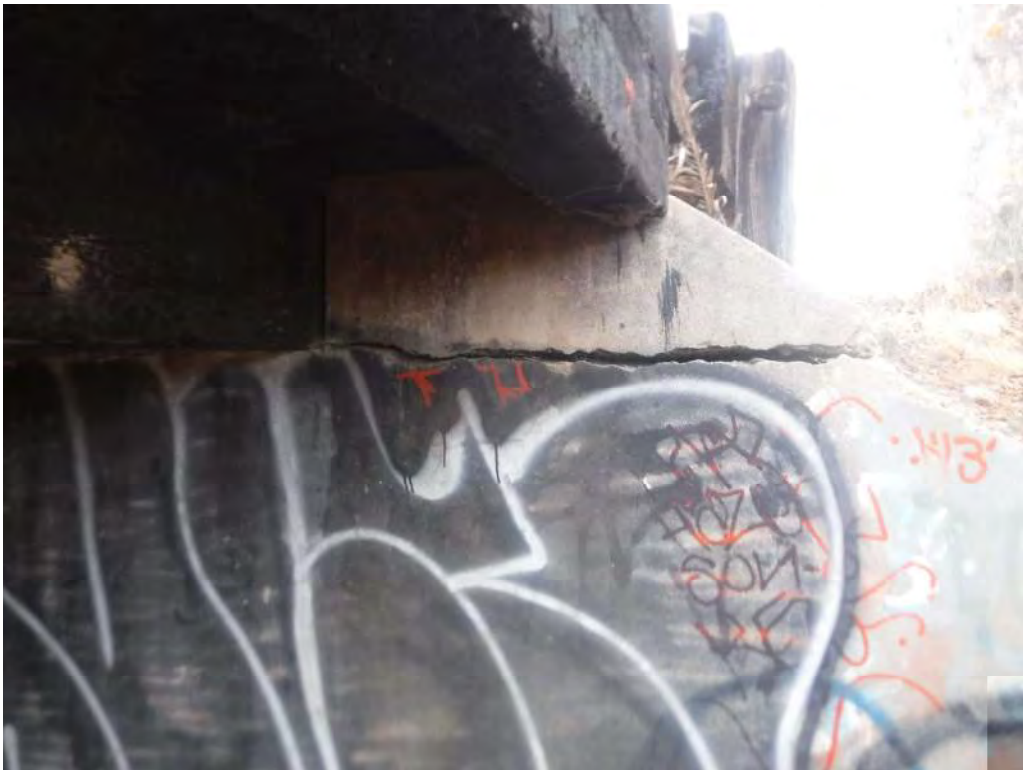
**415.82 Abutment stringer retainers cracked – typical all 4 corners**

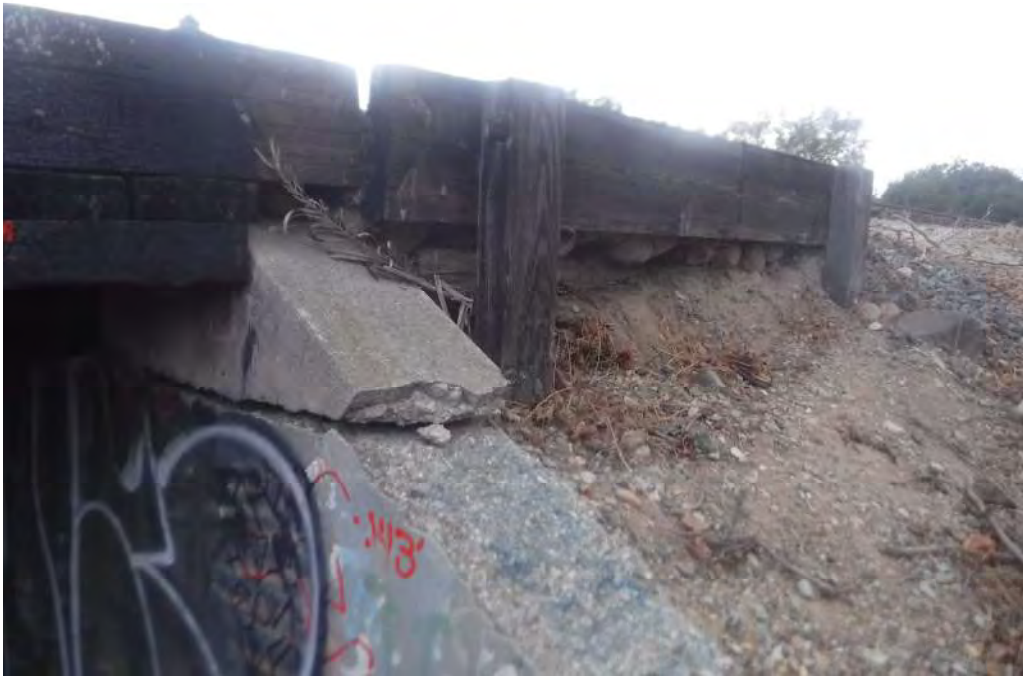
**415.82 Wingwalls undermined – typical all 4 corners**

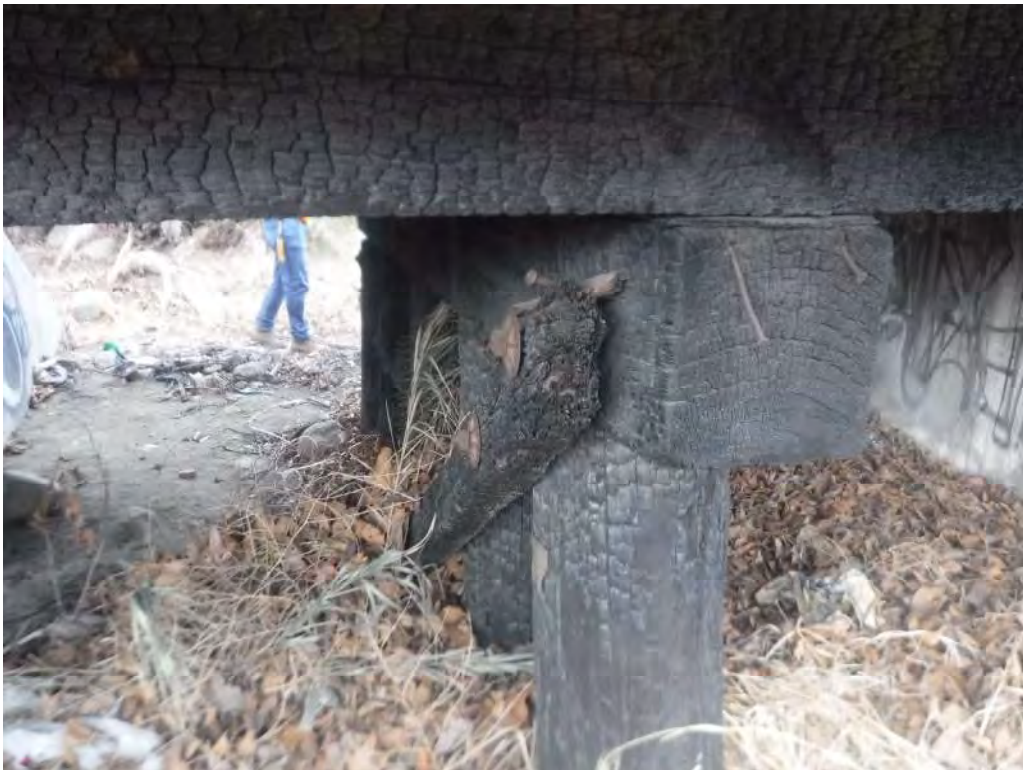
**415.82 Failed sway brace – pier 2**

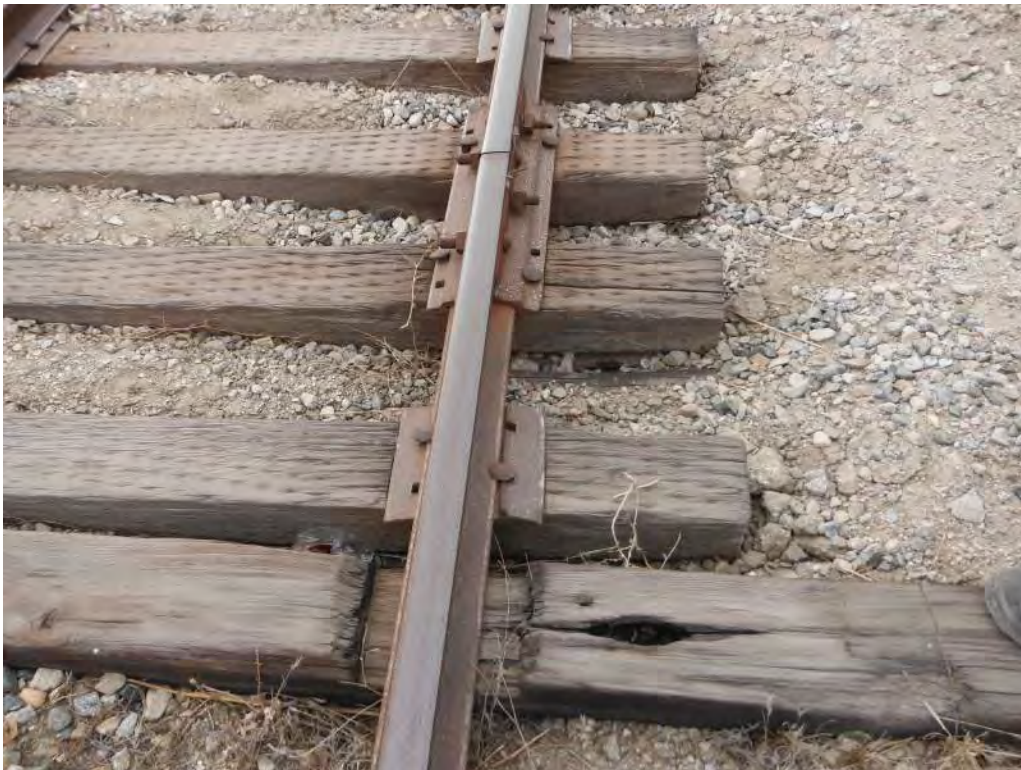
**415.92 Ballast leak – Span 2 north side**

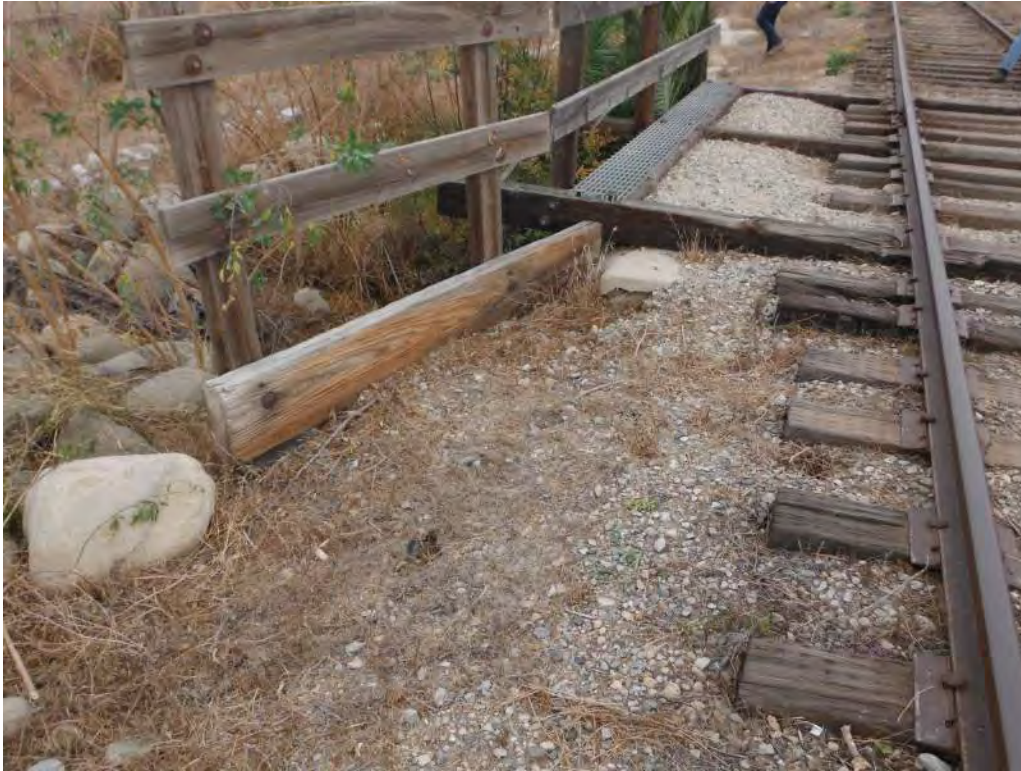
**415.92 NW wingwall leaking**

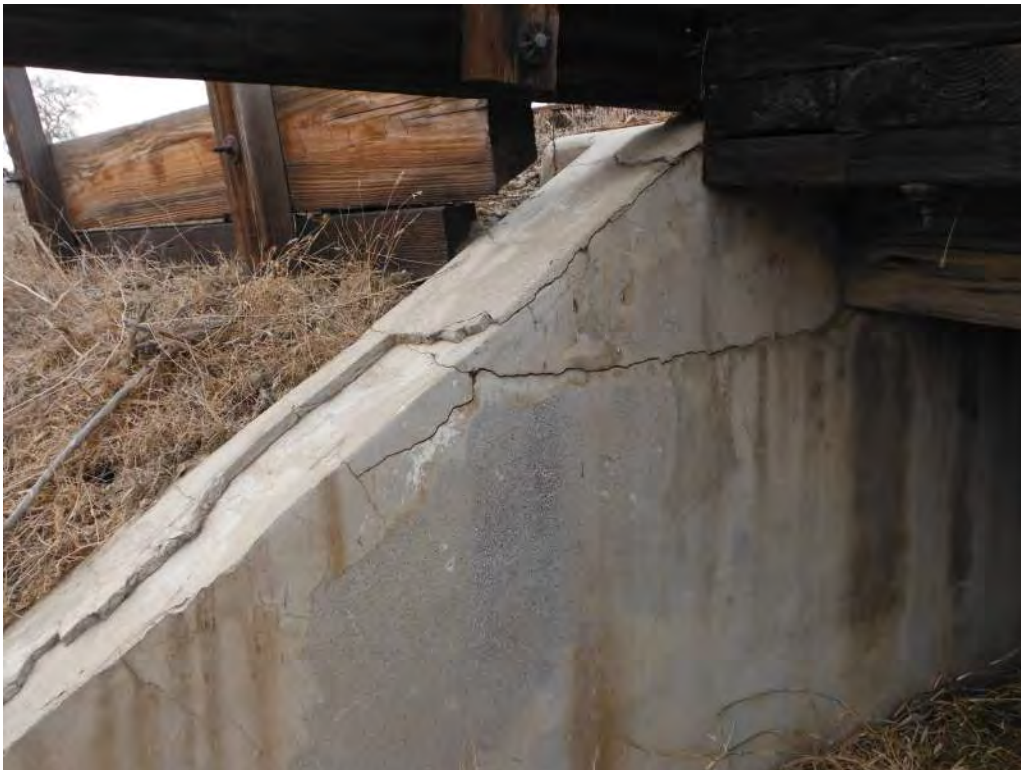
**415.92 Abutment stringer retainer cracked- typical NW, SW, SE**

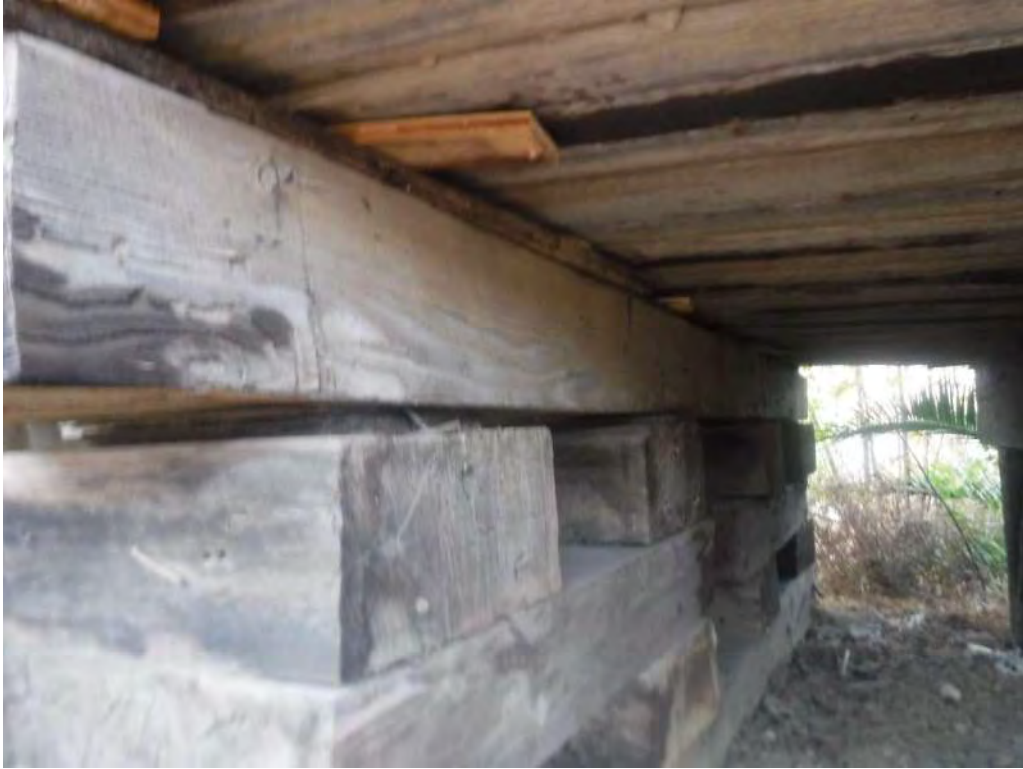
**415.92 Helper bents have loose shims to stringers – both spans**

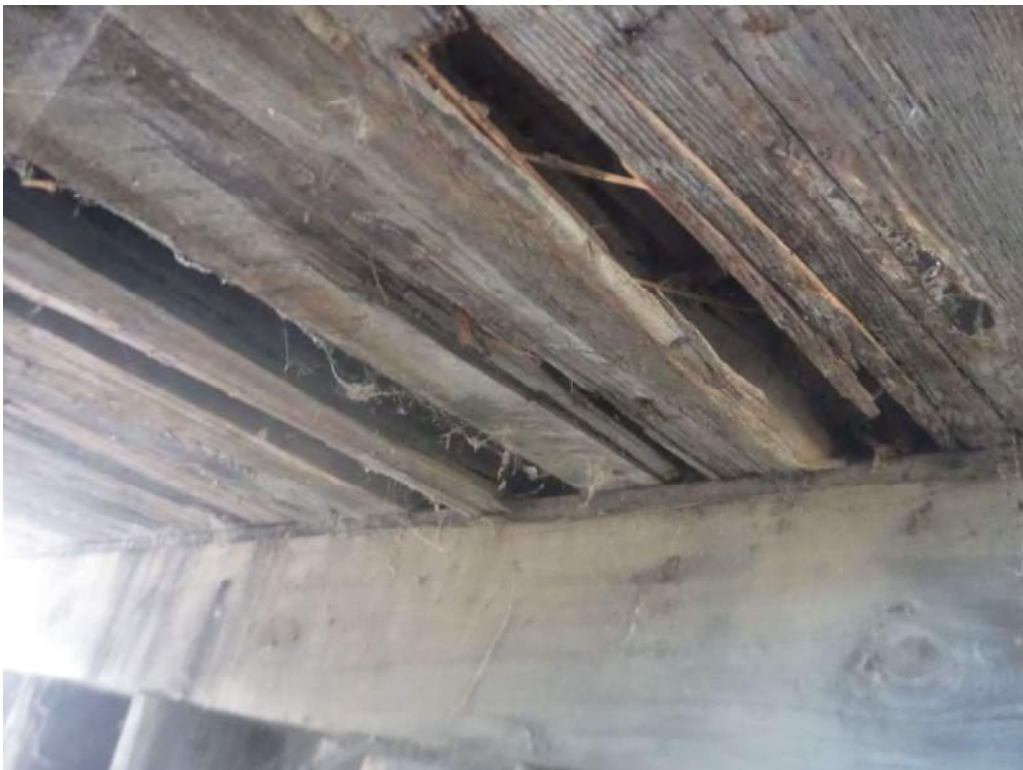
**415.92 Stringer 5 rotten, Stringer 2-4 failed, Span 2**

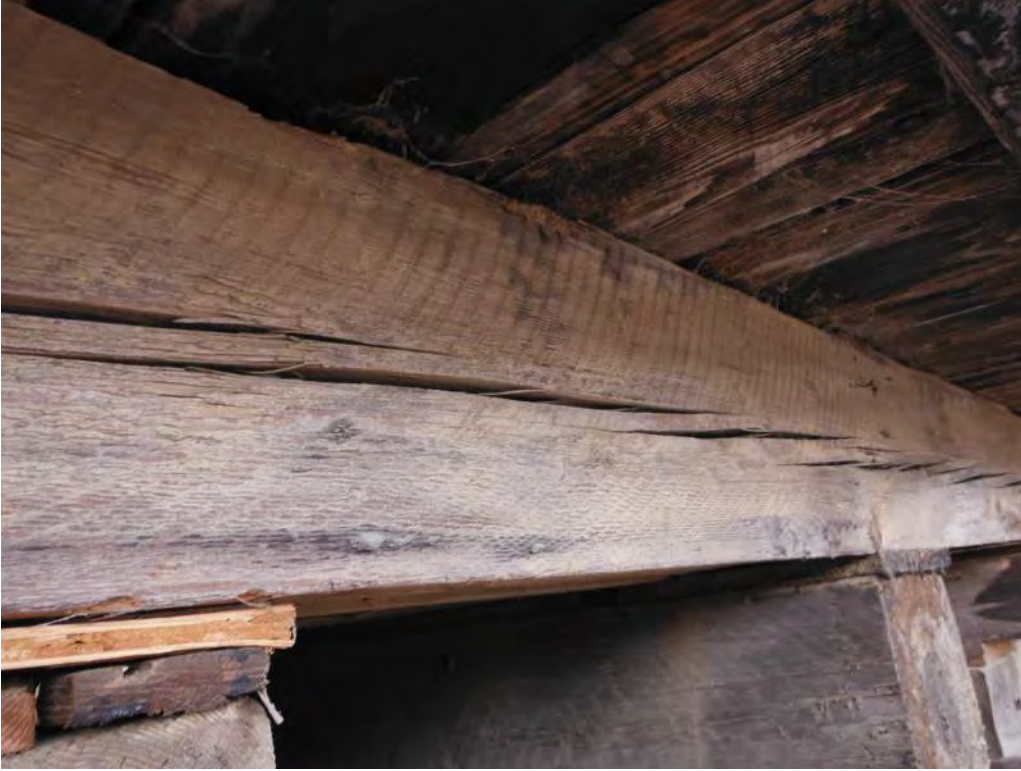
**415.92 Stringer 12 deep checking**

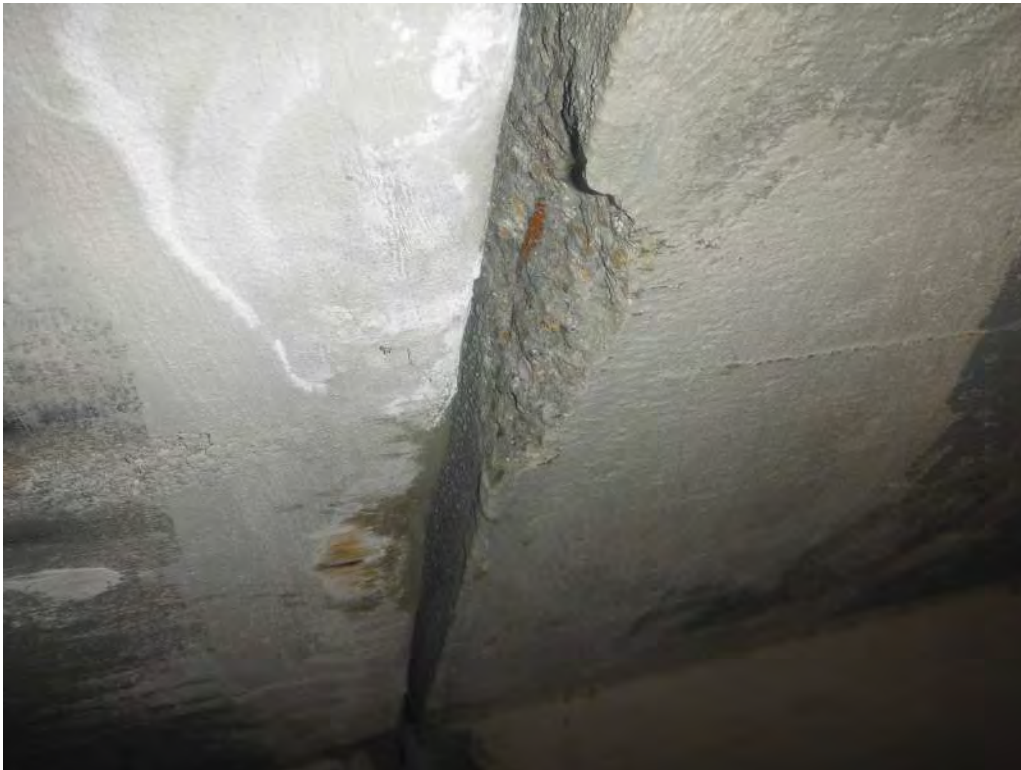
**416.21 Cell 3 concrete spall on underside of top slab. Rebar exposed**

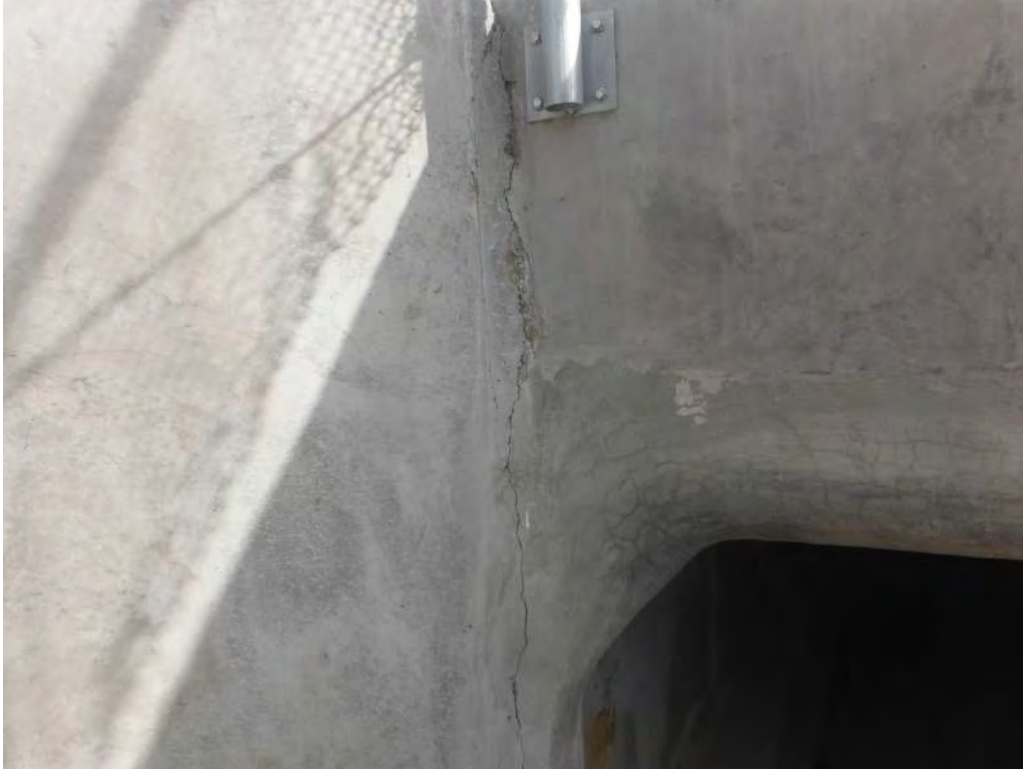
**416.21 Grout cracking at headwall to wingwall joint**

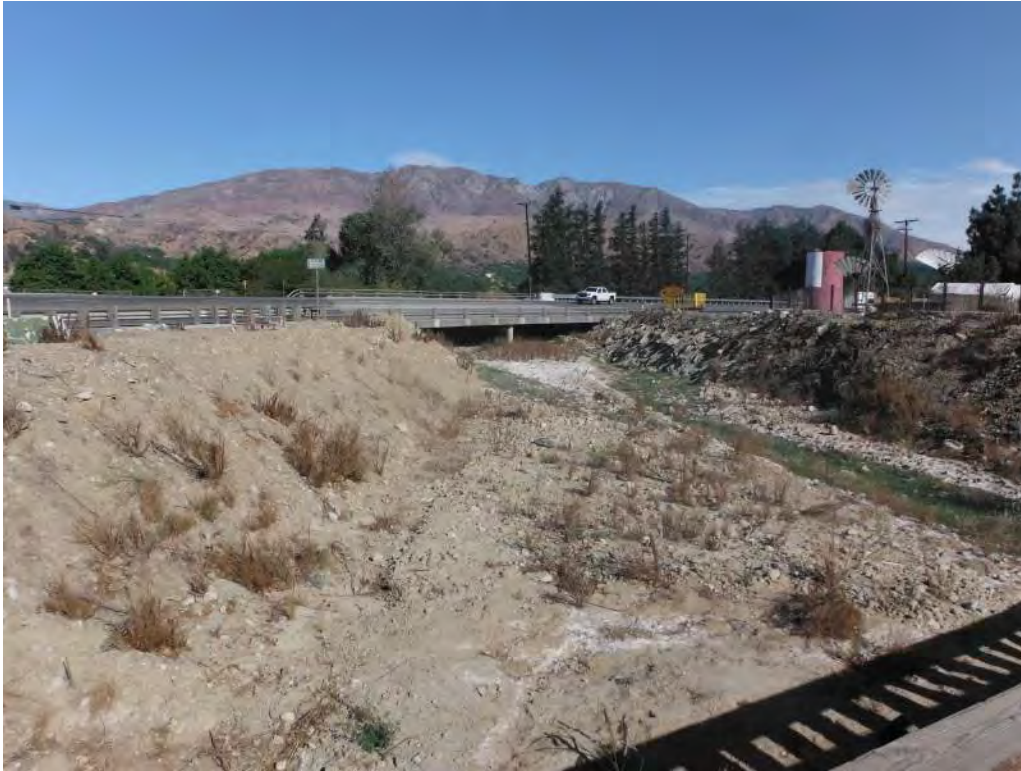
**416.32 Channel condition. Looking Upstream**

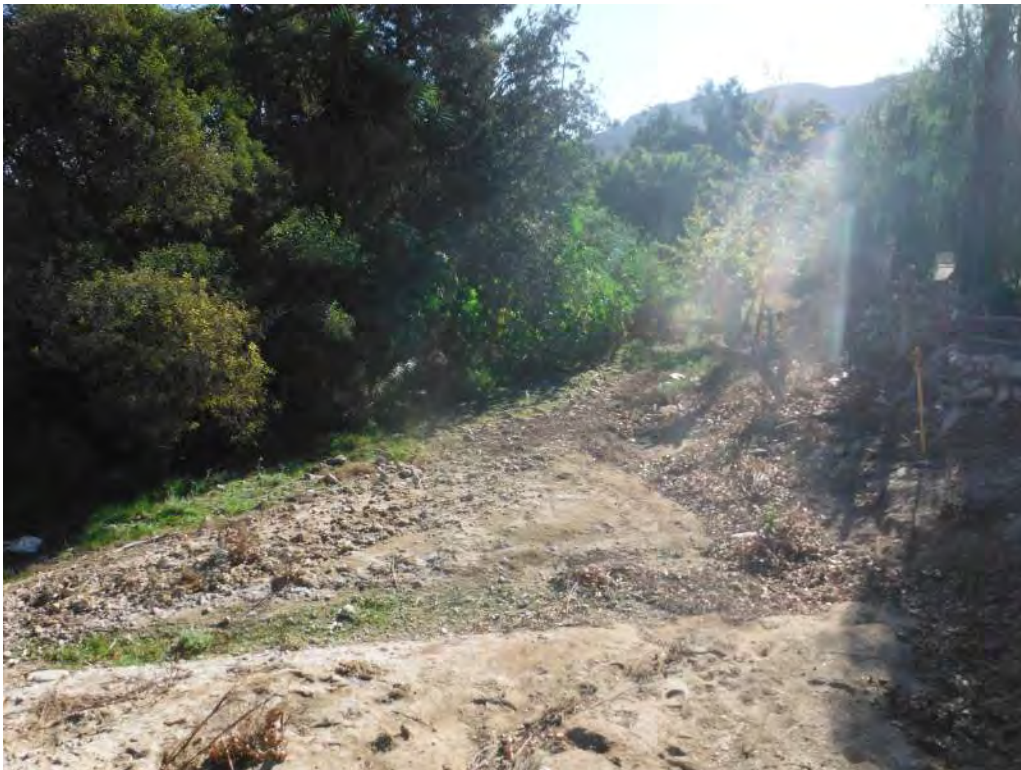
**416.32 Channel condition. Looking Downstream**

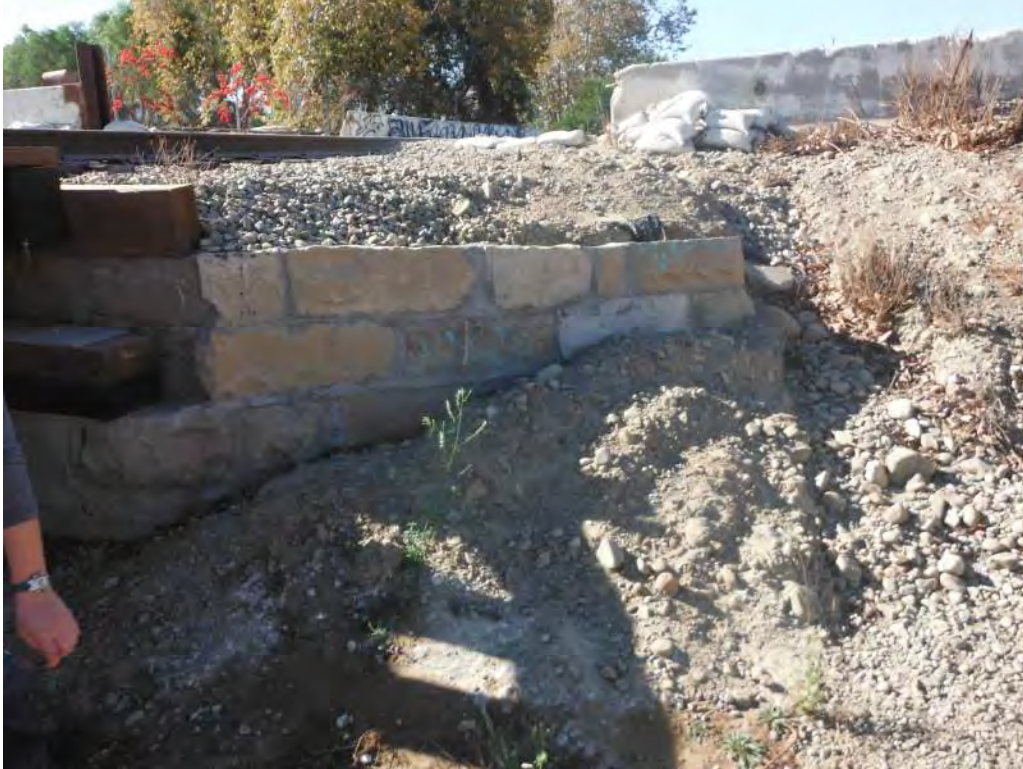
**416.32 Erosion around wingwalls (typ.)**

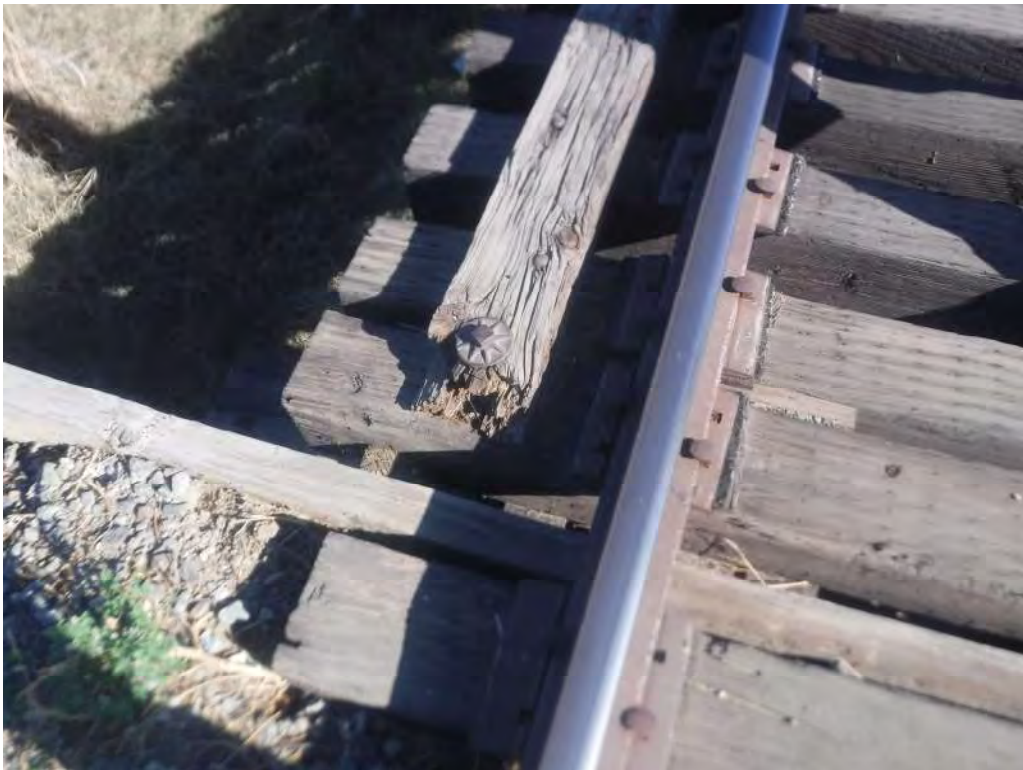
**416.63 Guard ties rotten and broken**

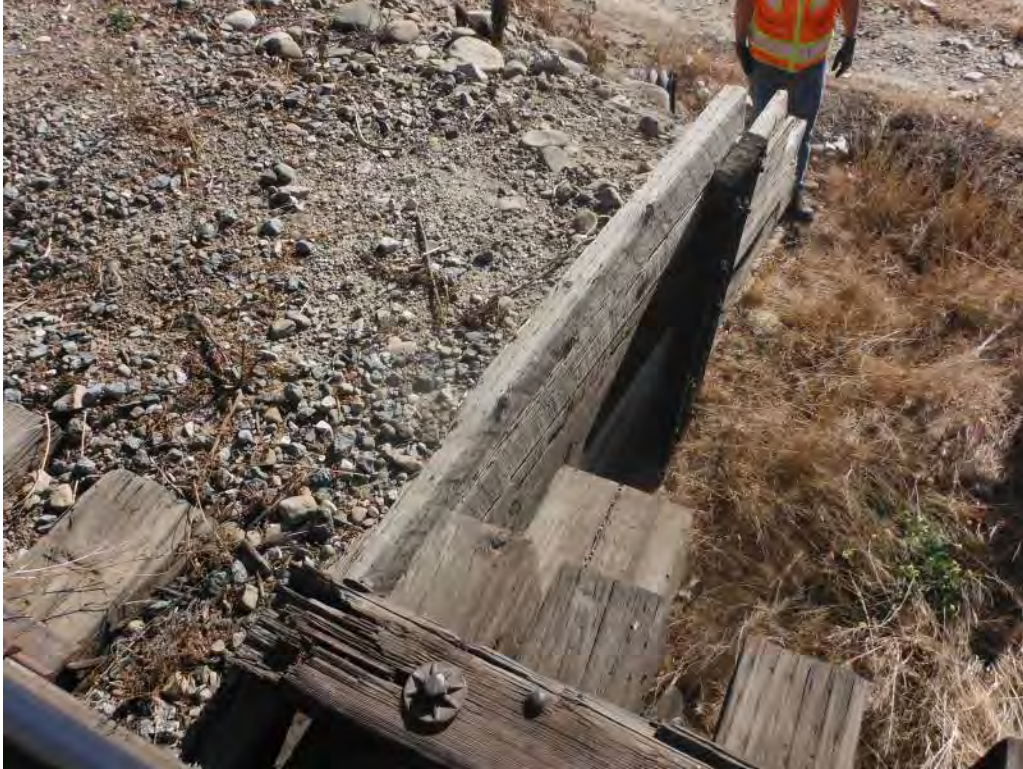
**416.63 Backwall leaning - Abutment 1 & 2**

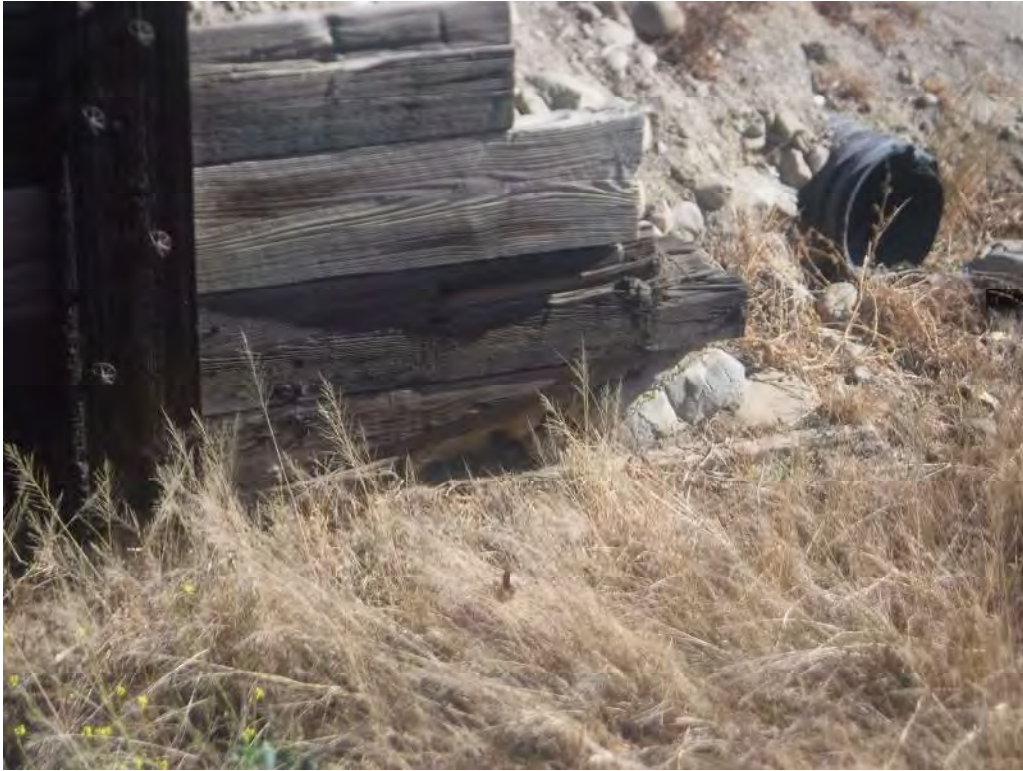
**416.63 Backwall rotting/leaking material at bottom (Typ.)**

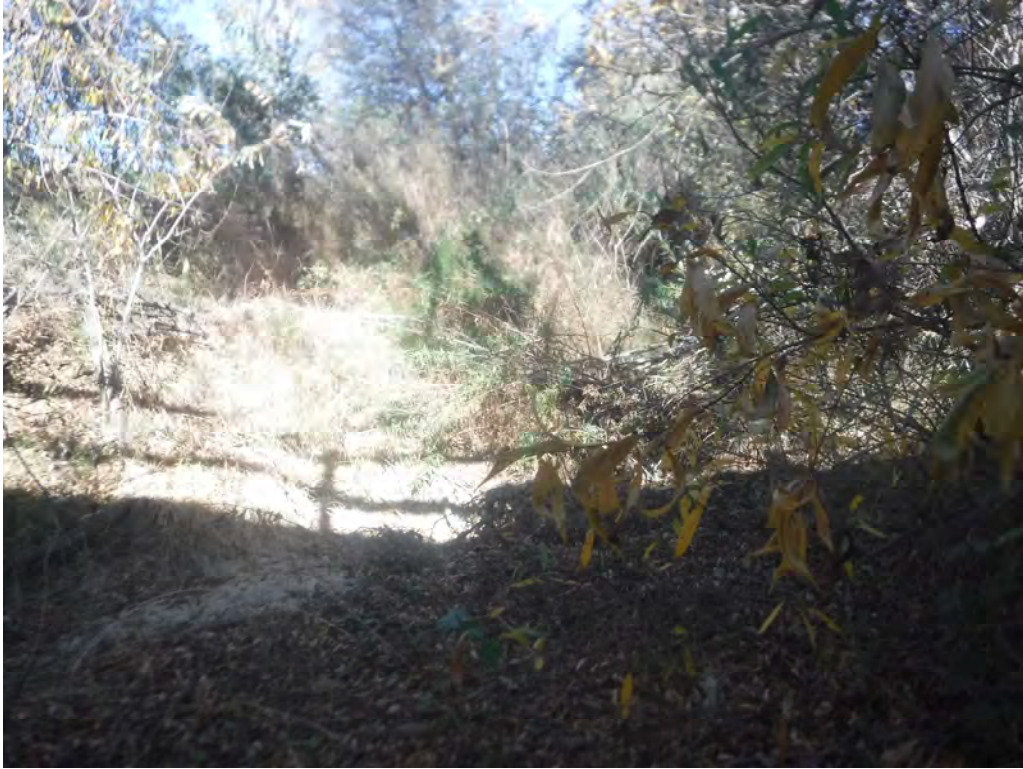
**417.24 Channel Condition – Looking Upstream**

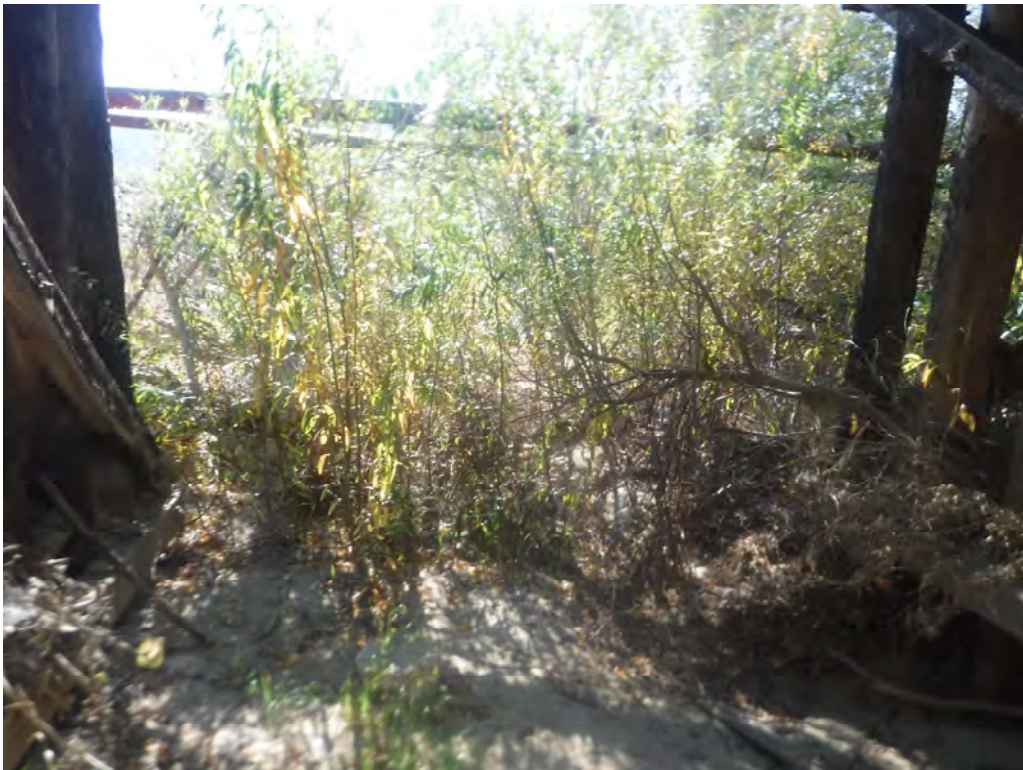
**417.24 Channel Condition – Looking Downstream**

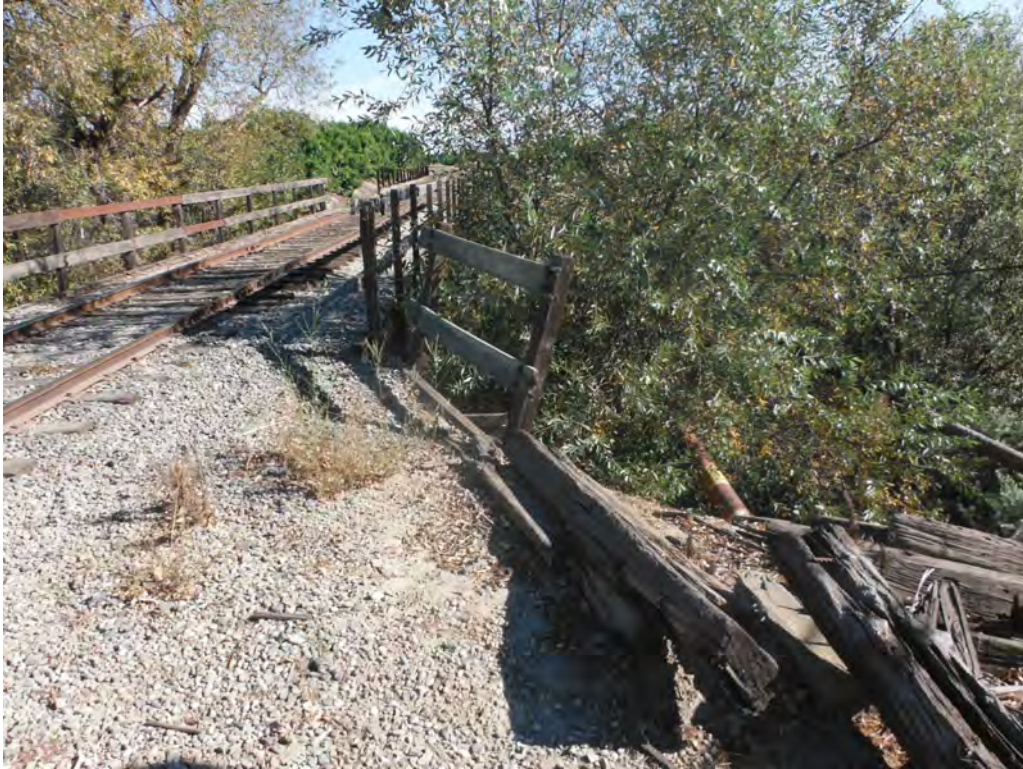
**417.24 Southwest ballast retainer leaning – ballast leaking**

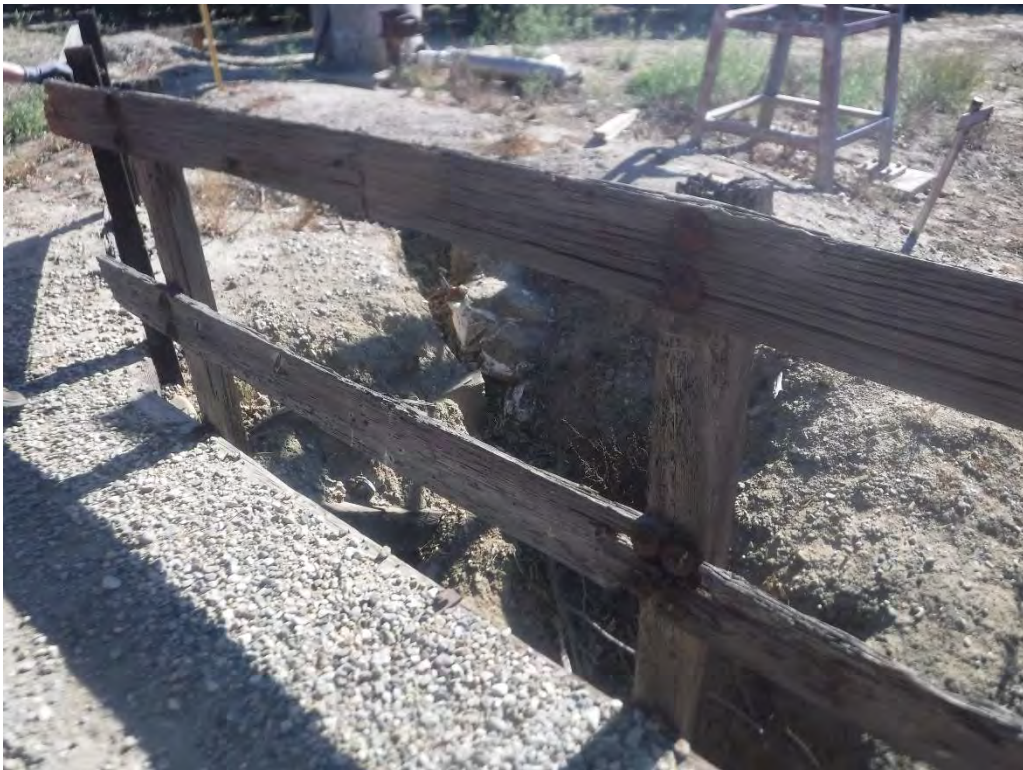
**417.24 Handrail mid-rail failed in two locations**

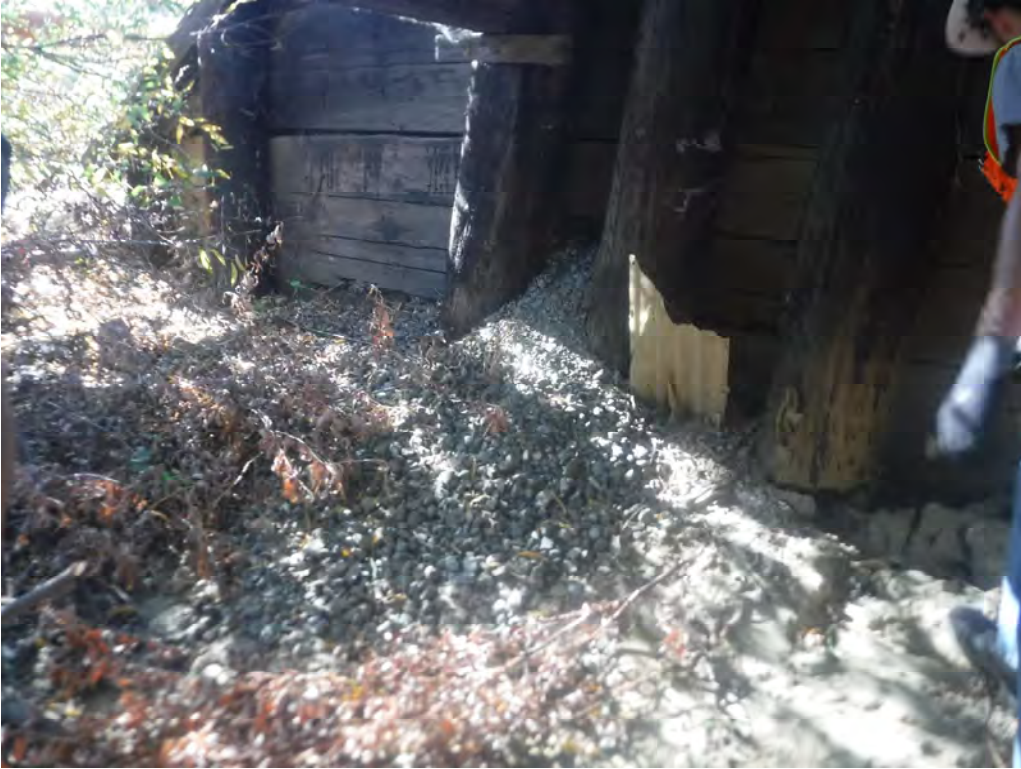
**417.24 Abutment 1 bulging and rotten bottom beam with ballast leaking**

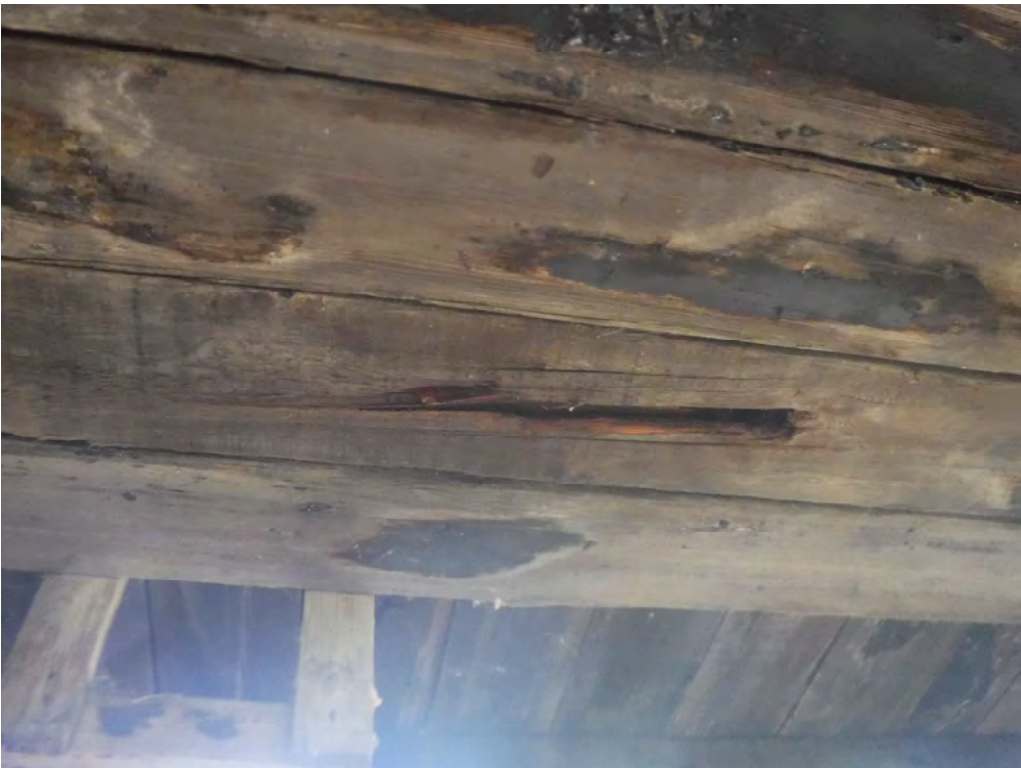
**417.24 Stringer 3 failed, Span 1**

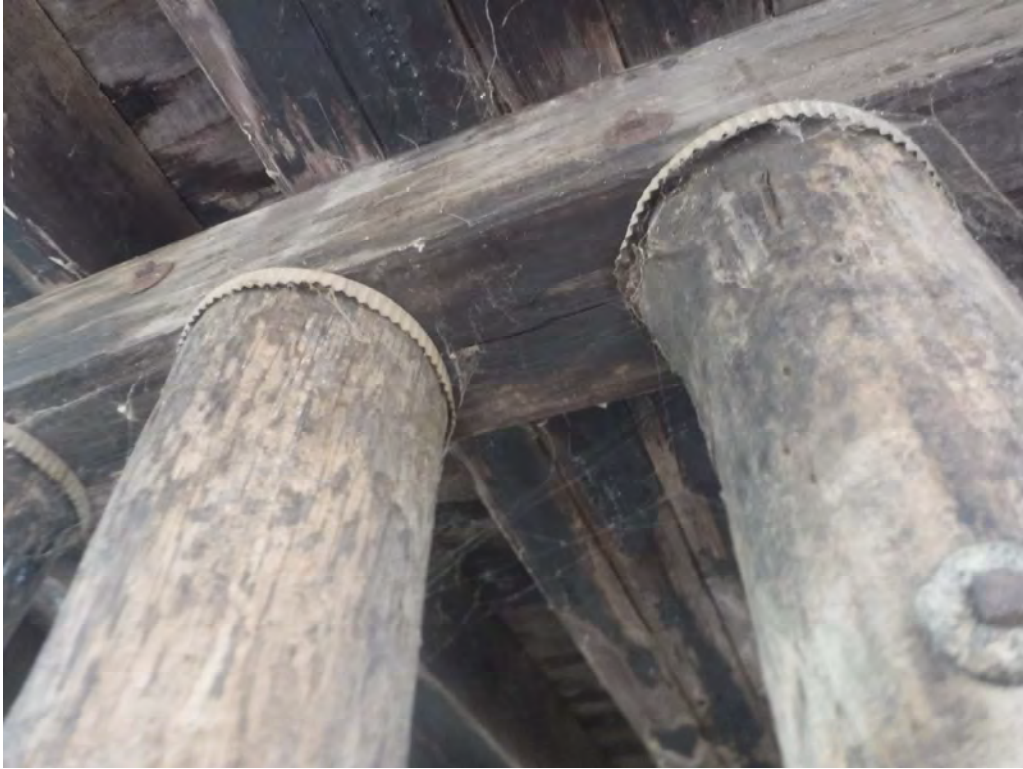
**417.24 Bent 2 cap split**

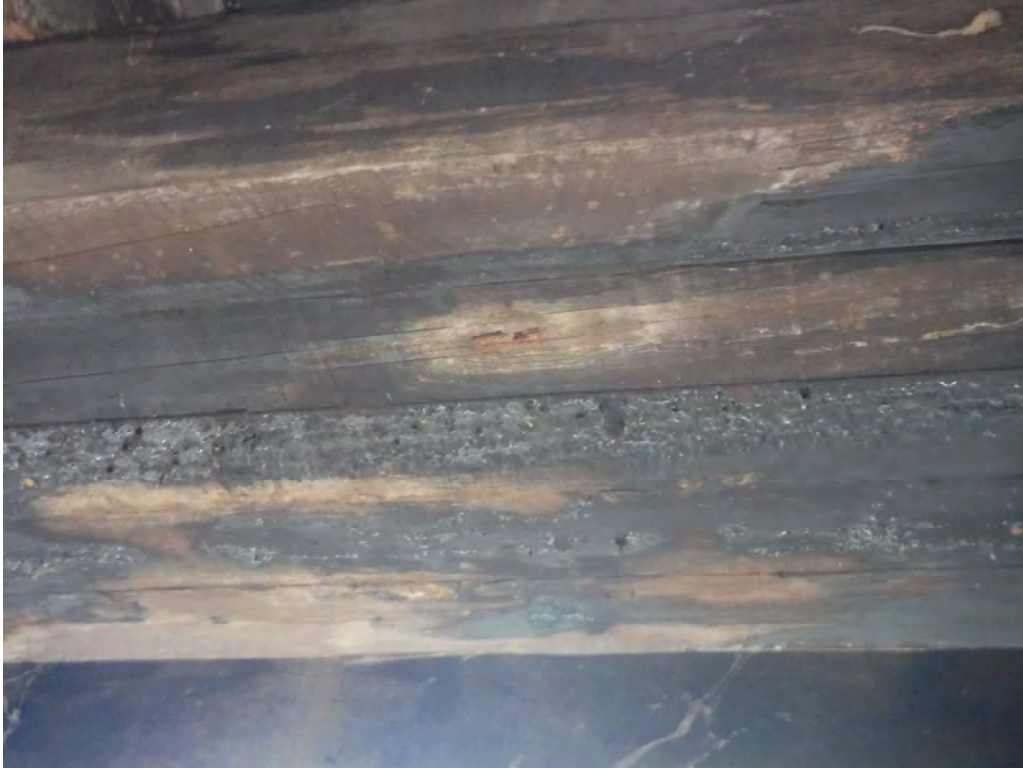
**417.24 Stringer 2 failed, Stringer 3 rotten with 3" hole depth, Span 3**

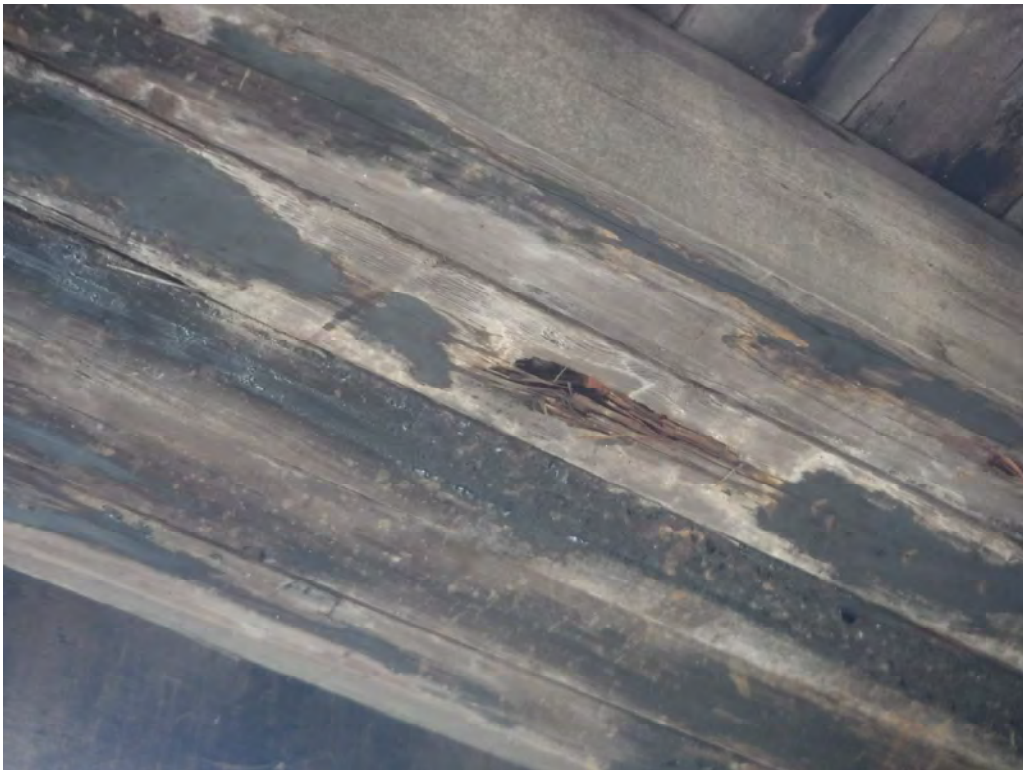
**417.24 Stringer 10 failed, Span 3**
