# BRIDGE INSPECTION REPORT

INSPECTION TYPE: Annual

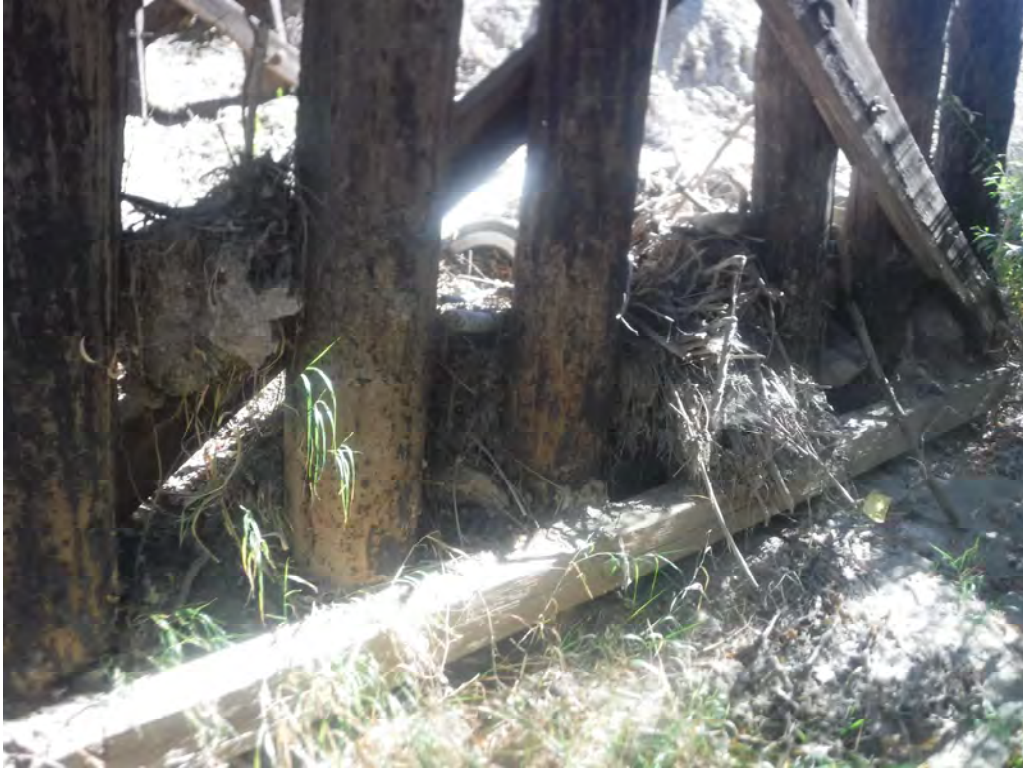
**417.24 Span 3 sash brace covered in dirt and debris at bent 3**

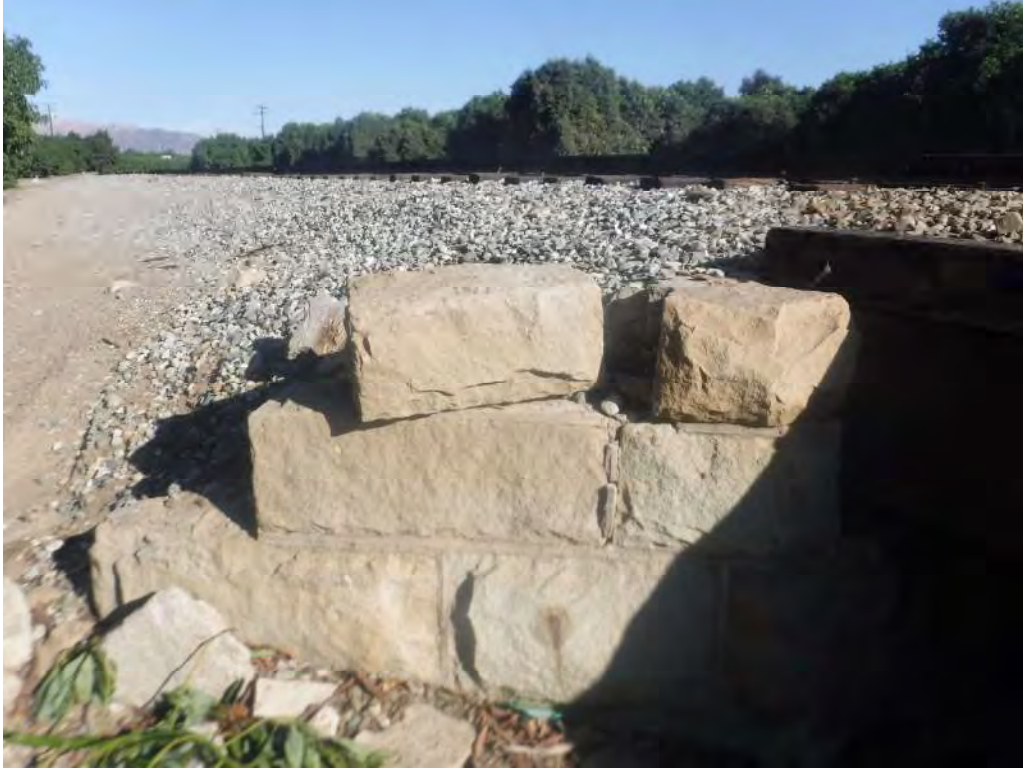
**417.96 Loose block in wingwall – Abutment 2**

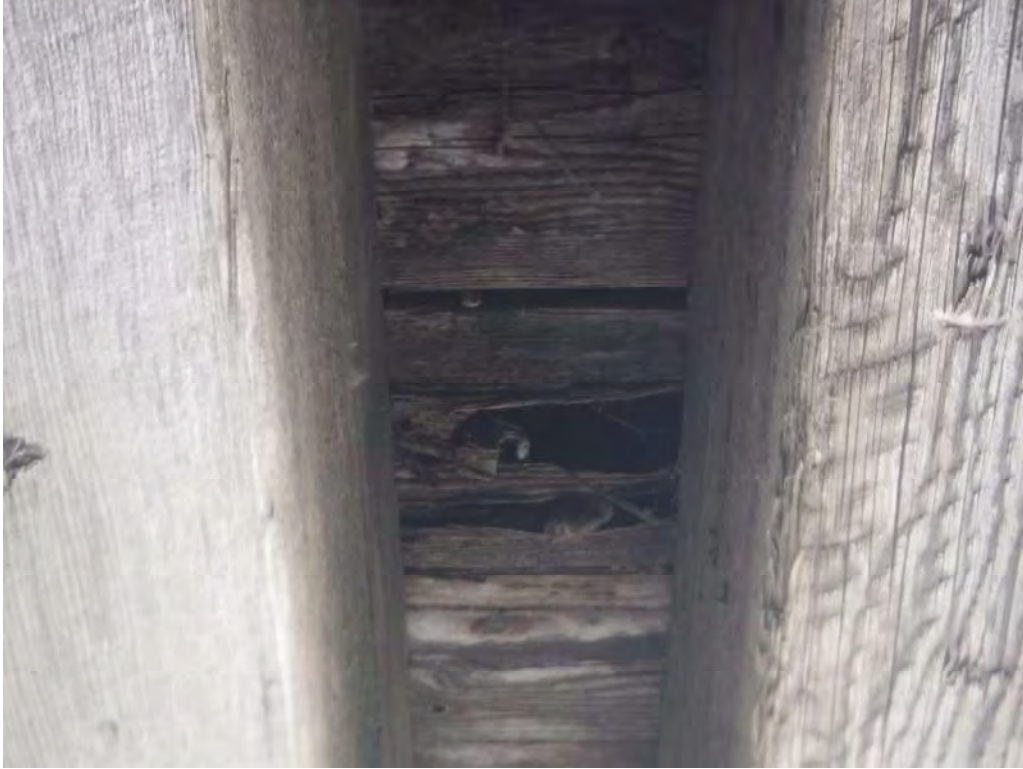
**418.02 Deck planks showing signs of rot and multiple holes**

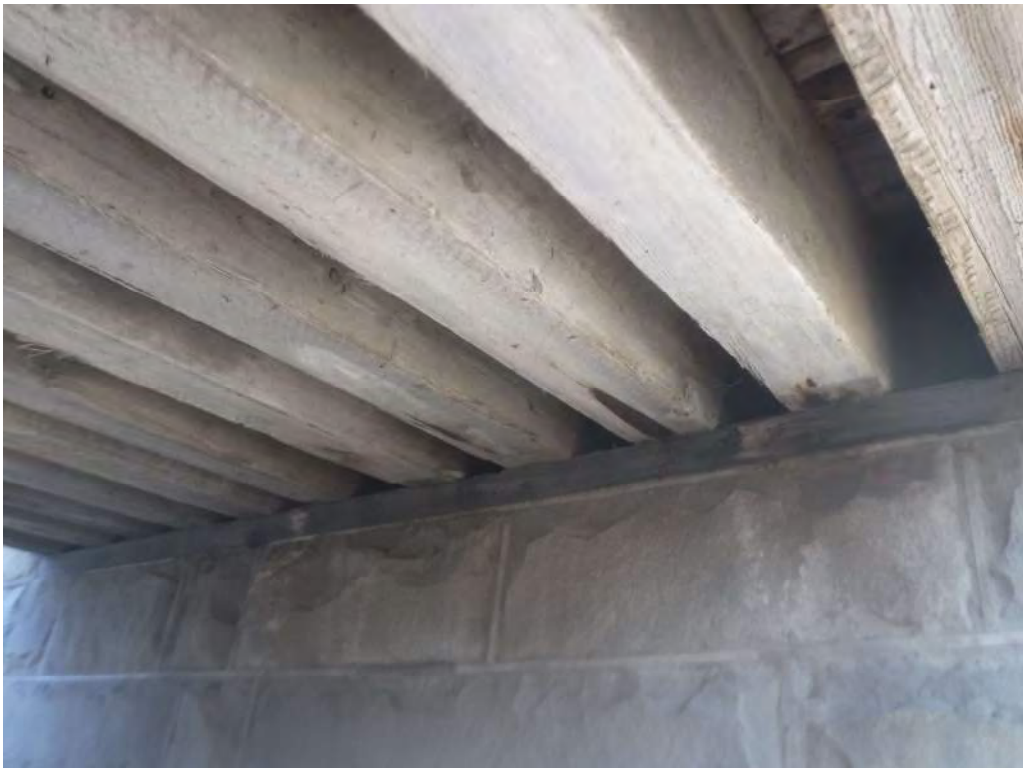
**418.02 Stringers #5 through #9 crushing at Abutment 2**

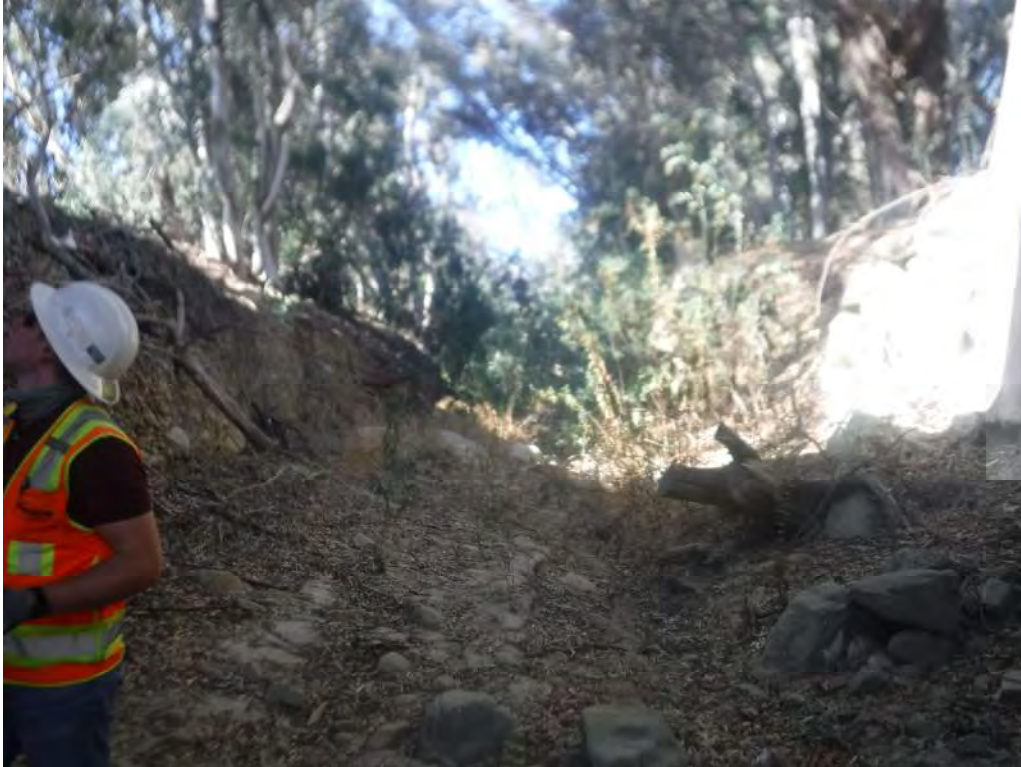
**419.42 Channel Condition - Looking Upstream**

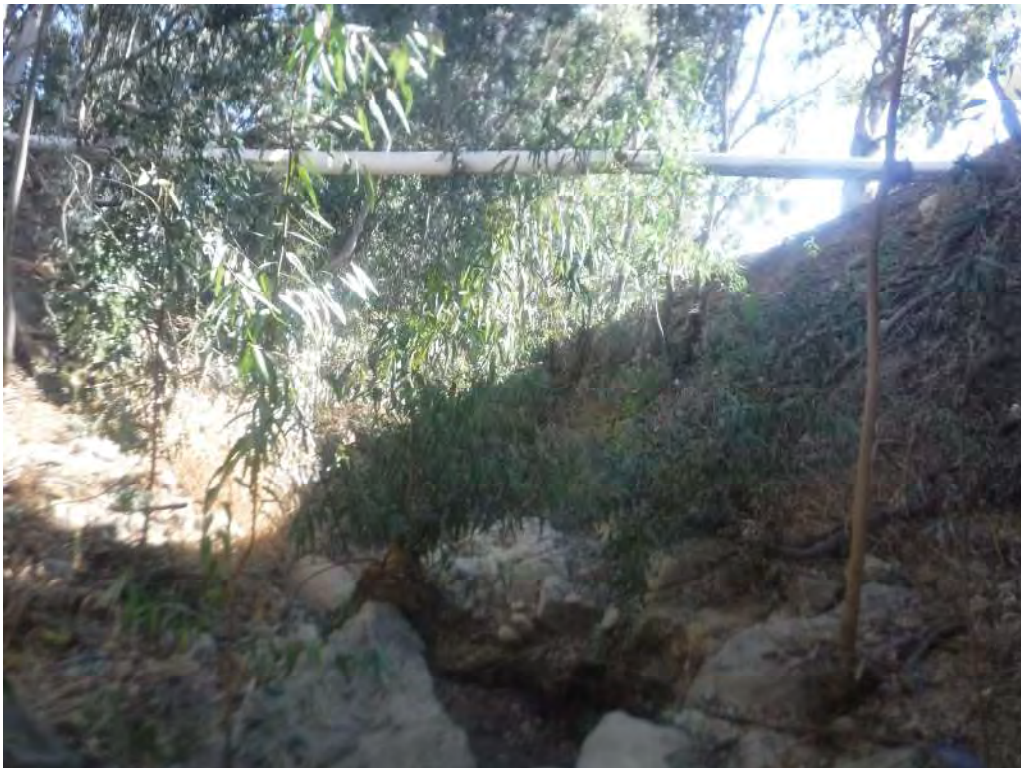
**419.42 Channel Condition – Looking Downstream**

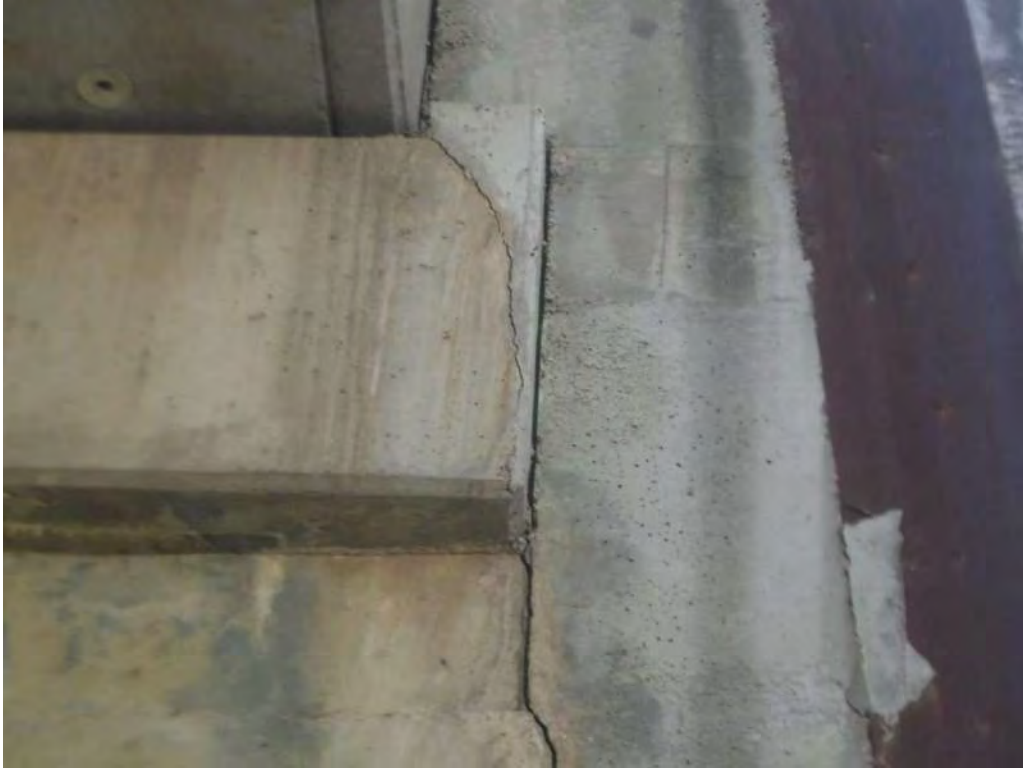
**419.42 Abutment 1 crack and keeper block cracked – North edge of cap**

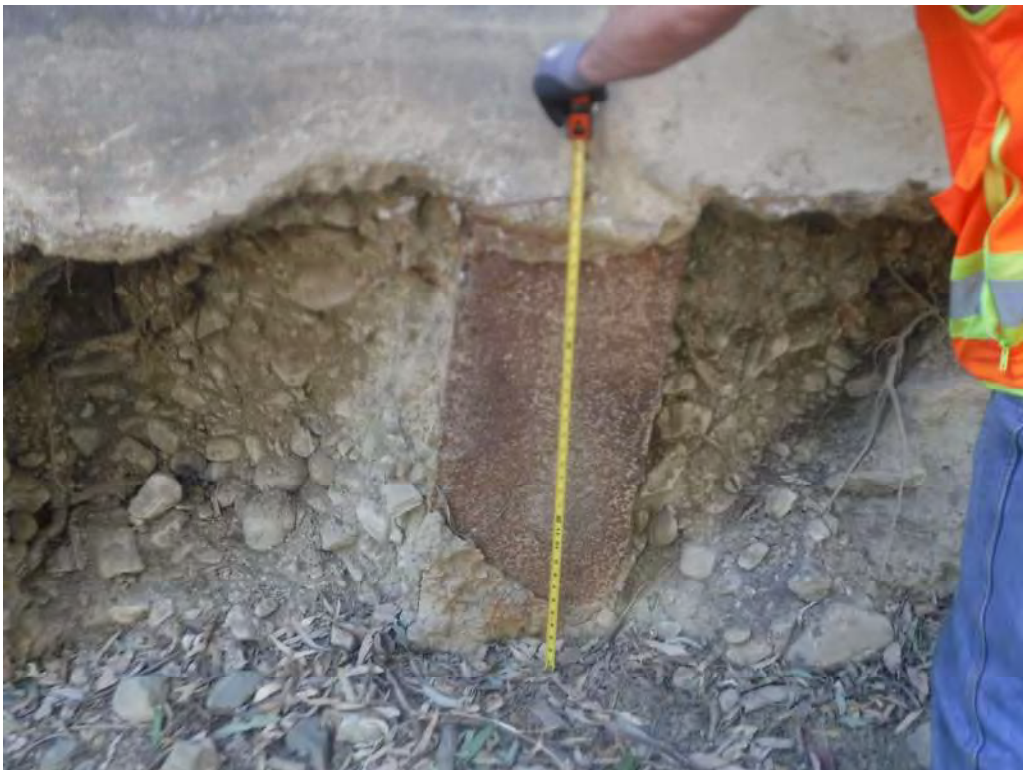
**419.42 Scour - Abutment 1**

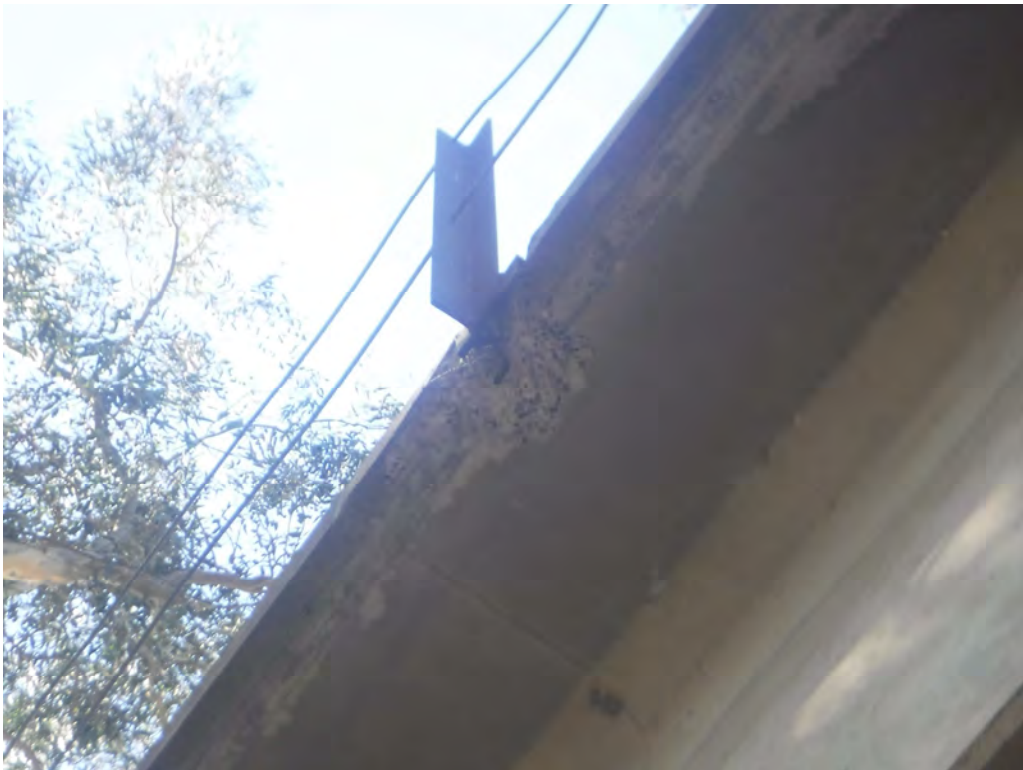
**419.42 Spall on South walkway**

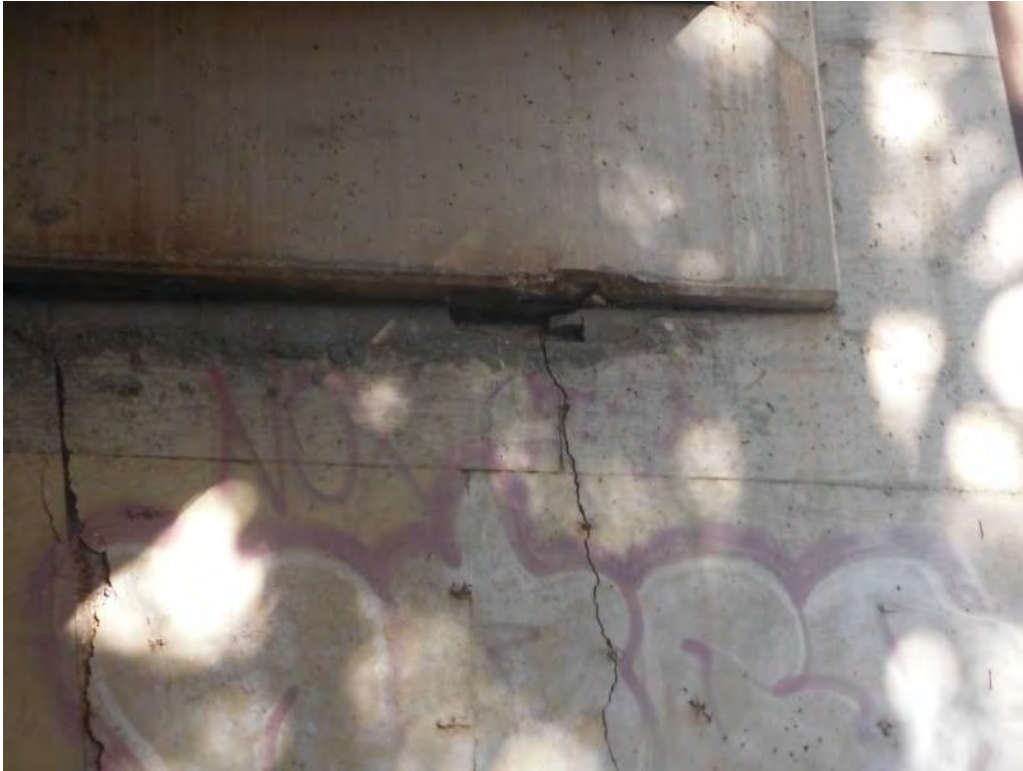
**419.42 Cracking and spall with exposed rebar - Abutment 2**

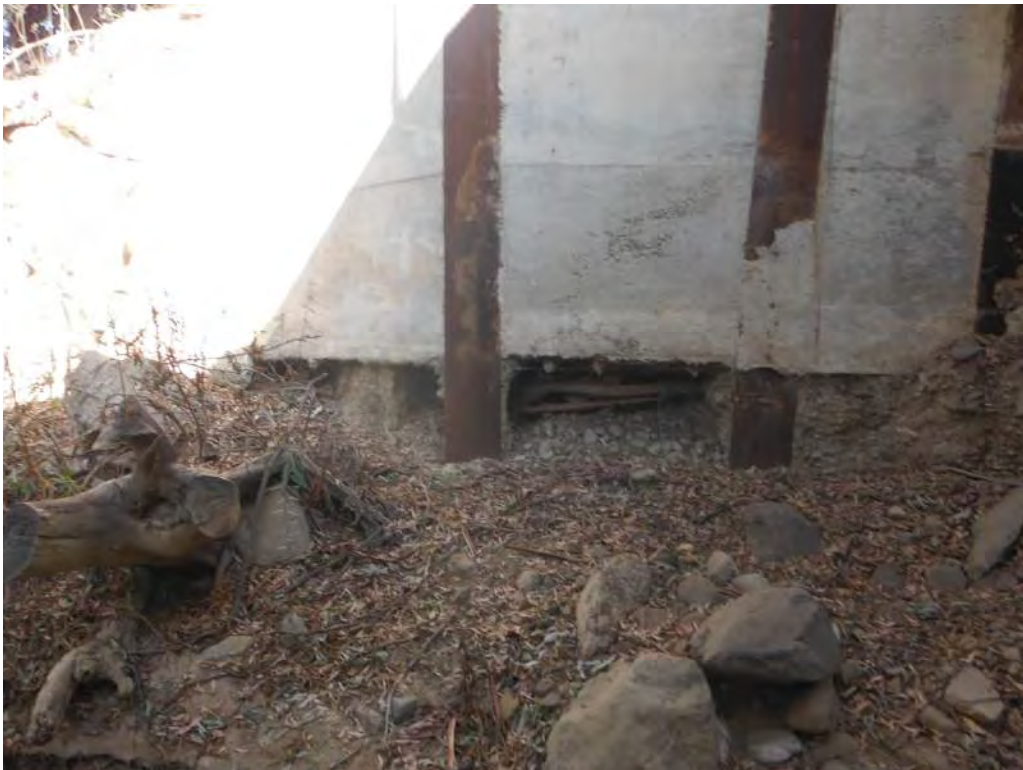
**419.42 Scour - Abutment 2**

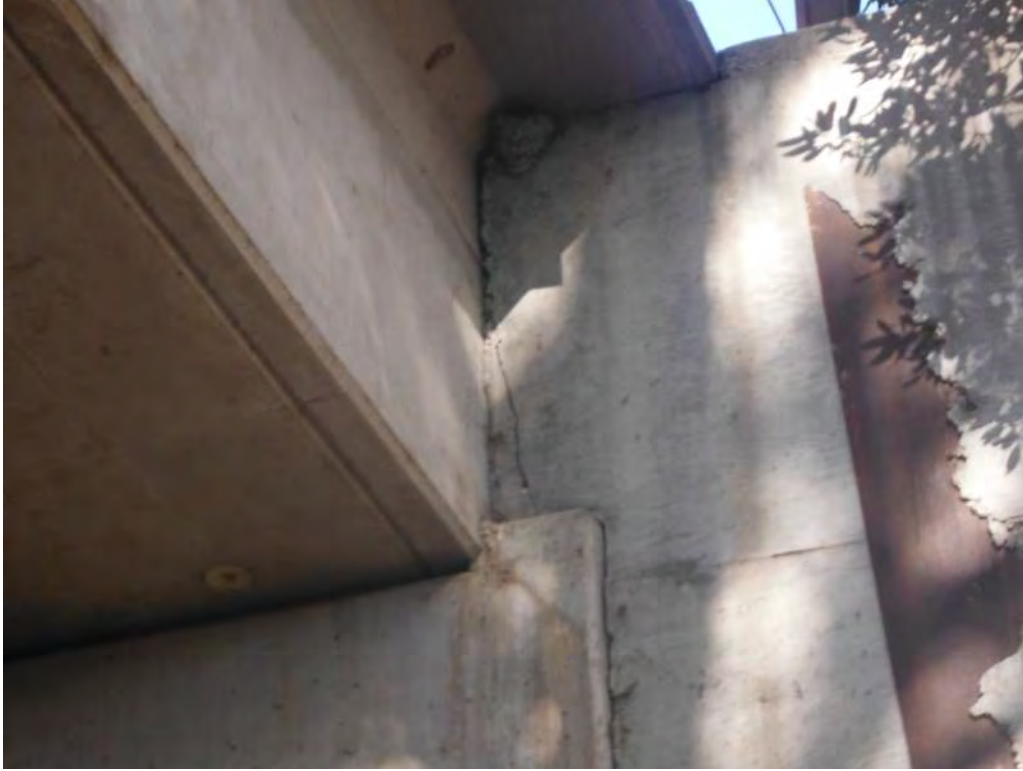
**419.42 Crack in backwall, and crack and spall on south keeper – Abutment 2**

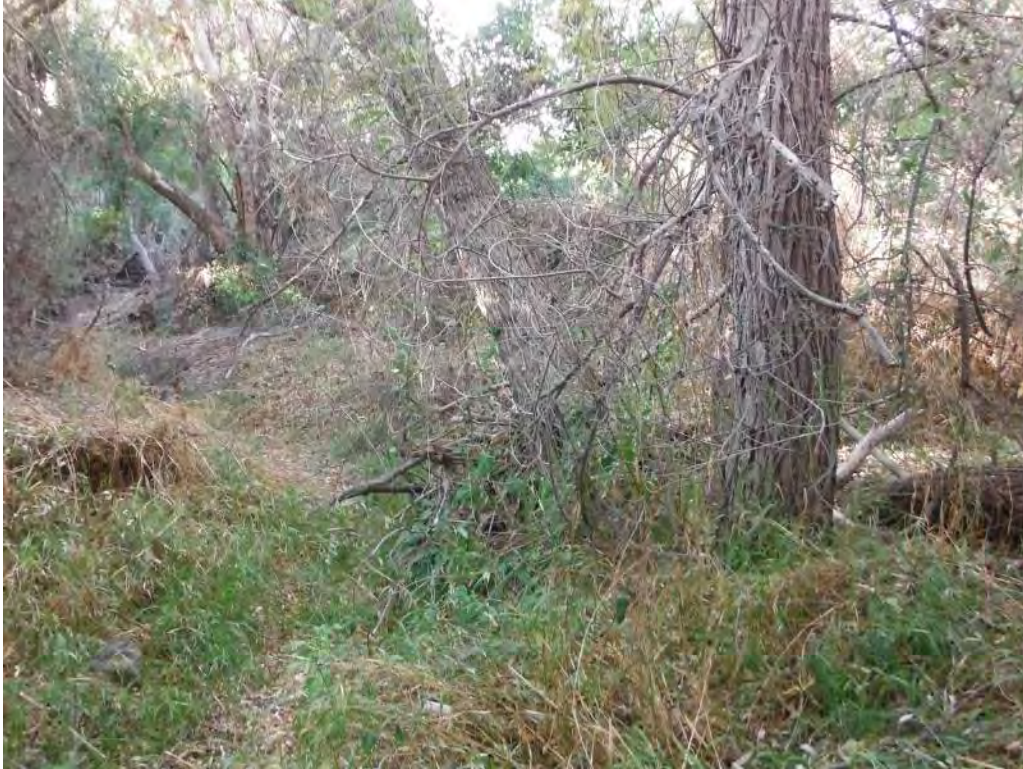
**419.92 Channel Condition – Looking Upstream**

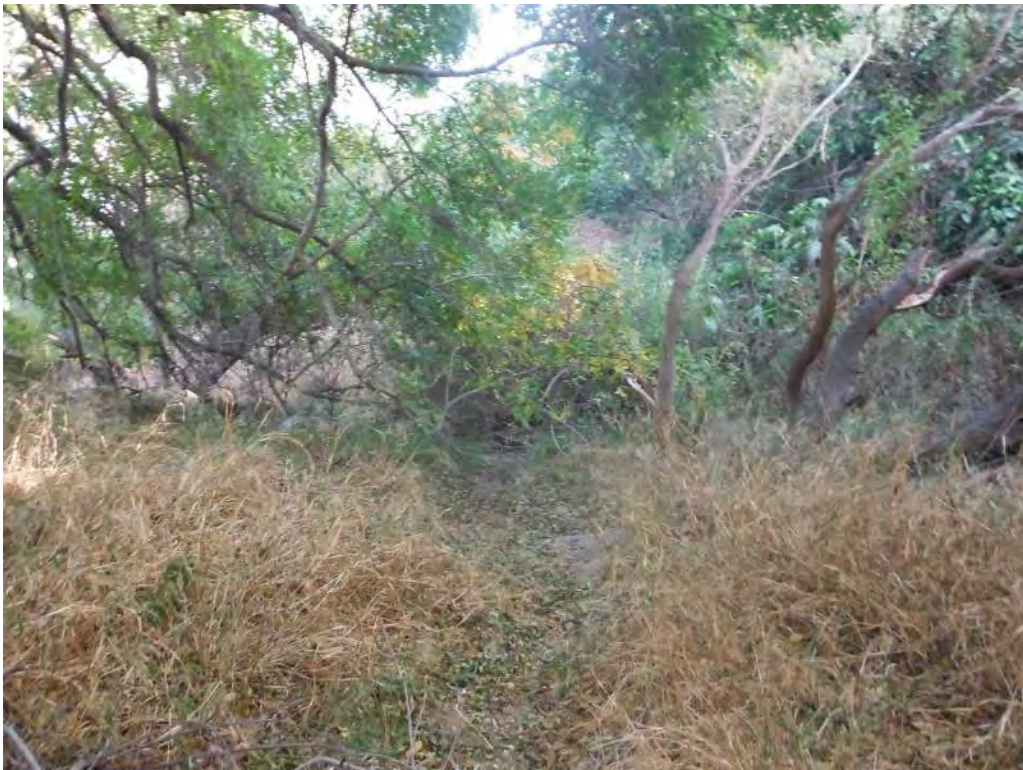
**419.92 Channel Condition - Looking Downstream**

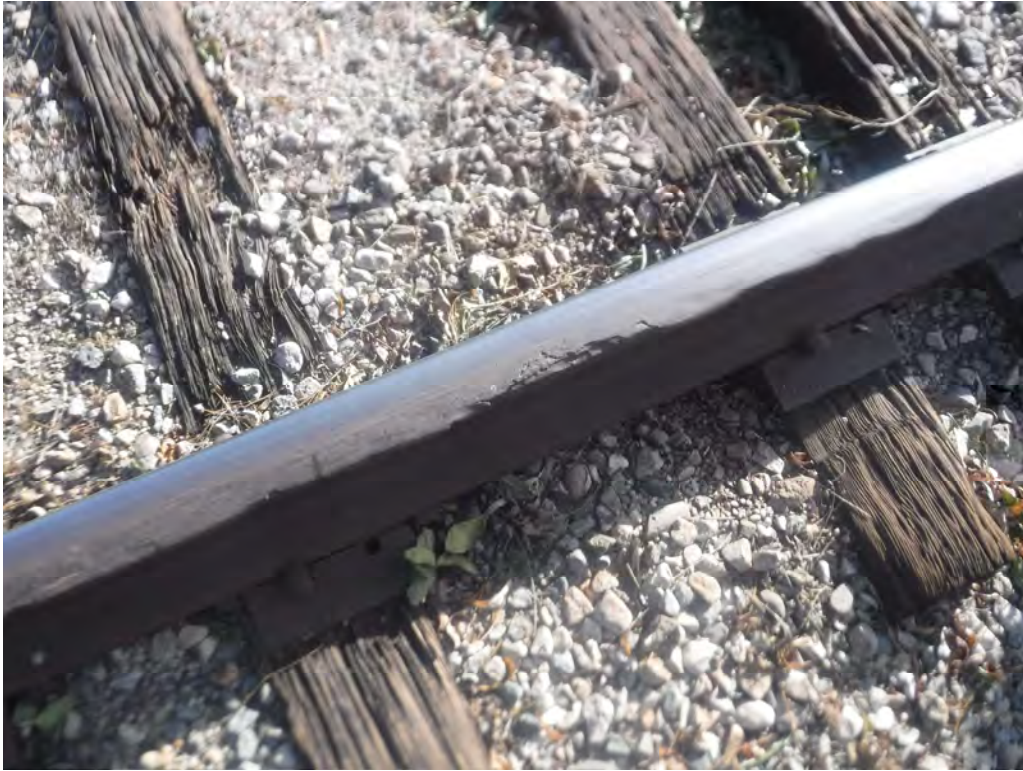
**419.92 Rail section loss – east and west sides and along length of bridge**

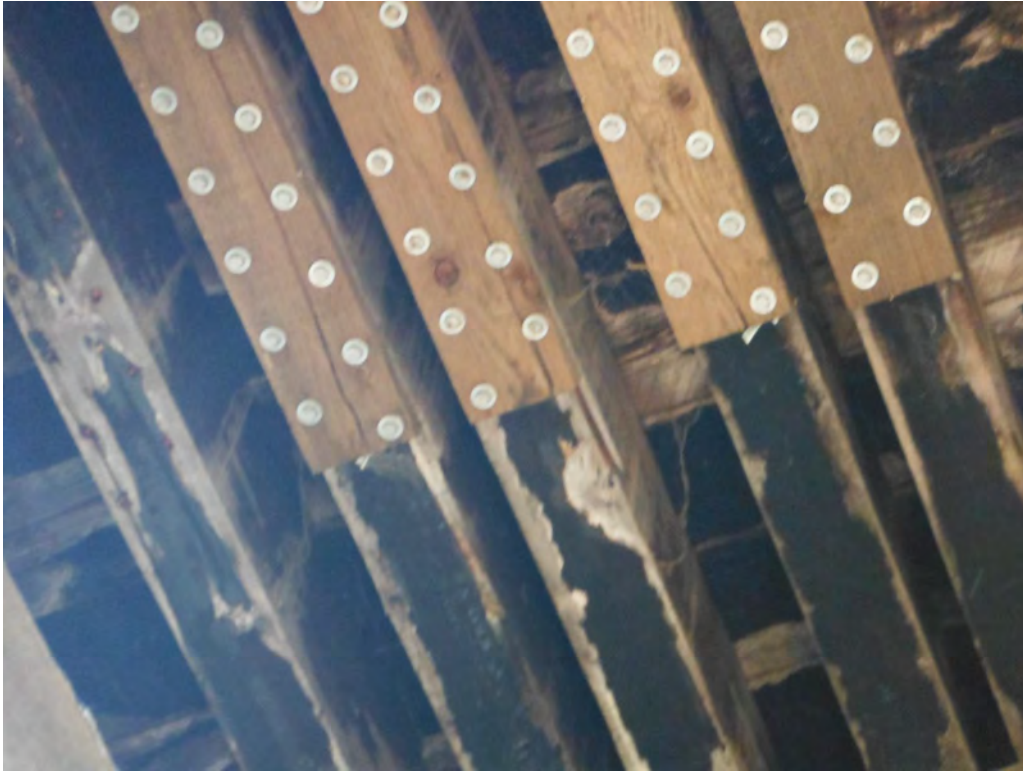
**419.92 Stringer 4 split at ends of repair locations - Bent 4**

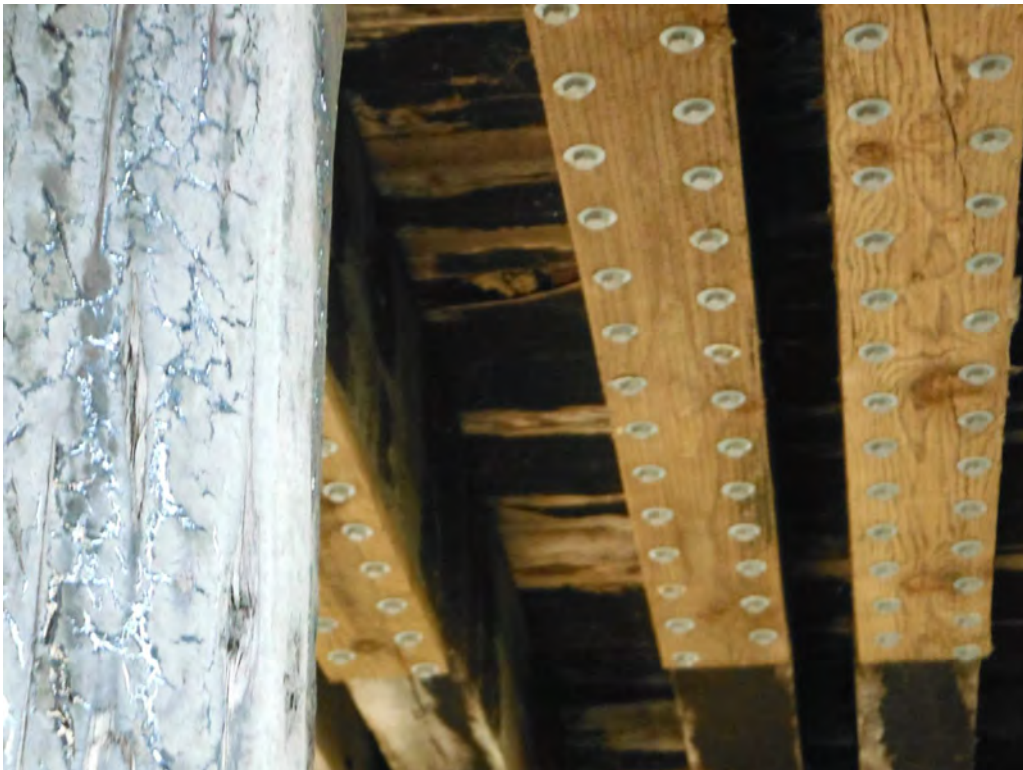
**419.92 Hole beginning in deck between stringer 6 and 7 - Span 4**

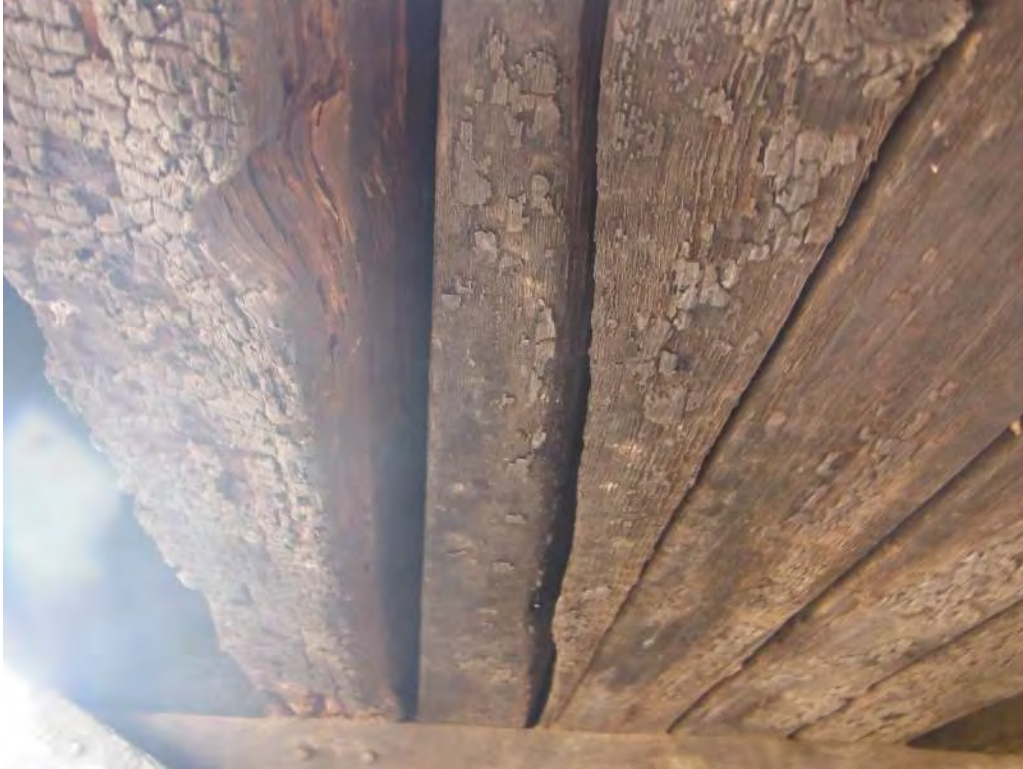
**420.20 Stringer 8 shear split and Stringer 9 failed Span 2**

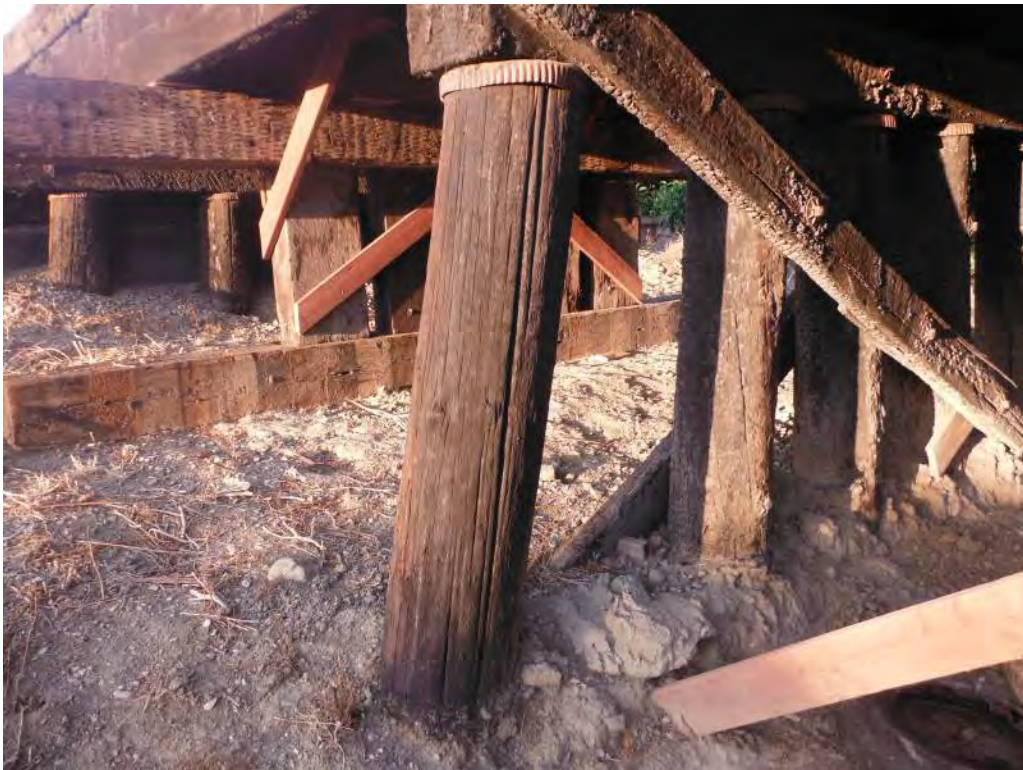
**420.20 Bent 2 Pile 5 Split**

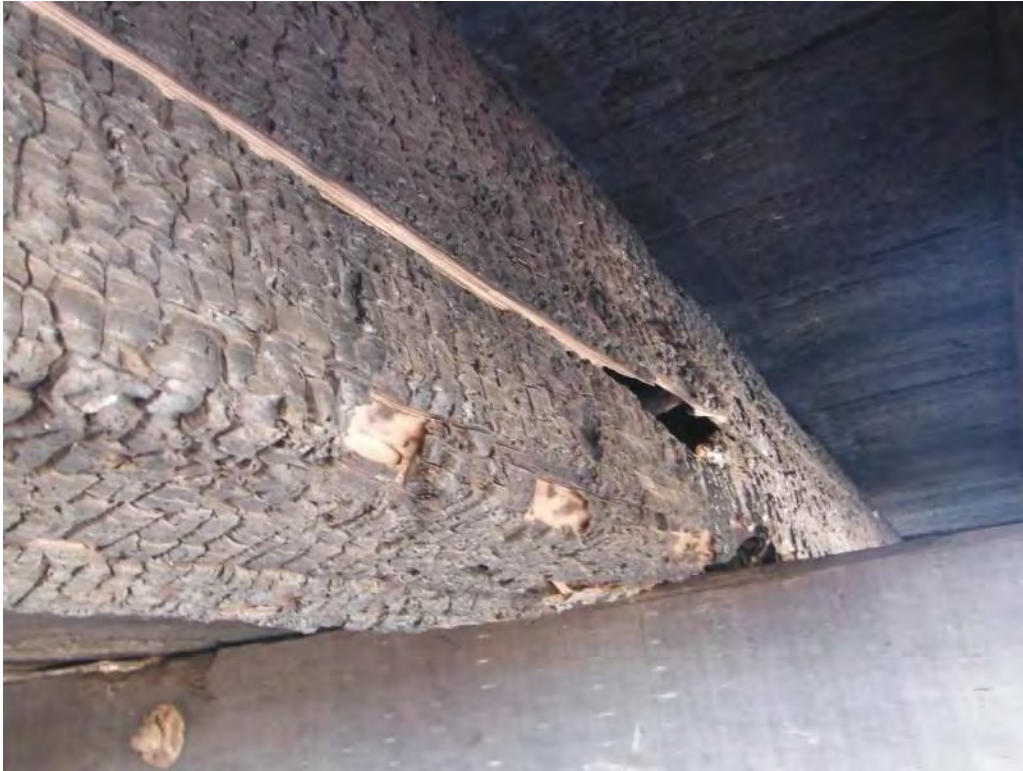
**420.20 Span 2, Stringer 9 failed at helper bent**

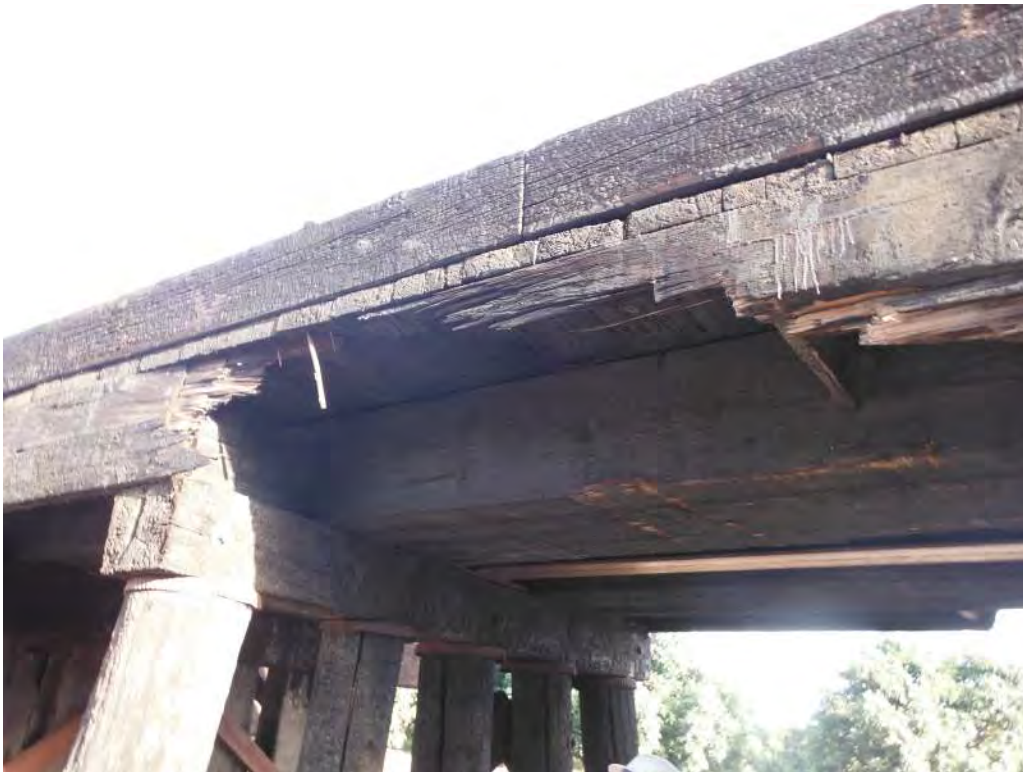
**420.20 Exterior stringer failed due to impact - Span 3 typ**

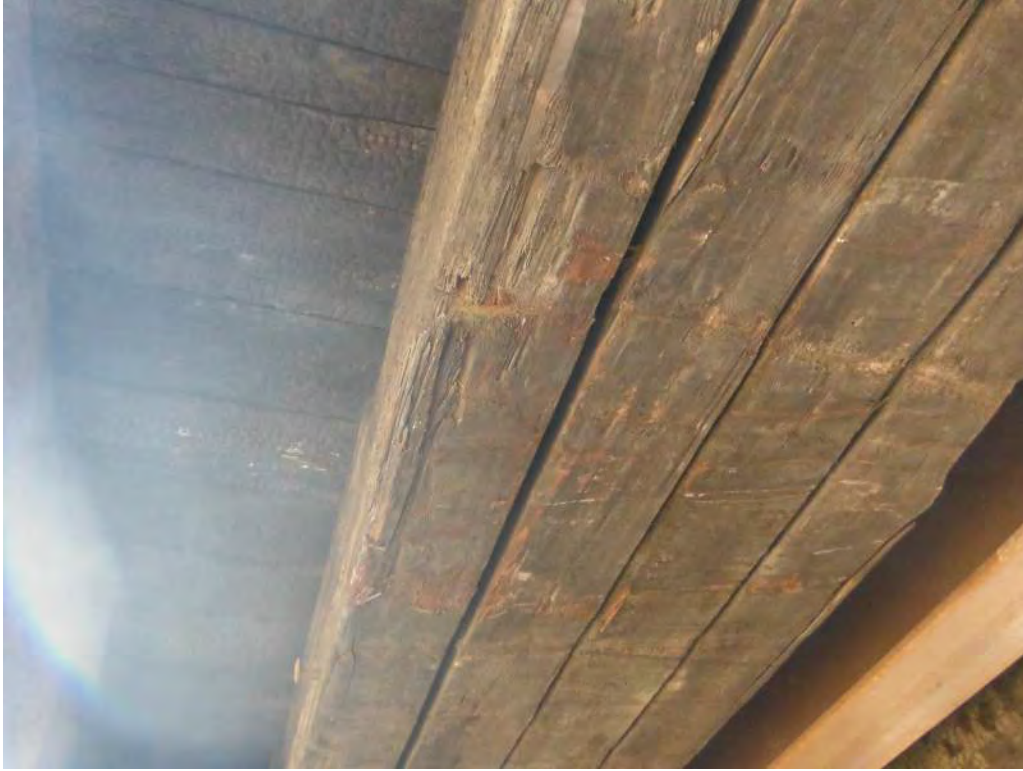
**420.20 Impact Damage – Span 3**

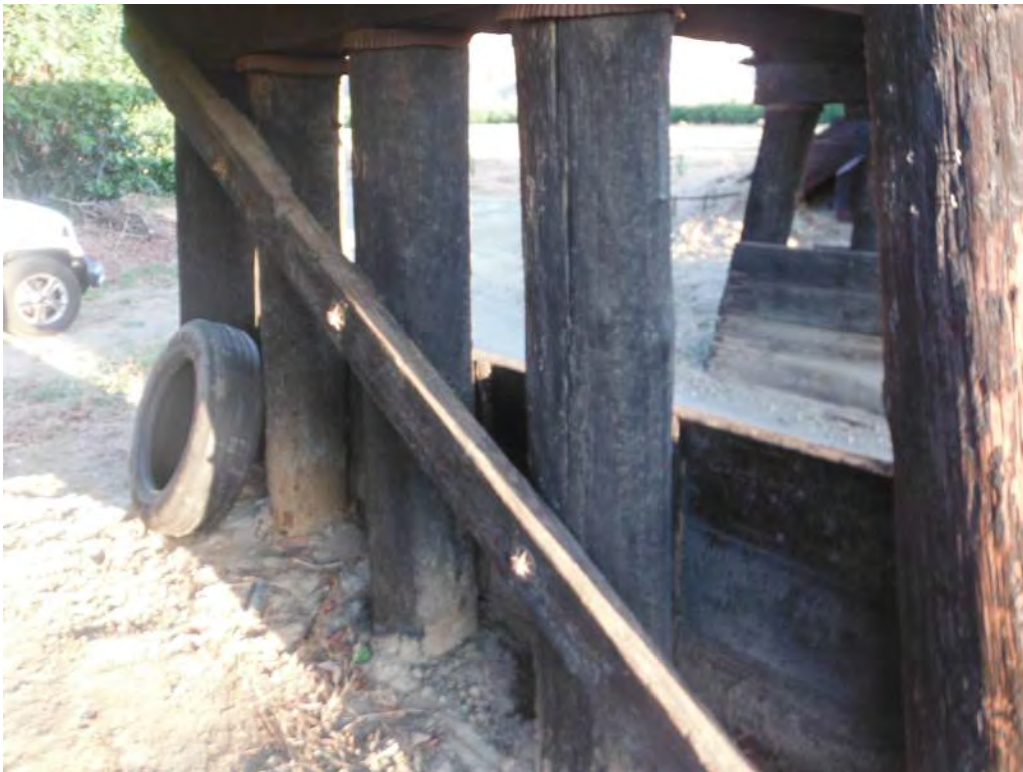
**420.20 Bent 3 piles split**

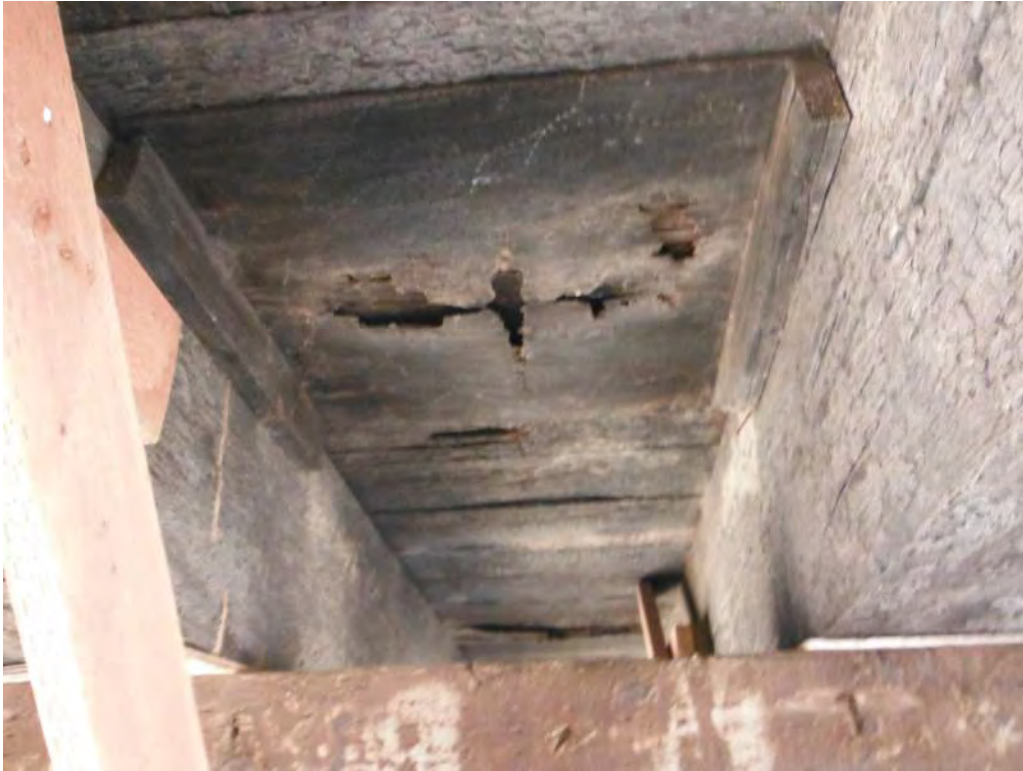
**420.20 Failing Deck Plank – Span 4**

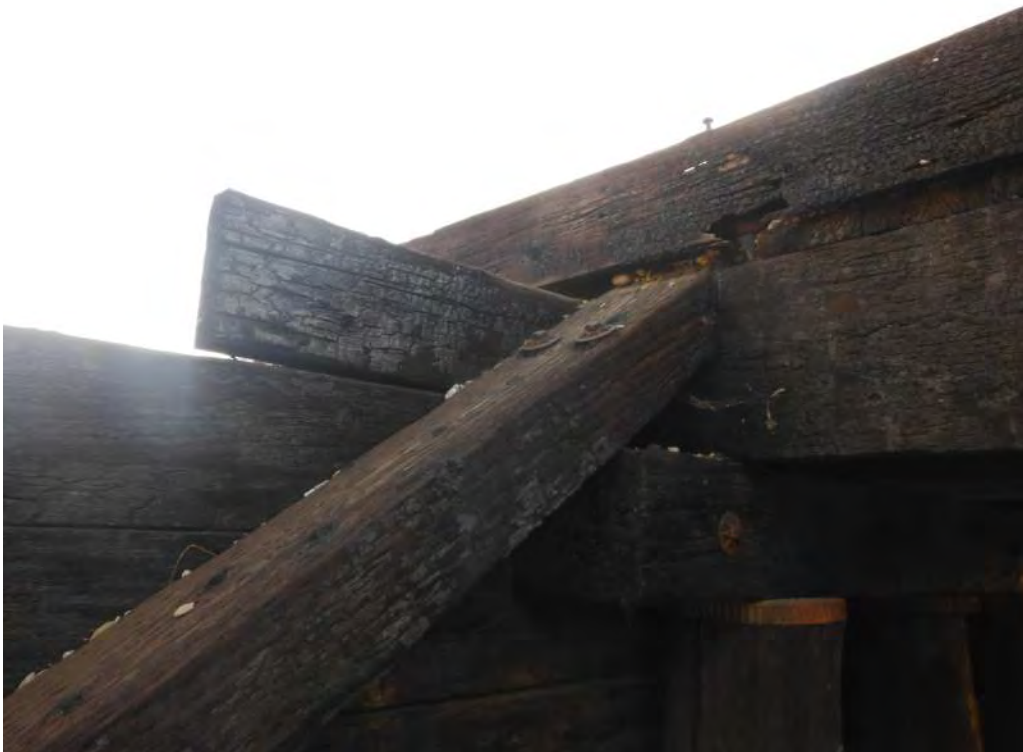
**420.20 Ballast boards failing at Abutment 5**

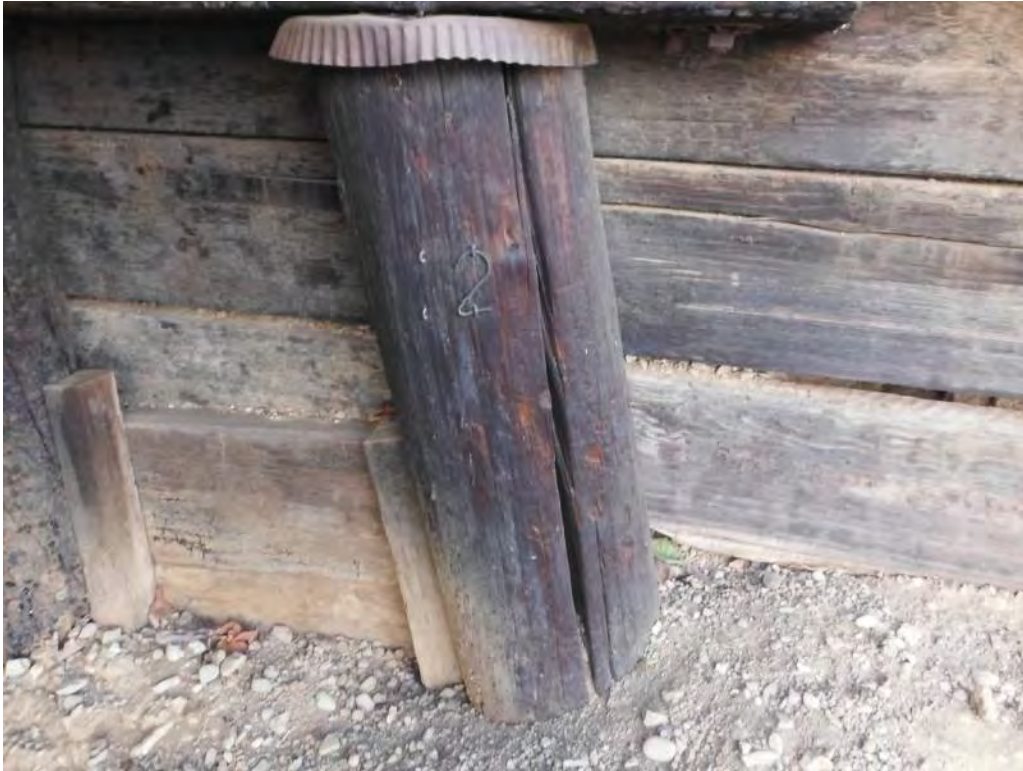
**420.20 Abutment 5 Pile 5 split**

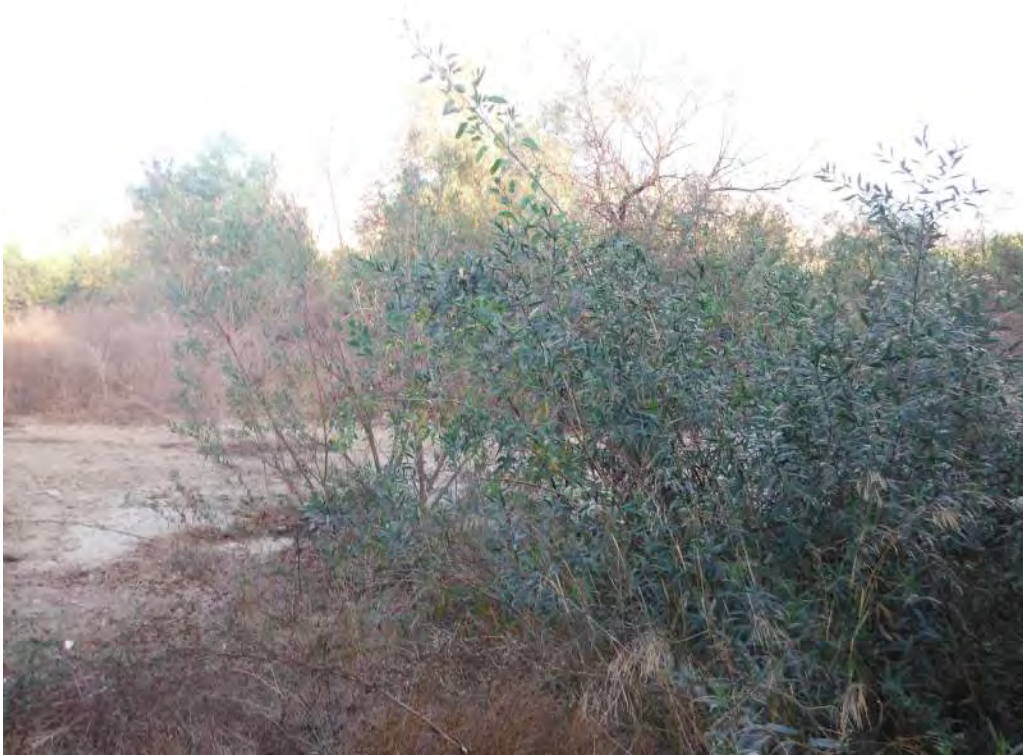
**420.46 Channel Condition – Looking Upstream**

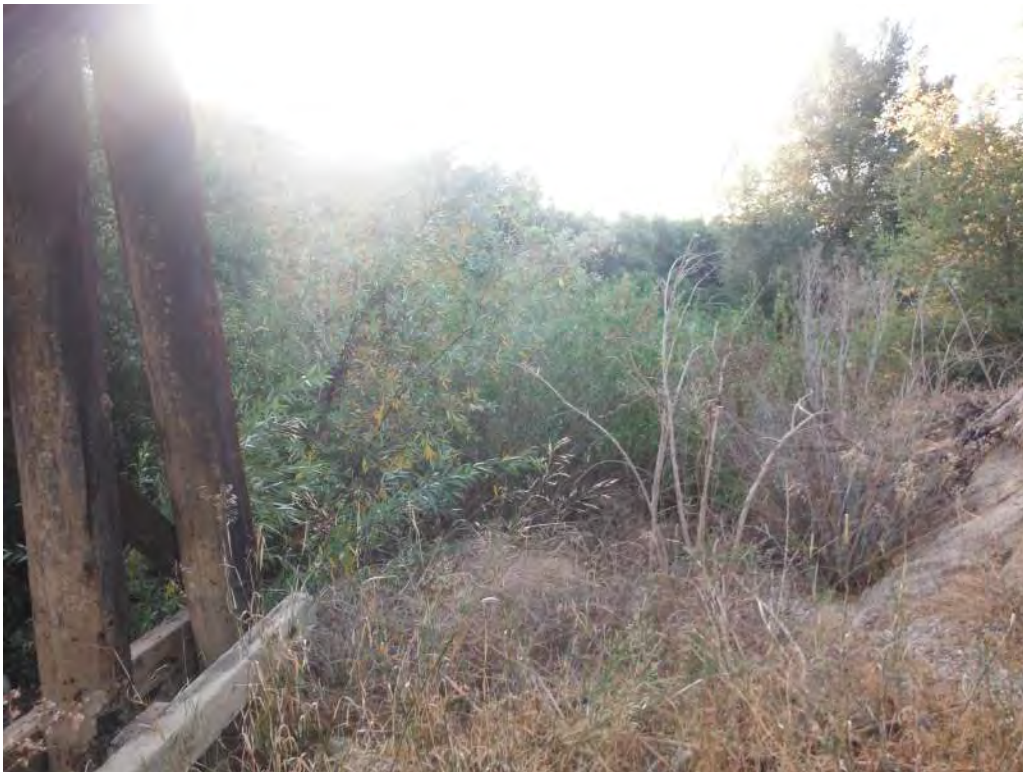
**420.46 Channel Condition - Looking Downstream**

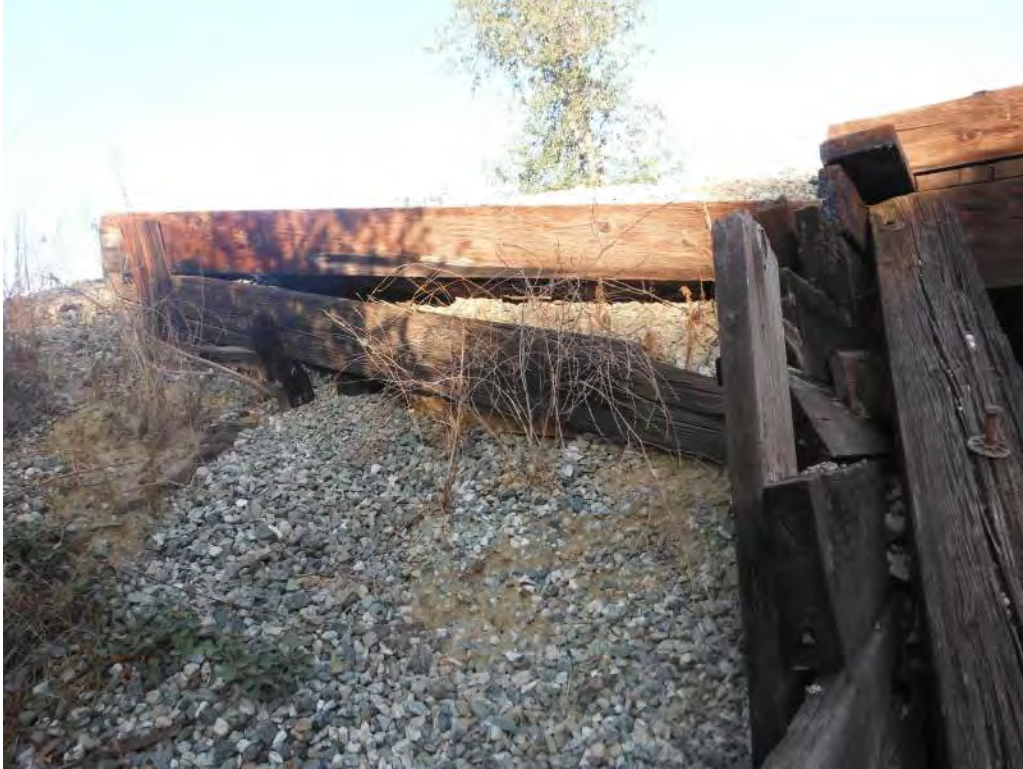
**420.46 Southwest wing failing**
