# BRIDGE INSPECTION REPORT

INSPECTION TYPE: Annual

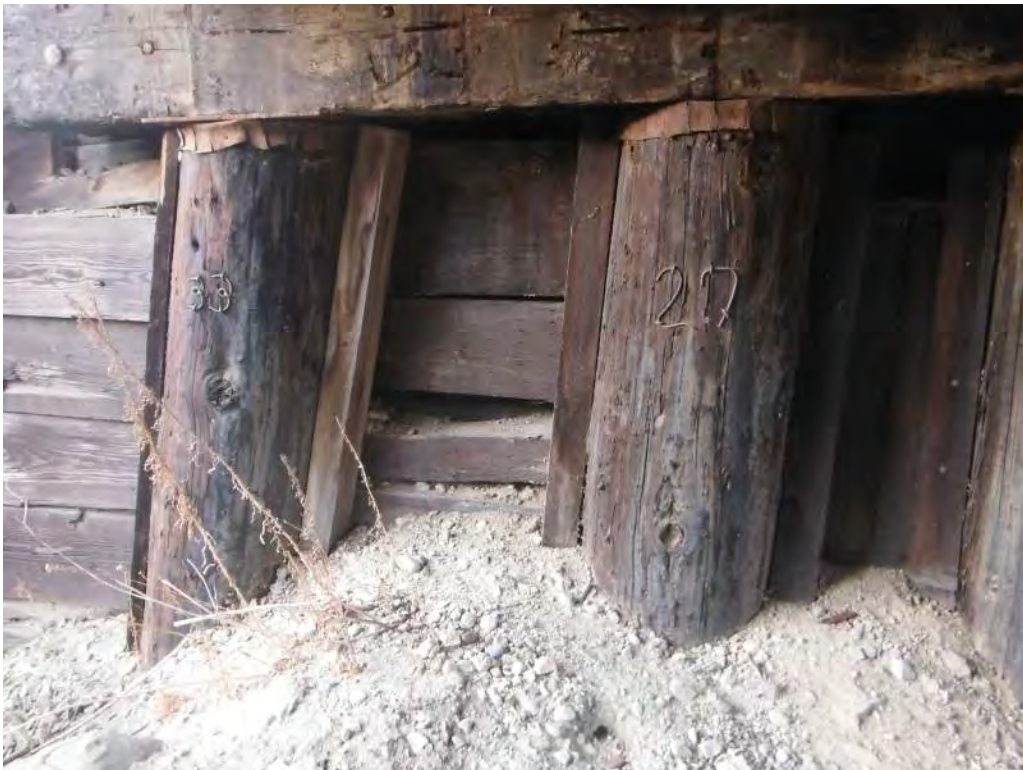
**420.46 Abutment 1 backwall failed plank's supplement failed**

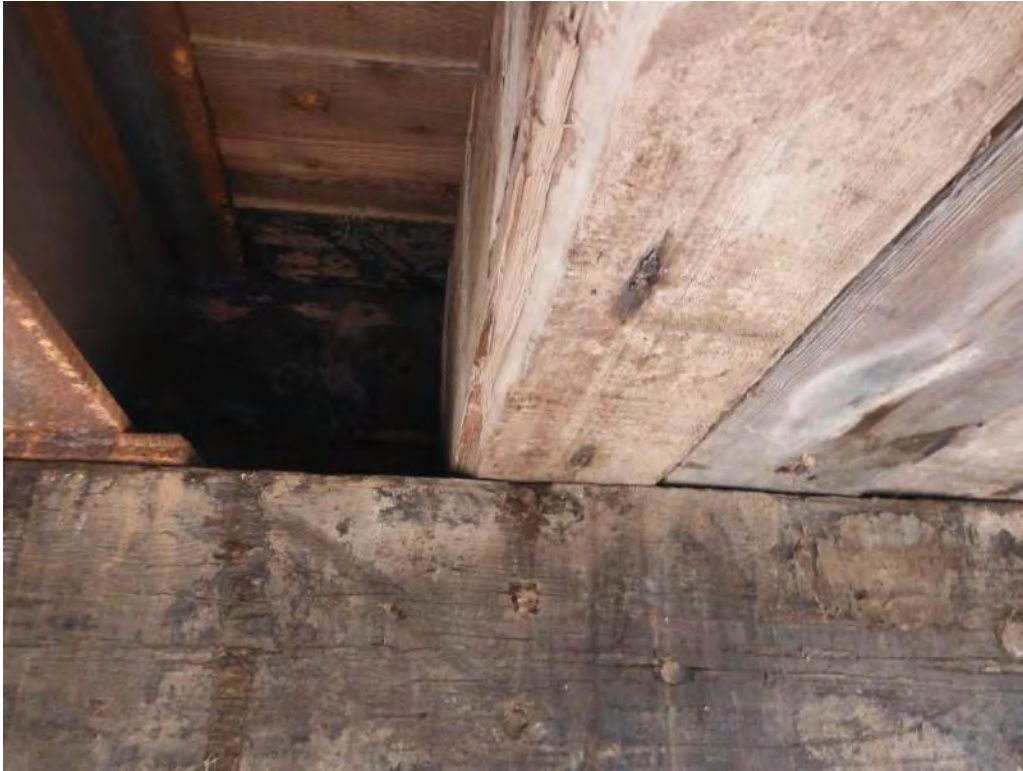
**420.46 Stringer 4 corner split, Abutment 1**

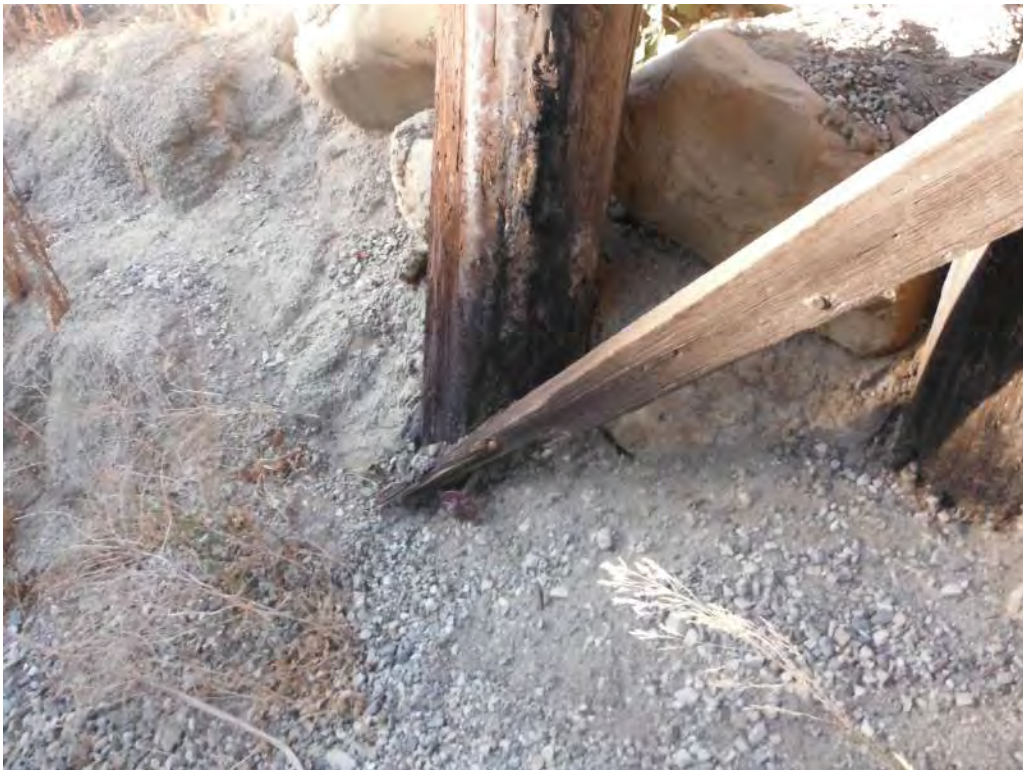
**420.46 Span 2, Bent 2 sway brace is broken on right side at pile 5**

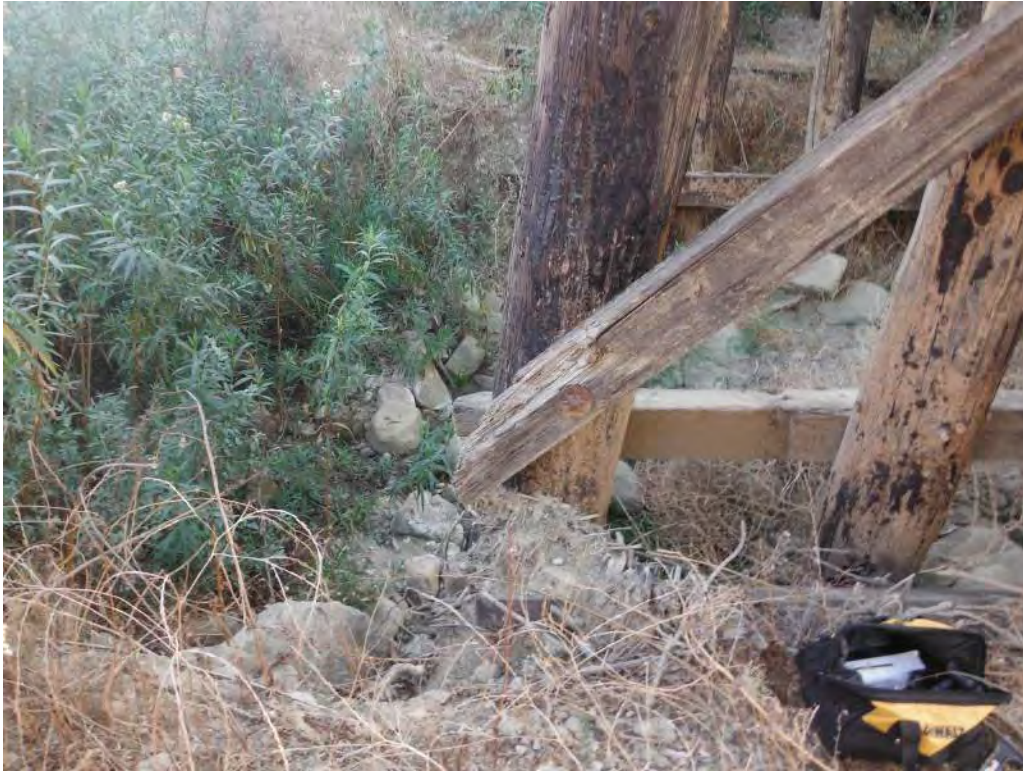
**420.46 Span 2 & Bent 3, tier 1 sash brace is broken on left side**

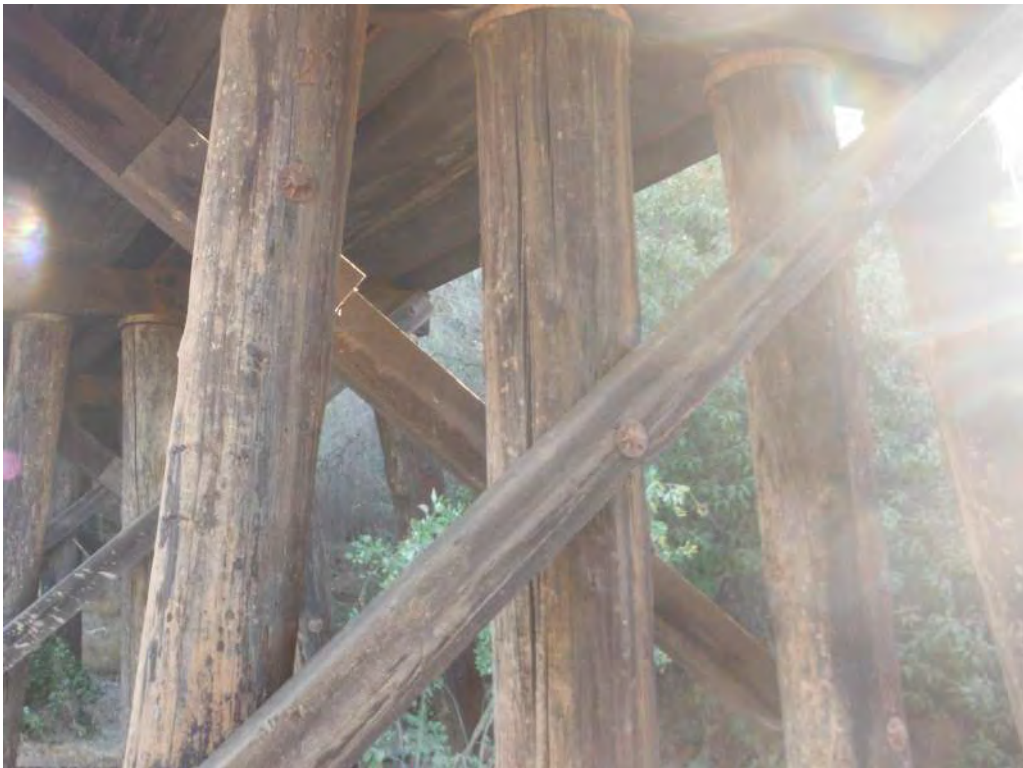
**420.46 Pile 3 vertical split, Bent 3**

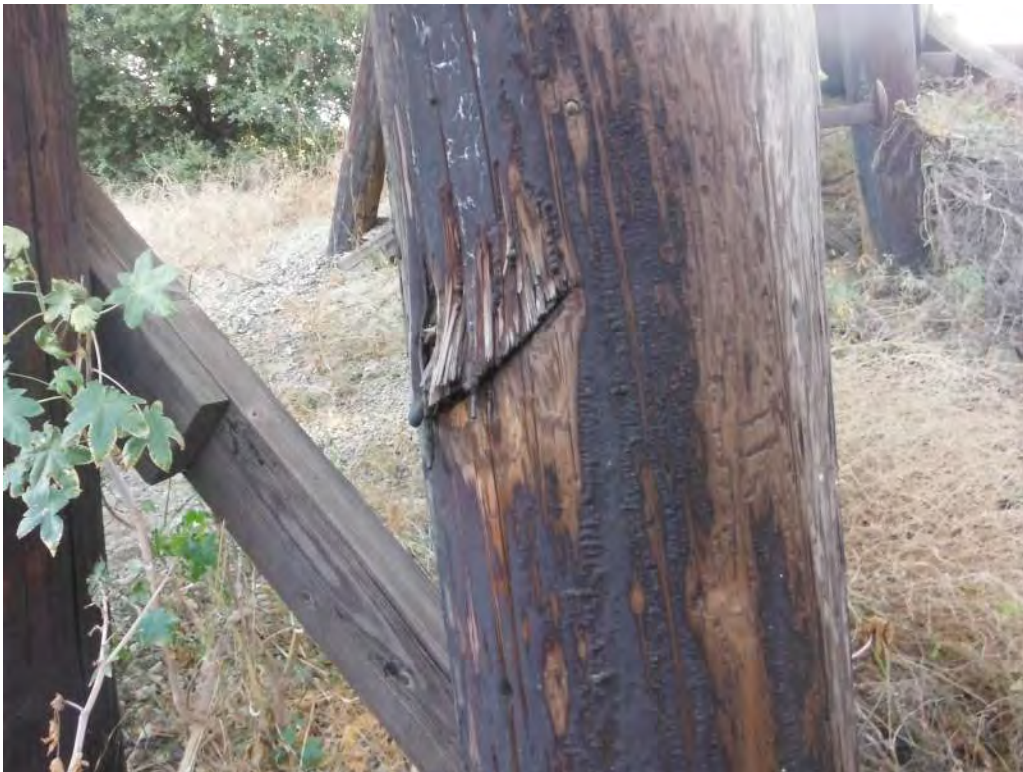
**420.46 Impact damage pile 5, Bent 5**

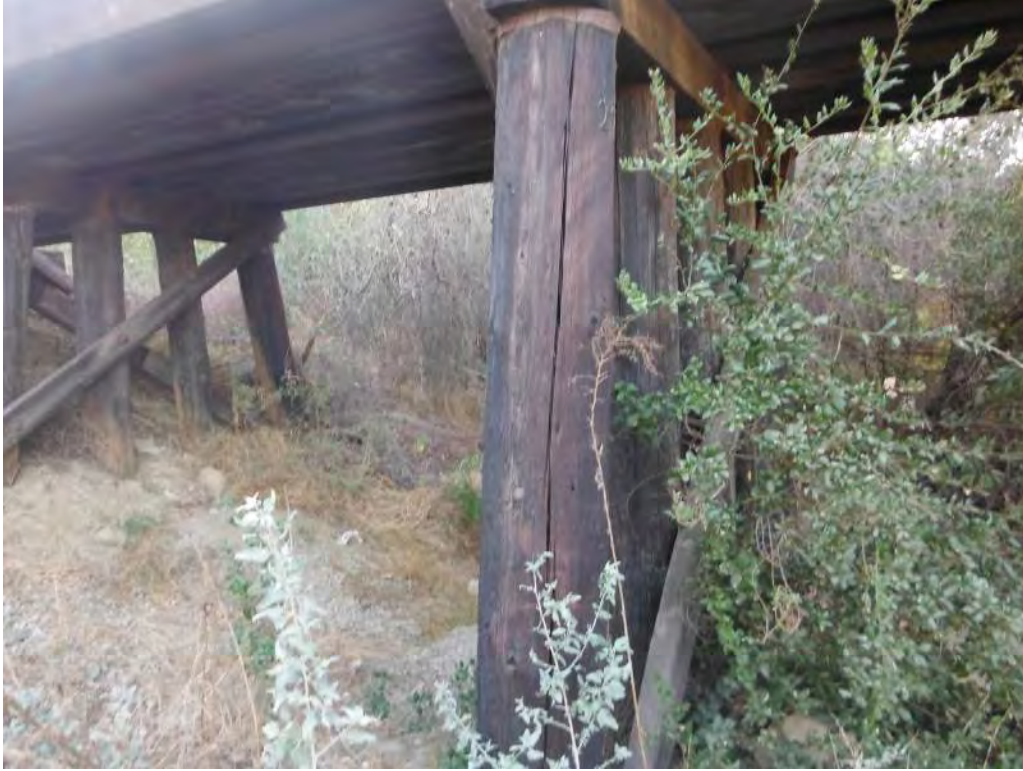
**420.46 Pile 1 vertical split, Bent 5**

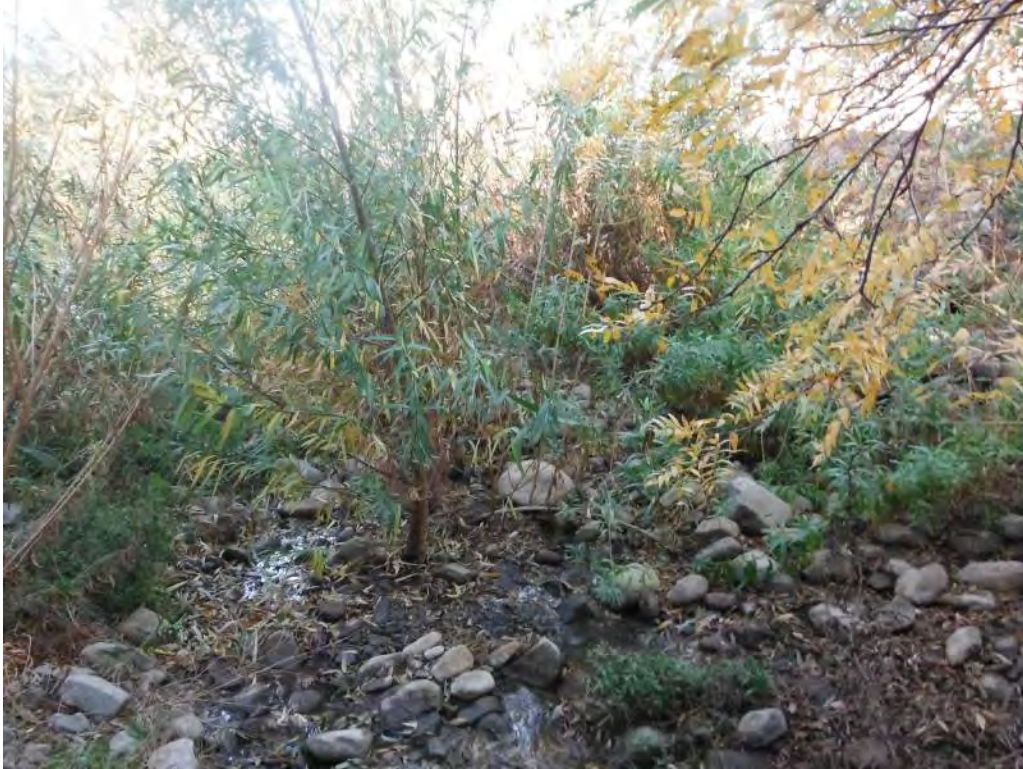
**421.05 Channel Condition – Looking Upstream**

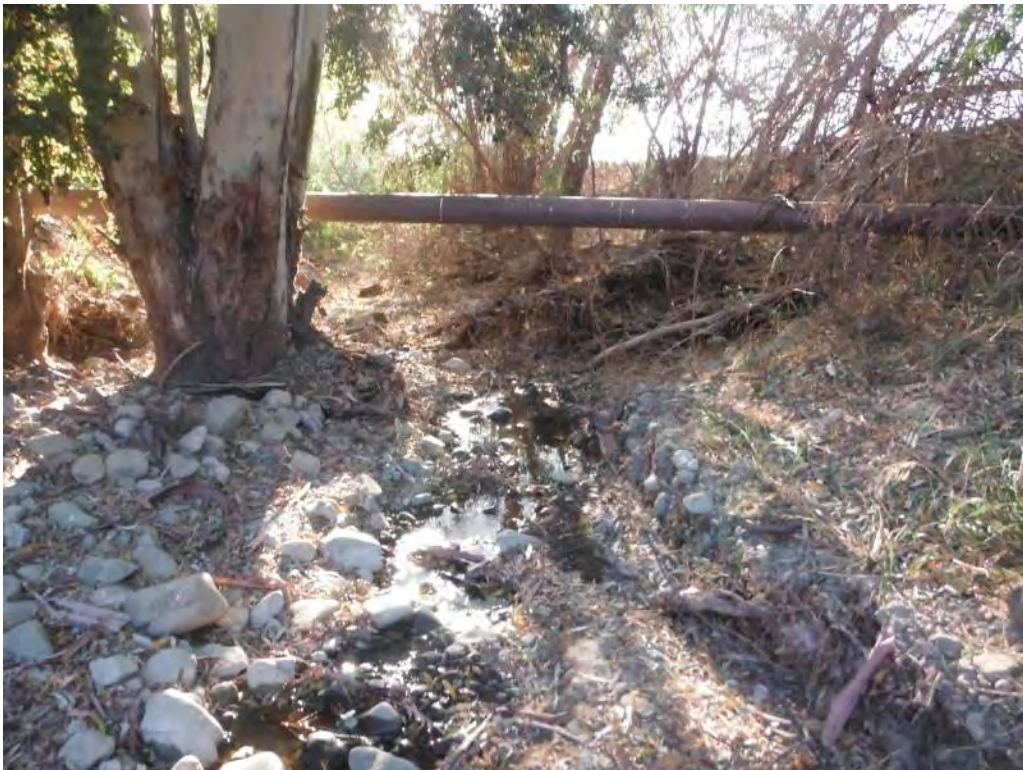
**421.05 Channel Condition - Looking Downstream**

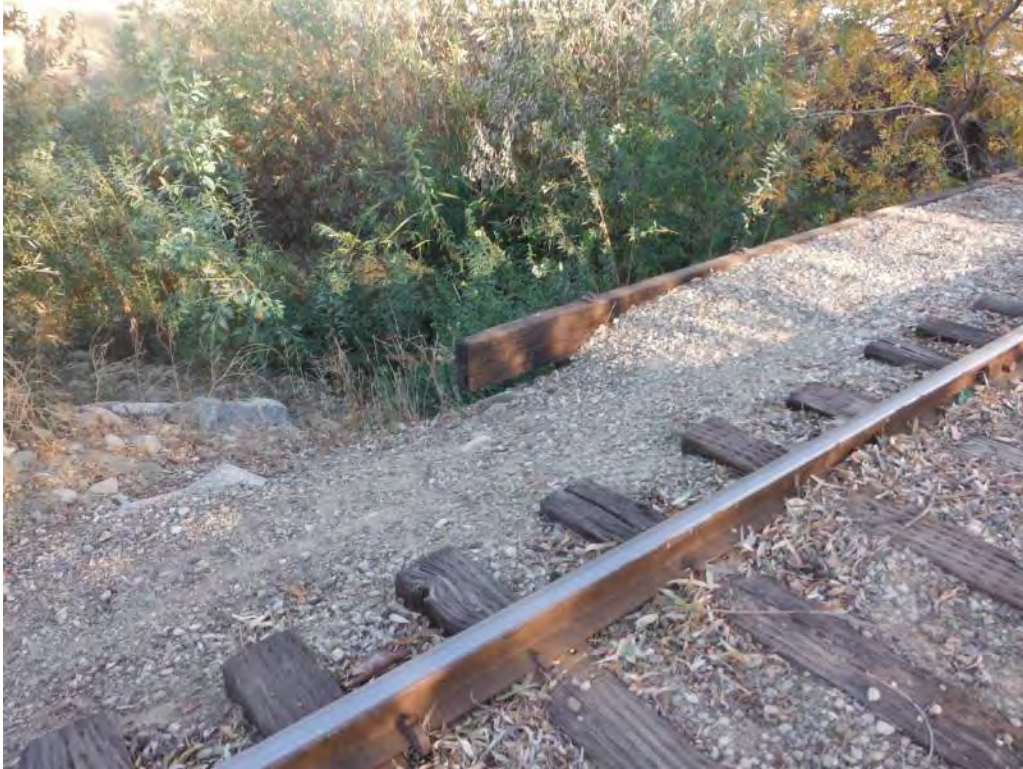
**421.05 Ballast Curb Undermined all 4 Corners**

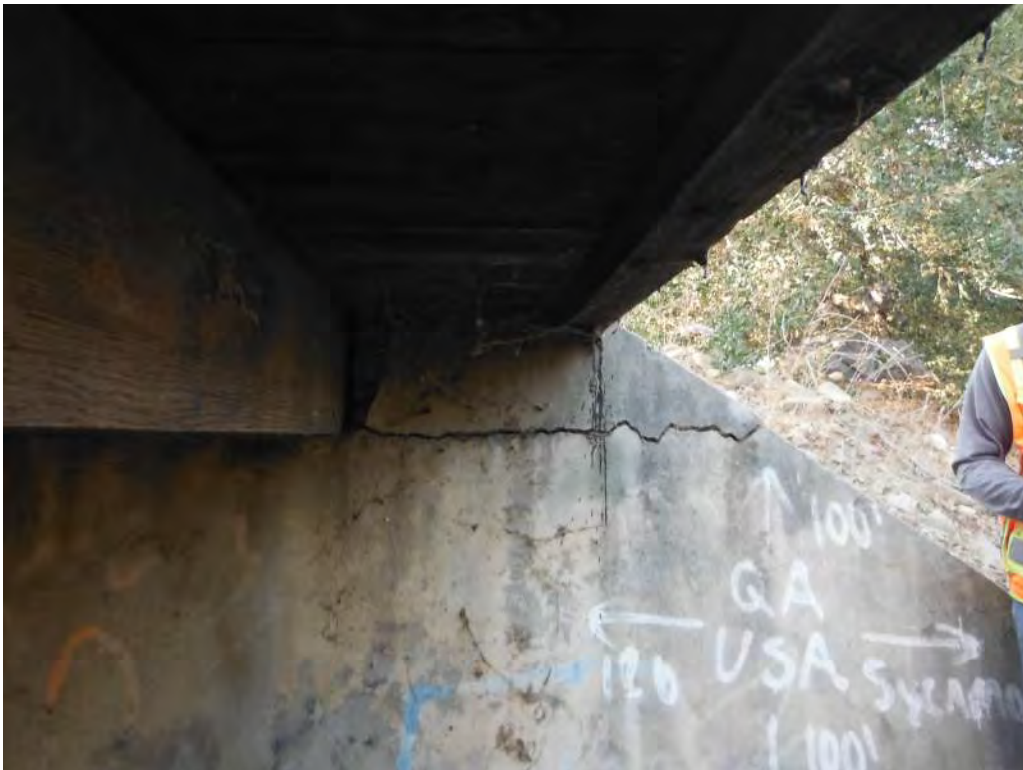
**421.05 Abutment stringer retainer cracked – typical all 4 corners**

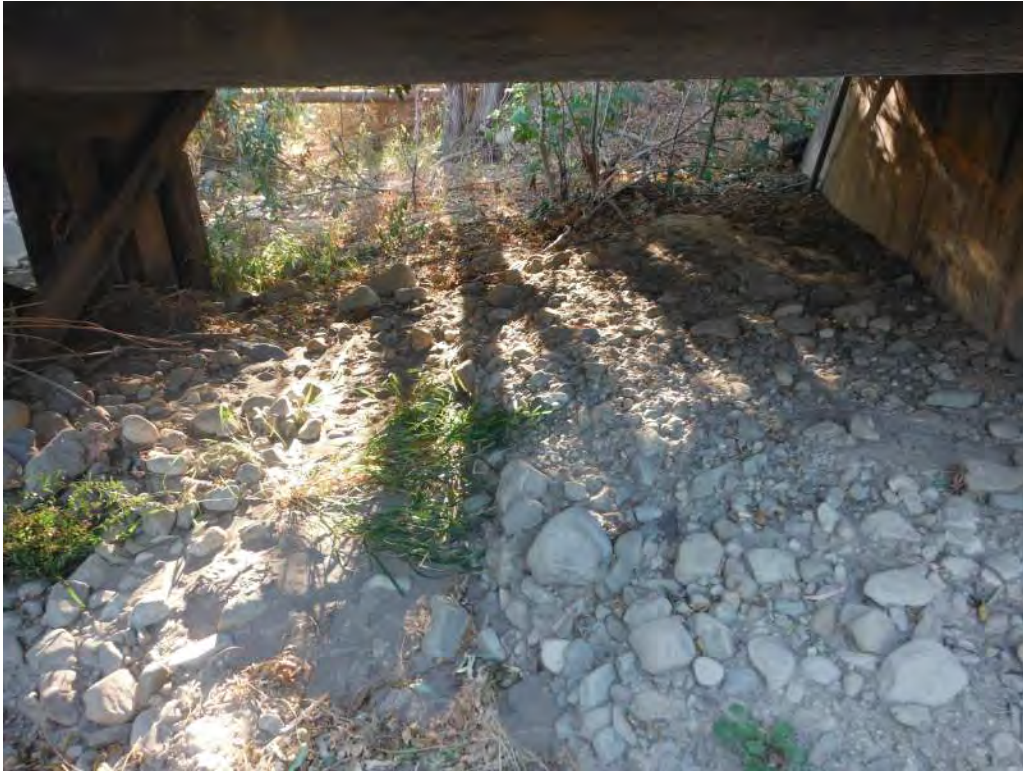
**421.05 Span 1 silting in**

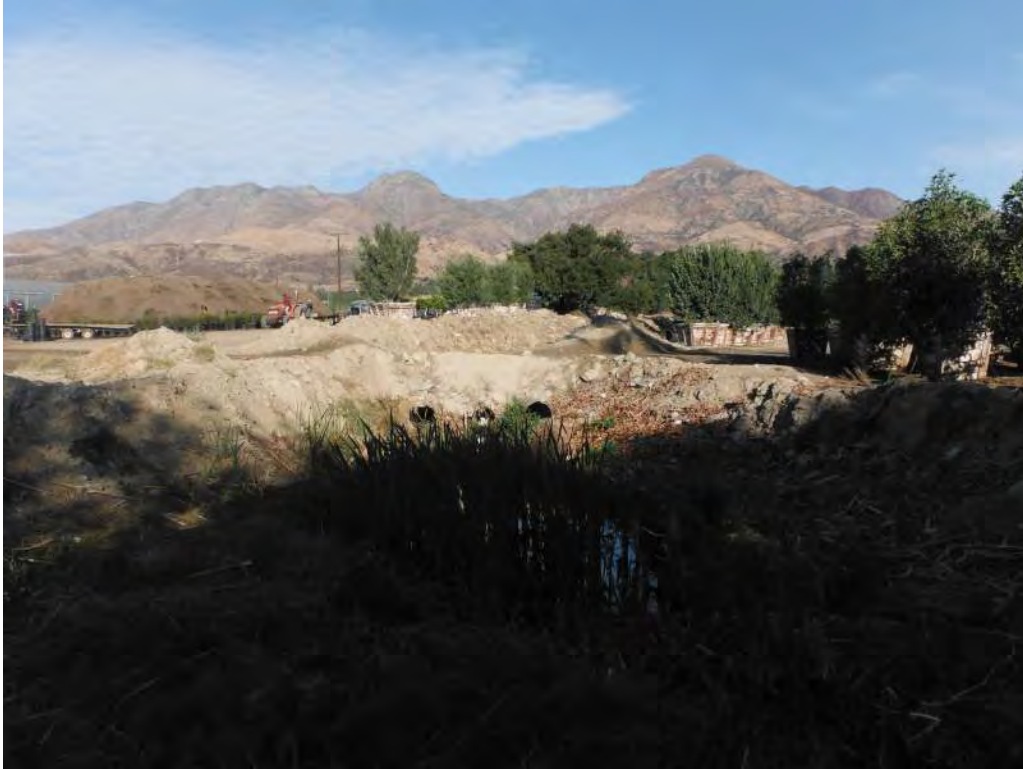
**421.23 Channel Condition – Looking Upstream**

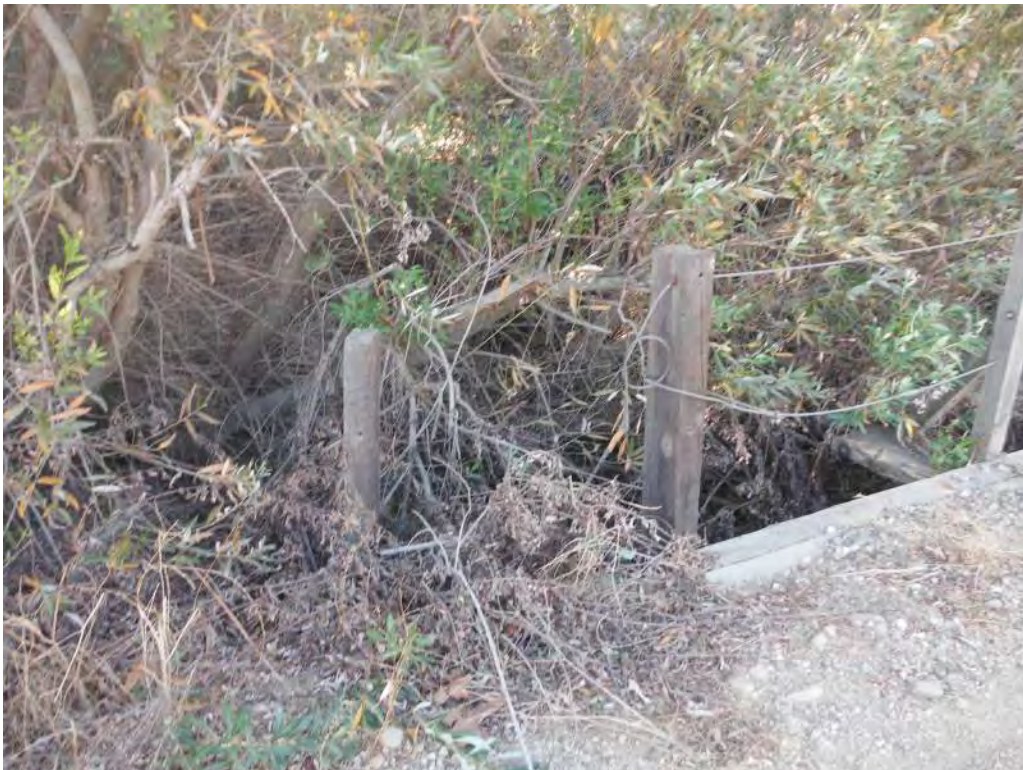
**421.23 Channel Condition – Looking Downstream**

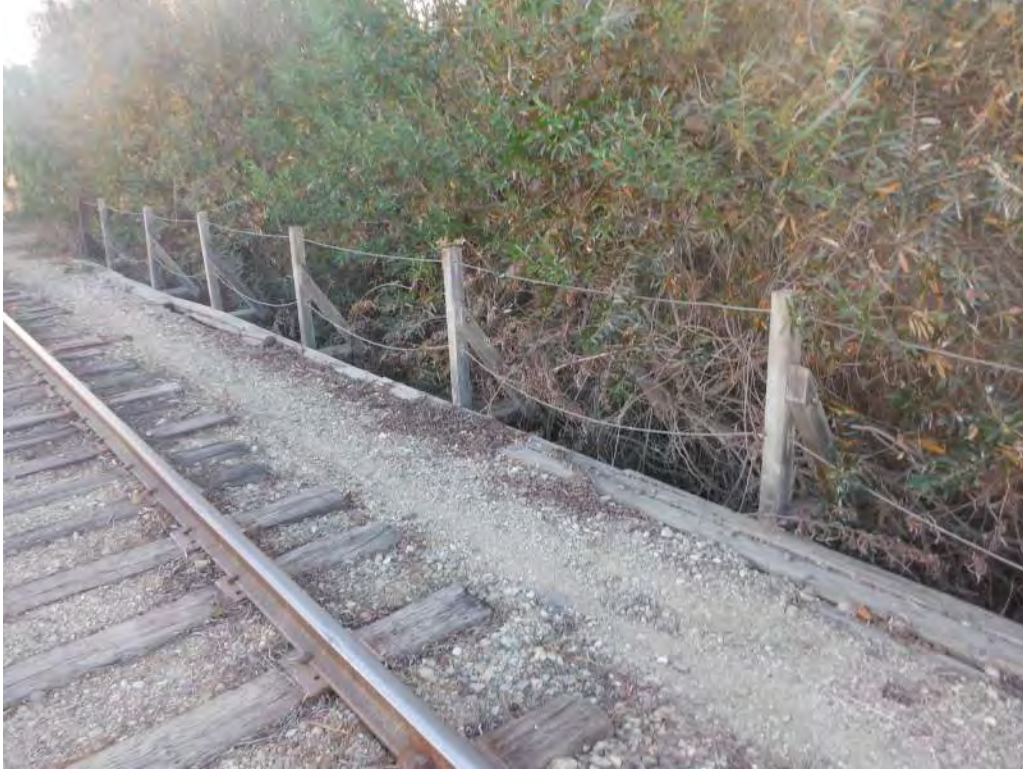
**421.23 Loose Handrail Cable Both Sides**

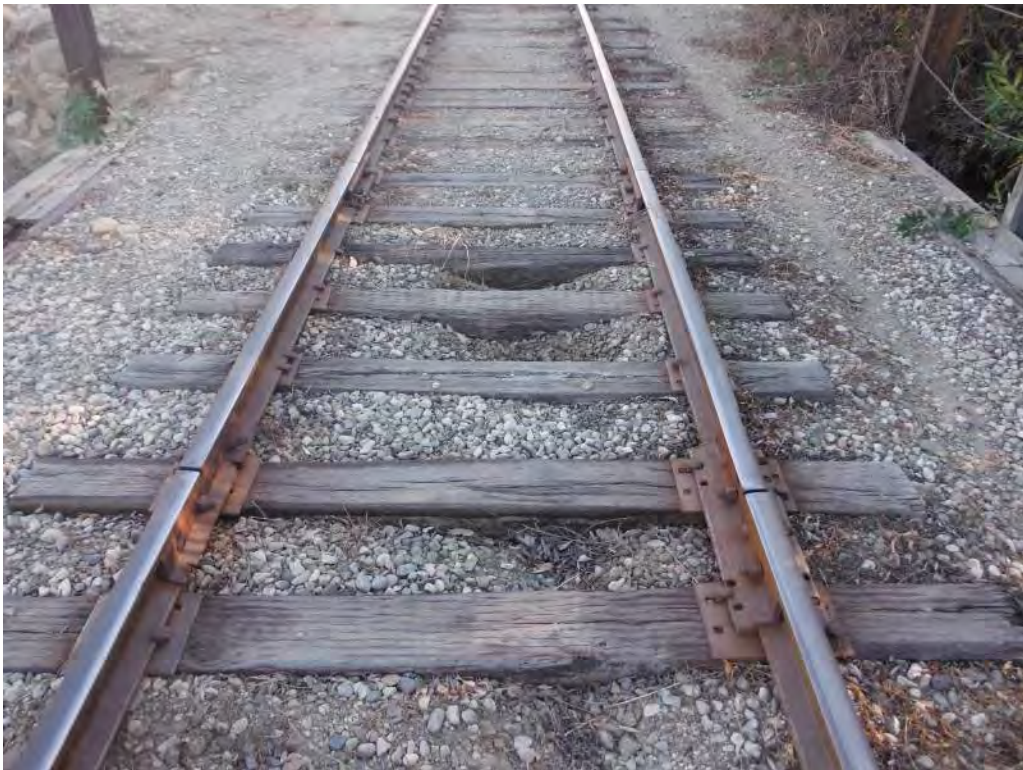
**421.23 Hole in Ballast**

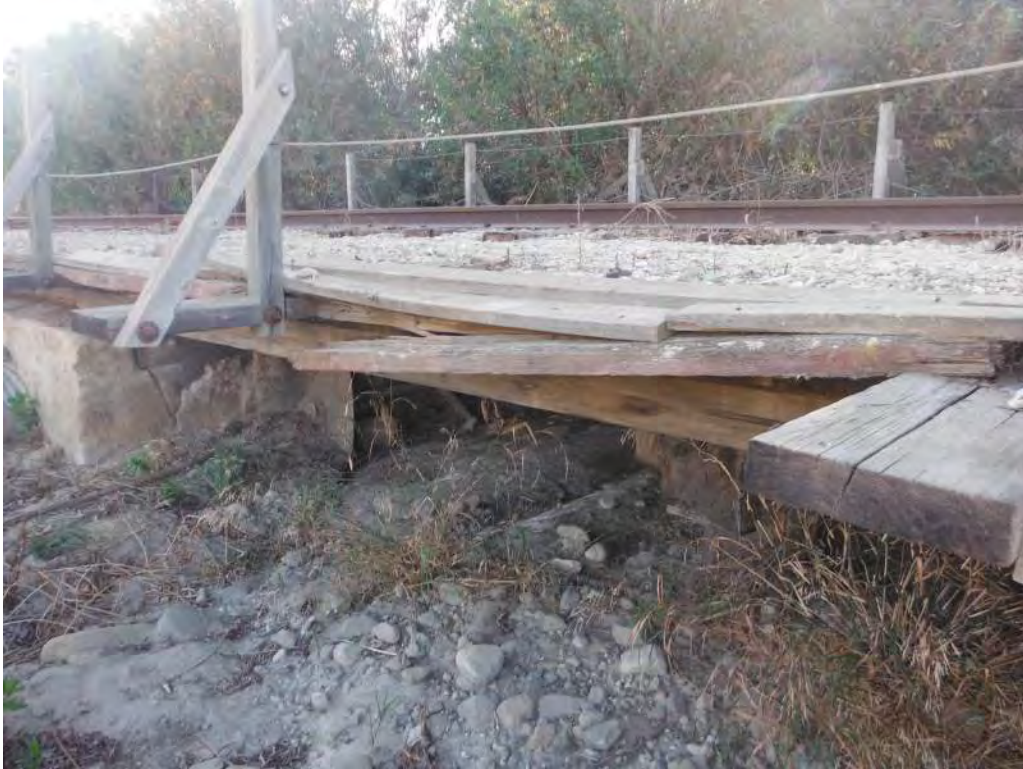
**421.23 Walkway Timbers Broken on North Side Span 2**

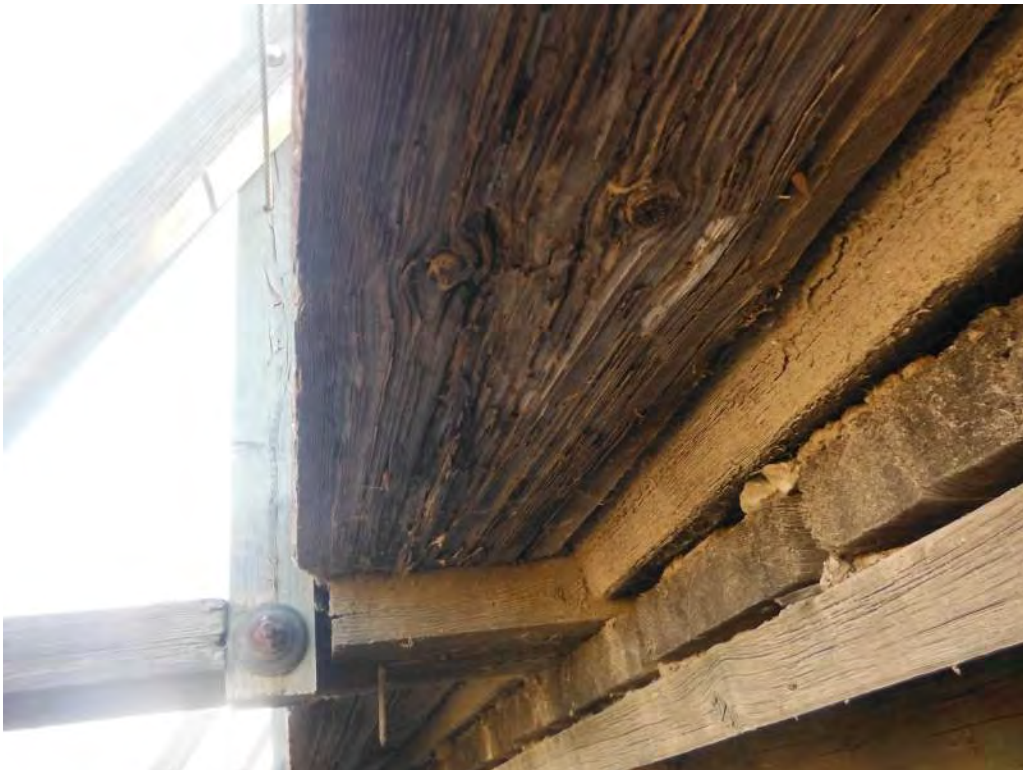
**421.23 South walkway rotten**

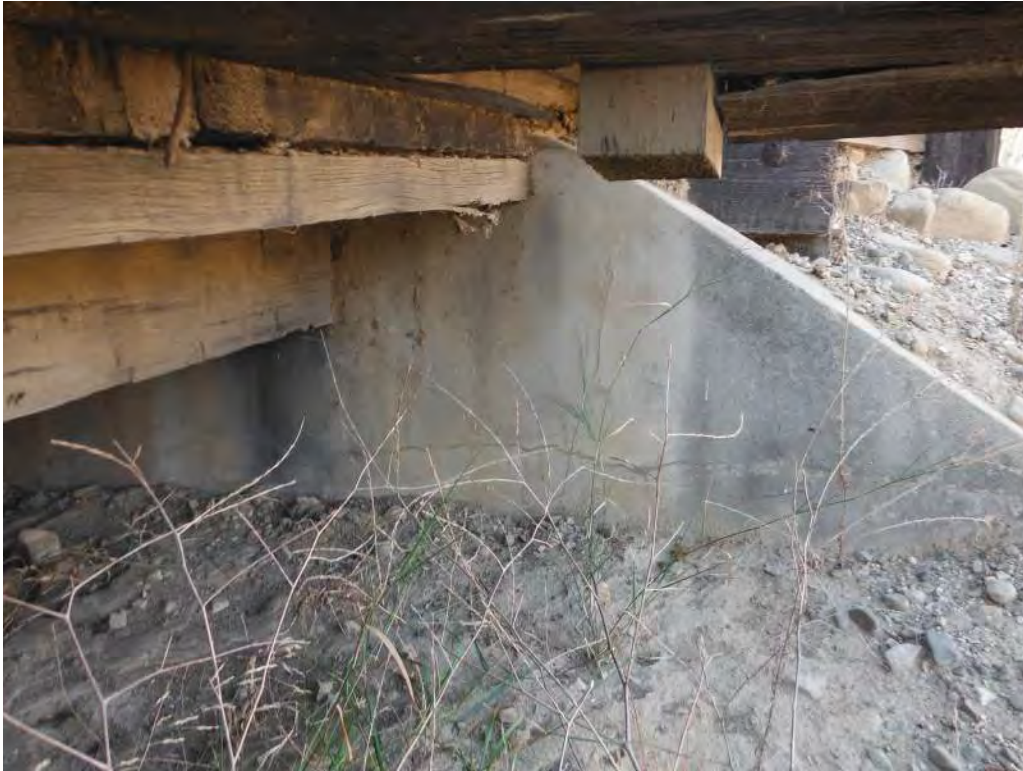
**421.23 Horizontal Crack in North Side Abutment 1**

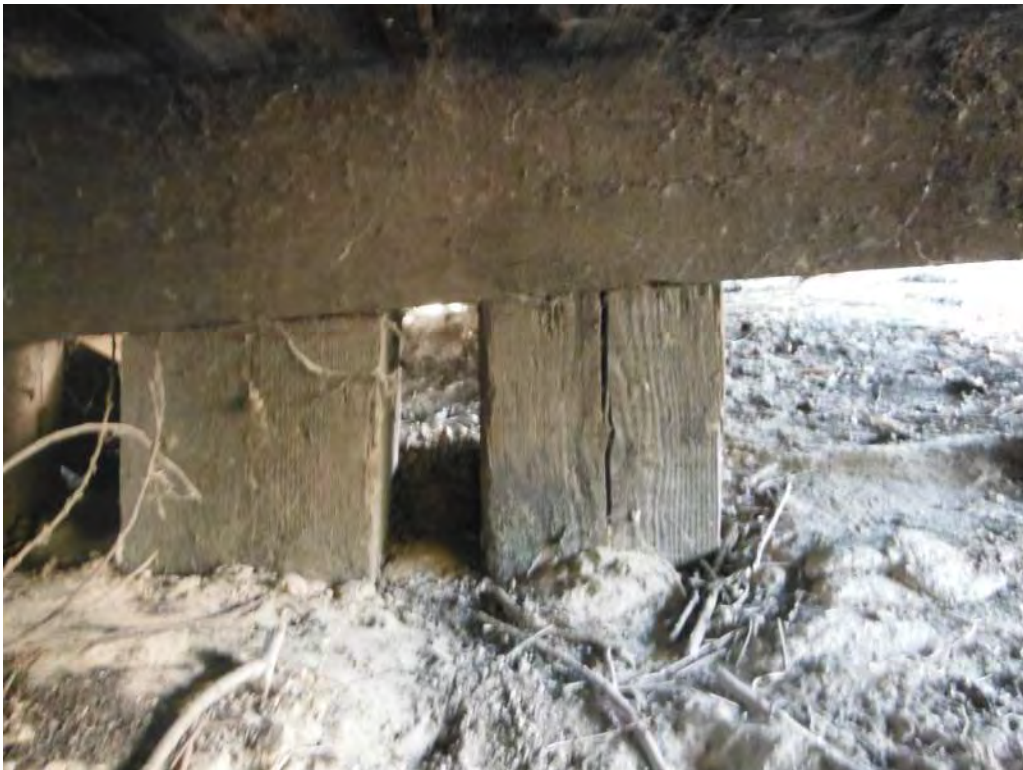
**421.23 Pile #4 Splitting, Bent 2**

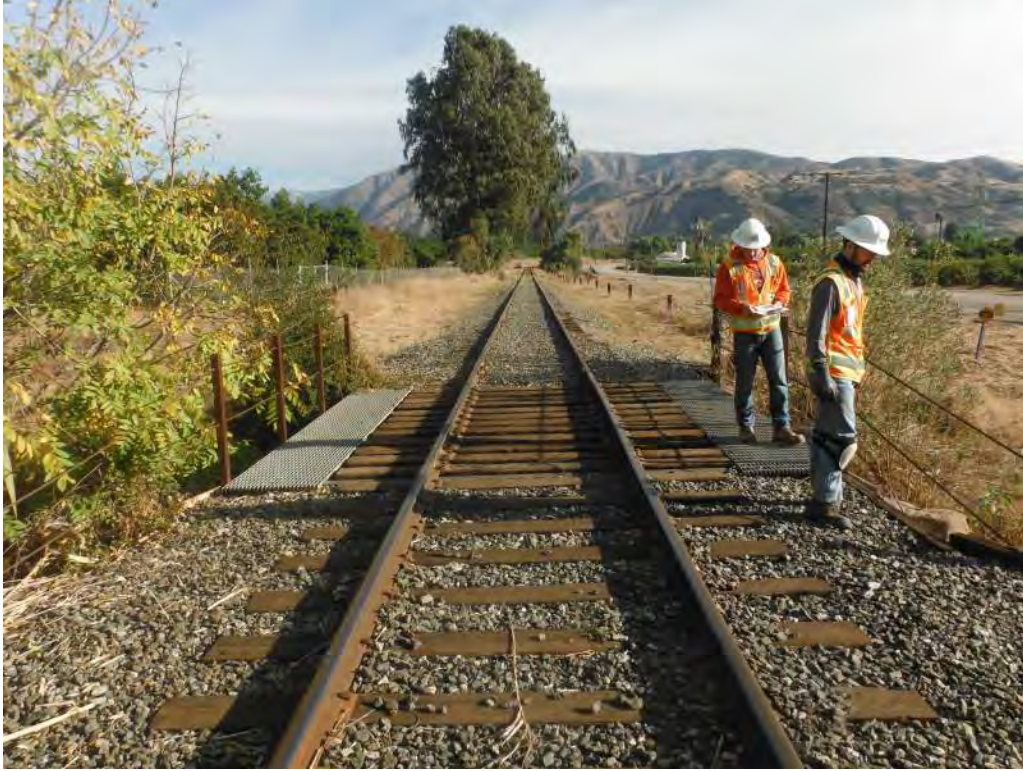
**422.53 Looking East**

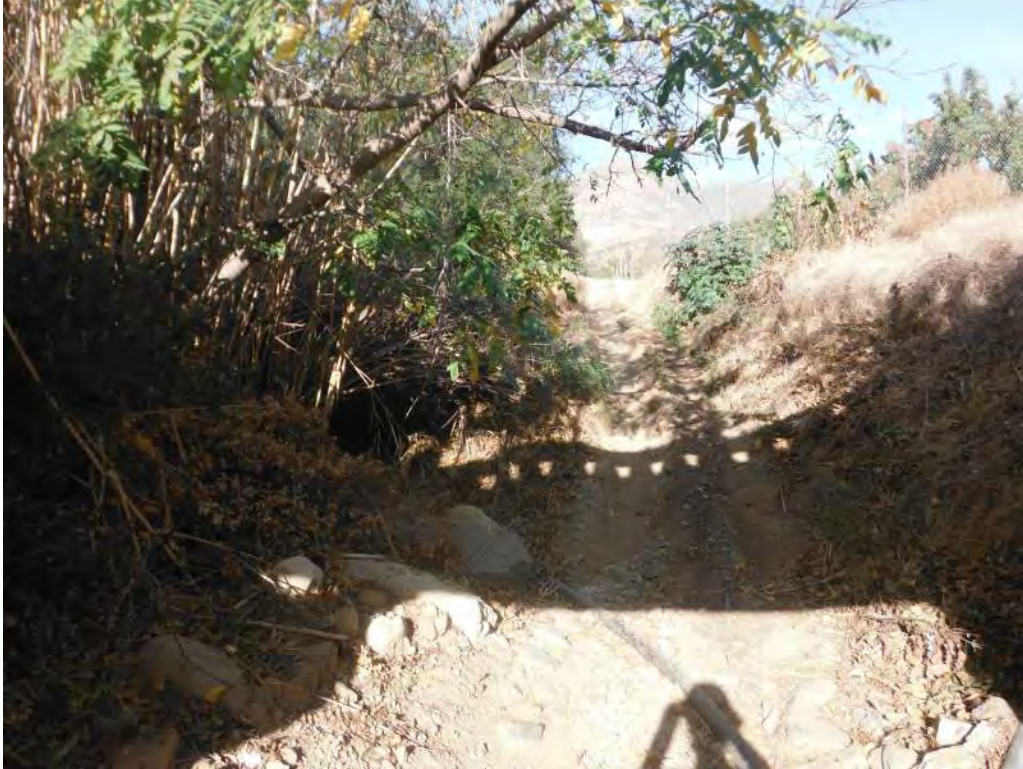
**422.53 Upstream channel condition**

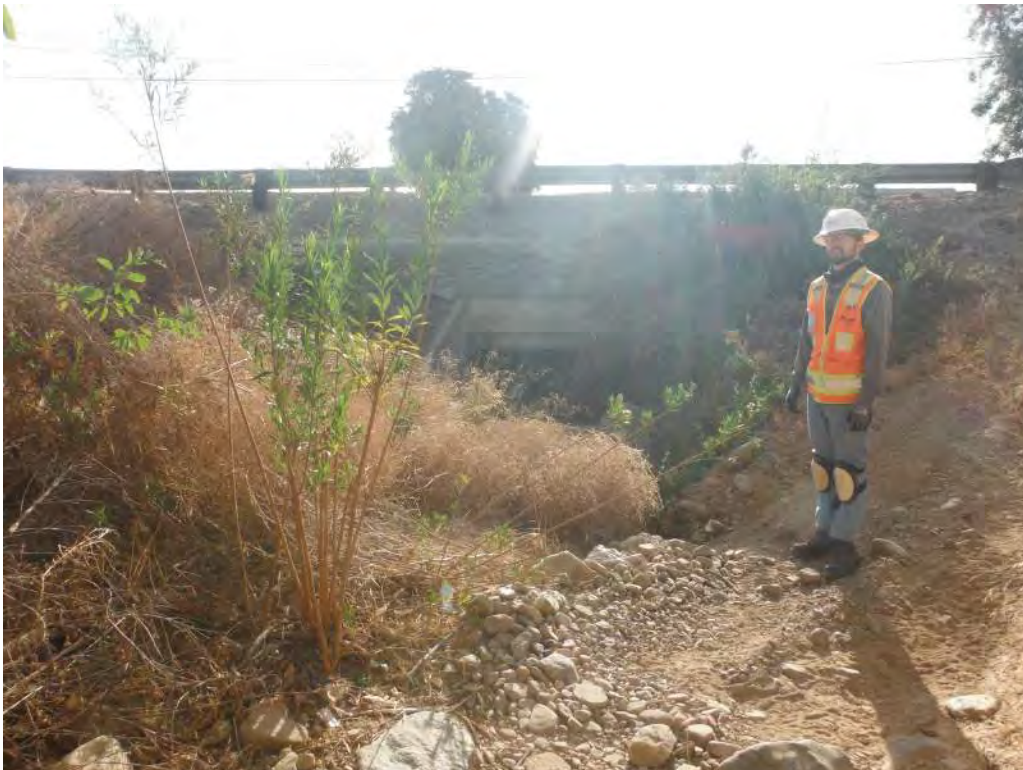
**422.53 Downstream channel condition**

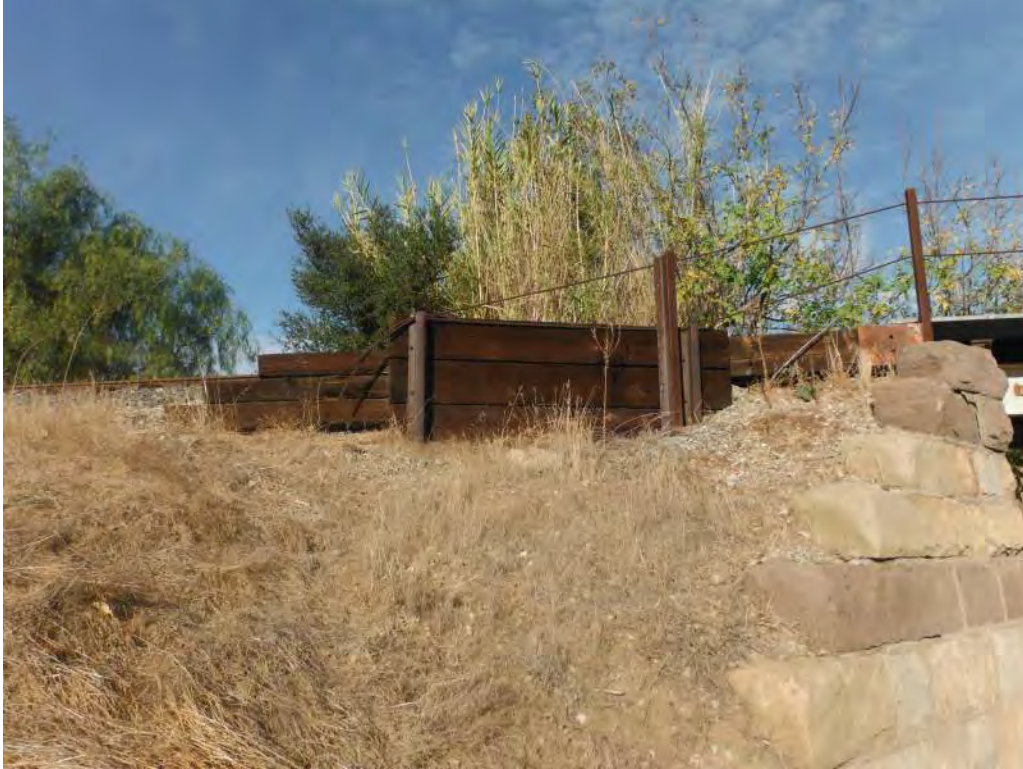
**422.53 Southwest ballast curb undermined**

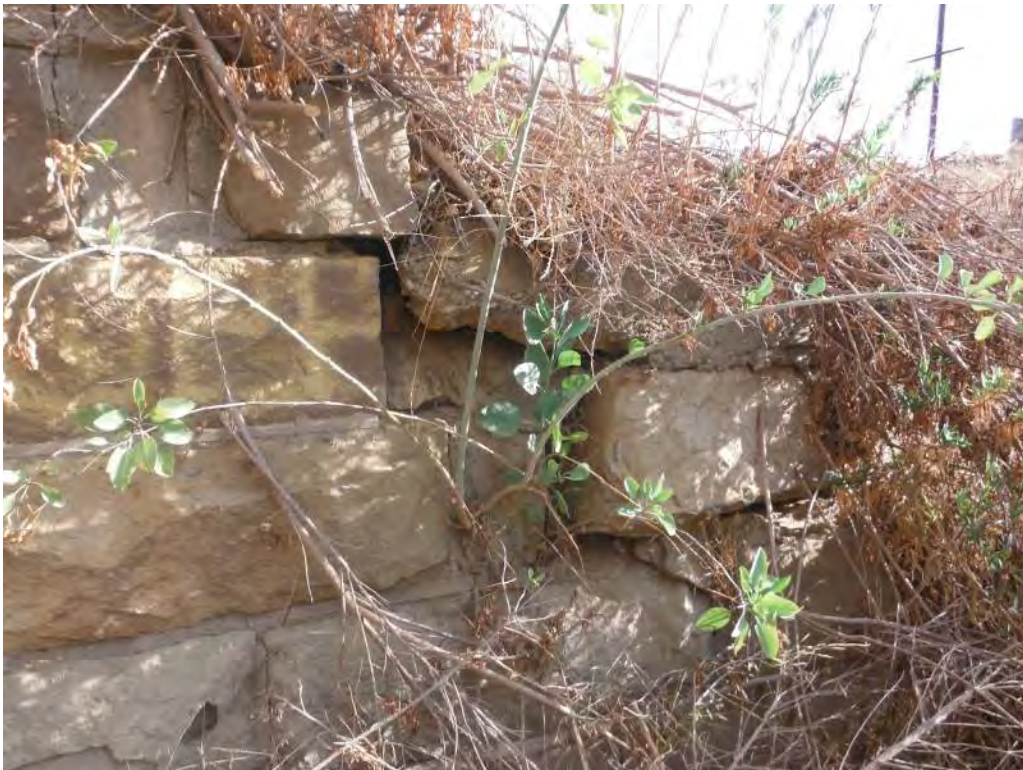
**422.53 Southeast Wingwall Blocks Loose**

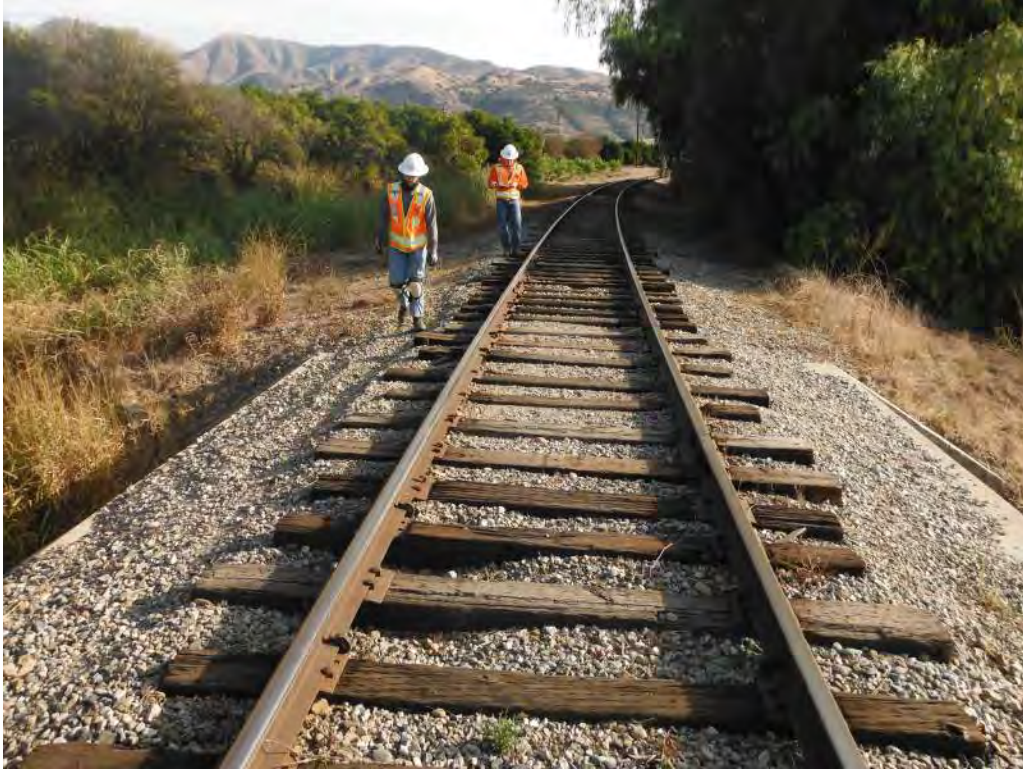
**422.89 Looking East**

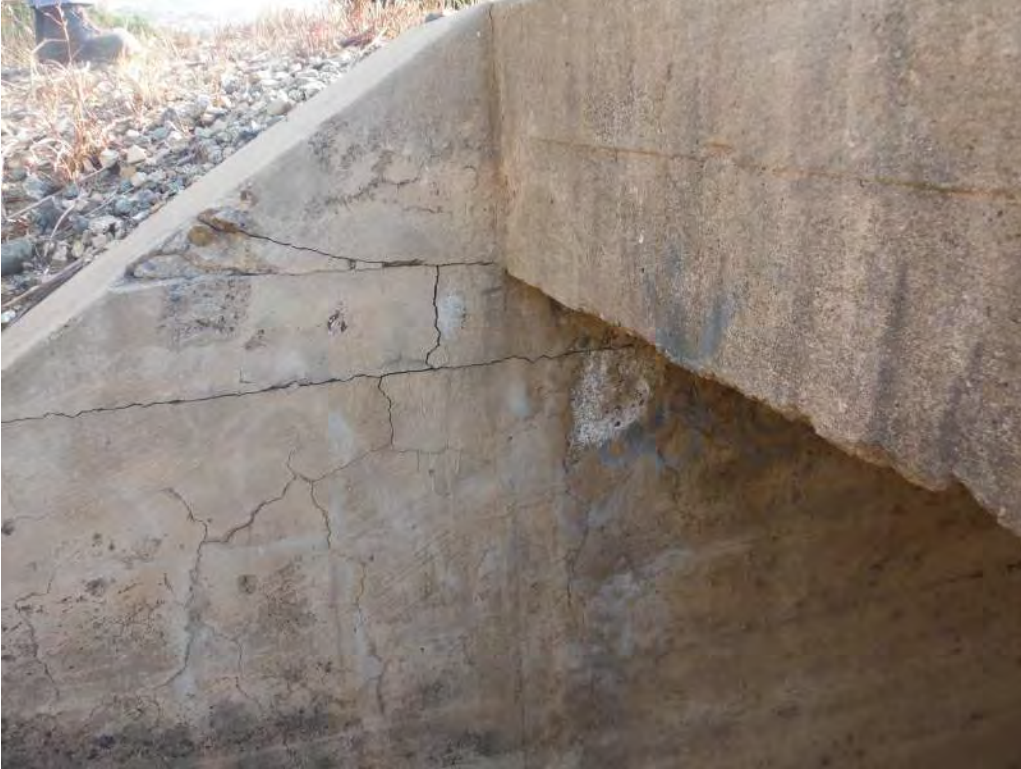
**422.89 Abutment 2 cracking – cracking typical both sides each Abutment**

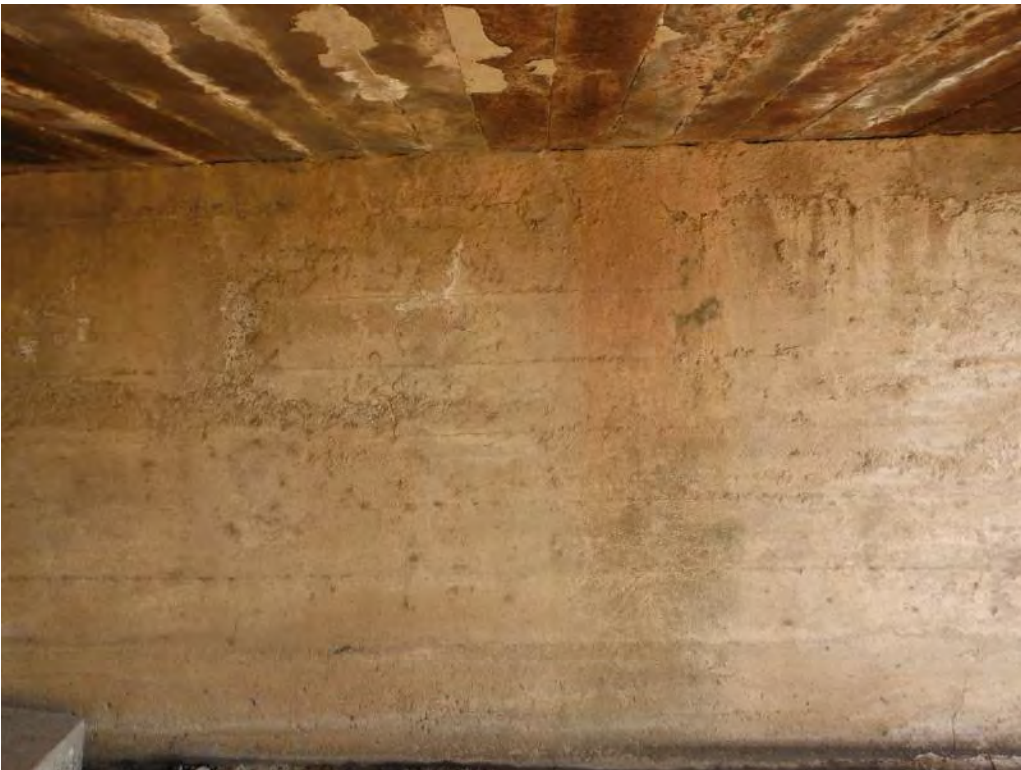
**422.89 Abutment scaling – typical each Abutment**

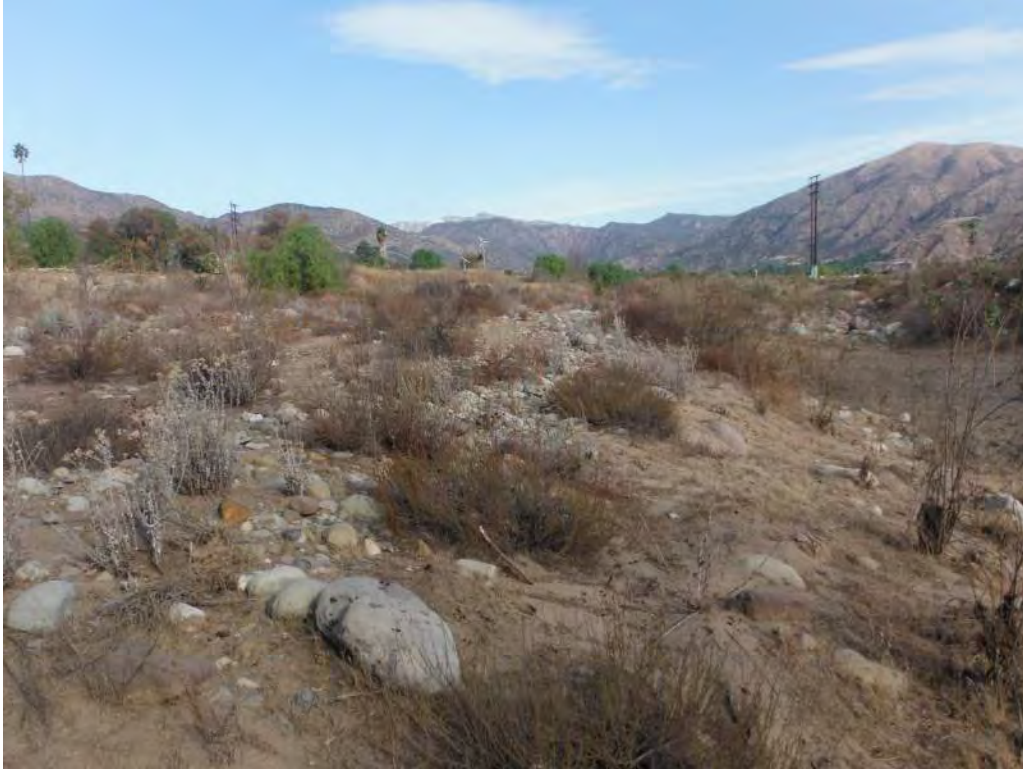
**423.28 Channel Condition – Looking Upstream**
