# BRIDGE INSPECTION REPORT

INSPECTION TYPE: Annual

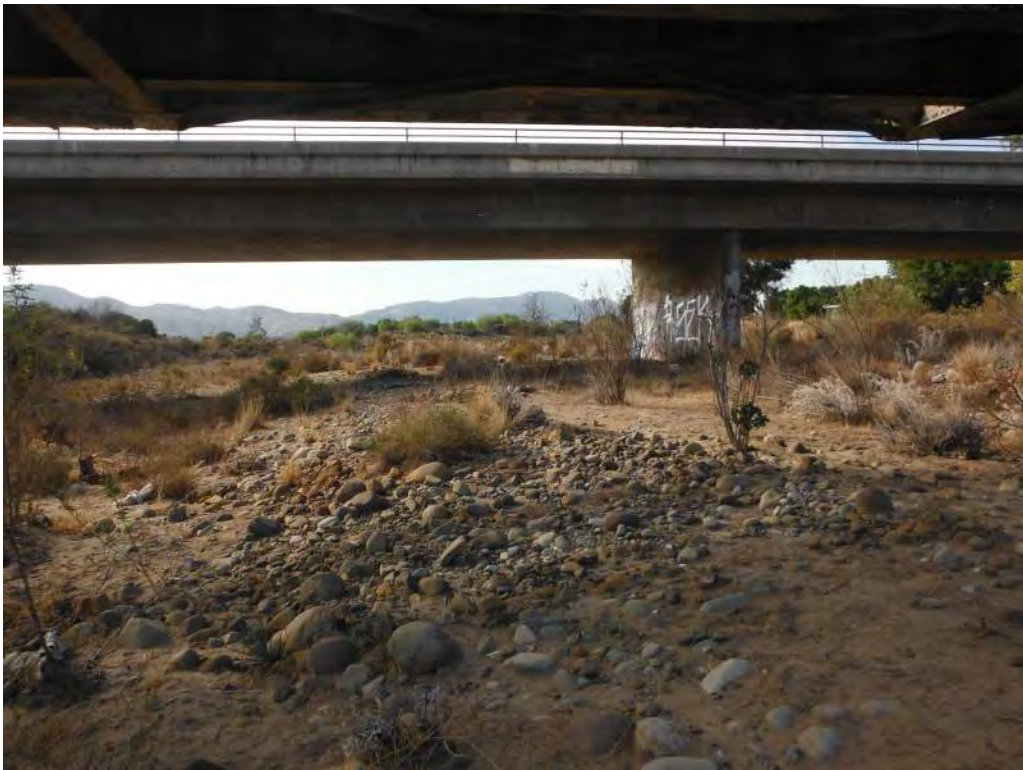
**423.28 Channel Condition – Looking Downstream**

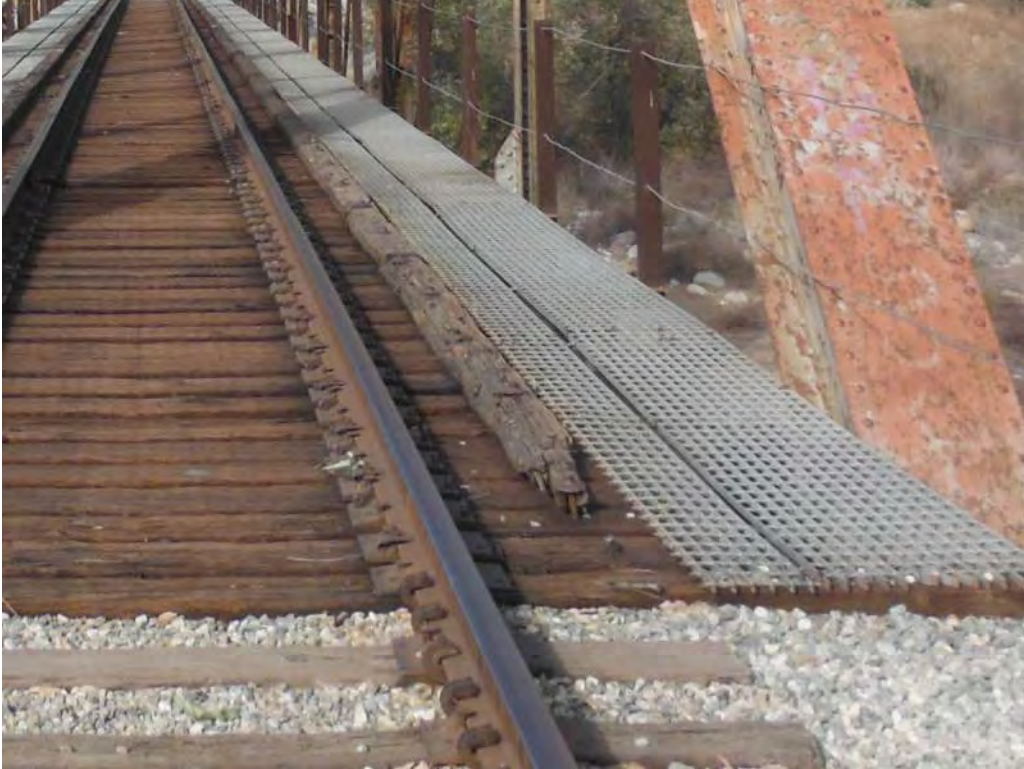
**423.28 Damaged timber curb west and east side, typ**

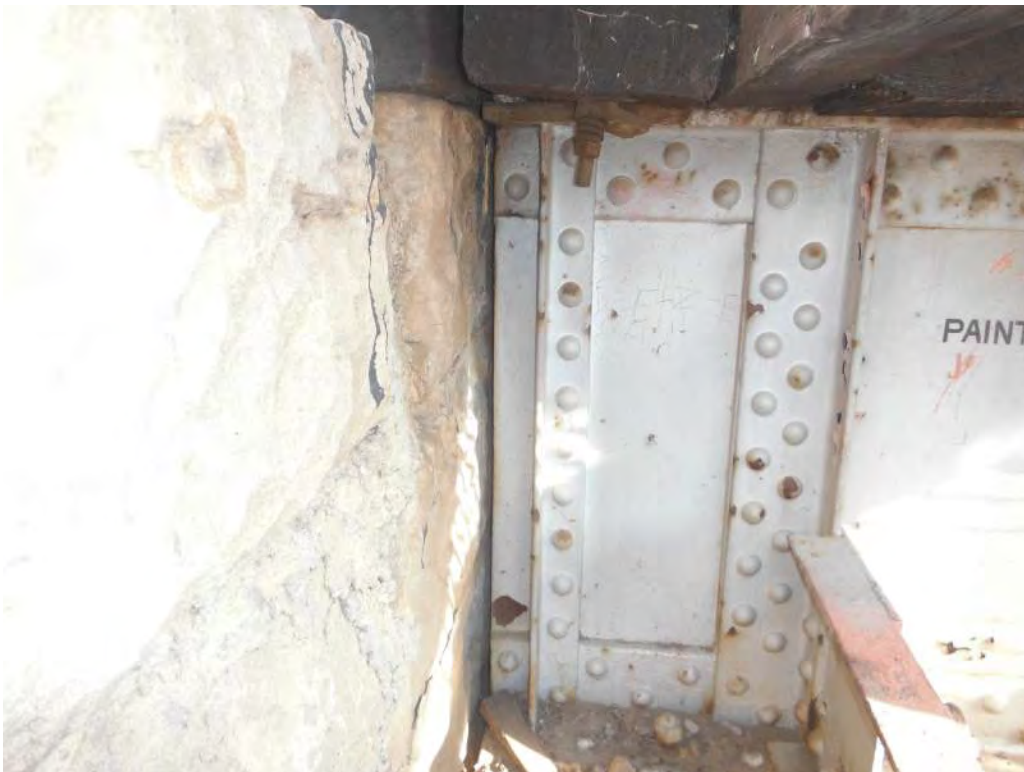
**423.28 No gap between end of stringer and backwall – Abutment 1**

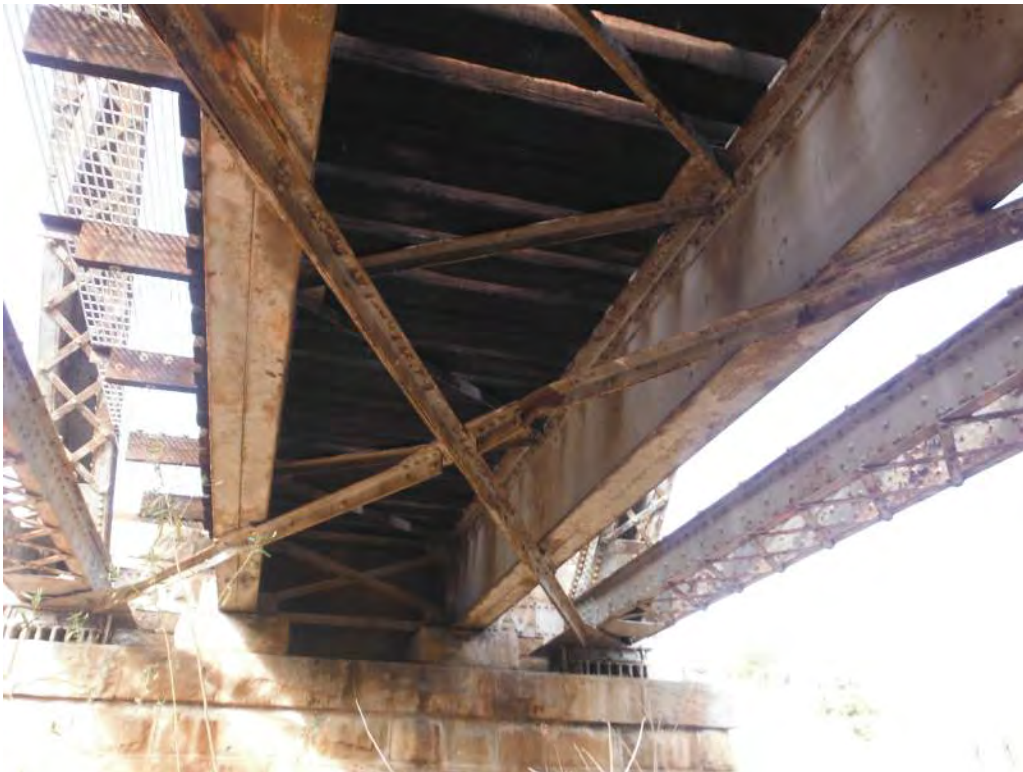
**423.28 Minor impact damage to cross bracing near Abutment 1**

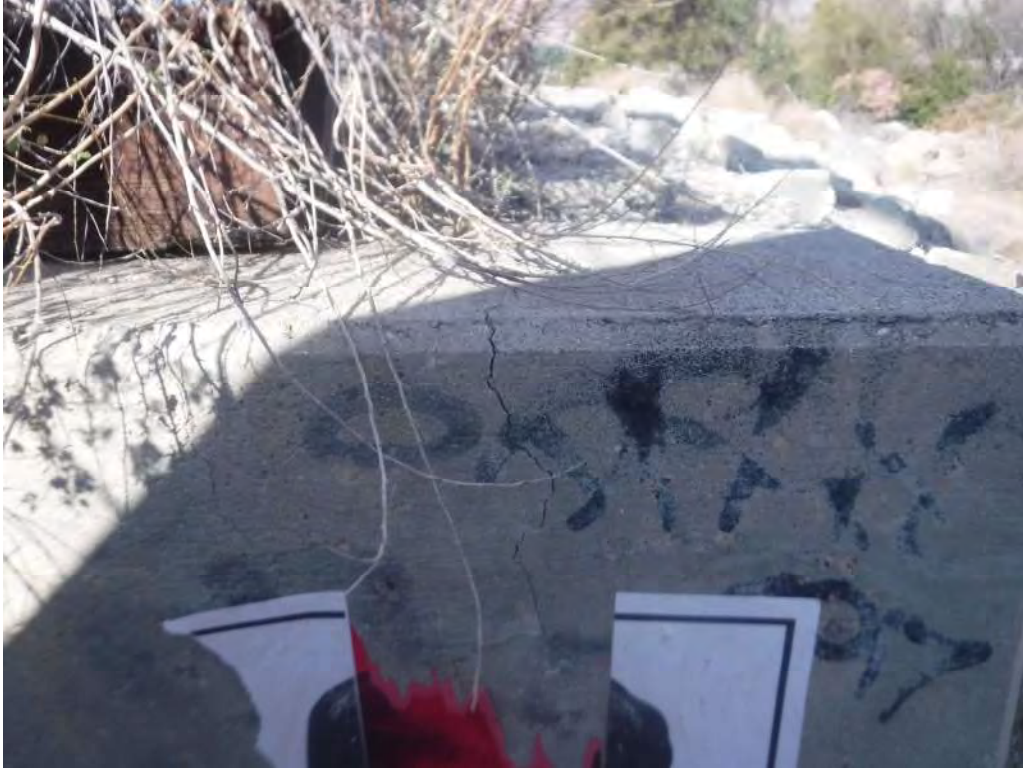
**423.28 Map cracking Northside of backwall - Abutment 1**

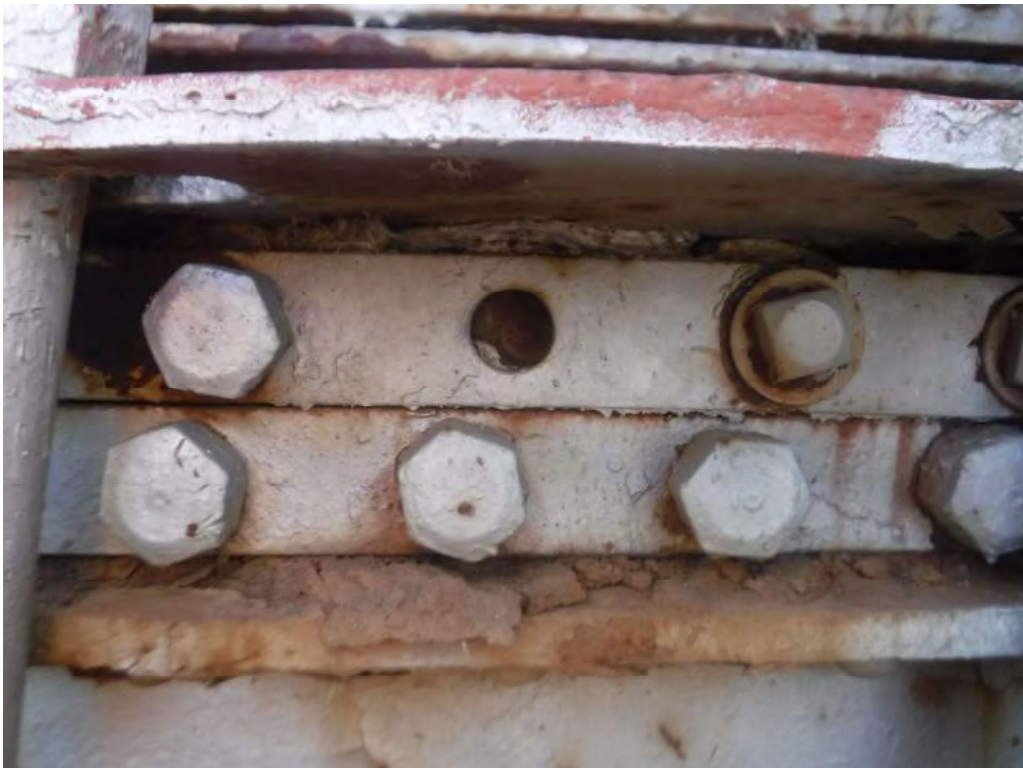
**423.28 Bolt missing at Northwest bearing bridge rollers**

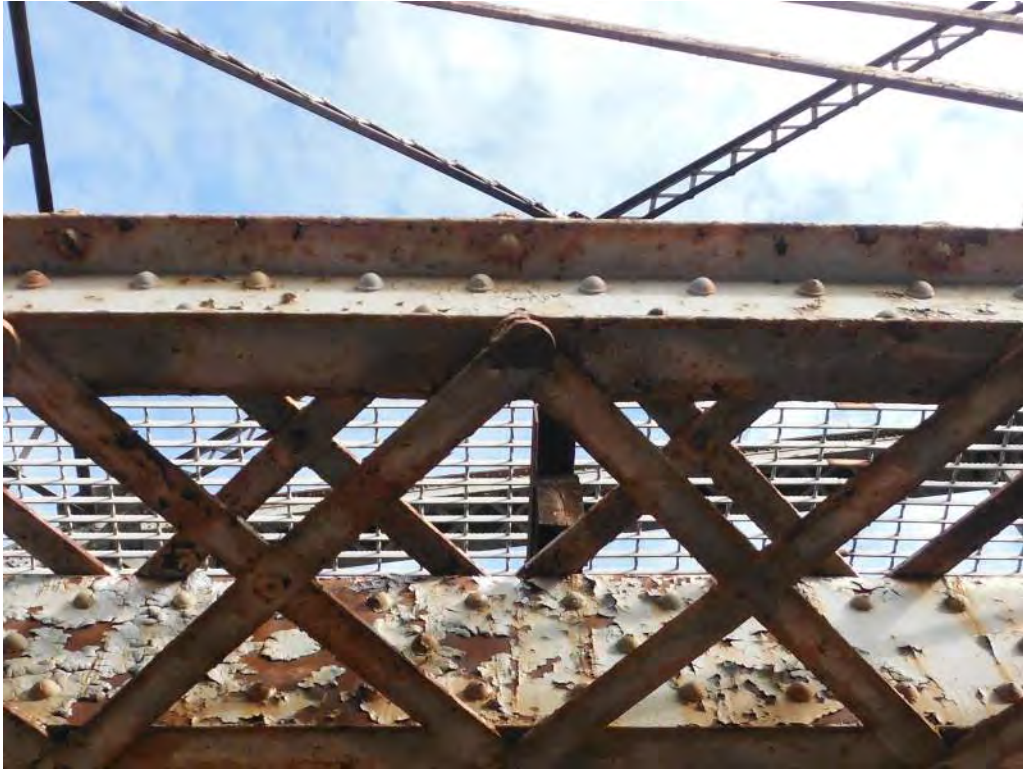
**423.28 Missing rivet near Bay 2 bottom chord**

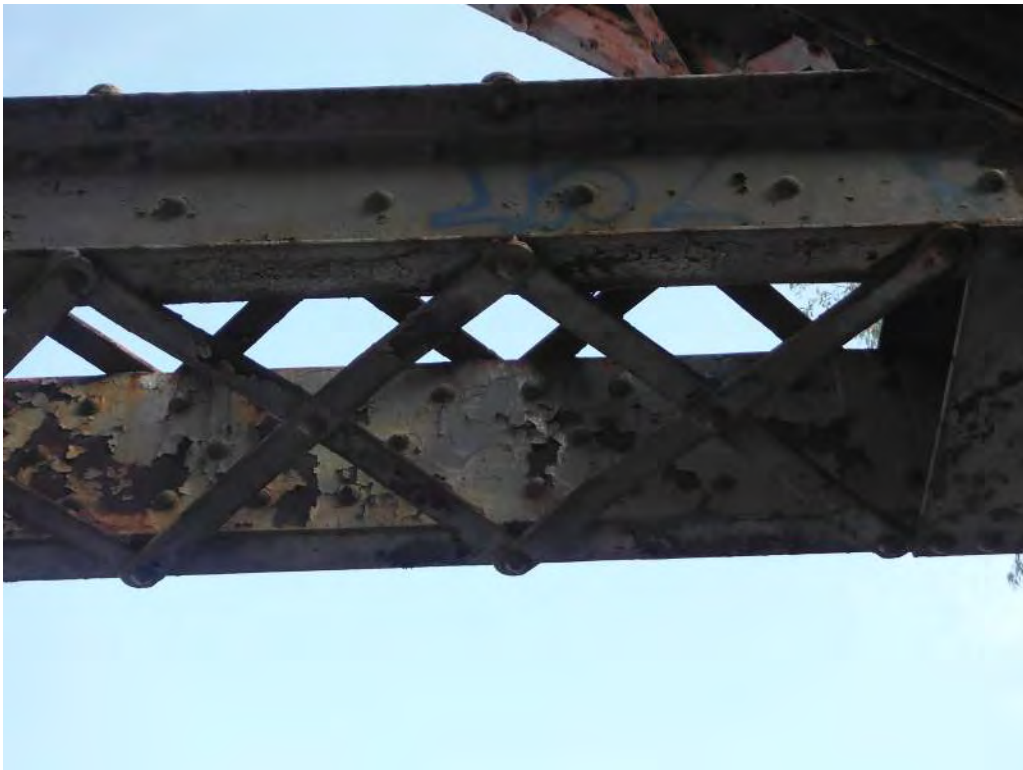
**423.28 Impact damage to bottom chord lattice bracing at bay 7**

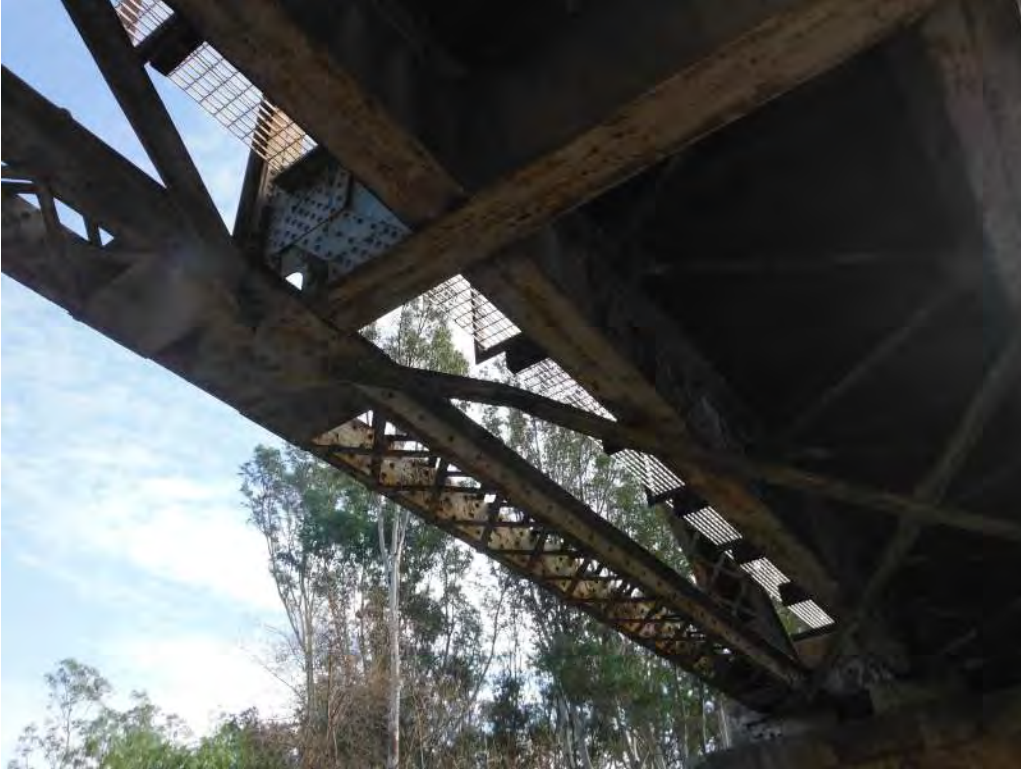
**423.28 Minor impact damage to cross bracing near Abutment 2**

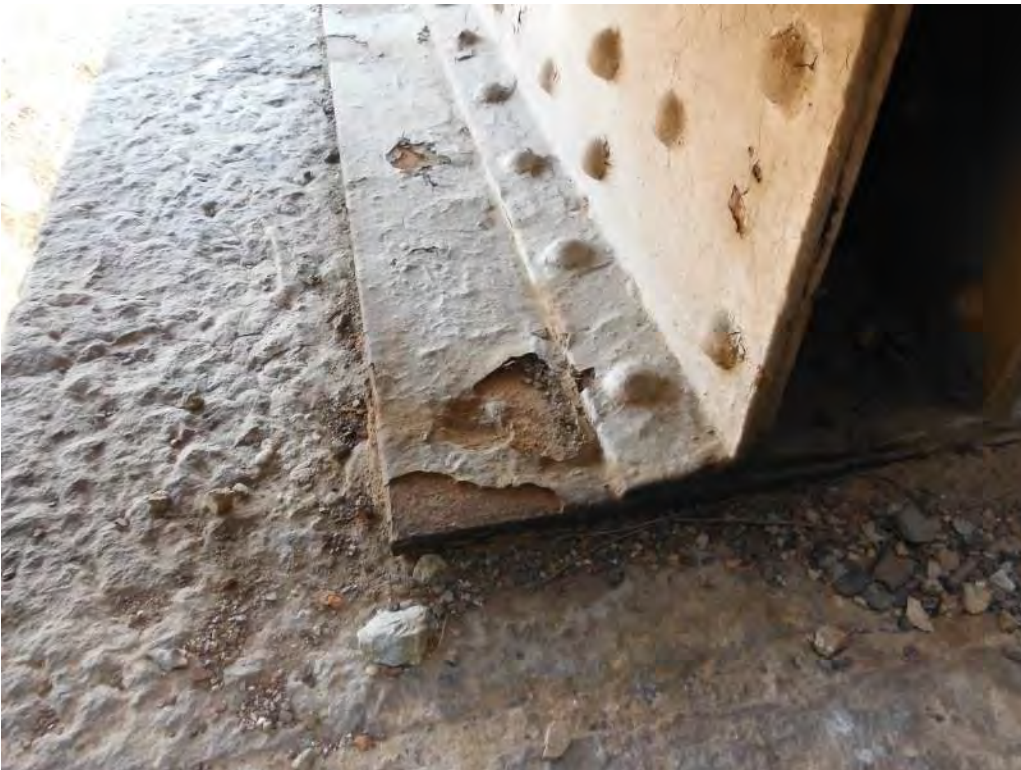
**423.28 North bearing, Abutment 2 – Missing SW anchor**

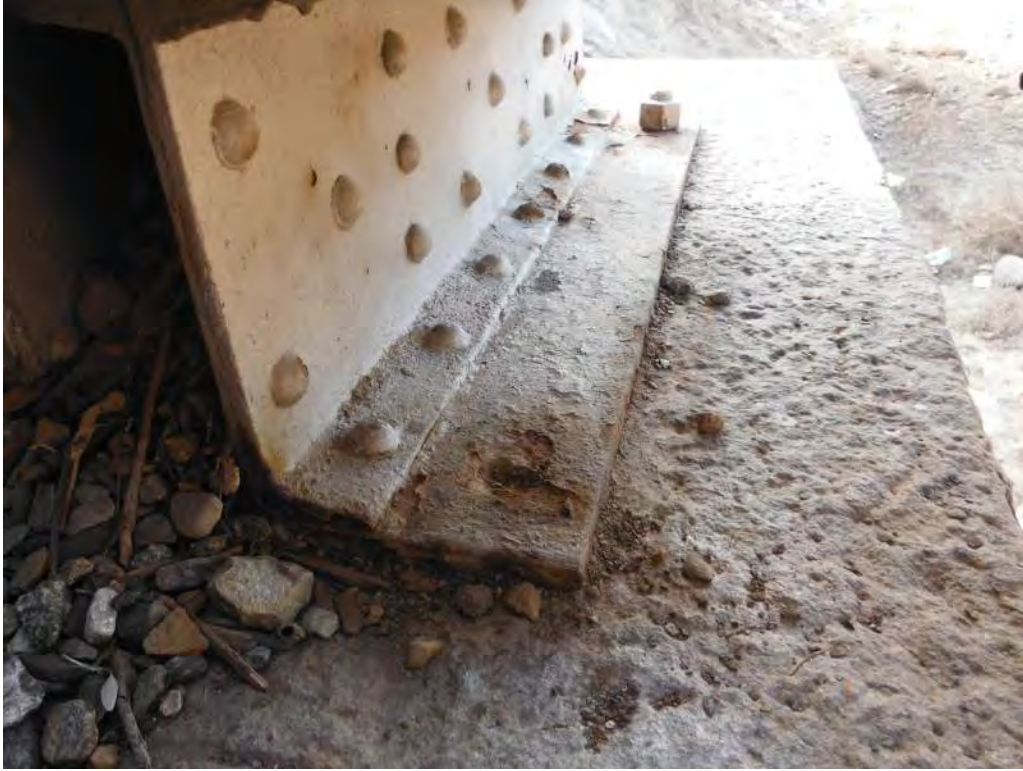
**423.28 South bearing, Abutment 2 – Missing NW anchor**

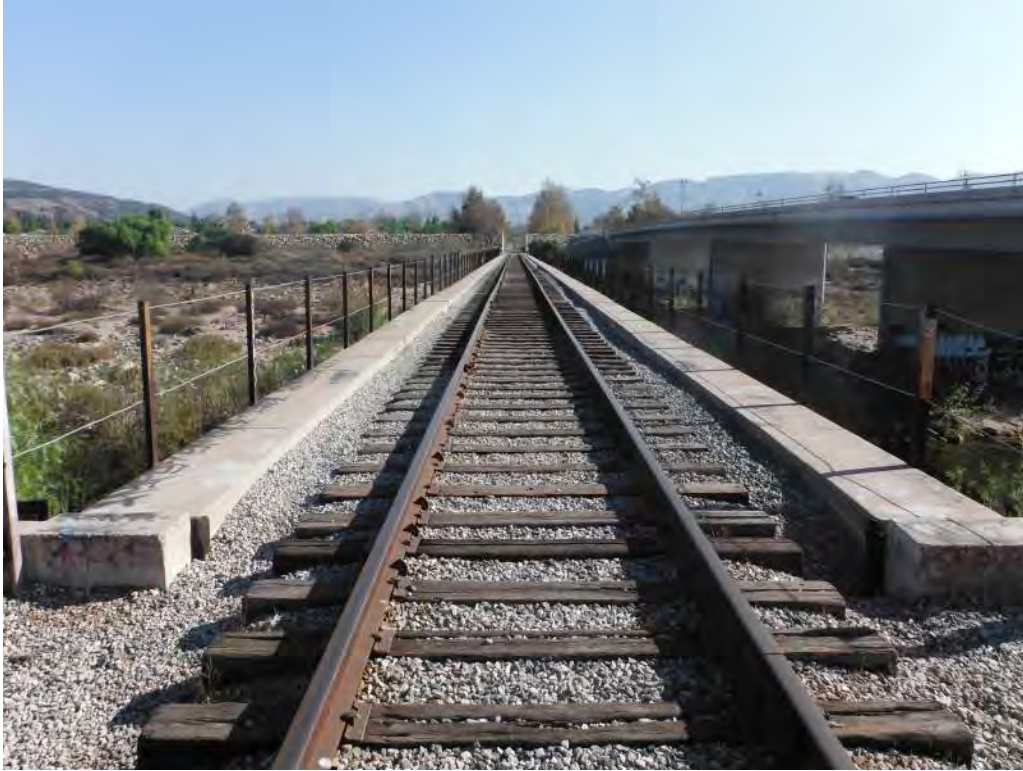
**423.44 Looking East**

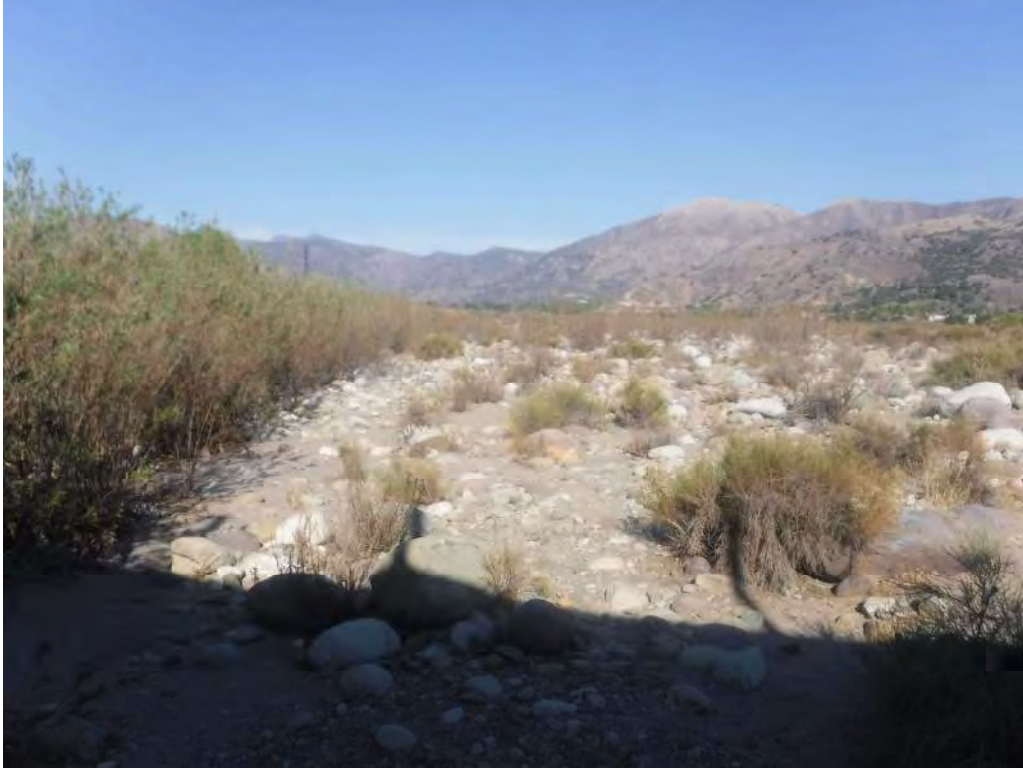
**423.44 Channel condition looking upstream**

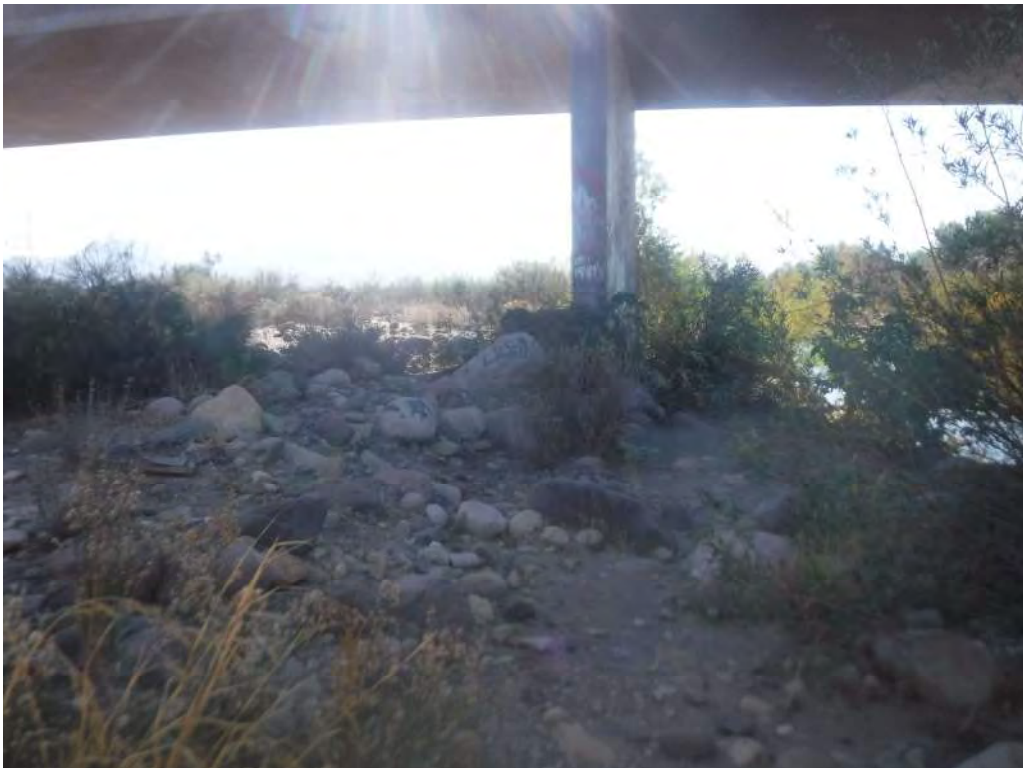
**423.44 Channel condition looking downstream**

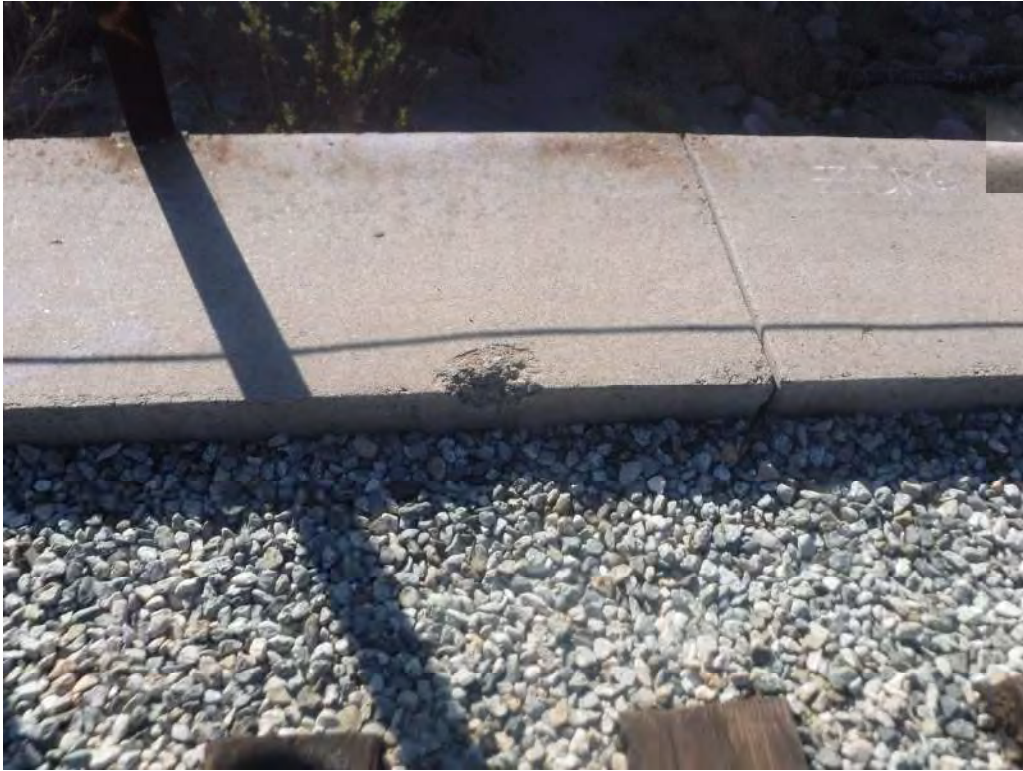
**423.44 Walkway Spall on Span 2 and multiple locations**

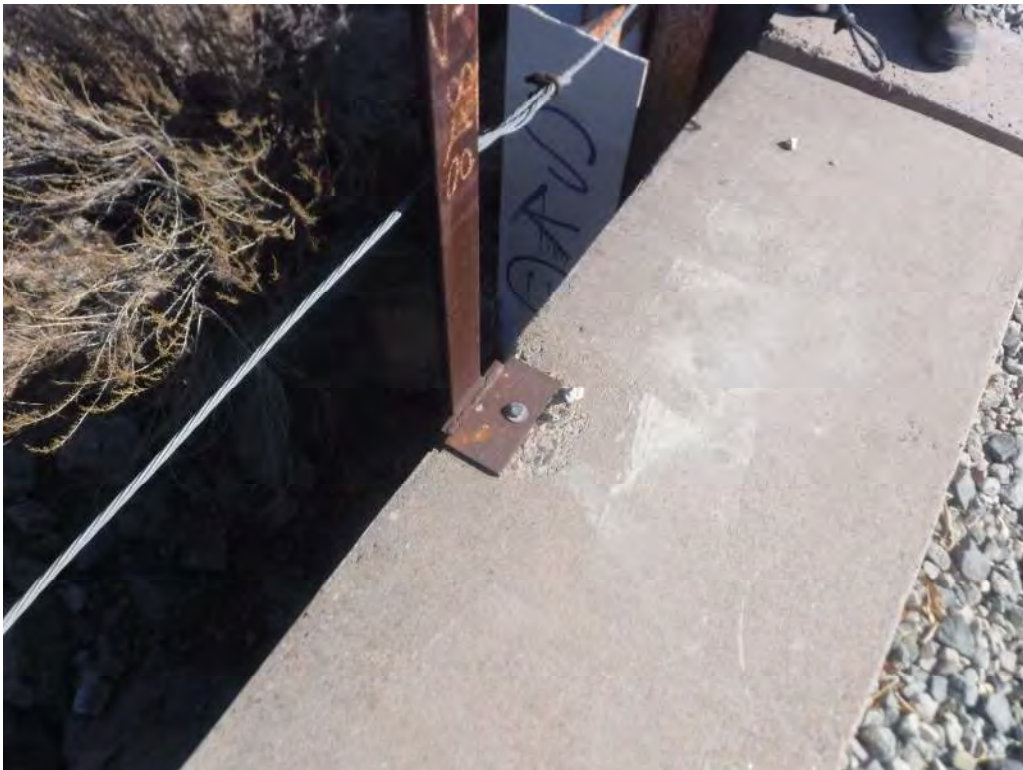
**423.44 Handrail embed failed. Post held with bolts, Span 3, 4 and 15**

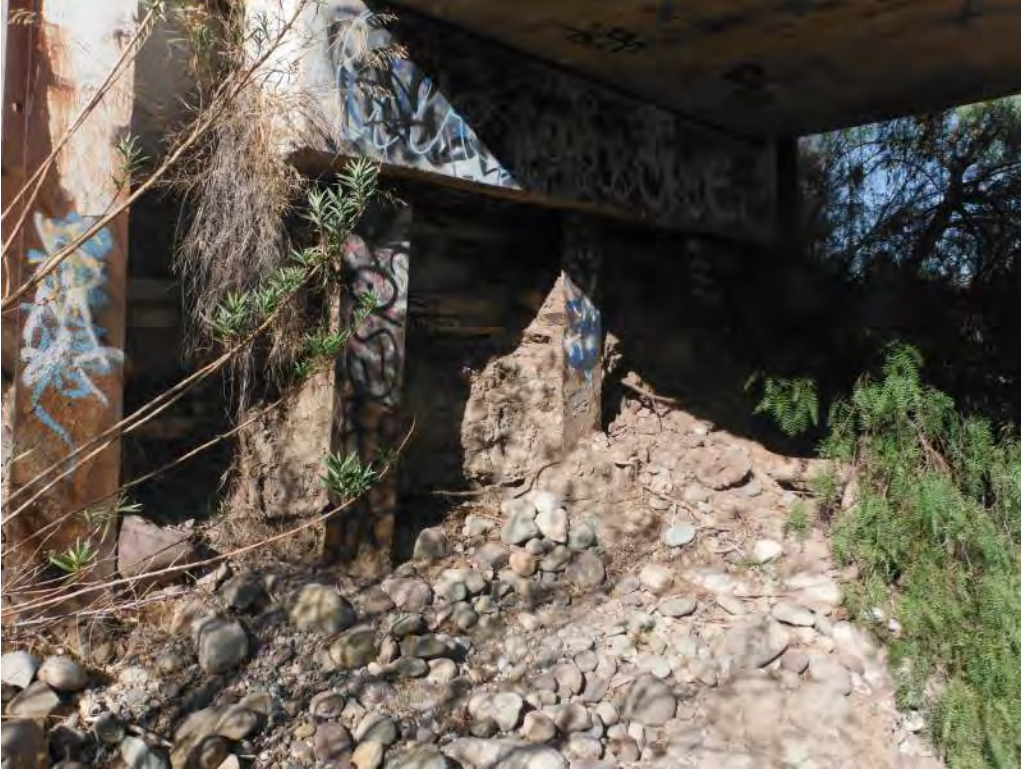
**423.44 Scour - Abutment 1**

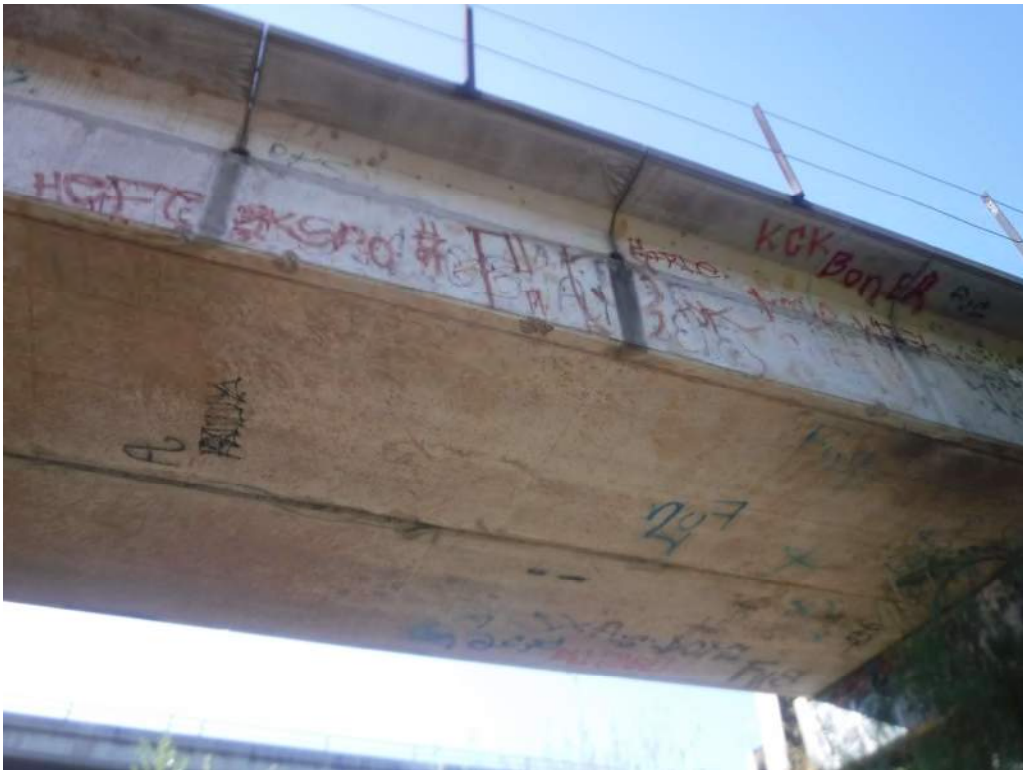
**423.44 Span 1 Impact Damage**

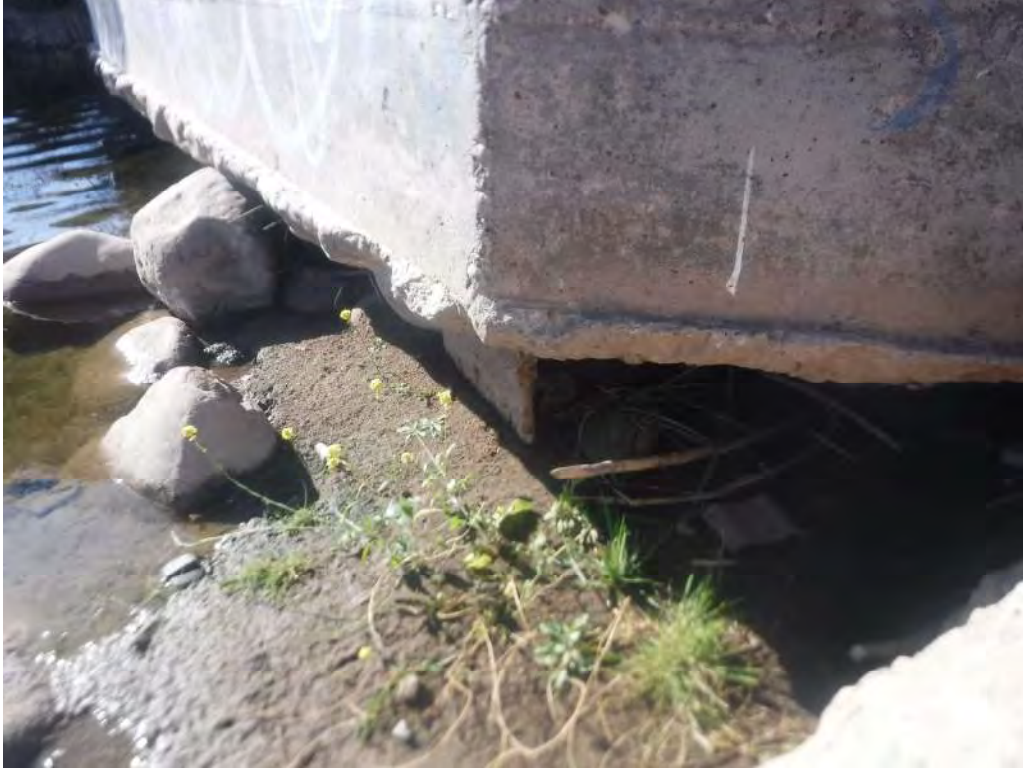
**423.44 2' Scour under cap 2**

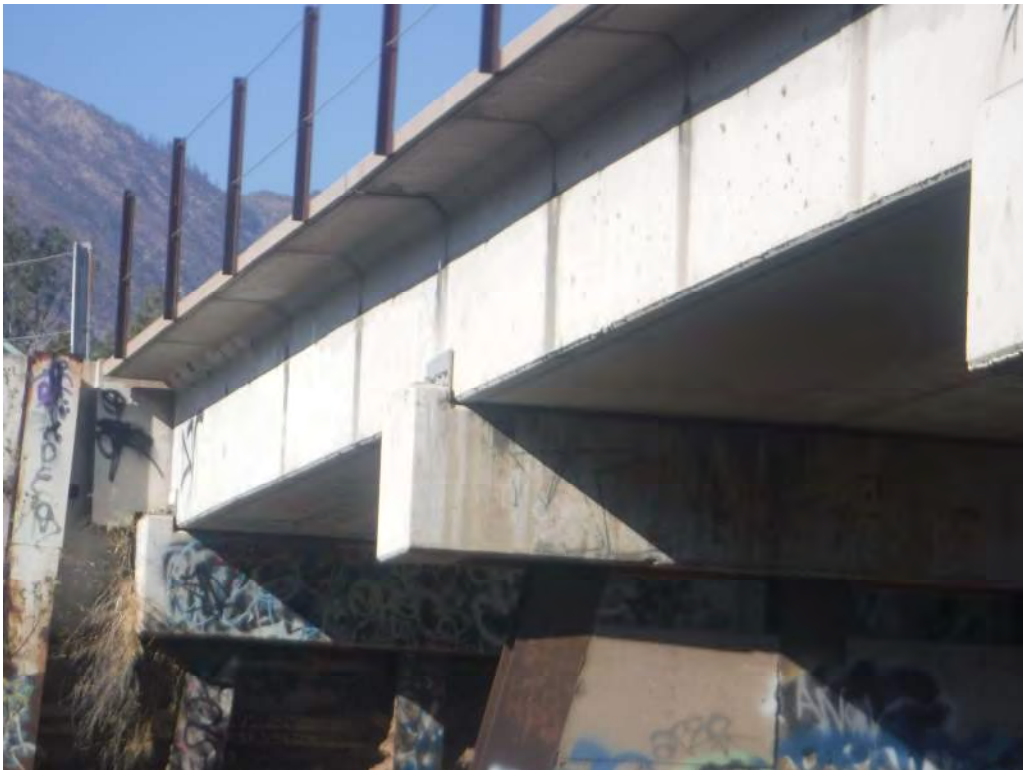
**423.44 Keeper spall on Pier 2**

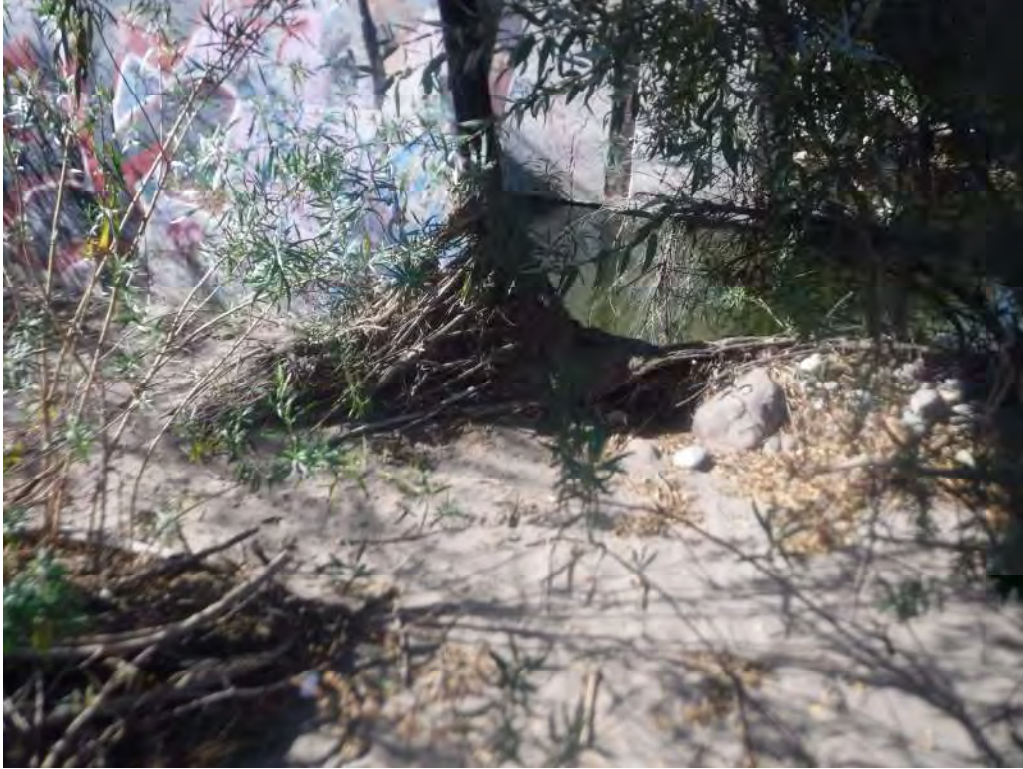
**423.44 Debris Upstream on Pier 4**

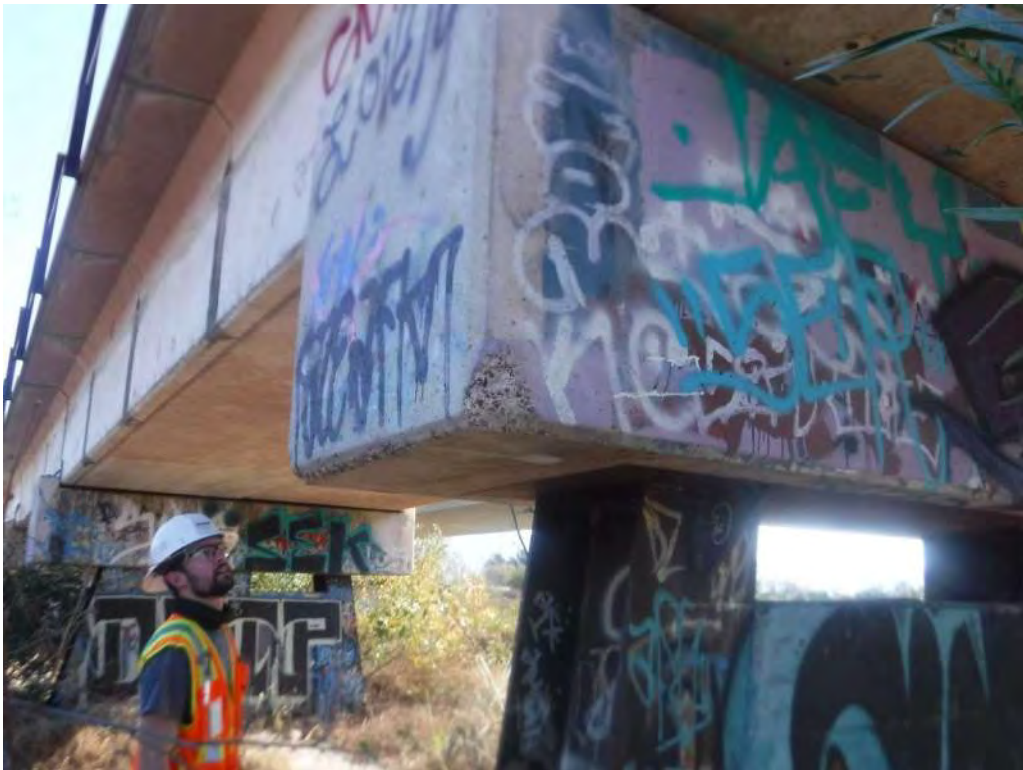
**423.44 Minor spall on bottom corner of pier cap, Pier 6**

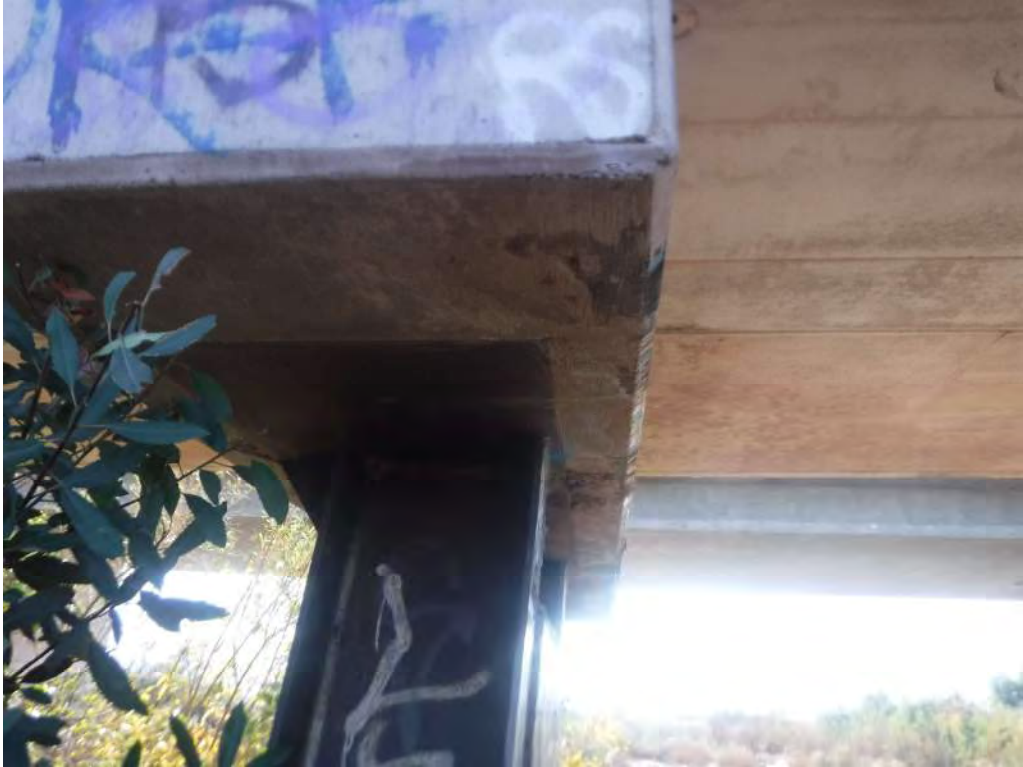
**423.44 Small spalls on the underside of cap at Pier 7**

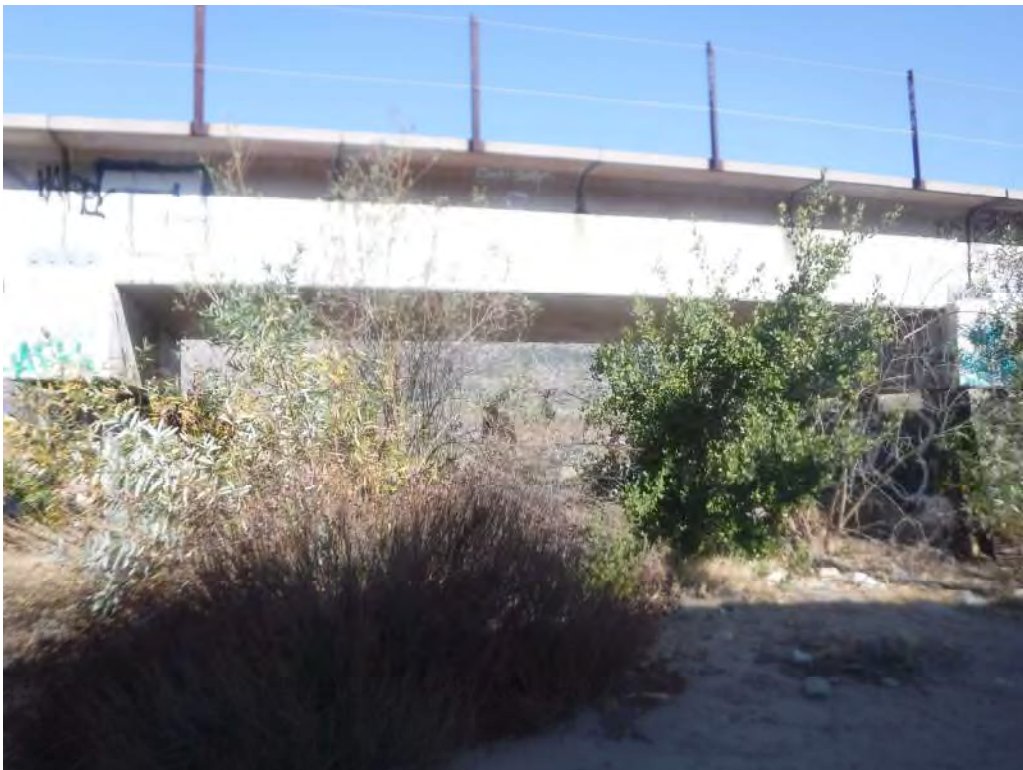
**423.44 Trees under Span 7 and 8 on south side**

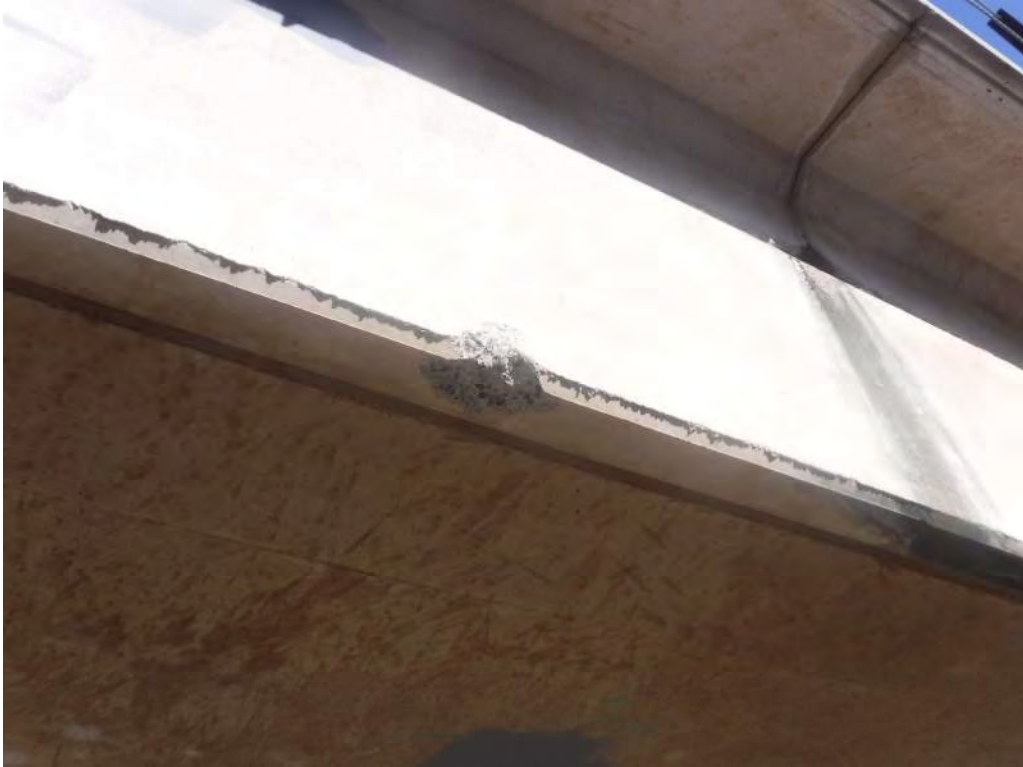
**423.44 Minor spall midspan, Span 11**

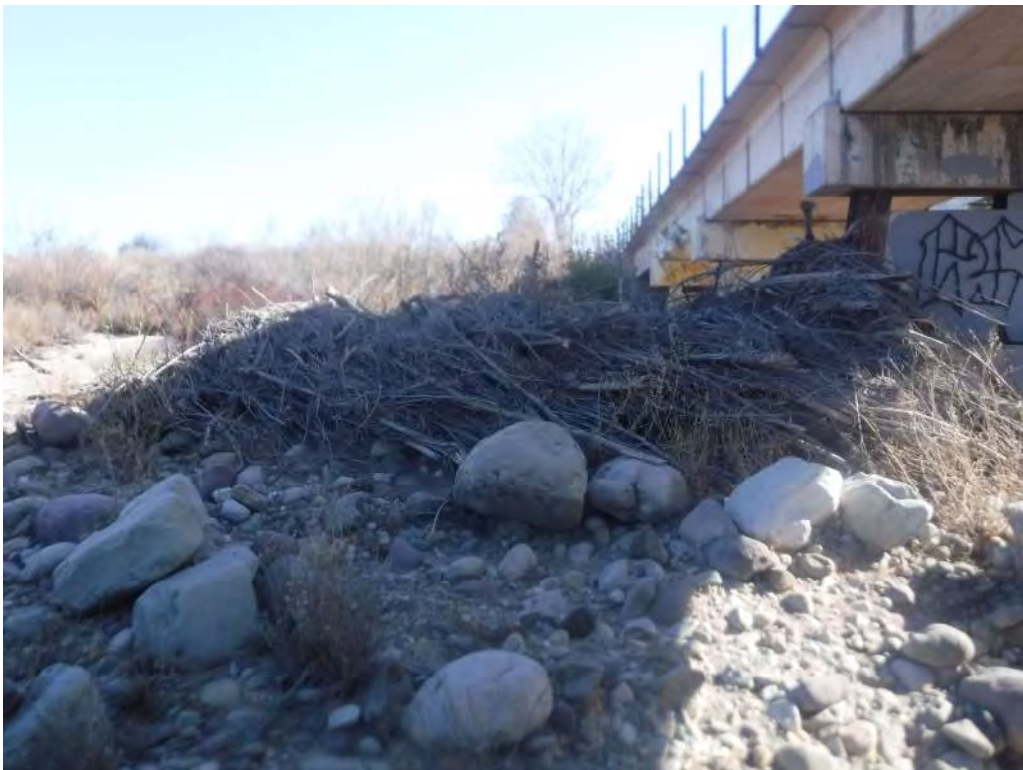
**423.44 Debris – Multiple locations**

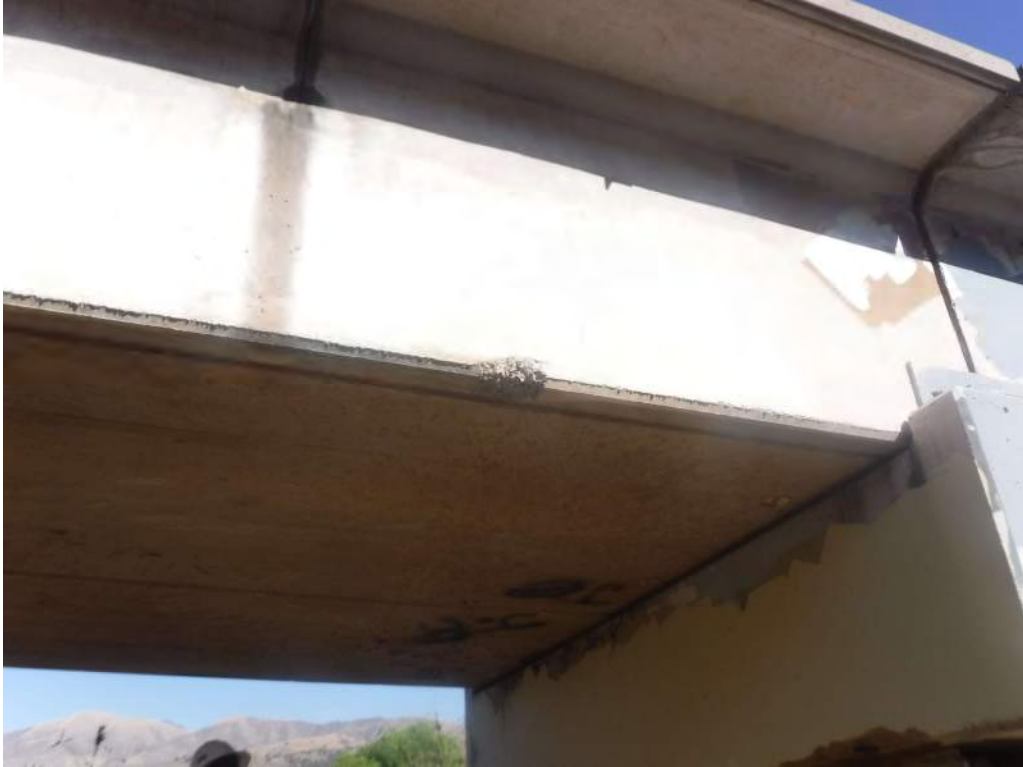
**423.44 Minor spall - south side Span 13**

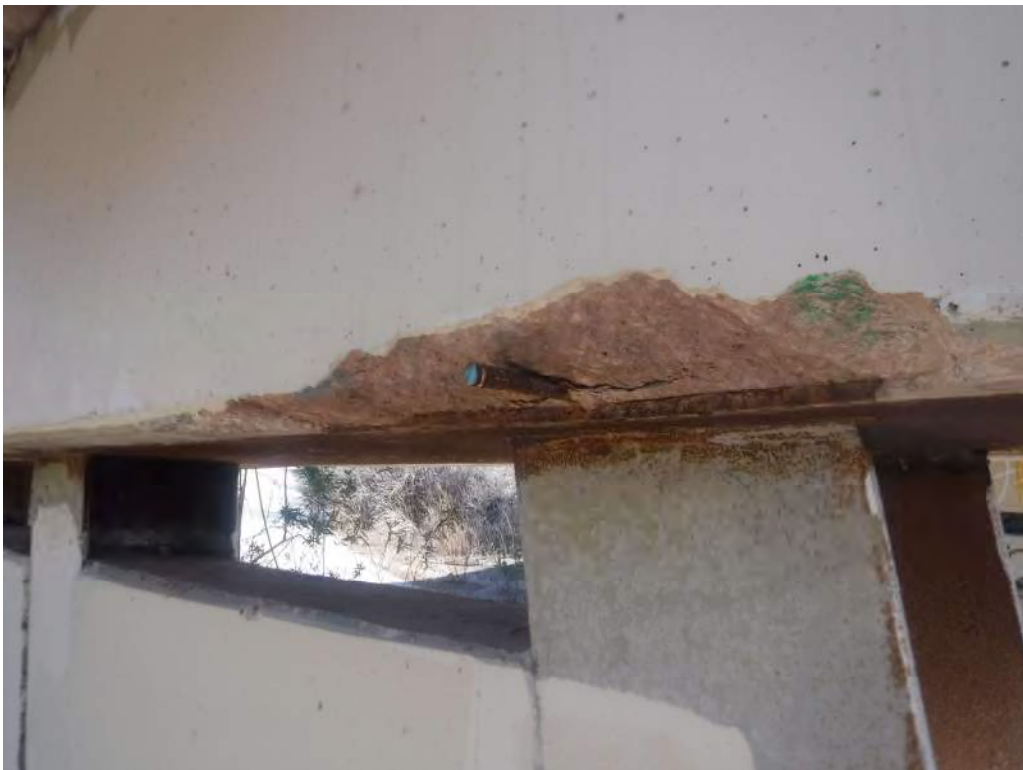
**423.44 Spall along underside of cap with exposed rebar – west side Pier 14**

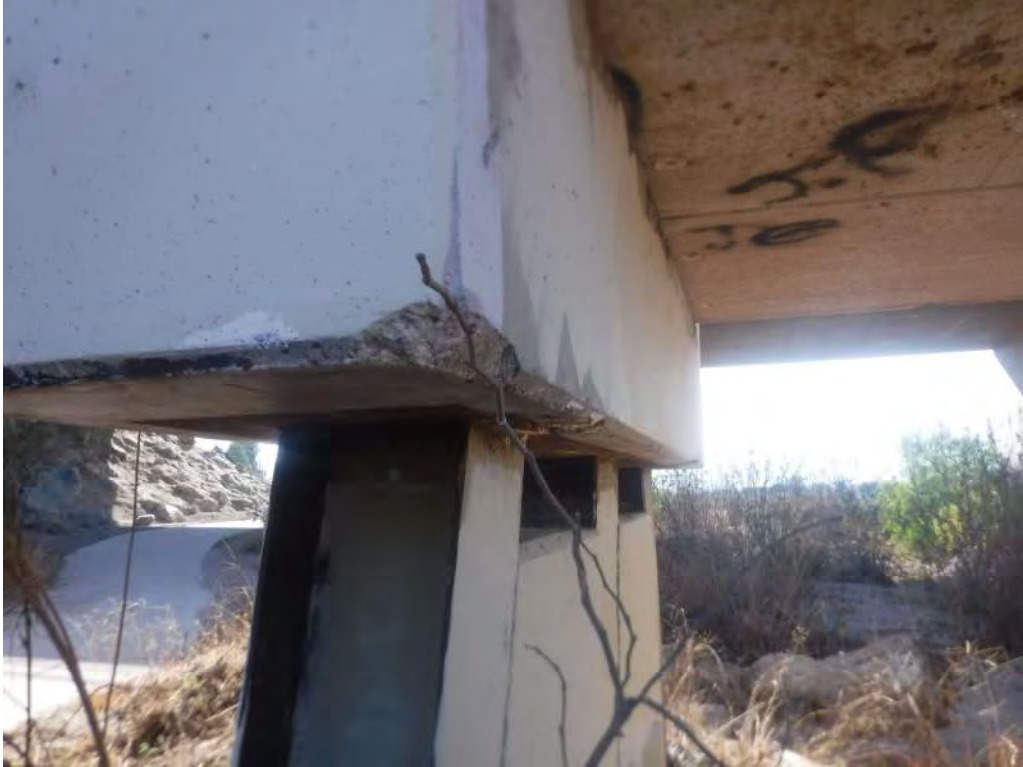
**423.44 Spall NE bottom corner of cap, Pier 14**
