# BRIDGE INSPECTION REPORT

INSPECTION TYPE: Annual

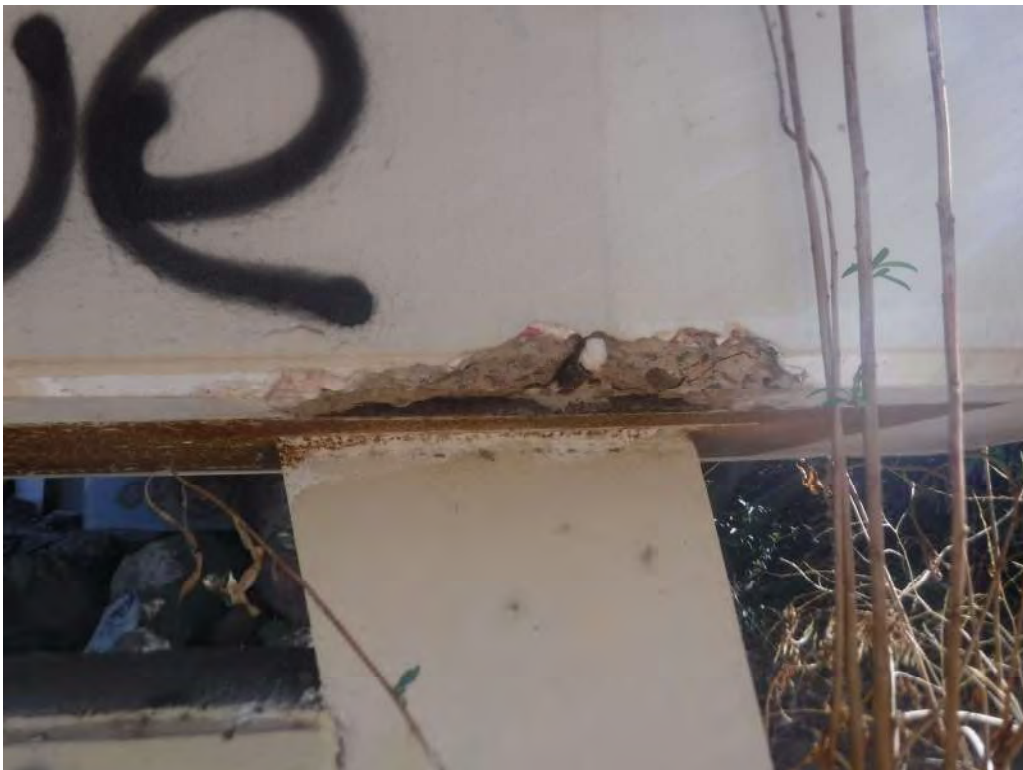
**423.44 Spall with Exposed Rebar – Pier 15 west side**

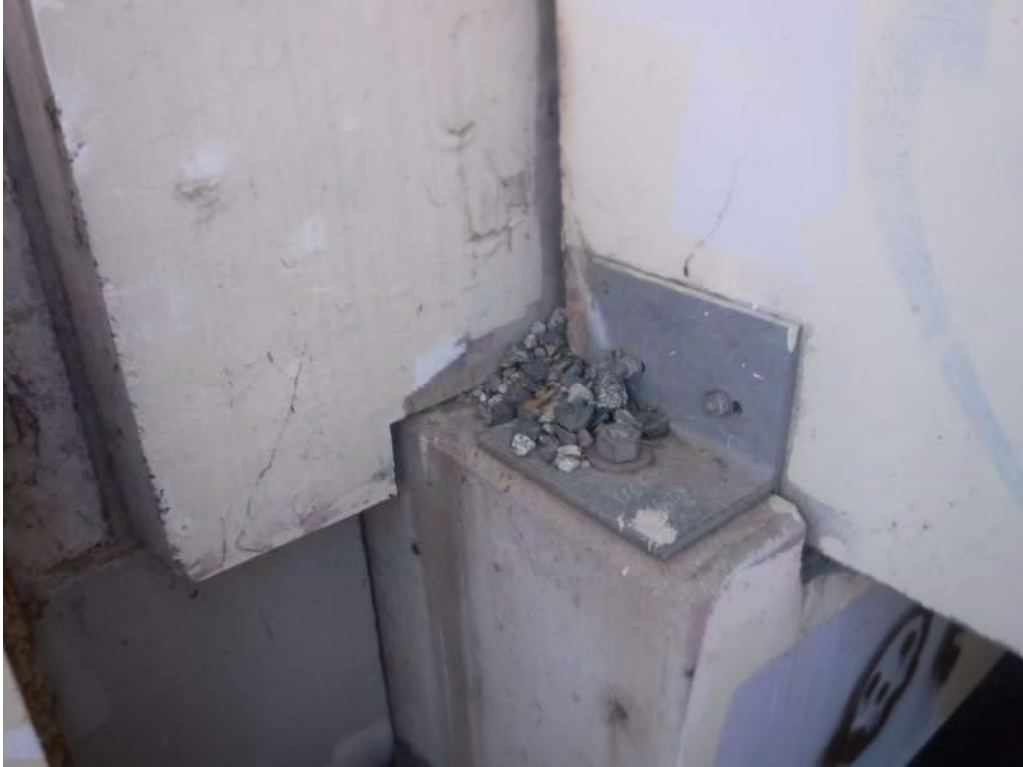
**423.44 Ballast leaking on bearing seats, near Abutment 16**

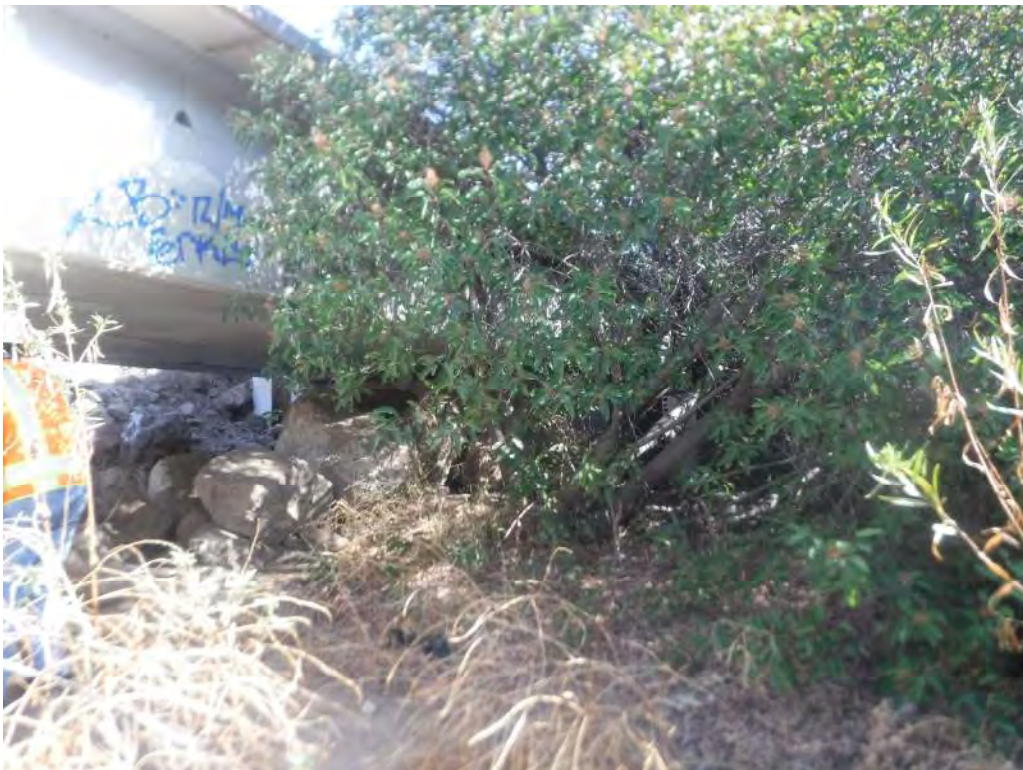
**423.44 Vegetation adjacent to Span 15**

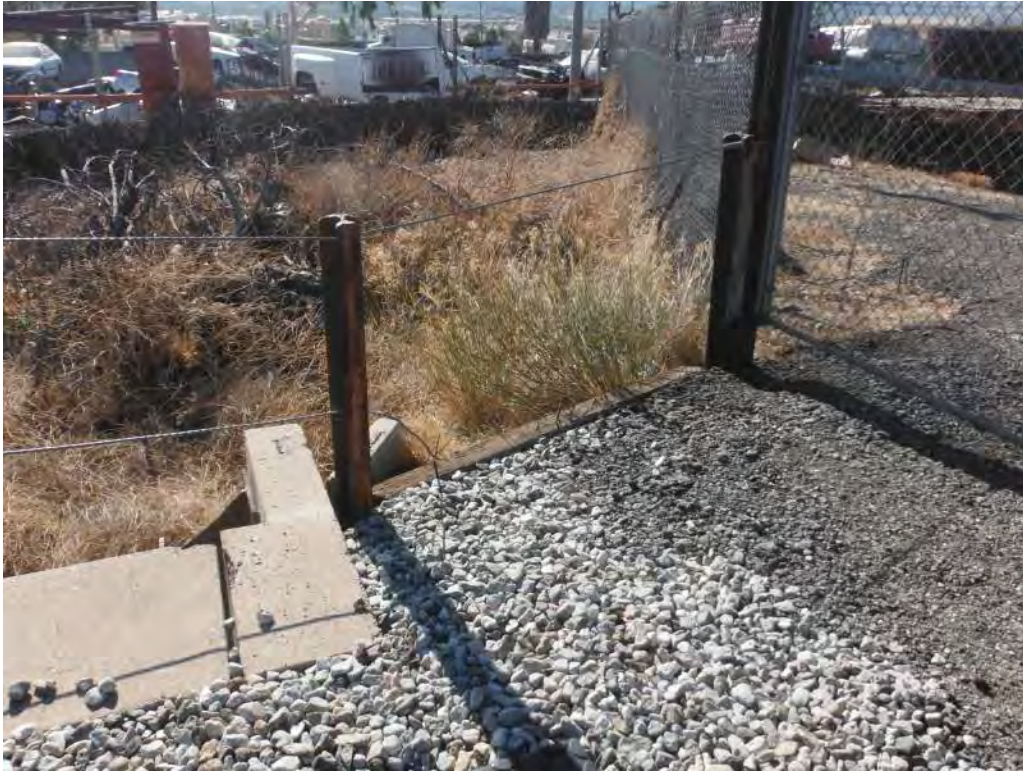
**425.15 Cable broken at southwest corner**

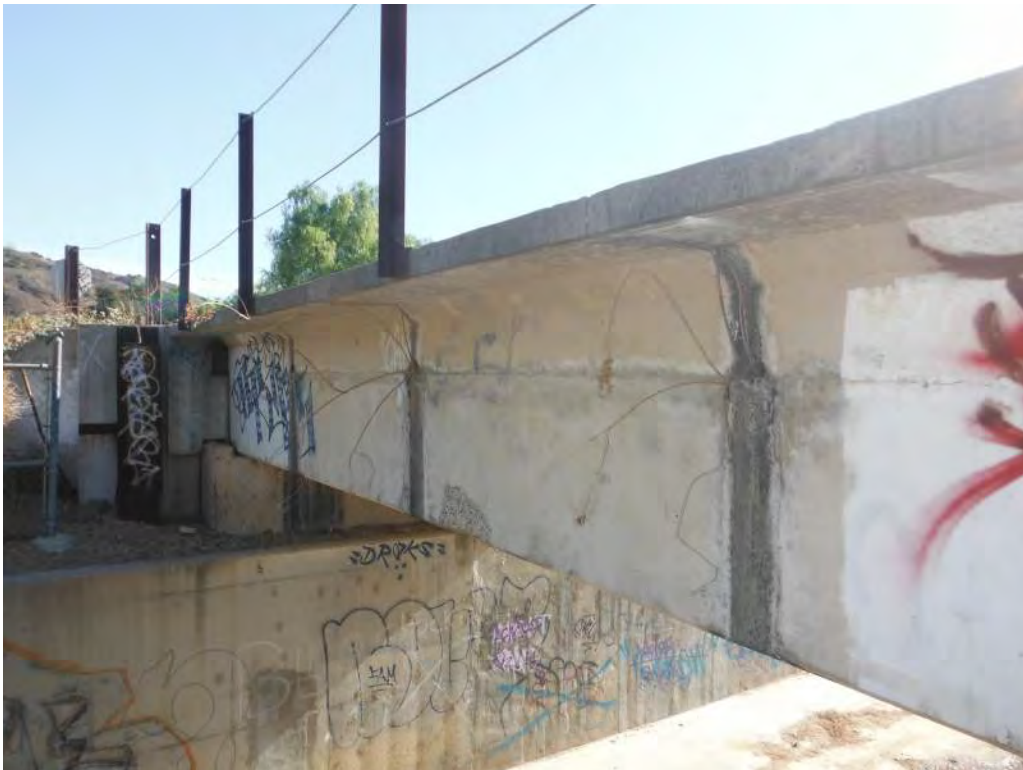
**425.15 Vegetation growing in drain holes**

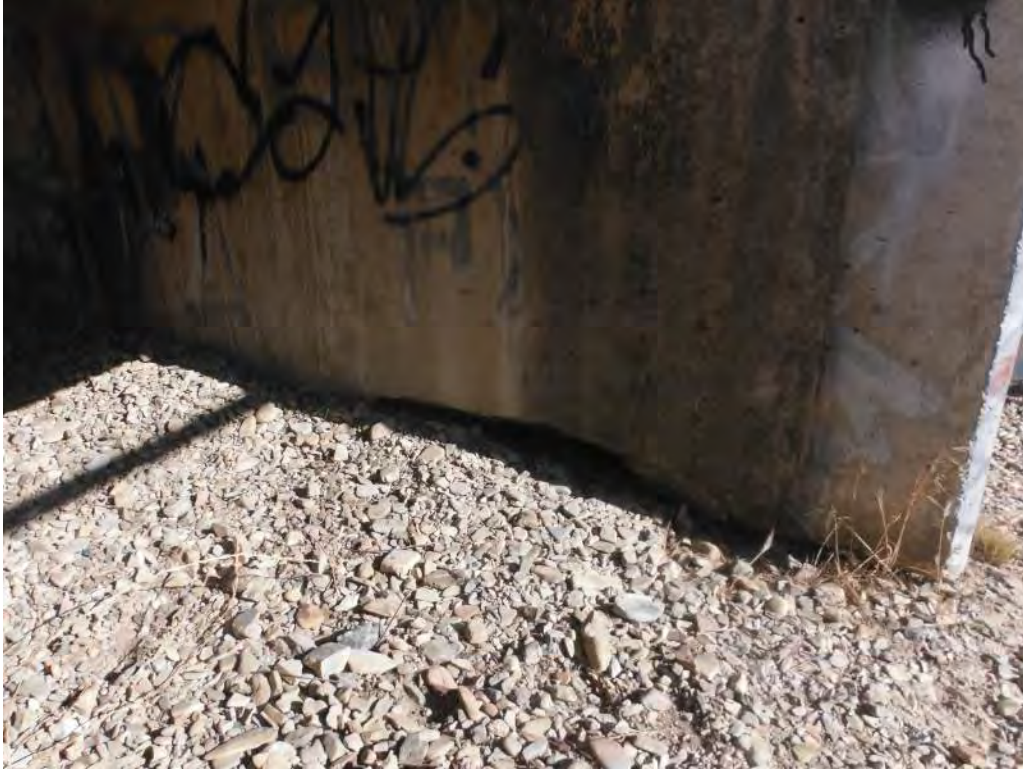
**425.15 Spall - Southwest pier 2**

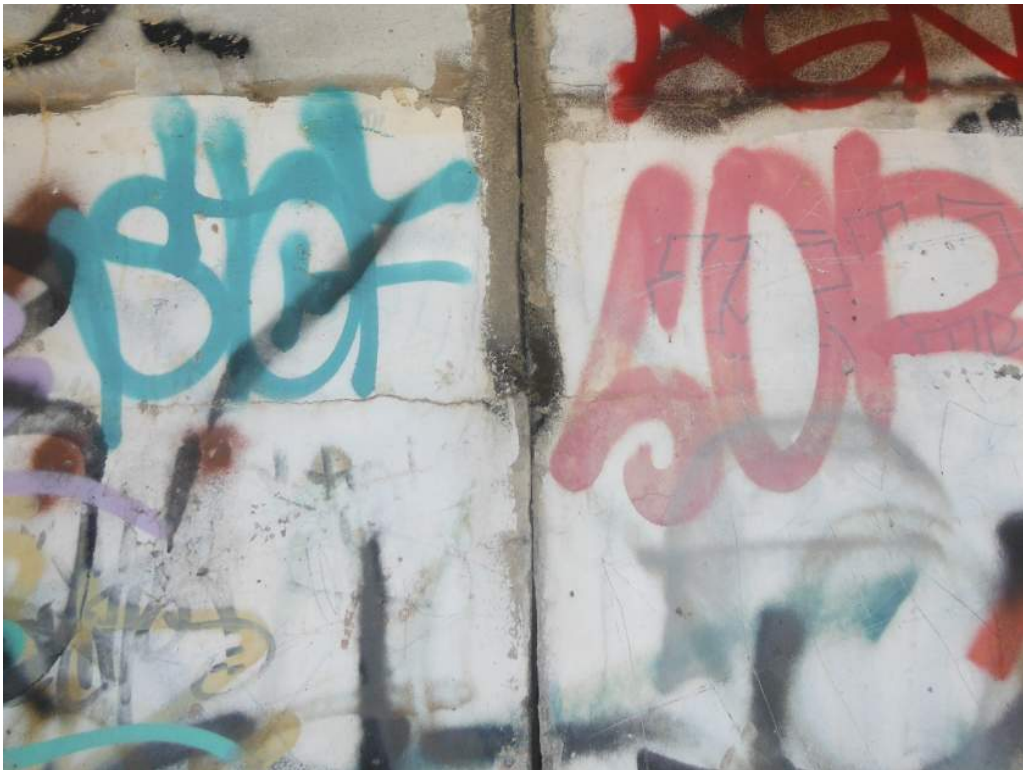
**425.15 No gap between girders - Pier 2**

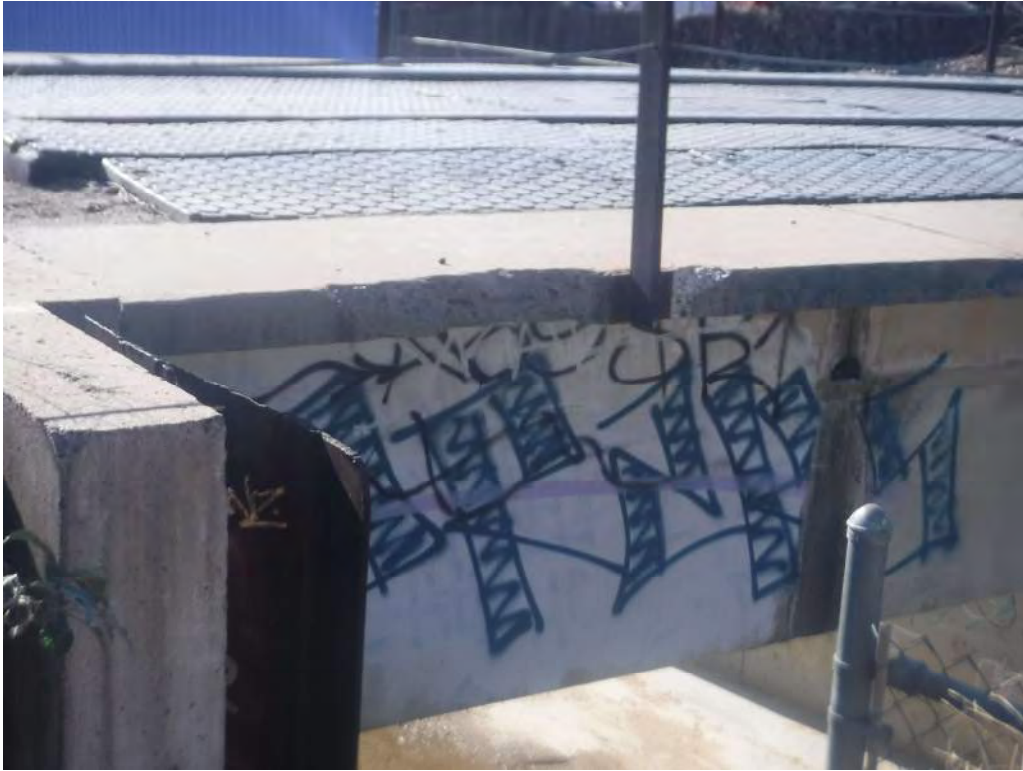
**425.15 Spall with exposed rebar - Span 2 north side**

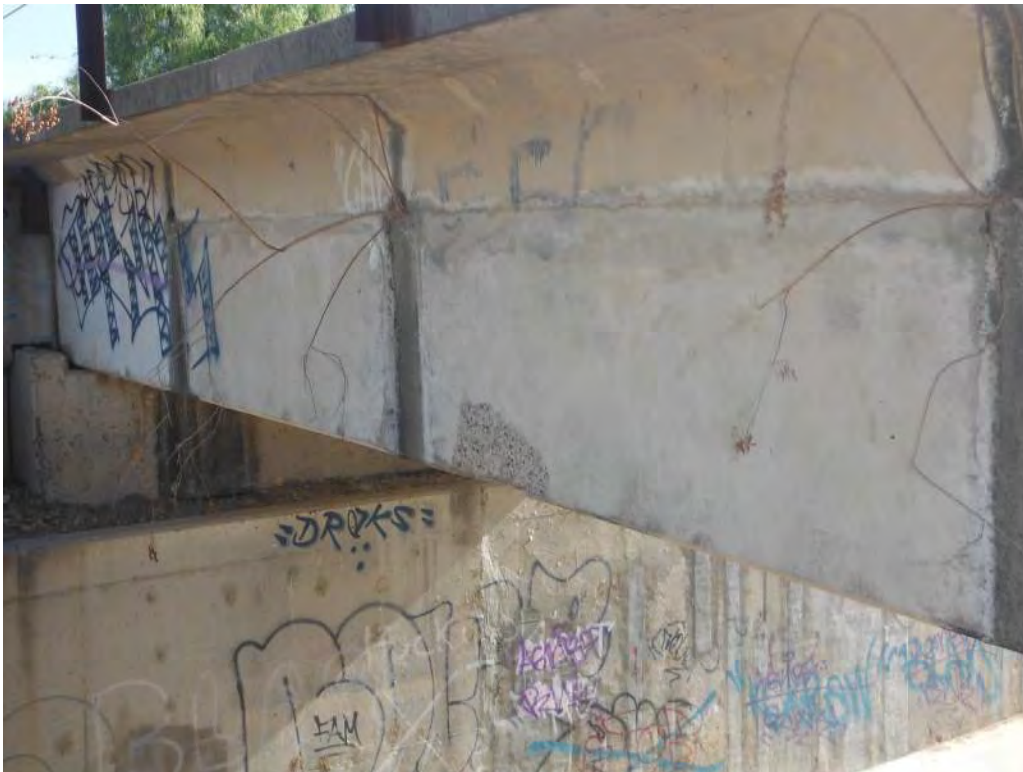
**425.15 Spall at midspan - Span 2 north side**

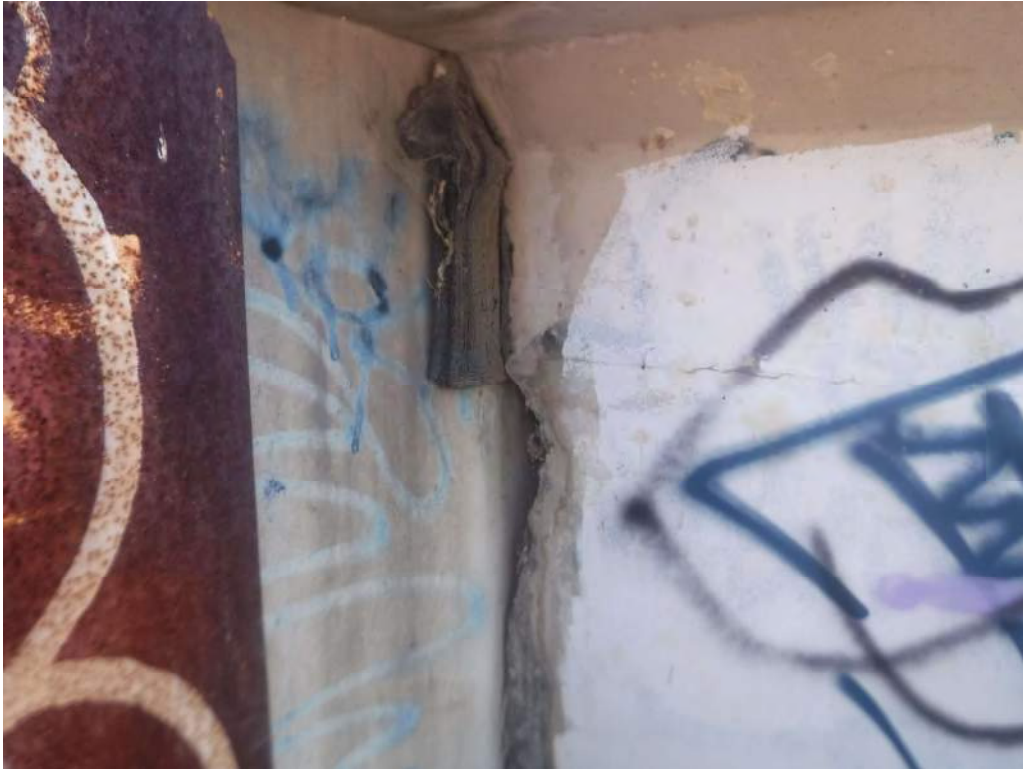
**425.15 Crack and spall in girder near Abutment 3 north side**

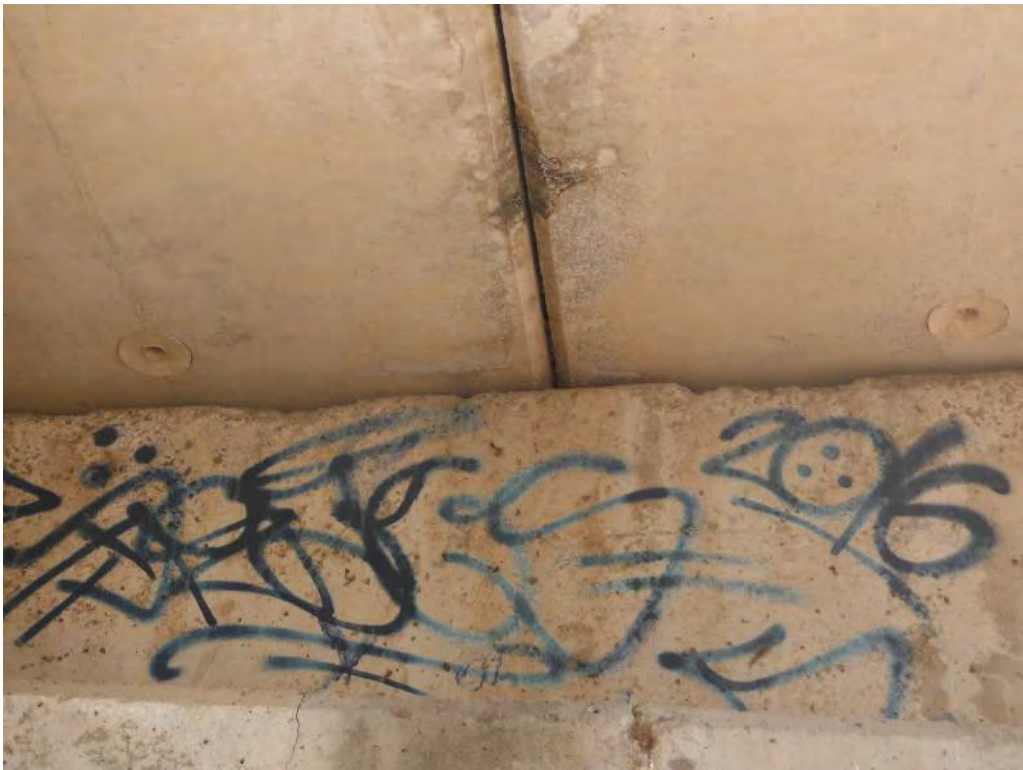
**425.15 Abutment 3 Cap Spall**

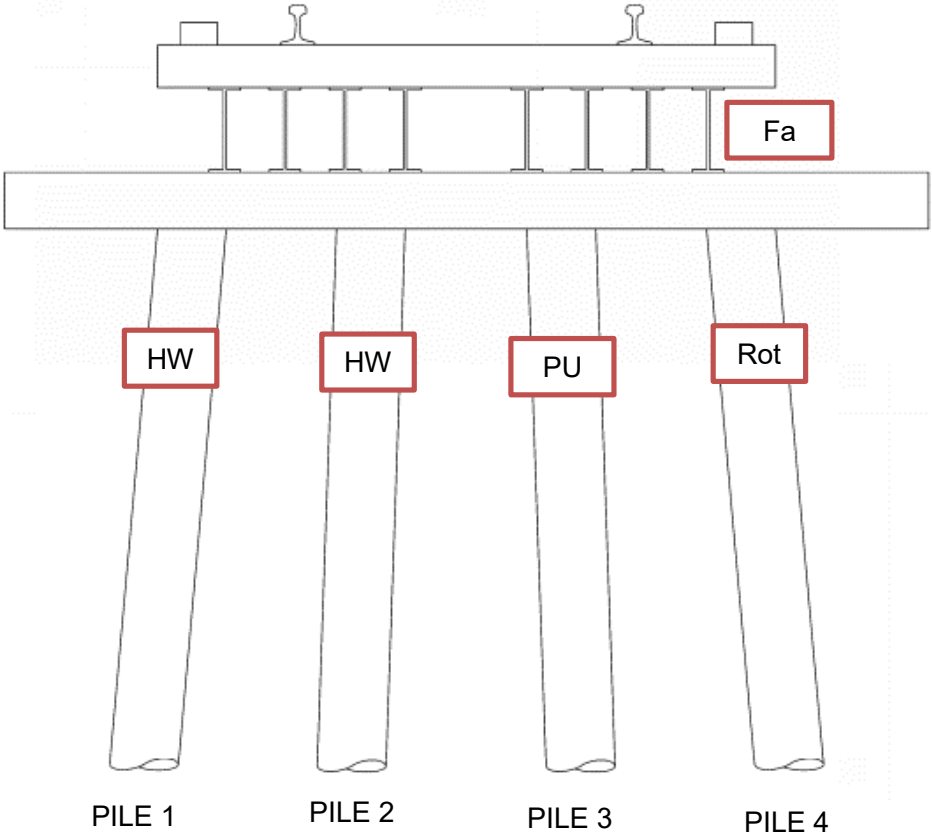
<div style="display: flex; justify-content: space-around; margin-top: 10px;"> <span>PILE 1</span> <span>PILE 2</span> <span>PILE 3</span> <span>PILE 4</span> </div>			
<b>Description: Looking East - (8) Steel Stringers, Abutment #2 is timber</b>			
<b>Remarks:</b>

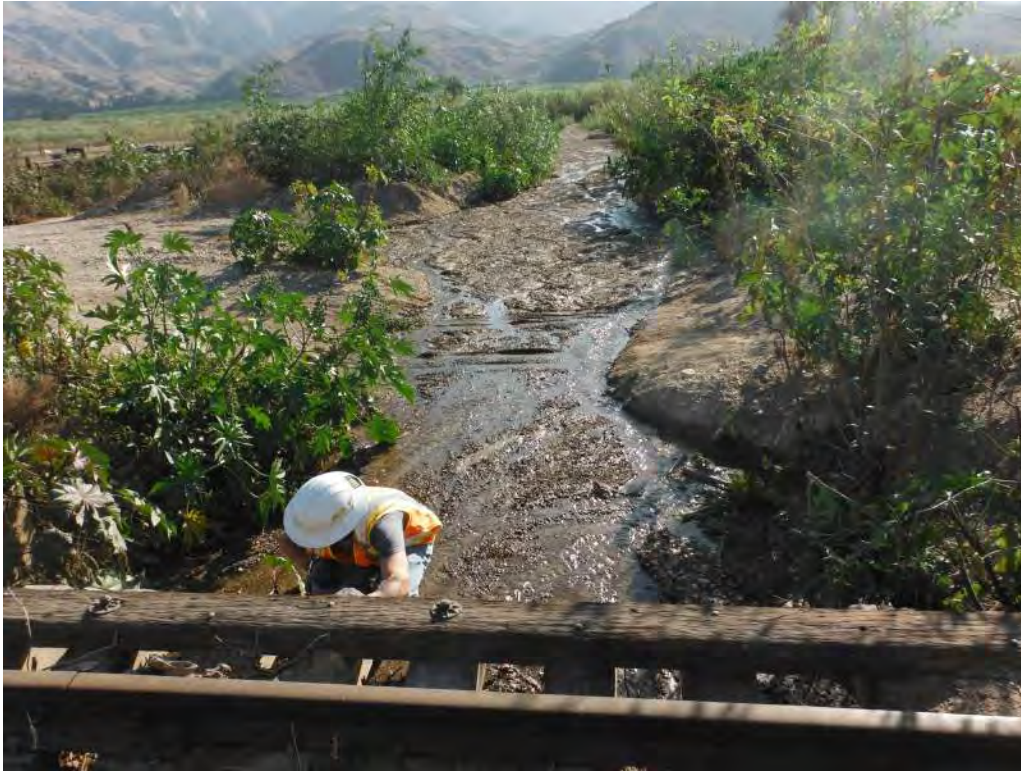
**427.64 Downstream channel condition**

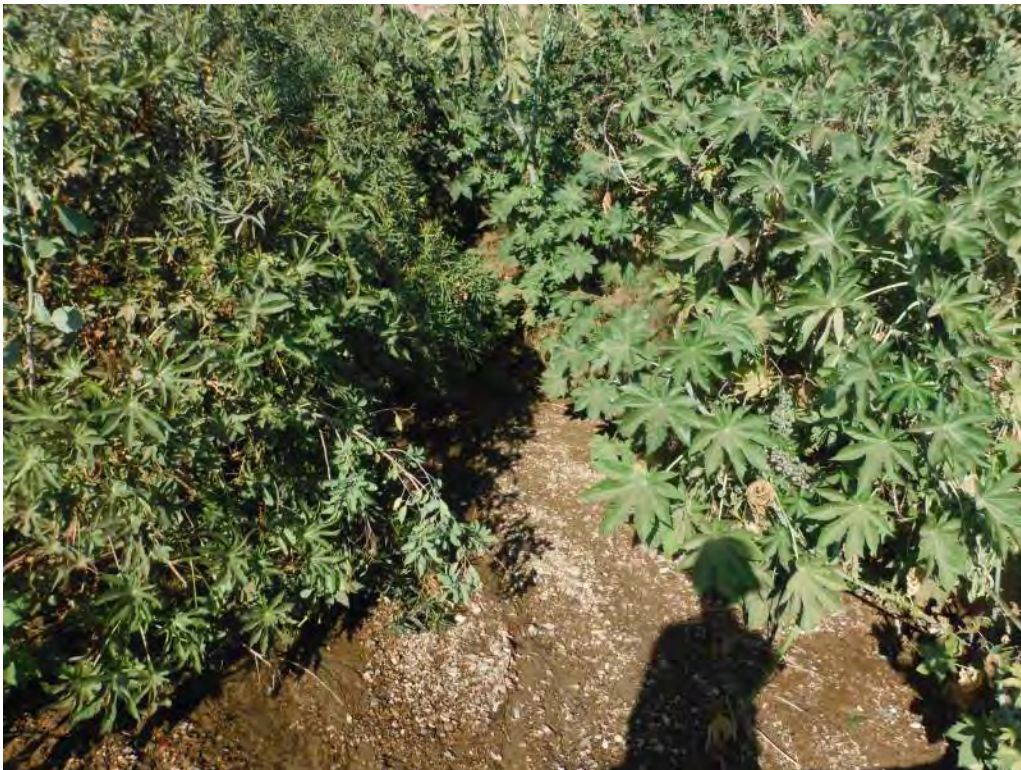
**427.64 Upstream channel condition**

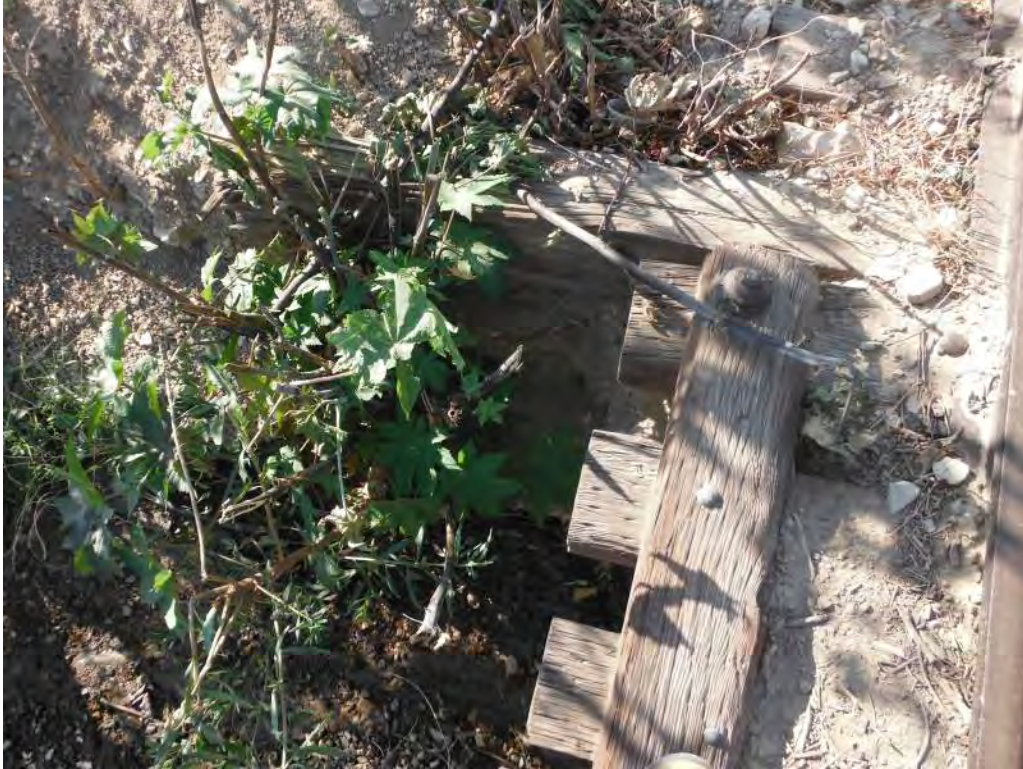
**427.64 Hole in ballast behind Abutment 2**

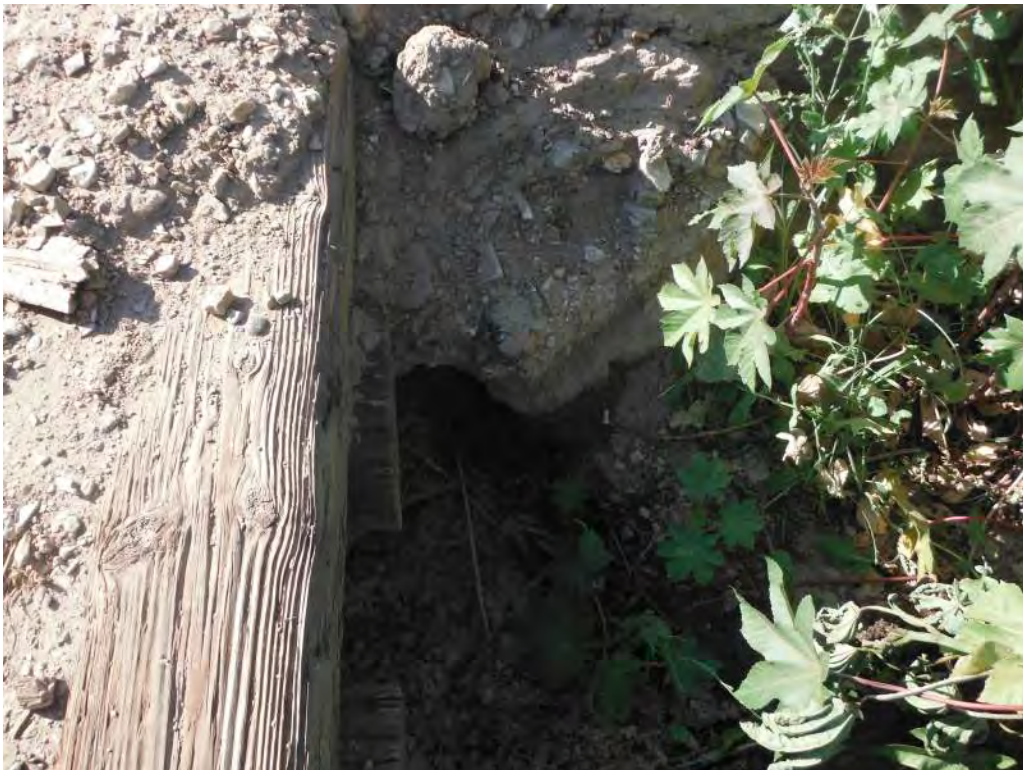
**427.64 Backwall rotting – top timber of backwall failing, Abutment 1**

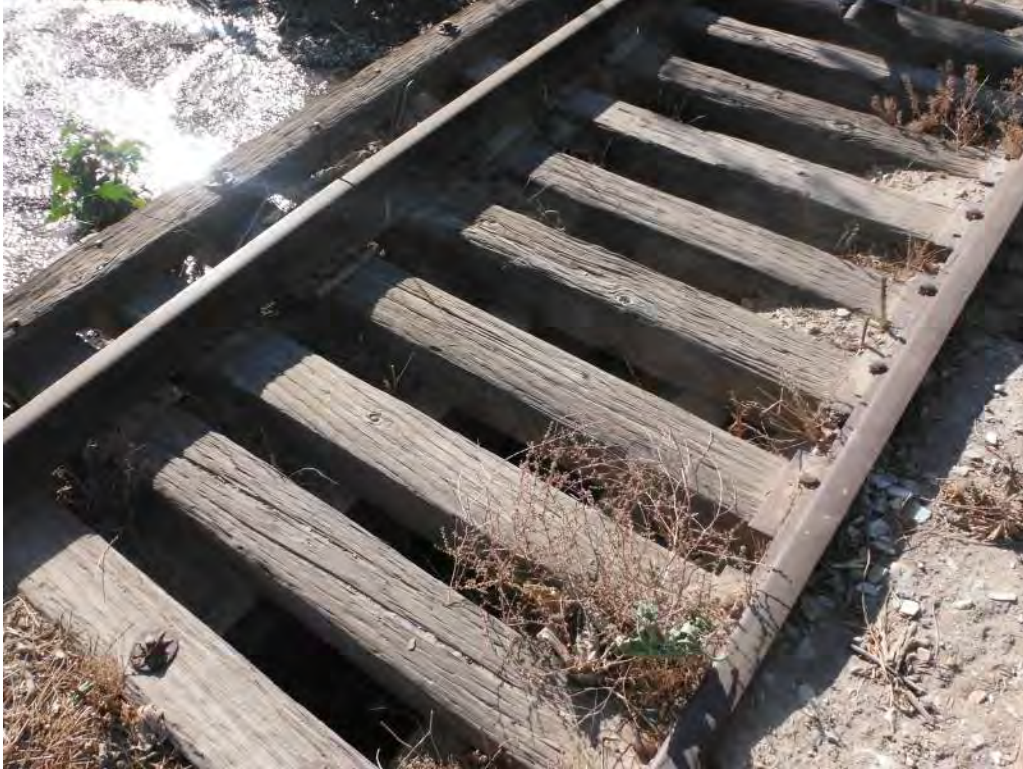
**427.64 Debris covering stringers**

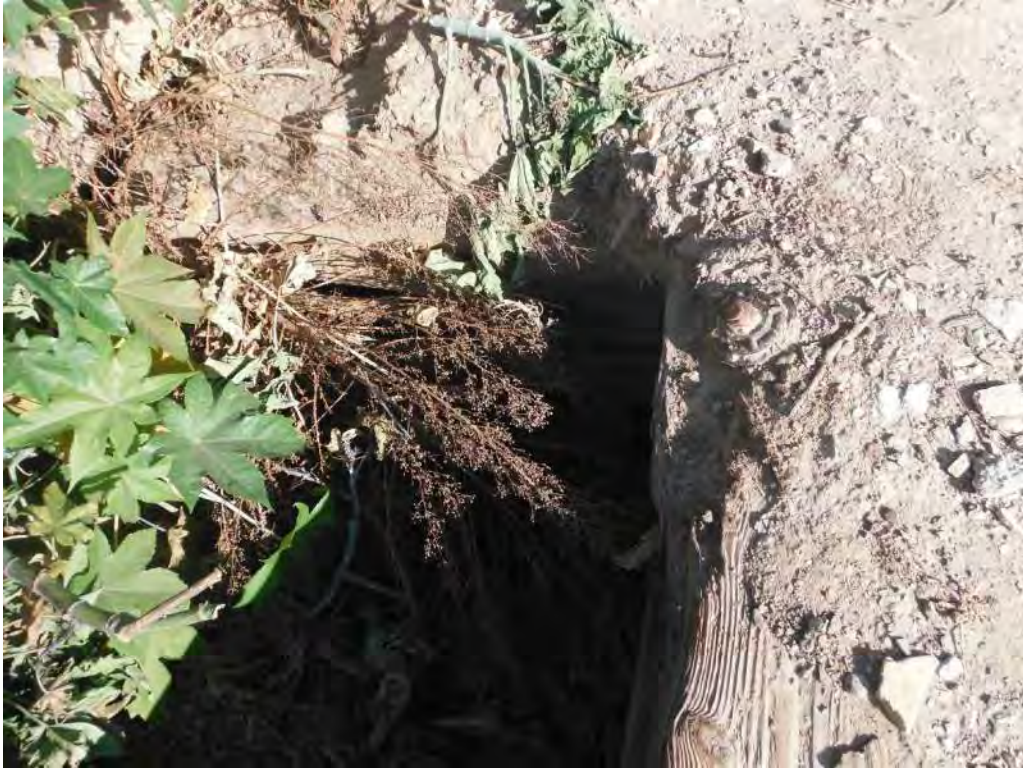
**427.64 Backwall failing – Abutment 2**

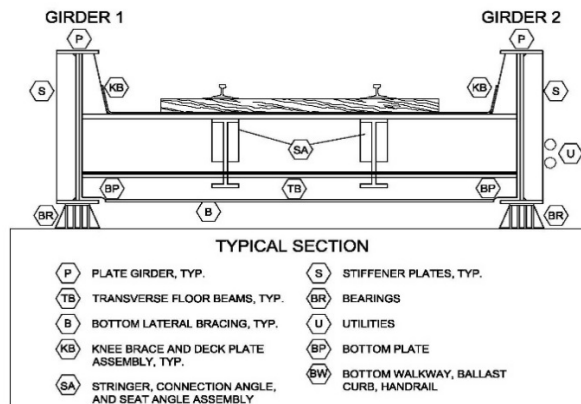
<b>DIVISION</b>	Santa Paula	<b>SPAN LENGTH</b>	70'-0"	<b>NUMBER OF TRACKS</b>	1
<b>CROSSING</b>	Hopper Creek	<b>TRACK ALIGNMENT</b>	Tangent	<b>SPAN No.</b>	1
<b>INSPECTION FINDINGS</b>					
	ALL BEARING AREAS REQUIRE CLEANING				
	North G1 stiffeners have minor impact				
	Impact damage to bottom flange floor beam 1 - see photo				
	Impact damage to bay 5 cross bracing

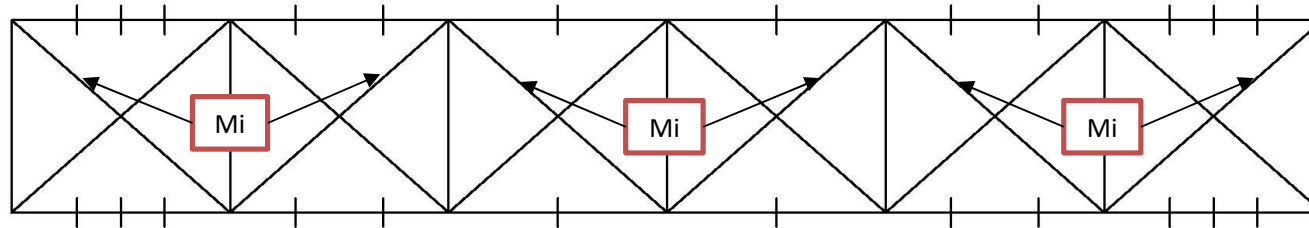
Inspected By:	Joseph Holste, PE	Date Inspected:	12/10/2020
---------------	-------------------	-----------------	------------

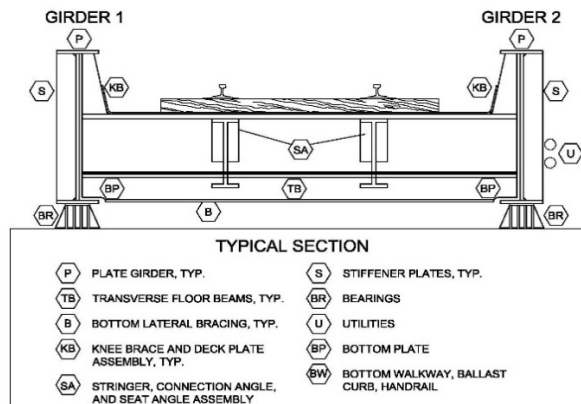
DIVISION	Santa Paula	SPAN LENGTH	82'-0"	NUMBER OF TRACKS	1
CROSSING	Hopper Creek	TRACK ALIGNMENT	Tangent	SPAN No.	2
INSPECTION FINDINGS					
Mi	Lower cross bracing has minor impact throughout - see photo				
	Impact damage to bay 1 crossbracing

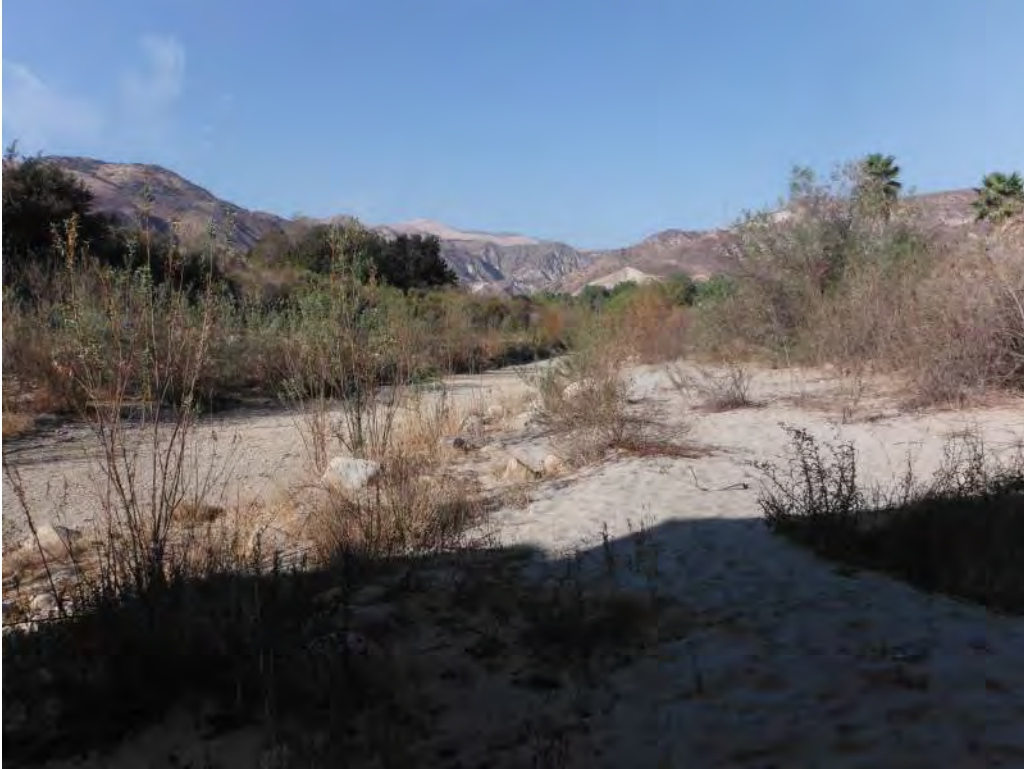
**429.79 Channel Condition – Looking Upstream**

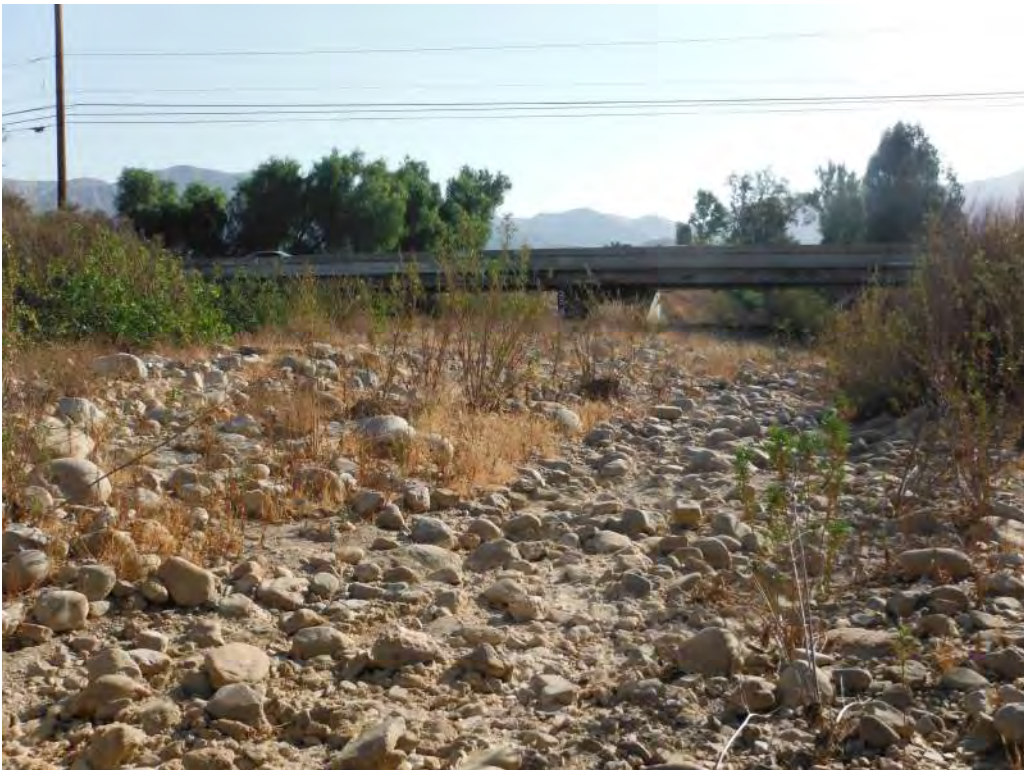
**429.79 Channel Condition – Looking Downstream**

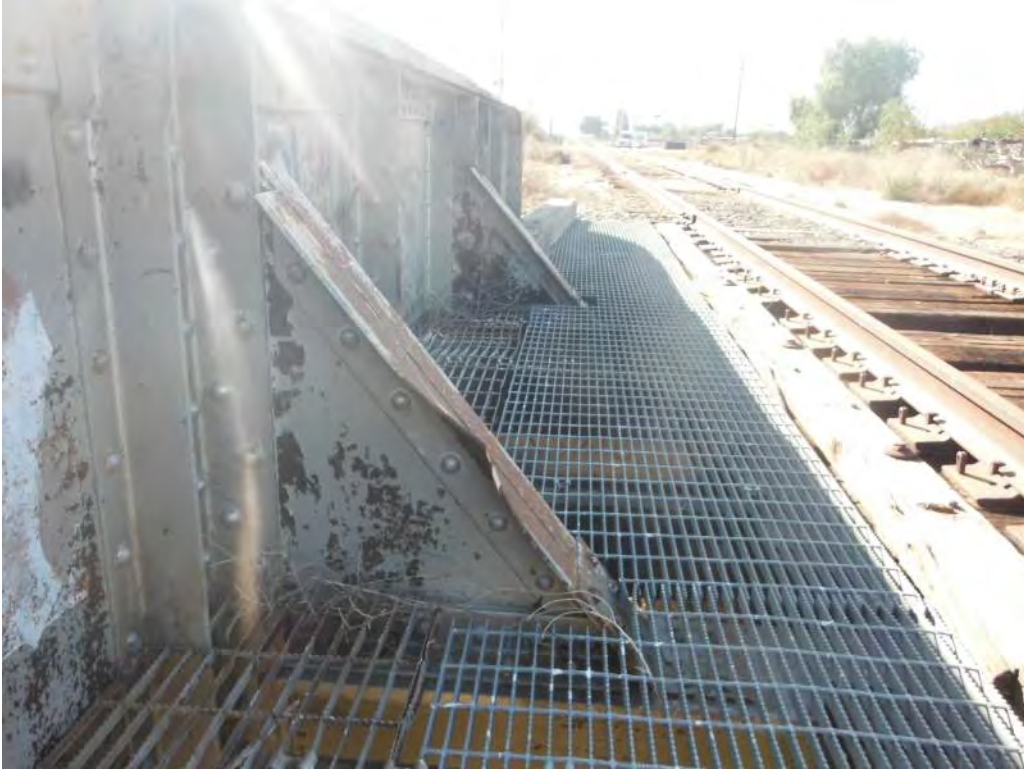
**429.79 Minor impact damage on knee braces**

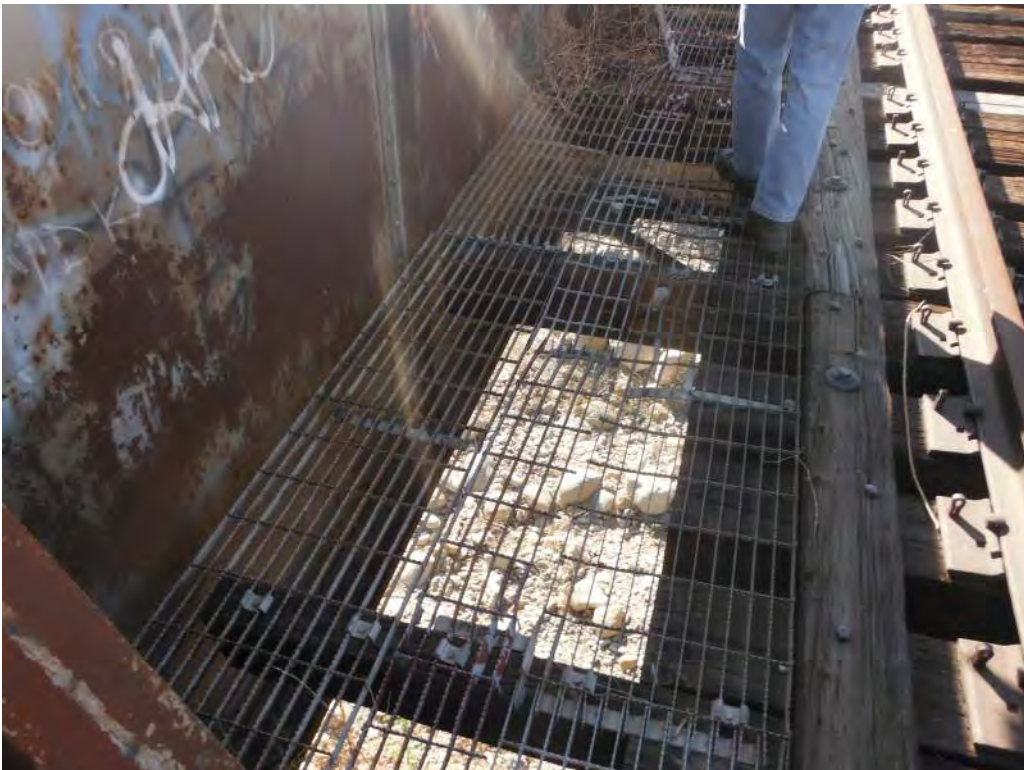
**429.79 South walkway damaged near Pier 2**

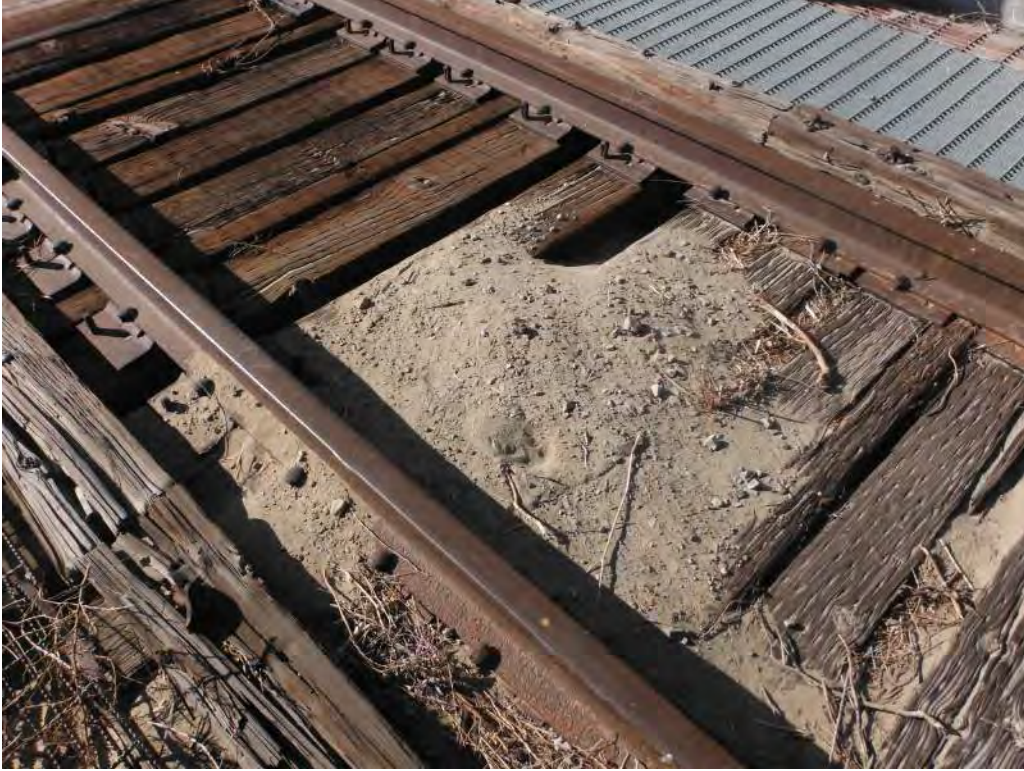
**429.79 Timber approach spans fully silted in**

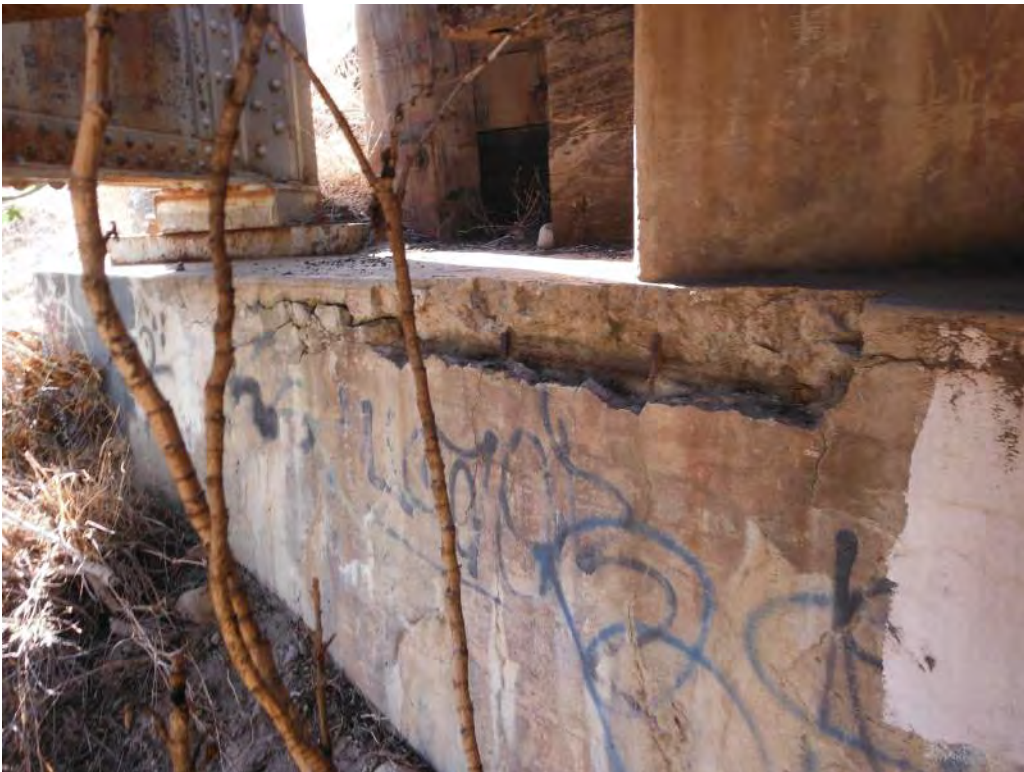
**429.79 Spall - Abutment 1**

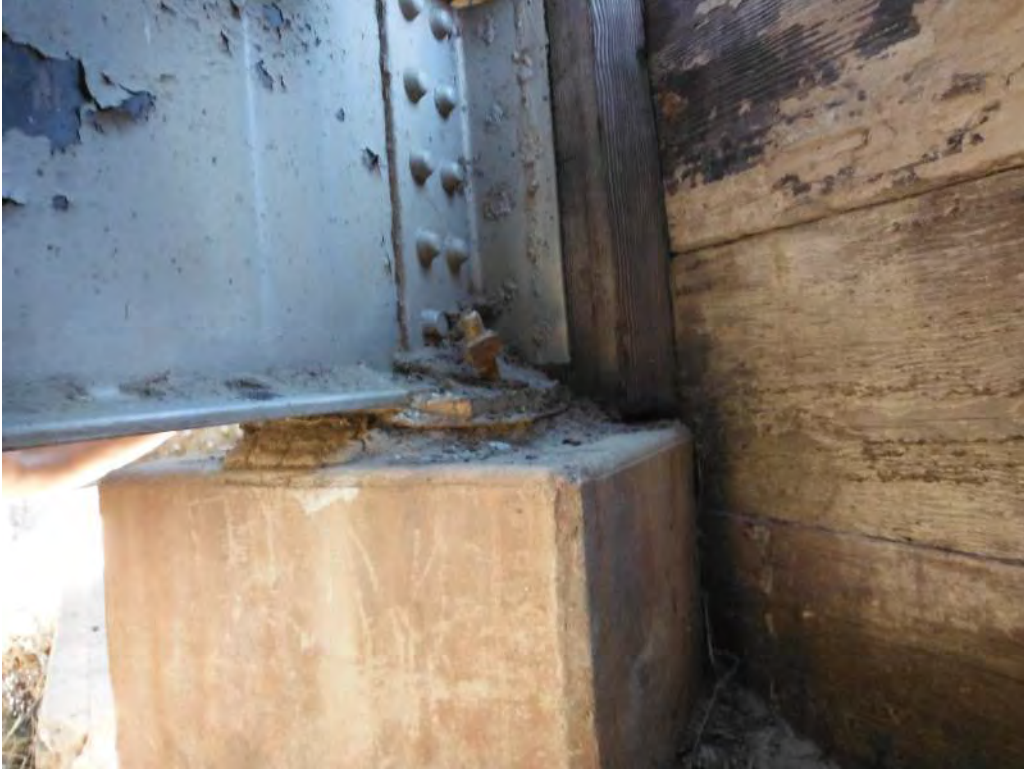
**429.79 Failed anchor bolt – Stringer 1 & 2, Abutment 1**

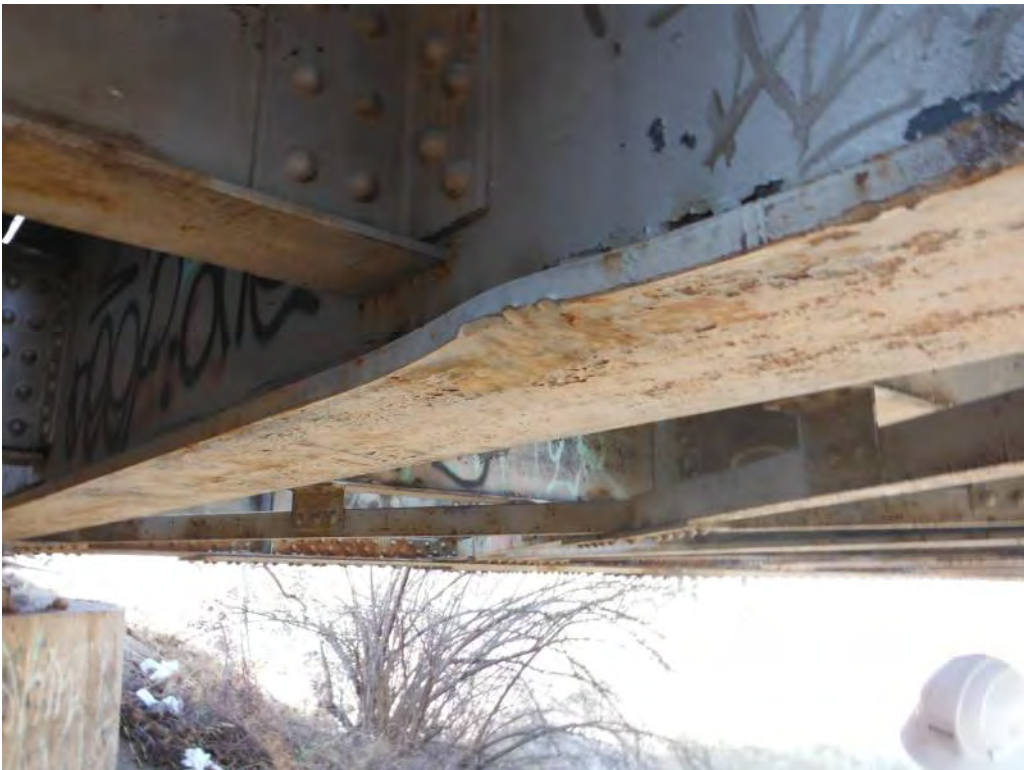
**429.79 Impact damage to bottom flange floor beam 1 – Span 1**

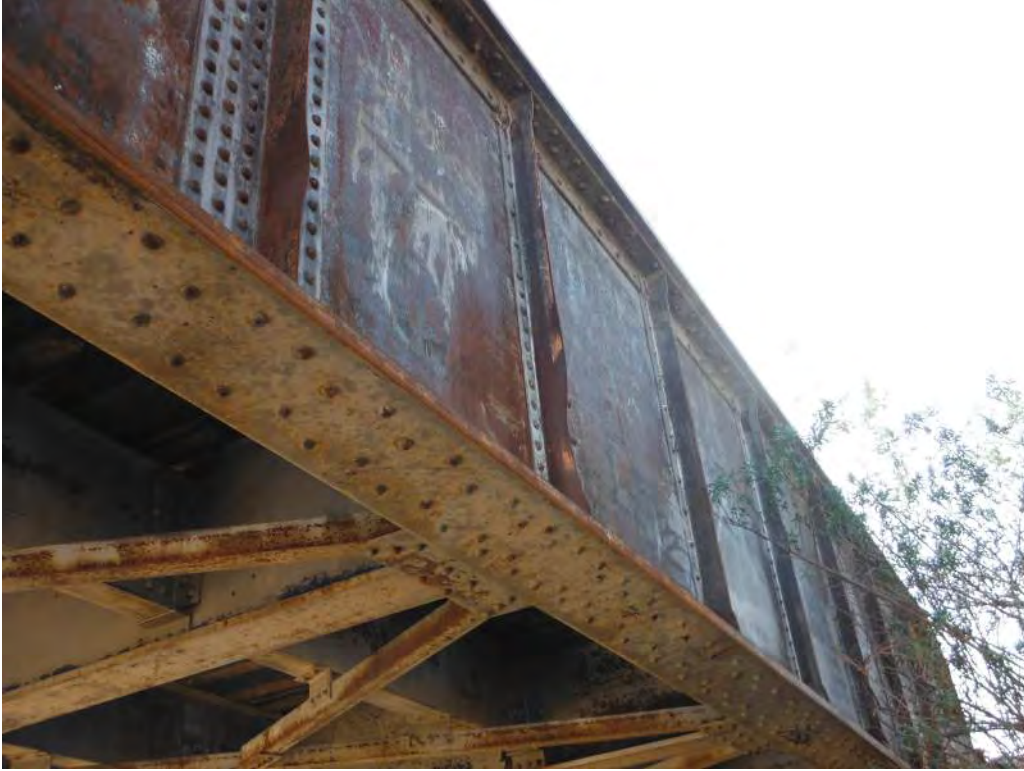
**429.79 Multiple stiffeners Impact damage - Span 1 north side**
