# BRIDGE INSPECTION REPORT

INSPECTION TYPE: Annual

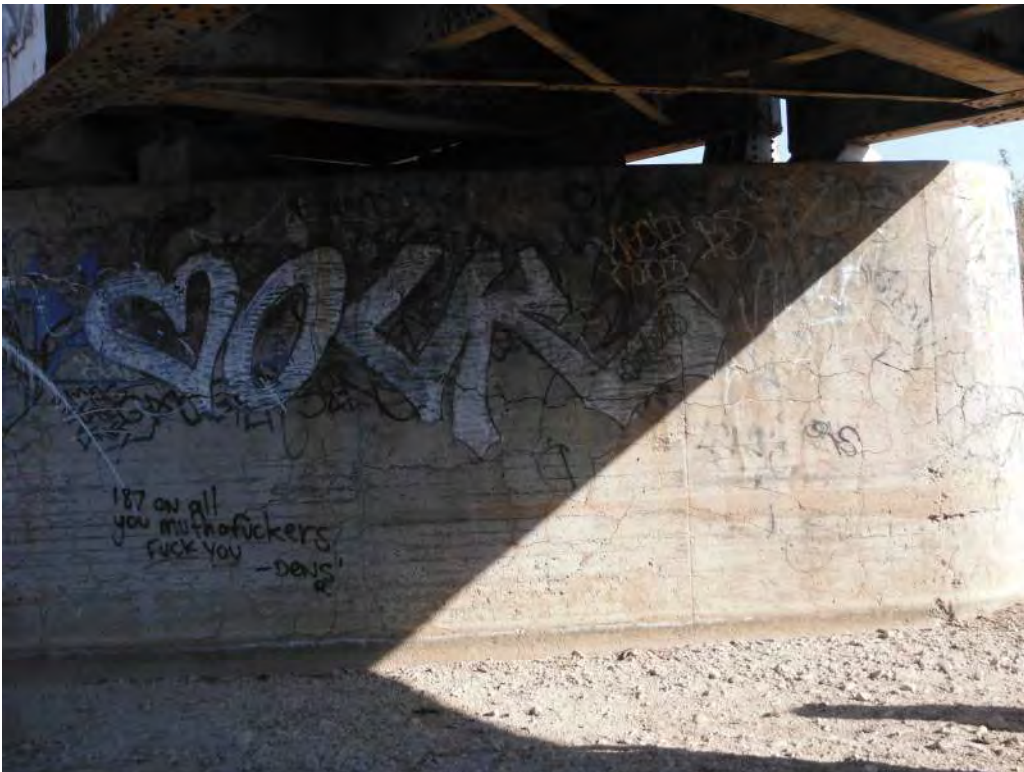
**429.79 Typical cracking - Pier 2**

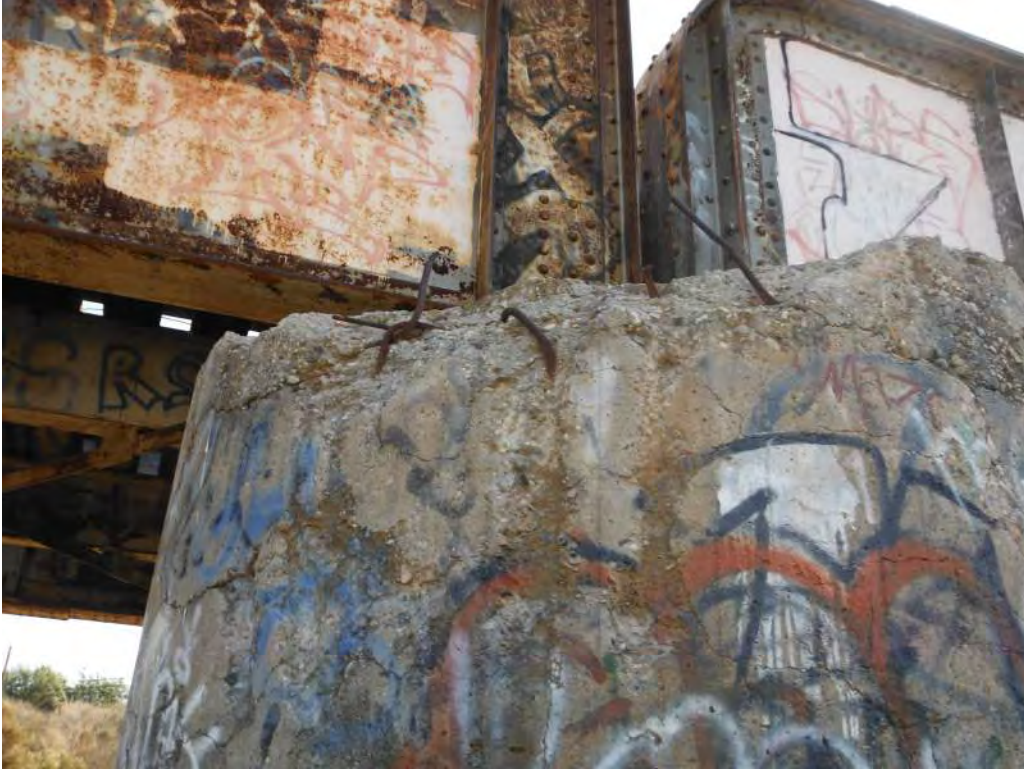
**429.79 Exposed rebar - Pier 2 north side**

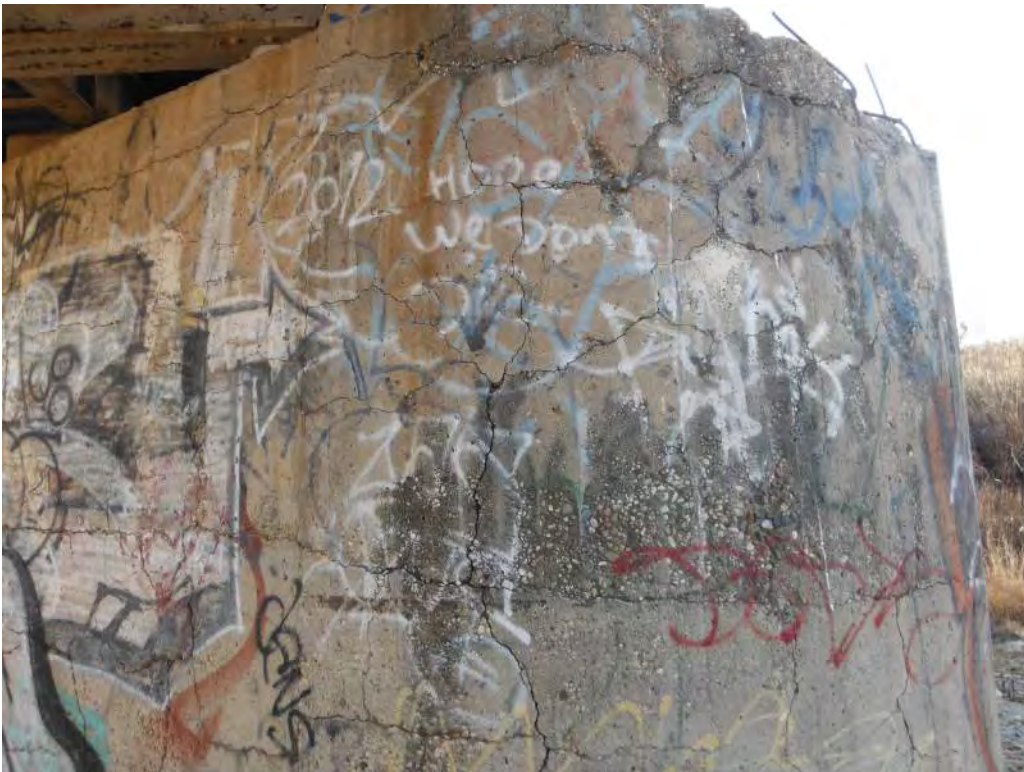
**429.79 Minor impact damage - Pier 2**

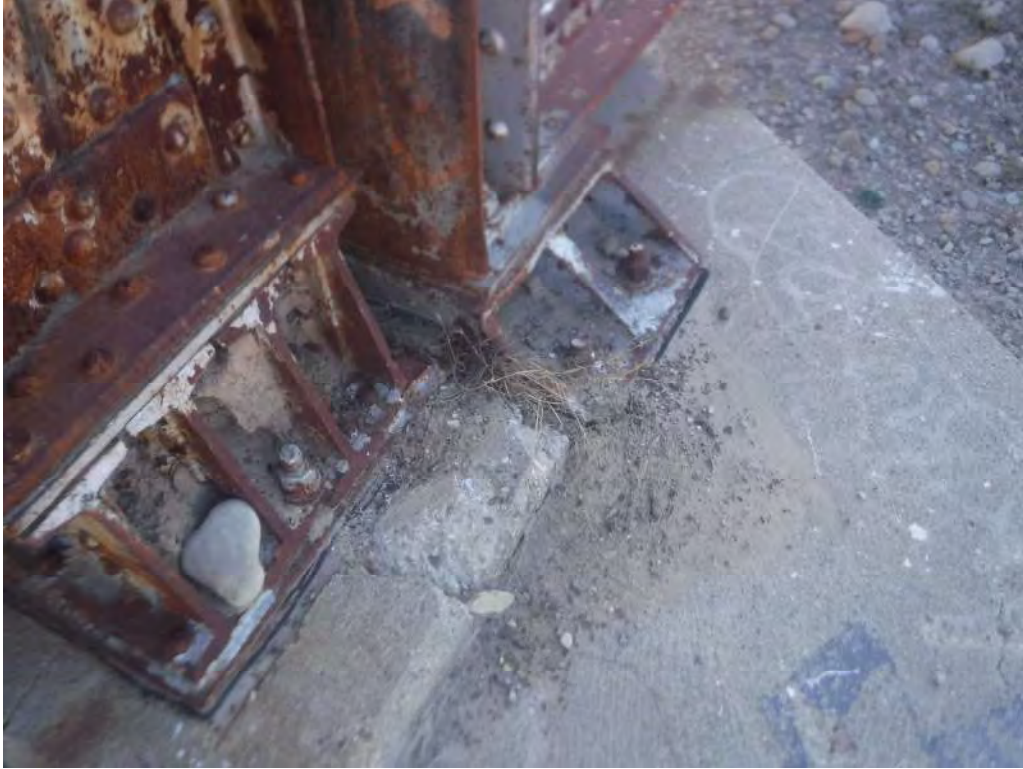
**429.79 Spalling under bearing - Pier 2**

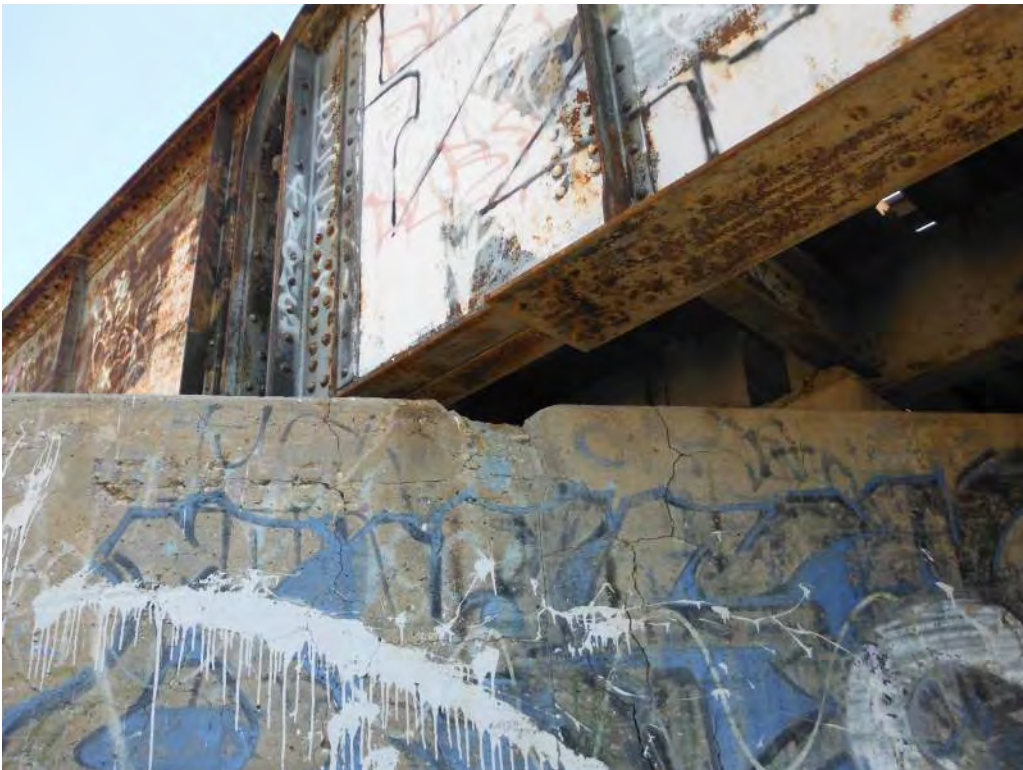
**429.79 Spall under bearing – Pier 2**

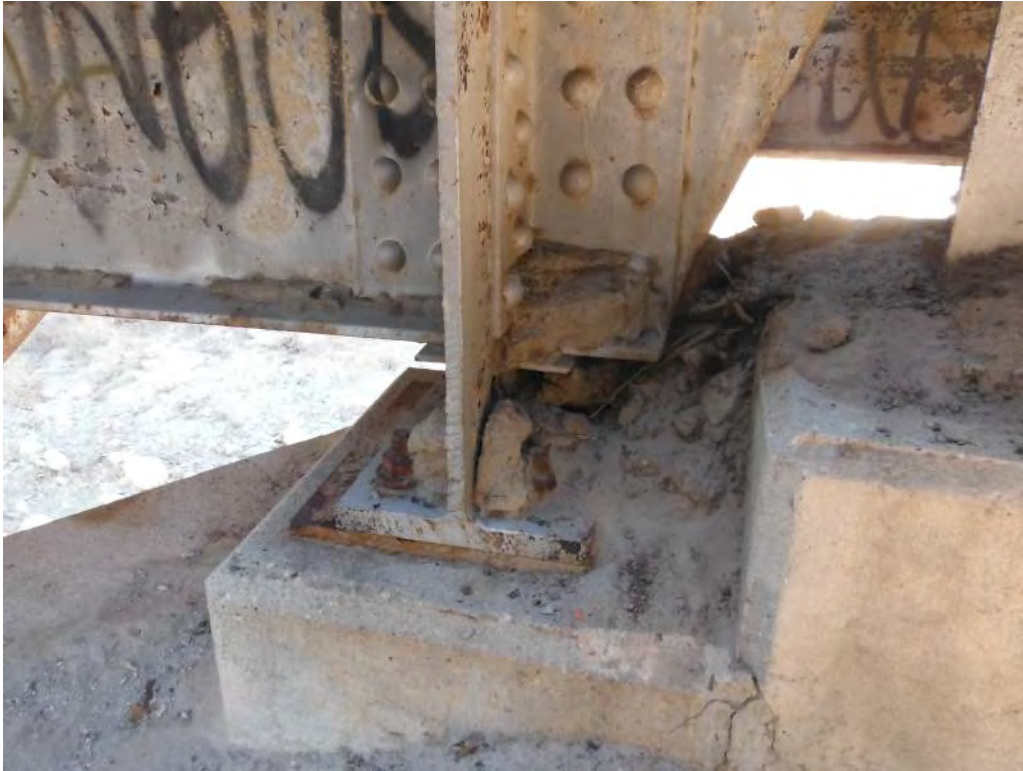
**429.79 Seats are covered with silt, Pier 2 Bearing**
