Sierra Northern Railway

Detailed Inspection 11/30/2022

Bridge 423.44

Bridge # 423.44	
Milepost: 423.44	Section: 1
Type: Concrete Box Girders	Location: Filmore, CA
Inspection Date(s): 11/30/2022	Inspector: G. Grumke, S. Radlinger
Inspection Type: Detailed	Critical Review By RBE: No

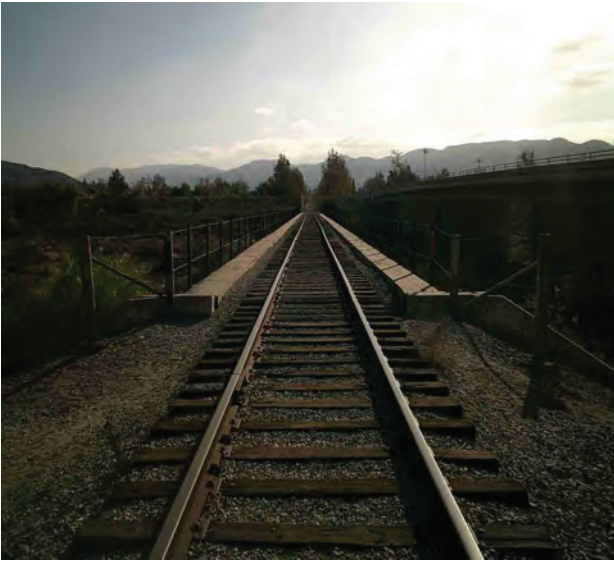
Bridge 423.44 Deck View

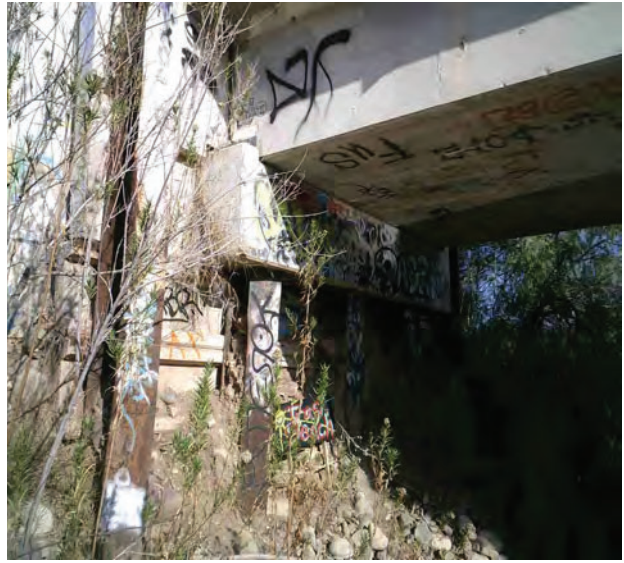
Bridge 423.44 Dump Bent

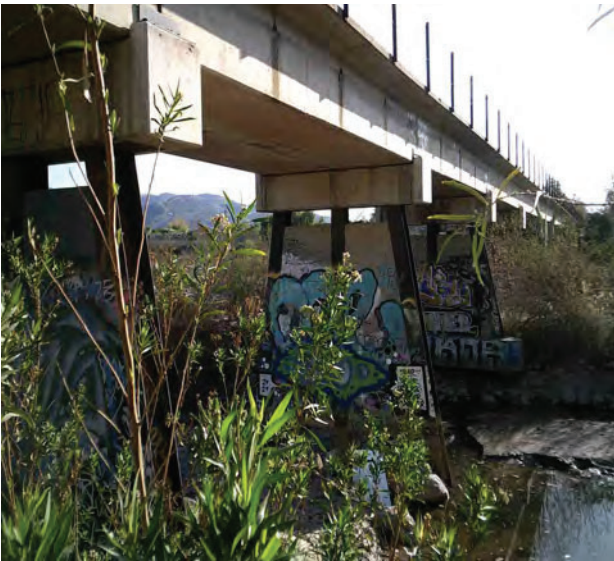
Bridge 423.44 Typical Bent

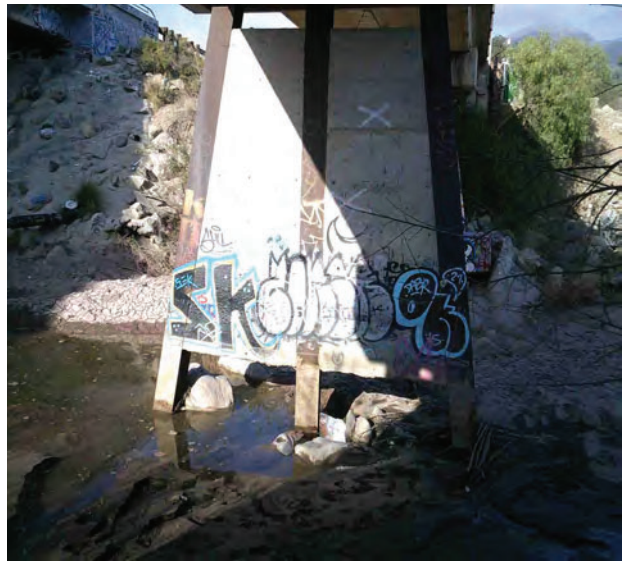
Bridge 423.44 Typical Concrete
between Piles

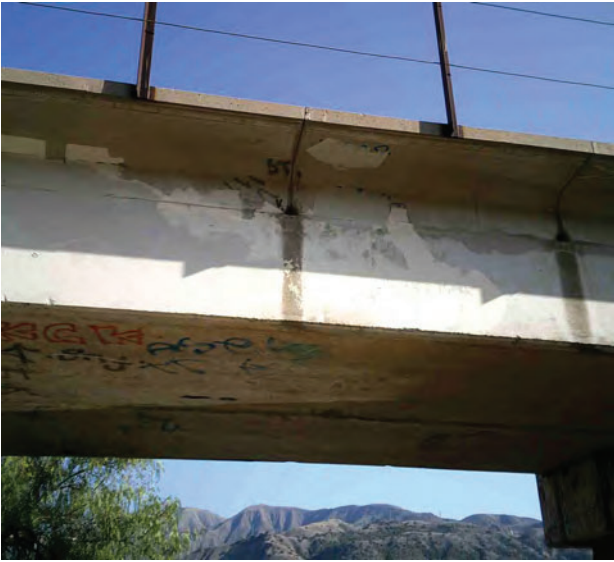
Bridge 423.44 Typical Span
