Ventura County Transportation Commission

Fleet Maintenance Audit

Eleven (11) MCI 4505 Buses & Five (5) Volvo 9700 Buses Conducted March 23 - 24, 2019

VENTURA COUNTY TRANSPORTATION COMMISSION FLEET MAINTENANCE AUDIT Sixteen (16) Buses Conducted March 23 - 24, 2019

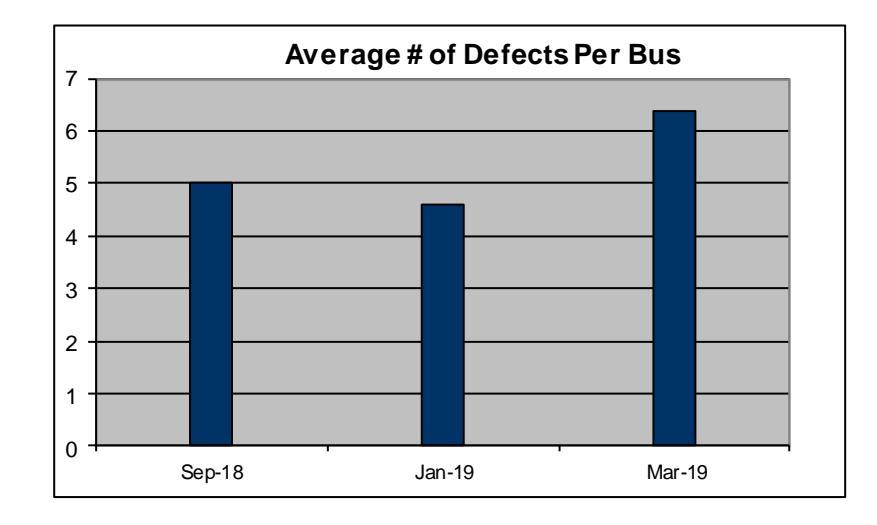
The total number of defects found during this audit was 102, or an average of 6.38 defects per bus. As can be seen in the chart which follows, this inspection showed an increase in the average number of defects per bus when compared to the initial audit conducted in September 2018 and the January 2019 audit.

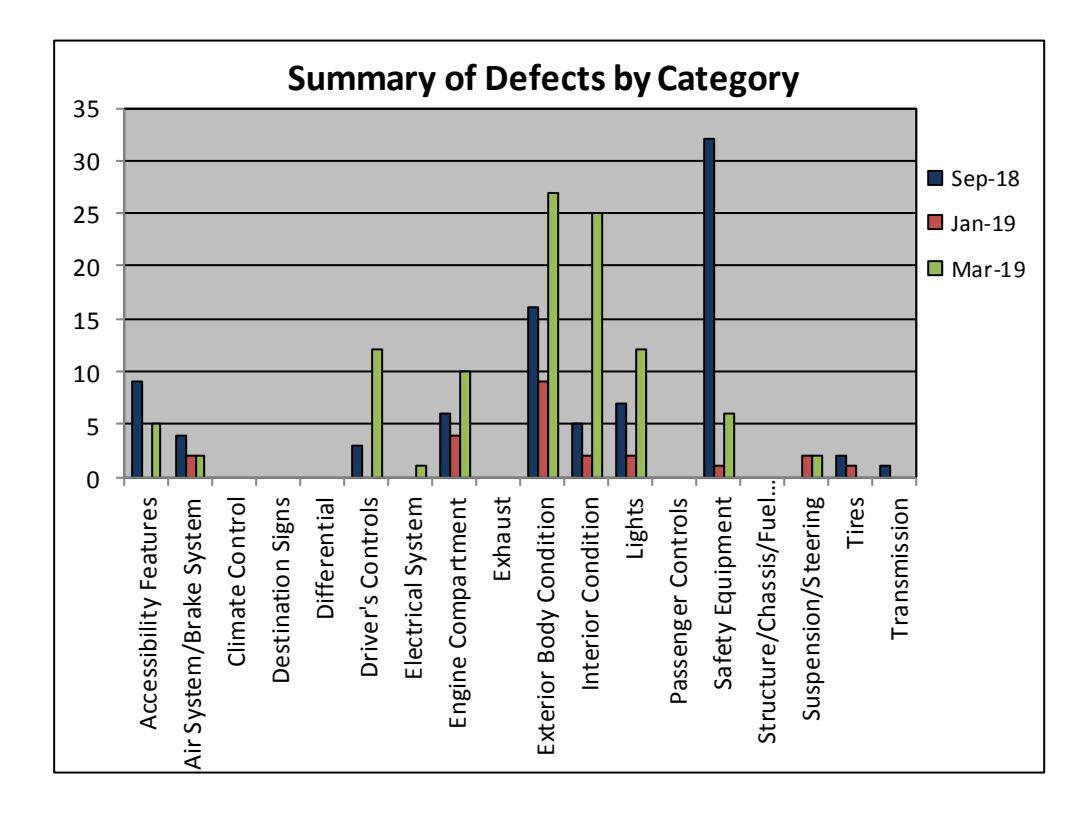
Defects were found in the Accessibility Features, Air System/Brake System, Driver's Controls, Electrical Systems, Engine Compartment, Exterior Body Condition, Interior Condition, Lights, Safety Equipment, and Suspension/Steering categories. The Exterior Body Condition category showed the most defects during this current audit with a total of twenty-seven (27) defects, followed by the Interior Condition category with a total of twenty-five (25) defects. A breakdown of defects by category can be found in Table 2 and the chart below.

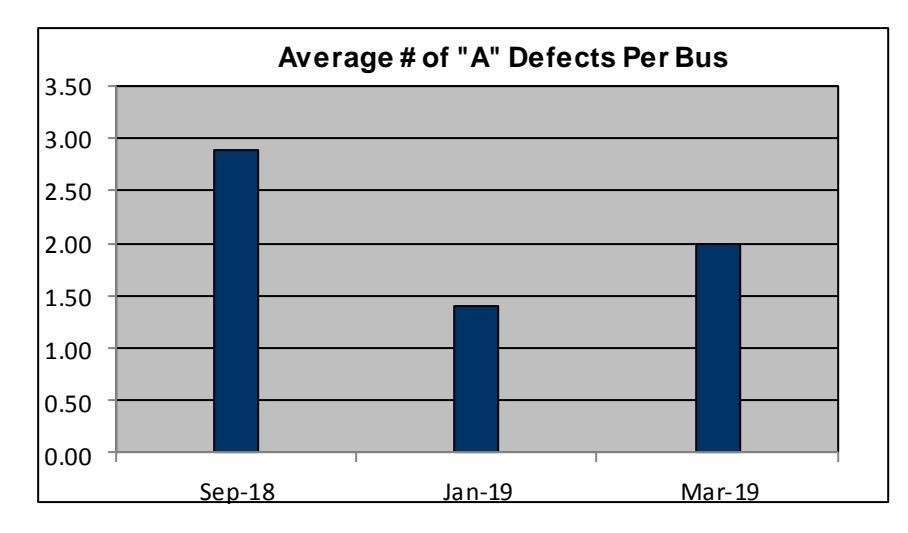
A Class "A" defect is a safety-related defect that requires immediate repair and keeps the bus from returning to revenue service until the defect is corrected. Class "A" defects were found on twelve (12) of the 16 buses inspected. The 32 Class "A" defects had to be repaired before these twelve buses could be allowed to return to revenue service. As can be seen in the chart below, this current inspection showed an increase in the average number of Class "A" defects per bus when compared to the January 2019 audit but showed a decrease when compared to the initial audit conducted in September 2018.

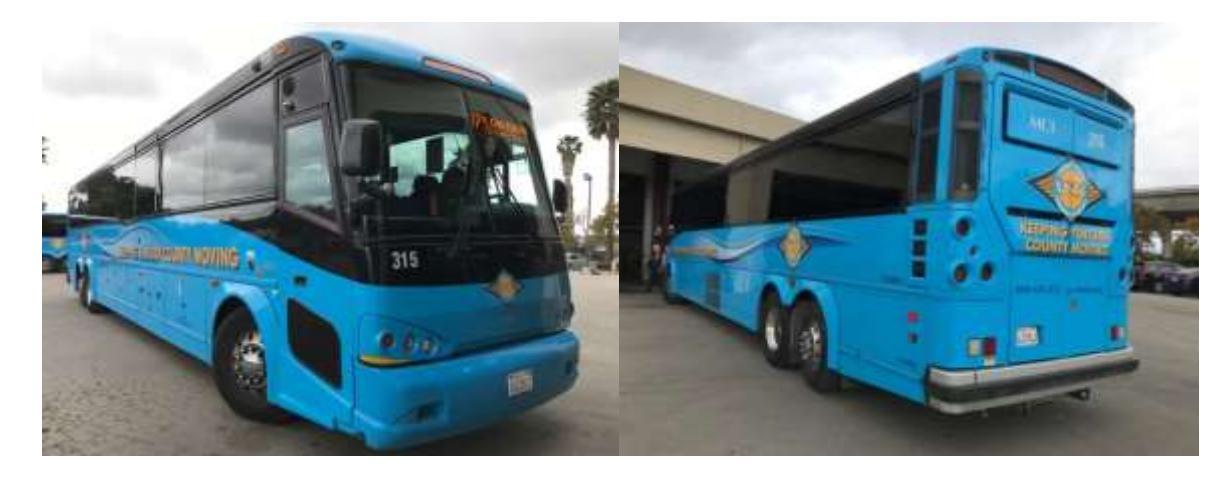
Coach 315

This Coach is in daily service, clean, with good overall appearance, and minimal body damage. Interior is in good used bus condition acceptable as a four-year-old bus in daily use. Driver's area is in acceptable condition with some clutter of current and new noncommissioned electronics. Wheels and tires are fleet owned in DOT acceptable tread depths. Mechanical condition is acceptable with Class A and B defects to be repaired by vender as noted in our inspection detail. Five-year engine and transmission warranties were purchased at time of original sale. VCTC should ask for verification and transfer documents as condition of sale.

315 – Abnormal: Glycol level is high. pH is low. Pressure check radiator cap, if it fails replace cap and recheck pressure. Check that proper coolant volume is being maintained. Recommend adjust coolant to a 50/50 mix. Recommend take corrective action and resample to monitor.

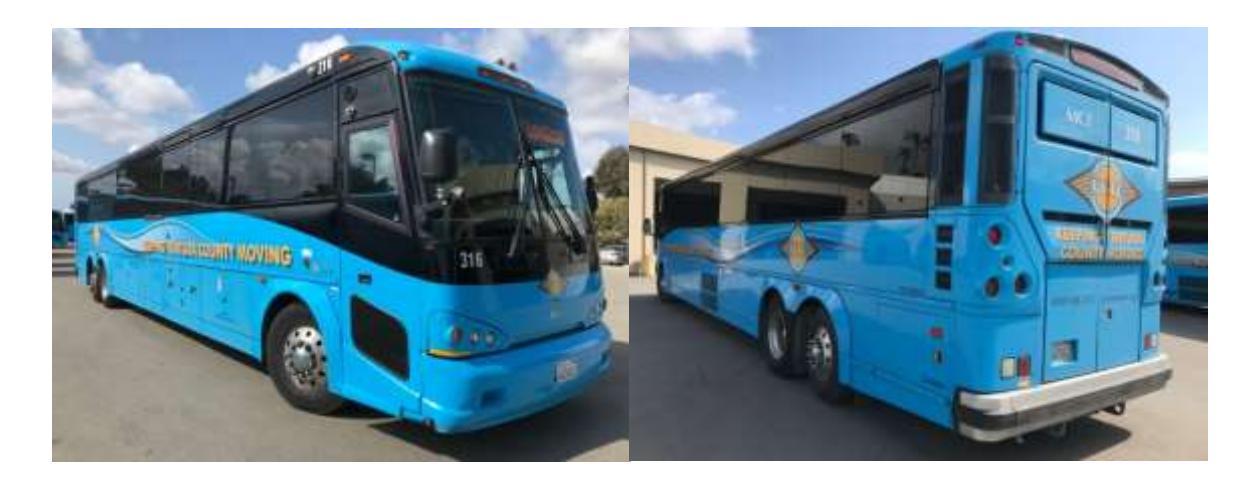
Coach 316

This Coach is in daily service, clean, with good overall appearance, and minimal body damage. Interior is in good used bus condition acceptable as a four-year-old bus in daily use. Driver's area is in acceptable condition with some clutter of current and new noncommissioned electronics. Wheels and tires are fleet owned in DOT acceptable tread depths. Mechanical condition is acceptable with Class A and B defects to be repaired by vender as noted in our inspection detail. Five-year engine and transmission warranties were purchased at time of original sale. VCTC should ask for verification and transfer documents as condition of sale.

316 - Caution: pH is low. Glycol level is normal. Recommend drain 50% and Re-Inhibit.

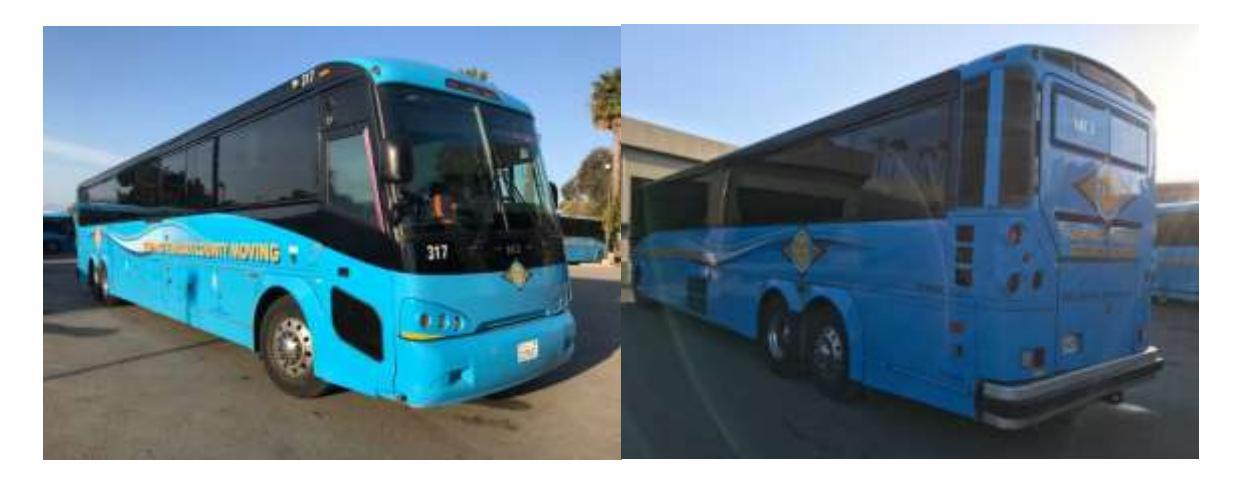
Coach 317

This Coach is in daily service, clean, with good overall appearance, and minimal body damage. Interior is in good used bus condition acceptable as a four-year-old bus in daily use. Driver's area is in acceptable condition with some clutter of current and new noncommissioned electronics. Wheels and tires are fleet owned in DOT acceptable tread depths. Mechanical condition is acceptable with Class A and B defects to be repaired by vender as noted in our inspection detail. Five-year engine and transmission warranties were purchased at time of original sale. VCTC should ask for verification and transfer documents as condition of sale.

317 – Abnormal: Glycol level is high. pH is low. Pressure check radiator cap, if it fails replace cap and recheck pressure. Check that proper coolant volume is being maintained. Recommend adjust coolant to a 50/50 mix. Recommend take corrective action and resample to monitor.

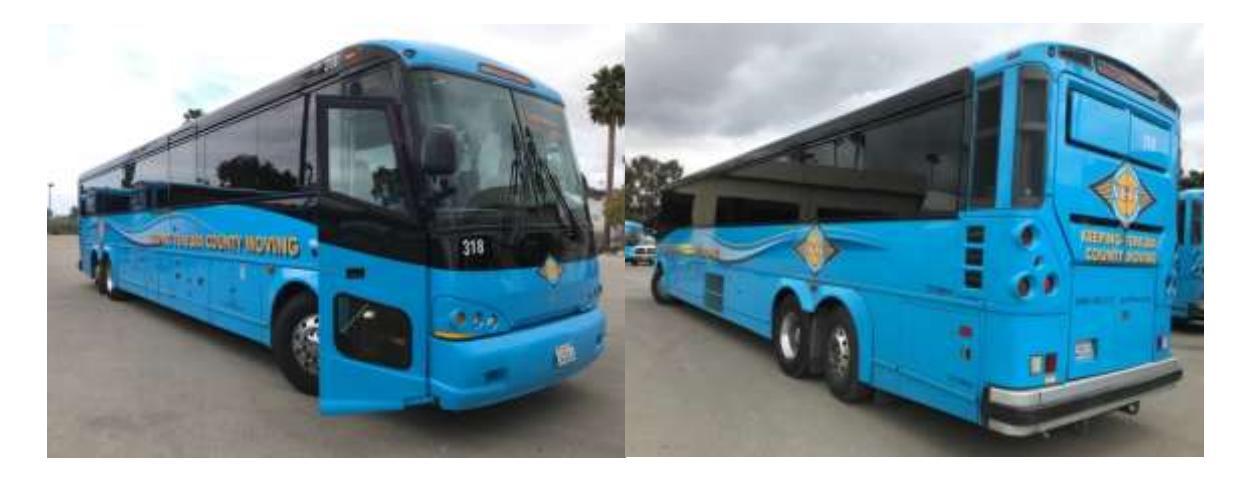
Coach 318

This Coach is in daily service, clean, with good overall appearance, and minimal body damage. Interior is in good used bus condition acceptable as a four-year-old bus in daily use. Driver's area is in acceptable condition with some clutter of current and new noncommissioned electronics. Wheels and tires are fleet owned in DOT acceptable tread depths. Mechanical condition is acceptable with Class A and B defects to be repaired by vender as noted in our inspection detail. Five-year engine and transmission warranties were purchased at time of original sale. VCTC should ask for verification and transfer documents as condition of sale.

Lights	Light, rear exterior top light, missing screws	В
Interior Condition	Windows, C/S & S/S, 3 windows scratched	В
Interior Condition	Luggage bay door lock knob, dash, missing	В

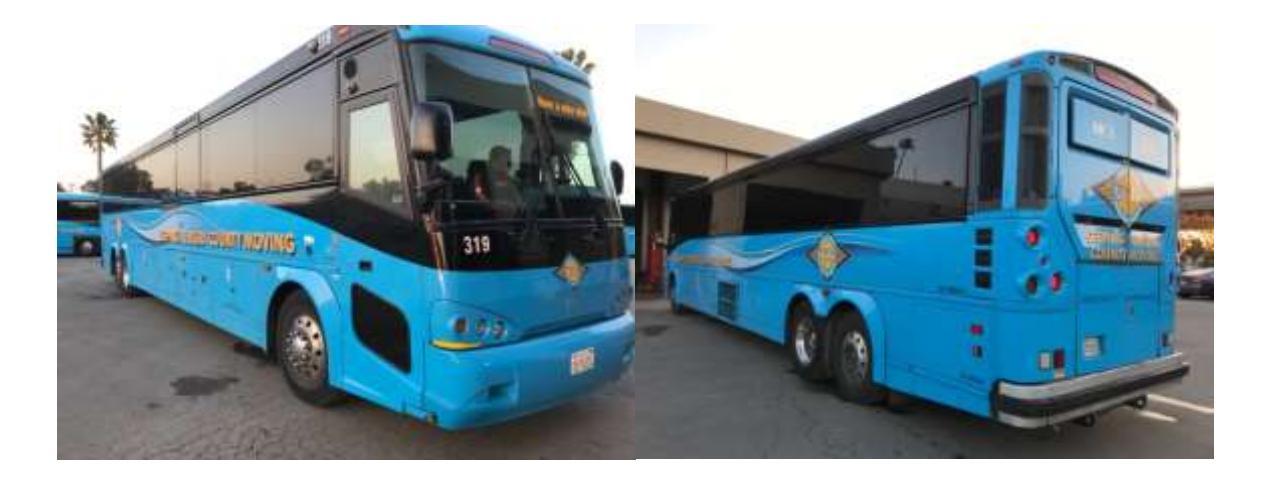
Coach 319

This Coach is in daily service, clean, with good overall appearance, and minimal body damage. Interior is in good used bus condition acceptable as a four-year-old bus in daily use. Driver's area is in acceptable condition with some clutter of current and new noncommissioned electronics. Wheels and tires are fleet owned in DOT acceptable tread depths. Mechanical condition is acceptable with Class A and B defects to be repaired by vender as noted in our inspection detail. Five-year engine and transmission warranties were purchased at time of original sale. VCTC should ask for verification and transfer documents as condition of sale.

319 – Abnormal: Glycol level is high. pH level is normal. Pressure check radiator cap, if it fails replace cap and recheck pressure. Check that proper coolant volume is being maintained. Recommend adjust coolant to a 50/50 mix. Recommend take corrective action and resample to monitor.

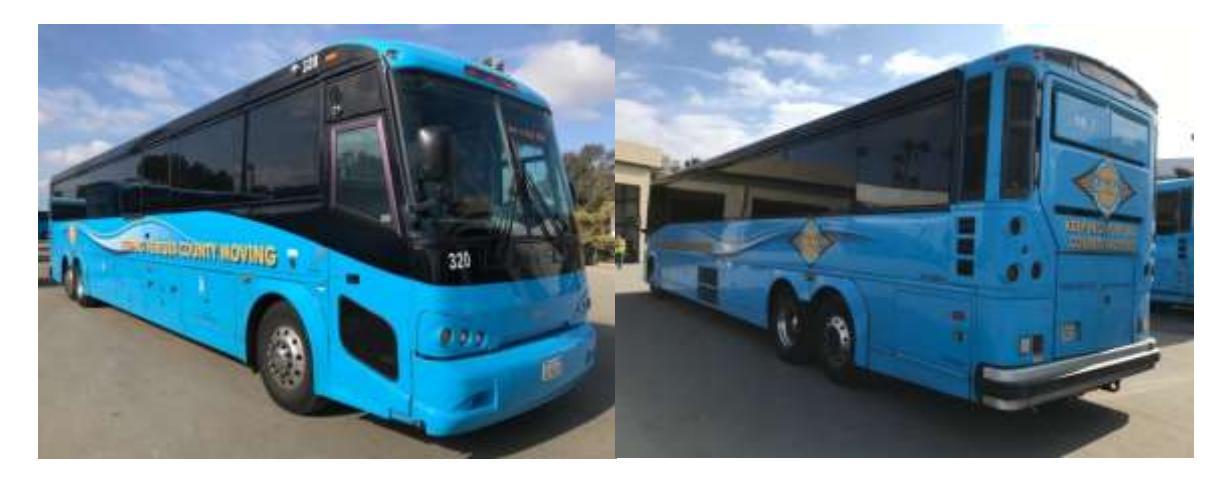
Coach 320

This Coach is in daily service, clean, with good overall appearance, and minimal body damage. Interior is in good used bus condition acceptable as a four-year-old bus in daily use. Driver's area is in acceptable condition with some clutter of current and new noncommissioned electronics. Wheels and tires are fleet owned in DOT acceptable tread depths. Mechanical condition is acceptable with Class A and B defects to be repaired by vender as noted in our inspection detail. Five-year engine and transmission warranties were purchased at time of original sale. VCTC should ask for verification and transfer documents as condition of sale.

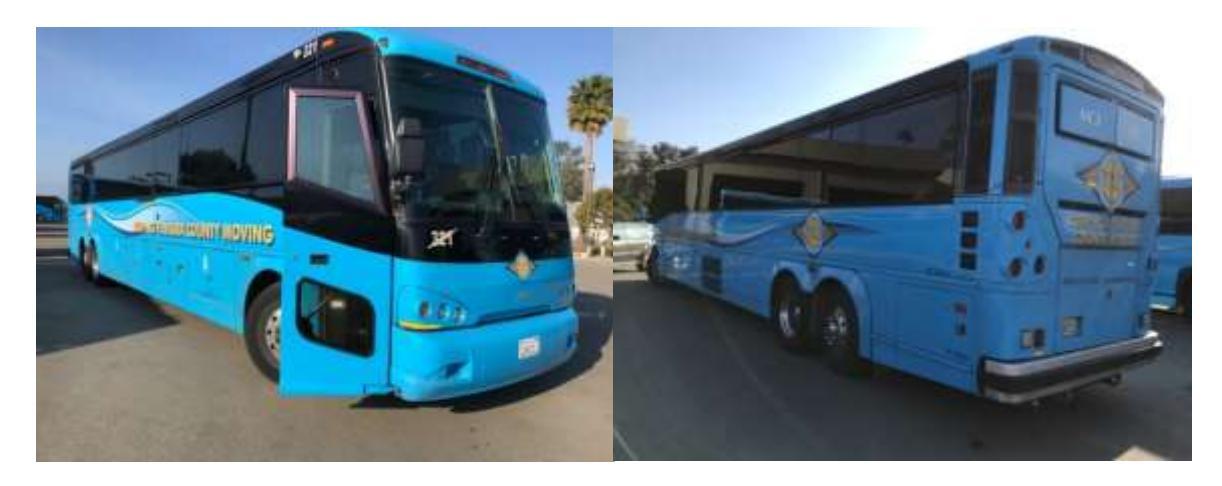
Coach 321

This Coach is in daily service, clean, with good overall appearance, and minimal body damage. Interior is in good used bus condition acceptable as a four-year-old bus in daily use. Driver's area is in acceptable condition with some clutter of current and new noncommissioned electronics. Wheels and tires are fleet owned in DOT acceptable tread depths. Mechanical condition is acceptable with Class A and B defects to be repaired by vender as noted in our inspection detail. Five-year engine and transmission warranties were purchased at time of original sale. VCTC should ask for verification and transfer documents as condition of sale.

321 – Caution: pH is low. Glycol level is normal. Recommend drain 50% and Re-Inhibit.

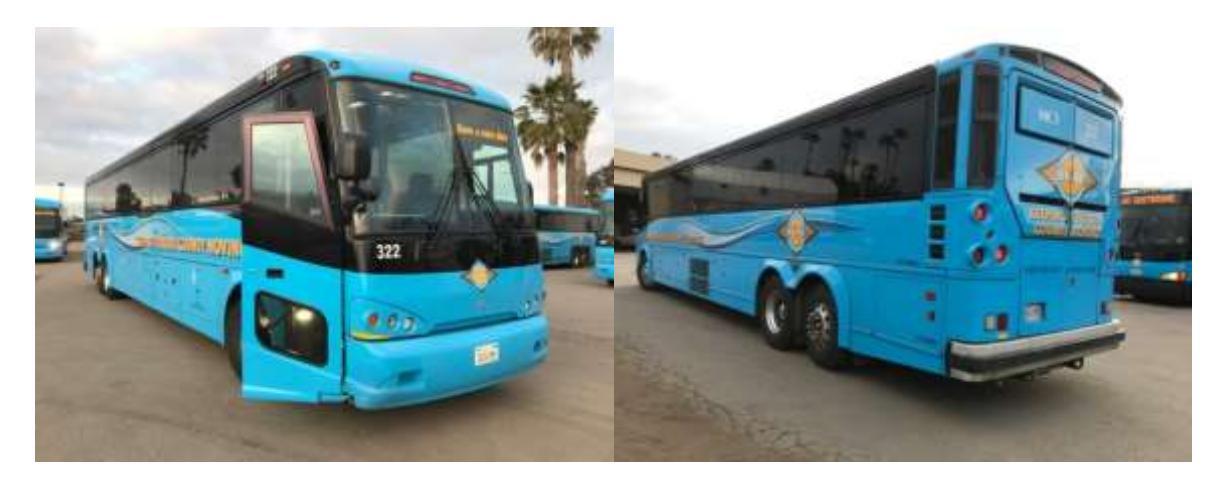
Coach 322

This Coach is in daily service, clean, with good overall appearance, and minimal body damage. Interior is in good used bus condition acceptable as a four-year-old bus in daily use. Driver's area is in acceptable condition with some clutter of current and new noncommissioned electronics. Wheels and tires are fleet owned in DOT acceptable tread depths. Mechanical condition is acceptable with Class A and B defects to be repaired by vender as noted in our inspection detail. Five-year engine and transmission warranties were purchased at time of original sale. VCTC should ask for verification and transfer documents as condition of sale.

Safety Equipment	Fire suppression system, interior front, inop	A
Interior Condition	Windows, C/S & S/S, 6 windows have scratches	В
Interior Condition	Luggage bay door lock knob, dash, missing	В

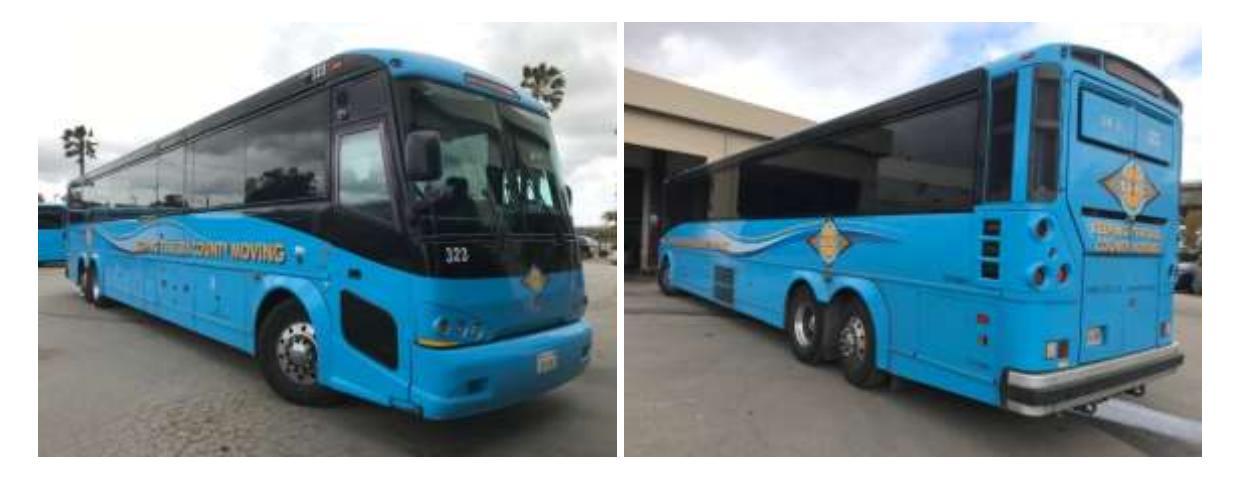
Coach 323

This Coach is in daily service, clean, with good overall appearance, and minimal body damage. Interior is in good used bus condition acceptable as a four-year-old bus in daily use. Driver's area is in acceptable condition with some clutter of current and new noncommissioned electronics. Wheels and tires are fleet owned in DOT acceptable tread depths. Mechanical condition is acceptable with Class A and B defects to be repaired by vender as noted in our inspection detail. Five-year engine and transmission warranties were purchased at time of original sale. VCTC should ask for verification and transfer documents as condition of sale.

323 – Caution: pH is low. Glycol level is normal. Recommend drain 50% and Re-Inhibit.

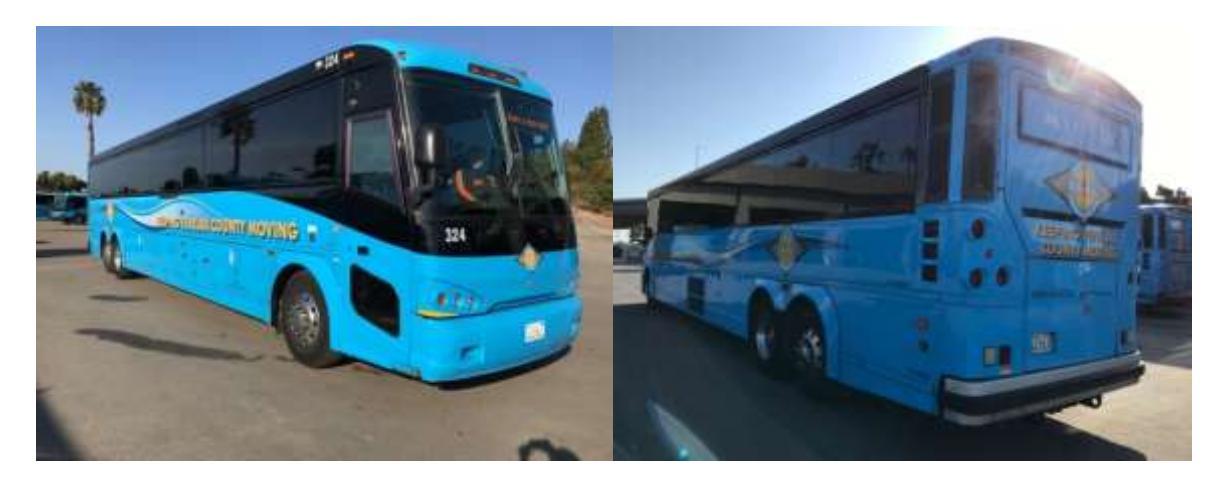
Coach 324

This Coach is in daily service, clean, with good overall appearance, and minimal body damage. Interior is in good used bus condition acceptable as a four-year-old bus in daily use. Driver's area is in acceptable condition with some clutter of current and new noncommissioned electronics. Wheels and tires are fleet owned in DOT acceptable tread depths. Mechanical condition is acceptable with Class A and B defects to be repaired by vender as noted in our inspection detail. Five-year engine and transmission warranties were purchased at time of original sale. VCTC should ask for verification and transfer documents as condition of sale.

Driver's Controls	ABS light, dash, light is on	Α
Driver's Controls	ATC light, dash, light is on	Α
Driver's Controls	Mil light, dash, light is on	Α
Exterior Body Condition	Body panel, S/S rear above engine access door, body damage	В
Interior Condition	Luggage bay door lock knob, dash, missing	В
Interior Condition	Window, C/S, 1 window scratched	В
Lights	Back-up light, C/S rear, inop	A

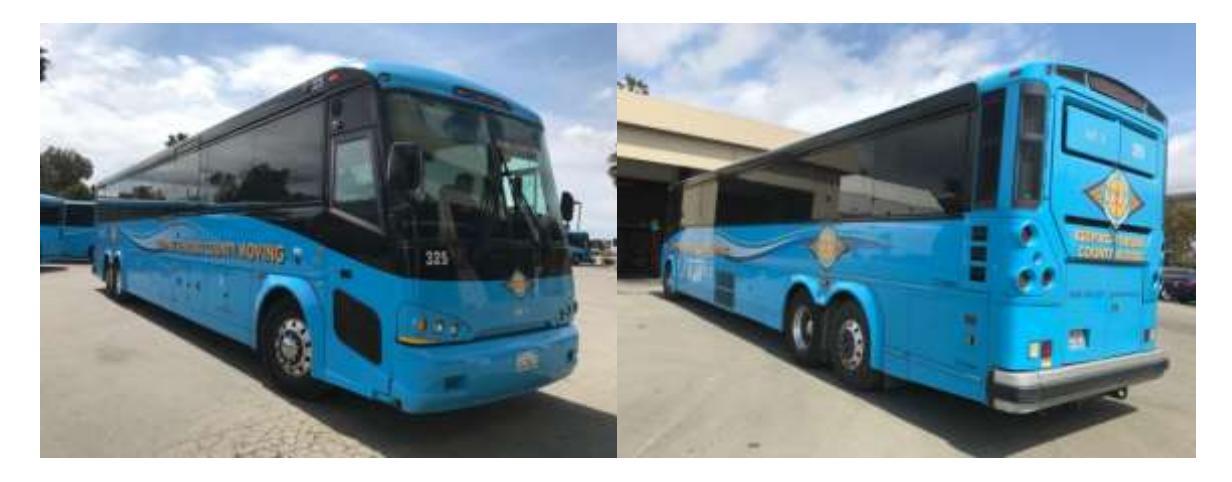
Coach 325

This Coach is in daily service, clean, with good overall appearance, and minimal body damage. Interior is in good used bus condition acceptable as a four-year-old bus in daily use. Driver's area is in acceptable condition with some clutter of current and new noncommissioned electronics. Wheels and tires are fleet owned in DOT acceptable tread depths. Mechanical condition is acceptable with Class A and B defects to be repaired by vender as noted in our inspection detail. Five-year engine and transmission warranties were purchased at time of original sale. VCTC should ask for verification and transfer documents as condition of sale.

325 – Abnormal: pH is low. Glycol level is high. Suggest drain, flush and refill cooling system.

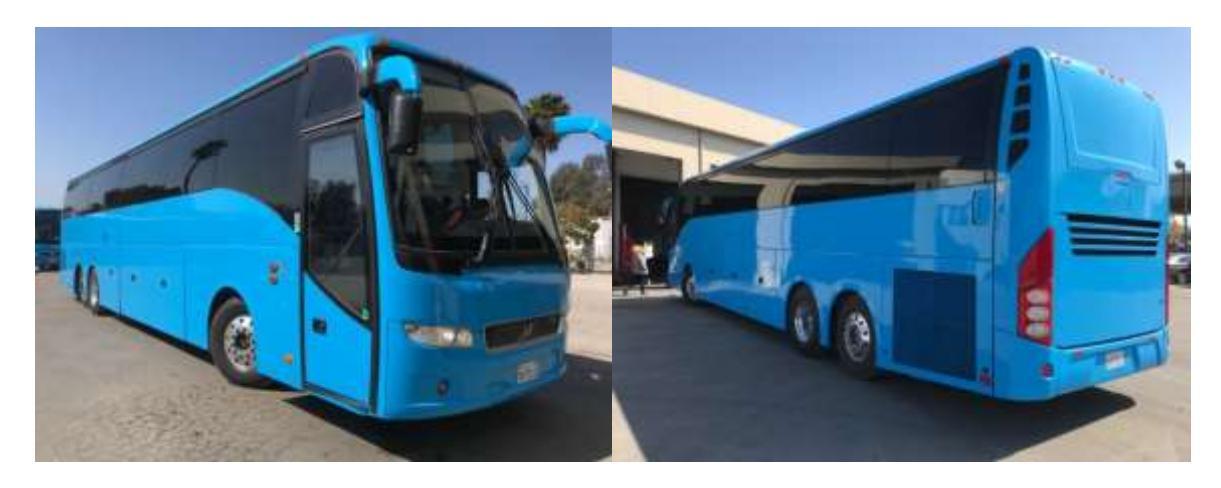
Coach 326

This Volvo bus is not currently in fleet service for VCTC. General exterior appearance noted new paint to VCTC livery base color with no livery decals. W/C lift does not operate. Interiors are acceptable with normal wear for the age and mileage of inspected buses. Driver's area shows more wear and loose dash parts for buses this age. Mechanical issues include glitchy electrical systems that cause some functions to not operate until two or more tries. Class A and B defects are noted on our complete inspection results spreadsheet. Wheels and tires are fleet owned in DOT acceptable tread depths. This is a low mileage bus.

Lights	Marker lights, upper, inop	A
Lights	Brake light, S/S lower rear brake light, inop	A
Lights	Marker light, C/S front, inop	A
Lights	Back-up lights, exterior, inop	A
Safety Equipment	Back-up alarm, exterior, inop	A
Accessibility Features	Wheelchair lift, inop	A

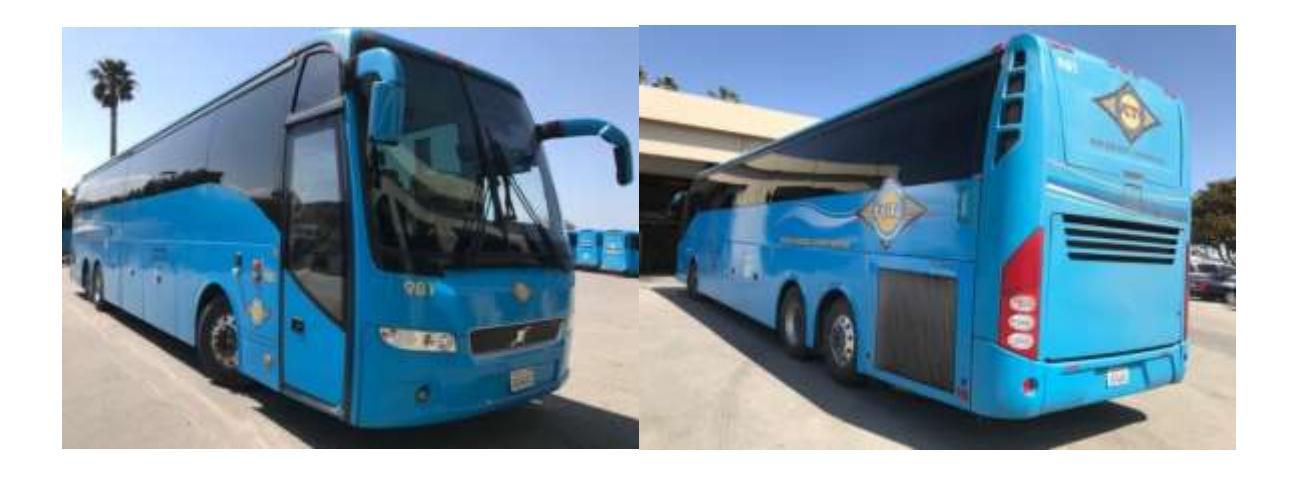
Coach 981

This Volvo bus is in daily service for VCTC. General exterior appearance noted new paint to VCTC livery base color with livery decals. W/C lift operates but operation seems more cumbersome than the fleet standard MCI. Interior is acceptable with normal wear for the age and mileage of inspected bus. Driver's area shows more wear and loose dash parts for a bus this age. Mechanical issues include glitchy electrical systems that cause some functions to not operate until two or more tries. Class A and B defects are noted on our complete inspection results spreadsheet. Wheels and tires are fleet owned in DOT acceptable tread depths.

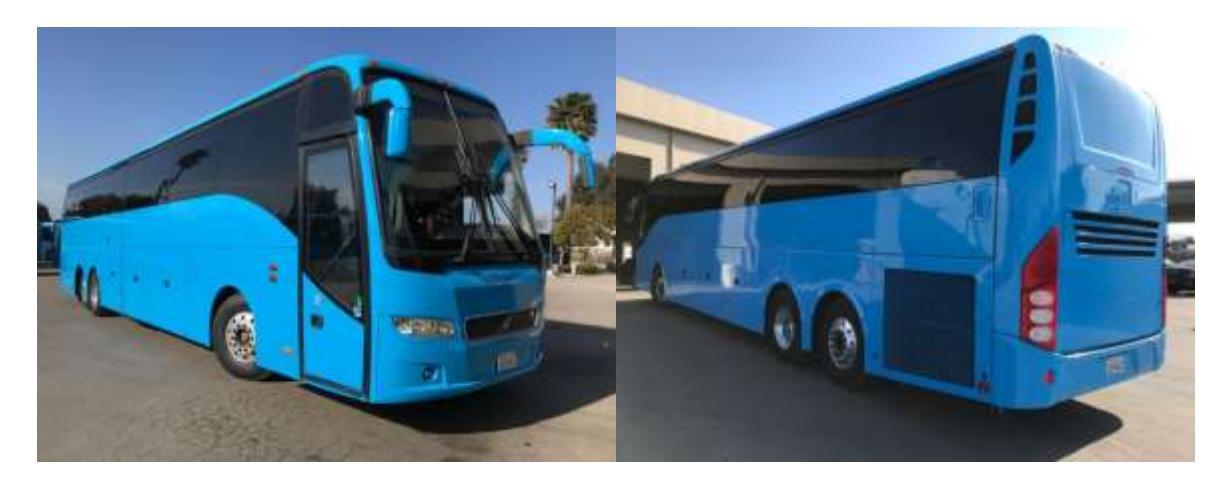
Coach 983

This Volvo bus is not currently in fleet service for VCTC. General exterior appearance noted new paint to VCTC livery base color with no livery decals. Not all W/C lifts operate and operation seems more cumbersome than the fleet standard MCI. Interiors are acceptable with normal wear for the age and mileage of inspected buses. Driver's area shows more wear and loose dash parts for buses this age. Mechanical issues include glitchy electrical systems that cause some functions to not operate until two or more tries. Class A and B defects are noted on our complete inspection results spreadsheet. Wheels and tires are fleet owned in DOT acceptable tread depths.

Engine Compartment	Coolant leak, engine compartment, companion flange leaking	В
Engine Compartment	Coolant leak, engine compartment, heater shutoff valves leaking	В
Engine Compartment	Oil leak, engine compartment, oil filter pressure sensor seeping	В
Engine Compartment	Electrical box, engine compartment, missing latches	В
Safety Equipment	Fire suppression system, dash, inop	А

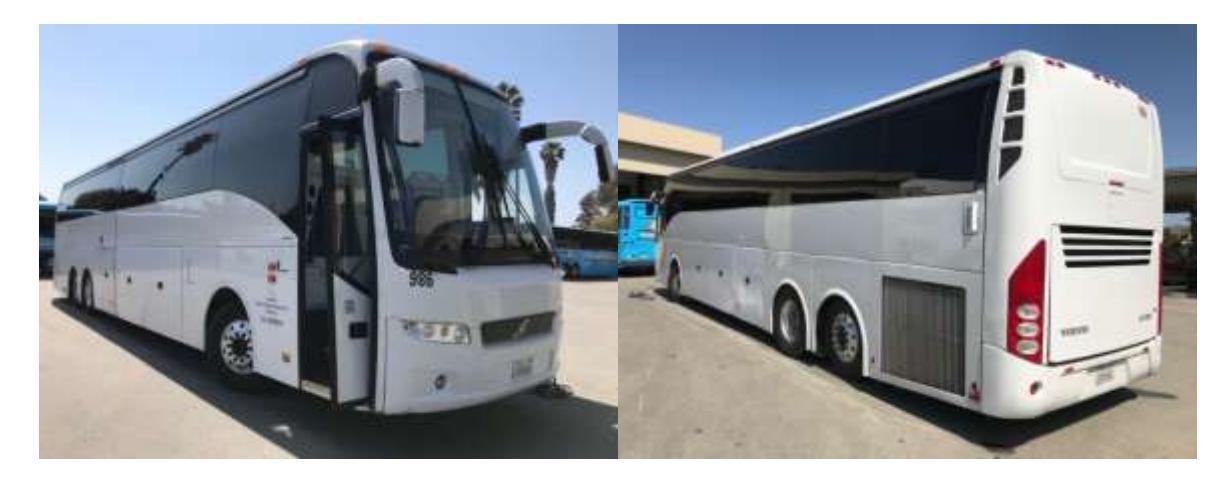
Coach 986

This Volvo bus is not currently in fleet service for VCTC. General exterior appearance noted body damage on both sides of the bus. W/C lift operates but operation seems more cumbersome than the fleet standard MCI. Interior is acceptable with normal wear for the age and mileage of inspected bus. Driver's area shows more wear and loose dash parts for a bus this age. Mechanical issues include glitchy electrical systems that cause some functions to not operate until two or more tries. Class A and B defects are noted on our complete inspection results spreadsheets. Wheels and tires are fleet owned in DOT acceptable tread depths.

986 – Abnormal: Cooler core leaching/clutch pack/thrust washer wear indicated. Dirt level (alumina + silica) high. Other contaminant levels acceptable. Viscosity within specified operating range. Action: Check all dirt access points. Advise inspect filter/strainer for abnormal wear metal (if applicable). Advise schedule for oil change. Resample at a reduced service interval to monitor and establish wear trend.

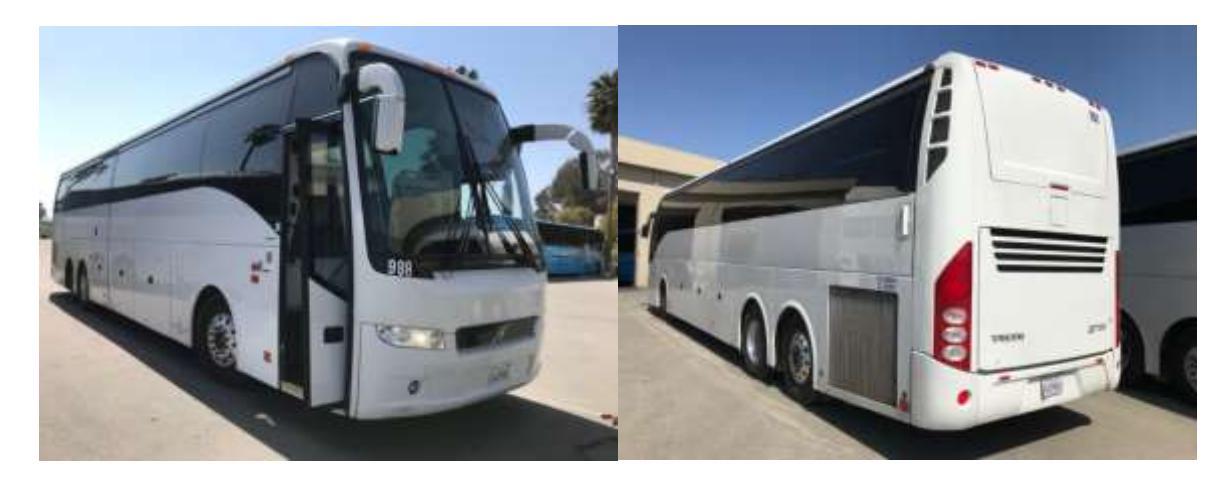
Coach 988

This Volvo bus is not currently in fleet service for VCTC. General exterior appearance noted body damage both sides. W/C lift operates but operation seems more cumbersome than the fleet standard MCI. Interior is acceptable with normal wear for the age and mileage of inspected bus. Driver's area shows more wear and loose dash parts for a bus this age. Mechanical issues include glitchy electrical systems that cause some functions to not operate until two or more tries. Class A and B defects are noted on our complete inspection results spreadsheet. Wheels and tires are fleet owned in DOT acceptable tread depths.
