# BRIDGE INSPECTION REPORT

INSPECTION TYPE: Annual

Milepost 407.48  
 Location Santa Paula Branch Line  
Saticoy, CA  
 Stream X Overpass        Other         
 Train Operating Speed: Freight: 10 mph Passenger: 15 mph

MAINLINE/SUBDIVISION: VCTC

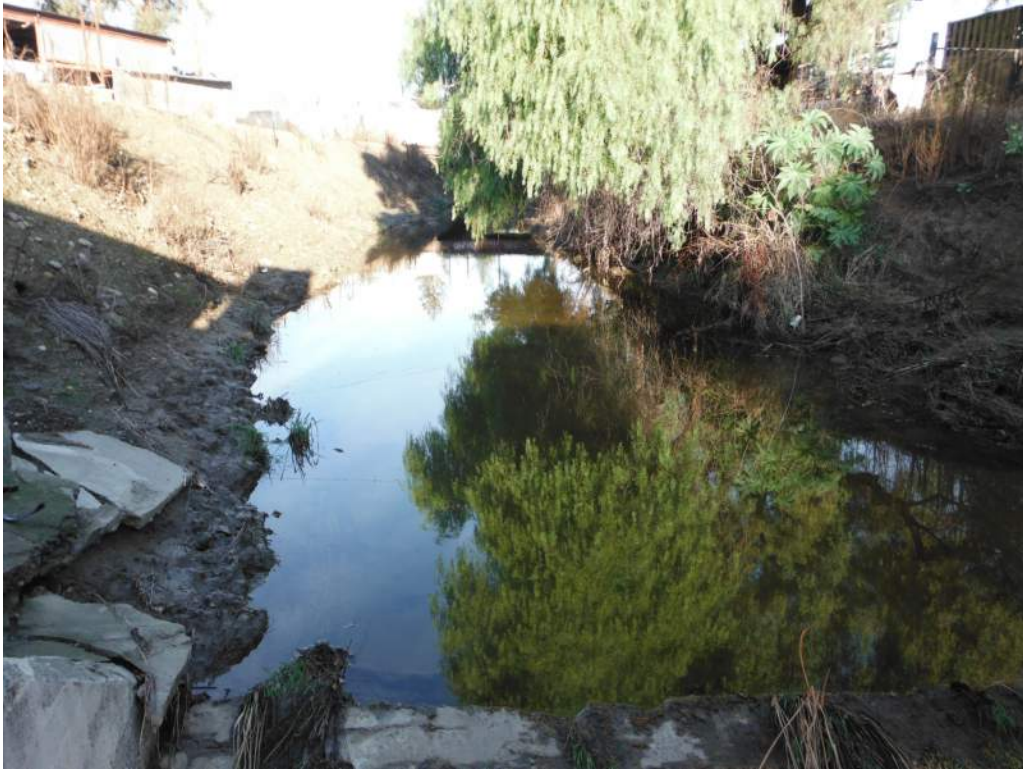
**407.48 Channel Condition – Looking Upstream**

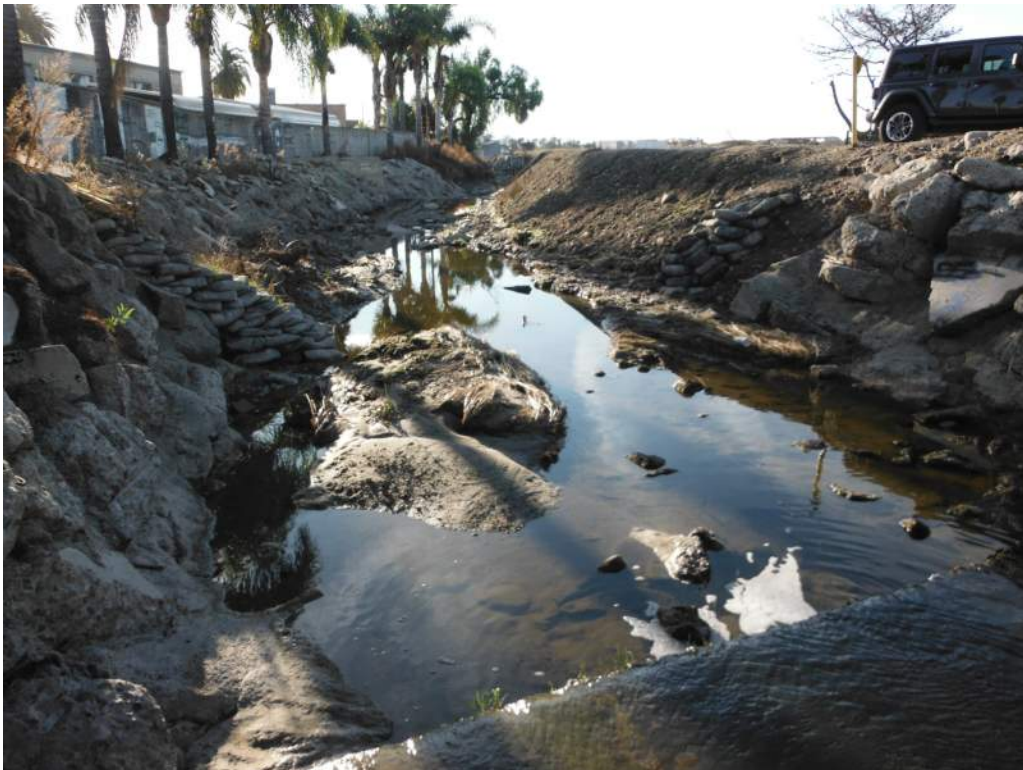
**407.48 Channel Condition – Looking Downstream**

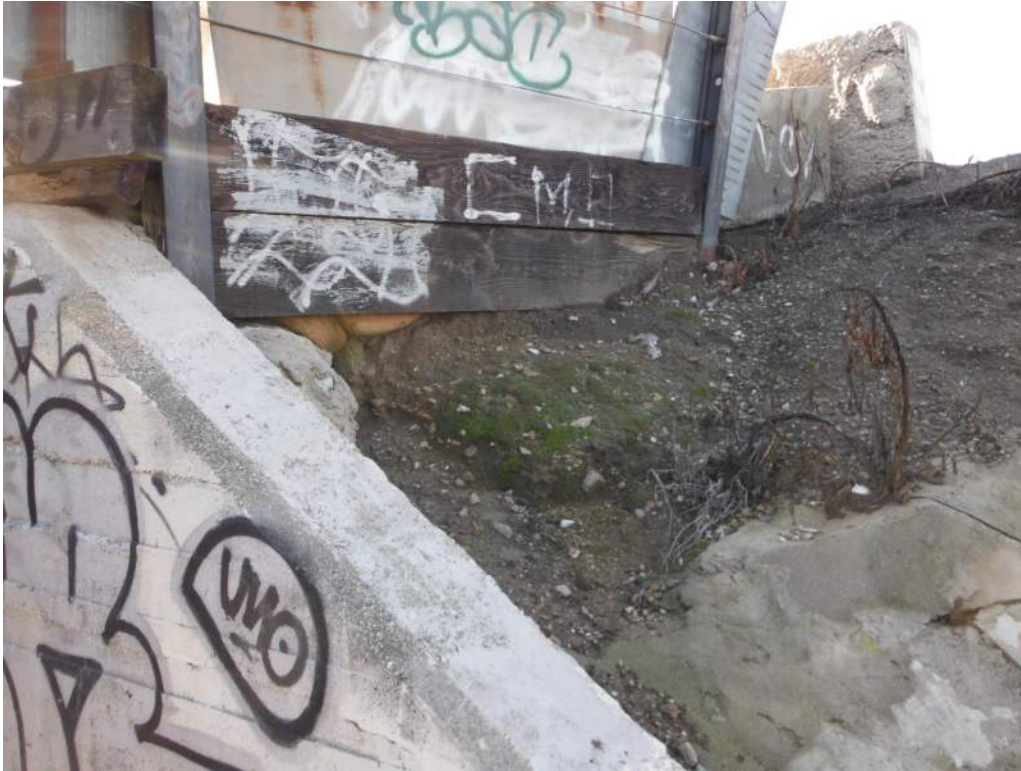
1. CR - Crack in southwest wingwall - see photo
2. North west wingwall undermining - see photo

**407.48 Northwest Wingwall Undermining**

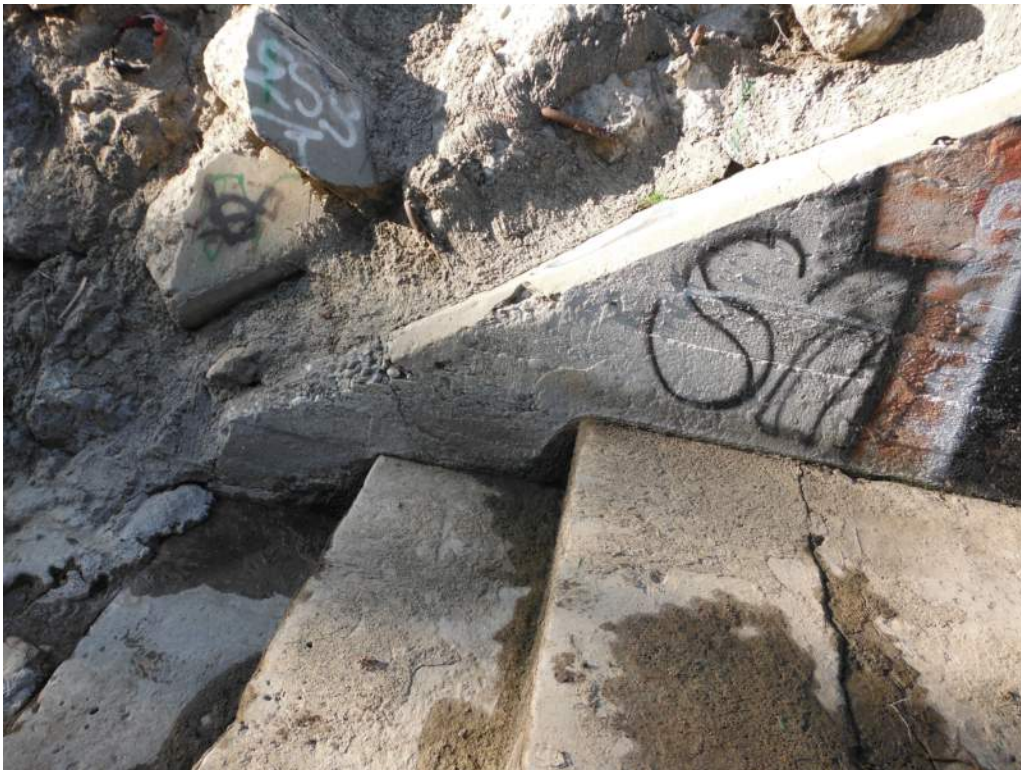
**407.48 Southwest Wingwall Crack**

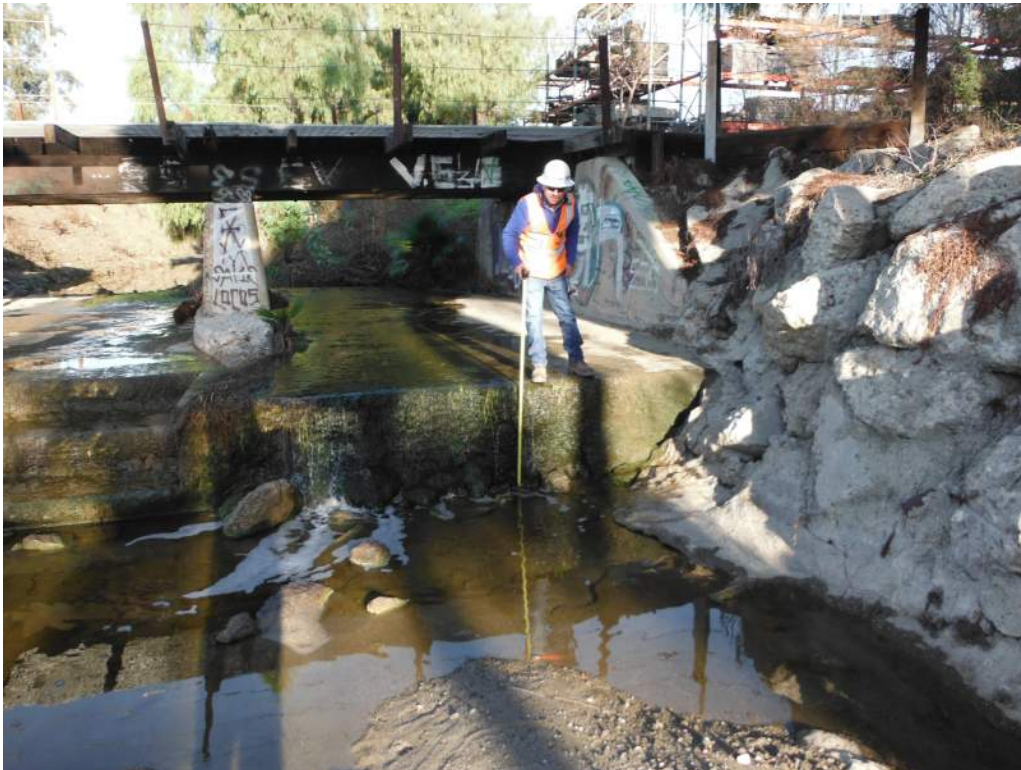
Visual Condition Rating 3  
 Stream Depth 1" Scour Evidence        Moving Water yes  
 Notes 3' scour downstream of pavement - see photo

**407.48 Scour at Downstream End of Channel Paving – approximately 3'**

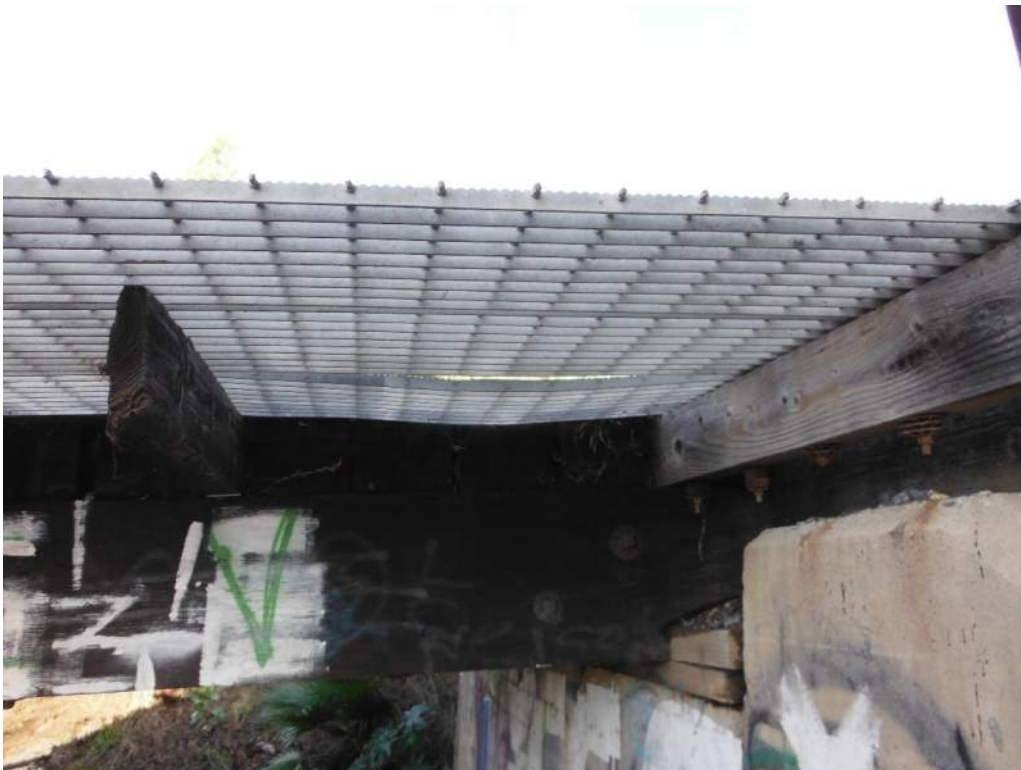
407.48 SE Walkway Panel Deflection Damage

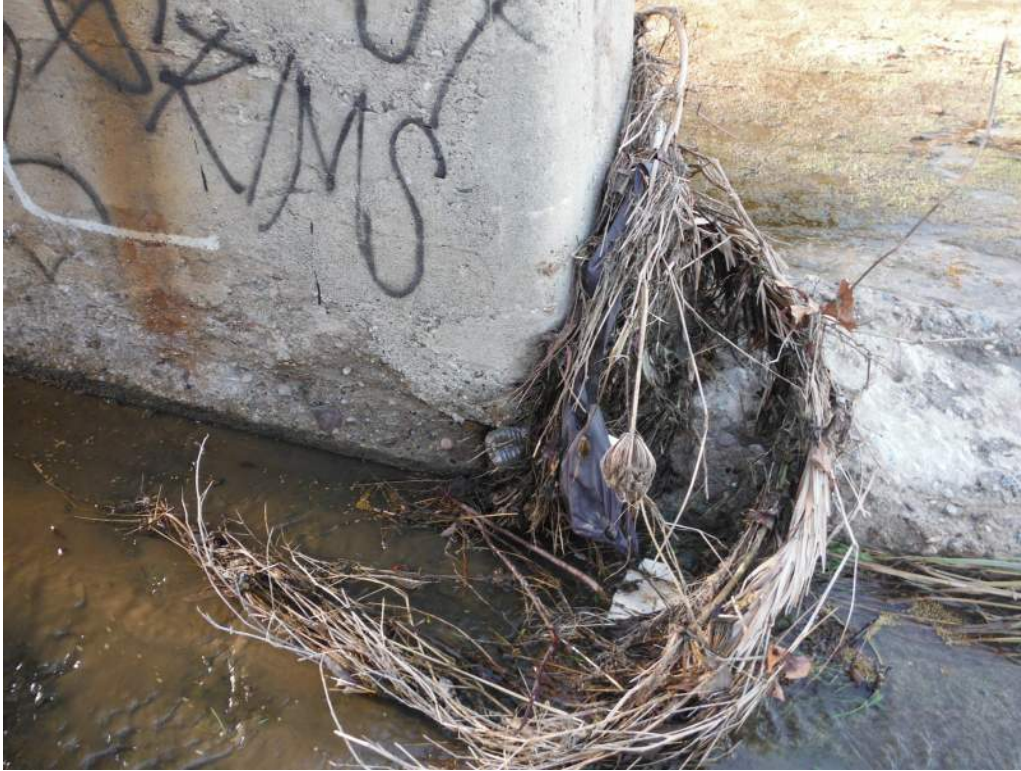
**407.48 Spall and debris on upstream side of Pier**

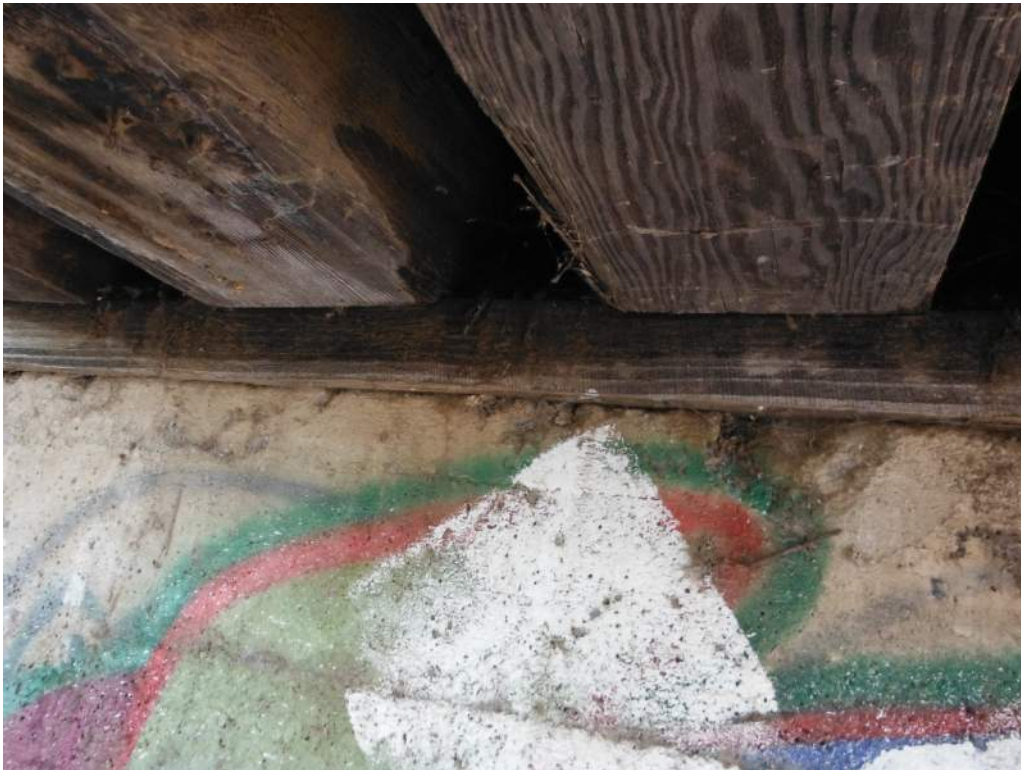
1. CRU - Stringers crushing 1/4" - see photo
2. SC - Scaling at base
3. Northeast wingwall eroding - see photo

**407.48 Stringers crushing  $\frac{1}{4}$ " at Abutment 3**

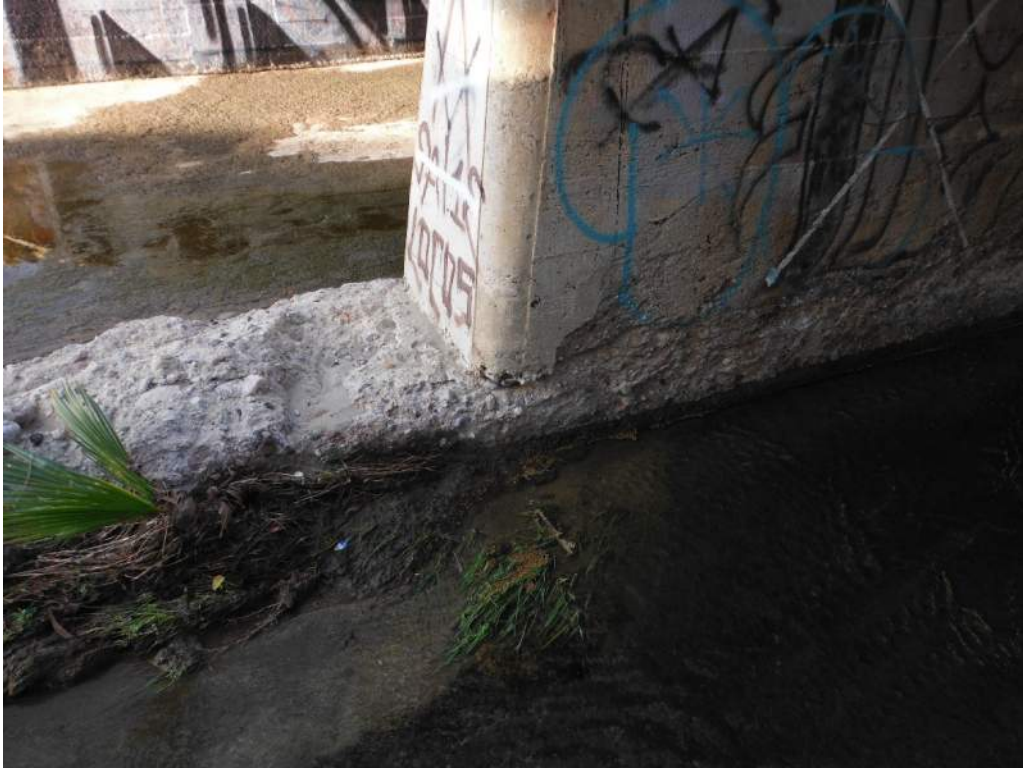
**407.48 Scaling at Base at Abutment 3**

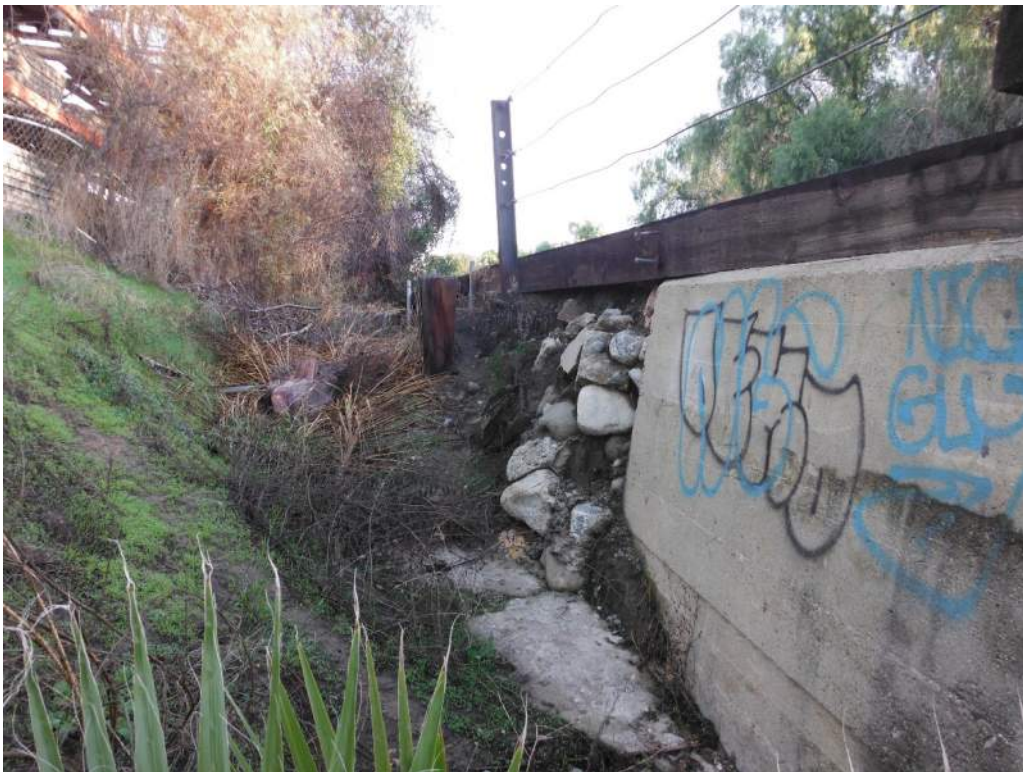
**407.48 NE Wingwall Erosion**

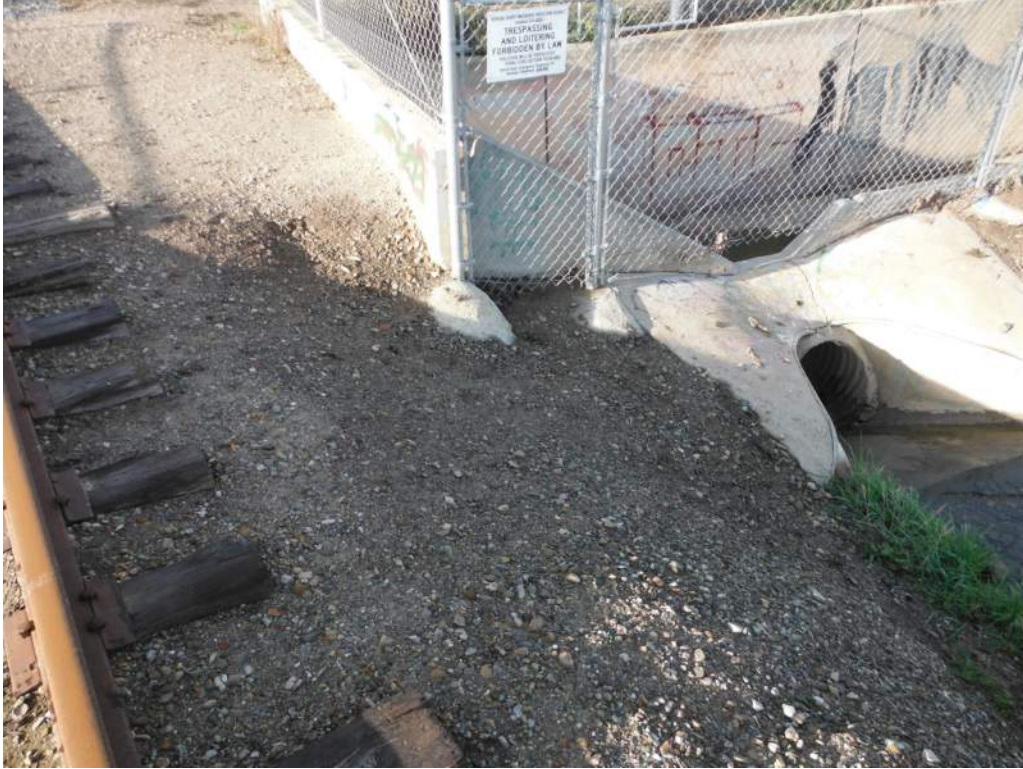
1. Minor cracking at abutments
2. Fouled ballast across culvert
3. Ties partially covered and in poor condition
4. Vertical crack center of abutments (East and West)
5. Longitudinal crack on the South underside of the slab.

**408.02 Fouled Ballast across Culvert**

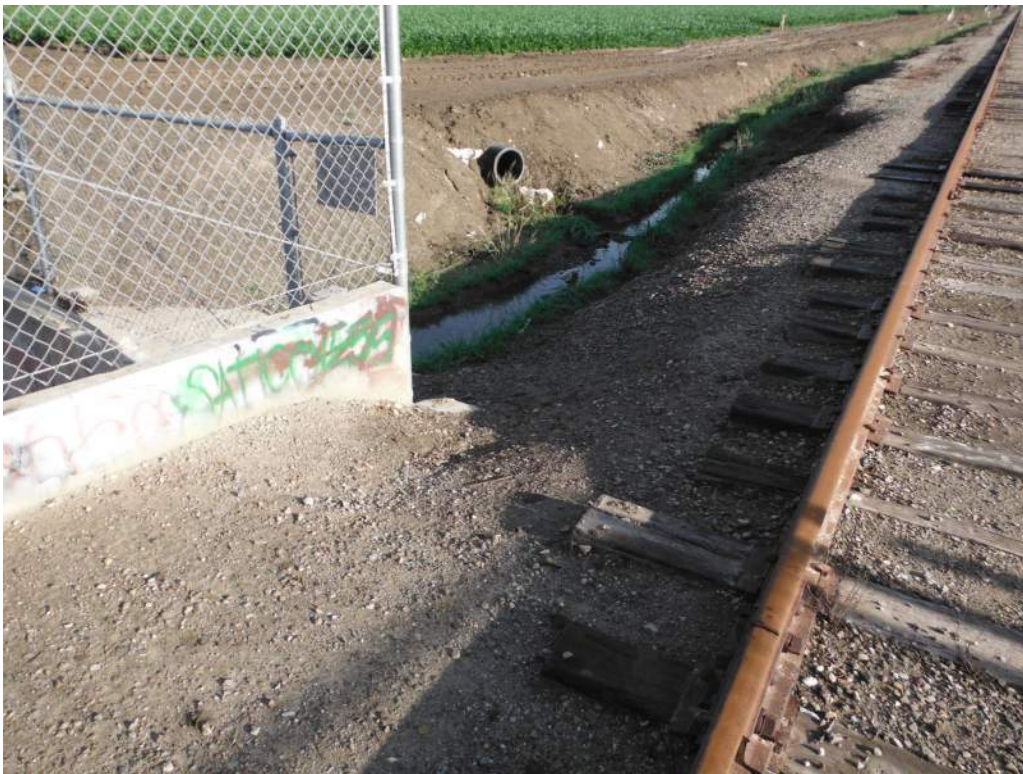
**408.02 Erosion at Northeast embankment**

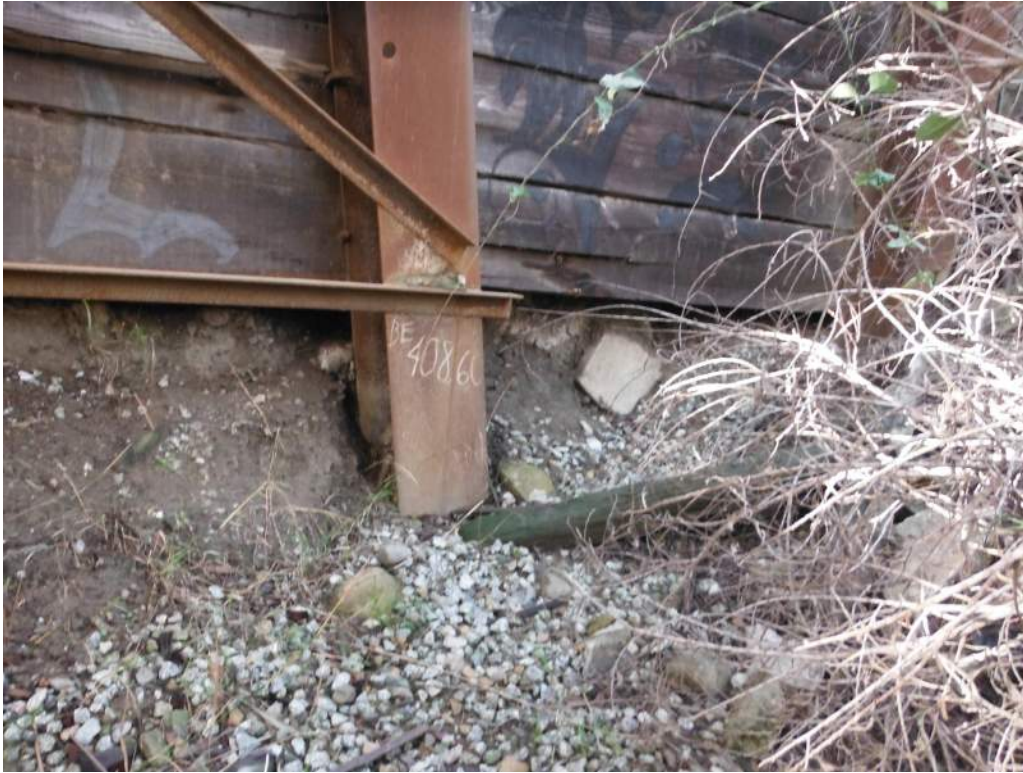
1. Rot - Backwall is rotted out, leaning, and failing, material loss at bottom - see photo
2. S - Scour on North side of abutment - see photo
3. Erosion present at Northwest embankment.

**408.84 Scour at the base on Abutment 1**

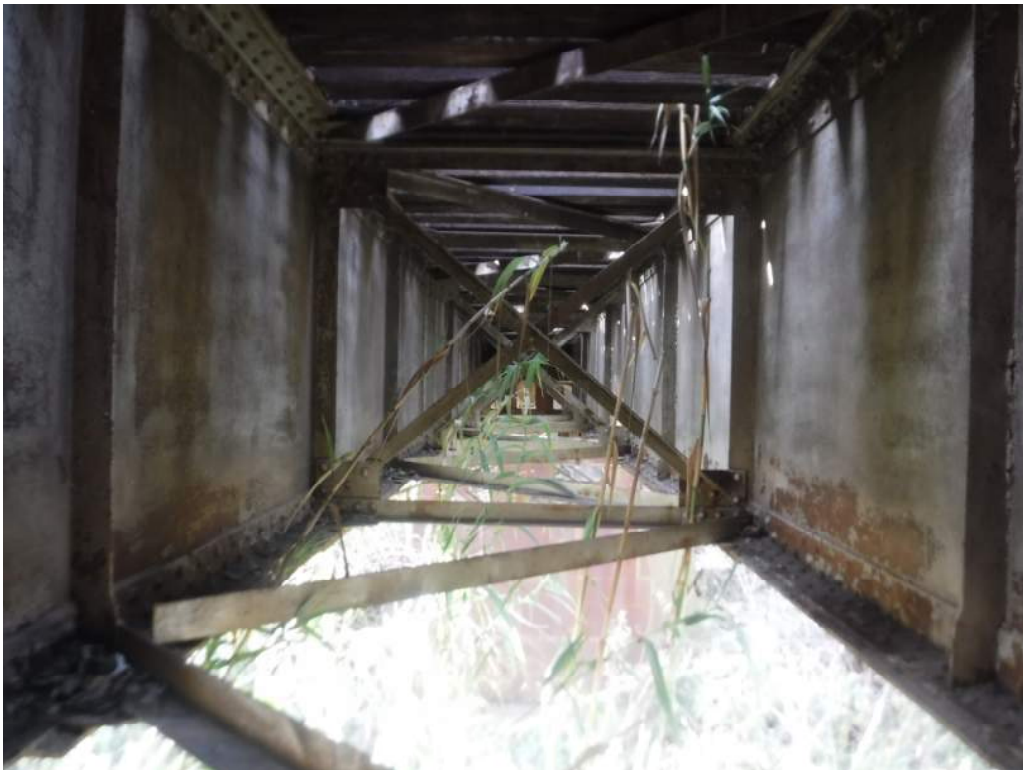
**408.84 Typical inside girder view**

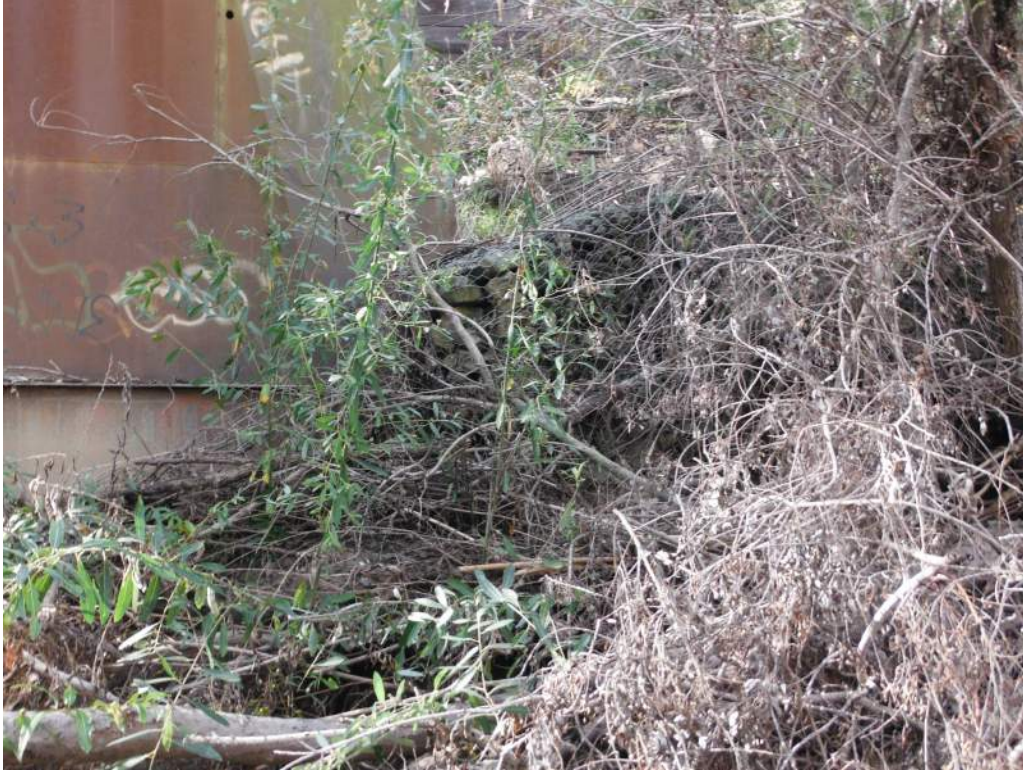
**408.84 Gabion undermined north side Pier 3**

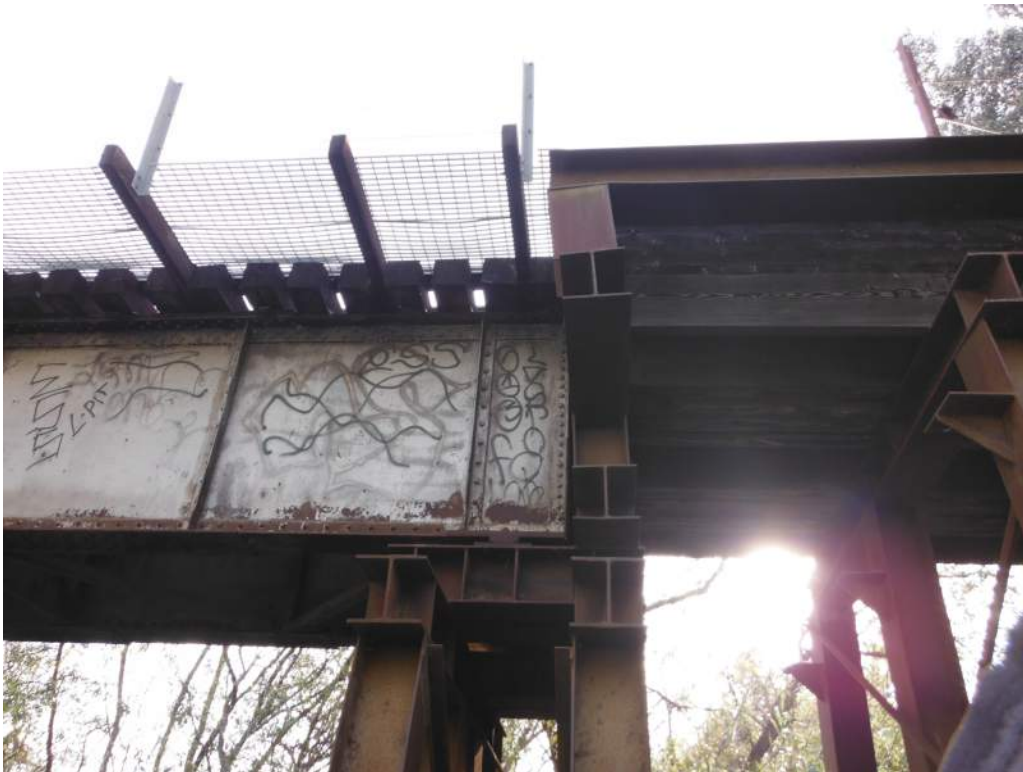
**408.84 Pier 2 & 4 built up section rotated**

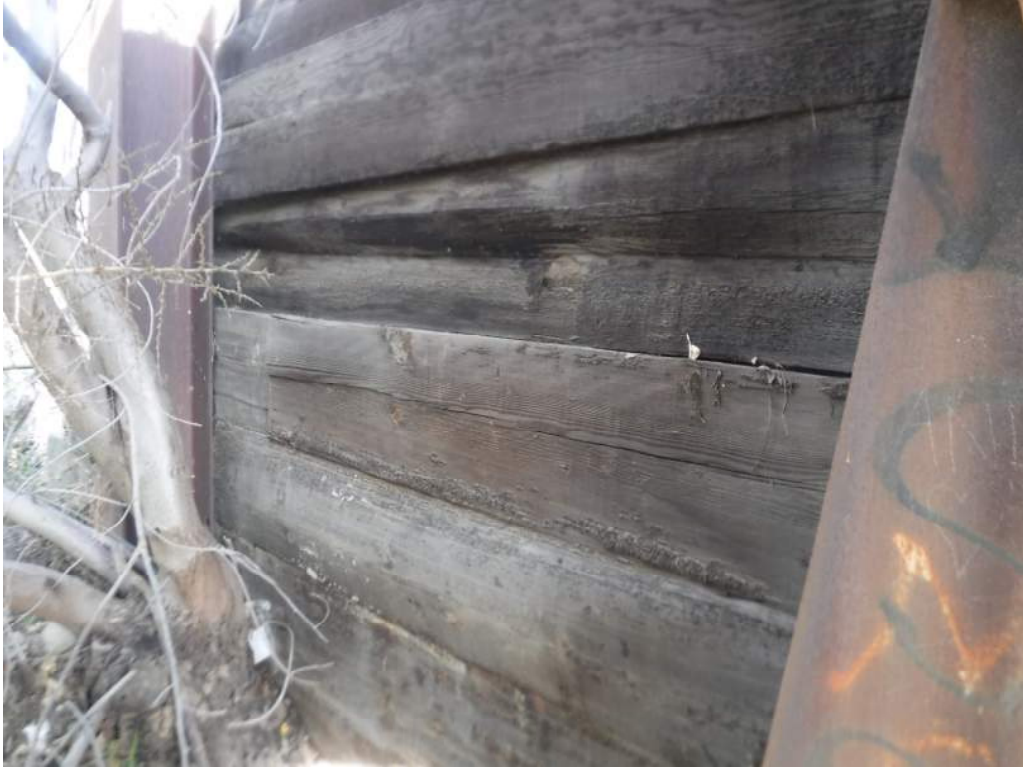
**408.84 Abutment 6 backwall rotten**

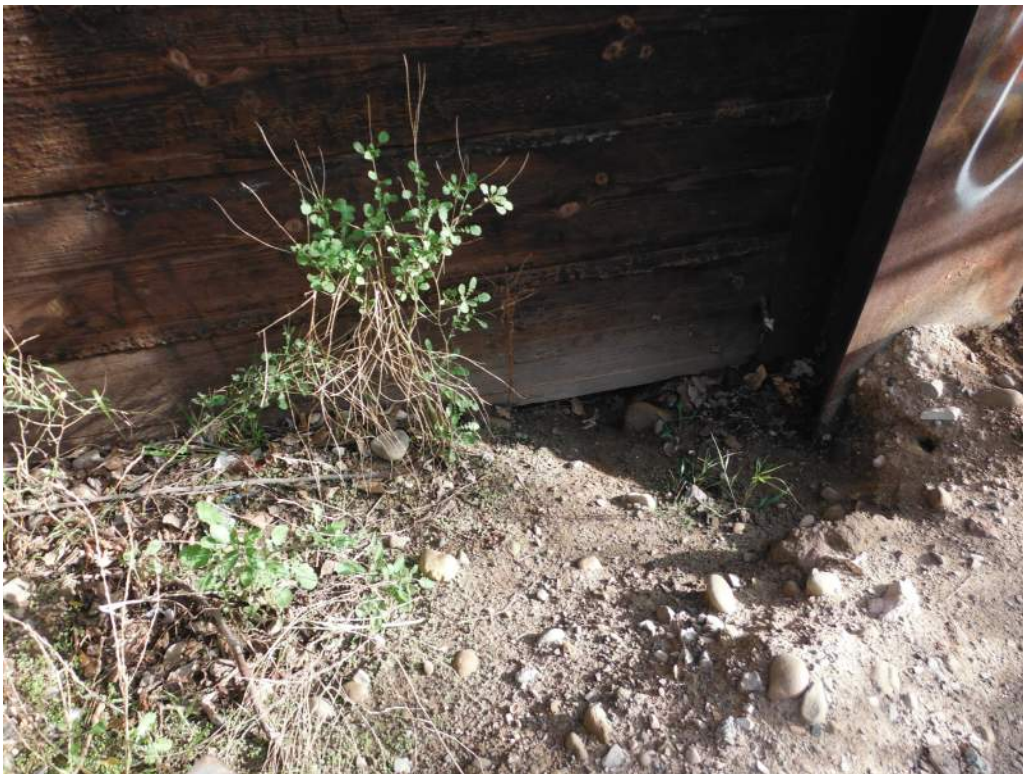
**408.84 Abutment 6 Southeast Backwall undermining**

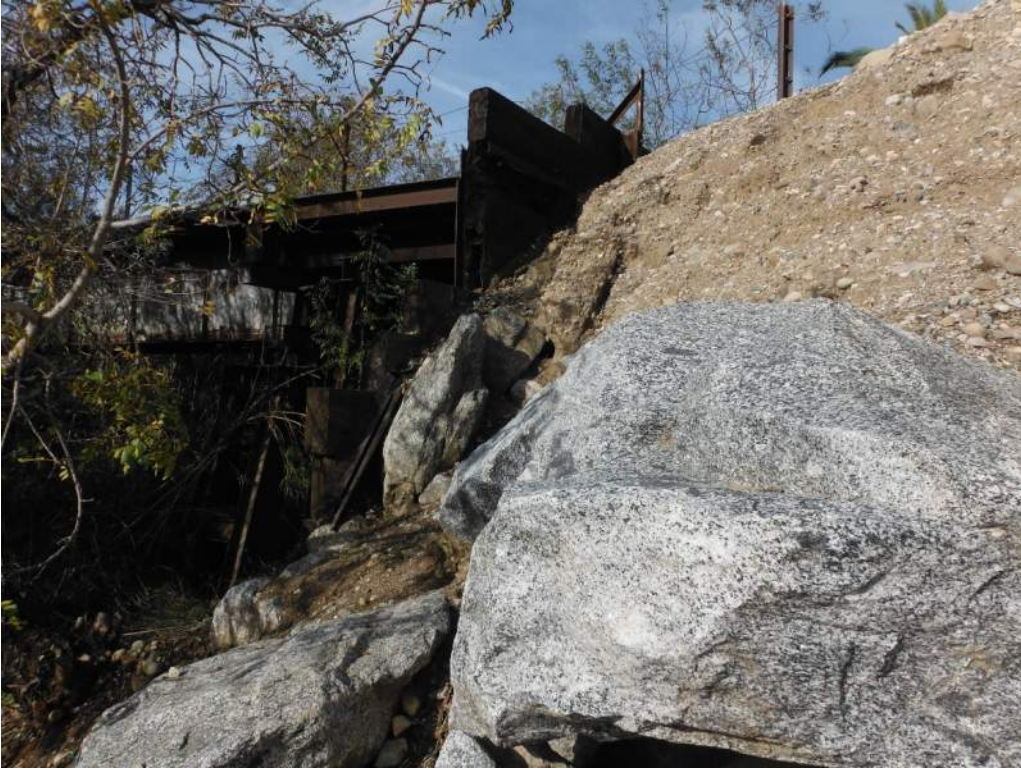
**408.84 Erosion at Southeast slope behind wingwall**

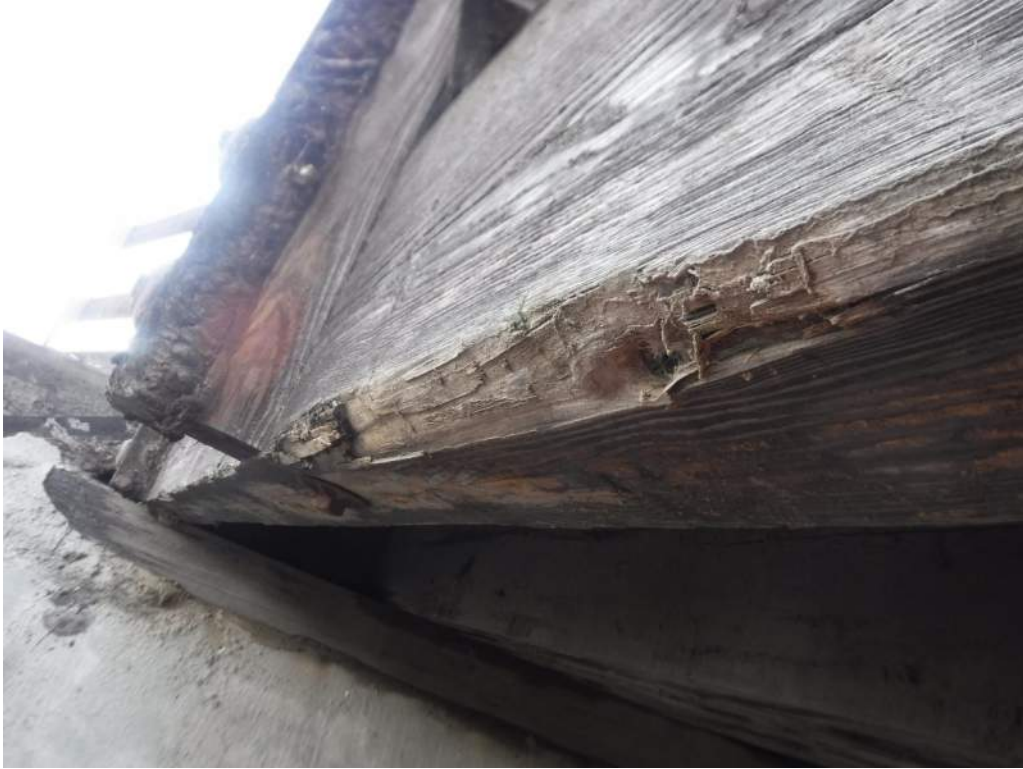
**409.74 Stringer 1 impact damage**

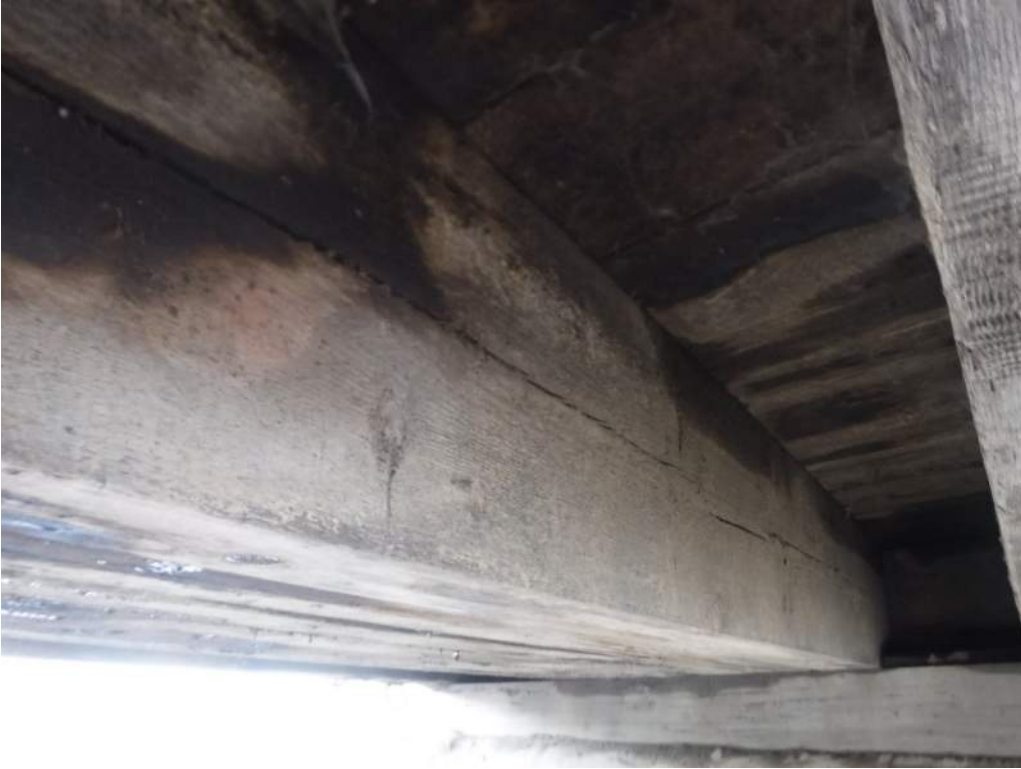
**409.74 Stringer 7 split on vertical face**

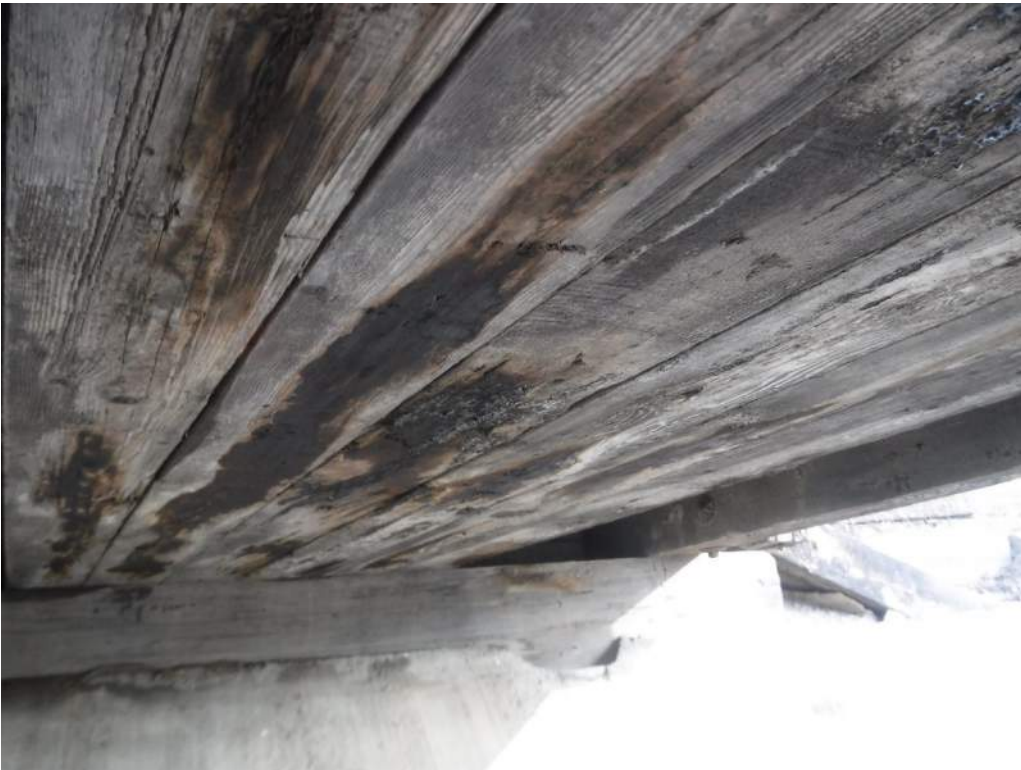
**409.74 Stringer 8 impact damage**

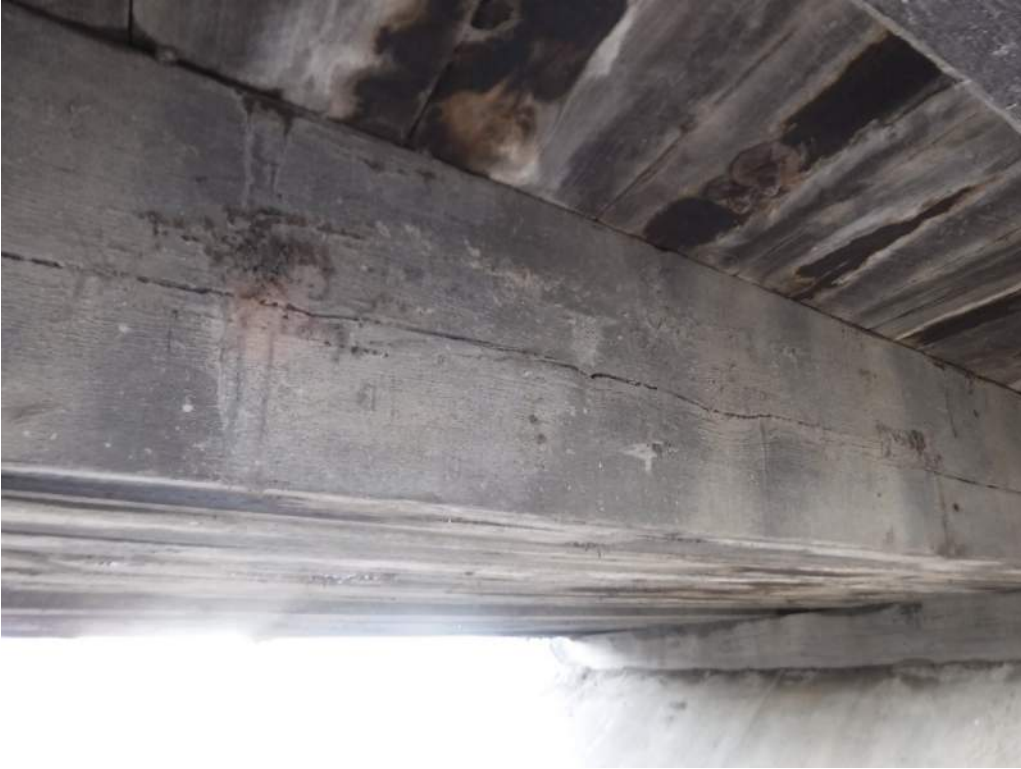
**409.74 Stringer 13 split on vertical face**

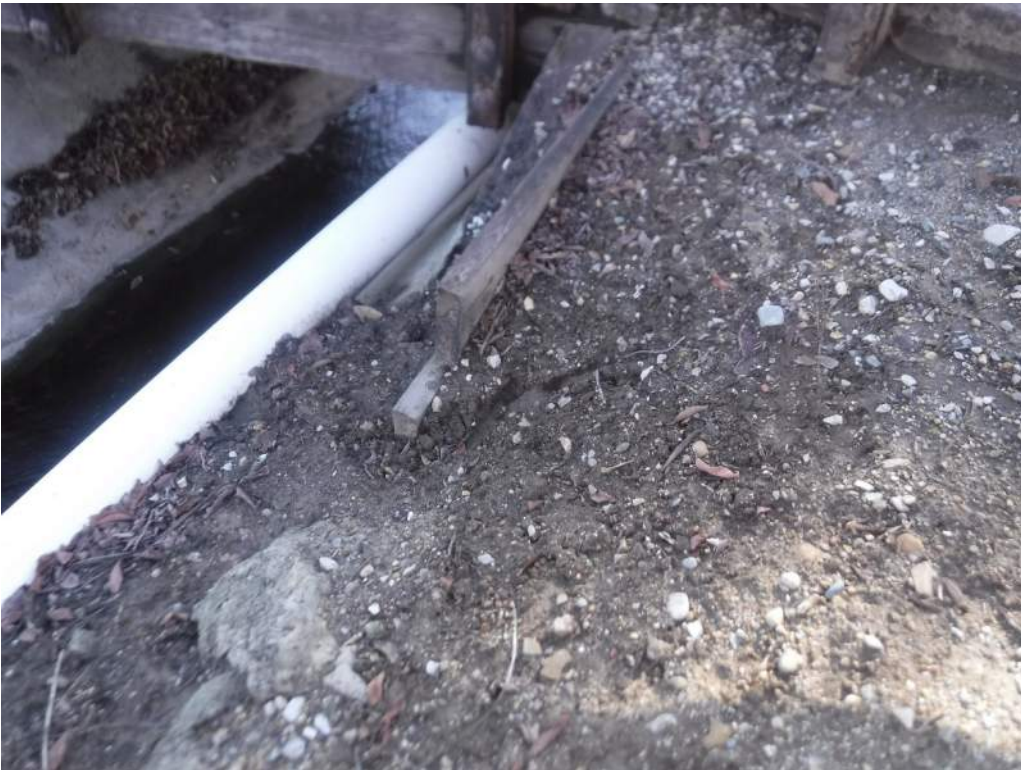
**409.74 Backwall on South side leaning**

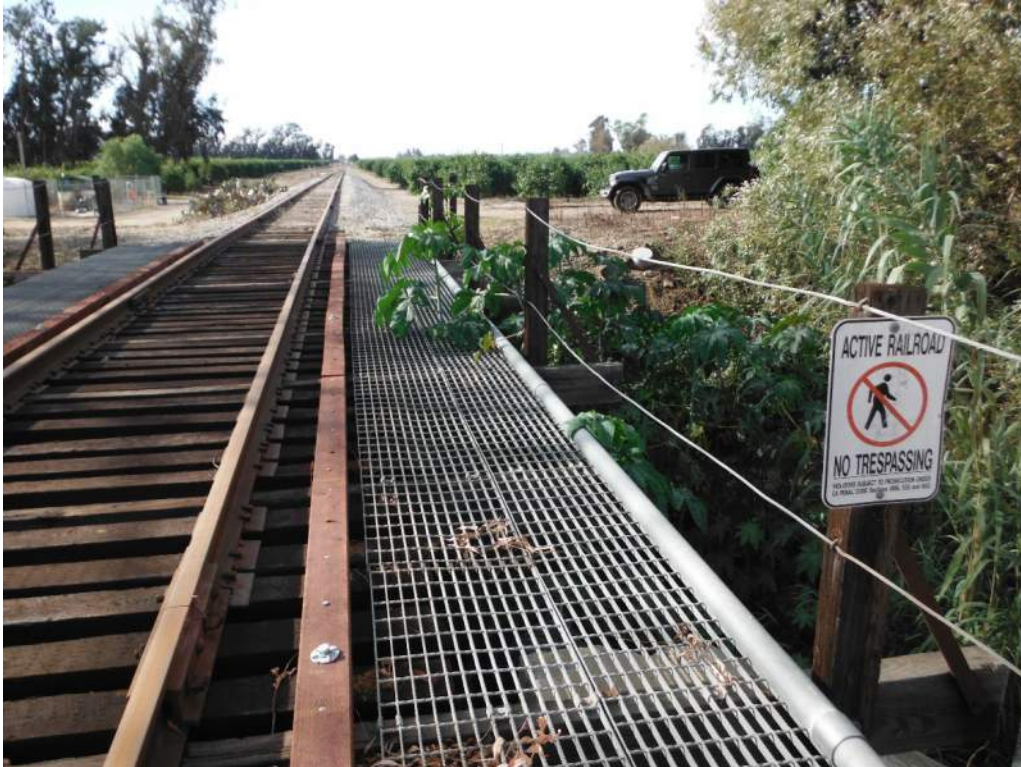
**410.40 Loose handrail cables (Typ.)**

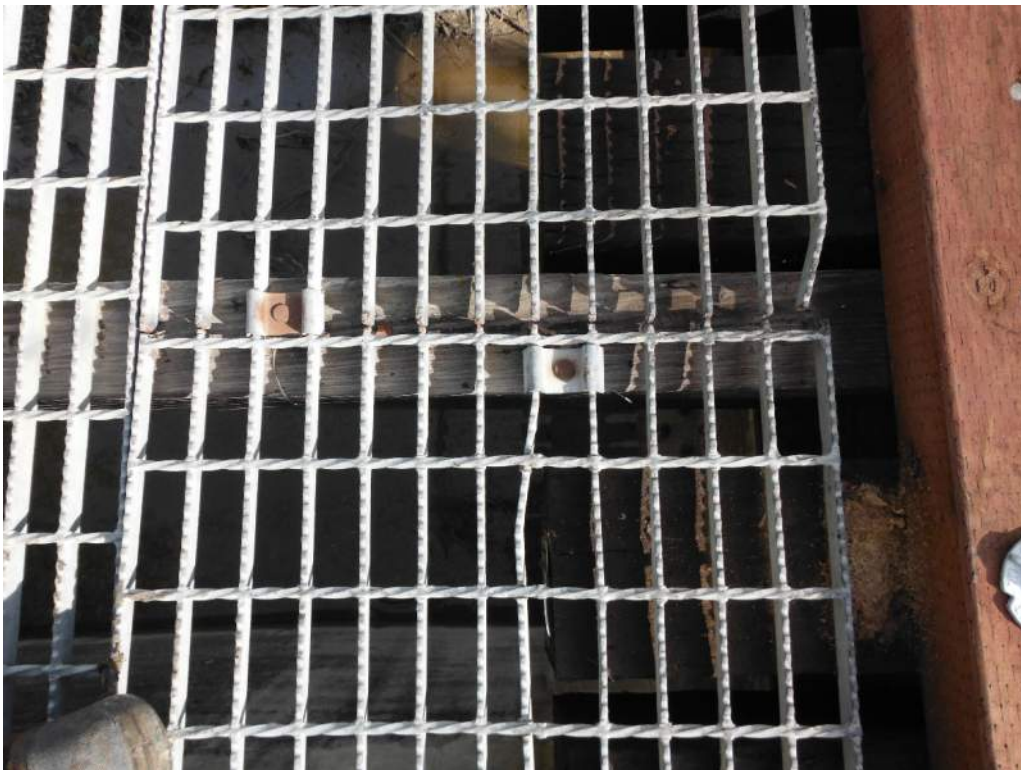
**410.40 Grating causing tripping hazard**

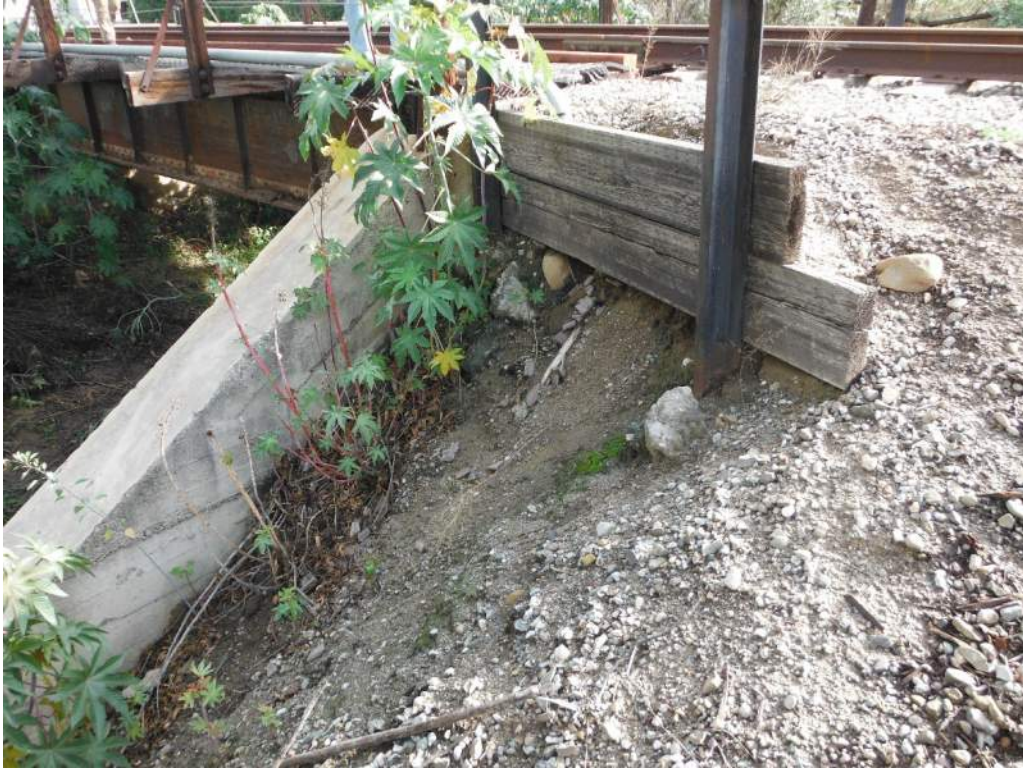
**410.40 NW ballast retainer undermining**

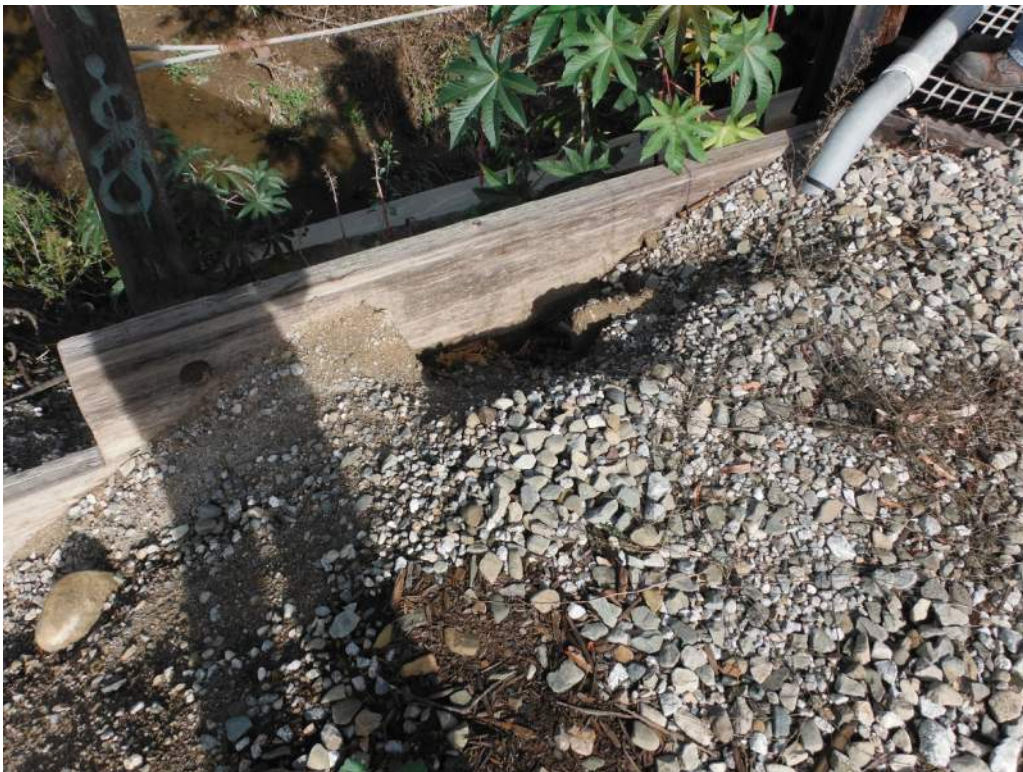
**410.40 NW Hole in Ballast due to Undermining**
