# BRIDGE INSPECTION REPORT

INSPECTION TYPE: Annual

Milepost 407.48  
 Location Santa Paula Branch Line  
Saticoy, CA  
 Stream X Overpass        Other         
 Train Operating Speed: Freight: 10 mph Passenger: 15 mph

MAINLINE/SUBDIVISION: VCTC

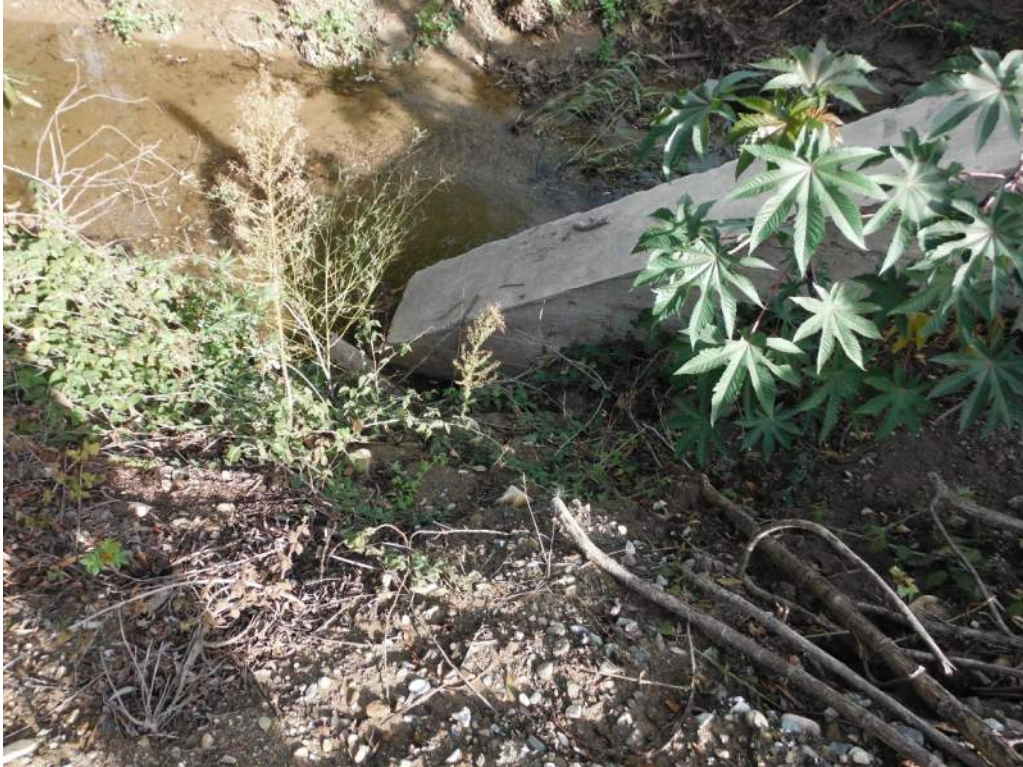
**410.40 Undermining and Scour behind NW Wingwall Upstream**

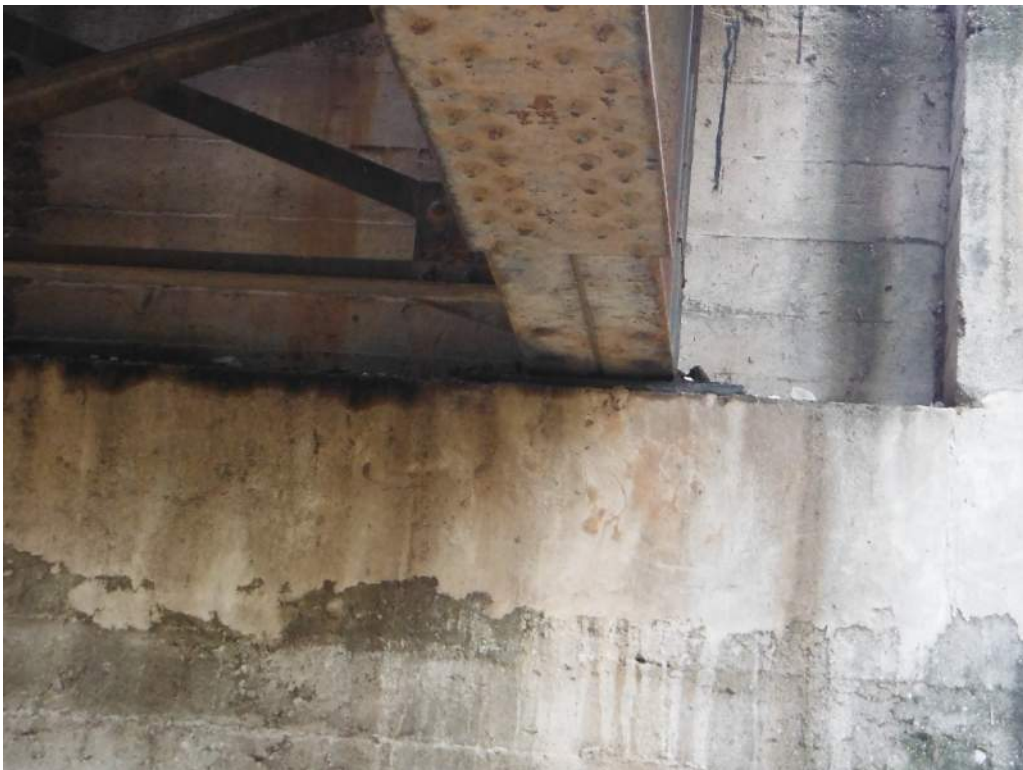
**410.40 Open Flange Holes near Bearing, Abutment 1**

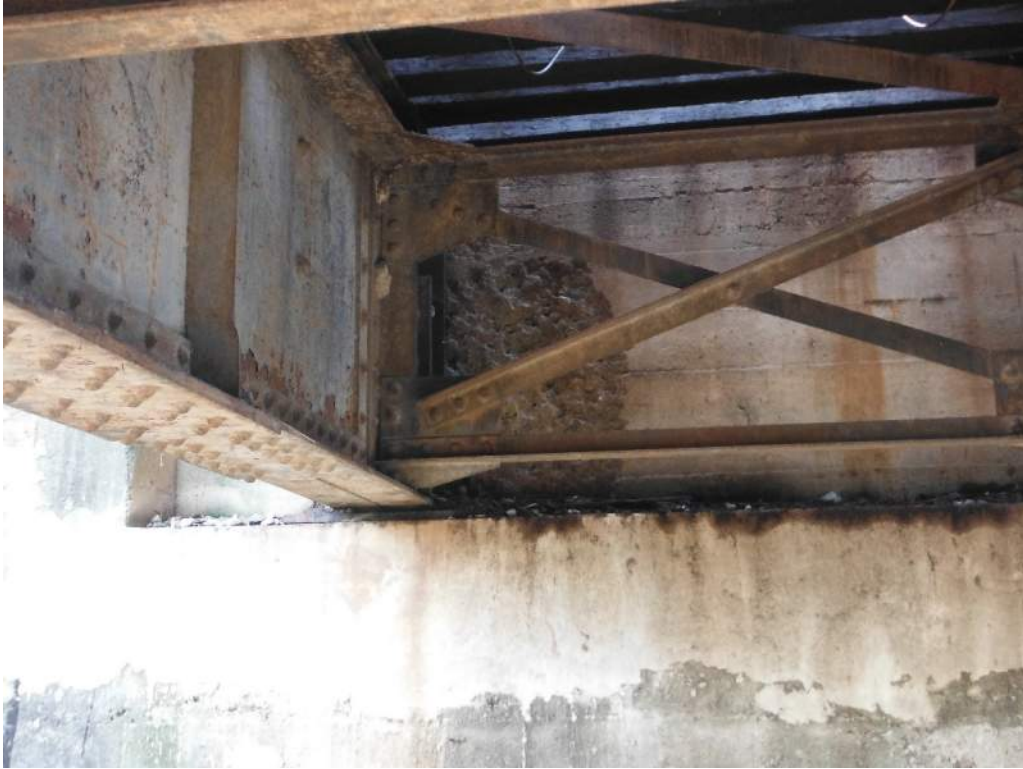
**410.40 Backwall spall – Abutment 1**

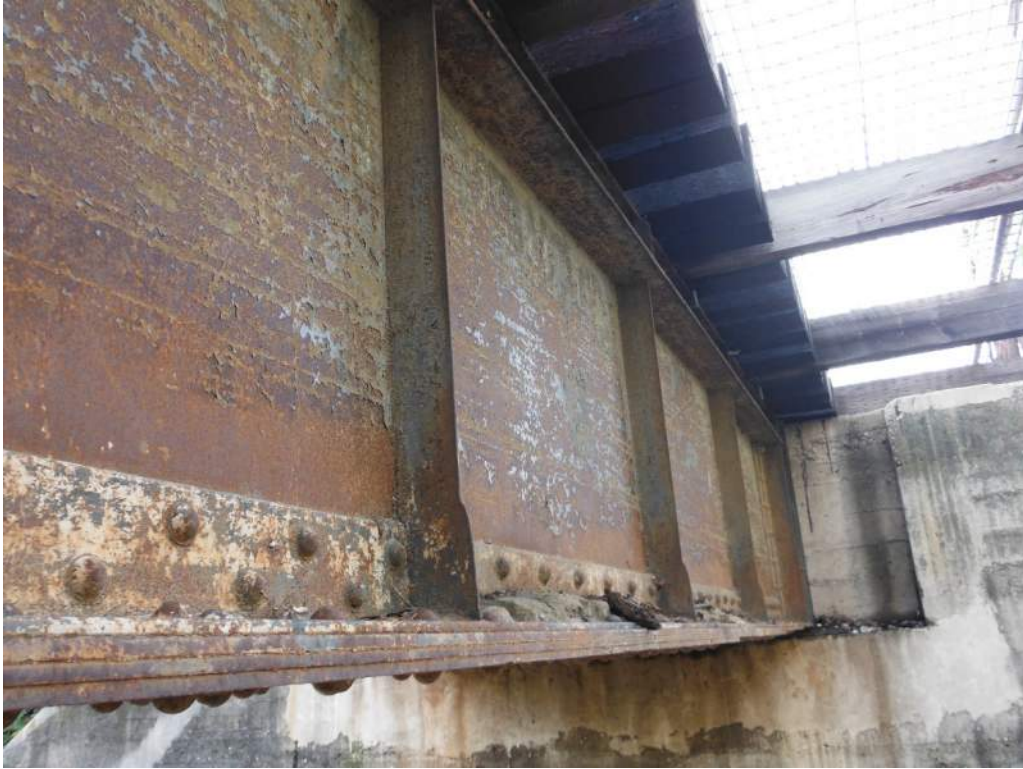
<b>DIVISION</b>	Santa Paula	<b>SPAN LENGTH</b>	39'	<b>NUMBER OF TRACKS</b>	1
<b>CROSSING</b>		<b>TRACK ALIGNMENT</b>	TANGENT	<b>SPAN No.</b>	1
<b>INSPECTION FINDINGS</b>					
	Deck girder is in fair condition with paint failure and surface rust - see photo

**410.40 Deck girder is in fair condition with paint failure and surface rust**

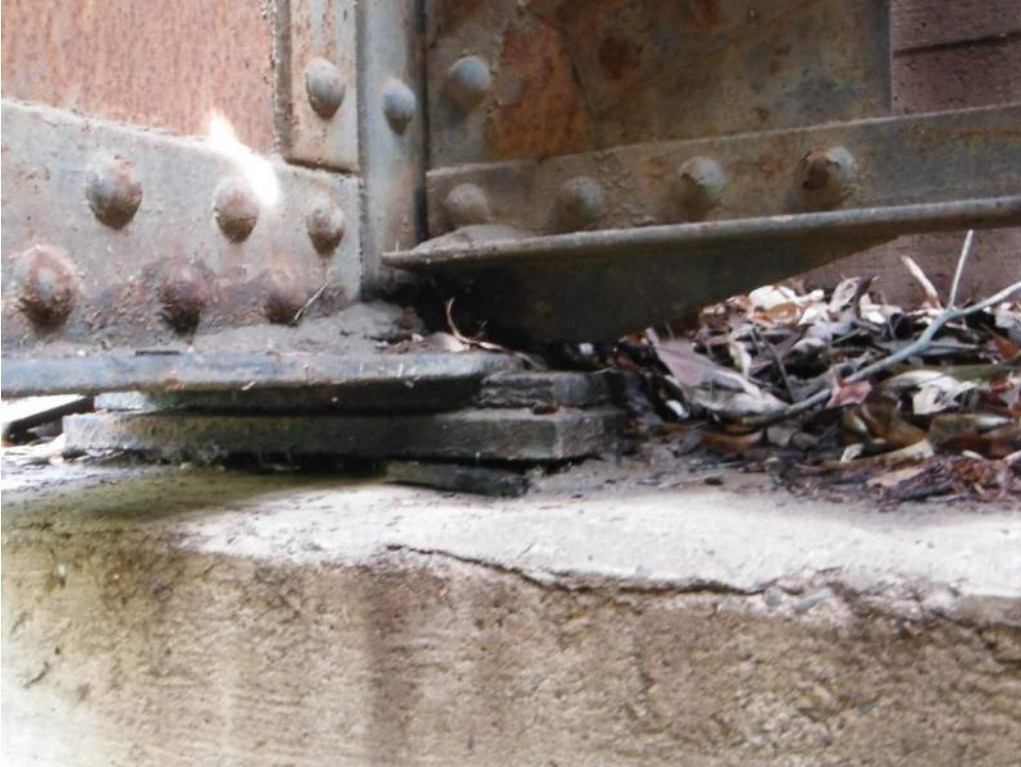
**410.40 Broken grout under bearing plates, Abutment 2**

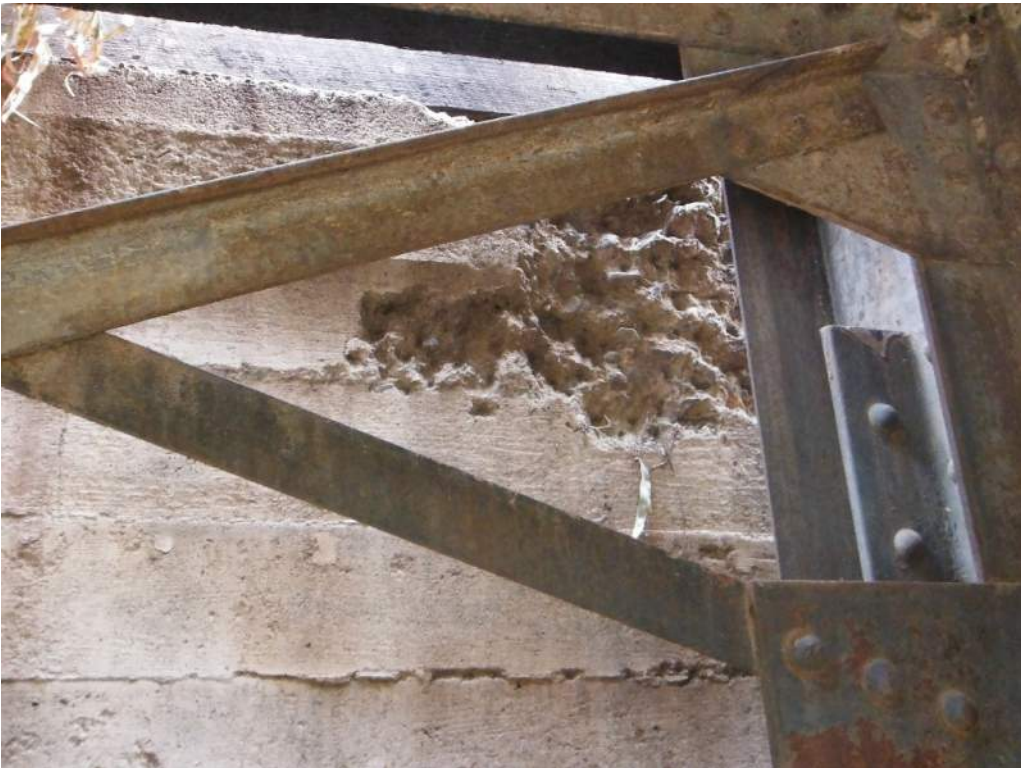
**410.40 Backwall spall – Abutment 2**

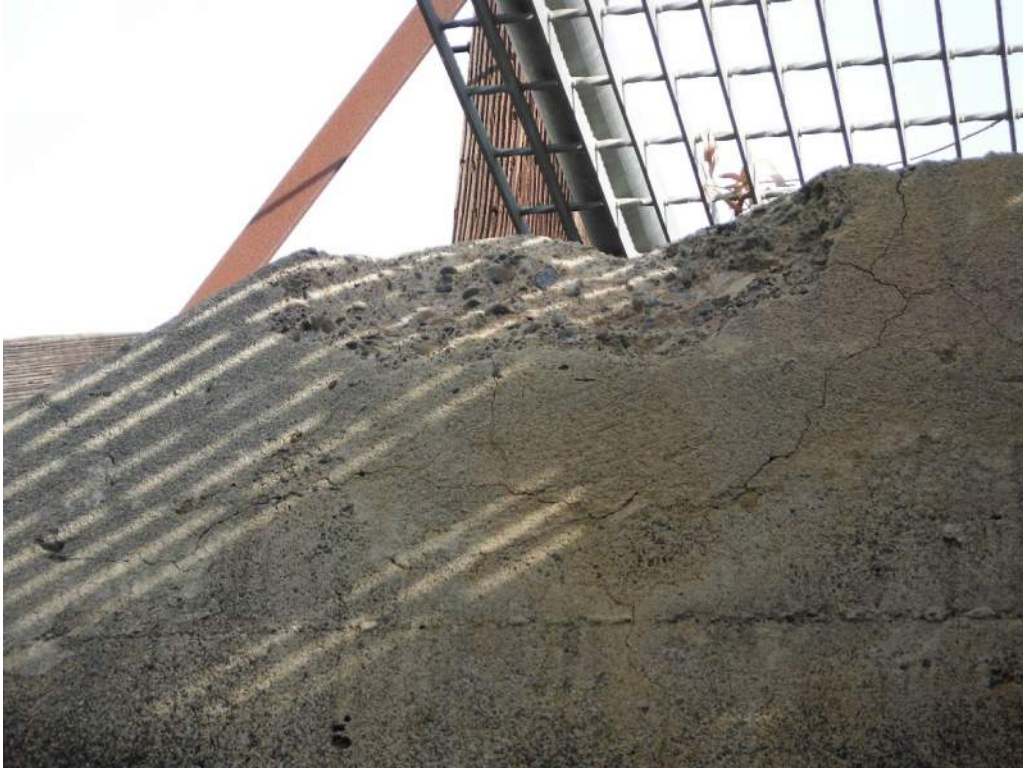
**410.40 NE Wingwall spall – Abutment 2**

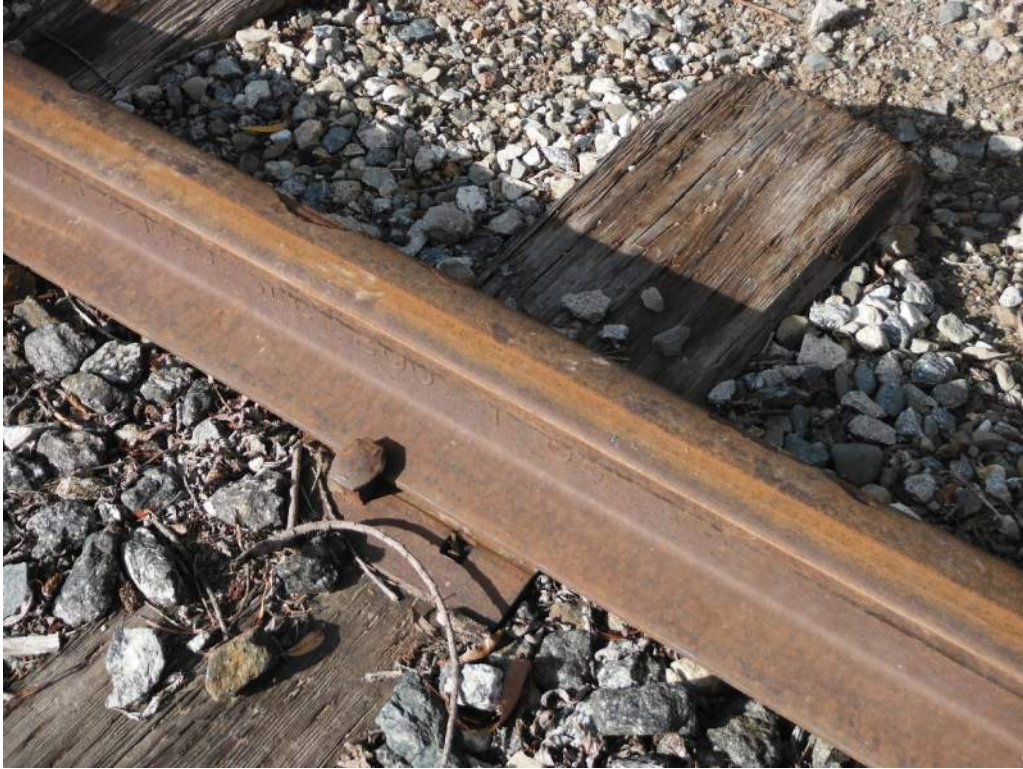
**411.97 NW rail section loss**

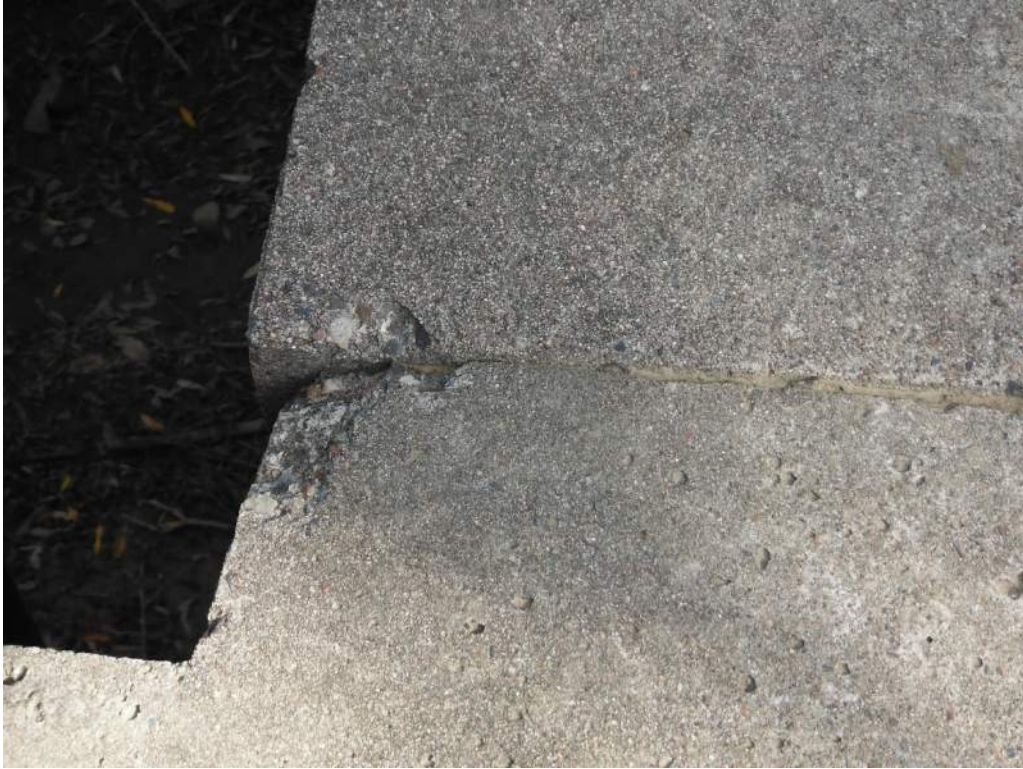
**411.97 Spall on NW Corner of Walkway**

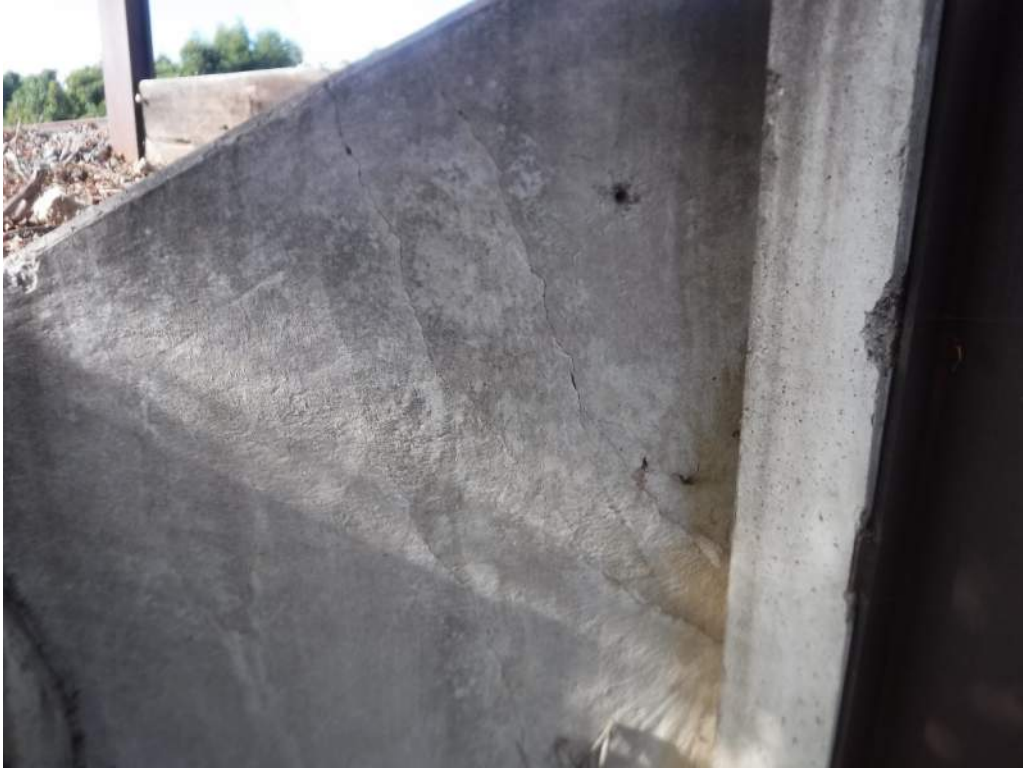
**411.97 Southwest wingwall cracking**

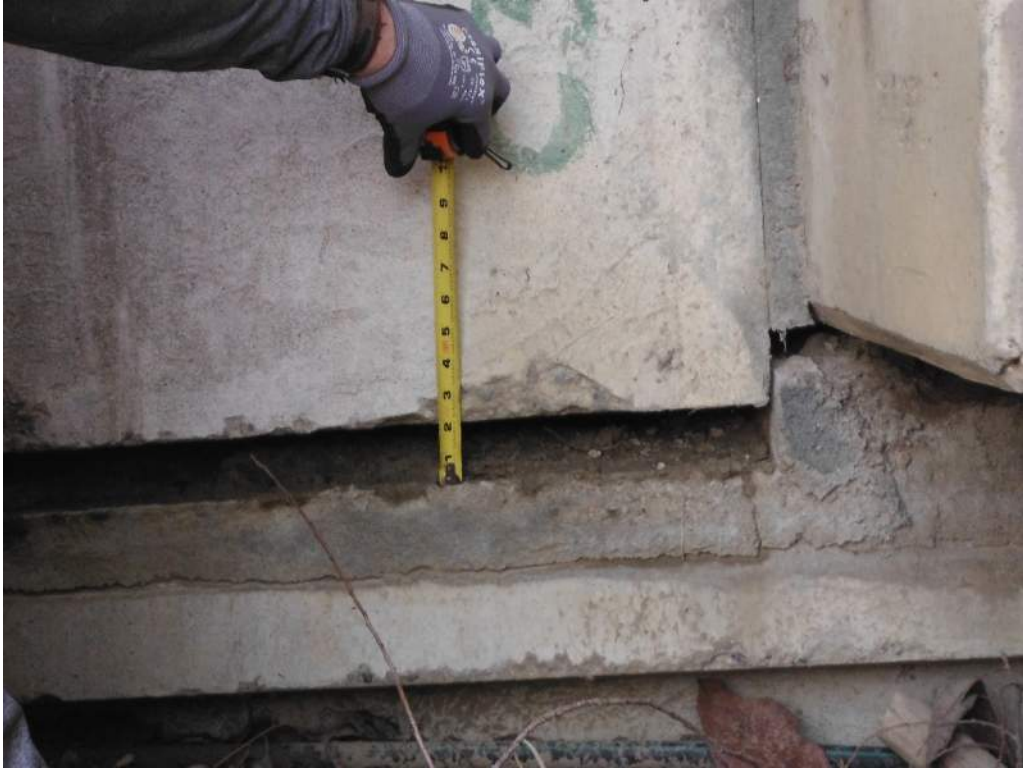
**411.97 2" gap between Abutment 1 and wingwall**

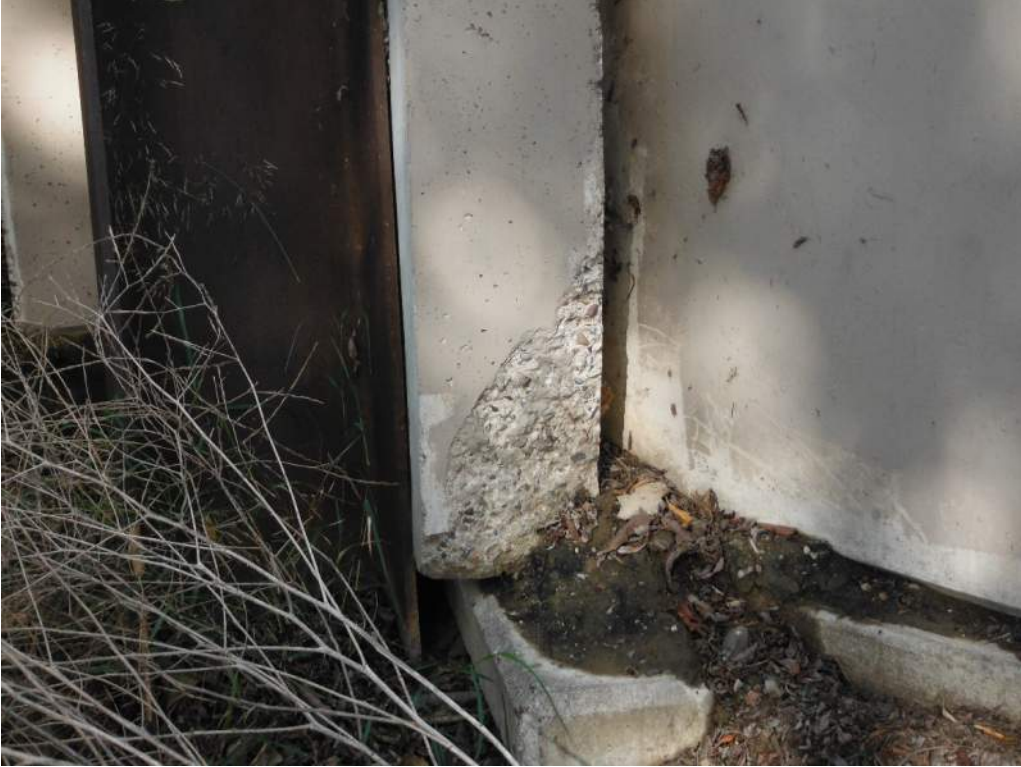
**411.97 Southeast Backwall Spall**

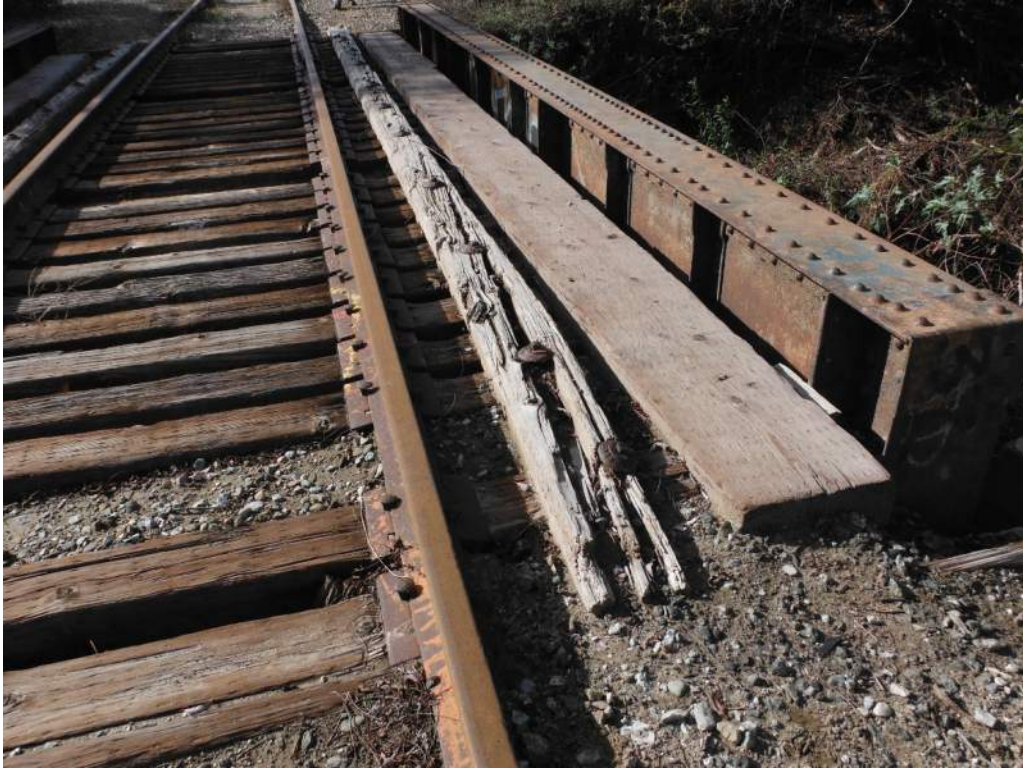
**412.25 Damaged curbs at east end**

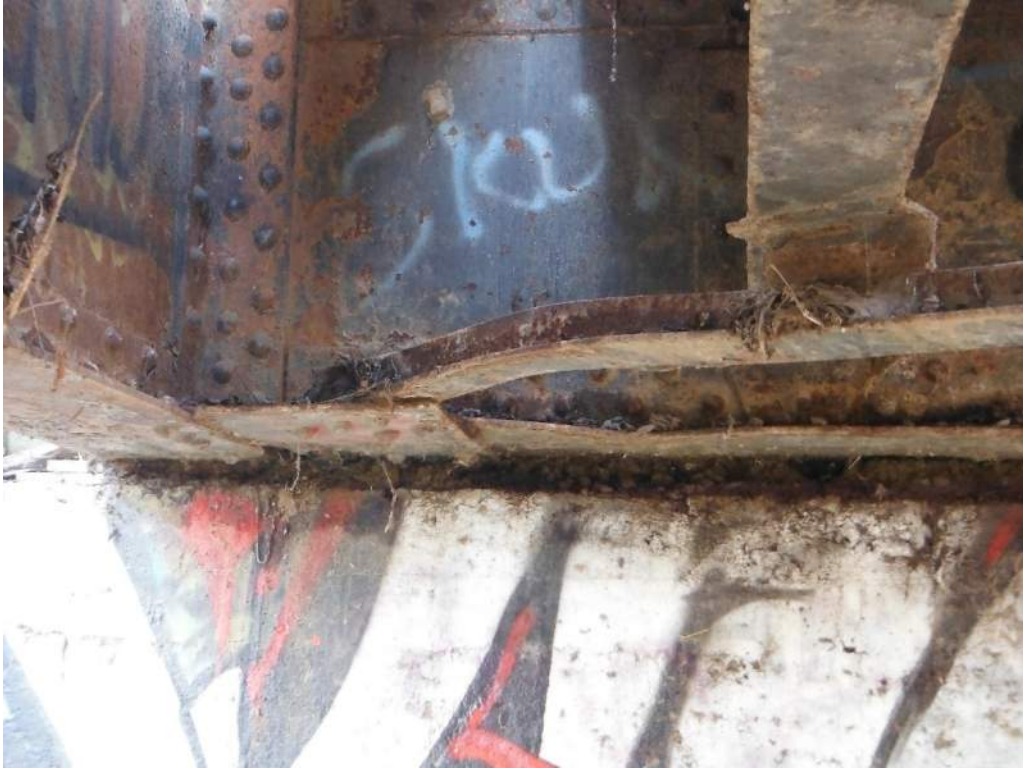
DIVISION	Santa Paula	SPAN LENGTH	29'	NUMBER OF TRACKS	1
CROSSING	Creek	TRACK ALIGNMENT	TANGENT	SPAN No.	1
<b>INSPECTION FINDINGS</b>					
Imp	Bay #1 right side cross bracing show signs of impact and slight deflection - see photo				
	Debris build-up on bottom flange, bearings, and cross bracing

**412.25 Minor impact damage near Abutment 1**

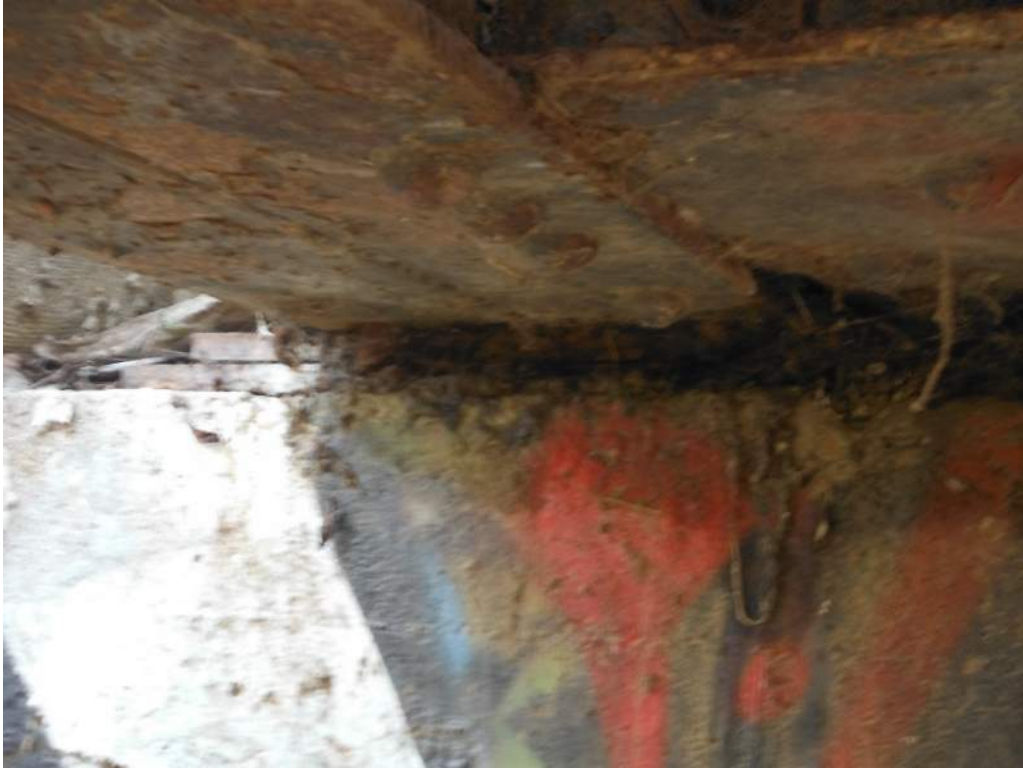
1. Abutment needs to be cleared of debris
2. End bearing areas show minor section loss due to rust
3. Pack rust at bearing plates - see photo
4. SP - Spalling along north wingwall

**412.25 Pack rust at bearing plates (typ.)**

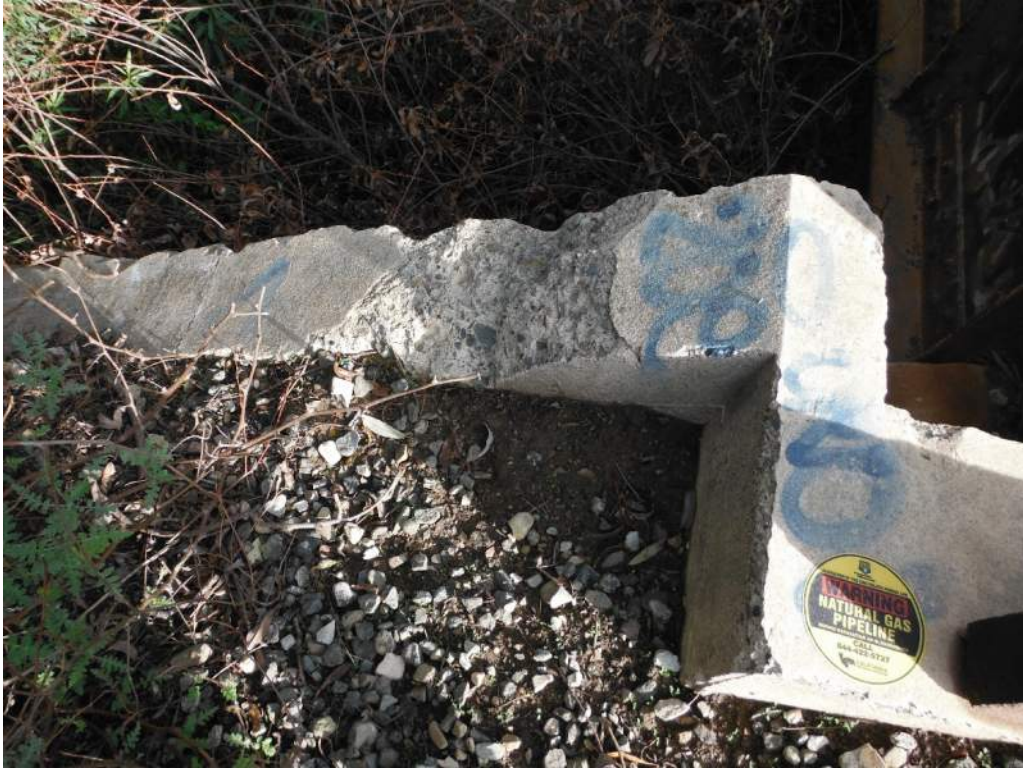
**412.25 Spalling on wingwall – see report for locations**

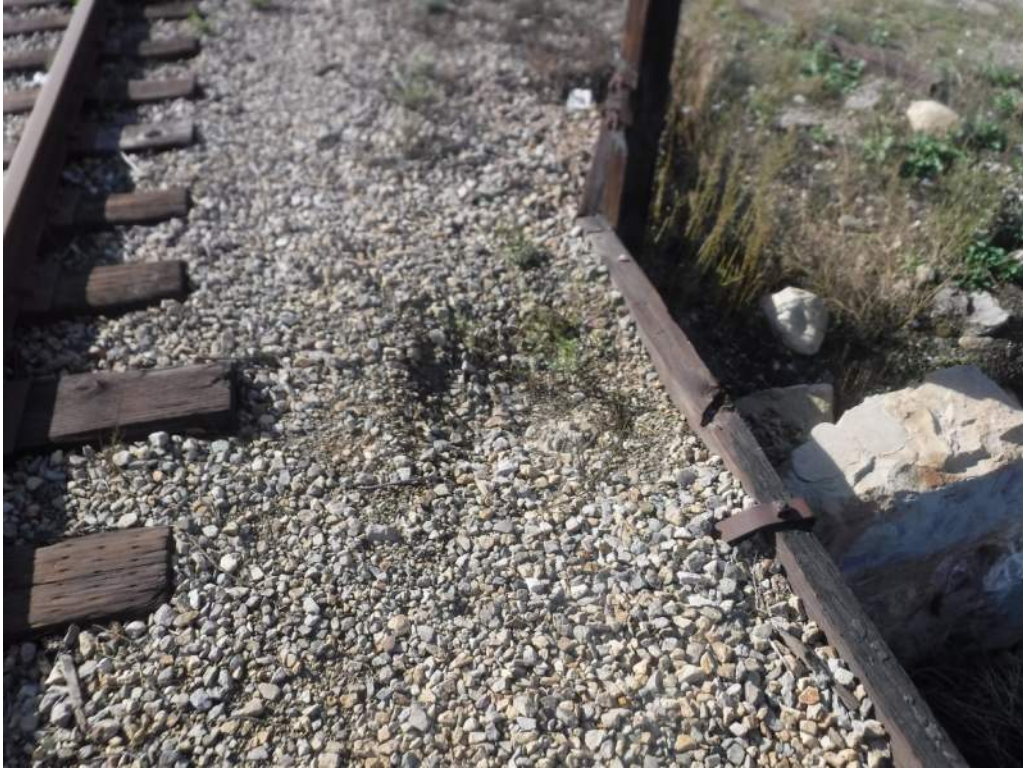
Wingwall	SW & SE wingwalls undermined - see photos						
Ballast	Holes in ballast, west side - see photo						
<b>MAINTENANCE RECOMMENDATIONS</b>							
Priority	Description						
E03, B	Raise approaches						
D03, C	Replace 80 lb rail as tonnage dictates						
D07, A	Repair handrail						
S01, S03, B01, B02, B03, B04, D04	Excavate to allow inspection or remove structure						
D05, C	Repair wings						
<b>CONDITION RATING</b>				<b>PRIORITY</b>

**415.20 Holes in ballast on west side**

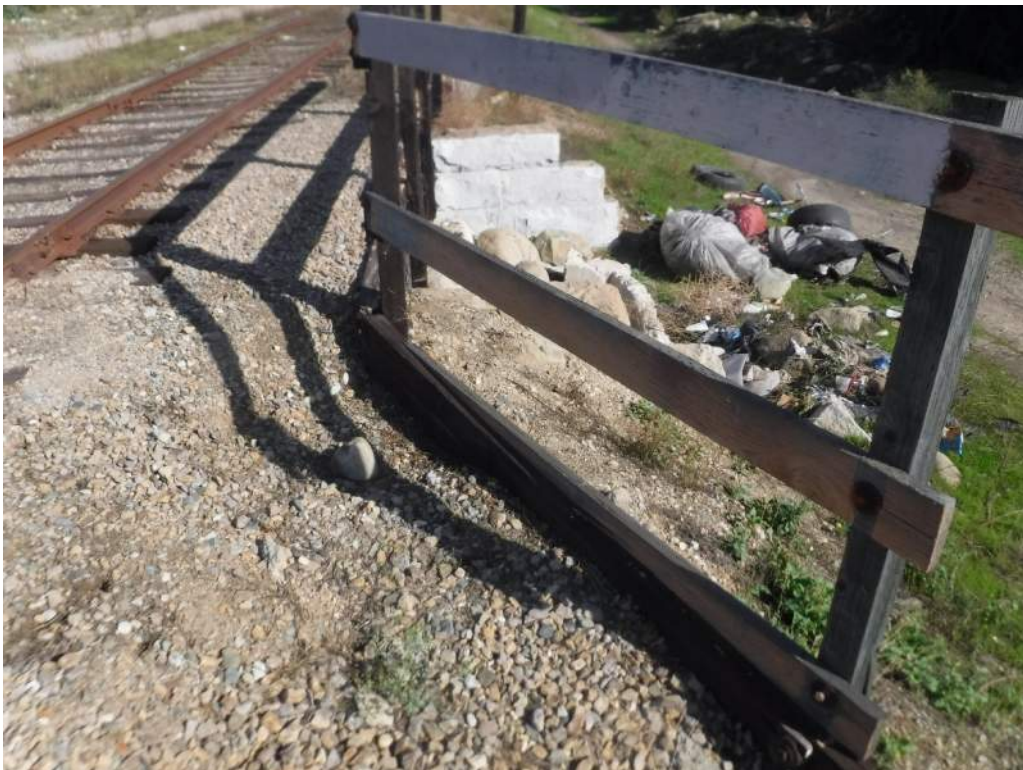
**415.20 Southwest wingwall undermined**

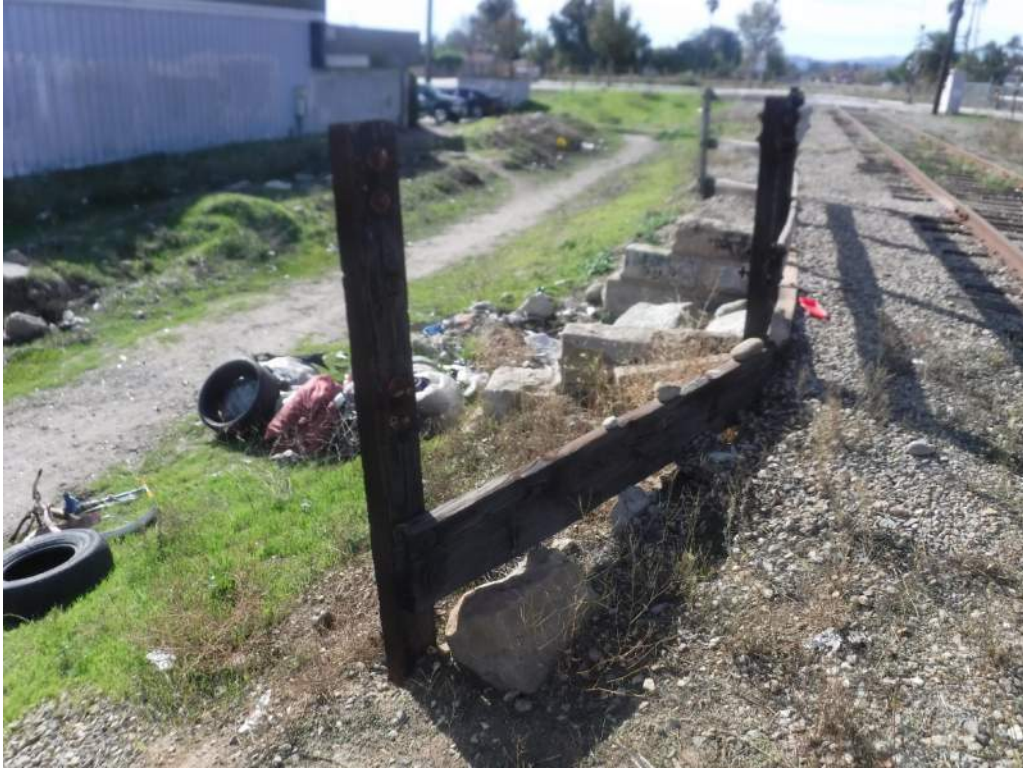
**415.20 Southeast wingwall undermining**

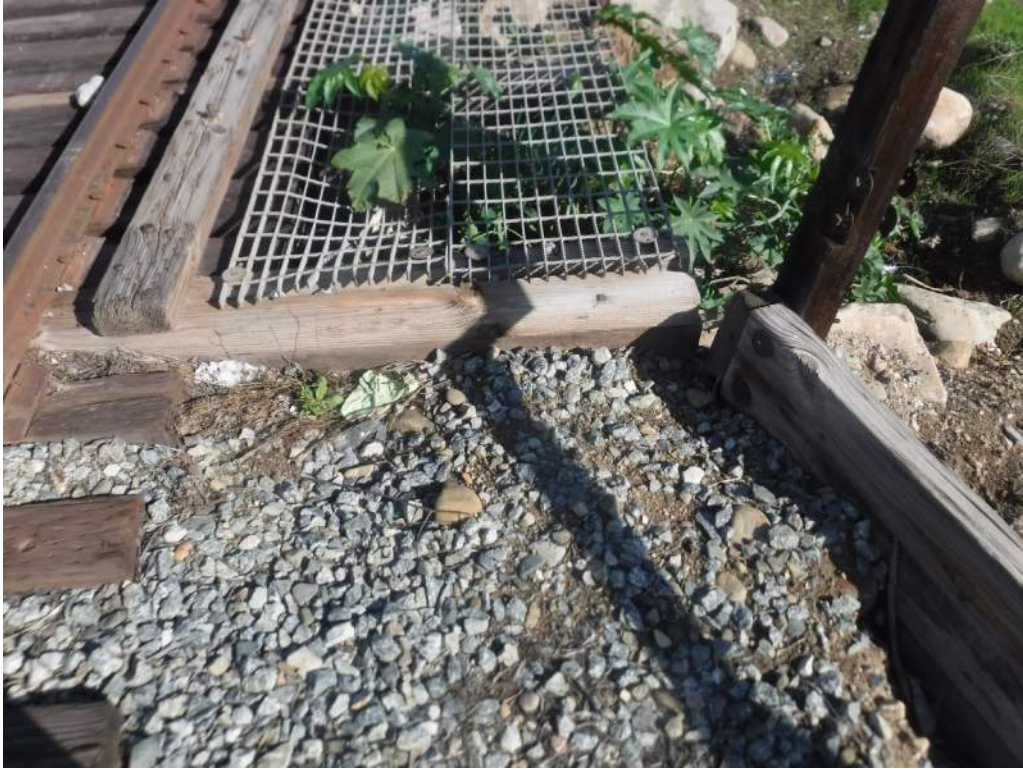
**415.32 Damaged walkway – south side**

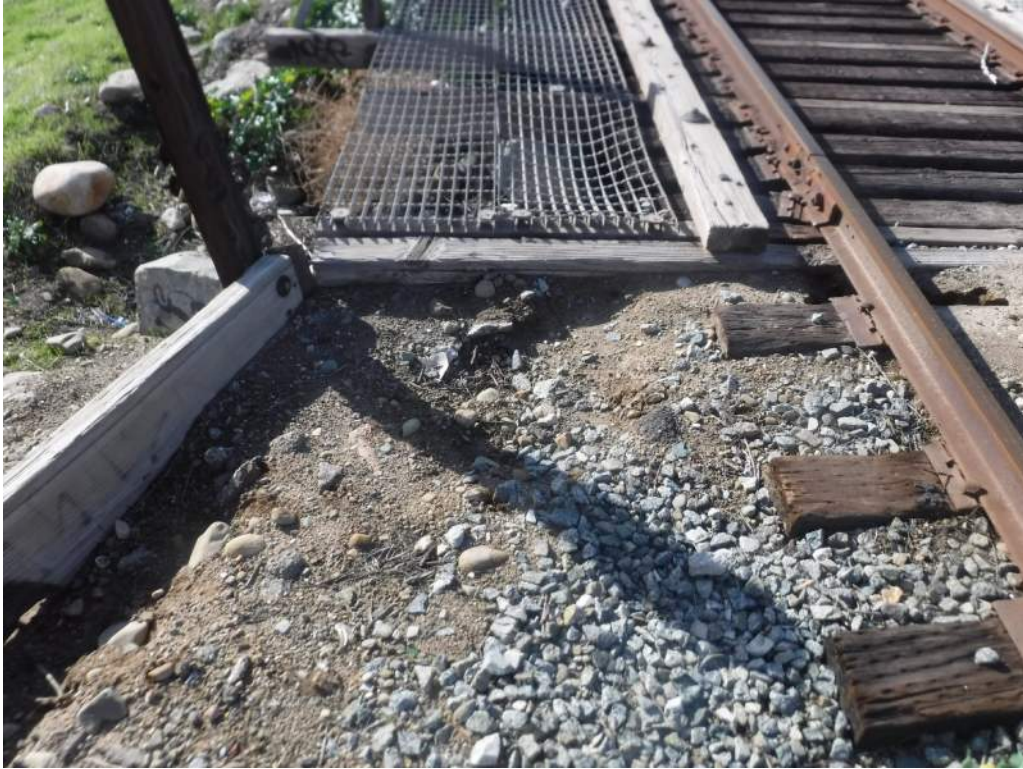
**415.32 Hole in Ballast, SE Corner**

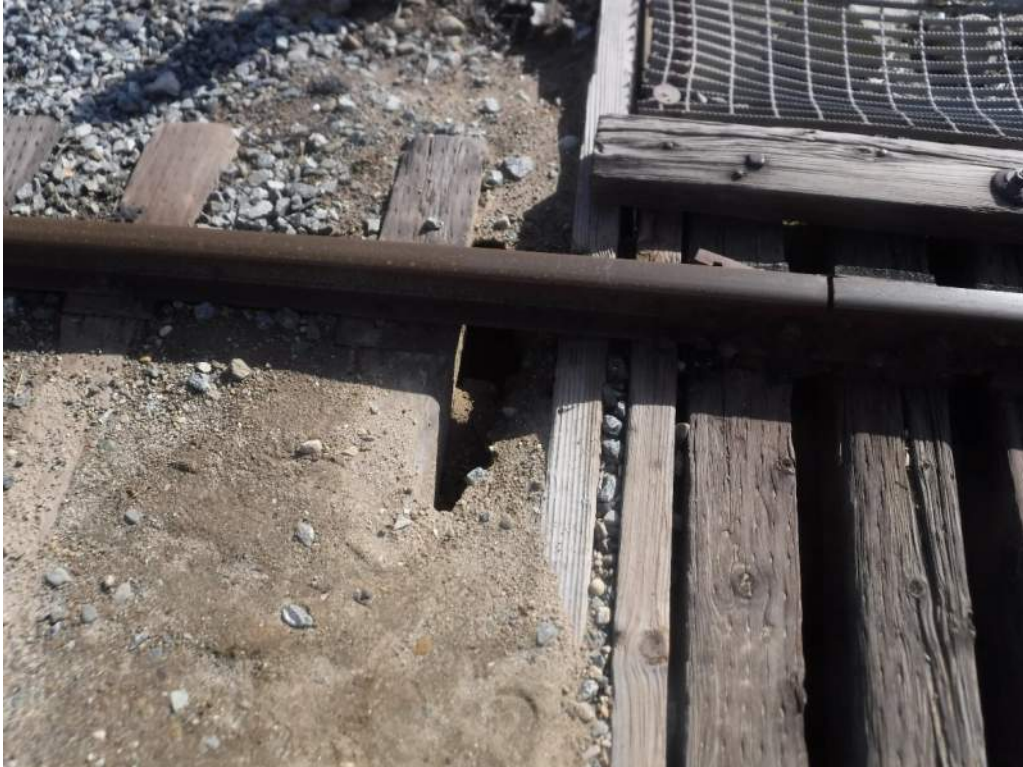
**415.32 Hole in soil behind Abutment 2**

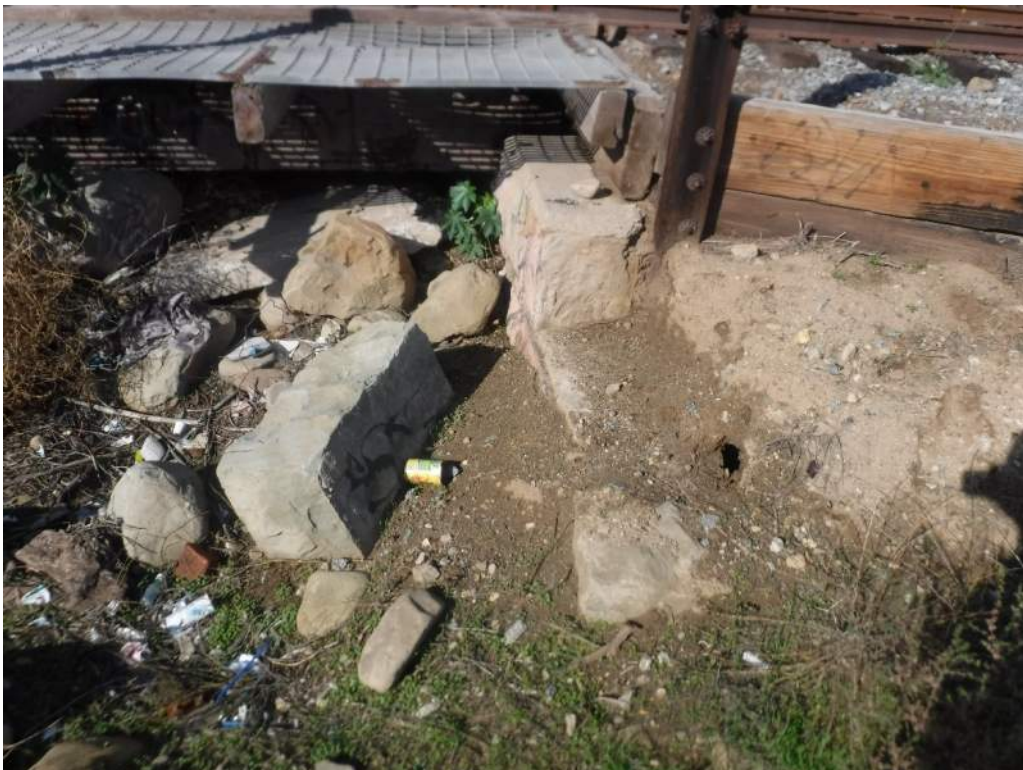
**415.32 SE abutment stone block dislodged**

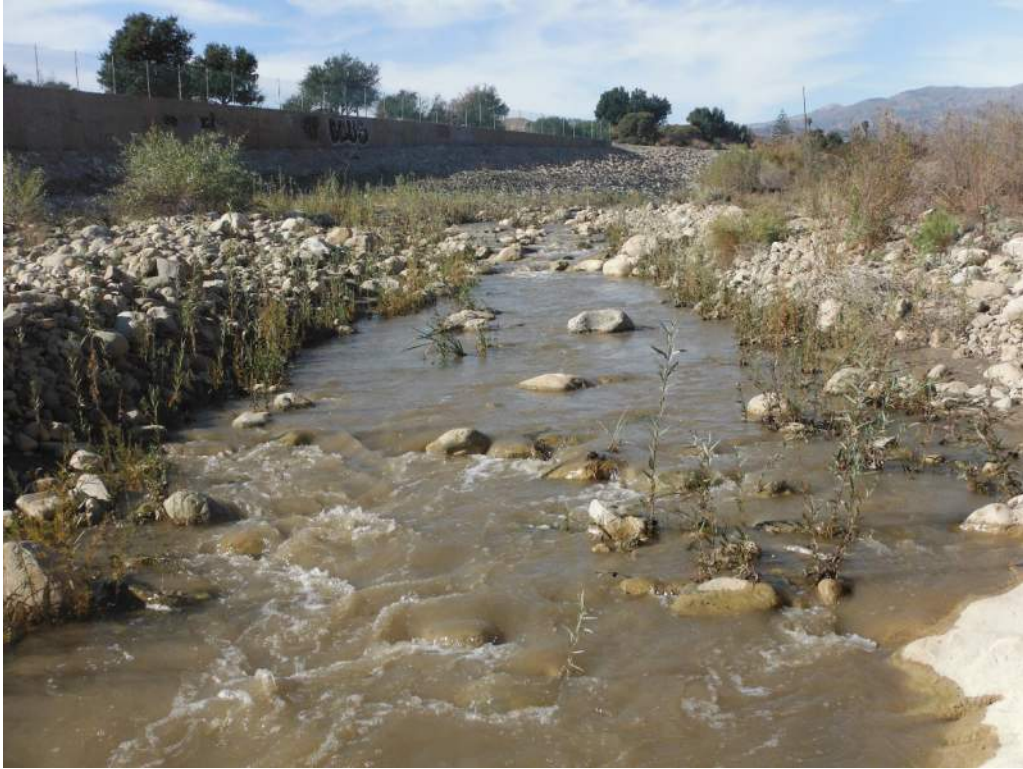
**415.59 Channel Condition. Looking upstream**

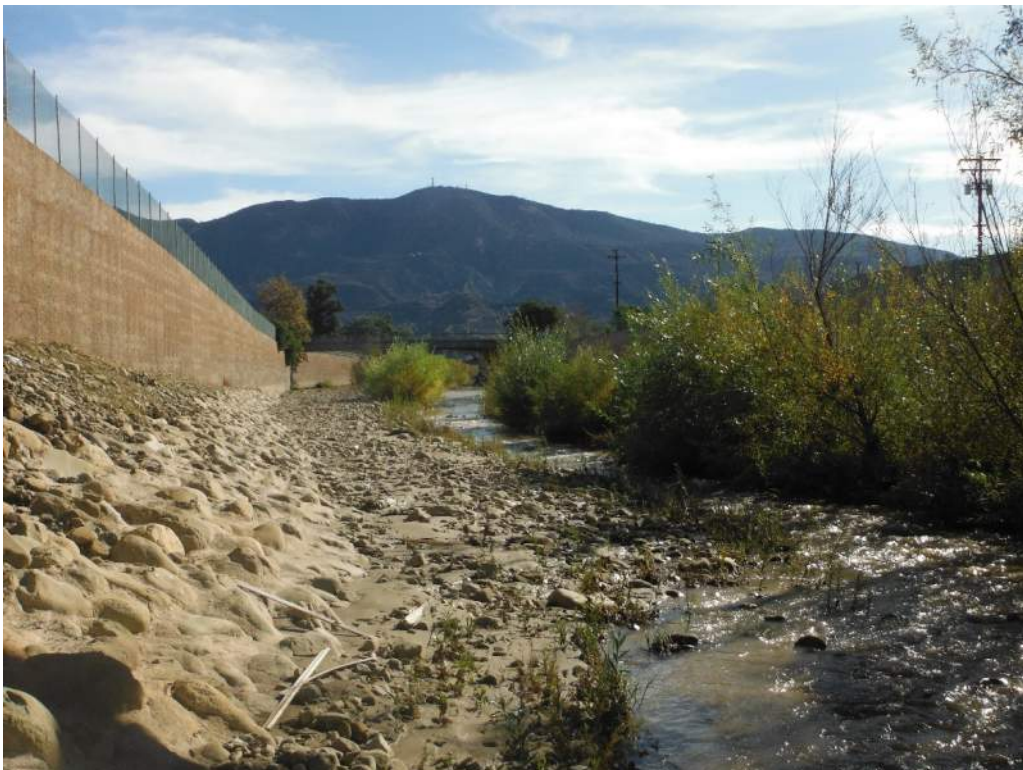
**415.59 Channel Condition. Looking downstream**

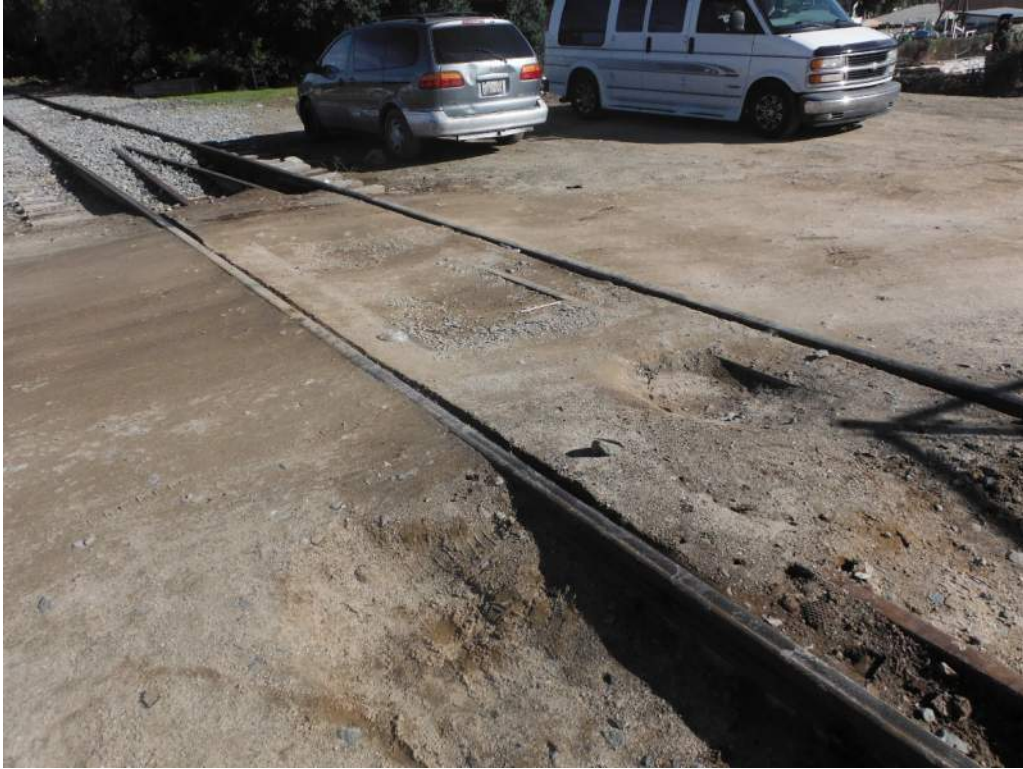
**415.59 Material between inside guardrail and running rail, typ both sides**

S05	Debris in bearings						
D03 Guard Rail	Material between inside guard rail and running rail both ends, both sides						
<b>MAINTENANCE RECOMMENDATIONS</b>							
Priority	Description						
S05, B	Clean bearings						
D03, B	Remove material between inside guard rail and running rail both ends, both sides						
<b>CONDITION RATING</b>				<b>PRIORITY</b>

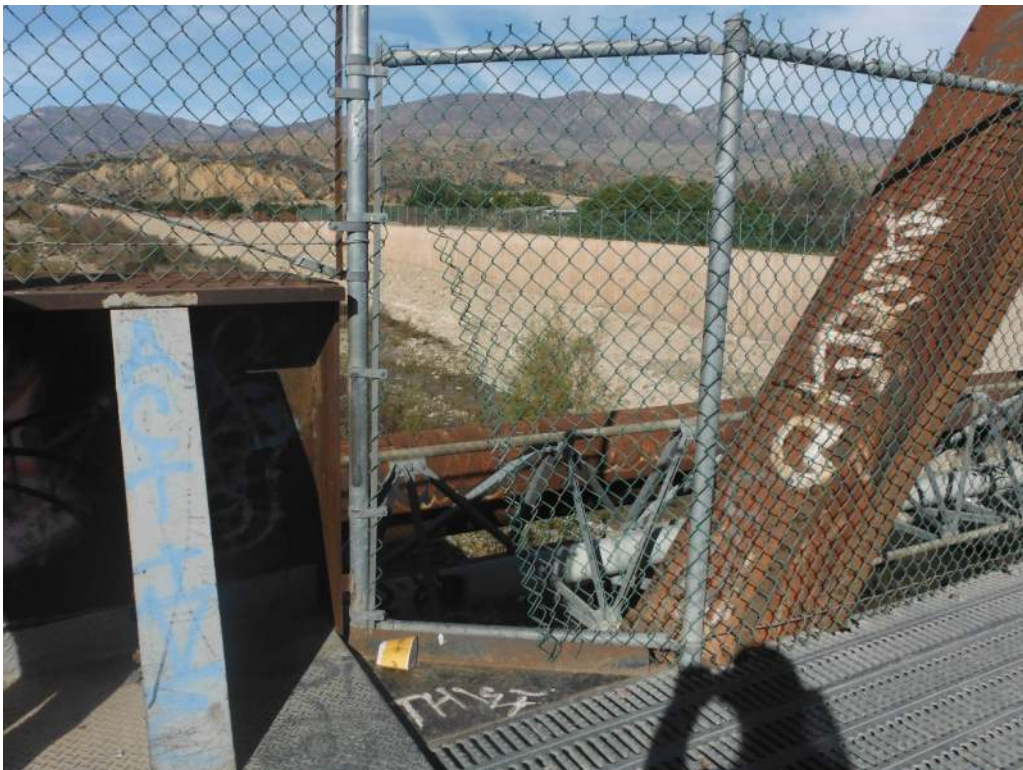
**415.59 Fence breach over Pier 2, north side**

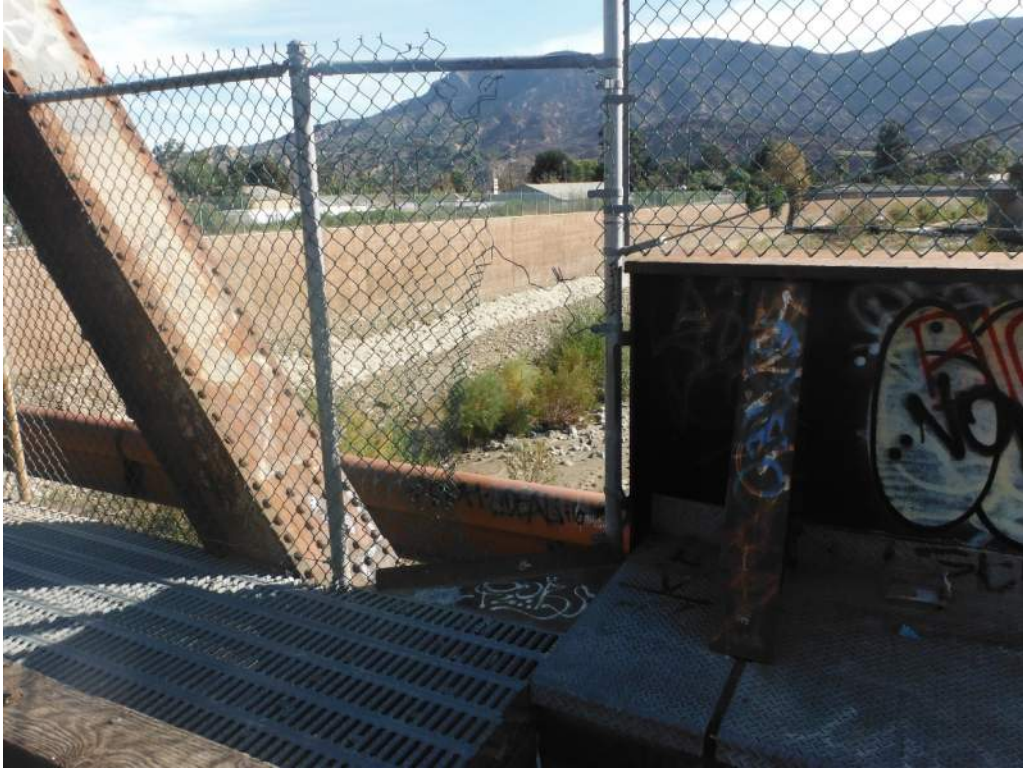
**415.59 Fence breach over Pier 2, south side**
