# BRIDGE INSPECTION REPORT

INSPECTION TYPE: Annual

Milepost 407.48  
 Location Santa Paula Branch Line  
Saticoy, CA  
 Stream X Overpass        Other         
 Train Operating Speed: Freight: 10 mph Passenger: 15 mph

MAINLINE/SUBDIVISION: VCTC

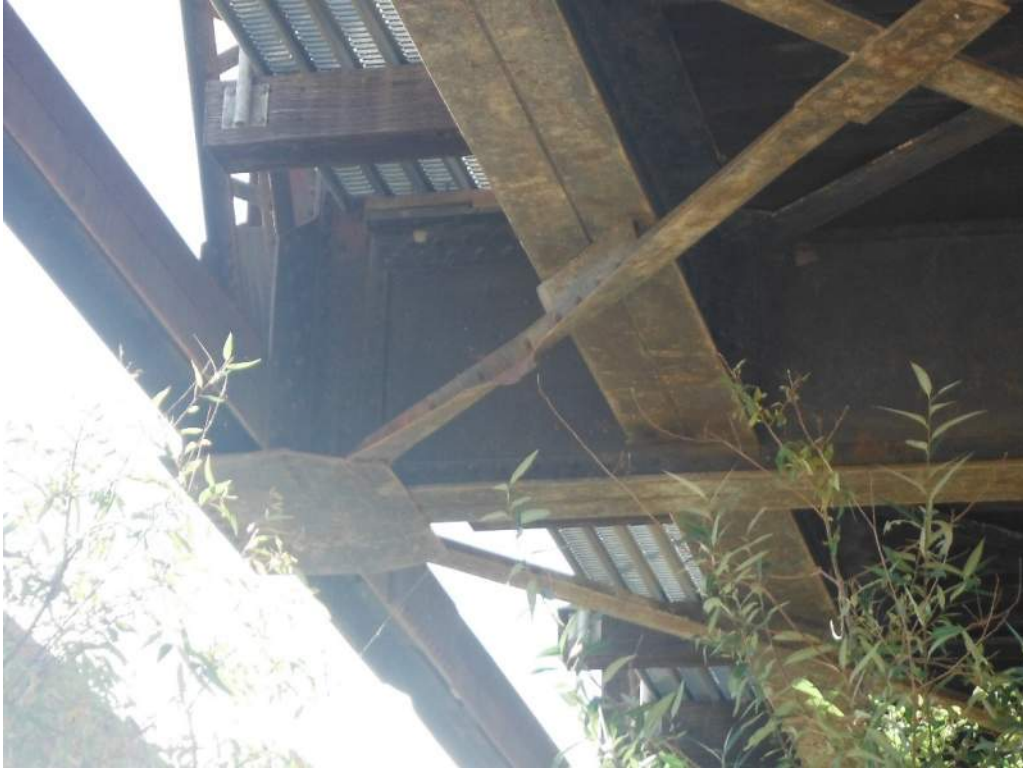
**415.59 Minor impact damage – typical bottom cross bracing**

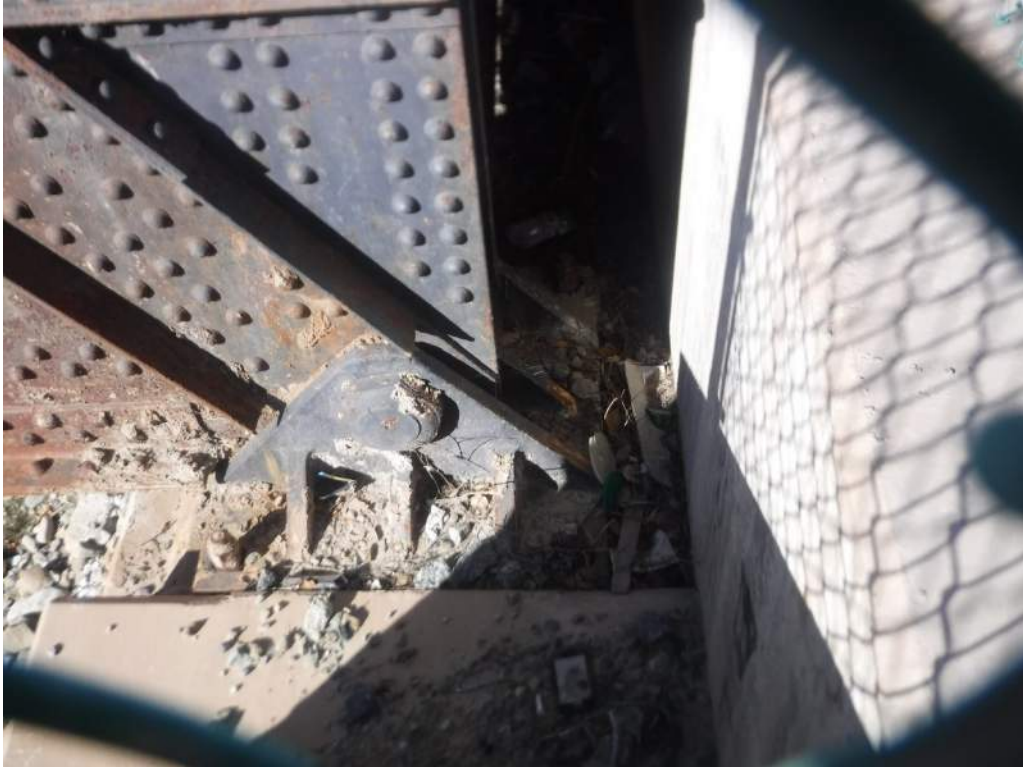
**415.59 Debris at SE Bearing**

S05	Debris in bearings						
D03 Guard Rail	Material between inside guard rail and running rail both ends, both sides						
<b>MAINTENANCE RECOMMENDATIONS</b>							
Priority	Description						
S05, B	Clean bearings						
D03, B	Remove material between inside guard rail and running rail both ends, both sides						
<b>CONDITION RATING</b>				<b>PRIORITY</b>

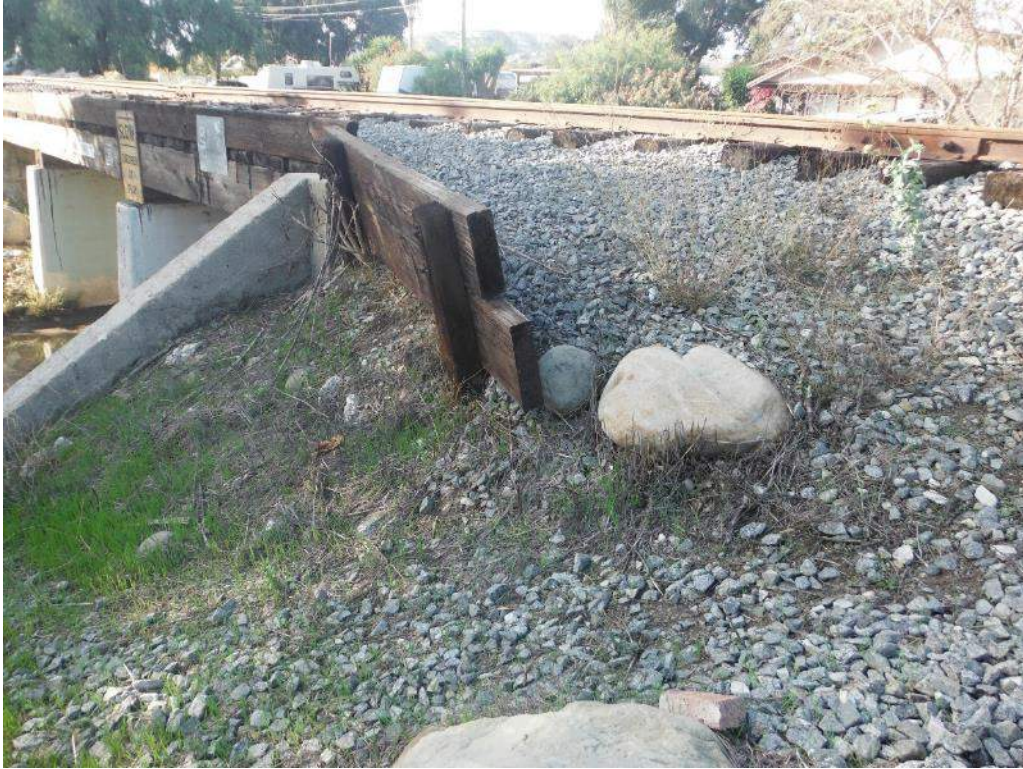
**415.69 Leaning wingwall, typ**

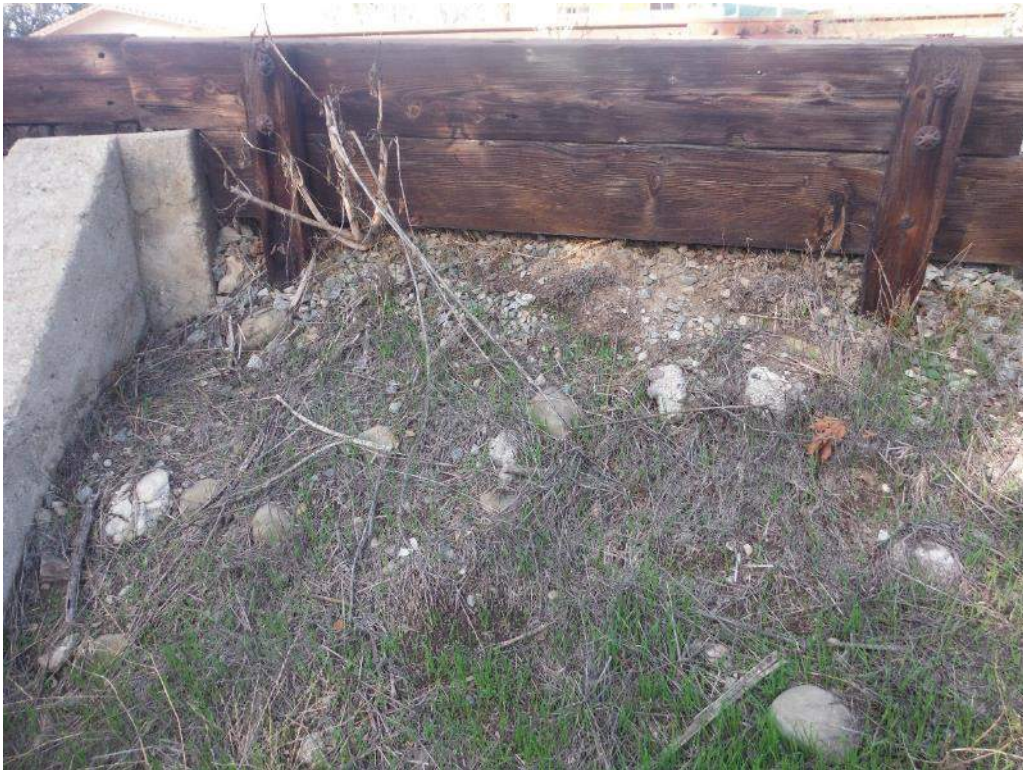
**415.69 Undermining SE ballast retainer**

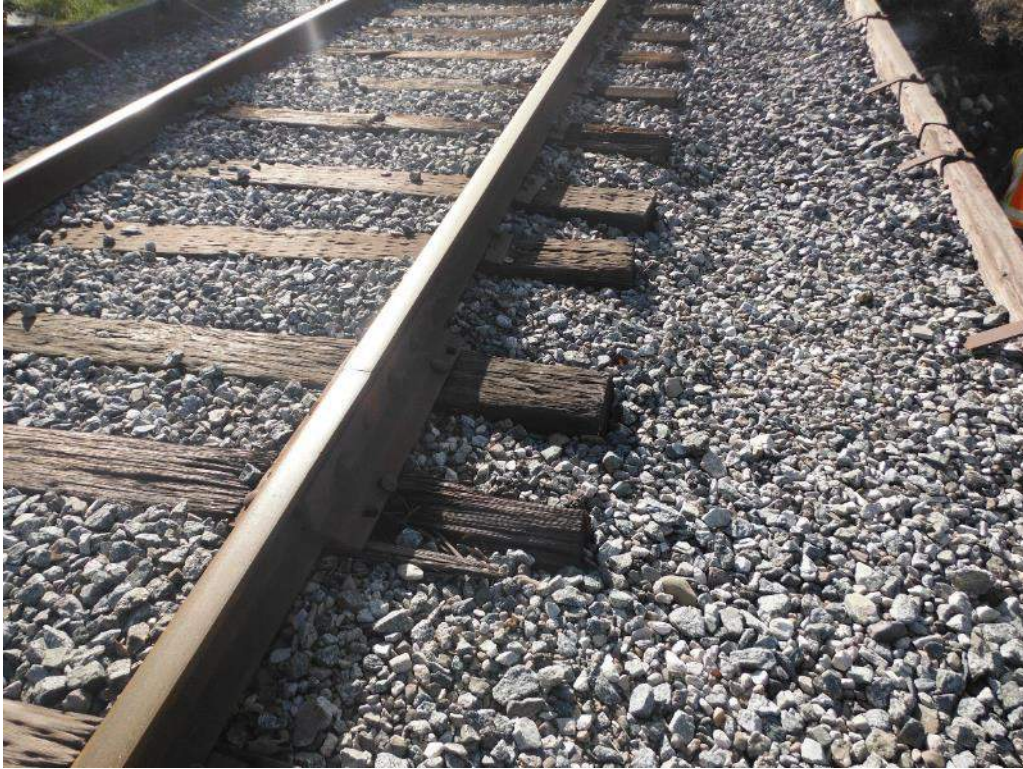
**415.69 Ties splitting**

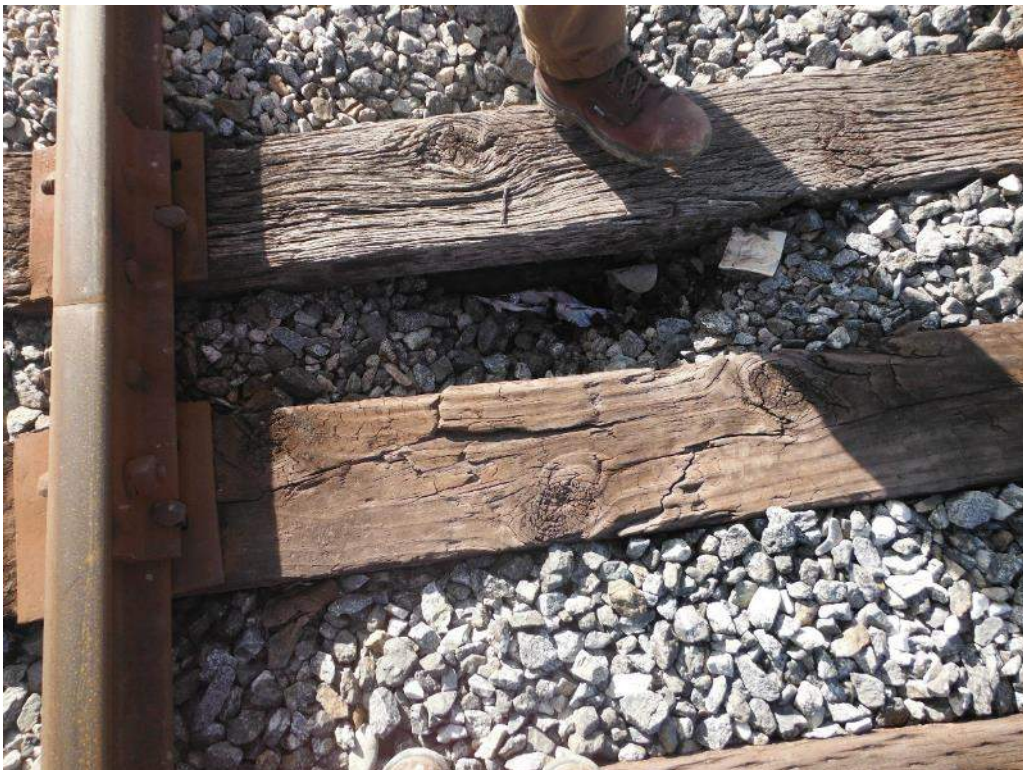
1. Rot - Ballast plank showing signs of decay and is rotten between stringer chords causing ballast leak - see photo
2. HW - Stringers #1, #3, #5, and #7 are hollow
3. Fail - Stringer #11 is failed and is crushing at pier #2 - see photo
4. SP - Minor spalls in abutment - see photo
5. CR - Cracking in wingwalls - see photo
6. CRU - Stringer 12 crushed at abutment 1 - see photo
7. Fail - Stringer 12 is rotten/failed - see photo
8. DEB - Debris under span - see photo
9. Holes in ballast - see photo

**415.69 Hole in ballast, Span 1**

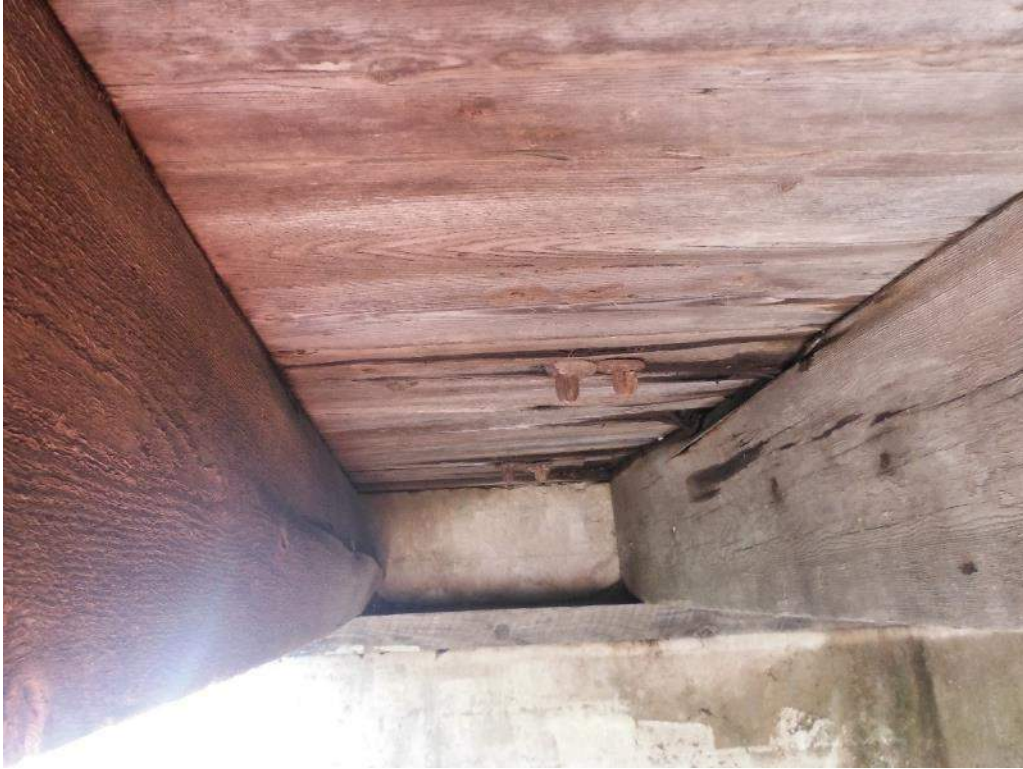
**415.69 Rotten deck plank at Abutment 1**

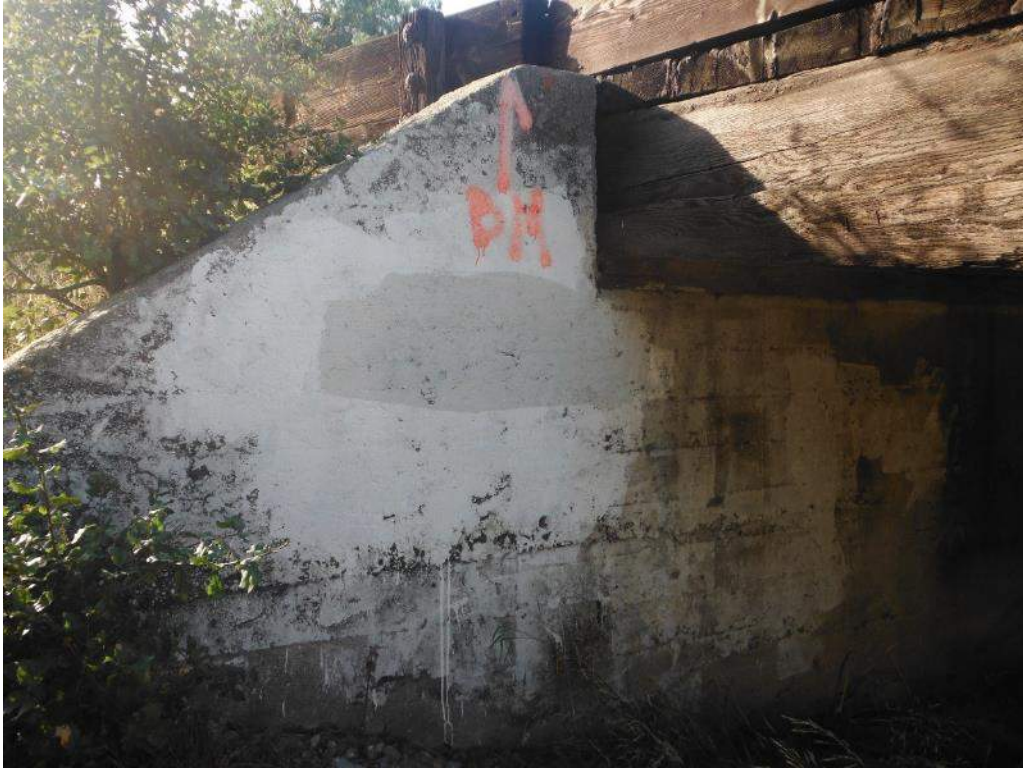
1. Minor spalls in abutment
2. Cracking and spall in wingwalls - see photo
3. CRU - Stringer 1 crushing at abutment 4

**415.69 Cracks in Southwest Wingwall**

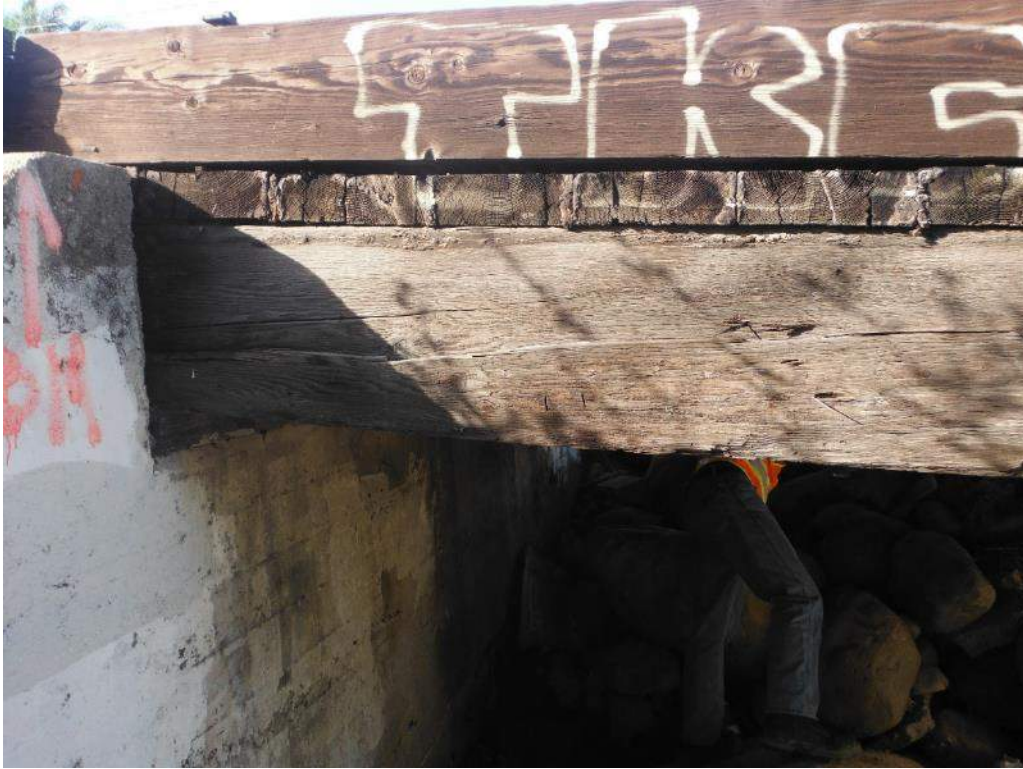
**415.69 Stringer 12 crushing – Abutment 1**

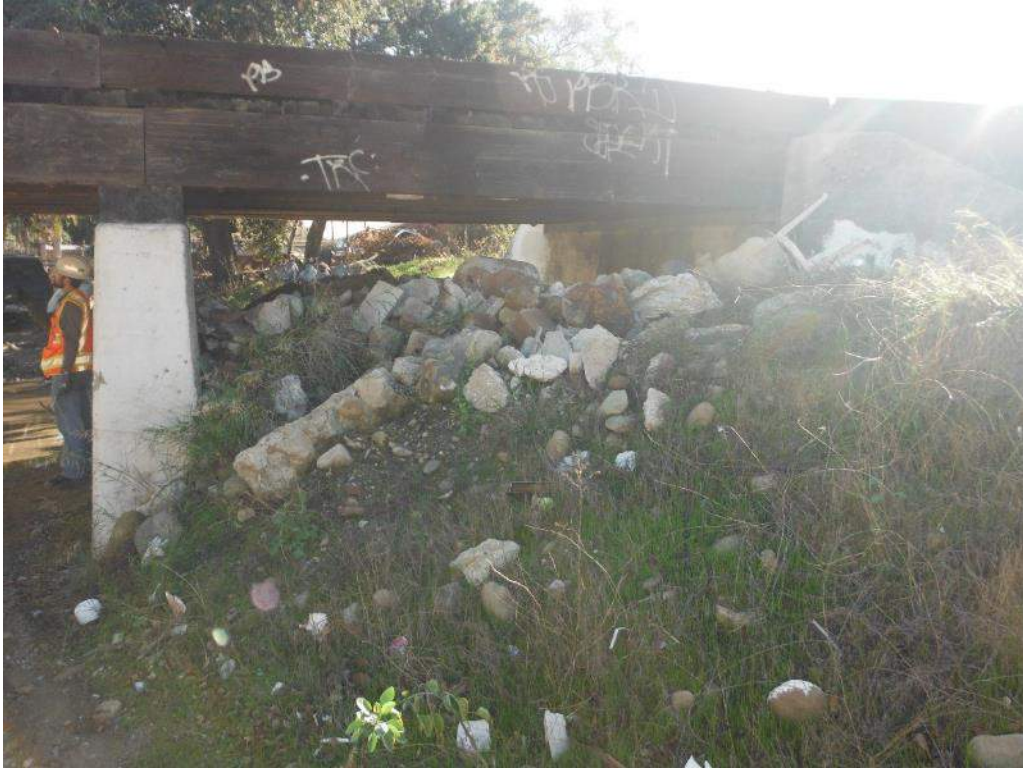
**415.69 Debris under Span 1**

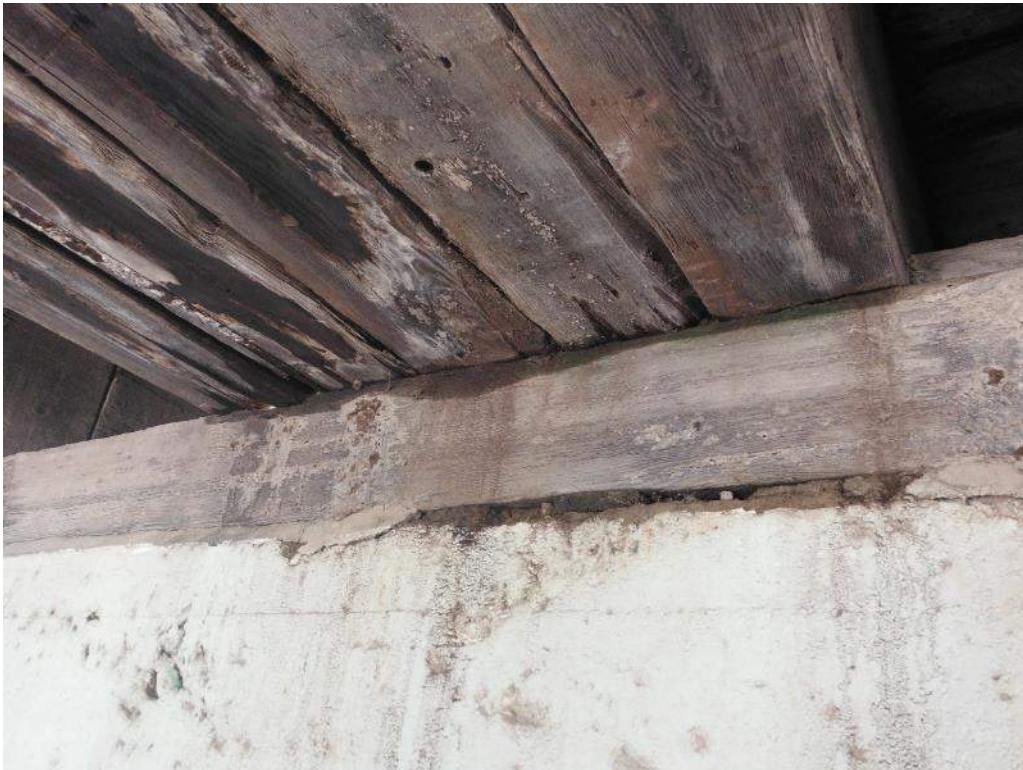
**415.69 Stringer 11 crushing - Pier 2**

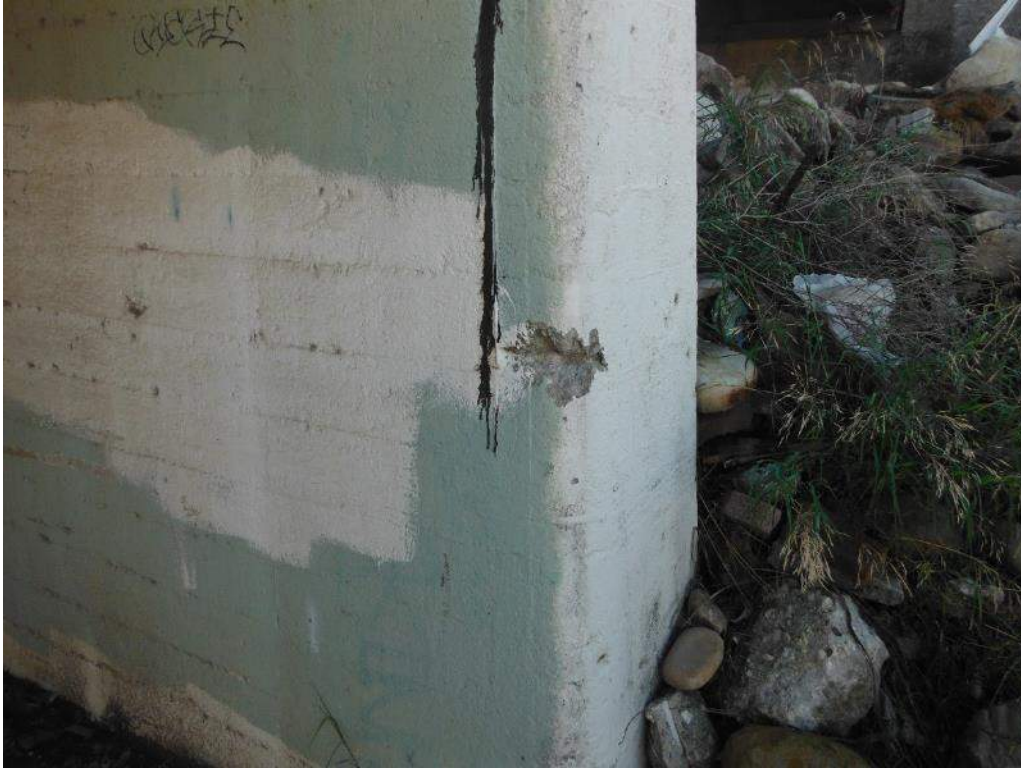
**415.69 Spall North Side of Pier 2**

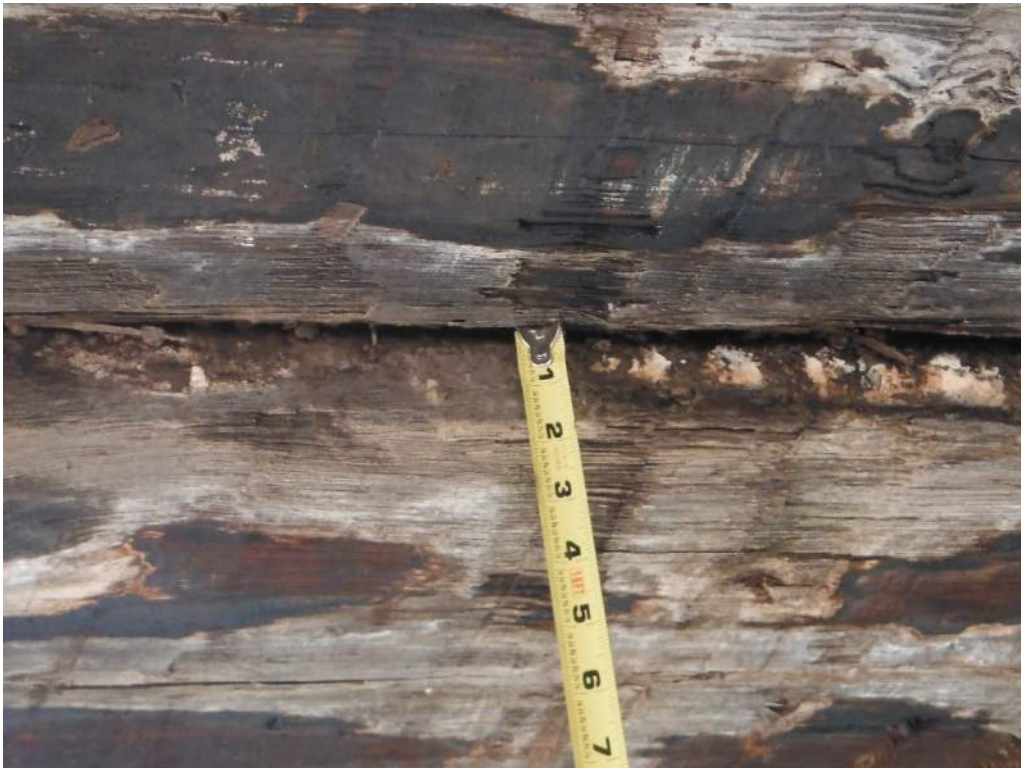
1. SP - Minor spalls on pier - see photo
2. Signs of minor hits on chord and ballast stringer - see photo
3. Dec - Ballast planks between chord are showing signs of decay
4. HW - Stringers #3 and #8 are hollow
5. Deck plank rotten with hole - see photo
6. Spl - Stringer #7 and #11 longitudinal split and bulging
7. Fail - Stringers #10 and #11 are failed
8. Stringer #10 deflected 1.75" - see photo

**415.69 Stringer 10 deflected 1.75" – Span 2**

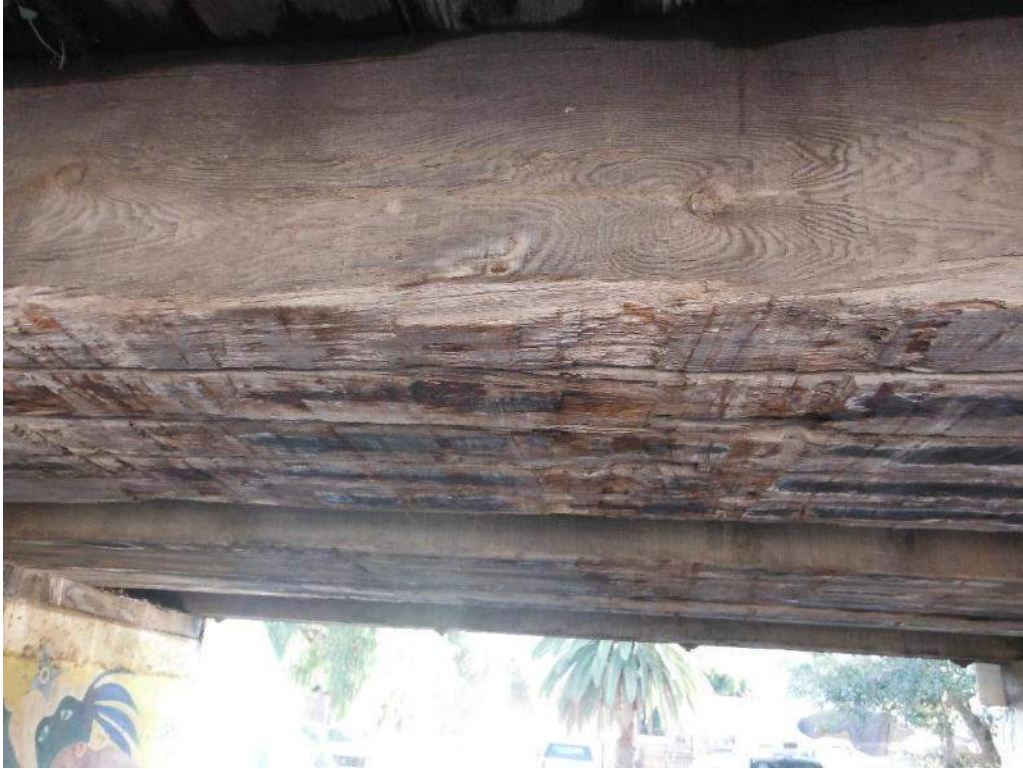
**415.69 Impact damage on stringers (typ.)**

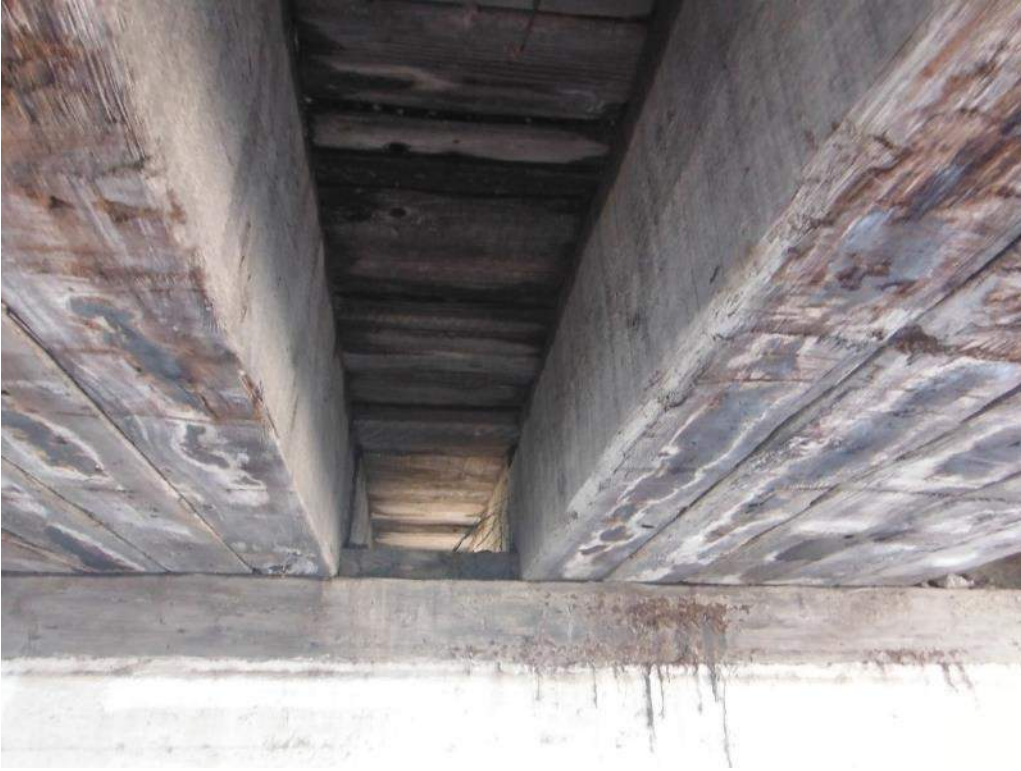
1. Stringers show signs of impact
2. Dec - Ballast planks show signs of decay with ballast showing in holes - see photo
3. Update clearance signs to 6'-10"
4. Stringers #8 & #11 hollow near pier #3
5. Stringer 6 rotated 1" - see photo
6. Spall North side pier #3
7. Stringer #10 is failed and deflected 0.5"

**415.69 Stringer 6 rotated 1" at Pier 3 & Abutment 4**

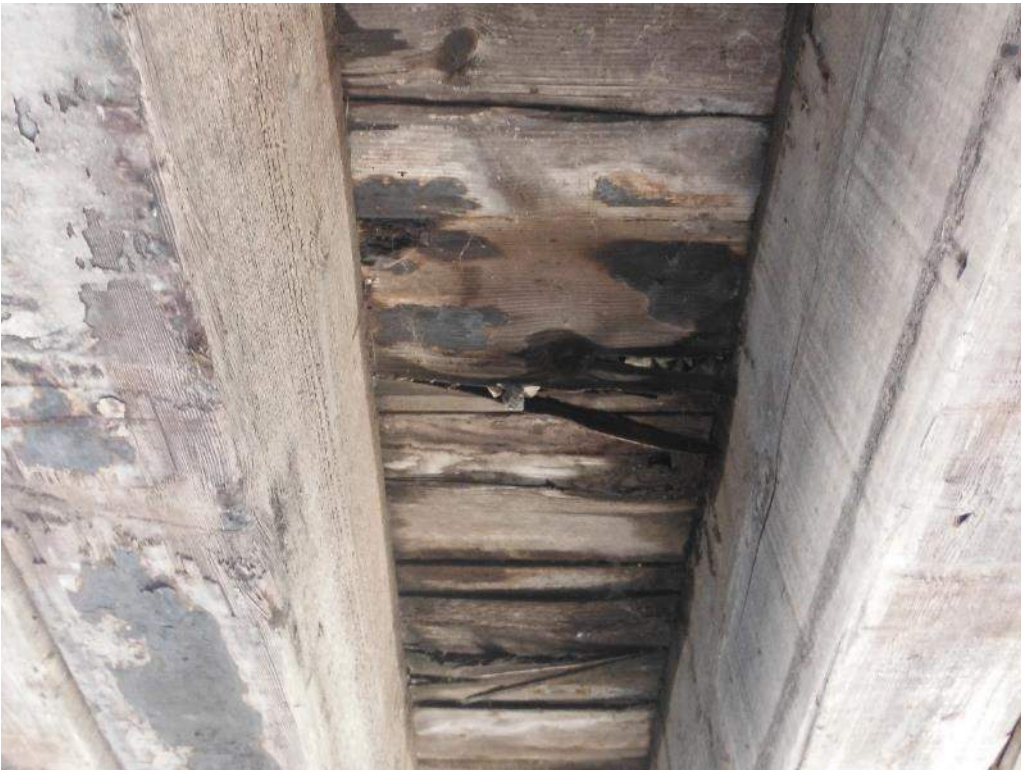
**415.69 Decay of deck ballast plank. Mid-span, Span 3**

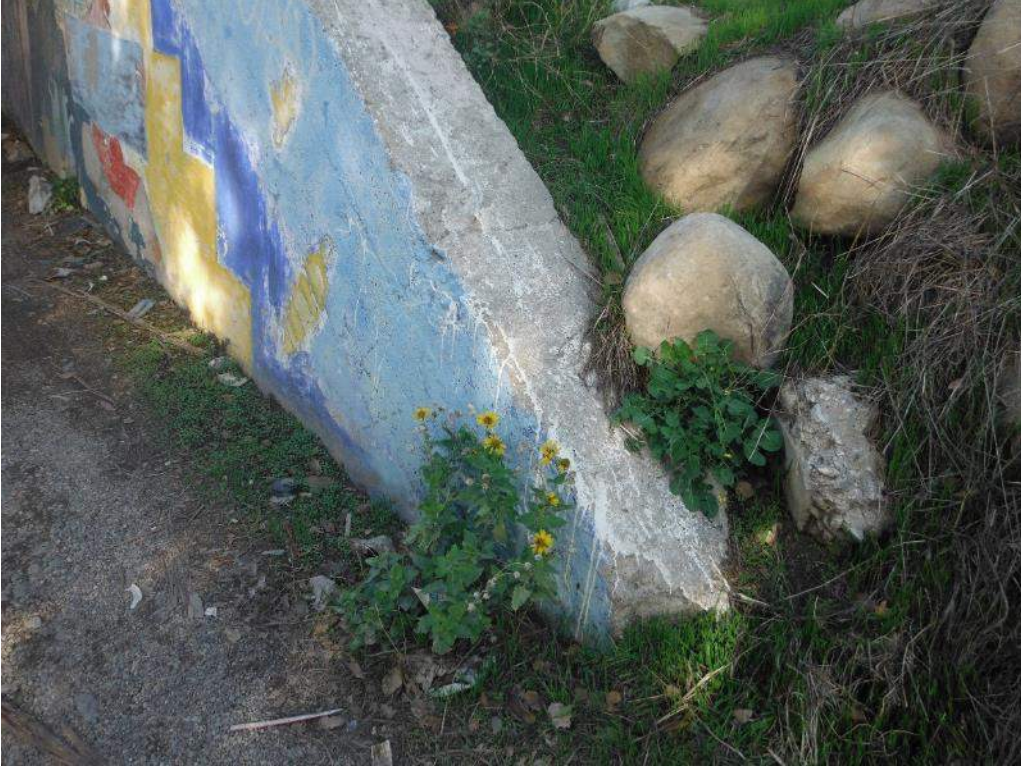
**415.69 Spall on wingwall at abutment 4**

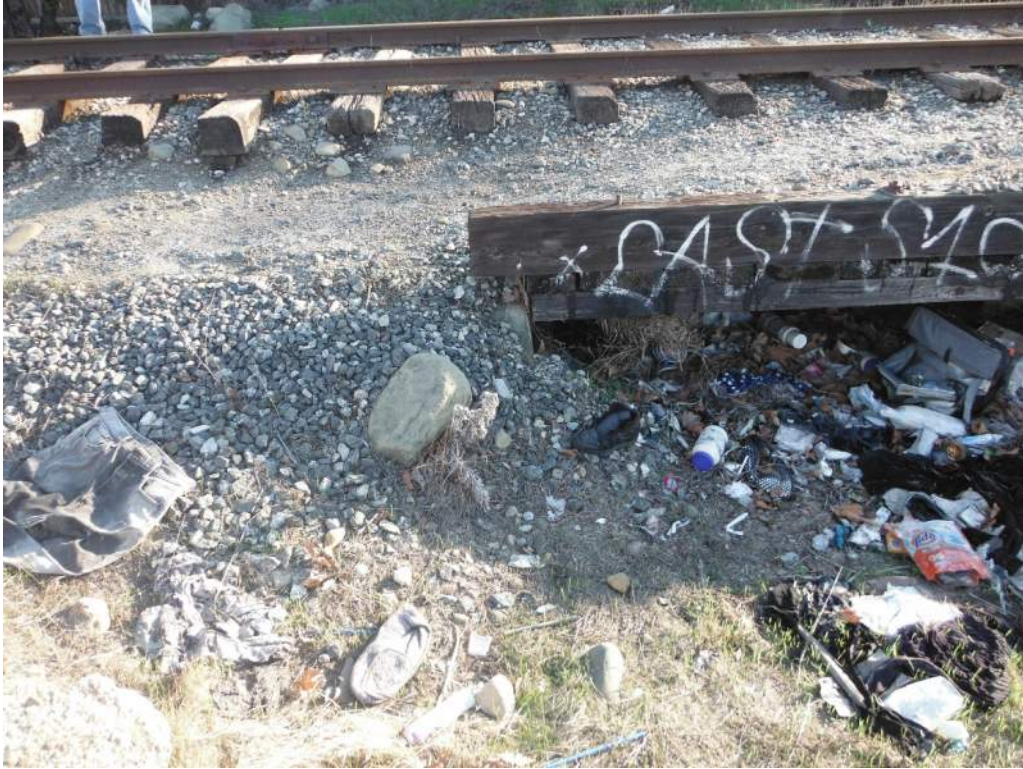
**415.79 Low ballast – East approach**

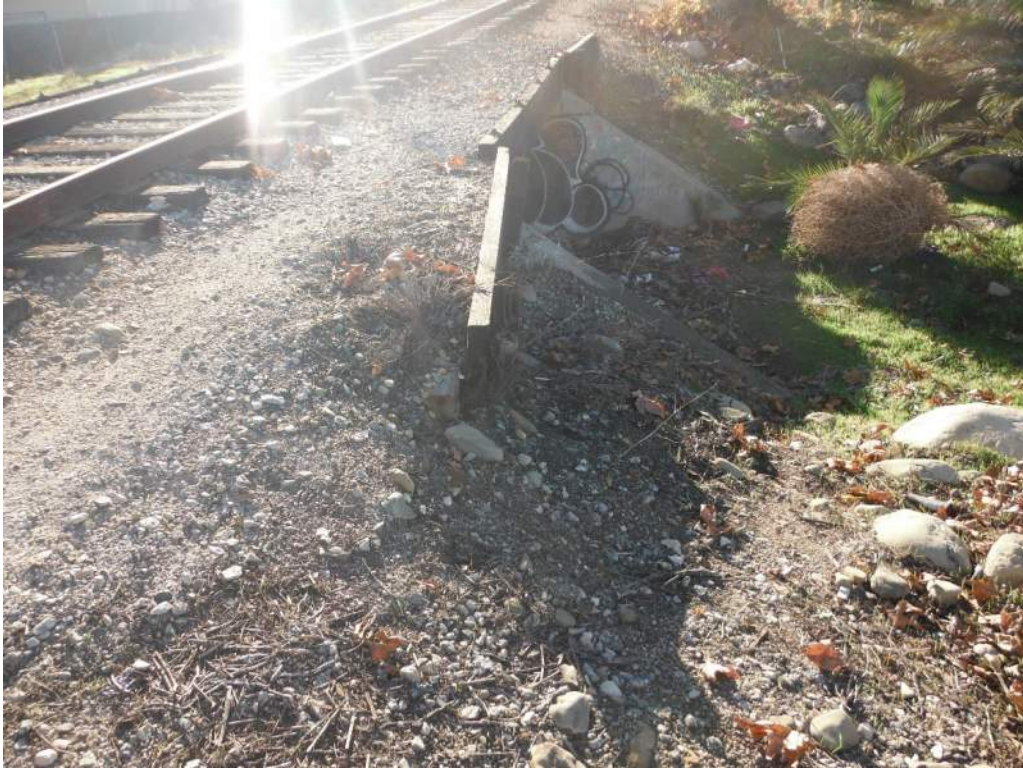
**415.82 North ballast retainer leaning**

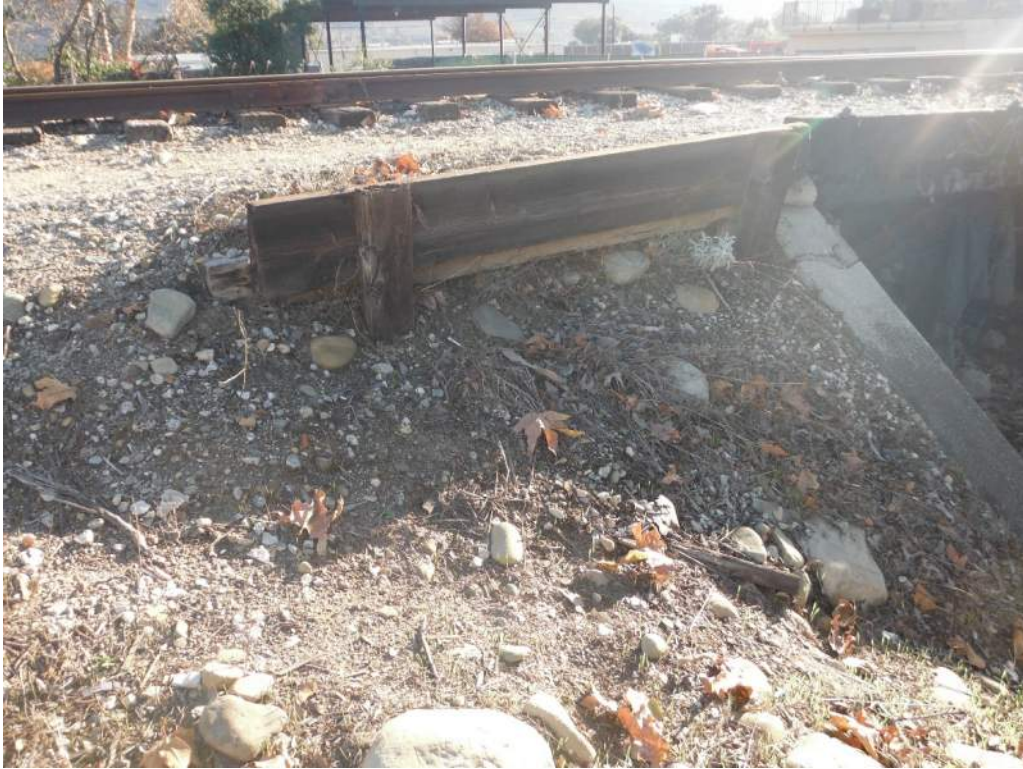
**415.82 Wingwalls undermined – typical all 4 corners**

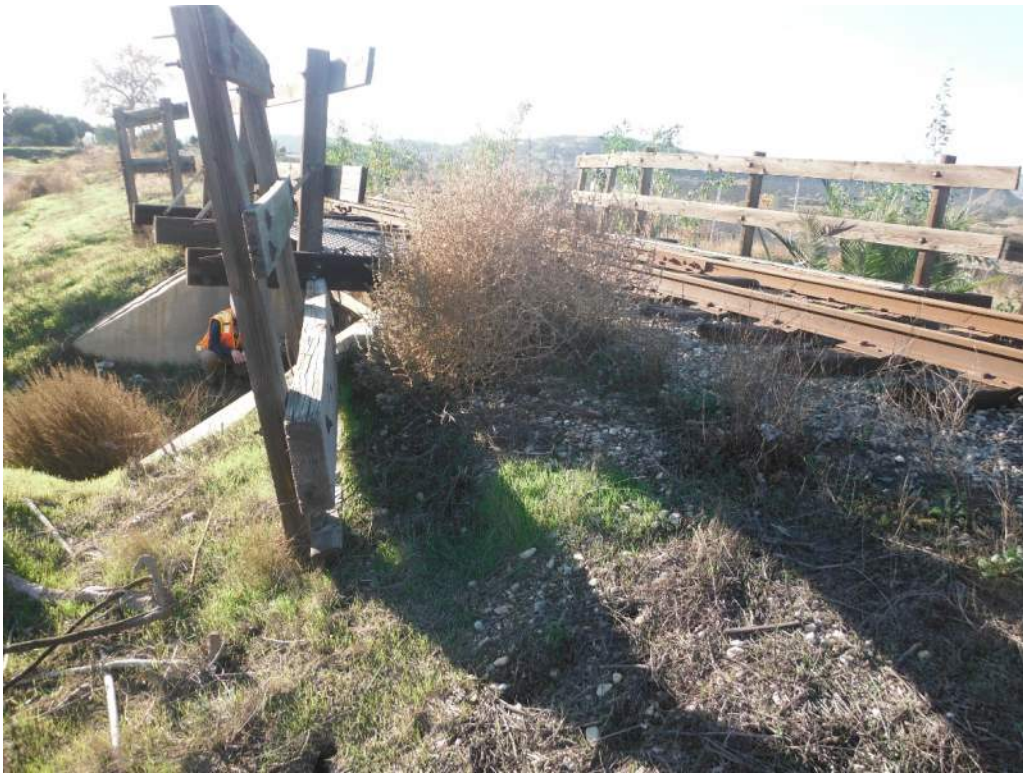
**415.92 Handrail leaning – all 4 corners**

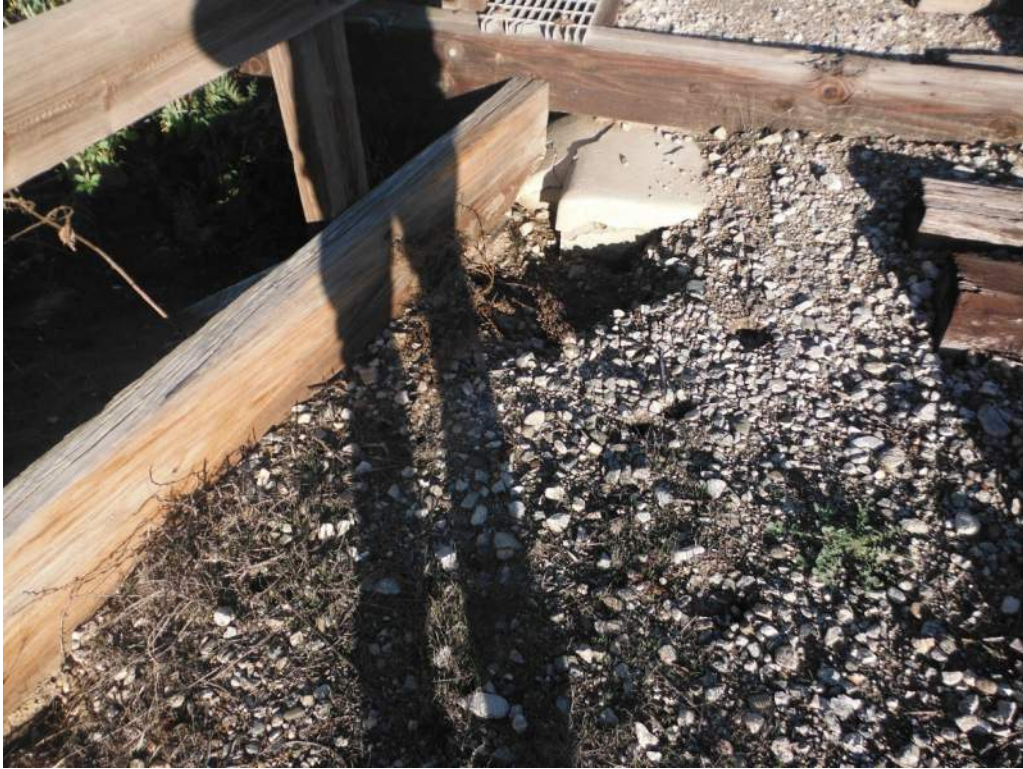
**415.92 NW wingwall leaking**

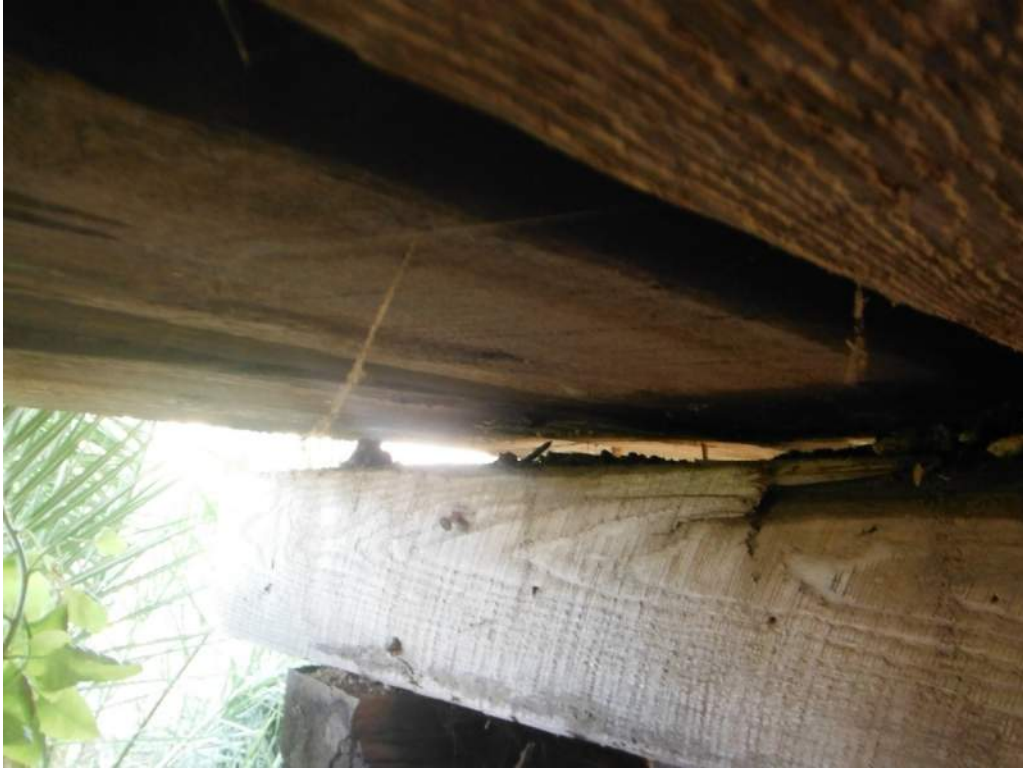
**415.92 Helper bents not shimmed to stringers – both spans**

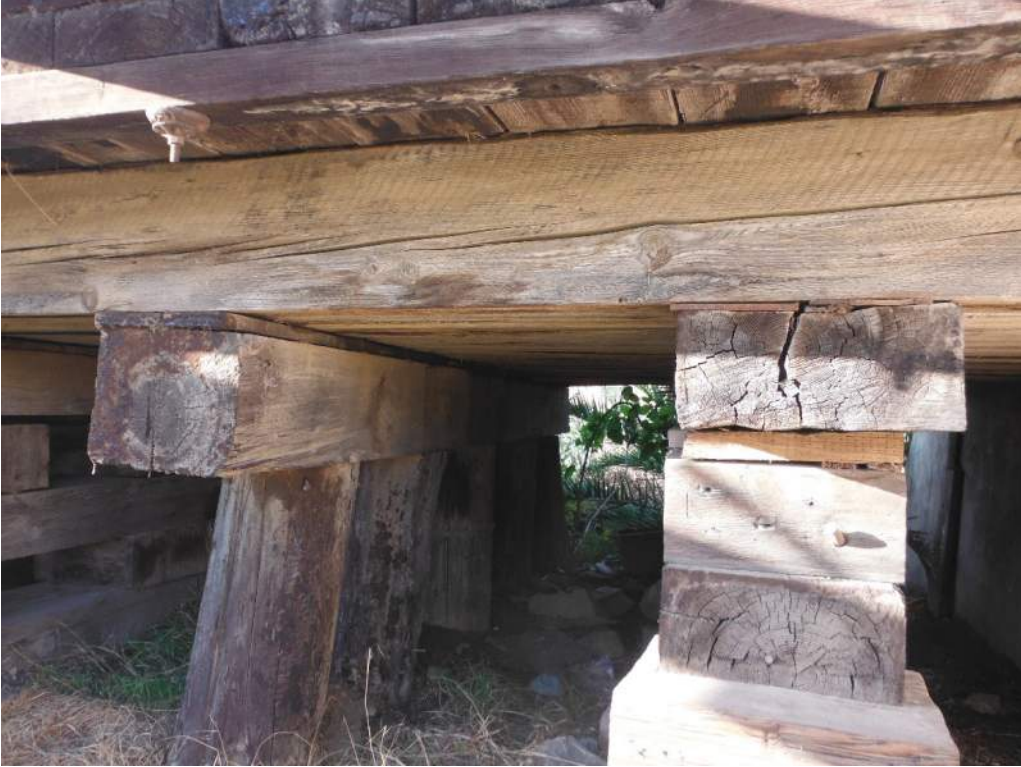
**415.92 Stringer 12 deep checking**

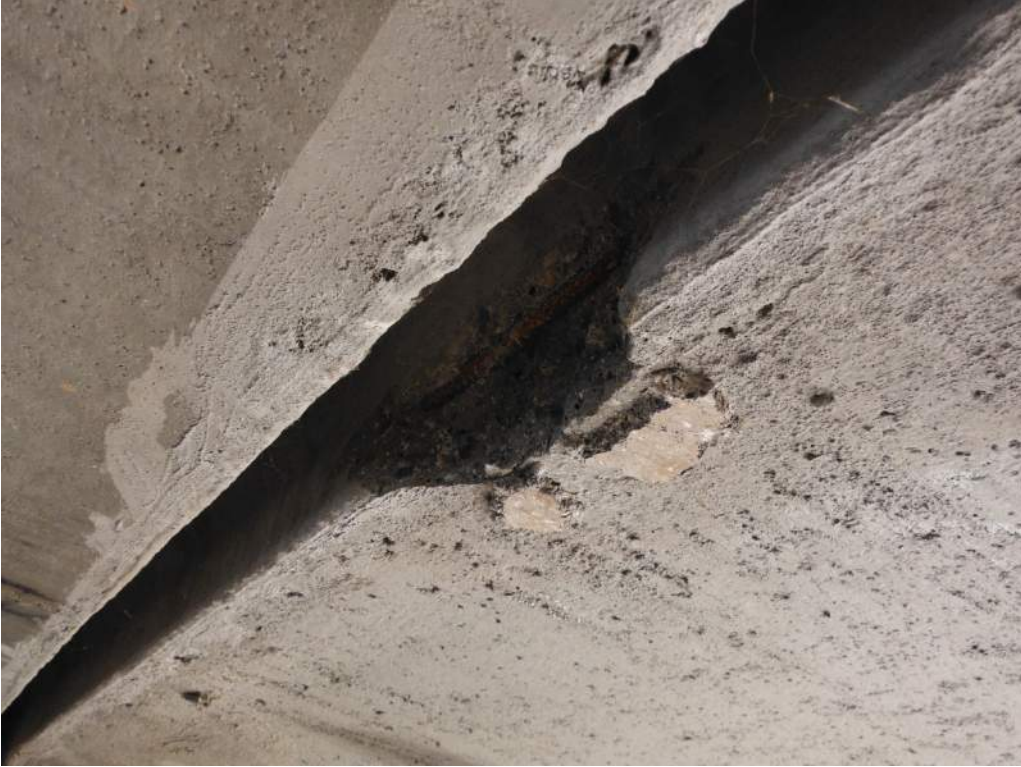
1. Concrete spall at joint on underside of top slab, cell 3. Rebar exposed. See photo
2. All interior joints need to be grouted
3. Soil cover above structure is between 3' to 4'
4. Needs handrail along headwalls

**416.21 Cell 3 concrete spall on underside of top slab. Rebar exposed**

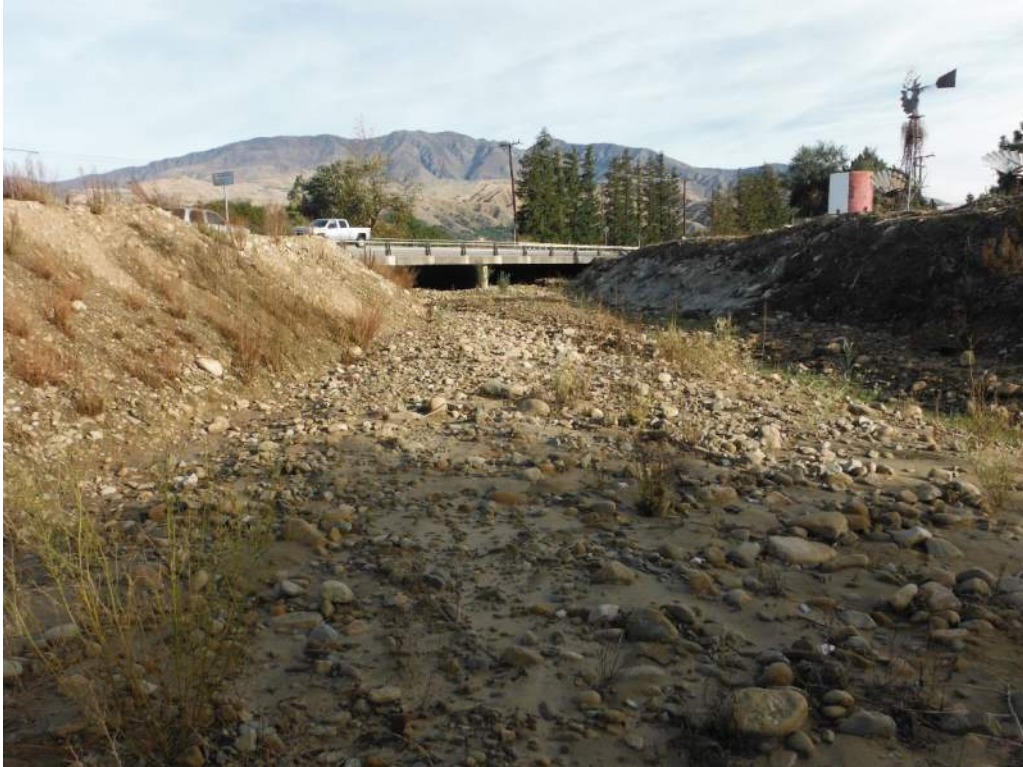
**416.32 Channel condition. Looking Upstream**

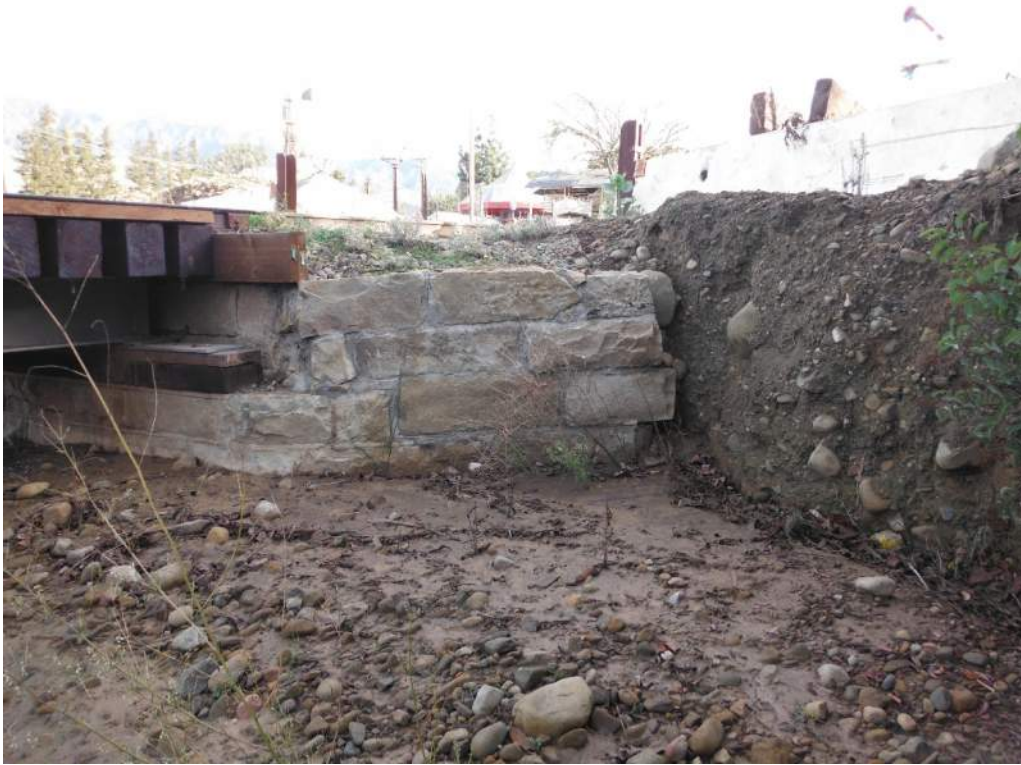
**416.32 Erosion around wingwalls (typ.)**

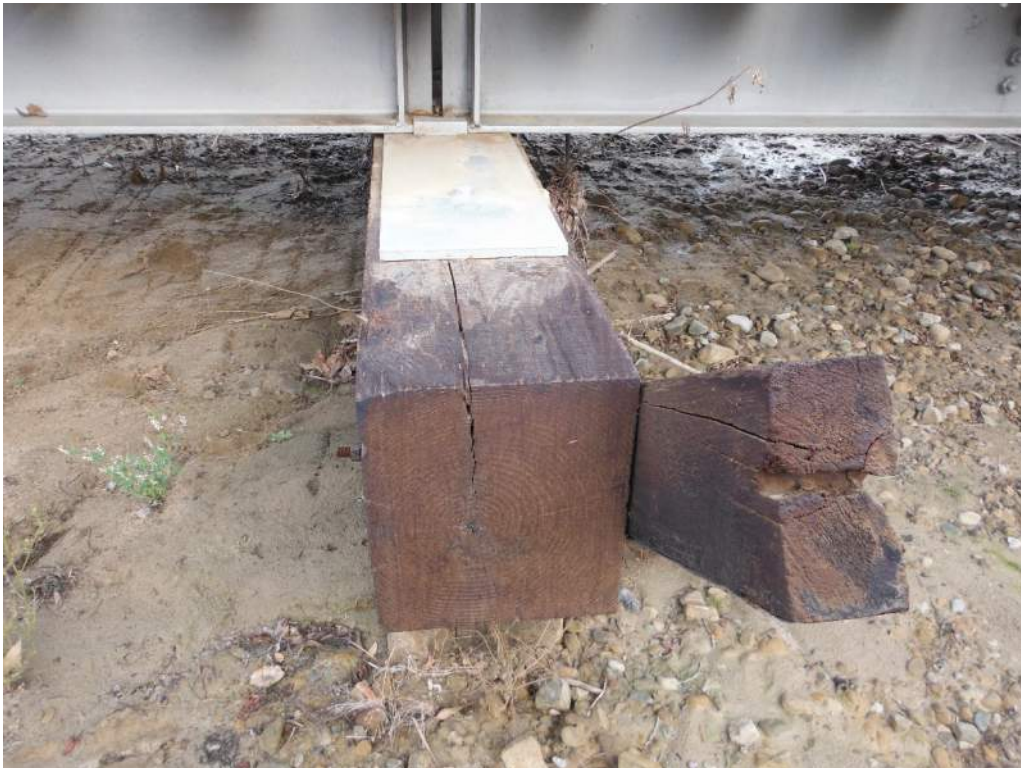
**416.32 Vertical split in cap – Pier 2**
