# BRIDGE INSPECTION REPORT

INSPECTION TYPE: Annual

Milepost 407.48  
 Location Santa Paula Branch Line  
Saticoy, CA  
 Stream X Overpass        Other         
 Train Operating Speed: Freight: 10 mph Passenger: 15 mph

MAINLINE/SUBDIVISION: VCTC

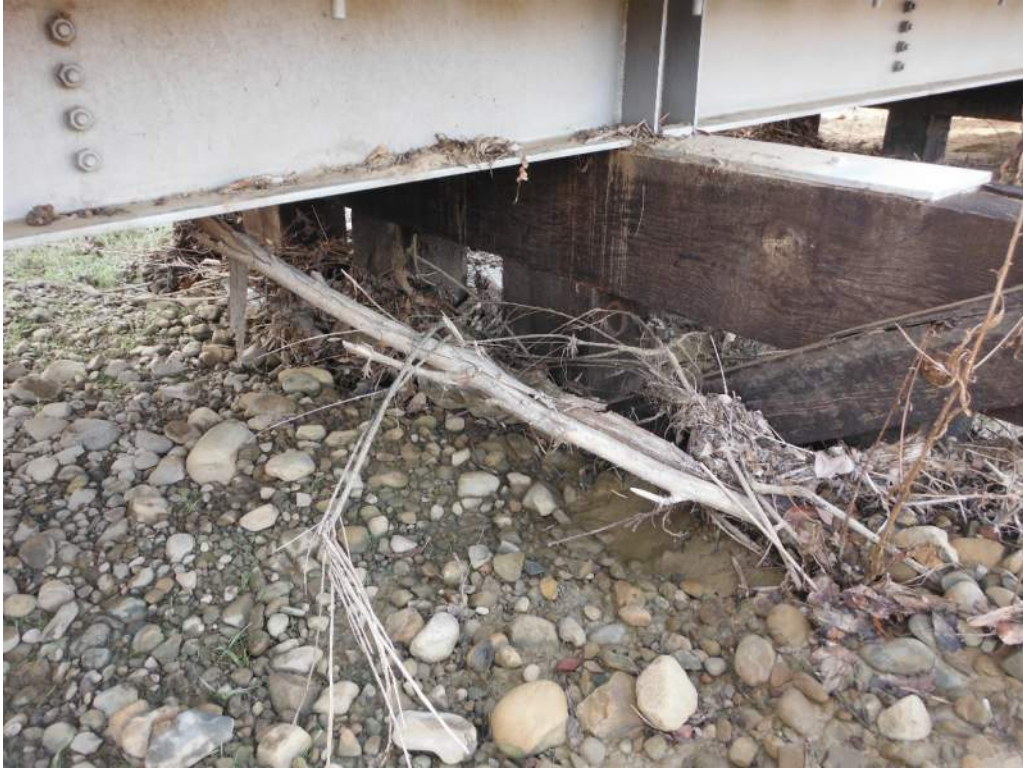
**416.32 Debris on piles – Pier 2**

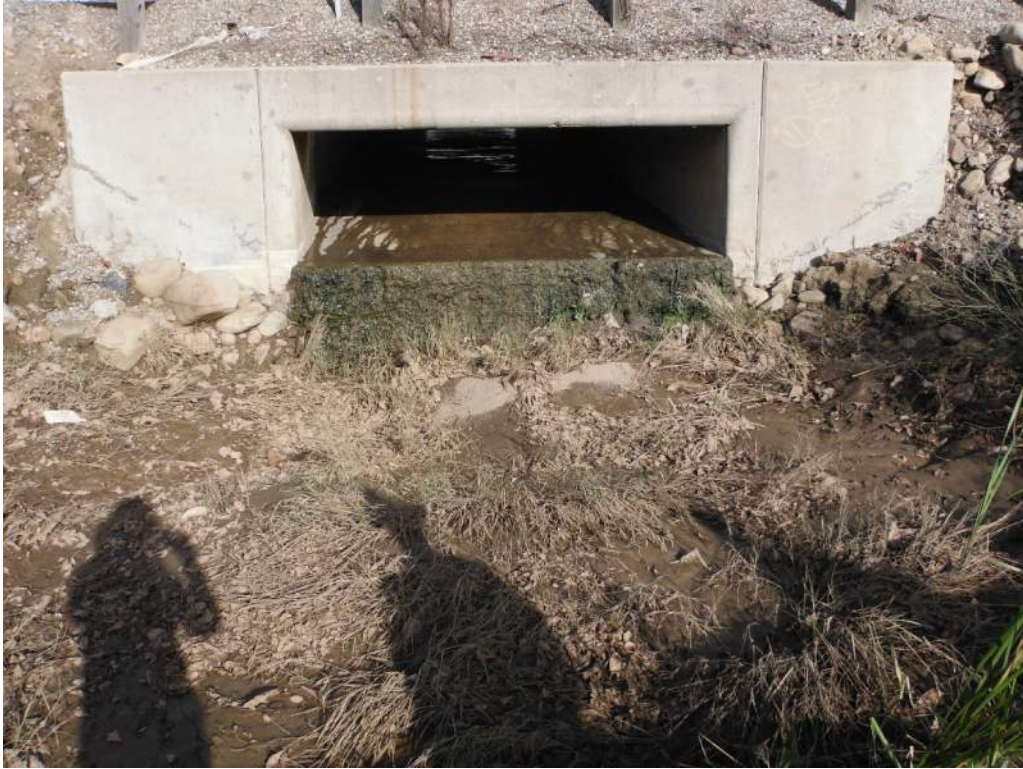
Visual Condition Rating 5  
 Stream Depth \_\_\_\_\_ Scour Evidence Yes Moving Water No  
 Notes 2' Scour at upstream culvert - see photo

**416.63 2' Scour at upstream culvert**

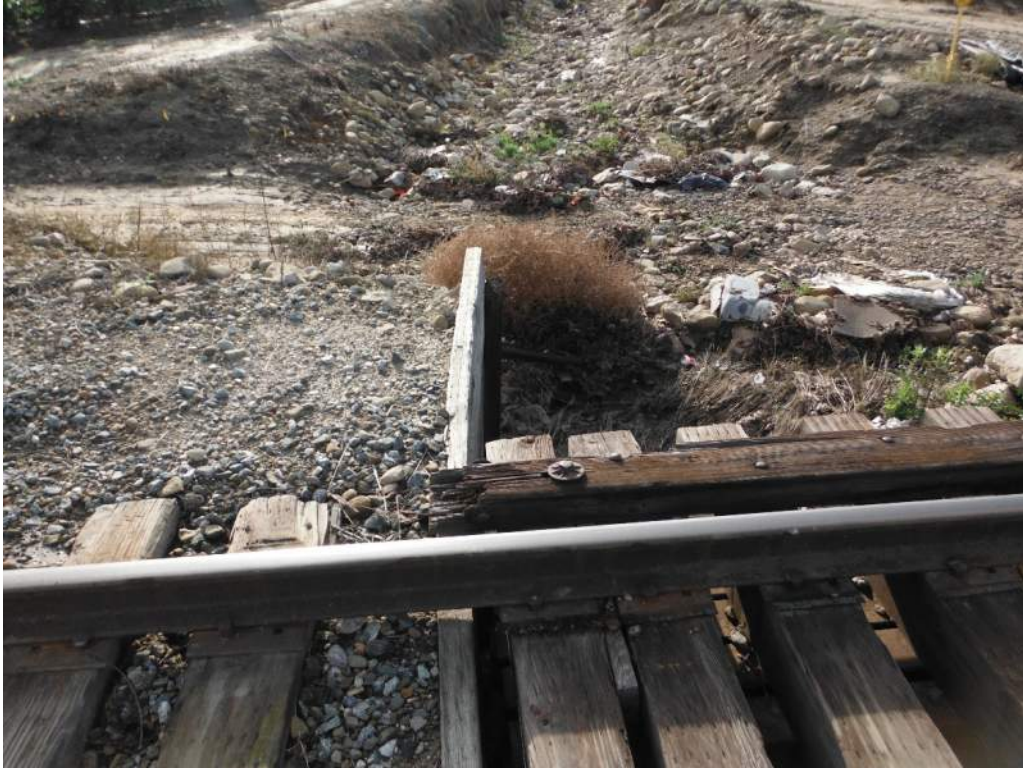
**416.63 Backwall leaning - Abutment 1 & 2**

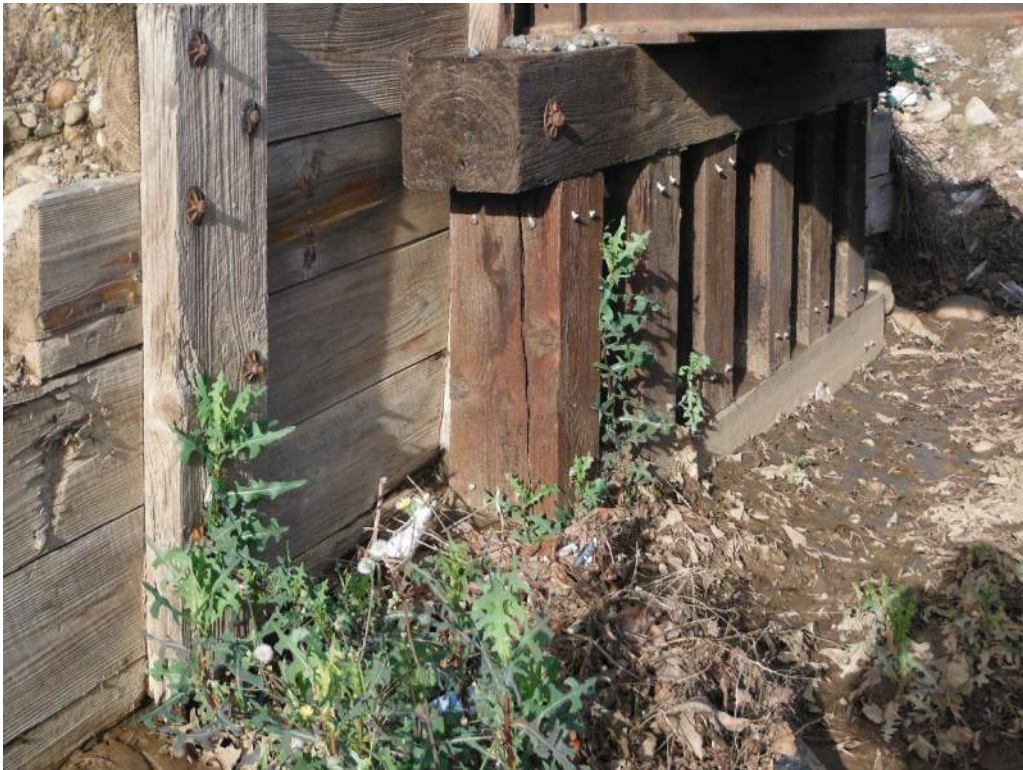
**416.63 Split pile 6 at Abutment 1, typ multiple locations**

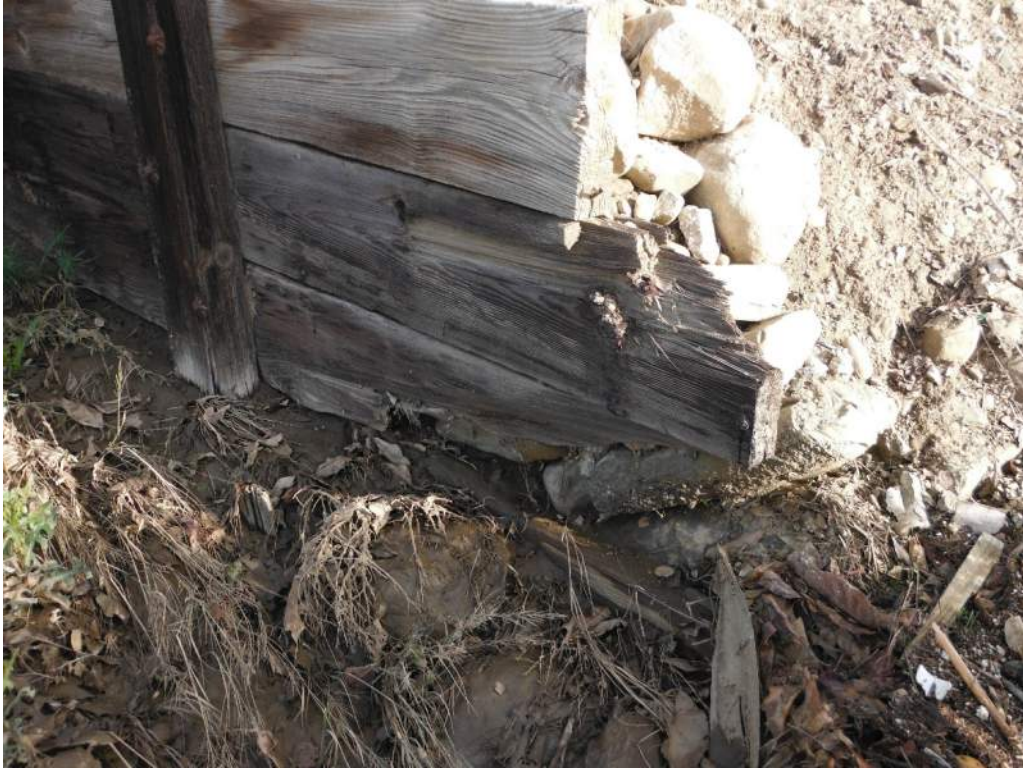
**416.63 Backwall rotting/leaking material at bottom (Typ.)**

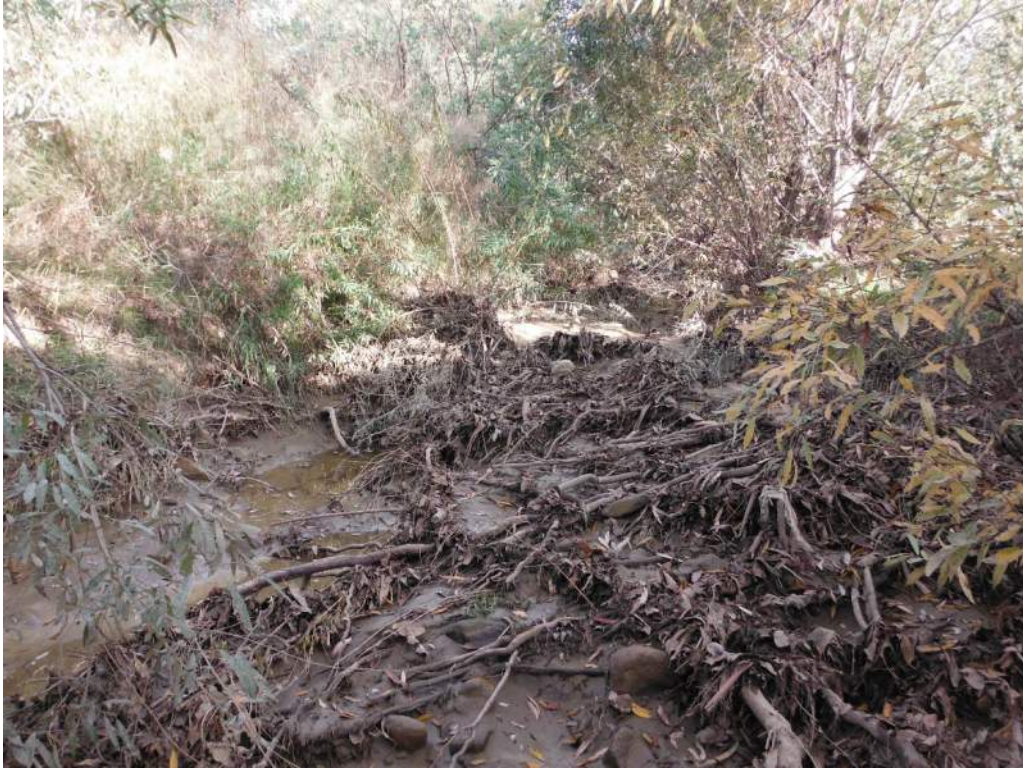
**417.24 Channel Condition – Looking Upstream**

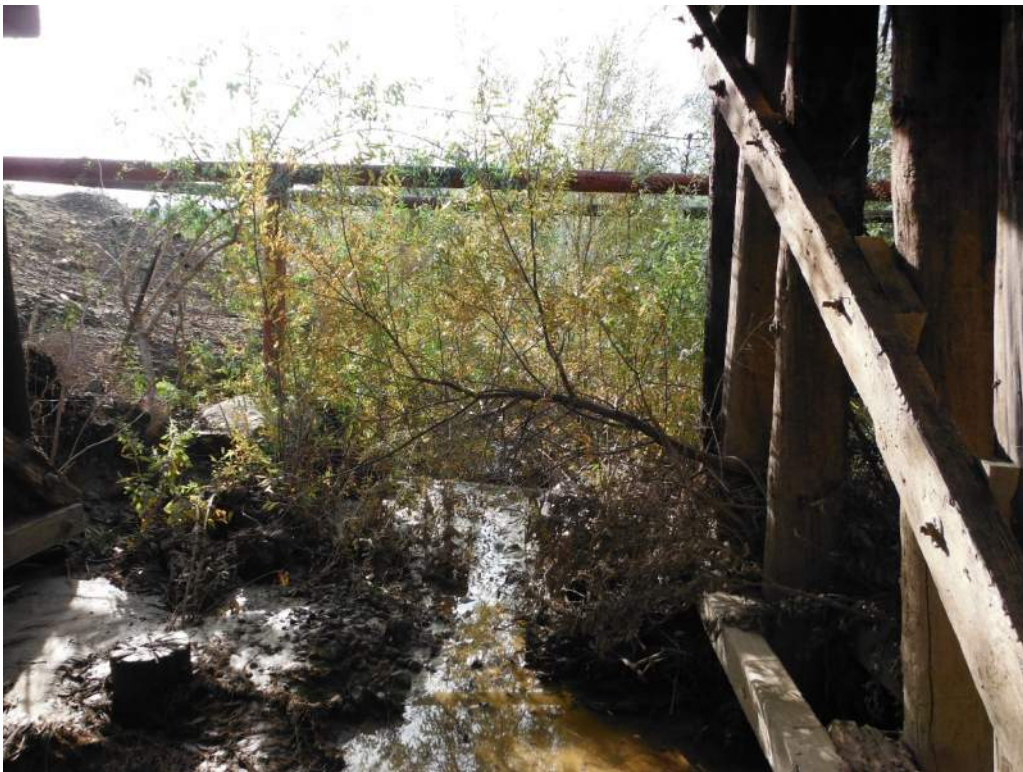
**417.24 Channel Condition – Looking Downstream**

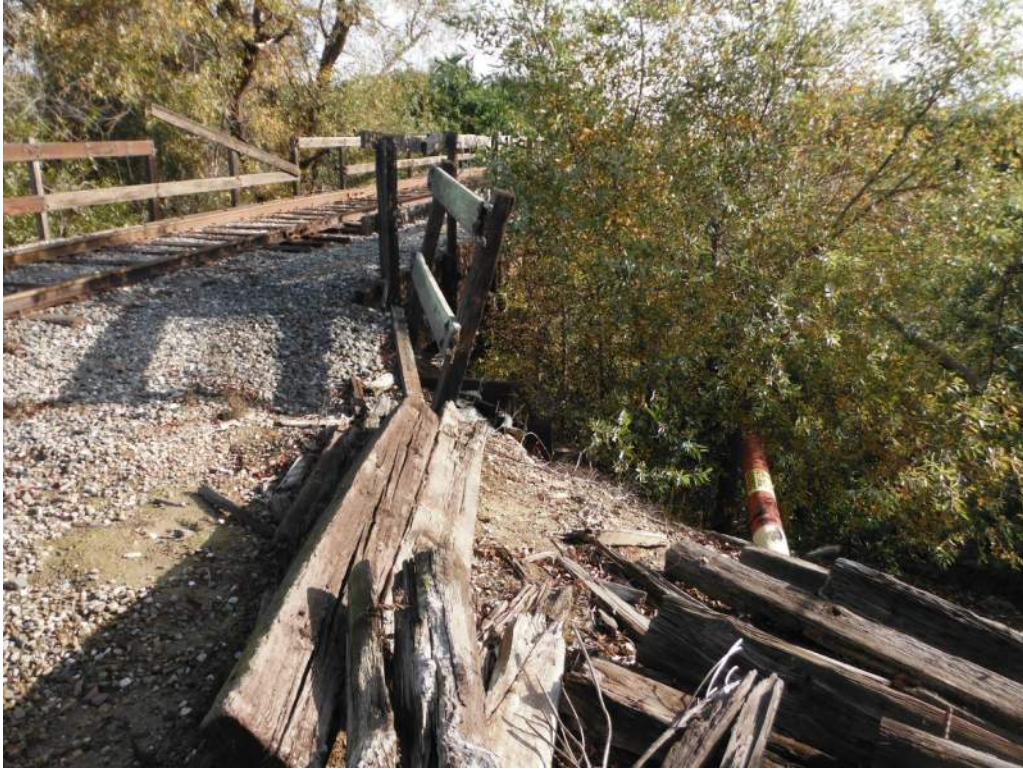
**417.24 Southwest ballast retainer leaning – ballast leaking**

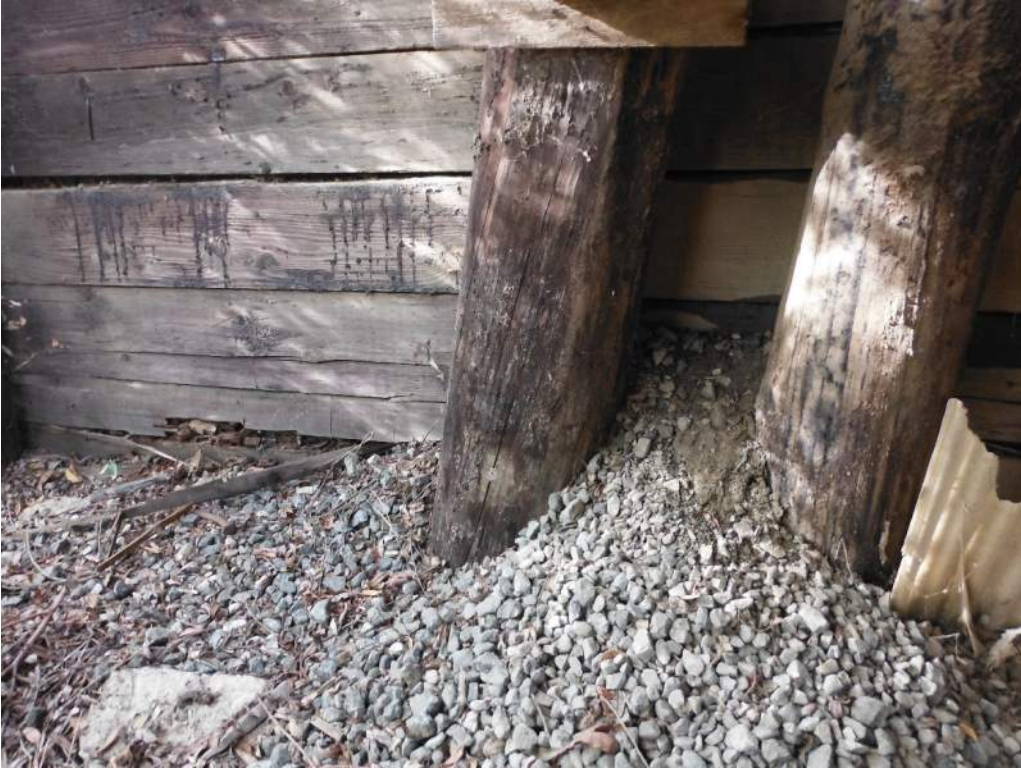
**417.24 Abutment 1 bulging and rotten bottom beam with ballast leaking**

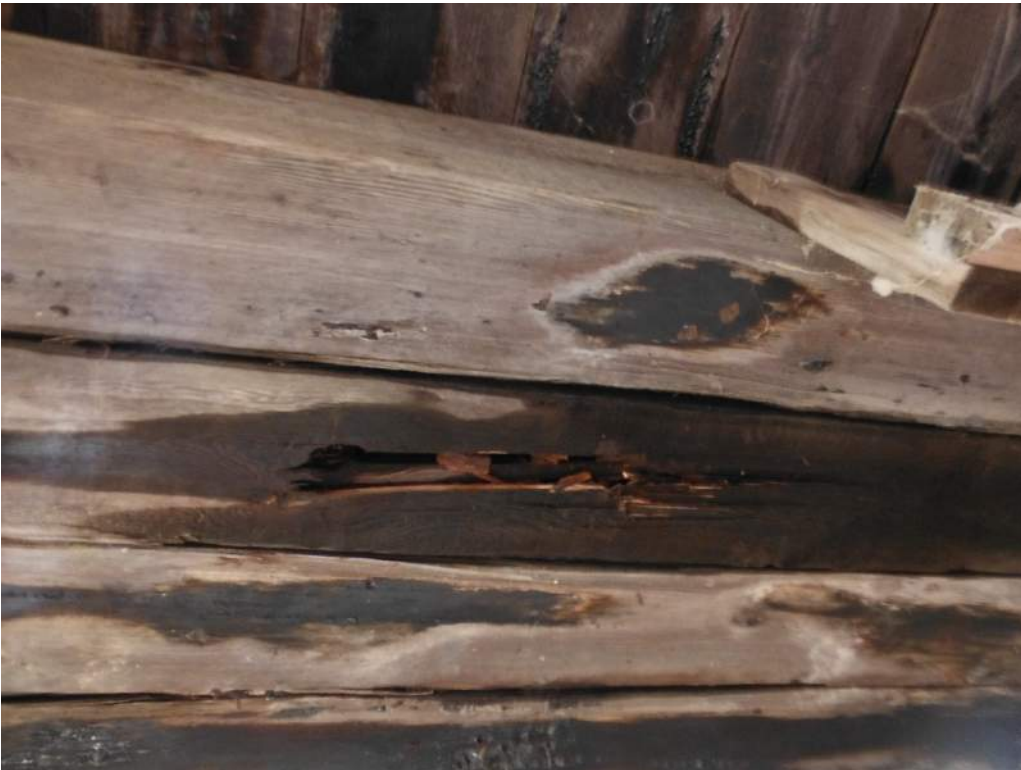
**417.24 Stringer 3 failed, Span 1**

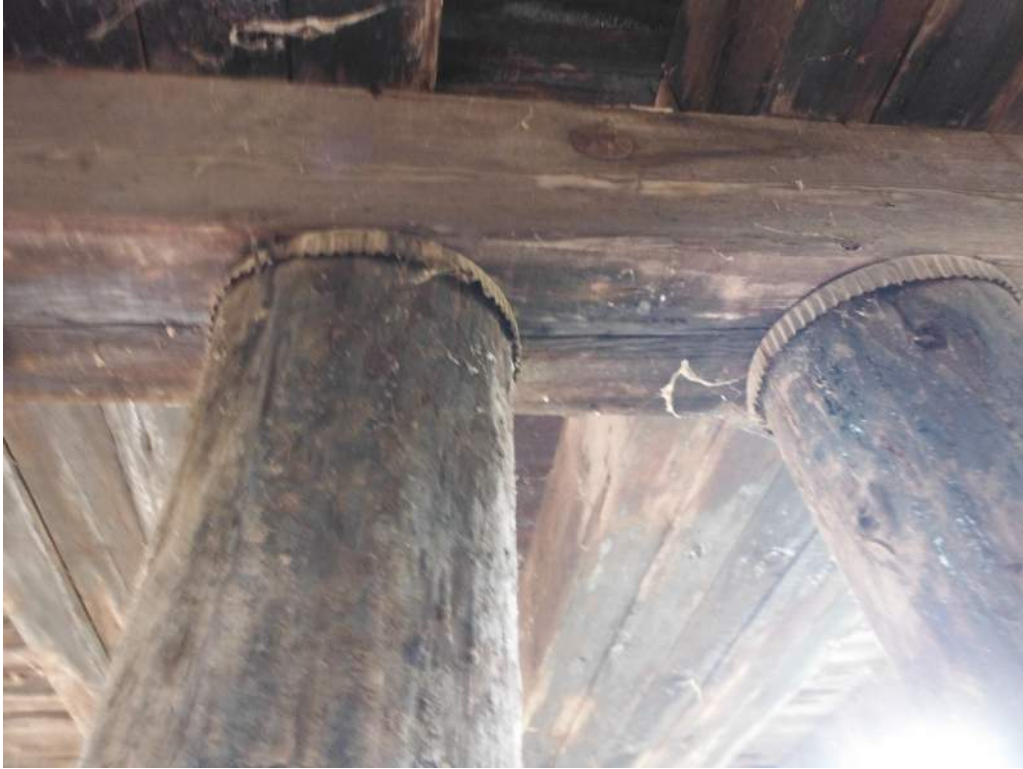
**417.24 Bent 2 cap split**

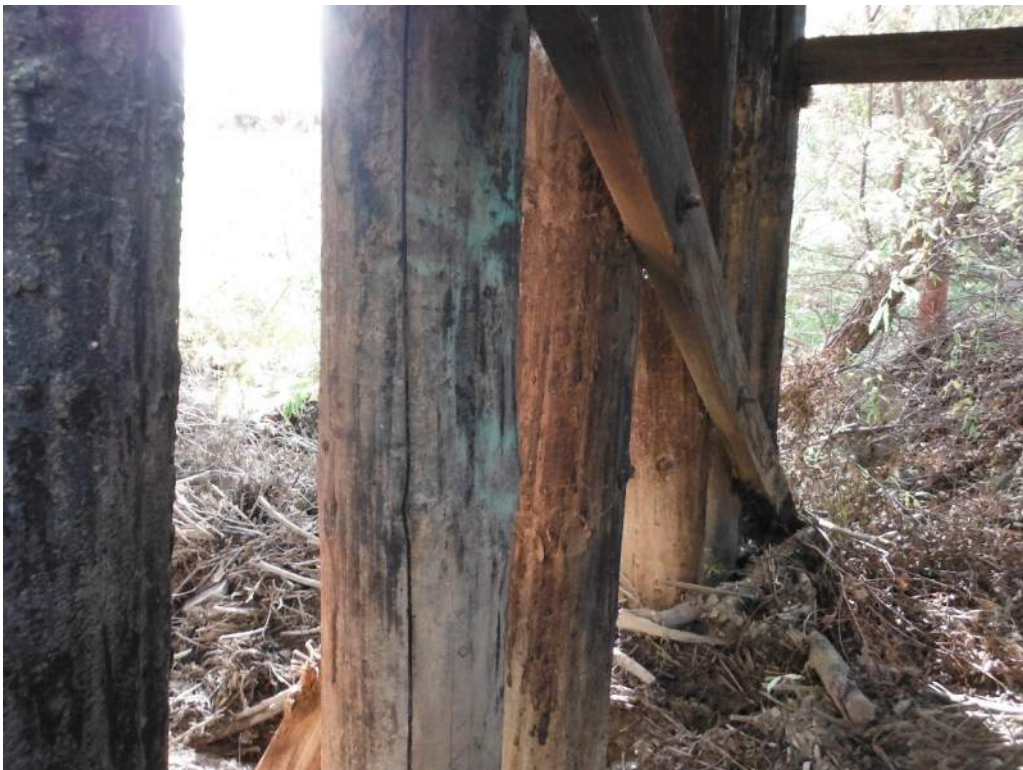
**417.24 Pile 2 split, Bent 2**

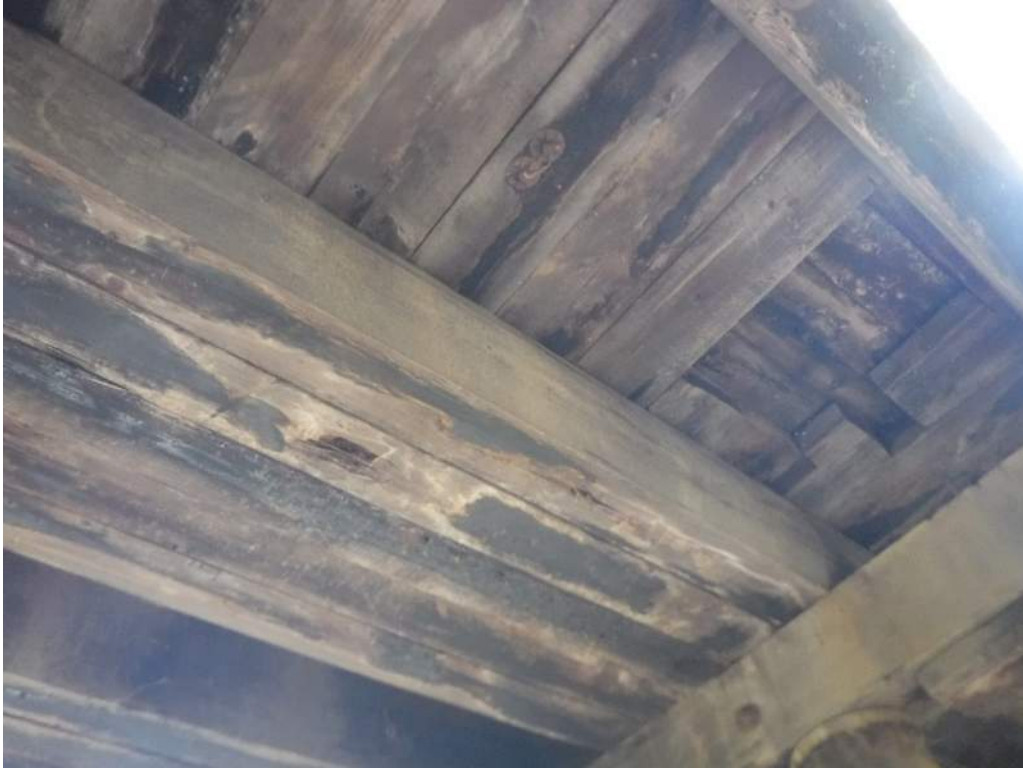
**417.24 Stringer 2 failed, Stringer 3 rotten with 3" hole depth, Span 3**

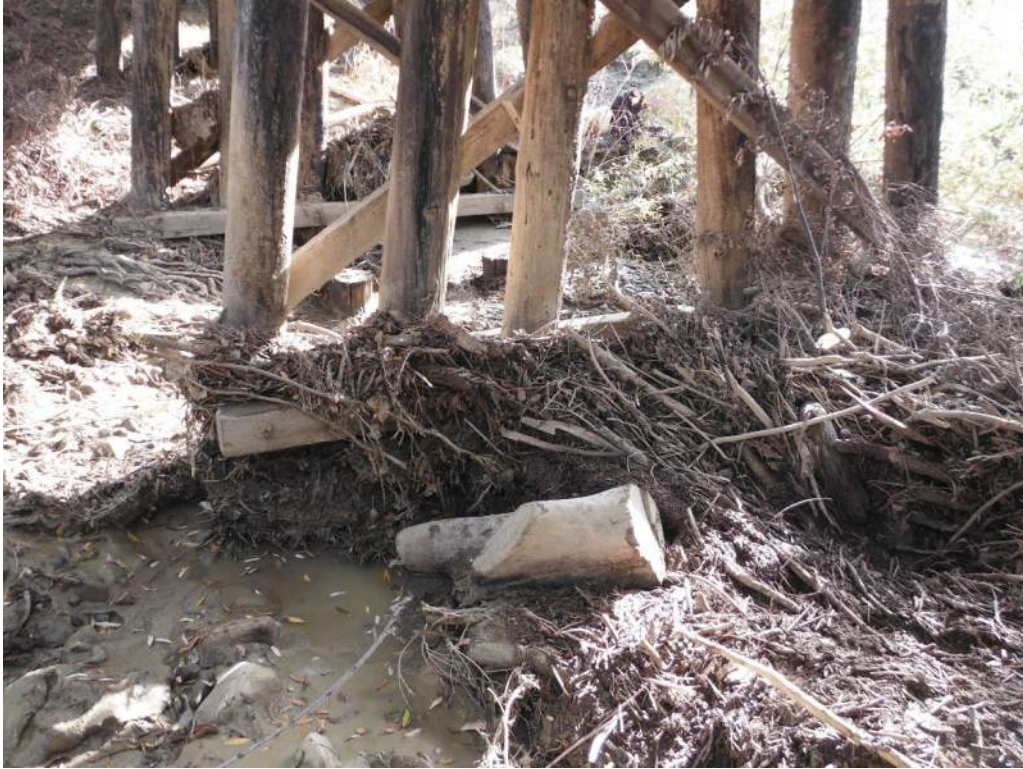
**417.24 Span 3 sash brace covered in dirt and debris at bent 3**

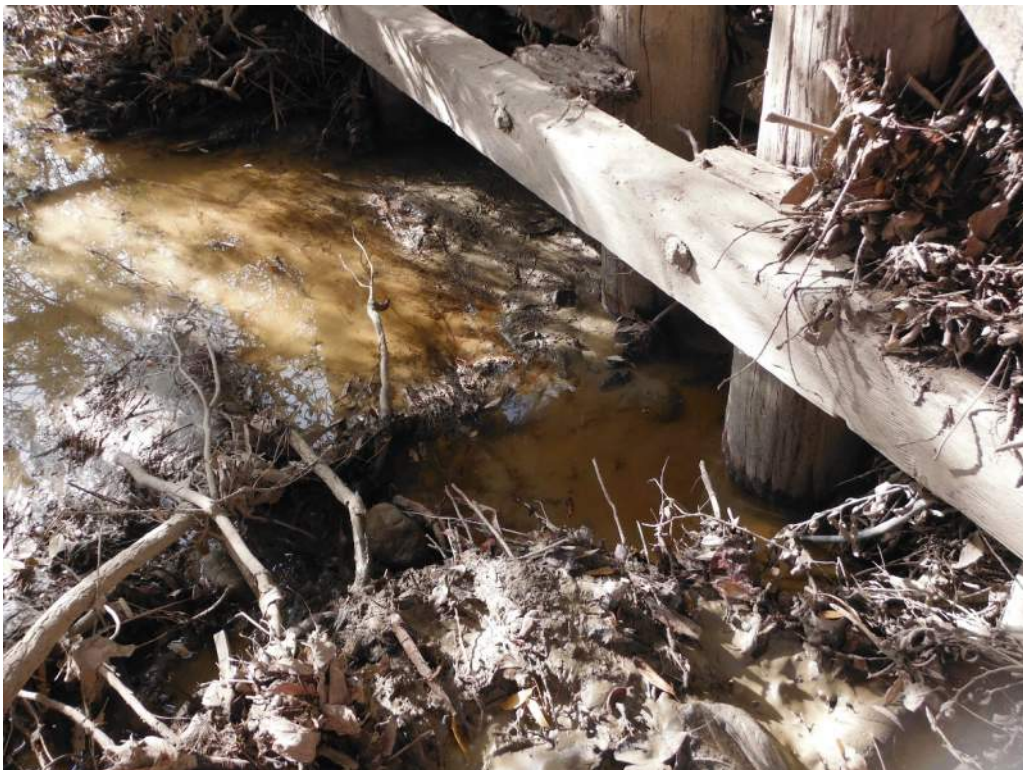
**417.24 Scour hole between bent 3 & 4 – approximately 4'**

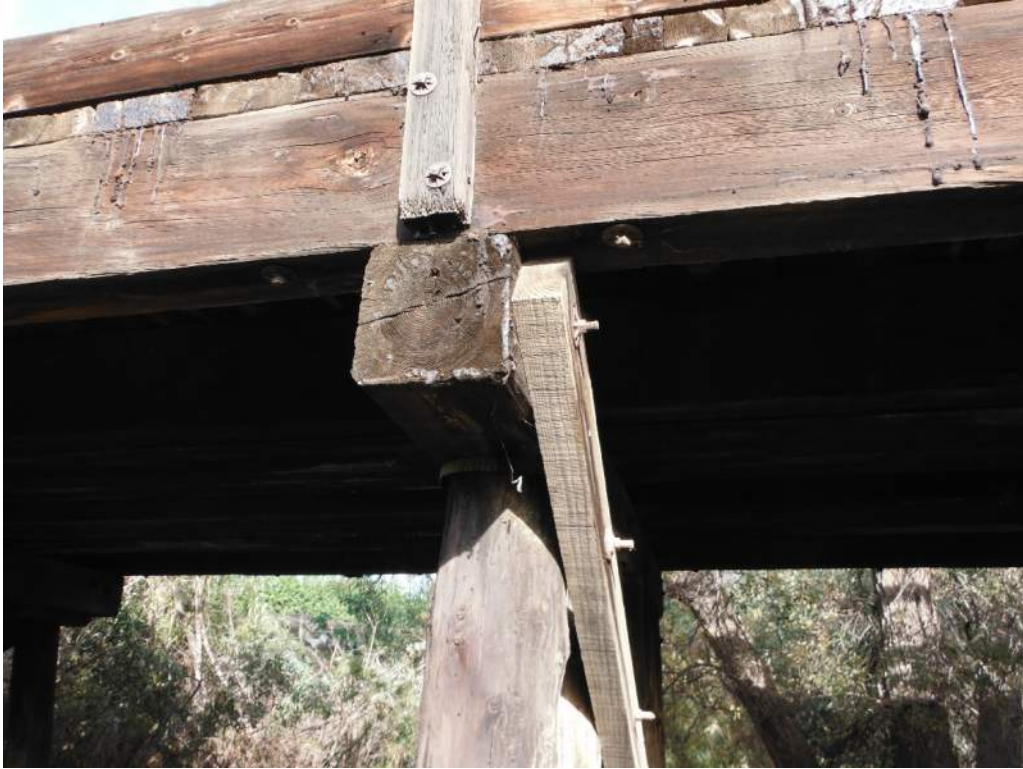
**417.24 Pier 4 cap split**

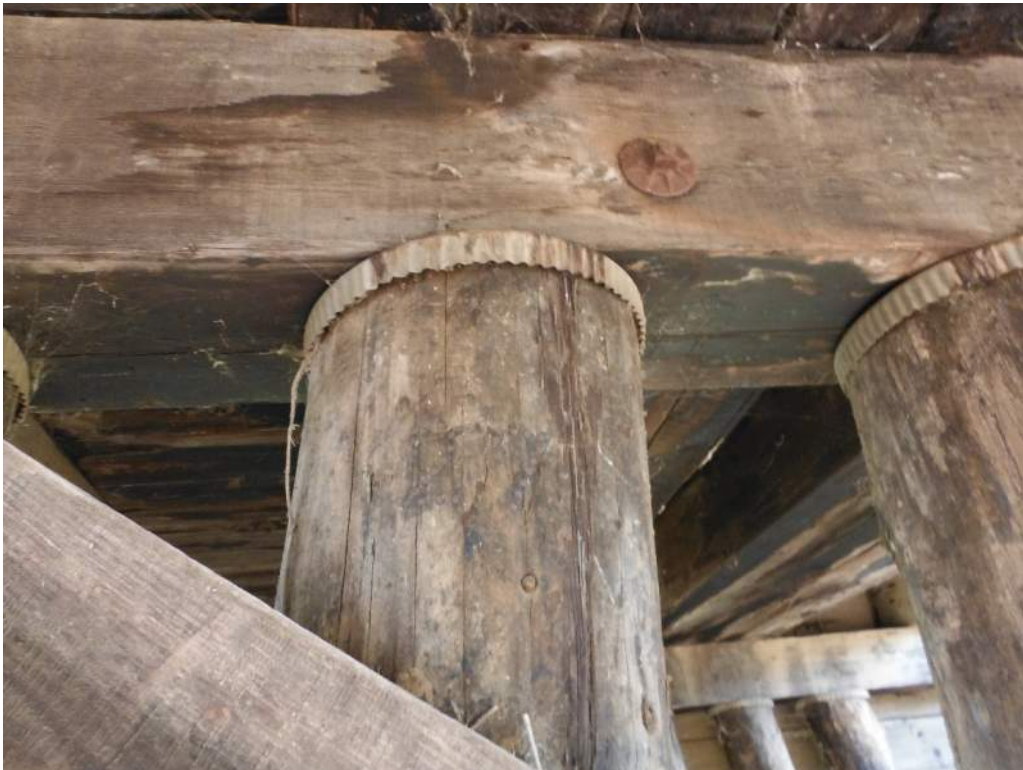
**417.24 Pier 5 cap split**

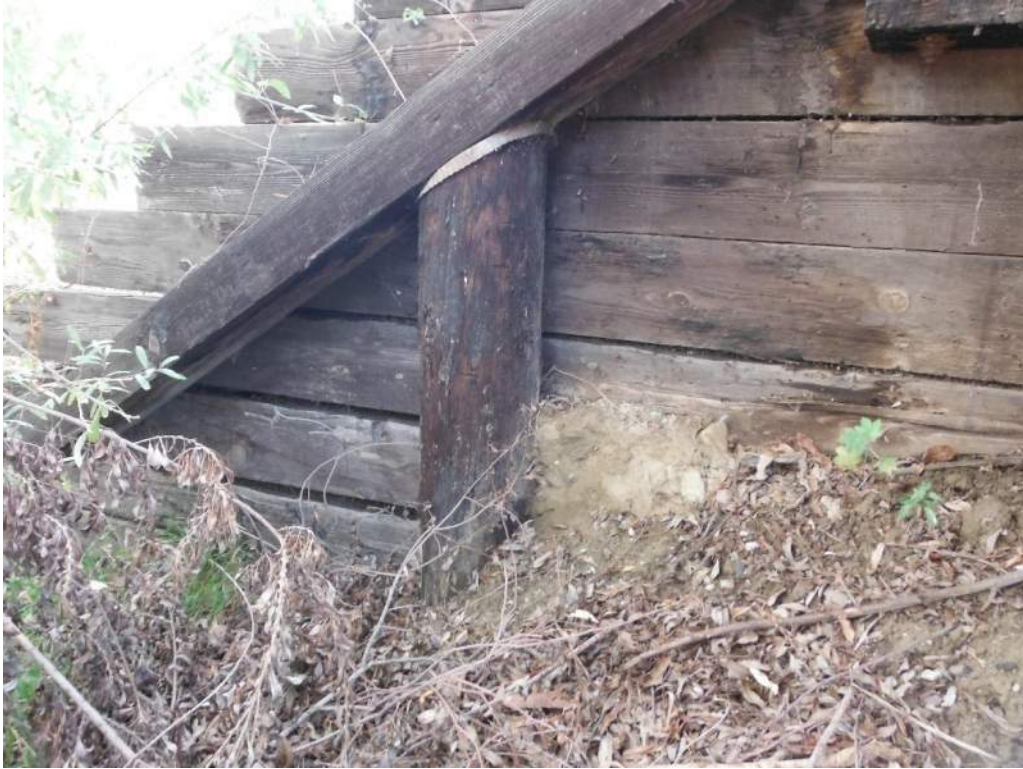
**417.24 Abutment 6 backwall rotten at bottom**

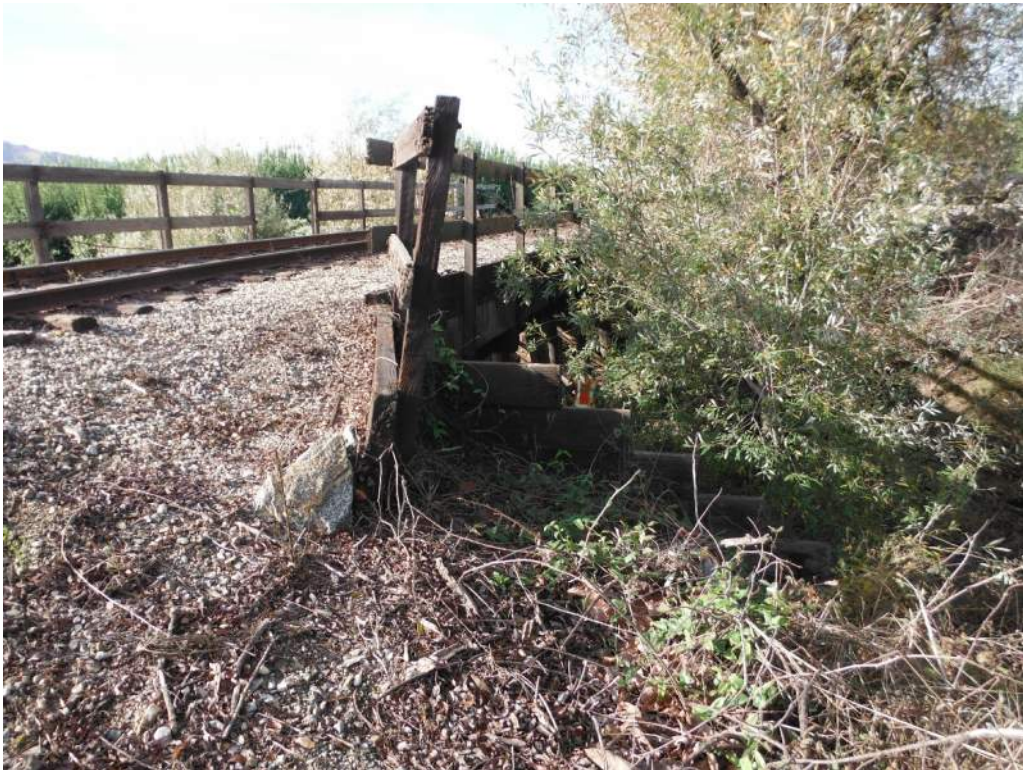
**417.24 Handrail leaning with gap at end of bridge**

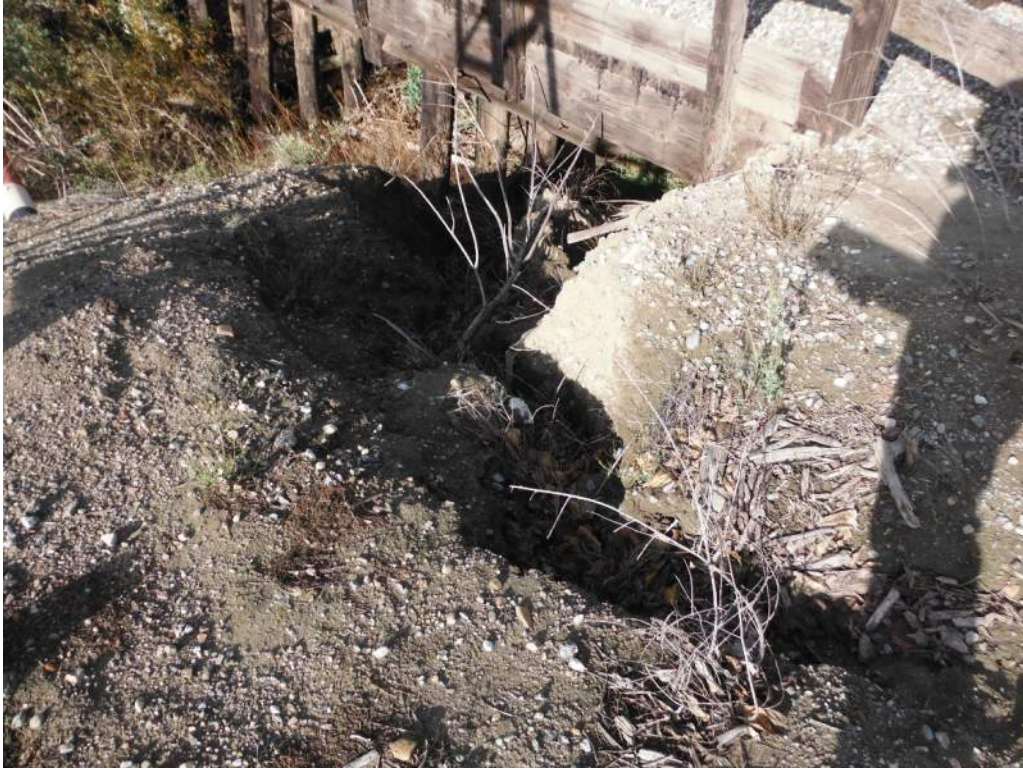
**417.24 SE wingwall erosion**

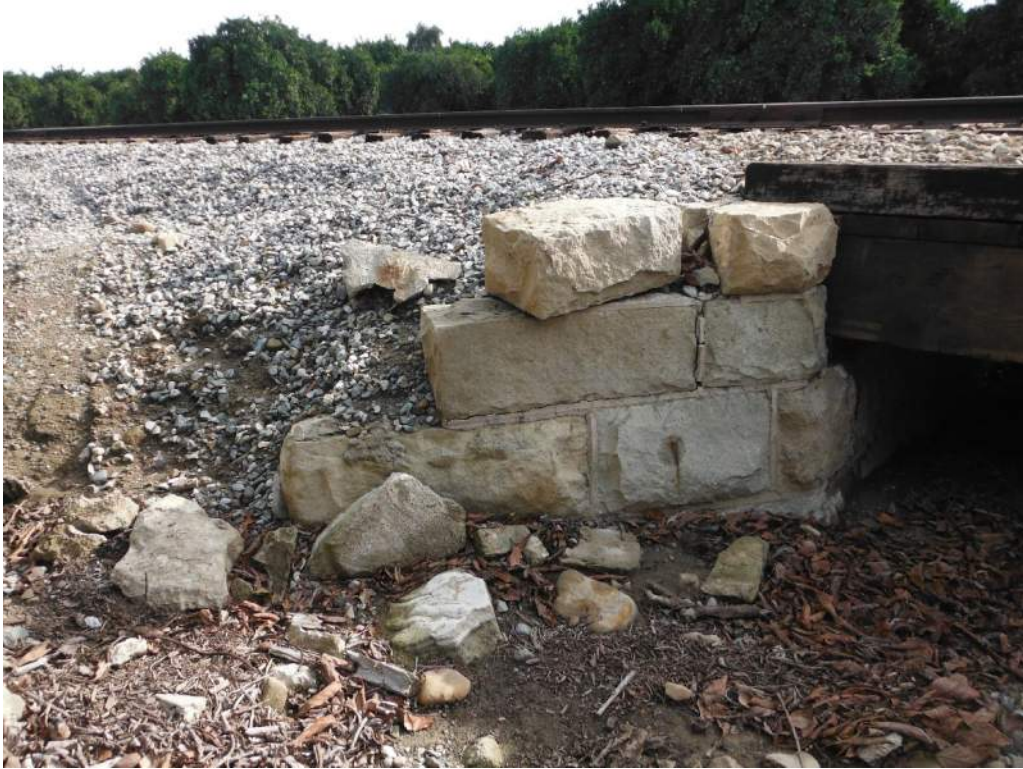
1. LS - Loose stone in wingwall - see photo

**417.96 Loose block in wingwall – Abutment 2**

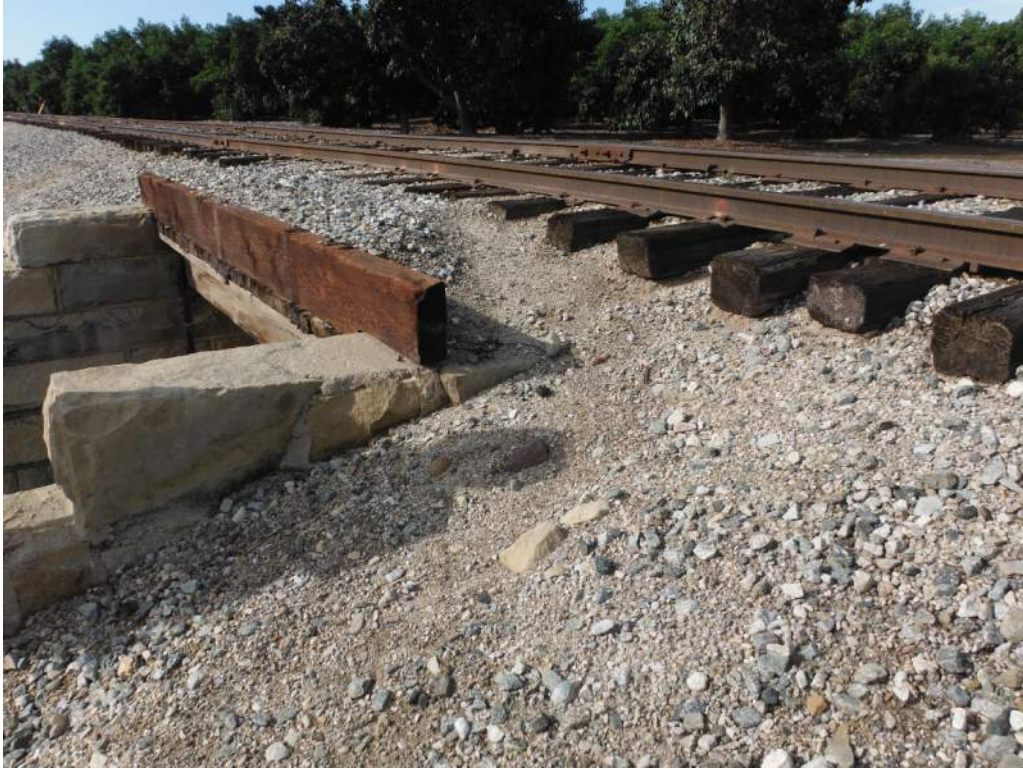
1. Low ballast at end of ballast retainer, extend retainer and add ballast (see photo)
2. Stringers 5, 6, 7 crushing 1/4" at abutment
3. Moisture on sill due to fouled ballast and backwall holding moisture

**418.02 Low shoulder ballast at SE approach**

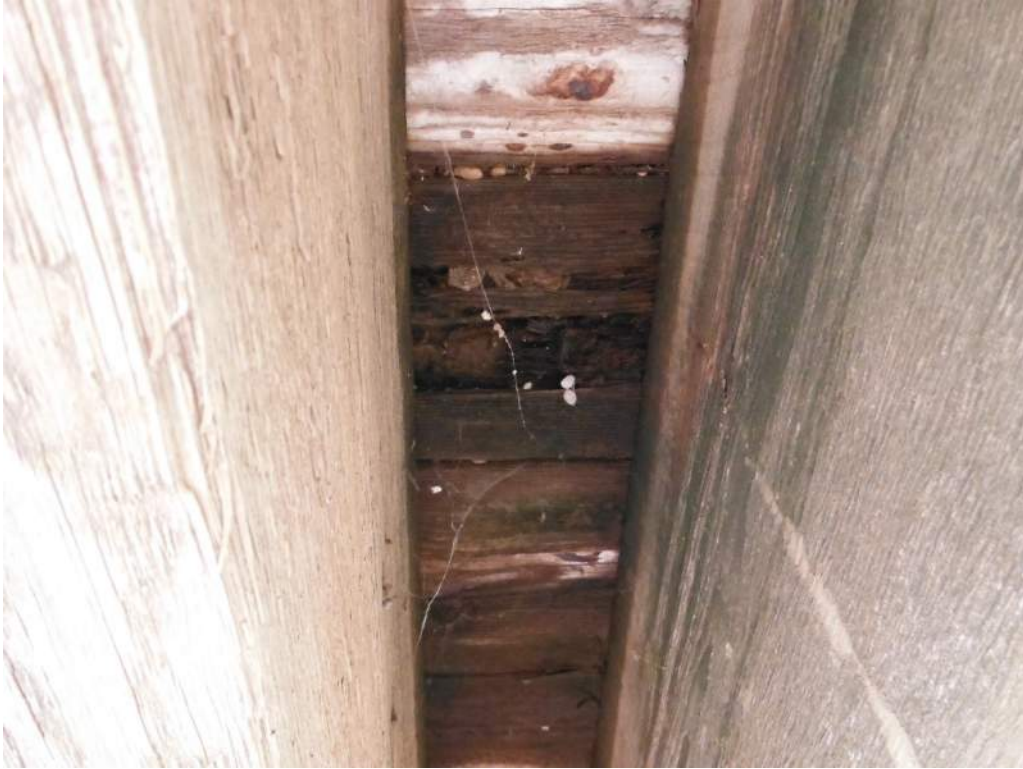
Deck	Multiple deck planks showing signs of rot and multiple holes - see photo						
<b>MAINTENANCE RECOMMENDATIONS</b>							
Priority	Description						
E02, B	Clear debris from under bridge						
E03, B	Raise approaches both ends						
D03	Replace rail with heavier section as tonnage dictates						
M02, B/C	Install wingwall east end to prevent ballast loss						
D04, B	Replace failed deck planks						
<b>CONDITION RATING</b>					<b>PRIORITY</b>

**418.02 Deck planks showing signs of rot and multiple holes**

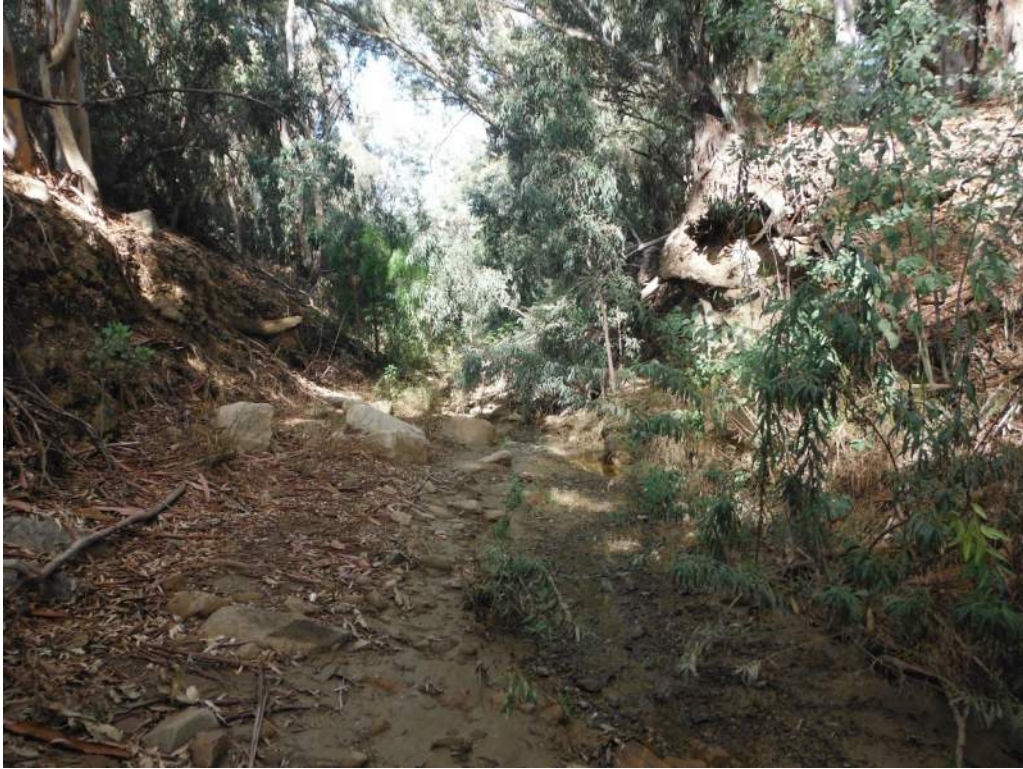
**419.42 Channel Condition - Looking Upstream**

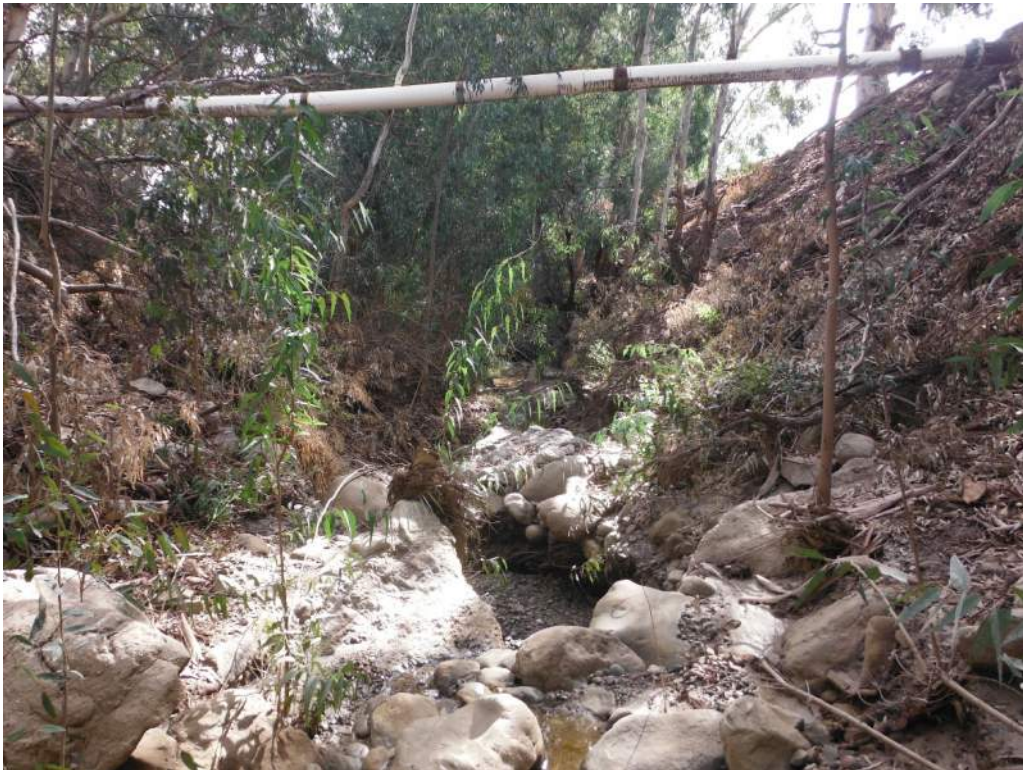
**419.42 Channel Condition – Looking Downstream**

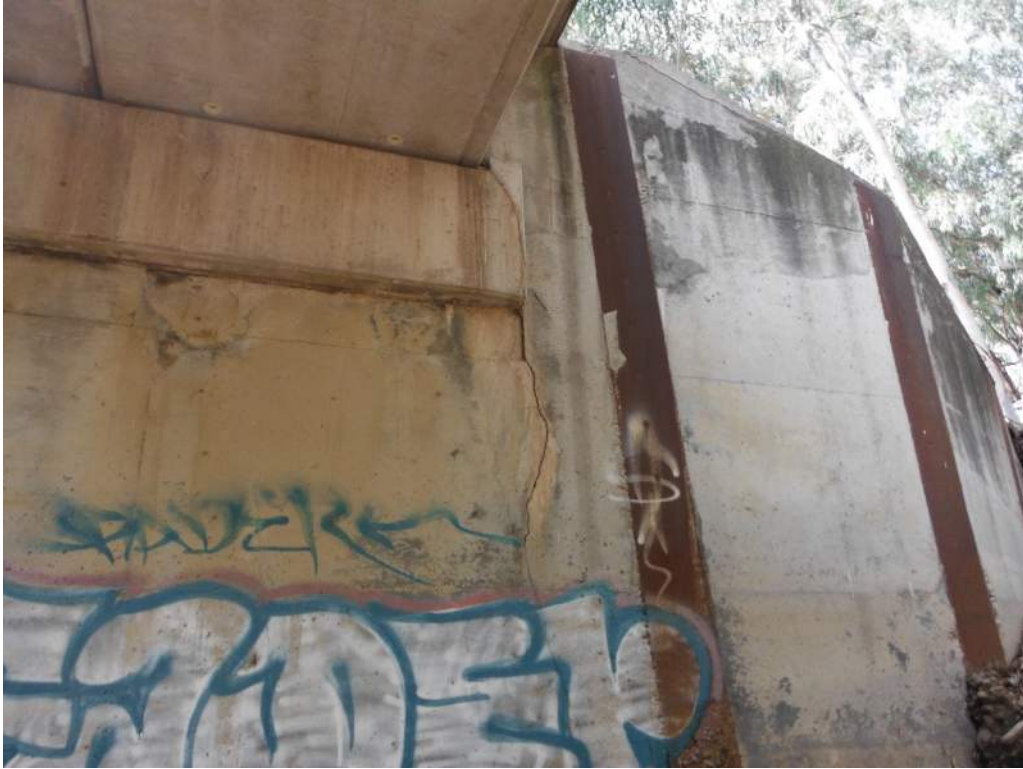
**419.42 Abutment 1 crack and keeper block cracked – North edge of cap**

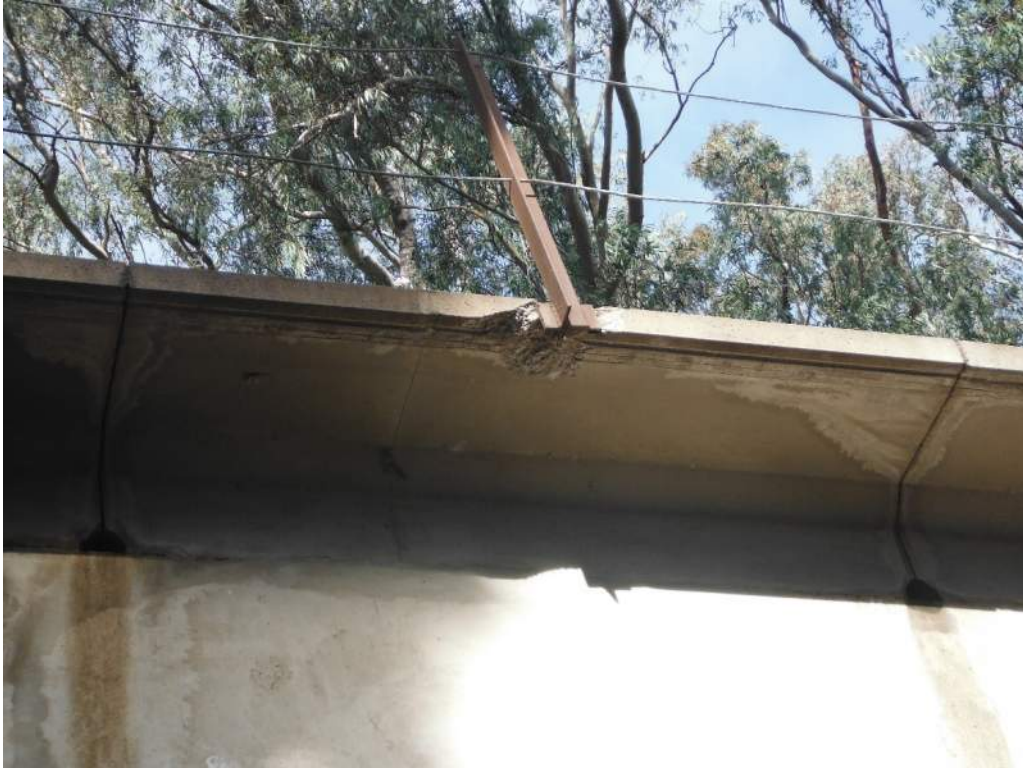
**419.42 Spall on South walkway**

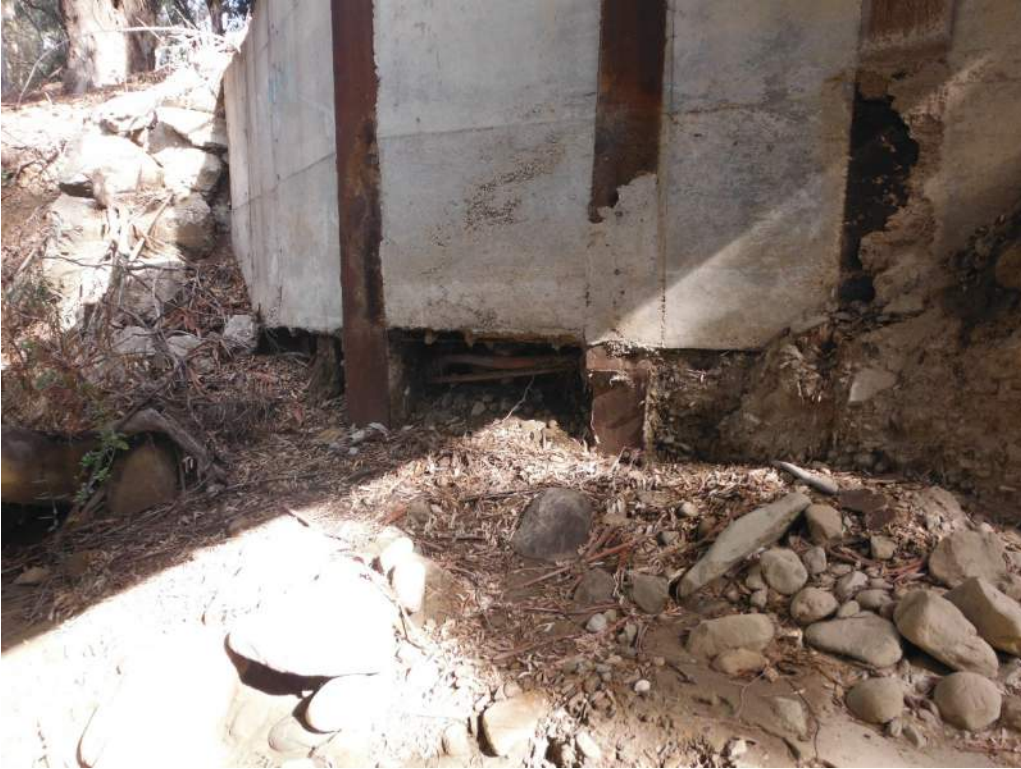
**419.42 Scour - Abutment 2**
