# BRIDGE INSPECTION REPORT

INSPECTION TYPE: Annual

Milepost 407.48  
 Location Santa Paula Branch Line  
Saticoy, CA  
 Stream X Overpass        Other         
 Train Operating Speed: Freight: 10 mph Passenger: 15 mph

MAINLINE/SUBDIVISION: VCTC

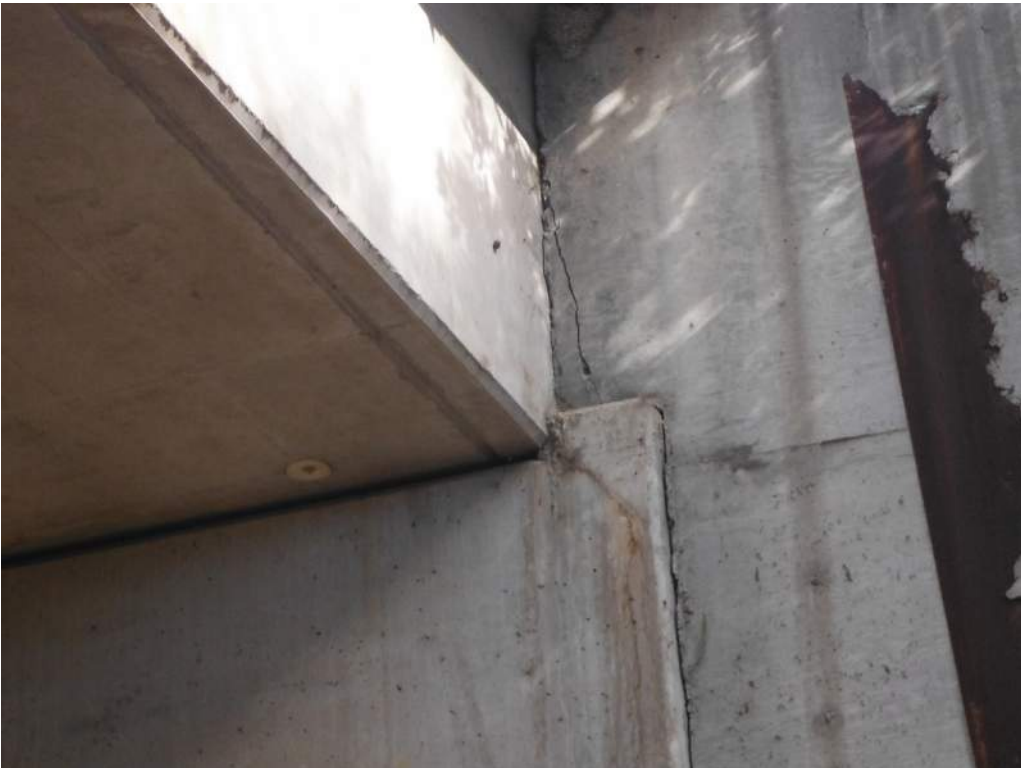
**419.42 Crack in backwall, and crack and spall on south keeper – Abutment 2**

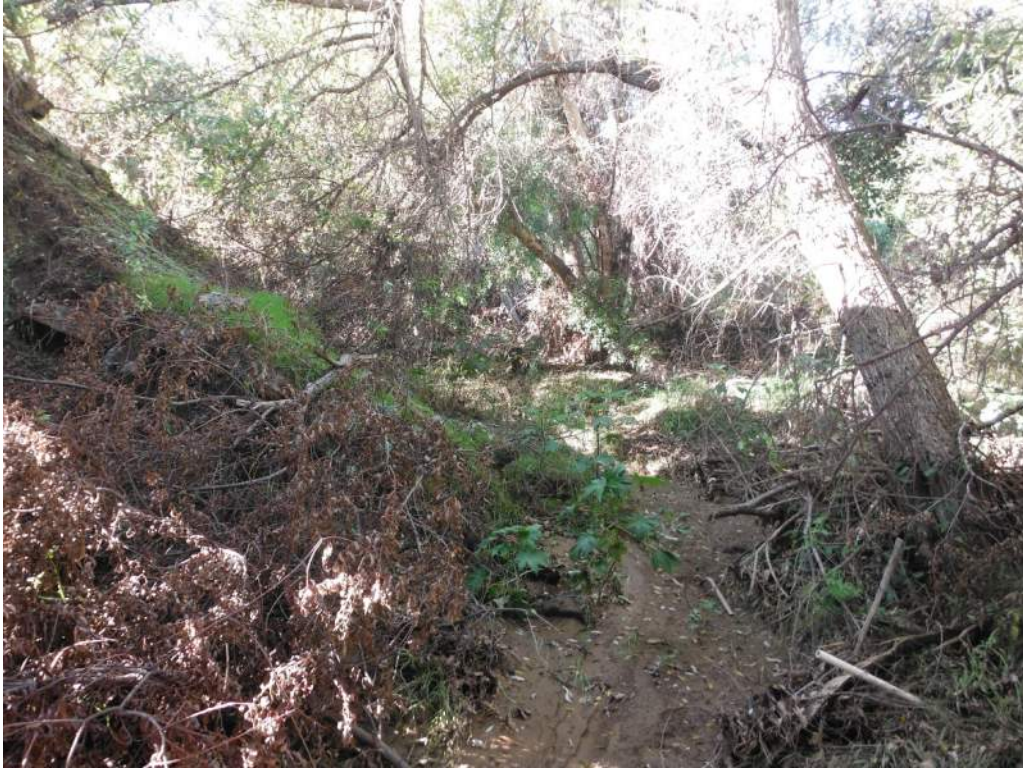
**419.92 Channel Condition – Looking Upstream**

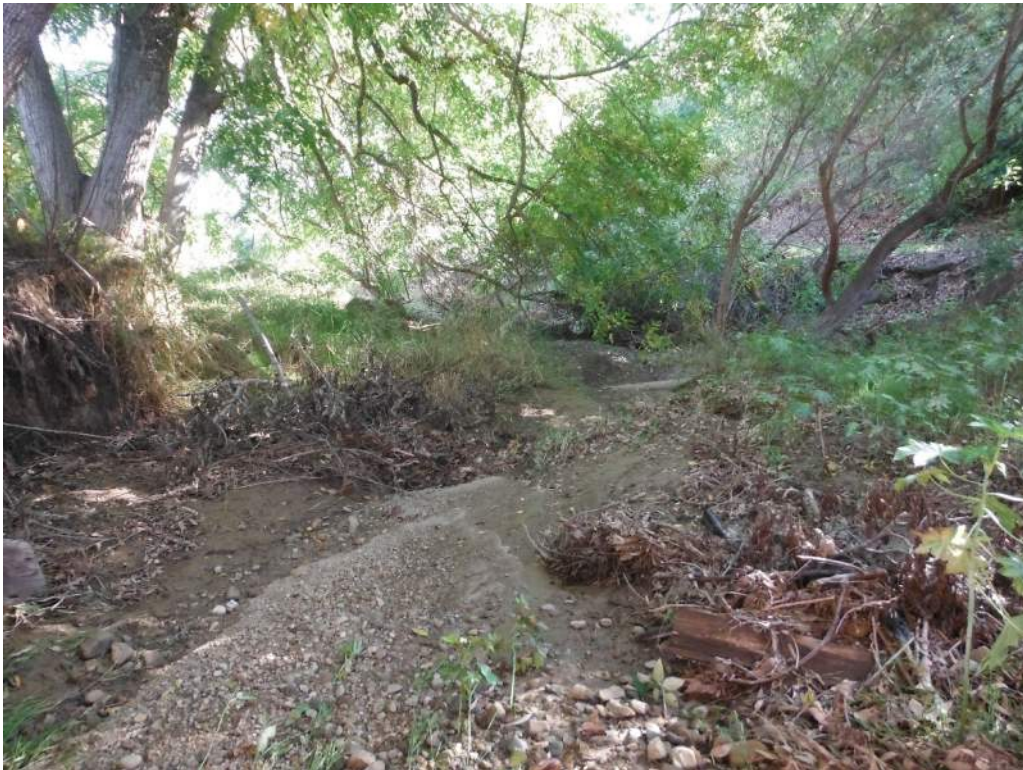
**419.92 Channel Condition - Looking Downstream**

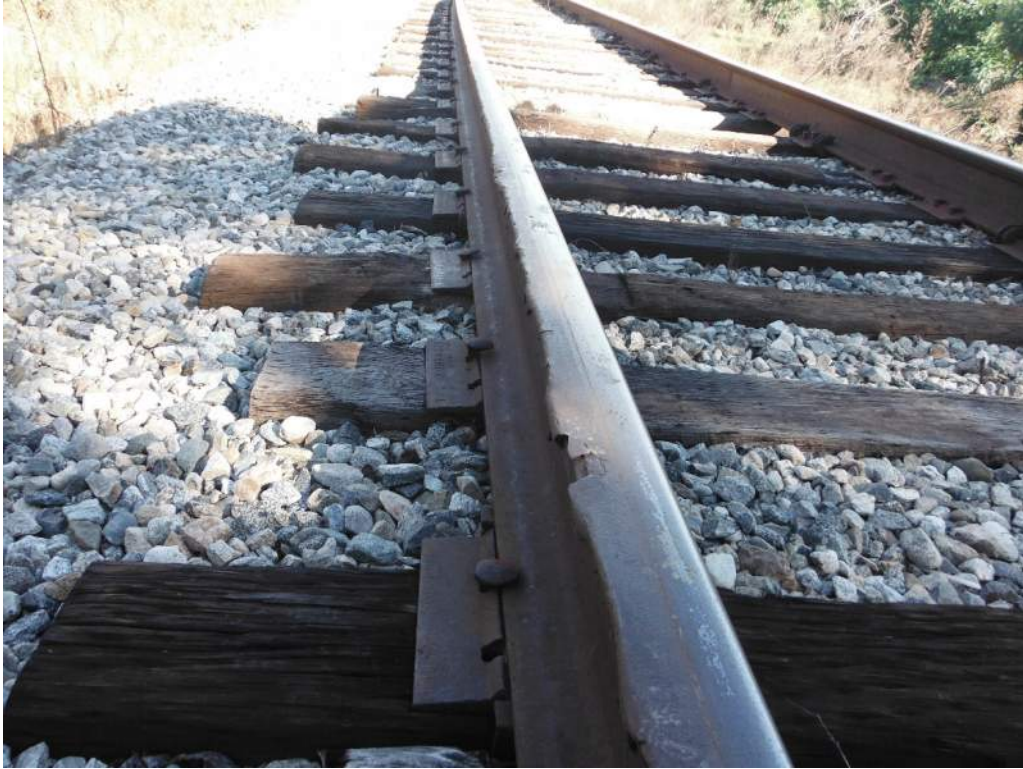
**419.92 Rail section loss – east and west sides and along length of bridge**

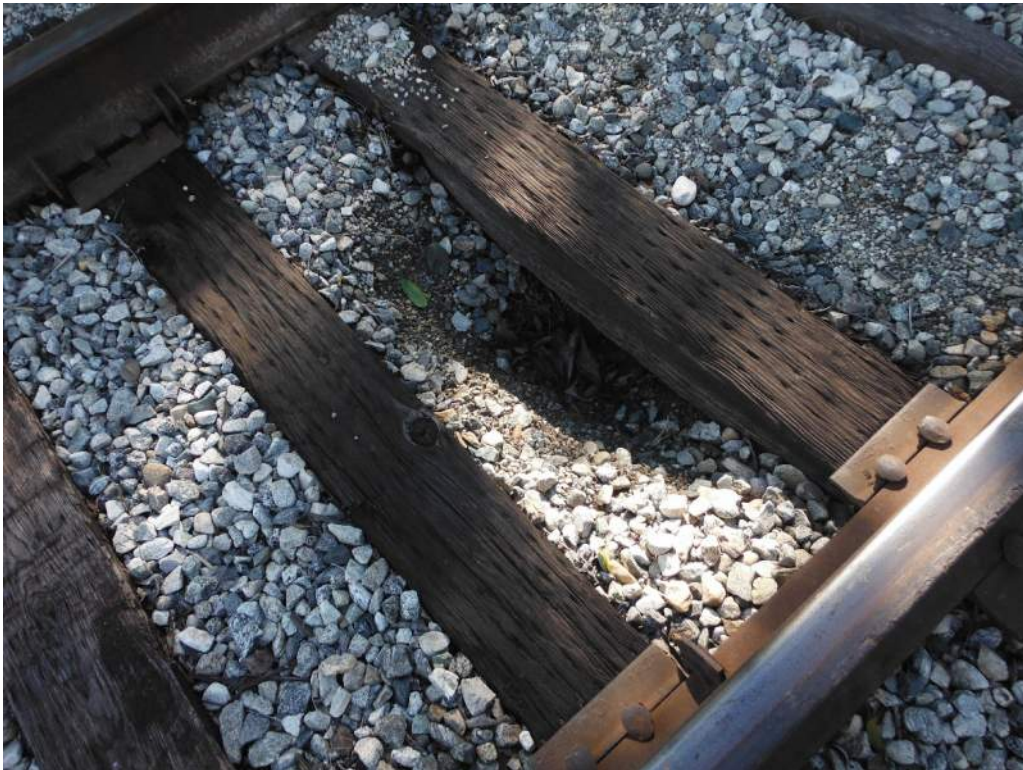
**419.92 Holes in ballast near abutment 1 & 7**

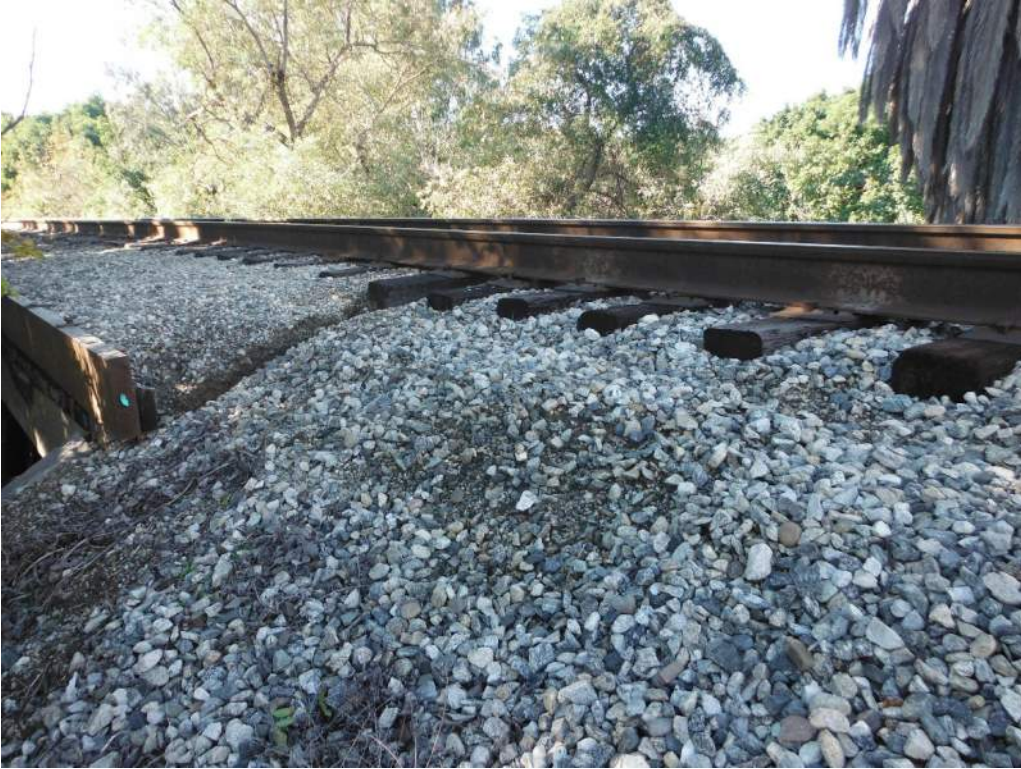
**419.92 Rail Dump Northeast approach**

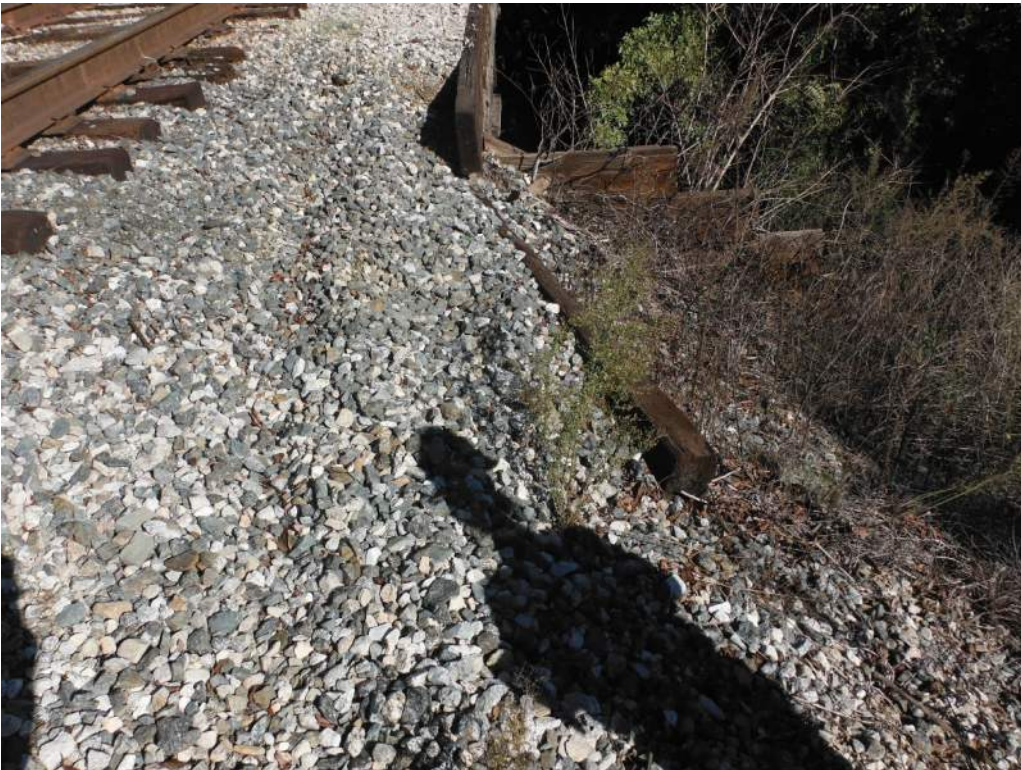
**419.92 Ballast overtopping SW ballast retainer**

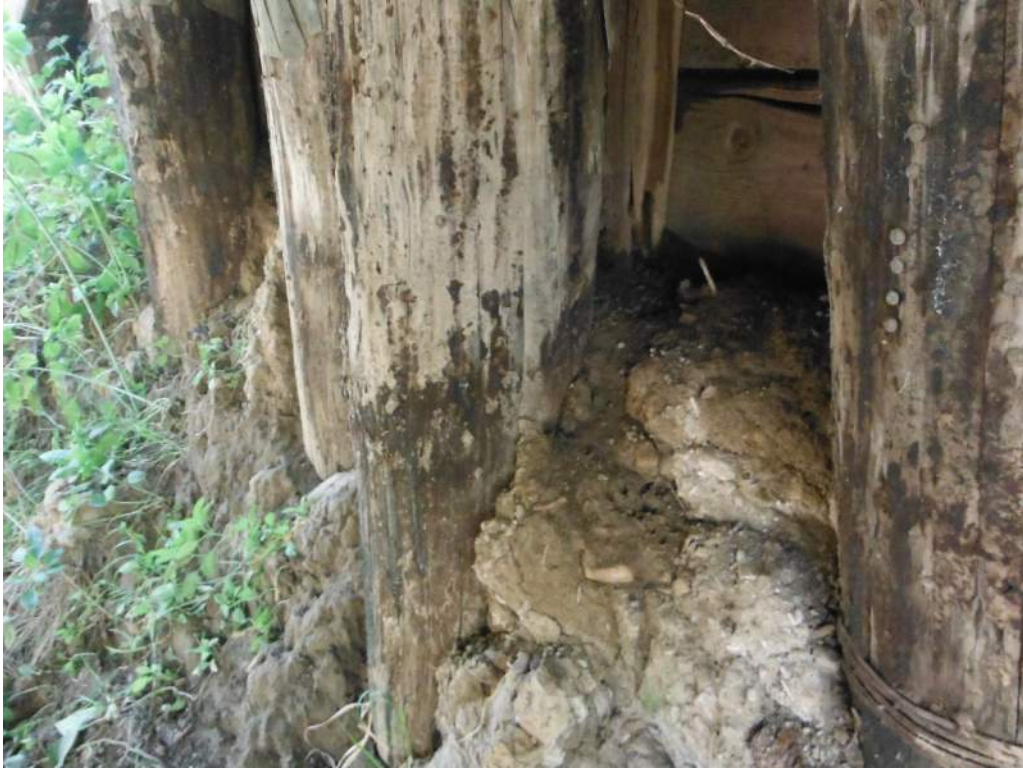
**419.92 Abutment 1 back wall scour**

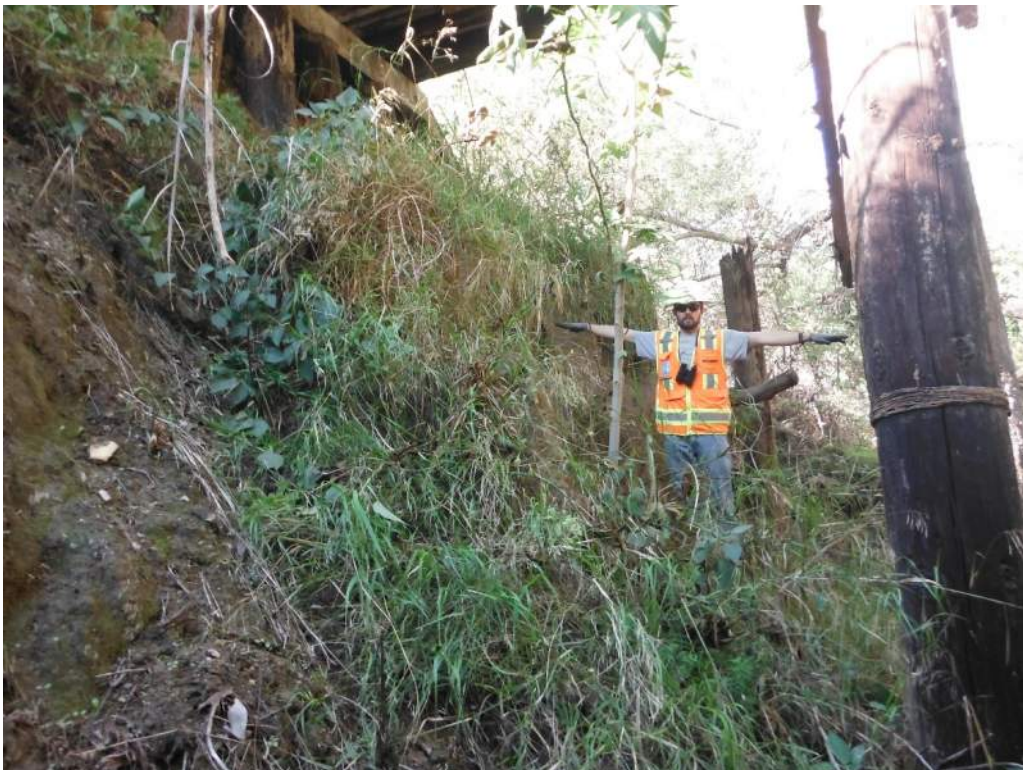
**419.92 Typical location of channel bank by Abutment 1**

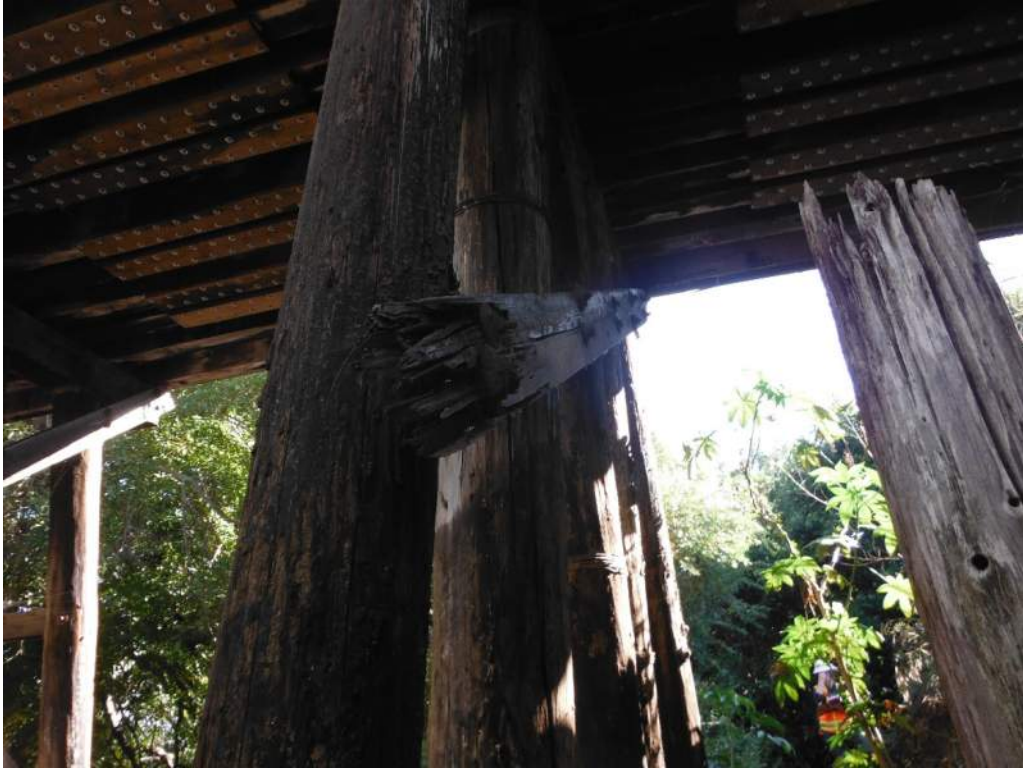
**419.92 Sway bracing rotten - Bent 2**

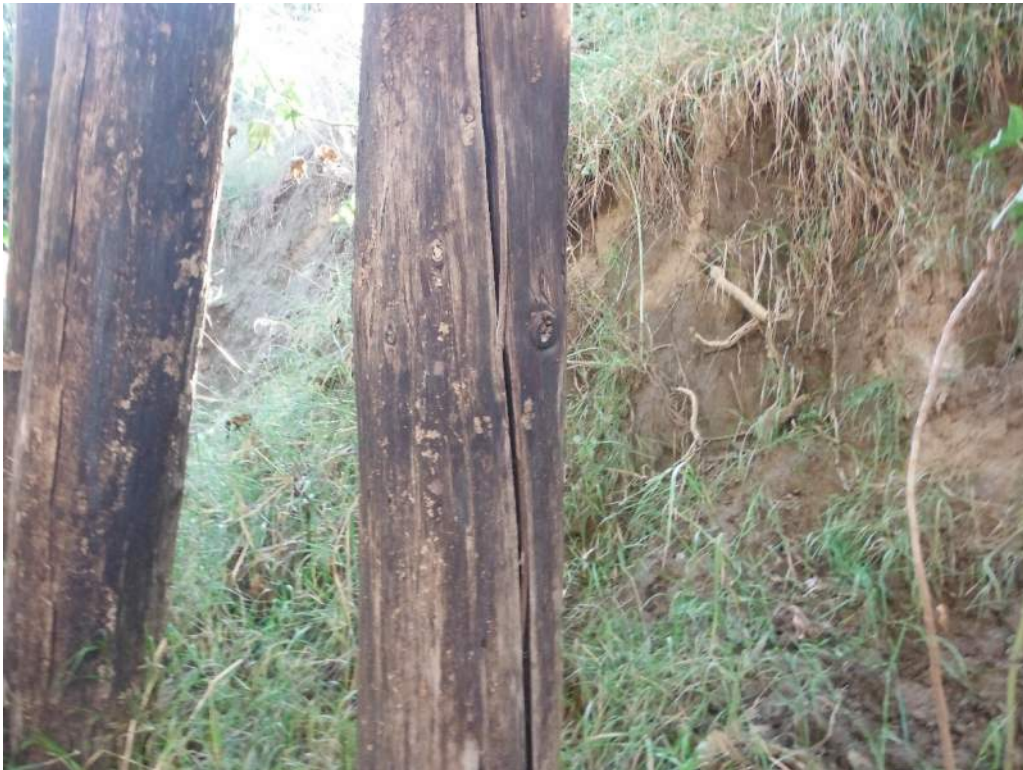
**419.92 Piles #2, #3, and #4 are split 1" - Bent 2**

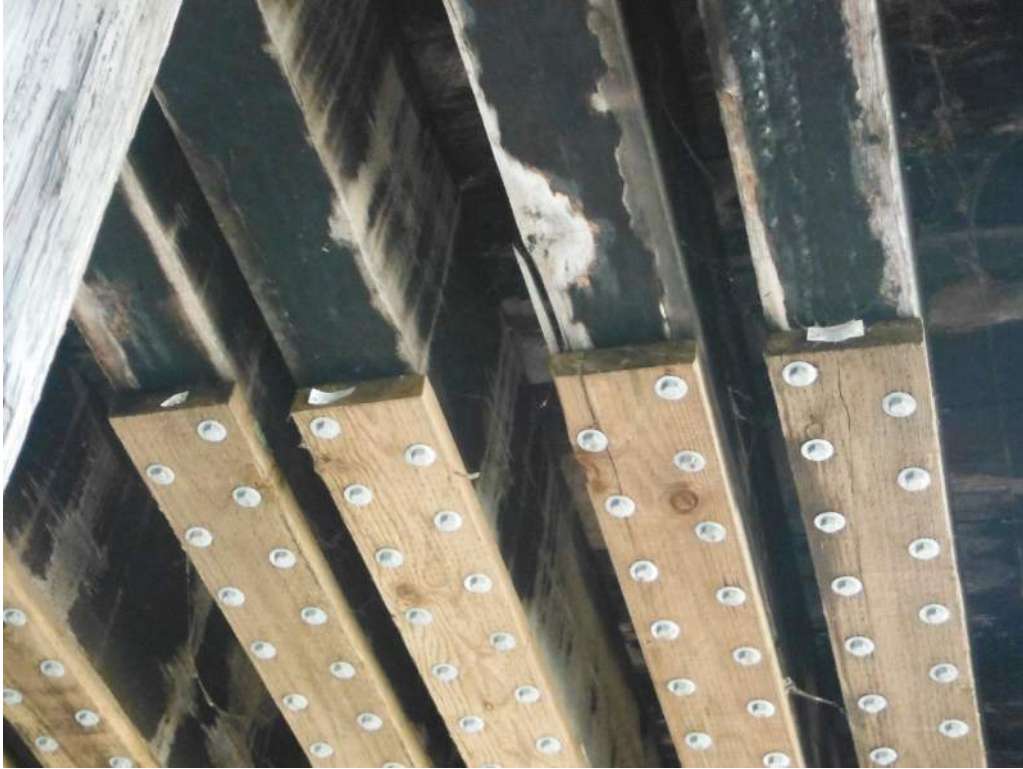
**419.92 Stringer 4 split at ends of repair locations - Bent 4**

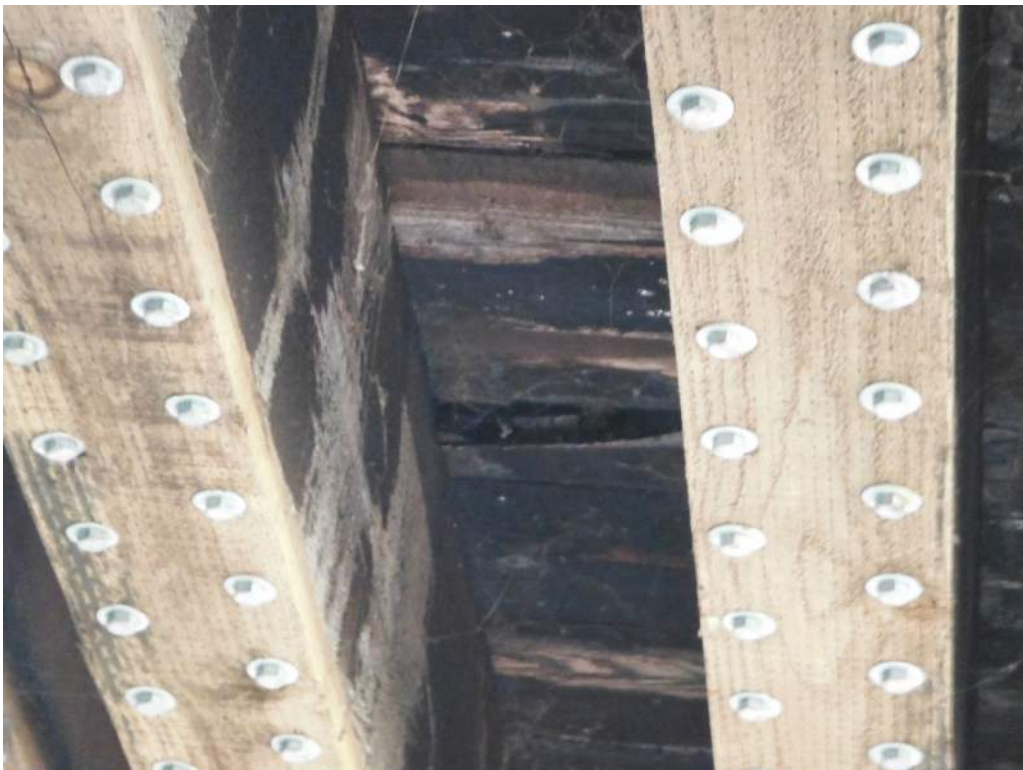
**419.92 Hole beginning in deck between stringer 6 and 7 - Span 4**

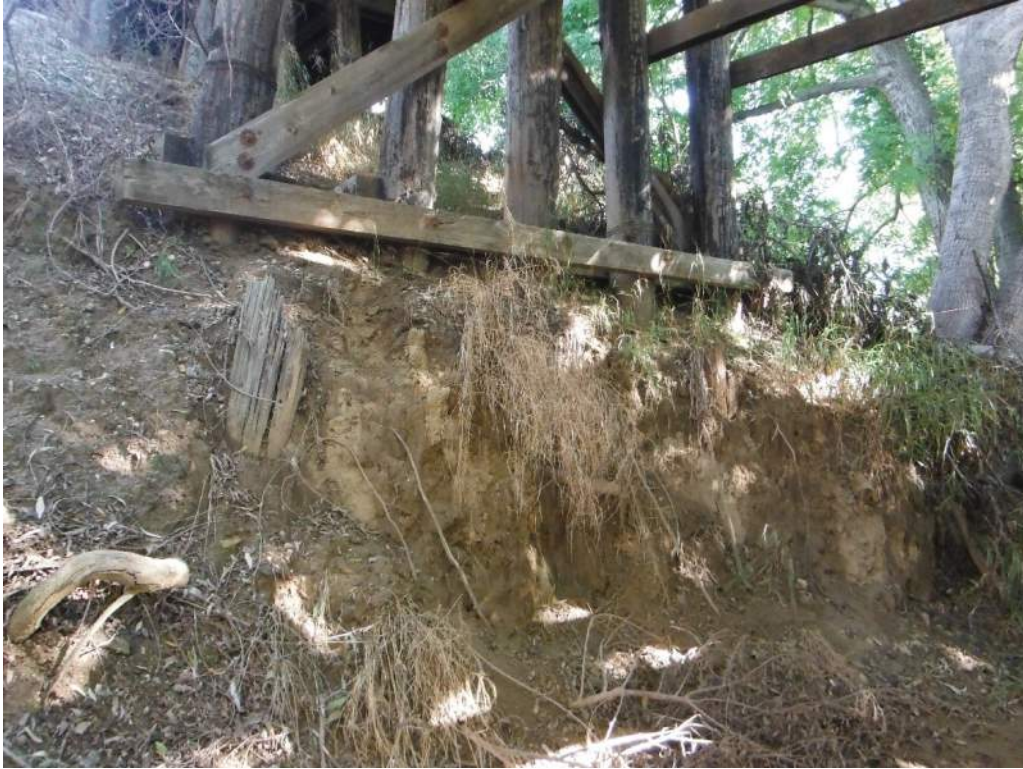
**419.92 Scour 5' from Bent 5**

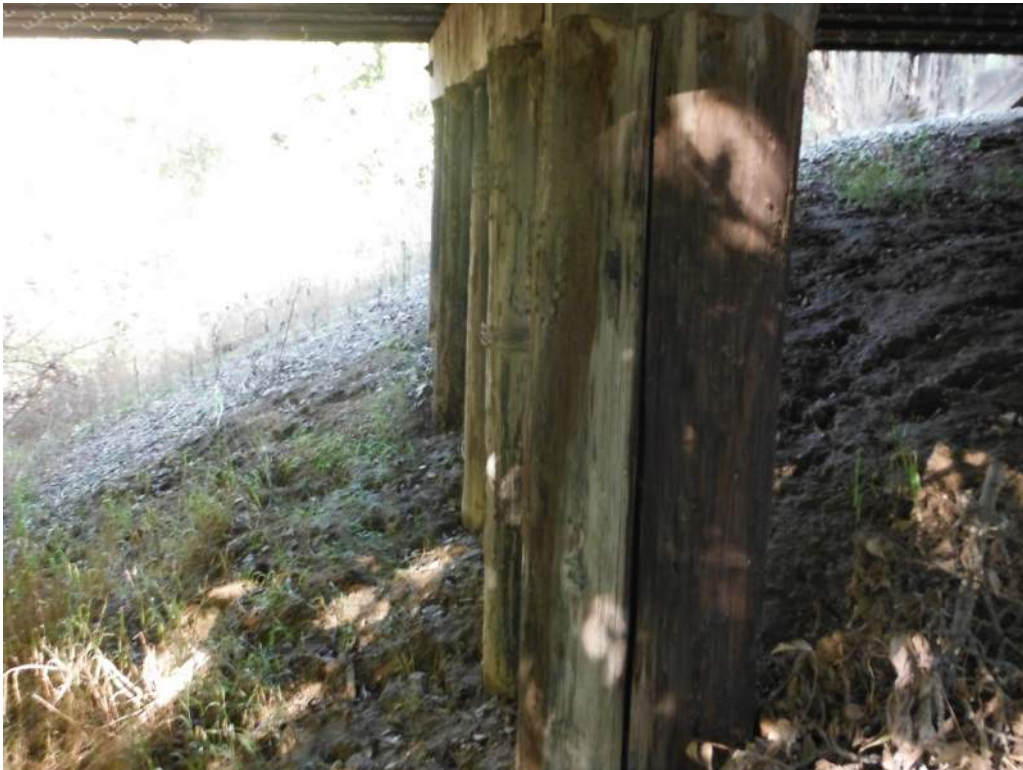
**419.92 Pile #5 is Split, Bent 6**

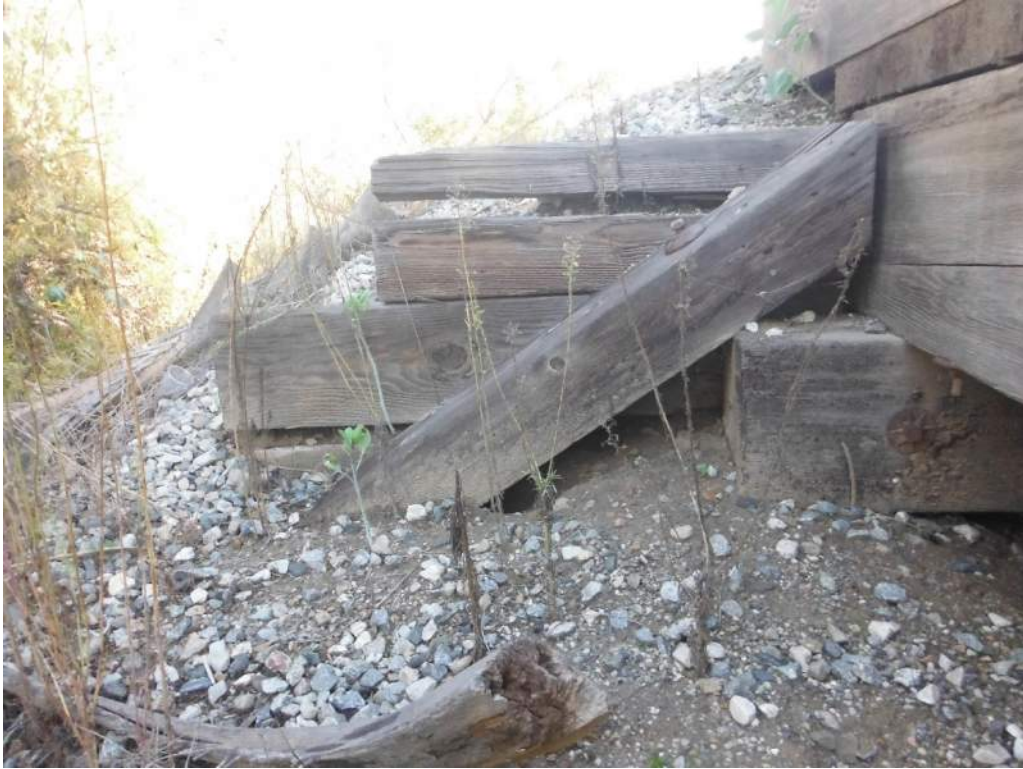
**419.92 NE Wingwall is Split**

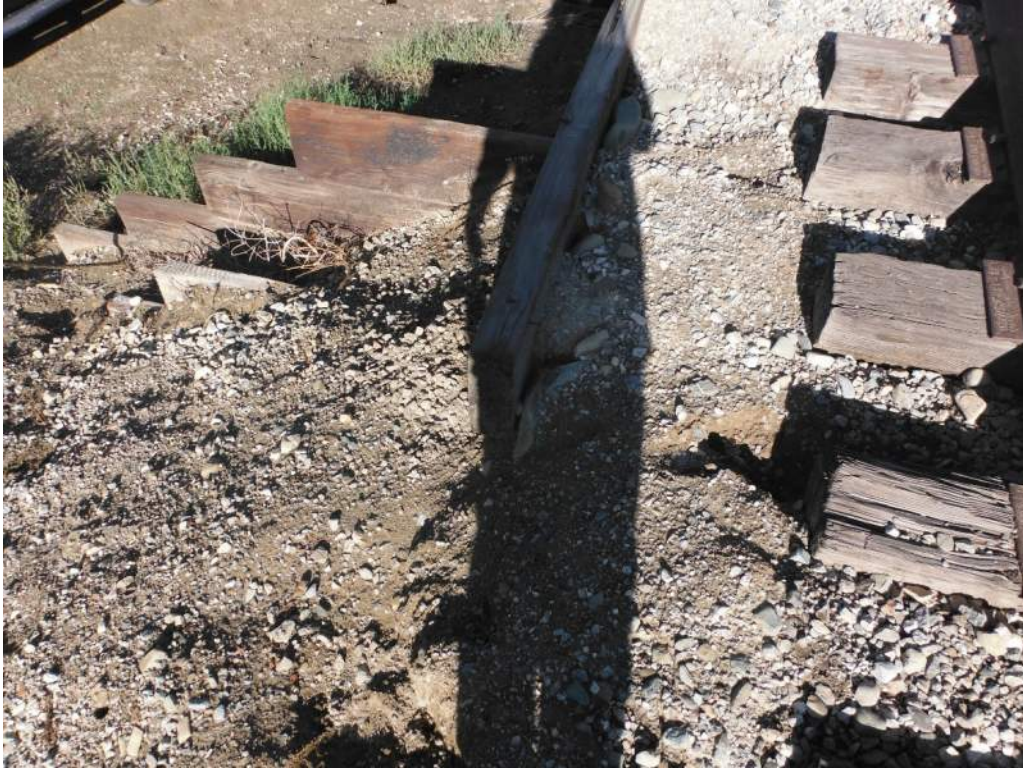
**420.20 Typical holes in ballast – east and west ends**

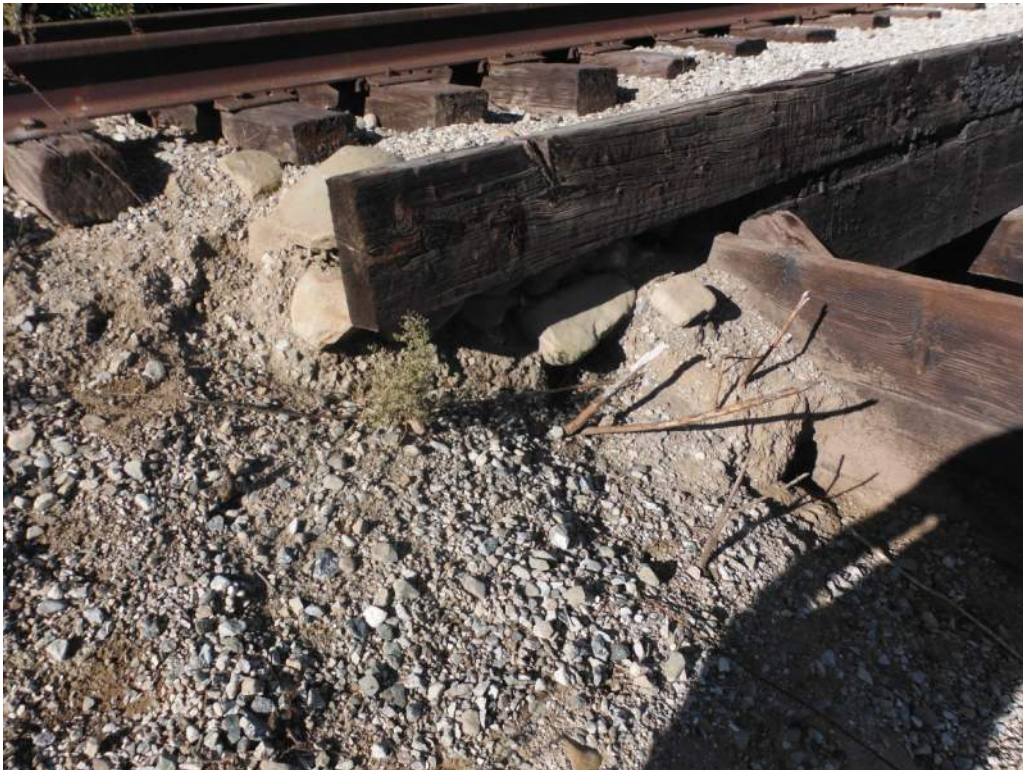
**420.20 Undermining ballast retainer – north and south sides**

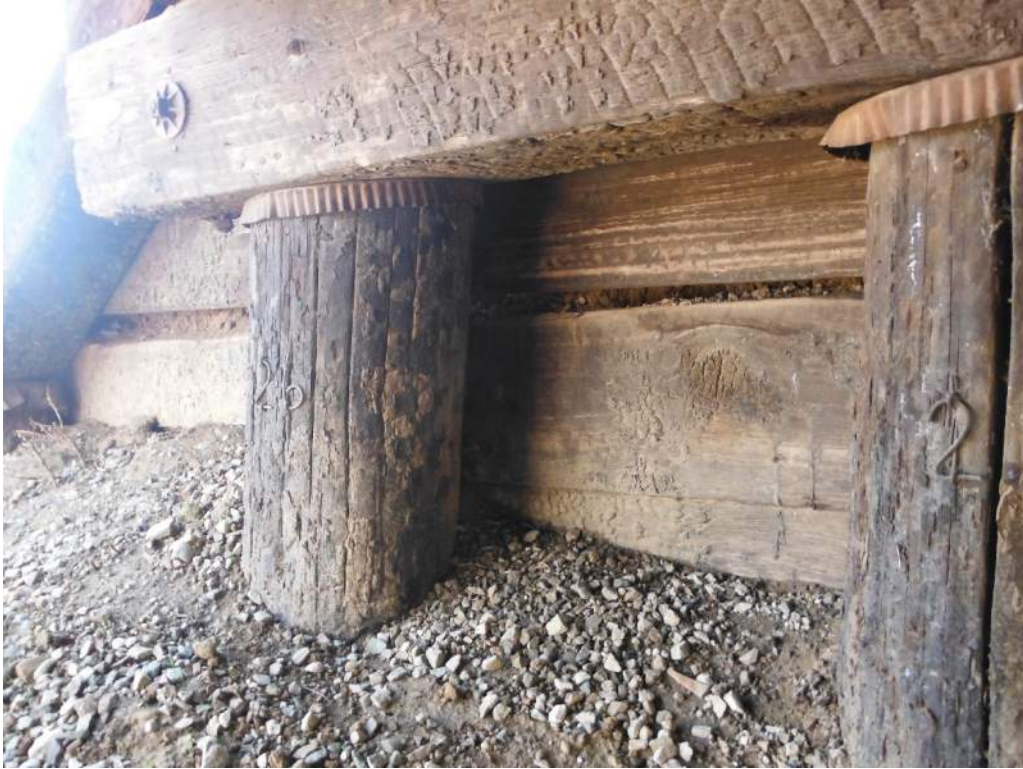
**420.20 Abutment 1 rotten backwall**

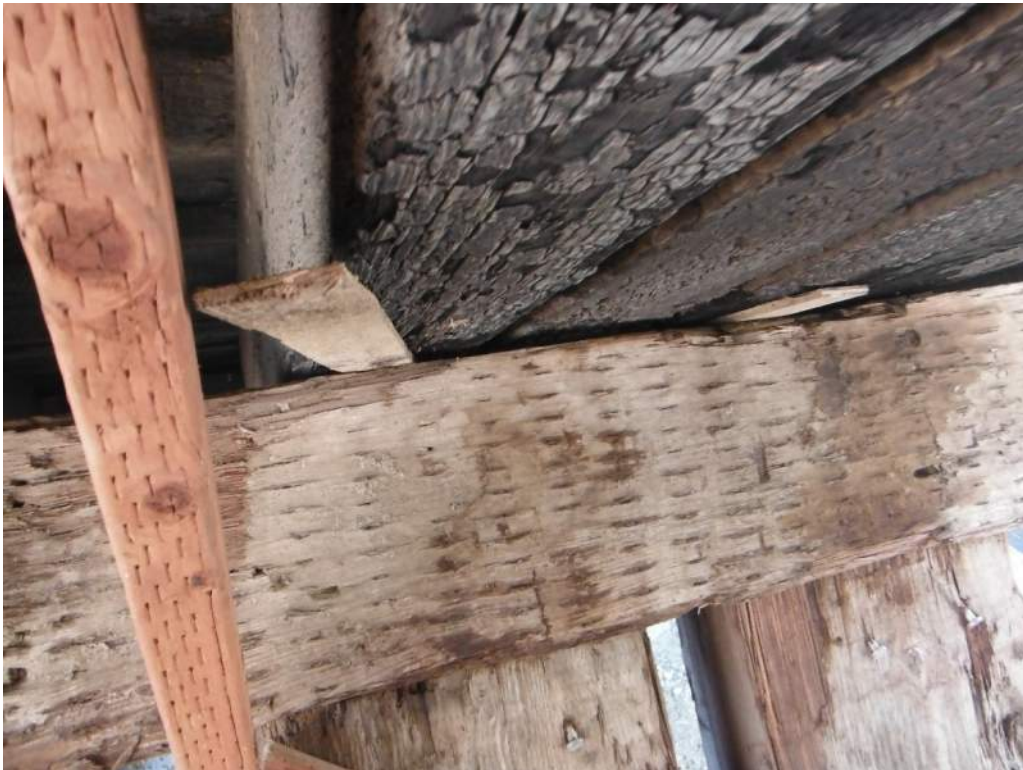
**420.20 Gap between stringer and helper bent, typ.**

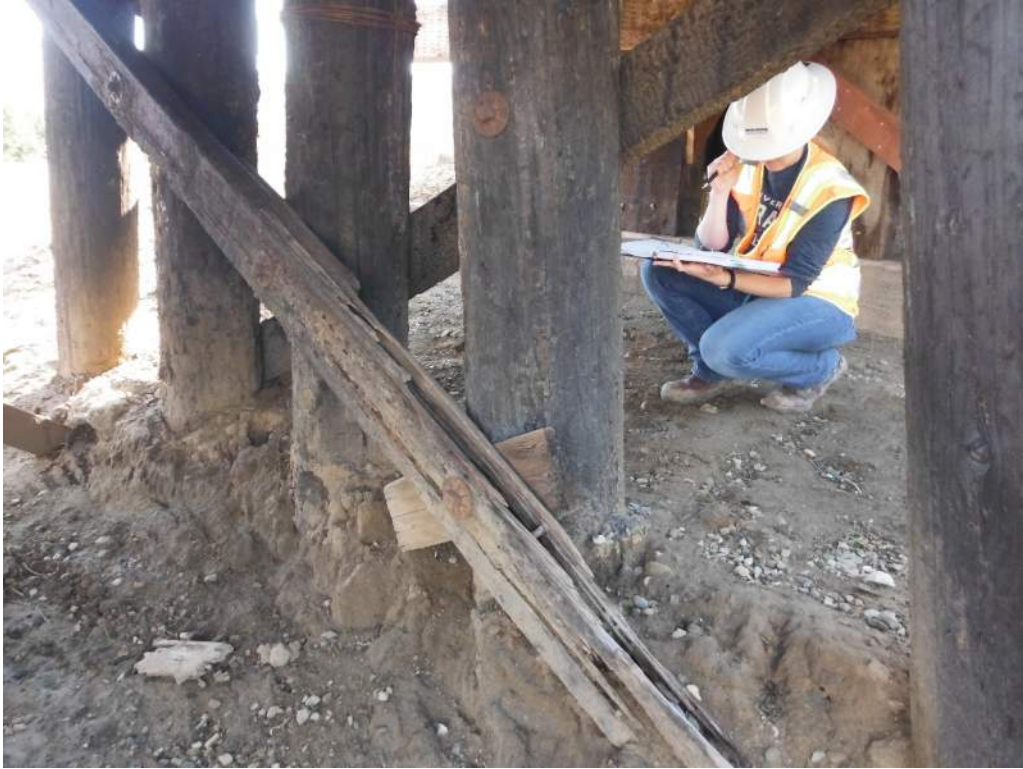
**420.20 Span 2 sway brace rotten**

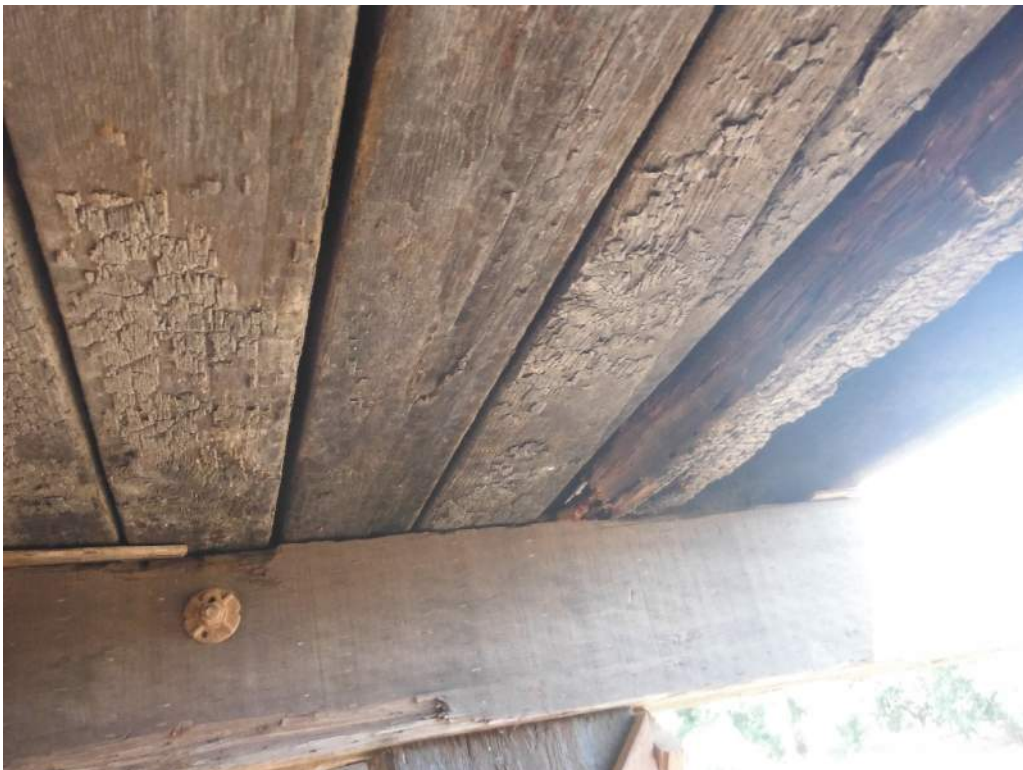
**420.20 Stringer 8 shear split and Stringer 9 failed Span 2**

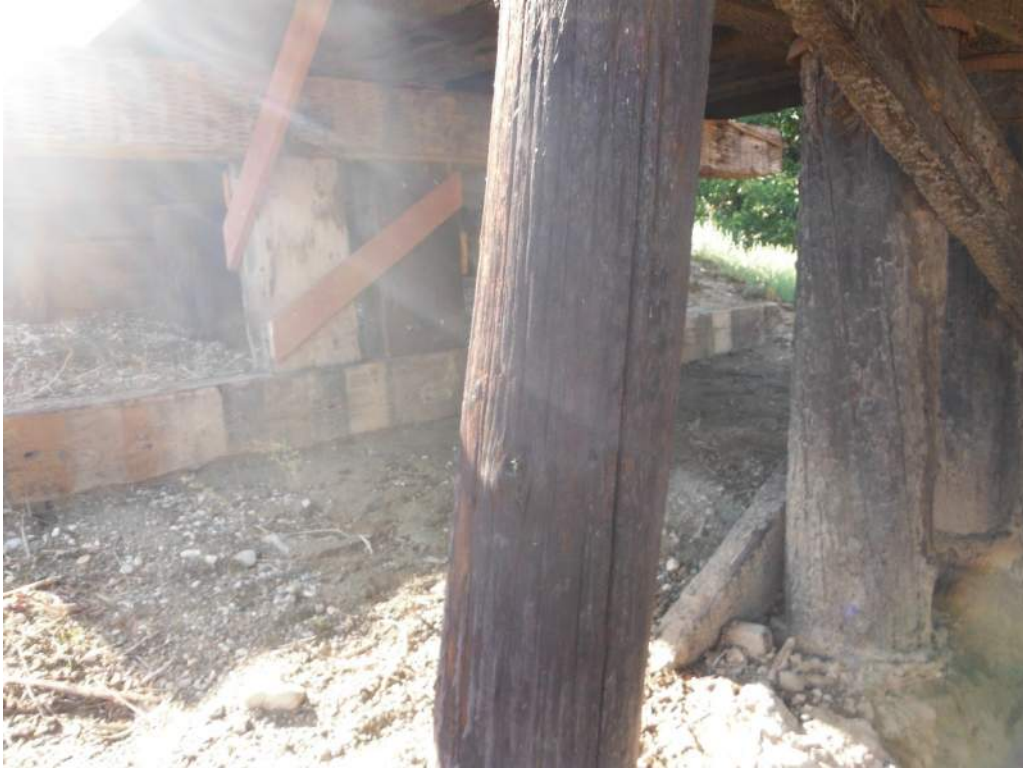
**420.20 Bent 2 Pile 5 Split**

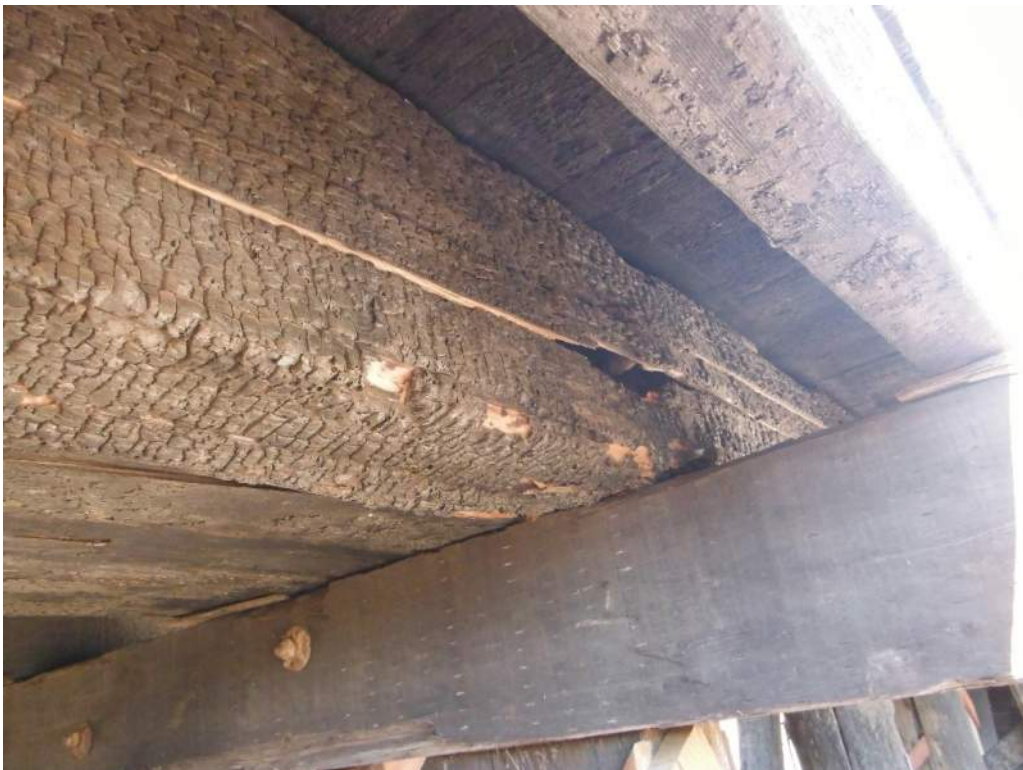
**420.20 Span 2, Stringer 9 failed at helper bent**

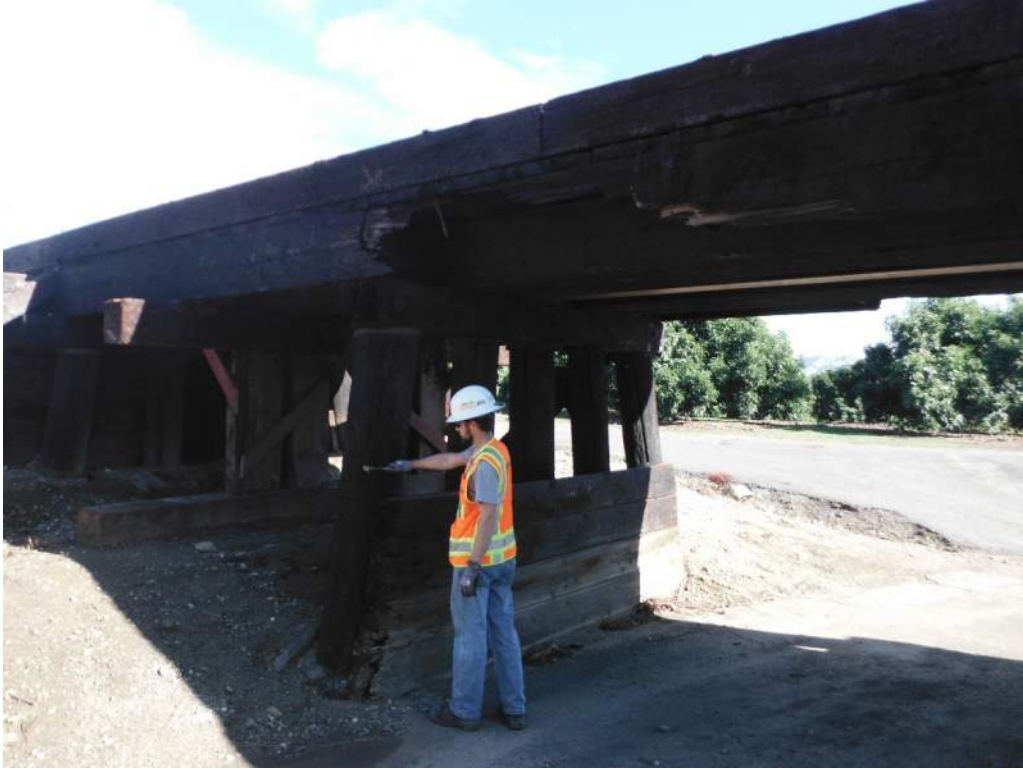
**420.20 Exterior stringer failed due to impact - Span 3 typ**

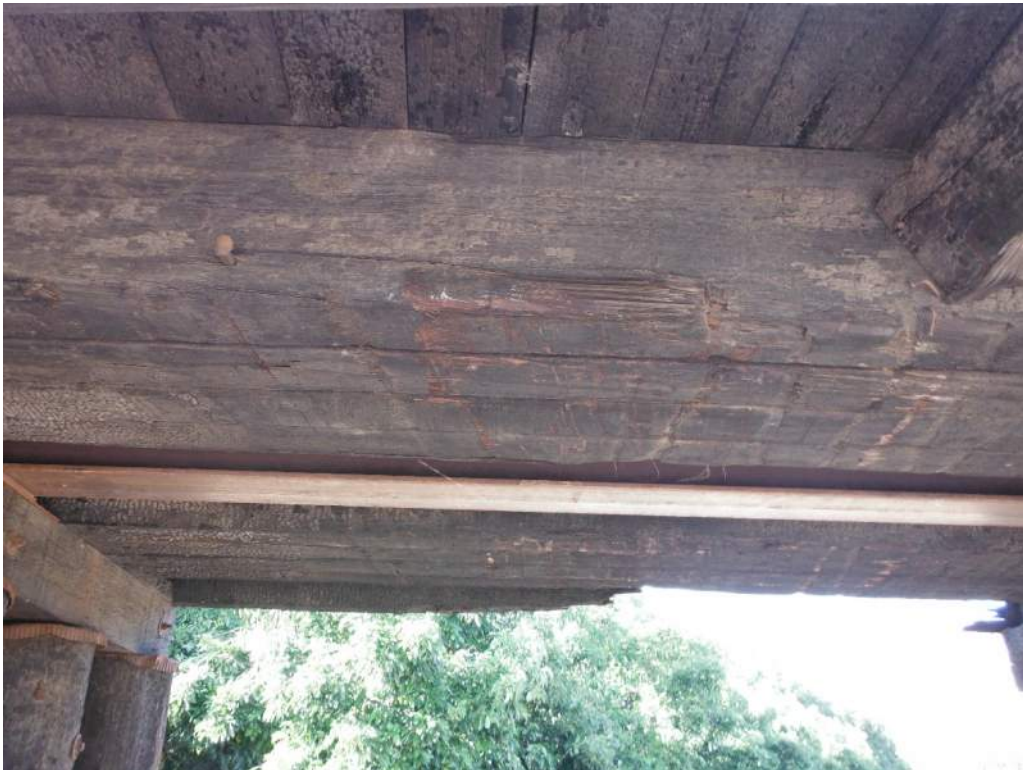
**420.20 Impact Damage – Span 3**

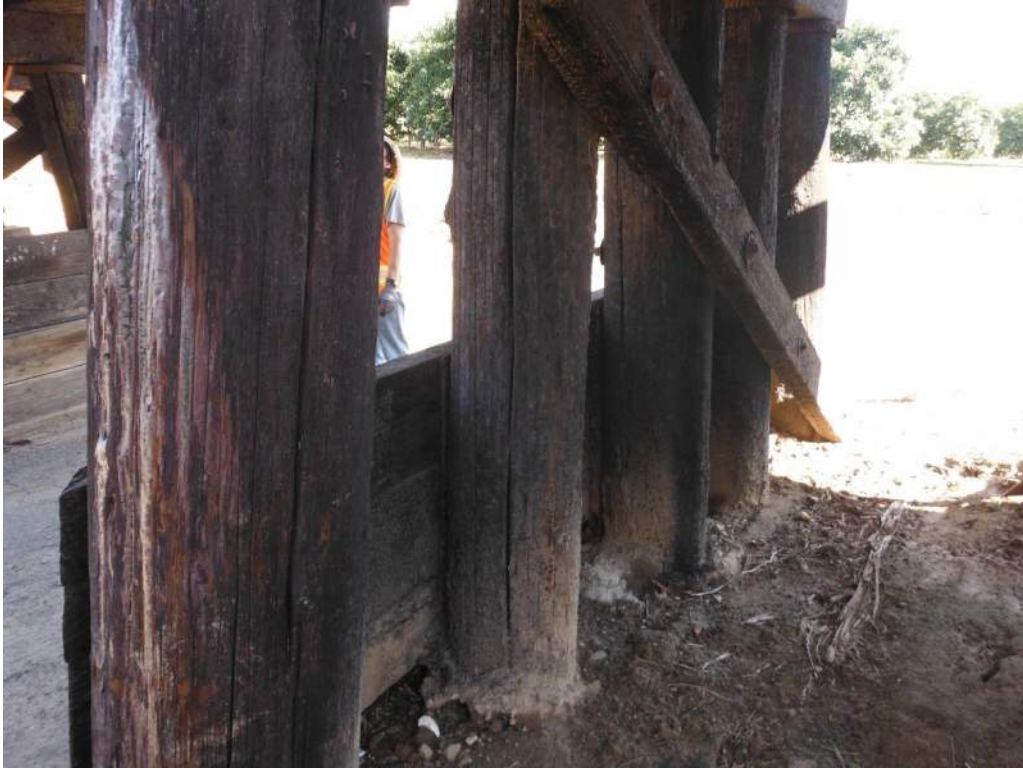
**420.20 Bent 3 piles split**

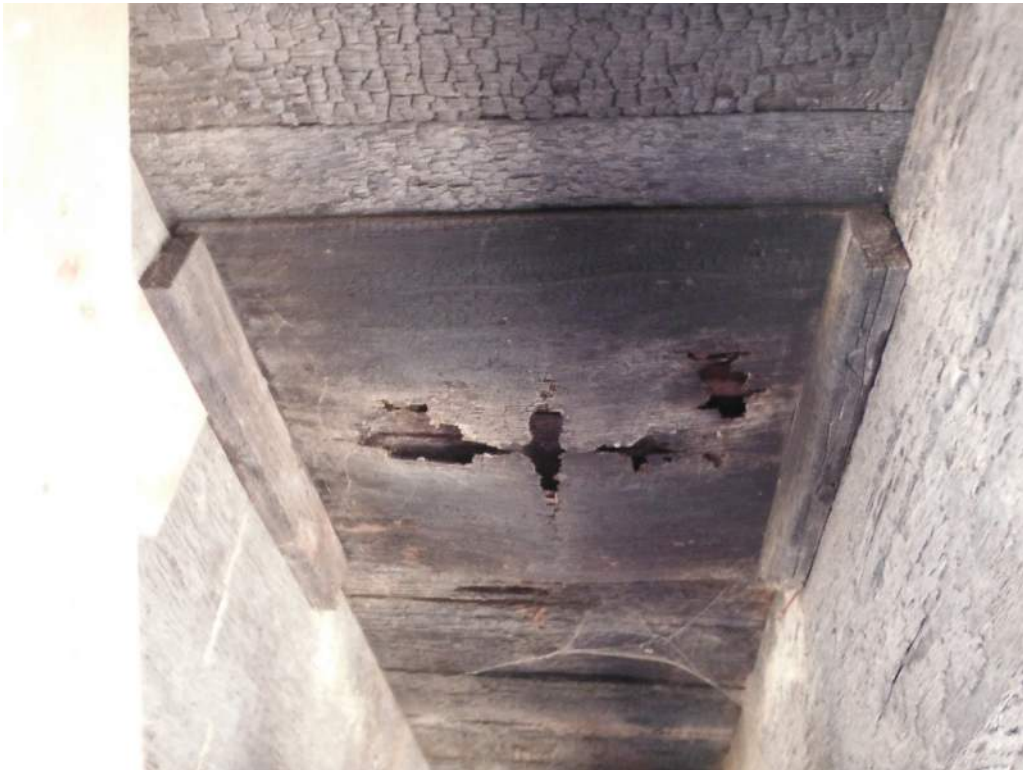
**420.20 Failing Deck Plank – Span 4**

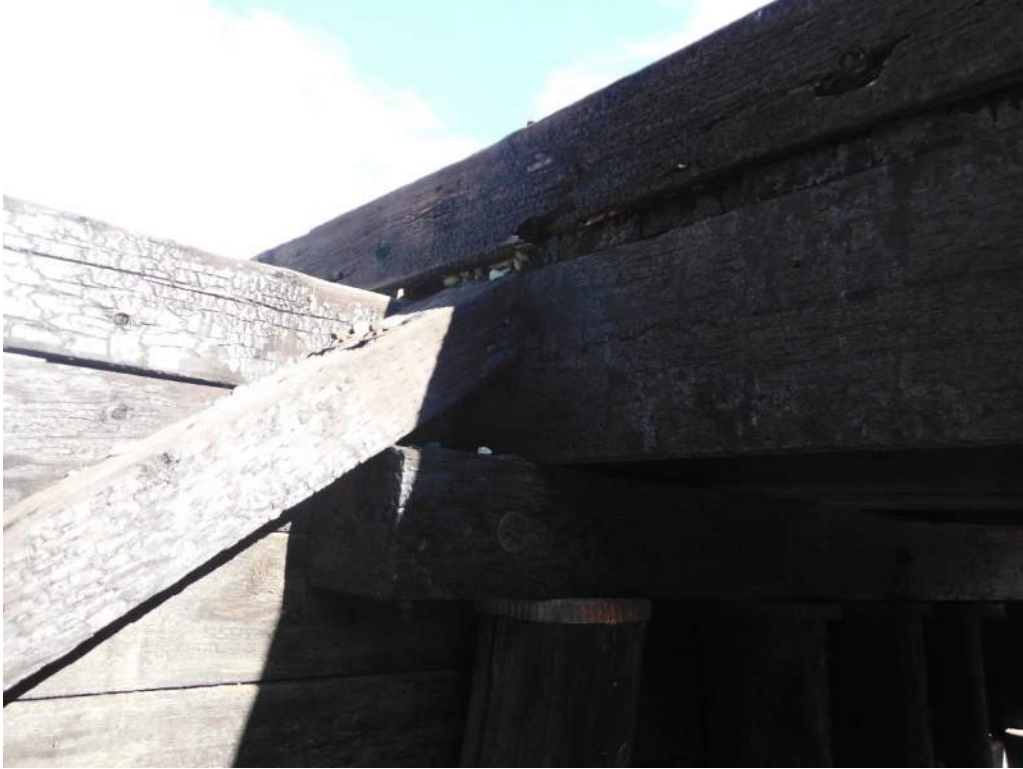
**420.20 Ballast boards failing at Abutment 5**
