# BRIDGE INSPECTION REPORT

INSPECTION TYPE: Annual

Milepost 407.48  
 Location Santa Paula Branch Line  
Saticoy, CA  
 Stream X Overpass        Other         
 Train Operating Speed: Freight: 10 mph Passenger: 15 mph

MAINLINE/SUBDIVISION: VCTC

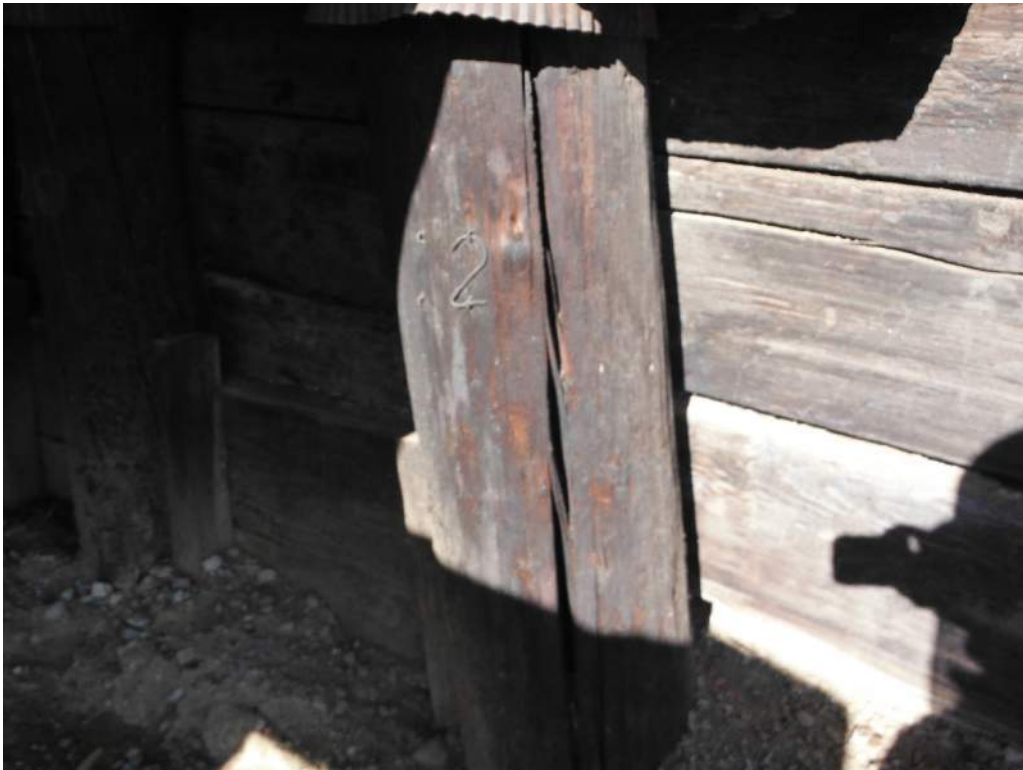
**420.20 Abutment 5 Pile 5 split**

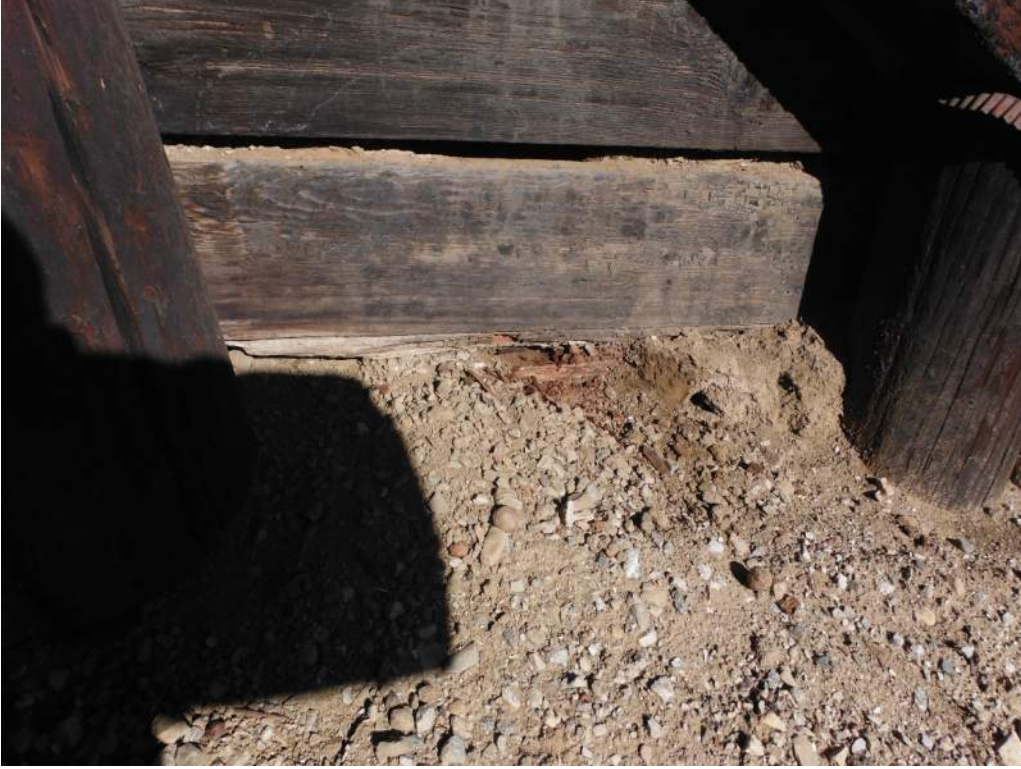
**420.20 Abutment 5 rotten backwall**

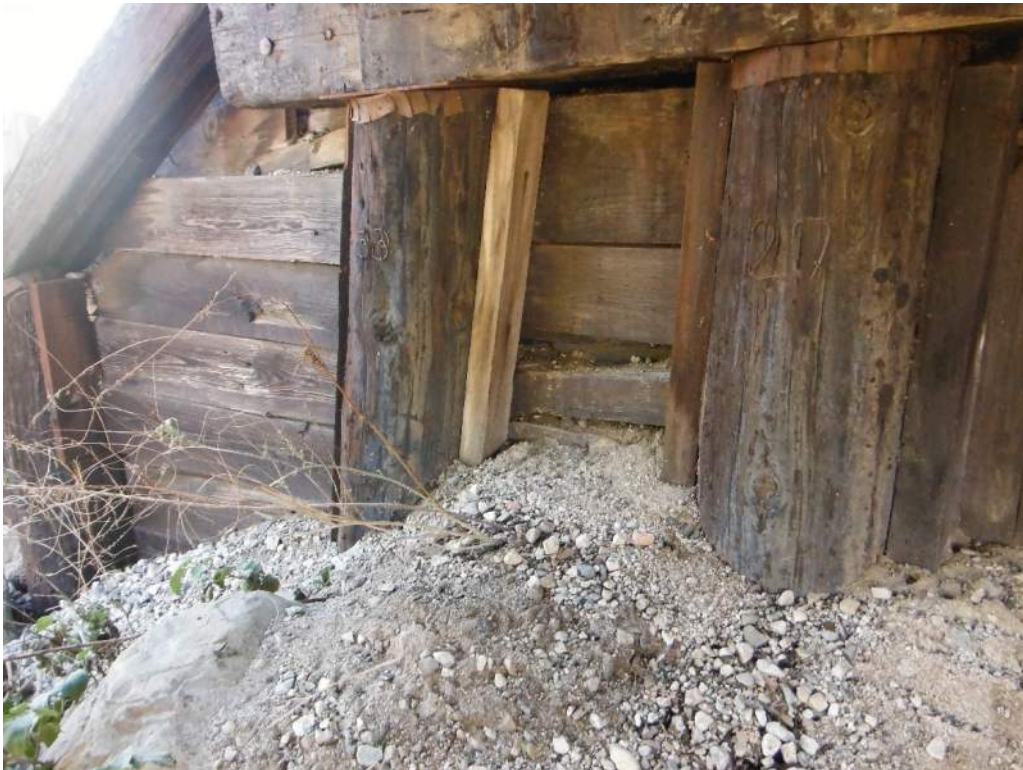
1. SW ballast retainer undermined and leaning - see photo
2. Abutment backwall failed plank has been supplemented; supplement failed - see photo
3. SP - Stringer #4 was corner split - see photo

**420.46 Abutment 1 backwall failed plank's supplement failed**

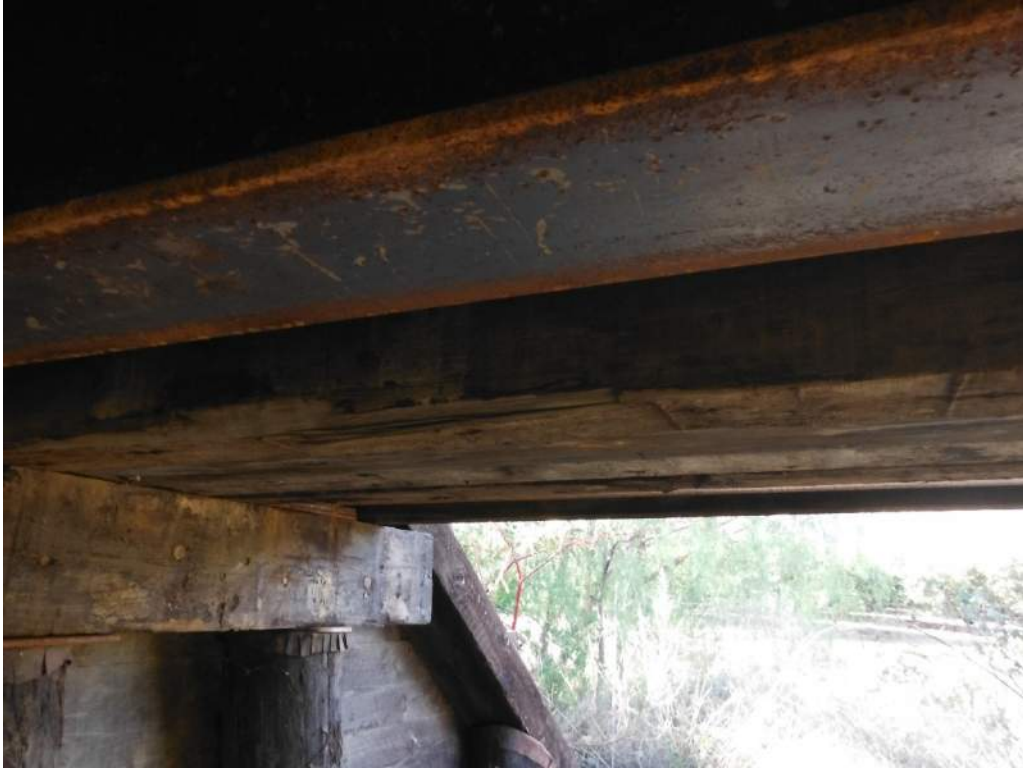
**420.46 Stringer 4 corner split, Abutment 1**

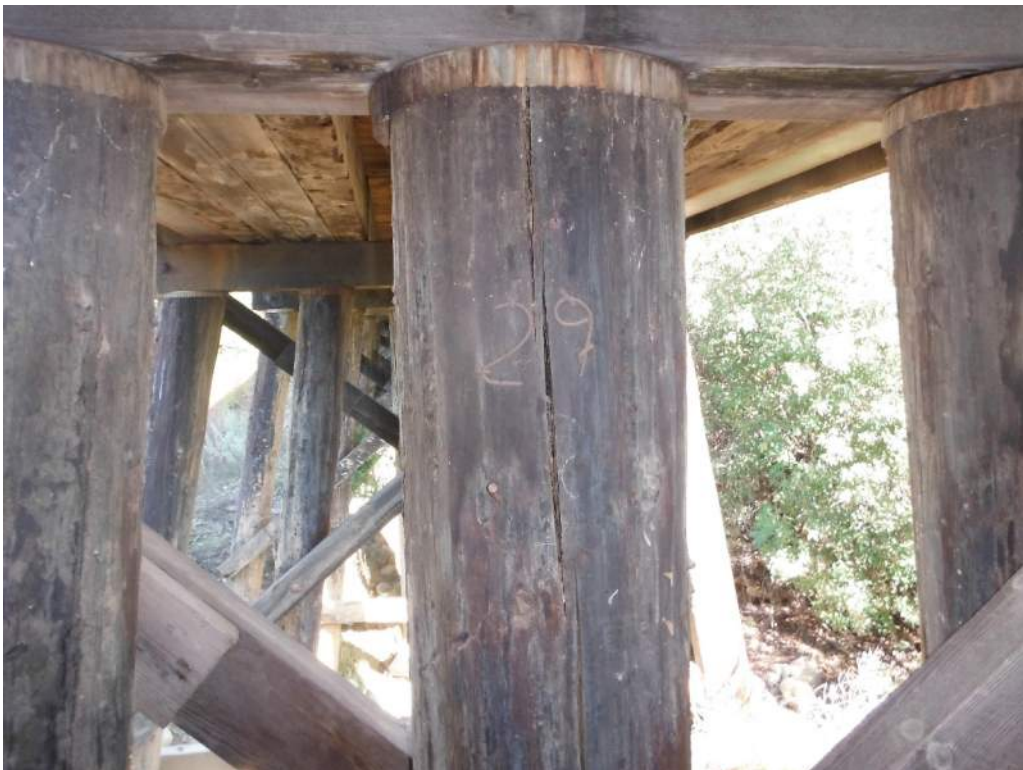
1. Br-Span #2, bent #2 sway brace is broken on south side at pile #5 - see photo
2. Spt - Piles #1, #3, #4 and #5 split - see photo

**420.46 Pile 3 split, Bent 2**

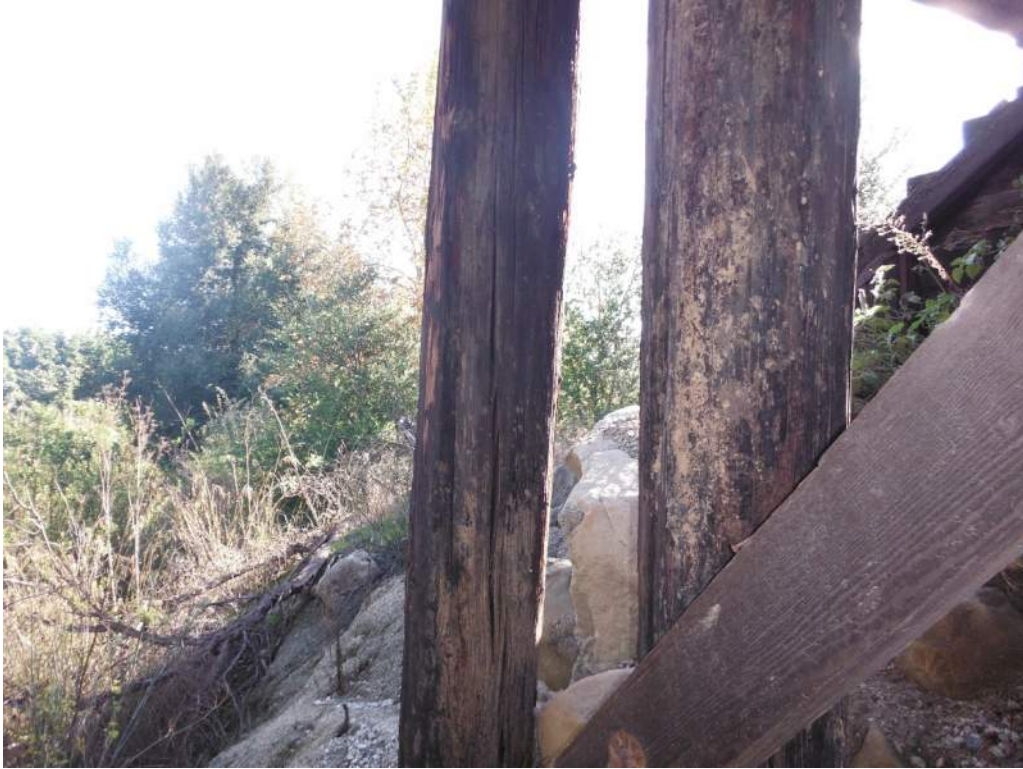
**420.46 Pile 5 split, Bent 2**

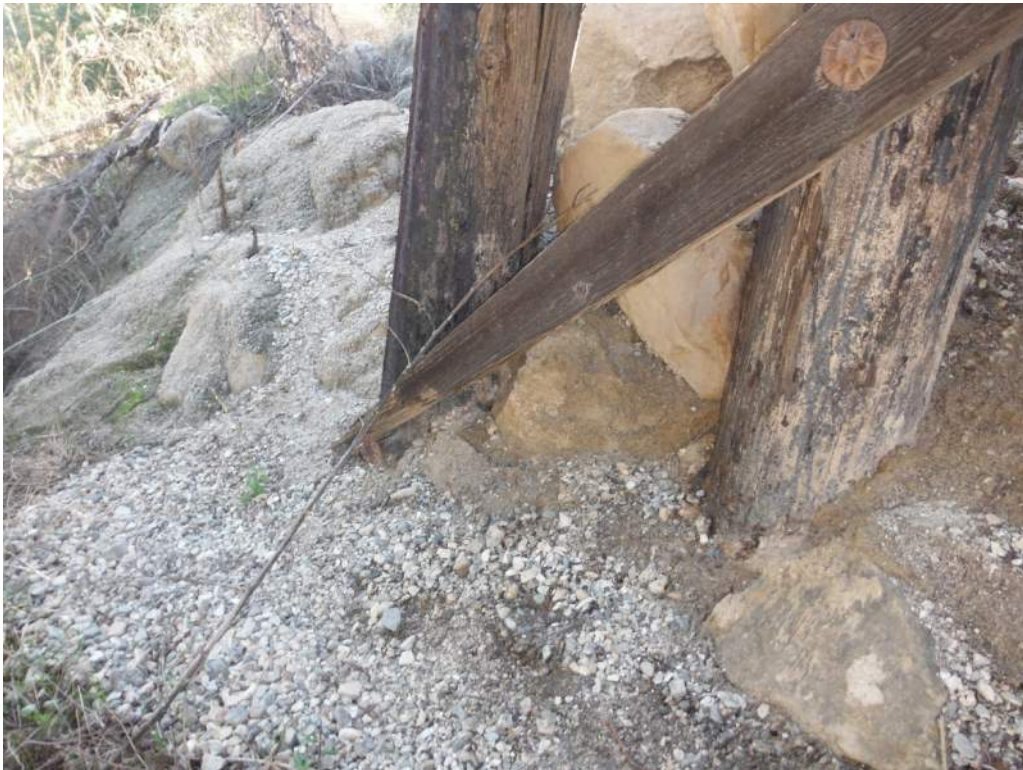
**420.46 Span 2, Bent 2 sway brace is broken on right side at pile 5**

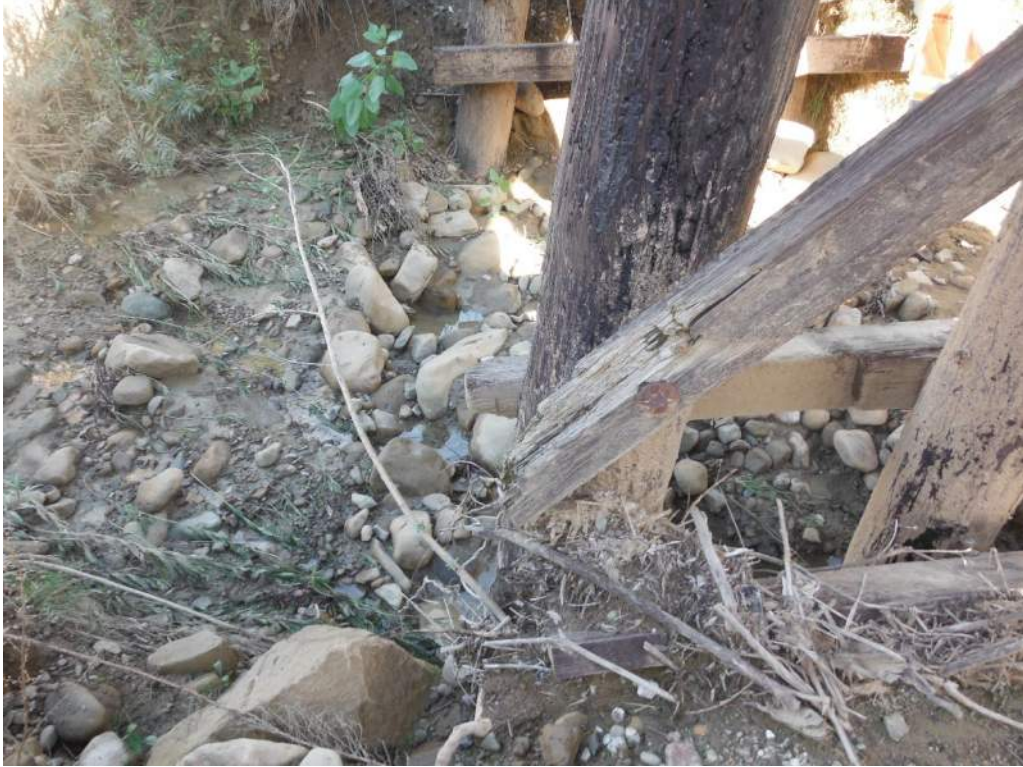
1. Spt, DR-Pile #1, #2 and #3 has vertical split, 2" to 3" shell remaining (2014) - see photo
2. Br-Span #2, tier #1 Sash brace is broken on left side - see photo
3. Spt - Stringer 8 corner split
4. Scour between bents 3 & 4 (4' to 5' max). Worst at bent 3 - see photo

**420.46 Span 2 & Bent 3, tier 1 sash brace is broken on left side**

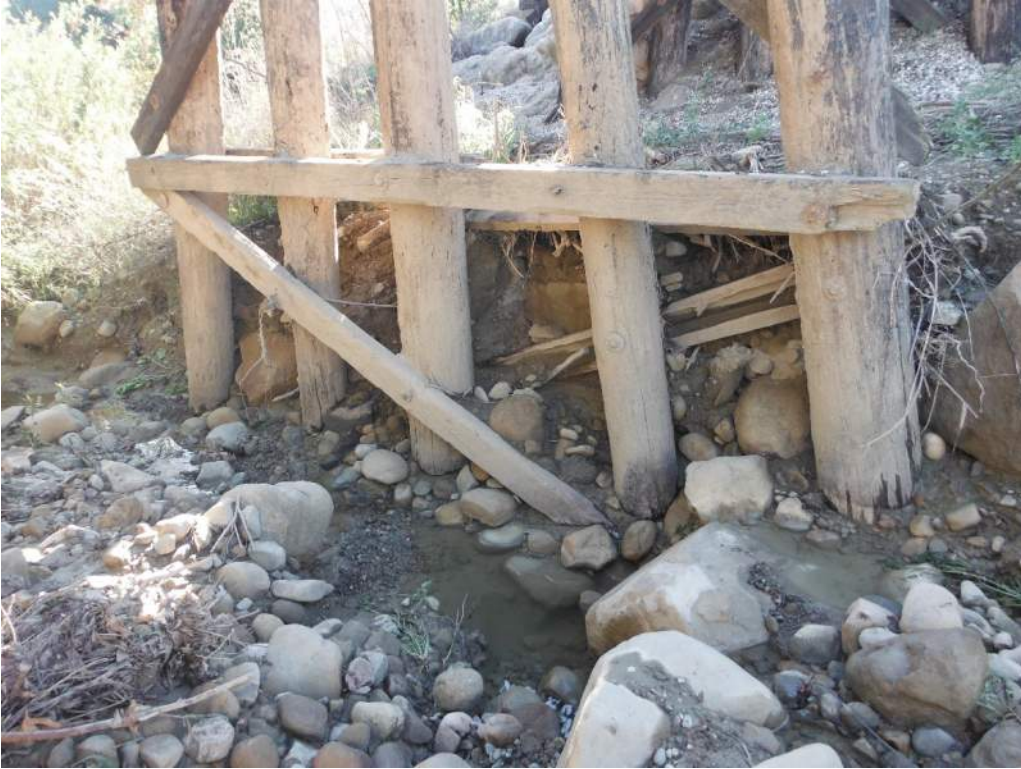
Visual Condition Rating 3  
 Stream Depth 0 Scour Evidence yes Moving Water no  
 Notes 4'-5' Scour between bent 2 and bent 3. 10 ft of pile embed remaining.

**420.46 Scour between Bent 3 and 4**

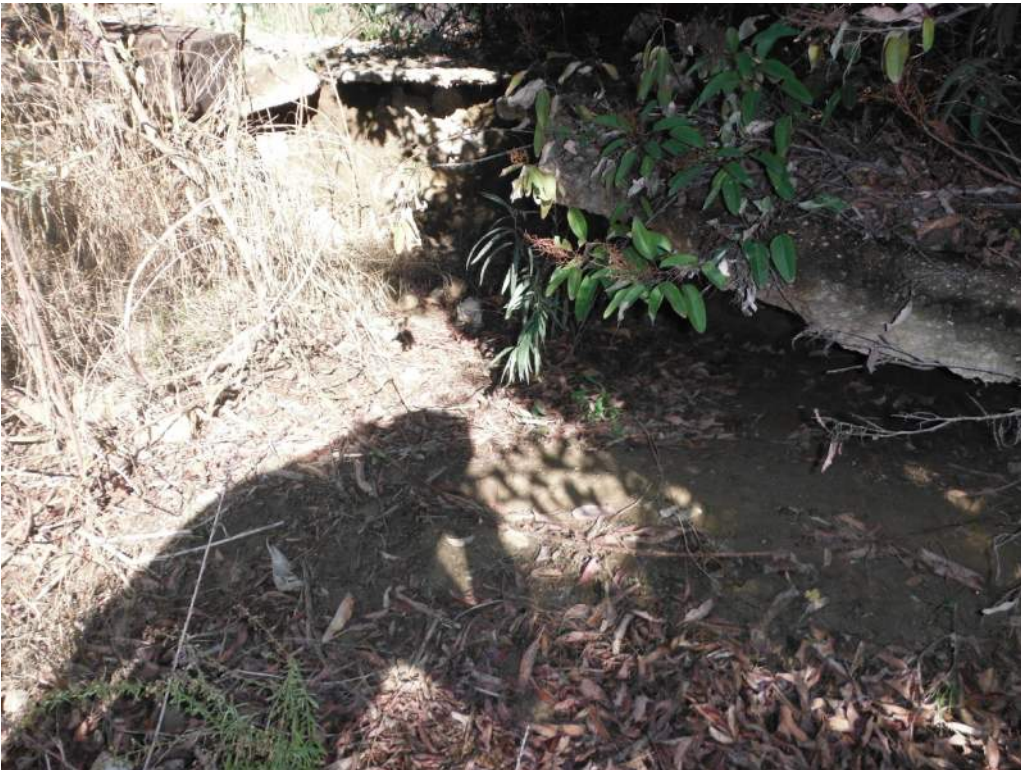
**420.46 Slope paving undermining downstream of Bent 4**

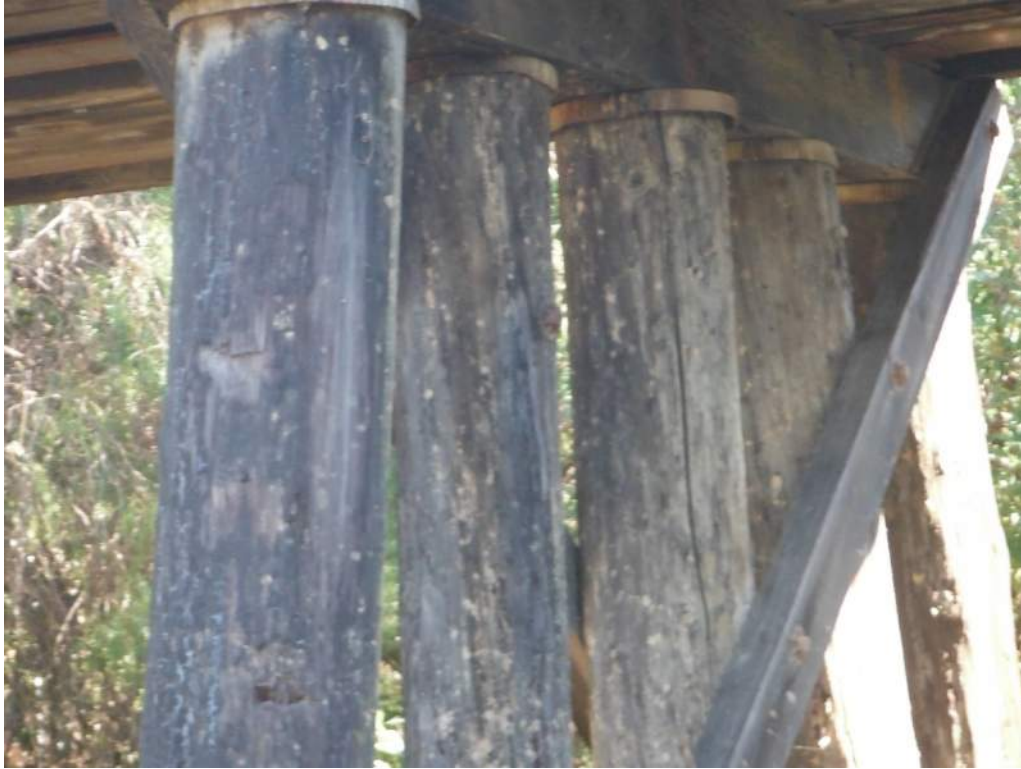
**420.46 Pile 3 is punky and has a vertical split, Bent 4**

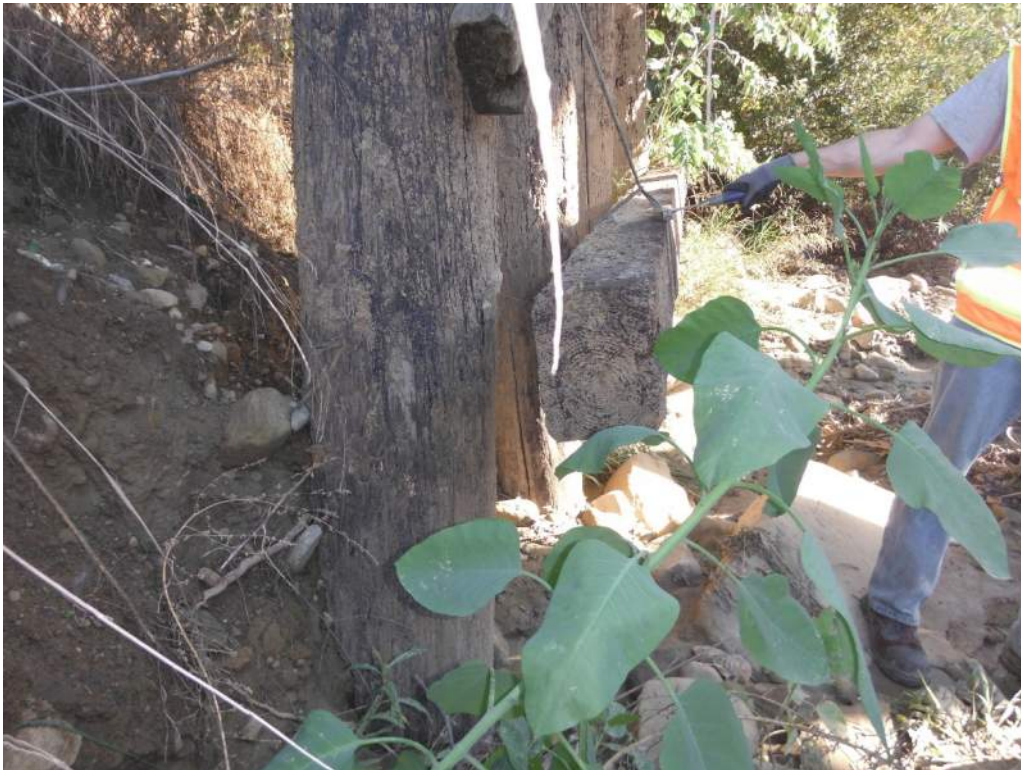
**420.46 Diagonal sash bracing is not attached, Bent 4**

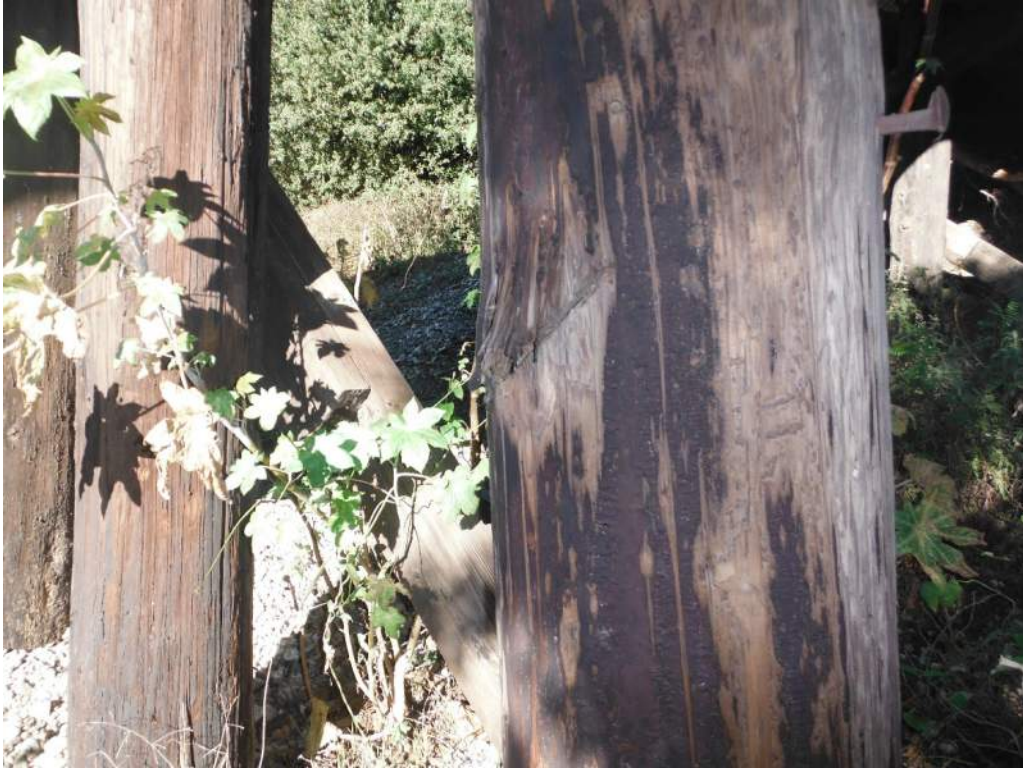
1. Spt - Pile #1 split - see photo
2. Imp - Impact damage Pile #5 - see photo
3. HW - Pile #3 is hollow
4. DC - South exterior stringer has deep checking - see photo

**420.46 Impact damage pile 5, Bent 5**

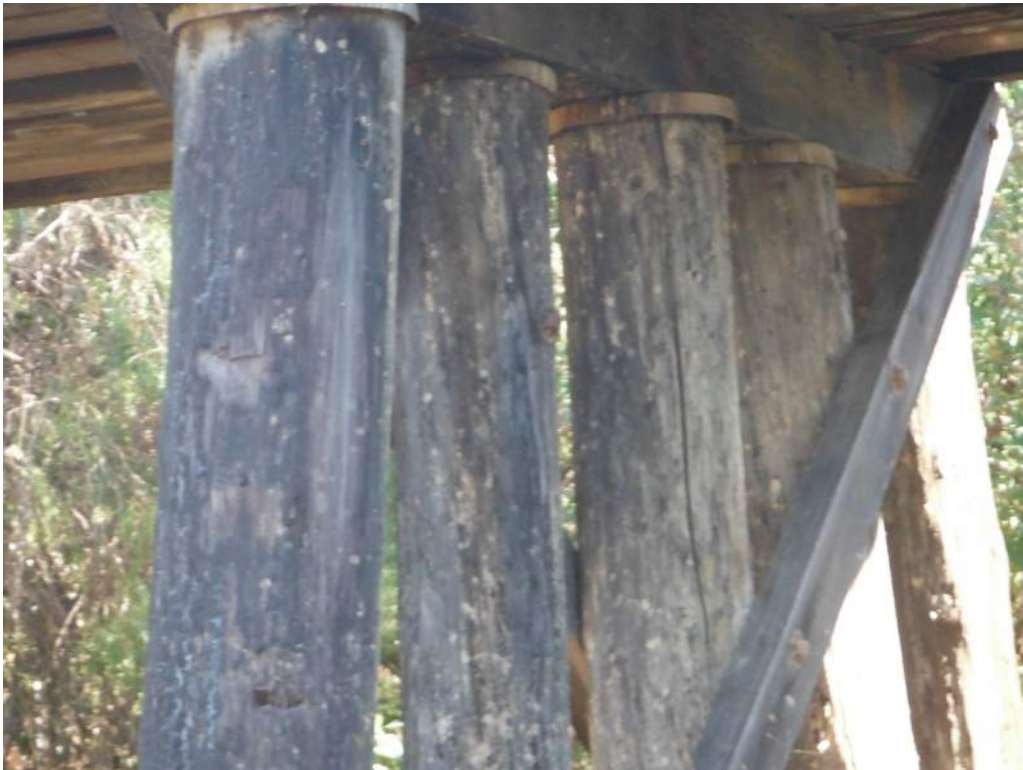
1. PU-Pile #4 is punky
2. Rot, DR (2014) - Pile #2 is rotted at bottom, 2" core shell
3. Spt-Piles #2, #3 and #5 have vertical split - see photo
4. SPT - Cap is split - see photo
5. Minor impact pile #1 - see photo
6. DC - South exterior stringer has deep checking - see photo
7. Stringer #5 and #8 is split
8. Sway brace rotten at pile #1 and #5 - see photo
9. Hole - Holes in deck planks - see photo
10. Stringer 4 corner split at midspan.

**420.46 Pile 1 minor impact, Bent 6**

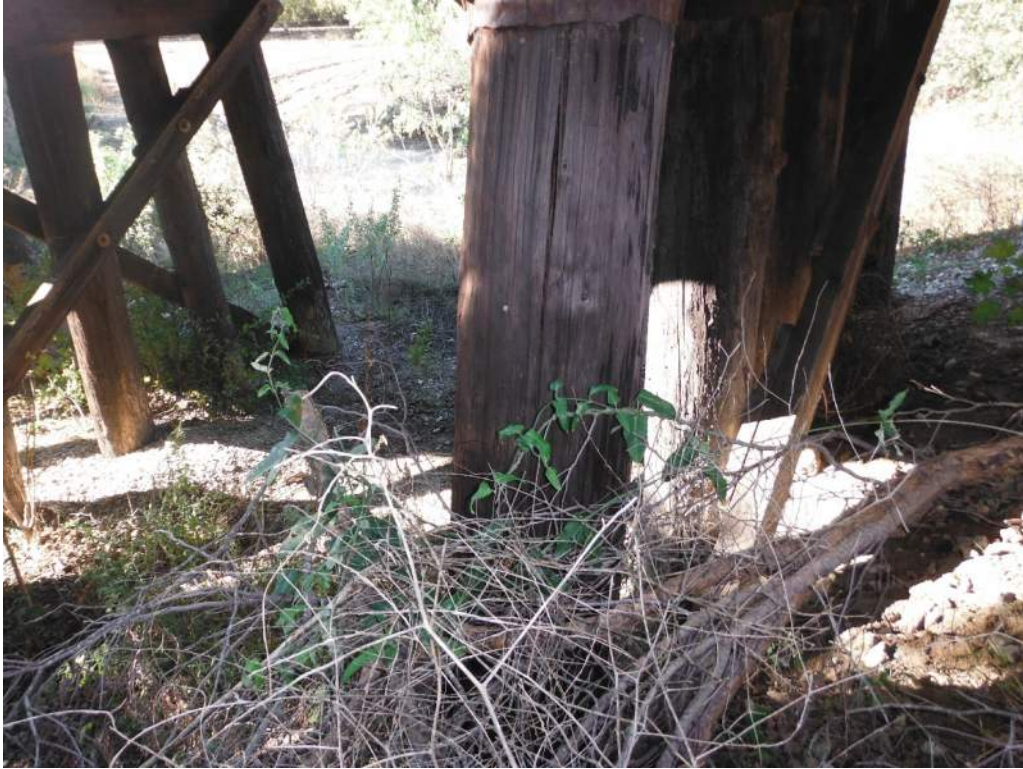
**420.46 Pile 5 vertical split, Bent 6**

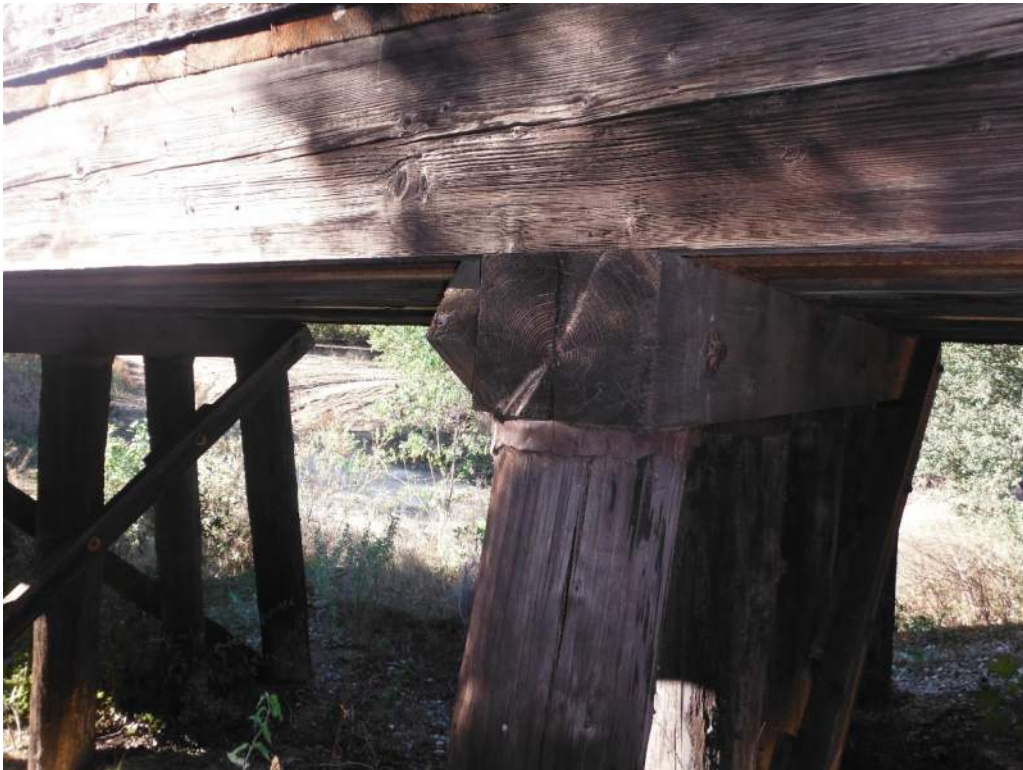
**420.46 Cap is split, Bent 6**

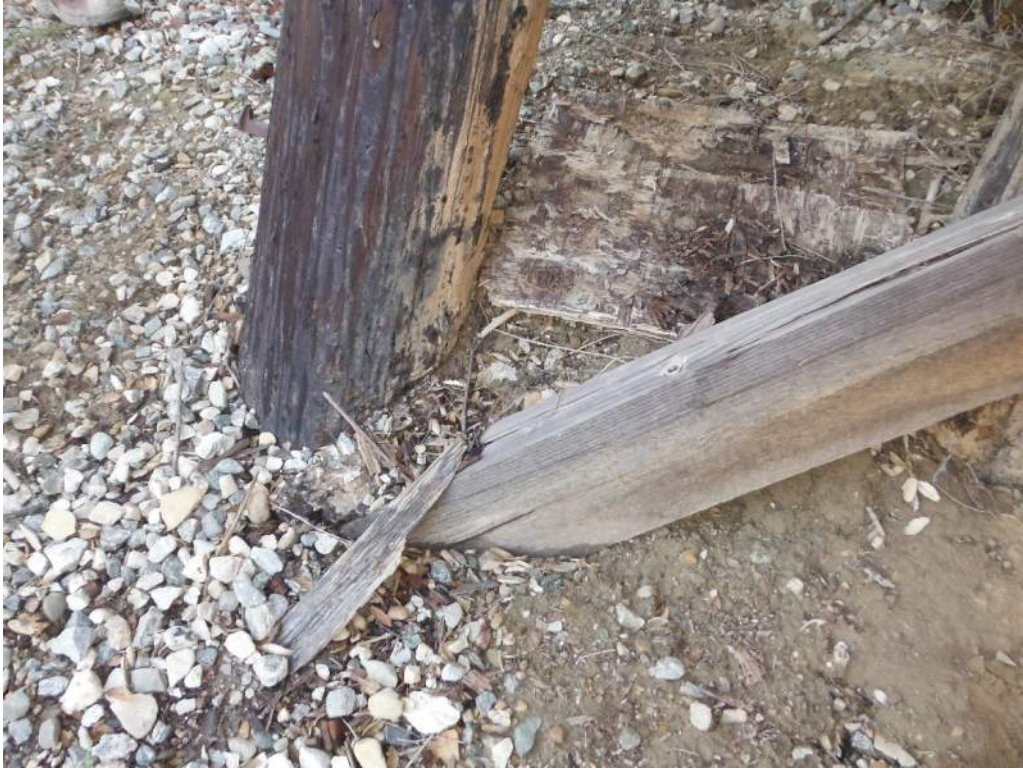
**420.46 Cross bracing rotten, Bent 6**

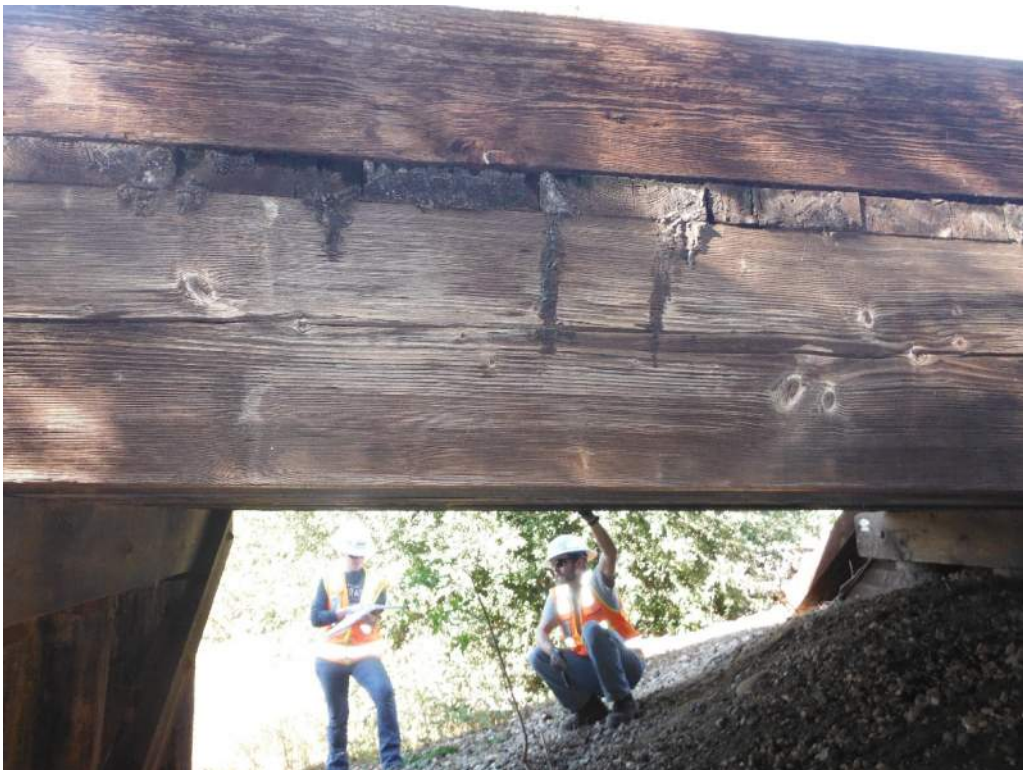
**420.46 Spans 5 and 6, south exterior stringer has deep checking**

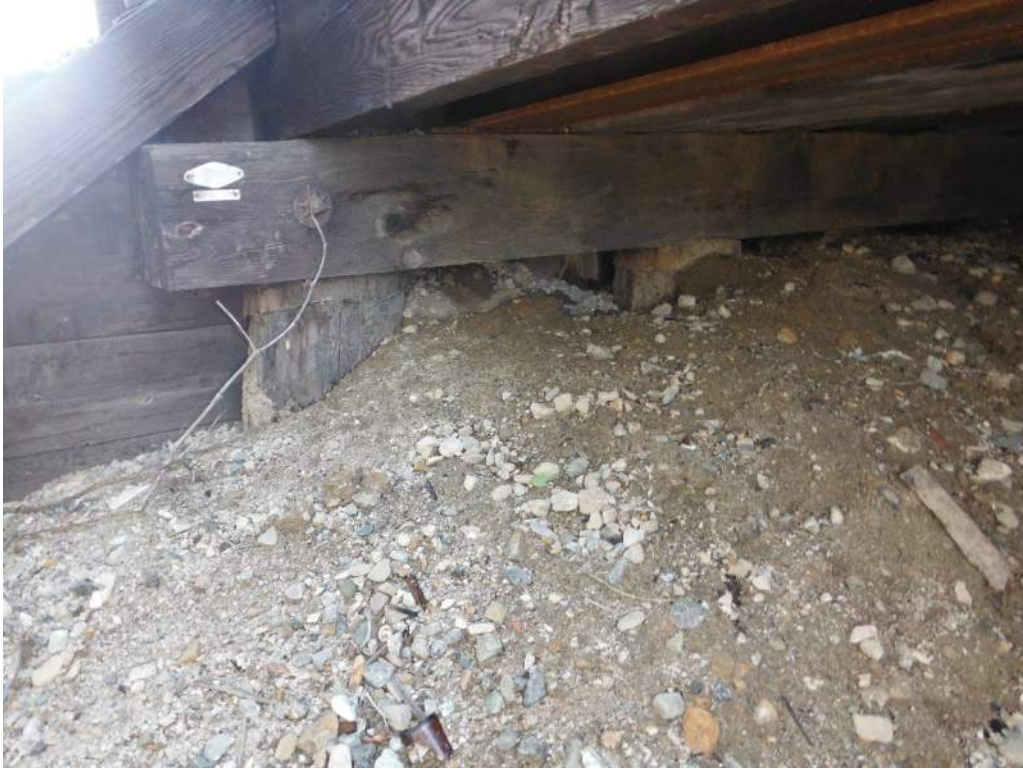
1. Abutment 7 is buried - see photo

**420.46 Abutment 7 is buried**

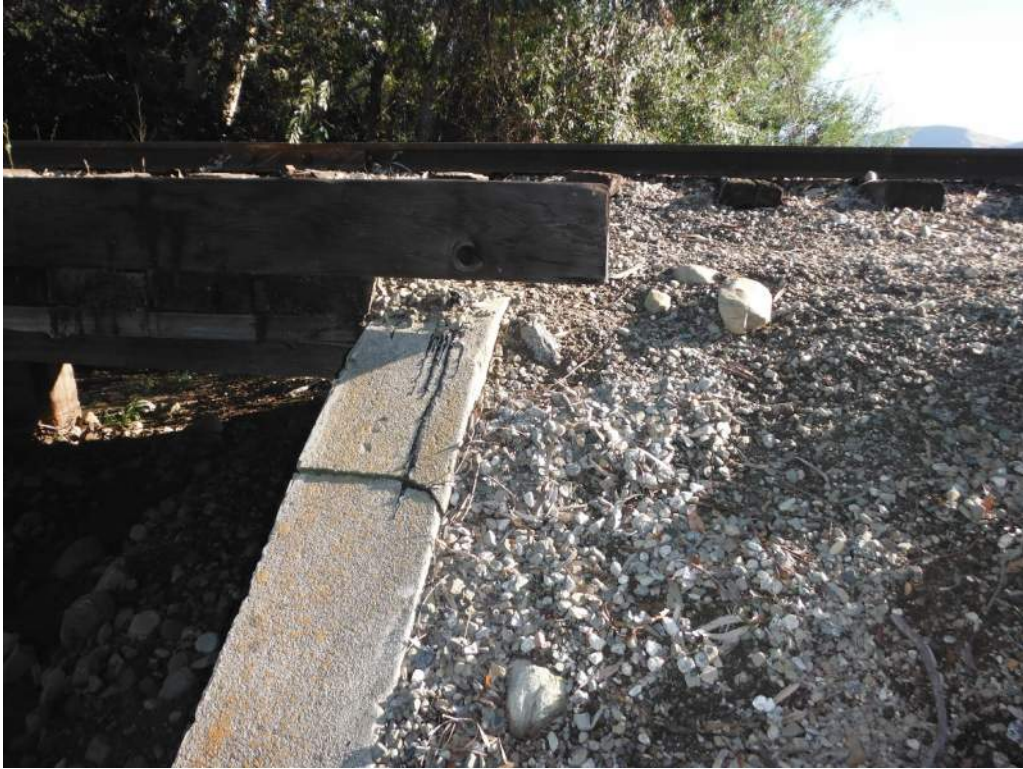
**421.05 Ballast Curb Undermined all 4 Corners**

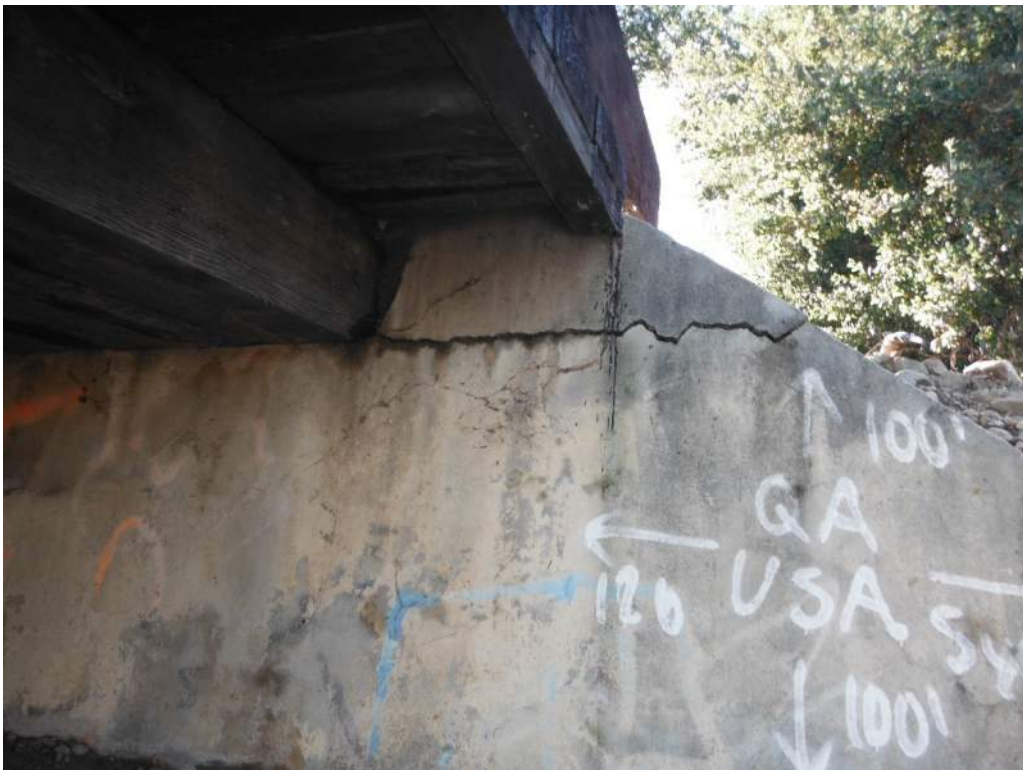
**421.05 Abutment stringer retainer cracked – typical all 4 corners**

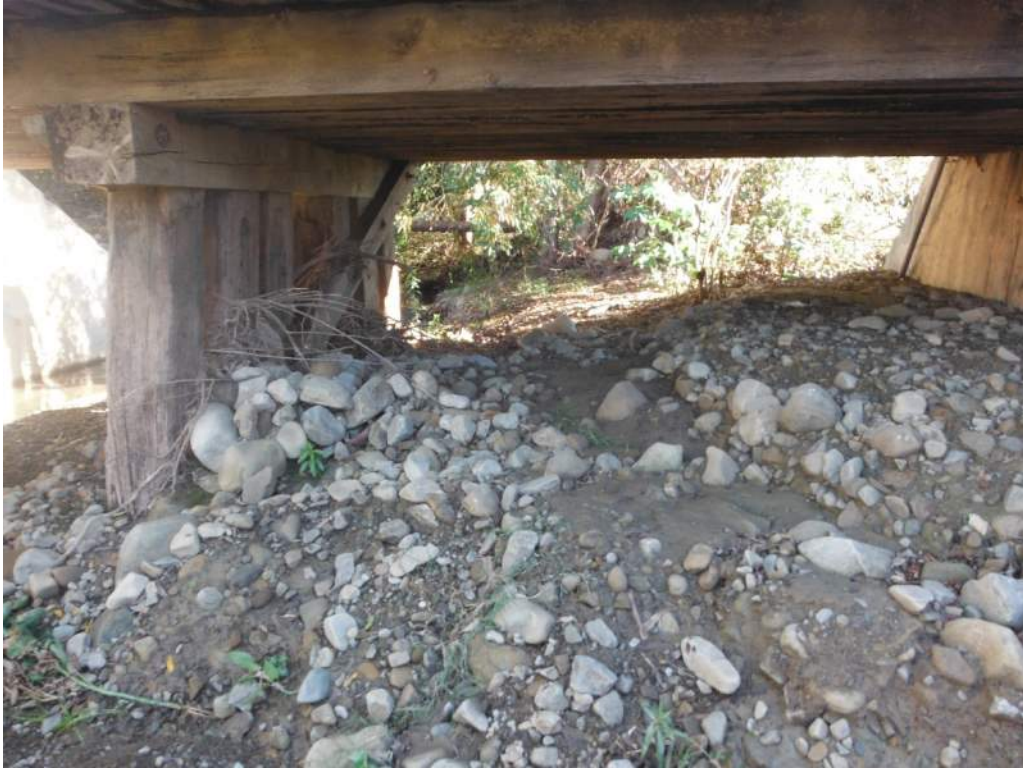
**421.05 Span 1 silting in**

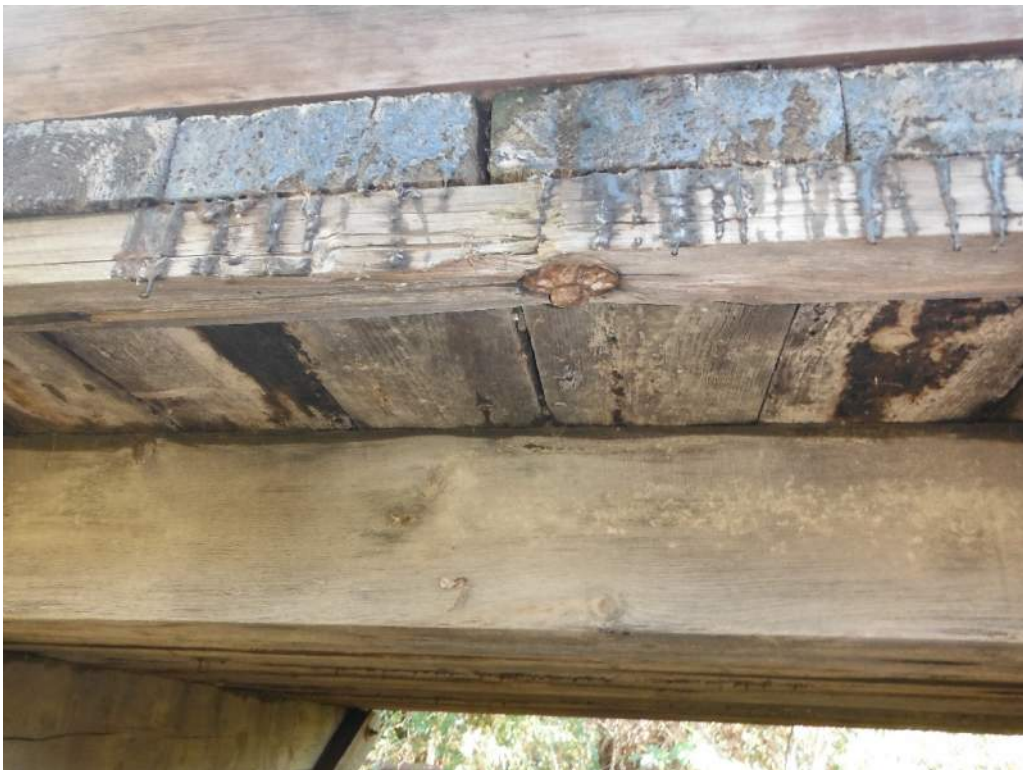
**421.05 Deck sill splitting – Span 1**

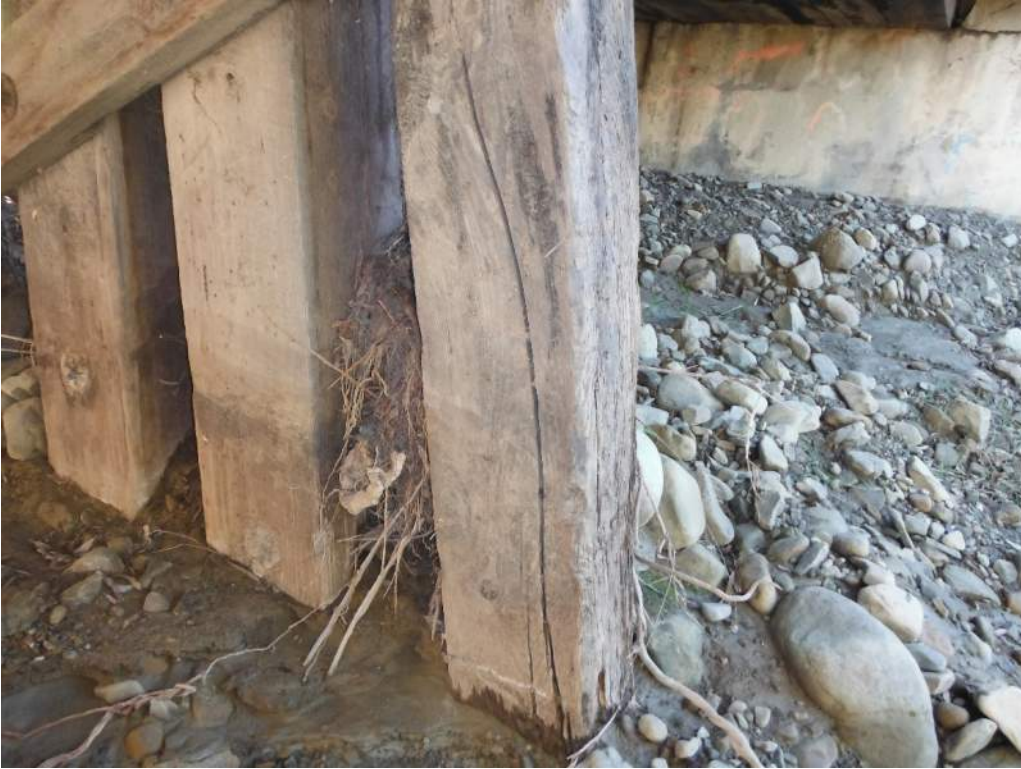
**421.05 Vertical split in Pile 1 – Bent 2**

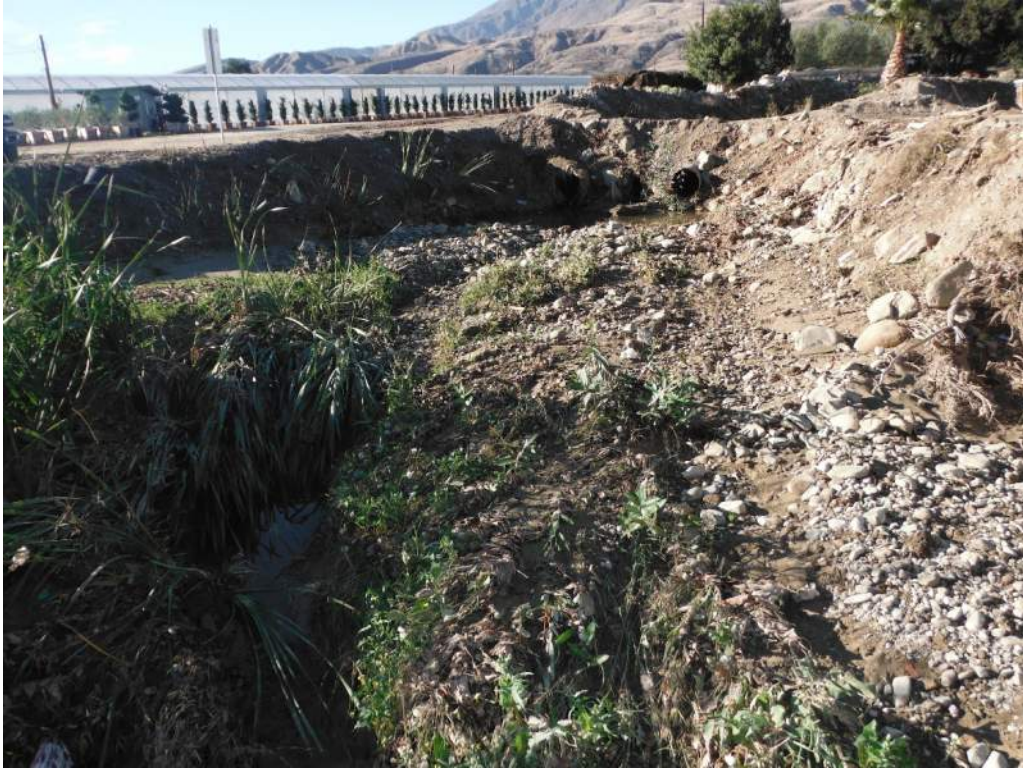
**421.23 Channel Condition – Looking Upstream**

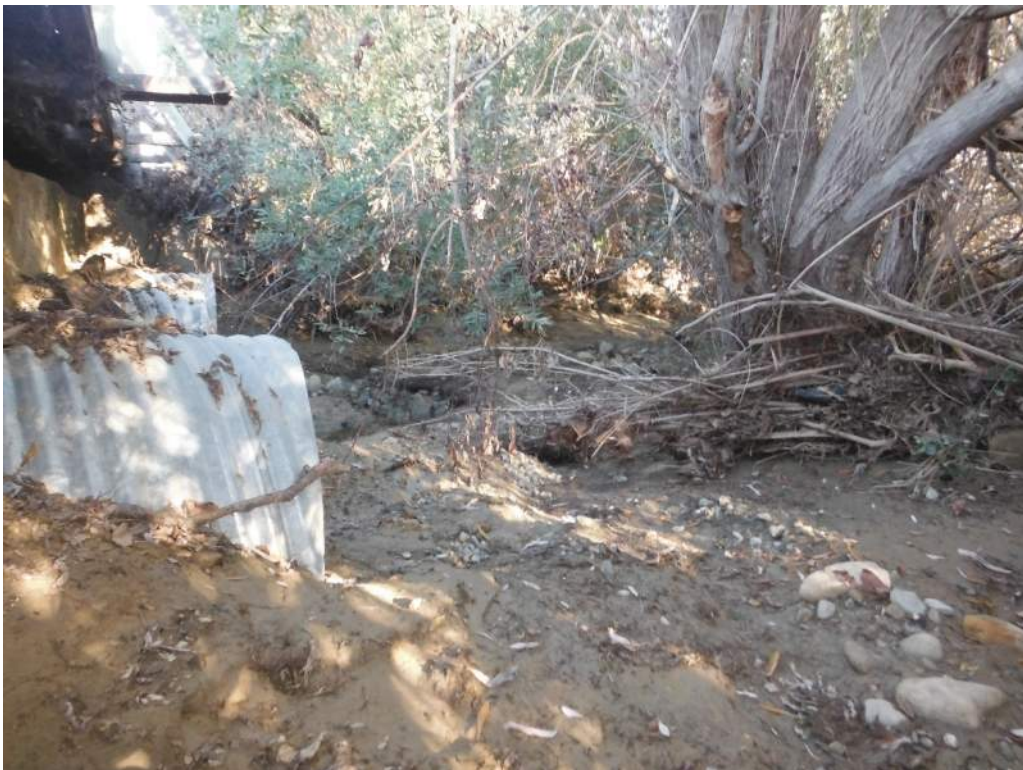
**421.23 Channel Condition – Looking Downstream**

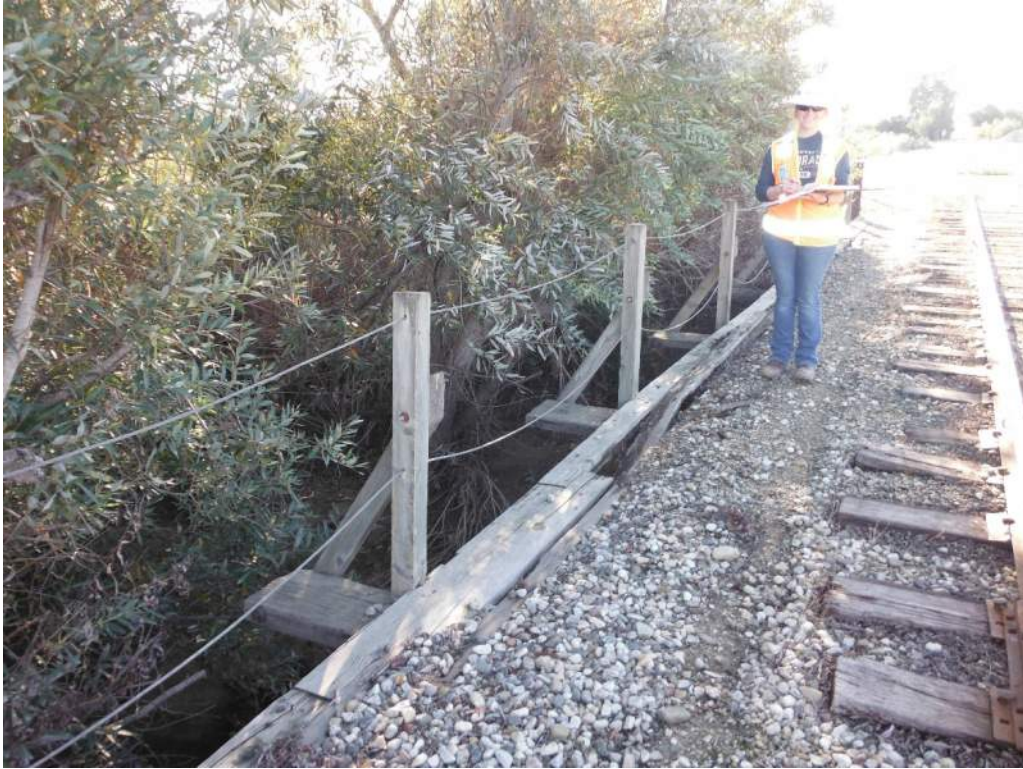
**421.23 Loose Handrail Cable Both Sides**

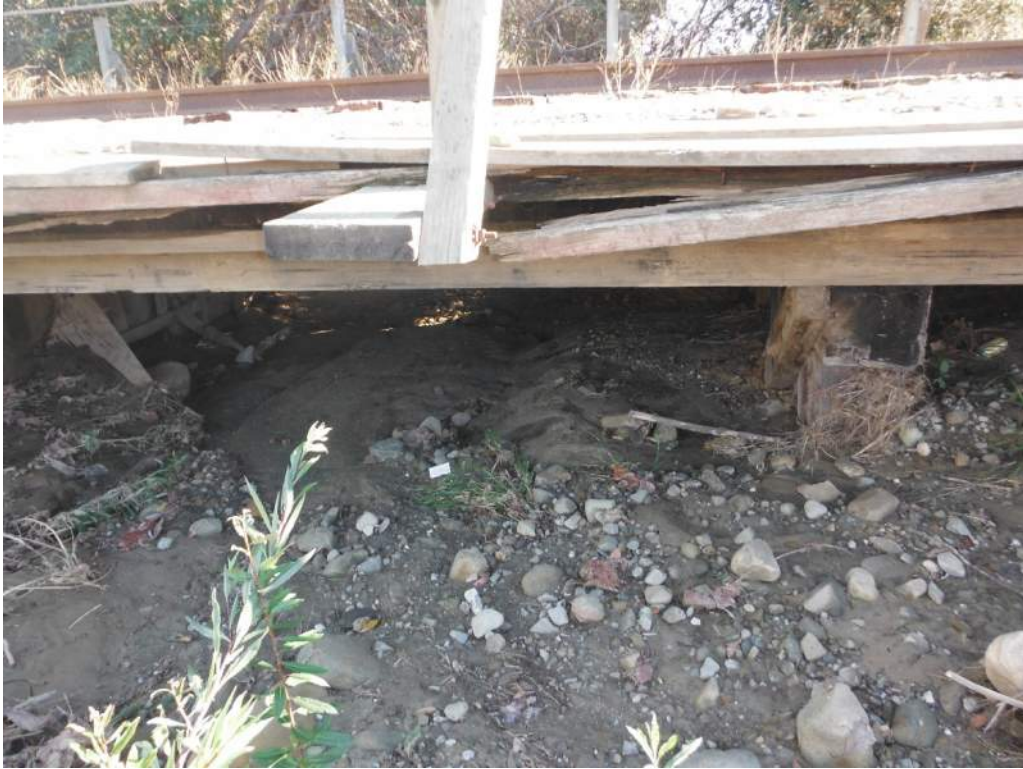
**421.23 Walkway Timbers Broken on North Side Span 2**
