# BRIDGE INSPECTION REPORT

INSPECTION TYPE: Annual

Milepost 407.48  
 Location Santa Paula Branch Line  
Saticoy, CA  
 Stream X Overpass        Other         
 Train Operating Speed: Freight: 10 mph Passenger: 15 mph

MAINLINE/SUBDIVISION: VCTC

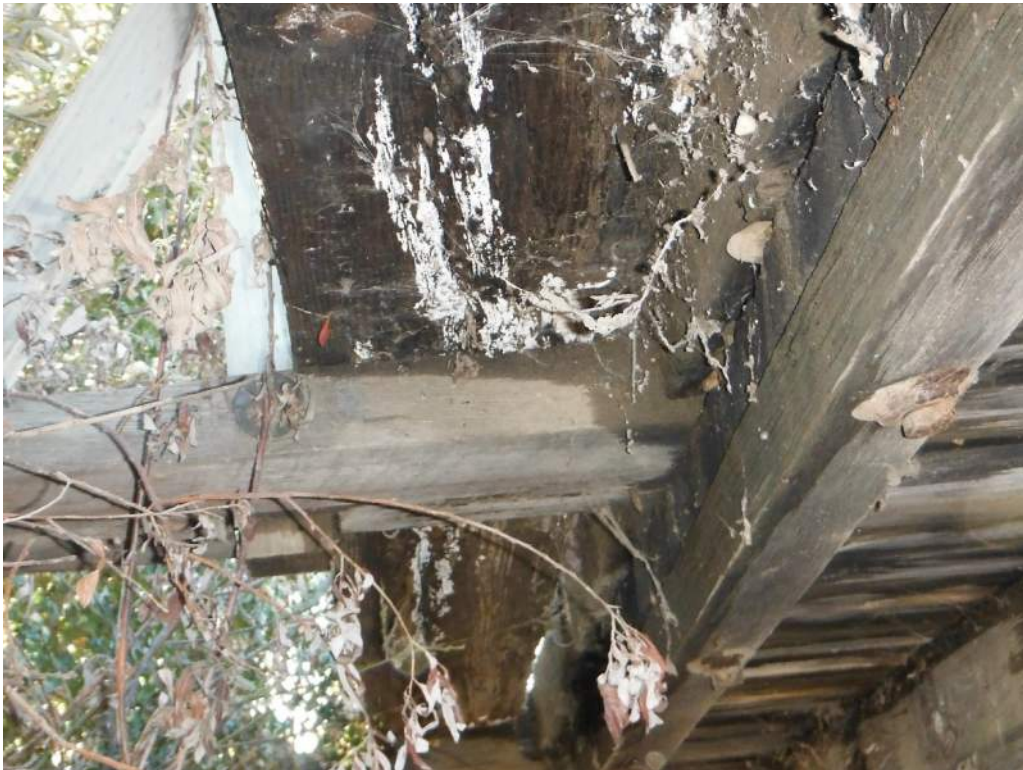
**421.23 South walkway rotten**

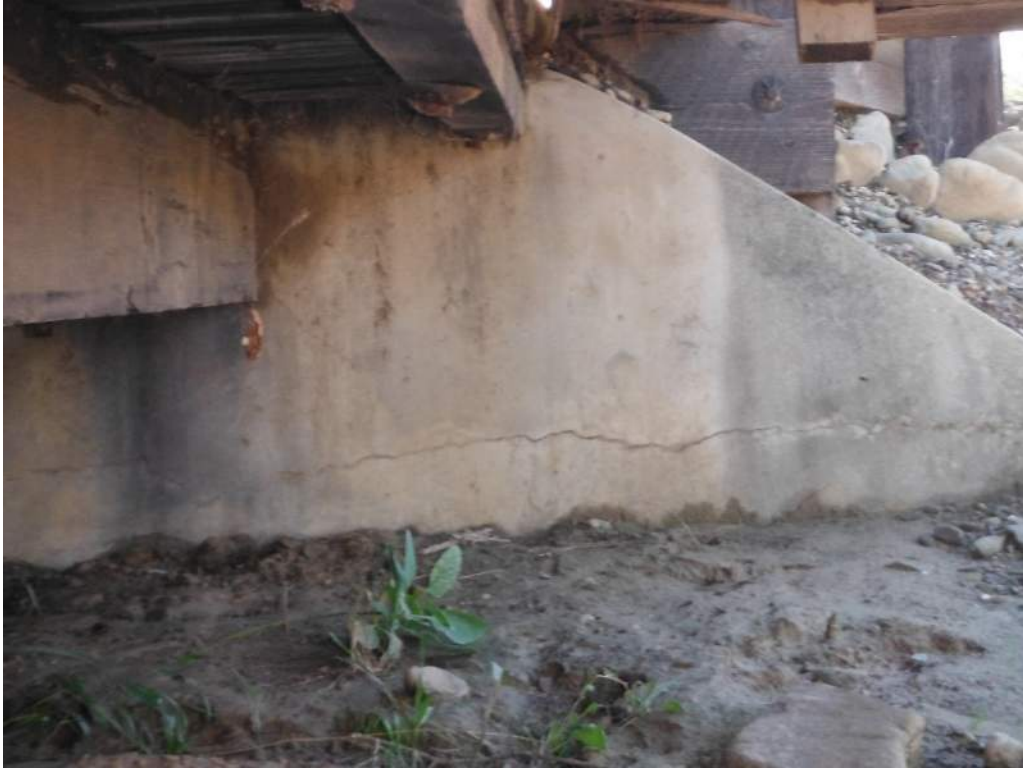
**421.23 Horizontal Crack in North Side Abutment 1**

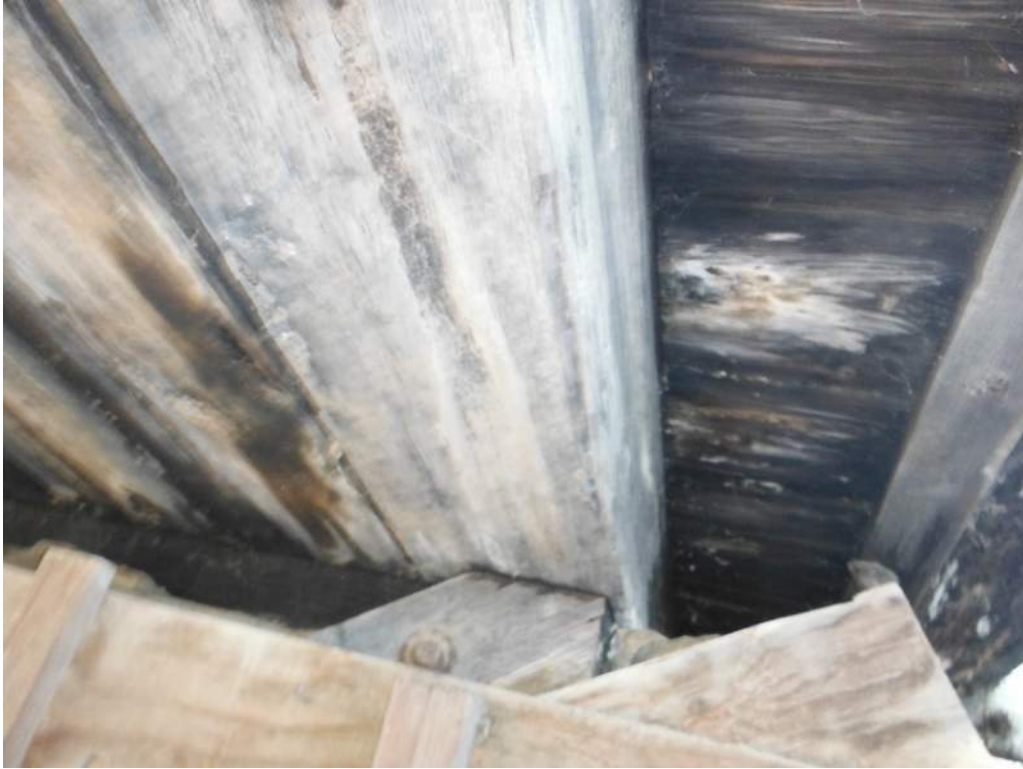
**421.23 Stringer 12 Splitting, Span 2**

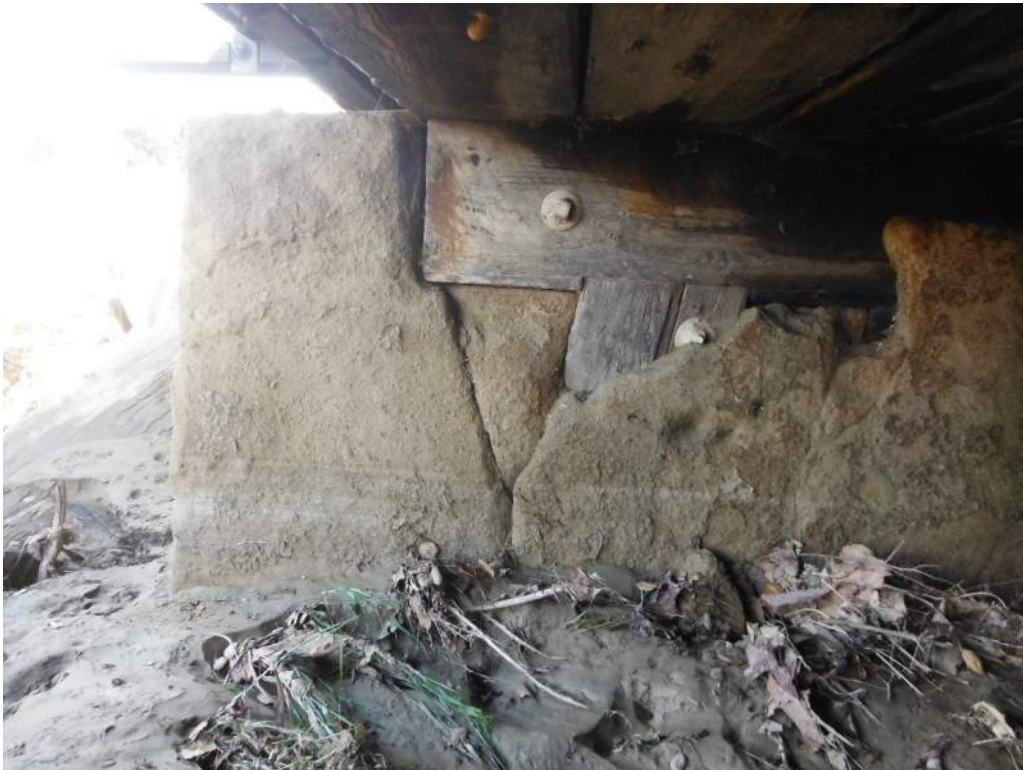
**421.23 Concrete Encased Bent 3**

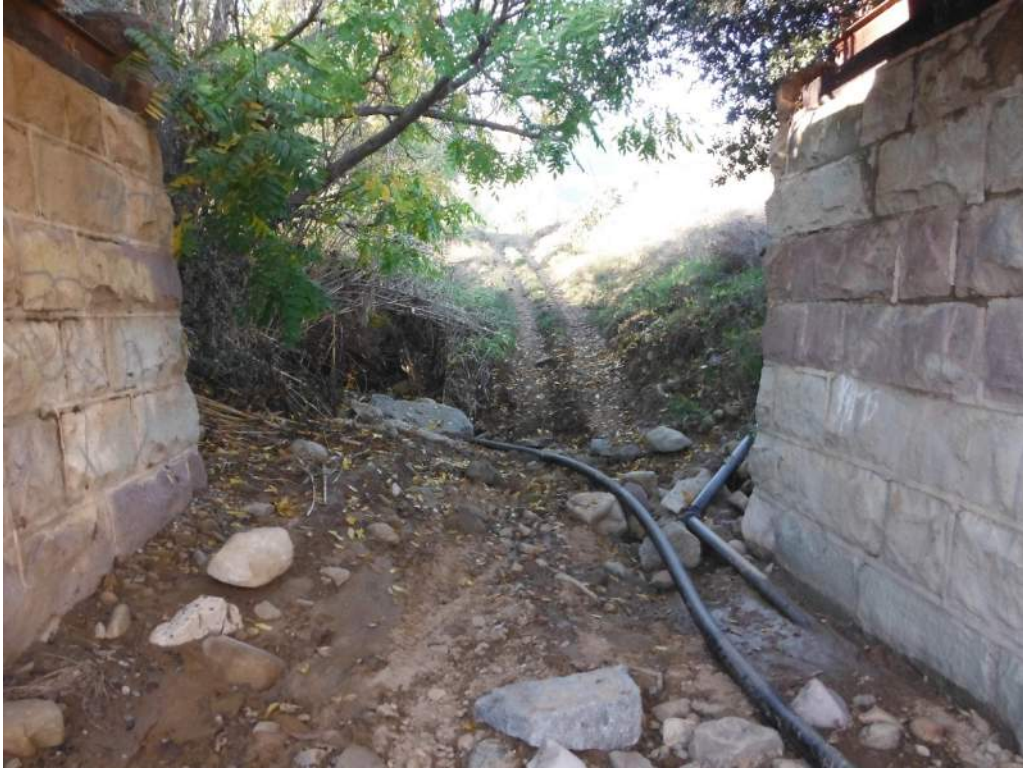
**422.53 Upstream channel condition**

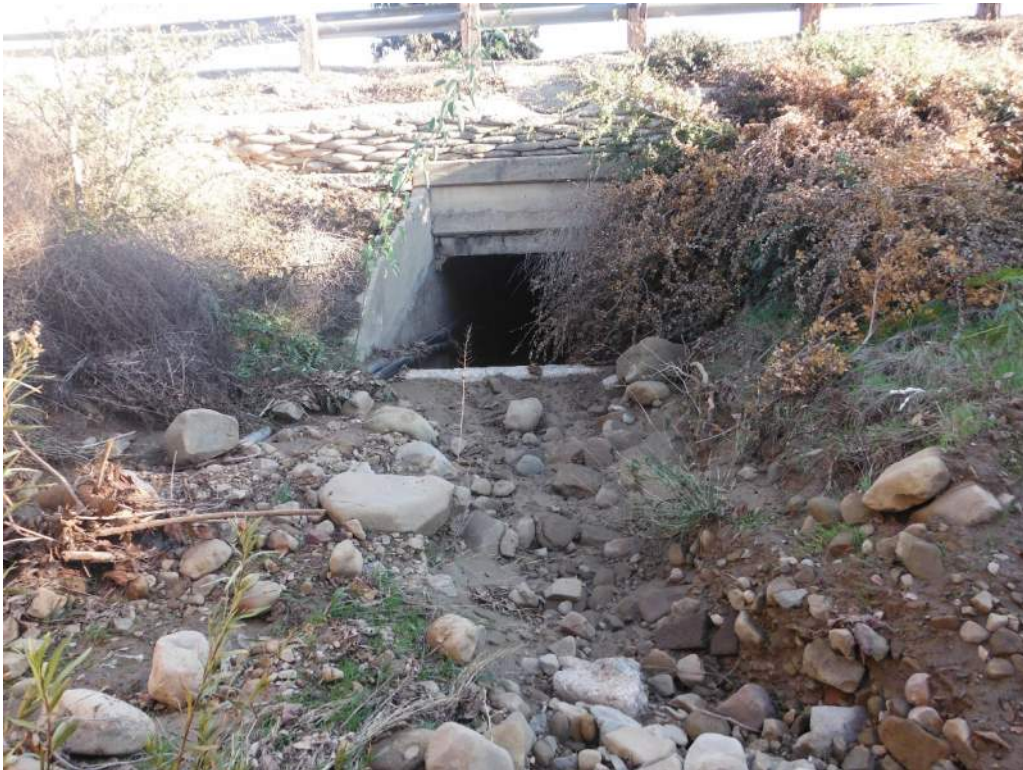
**422.53 Downstream channel condition**

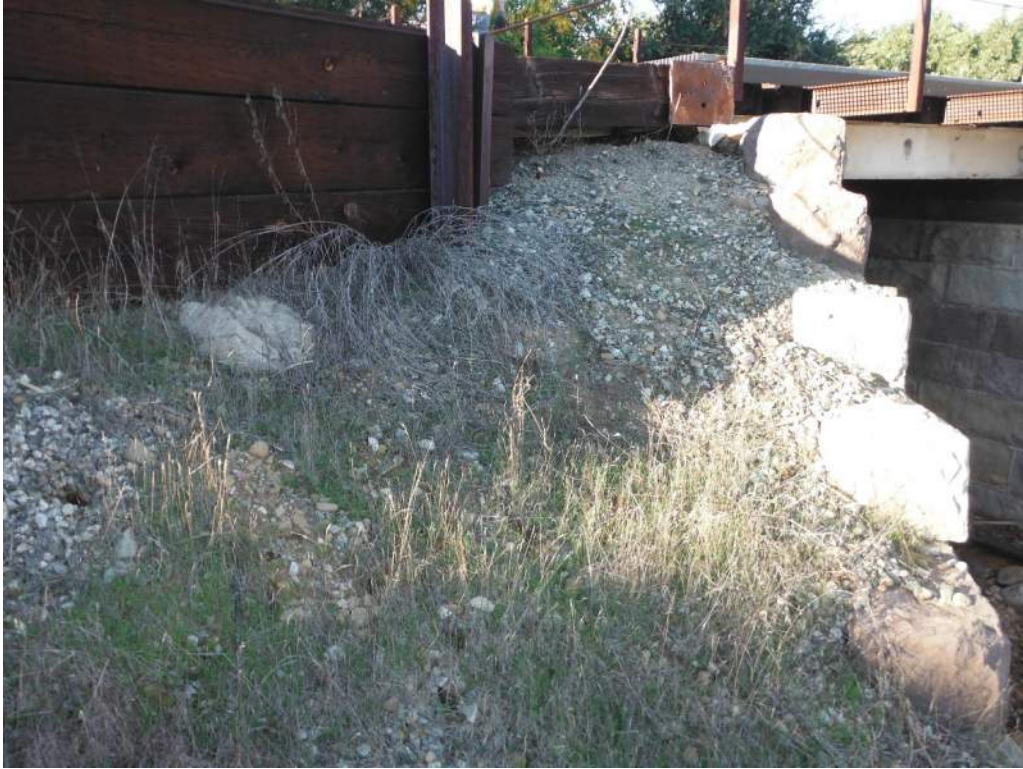
**422.53 Southwest ballast curb undermined**

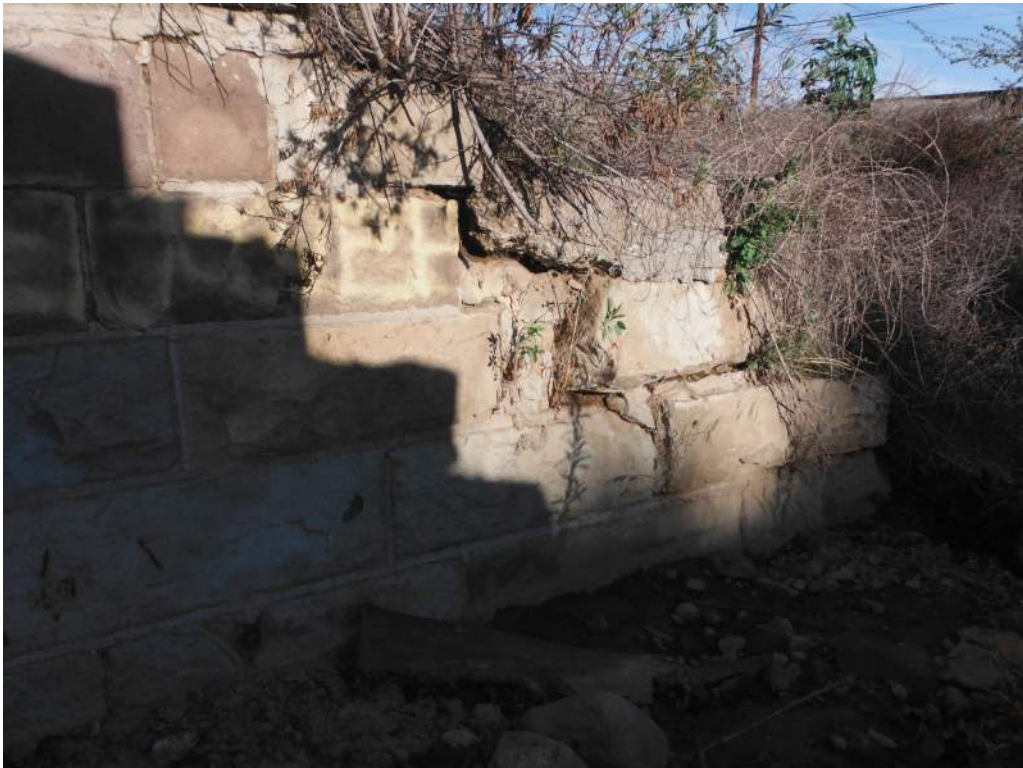
**422.53 Southeast Wingwall Blocks Loose**

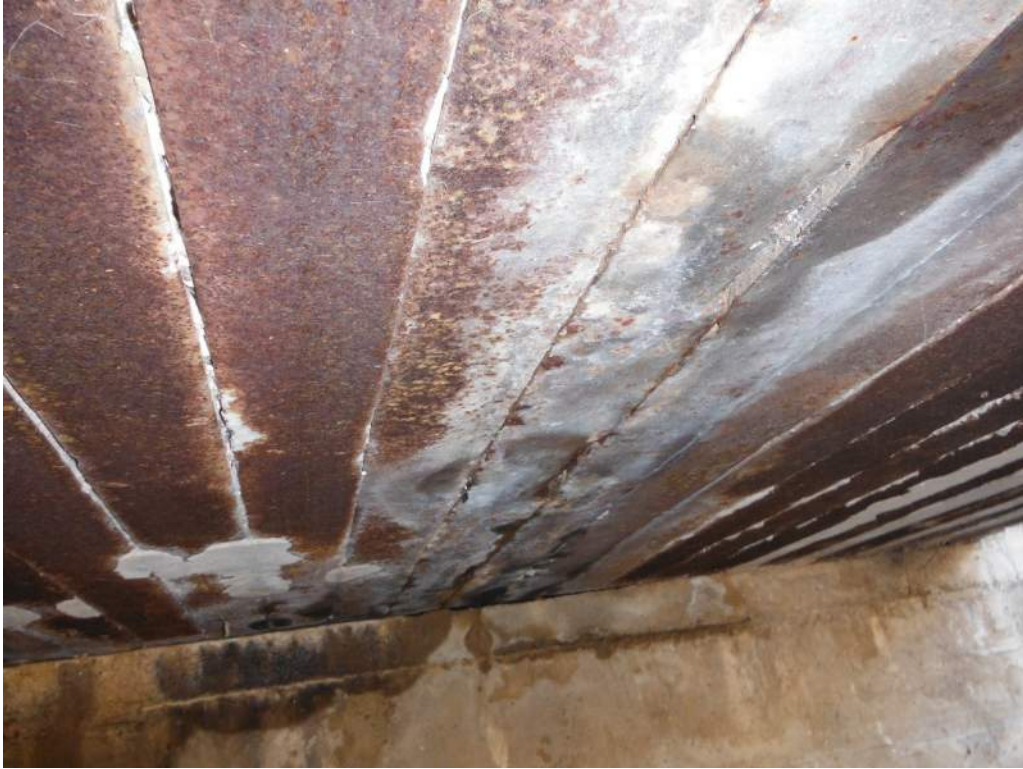
**422.89 Efflorescence on rail top superstructure**

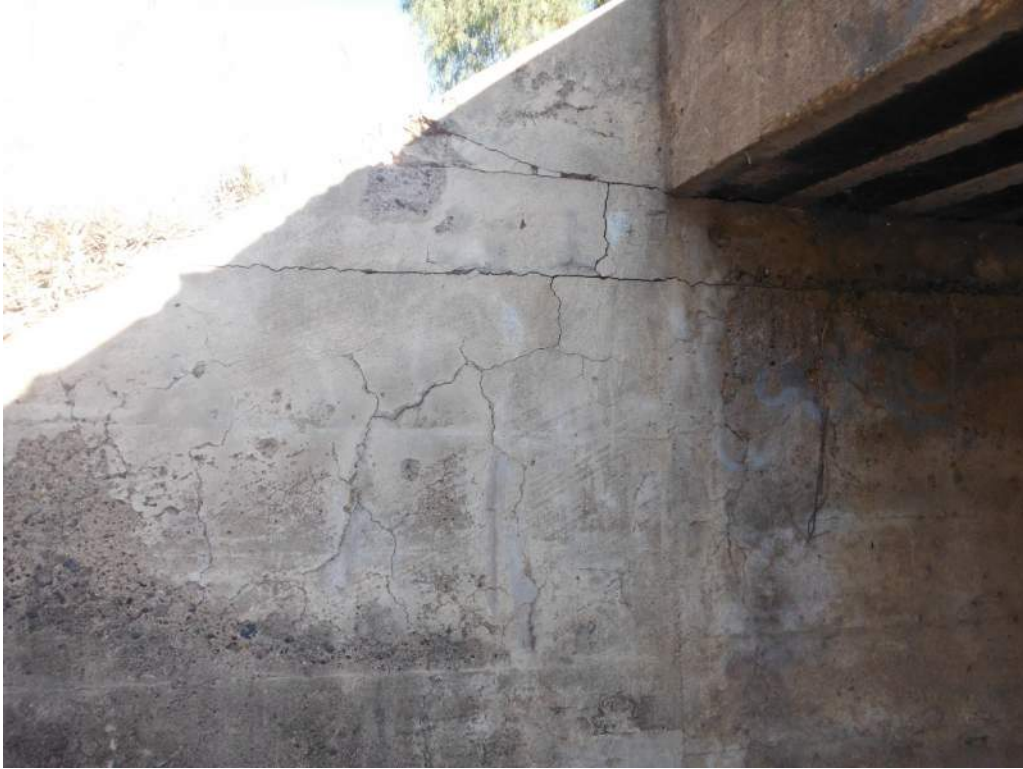
**422.89 Abutment 2 cracking – cracking typical both sides each Abutment**

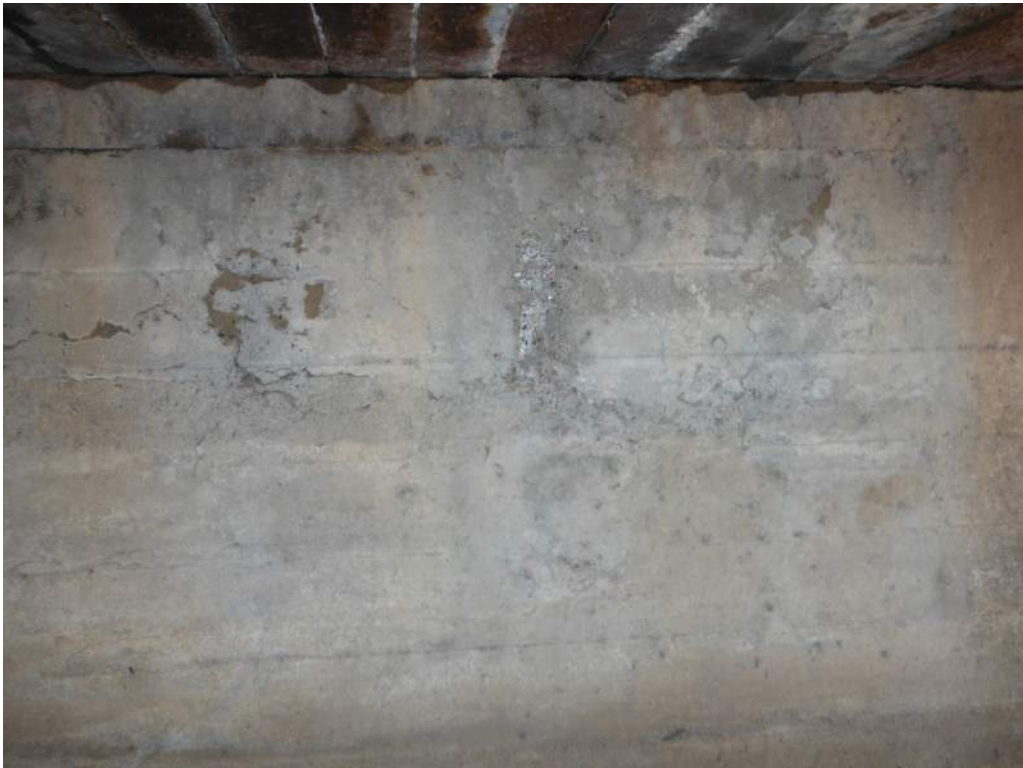
**422.89 Abutment scaling – typical each Abutment**

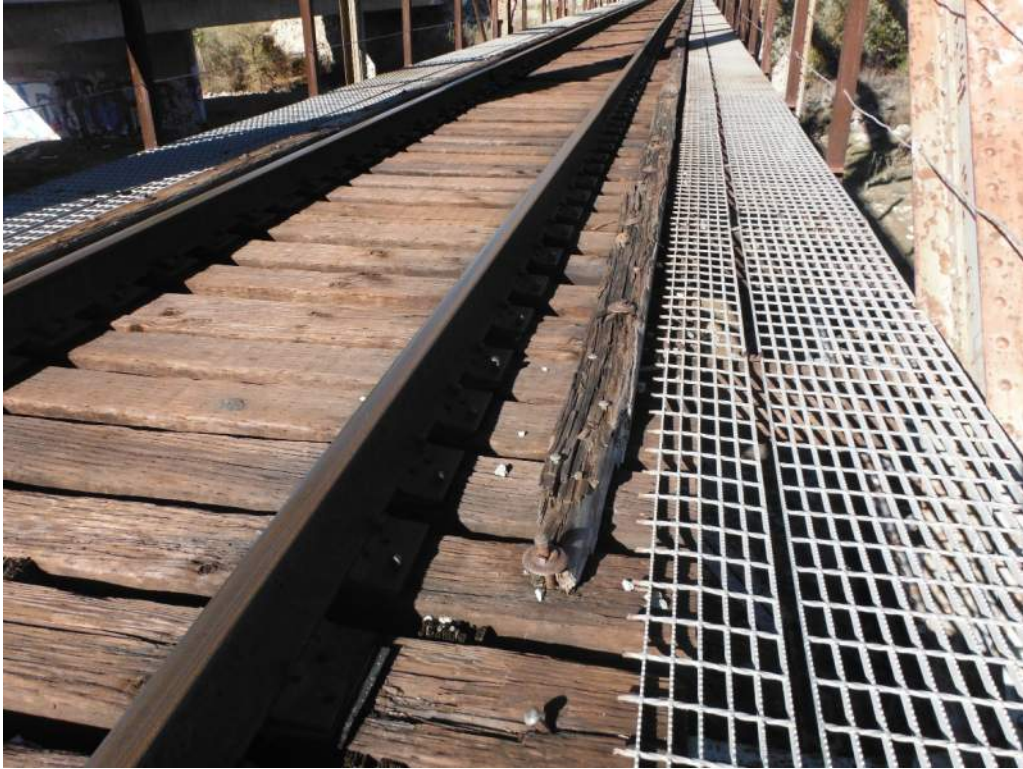
Curb	Damaged timber curb west and east side, north east corner is worst - see photo						
<b>MAINTENANCE RECOMMENDATIONS</b>							
Priority	Description						
E03, B	Raise approaches						
D05, A	Repair handrail cable north side						
S05, B/C, M	Clean bearings. Monitor condition and raise priority if necessary						
	Bearings may need to be replaced						
A03, A	Remove bees at abutment 1						
D03	Increase rail with heavier section as tonnage dictates						
<b>CONDITION RATING</b>				<b>PRIORITY</b>

**423.28 Damaged timber curb west and east side, typ**

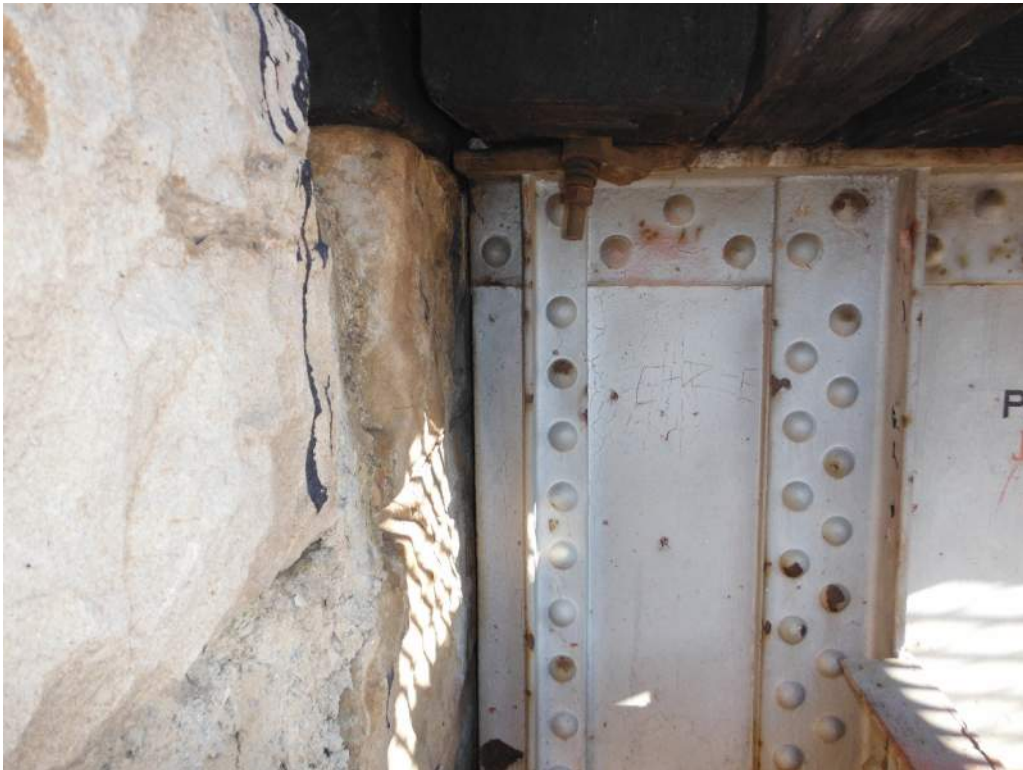
**423.28 No gap between end of stringer and backwall – Abutment 1**

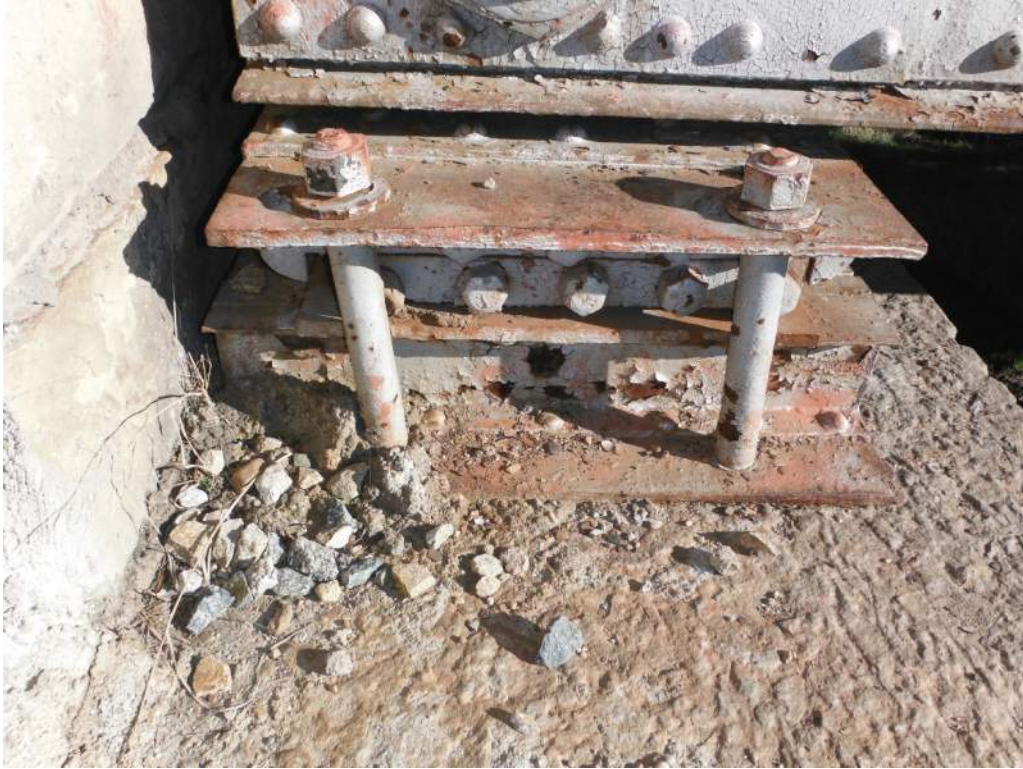
**423.28 Abutment 1 bearings rocked**

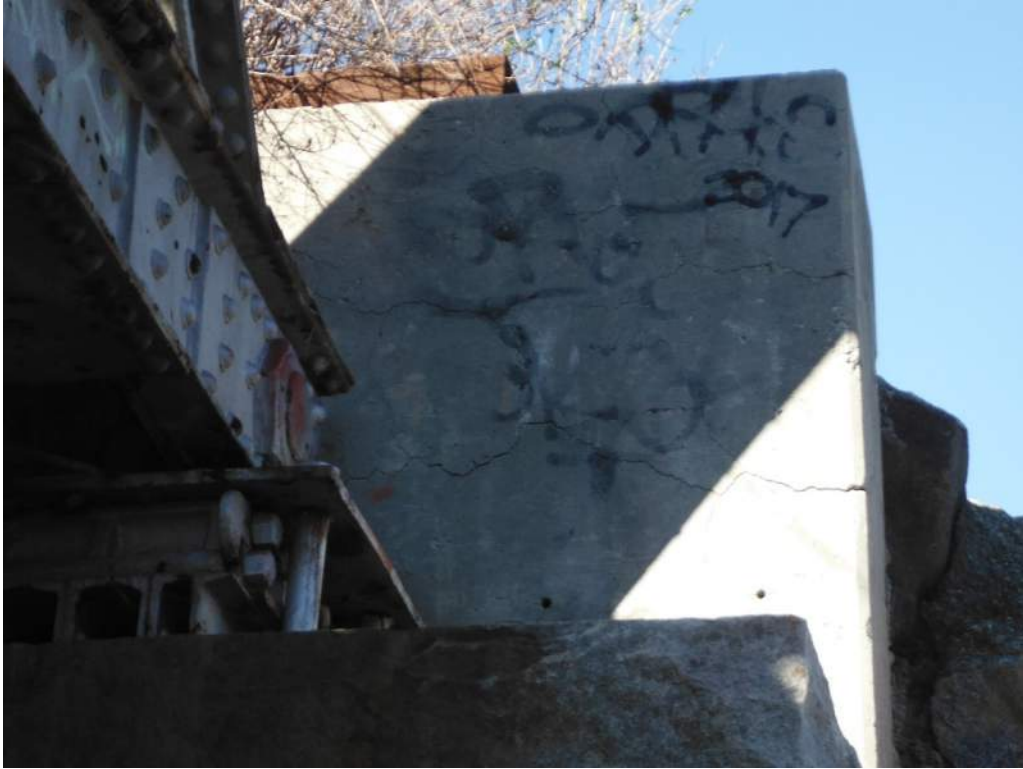
**423.28 Map cracking Northside of backwall - Abutment 1**

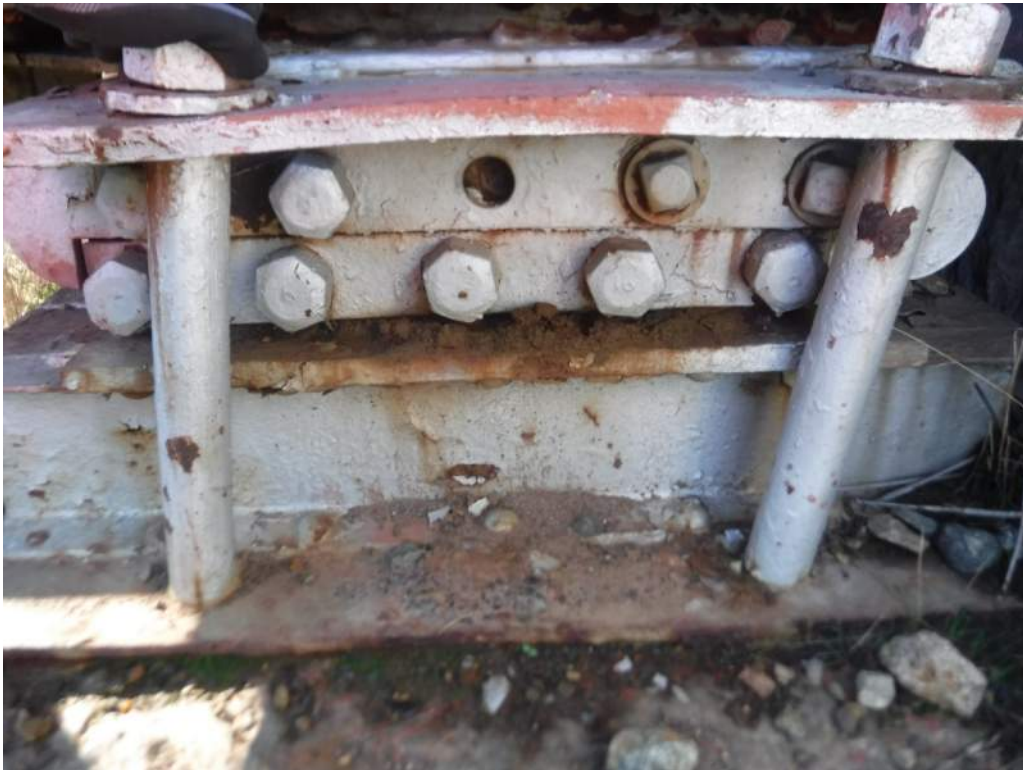
**423.28 Bolt missing at Northwest bearing bridge rollers**

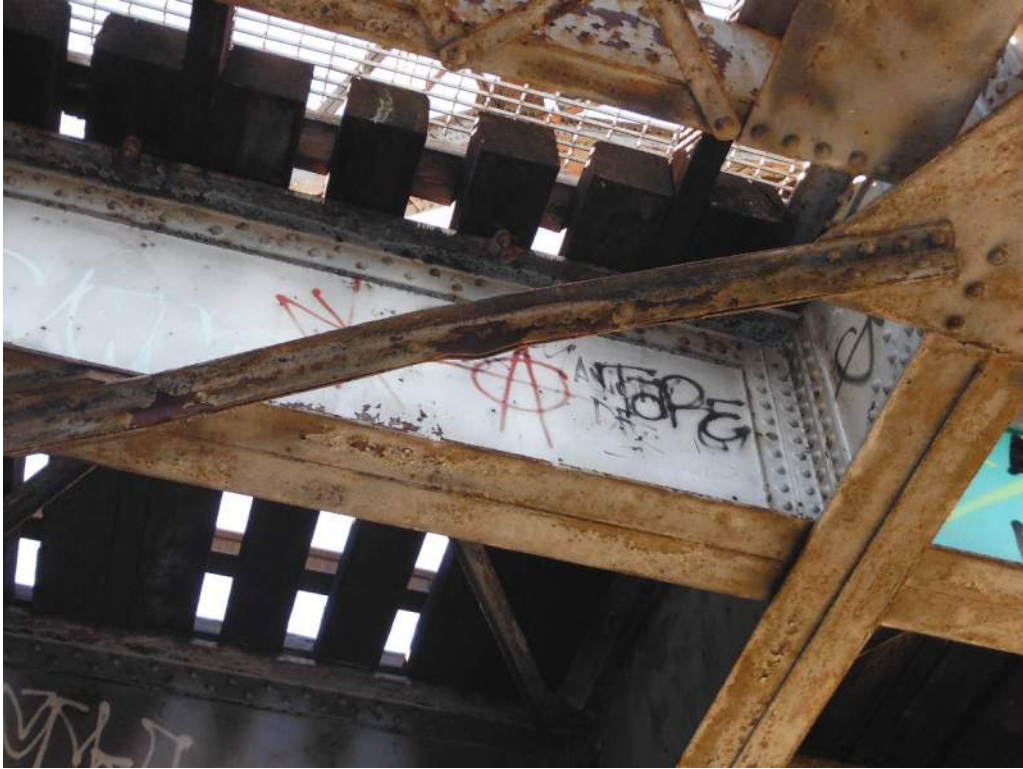
**423.28 Minor impact damage to cross bracing near Abutment 2**

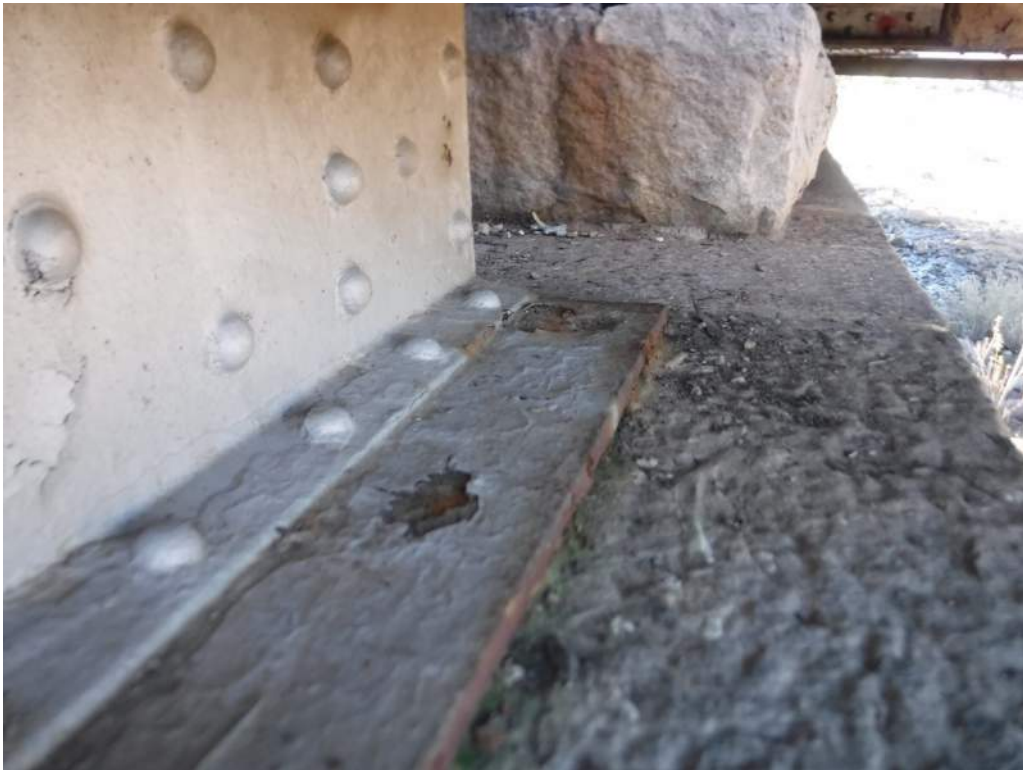
**423.28 North bearing, Abutment 2 – Missing SW anchor**

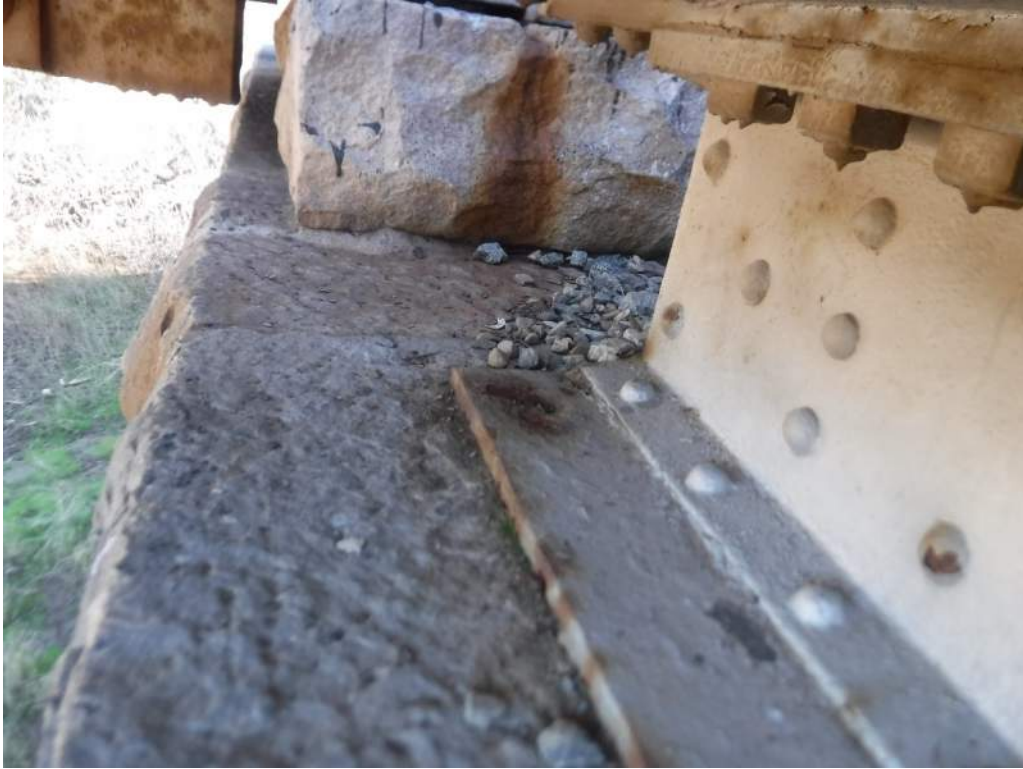
**423.28 South bearing, Abutment 2 – Missing NW anchor**

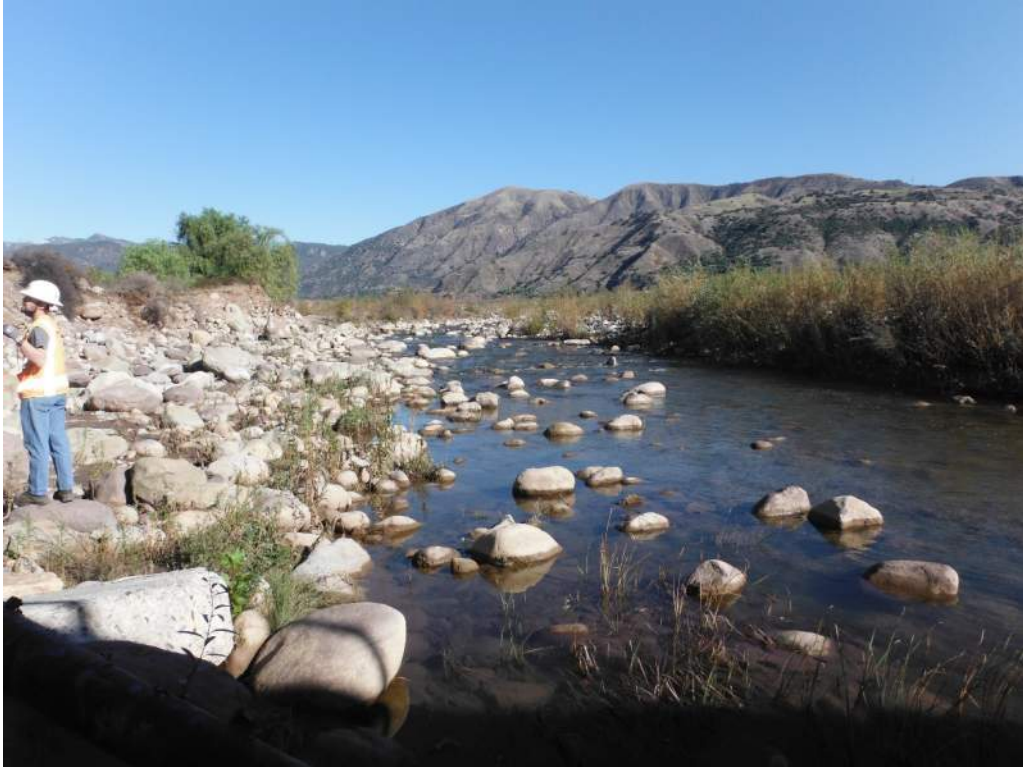
**423.44 Channel condition looking upstream**

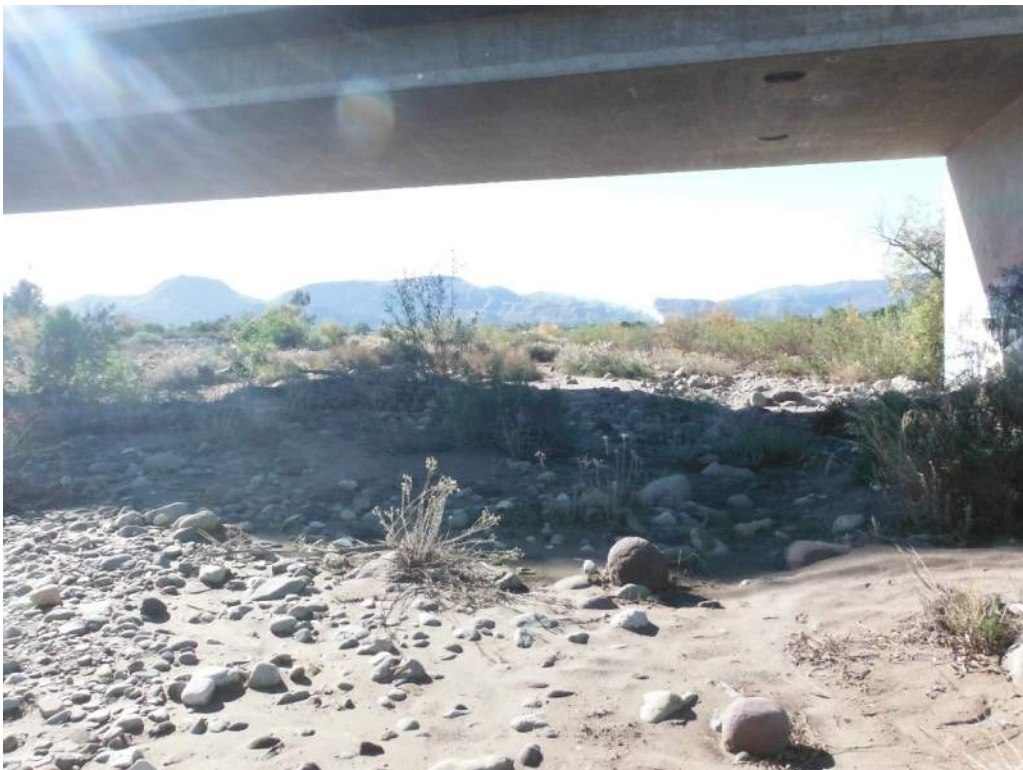
**423.44 Channel condition looking downstream**

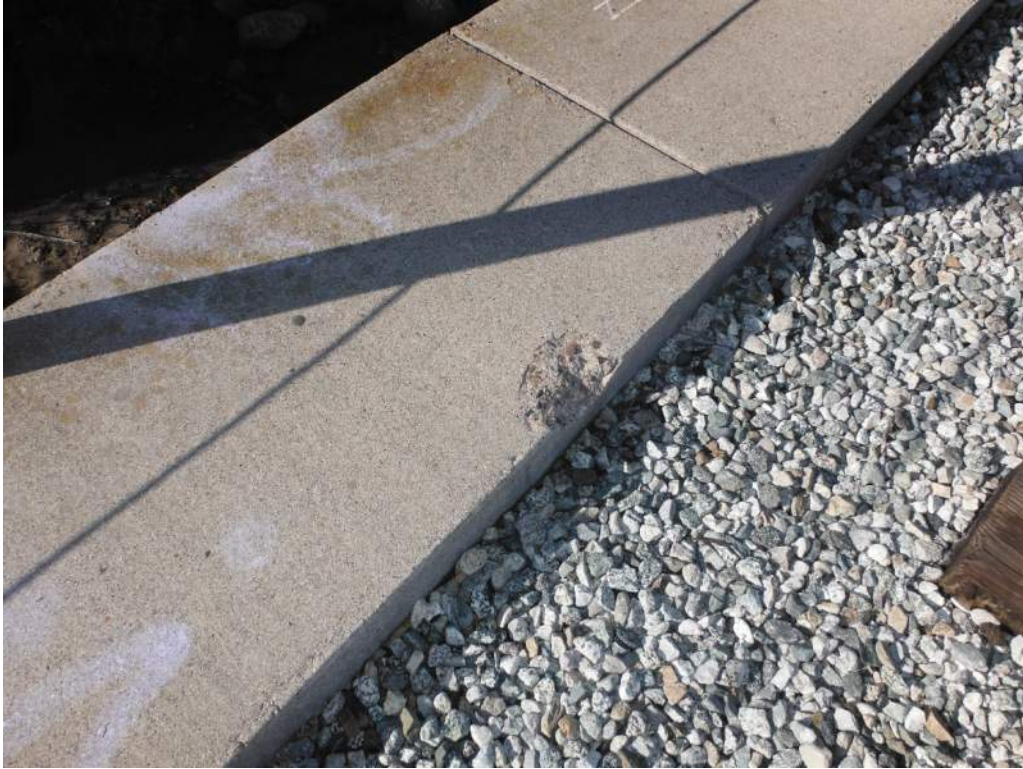
**423.44 Walkway Spall on Span 2 and multiple locations**

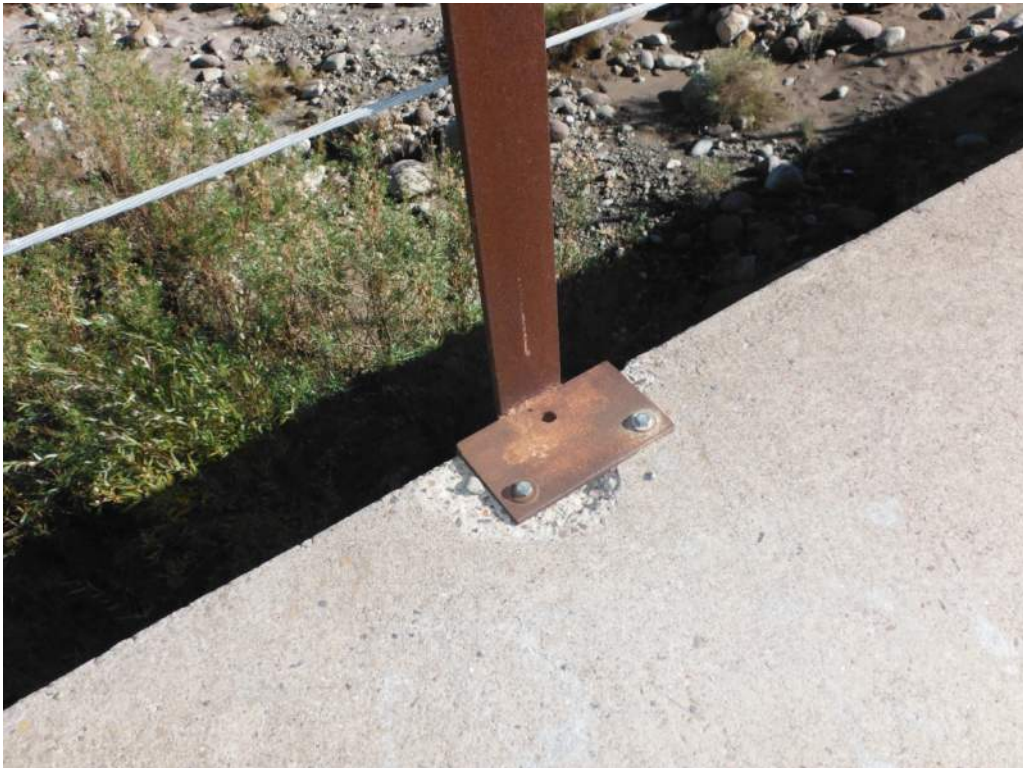
**423.44 Handrail embed failed. Post held with bolts, Span 3 and 4**

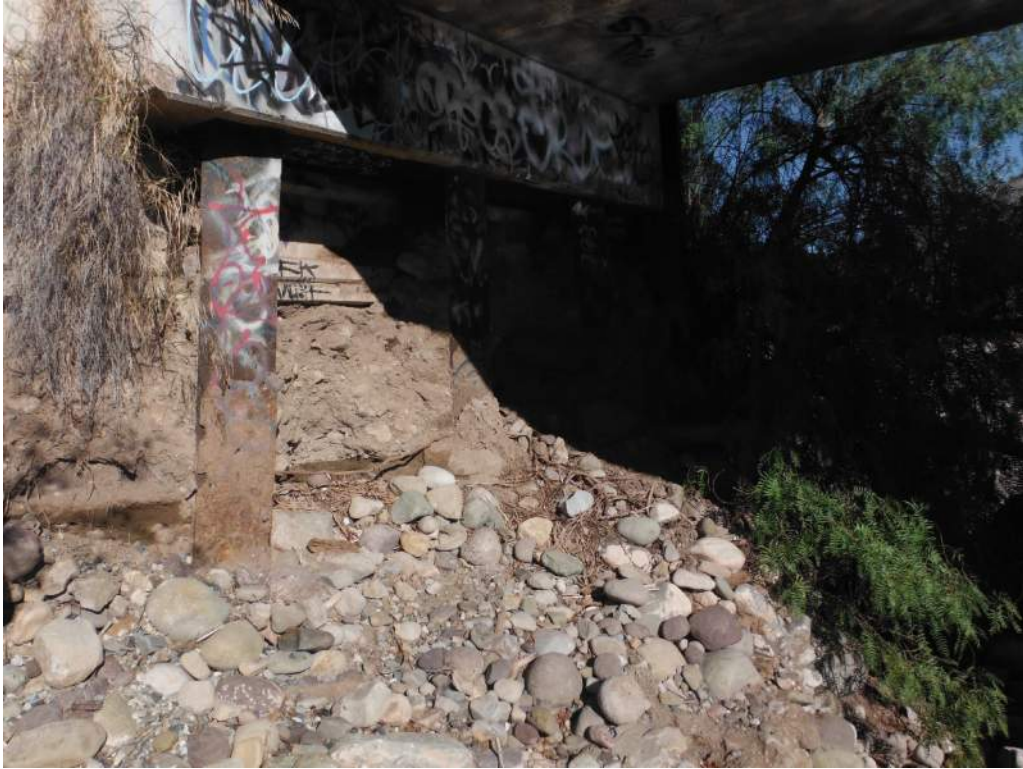
**423.44 Scour - Abutment 1**

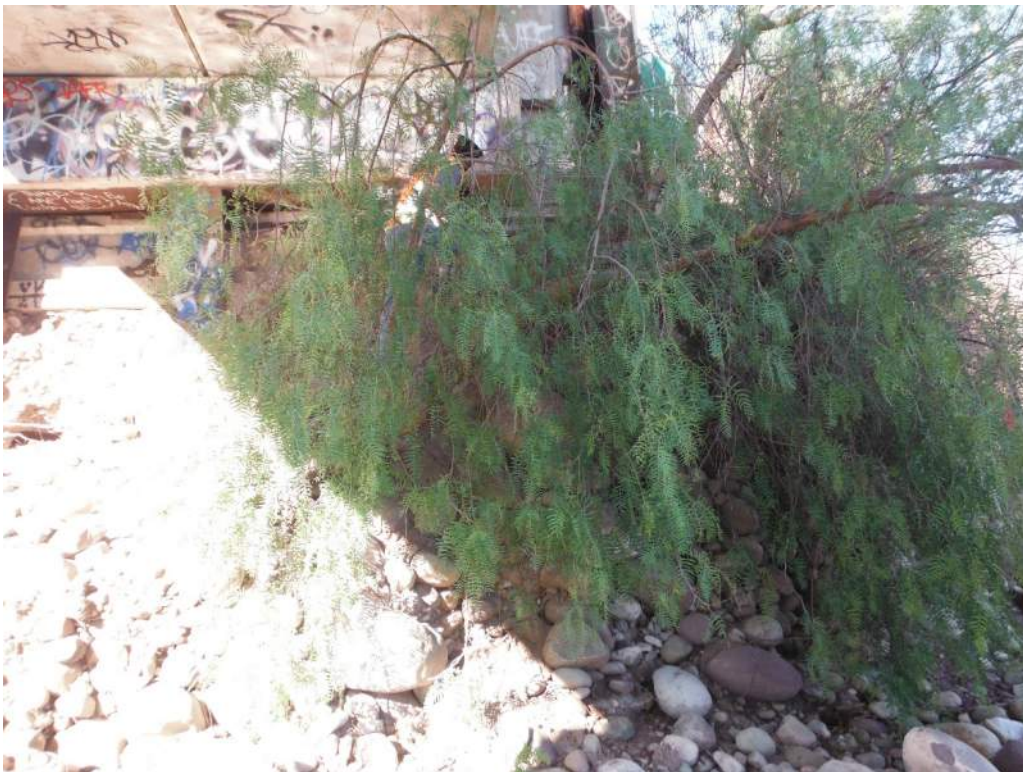
**423.44 Tree under Abutment**

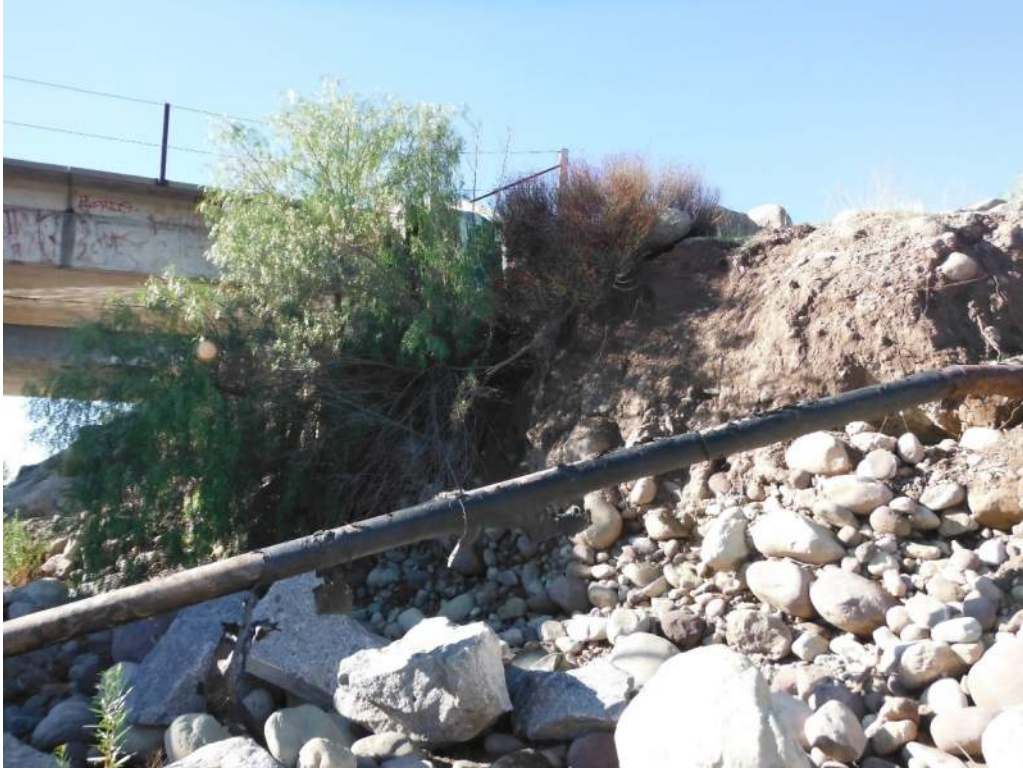
**423.44 Deep erosion from heavy water on North slope**

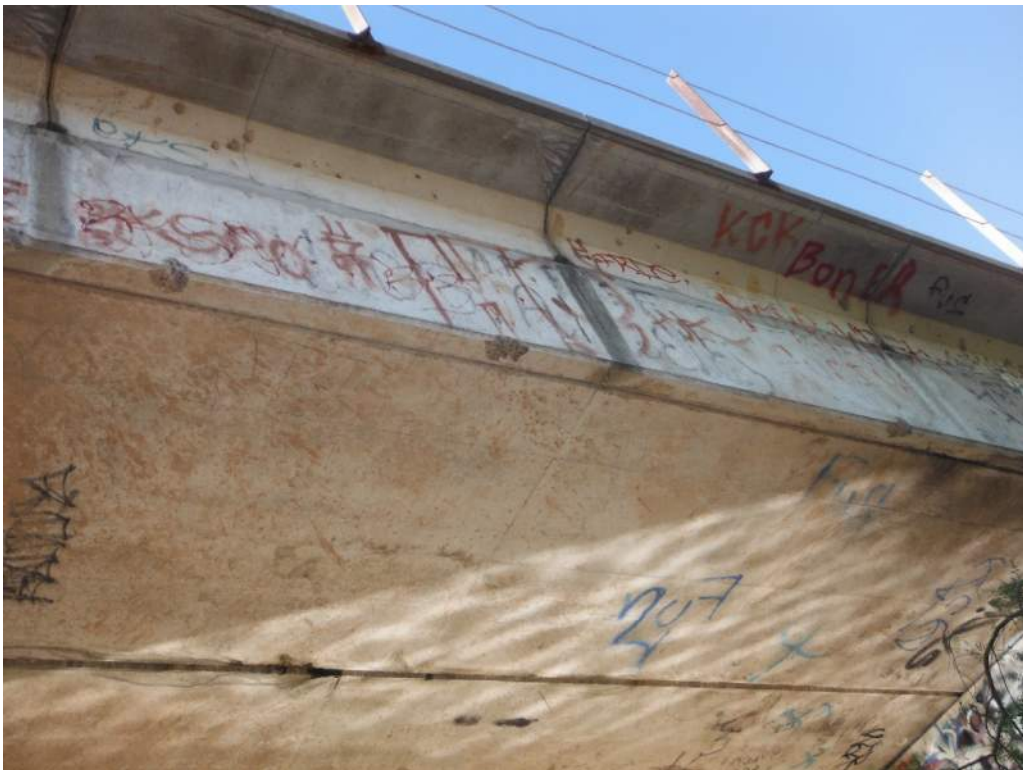
**423.44 Span 1 Impact Damage**

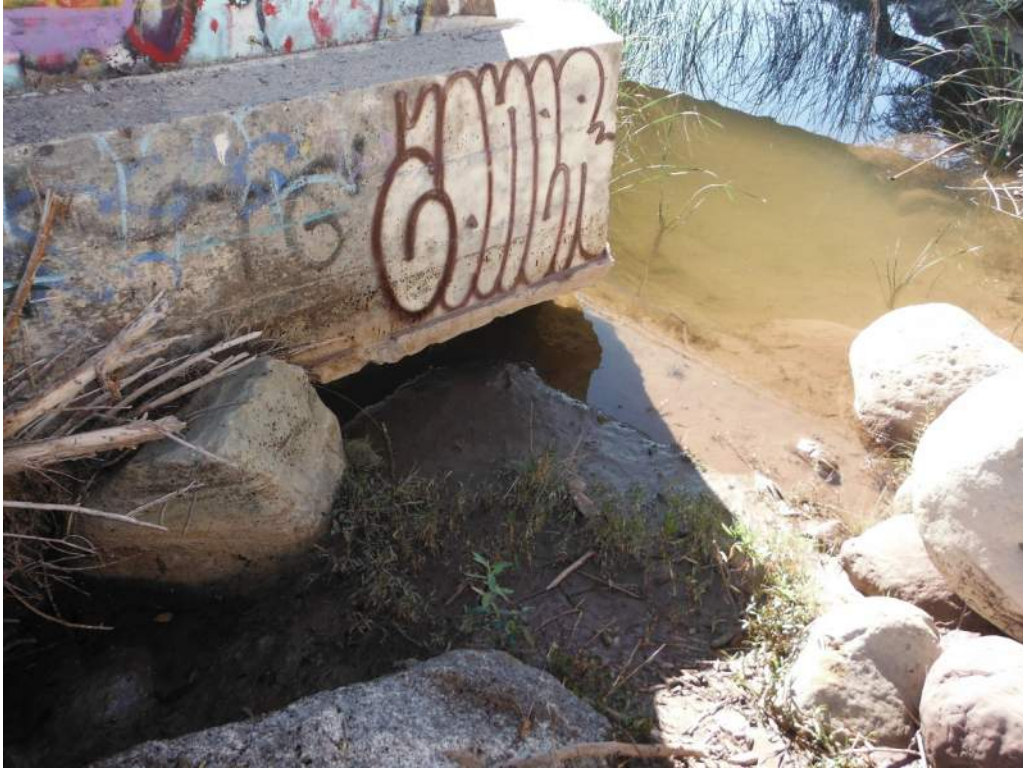
**423.44 2' Scour under cap 2**

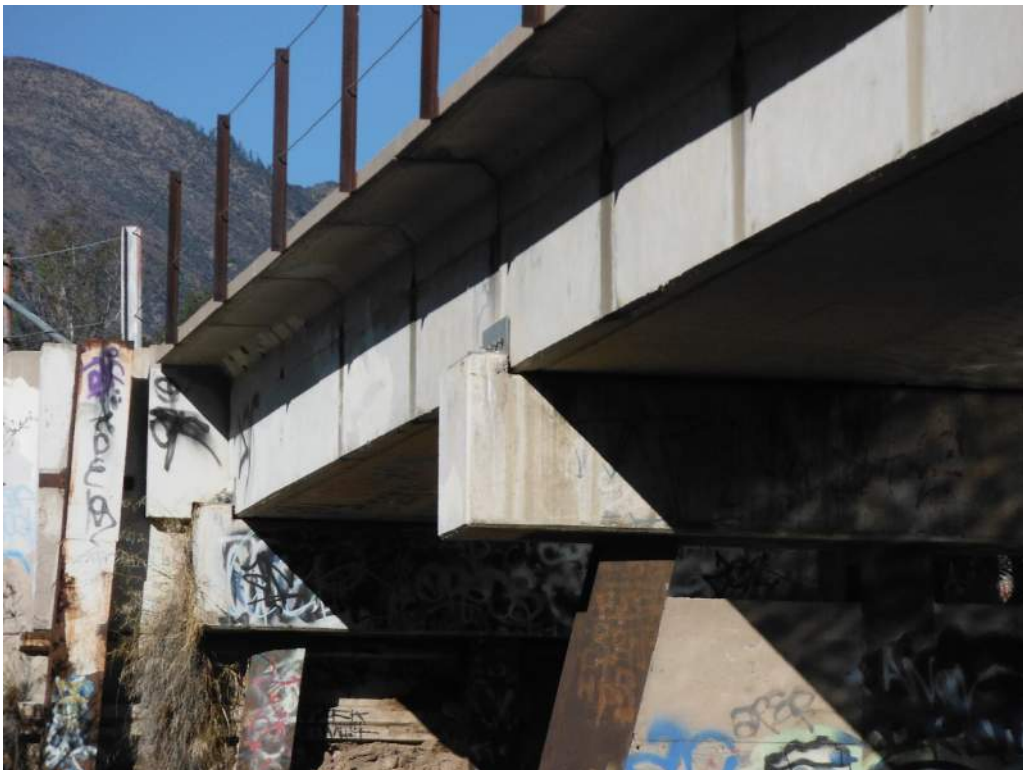
**423.44 Keeper spall on Pier 2**
