# BRIDGE INSPECTION REPORT

INSPECTION TYPE: Annual

Milepost 407.48  
 Location Santa Paula Branch Line  
Saticoy, CA  
 Stream X Overpass        Other         
 Train Operating Speed: Freight: 10 mph Passenger: 15 mph

MAINLINE/SUBDIVISION: VCTC

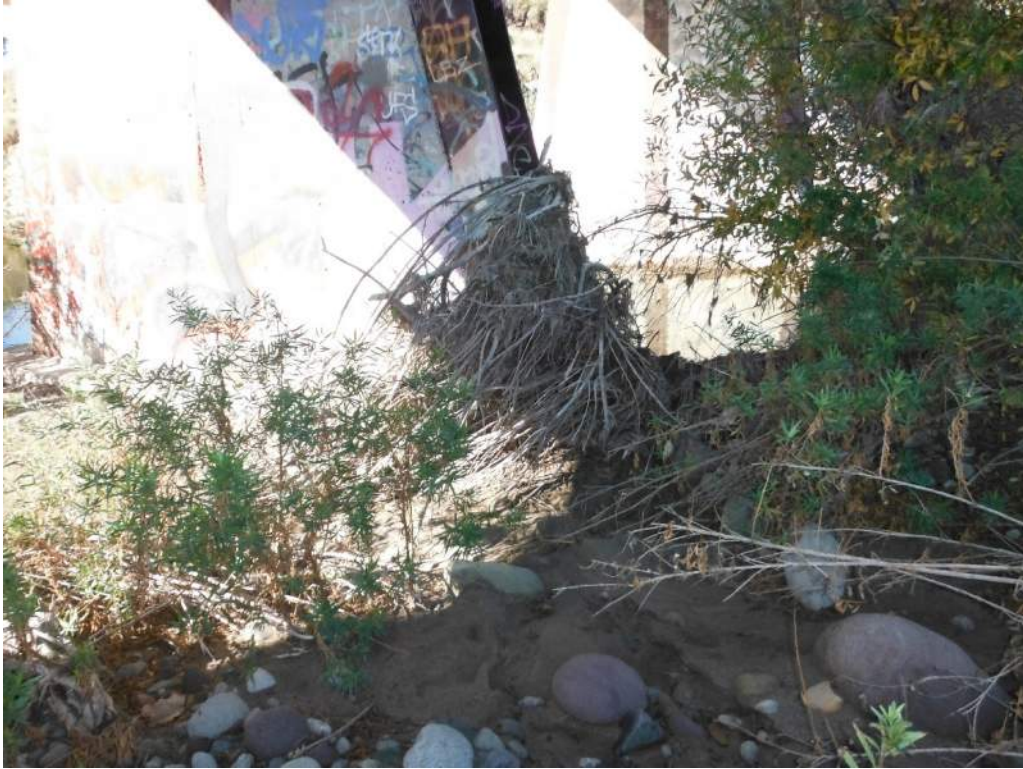
**423.44 Debris Upstream on Pier 4**

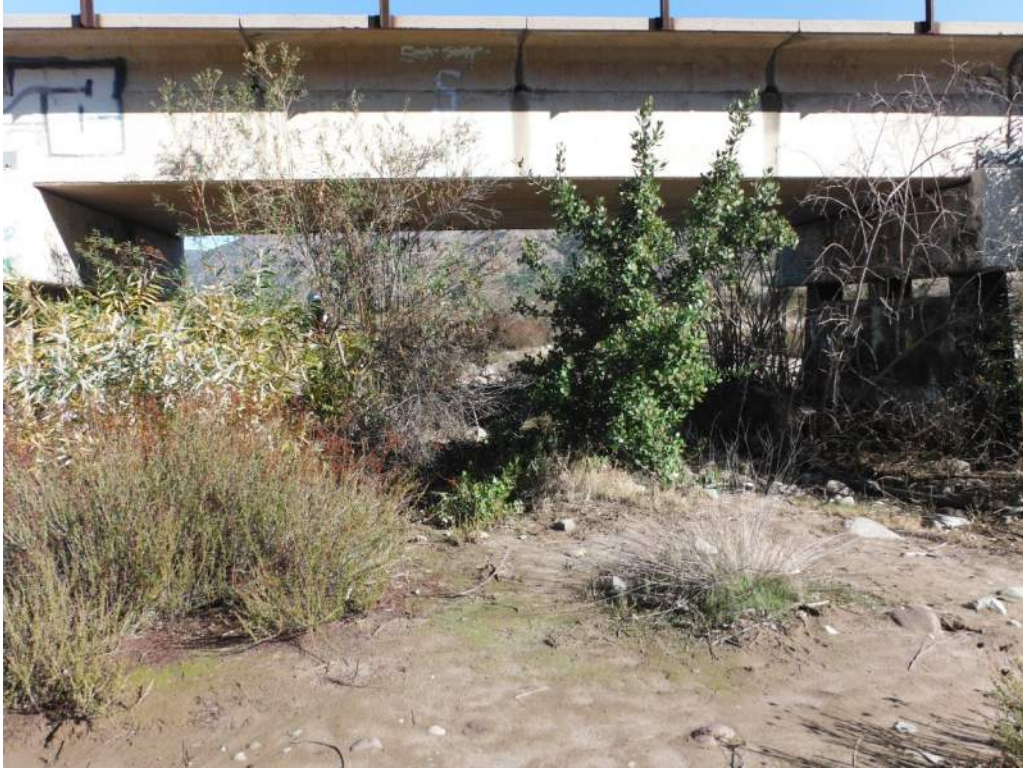
**423.44 Trees under Span 7 and 8 on south side**

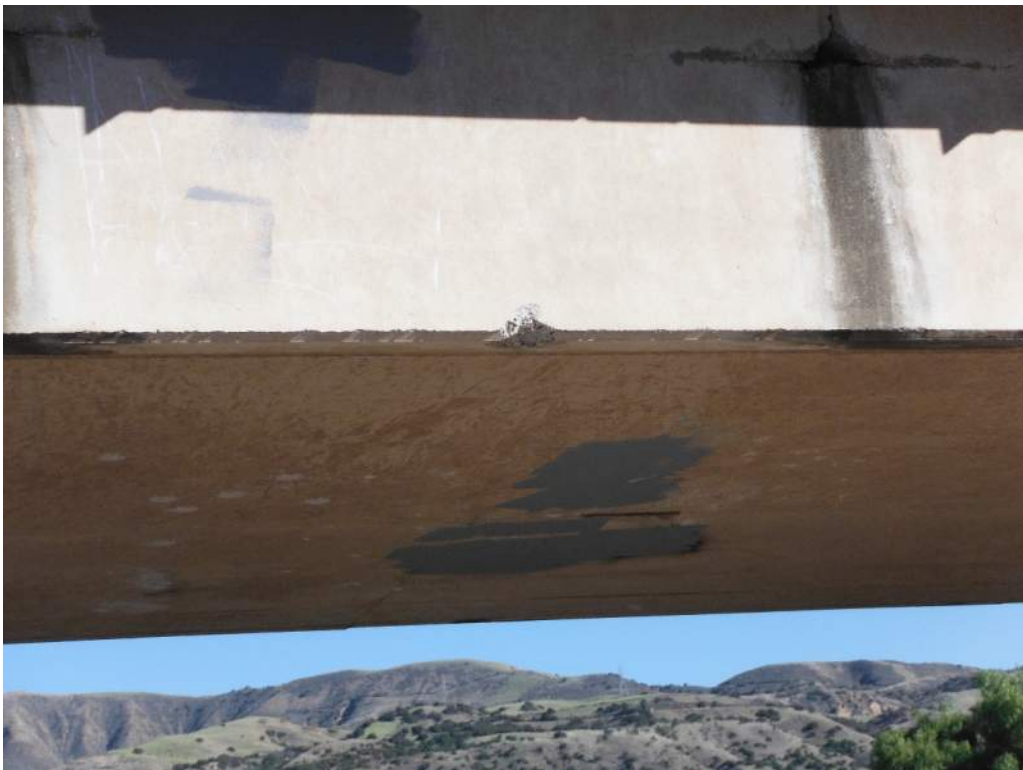
1. Minor spall midspan of girder 2 span #11 on southside - see photo
2. Deb - Debris built up on northside pier
3. 2' scour on northside of pier

**423.44 Minor spall midspan, Span 11**

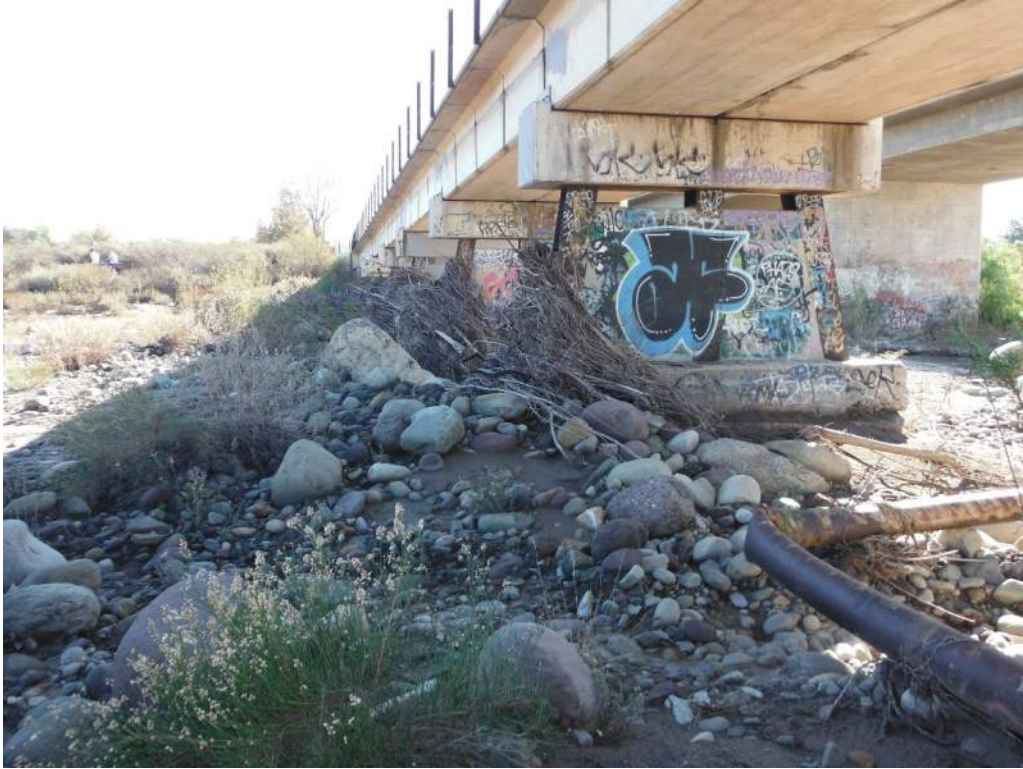
**423.44 Debris – Multiple locations**

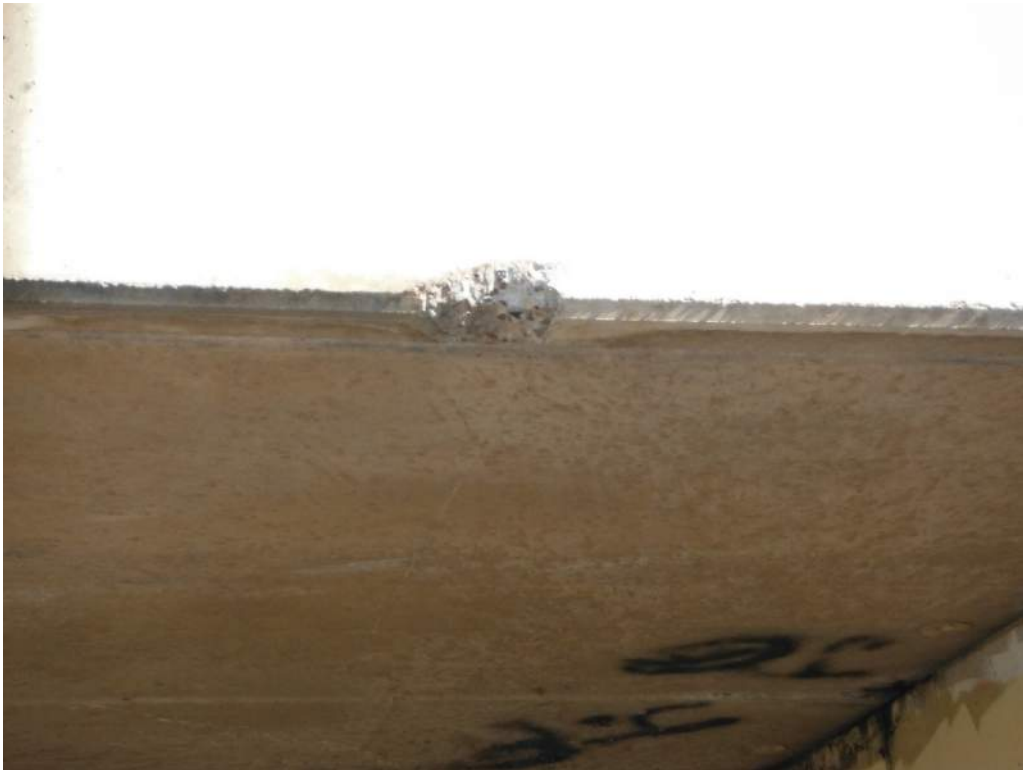
**423.44 Minor spall - south side Span 13**

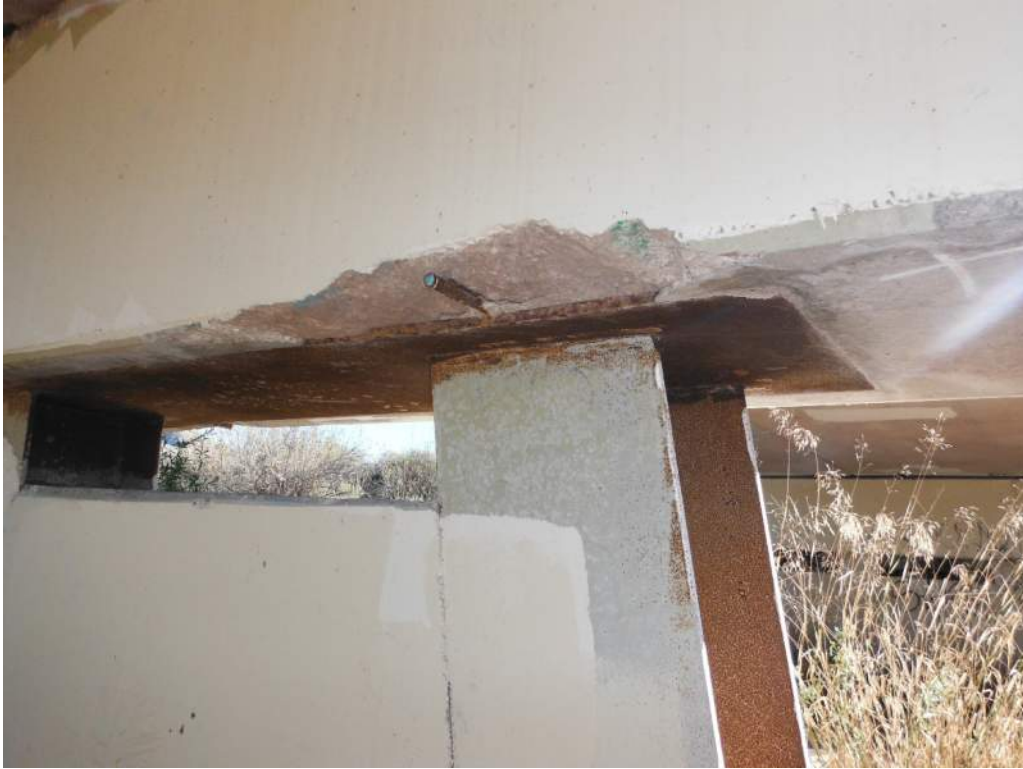
**423.44 Spall along underside of cap with exposed rebar – west side Pier 14**

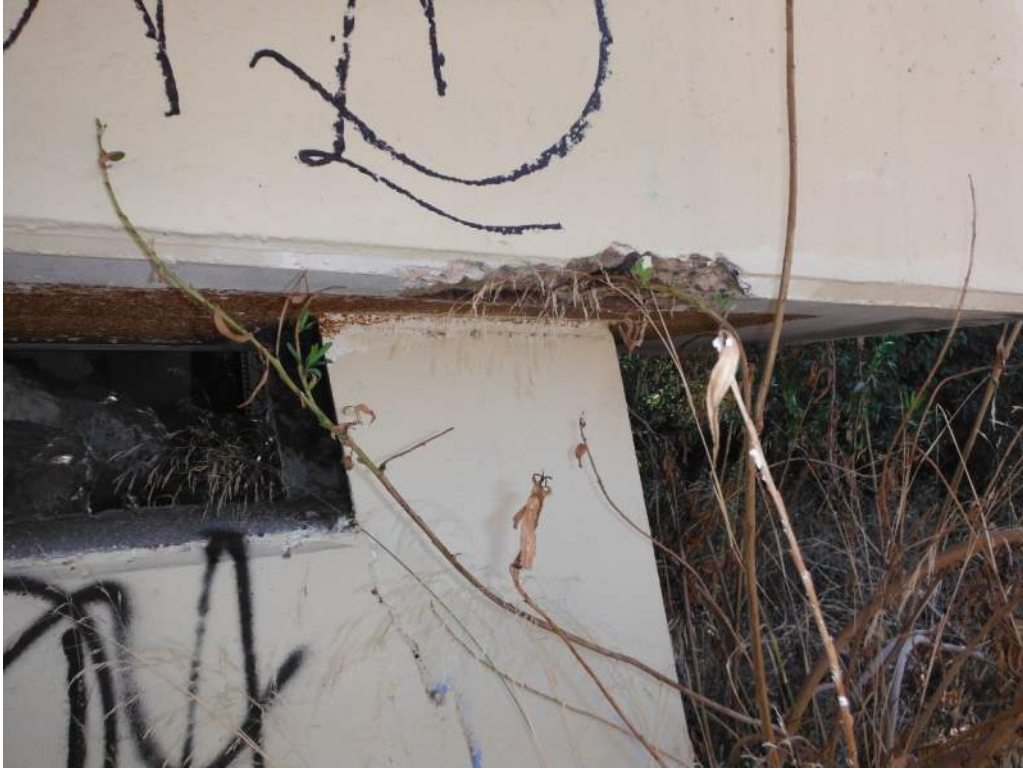
1. SP - Spall along underside of cap with exposed rebar - west side - see photo
2. SP - Spall on NE corner of pier cap

**423.44 Spall with Exposed Rebar – Pier 15 west side**

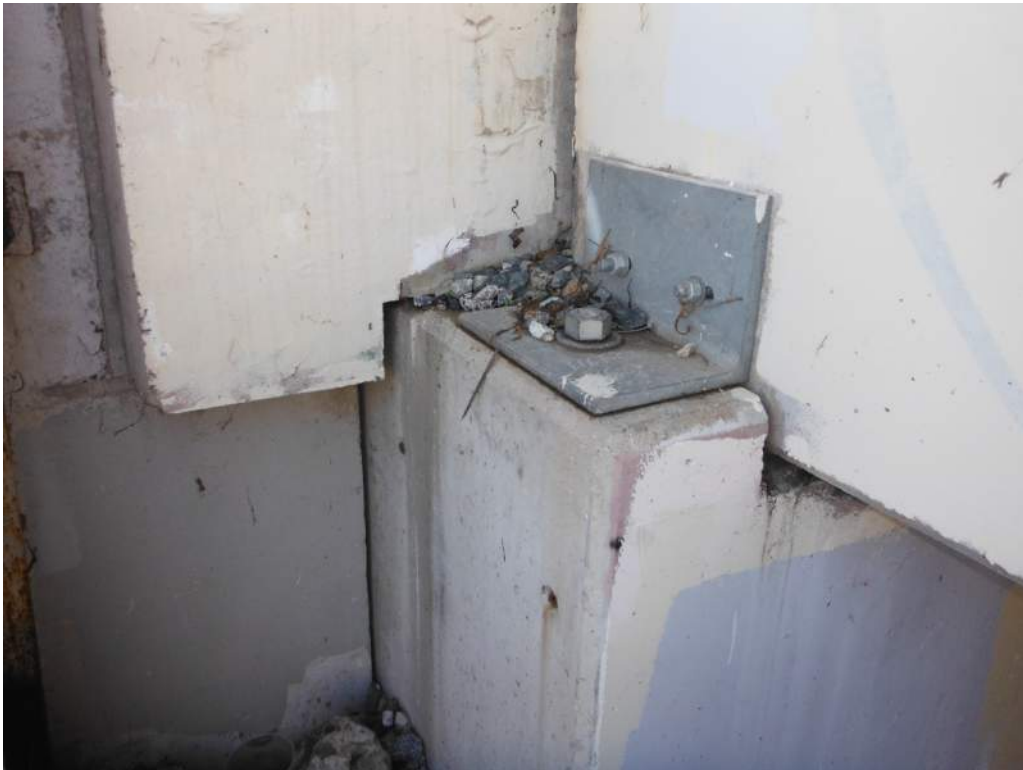
Description: Looking East (2) 80"x30" Concrete box, concrete abutment with steel piles			
Remarks:			
1. Ballast leaking on bearing seats - see photo			
Inspected By:	Joseph Holste, PE	Date Inspected:	12/13/2019

**423.44 Ballast leaking on bearing seats, near Abutment 16**

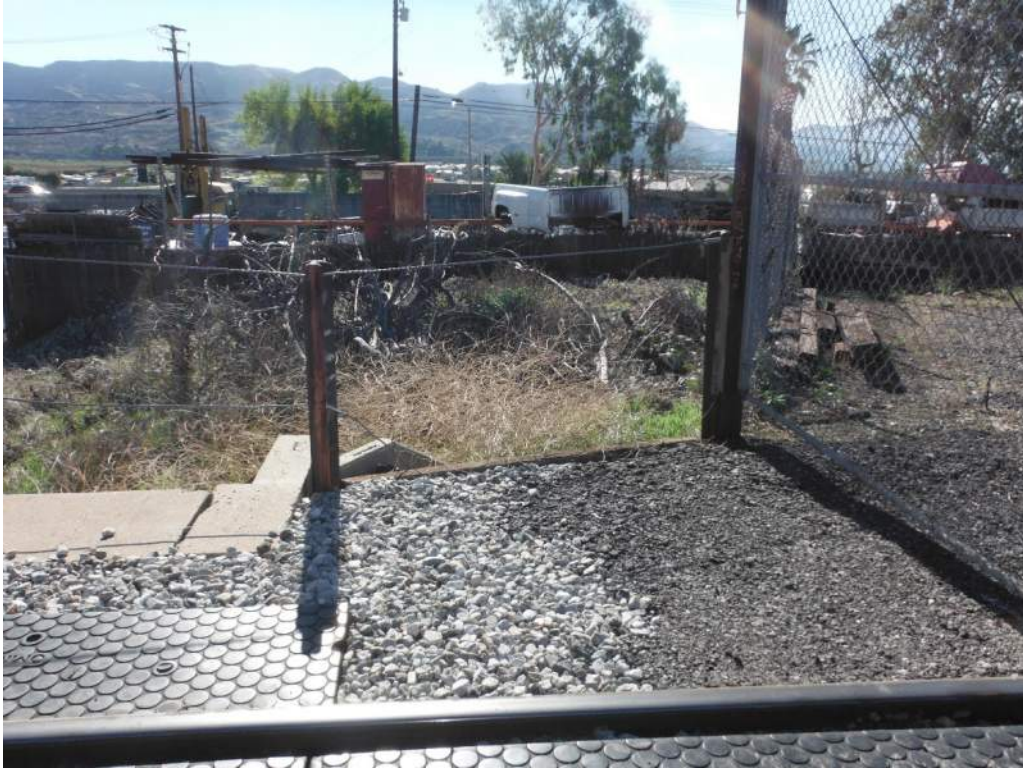
**425.15 Cable broken at southwest corner**

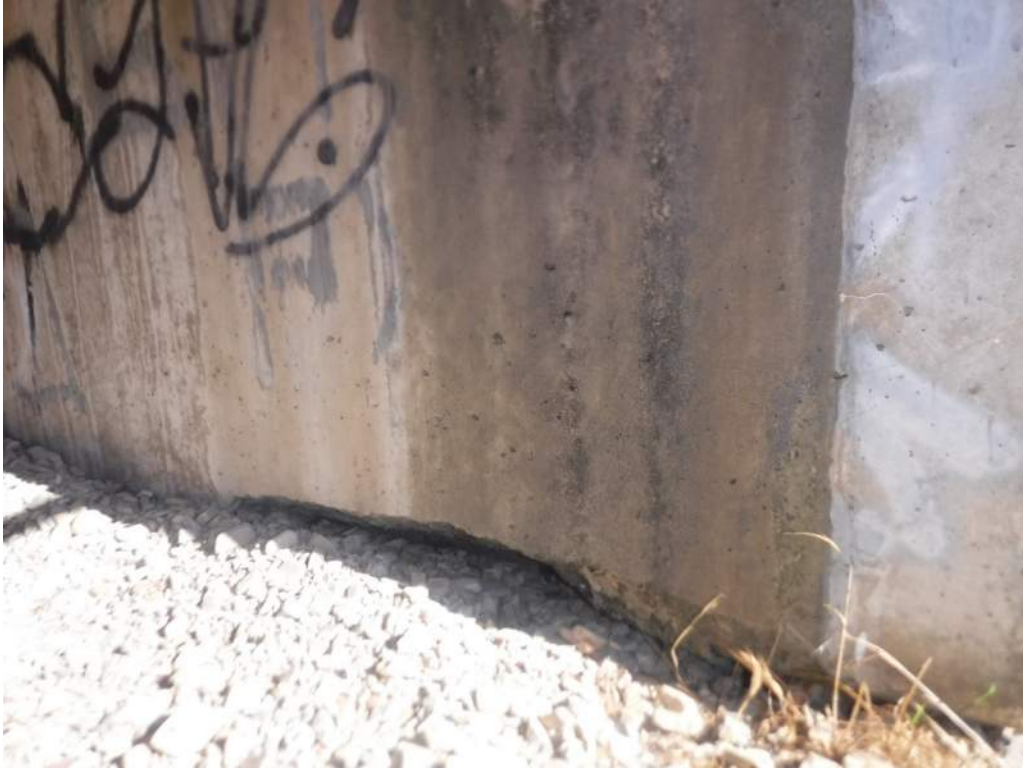
**425.15 Spall - Southwest pier 2**

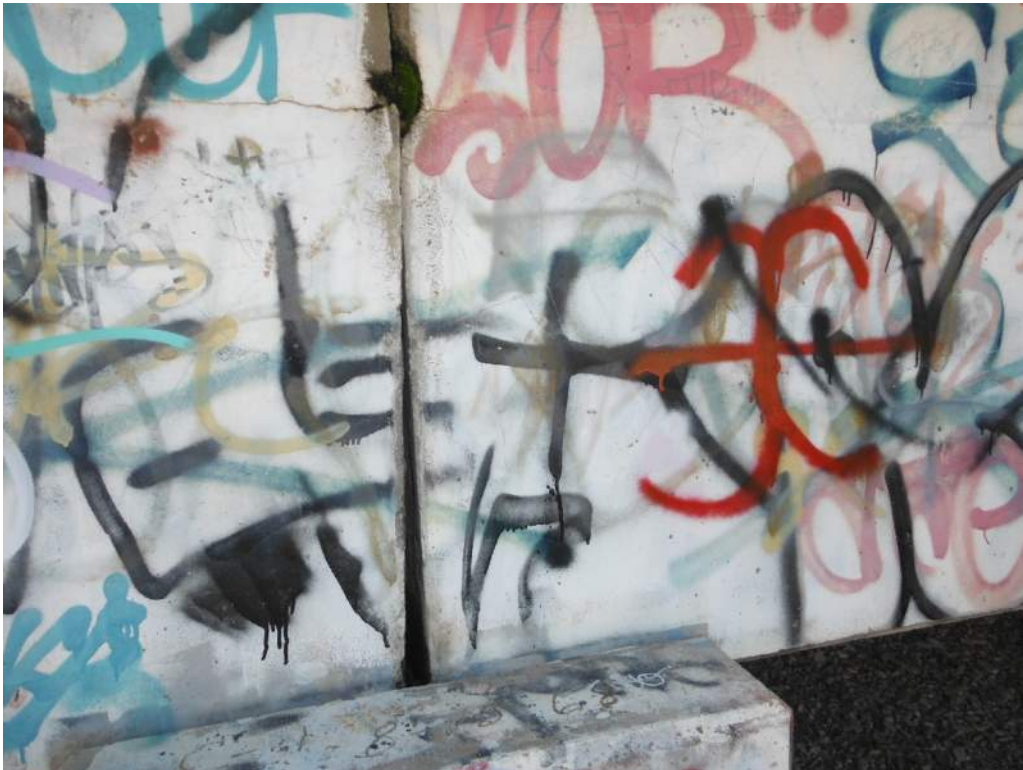
**425.15 No gap between girders - Pier 2**

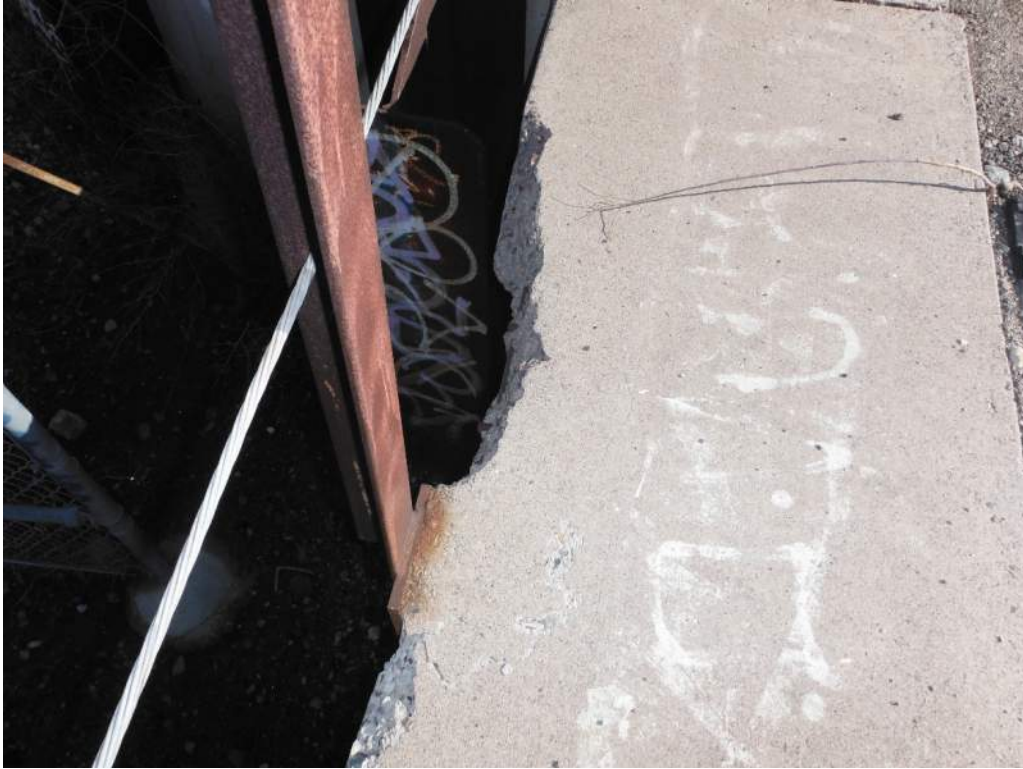
**425.15 Spall with exposed rebar - Span 2 north side**

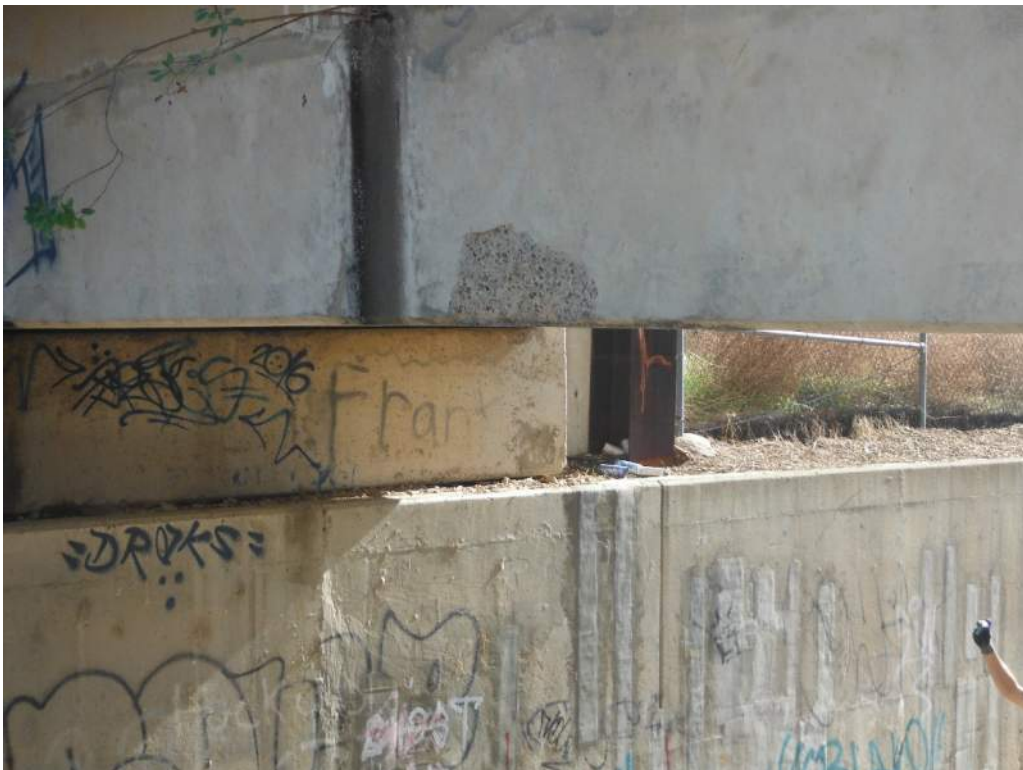
**425.15 Spall at midspan - Span 2 north side**

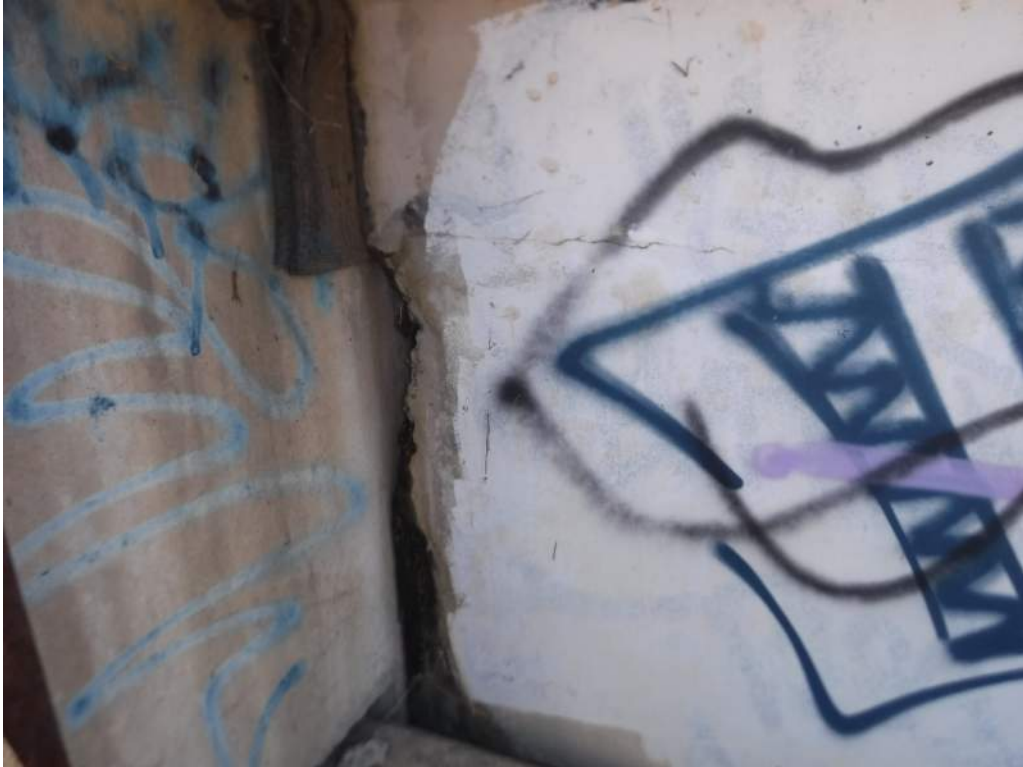
**425.15 Crack and spall in girder near Abutment 3 north side**

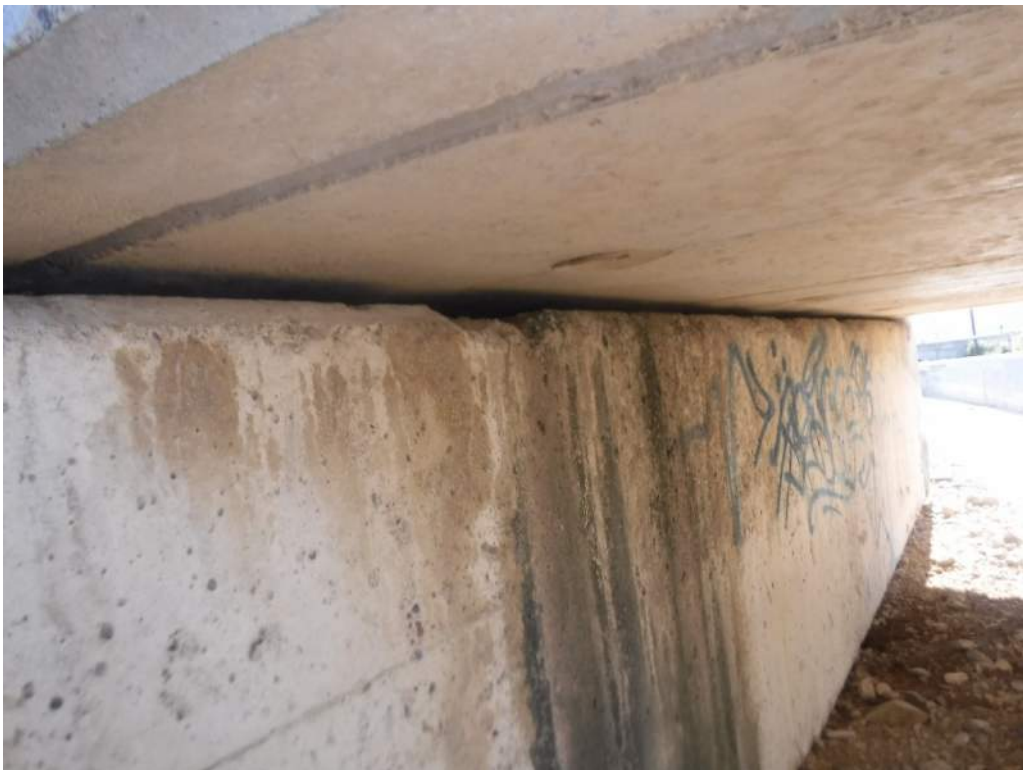
**425.15 Abutment 3 Cap Spall**

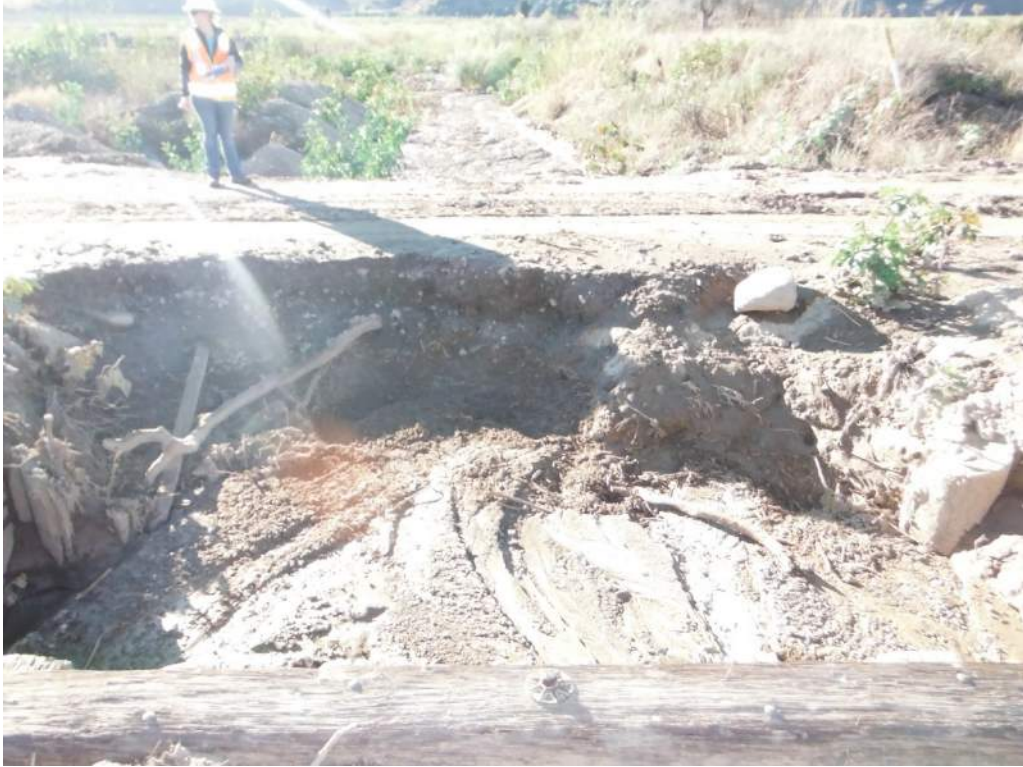
**427.64 Downstream channel condition**

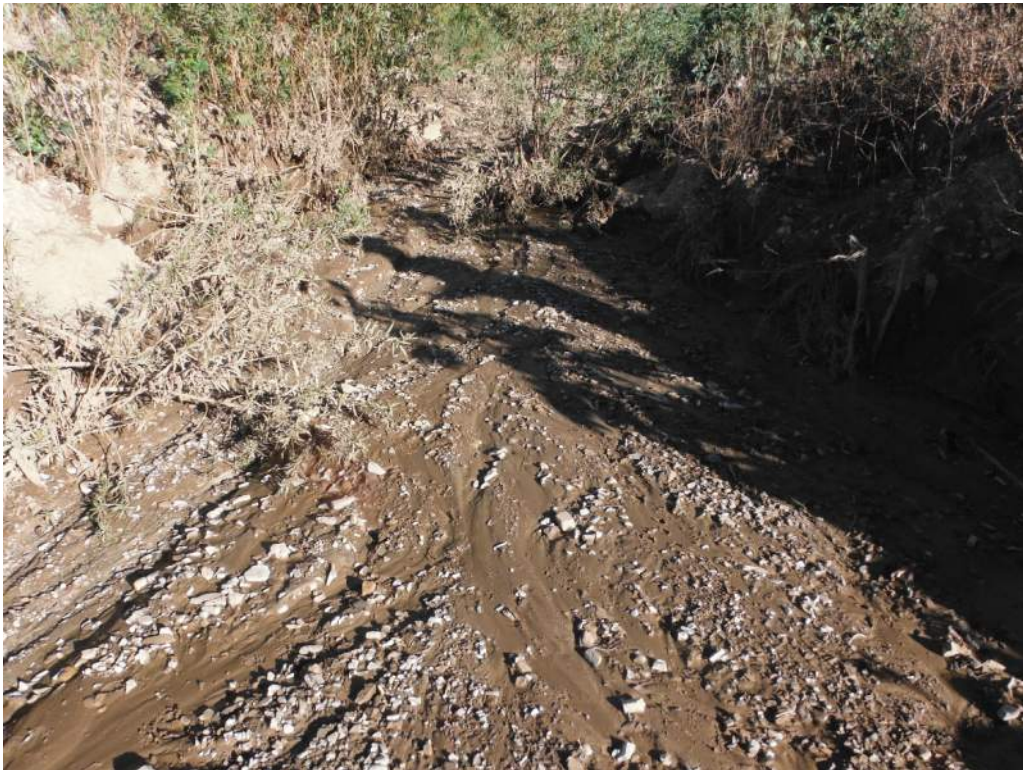
**427.64 Upstream channel condition**

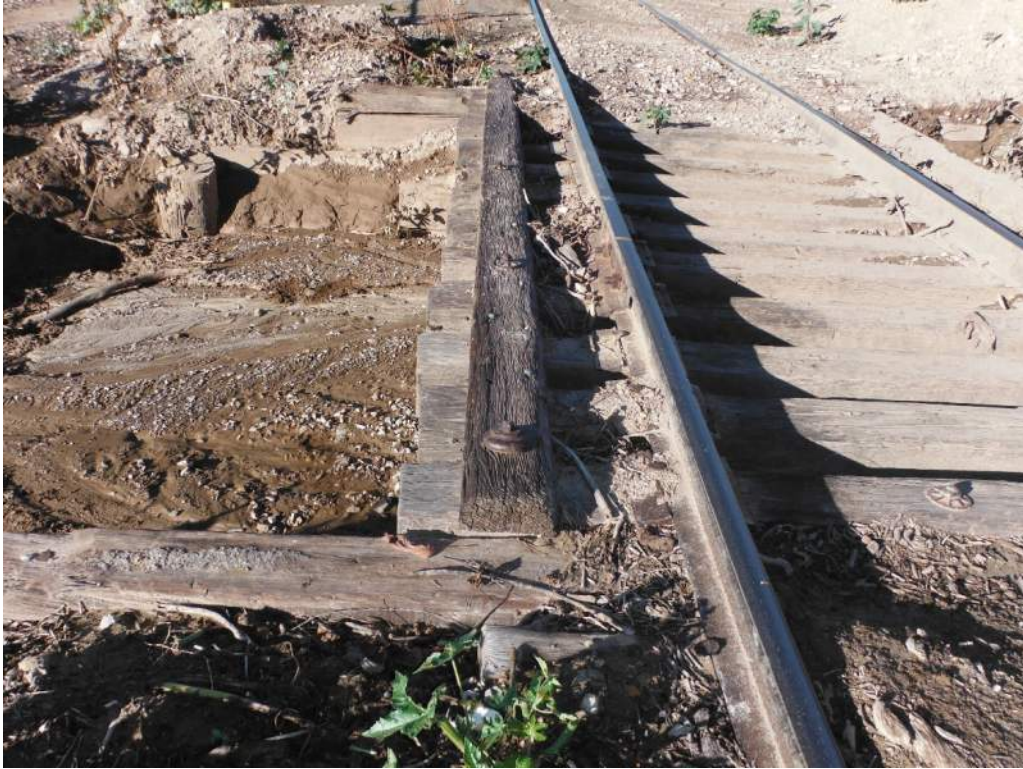
**427.64 Hole in ballast behind Abutment 2**

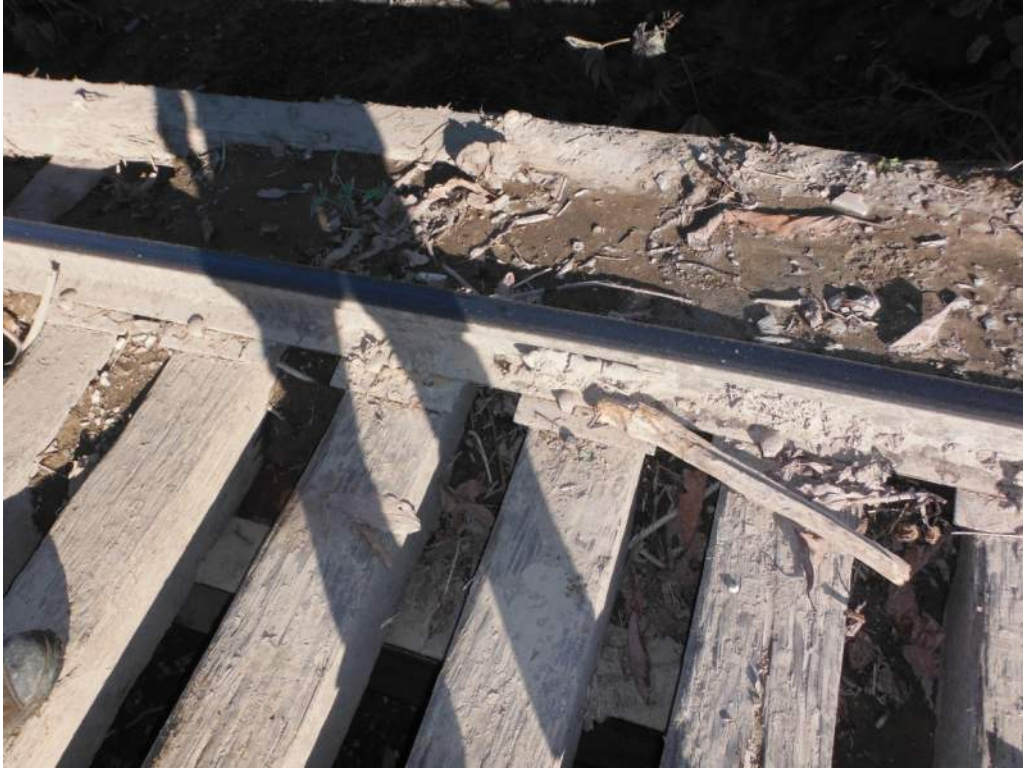
**427.64 Debris covering stringers**

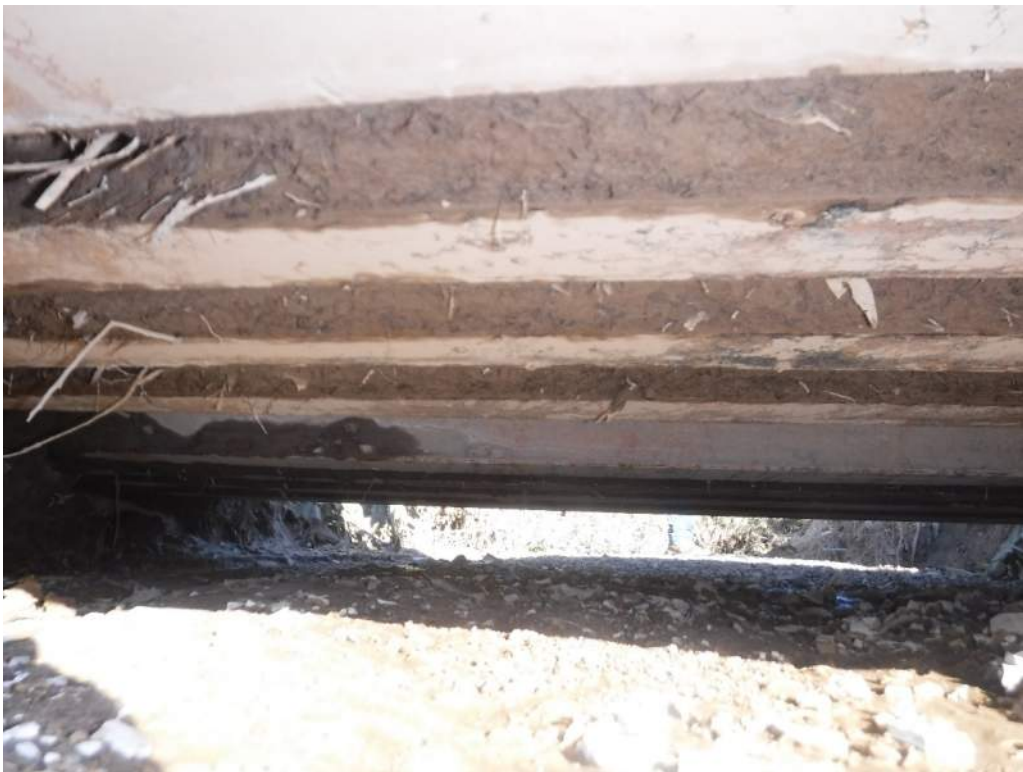
**427.64 Debris between stringers**

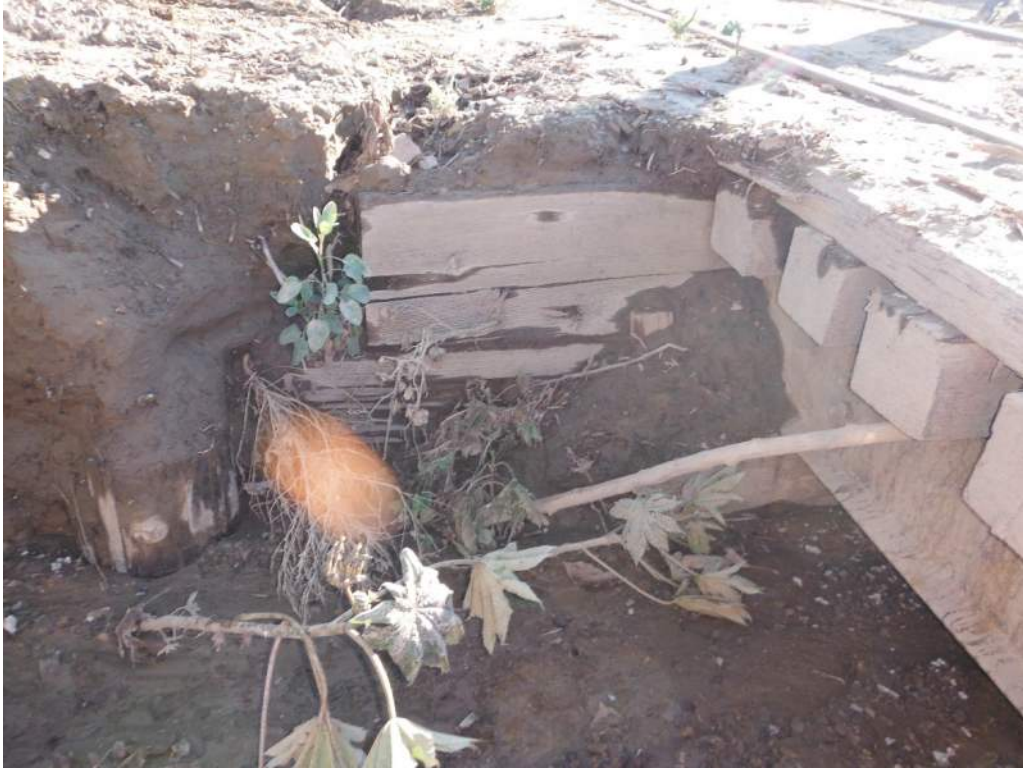
1. Could not inspect, completely silted in
2. Debris between and covering stringers - see photo
3. Backwall rotting. Top timber of backwall failing - see photo
4. HW: Pile #1 is hollow at top (2018 Notes)
5. PU: Piles #2, #3, and #4 are punky (2018 Notes)
6. Spt: Pile #1 and #2 split (2018 Notes)

**427.64 Backwall failing – Abutment 2**

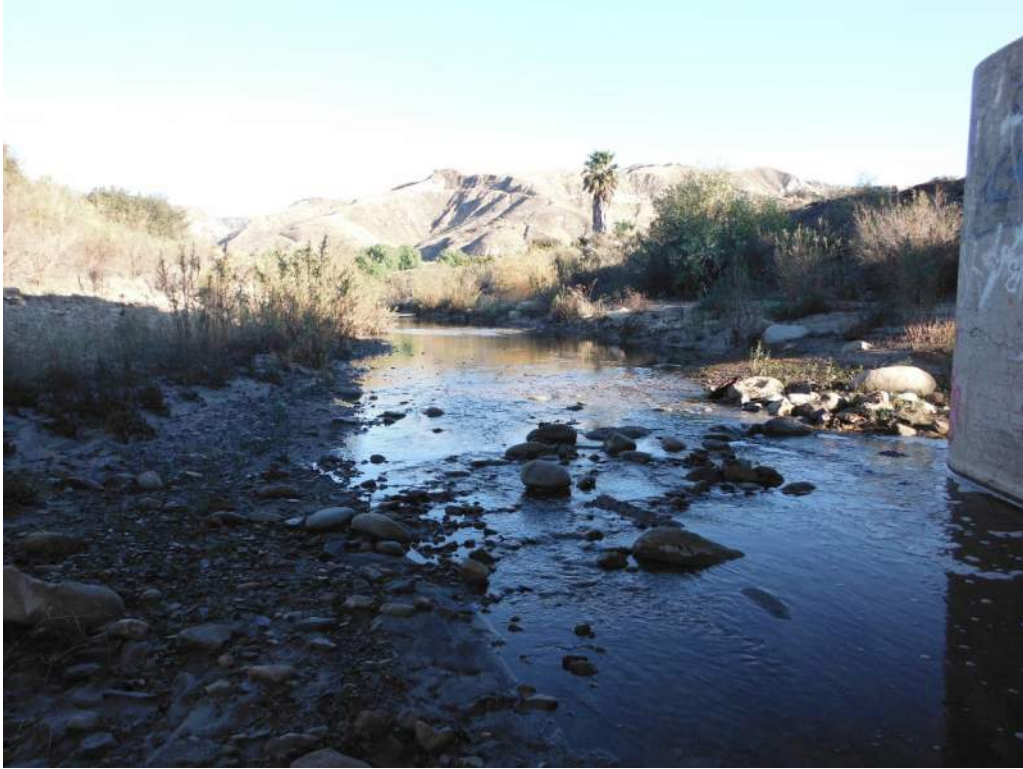
**429.79 Channel Condition – Looking Upstream**

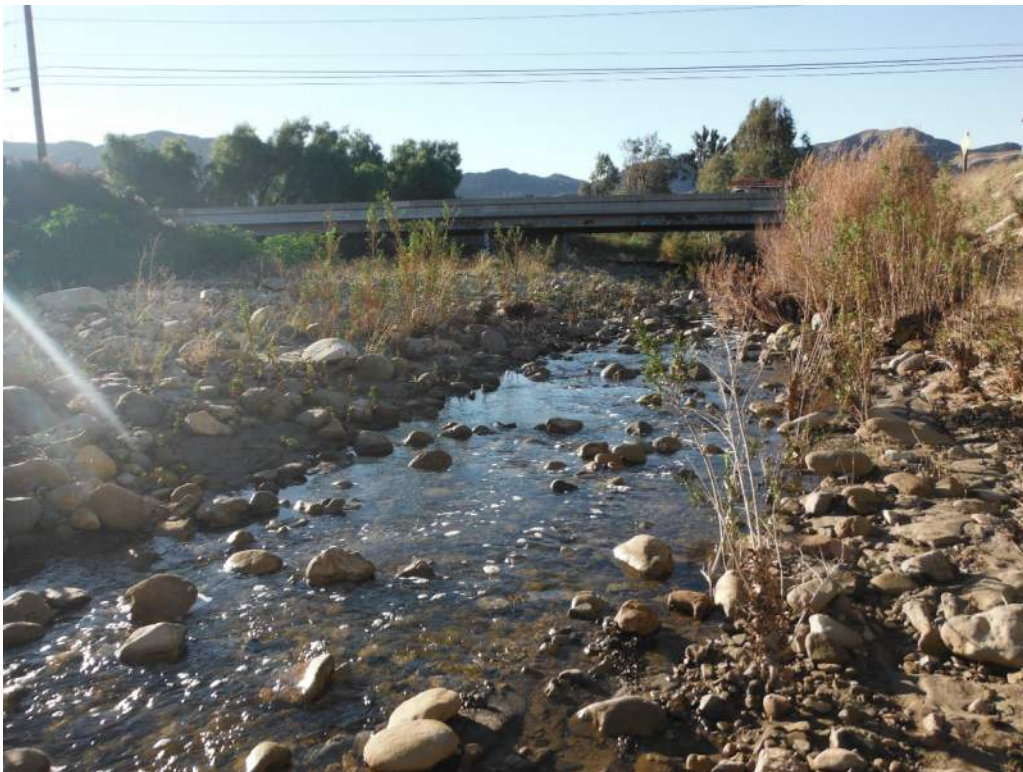
**429.79 Channel Condition – Looking Downstream**

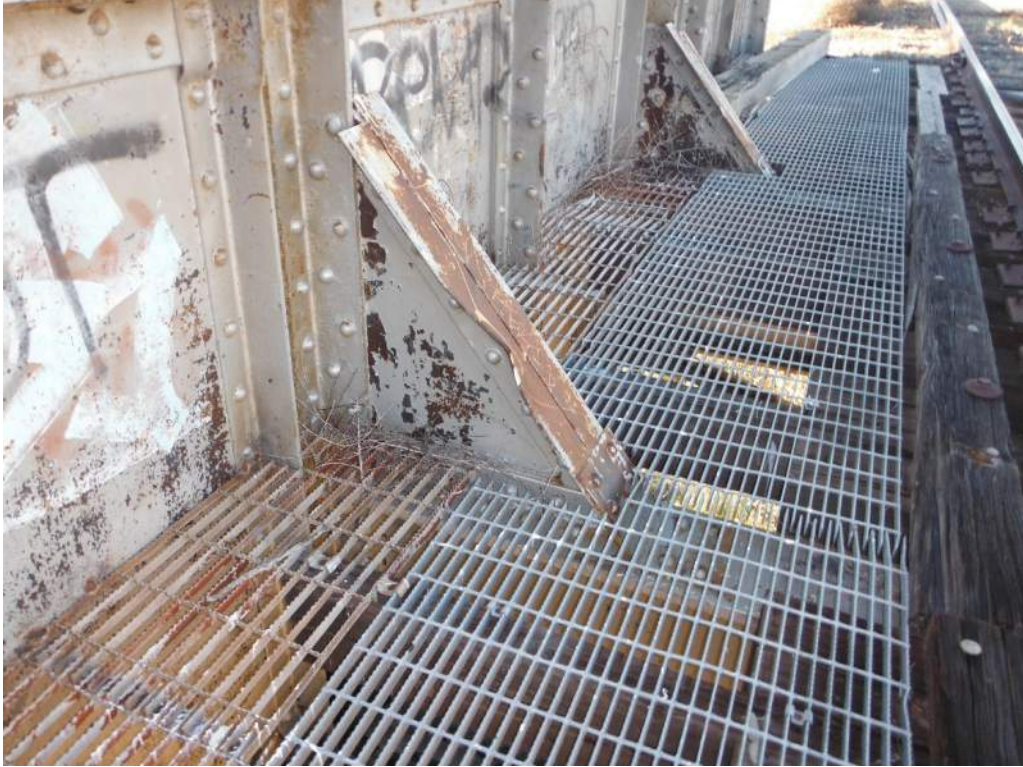
**429.79 Minor impact damage on knee braces**

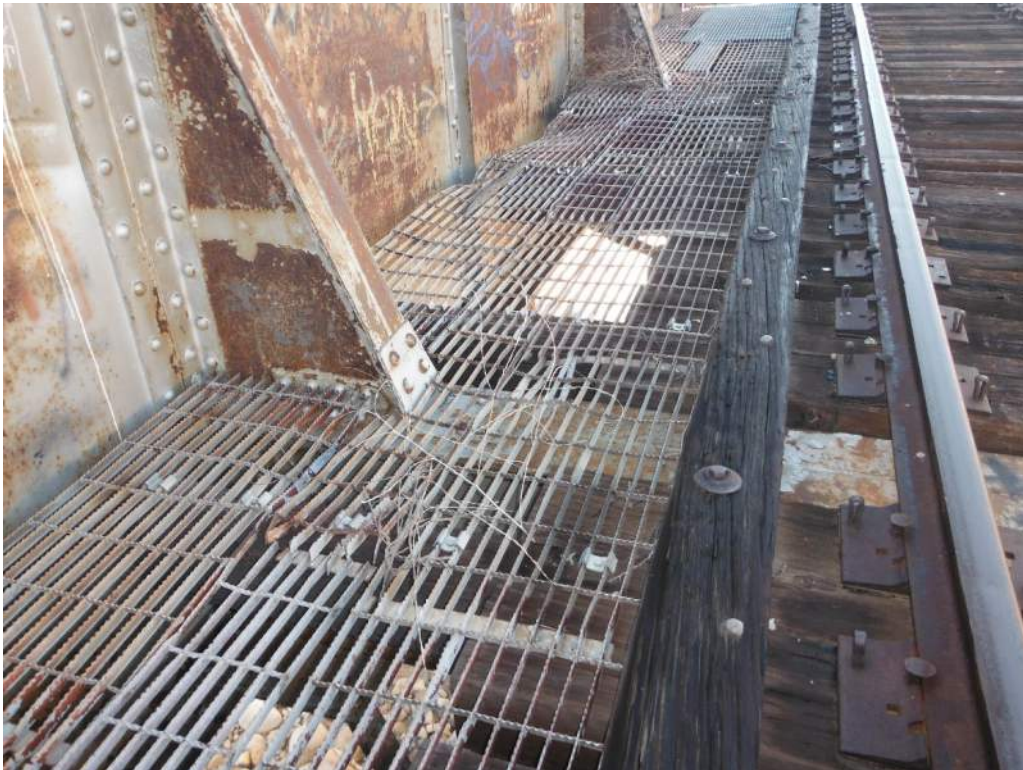
**429.79 South walkway damaged near Pier 2**

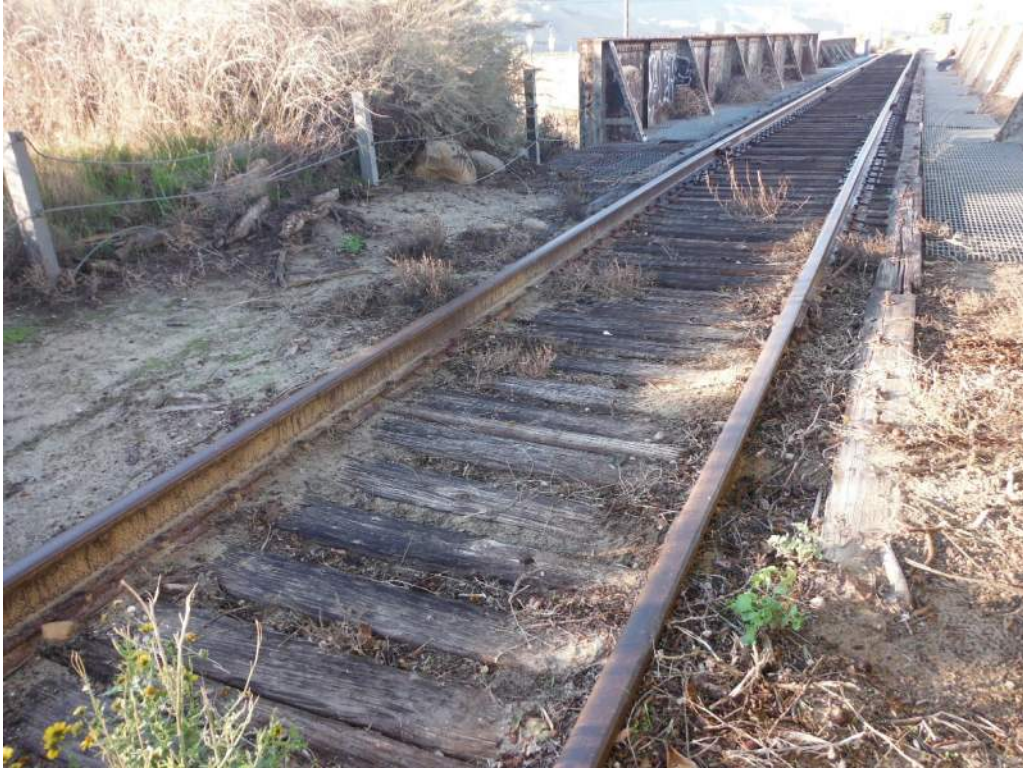
Visual Condition Rating 3  
Bent:          Type          Notes           
Abutment:          Type          Notes           
Wingwalls:          Type          Notes           
Embank          Type          Notes           
Footing          Type          Notes           
Inaccessible areas: Inspection of TPG's only; east timber trestle silted in

**429.79 Timber approach spans fully silted in**

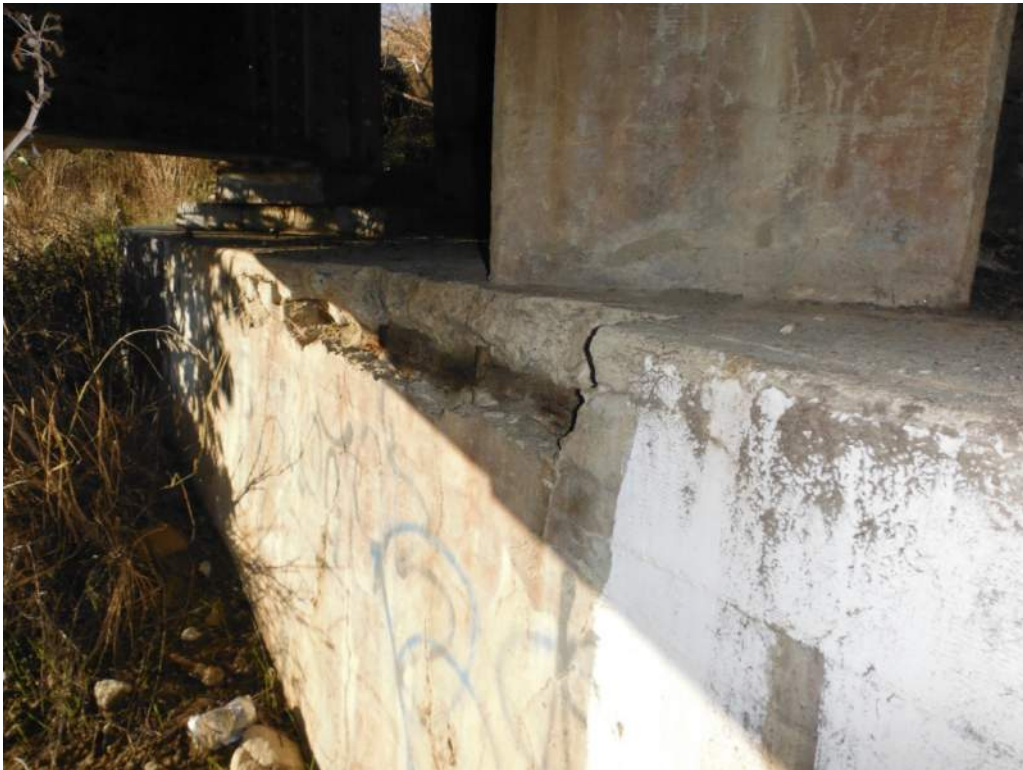
1. Cr - Abutment has minor cracking
2. SP - Spall on abutment - see photo
3. Deb - Damage due to high water debris - see photo
4. AB - Loose anchor bolt, stringer 1 and 2 - see photo
5. Sandy silt buildup on bottom flanges of floor beams

**429.79 Spall - Abutment 1**

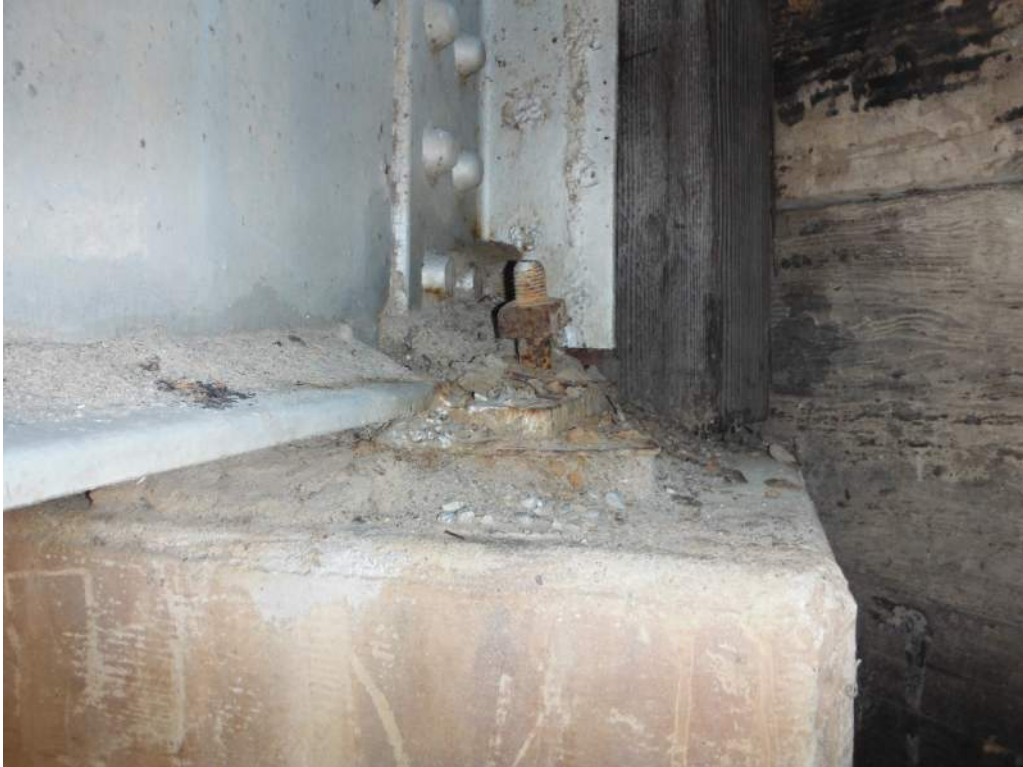
**429.79 Loose anchor bolt – Stringer 1 & 2, Abutment 1**
