# BRIDGE INSPECTION REPORT

INSPECTION TYPE: Annual

Milepost 407.48  
 Location Santa Paula Branch Line  
Saticoy, CA  
 Stream X Overpass        Other         
 Train Operating Speed: Freight: 10 mph Passenger: 15 mph

MAINLINE/SUBDIVISION: VCTC

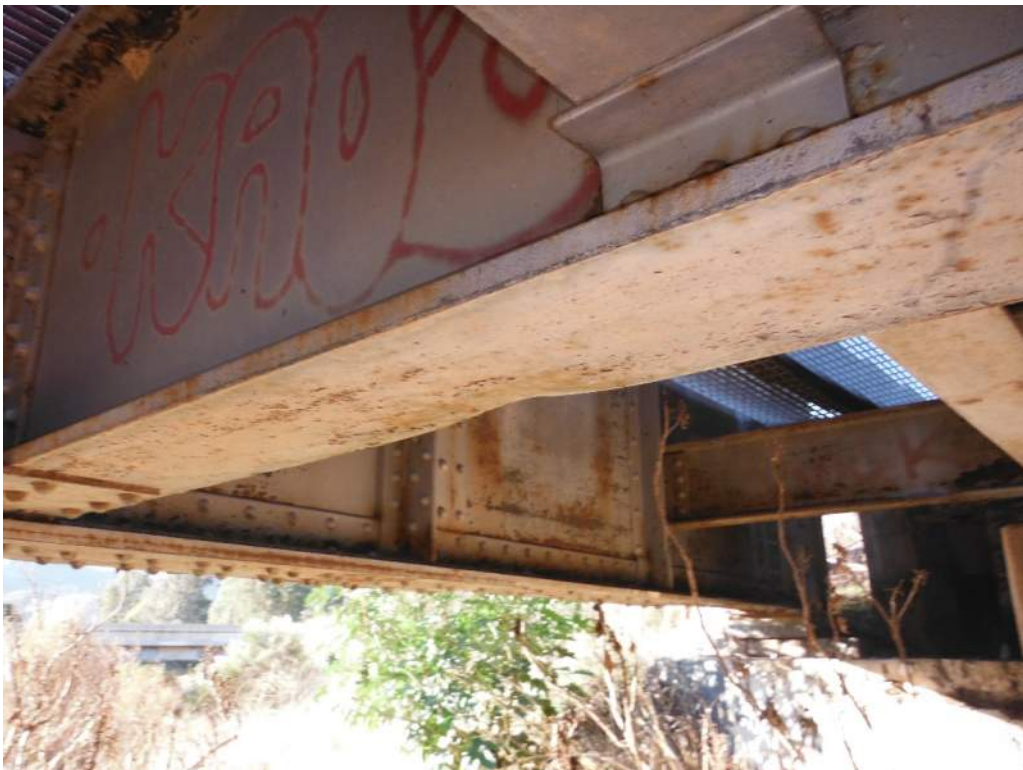
DIVISION	Santa Paula	SPAN LENGTH	70'-0"	NUMBER OF TRACKS	1
CROSSING	Hopper Creek	TRACK ALIGNMENT	Tangent	SPAN No.	1
INSPECTION FINDINGS					
	ALL BEARING AREAS REQUIRE CLEANING				
	North G1 stiffeners have minor impact				
	Impact damage to bottom flange floor beam 1 - see photo				
	Impact damage to bay 5 cross bracing

**429.79 Impact damage to bottom flange floor beam 1 – Span 1**

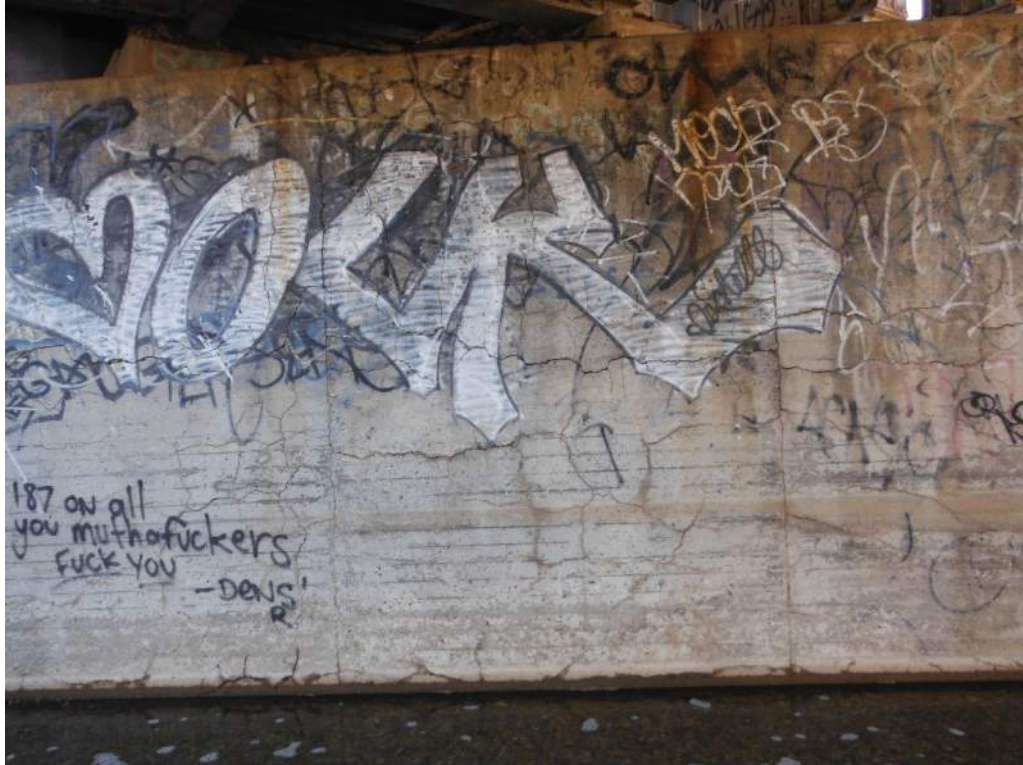
429.79 Typical cracking - Pier 2

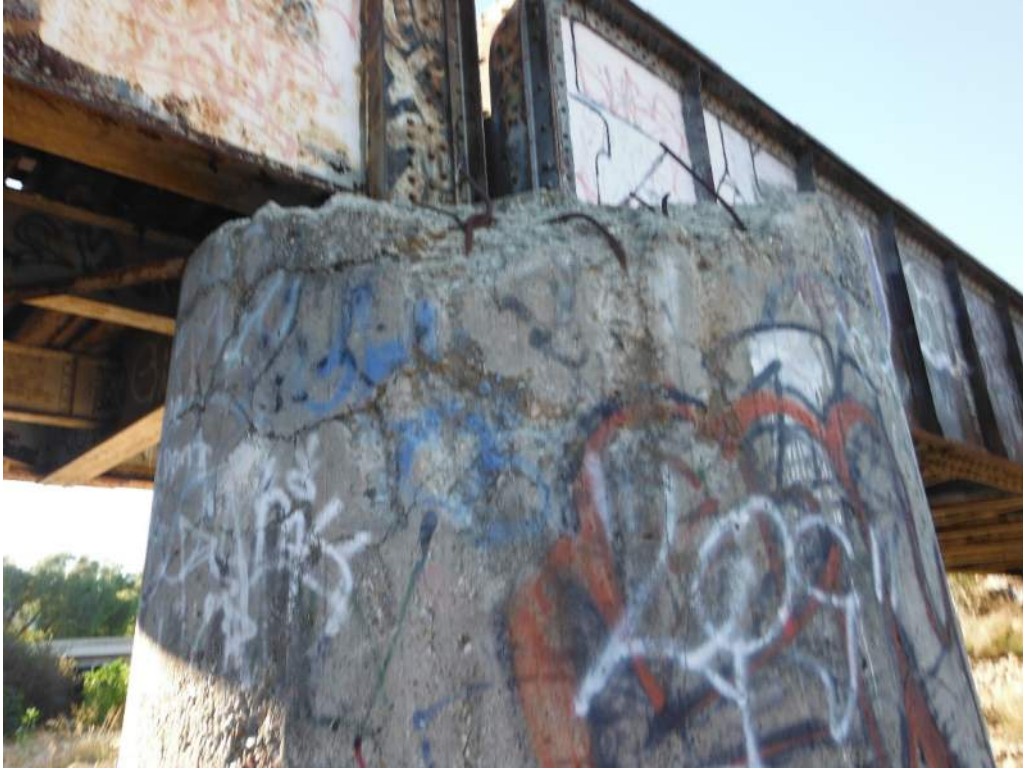
**429.79 Exposed rebar - Pier 2 north side**

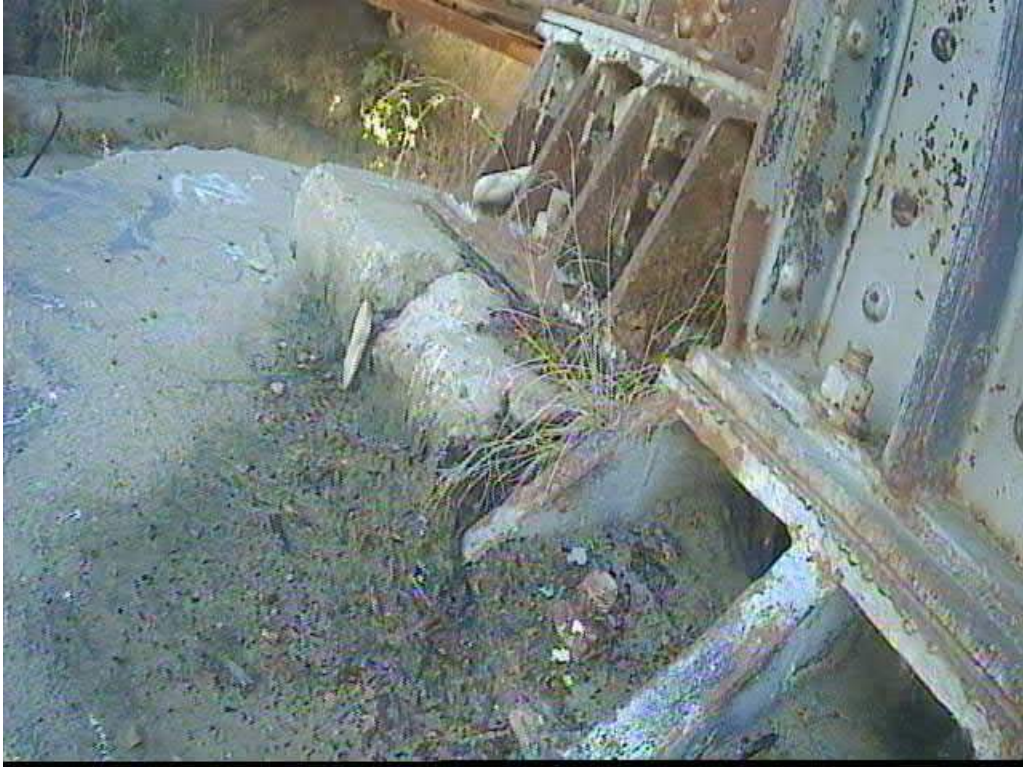
**429.79 Spalling under bearing - Pier 2**

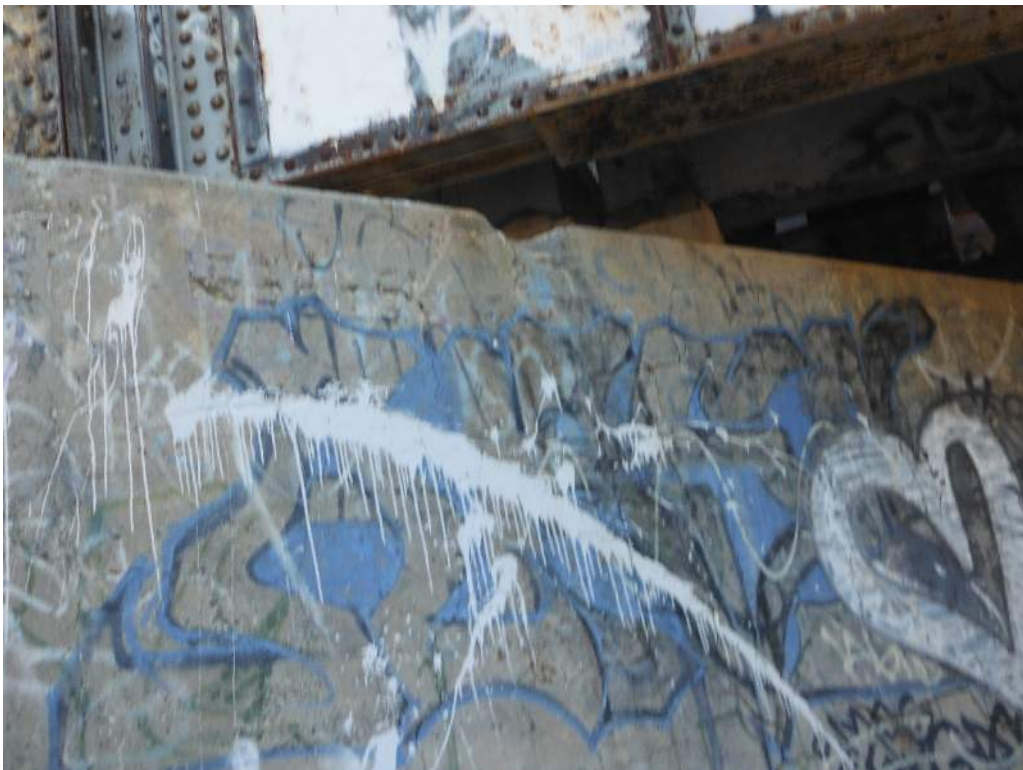
**429.79 Spall under bearing – Pier 2**

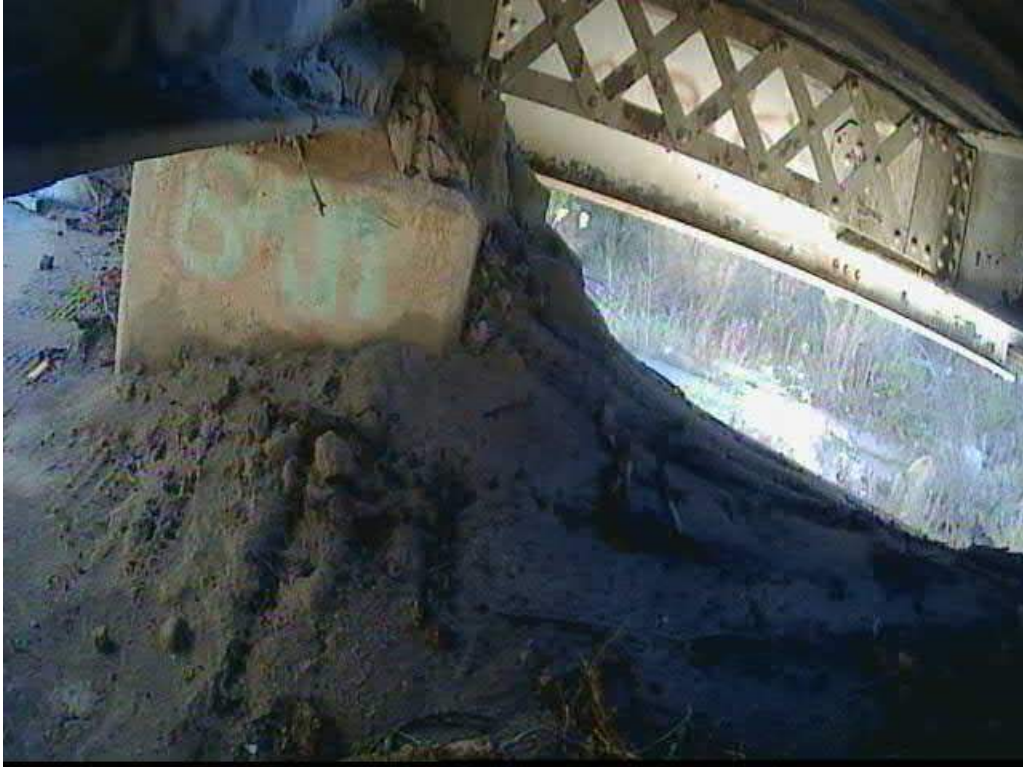
<b>Remarks:</b>	
1. CB - Between thru plate girder, seats are covered with silt from high water at stringers and floorbeam. Needs cleaning around bearings and seat	
2. CB - Some silting outside seat bearing pad	
3. Mi: Minor impact damage to intermediate stiffeners on north side - see photo	
4. Cr: Pier #2 - many horizontal and vertical cracks upstream side due to impact from rocks in stream (see photo)	
5. ER: Pier has exposed rebar on top north end (see photo)	
6. SP - Span #2 bearing seat spall (see photo)	
7. Span #2 floor beam #4 impact damage top flange	
8. Sheared rivet GI mid span - see photo	
9. Stringers #1 and #2 has south loose anchor bolt. Pedestal is cracked	
10. Multiple members have miss punched holes in flanges. See photo	
Inspected By:	Joseph Holste, PE
Date Inspected:	12/13/2019

**429.79 Seats are covered with silt, Pier 2 Bearing**

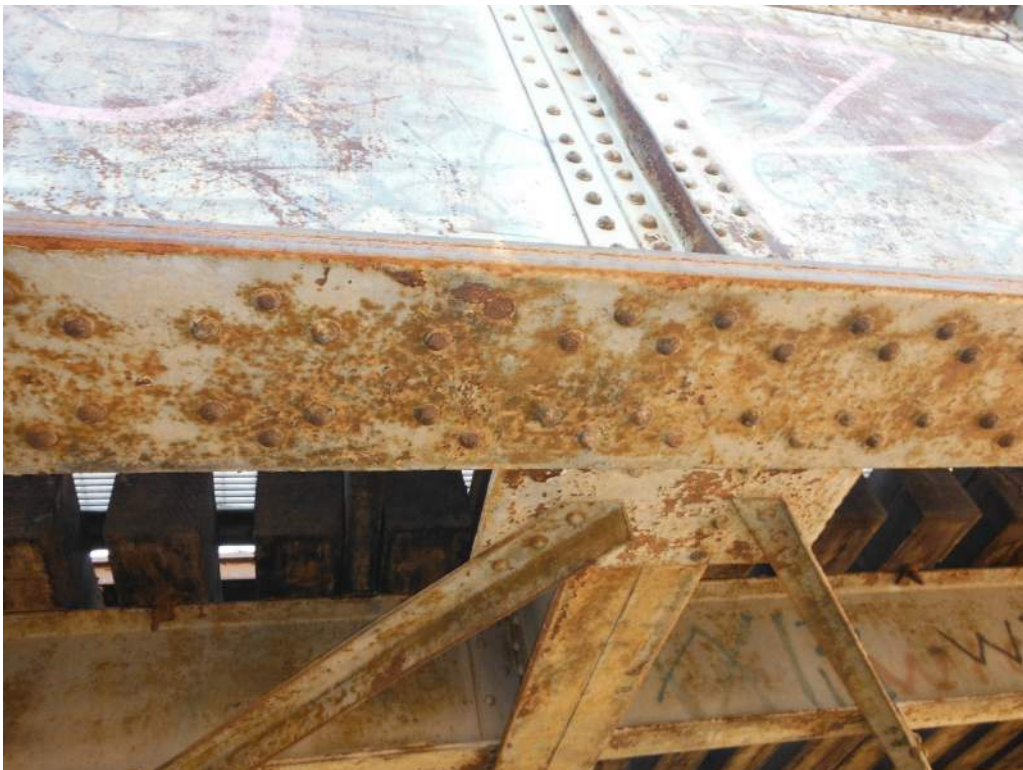
**429.79 Sheared rivet GI mid span, Span 2 at floor beam 3**

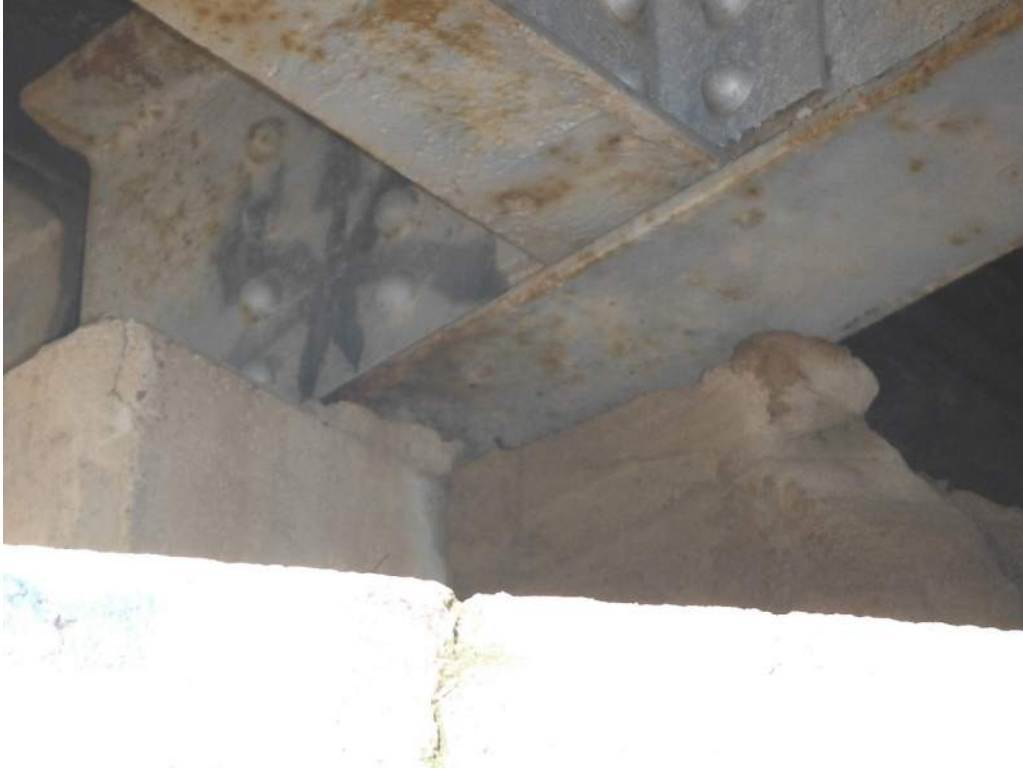
**429.79 Miss punched holes in flanges. Multiple members, Span 2**

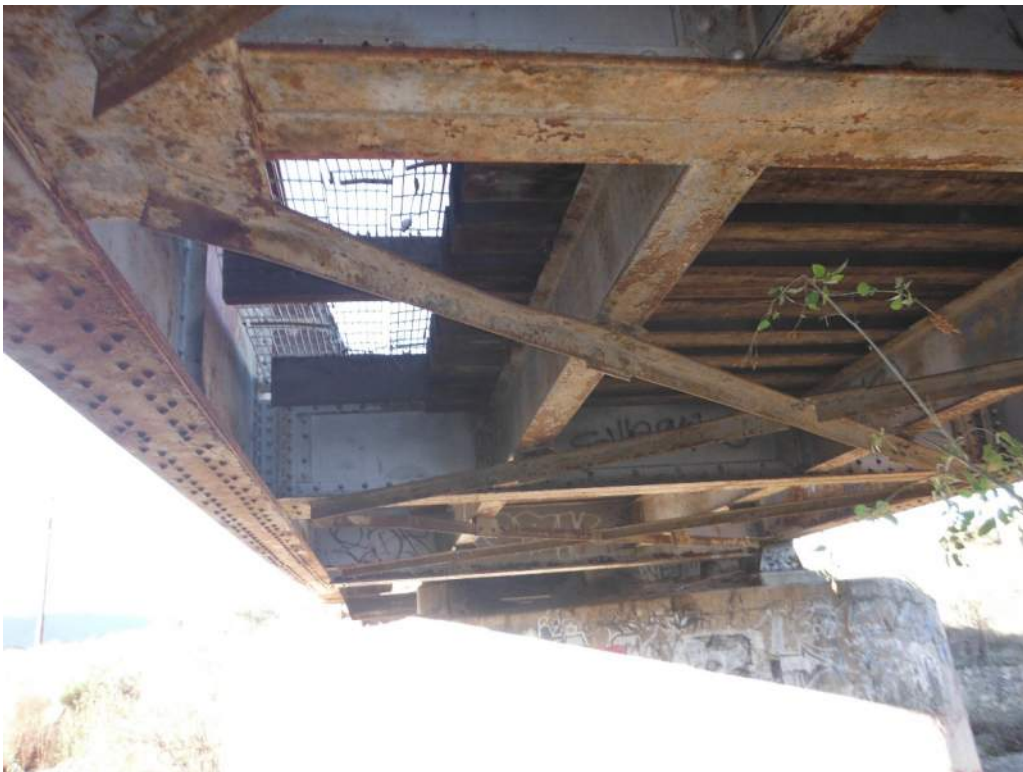
DIVISION	Santa Paula	SPAN LENGTH	82'-0"	NUMBER OF TRACKS	1
CROSSING	Hopper Creek	TRACK ALIGNMENT	Tangent	SPAN No.	2
INSPECTION FINDINGS					
Mi	Lower cross bracing has minor impact throughout - see photo				
	Impact damage to bay 1 crossbracing

**429.79 Lower cross bracing has minor impact throughout**

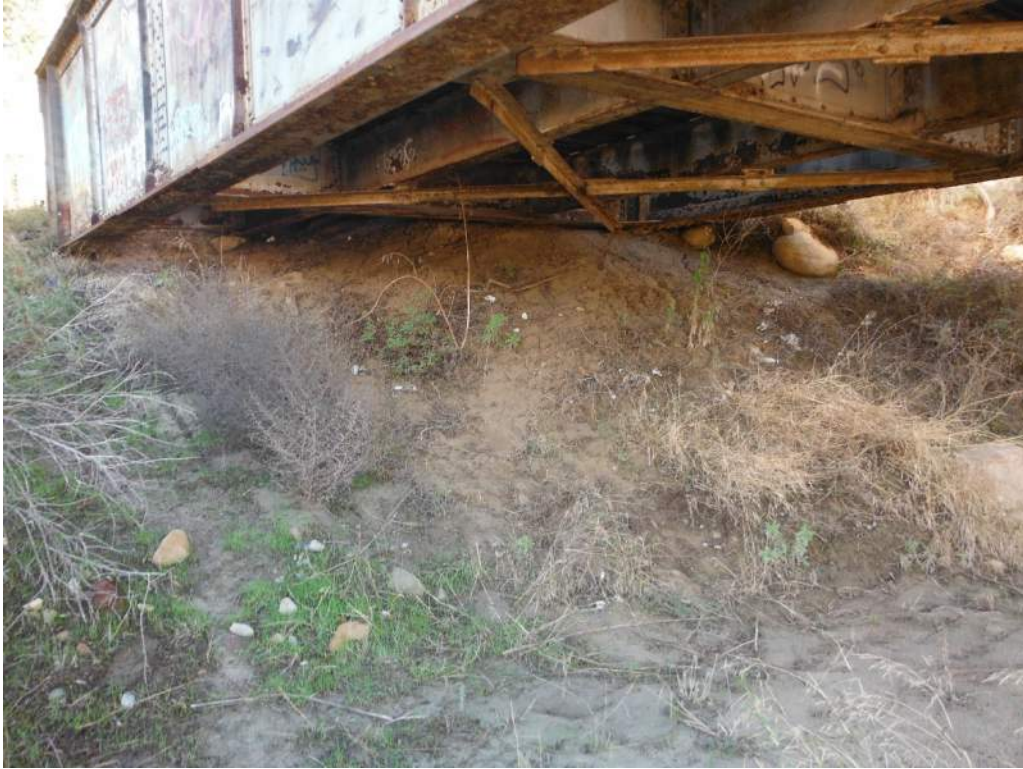
**429.79 Abutment 3 – buried**
