Ventura County Transportation Commission (VCTC)

Santa Paula Branch Line (SPBL) Track Assessment Report

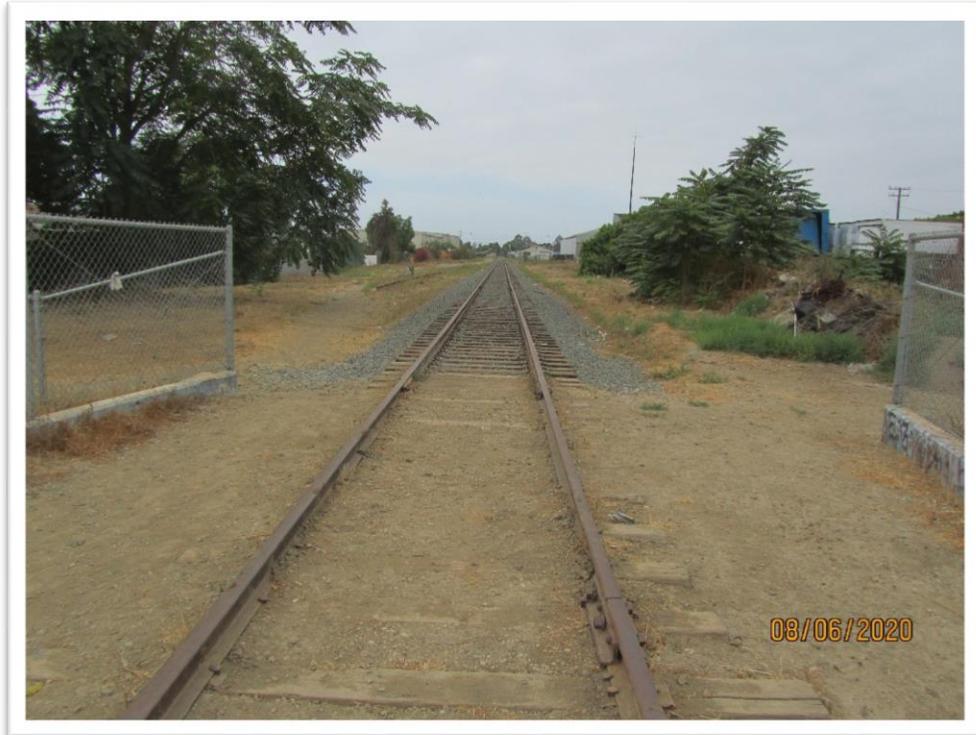
Image 3. MP 407.79 Ballast Limits.

Approximately 50% of the remaining SPBL between MP 407.79 to MP 429.23 consists of alluvial rock rounded in shape, with no angular edges present, poorly graded on top of a weak subgrade as shown in Figure 3. Over most of the site the ballast rock is fouled with dirt and fine soils.

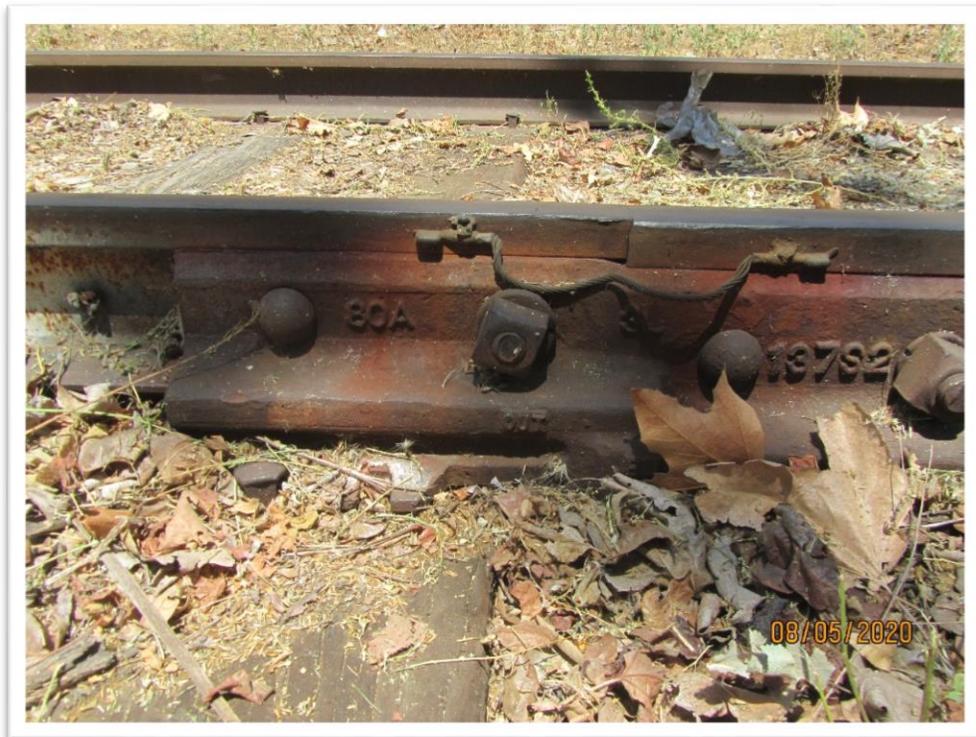
Image 15. Rail joint matching rail sizes, MP 408.0

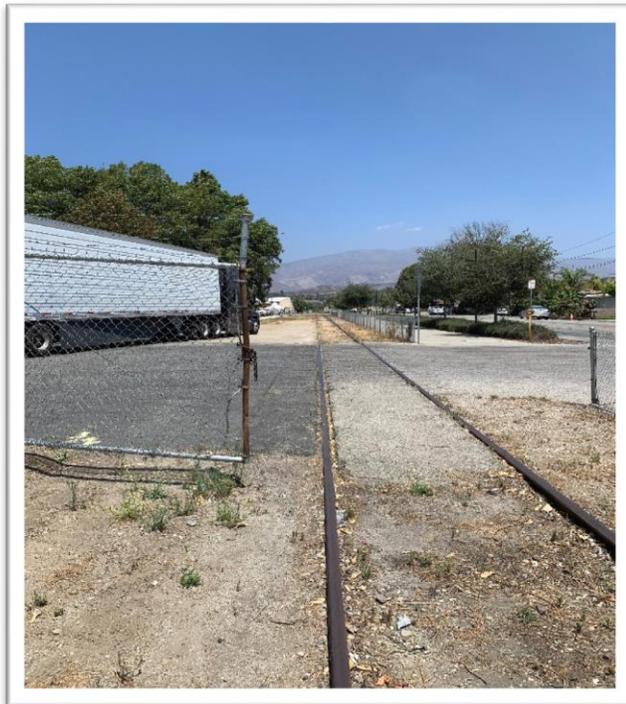
Image 37. MP 413.02 Private At-Grade Crossing.

An open gate was observed fouling the tracks at the Private At-Grade Crossing at MP 413.02. It is recommended to advise any adjacent owners they are not allowed to place objects within four feet of the nearest rail.

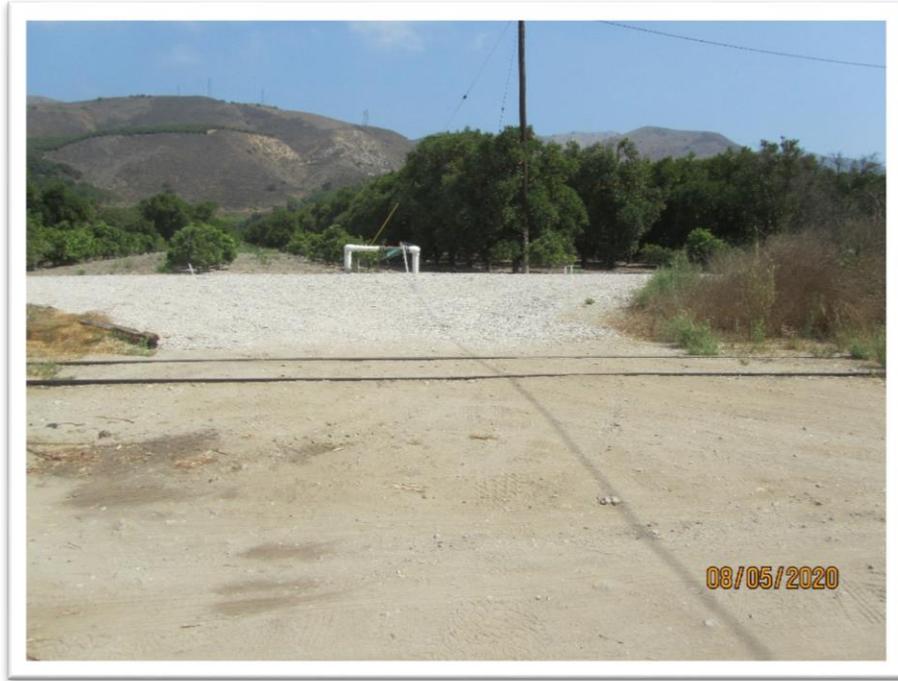
Image 88. MP 426.50 Private At-Grade Crossing.

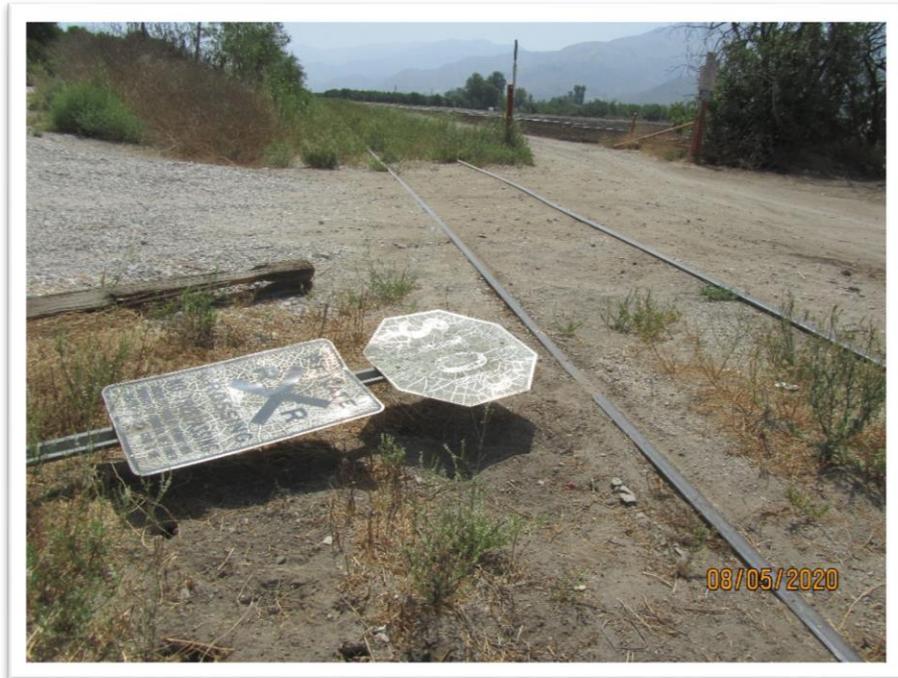
Image 89. MP 426.95 Private At-Grade Crossing.

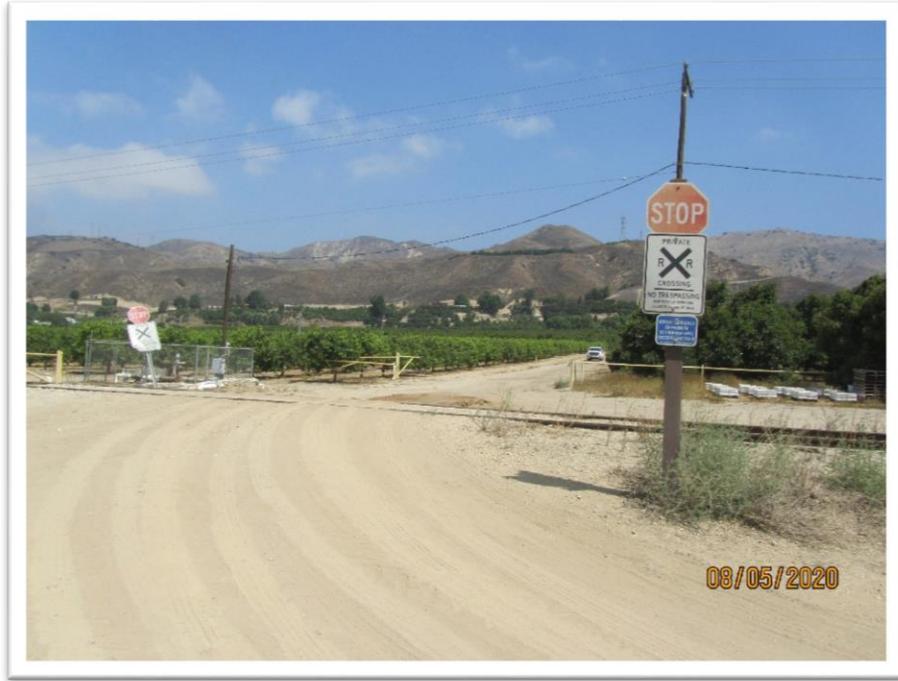
Image 90. MP 427.28 Private At-Grade Crossing.

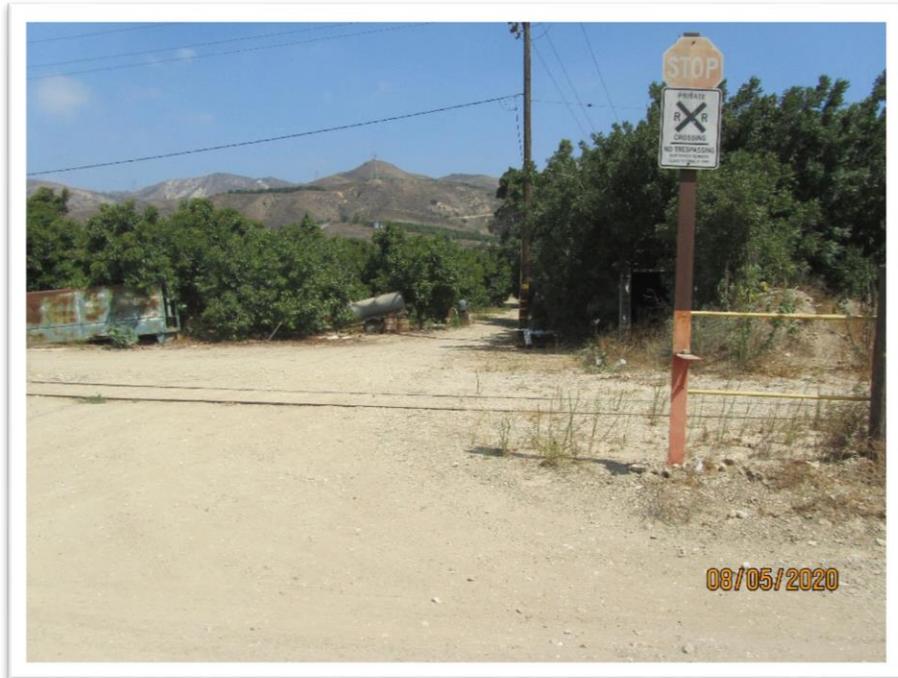
Image 91. MP 427.40 Private At-Grade Crossing.

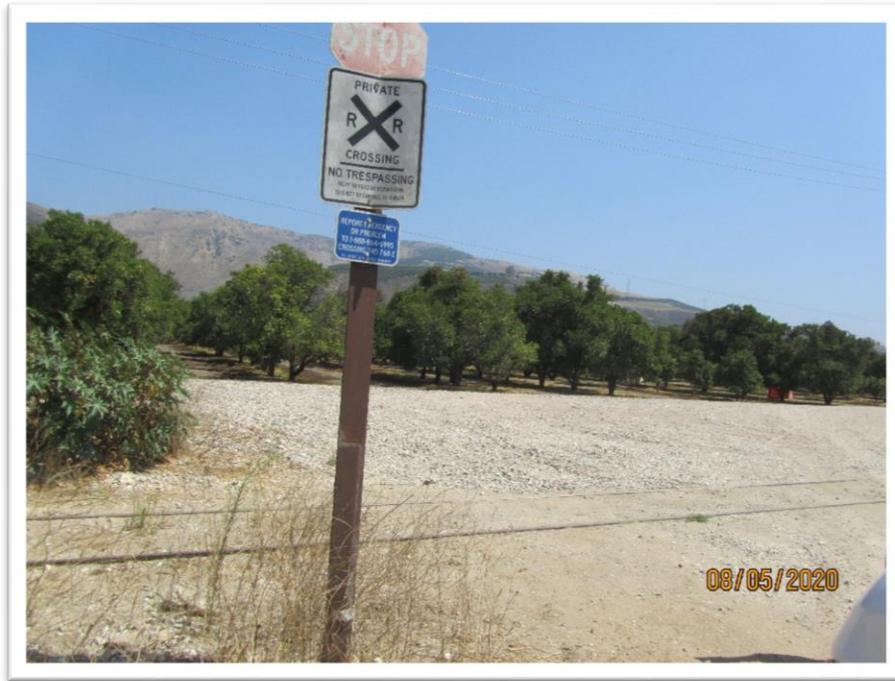
Image 92. MP 427.42 Private At-Grade Crossing.

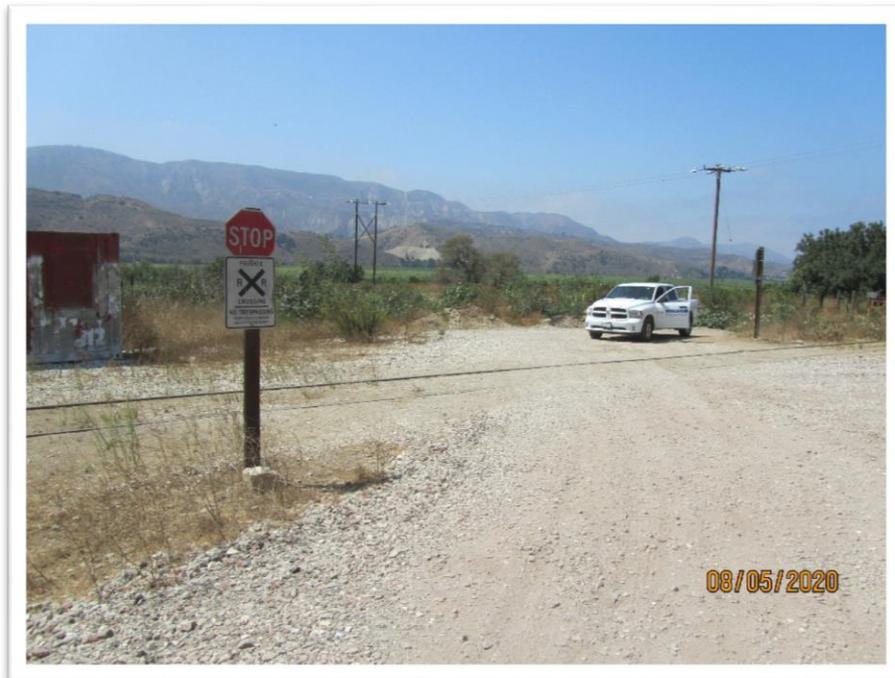
Image 93. MP 427.65 Private At-Grade Crossing.

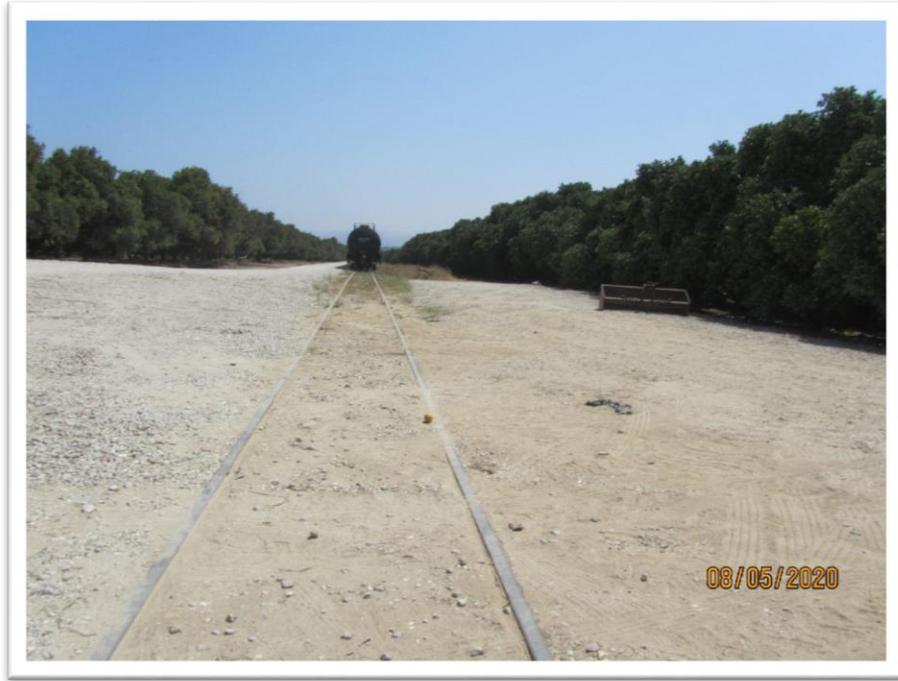
Image 94. MP 427.80 Private At-Grade Crossing.

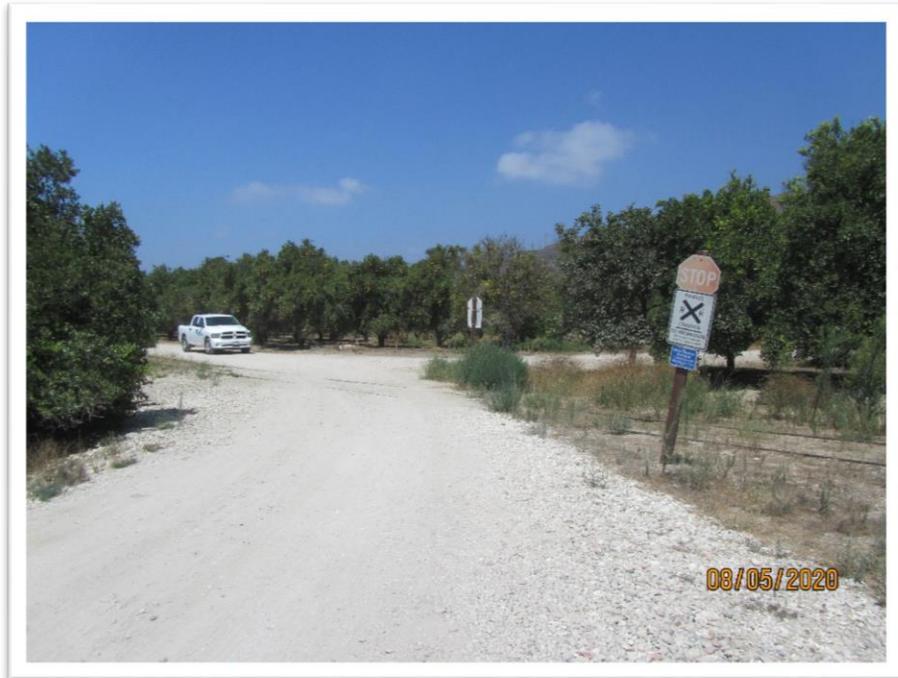
Image 95. MP 428.20 Lawton Ranch Road Private At-Grade Crossing.

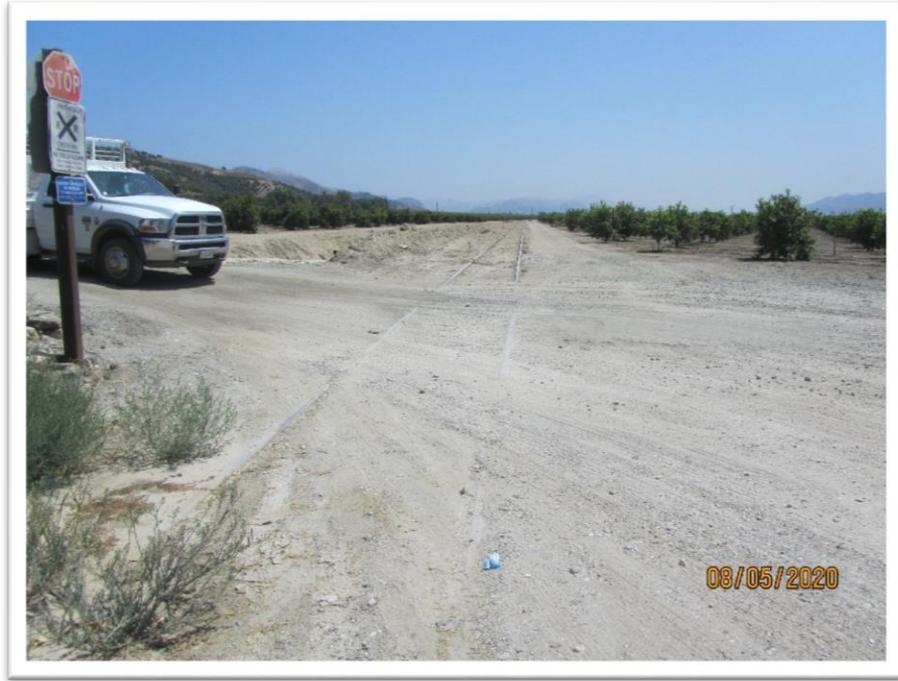
Image 96. MP 428.30 Cavin Road At-Grade Crossing.

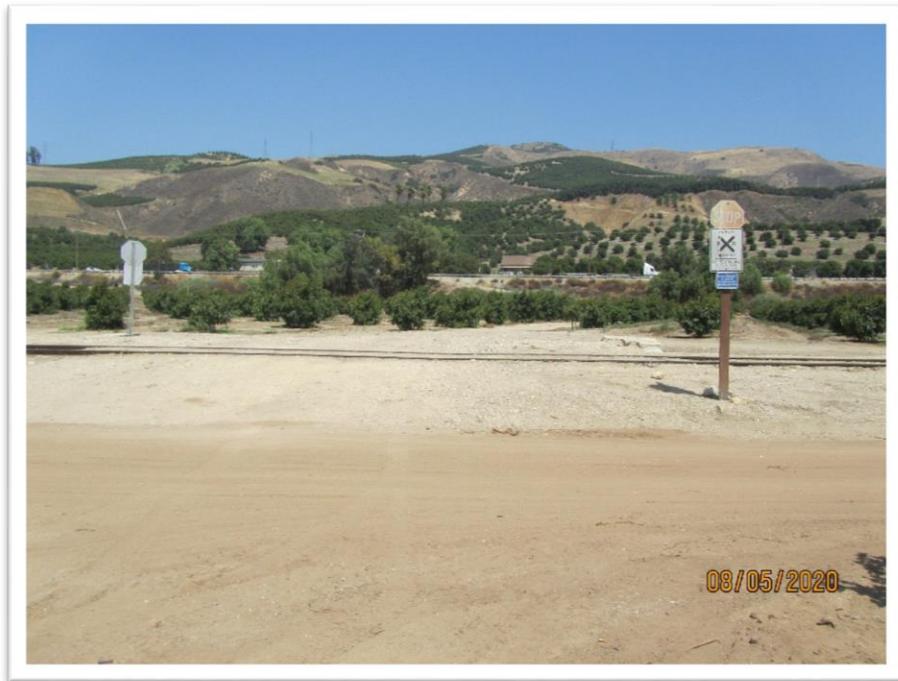
Image 97. MP 428.40 Private At-Grade Crossing.

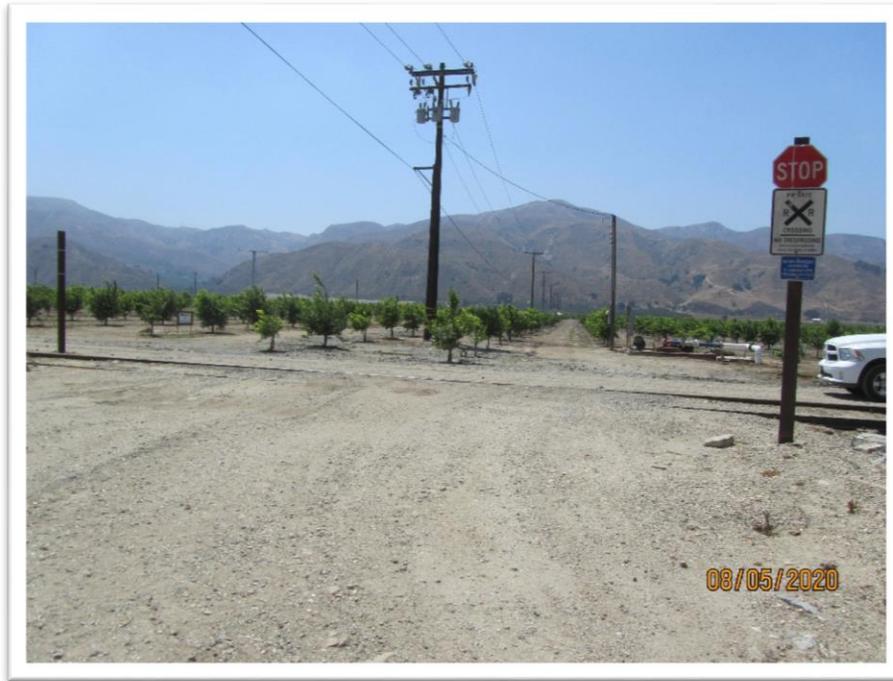
Image 98. MP 428.61 Private At-Grade Crossing.

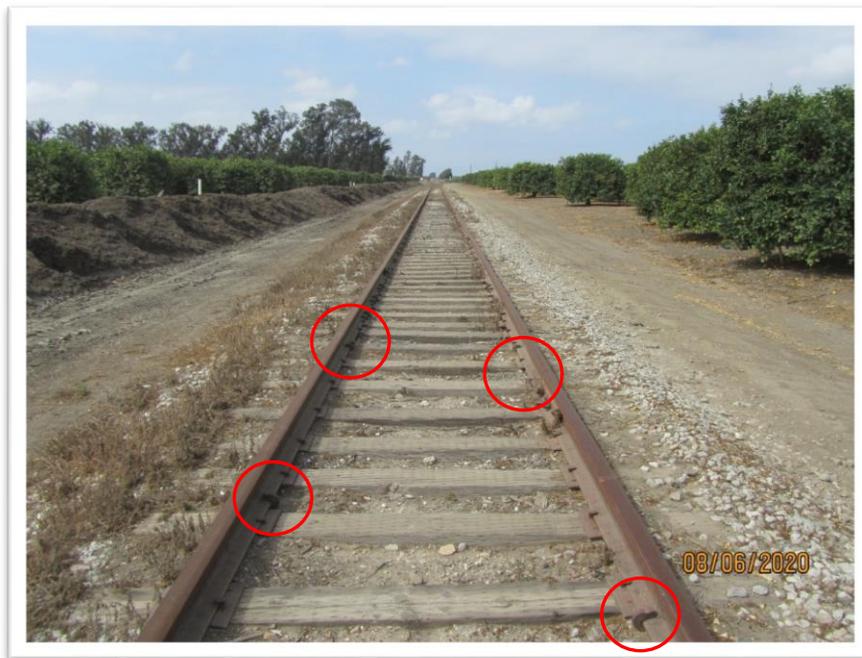
For industrial tracks it is recommended to install rail anchorage at a minimum rate of 16 anchors per 39 feet of rail. Rail anchors found along the SPBL were in acceptable condition.

Image 100. Anchors.
